National Register of Historic Places Registration Form

historic name John, David, House

street & number 103 South 23rd Street [n/a] not for publication

SUMMARY: The David John House, 103 S. 23rd St., Lexington, Lafayette County, is a one-story red brick residence constructed in a traditional, double-pen plan with historic frame additions. The form of the David John House exemplifies vernacular efforts to convey a prevailing style, in this case Greek Revival (see "Historic Resources of Lexington, Missouri (Partial Inventory: Historic and Architectural Properties): Associated Property Types: Greek Revival Buildings"). The David John House was built in circa 1848.¹ Greek Revival styling is minimal but such elements as cornice returns (suggestive of pediments), dentil bands in the porches and formal balance point in that direction, considering the time and place of the house's construction. The house and a circa 1930s privy occupy a corner lot in a residential neighborhood in the oldest part of Lexington.

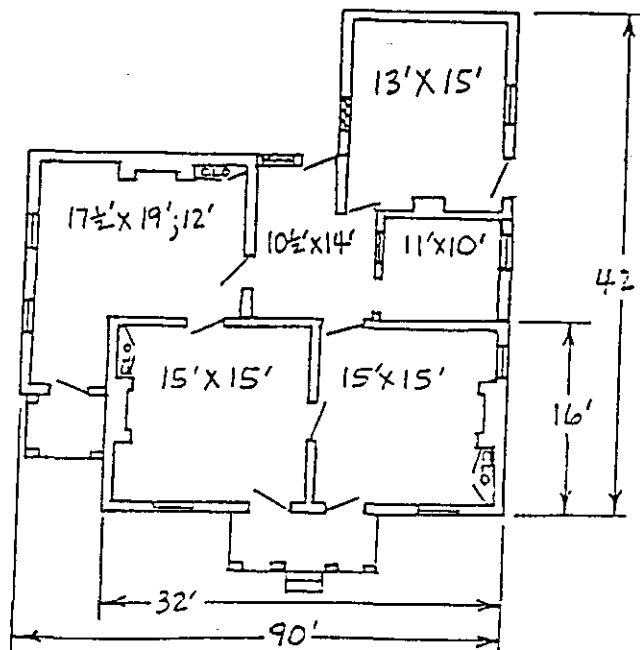
First Floor Plan

NARRATIVE: The floor plan of the approximately 32 feet wide by 16 feet deep core structure consists of two essentially identical, side-by-side square rooms with individual front doors. Two and three header courses are found in the lower portions of the walls, but the balance of the soft red brick is laid in stretcher bond. The primary elevation faces east. The house rests on its original foundation of brick.

On the interior, enframements are plain flat boards but architraves are pediment shaped. Pilaster mantels in the two rooms in the core structure have wide, arched friezes which accommodate cast iron inserts for burning coal. These rooms are square. Their dimensions are 15 feet by 15 feet. In addition to a doorway between them and doors to the outside, each core structure room also has a doorway at the rear leading into the additions.

There are two interior end chimneys in the core structure. On the north end, the chimney has been shortened but the south chimney is of shaped masonry. Behind the front block of the David John House, additions with weatherboard and board-and-batten siding provide four additional small rooms. The oldest addition, on the southwest, probably dates from circa 1900. The other additions are also old but appear to have been constructed after 1900. Primary roofs are gabled.

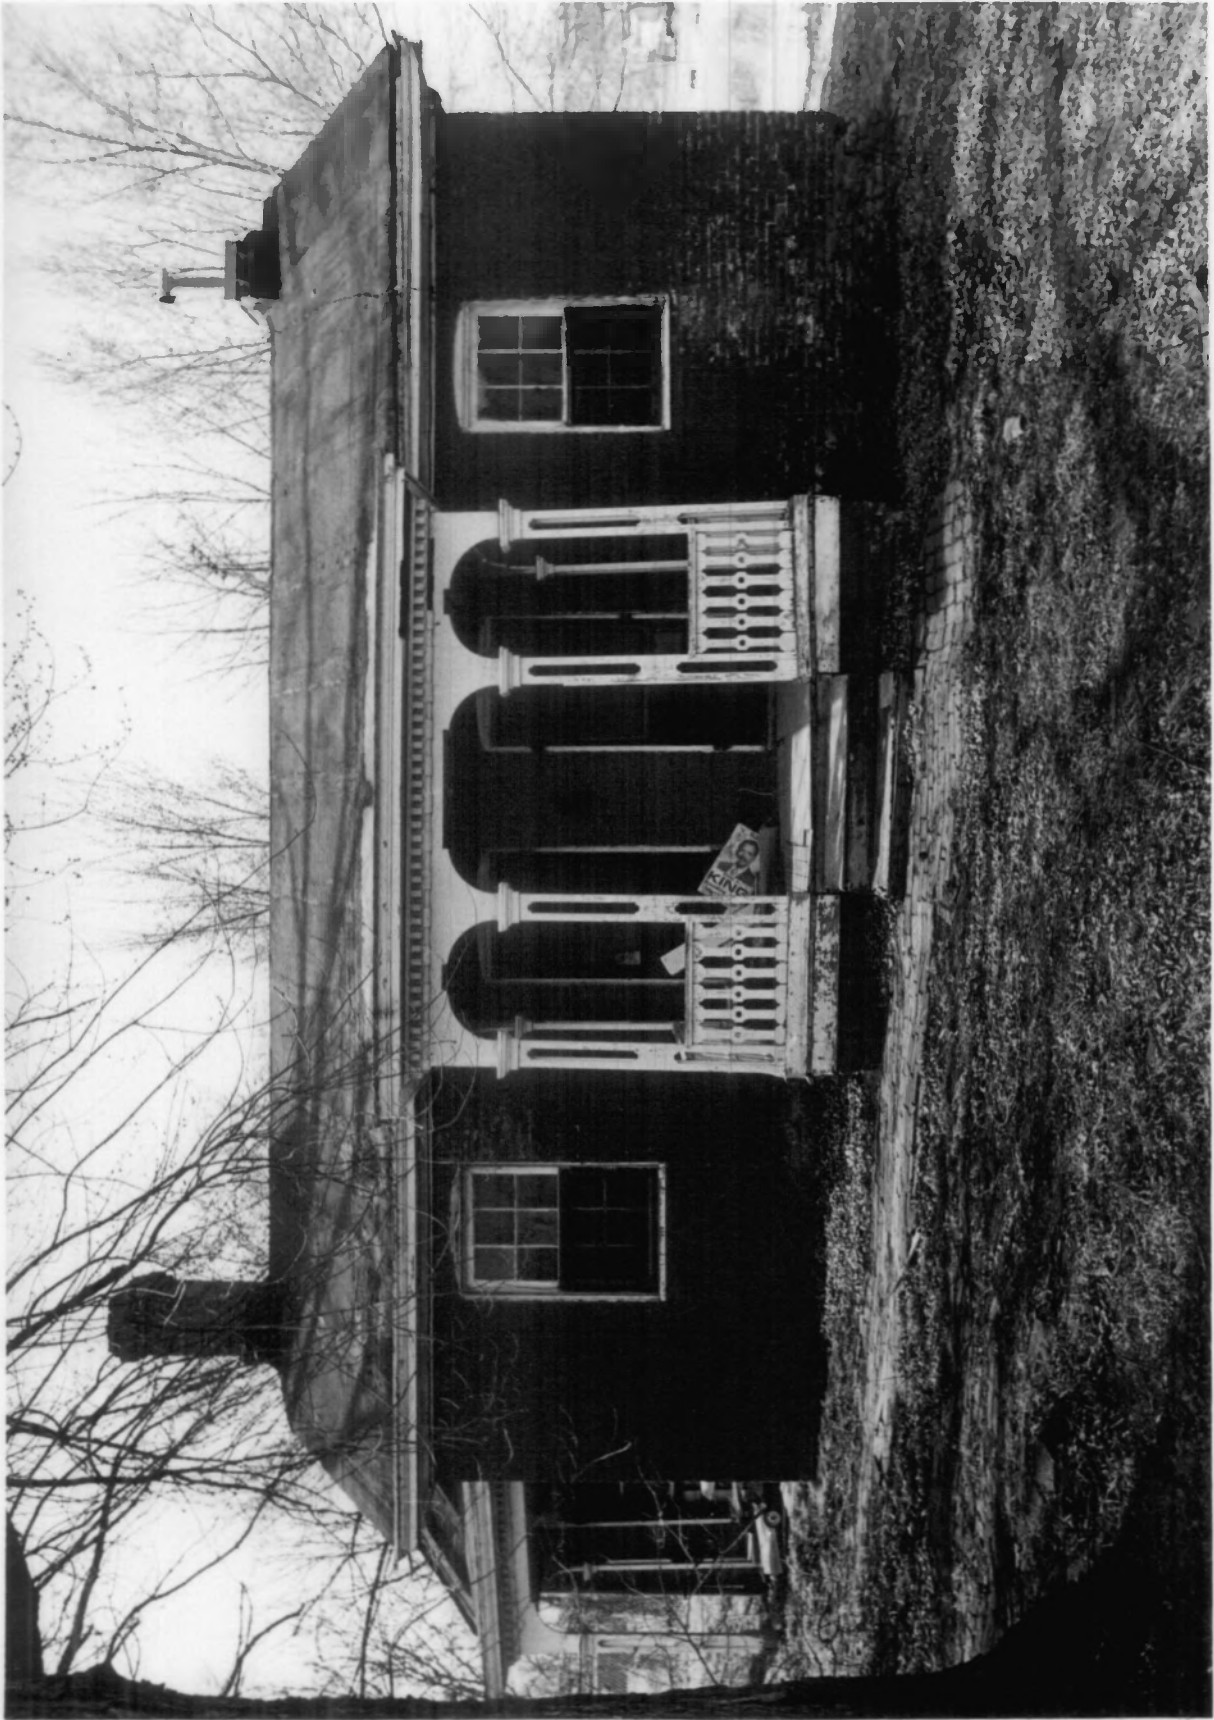
- #1: View from east
March 1991
1 of 9
- #2: View from northeast
March 1991
2 of 9
- #3: View from southeast
March 1991
3 of 9
- #4: View from southwest
March 1991
4 of 9
- #5: Porch detail, view from northeast
March 1991
5 of 9
- #6: View of north pen, facing south
May 1991
6 of 9
- #7: Mantel in north pen, facing north
May 1991
7 of 9
- #8: South rear room, facing east
May 1991
8 of 9
- #9: Mantel in south pen, facing south
May 1991
9 of 9

Fenestration in the main elevation of the core structure consists of two windows flanking two central but separate entrances. The openings have slightly rounded segmental arches of brick which typify construction techniques of German craftsmen. Most windows are double-hung 6/6s, an appropriate Greek Revival form. With the exception of those in the primary elevation, window and door openings have flat arches. Front doors are an old, paneled type.
