1. Survey number: JP-AS-006-001		2. Survey Name: East Town (Original Joplin) Historic Survey Phase 1	
3. County: JASPER		4. Address 503	Street (name): E. Broadway Street
5. City: Joplin	Vicinity <input type="checkbox"/>	7. Township/Range/Section: T: R: S:	
8. Historic name (if known):		9. Present/other name (if known):	
10. Ownership: <input checked="" type="checkbox"/> Private <input type="checkbox"/> Public		11a. Historic use (if known): Domestic/Single Dwelling	11b. Current use: Domestic/Single Dwelling

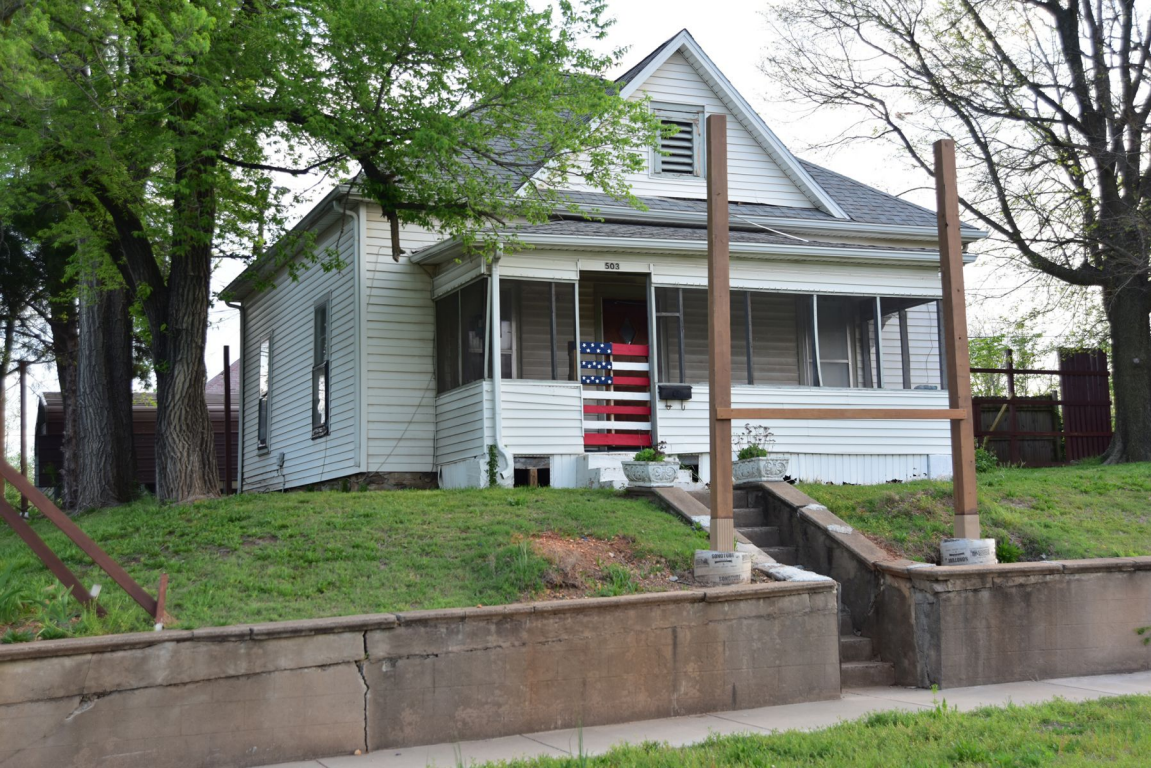
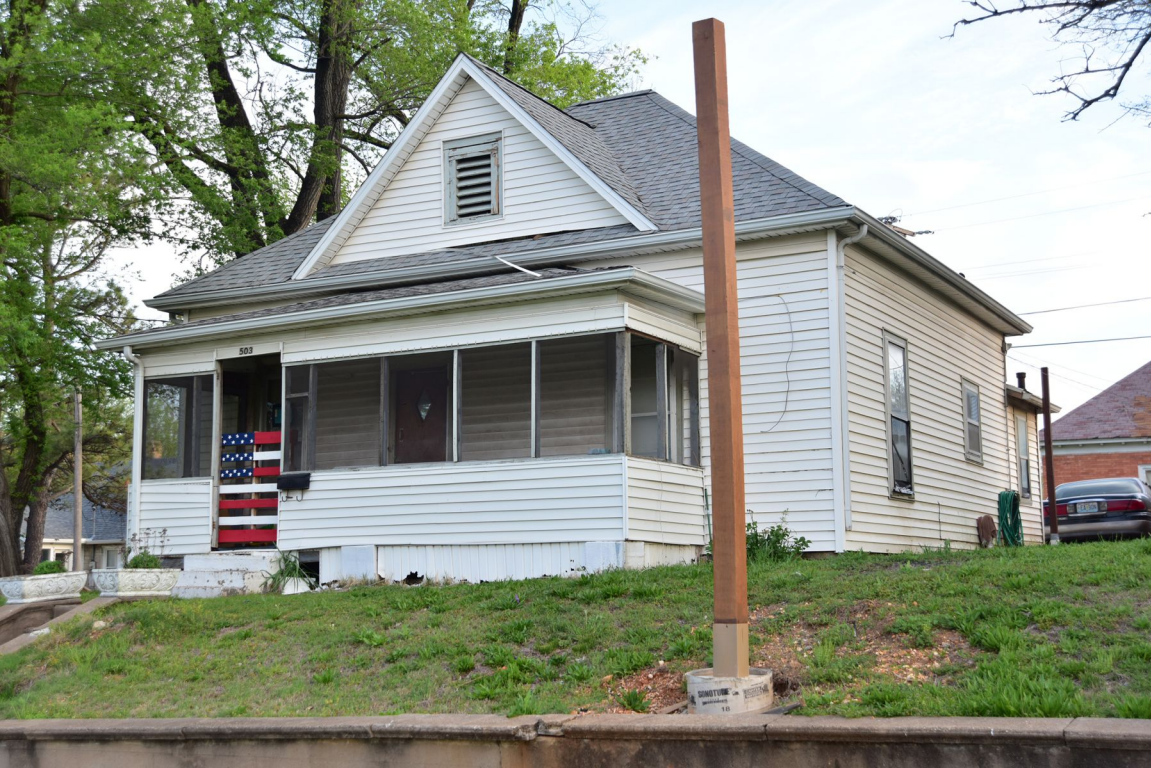
This one-story house faces south and sits on a corner lot. It has a stone foundation and a steeply-pitched truncated hipped roof with asphalt shingles. The exterior is clad with vinyl siding. A historic porch spans the south façade. The porch is enclosed with non-historic vinyl-clad kneewalls and wood-framed screens. The south façade has three bays. The west bay contains a non-historic door. The center bay contains a mid-twentieth-century wood door with diamond-shaped light. The east bay contains a non-historic one-over-one metal window. A front-gabled dormer rises from the south pitch of the roof and contains a wood attic vent and vinyl cladding.

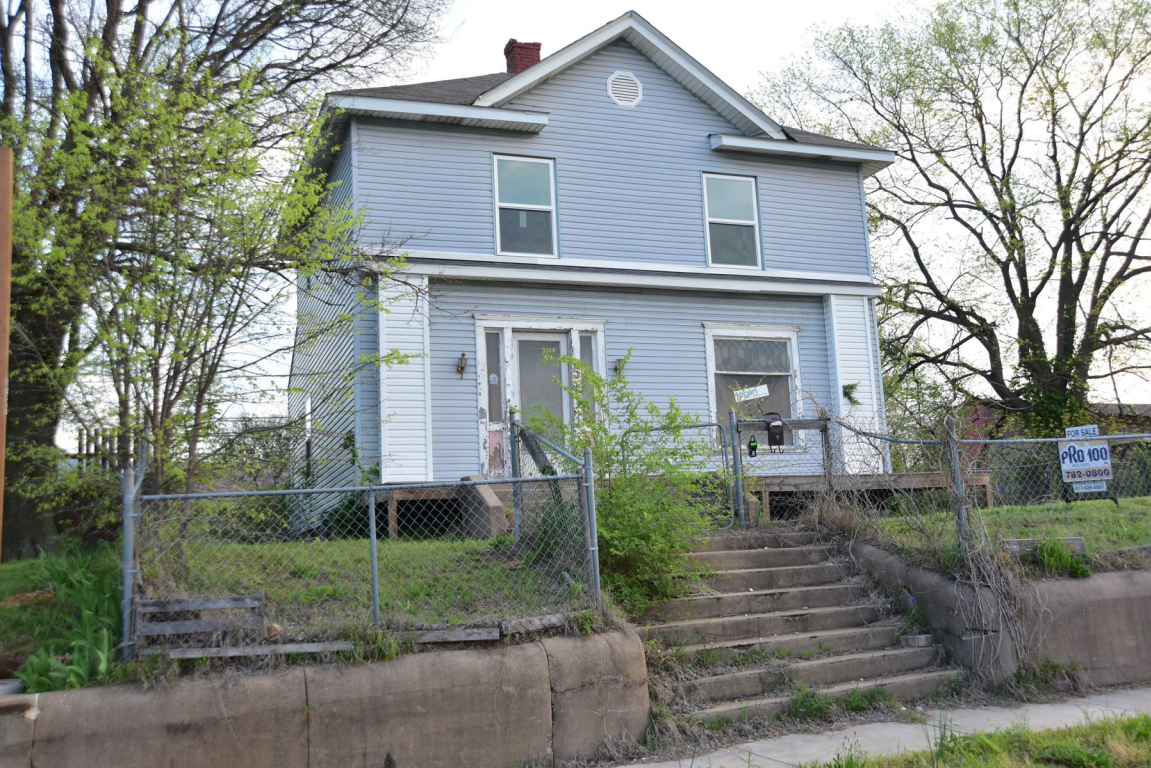
This two-story American Foursquare type house faces south. It has a stone foundation and a hipped roof with asphalt shingles and a front-gabled gablet in the center of the south slope. A brick chimney rises from the north slope. The exterior is clad with vinyl siding. A non-historic full-width wood deck fronts the south façade where a historic one-story porch has been removed. The first floor of the south façade has two bays. The west bay contains a historic wood door with a large glazed panel flanked by thin sidelights with historic wood trim. The east bay contains a historic double-hung wood window with historic wood trim. The upper sash has multiple lights with muntins in a geometric pattern. The lower sash has one light. Vinyl-clad piers flank the first-floor bays. The second floor of the south façade has two bays. Each contains a non-historic one-over-one vinyl window. A non-historic octagonal vinyl attic vent pierces the wall under the gablet.

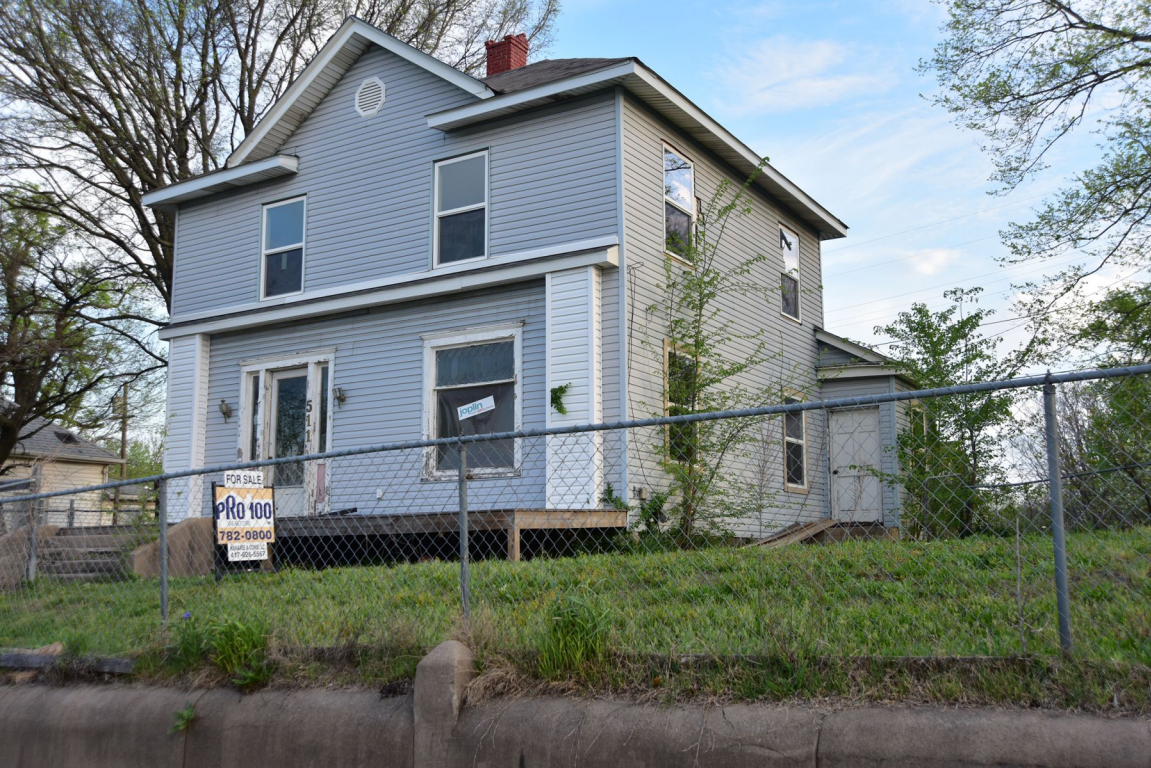
The dwelling faces south on E. Broadway street, a commercial thoroughfare, and is located in the southwest portion of the Survey Area. It sits on an 87x100 feet lot. A grass lawn surrounds the property. A concrete sidewalk and a public bus stop abut the south edge of the property. A gravel east-west alley abuts the north edge of the property. The front lawn is bound with a chain-link fence. A concrete retaining wall with concrete steps leading to the house bounds the south edge of the property. No outbuildings were observed.

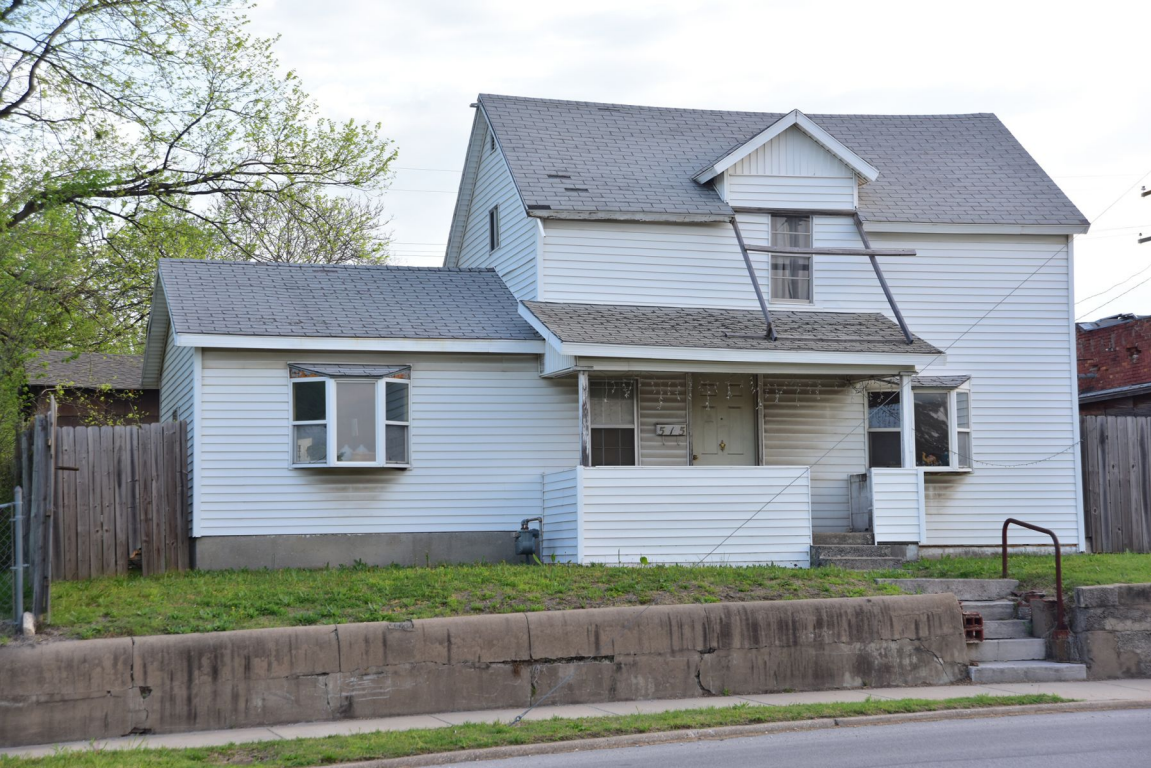
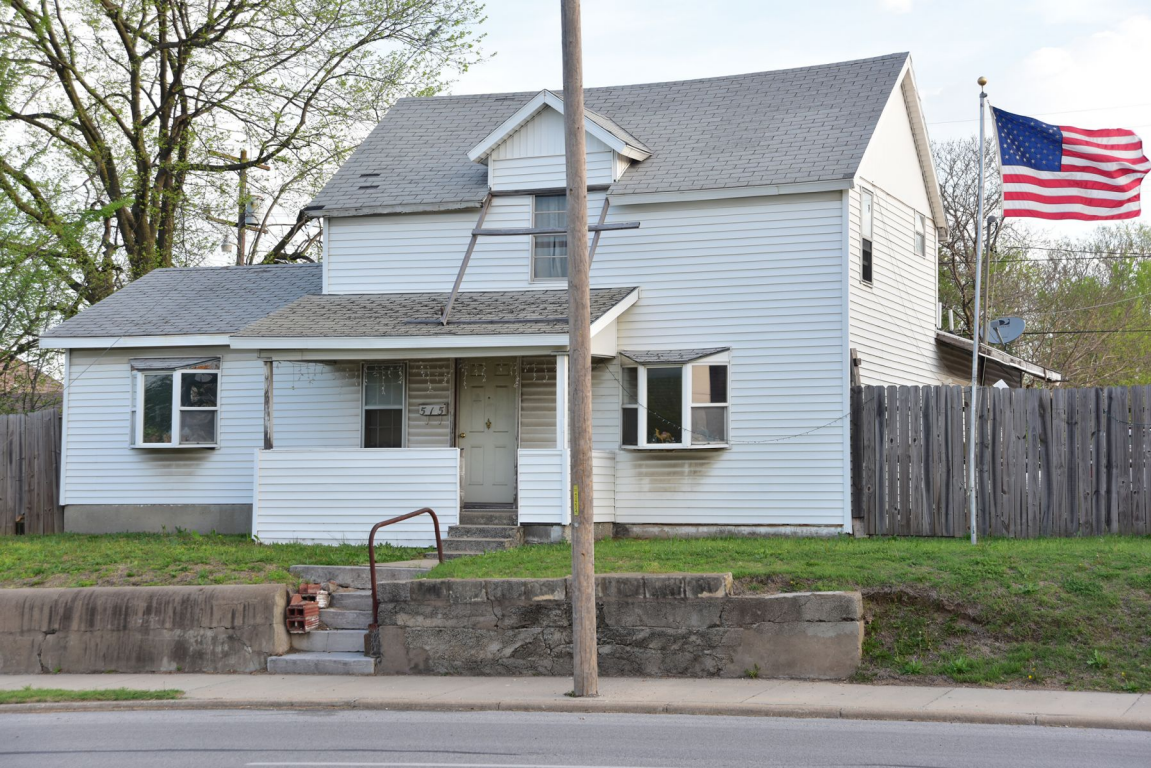
This two-story National Folk house faces south. It has a parged foundation and a side-gabled roof with asphalt shingles and a front-gabled gablet in the center of the south slope. The exterior is clad with vinyl siding. A one-story, partial-width porch spans the west half of the south façade. The porch has a shed roof with asphalt shingles and a non-historic concrete foundation with vinyl-clad kneewalls and non-historic wood posts. The first floor of the south façade has three bays. The west and center bays are sheltered under the porch. The west bay contains a non-historic six-over-six wood window. The center bay contains a non-historic fiberglass door. The east bay contains a non-historic vinyl bay window containing a fixed one-light sash flanked with one-over-one sash. The second floor of the south façade has one centered bay containing a non-historic two-over-two metal window. A non-historic one-story addition is attached to the west elevation and flush with the south façade. It has a poured concrete foundation, vinyl siding, and a side-gabled roof. The south elevation of the addition has a centered bay containing a non-historic vinyl bay window.

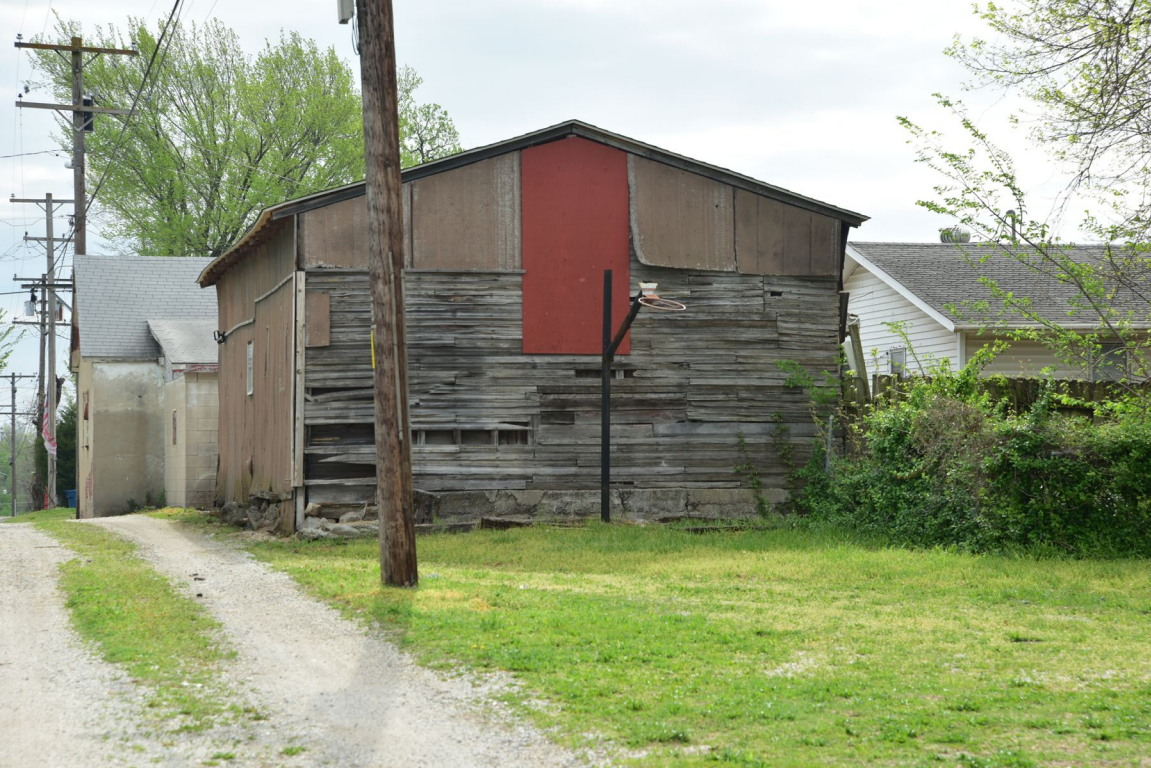
A historic outbuilding constructed circa 1900 sits at the rear of the dwelling. The one-story outbuilding has a parged stone foundation, a wood frame structure with historic wood clapboard siding, and a front-gabled roof. The historic wood siding is exposed on the east and west elevations and covered with deteriorating non-historic wood panel siding on the other elevations. An entrance was not observed.

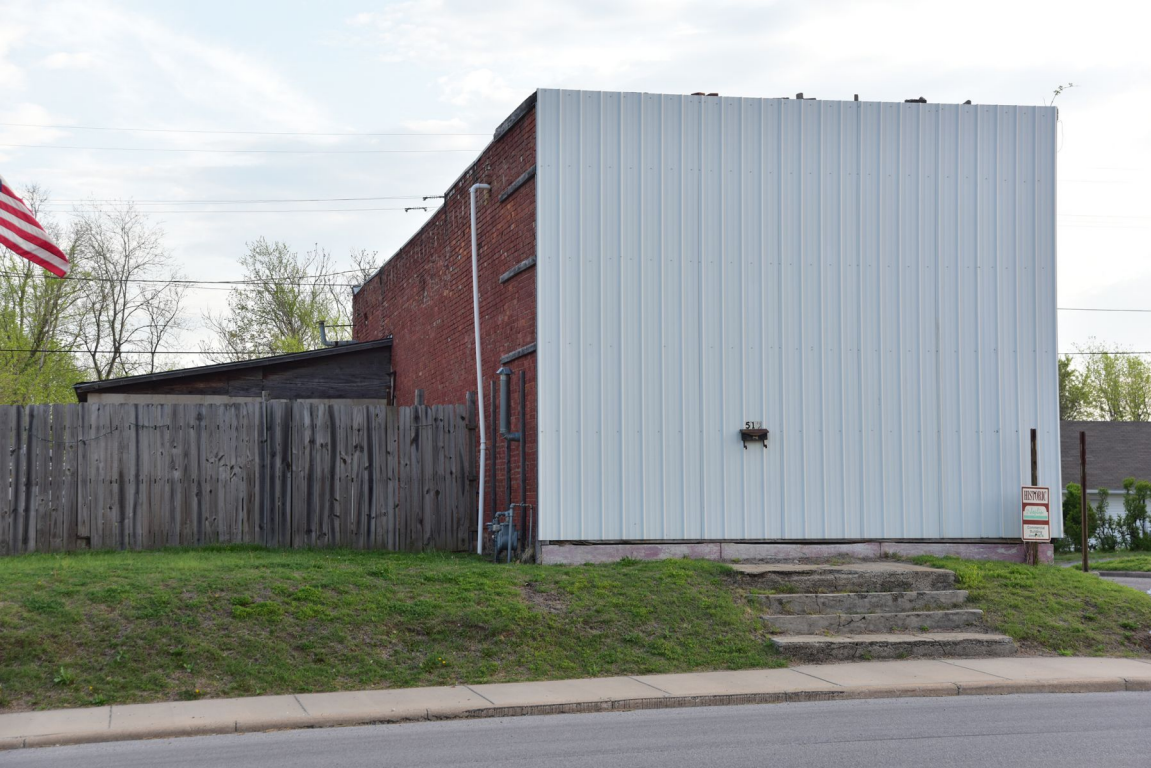
This two-story brick commercial building faces south and has an L-shaped footprint. It has a stone foundation and vertical metal siding clads the entire primary elevation. The building lacks fenestration. A non-historic metal door with glazing is located at the east elevation. A front-gable addition with stucco and wood panel cladding is located at the rear. A non-historic enclosed porch with shed-roof and wood panel cladding projects from the west elevation.

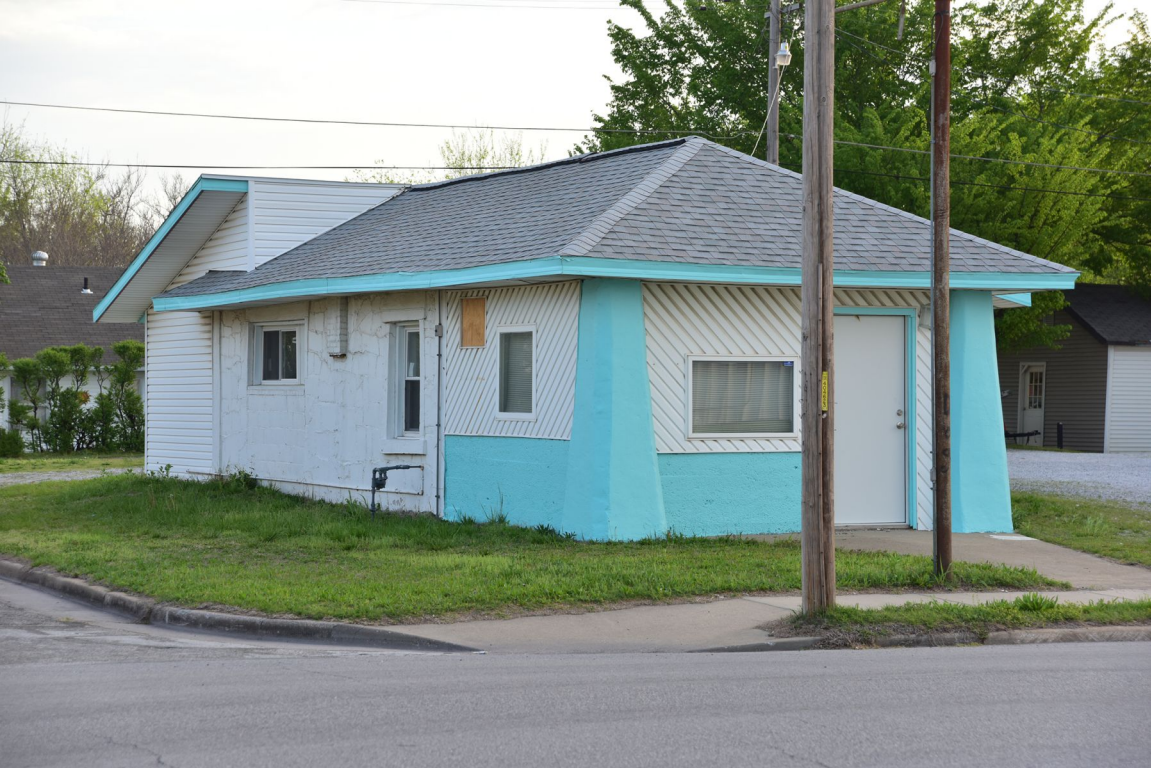
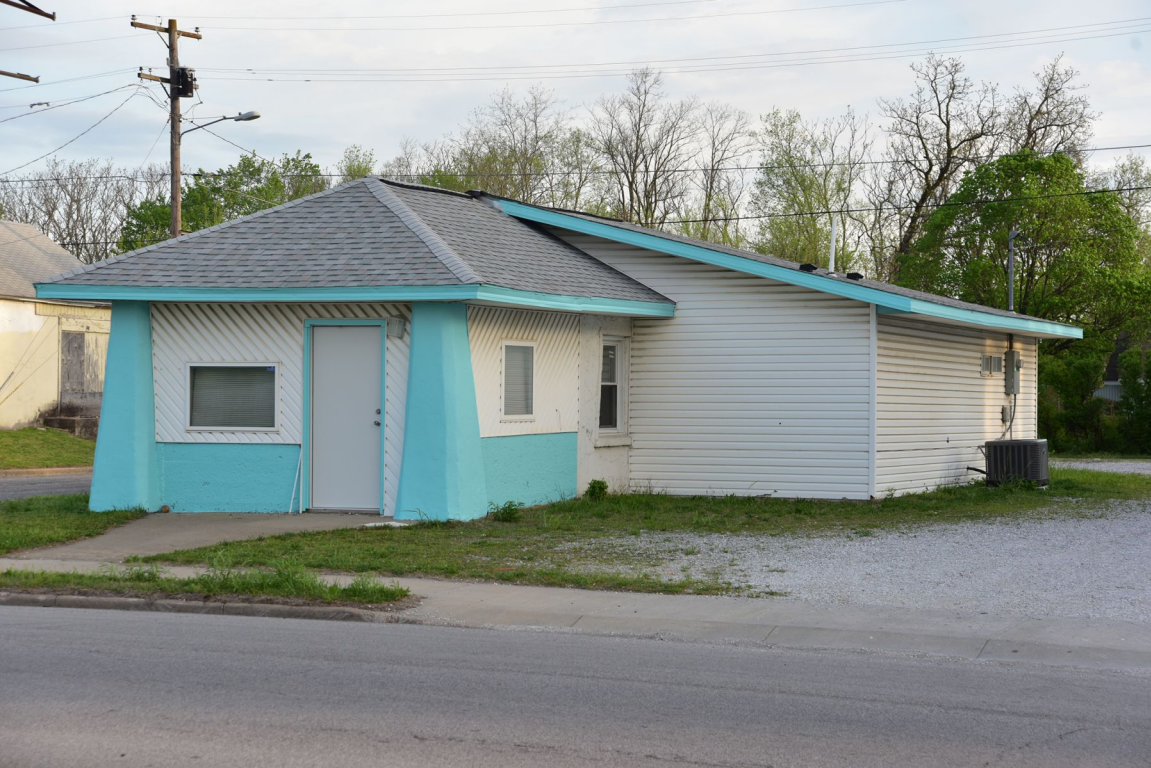
This commercial building faces south and has an L-shaped footprint. It has a stone foundation and asphalt shingle roof. The building features a combination of historic stucco and non-historic vinyl and concrete cladding. It is two bays wide and three bays deep. An L-shaped c.2000 addition with a shed roof wraps around the northeast corner of the historic building. An enclosed canopy with a hipped roof and non-historic concrete walls is located at the primary elevation. Historic tapered stucco-clad piers support the canopy roof. The canopy enclosure with concrete and vinyl siding oriented diagonally is an alteration. A non-historic wood door occupies the east bay while a vinyl fixed-sash window occupies the west bay. No historic windows remain. A small sliding window and concrete block fill a historic door opening.

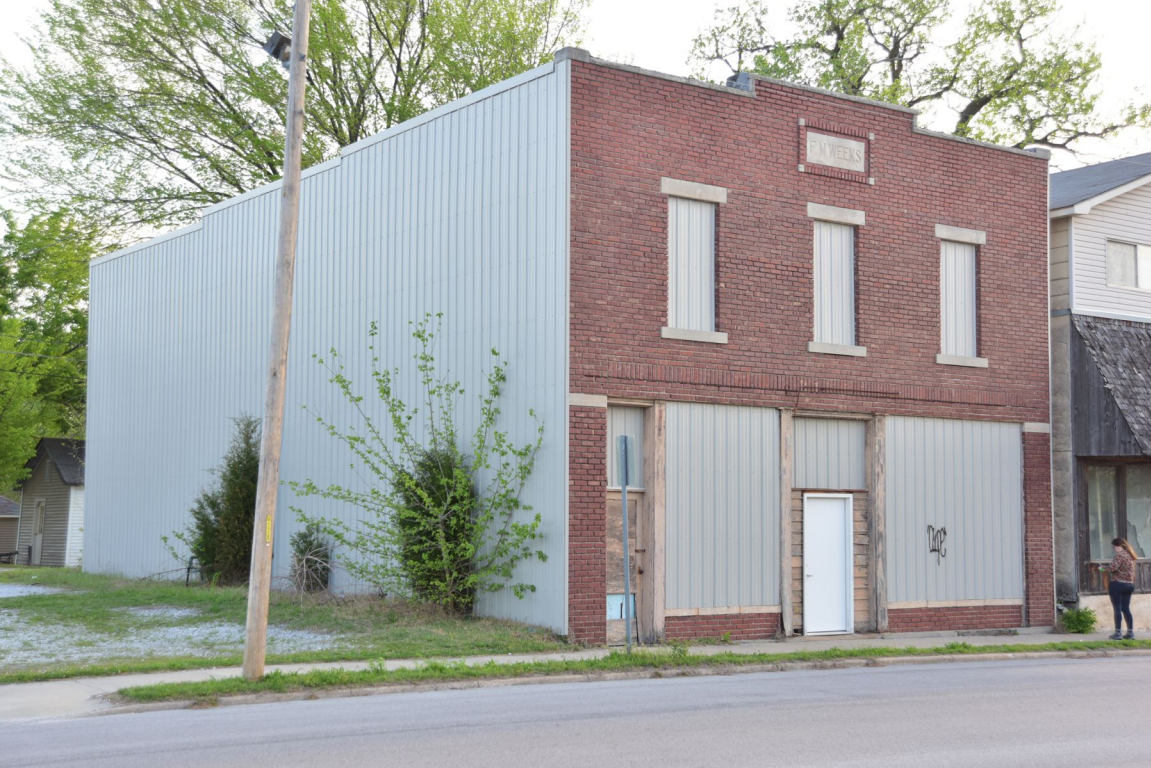
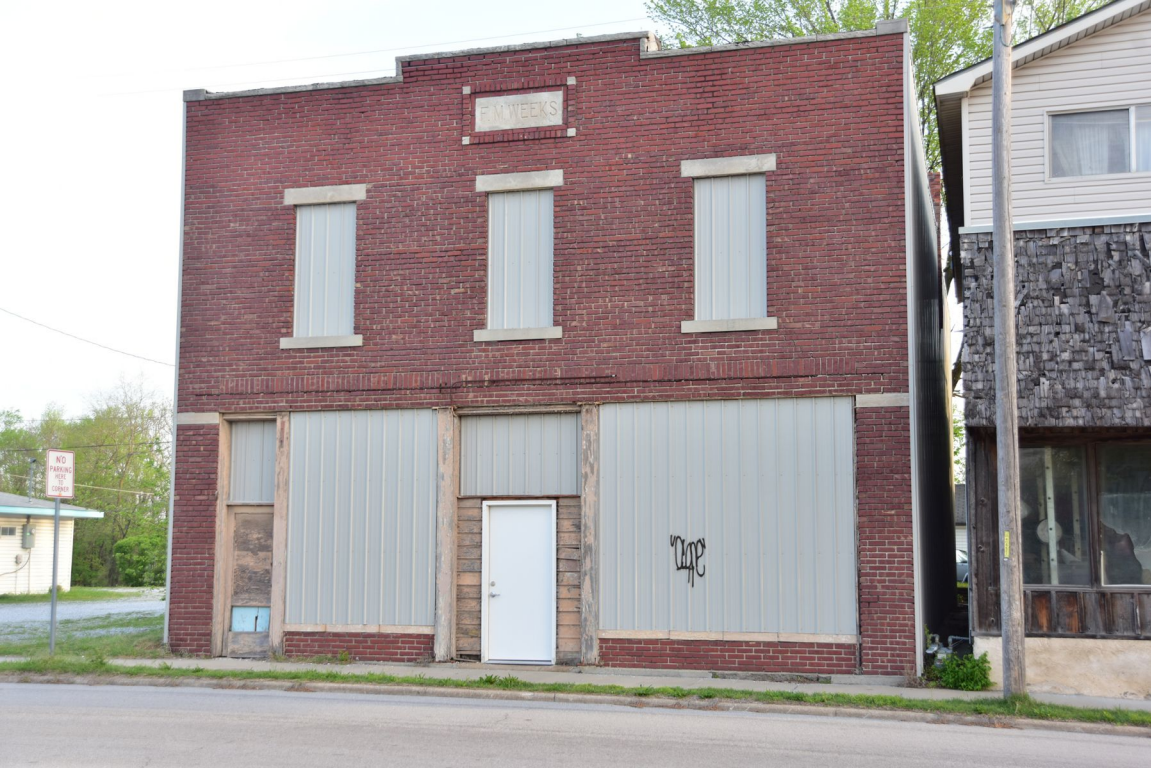
This two-story, two-part commercial block building faces south and has a rectangular footprint and a flat roof. The exterior of the south façade retains historic brick cladding. The secondary elevations have corrugated metal cladding. The first story has four bays. Brick pilasters with stone caps frame the bays. The west bay contains a historic wood paneled door with metal siding covering the transom. The second and fourth bays correspond to historic storefronts and retain historic brick bulkheads with stone caps. The display areas are infilled with corrugated metal siding. The third bay contains a non-historic fiberglass door flanked with non-historic wood clapboard infill. The transom is infilled with corrugated metal siding. A soldier brick stringcourse ornaments the wall between the first and second stories. The second story has three bays, each containing a rectangular window opening with stone sills and lintels, infilled with corrugated metal siding. The center of the parapet is slightly raised and has stone coping. The parapet has a stone panel carved with "F.M. WEEKS" with a brick rowlock outline with stone corner blocks.

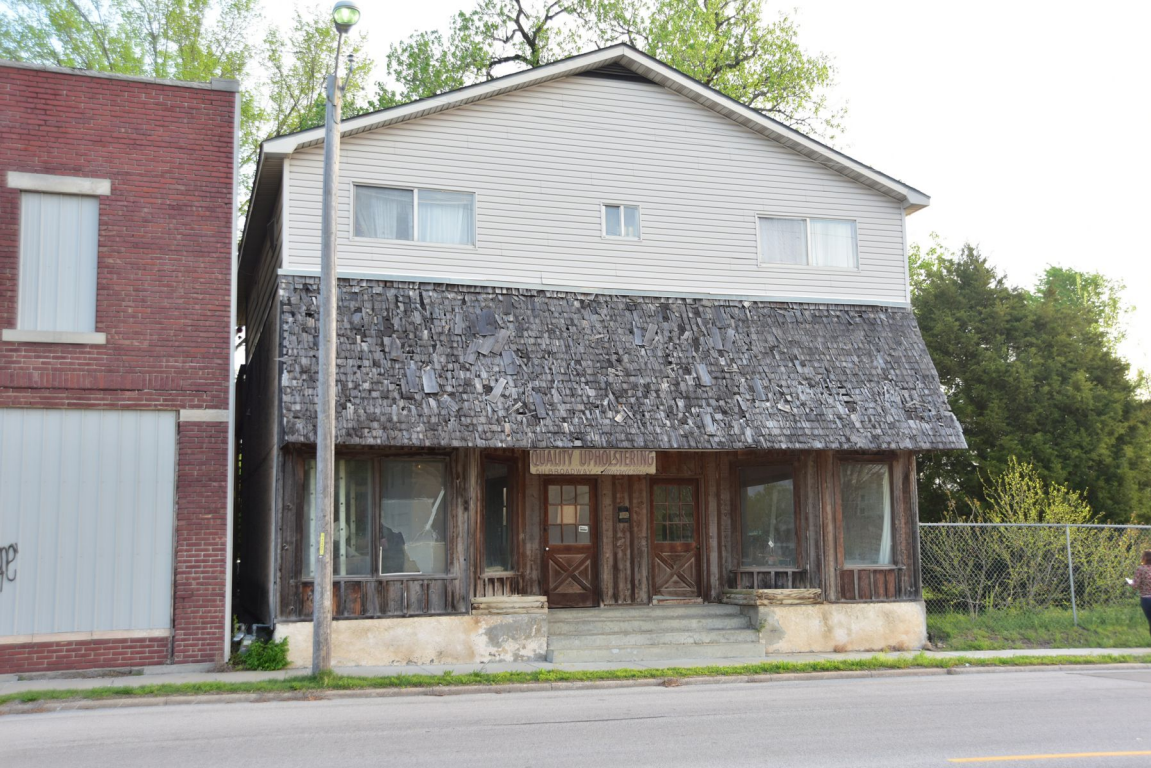
This two-story, two-part commercial block building faces south and has a rectangular footprint. It has a stone foundation and a front-gabled roof with asphalt shingles. The first story of the south façade has wood board and batten siding. The second story of the south façade has vinyl siding. The secondary elevations have stucco cladding on the lower story and vinyl cladding on the upper story. The first story of the south façade has six bays. The four central bays are recessed and accessed via a concrete stoop. The west bay contains a non-historic wood-frame window with two fixed lights. The second, fifth and sixth bays each contain a non-historic wood-frame window with one fixed light. The third and fourth bays each contain a non-historic wood door with nine-light glazing in the upper half. The first story is sheltered by a tall non-historic awning with wood shingle cladding. The second story has three bays. The outer bays each contain a short, non-historic metal window with two lights. The center bay contains a smaller non-historic metal window with two lights.

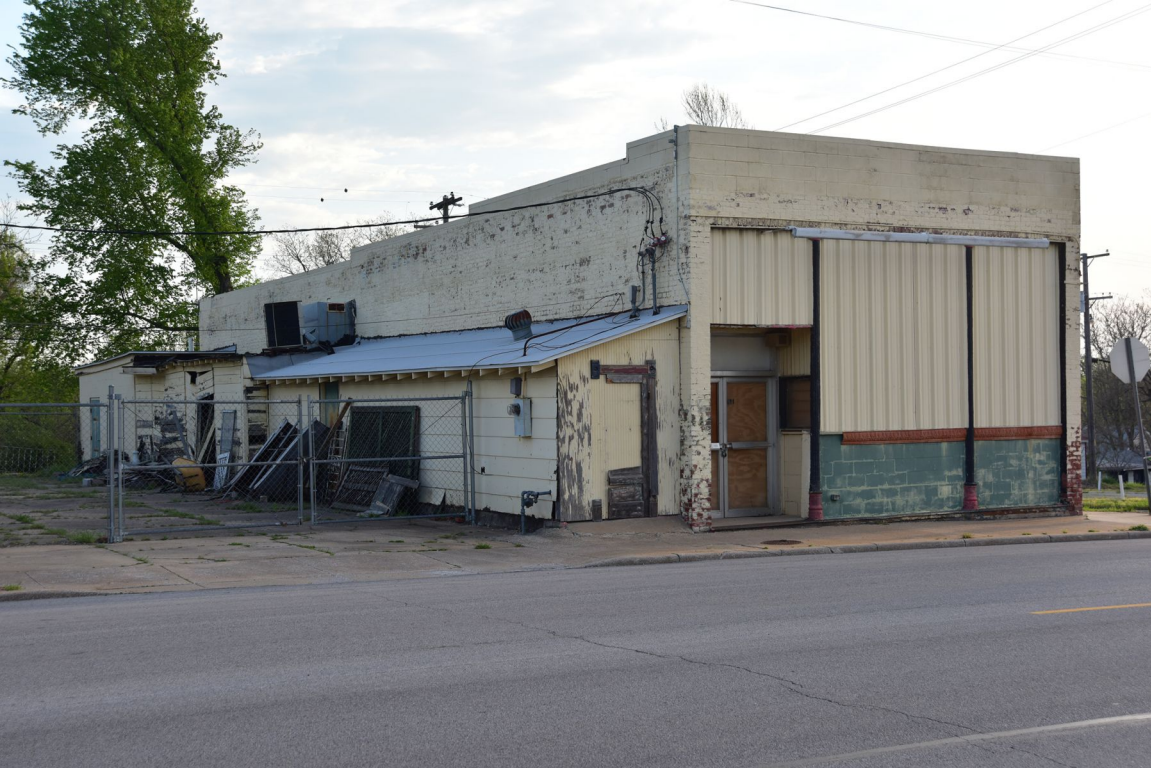
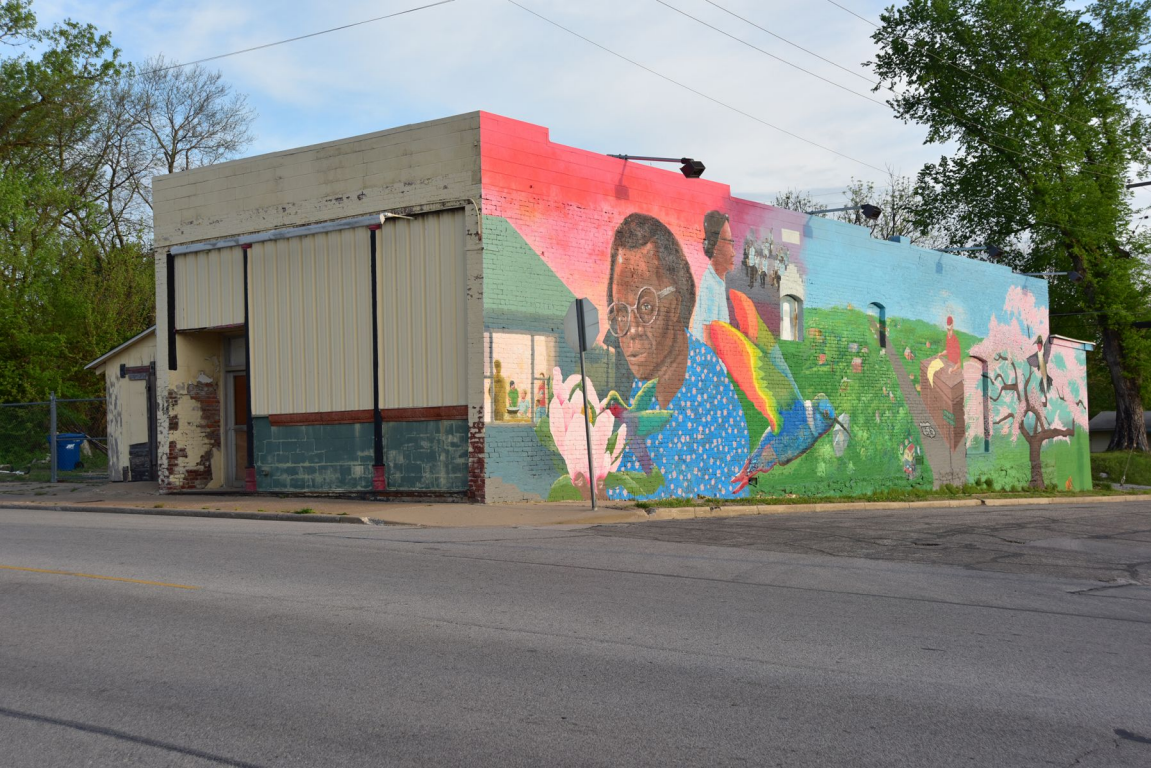
This brick commercial building faces south and has a rectangular footprint. It has a stone foundation and a stepped roof with parapet. The building has brick, concrete block, and corrugated metal cladding. It is four bays wide and three asymmetrical bays deep. An enclosed porch with a shed-roof porch forms the west bay at the primary elevation. Non-historic metal doors with glazing fill the second-from-west bay while iron columns define the remaining bays. Three segmental arch windows are infilled at the east elevation.

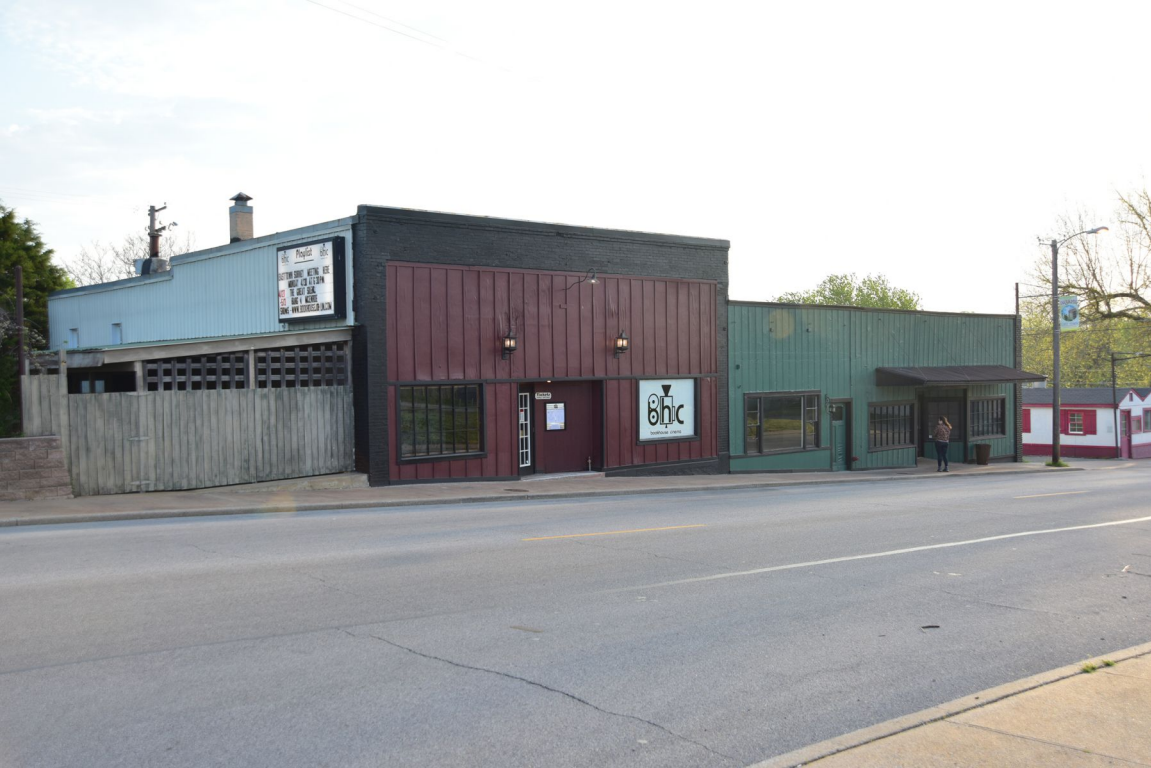
This one-part brick commercial building faces south and has a rectangular footprint. The building has a stone foundation and is eight bays wide. The primary elevation has three storefront display areas. The storefront display areas set within brick frames are infilled with vertical wood siding. The storefronts have large display windows and recessed entrances that communicate the historic commercial character of the building. Non-historic wood doors occupy the second, fifth, and seventh bays. The second and seventh bays feature recessed stoops. Non-historic multi-light wood display windows occupy the remaining bays. The multi-light windows have aluminum muntins. The east and west elevations have corrugated metal cladding.

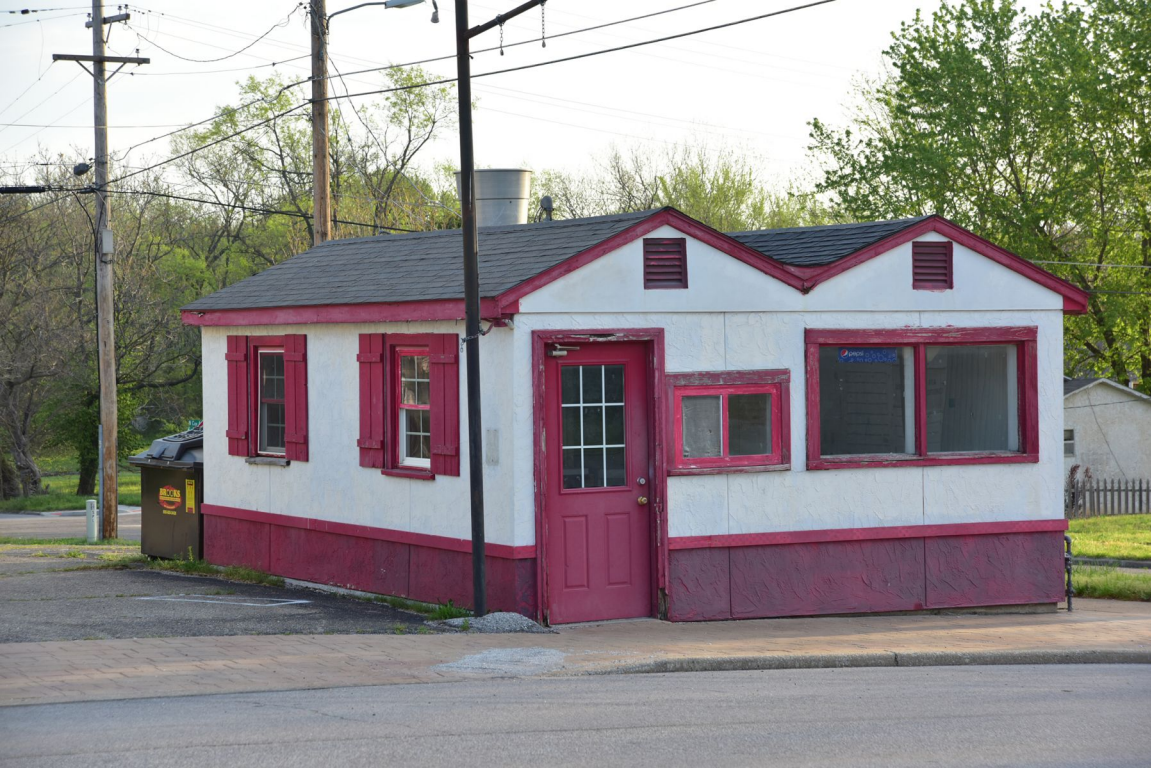
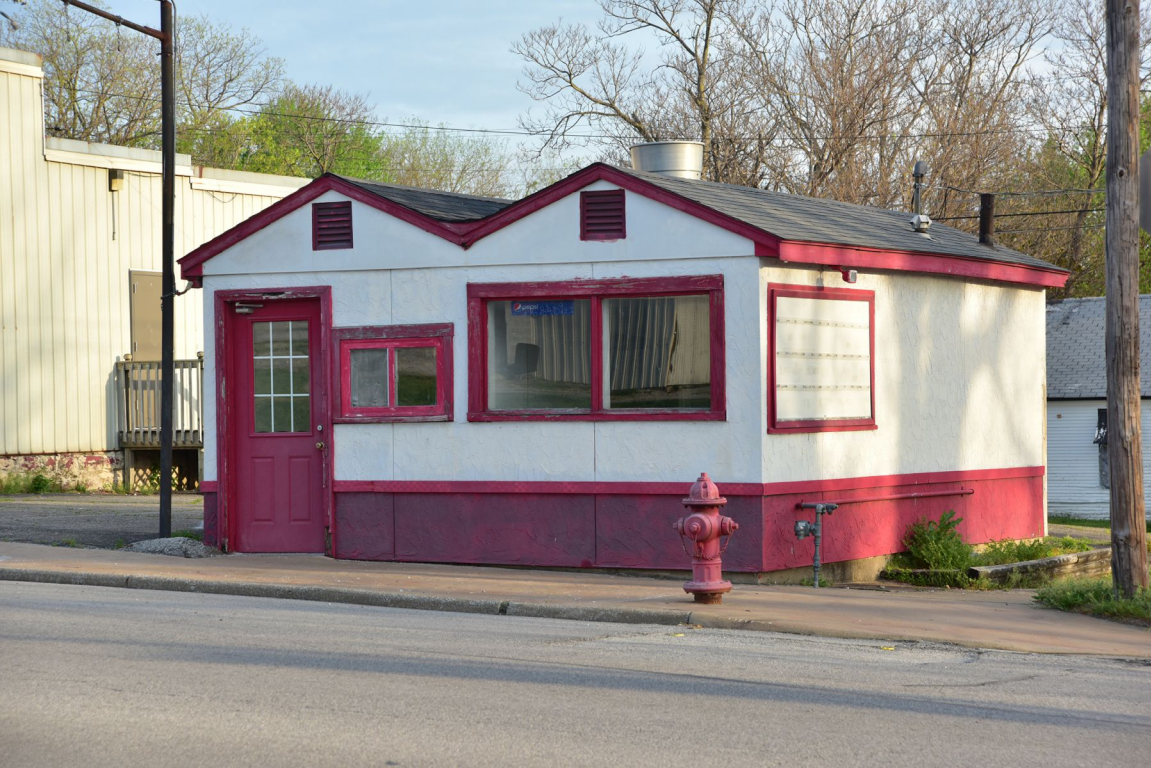
This small, one-story commercial building faces south and has a rectangular footprint. It has a concrete foundation and non-historic stucco panel cladding. The twin gable roof has asphalt shingles. Rectangular louvers occupy the gable peaks. The building is three bays wide and two bays deep. A non-historic wood door with nine-light glazing occupies the west bay while non-historic two-part wood display windows occupy the remaining bays. Non-historic four-over-four vinyl windows with false shutters are located at the west elevation while the single window at the east elevation is boarded up.

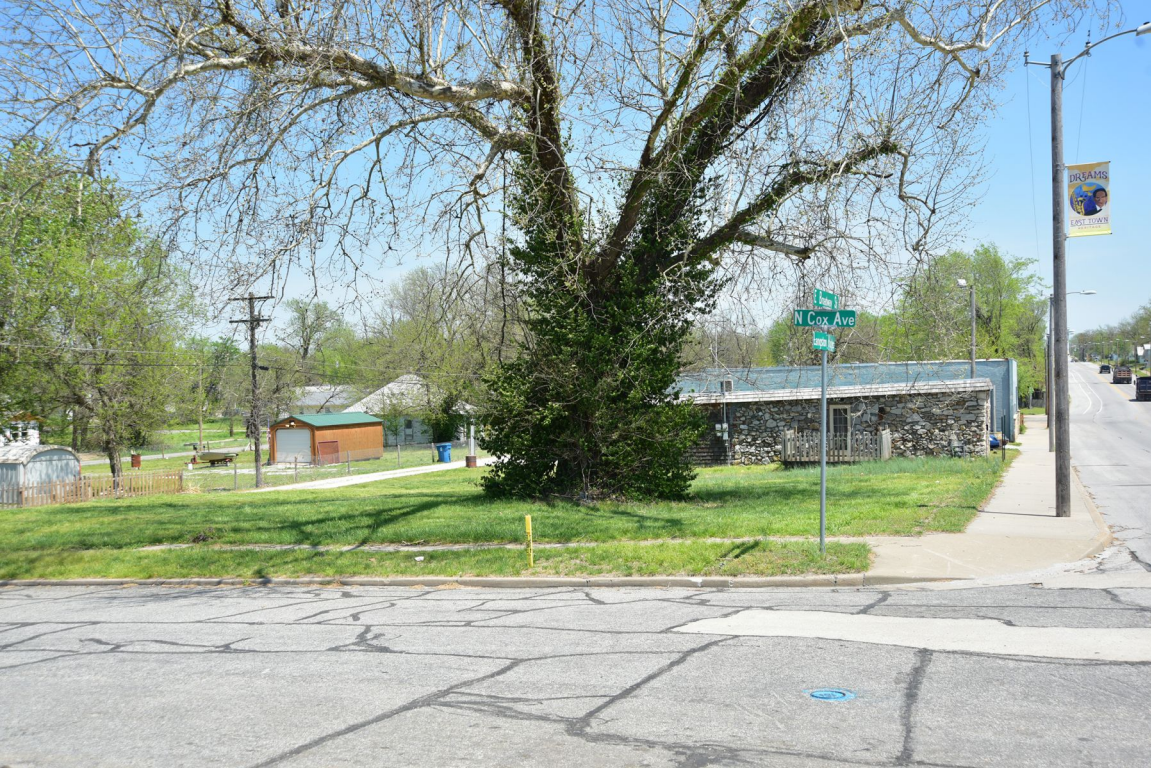
The vacant lot is approximately sixty-six feet wide and one-hundred feet deep. It is characterized by a grass lawn with a large deciduous tree in the center.

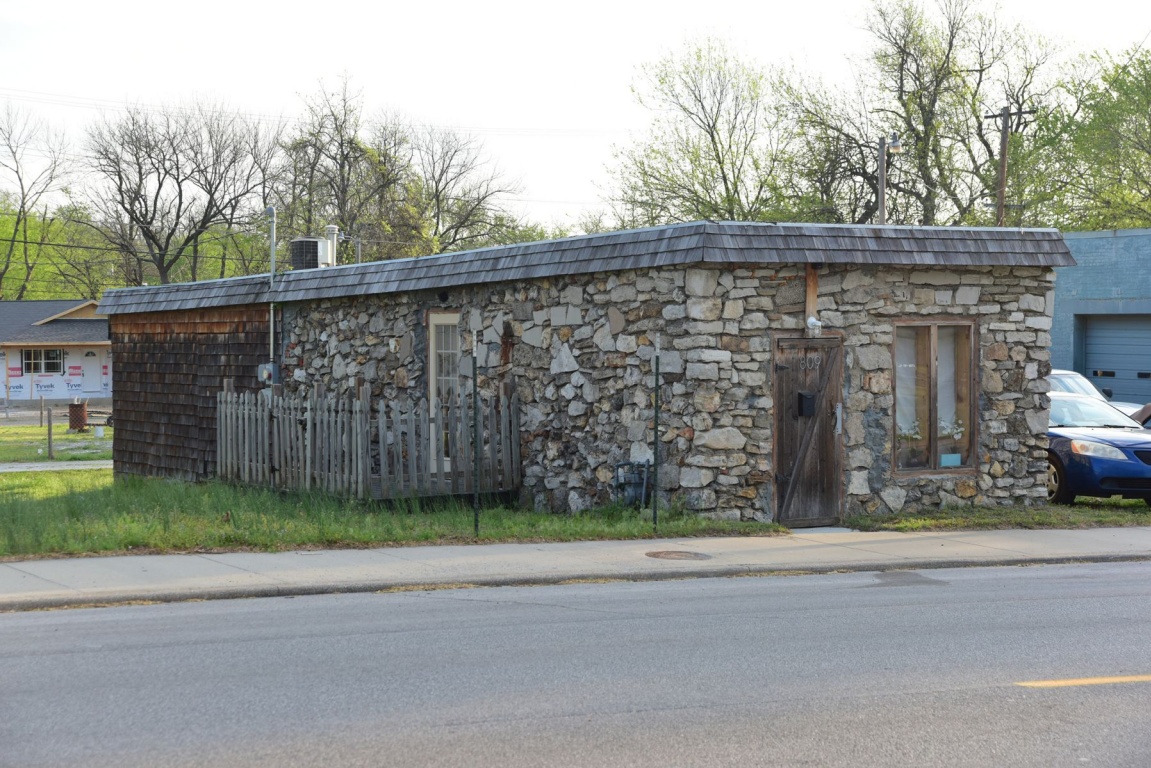
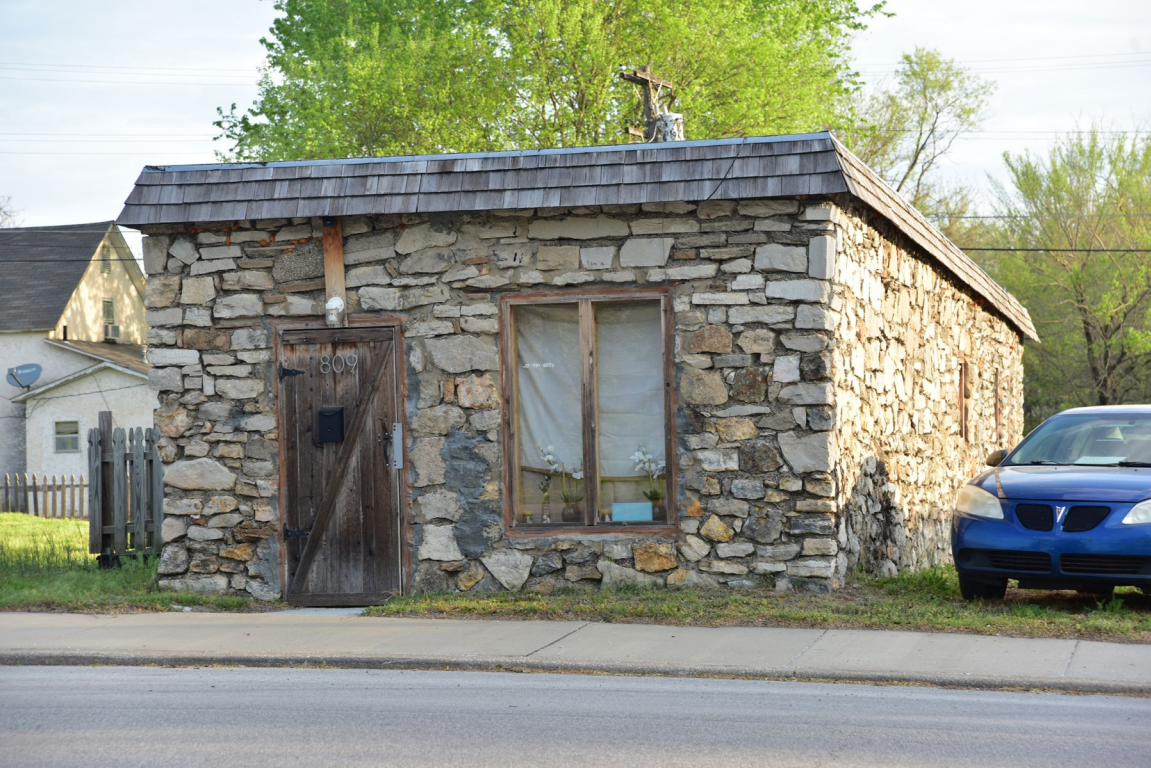
This one-story commercial building has a rectangular plan and faces south. It has a flat roof and stone foundation. A non-historic wood shingle pent roof at the parapet wraps around the building. Wood shingle siding clads the north half of the west elevation. The remainder of the building is clad in fieldstone. The primary elevation has two bays. A non-historic two-part wood display window forms the east bay while a non-historic hinged wood door forms the west bay. A secondary entrance is located in the south half of the west elevation. This entrance has a non-historic fifteen-light door and opens to a non-historic wood deck with picket fencing. The pent roof and the front window are alterations that date to the c.1970s.

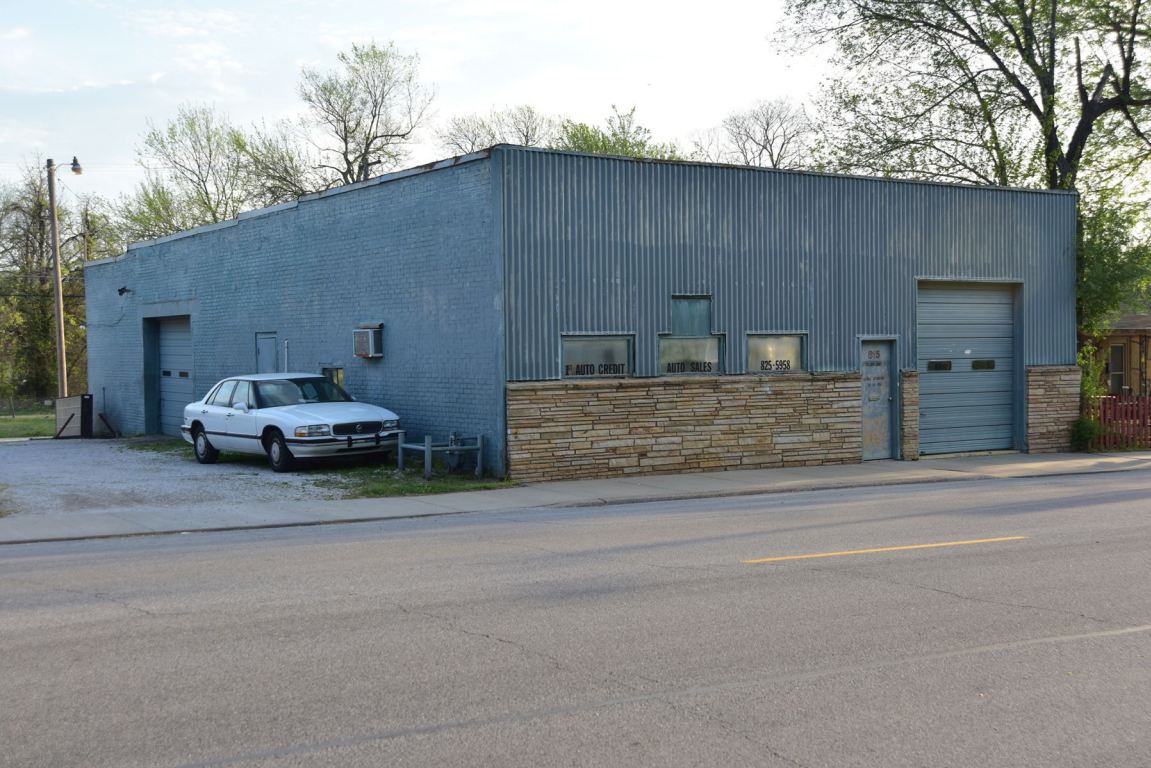
This one-story commercial building faces south and has a rectangular footprint. It has a brick foundation and flat roof. Stone veneer clads the lower third of the primary elevation while corrugated metal clads the upper portion. The stone veneer may be a historic alteration while the corrugated metal siding may be a non-historic alteration. The secondary elevations are brick. The primary elevation has five bays. A non-historic metal vehicular entrance forms the east bay and a non-historic metal pedestrian door forms the adjacent bay. Non-historic wood one-light fixed-sash windows form the remaining bays. The west elevation is two bays deep. A non-historic vehicular door forms the north bay while a non-historic pedestrian door forms the south bay. The east elevation lacks fenestration.
