1. Survey number: JP-AS-006-001		2. Survey Name: East Town (Original Joplin) Historic Survey Phase 1	
3. County: JASPER		4. Address 503	Street (name): E. Broadway Street
5. City: Joplin	Vicinity <input type="checkbox"/>	7. Township/Range/Section: T: R: S:	
8. Historic name (if known):		9. Present/other name (if known):	
10. Ownership: <input checked="" type="checkbox"/> Private <input type="checkbox"/> Public		11a. Historic use (if known): Domestic/Single Dwelling	11b. Current use: Domestic/Single Dwelling

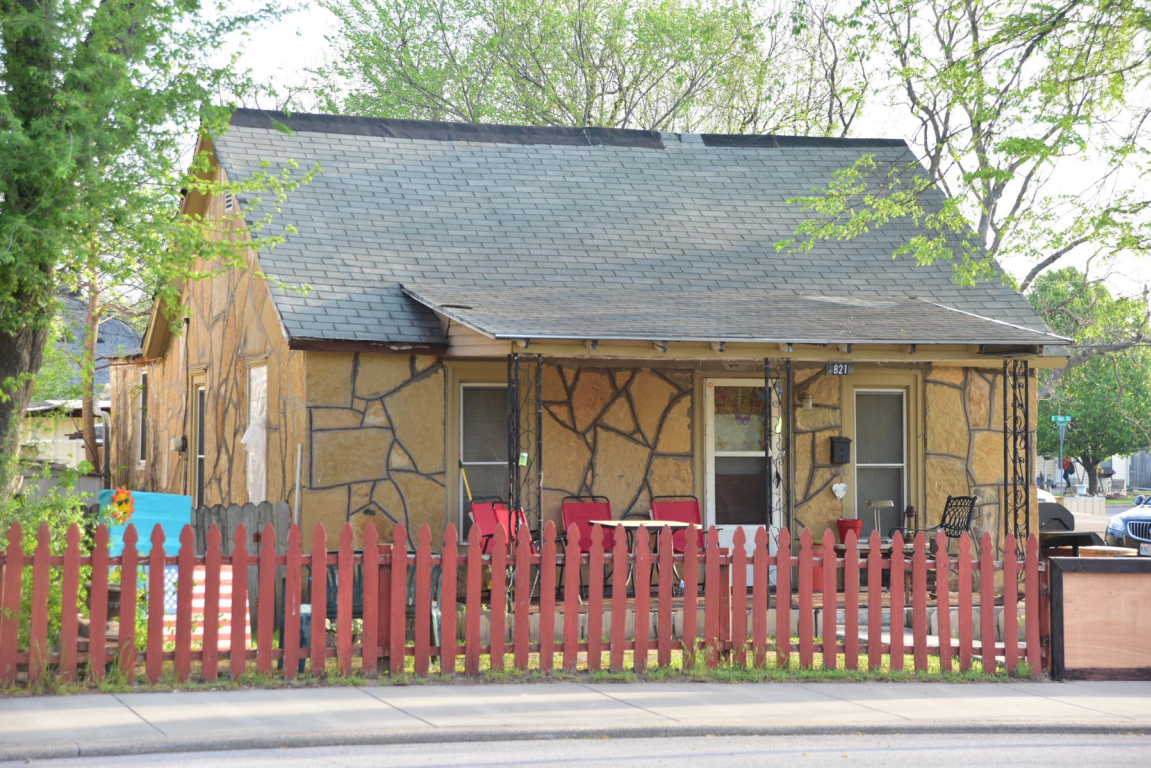
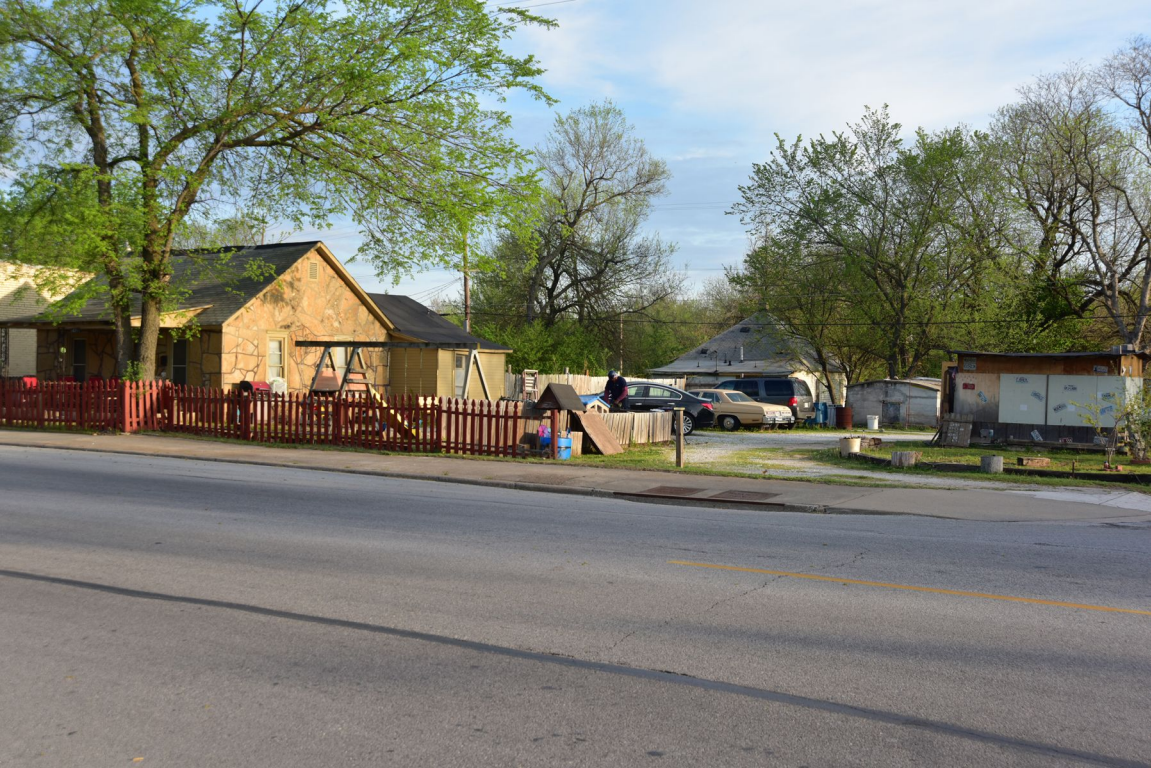
The one-story dwelling faces south and is three bays wide and three asymmetrical bays deep. It features a field stone foundation and side-gable asphalt roof. The dwelling is clad in split-slab fieldstone. A historic wood door with glazing forms the center bay of the primary elevation. Historic one-over-one wood windows with storm windows form the other bays. A shed roof with exposed rafter tails covers the partial-width front porch. Non-original decorative iron posts support the porch roof. A rear addition with shed roof and clapboard cladding projects past the east elevation, creating an L-shaped footprint.

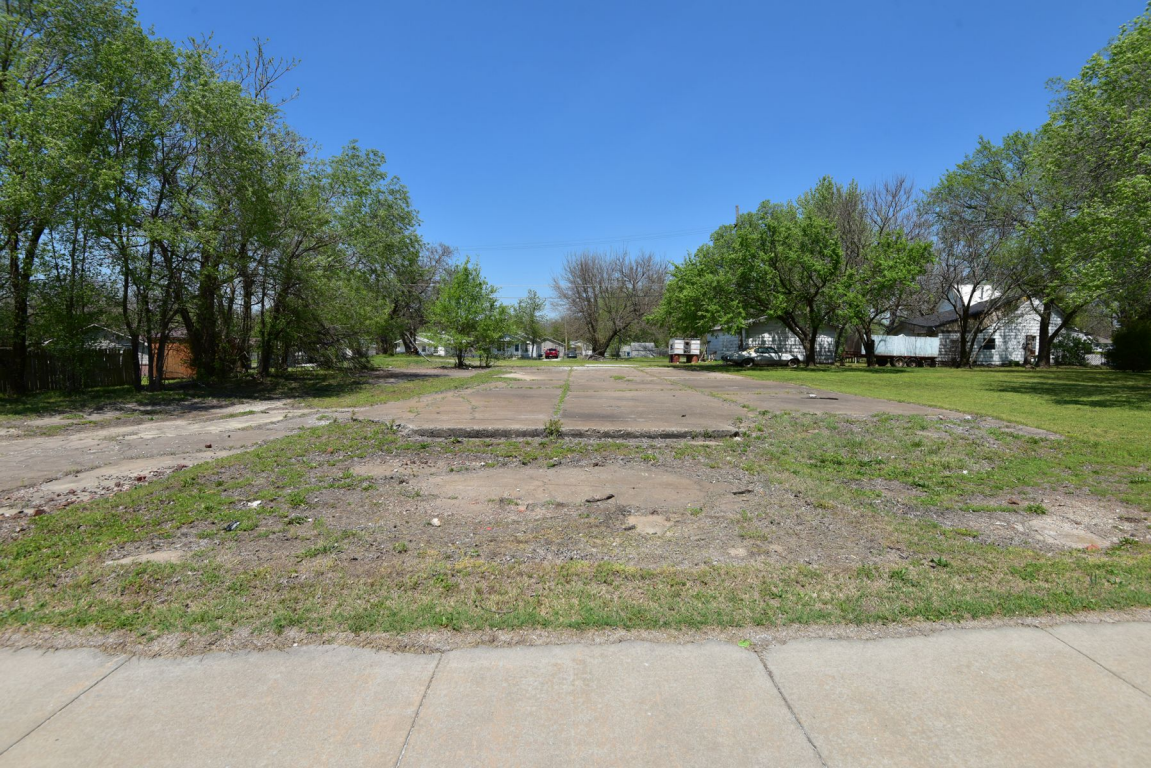
This lot is fronts E. Broadway Street and is located in the south portion of the Survey Area. The lot is approximately one-hundred-ten wide and ninety-five feet deep. It is characterized by a large concrete pad bordered by grassy areas and mature deciduous trees. An east-west gravel alley abuts the north edge of the property while a concrete sidewalk abuts the south edge. Railroad tracks abut the east edge.

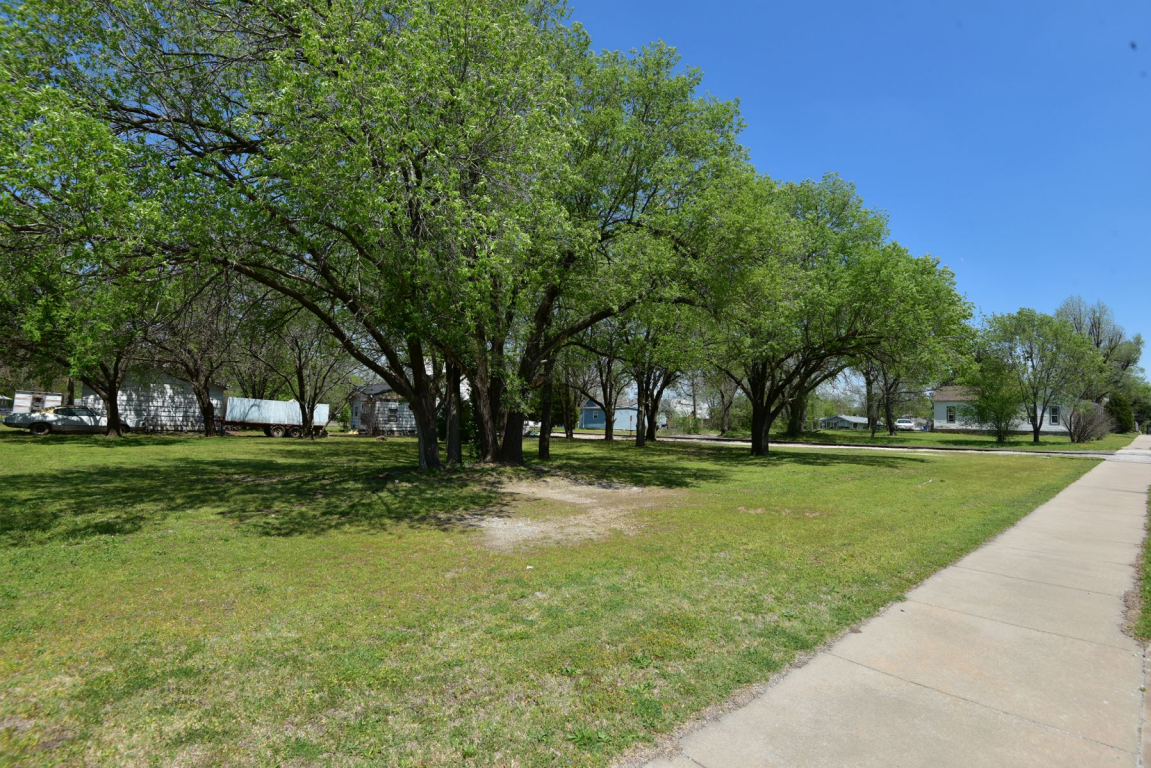
This lot is located at the northwest corner of N. Railroad Avenue and E. Broadway Street. The lot is approximately ninety feet wide and ninety-five feet deep. It is characterized by open grassy areas and mature deciduous trees. An east-west gravel alley abuts the north edge of the property while a concrete sidewalk abuts the south edge. Railroad tracks abut the east edge.

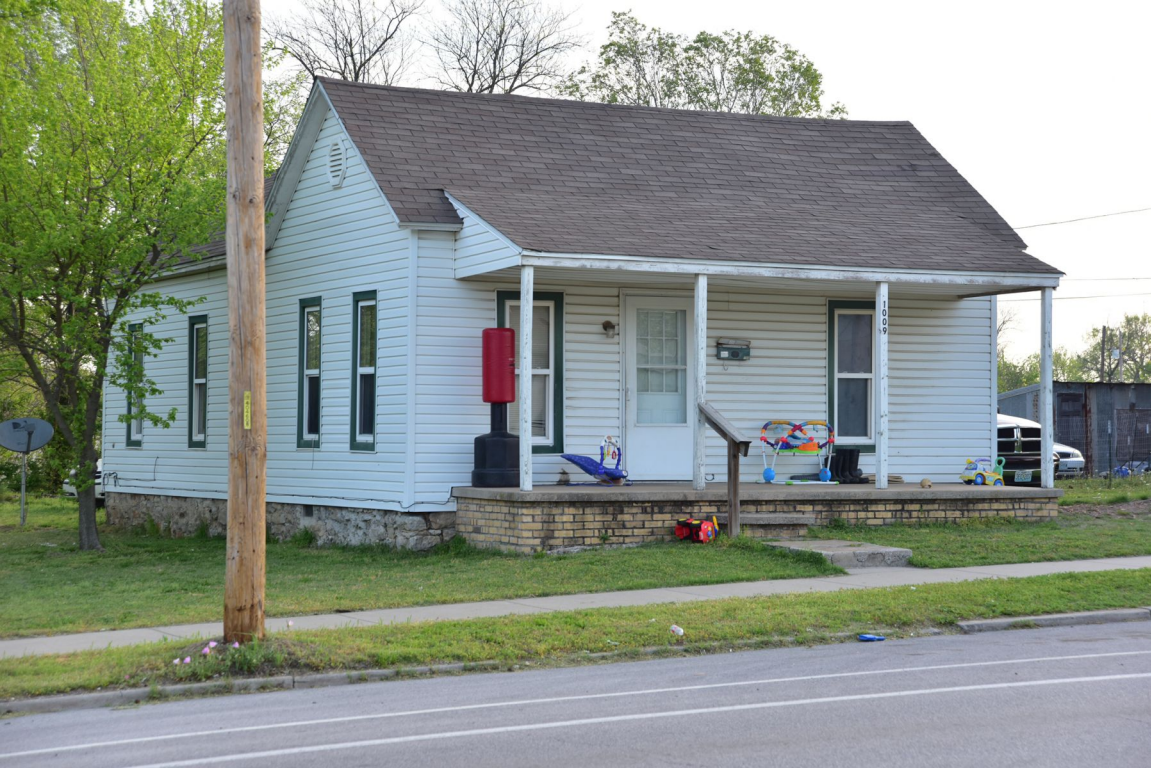
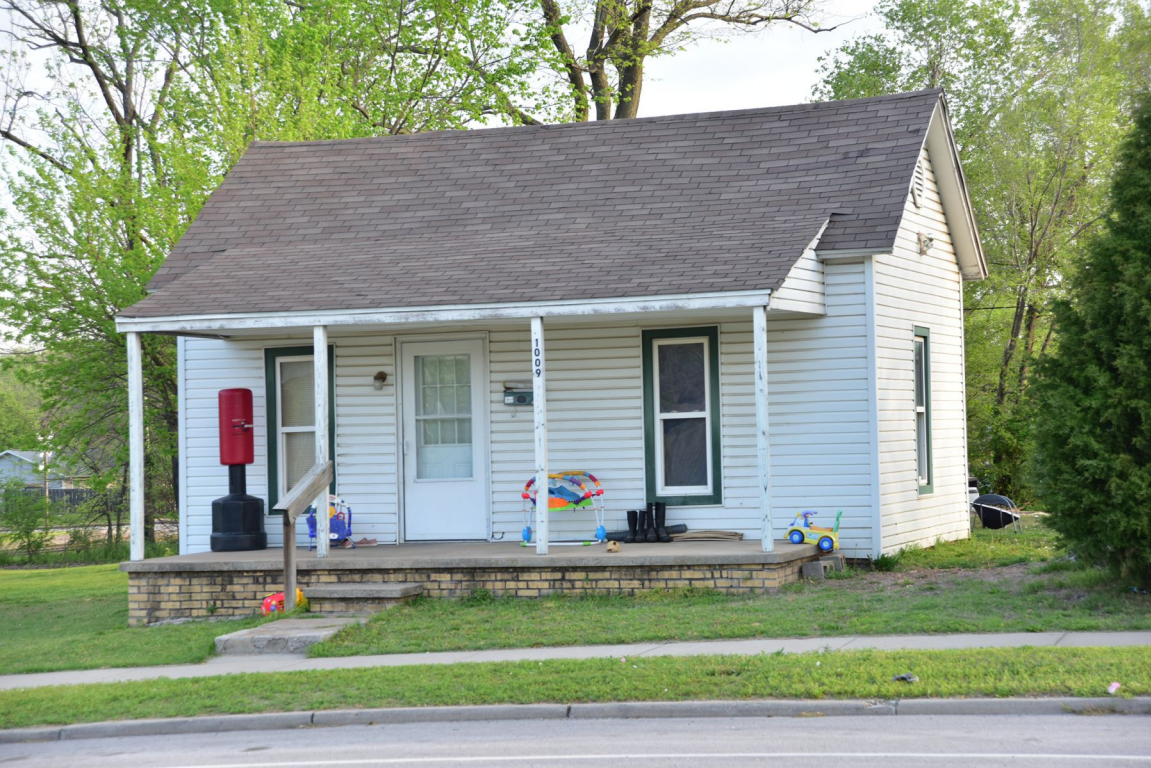
The one-story dwelling faces south and has a L-shaped footprint. It is three bays wide and four bays deep. It has a stone foundation and intersecting-gable asphalt roof. The dwelling is vinyl-clad. A shed roof projects from the primary elevation to cover a nearly full-width historic porch with brick foundation. Square wood posts support the porch roof. A non-historic wood door with nine-light glazing forms the center bay of the primary elevation. Non-historic one-over-one vinyl windows form the remaining two bays of the primary elevation and all four bays of the secondary elevation.

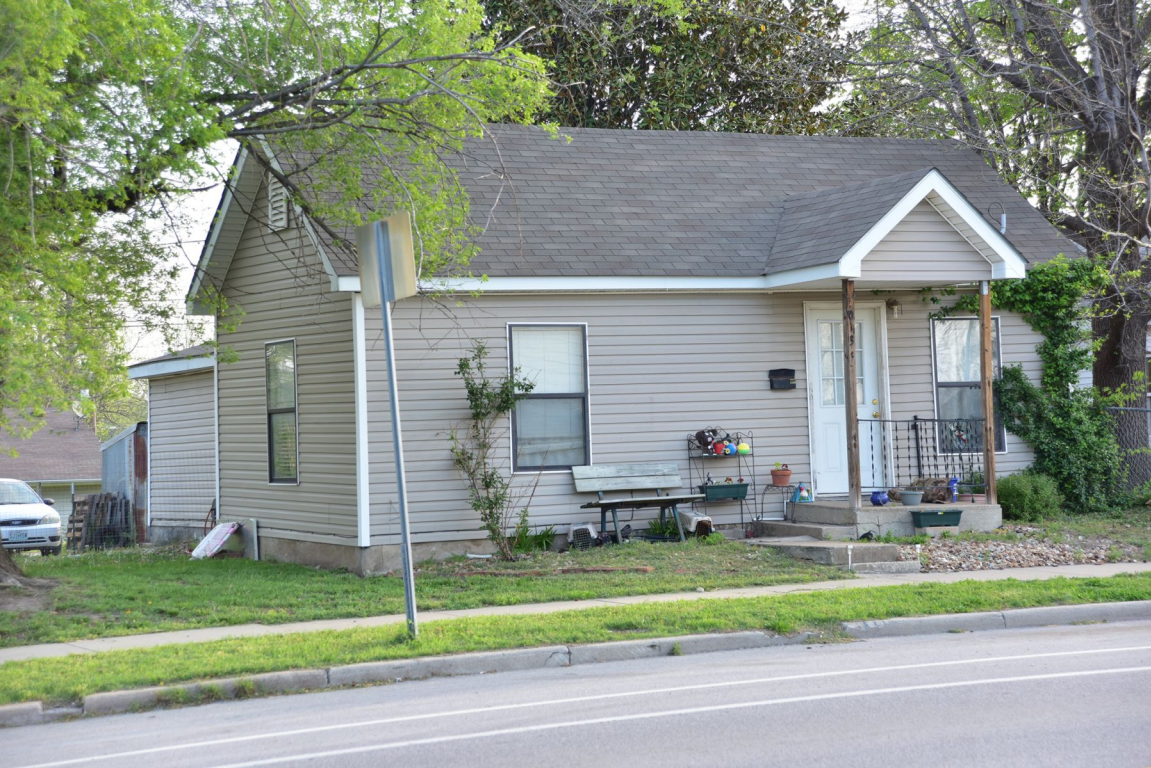
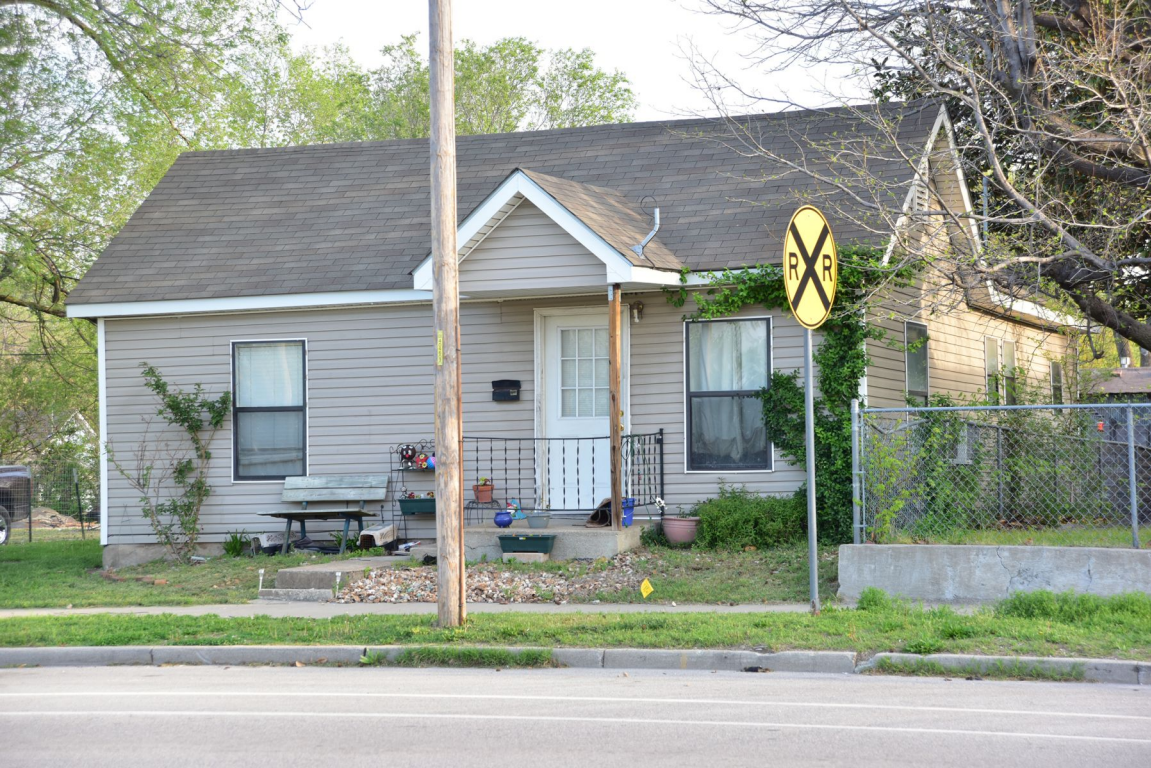
1013 E. Broadway Street faces south and has a rectangular footprint. The one-story dwelling has a concrete foundation, vinyl cladding, and a side-gable asphalt roof. The dwelling possesses a crawl space basement. The primary elevation features three asymmetrical bays. A non-historic wood door with nine-light glazing forms the center bay. Non-historic one-over-one metal windows form the east and west bays. A gable porch roof projects over the stoop, sheltering the entrance. Non-historic square wood posts support the porch roof. The stoop's iron railing is non-historic.

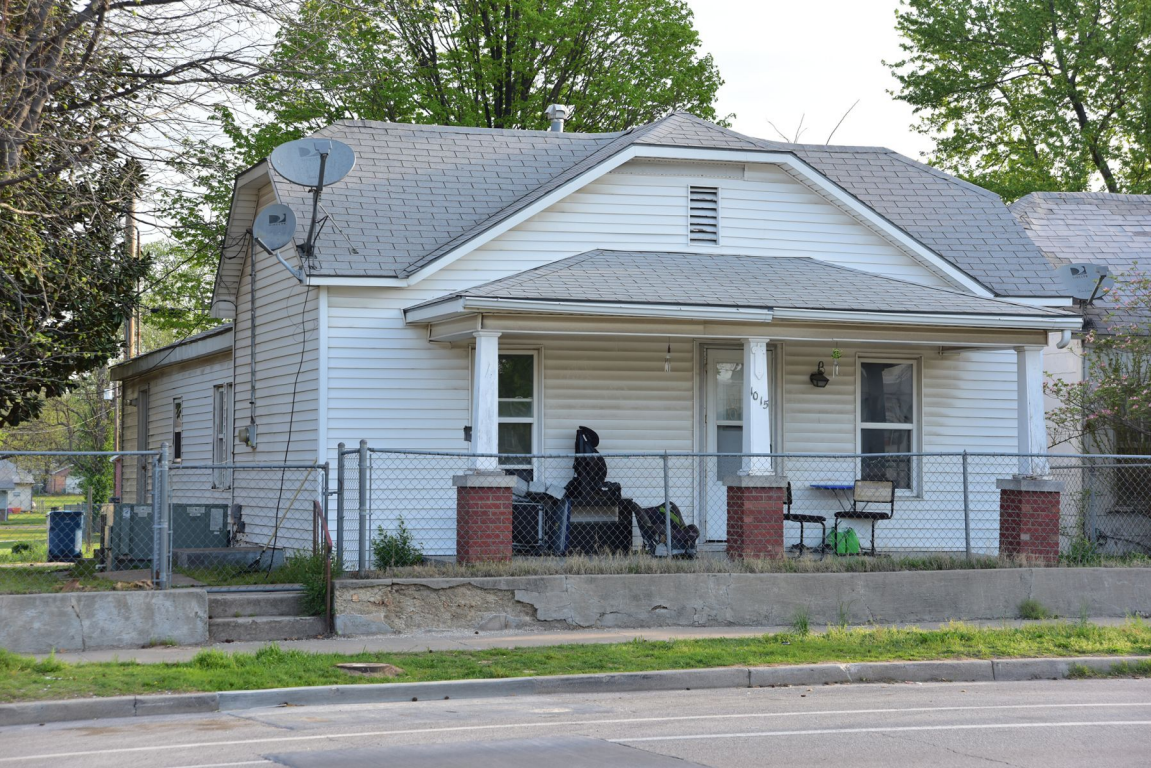
The one-story dwelling faces south and has a rectangular footprint. It features a concrete foundation, vinyl cladding, and a clipped cross-gable asphalt roof. The dwelling has a crawl space basement. The primary elevation is three bays wide. A non-historic wood door with glazing forms the center bay. Non-historic one-over-one vinyl windows form the remaining two bays. A hipped porch roof projects from the primary elevation, sheltering the bays. Tuscan wood columns on brick piers support the porch roof.

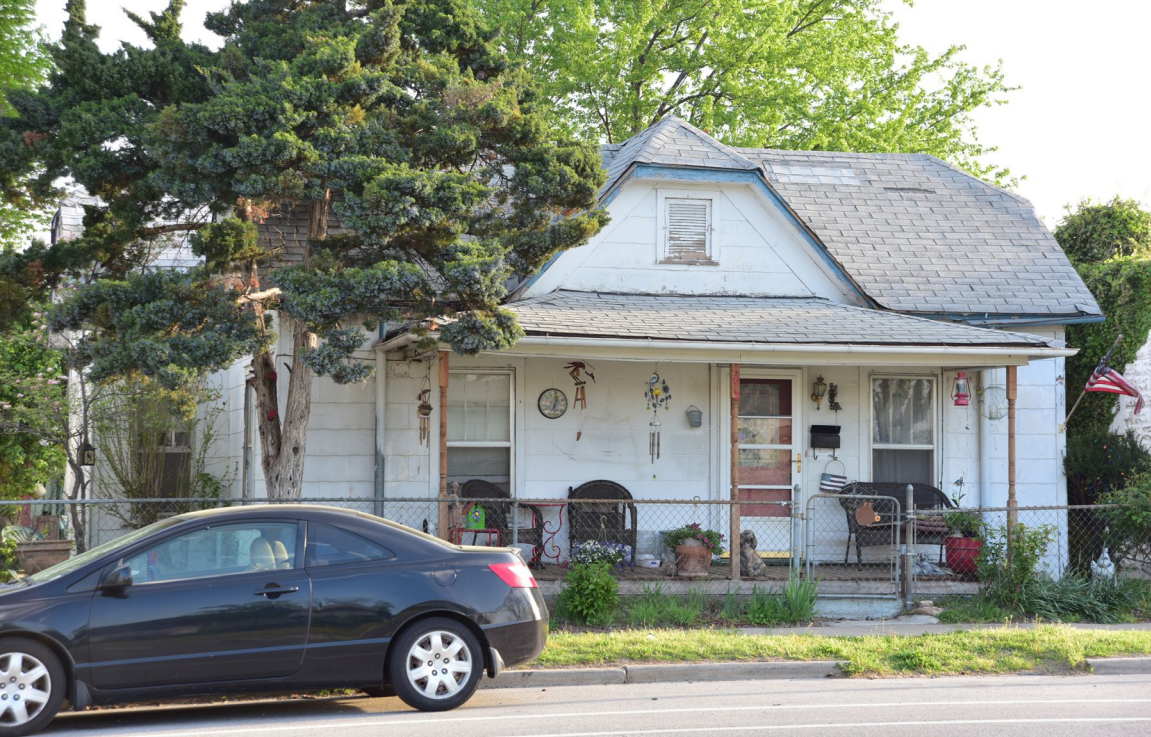
1017 E. Broadway faces south and has an irregular footprint. The one-story dwelling features a concrete foundation, asbestos shingle cladding, and complex hipped gable roof with asphalt shingles. The basement is a crawl space. The primary elevation is three bays wide. A non-historic wood door with glazing forms the center bay while historic three-over-one wood windows form the outer bays. A non-historic three-quarter width porch is supported by turned wood posts. A brick rear-slope chimney is offset east.

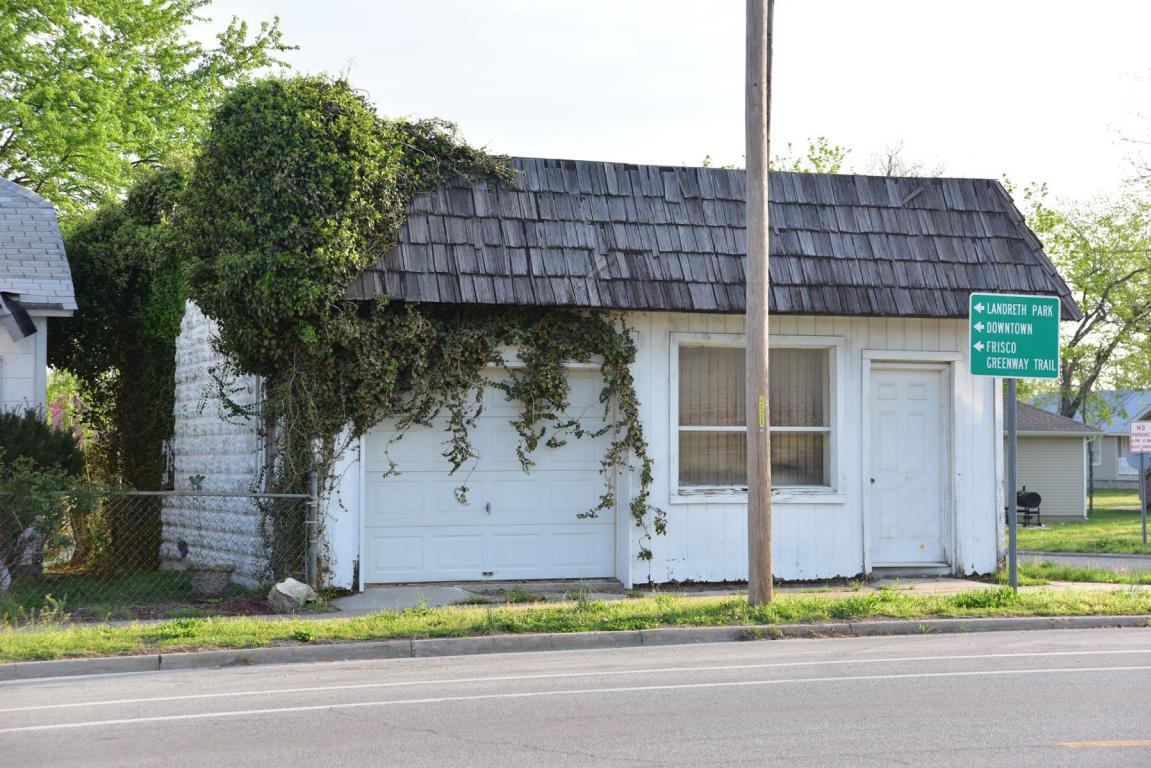
This one-story commercial building faces south and has a rectangular footprint. It has a concrete foundation and a flat roof. Wood shingles clad the parapet at the primary elevation and first third of the east and west elevations. The west elevation features concrete block while other elevations feature pressboard siding. A short brick chimney is in the northeast corner of the roof. The building is three asymmetrical bays wide and two bays deep. A non-historic six-panel wood door forms the east bay while a non-historic overhead garage door forms the west bay. A non-historic one-over-one wood window defines the center bay.

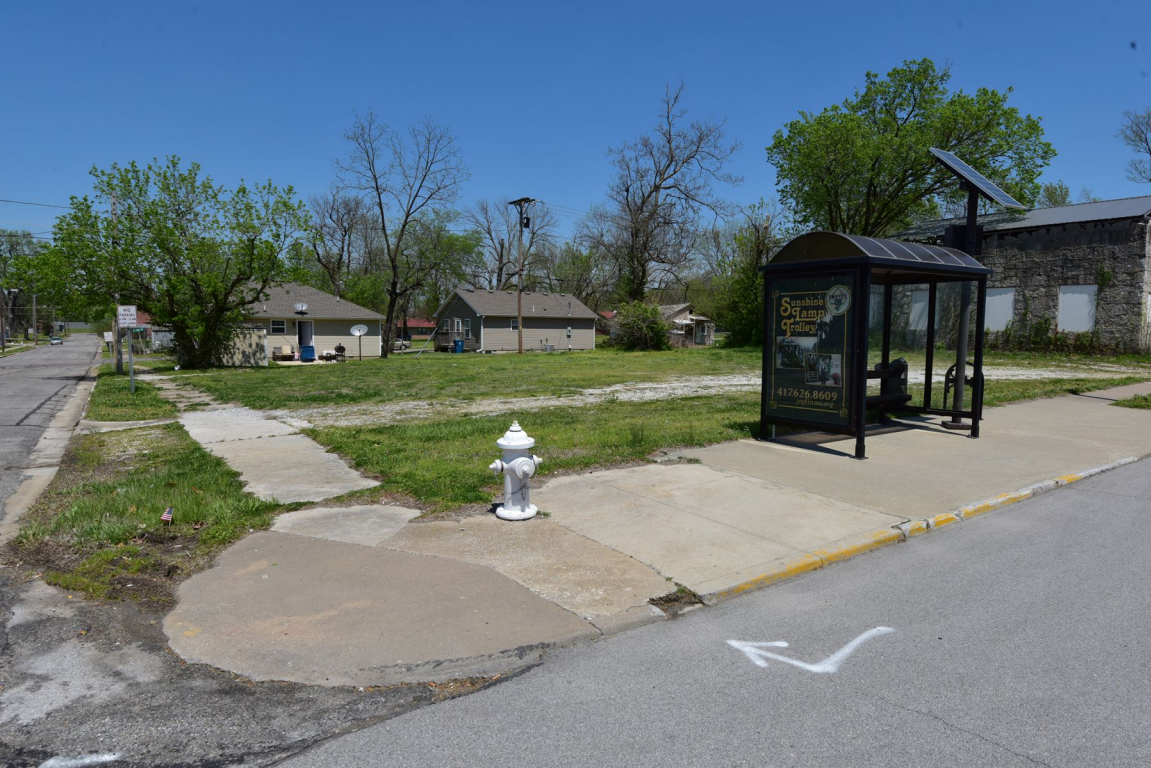
This vacant lot is located at the northeast corner of N. School Avenue and E. Broadway Street in the south portion of the Survey Area. It is approximately seventy-five feet wide and ninety-five feet deep. A large, open grass area characterizes the lot. An east-west gravel drive is located at the south end of the lot. Concrete sidewalks abut the south and west edges of the lot while an east-west gravel alley abuts the north edge.

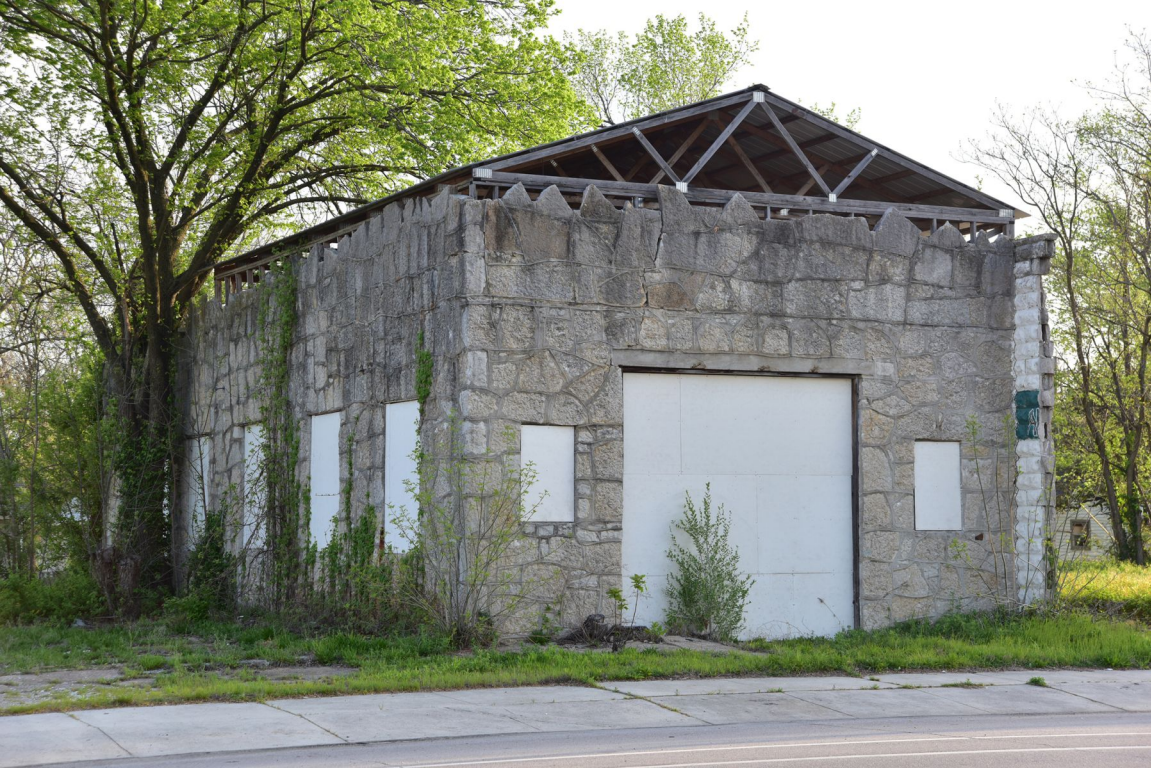
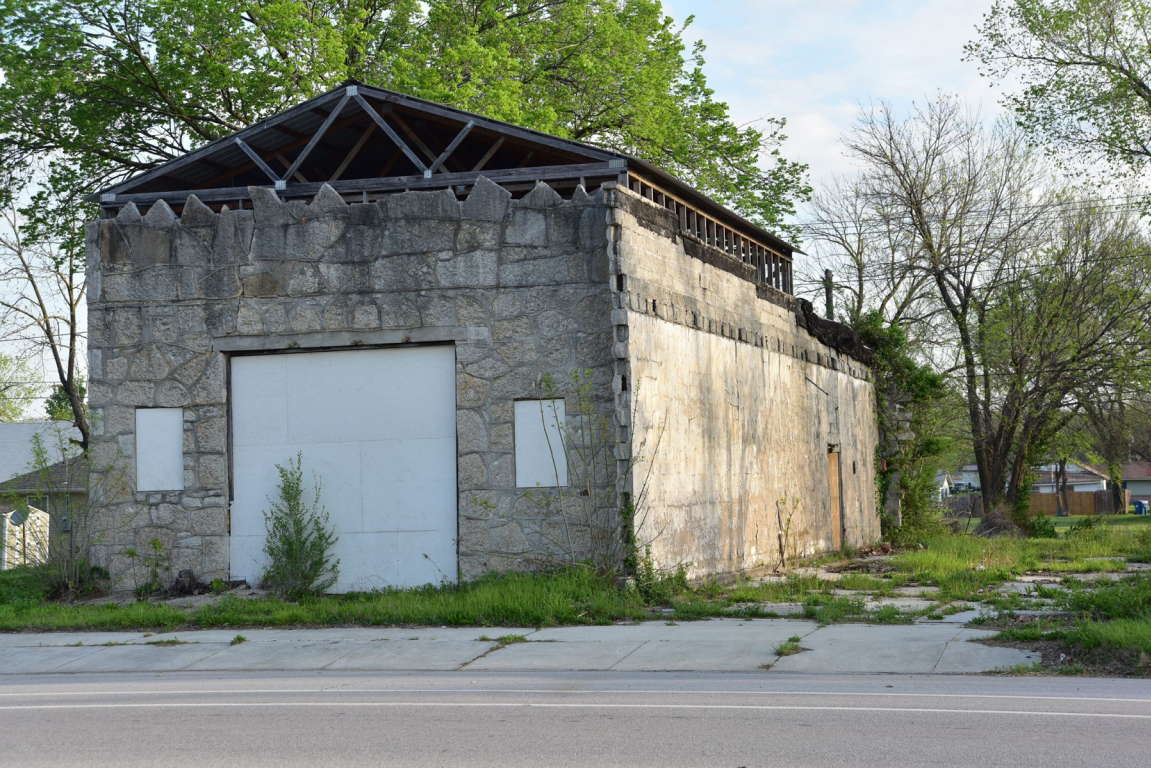
This warehouse faces south and has a rectangular footprint. It has a stone foundation and split-slab fieldstone cladding. A non-historic gable roof was installed over the building. The warehouse is three bays wide and five bays deep. The center bay has a large vehicular opening. Small rectangular windows flank the center opening. All bays are boarded up. A small portion of the CMU wall of the east addition remains while the rest of the addition was demolished in 2011.

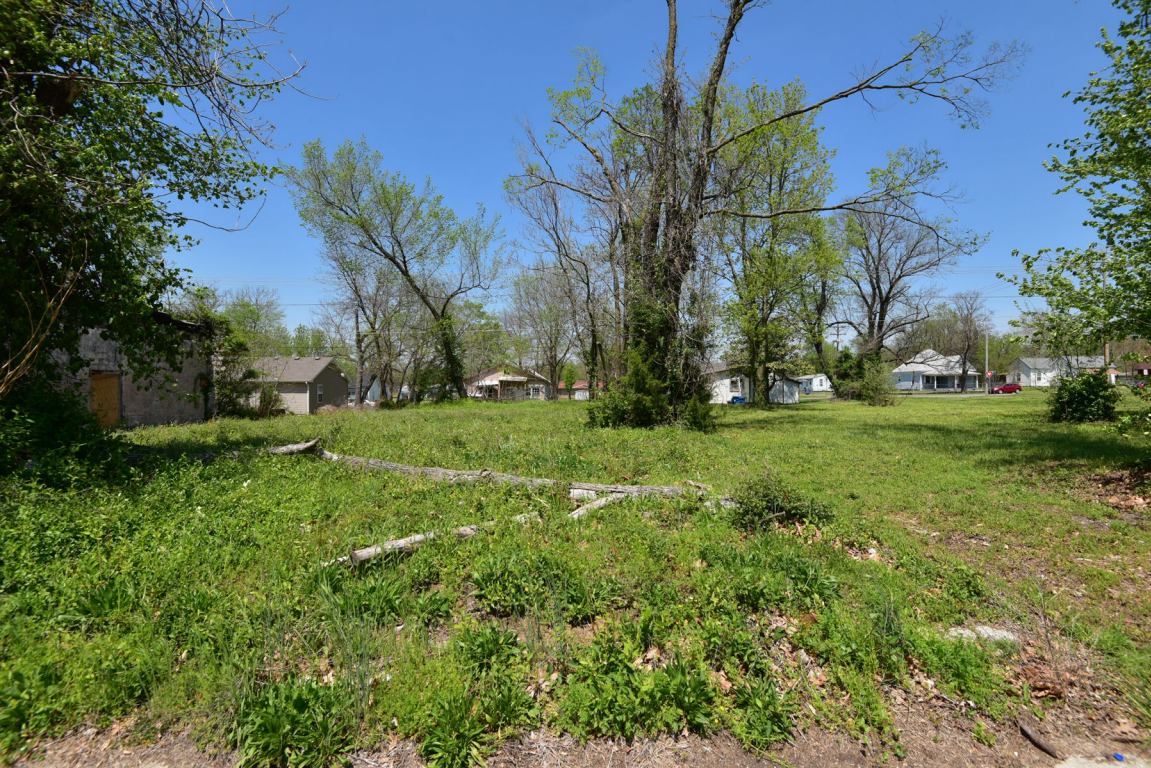
This vacant lot is located faces south and is located in the south portion of the Survey area. It is approximately fifty feet wide and ninety-five feet deep. Open grass areas, mature trees, and scrub characterize the lot. A concrete sidewalk abuts the south edged of the property while an east-west gravel alley abuts the north edge.

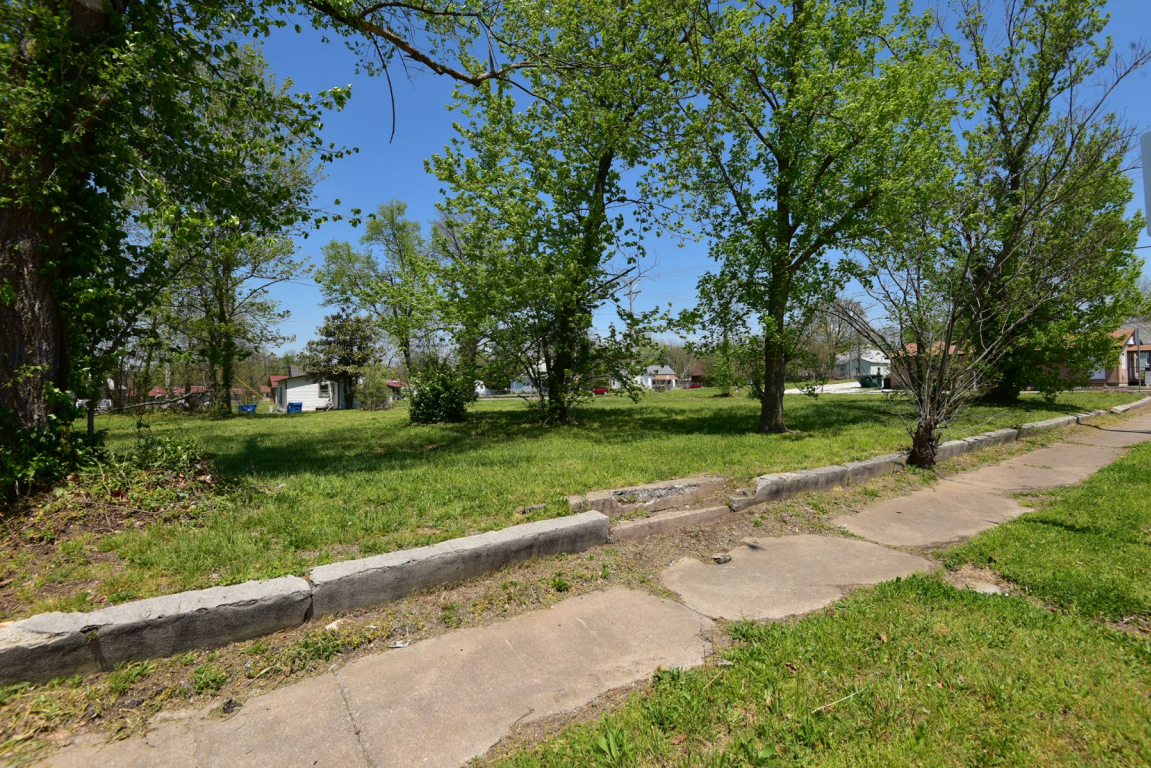
This lot is located at the northwest corner of Michigan Avenue and E. Broadway Street in the south portion of the Survey Area. It is approximately fifty feet wide and ninety-five feet deep. It is characterized by open grass areas, mature trees, and scrub. A low, concrete retaining wall with concrete stairs lines the south edge of the lot. A concrete sidewalk abuts the south edge of the property while an east-west gravel alley abuts the north edge.

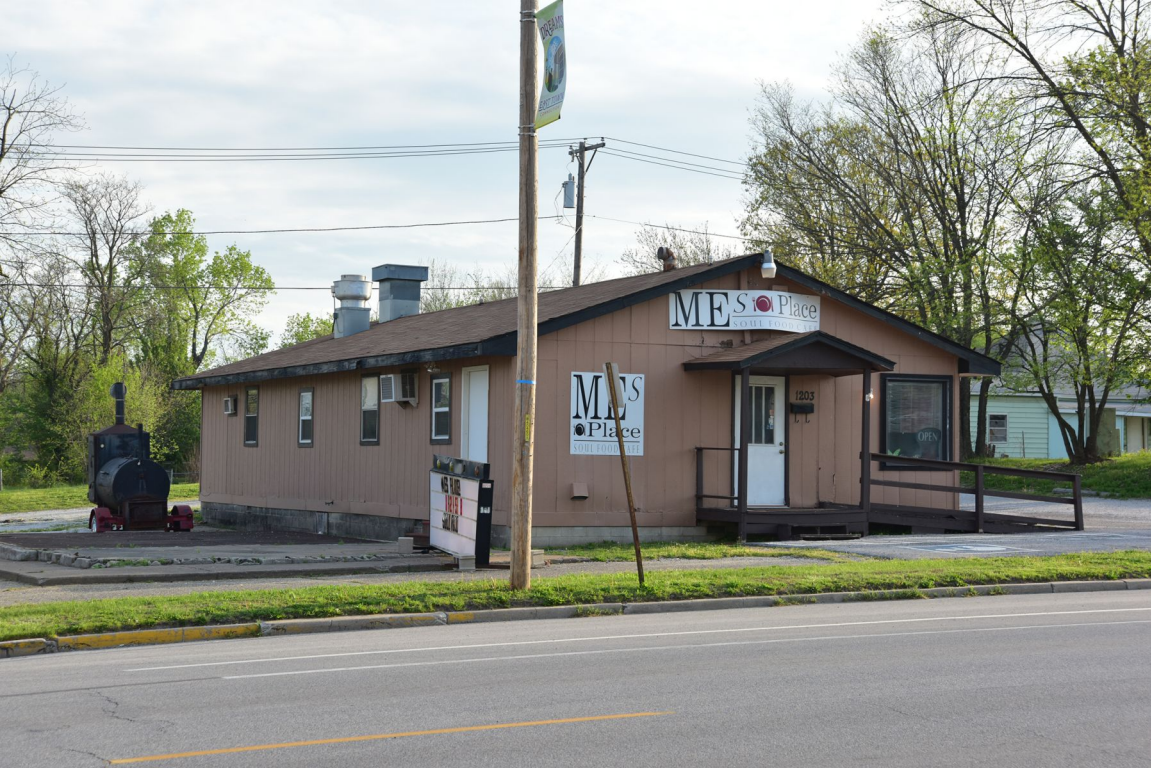
1203 E. Broadway Street is a one-story front-gable commercial building. It faces south and has a rectangular footprint. The building has a concrete block foundation and vertically oriented wood siding. The front-gable roof features asphalt shingle. The building is two asymmetrical bays wide and five bays deep. A one-part fixed display window forms the east bay. The remaining bay is centered on the primary elevation. A non-historic wood door with three-light glazing defines the centered bay. A front-gable porch roof shelters the entrance and a non-historic wood porch with ramp. Square wood posts support the porch roof. Secondary entrances are present at the east and west elevations. The east elevation features a one-by-one sliding metal window with narrow counter below.

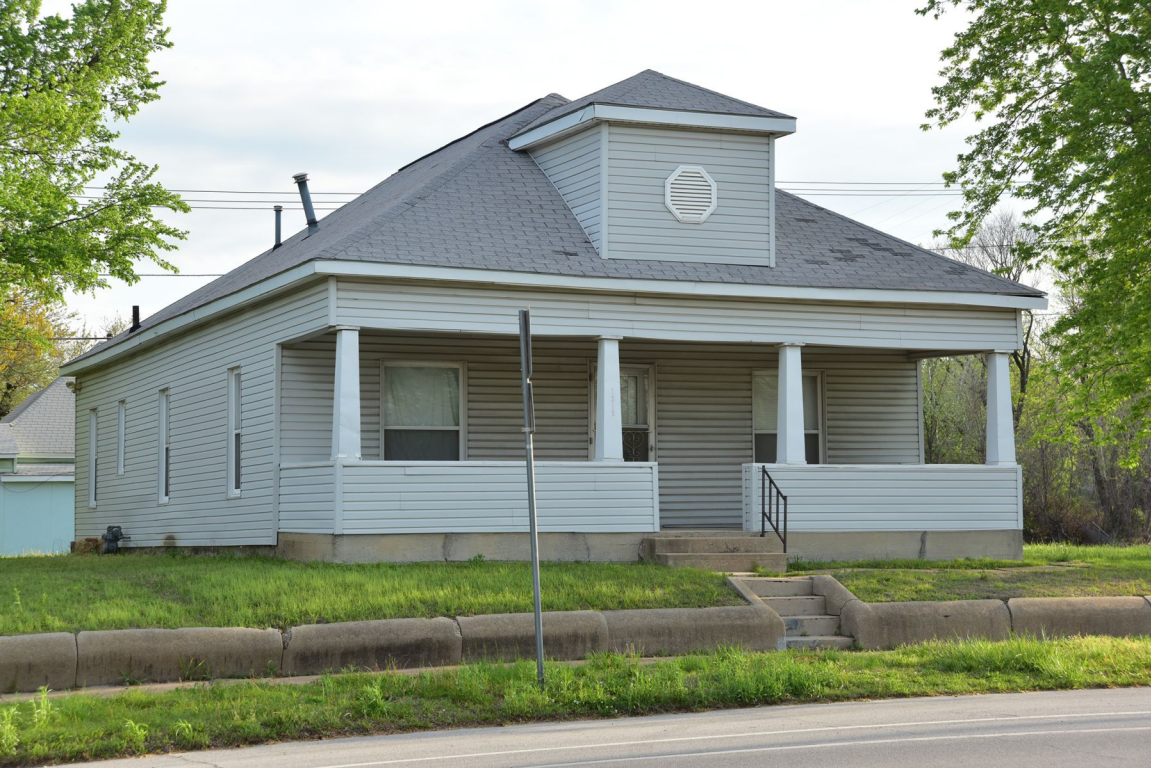
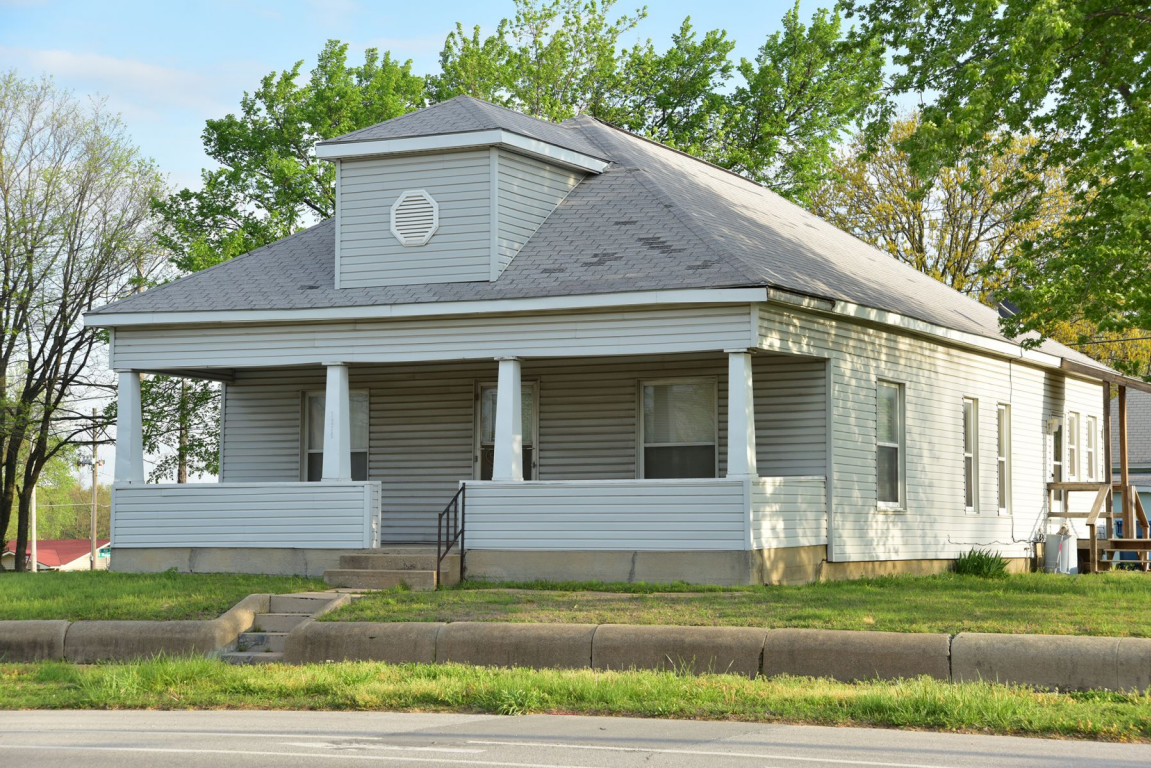
This one-story bungalow dwelling faces south and has a rectangular footprint. It features parged stone foundation and crawl space basement. The hipped roof is asphalt shingle and vinyl siding clads the dwelling. A hipped dormer with octagonal louver projects from the roof at the primary elevation. The dwelling is three symmetrical bays wide and six asymmetrical bays deep. The center bay features a non-historic wood door with glazing while one-over-one vinyl windows form the east and west bays. A full-width open porch spans the primary elevation, sheltering the bays. Vinyl-clad Tuscan columns support the porch roof while vinyl wraps the porch front. A secondary entrance is located in the second-from-north bay on the east elevation. A non-historic shed roof porch shelters this entrance. One-over-one vinyl windows define the remaining bays.

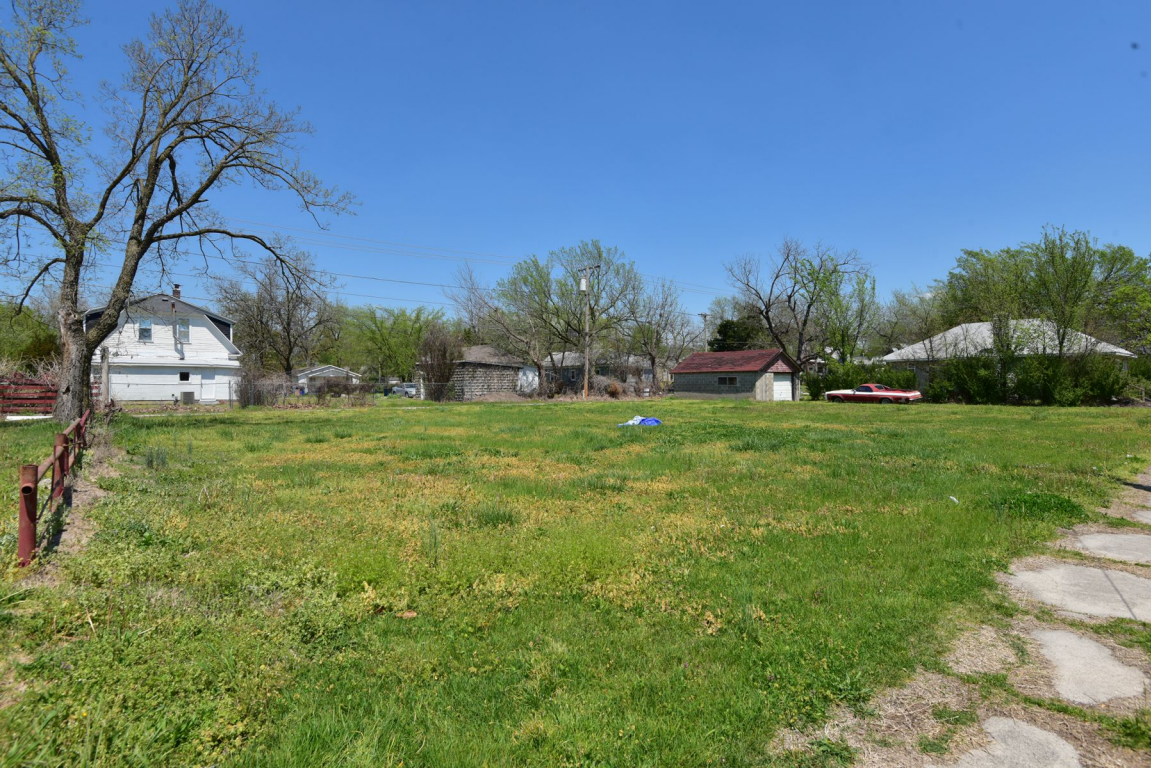
This lot faces south and is located in the south portion of the Survey Area. A c.1980 concrete block garage is located in the northeast corner of the lot. The garage is two-bays wide and has a rectangular footprint. The front-gable roof has asphalt shingles. A metal overhead garage door occupies the east bay while a wood door occupies the west bay. A one-by-one sliding window is located at the west elevation. An east-west gravel alley abuts the north edge of the property while a concrete sidewalk abuts the south edge.

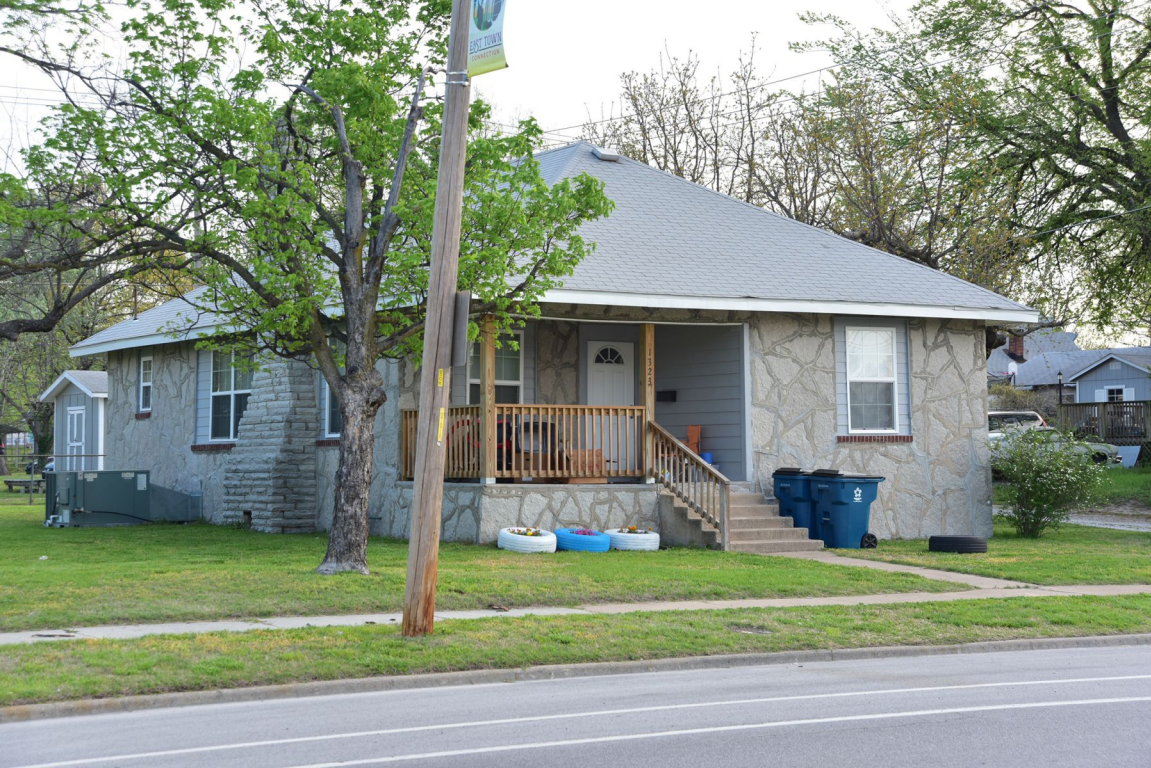
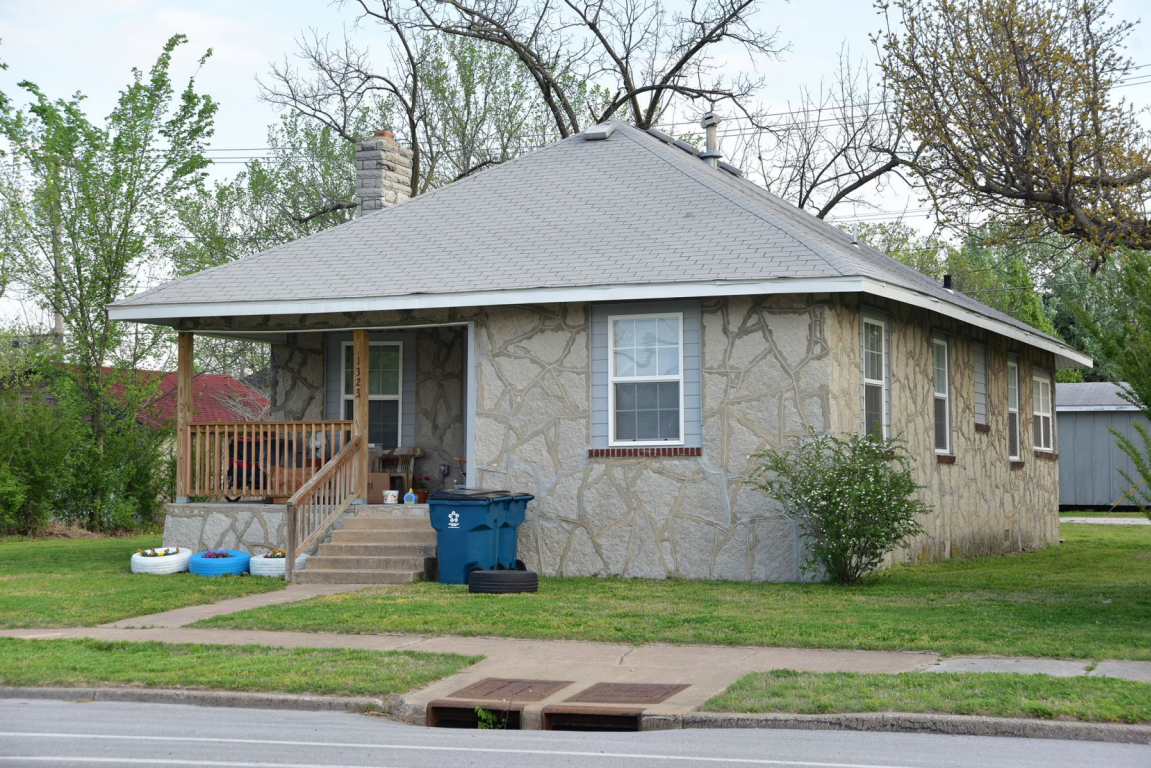
This one-story Pyramidal Folk House faces south and has a rectangular footprint. It features a field stone foundation with crawl space basement and hipped roof with asphalt shingle. Split slab fieldstone clads the dwelling. A limestone exterior chimney is located at the west elevation. The dwelling is three bays wide and five asymmetrical bays deep. A partial-width recessed porch shelters the west two bays of the primary elevation, including the primary entrance with a non-historic fiberglass door. A single six-over-six vinyl window defines the remaining bays. The porch features non-historic matchstick balusters and concrete steps. The east wall of the recessed porch features wide-profile clapboard siding. The dwelling's windows are six-over-six vinyl that are slightly smaller than the historic openings with head brick sills. Vinyl siding fills the opening around the window.
