1. Survey number: JP-AS-006-001		2. Survey Name: East Town (Original Joplin) Historic Survey Phase 1	
3. County: JASPER		4. Address 503	Street (name): E. Broadway Street
5. City: Joplin	Vicinity <input type="checkbox"/>	7. Township/Range/Section: T: R: S:	
8. Historic name (if known):		9. Present/other name (if known):	
10. Ownership: <input checked="" type="checkbox"/> Private <input type="checkbox"/> Public		11a. Historic use (if known): Domestic/Single Dwelling	11b. Current use: Domestic/Single Dwelling

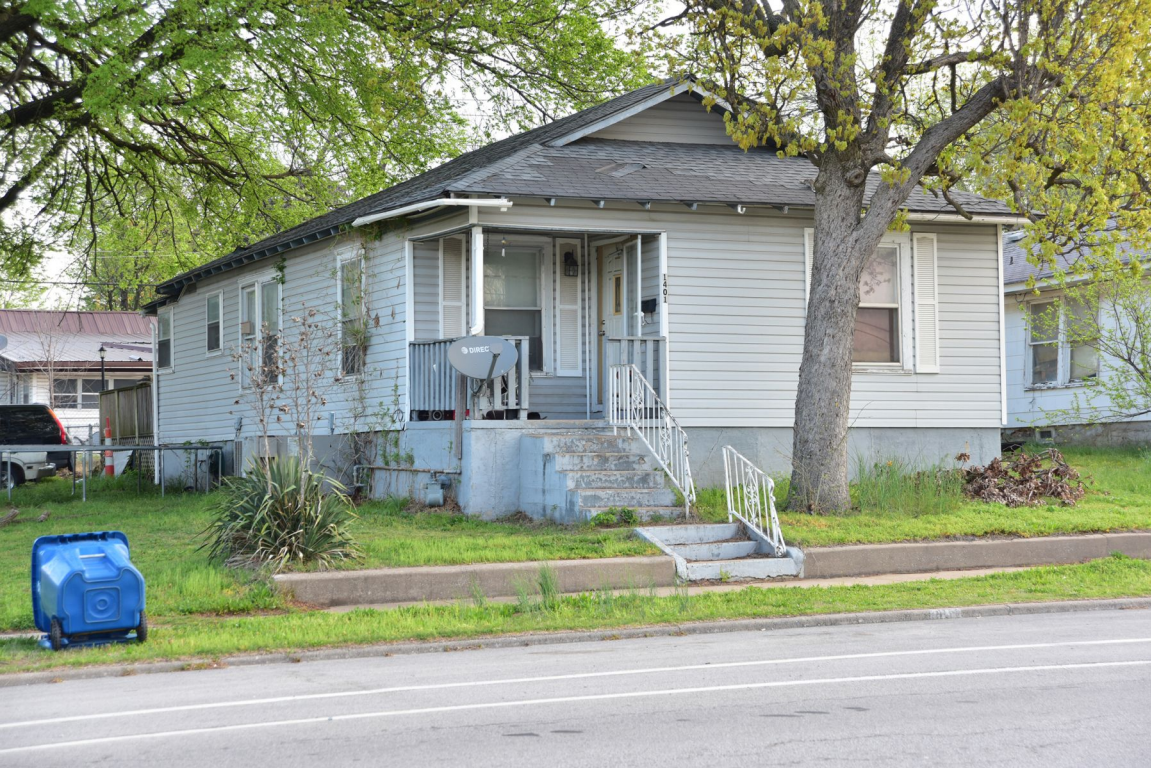
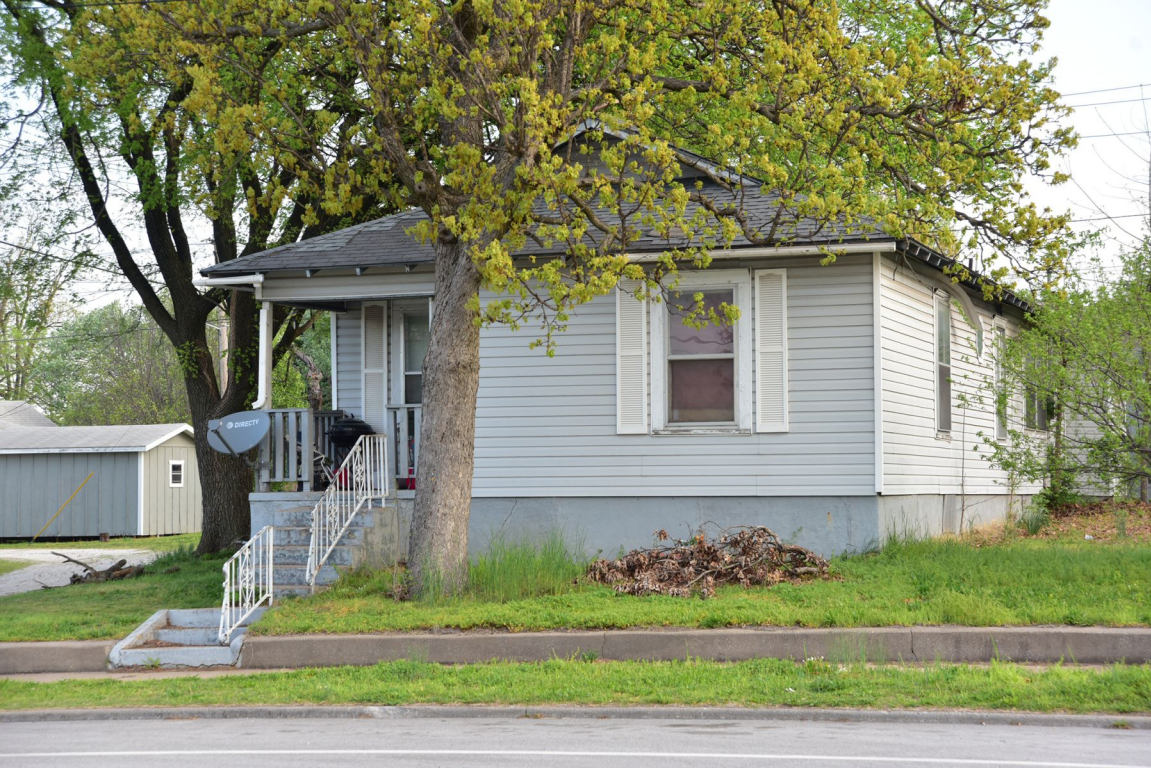
This one-story dwelling faces south and has a rectangular footprint. The stone foundation is parged. The front-gable roof features asphalt shingle and exposed rafter tails. The dwelling features vinyl siding. A recessed partial-width porch forms the southwest corner of the dwelling and shelters a single window and the primary entrance. The entrance is located on the east wall of the porch and features a non-historic wood door with glazing. A non-historic square wood post supports the porch. The wood railing and balusters are non-historic. Windows are historic one-over-one with wood sash and feature flat board trim and modest crown molding. Narrow false shutters flank both windows at the primary elevation.

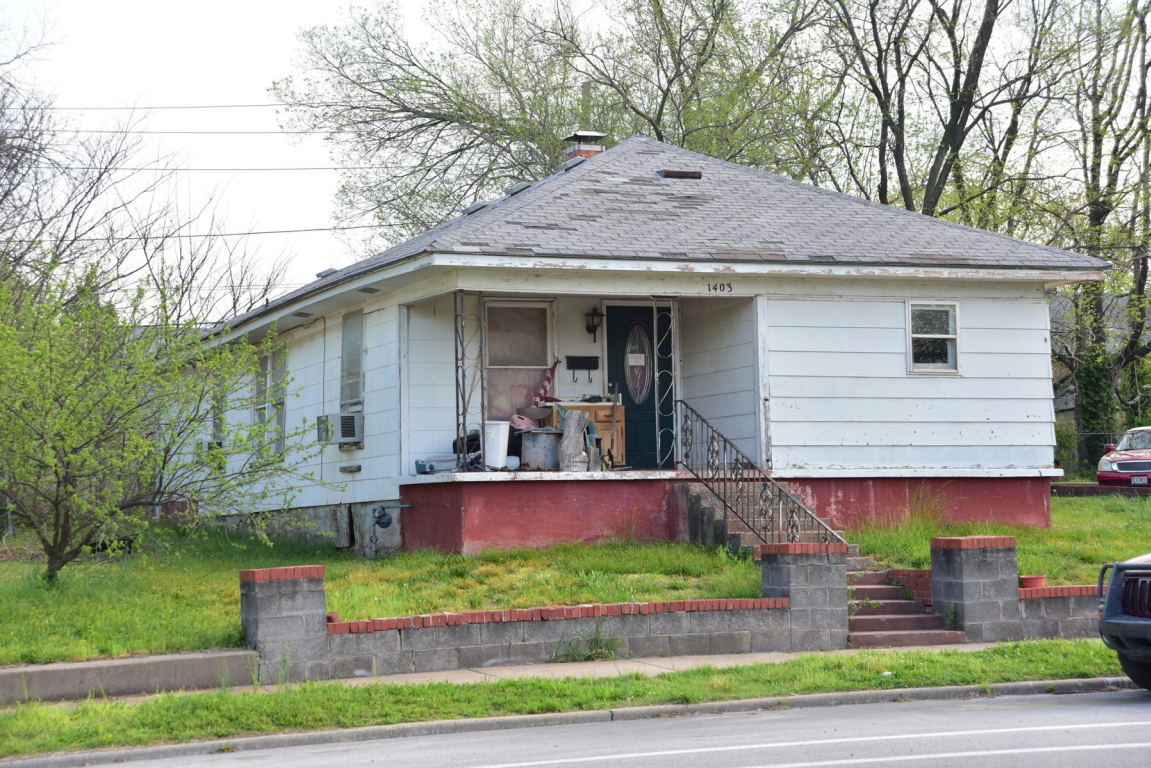
This one-story bungaloid dwelling faces south and has a rectangular footprint. It has a concrete foundation, crawl space basement, and hipped asphalt shingle roof with wide eaves. A combination of asbestos shingle and wide-profile pressboard clads the dwelling. It is three bays wide and five bays deep. A recessed porch shelters the two west bays of primary elevation, including the primary entrance with non-historic wood door with glazing. A single one-over-one wood window forms the westernmost bay while a small one-over-one wood window forms defines the east bay. The windows at the secondary windows are wood one-over-one. The recessed porch is supported by non-historic decorative iron posts and does not possess railings. A run of concrete steps with decorative railing provides access to the porch. A short, straddle ridge brick chimney pierces the roof.

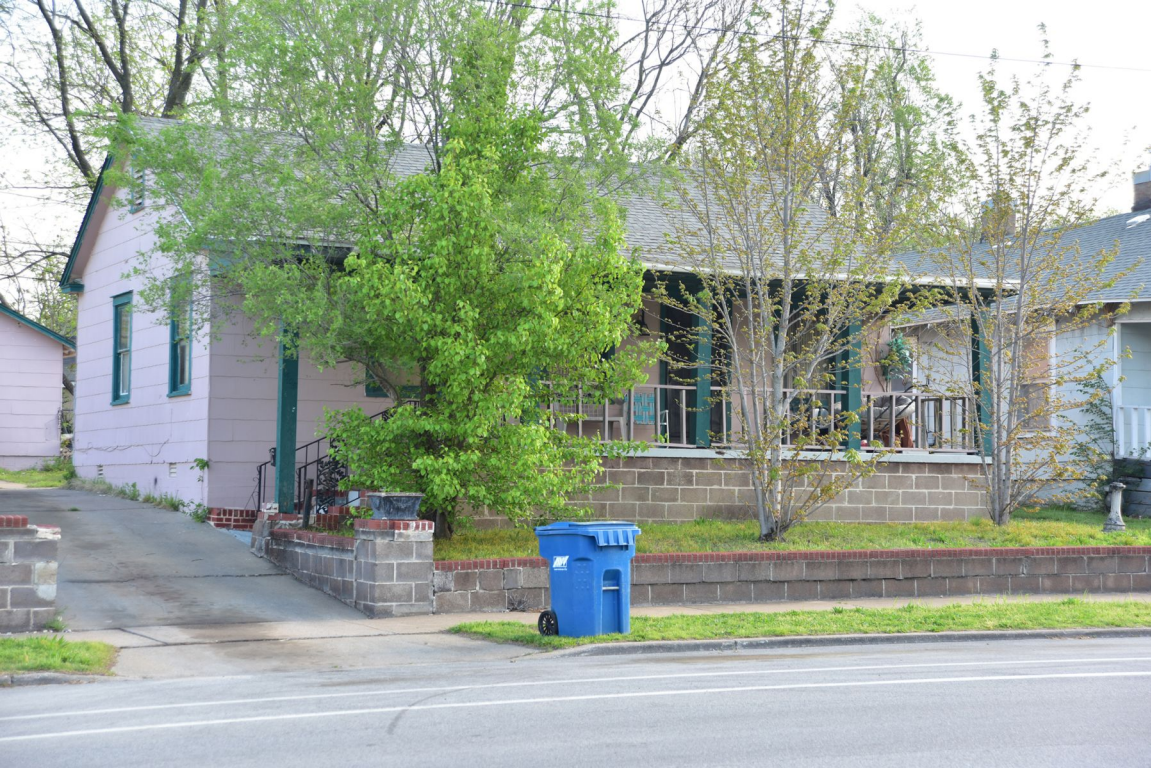
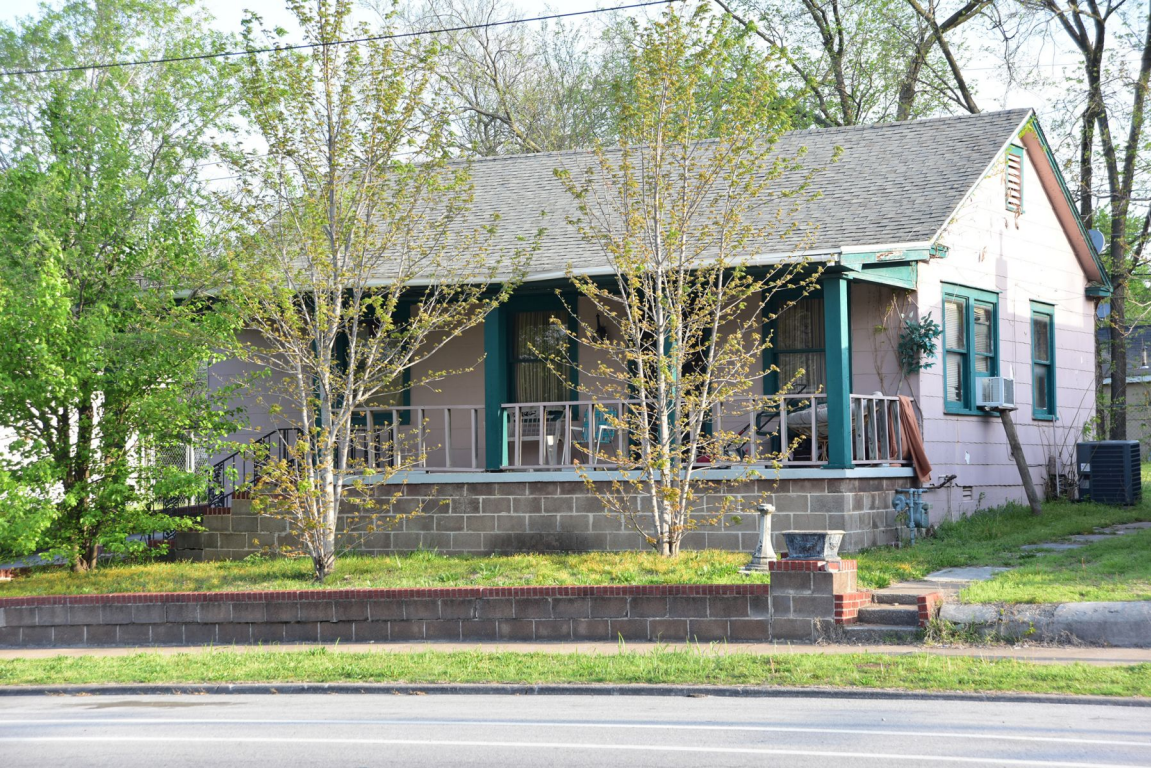
This one-story dwelling faces south and has a rectangular footprint. It has a concrete block foundation and asbestos shingle cladding. The side-gable roof has asphalt shingles and is characterized by short cornice returns and rectangular louvers at the gable ends. A shed roof porch spans the width of the primary elevation and is accessed by concrete and brick steps at the west edge. The porch has a concrete block foundation and is supported by square wood posts with non-historic matchstick balusters. A non-historic decorative metal railing lines the steps of the porch. The primary elevation features four bays. A non-historic wood door with glazing defines the second-from-east bay while single one-over-one windows define the remaining three bays. The wood one-over-one windows are historic and feature flat board trim with modest crown molding.

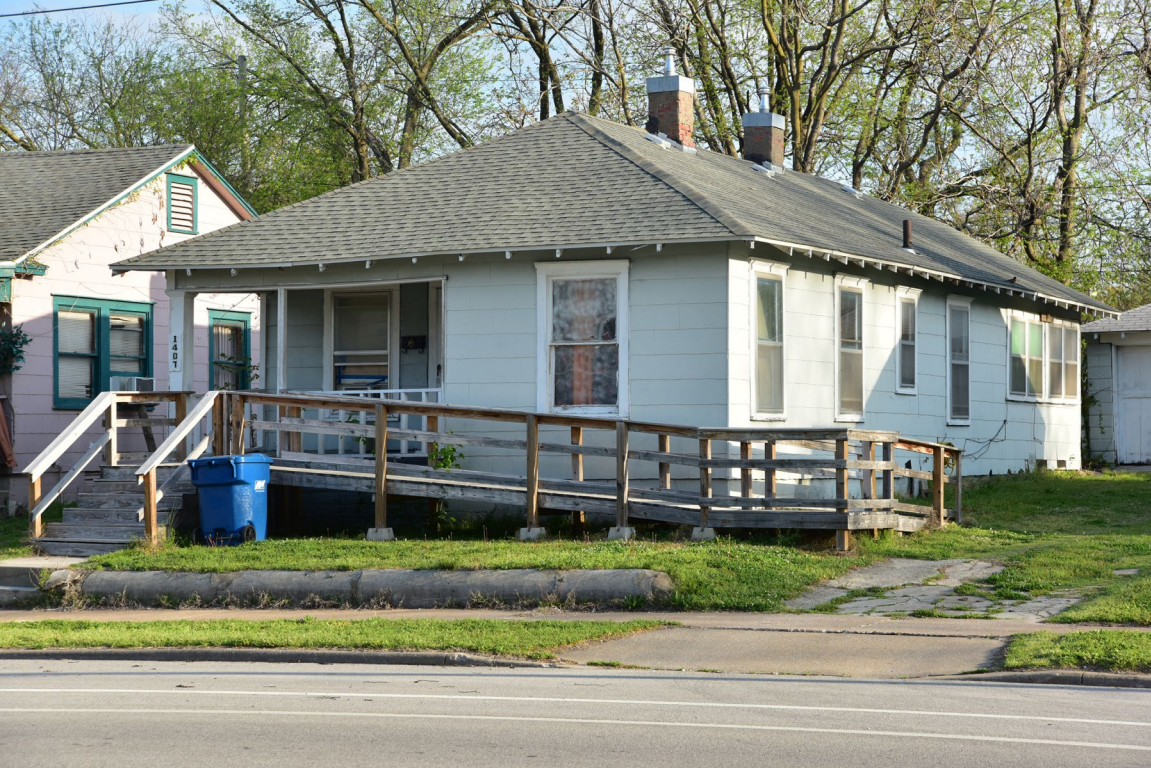
This one-story bungalow dwelling faces south and has a rectangular footprint. It has a concrete foundation with crawl space basement and hipped roof with asphalt shingle and exposed rafter tails. The dwelling features asbestos shingle over wood clapboard cladding. The primary elevation has three bays. A non-historic fiberglass door forms the center bay while historic one-over-one wood windows define the remaining bays. A recessed porch shelters the two west bays and features wood columns and matchstick balusters. A non-historic wood ramp and stair system spans the width of the primary elevation. The historic one-over-one wood windows have flat board trim and modest crown molding. Two short, straddle ridge brick chimneys pierce the roof.

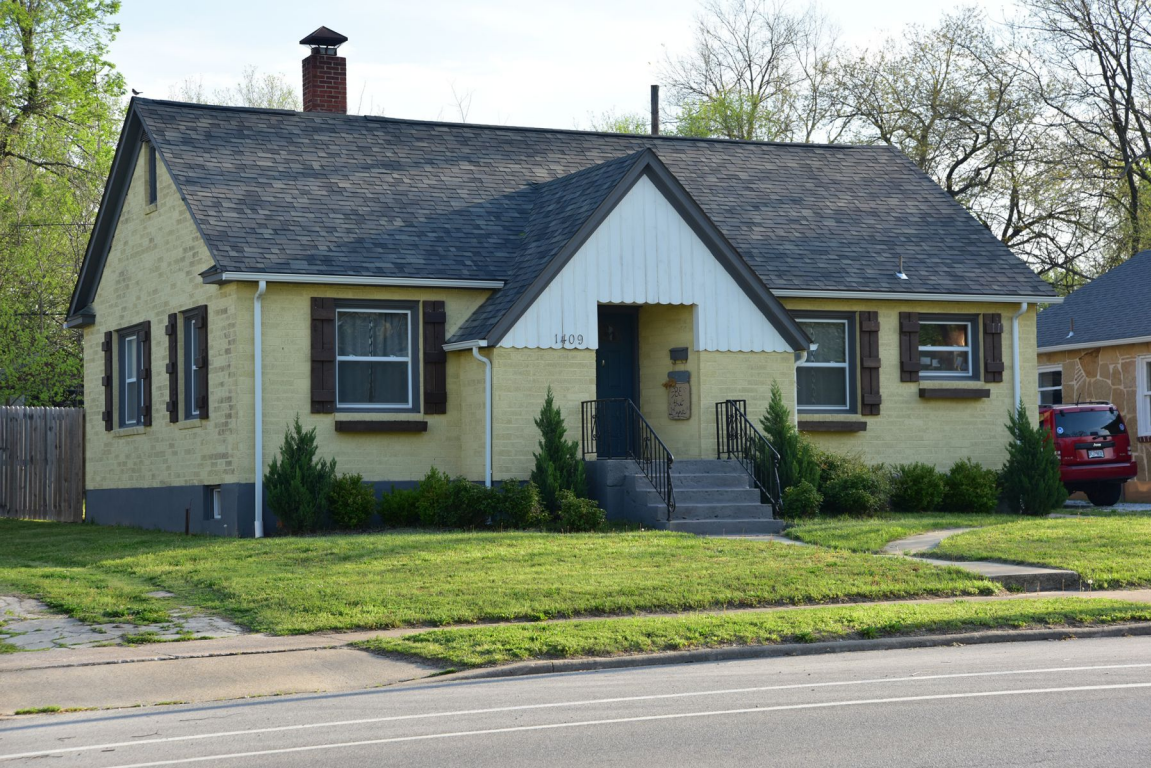
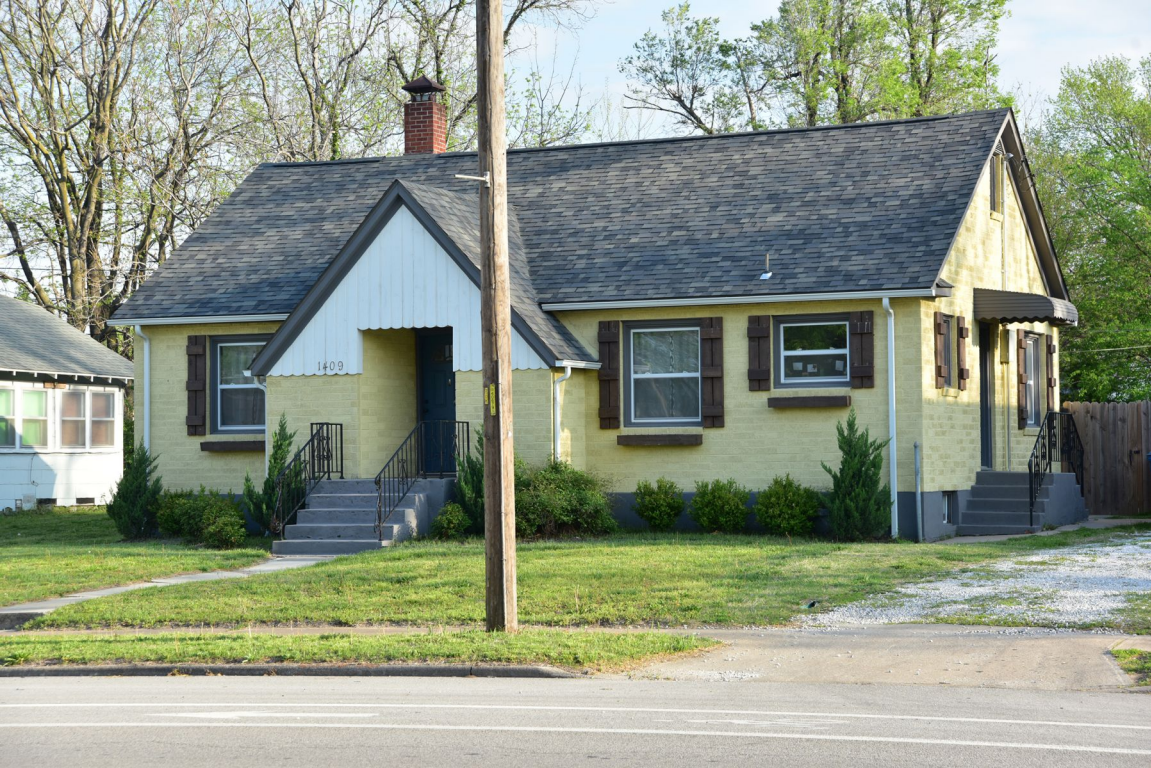
This one-story Minimal Traditional brick dwelling faces south and has a rectangular footprint. The foundation is parged concrete with a partial basement and the side-gable roof has asphalt shingles. The gable ends are characterized by short cornice returns and small, one-over-one windows. A center gable projects from the primary elevation and shelters the recessed stoop and non-historic fiberglass door. Scalloped wood planks clad the upper half of the center gable. A secondary stoop porch is located at the east elevation. A metal awning projects over the porch. The one-over-one vinyl windows feature modest crown molding, header brick sills, and false shutters. A brick rear-slope chimney is off set west.

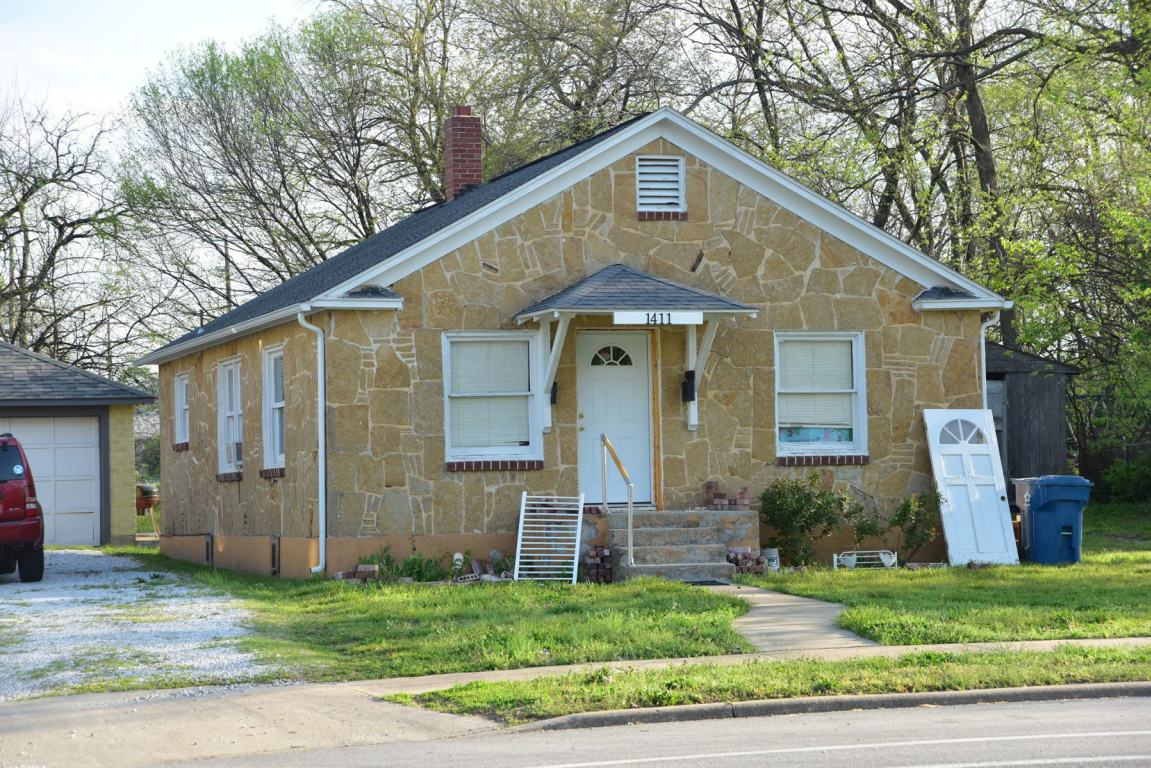
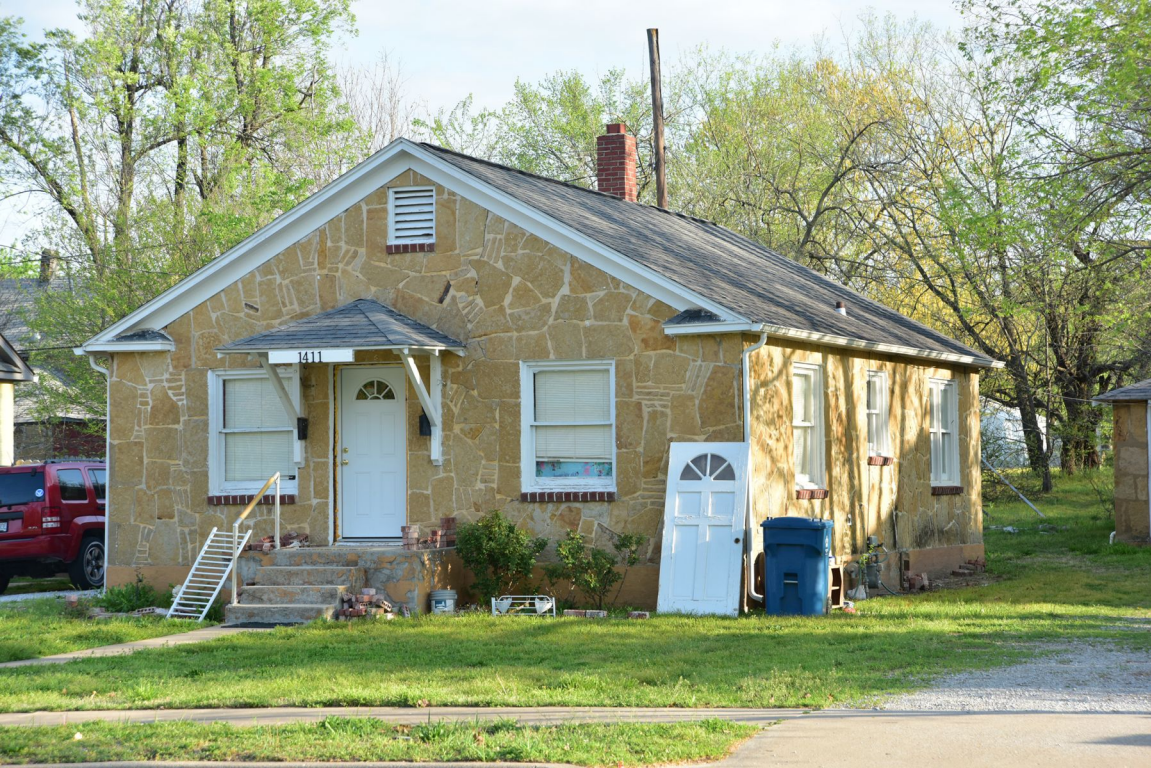
This one-story dwelling faces south and has a rectangular footprint. It has a parged stone foundation with crawl space basement and split slab field stone cladding. The front-gable roof has asphalt shingles and is characterized by narrow eaves and cornice returns. A rectangular louver is present in the gable at the primary elevation. The dwelling is asymmetrical three bays wide and three bays deep. One-over-one historic wood windows with header brick sills define the east and west bays of the primary elevation while a non-historic fiberglass door forms the center bay. A hipped roof with exposed rafter tails projects over the stoop entrance. Knee brackets support the porch roof. A non-historic metal railing is present on the west side of the stoop steps. A brick chimney is slightly off set west of the roof ridgeline.

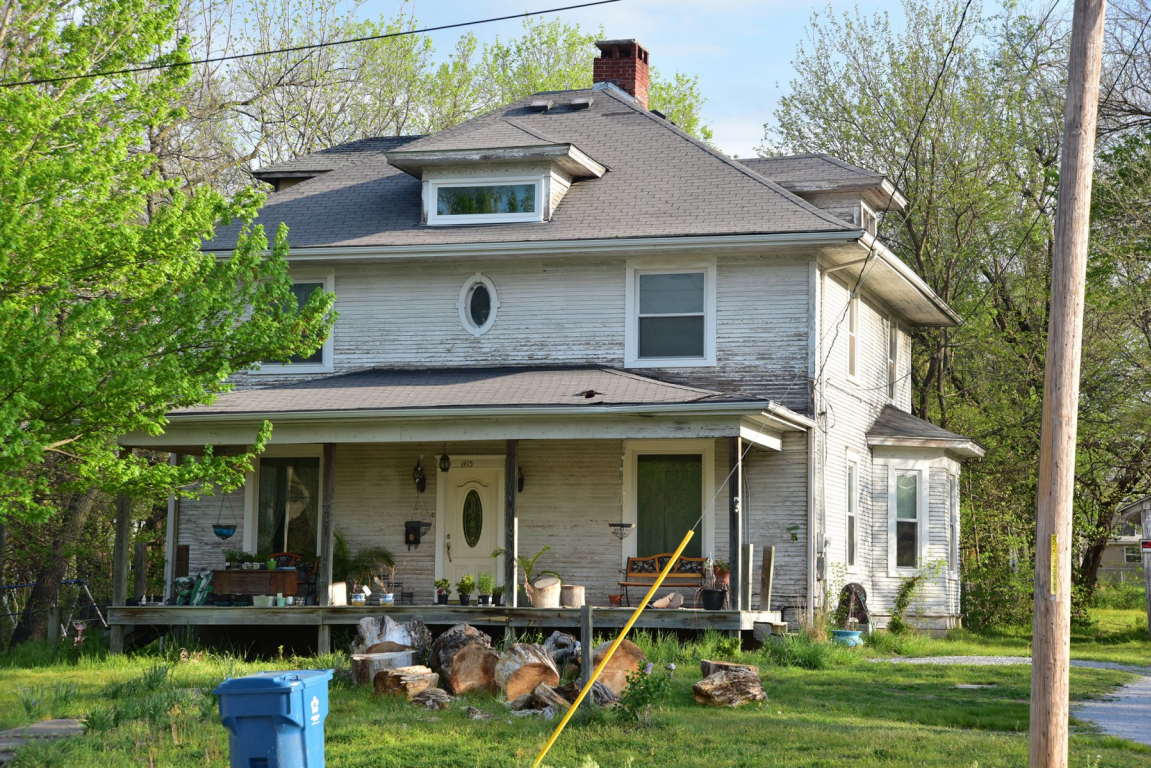
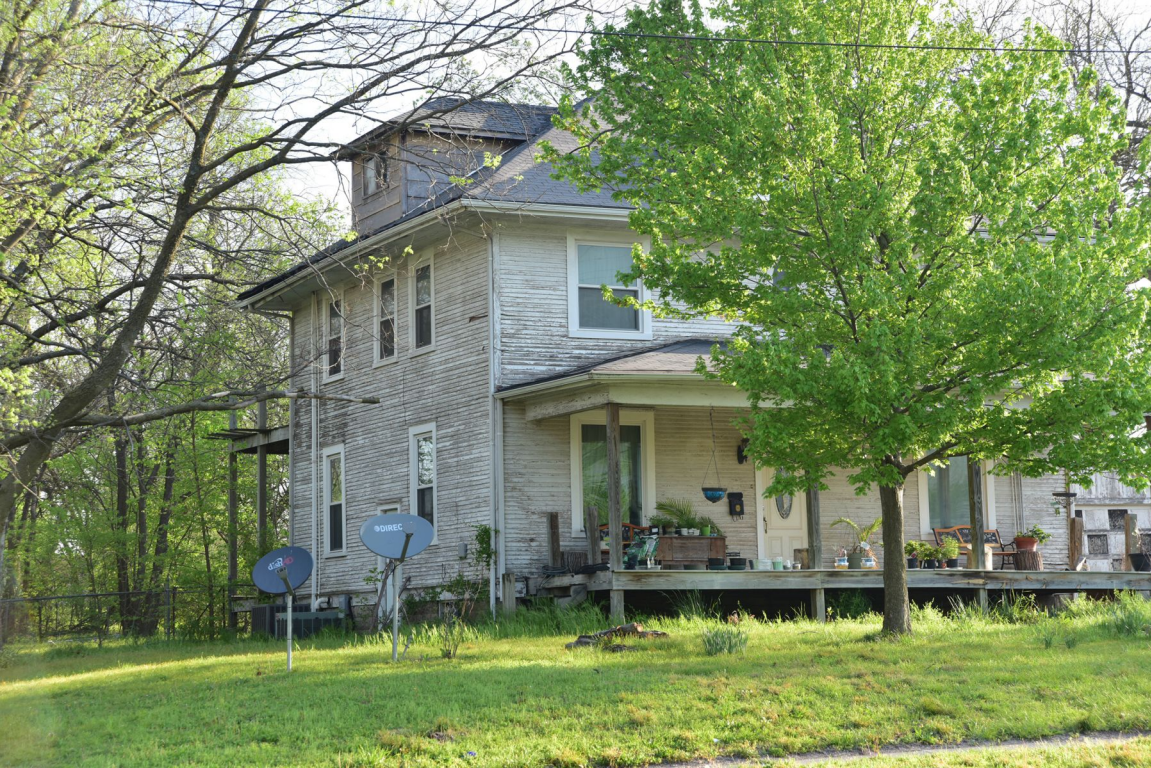
This two story American Foursquare dwelling faces south and has a rectangular footprint. It has concrete block foundation and narrow profile wood clapboard cladding. The hipped roof features asphalt shingles and wide eaves. Hipped dormers are located at the east, south, and west elevations. The dwelling is three bays wide and three asymmetrical bays deep. A non-historic wood door with glazing forms the center bay of the first story at the primary elevation. One-light fixed sash vinyl windows form the east and west bays. One-over-one vinyl windows form the east and west bays at the second story of the primary elevation while a fixed oval window forms the center bay. The dormer at this elevation features a fixed sash vinyl window while the dormers at the east and west elevations feature hopper windows. One-over-one vinyl windows are present at the secondary elevations. A bay window projects from the rear of the east elevation. An open, full-width porch with hipped roof spans the primary elevation. Non-historic square wood posts support the roof and the porch lacks a railing and balustrade. A brick chimney projects from the roof peak.

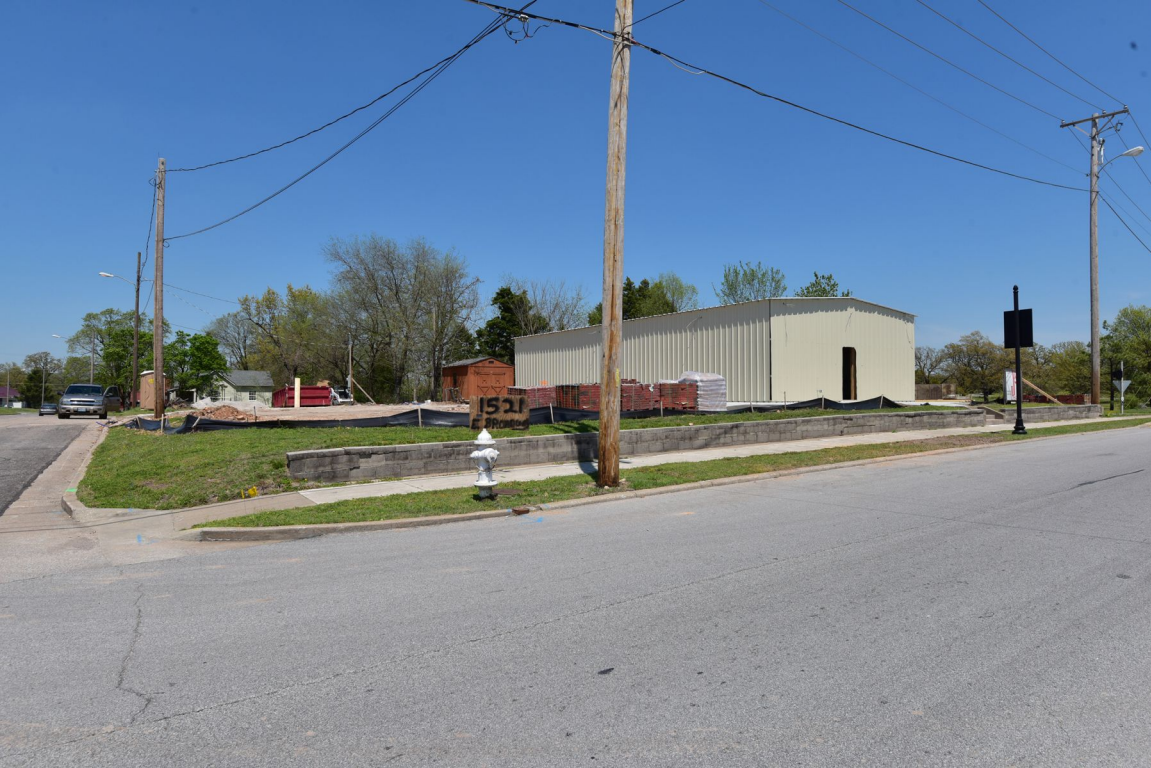
The one-story Butler Building has a concrete foundation, metal siding, and a gabled roof with metal roofing. There is a single pedestrian opening in the south elevation. Construction does not appear to be complete.

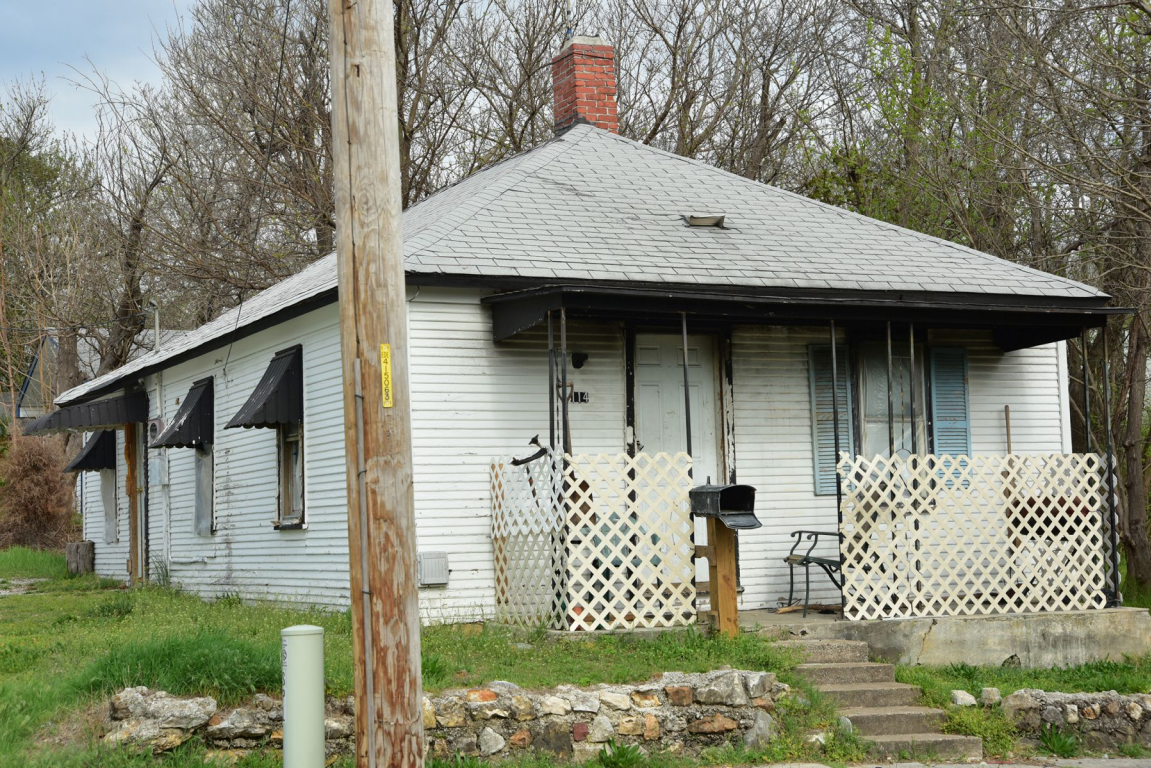
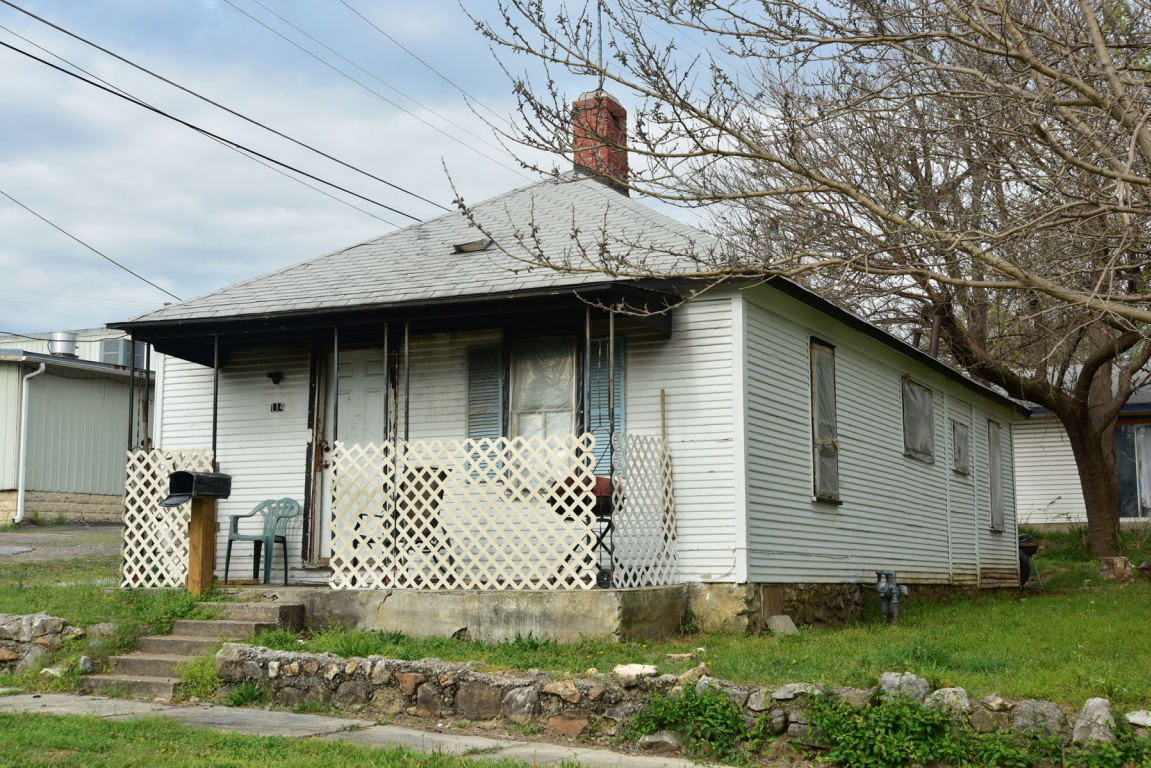
This one-story bungalow dwelling faces east and has a rectangular footprint. It has a field stone foundation and hipped roof with asphalt shingles. Narrow profile wood clapboards clad the dwelling. It is two asymmetrical bays wide and four bays deep. A non-historic flat roof porch with decorative iron posts shelters the bays of the primary elevation. A non-historic six-panel wood door with flat board trim forms the south bay while a historic one-over-four wood window with false shutters forms the north bay. A secondary entrance is located in the second-to-west bay of the south elevation. Windows at this elevation are historic one-over-four historic wood windows. Metal awnings shelter the bays of this elevation. A brick chimney pierces the roof on the north slope.

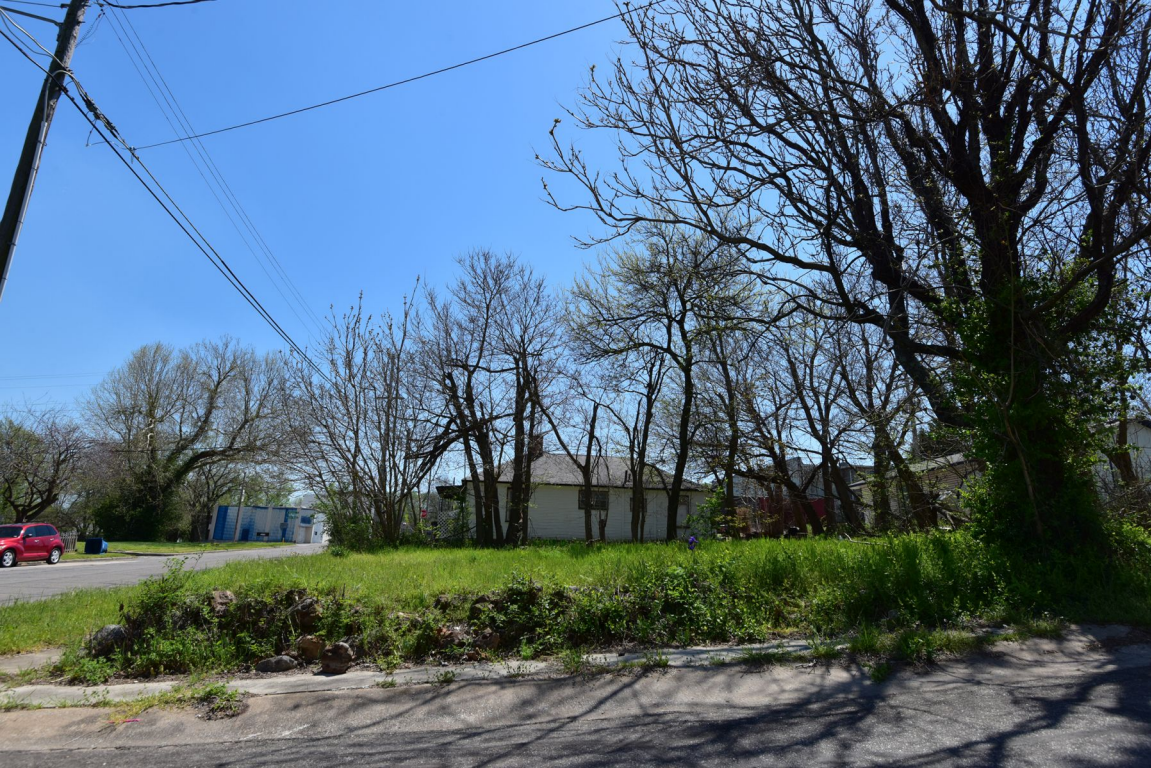
A large, open grass area bordered by mature trees and scrub characterizes the lot. The remains of a fieldstone retaining wall line the north and east edges of the lot. Concrete sidewalks abut the north and east edges of the property.

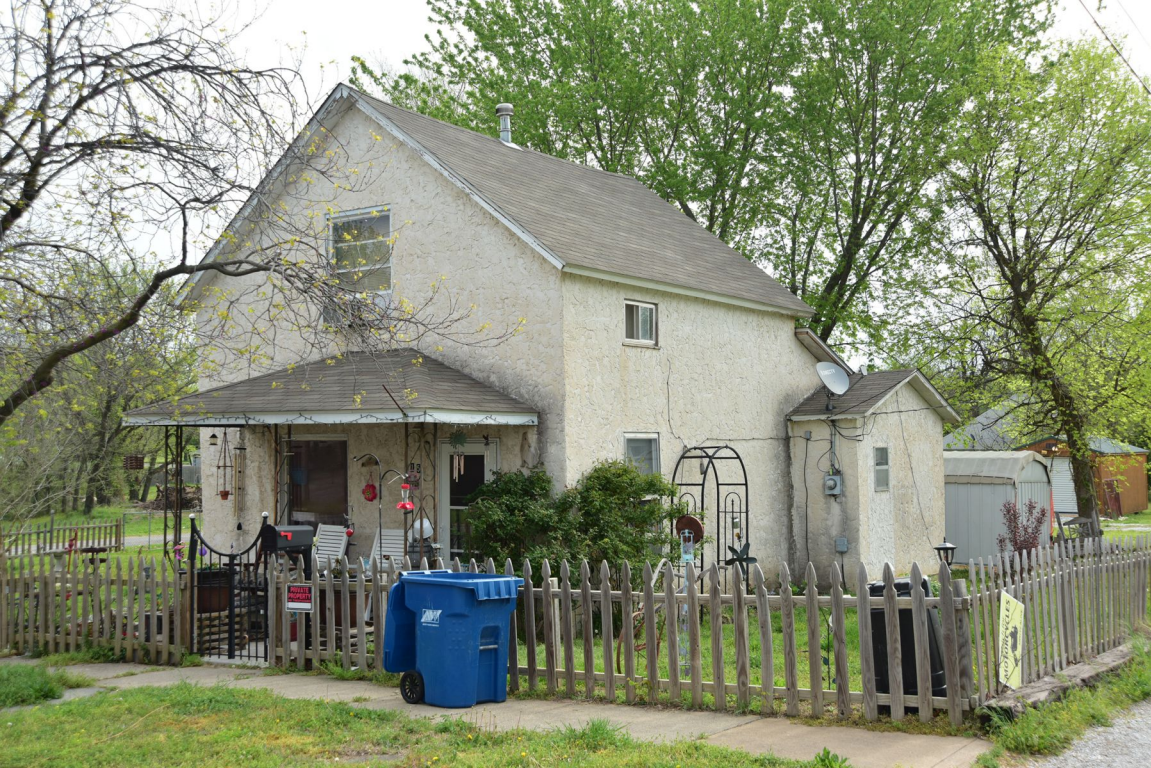
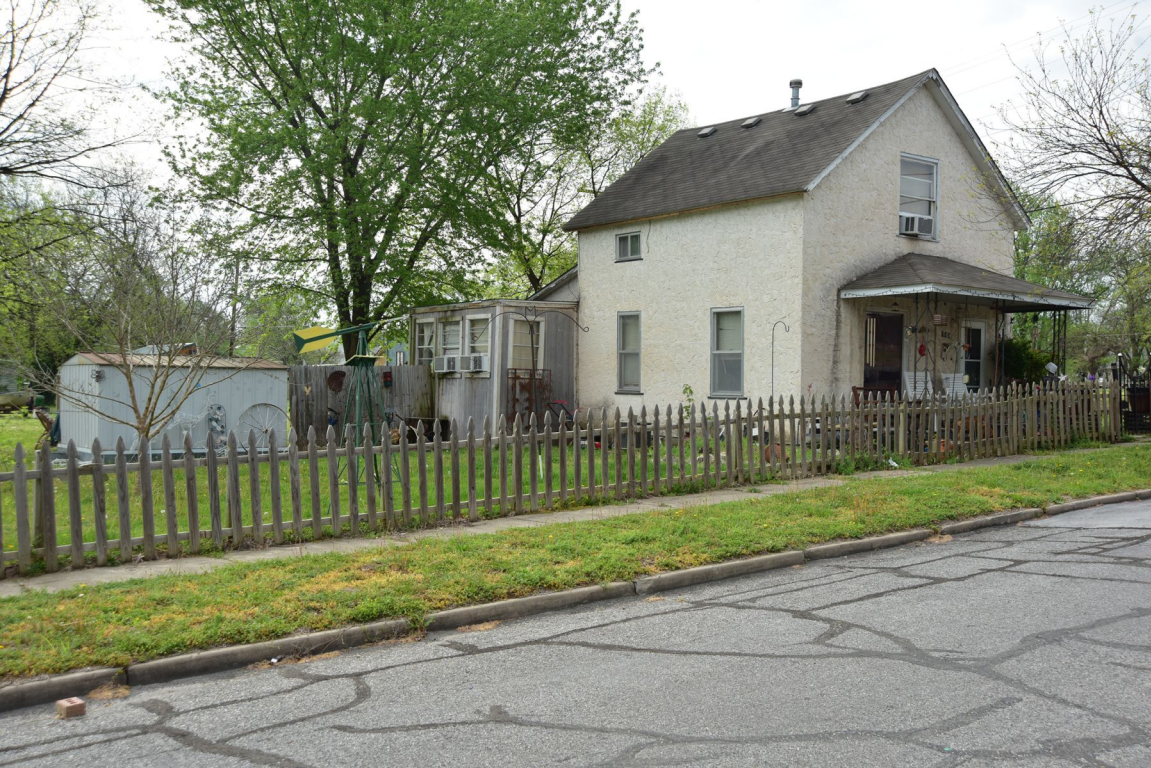
This two-story dwelling faces west and has an irregular footprint. It has a stone foundation and stucco cladding. The front-gable roof has asphalt shingles and narrow eaves. The stucco does not appear to be historic because the windows are recessed in the stucco and there is no trim on the windows. The first story of the primary elevation has two bays. A non-historic wood door fills the south bay while a one-light fixed sash wood window forms the north bay. The second story has one central bay at the primary elevation. The second story of the north and south elevations features one non-historic two-part hopper window. A historic one-over-one wood window defines this bay on each elevation. A three-quarter width porch shelters the bays of the primary elevation. The porch features a hipped roof with asphalt shingles and decorative iron support posts. An addition with shed roof and stucco cladding is located at the rear. A flat roof enclosed porch with wood plank cladding and two-over-two wood windows projects from the north elevation of the rear addition.

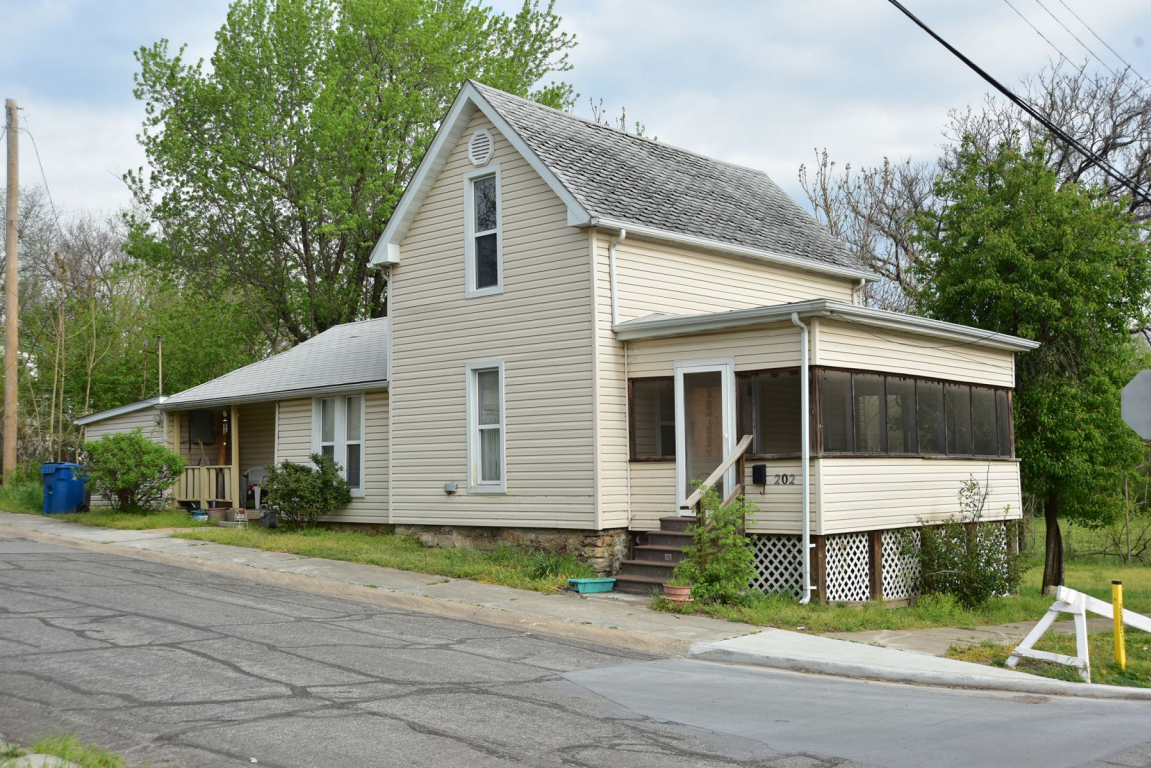
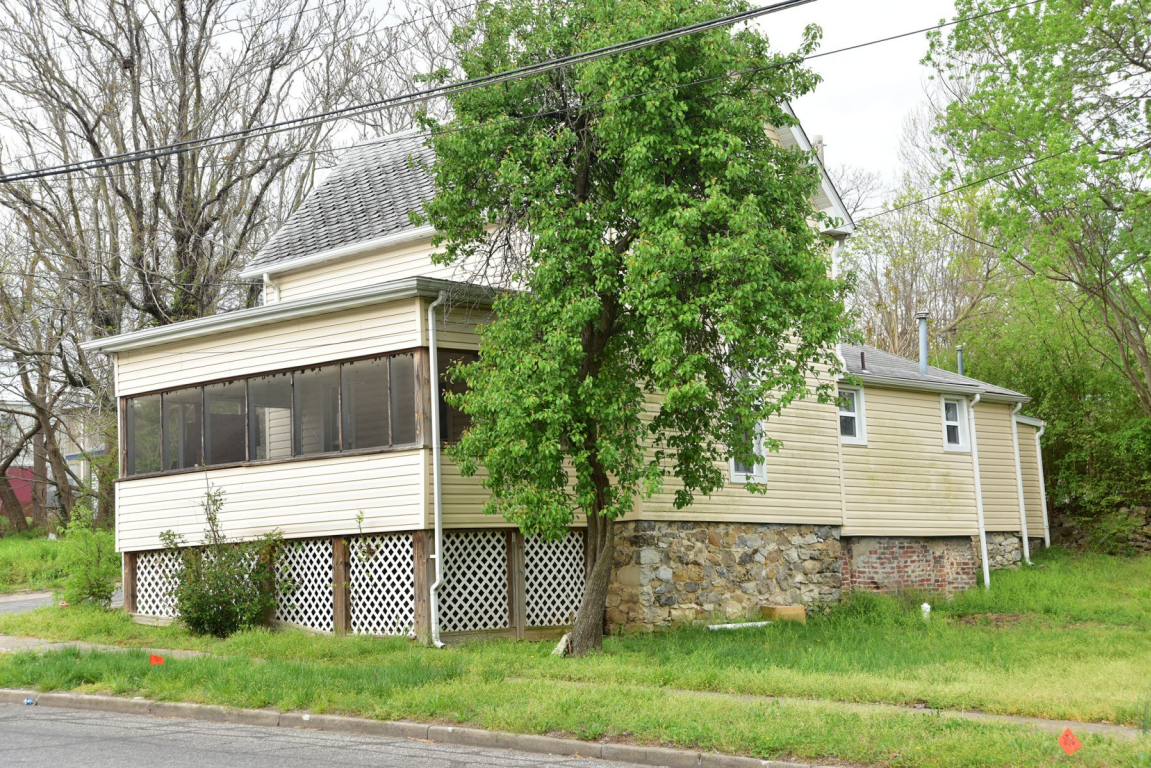
This two-story Gabled-ElI dwelling faces east and has an irregular footprint. It has a fieldstone foundation and is vinyl clad. The roof has asphalt shingles. A non-historic enclosed porch with flat roof obscures the east elevation. The north south elevation has single tall narrow windows at each story. The gabled west wing has a pair of tall narrow windows and a recessed porch. The siding, windows, and porch have all been replaced.

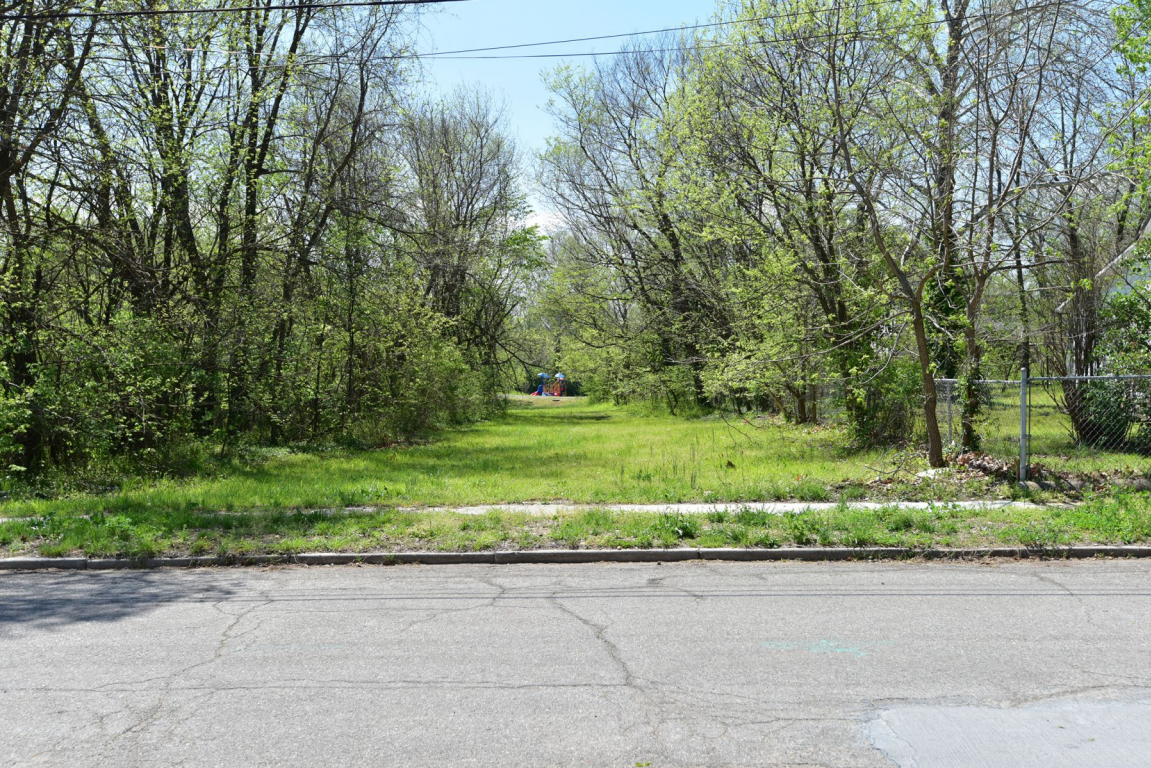
This lot is characterized by a narrow, open grass area boarded by trees and scrub. A concrete sidewalk abuts the east edge of the property.

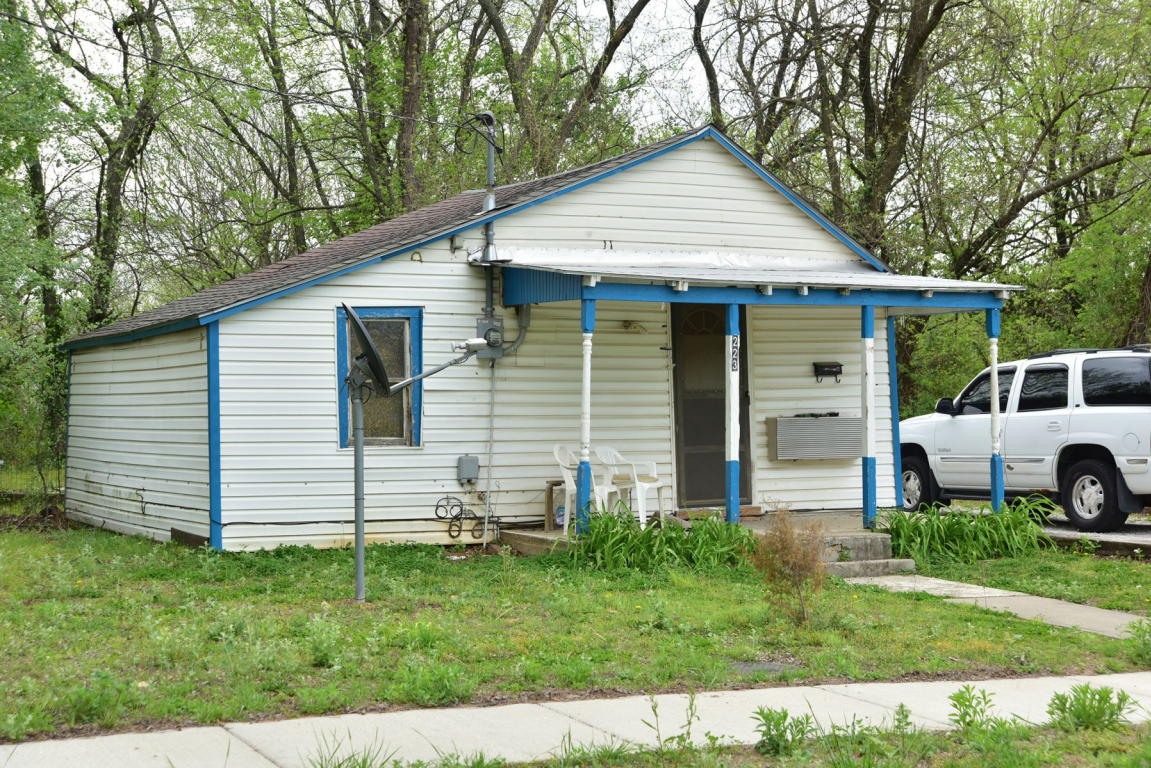
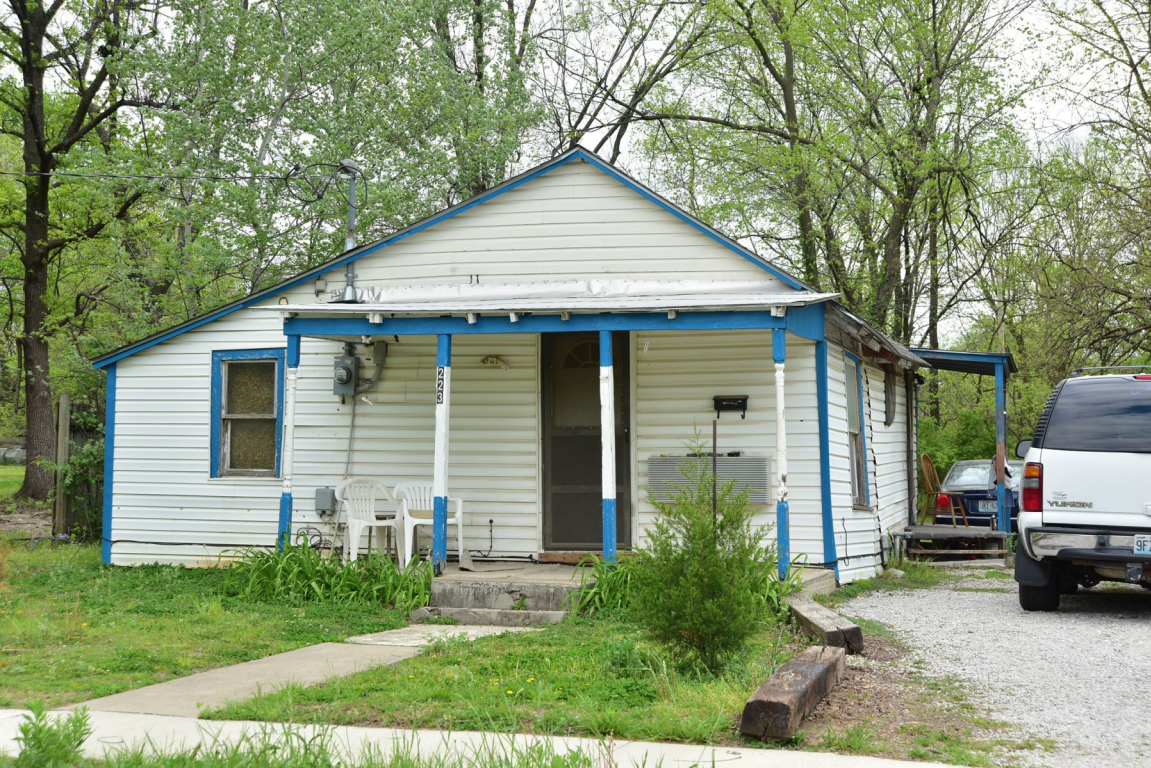
This one-story dwelling faces west and has a rectangular footprint. The foundation of the dwelling is not visible. It has an asphalt shingle roof and vinyl cladding. It is two asymmetrical bays wide and two asymmetrical bays deep. A one-over-one historic wood window with flat board trim forms the north bay of the primary elevation while a non-historic fiberglass door forms the south bay. An open partial-width shed roof porch projects from the west elevation. A combination of squared and turned non-historic wood posts support the porch roof. A non-historic shed roof porch with squared wood posts shelters a secondary entrance at the south elevation's east bay.
