1. Survey number: JP-AS-006-001		2. Survey Name: East Town (Original Joplin) Historic Survey Phase 1	
3. County: JASPER		4. Address 503	Street (name): E. Broadway Street
5. City: Joplin	Vicinity <input type="checkbox"/>	7. Township/Range/Section: T: R: S:	
8. Historic name (if known):		9. Present/other name (if known):	
10. Ownership: <input checked="" type="checkbox"/> Private <input type="checkbox"/> Public		11a. Historic use (if known): Domestic/Single Dwelling	11b. Current use: Domestic/Single Dwelling

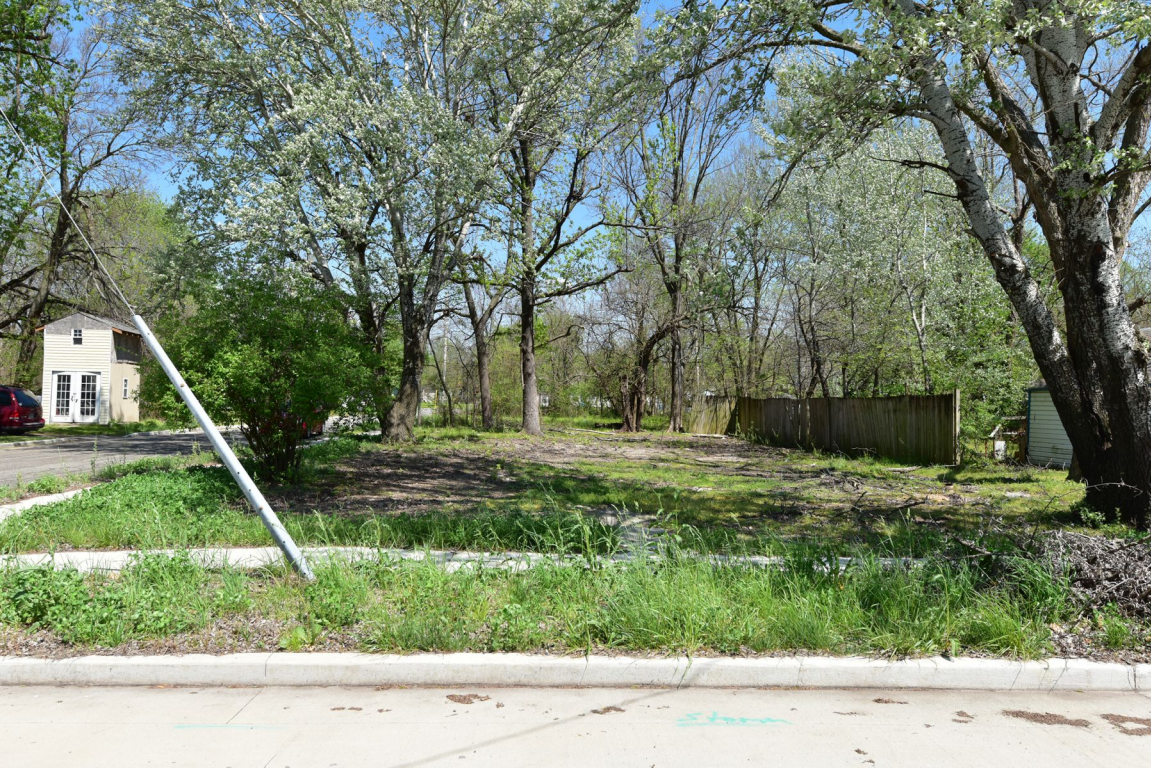
The lot fronts N. Cox Avenue to the west and is characterized by mature deciduous trees and shrubs. A concrete sidewalk butts the north and west edges of the property. A short concrete walkway is located at the west end of the lot and is perpendicular to the sidewalk.

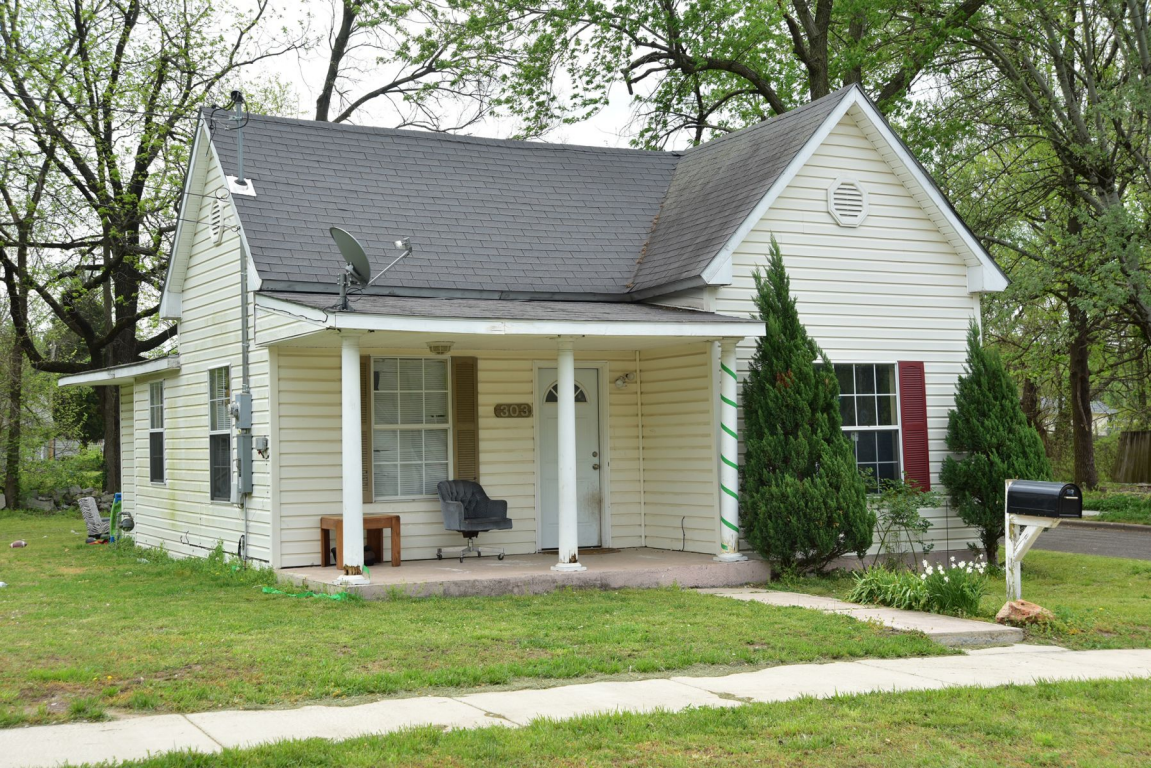
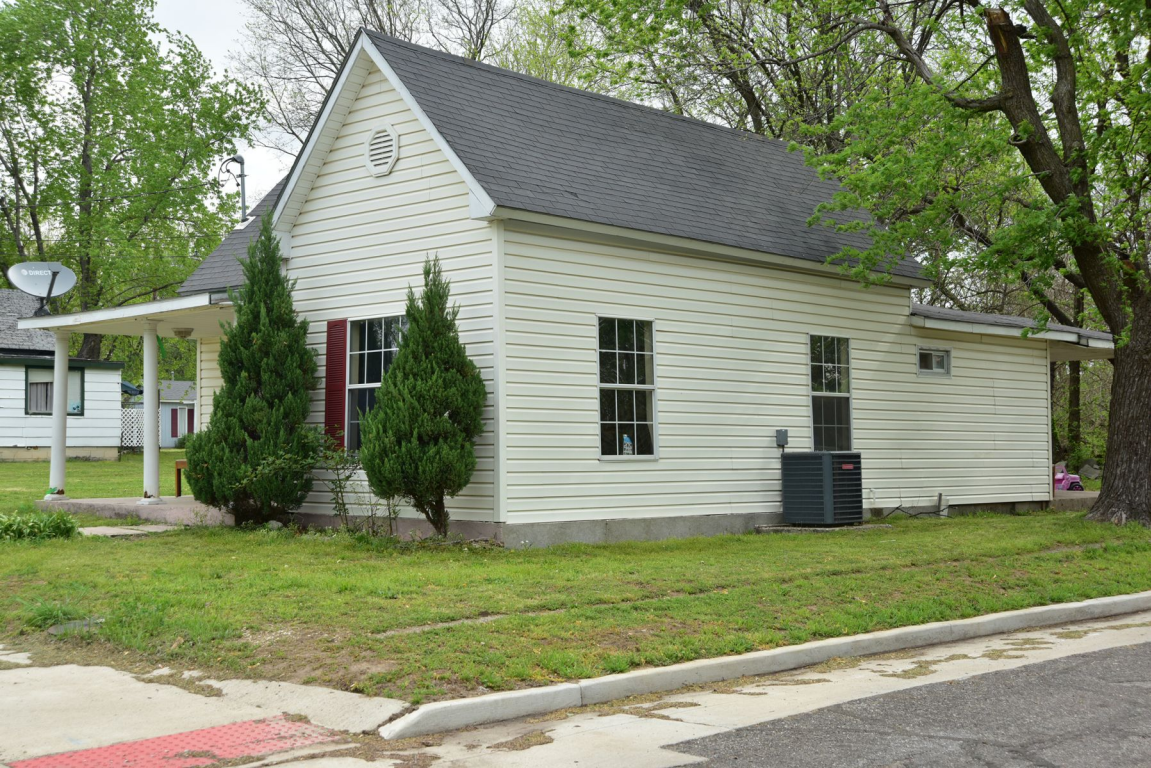
This one-and-a-half story Gabled-ElI dwelling has a concrete foundation, asphalt shingle roof, and vinyl cladding. Octagonal louverers are present in the gable ends. A front-gable addition is located at the rear. The dwelling is three bays wide and three asymmetrical bays wide. A shed roof porch shelters the north and center bay of the primary elevation. A non-historic fiberglass door fills the center bay while a non-historic vinyl six-over-six window form the north bay. A non-historic eight-over-eight vinyl window defines the south bay. Six-over-six vinyl windows define the two western bays of the north and south elevation while a one-by-one sliding window forms the east bay. Wood Tuscan columns support the porch roof. The porch floor is concrete.

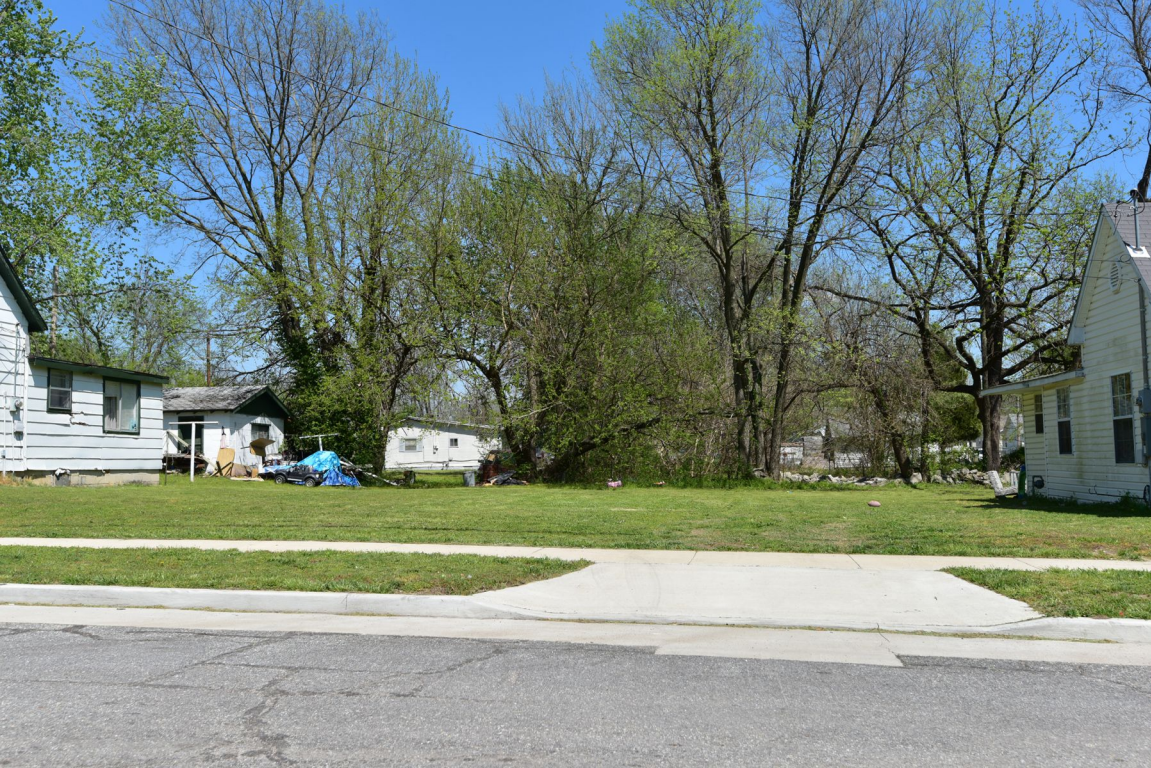
This lot faces Cox Avenue to the west. It is characterized by a large, open grass area. A concrete sidewalk abuts the west edge of the property.

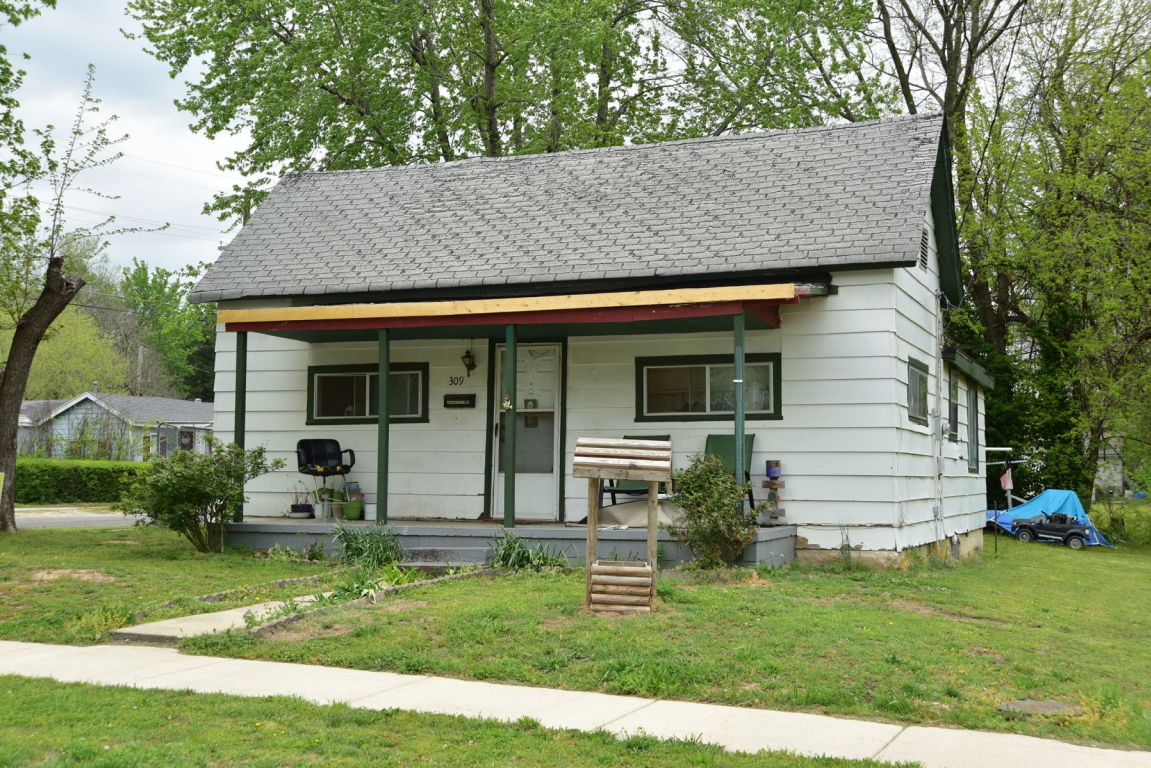
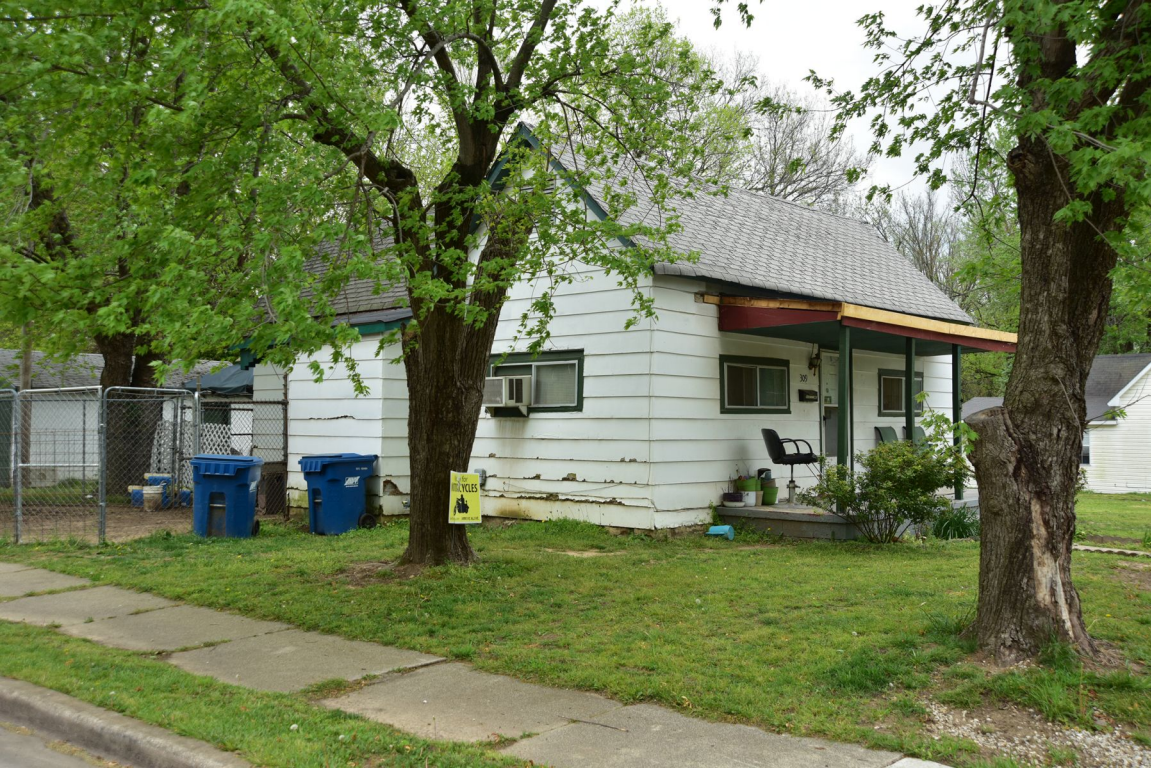
This one-story intersecting gable dwelling faces west and has a rectangular footprint. It has a concrete foundation and asphalt roof. The cladding is pressboard. The dwelling is three bays wide and three asymmetrical bays deep. A non-historic paneled wood door forms the center bay of the primary elevation. Non-historic one-by-one sliding metal windows fill the north and south bays. The size of the openings has been greatly reduced from what they were historically. A three-quarter width open porch shelters the bays. The porch has a concrete block foundation and shed roof. Rectangular wood posts support the porch roof. An enclosed porch with a shed roof projects from the north elevation.

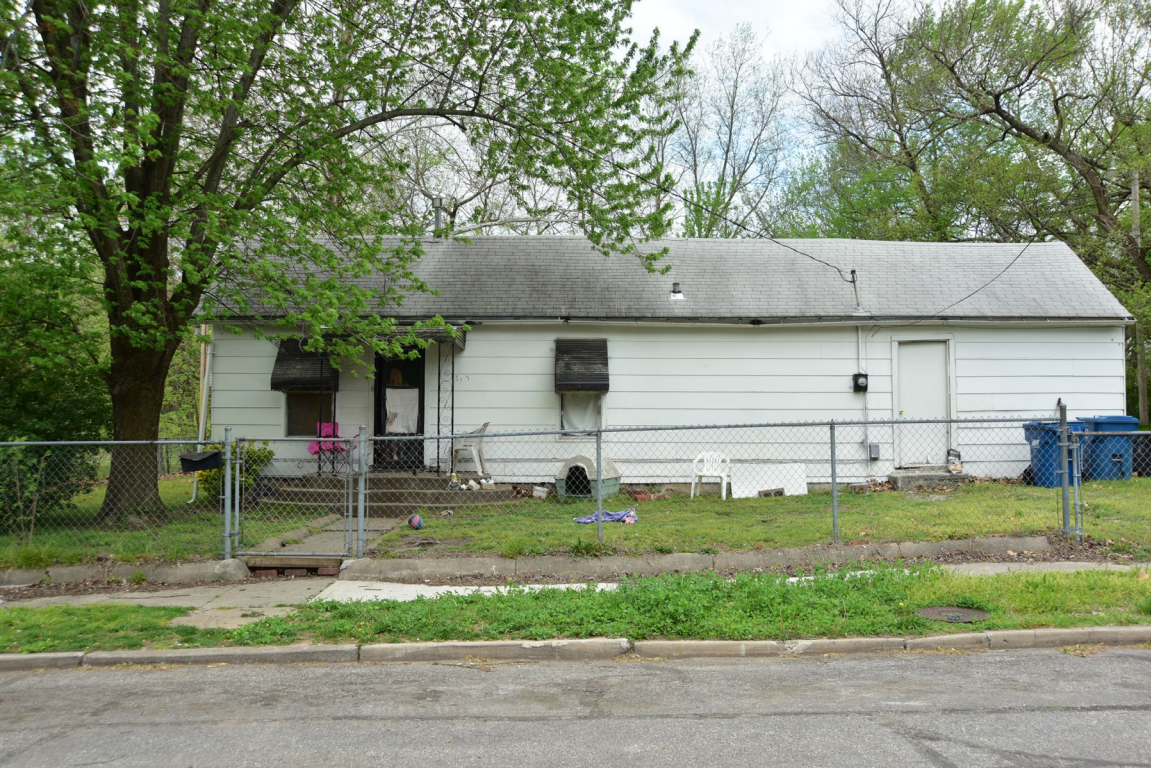
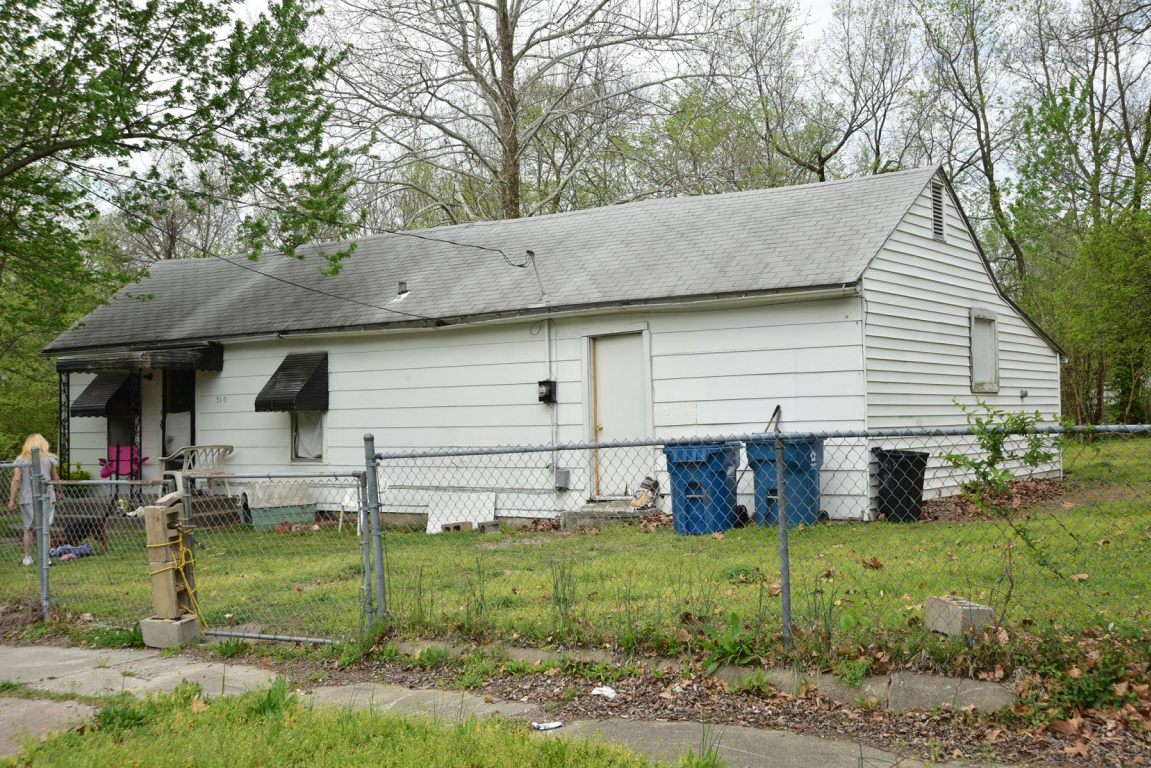
This one-story dwelling faces east and has a rectangular footprint. It has a concrete foundation and side-gable roof with asphalt shingles. The dwelling features pressboard cladding. The dwelling is four bays wide and one asymmetrical bay deep. Pedestrian entrances define the second and fourth from south bays while historic one-over-one wood windows define the remaining bays. The primary entrance door is not visible, while the secondary entrance door is non-historic wood. Metal awnings project over the windows. A shed roof with decorative iron posts shelters the front stoop. The concrete stoop features curved steps.

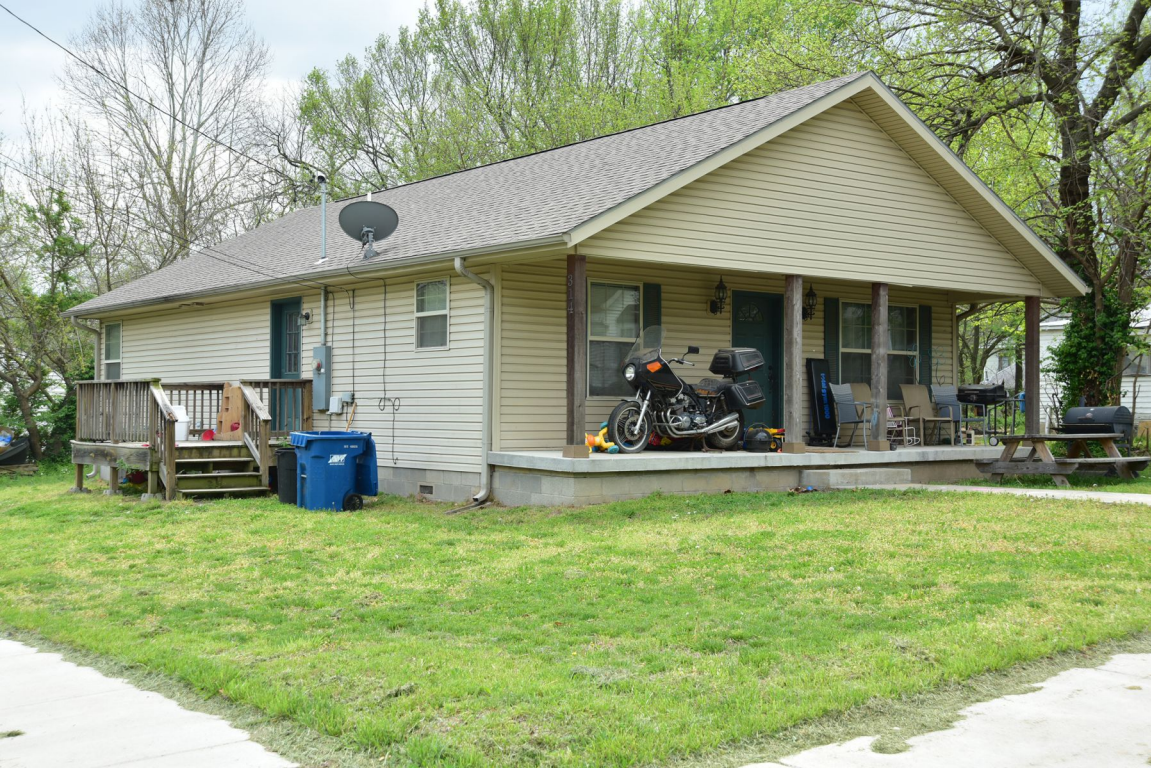
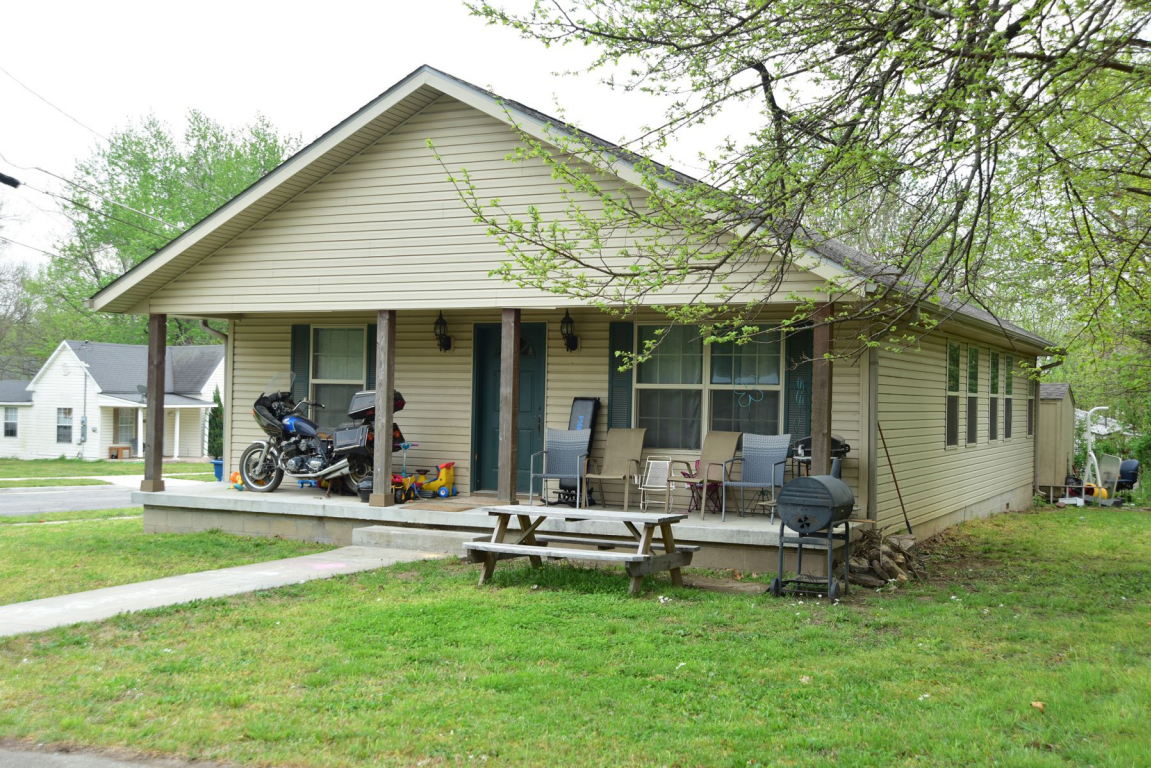
This one-story bungaloid dwelling faces north and has a rectangular footprint. It has a concrete masonry unit foundation and vinyl cladding. The front-gable roof features asphalt shingles. The dwelling is three bays wide and three bays deep. An open, full-width porch shelters the bays at the north elevation. Non-historic squared wood posts support the porch roof. The porch lacks railings or balusters. A non-historic fiberglass door fills the center bay of the primary elevation. Non-historic six-over-six vinyl windows with false shutters fill the other bays. A secondary entrance is located in the center bay of the east elevation and is accessed from a non-historic wood deck.

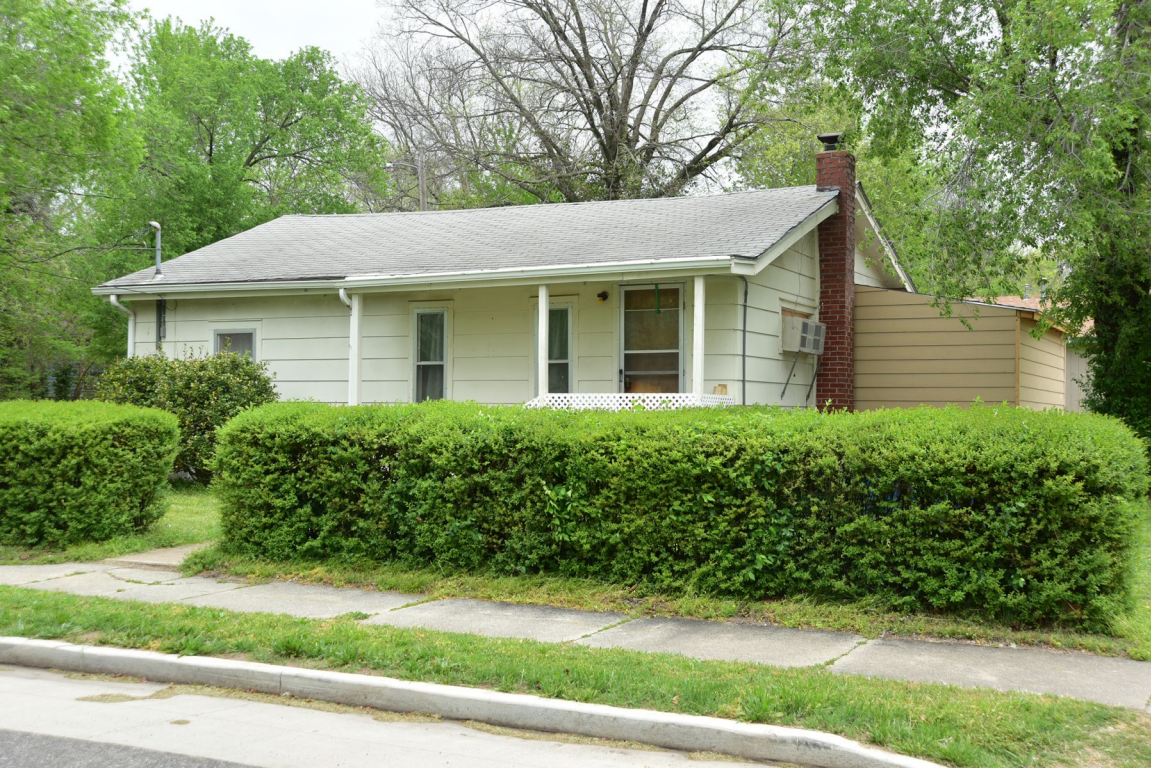
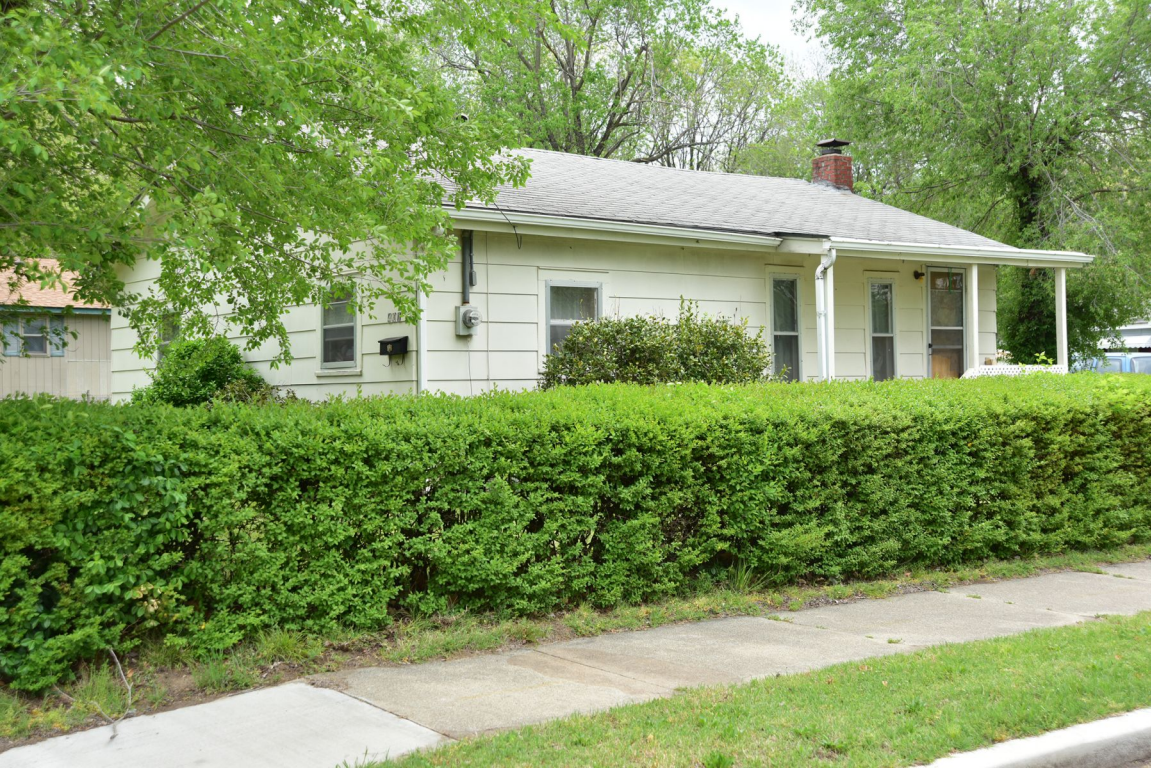
This one-story dwelling faces south and has a rectangular footprint. It features a side-gable roof with asphalt shingle and wide-profile cementitious cladding. The foundation is not visible. The dwelling is four asymmetrical bays wide and two bays deep. A non-historic wood door forms the easternmost bay while one-over one windows with flat board trim occupy the remaining bays. A brick exterior chimney and an enclosed porch are located at the east elevation.

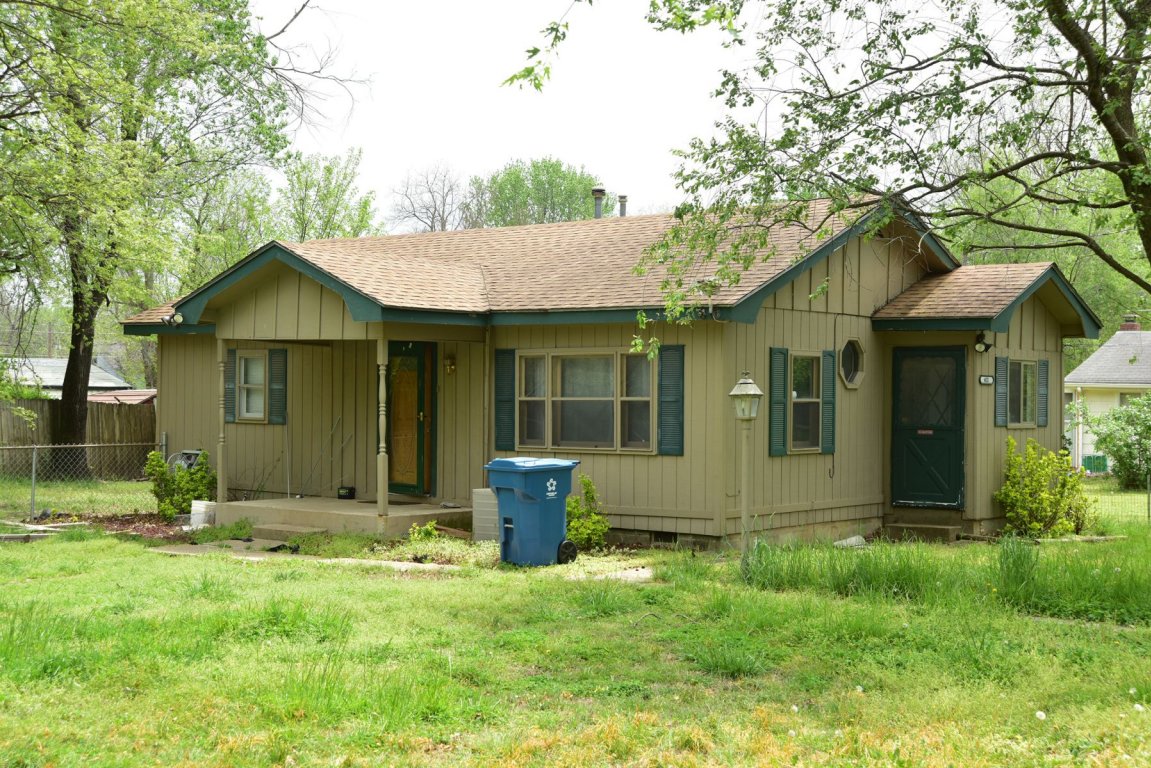
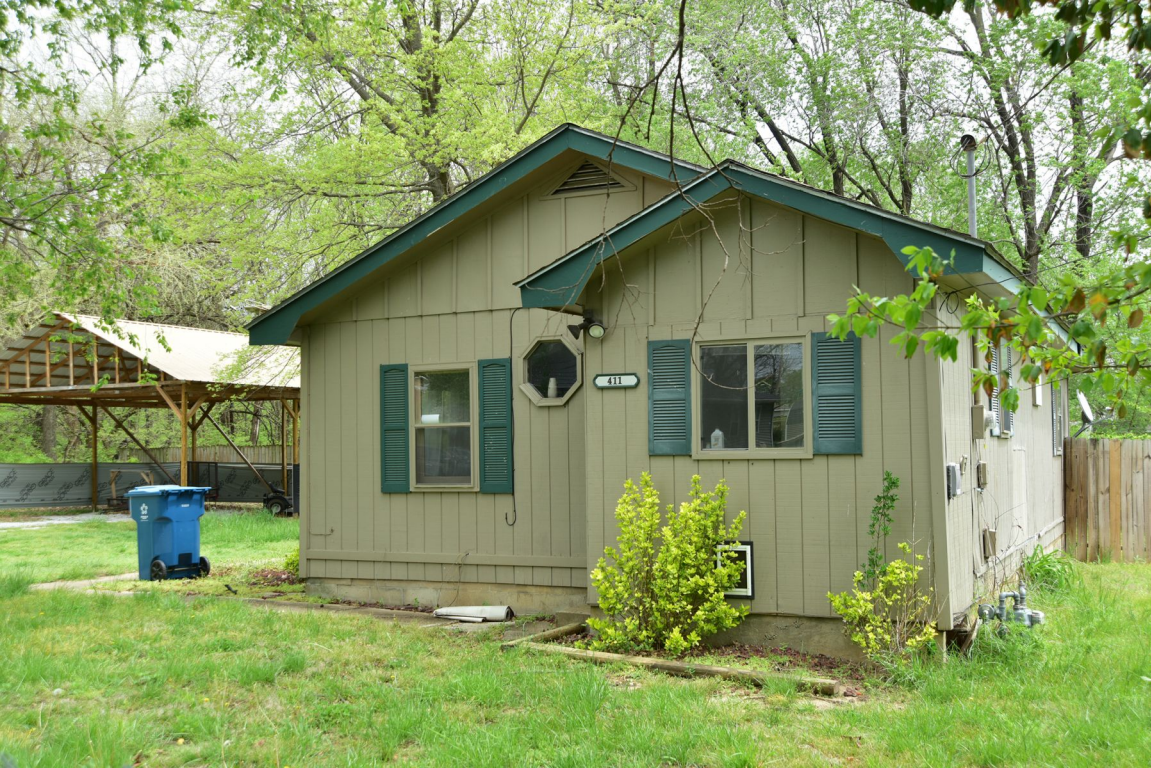
This one-story dwelling faces north and has a rectangular footprint. It has a concrete masonry unit foundation and wood siding. The side-gable roof features asphalt shingles, wide eaves, and board-and-batten treatment at the gable ends. The dwelling is three asymmetrical bays wide and three bays deep. A wood door defines the center bay of the primary elevation. A one-over-one wood single window fills the east bay while a wood one-over-one tripartite picture window fills the west bay. A partial-width open porch with front-gable roof shelters the entrance. Turned wood posts support the porch roof. An enclosed porch with side-gable roof is forms the south bay of the west elevation while a small, octagonal fixed window defines the center bay. False shutters flank the dwelling's windows.

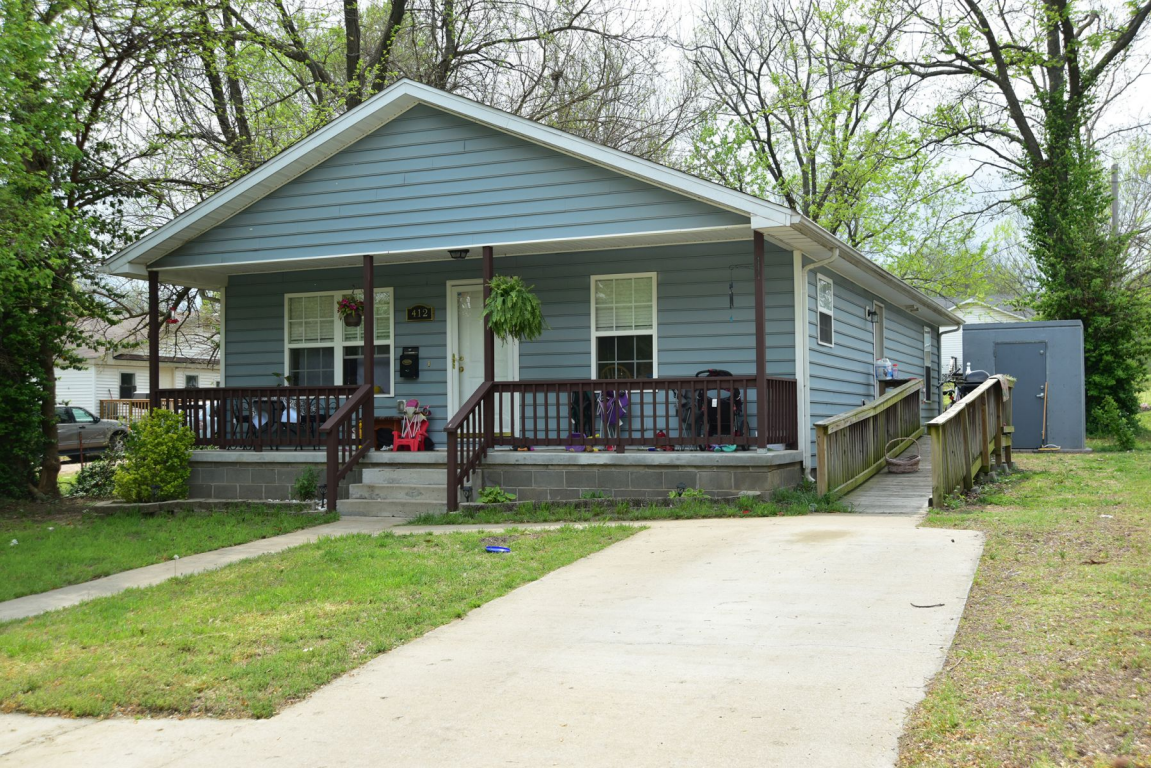
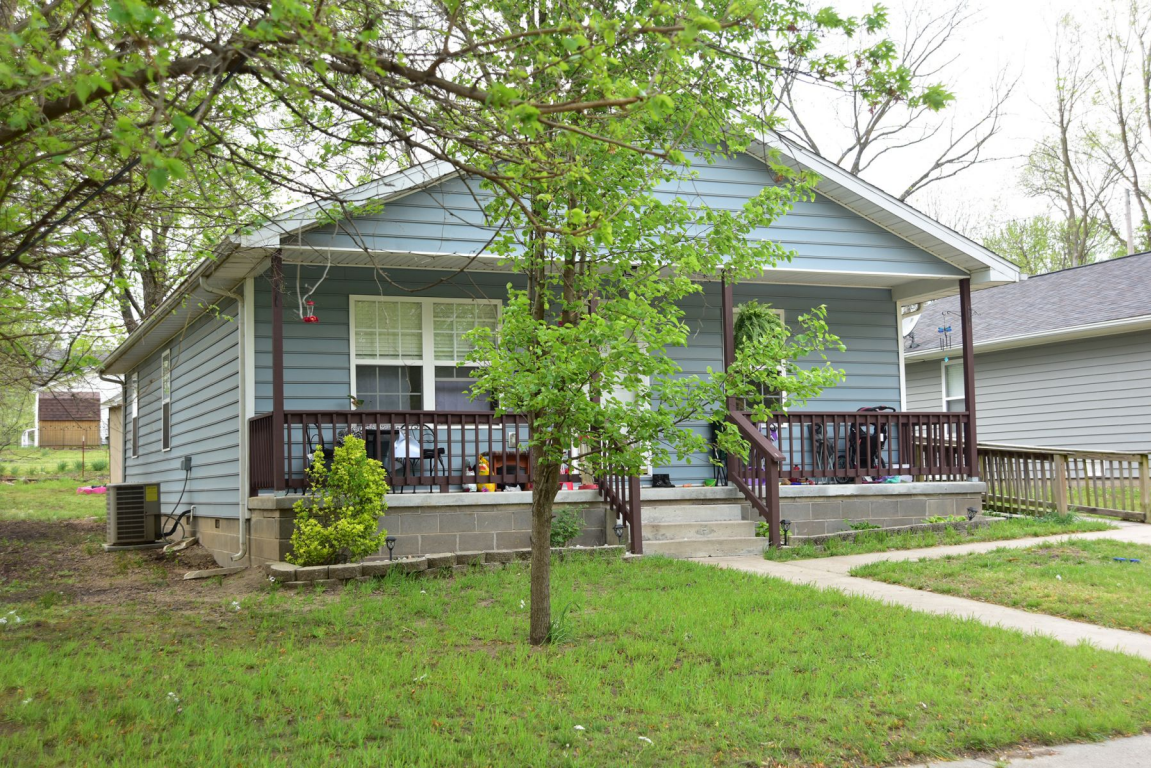
This one-story bungaloid dwelling faces east and has a rectangular footprint. It has a concrete masonry unit foundation and vinyl siding. The front-gable roof features asphalt shingles and modest cornice returns. The dwelling is three bays wide and three bays deep. An open porch spans the width of the primary elevation. The porch has a concrete masonry unit foundation and non-historic matchstick balustrade and stair railings. Non-historic squared wood posts support the porch roof. A non-historic wood door fills the center bay of the primary elevation while non-historic six-over-six vinyl windows fill the north and south bays. A non-historic wood ramp leads to a secondary entrance at the north elevation. No historic windows remain.

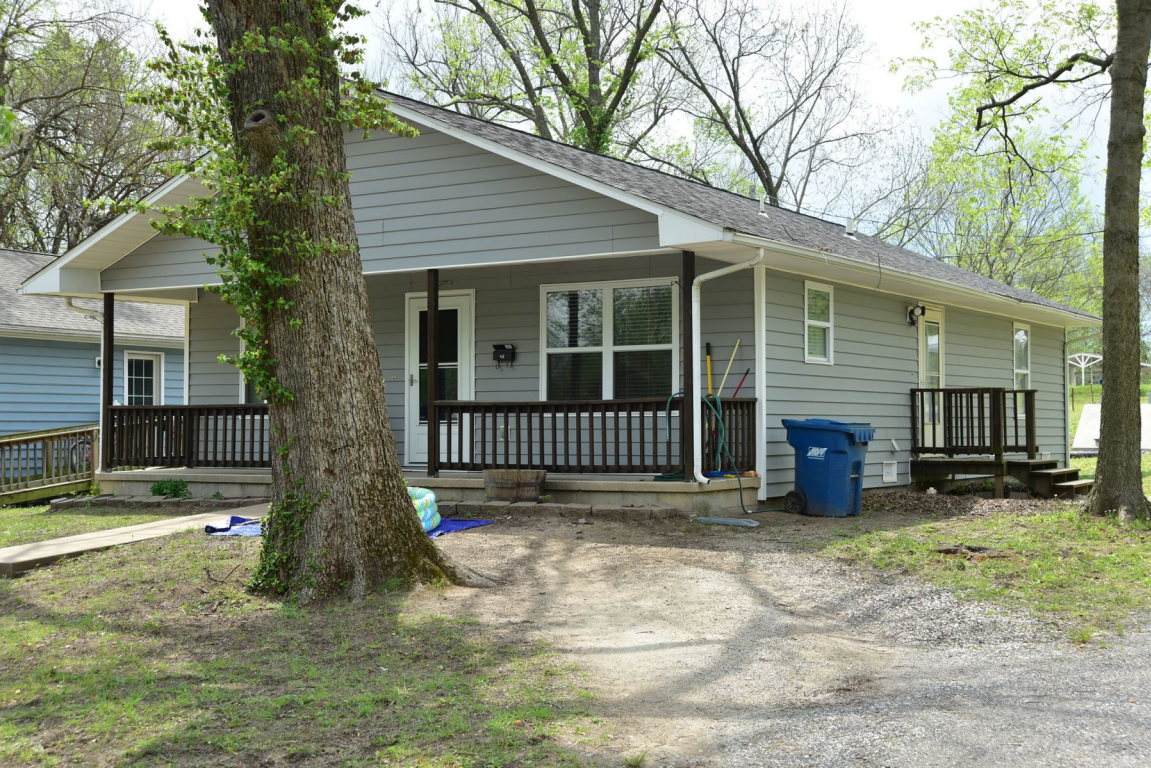
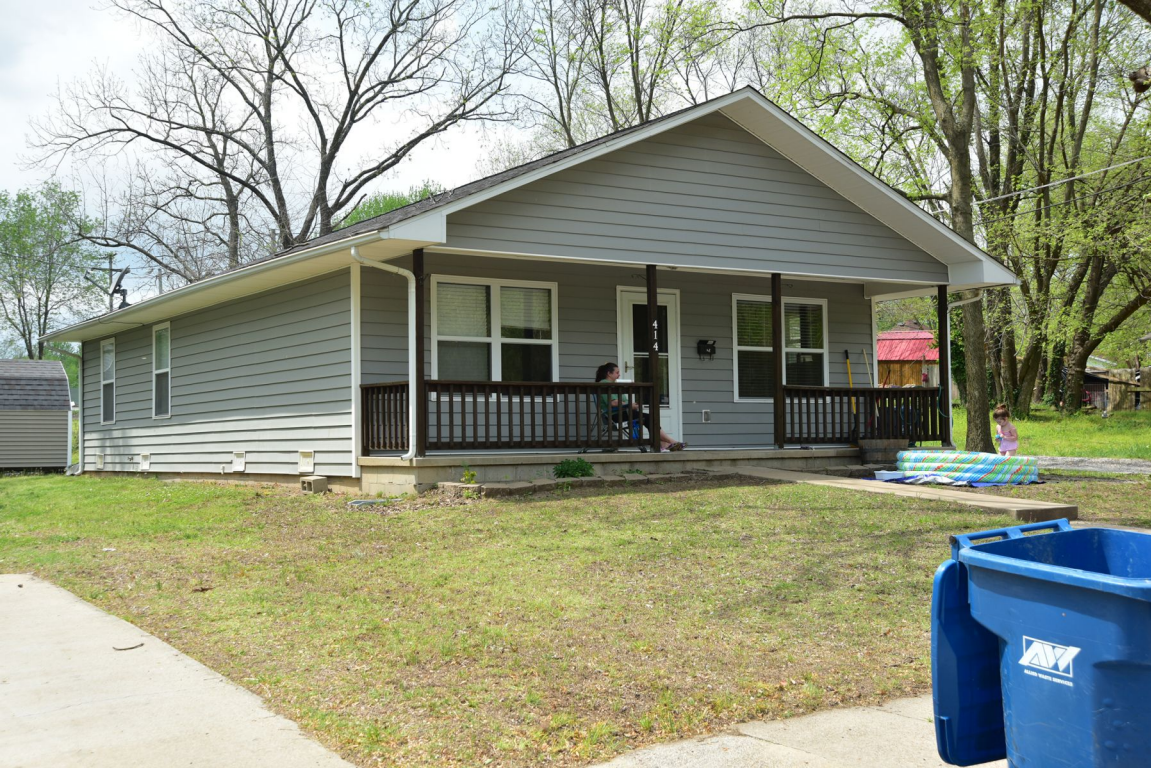
A near-twin to 412 N. Cox Avenue, this one-story dwelling faces east and has a rectangular footprint. It has a concrete masonry unit foundation and cementitious siding. The front-gable roof features asphalt shingles and boxed cornice returns. The dwelling is three bays wide and three bays deep. An open porch spans the width of the primary elevation. The porch has a concrete masonry unit foundation and matchstick balustrade and non-historic squared wood posts support the porch roof. The bay of the primary elevation contains the primary entrance. The door was not visible at the time of survey. Paired, one-over-one vinyl windows define the north and south bays. A secondary entrance is located in the center bay of the north elevation. A wood stoop with matchstick balustrade is present at the entrance.

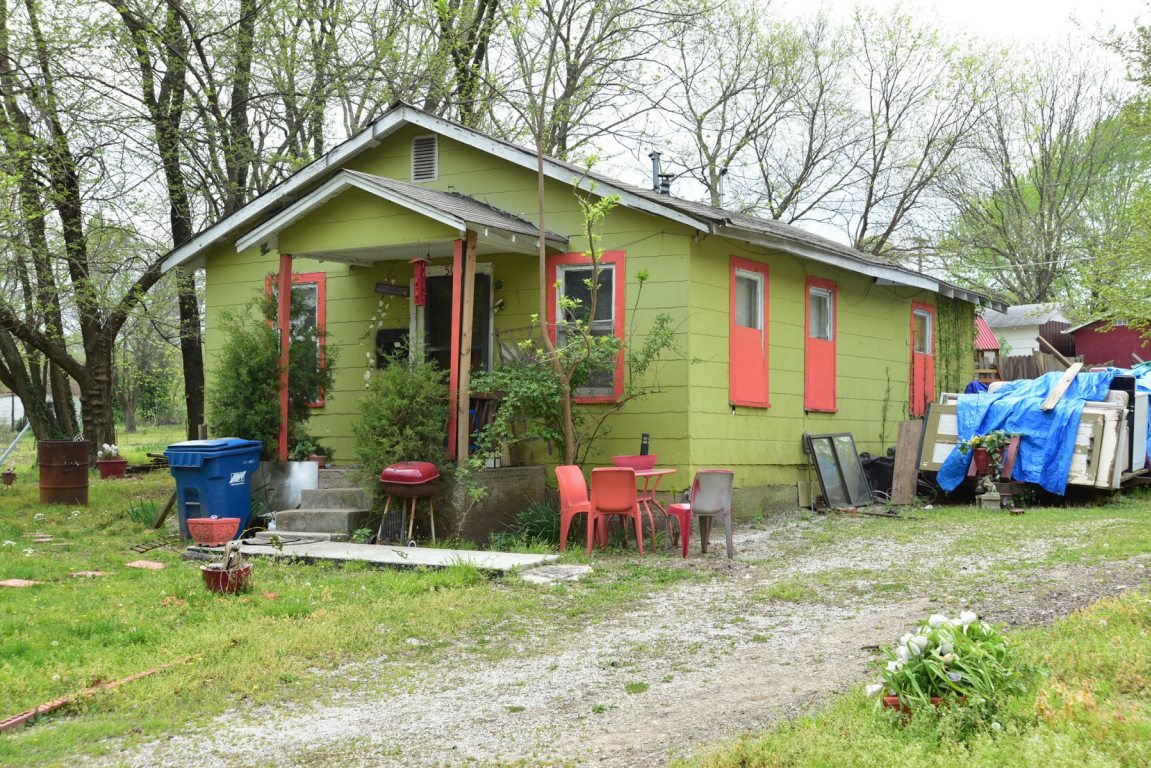
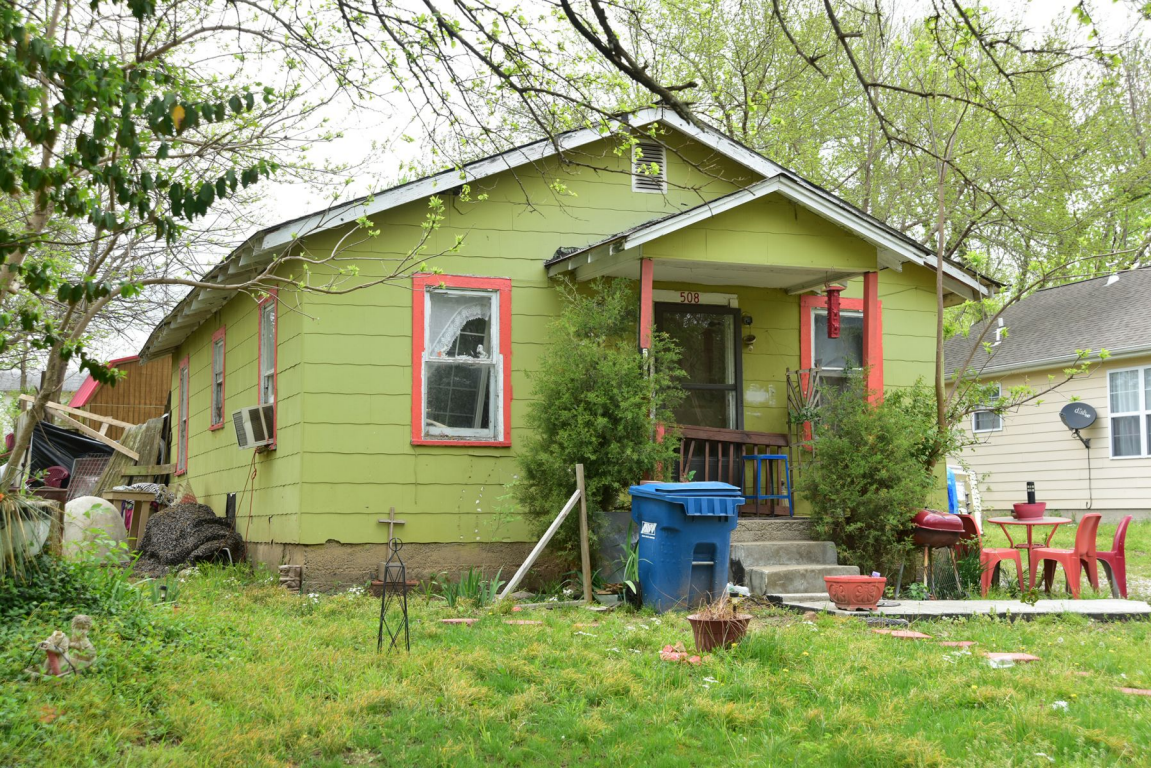
This one-story bungaloid dwelling faces east and has a rectangular footprint. It has a parged concrete foundation and asbestos shingle cladding. The front-gable roof features asphalt shingles and exposed rafter tails. The dwelling is three bays wide and three bays deep. A front-gable roof shelters the concrete stoop. Non-historic wood posts support the porch roof. A non-historic wood door forms the center bay of the primary elevation while historic one-over-one wood windows define the remaining bays. The windows feature wood flat board trim. The lower-half of the north elevation windows are boarded.

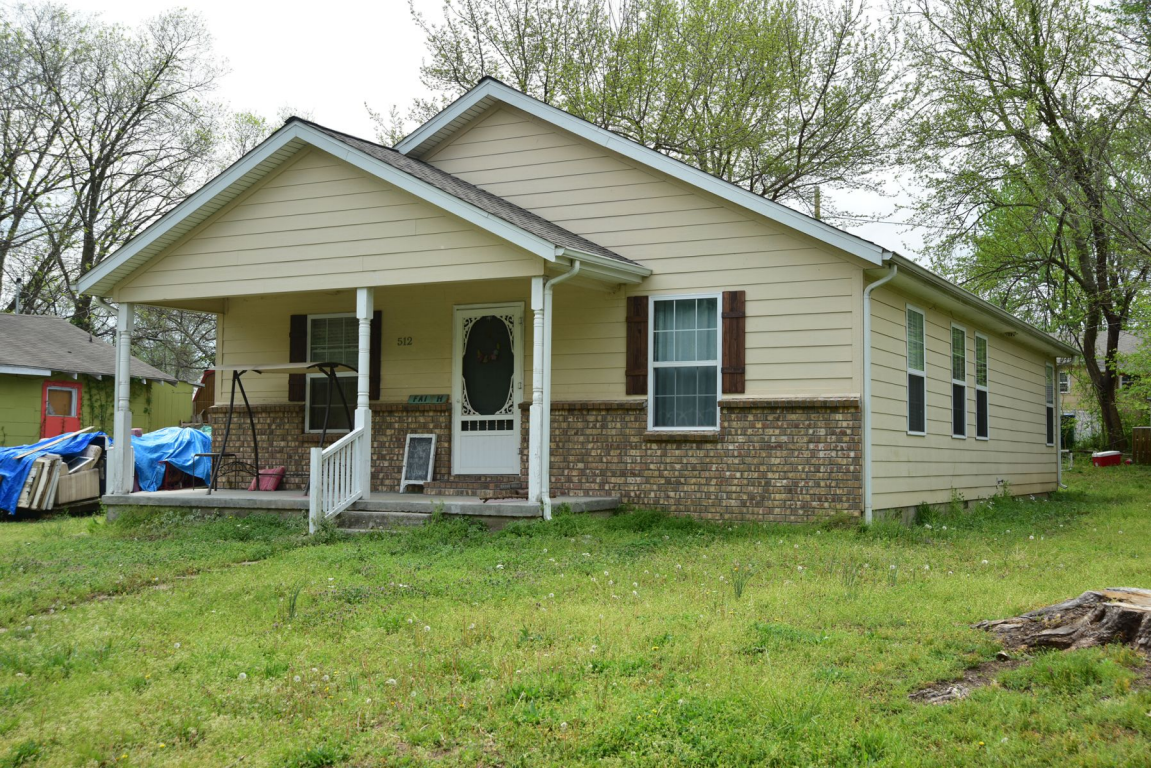
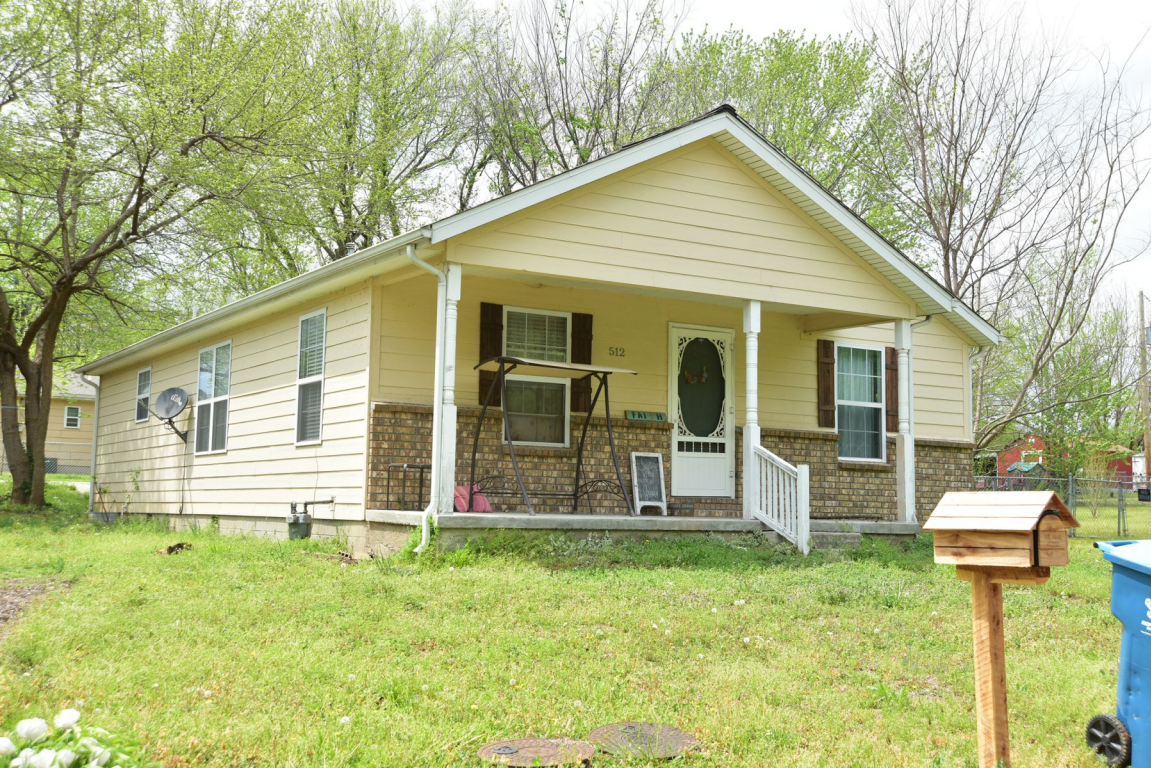
This one-story dwelling faces east and has a rectangular footprint. It has as a concrete masonry unit foundation and cementitious siding. Brick veneer clads the lower third of the primary elevation. The front-gable roof has asphalt shingles. The dwelling is three bays wide and four asymmetrical bays deep. An open, partial-width porch with front-gable roof shelters the center and south bays of the primary elevation. The porch has a concrete foundation and non-historic turned wood posts support the roof. A non-historic wood door defines the center bay. Six-over-six vinyl windows fill the north and south bays. The windows have header brick sills and false shutters. The six-over-six vinyl windows located at the secondary elevations do not have brick sills or shutters.
