1. Survey number: JP-AS-006-001		2. Survey Name: East Town (Original Joplin) Historic Survey Phase 1	
3. County: JASPER		4. Address 503	Street (name): E. Broadway Street
5. City: Joplin	Vicinity <input type="checkbox"/>	7. Township/Range/Section: T: R: S:	
8. Historic name (if known):		9. Present/other name (if known):	
10. Ownership: <input checked="" type="checkbox"/> Private <input type="checkbox"/> Public		11a. Historic use (if known): Domestic/Single Dwelling	11b. Current use: Domestic/Single Dwelling

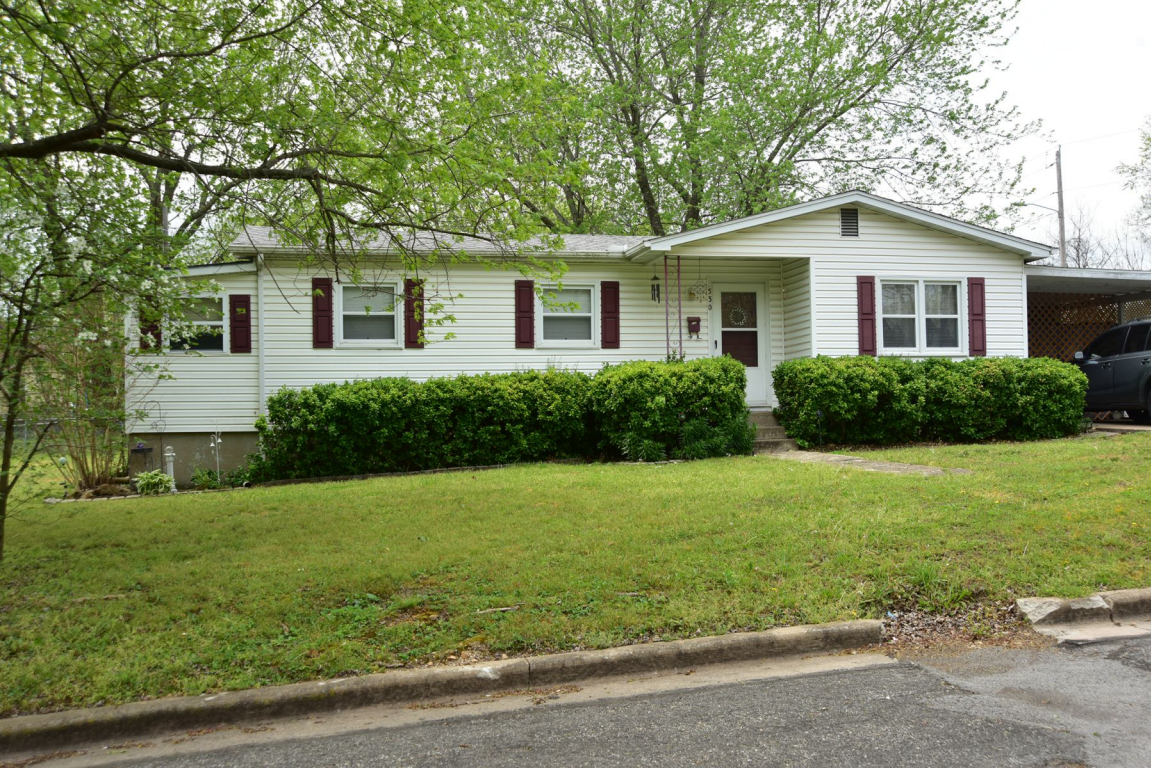
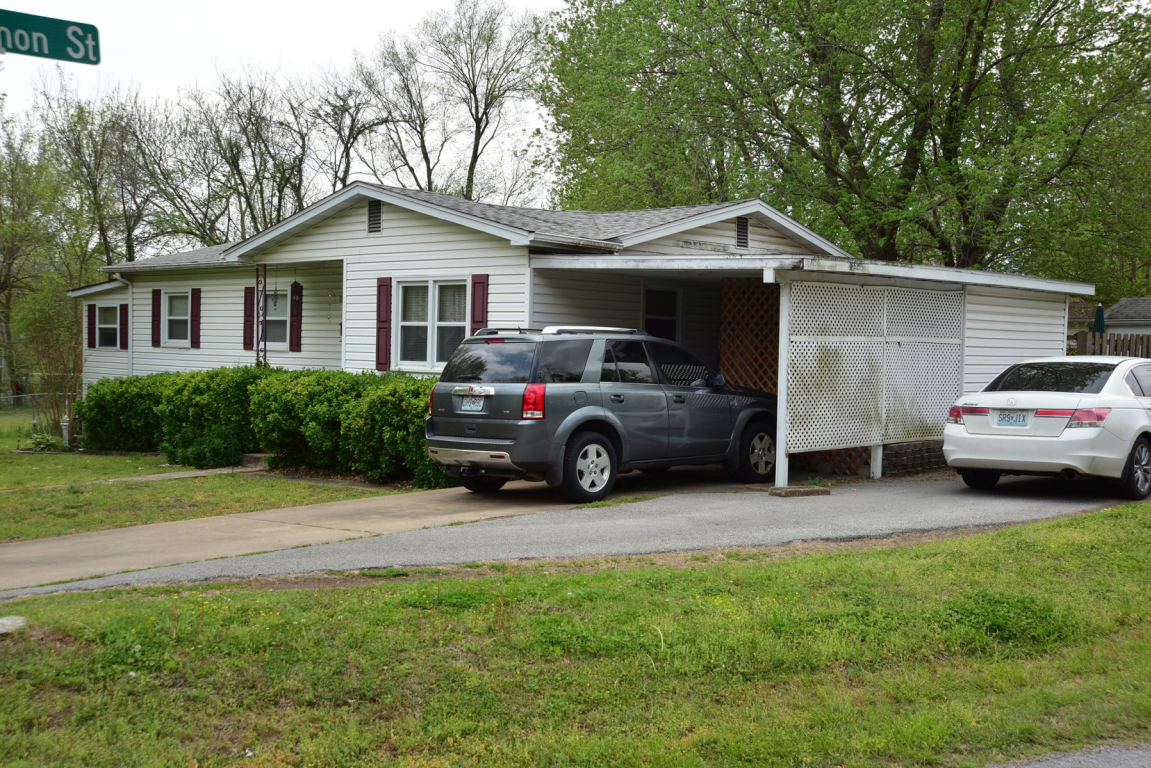
This one-story dwelling faces east and has a rectangular footprint. The foundation is not visible, however a shed-roof addition at the south elevation has a concrete foundation. The side-gable roof features asphalt shingles and the dwelling is clad in vinyl. The dwelling is five bays wide and two bays deep. A front gable wall dormer projects over the north two bays of the primary elevation. The south four bays recede, creating a recessed stoop porch. A decorative iron post supports the southeast corner of the wall dormer. The primary entrance is located in the second-from-north bay and features a non-historic wood door. One-over-one vinyl windows with false shutters fill the remaining bays. A flat-roof carport projects from the north elevation.

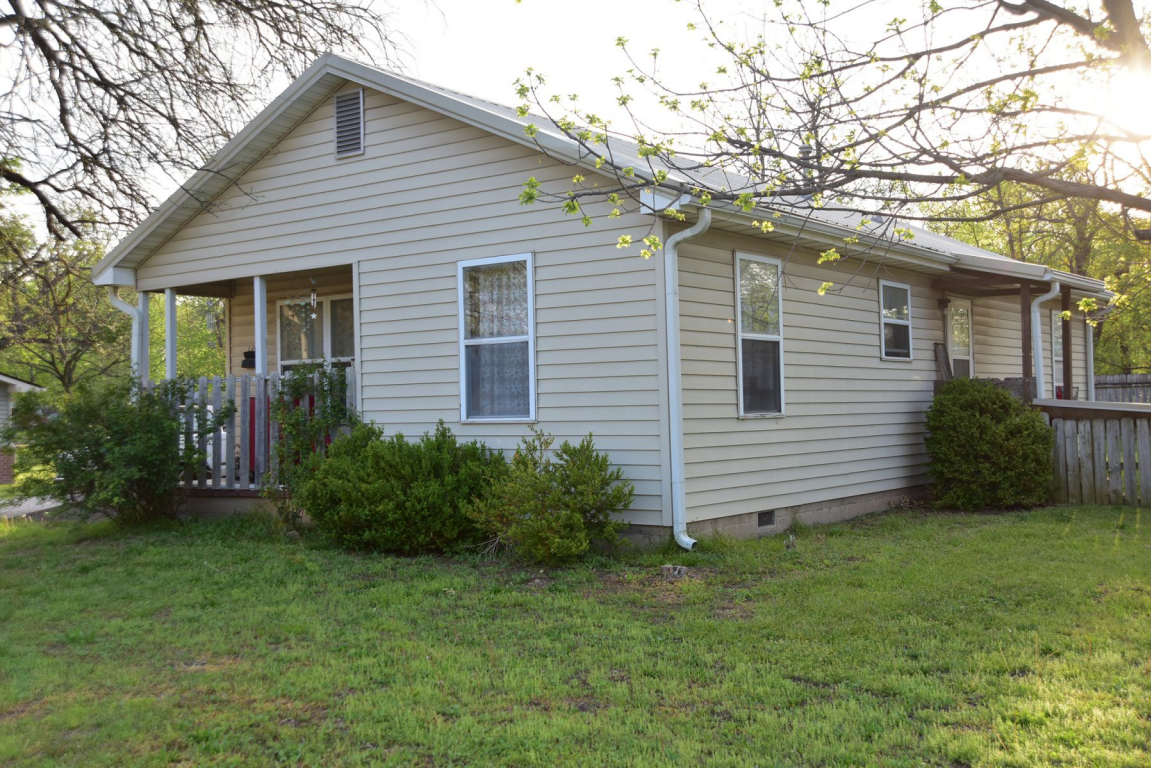
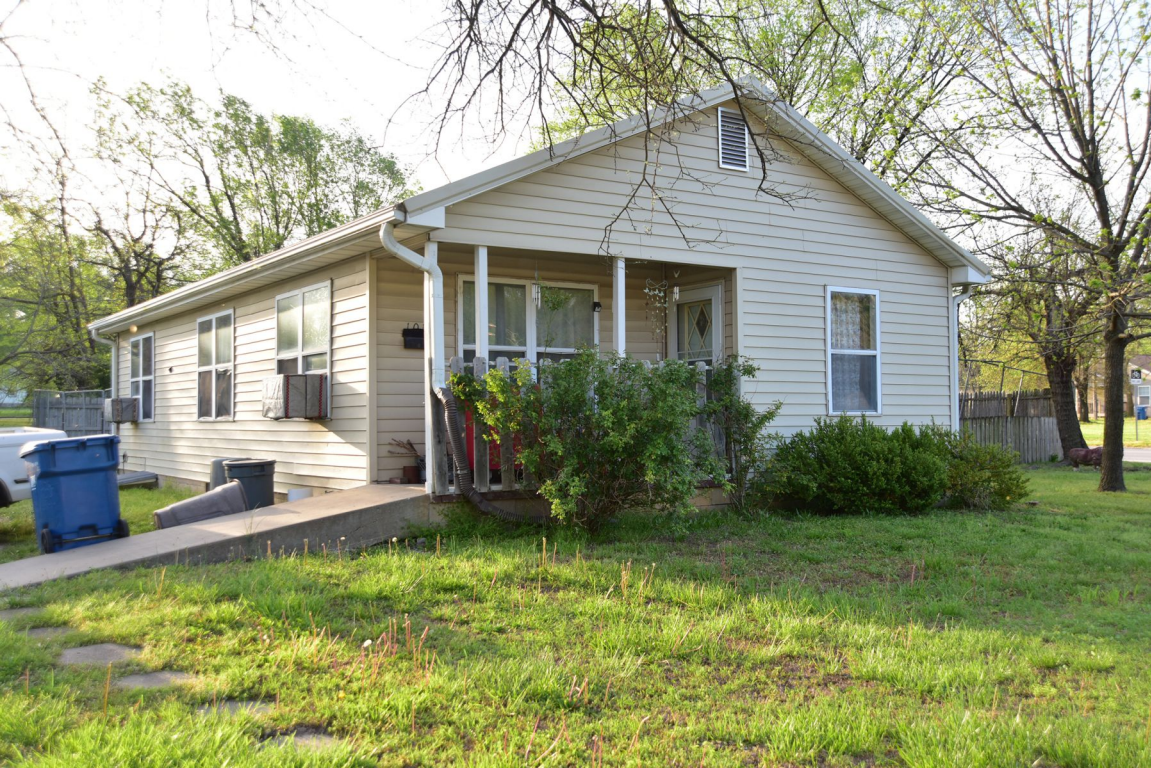
This one-story dwelling faces west and has a rectangular footprint. It has a concrete block foundation with crawl space and vinyl siding. The front-gable roof has asphalt shingles. The dwelling is two bays wide and four bays deep. The north bay of the primary elevation is recessed, creating a partial-width porch. Non-historic squared wood posts support the porch roof and non-historic wood picket fence planks form the balusters. A non-historic wood door is in the south wall of the porch. One-over-one vinyl windows define the north and south bays of the primary elevation. A shed-roof porch projects from the second-from-west bay of the south elevation and shelters a secondary entrance. Non-historic squared wood posts support the porch roof.

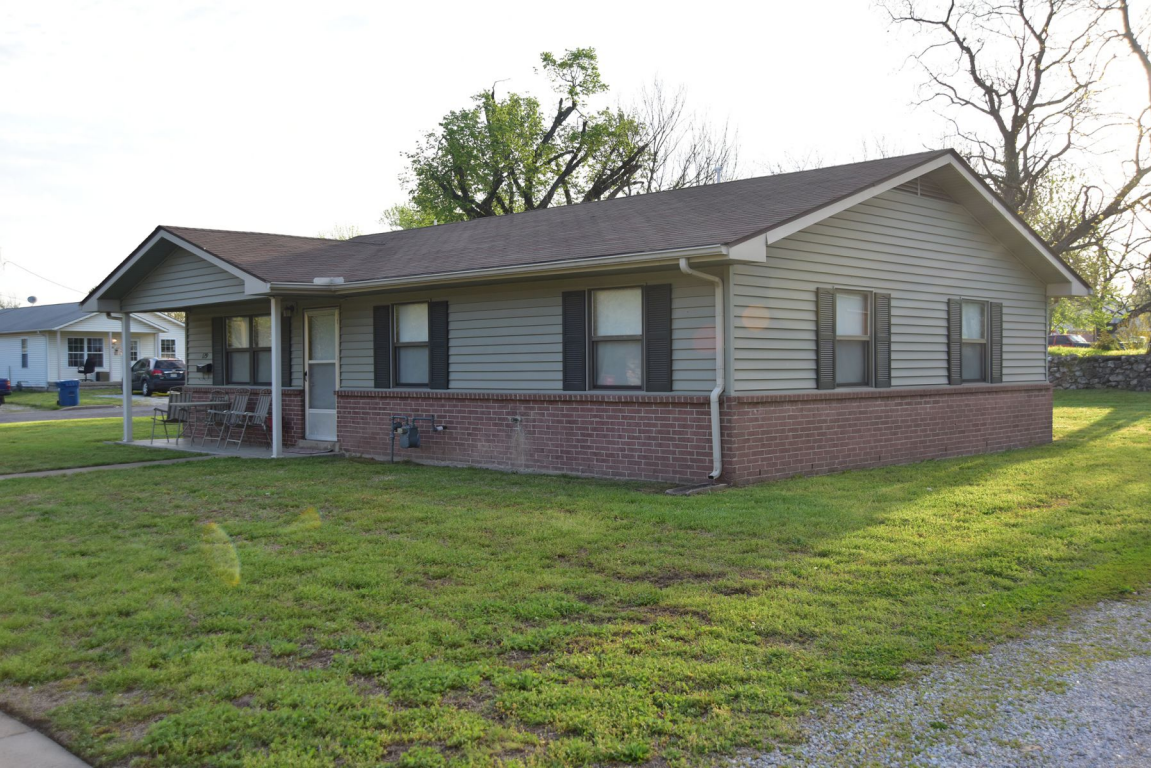
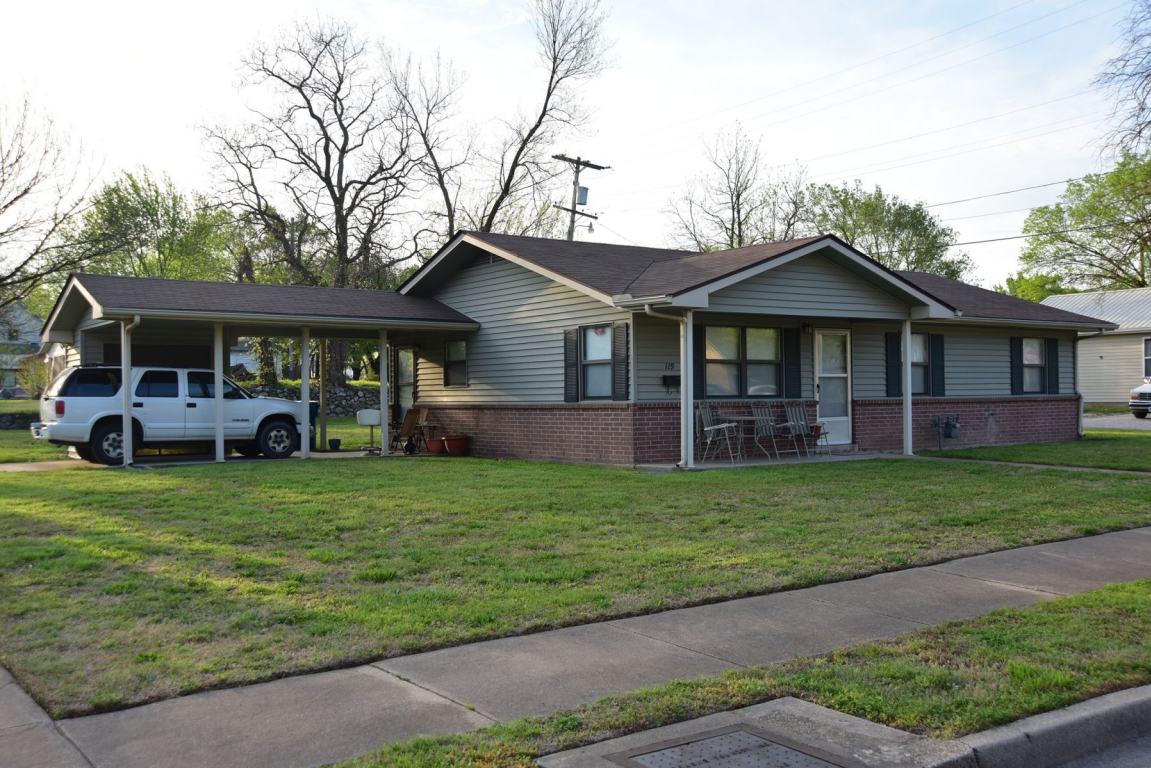
This one-story dwelling faces west and has an L-shaped footprint. It has a concrete foundation and vinyl cladding. Brick veneer clads the lower third of the exterior. The side-gable roof features asphalt shingles. The dwelling is four asymmetrical bays wide and three bays deep. A front-gable wall dormer shelters the two north bays of the primary elevation and creates a partial-width open porch. Squared posts support the porch roof. A non-historic wood door fills the second-from-north bay. One-over-one vinyl windows with false shutters define the remaining bays. A carport with gable roof and squared wood posts projects from the north elevation and shelters the east two bays, including a secondary entrance. The northeast corner of the carport is enclosed.

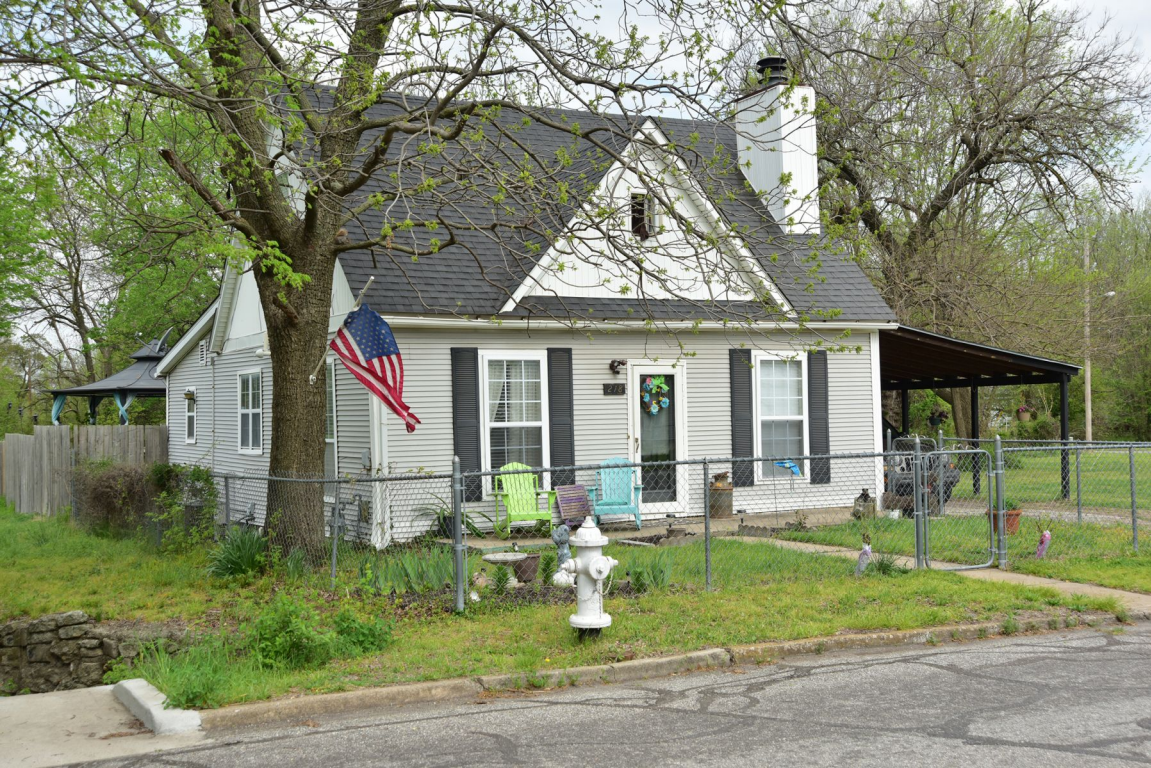
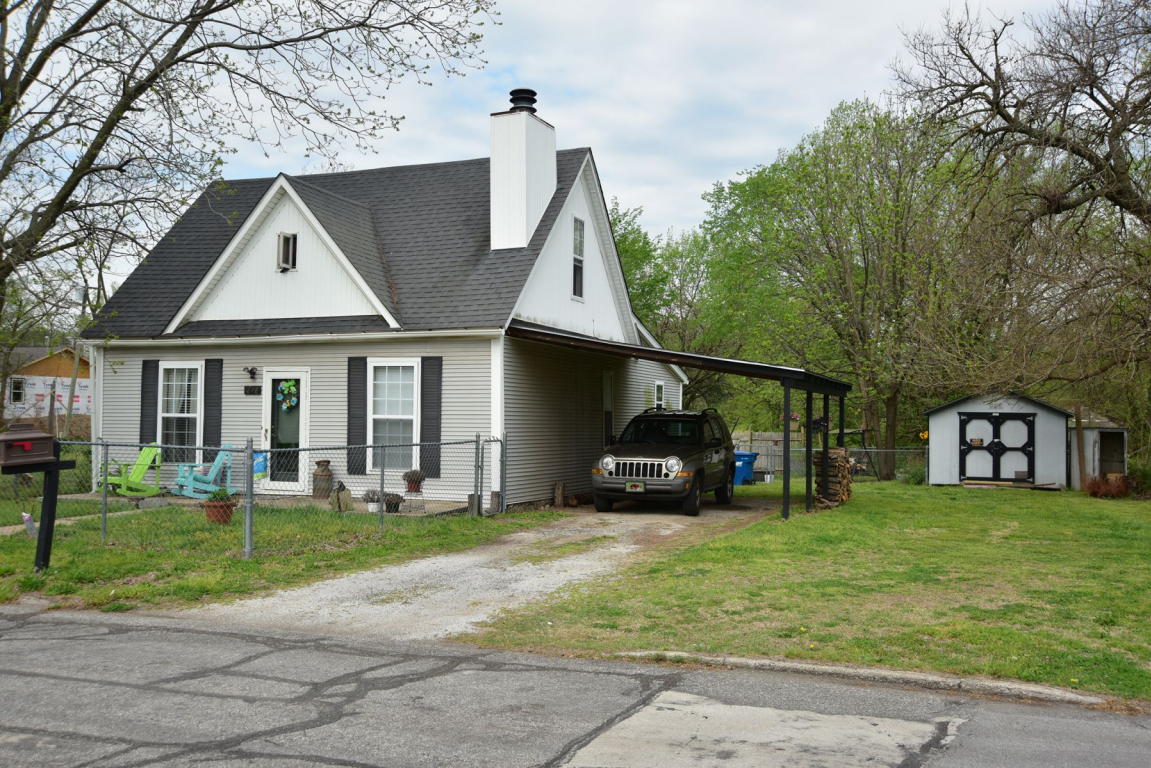
This one-and-one-half story dwelling faces east and has a rectangular footprint. It has a stone foundation and vinyl cladding with cornerboards. The side-gable roof features asphalt shingles. Nine-over-nine vinyl windows are located in the gable ends. A large gable dormer with one-light casement window projects from the center of east slope. The dwelling is three bays wide and three bays deep. A wood door with glazing fills the center bay of the primary elevation. Nine-over-nine vinyl windows with false shutters define the north and south bays. A frame shed-roof carport projects from the north elevation and is supported by squared wood posts. A vinyl-wrapped chimney pierces the north end of the east roof slope.

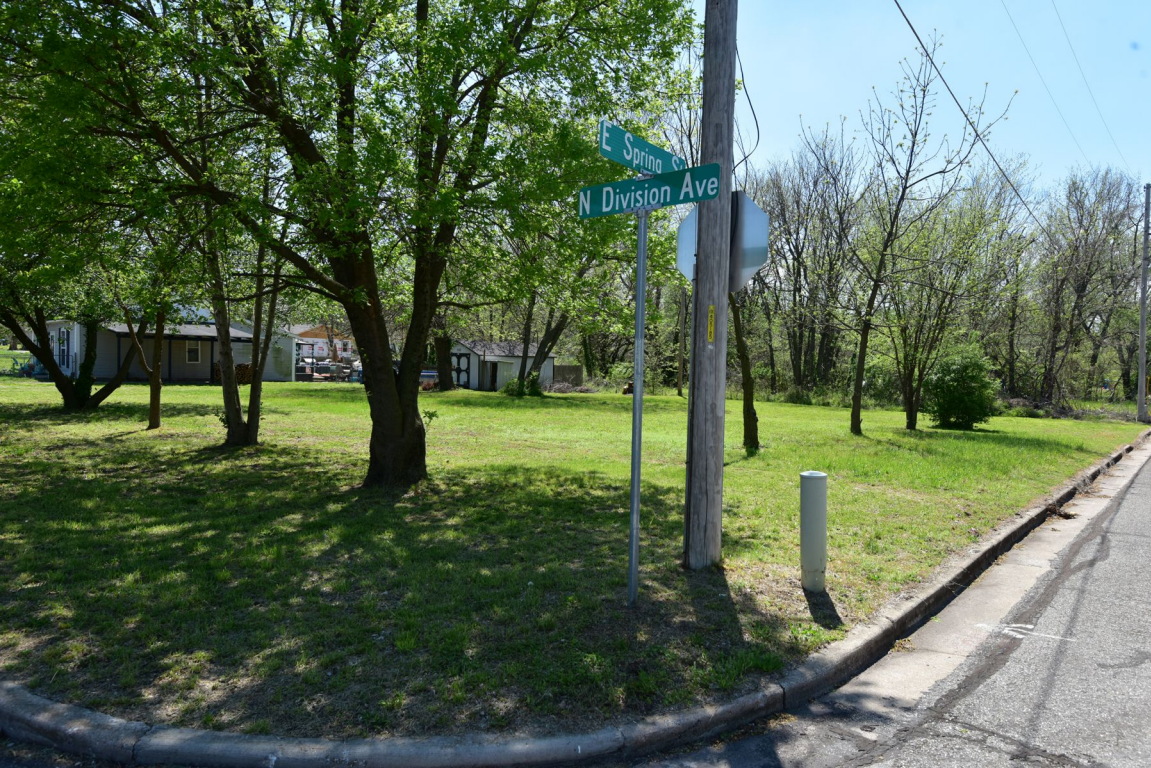
This vacant lot is located at the southwest corner of E. Spring Street and N. Division Avenue. It is characterized by a large, open grass area bordered by mature deciduous trees at the north, east, and west edges.

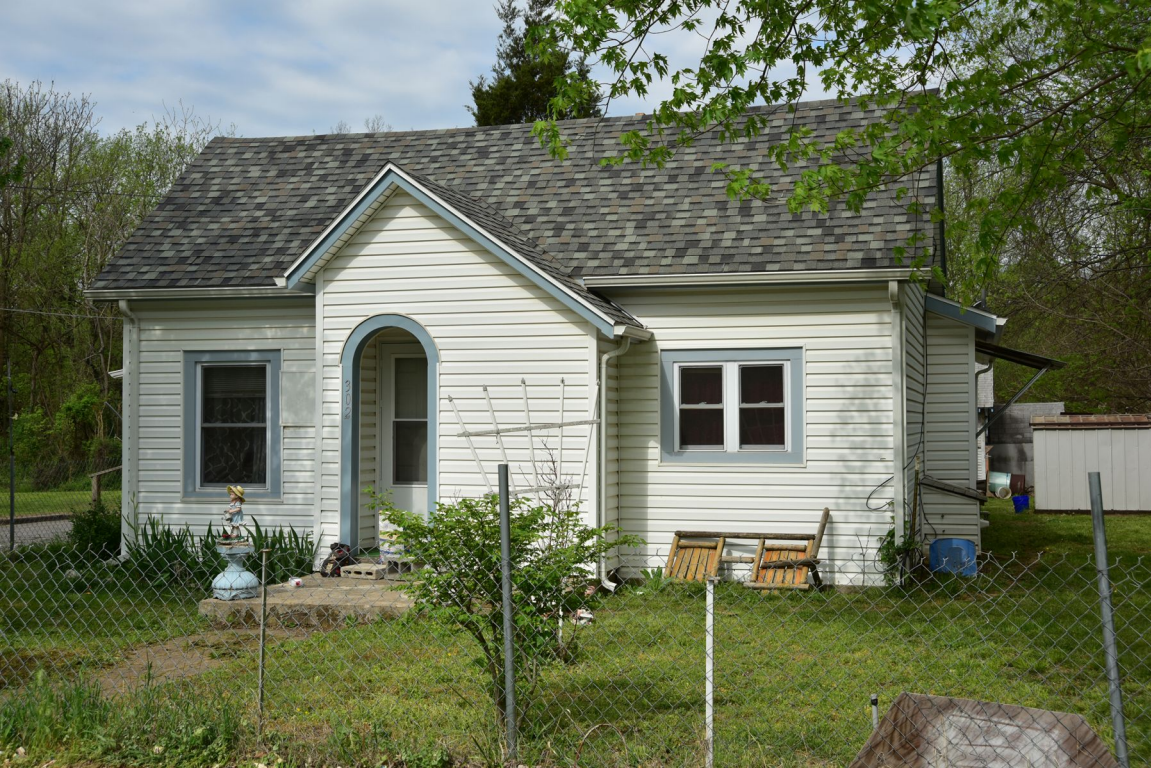
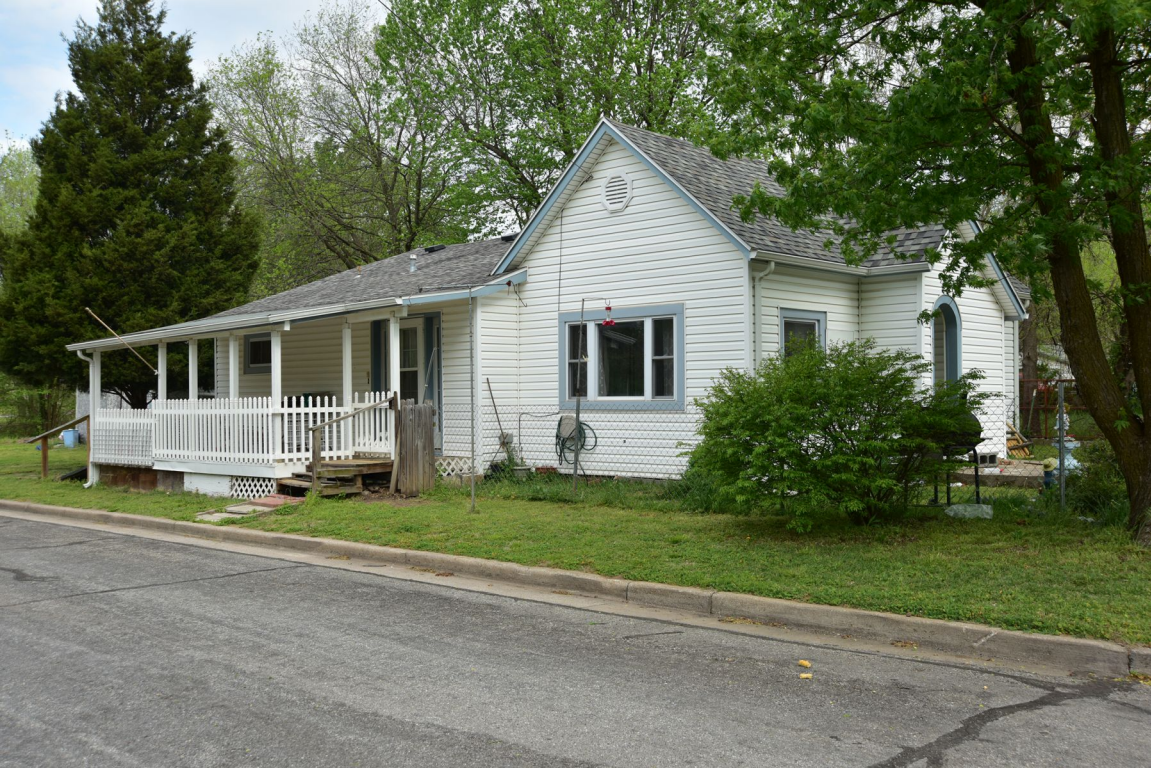
This one-story Gabled Ell dwelling faces east and has an irregular footprint. It has a parged stone foundation, asphalt shingle roof, and vinyl cladding. The dwelling is three bays wide and three asymmetrical bays deep. An enclosed porch with asymmetrical front-gable roof forms the center bay of the primary elevation. The porch has an arched doorway and the recessed wood door is non-historic. One-over-one vinyl windows with flat board trim form the north and south bays. The south bay contains a single window while the north bay contains a pair. A shed roof porch with squared wood posts shelters the west two bays of the south elevation. Wood picket fencing forms the porch balustrade. The center bay of the south elevation contains a secondary entrance with sidelights.

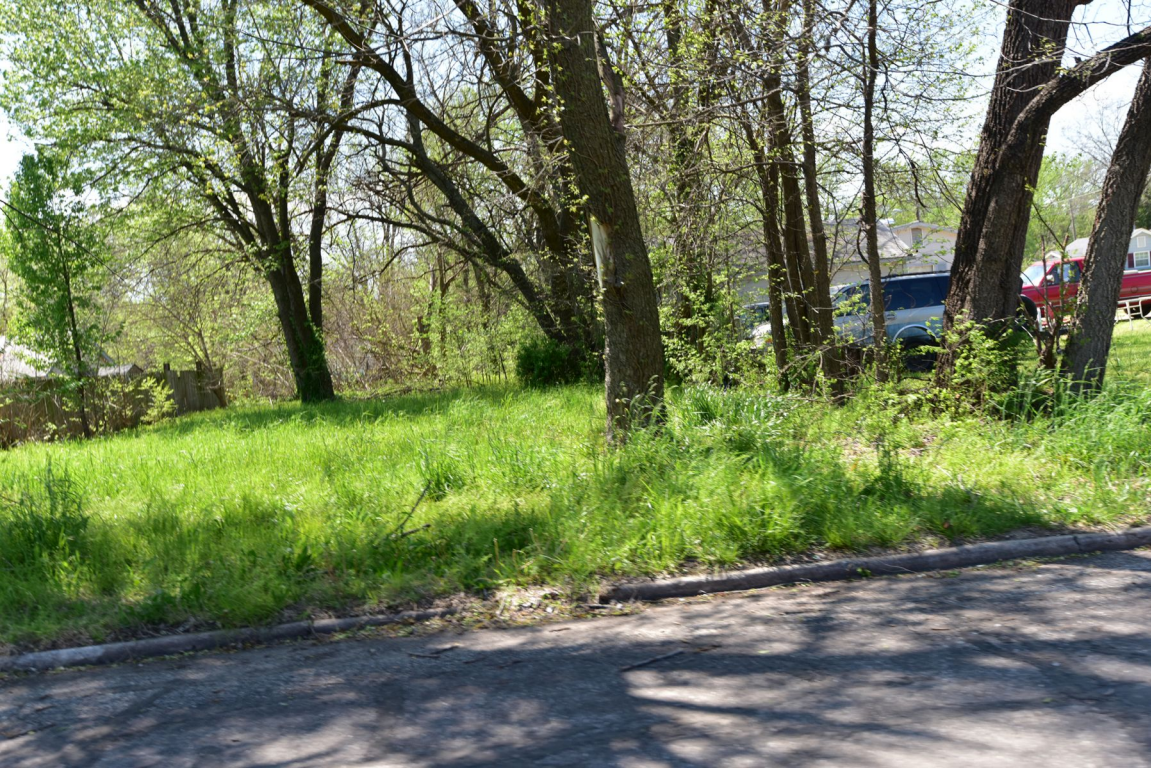
This vacant lot fronts N. Division Avenue to the east and is located in the east portion of the Survey Area. It is characterized by open grass areas, deciduous trees, and scrub.

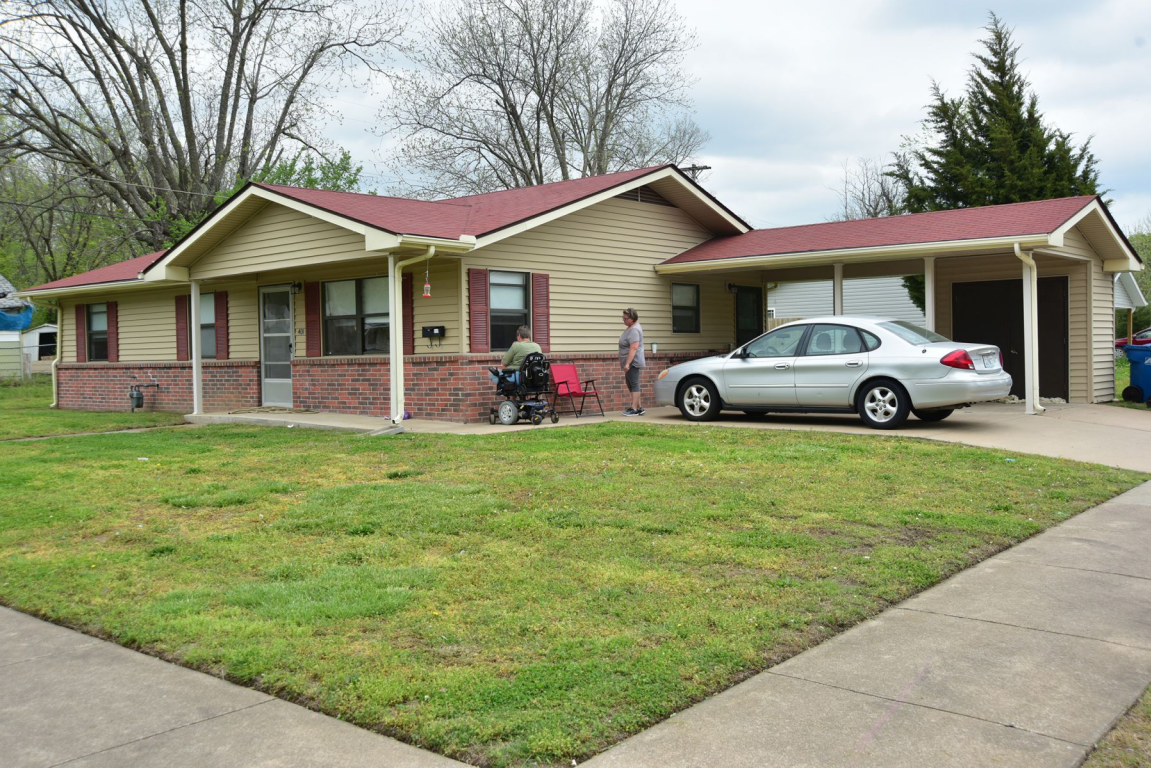
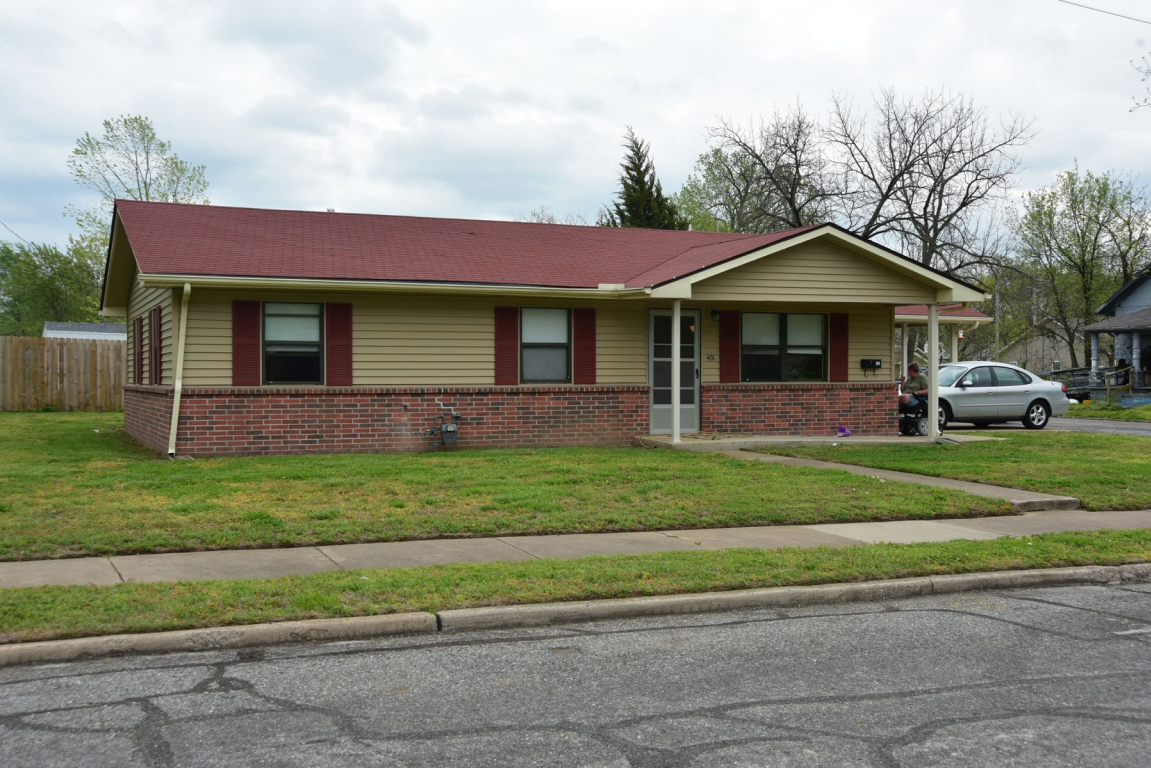
A twin to 129 N. Division Avenue, this one-story dwelling faces west and has an L-shaped footprint. It has a concrete foundation and side-gable roof with asphalt shingle. Brick veneer clads the lower third of the exterior while the vinyl clads the upper two-thirds. The dwelling is four asymmetrical bays wide and three bays deep. A front-gable wall dormer shelters the two south bays of the primary elevation and creates a partial-width open porch. Squared posts support the porch roof. A non-historic wood door fills the second-from-south bay. One-over-one metal windows with false shutters define the remaining bays. A carport with gable roof and squared wood posts projects from the south elevation and shelters the east two bays, including a secondary entrance. The southeast corner of the carport is enclosed.

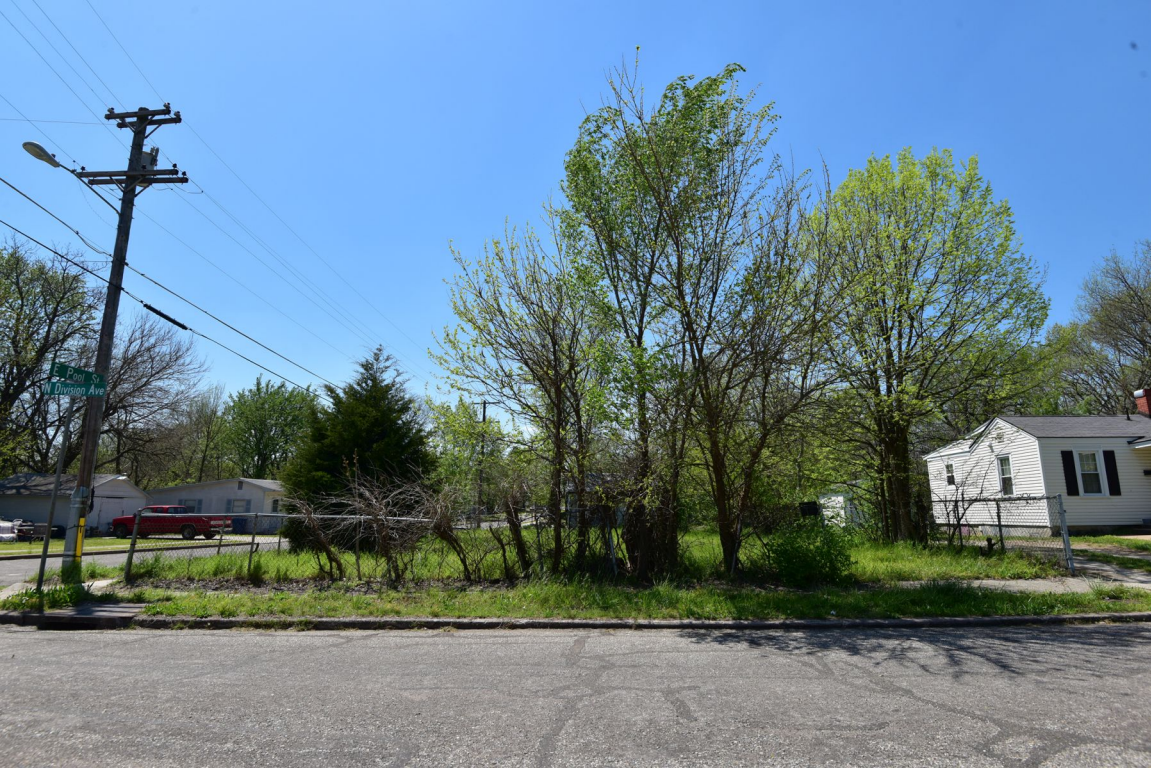
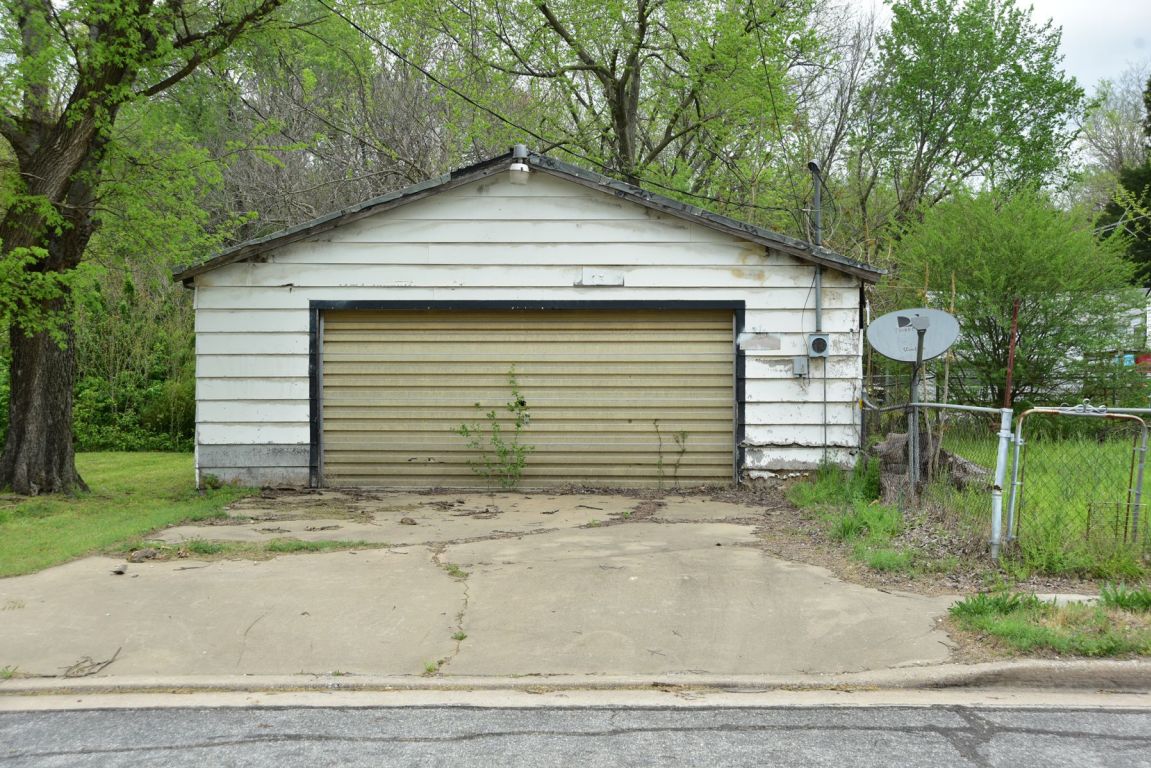
The dwelling associated with this outbuilding was demolished c.1980.

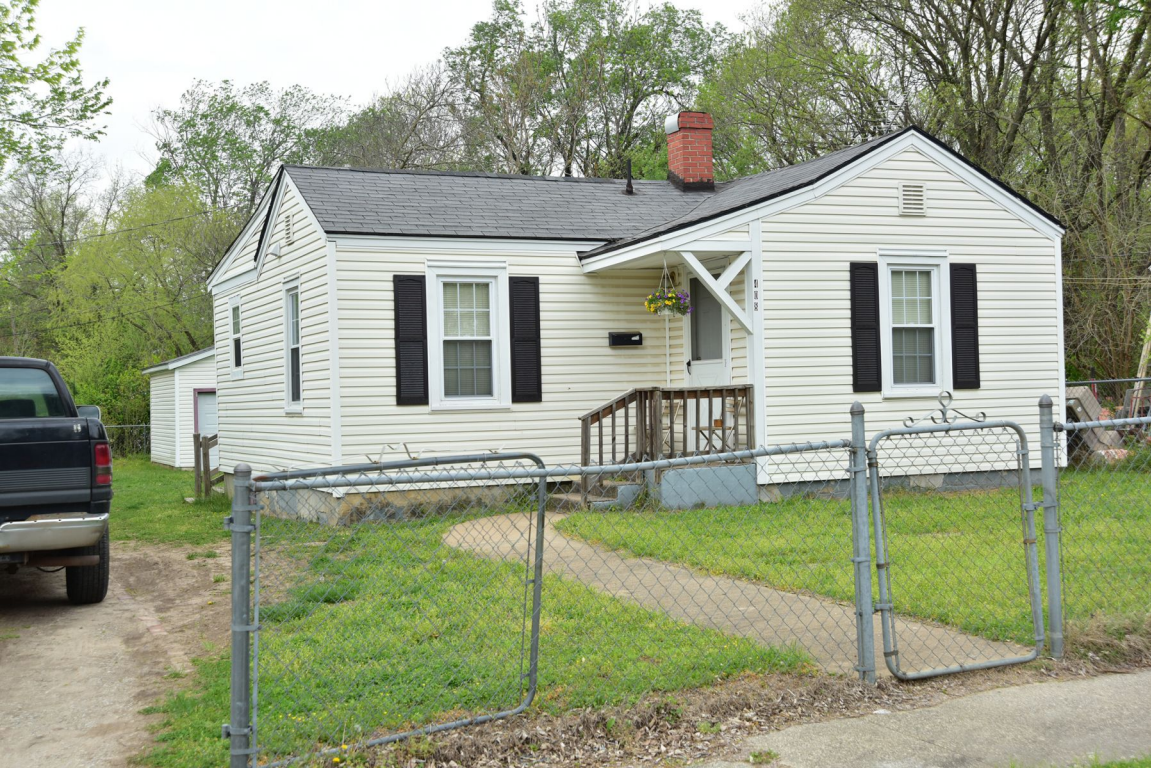
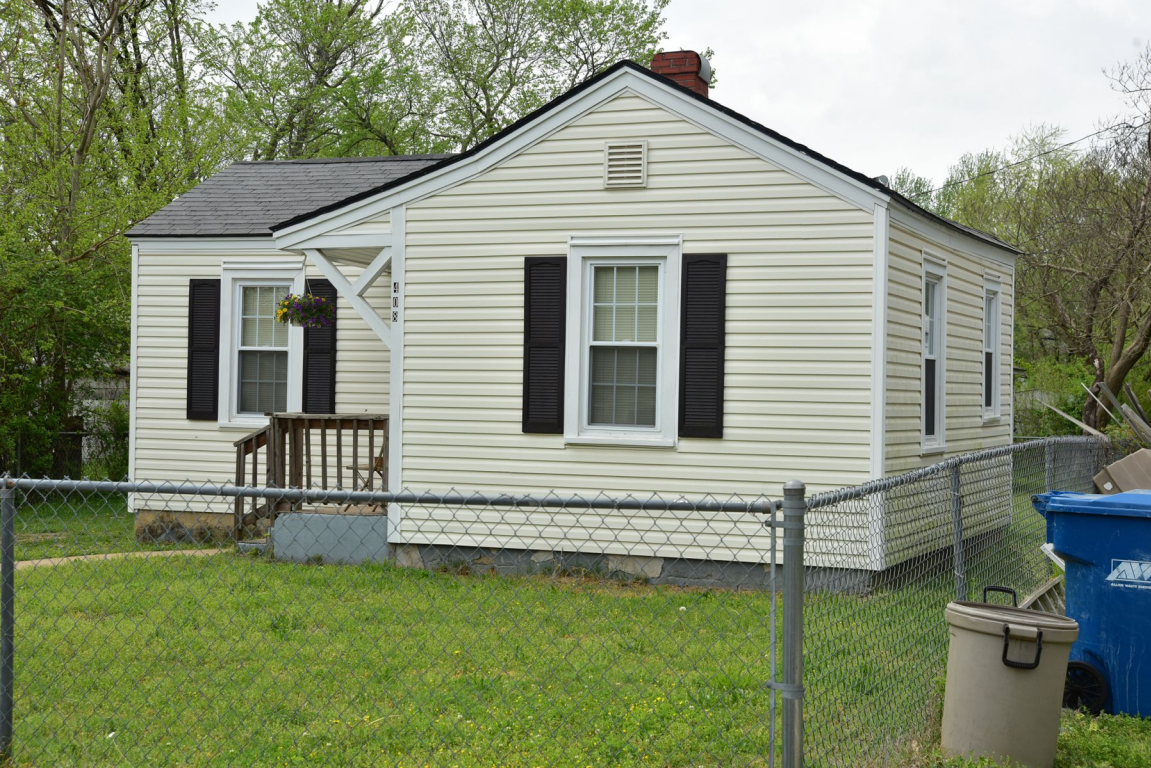
This one-story dwelling faces east and has an irregular footprint. It has a concrete masonry unit foundation and vinyl cladding with corner boards. The intersecting gable roof features asphalt shingles and lacks eaves. The dwelling is two bays wide and two bays deep. The north bay projects from the primary elevation and contains a six-over-six vinyl window with false shutters. A shed roof projects from the south wall of the projecting bay and shelters the stoop porch which features a non-historic wood door and matchstick balustrade. The roof was raised slightly (much less than a full story) over the rear southwest corner of the building. A knee bracket supports the east edge of the porch roof. A brick straddle ridge chimney is present at the north end of the roof.

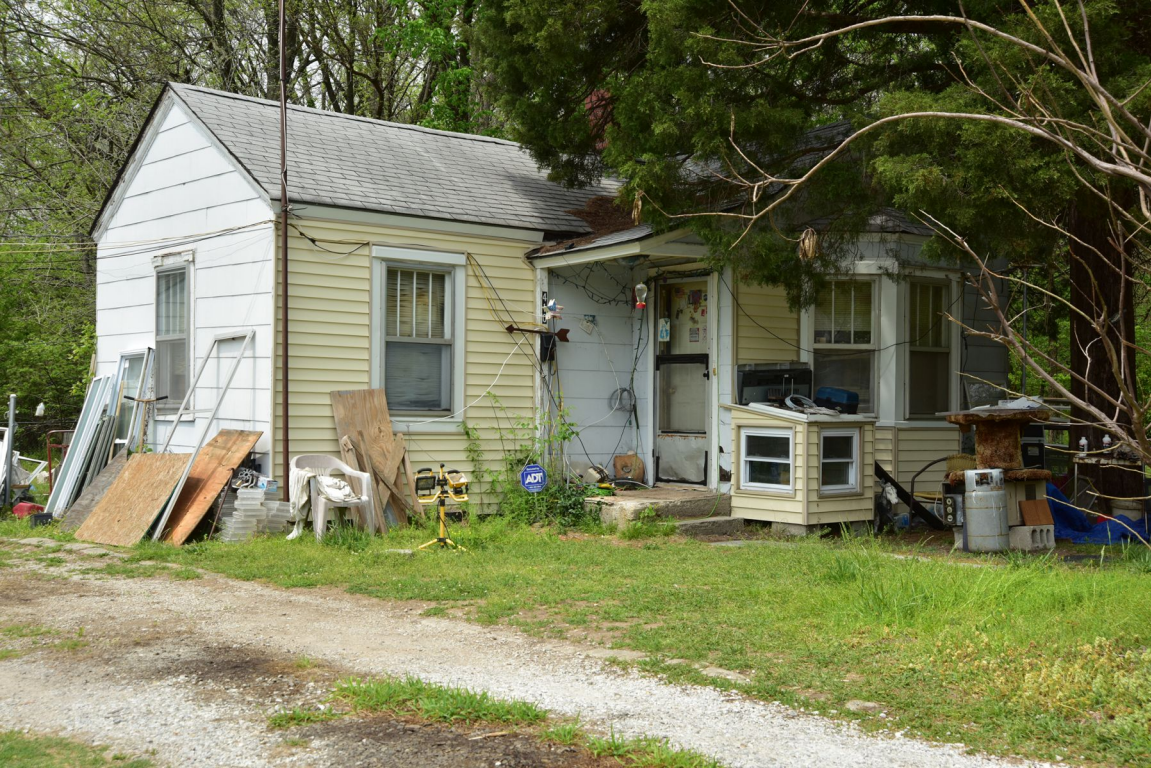
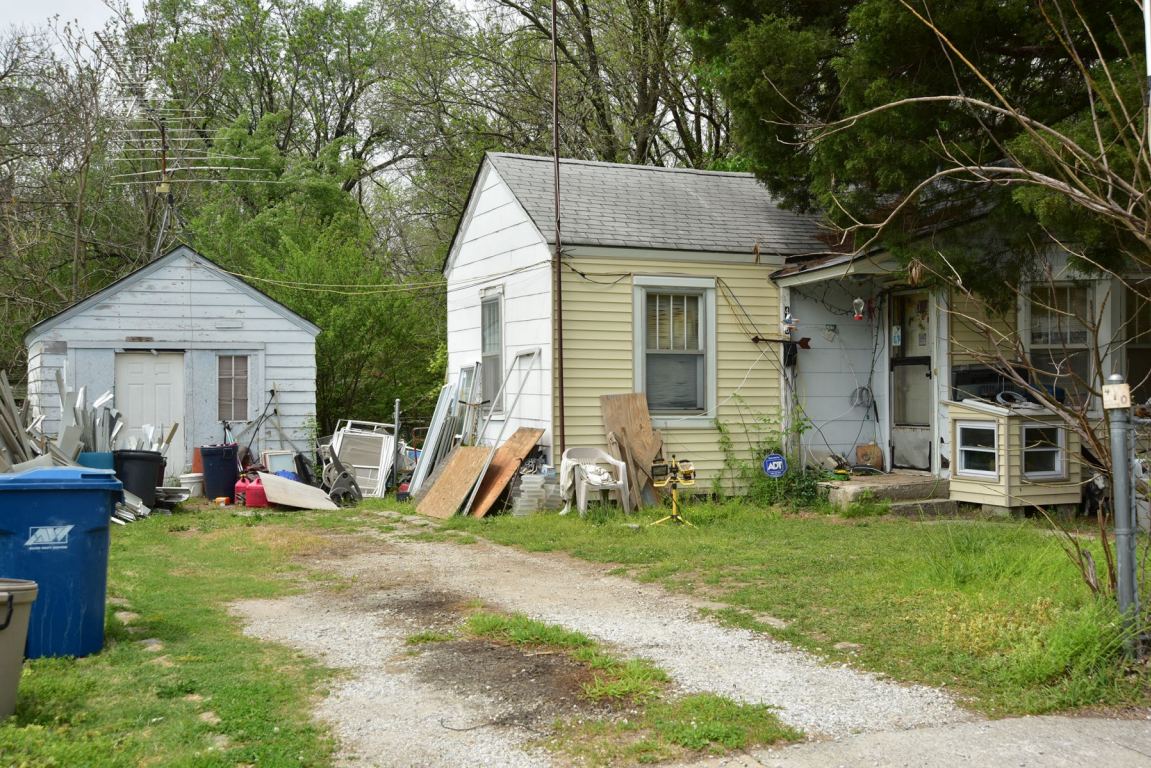
This one-story dwelling faces east and has an L-shaped footprint. The foundation is not visible. The intersecting gable roof features asphalt shingle and lacks eaves. The primary elevation features asbestos shingle and vinyl cladding. The remaining elevations visible from the right-of-way are clad with asbestos shingle. The dwelling is two asymmetrical bays wide and two bays deep. The north bay projects from the primary elevation and features a tripartite bay window with historic three-over-one wood windows. A non-historic wood door is located in the south wall of the projecting bay and sheltered by a shed porch roof. A historic four-over-one wood window defines the south bay of the primary elevation. The secondary elevations feature historic four-over-one wood windows.

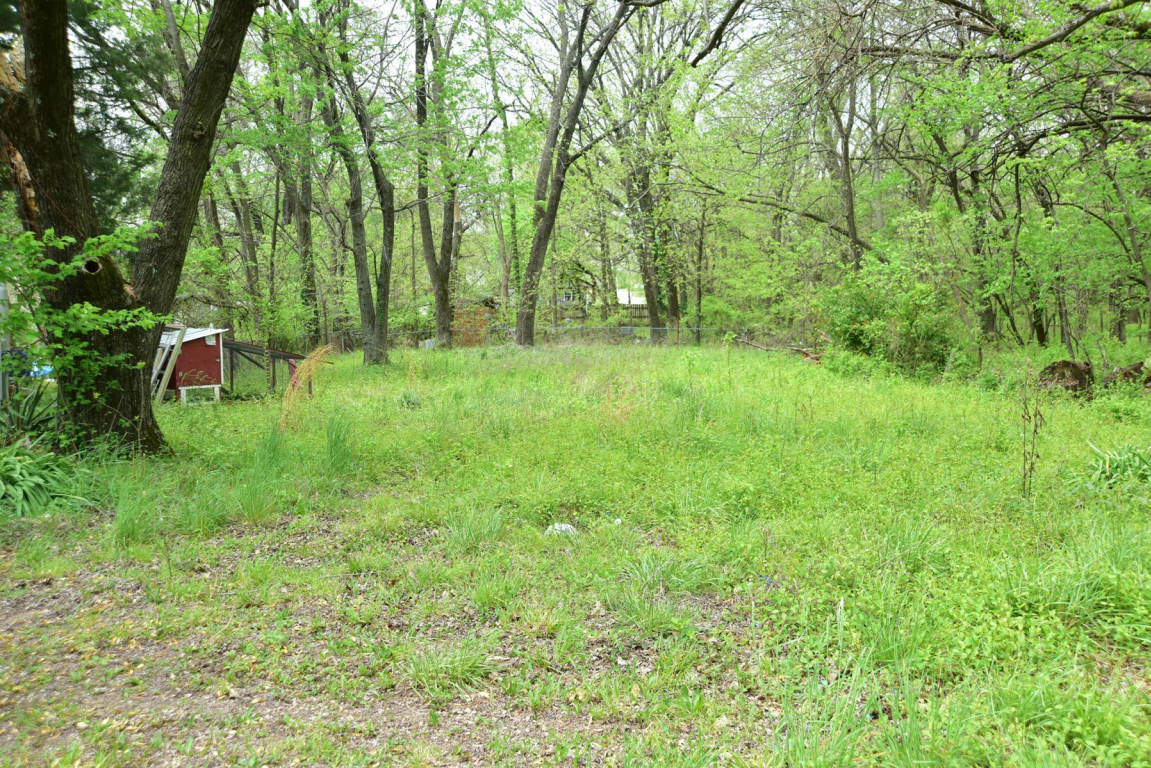
412 N. Division Avenue is a vacant lot characterized by an open grassy area. Mature deciduous trees and scrub are concentrated along the edges of the lot.

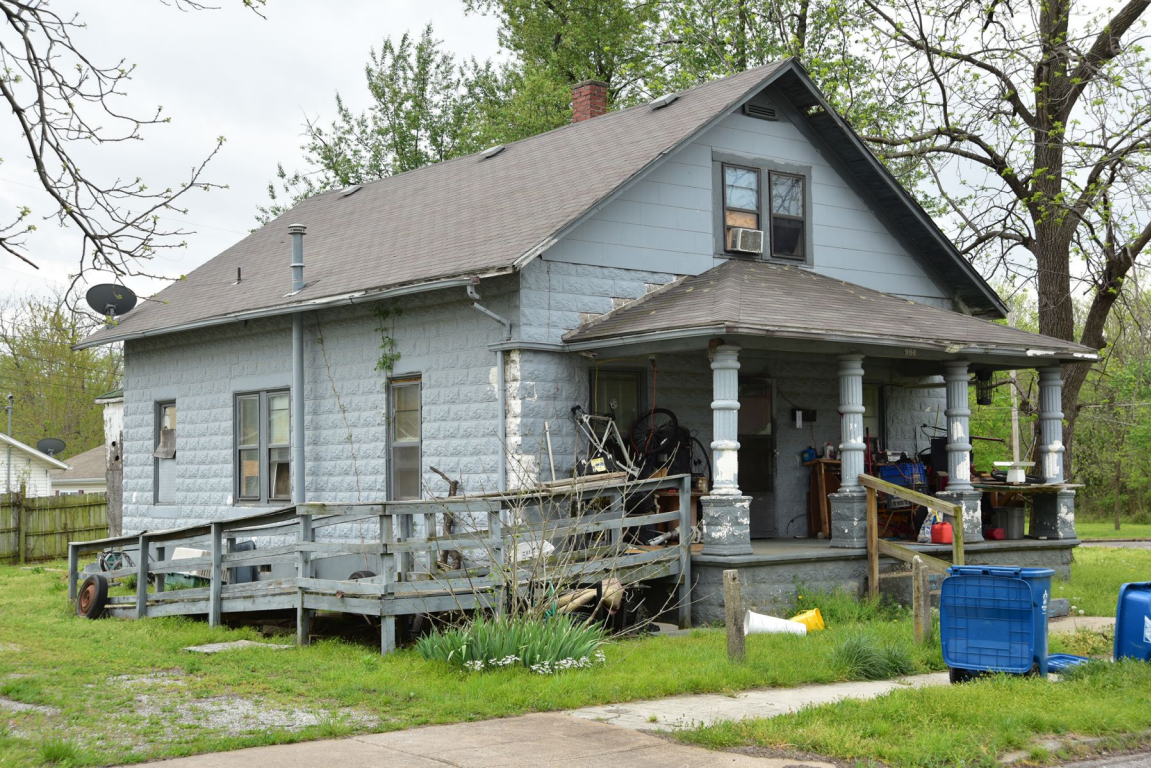
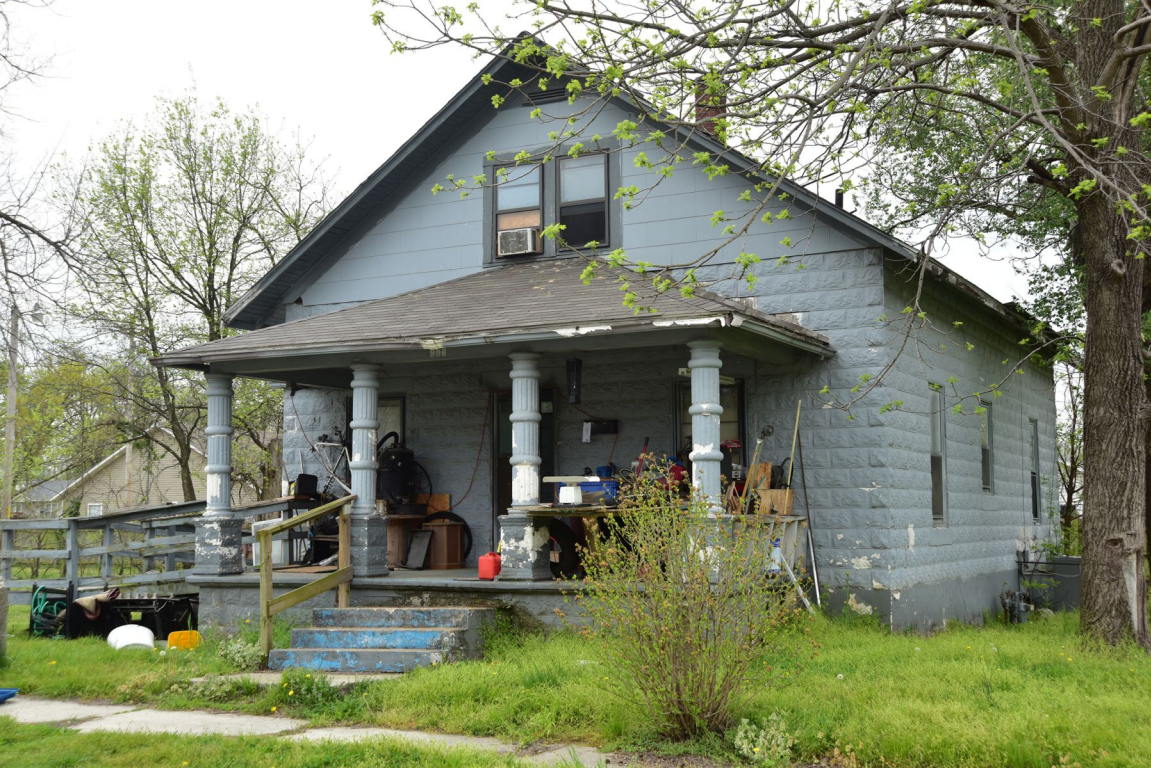
This one-and-one-half story dwelling faces north and has a rectangular footprint. The concrete block foundation is parged and the front-gable roof features asphalt shingles. The front gable features asbestos shingle while the remainder of the exterior is exposed concrete block. The dwelling is three bays wide and three asymmetrical bays deep. A three-quarter width open porch with hipped roof is supported by cast concrete columns on concrete block piers. A non-historic wood ramp is located at the east end of the porch and wraps around the east elevation. A non-historic wood door forms the center bay of the primary elevation. A historic three-over-one wood window fills the west bay while a one-over-one wood window fills the east bay. Paired one-over-one wood windows are centered in the front gable and present at the secondary elevations. A brick chimney is located on the west slope of the roof and near the ridge line.
