1. Survey number: JP-AS-006-001		2. Survey Name: East Town (Original Joplin) Historic Survey Phase 1	
3. County: JASPER		4. Address 503	Street (name): E. Broadway Street
5. City: Joplin	Vicinity <input type="checkbox"/>	7. Township/Range/Section: T: R: S:	
8. Historic name (if known):		9. Present/other name (if known):	
10. Ownership: <input checked="" type="checkbox"/> Private <input type="checkbox"/> Public		11a. Historic use (if known): Domestic/Single Dwelling	11b. Current use: Domestic/Single Dwelling

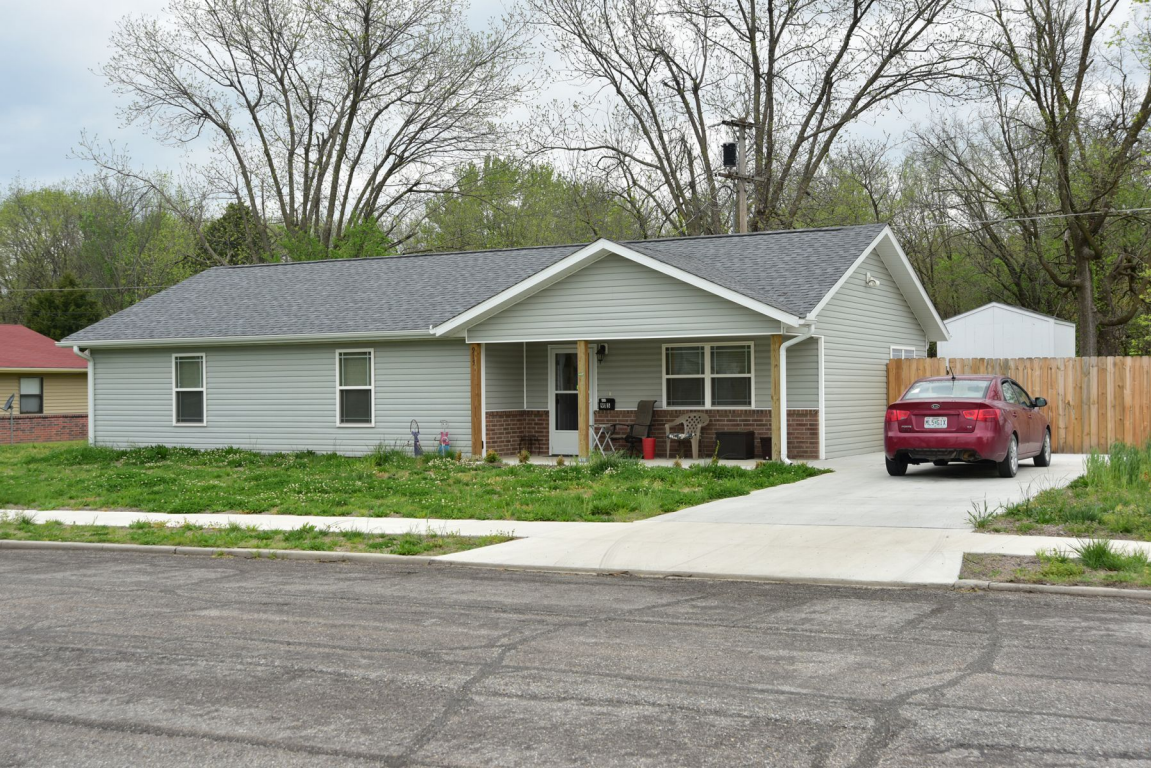
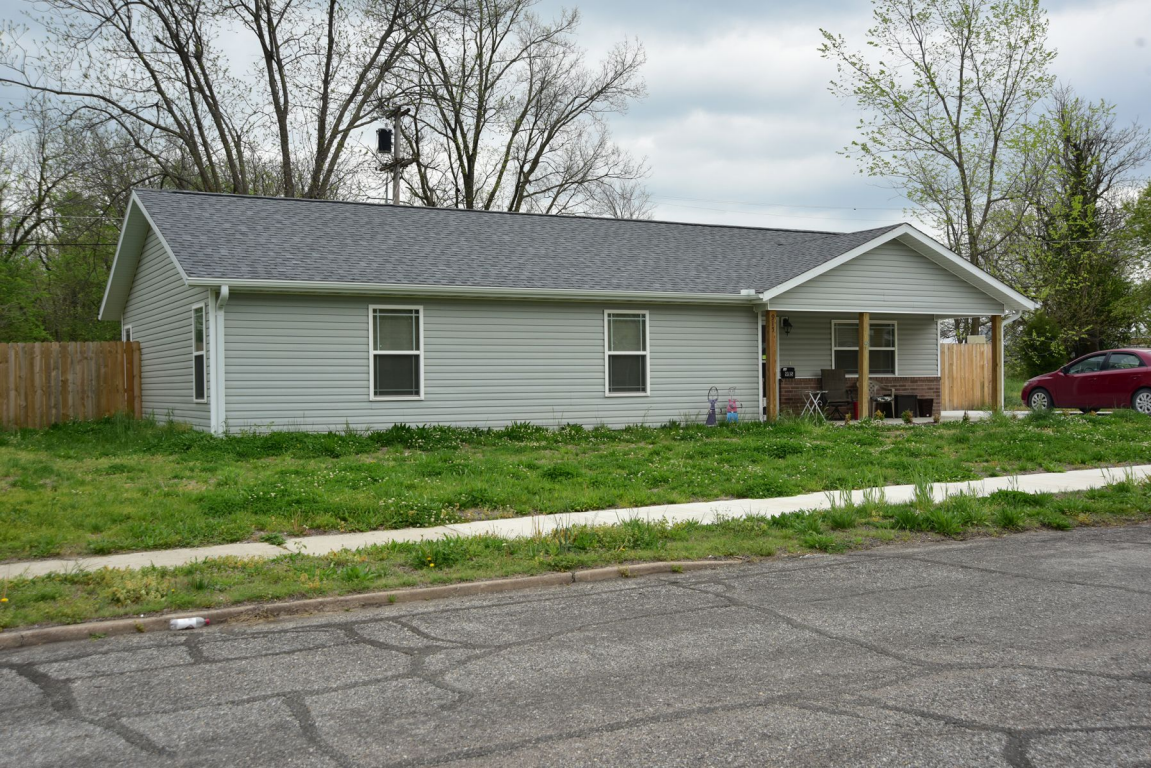
This modern one-story dwelling faces south and has a rectangular footprint. It has a concrete foundation and side-gable roof with asphalt shingles. Brick veneer clads the lower third of the recessed front porch while the remainder of the exterior is clad in vinyl. The dwelling is four bays wide and two asymmetrical bays deep. The east two bays recede and form a recessed open porch. A front-gable roof shelters the porch and is supported by squared wood posts. Paired multi-light-over-multi-light vinyl windows form the easternmost bay while a wood door with glazing fills the adjacent bay. Single multi-over-multi vinyl fill the remaining two bays.

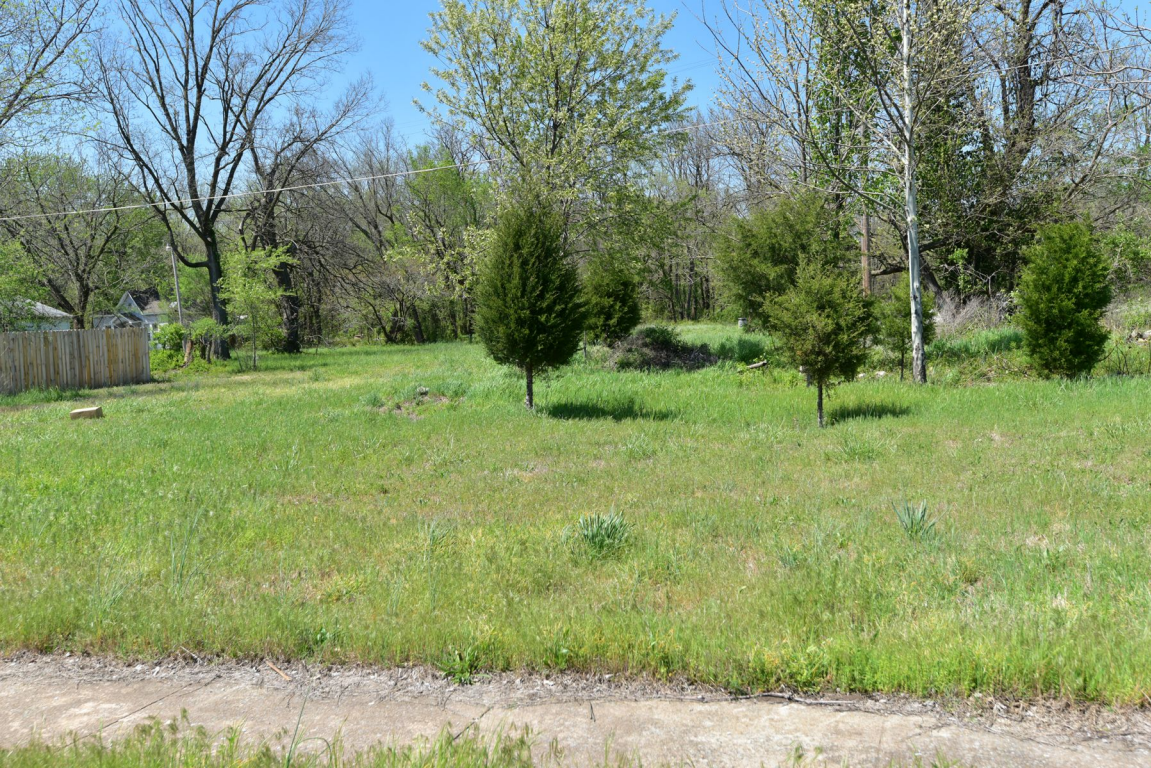
An open grassy area featuring a mixture of large trees and small shrubs characterizes the lots.

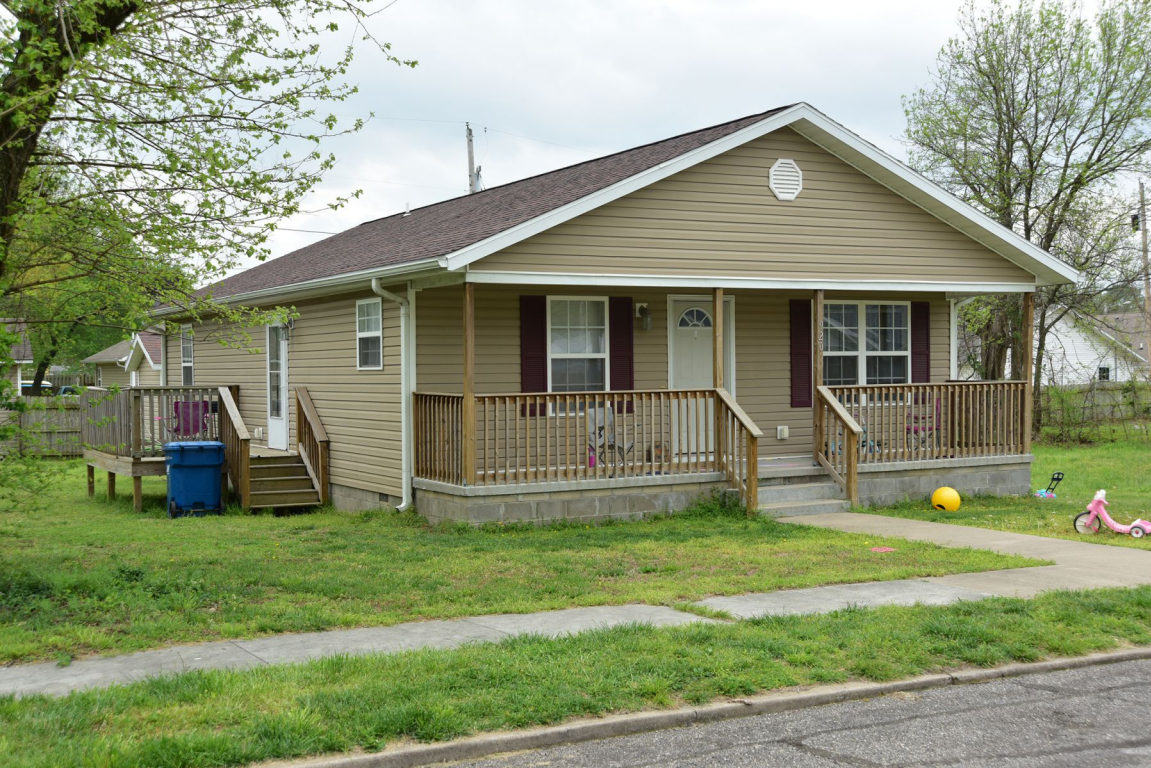
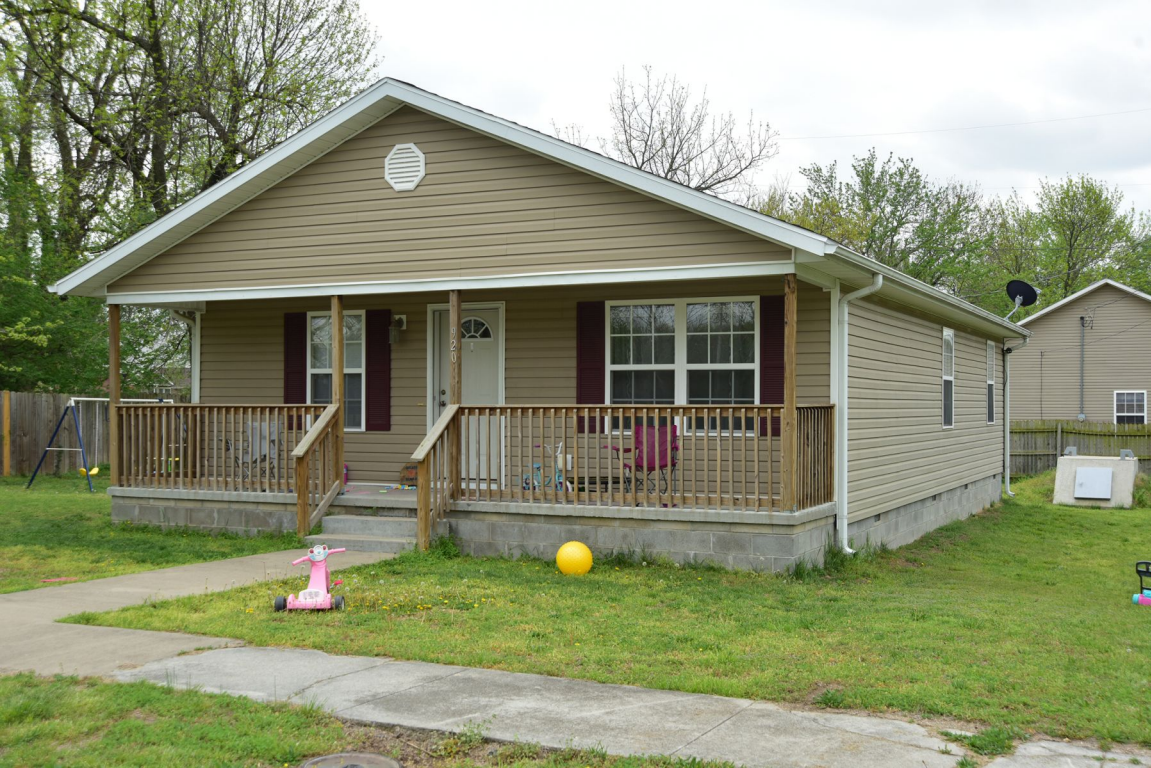
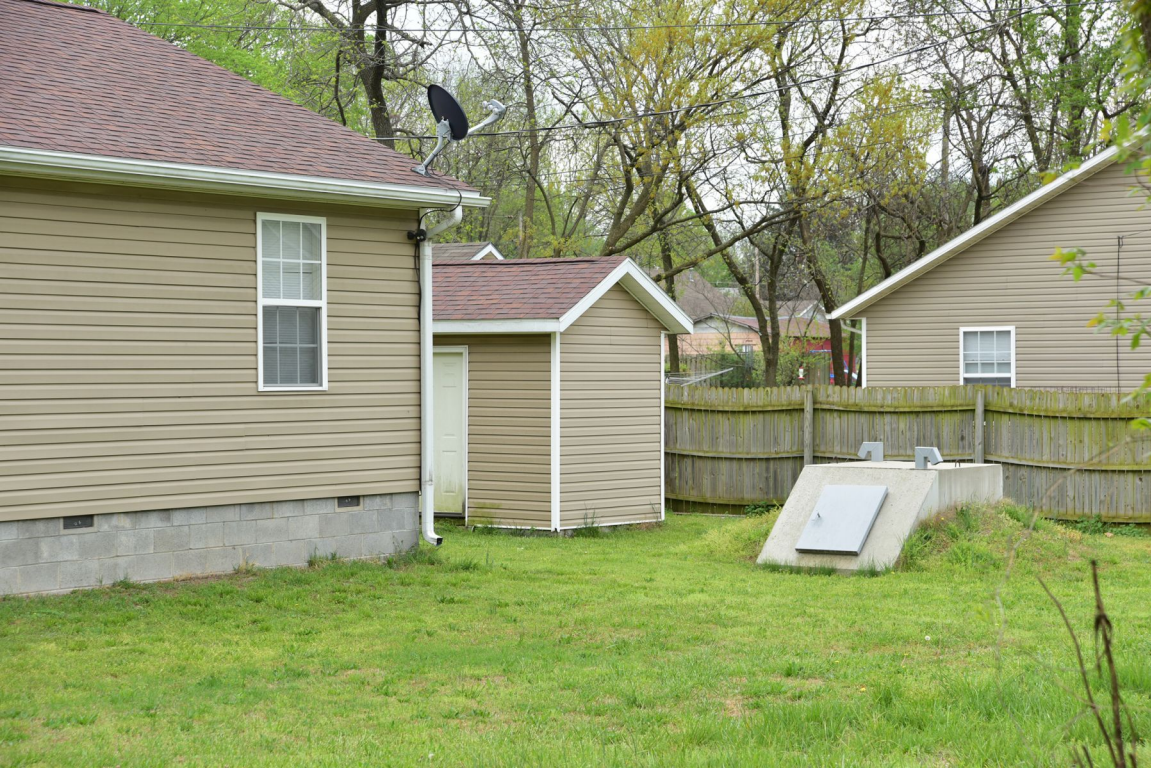
This modern one-story dwelling faces north and has a rectangular footprint. It has a concrete block foundation and vinyl cladding. The front-gable roof has asphalt shingles. The dwelling is three bays wide and three bays deep. An open porch spans the width of the primary elevation and features a matchstick balustrade. A fiberglass door forms the center bay of the primary elevation while six-over-six vinyl windows fill the remaining bays. A secondary entrance is located in the center bay of the east elevation.

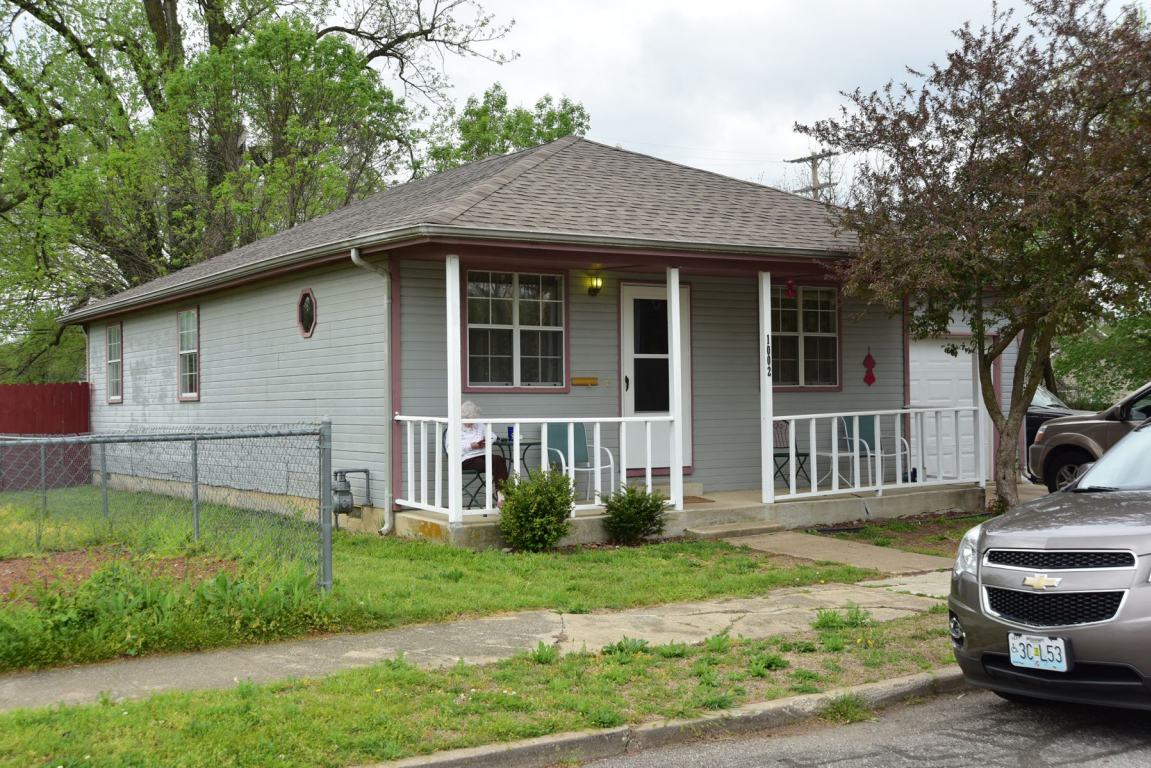
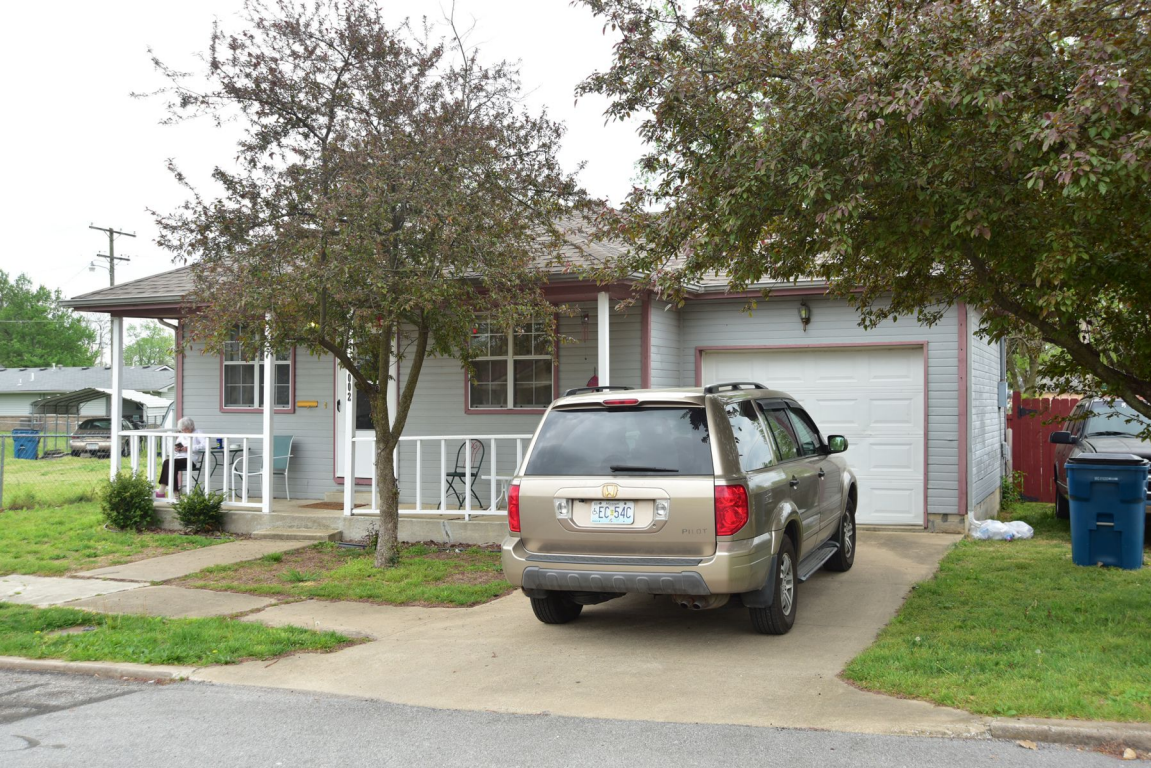
This modern dwelling faces north and has a rectangular footprint. It has a concrete masonry unit foundation and vinyl cladding. The hipped roof has asphalt shingles. The dwelling is three bays wide and three bays deep. An attached garage forms the west bay of the primary elevation and is slightly recessed. An open porch with wood support posts and matchstick balustrade shelters the remaining three bays. Paired four-over-four vinyl windows flank the primary entrance which features an aluminum storm door. The main door was not visible at the time of survey. A small octagonal fixed window is located at the north end of the east elevation. Single six-over-six vinyl windows define the remaining bays of that elevation.

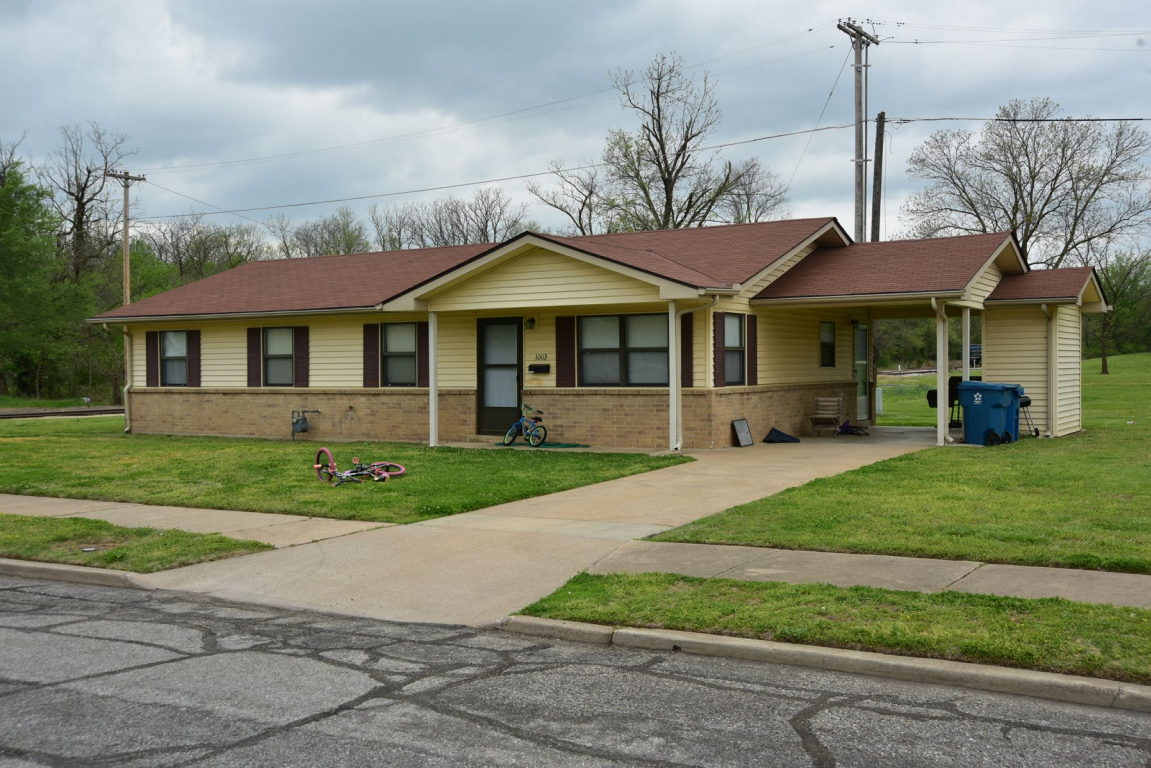
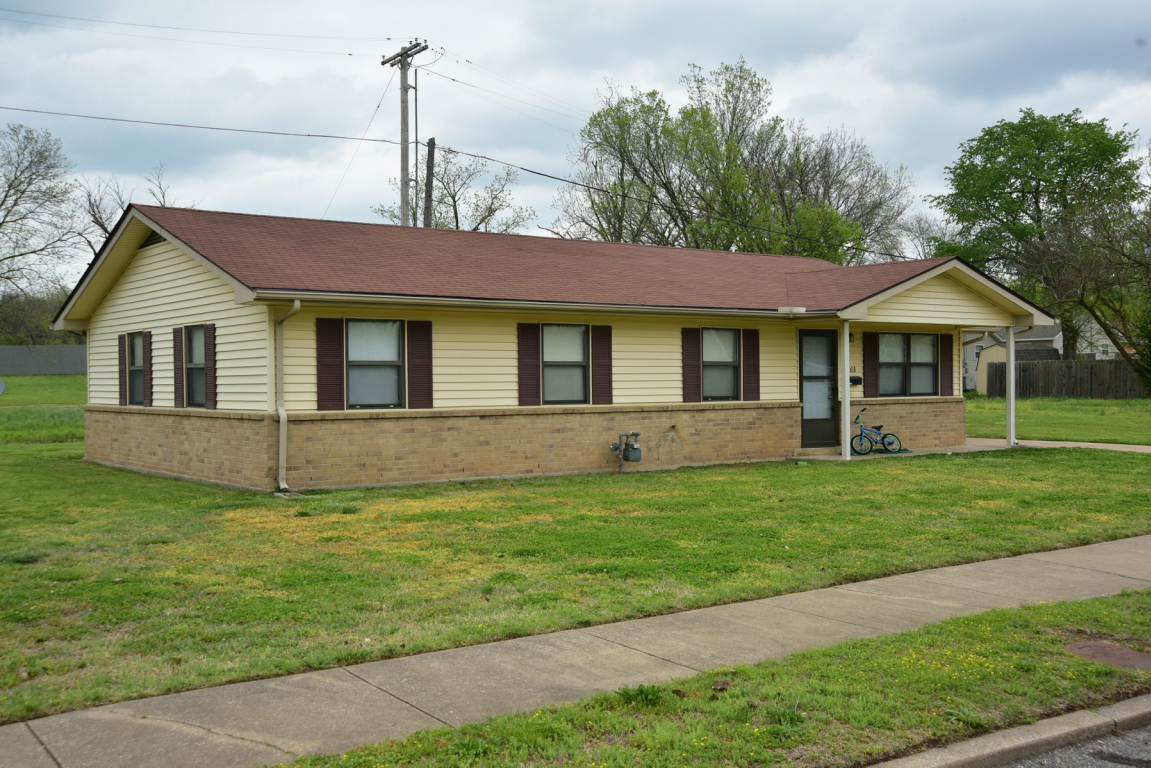
This one-story dwelling faces south and has a rectangular footprint. It has a concrete foundation and side-gable roof with asphalt shingles. Brick veneer clads the lower third of the dwelling while the remainder is vinyl clad. The dwelling is five bays wide and three bays deep. A front-gable porch shelters the two east bays of the primary elevation. A wood door with metal storm door fills the second-from-east bay. One-over-one metal windows with false shutters define the remaining bays. A side-gable carport projects from the east elevation and shelters a secondary entrance. An enclosed storage area with gable roof is located at the east end of the carport.

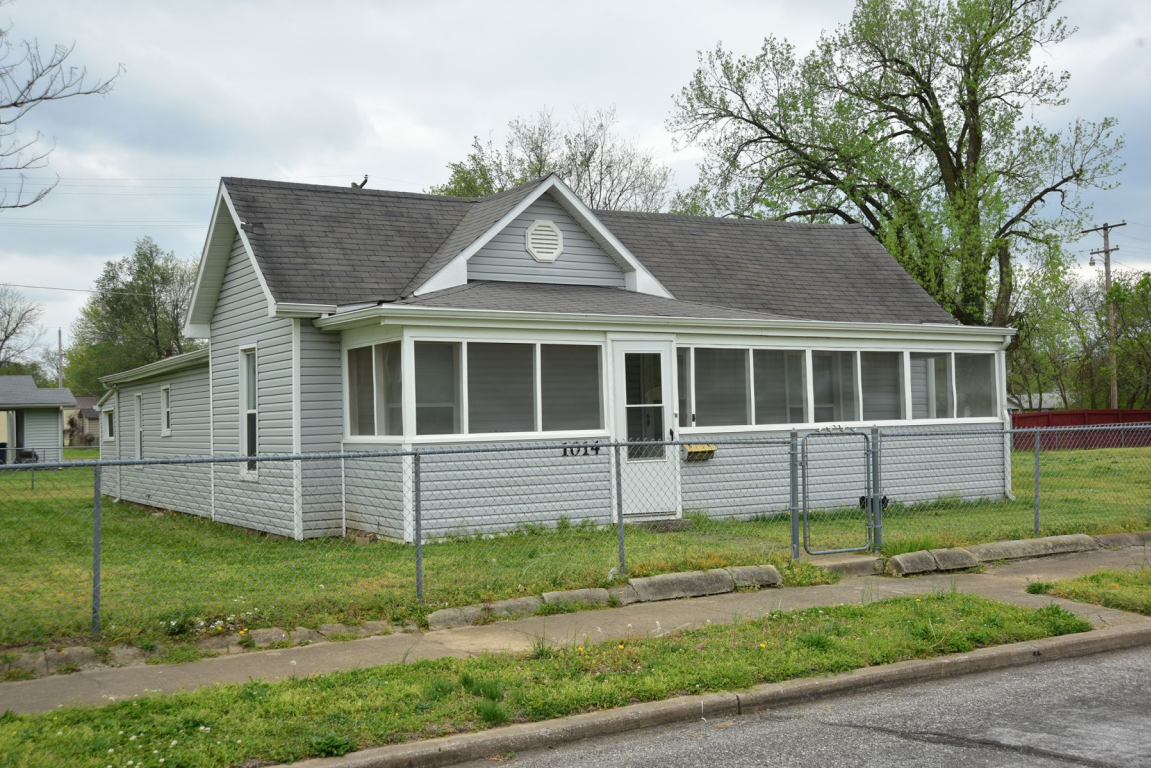
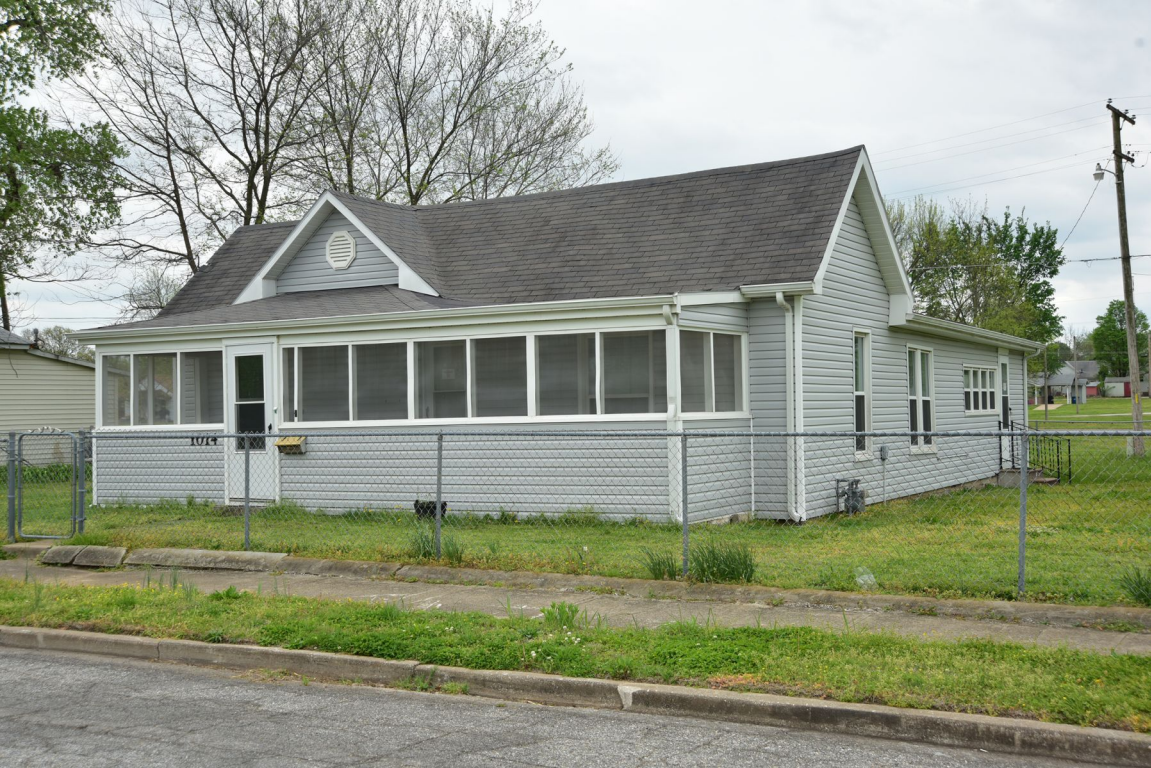
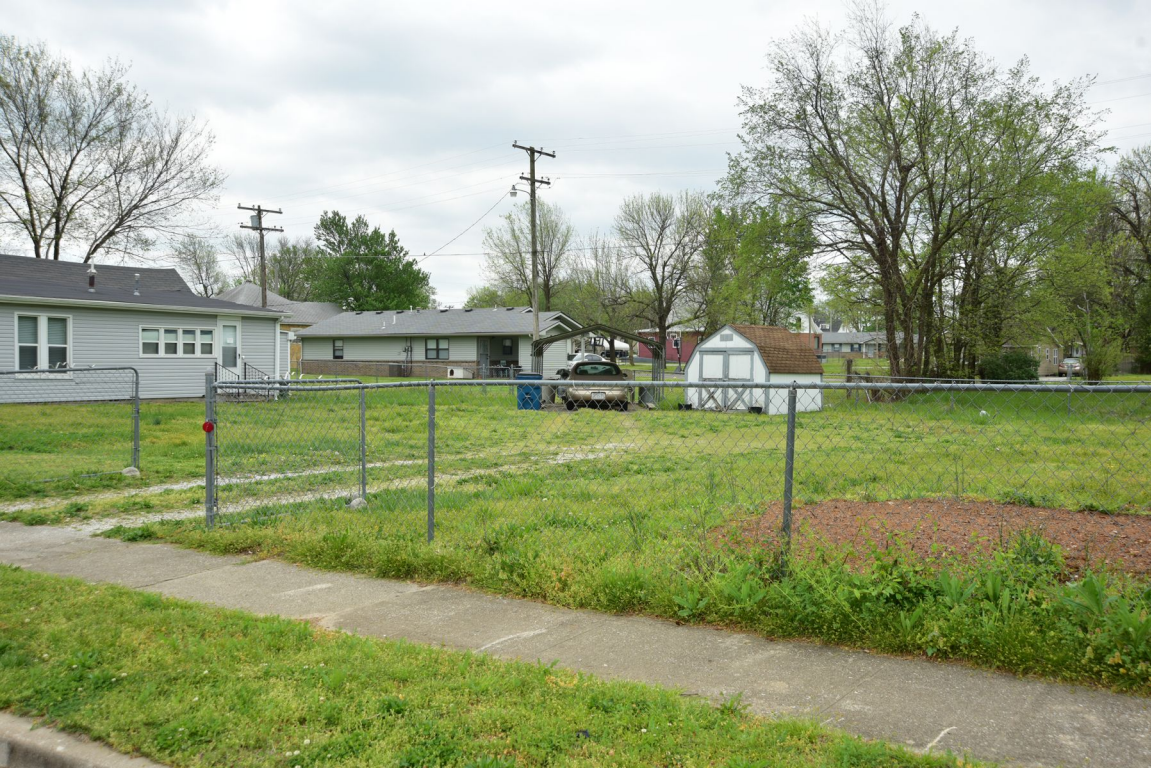
This one-story dwelling faces north and has a rectangular footprint. It has a concrete foundation and vinyl cladding. A side-gable roof with gabled dormer fronts the street and is intersected with a perpendicular gablet roof at the rear. The complex roof has asphalt shingles and an octagonal louver is located in the dormer. The dwelling is three bays wide and four asymmetrical bays deep. The small one-story addition to the rear is historic (c.1955). A non-historic enclosed porch with vinyl cladding and mesh screens partially obscures the primary elevation. A non-historic wood door occupies the center bay of the primary elevation. One-over-one vinyl windows occupy the east and west bays. A secondary entrance with stoop occupies the fourth bay of the west elevation.

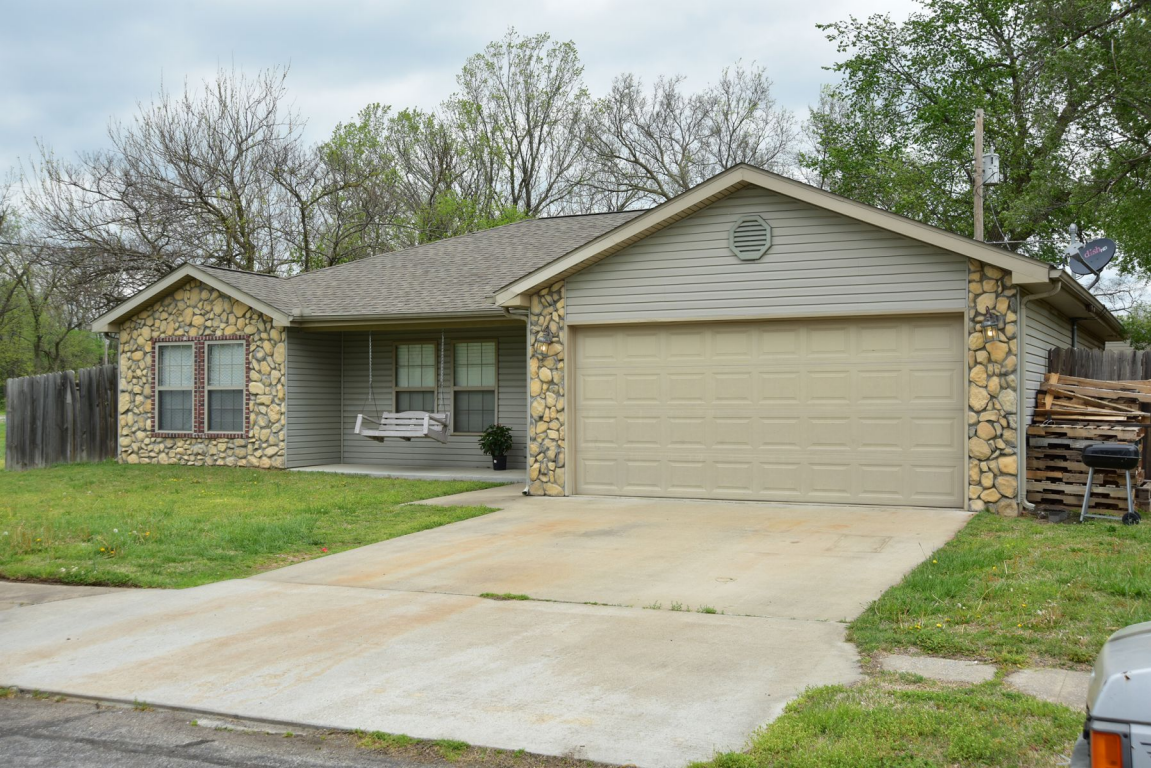
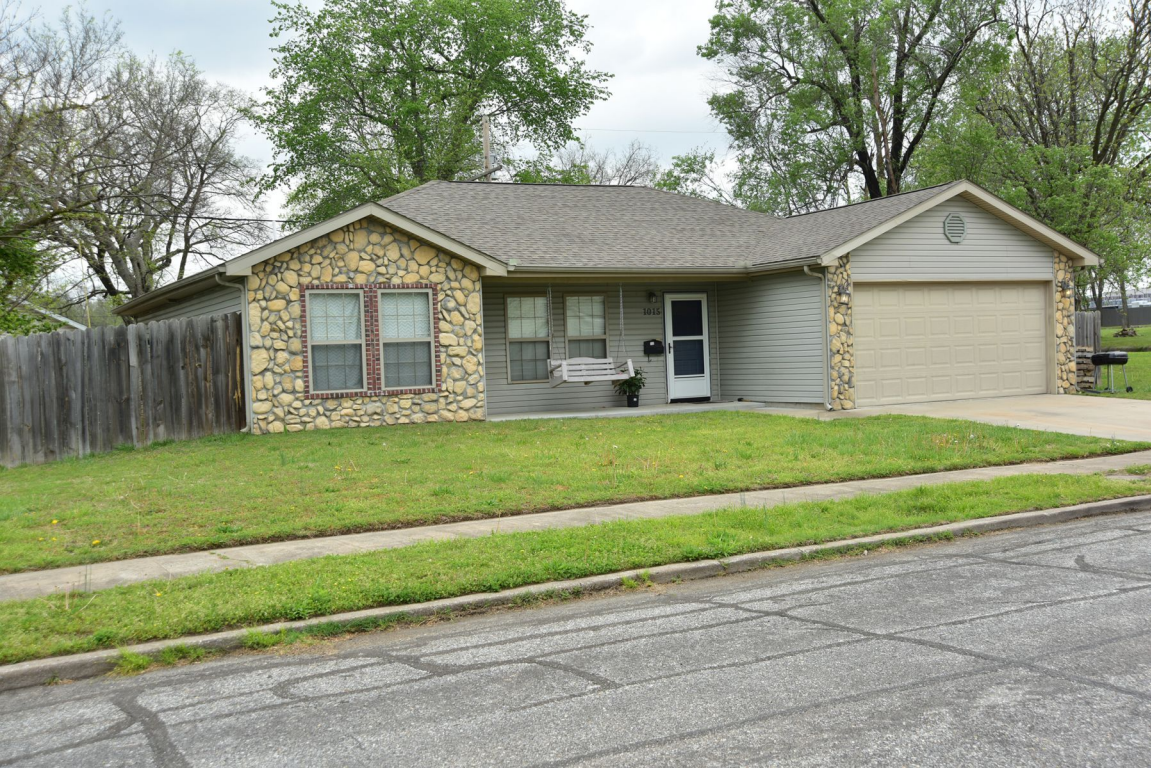
This modern dwelling faces south and has an L-shaped footprint. It has a concrete foundation and hipped roof with asphalt shingles. The dwelling is vinyl clad with stone veneer accents at the primary elevation. It is five asymmetrical bays wide. A wide, single-bay garage with front-gable roof occupies the east bay. Stone veneer accents the east and west ends of the bay. The adjacent bay contains a wood door with glazing and metal storm door. A shallow cross gable defines the west bay. Paired six-over-six vinyl windows with header brick trim occupy the west bay. Stone veneer clads this bay. Six-over-six vinyl windows fill the remaining bays. A wood privacy fence shields the secondary elevations.

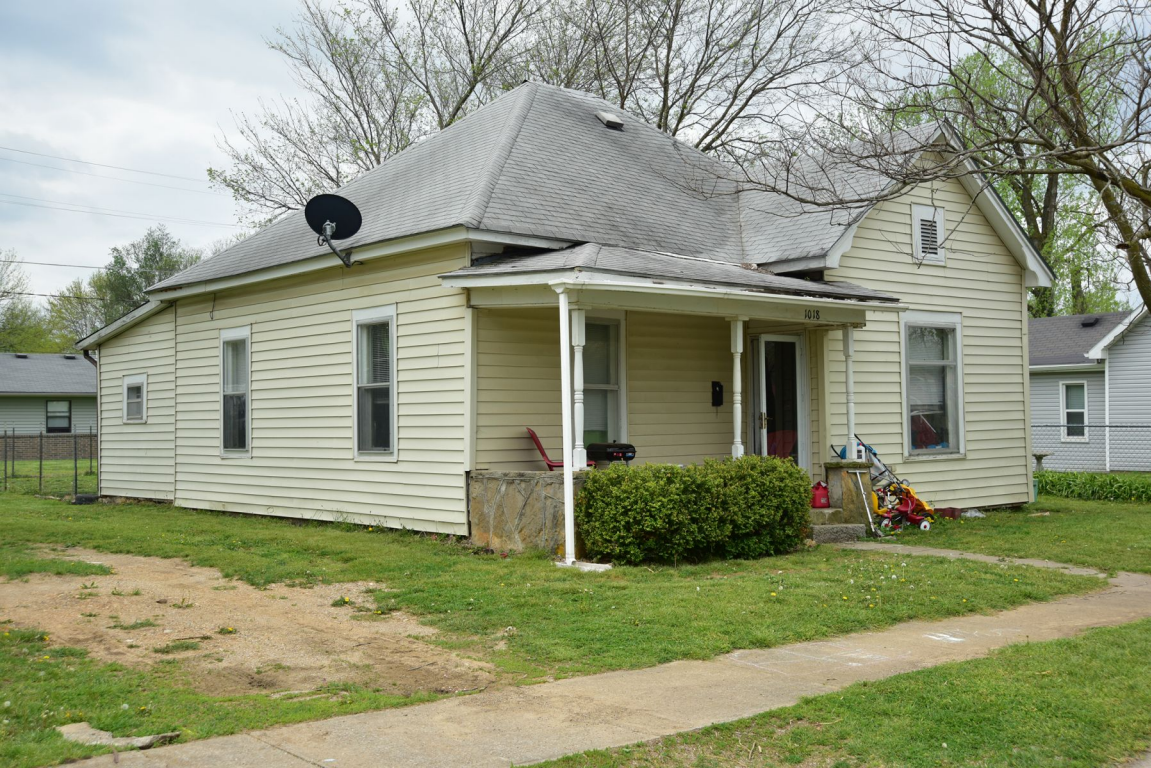
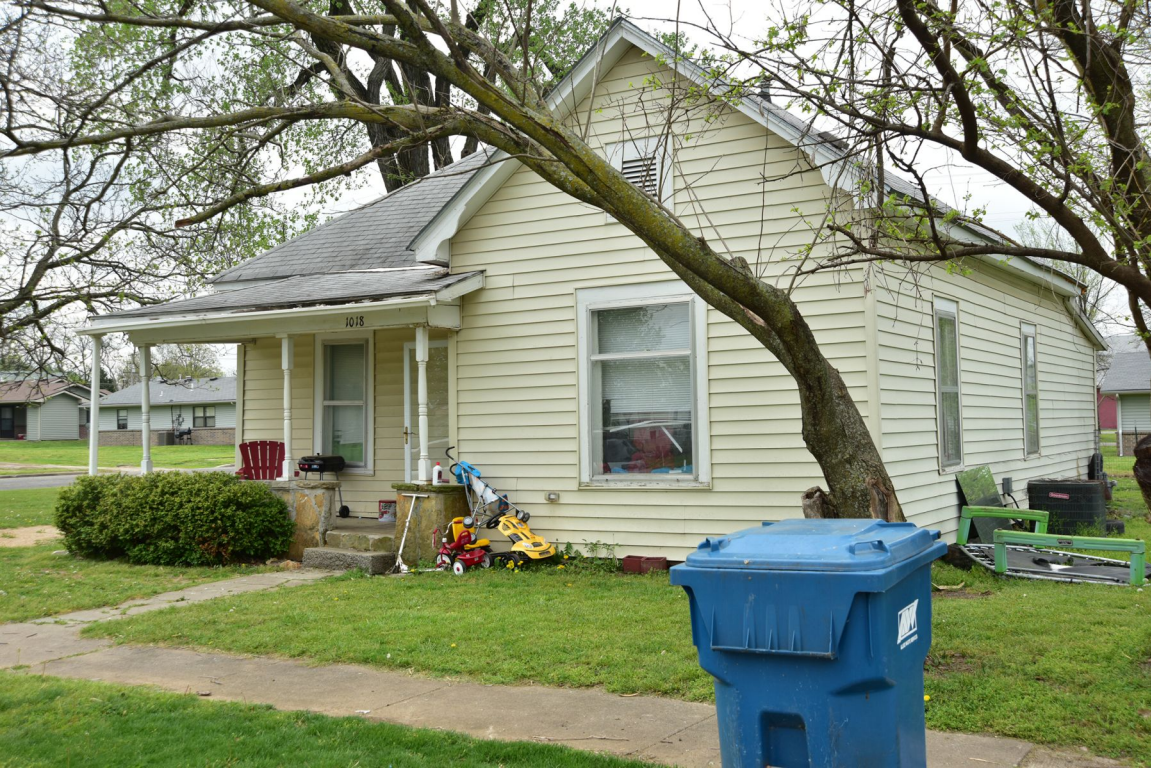
This one-story dwelling faces north and has a rectangular footprint. It has a stone foundation and vinyl cladding. The hipped roof with cross gable features asphalt shingle. The cross gable is located at the west end of the dwelling and features boxed eaves with decorative molding and a rectangular louver. The dwelling is two bays wide and three bays deep. An open porch with hipped roof shelters the east two bays of the primary elevation and is supported by turned wood posts on split slab fieldstone walls. Historic one-over-one wood windows occupy the east and west bays of the primary elevation. A wood door with metal storm door is located on the east wall of the projecting west bay.

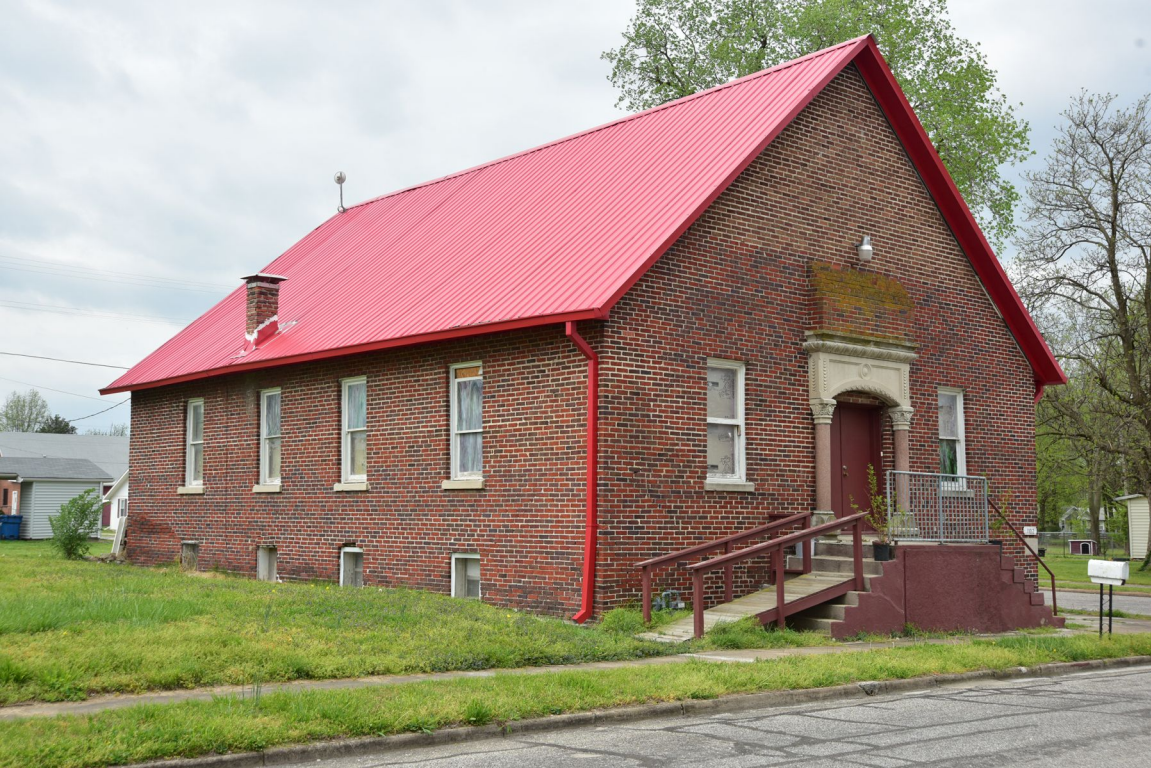
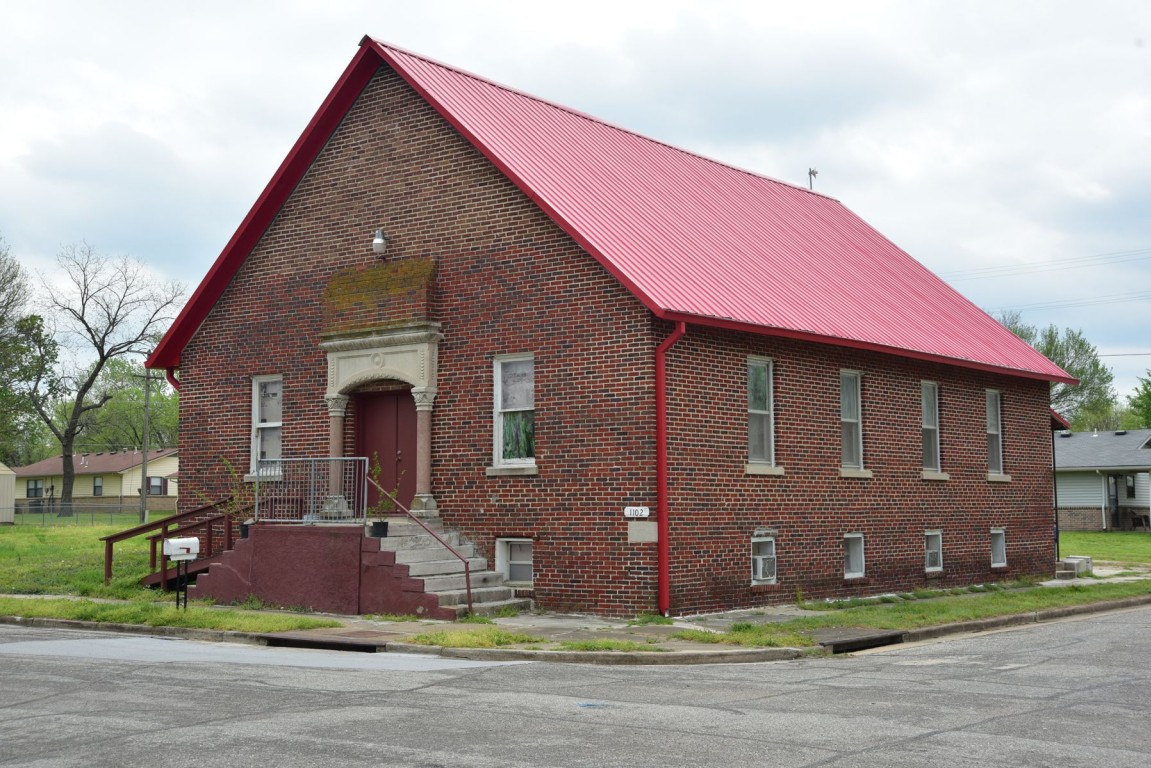
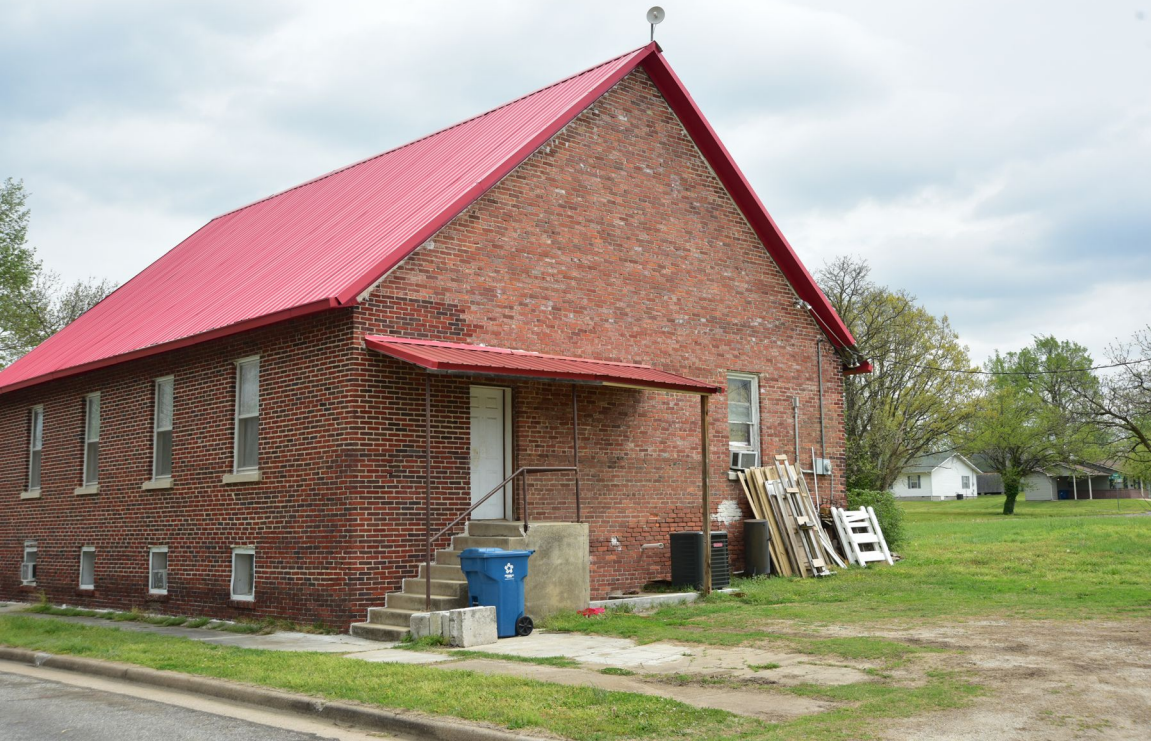
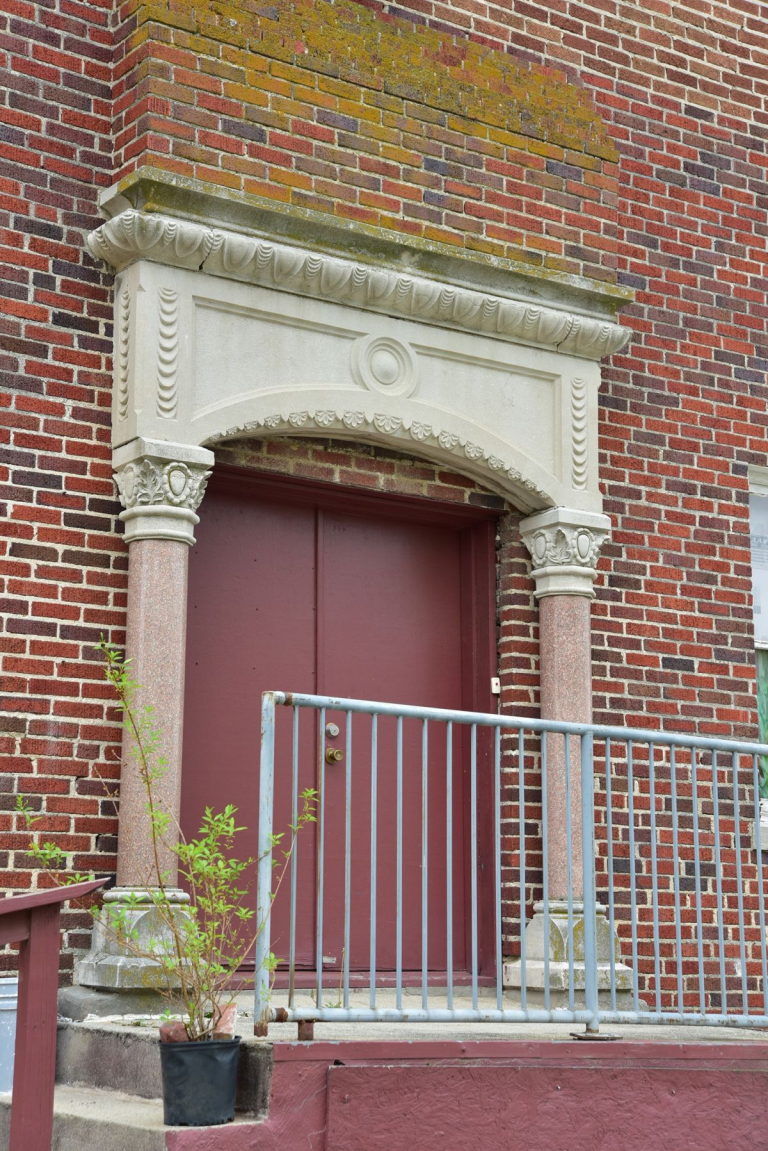
This one-and-one-half story church with exposed basement level faces north and has a rectangular footprint. It has a brick foundation and cladding. Large segments of replacement brick are visible. The front-gable roof is corrugated metal. It is three bays wide and four bays deep. Paired wood doors fill the center bay. Polished granite columns with cast stone bases and composite cast stone capitals support a cast stone surround at the entrance. A limestone plaque with inscription is in the southwest corner of the primary elevation. Historic one-over-one wood windows with stained glass glazing and stone sills fill the east and west bays. A concrete stoop porch is located at the primary entrance and features east and west stairs with non-historic metal railings. Historic one-over-one wood windows with stained glass in the upper sash and stone sills define the first-story bays of the secondary elevations. Historic one-over-one wood windows with brick sills occupy the basement-level bays. A secondary entrance with concrete stoop and shed roof is located in the southwest corner of the south elevation.

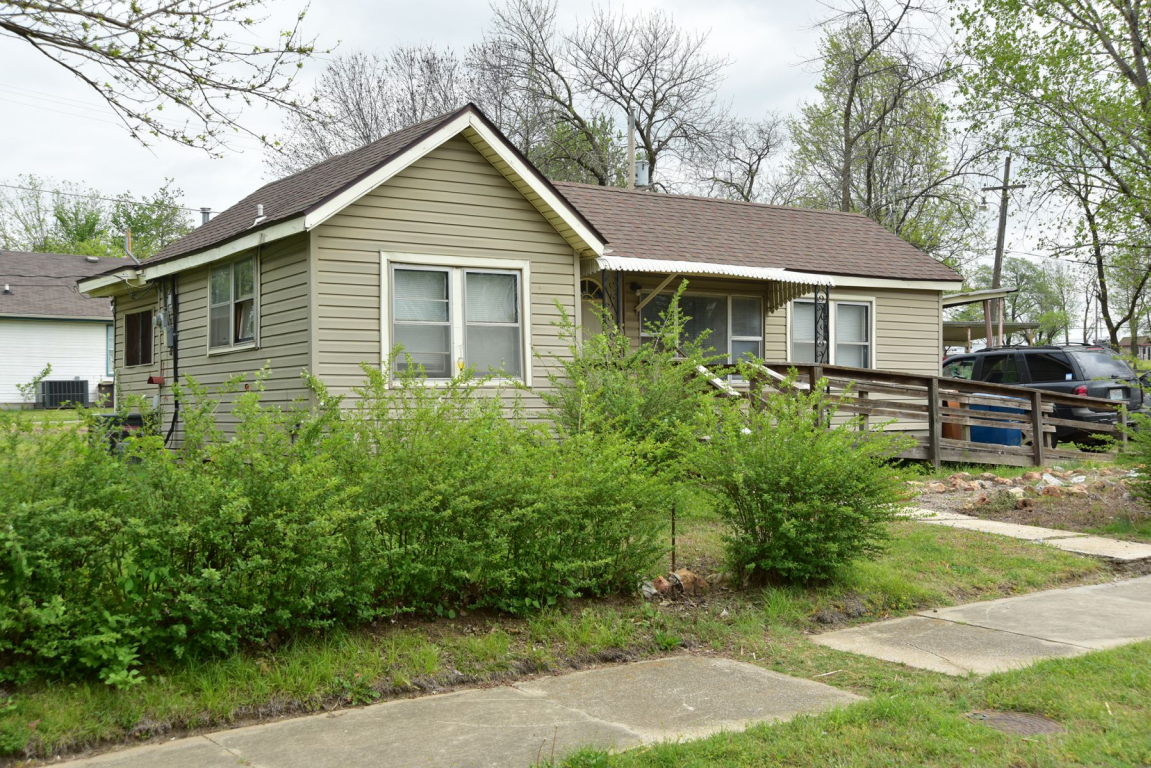
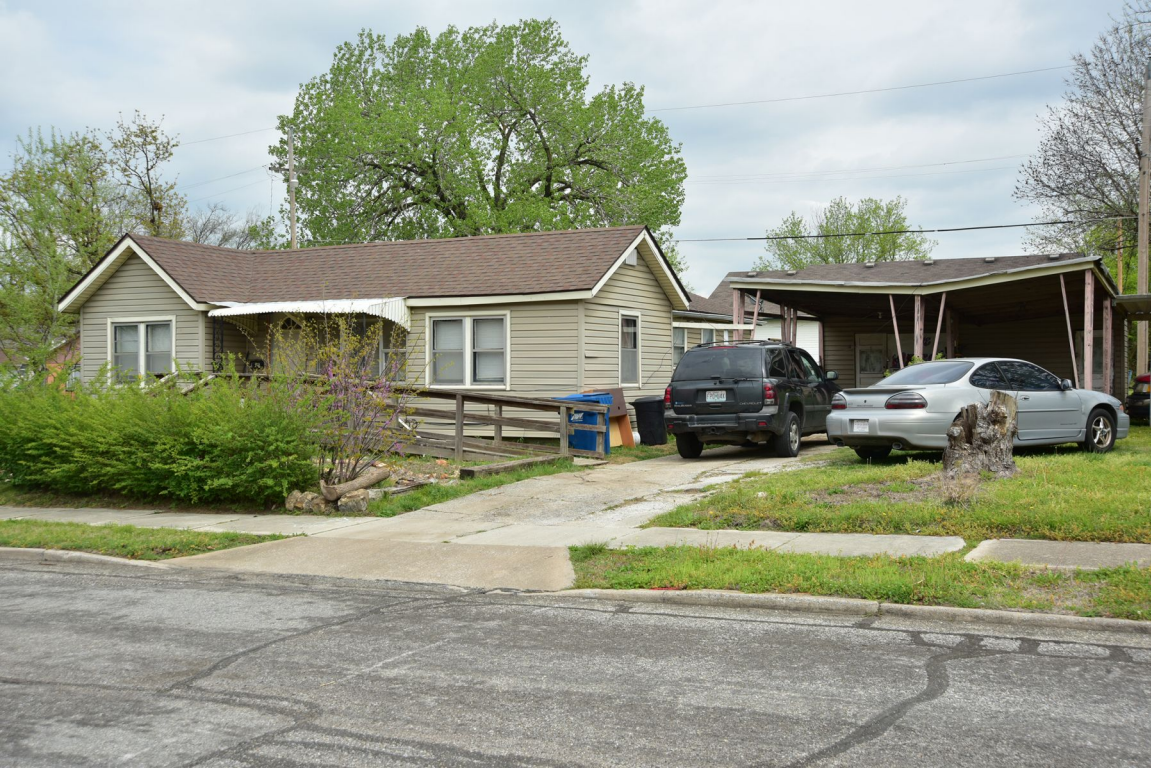
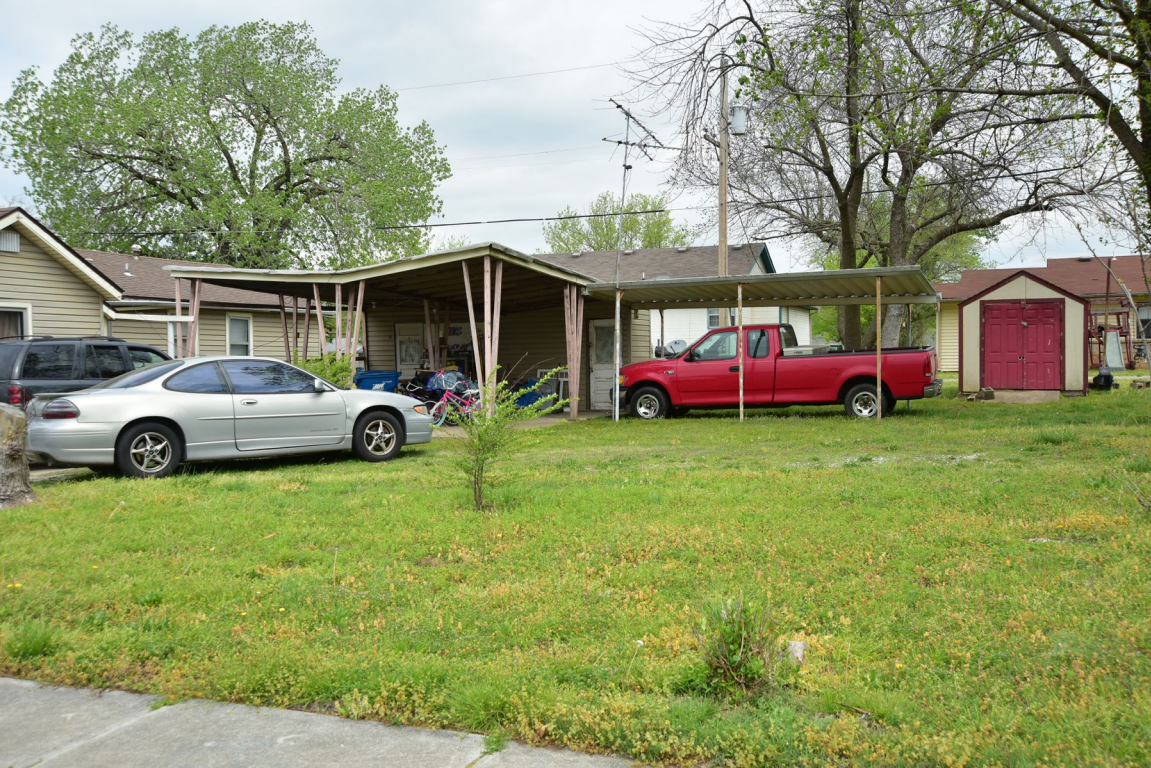
This one-story dwelling faces south and has an irregular footprint. It has a concrete foundation and vinyl cladding. The intersecting gable roof with gable-roof rear addition (c.1980) has asphalt shingles. The dwelling is four bays wide and four asymmetrical bays deep. Paired one-over-one wood windows occupy the east and west bays. A wood tripartite picture window fills the second-from-east bay. The picture window features a single-light center flanked by one-over-one windows. A fiberglass door occupies the second-from-west bay. A non-historic metal awning with decoration metal support posts shelters the center two bays. A non-historic wood ramp and stair system spans three-quarts the primary elevation.
