1. Survey number: JP-AS-006-001		2. Survey Name: East Town (Original Joplin) Historic Survey Phase 1	
3. County: JASPER		4. Address 503	Street (name): E. Broadway Street
5. City: Joplin	Vicinity <input type="checkbox"/>	7. Township/Range/Section: T: R: S:	
8. Historic name (if known):		9. Present/other name (if known):	
10. Ownership: <input checked="" type="checkbox"/> Private <input type="checkbox"/> Public		11a. Historic use (if known): Domestic/Single Dwelling	11b. Current use: Domestic/Single Dwelling

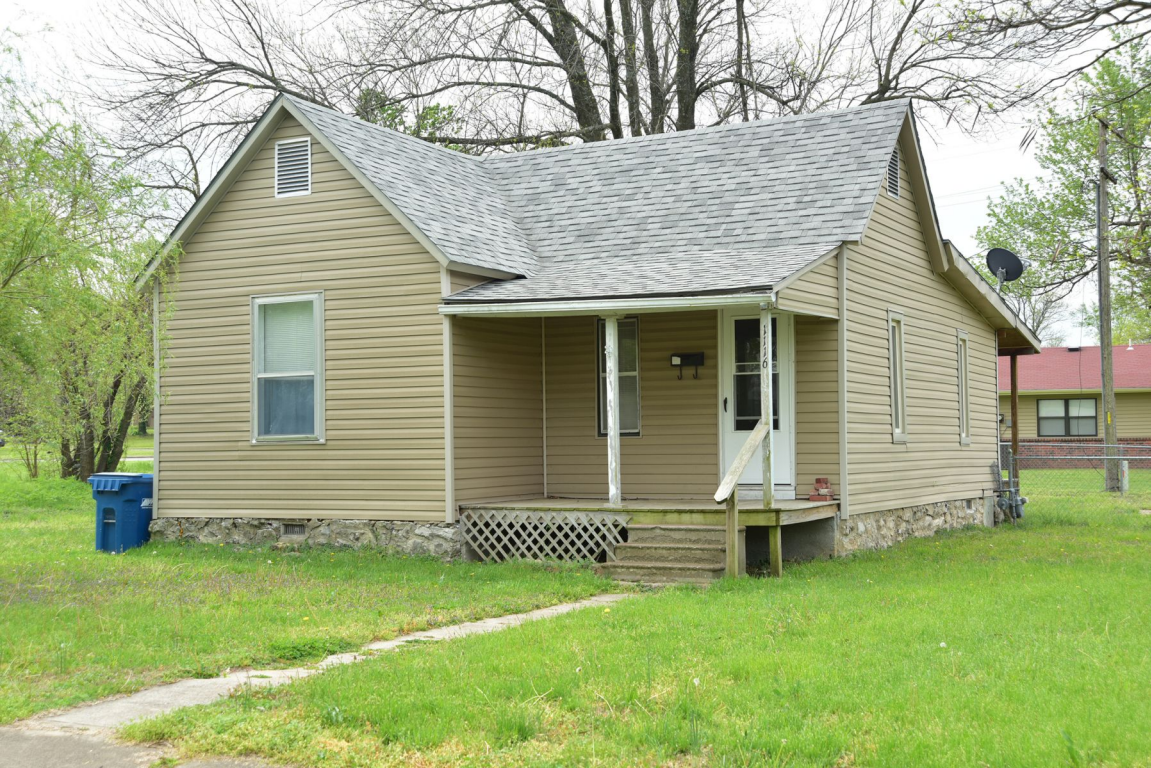
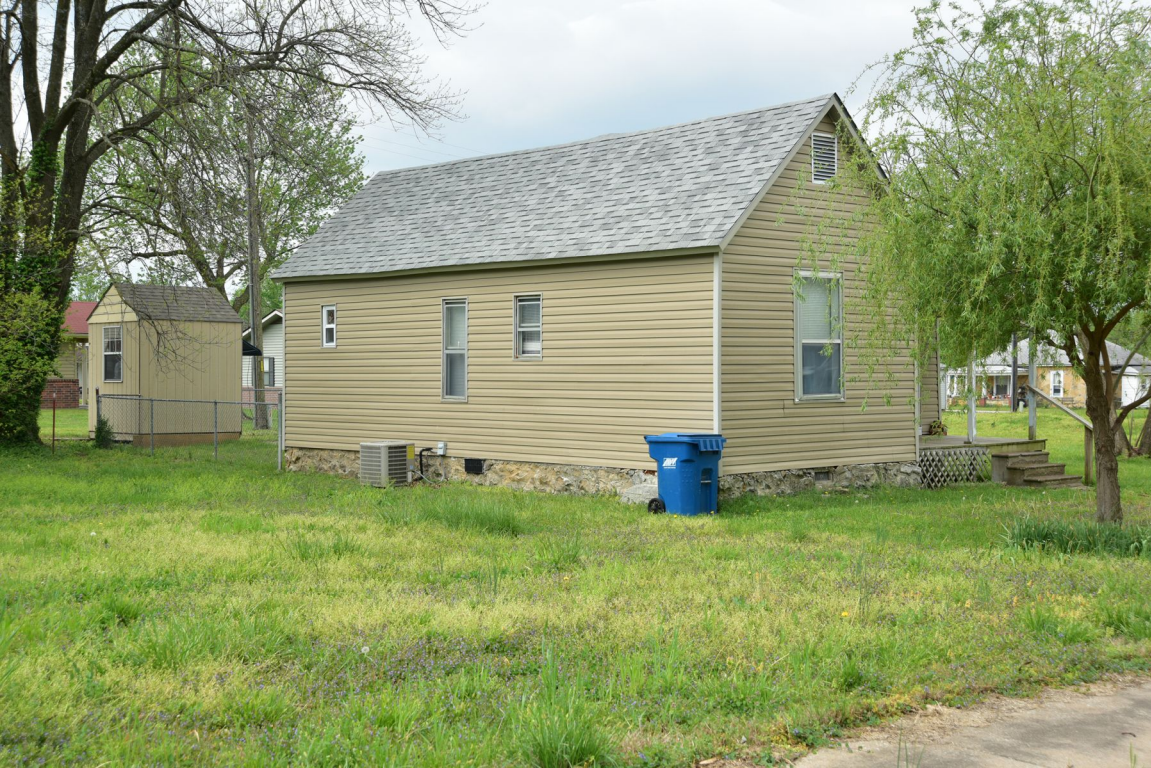
This one-story dwelling faces north and has an L-shaped footprint. It has a stone foundation and vinyl cladding. The intersecting gable roof has asphalt shingles. The dwelling is three bays wide and three asymmetrical bays deep. A shed-roof porch shelters the west two bays of the primary elevation. The non-historic wood porch has a wood floor with wood support posts and squared wood posts support the roof. The porch has concrete stairs. A non-historic wood door with glazing occupies the west bay. One-over-one wood windows occupy the remaining two bays. Irregularly sized, narrow one-over-one wood windows are present at the east elevation. A shed-roof porch shelters a secondary entrance at the south elevation.

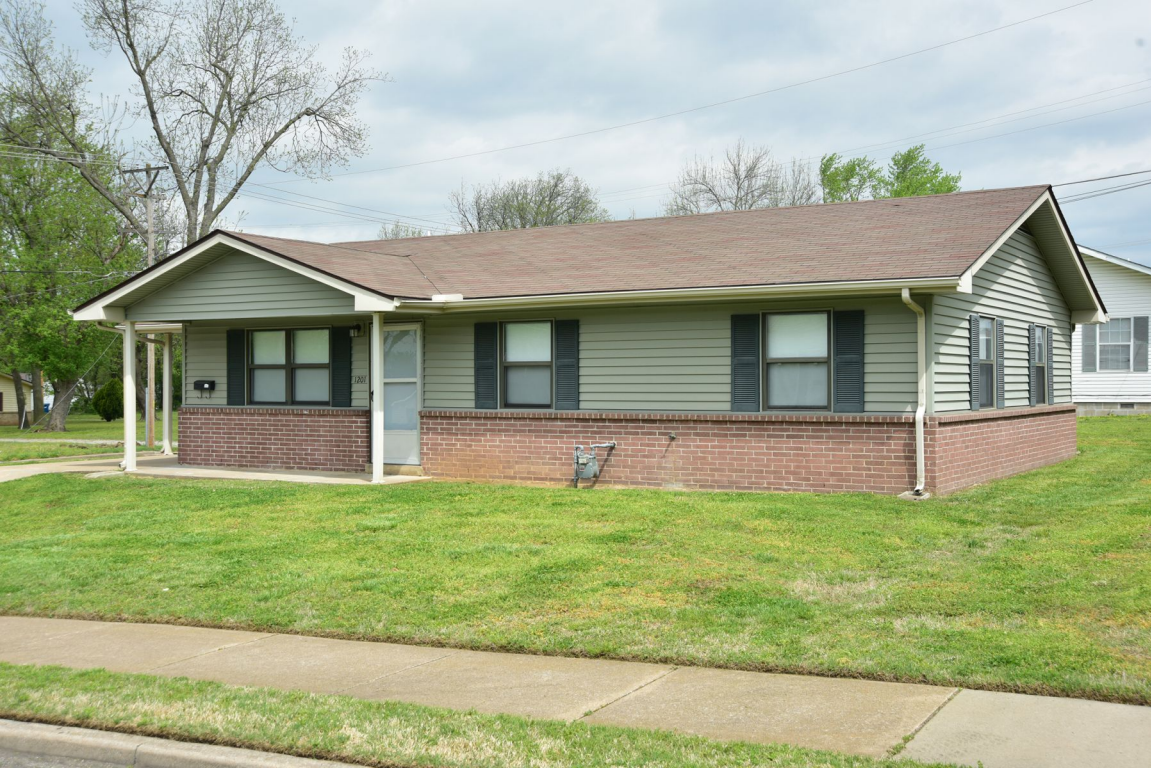
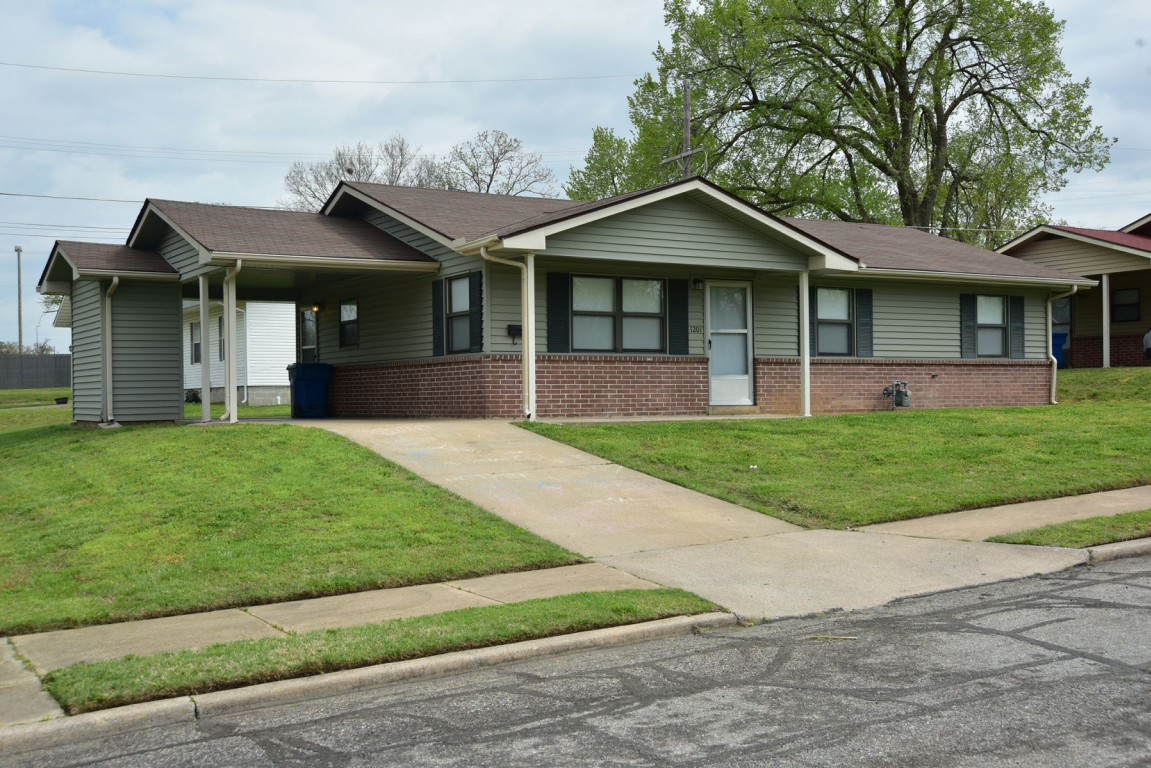
This one-story dwelling faces south and has a rectangular footprint. It is a twin to the adjacent dwelling, 1209 E. Furnace Street. It has a concrete foundation and a side-gable roof with cross-gable and asphalt shingles. Brick veneer clads the lower third of the dwelling while vinyl clads the upper portion. It is four bays wide and three bays deep. A wood door occupies the second-from-west bay while paired one-over-one metal windows fill the westernmost bay. Single one-over-one metal windows occupy the remaining bays. The windows feature false shutters. A cross-gable forms an open porch over the two west bays. It is supported by squared wood posts. A side-gable carport projects from the west elevation and shelters a secondary entrance. A small nested gable enclosed storage area is located at the west end of the carport. The storage area is vinyl clad and has a concrete foundation.

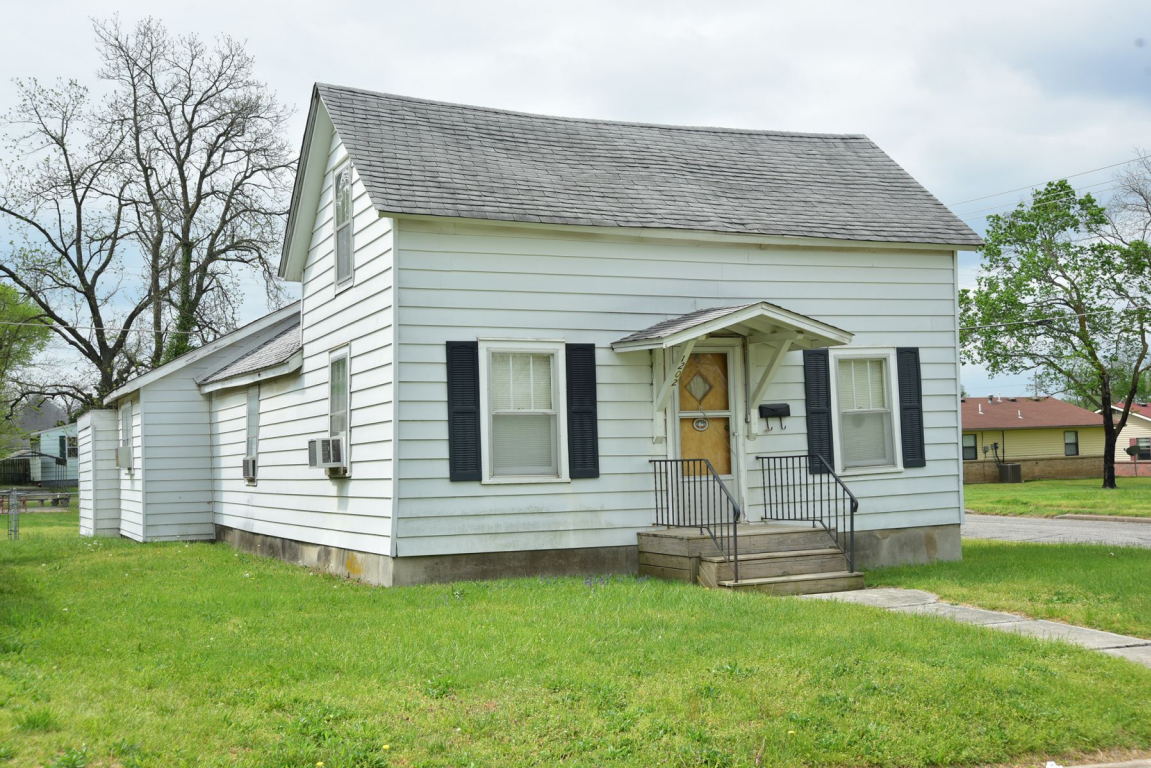
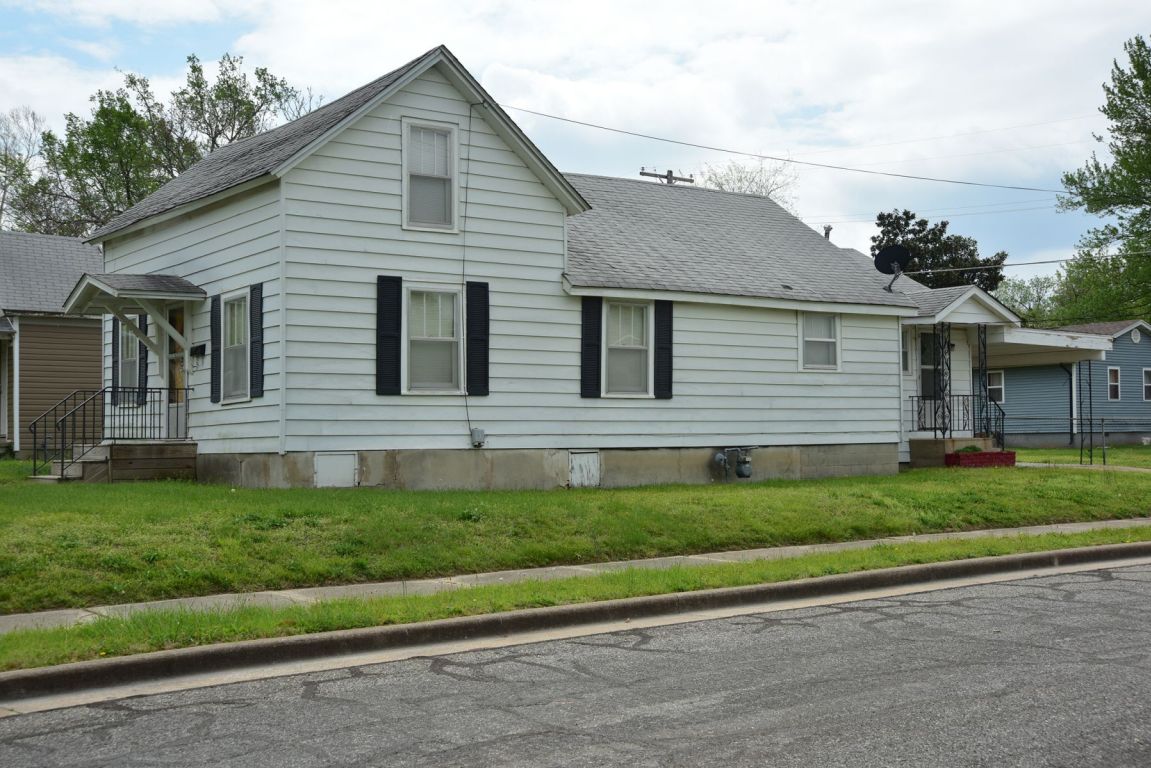
This one-and-one-half story dwelling faces north and has an irregular footprint. It features a concrete parged foundation and aluminum cladding. The intersecting gable roof has asphalt shingles. A c.2000 gabled addition is located at the rear. The dwelling is three bays wide and five asymmetrical bays wide. A wood door with one-light diamond window and metal storm door occupies the center bay of the primary elevation while historic three-over-one wood windows with false shutters occupy the east and west bays. A gabled roof with knee brackets shelters the non-historic wood stoop with metal railing. A secondary entrance is located at the west elevation of the rear addition. It features a concrete stoop with gabled roof. Decorative metal posts support the roof. The metal railing matches the support posts. A carport projects from the south elevation of the addition. It has a shed roof and is supported by decorative metal posts.

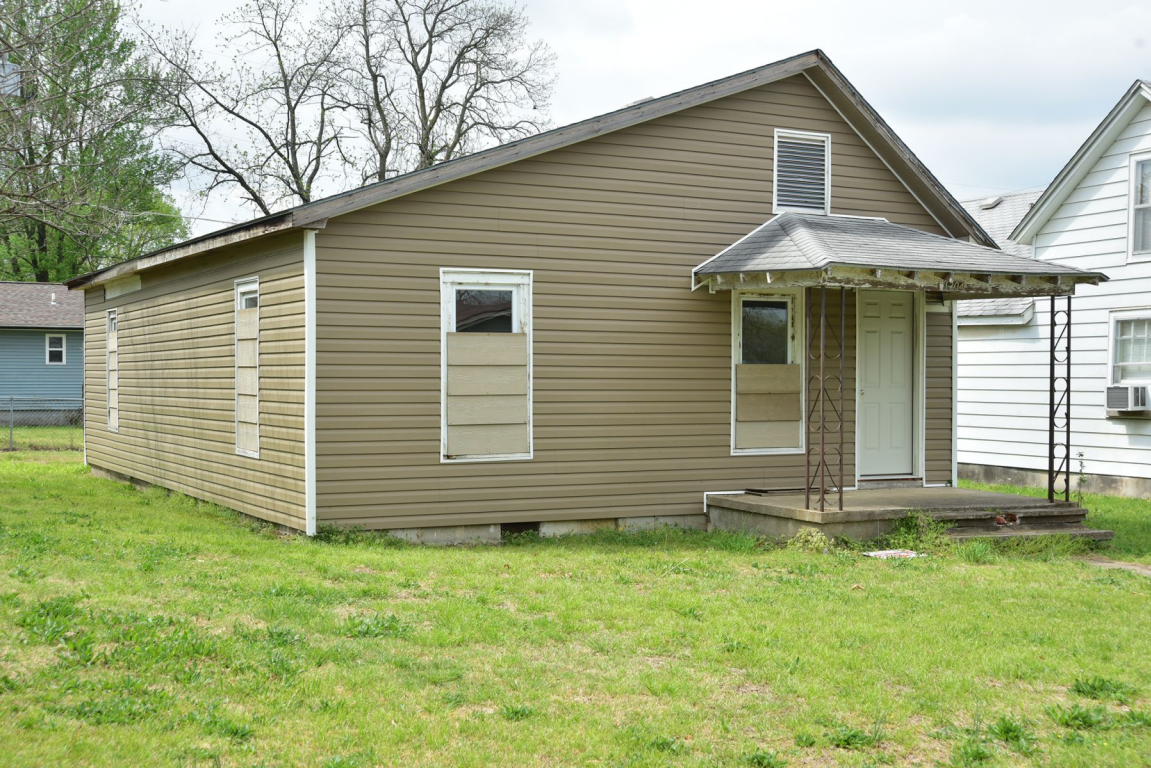
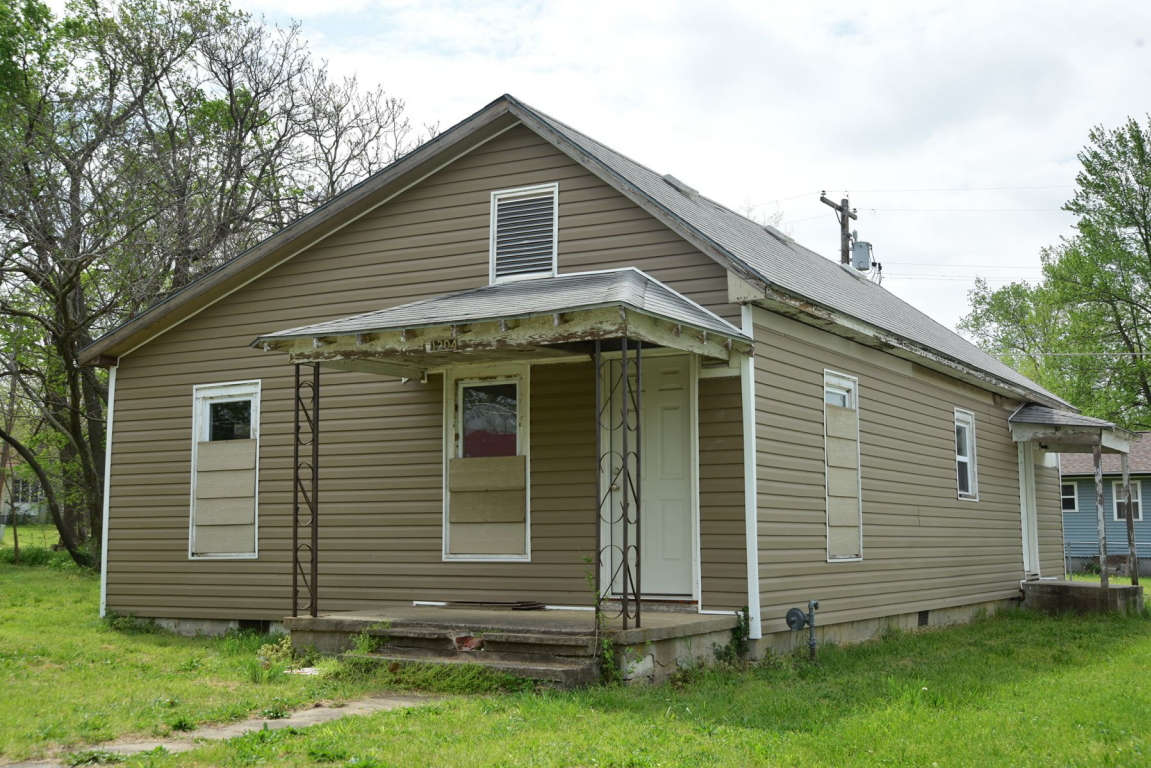
This one-story dwelling faces north and has a rectangular footprint. It has a concrete block foundation and vinyl cladding with corner boards. The asymmetrical front-gable roof has asphalt shingles and wood fascia boards. A rectangular louver is located at the gable end. The dwelling is three asymmetrical bays wide and three bays deep. A non-historic wood door occupies the west bay of the primary elevation. Historic wood windows occupy the remaining bays. The one-light upper sash is visible however the lower half of each window is boarded. A hipped-roof porch with exposed rafter tails and a concrete foundation shelters the two west bays. Non-historic decorative metal posts support the porch roof. Historic wood windows are present at the secondary elevations and are partially boarded. A secondary entrance is located in the south bay of the west elevation. It features a non-historic wood door and is sheltered by a hipped stoop roof with exposed rafter tails. Squared wood posts support the stoop roof. It has a concrete foundation.

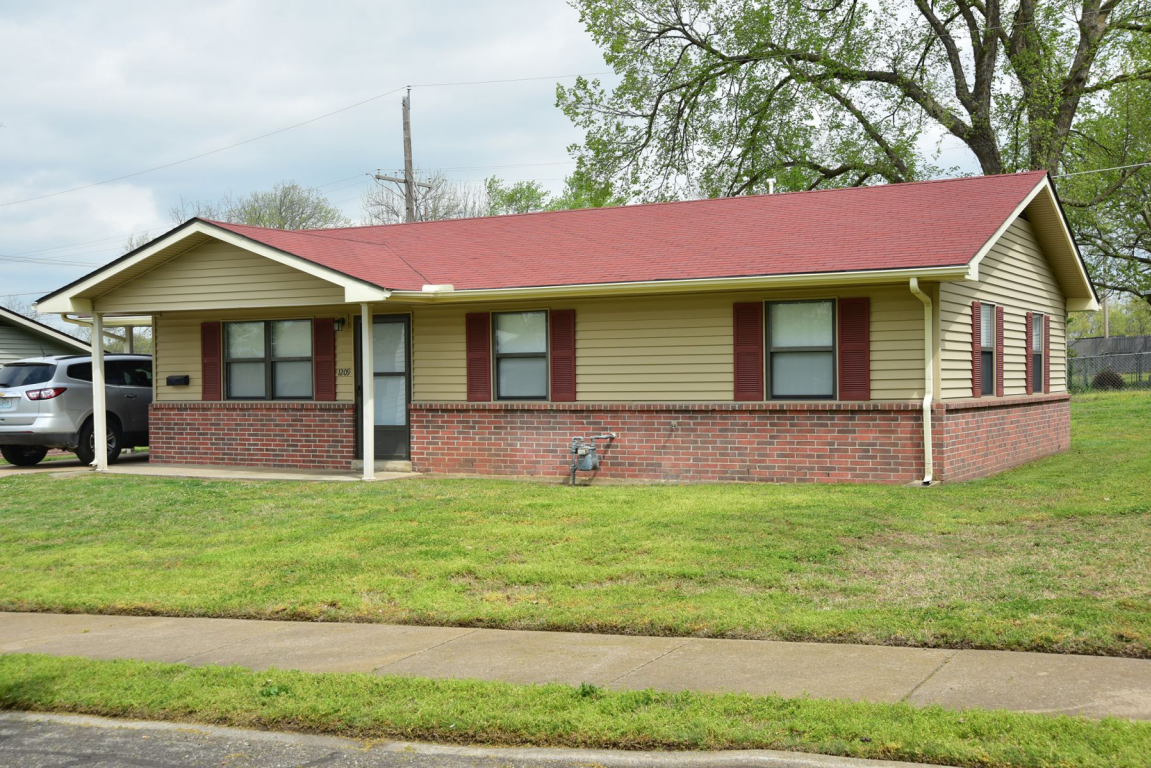
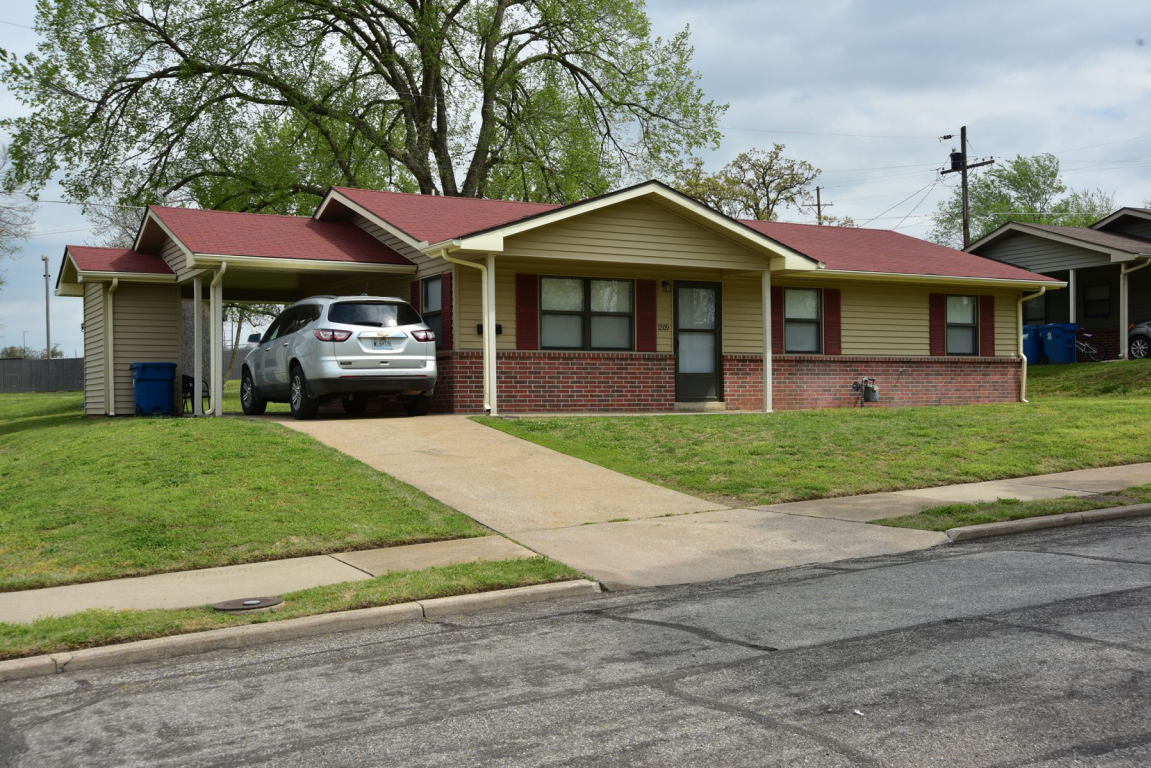
This one-story dwelling is identical to the adjacent dwellings, 12907 and 12917 E. Furnace Street. It faces south and has a rectangular footprint. It has a concrete foundation and a side-gable roof with cross-gable and asphalt shingles. Brick veneer clads the lower third of the dwelling while vinyl clads the upper portion. It is four bays wide and three bays deep. A wood door occupies the second-from-west bay while paired one-over-one metal windows fill the westernmost bay. Single one-over-one metal windows occupy the remaining bays. False shutters flank the windows. A cross-gable forms an open porch over the two west bays. It is supported by squared wood posts. A side-gable carport projects from the west elevation and shelters a secondary entrance. A small nested gable enclosed storage area is located at the west end of the carport. The storage area is vinyl clad and has a concrete foundation.

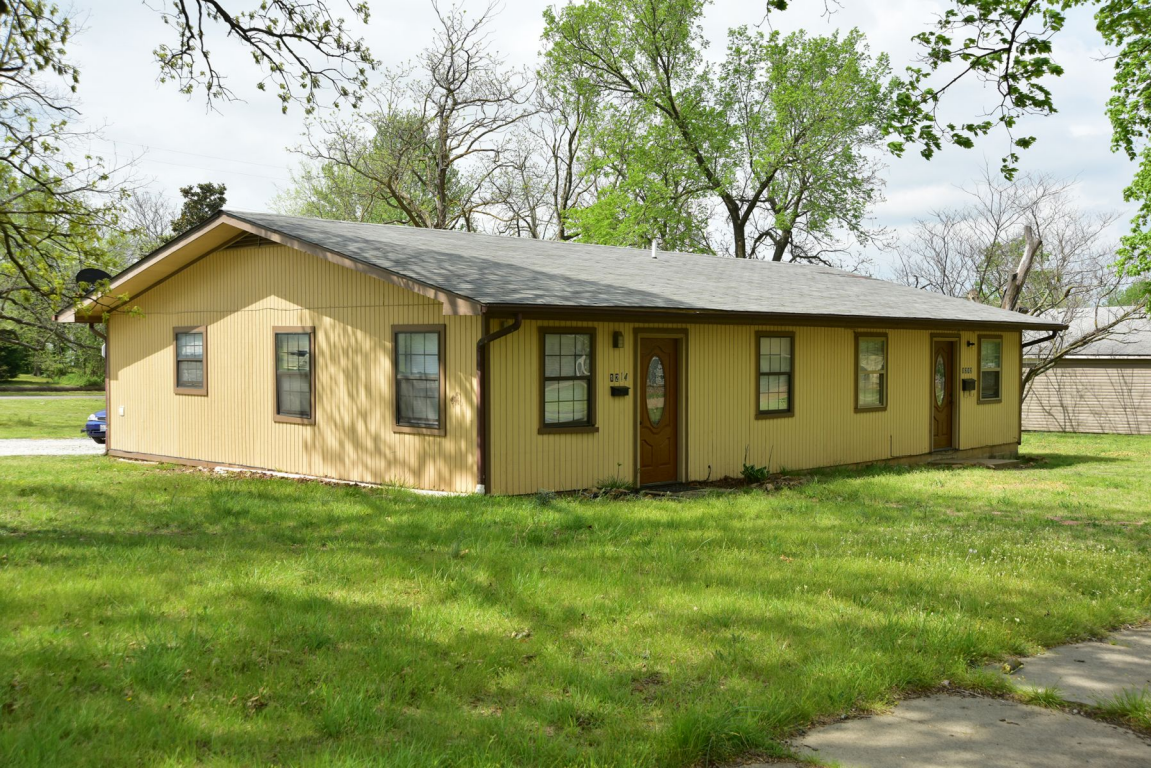
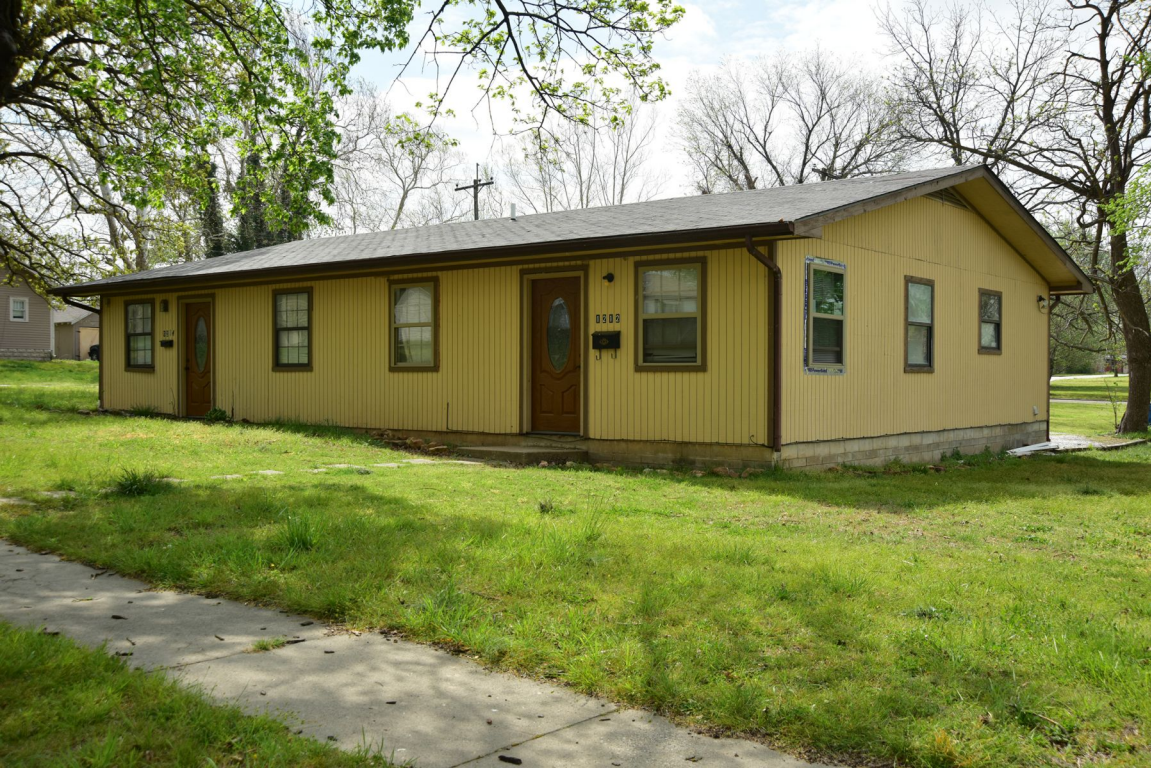
This one-story duplex displays the addresses 1212 and 1214. It faces north and has a rectangular footprint. The dwelling has a concrete masonry unit foundation and side-gable roof with asphalt shingles and wide eaves. The wood cladding is vertically oriented. The dwelling is six bays wide and three bays deep. Non-historic wood doors with oval glazing fill the second and fifth bays. Six-over-six vinyl windows with flat board trim fill the remaining bays.

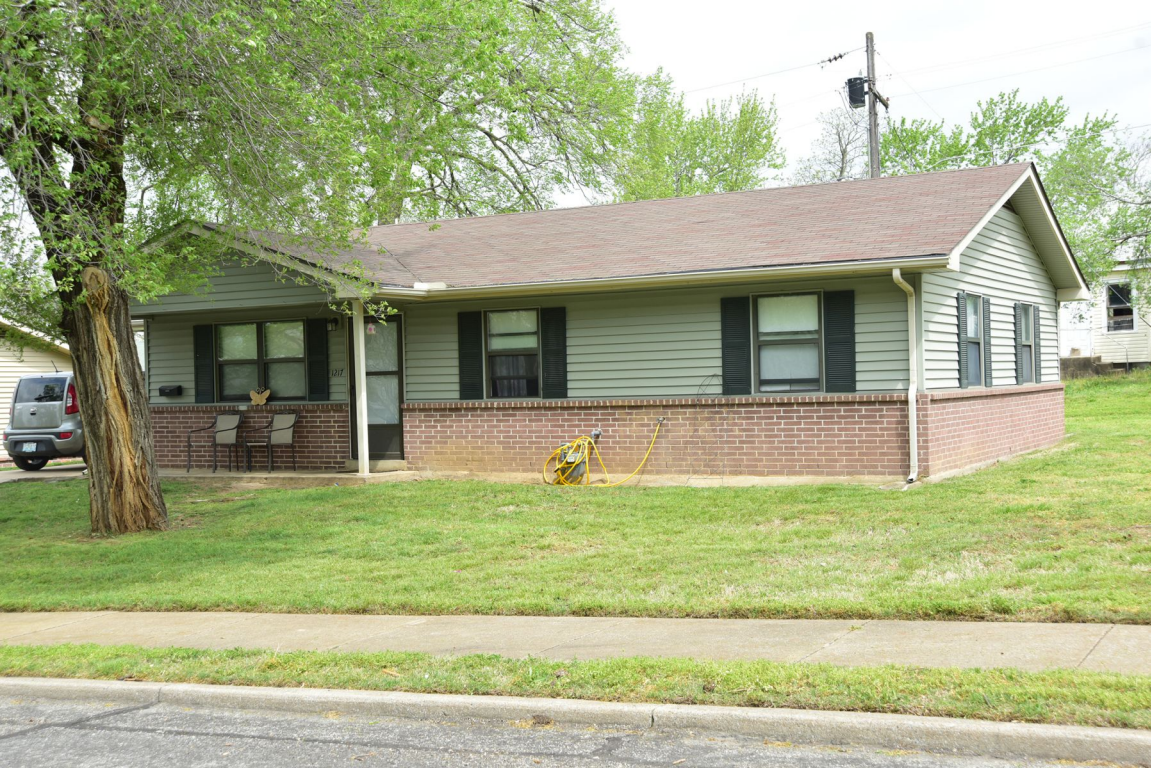
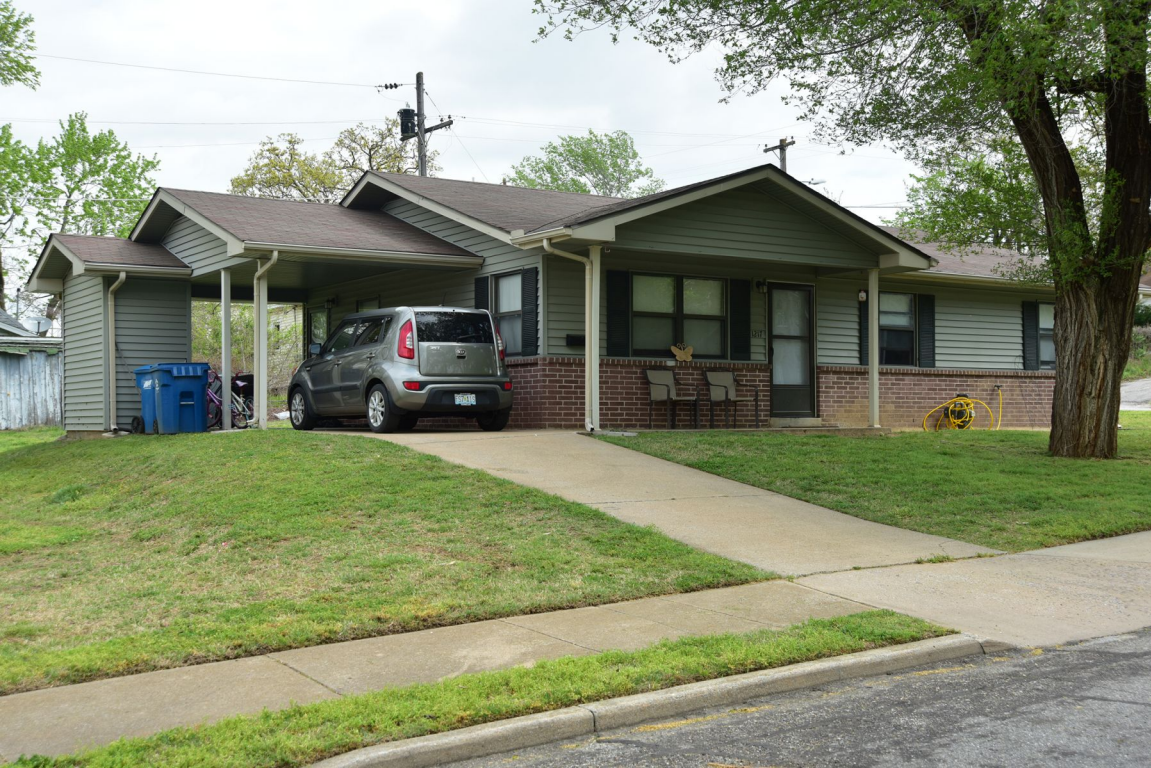
This one-story dwelling is a twin to the adjacent dwelling, 12907 E. Furnace Street. It faces south and has a rectangular footprint. It has a concrete foundation and a side-gable roof with cross-gable and asphalt shingles. Brick veneer clads the lower third of the dwelling while vinyl clads the upper portion. It is four bays wide and three bays deep. A wood door occupies the second-from-west bay while paired one-over-one metal windows fill the westernmost bay. Single one-over-one metal windows occupy the remaining bays. The windows feature false shutters. A cross-gable forms an open porch over the two west bays. It is supported by squared wood posts. A side-gable carport projects from the west elevation and shelters a secondary entrance. A small nested gable enclosed storage area is located at the west end of the carport. The storage area is vinyl clad and has a concrete foundation.
