MISSOURI DEPARTMENT OF NATURAL RESOURCES
STATE HISTORIC PRESERVATION OFFICE, P.O. Box 176, Jefferson City, MO 65102
ARCHITECTURAL/HISTORIC INVENTORY FORM

1. Survey number: JP-AS-006-093		2. Survey Name: East Town (Original Joplin) Historic Survey Phase 1	
3. County: JASPER		4. Address 1302	Street (name): E. Furnace Street
5. City: Joplin	Vicinity <input type="checkbox"/>	7. Township/Range/Section: T: R: S:	
8. Historic name (if known):		9. Present/other name (if known):	
10. Ownership: <input checked="" type="checkbox"/> Private <input type="checkbox"/> Public		11a. Historic use (if known): Domestic/Single Dwelling	11b. Current use: Domestic/Single Dwelling

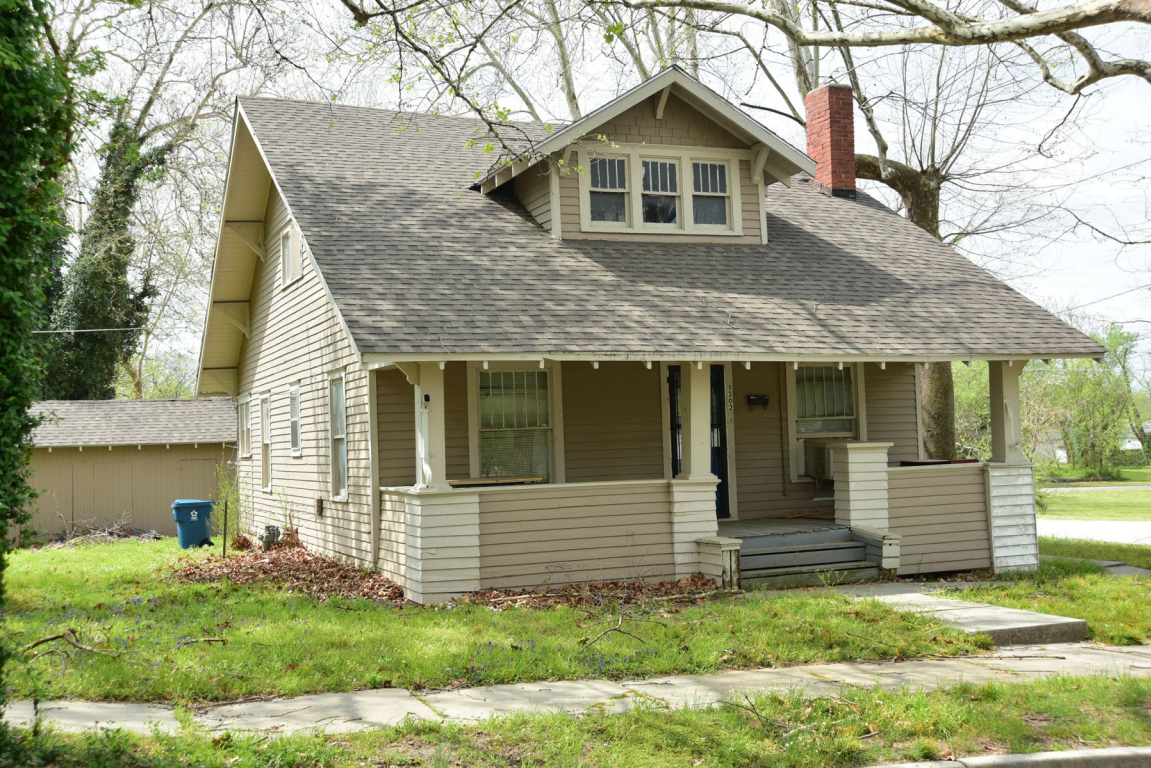
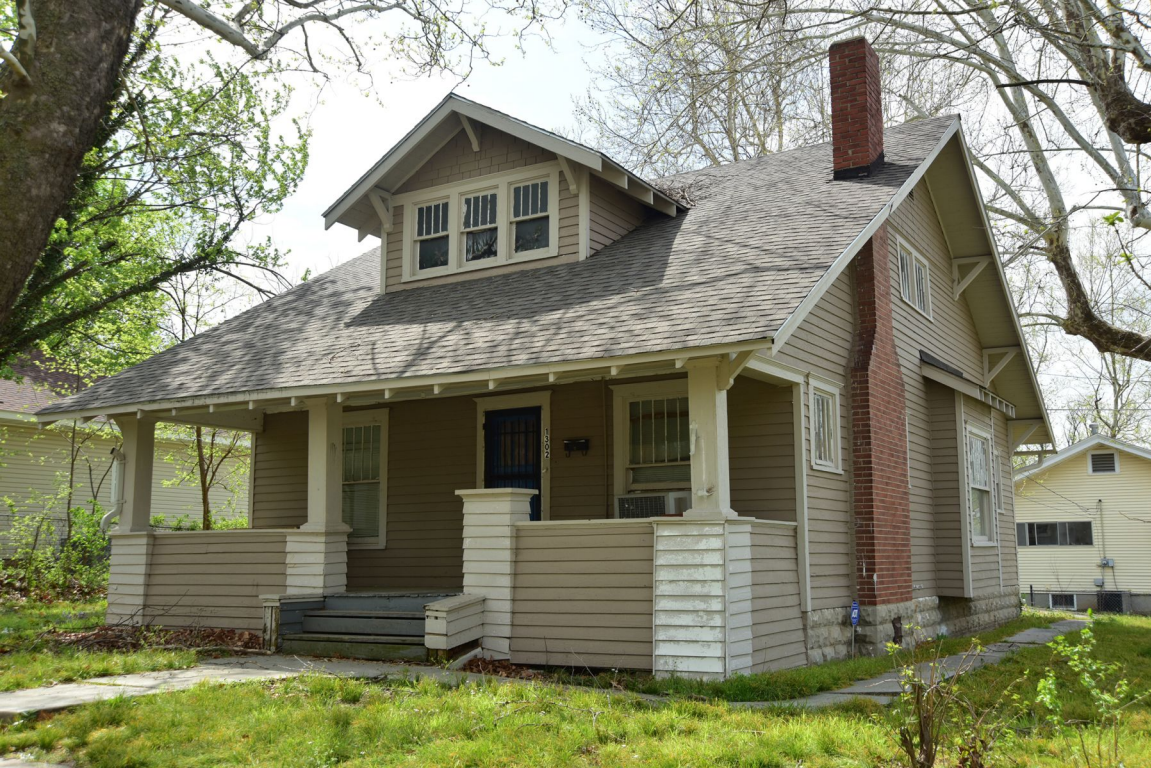
This Bungalow/Craftsman dwelling faces north and has a rectangular footprint. It has a concrete foundation and side-gable roof with asphalt shingles. Wide eaves and brackets characterize the roof. A gabled dormer with exposed rafter tails and brackets is present on the front slope. An exterior brick chimney is located at the west elevation and pierces the roof through the eaves. A historic porch spans the width of the primary elevation. Squared wood columns on clapboard-clad walls support the roof. The porch roof features exposed rafter tails. The porch has a wood-plank floor and wood steps. The dwelling is three bays wide and four bays deep. A historic wood door with three-light glazing defines the center bay of the primary elevation. Historic six-over-one wood windows occupy the east and west bays. Three historic four-over-one wood windows occupy the dormer. Square, historic four-light wood windows are present at the secondary elevations. The third first-story bay of the west elevation projects slightly and features a shed roof with exposed rafter tails. First story windows and the primary entrance feature wood trim with modest crown molding.

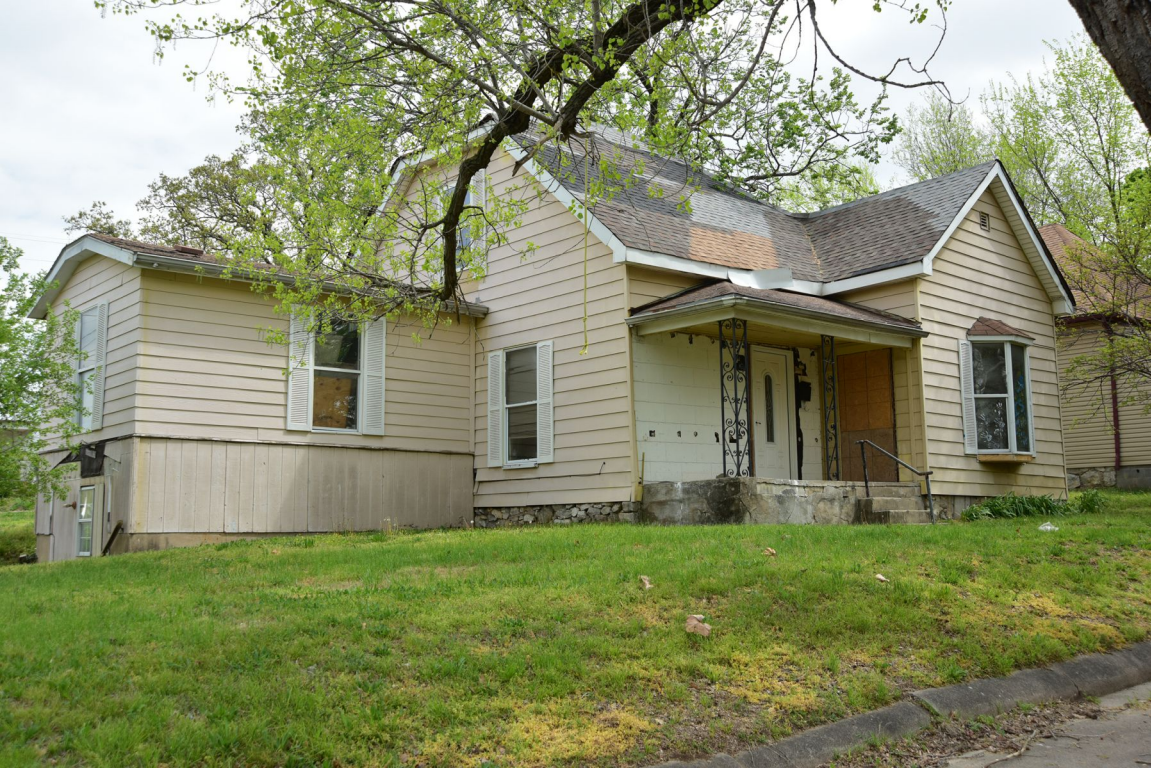
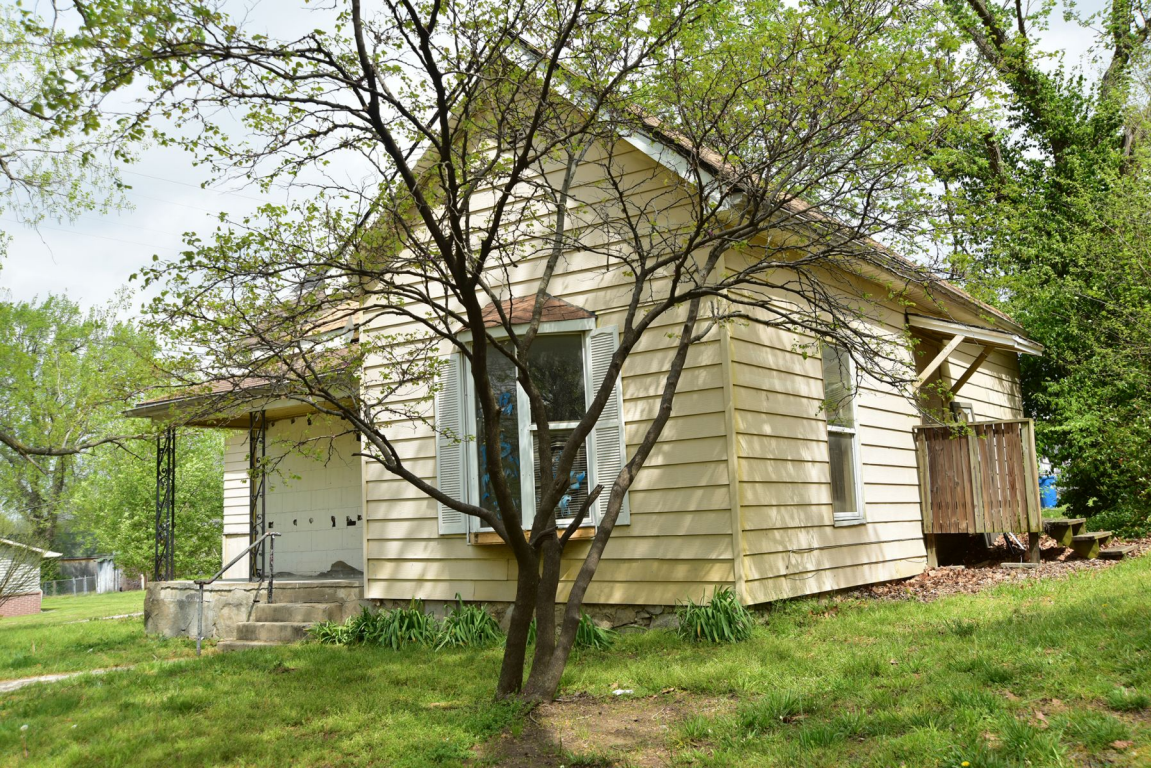
The one-and-one-half story dwelling faces south and has an irregular footprint. It has a stone foundation and a combination of wood, asbestos shingle, and metal cladding. The clipped gable roof has asphalt shingles and a cross gable is located at the east end. A c.2000 attached garage addition with clipped gable roof and concrete foundation projects from the west elevation. The lower third of the addition features vertical wood cladding while the upper portion has metal siding. The dwelling is three bays wide and two bays deep. A non-historic one-over-one vinyl window with false shutters occupies the west bay and is located on the addition. A non-historic bay window occupies the east bay. A non-historic wood door with glazing forms the center bay. The entrance has been relocated from the west wall of the cross-gable ell. The former door opening is boarded. A hipped-roof porch shelters the entrance. Non-historic decorative metal posts support the roof. The porch has a concrete foundation and steps. A secondary entrance with non-historic wood stoop is located at the east elevation. The garage vehicular entrance has been infilled and contains a four-over-four vinyl window. Non-historic one-over-one wood windows with false shutters are located at the upper half of the garage.

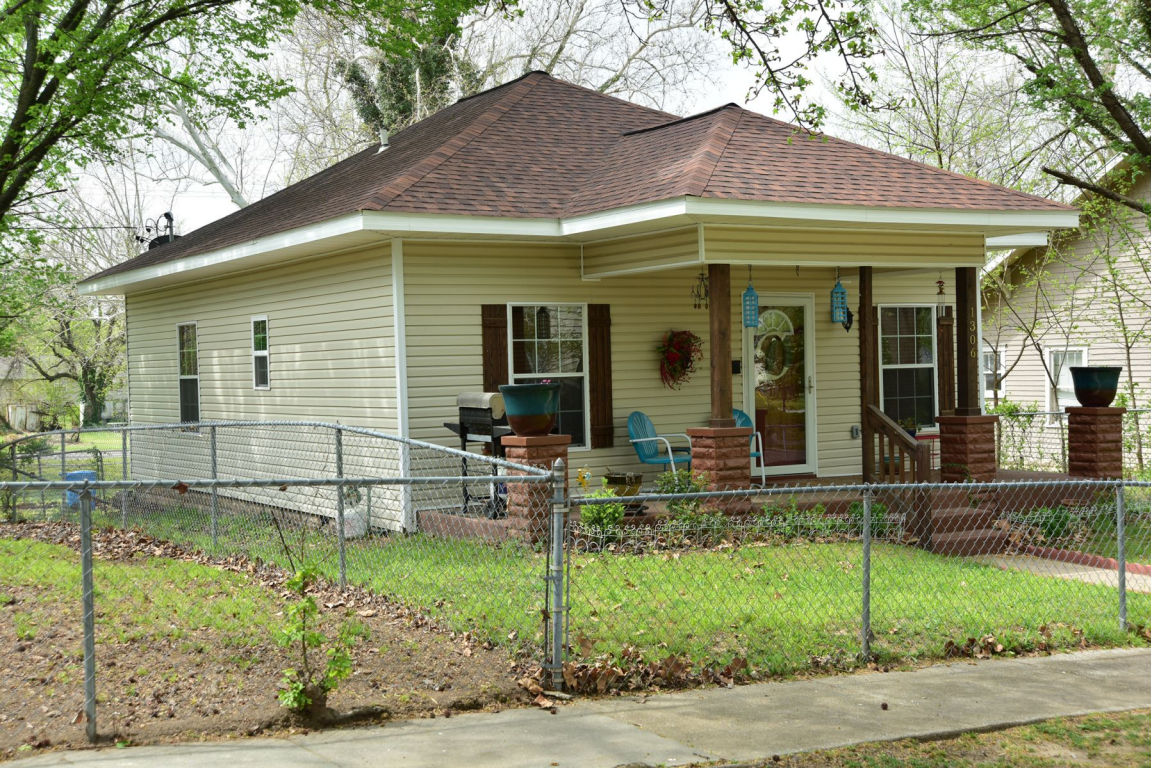
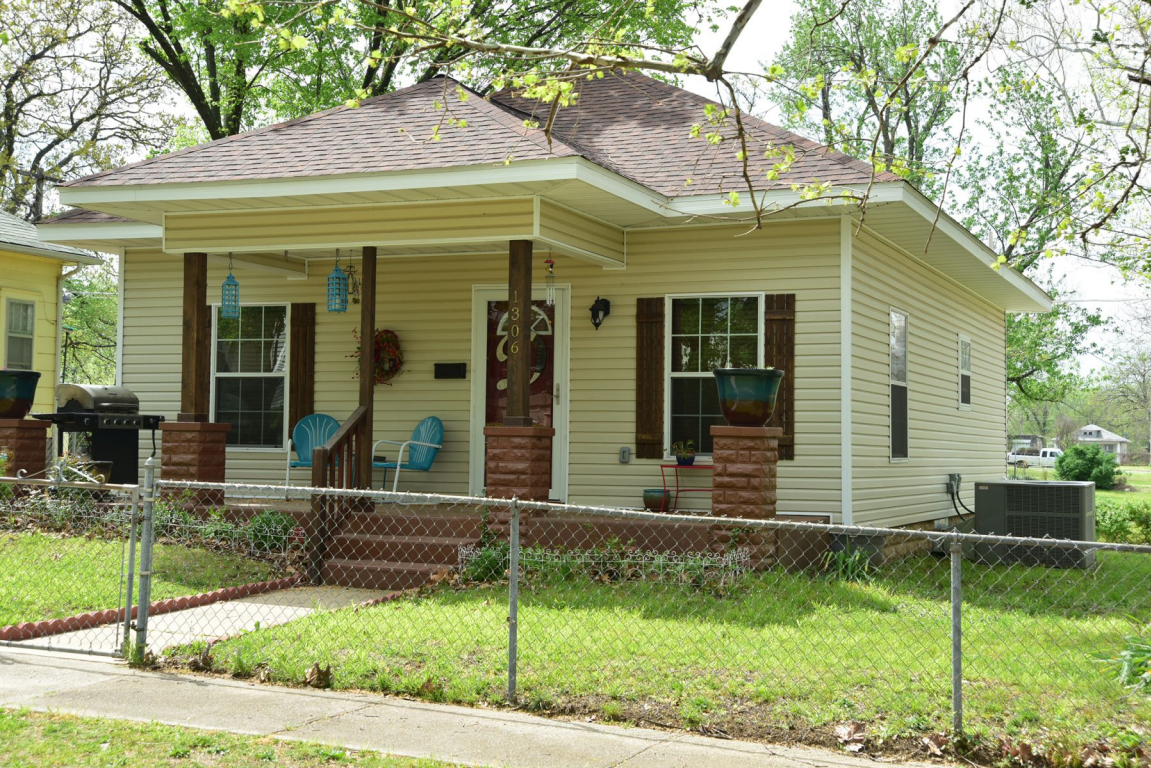
This one-story bungaloid dwelling faces north and has a rectangular footprint. It features a concrete block foundation, vinyl cladding, and hipped roof with asphalt shingles. A hipped-roof porch projects from the center of the primary elevation and shelters the entrance. The porch has a concrete foundation and stairs. Squared wood posts on concrete block piers support the roof. The dwelling is three bays wide and two bays deep. A non-historic fiberglass door occupies the center bay of the primary elevation. Six-over-six vinyl windows with false shutters occupy the remaining bays.

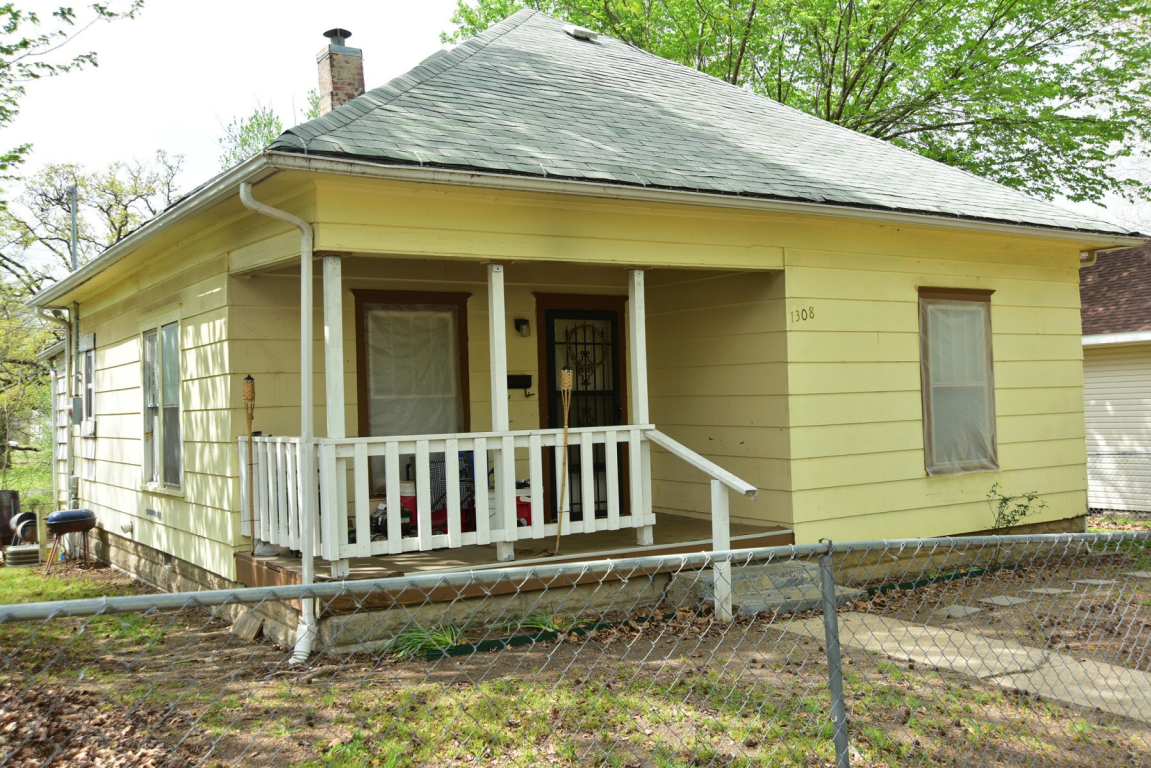
1308

This Pyramid Square Folk House faces north and has a rectangular footprint. The dwelling features a concrete block foundation, pyramidal roof with asphalt shingles, and asbestos shingle cladding. It is three bays wide and three bays deep. The two east bays of the primary elevation are recessed, creating a partial-width recessed porch with a non-historic matchstick balustrade and squared support posts. A wood door with decorative metal storm door occupies the center bay. Historic four-over-one wood windows occupy the remaining bays. Matching windows define the bays of the secondary elevations. The door and windows feature wood trim and modest crown molding. A brick chimney is located on the east slope of the roof.

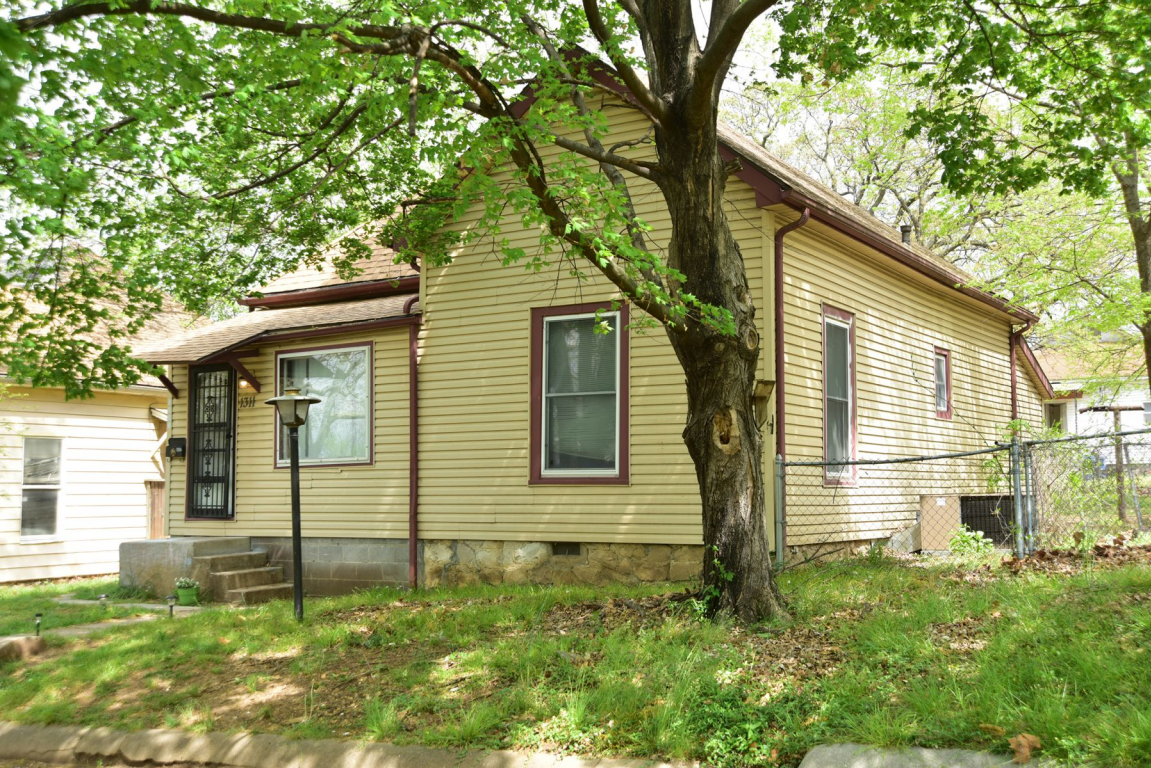
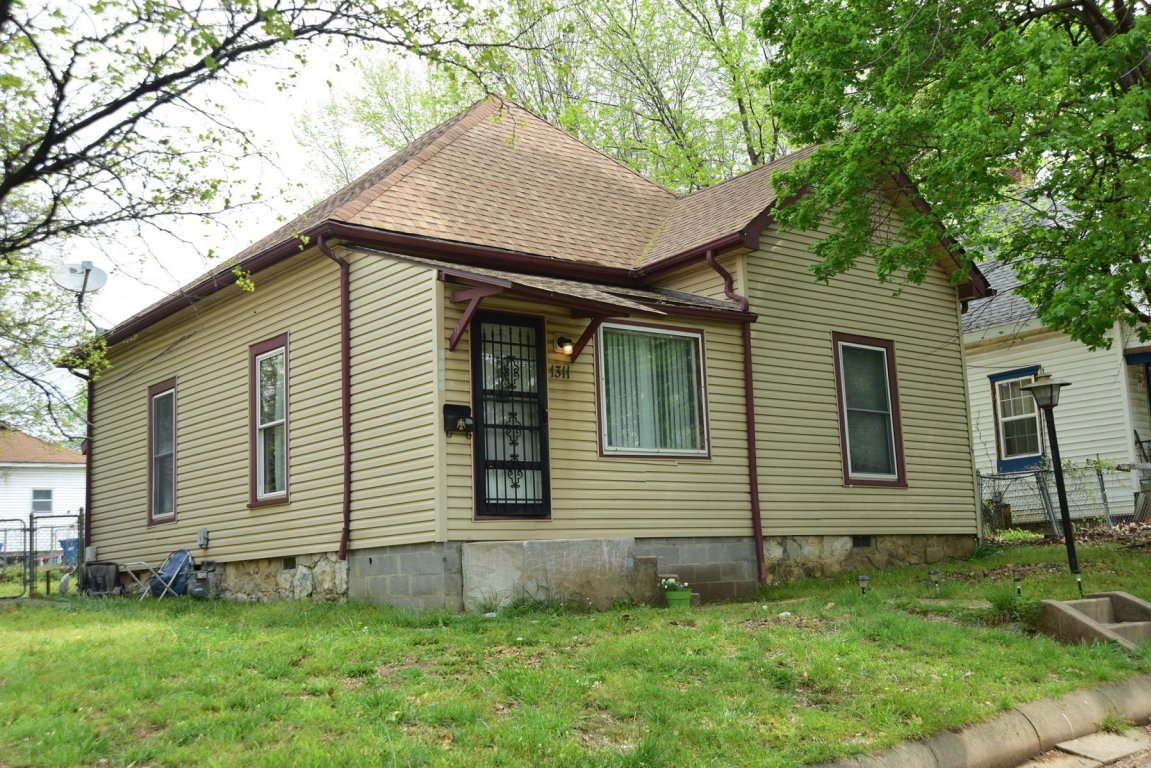
This one-story dwelling faces south and has a rectangular footprint. It features a stone foundation, vinyl cladding, and hipped roof with a cross-gable and asphalt shingles. The dwelling is three asymmetrical bays wide and two bays deep. An enclosed porch forms the west two bays. The porch enclosure is an alteration and has a concrete block foundation. A non-historic wood door occupies the west bay. A non-historic one-light fixed sash wood window occupies the second-from-west bay. A one-over-one wood window occupies the east bay. One-over-one wood windows are present at the secondary elevations. The windows feature flat board trim. A shed-roof enclosed porch is present at the rear elevation.

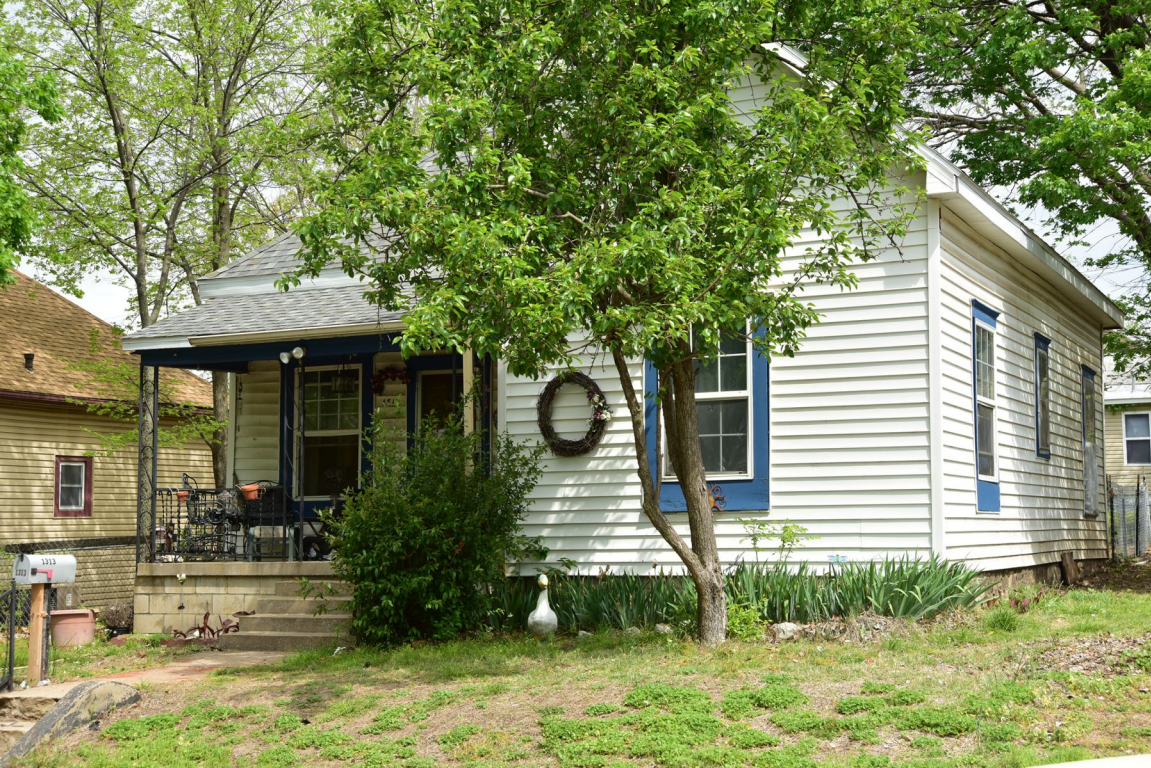
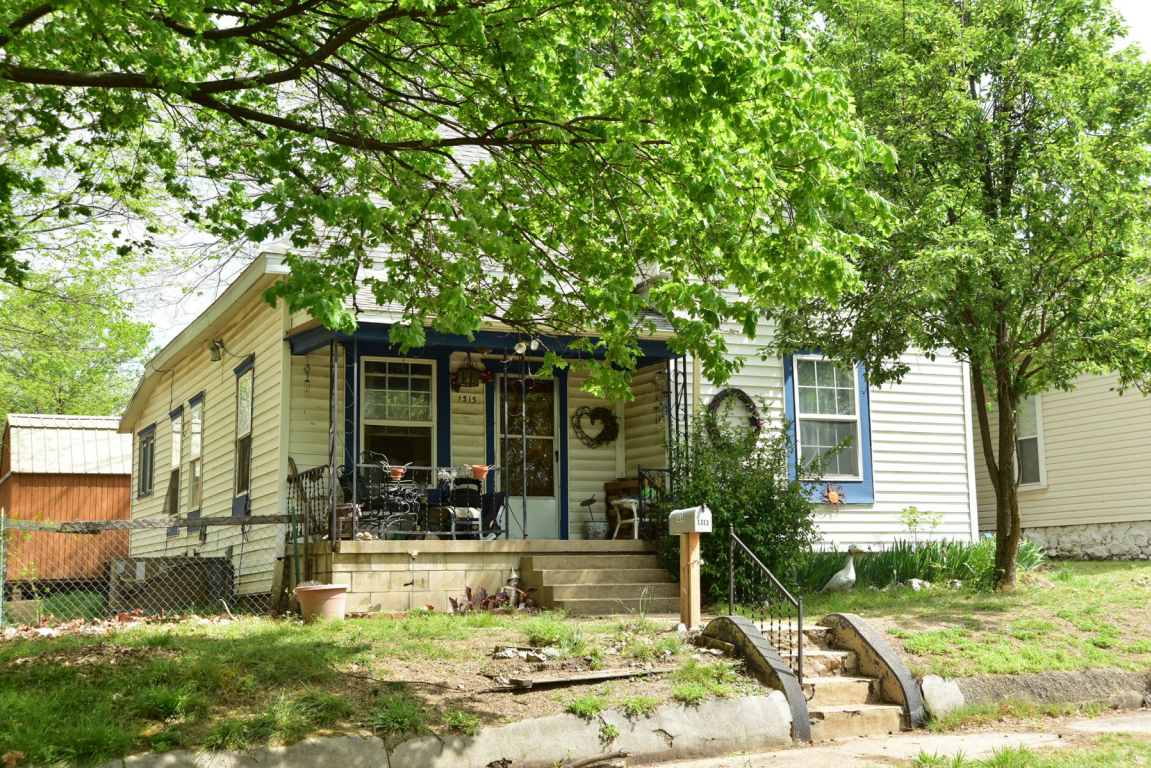
This resource has poor integrity due to the application of non-historic siding, windows, alterations to the window openings, and replacement of porch materials. This resource would be non-contributing to the East Joplin Residential Historic District, significant for its associations with the early residential development of Joplin, specifically the African American community. Areas of significance are Community Planning & Development, and Ethnic History/Black.

This one-story dwelling faces south and has a rectangular footprint. It features a stone foundation and vinyl cladding. The hipped roof with cross-gable features asphalt shingles. The dwelling is three bays wide and there bays deep. An enclosed porch is located at the rear. The west two bays of the primary elevation recede, creating a partial-width open porch. The porch features a shed roof and concrete masonry unit foundation. Non-historic decorative metal posts support the porch roof. A non-historic wood door occupies the center bay of the primary elevation. Six-over-six vinyl windows occupy the east and west bays, although these are smaller than the historic openings and contain non-historic fill material. Matching windows define the bays of the secondary elevations. The windows feature flat board trim and modest crown molding. A brick chimney is positioned near the roof peak.

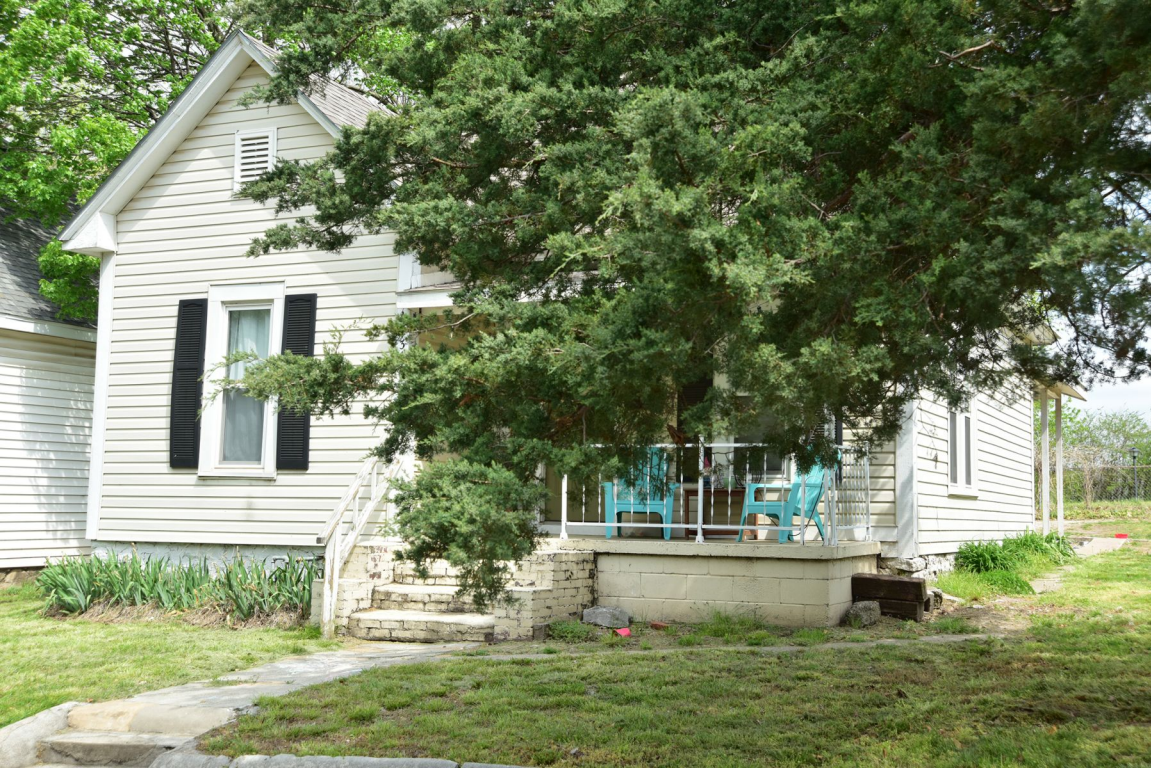
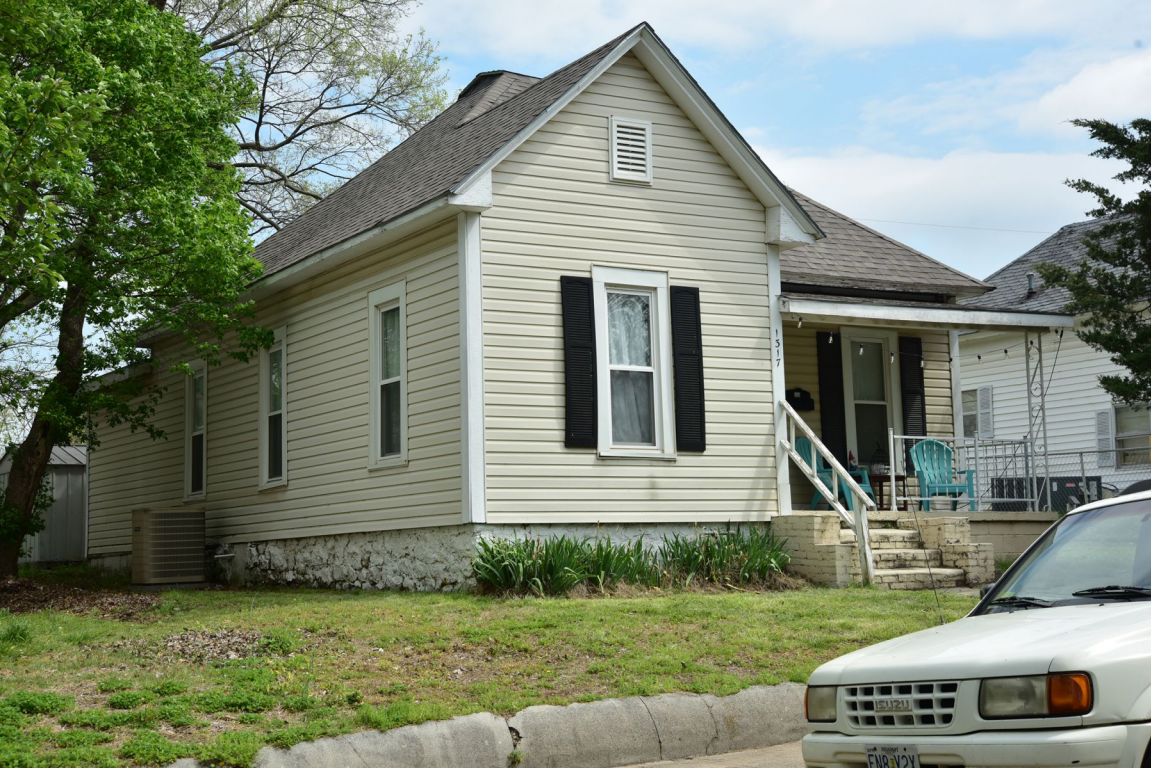
This resource has poor integrity due to the application of non-historic siding, windows, alterations to the window openings, and replacement of porch materials. This resource would be non-contributing to the East Joplin Residential Historic District, significant for its associations with the early residential development of Joplin, specifically the African American community. Areas of significance are Community Planning & Development, and Ethnic History/Black.

This one-story dwelling faces south and has a rectangular footprint. It has a parged stone foundation and vinyl cladding. The hipped roof with cross-gable features asphalt shingles. A rectangular louver is located in the gable peak. An enclosed porch with shed roof is located at the rear. The dwelling is three bays wide and three asymmetrical bays deep. The east two bays recede, creating a partial-width recessed porch with a shed roof. The porch features a concrete masonry unit foundation and brick steps. A non-historic decorative metal post support the porch roof. The metal porch balustrade is non-historic. A non-historic wood door occupies the center bay of the primary elevation. Narrow, one-over-one vinyl windows with flat board trim occupy the east and west bays.

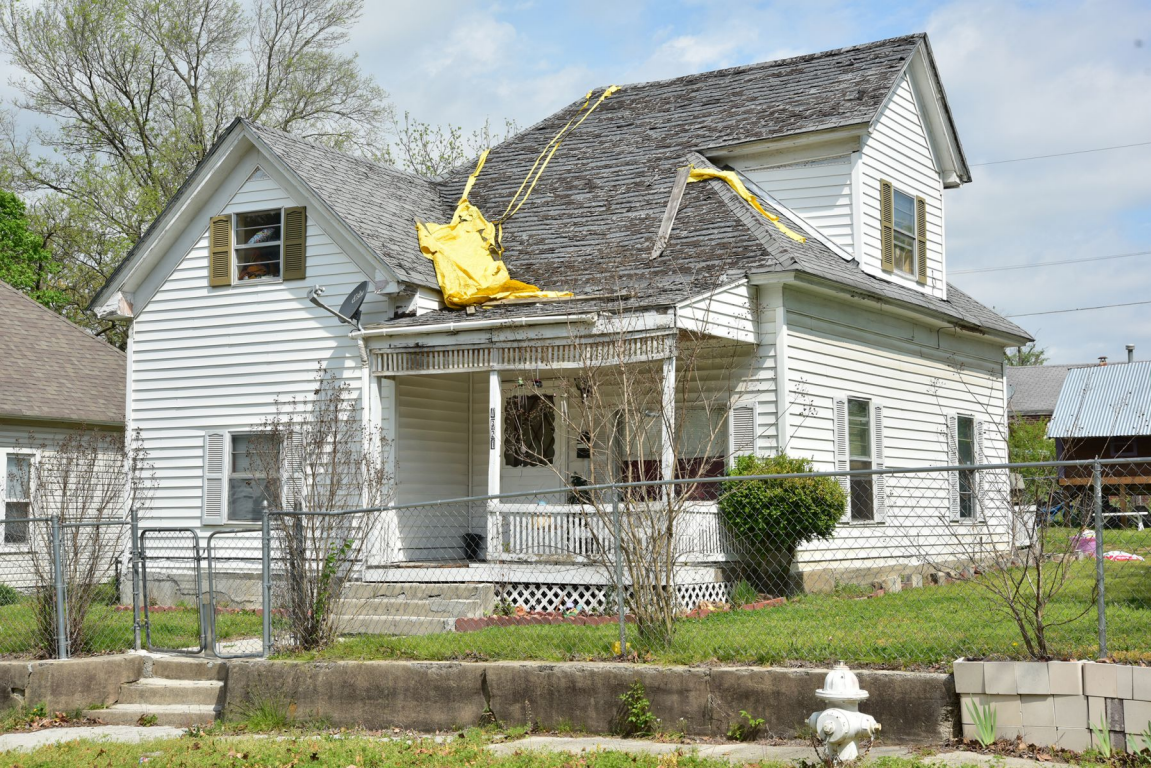
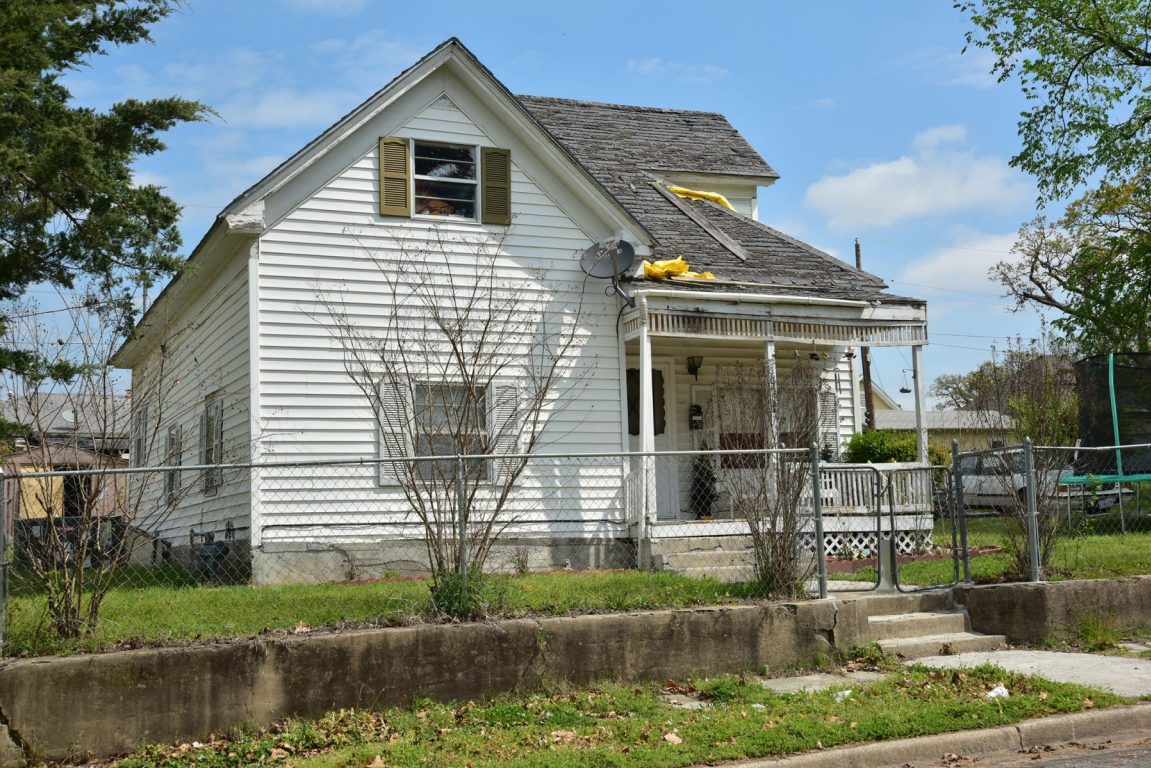
This dwelling faces south and has a rectangular footprint. It has a concrete foundation and vinyl cladding. The hipped roof with cross-gable features asphalt shingles and wood soffits. A gabled dormer is located on the east slope of the hipped roof. This is a c.1955 addition The dwelling is three bays wide and three bays deep. The east two bays of the primary elevation recede, creating a partial-width open porch. The historic porch features a shed roof with squared wood support posts and matchstick rail ornament. A matchstick balustrade wraps around the porch. A non-historic wood door with glazing occupies the center bay of the primary elevation. Paired, one-over-one metal windows occupy the east bay while a historic two-over-two metal window occupies the west bay. All windows feature false shutters.

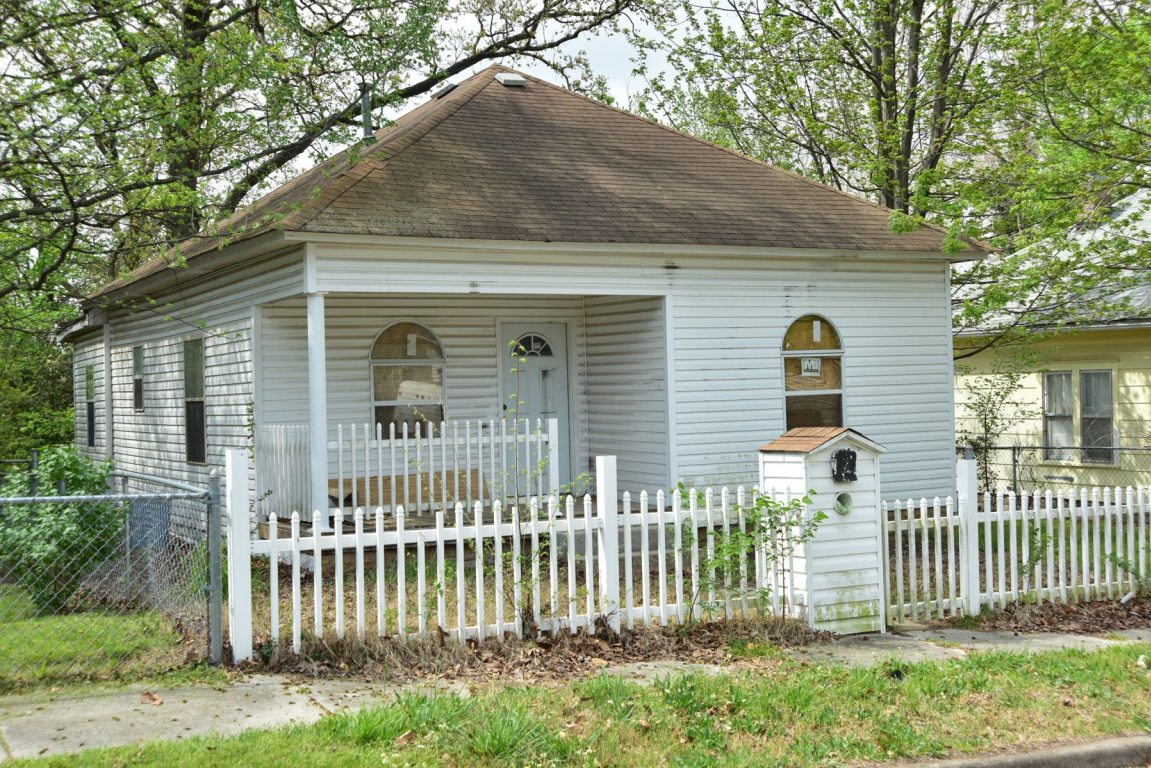
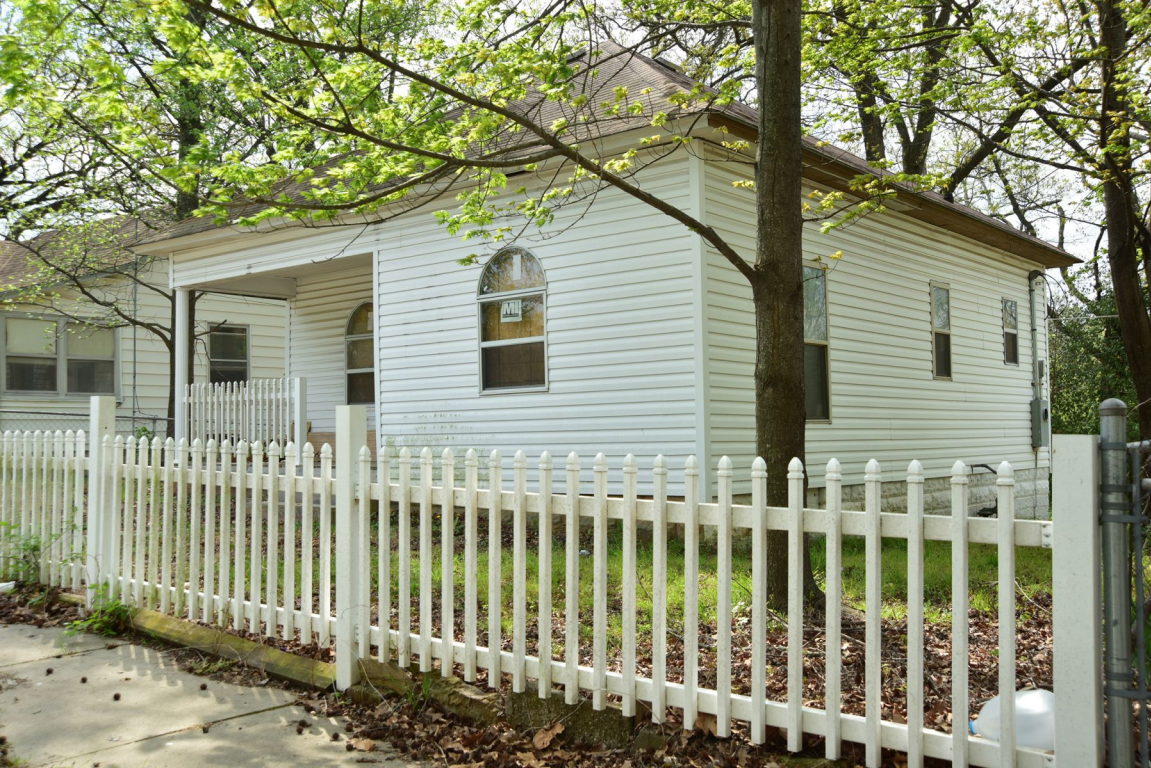
This one-story Pyramid Square Folk House faces north and has a rectangular footprint. It features a concrete block foundation, vinyl cladding, and pyramidal hipped roof with asphalt shingles. The dwelling is three bays wide and three bays deep. The east two bays of the primary elevation recede, creating a partial-width open porch. The porch features a vinyl Doric column and balustrade. It has a concrete block foundation and wood plank floor. A fiberglass door occupies the center bay of the primary elevation. One-over-one vinyl windows with elliptical transoms occupy the remaining bays and alter the historic window openings. One-over-one vinyl windows occupy the bays of the secondary elevations.

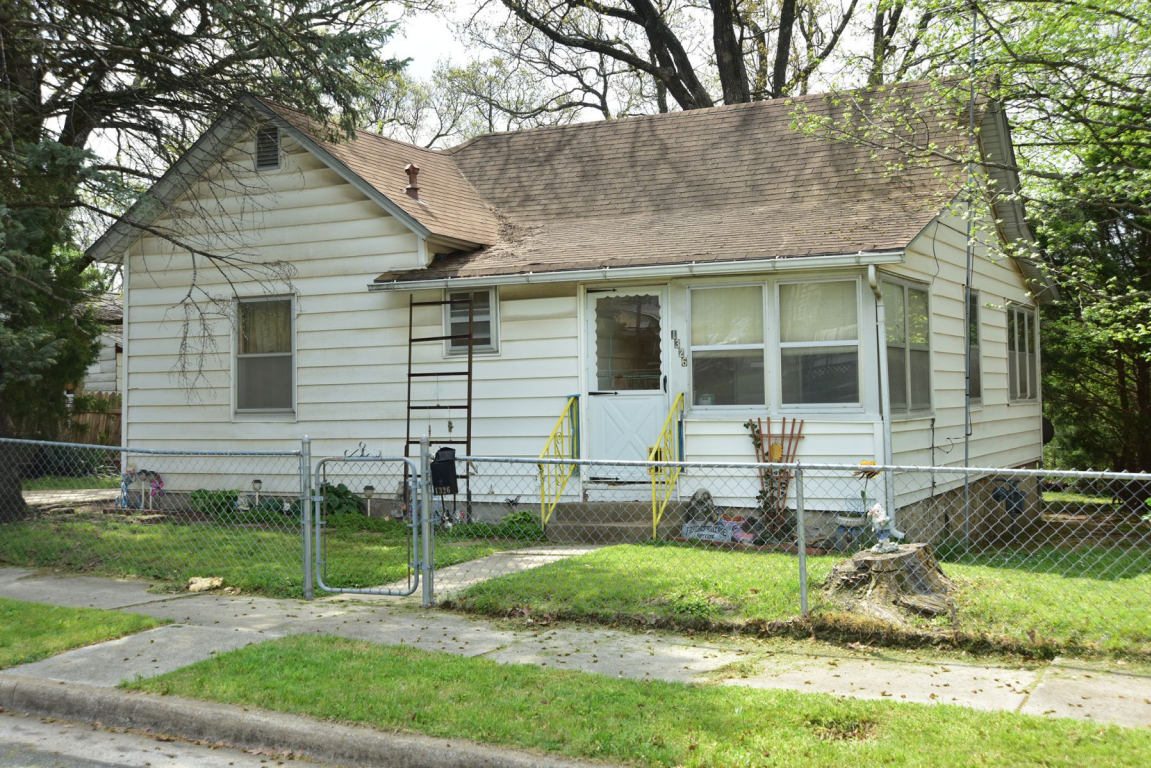
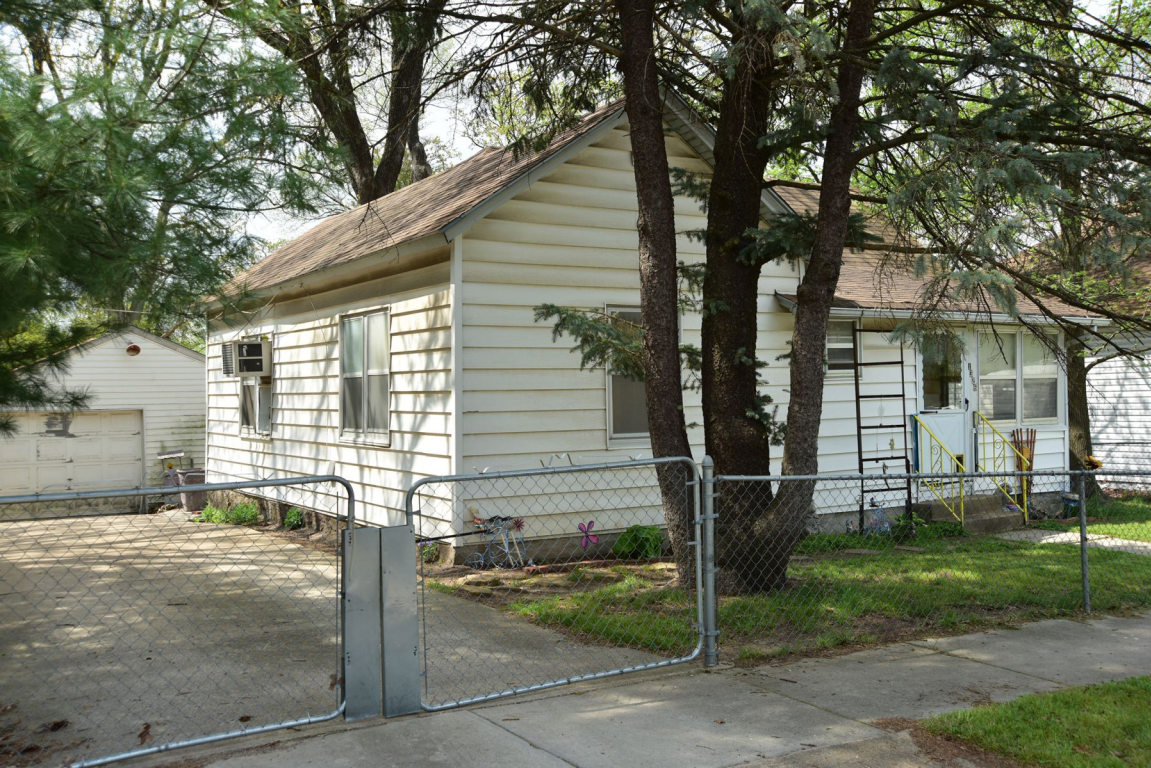
This one-story dwelling faces north and has a rectangular footprint. It features a parged stone foundation and metal siding. Its intersecting gable roof features asphalt shingle. The dwelling is three bays wide and three bays deep. A non-historic enclosed porch partially obscures the west two bays. One-over-one metal windows and an aluminum storm door characterize the enclosed porch. One-over-one historic wood windows occupy the east and west bays of the primary elevation. A non-historic metal door occupies the center bay.

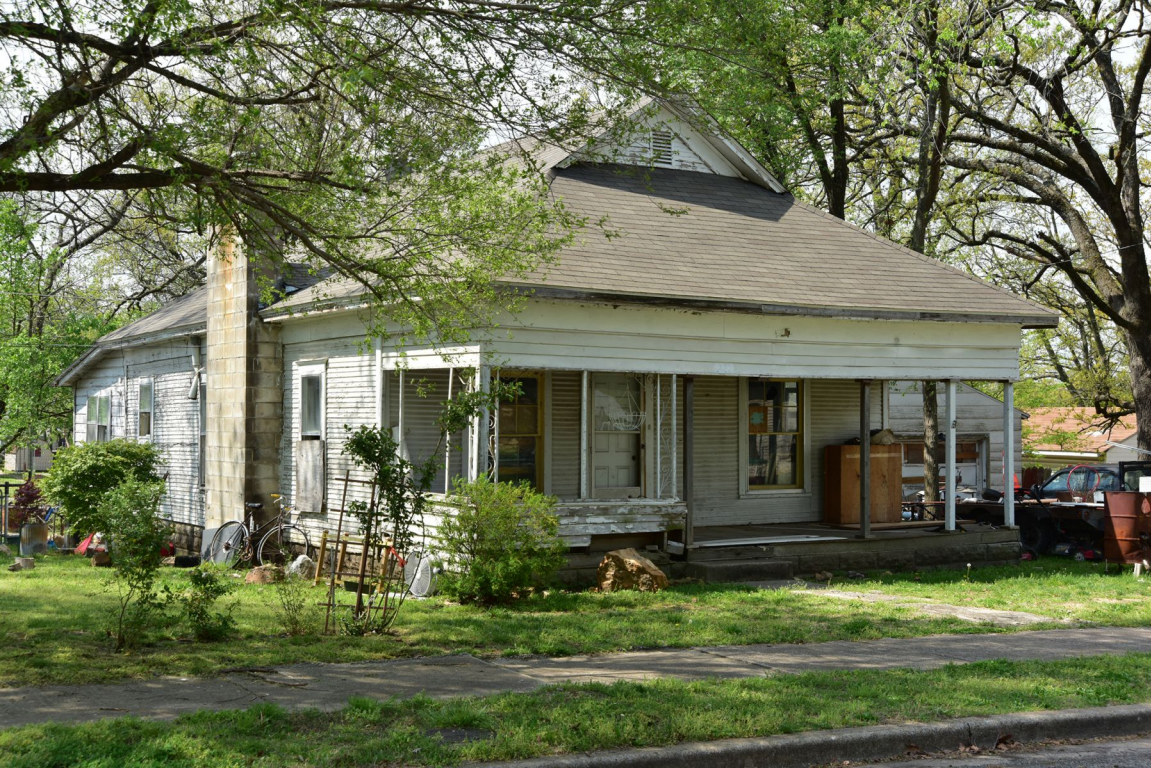
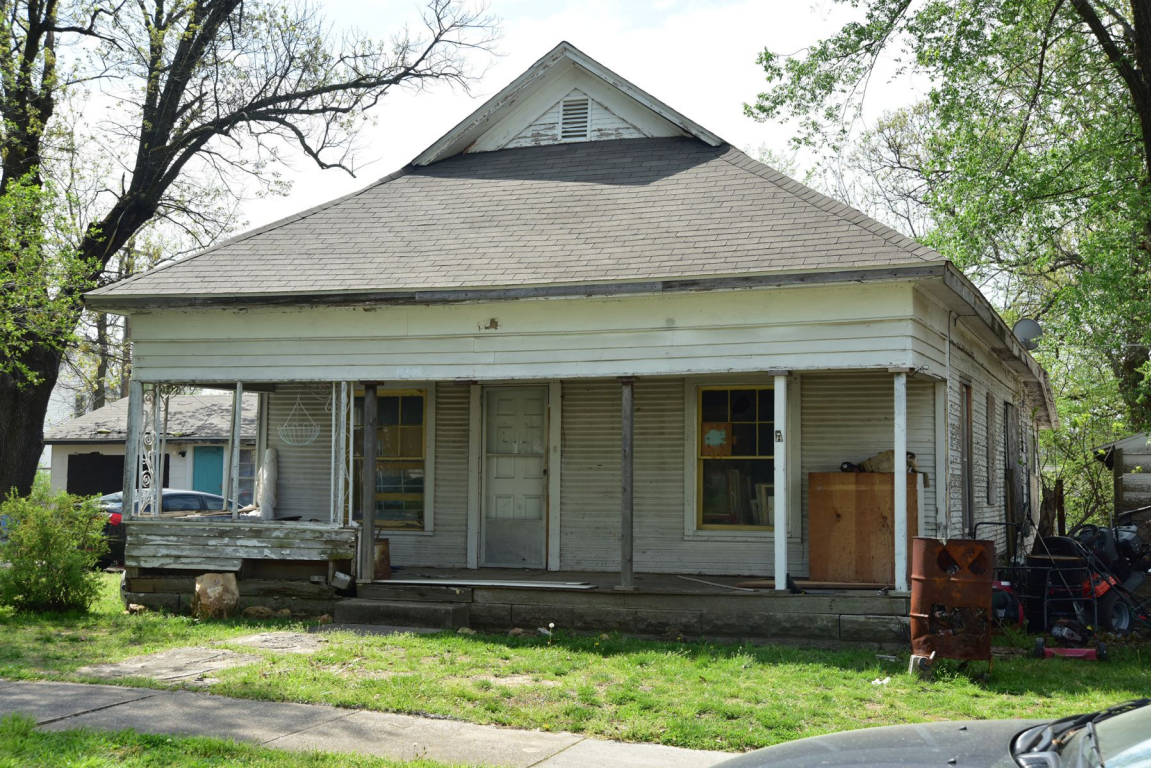
This one-story bungaloid dwelling faces north and has a rectangular footprint. The dwelling features a concrete block foundation and wood clapboard cladding with corner boards. The gabled roof has asphalt shingles. A shed-roof enclosed porch is present at the south elevation. A concrete masonry unit exterior chimney is present at the east elevation. A historic porch spans the width of the primary elevation. Squared wood and non-historic decorative metal posts support the roof. A non-historic wood door occupies the center bay of the primary elevation. Historic six-over-one wood windows occupy the east and west bays. The door and windows feature wood flat board trim.
