MISSOURI DEPARTMENT OF NATURAL RESOURCES
STATE HISTORIC PRESERVATION OFFICE, P.O. Box 176, Jefferson City, MO 65102
ARCHITECTURAL/HISTORIC INVENTORY FORM

1. Survey number: JP-AS-006-093		2. Survey Name: East Town (Original Joplin) Historic Survey Phase 1	
3. County: JASPER		4. Address 1302	Street (name): E. Furnace Street
5. City: Joplin	Vicinity <input type="checkbox"/>	7. Township/Range/Section: T: R: S:	
8. Historic name (if known):		9. Present/other name (if known):	
10. Ownership: <input checked="" type="checkbox"/> Private <input type="checkbox"/> Public		11a. Historic use (if known): Domestic/Single Dwelling	11b. Current use: Domestic/Single Dwelling

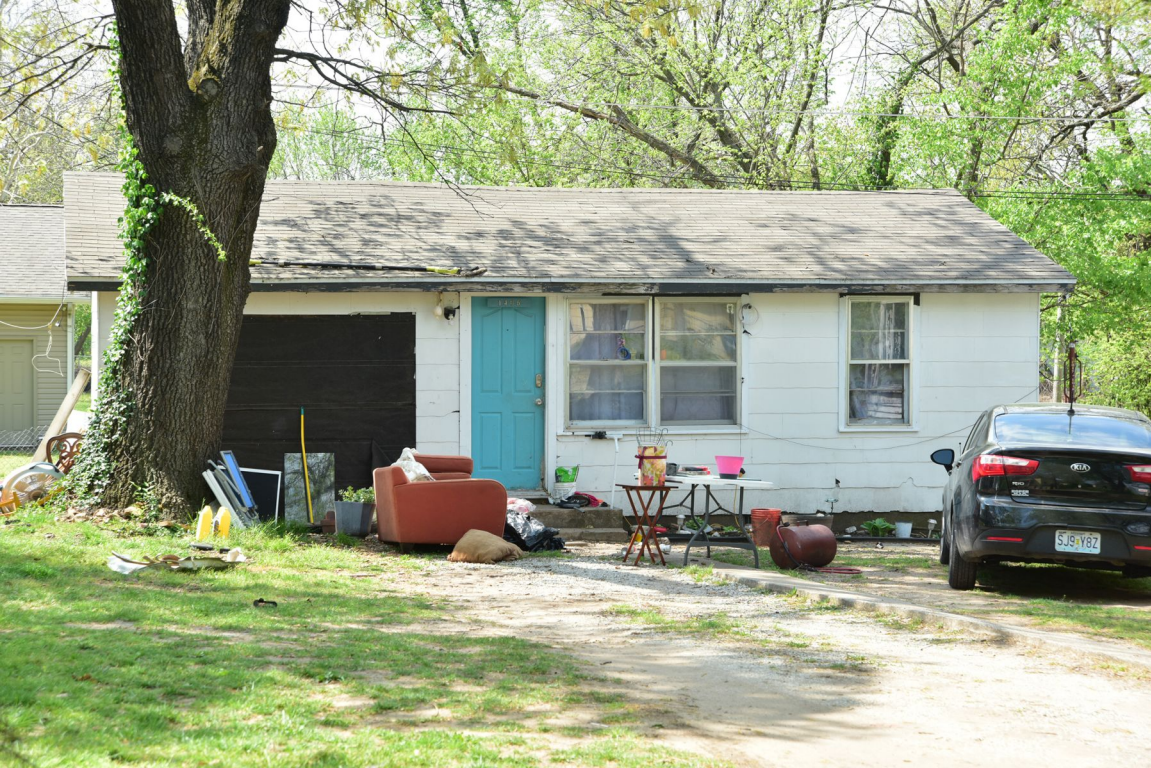
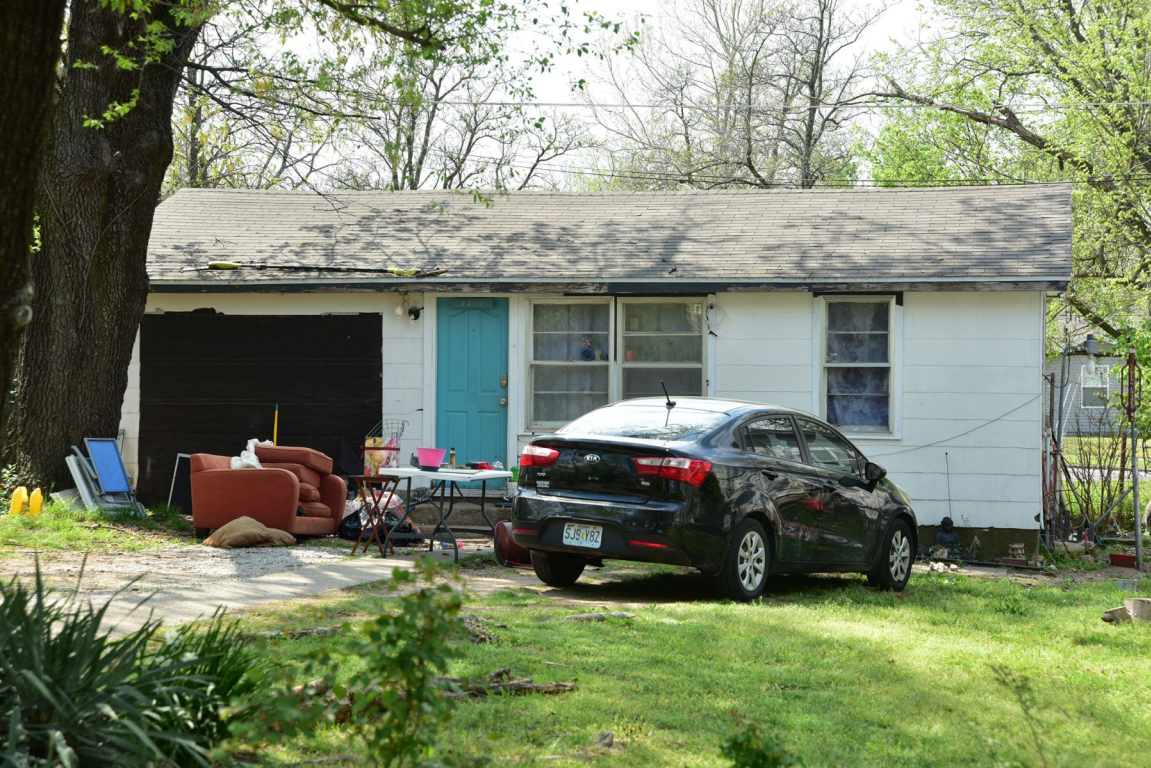
This dwelling faces north and has a rectangular footprint. It features a concrete foundation, asbestos shingle cladding, and a side-gable roof with asphalt shingles. The dwelling is four asymmetrical bays wide. Historic two-over-two windows occupy the west two bays. A non-historic wood door occupies the second-from-west bay while a wood garage door fills the west bay. A concrete stoop is present.

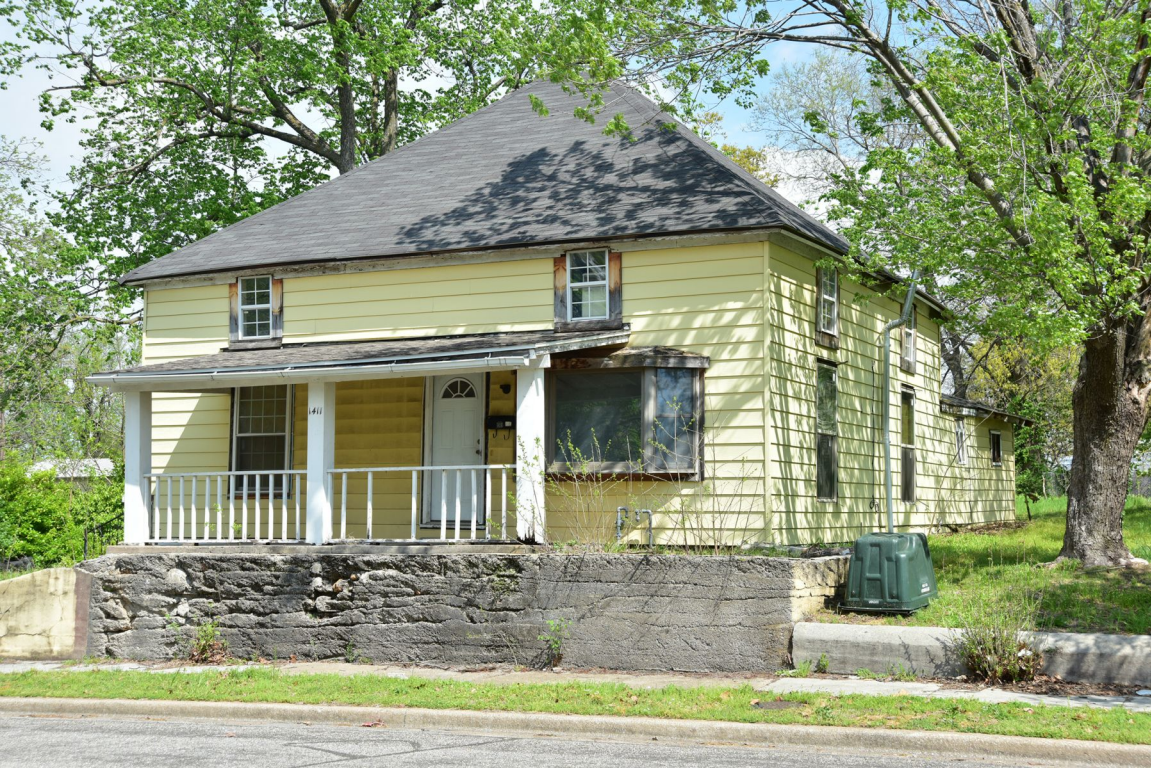
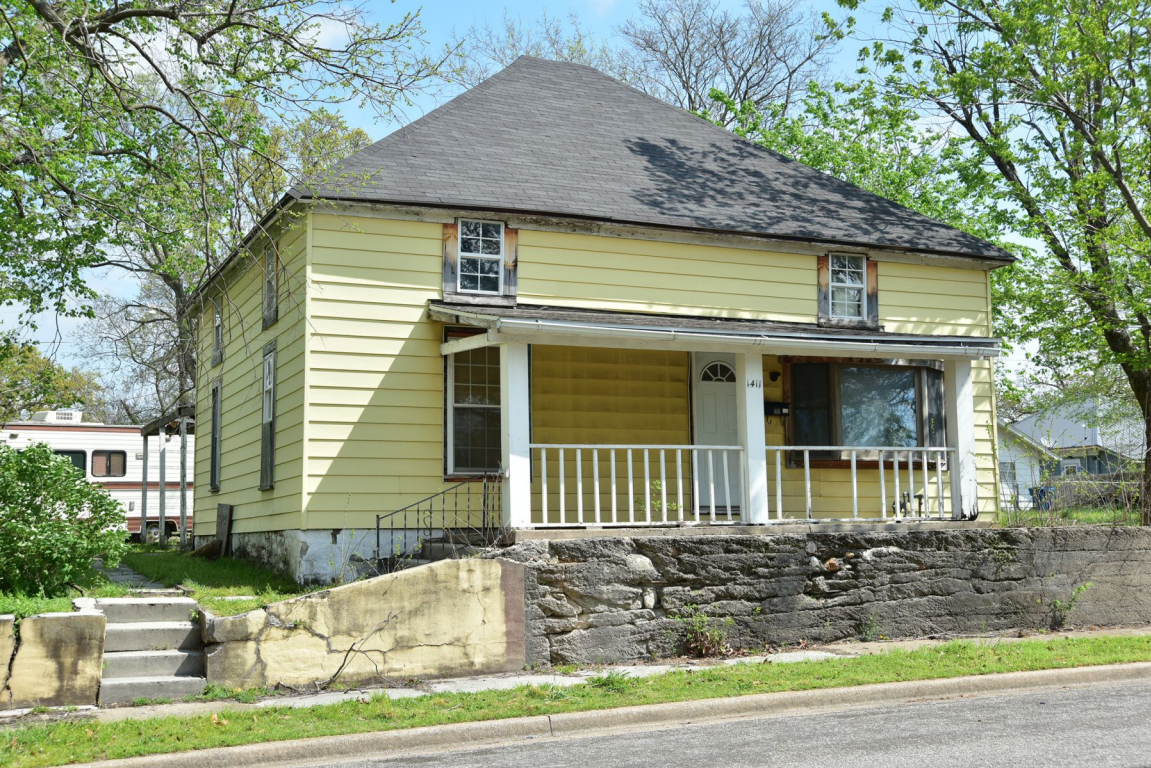
This Pyramid Square Folk House faces south and has a rectangular footprint. It features a parged stone foundation, metal siding, and a hipped roof with asphalt shingles. A historic gabled wing is present at the south elevation. A historic three-quarter width shed-roof porch with squared wood posts and a matchstick balustrade is located at the primary elevation. A fiberglass door occupies the center bay of the first story. A twelve-over-twelve vinyl window occupies the west bay and a non-historic metal bay window occupies the east bay. One-over-one windows flank a single-light in the bay window. Four-over-four vinyl windows occupy both bays of the upper half-story at all elevations visible from the right-of-way. The window openings cut into the wood frieze. The windows are much smaller than the historic openings and thus feature wide wood infill.

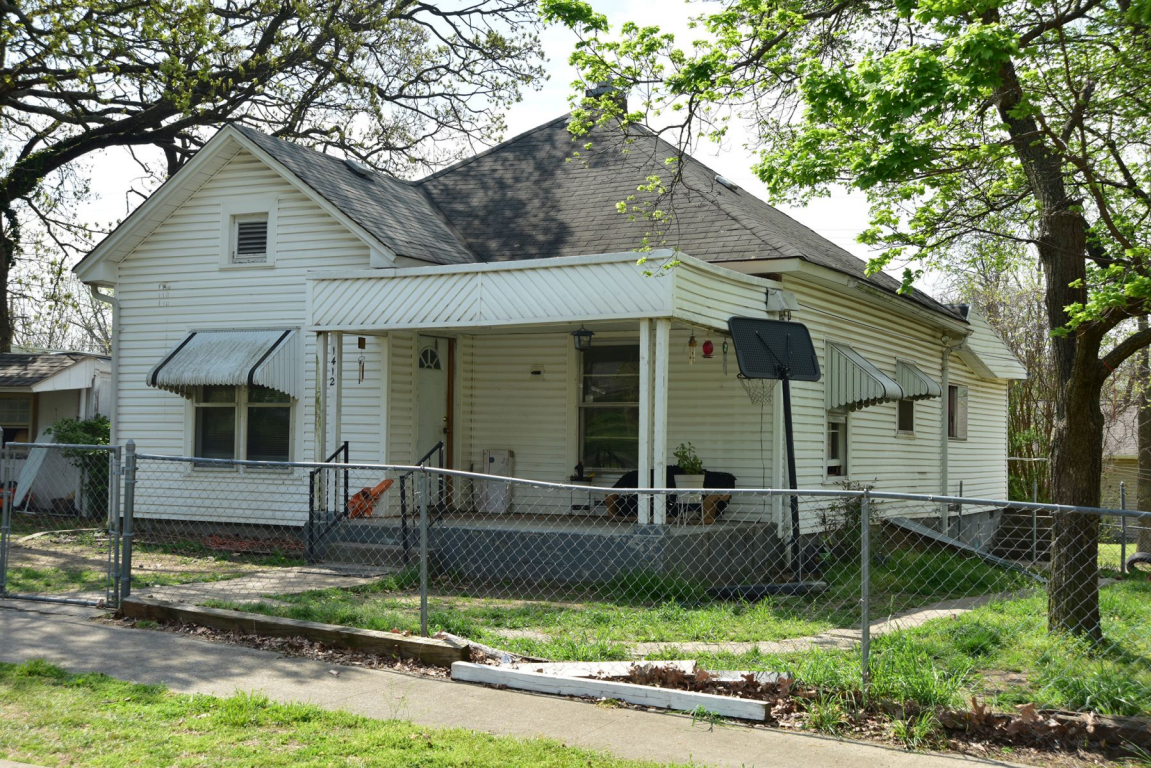
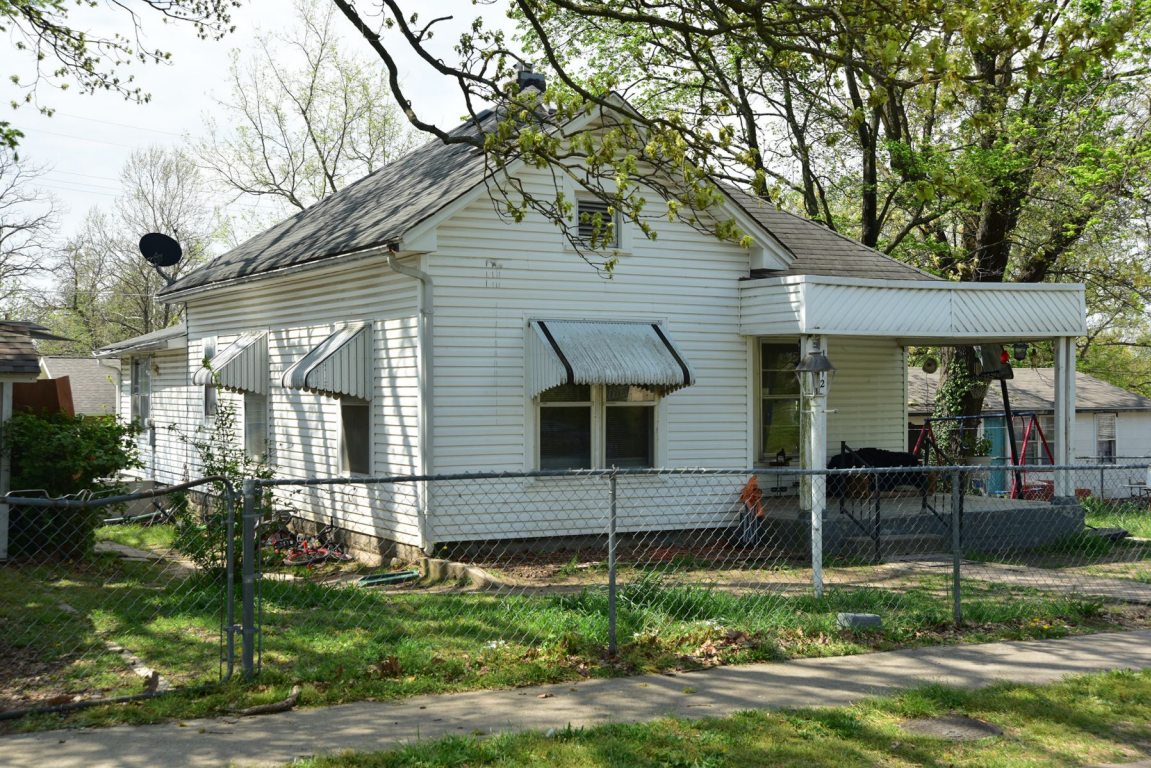
This one-story dwelling faces north and has a rectangular footprint. It features a stone foundation and vinyl cladding. The pyramidal hipped roof with cross-gable has asphalt shingles. A rectangular louver is located in the gable peak. A vinyl-clad addition with a concrete block foundation is located at the rear. The dwelling is two bays wide and three bays deep. The east bay is located in the projecting cross-gable. Paired one-over-one historic wood windows occupy the bay. A metal awning shelters the windows. A fiberglass door is located in the west wall of the projecting cross-gable. A historic one-over-one wood window occupies the west bay of the primary elevation and is sheltered by a non-historic flat-roof porch with squared support posts. Metal awnings shelter the north two bays of the east and west elevations.

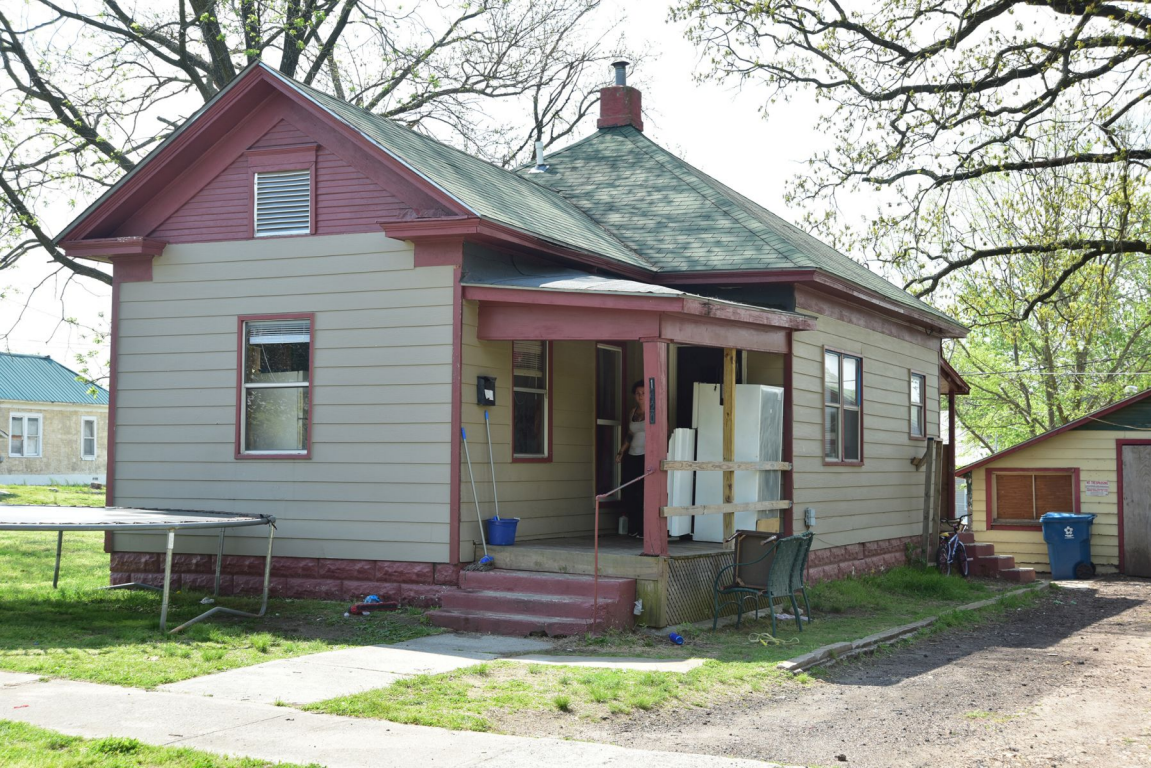
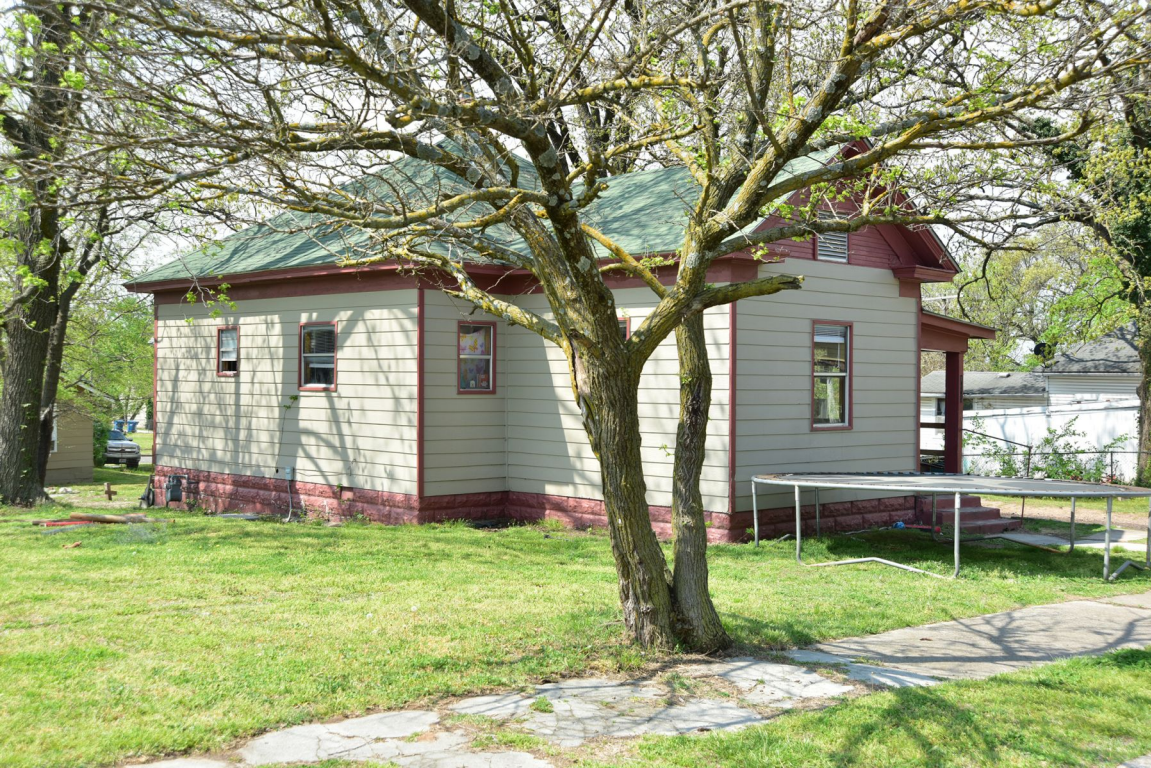
This one-story dwelling faces north and has a T-shaped footprint. It has a concrete block foundation and cementitious siding. The pyramidal hipped roof with cross-gable features asphalt shingles. A rectangular louver with modest crown molding and cornice returns characterize the gable. A brick chimney pierces the roof peak. The dwelling is two bays wide and three asymmetrical bays deep. A non-historic wood porch with shallow hipped roof shelters the west bay of the primary elevation. A non-historic door of unknown material occupies the bay. A non-historic one-over-one metal window occupies the east bay. A secondary entrance with shed-roof porch and concrete stoop is located at the rear elevation.

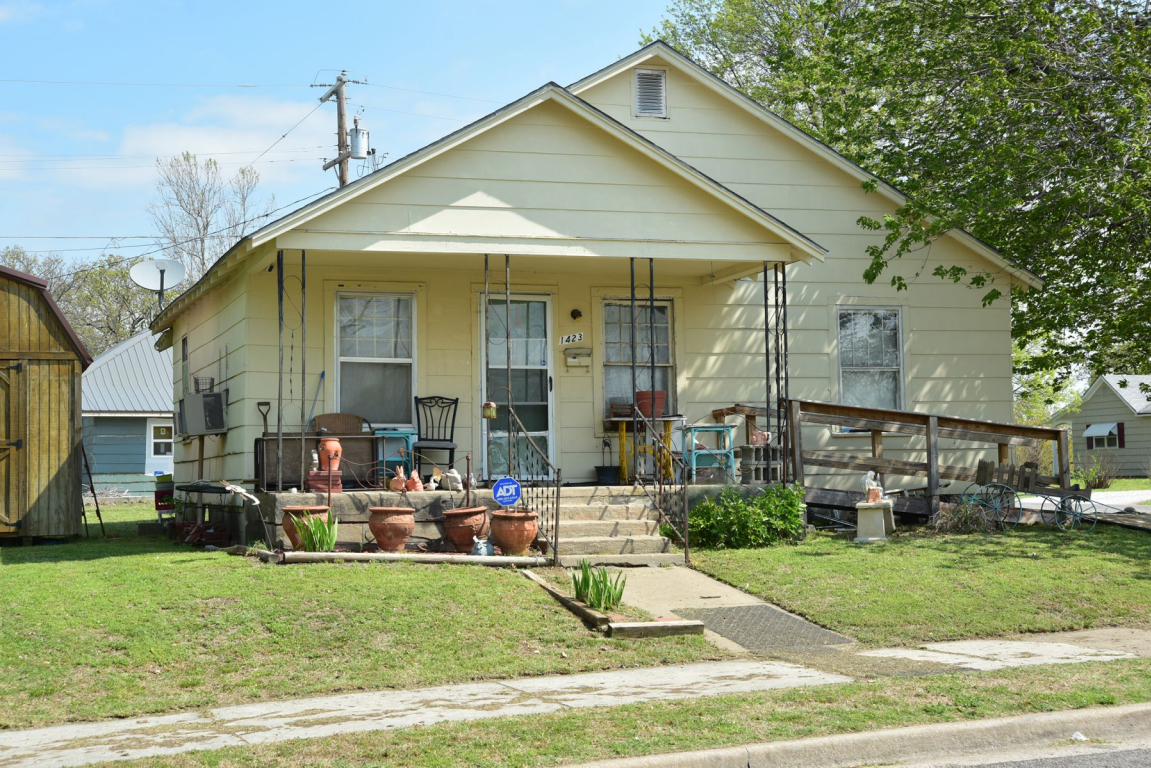
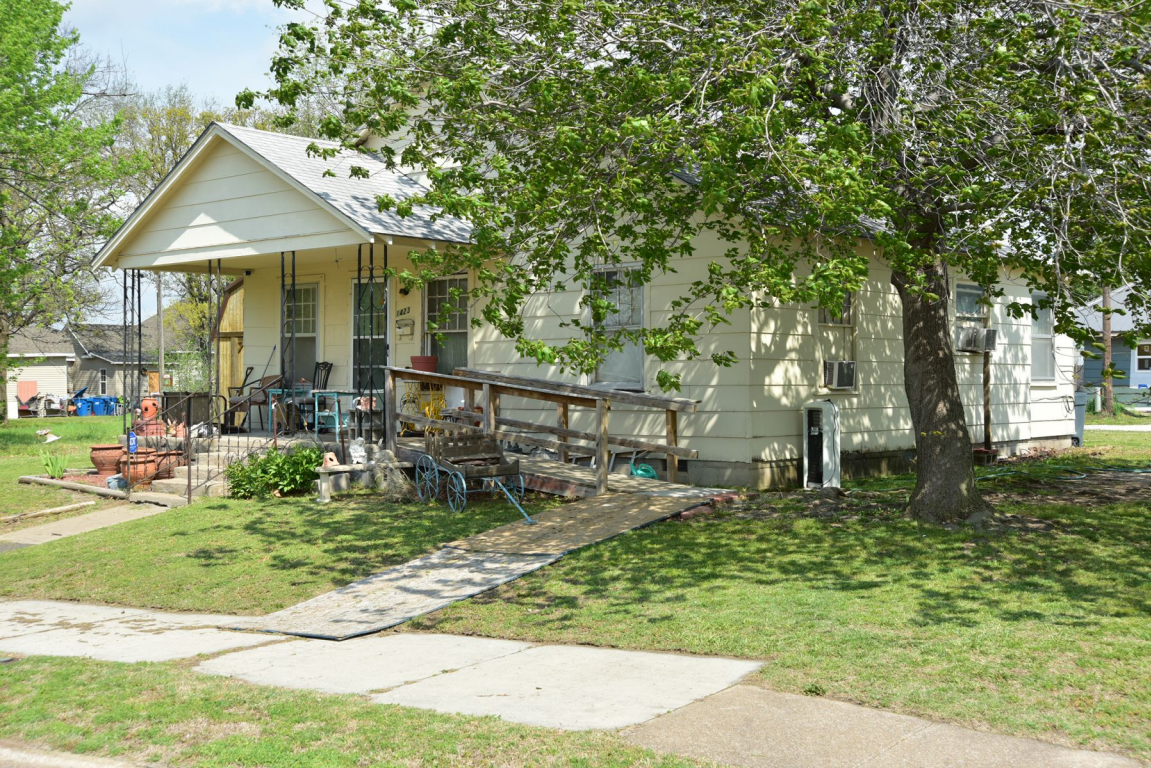
This one-story dwelling faces south and has a rectangular footprint. It features a cement masonry unit foundation and pressboard cladding. The front-gable roof features asphalt shingles and exposed rafter tails. The dwelling is four asymmetrical bays wide and three bays deep. A front-gable porch with non-historic decorative iron posts shelters the west three bays. A wood door occupies the second-from-west bay. Historic twelve-over-one wood windows occupy the remaining bays.

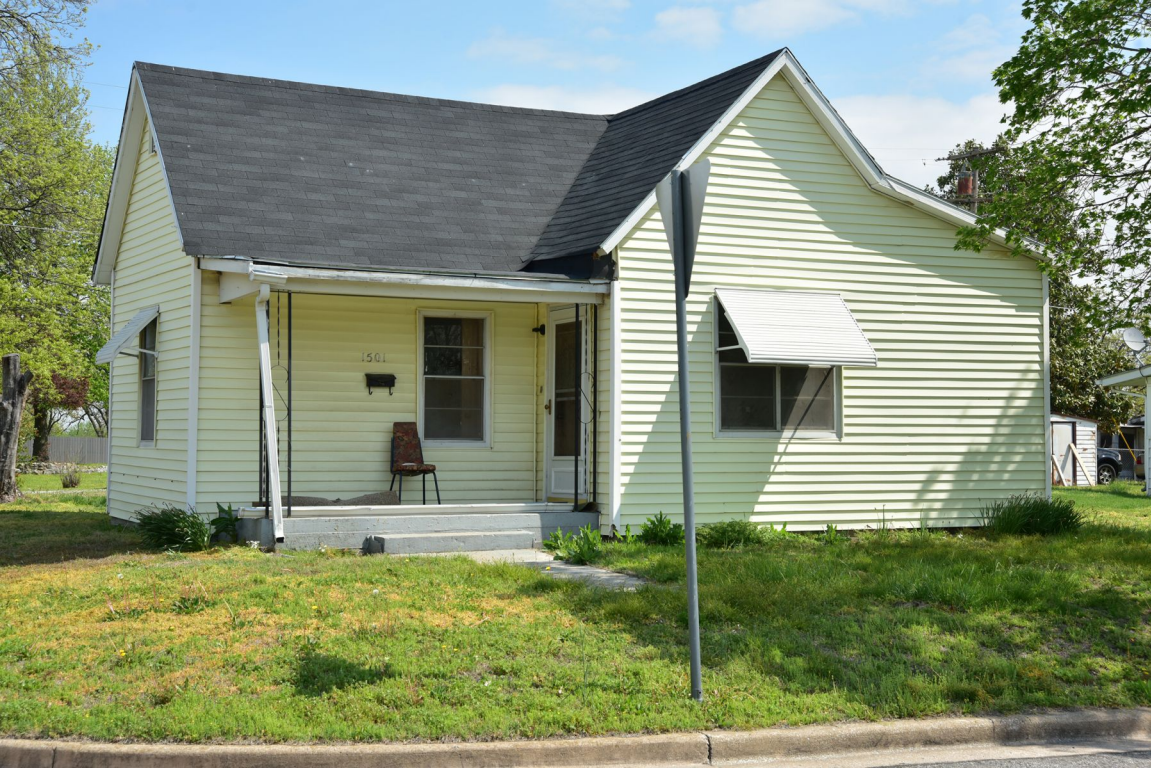
1501

This one-story dwelling faces south and has an irregular footprint. It features a concrete foundation, vinyl cladding, and a complex roof with asphalt shingles. The dwelling features historic two-over-two metal windows. A non-historic wood door with glazing is located in the east wall of the gabled ell at the primary elevation. A shed roof porch with a concrete foundation and non-historic decorative metal support posts shelters the west bay.

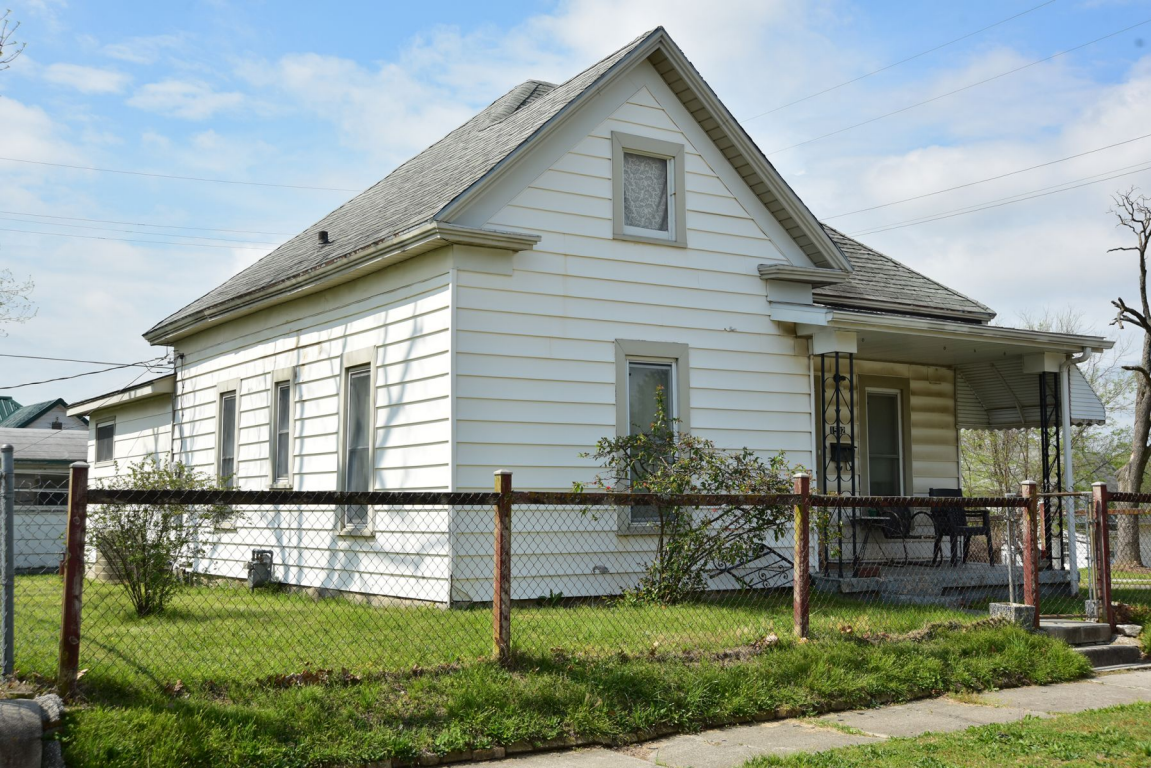
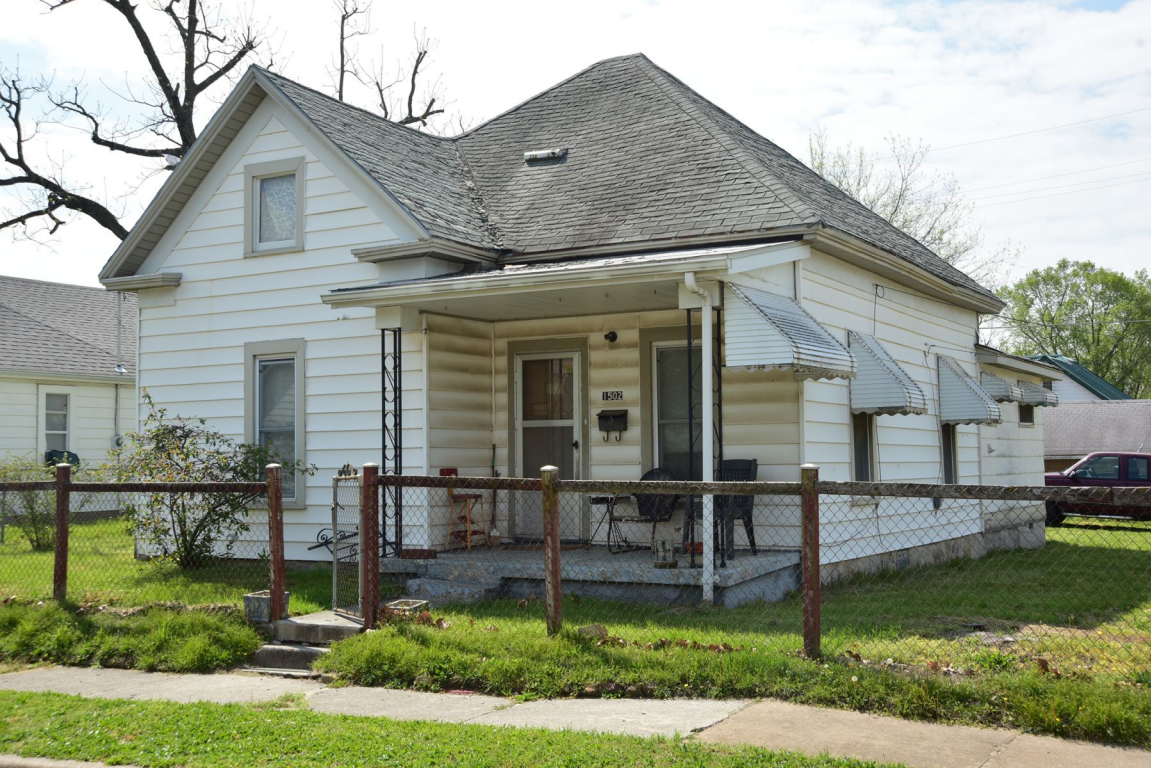
This dwelling faces north and has a rectangular footprint. It features a stone foundation, wide-profile metal cladding, and a pyramidal hipped roof with a cross-gable and asphalt shingles. Cornice returns and a single-light wood casement window characterize the gable end. An enclosed porch with hipped roof is located at the rear of the dwelling. The dwelling is three bays wide and four bays deep. A shed-roof porch with non-historic decorative metal support posts shelters the west two bays. A wood door with three, square single-light windows occupies the center bay. One-over-one wood windows occupy the remaining bays. Metal awnings shelter the windows at the west elevation.

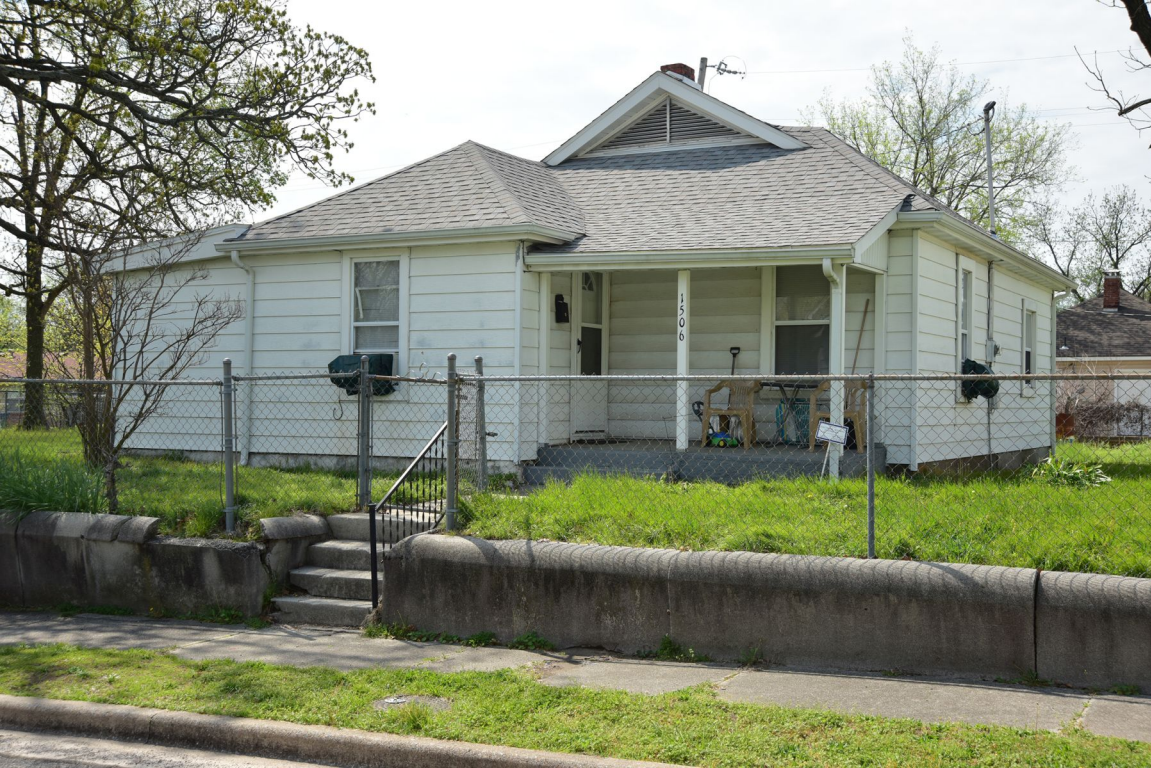
1506

This one-story dwelling faces north and has an L-shaped footprint. It features a concrete foundation and metal siding. The complex hipped roof has asphalt shingles. A low gabled dormer is located on the front slope of the roof and a historic shed-roof addition is located at the east elevation. A hipped roof ell projects from the east side of the primary elevation. The dwelling two asymmetrical bays wide and two bays deep. A shed-roof porch with non-historic squared support posts shelters the west bay and a fiberglass door is located in the west wall of the ell. Historic one-over-one wood windows occupy the primary elevation bays.

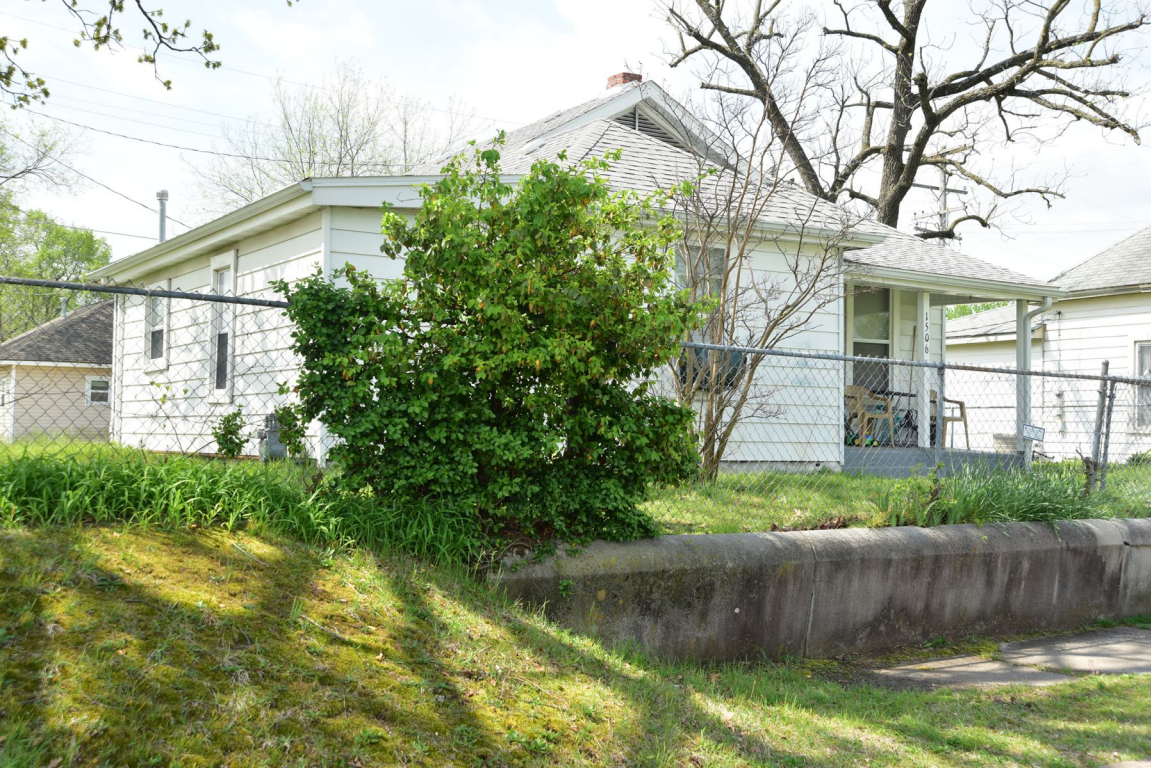
This one-story Gabled Ell dwelling faces south and has an irregular footprint. It features a stone foundation, asphalt shingle roof, and metal siding. An enclosed porch with shed roof is located at the north elevation. The dwelling is two bays wide and three bays deep. Historic one-over-one wood windows occupy the primary elevation bays. A non-historic wood door and historic one-over-one wood window are located in the west wall of the ell. A shed-roof porch shelters the entrance and west bay. The porch features a concrete foundation and stairs. A non-historic decorative metal post and non-historic squared wood post support the porch roof.

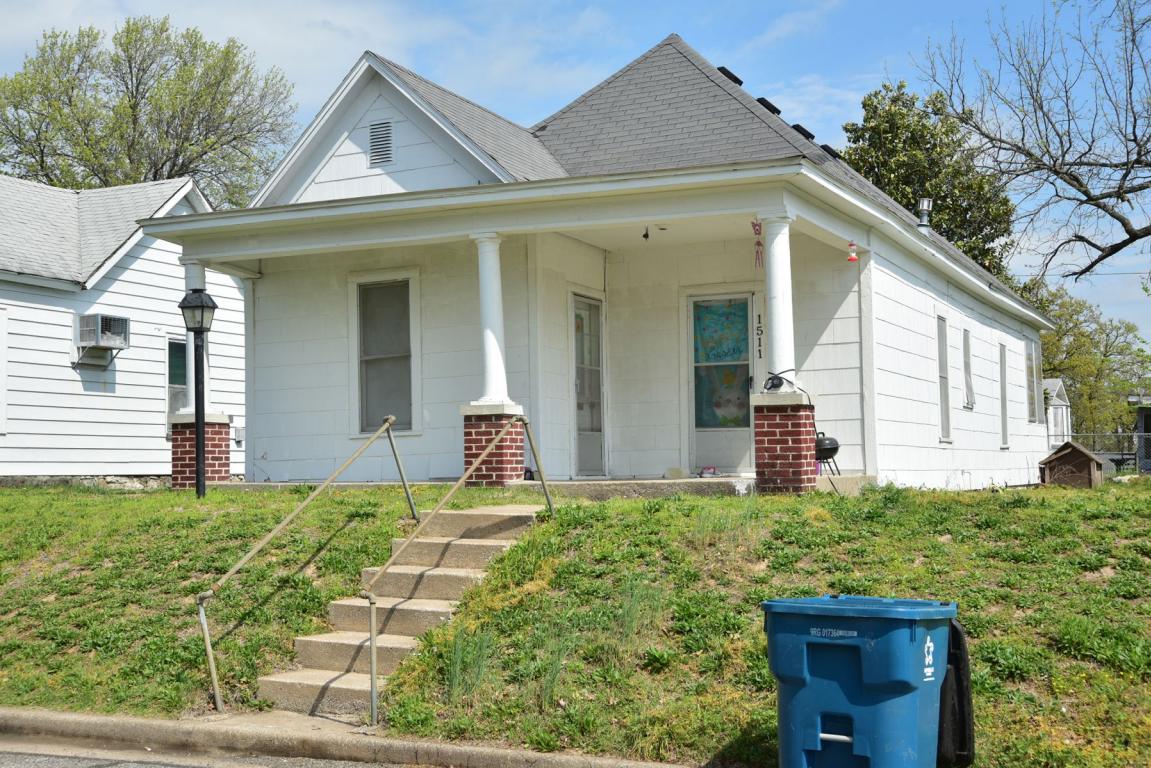
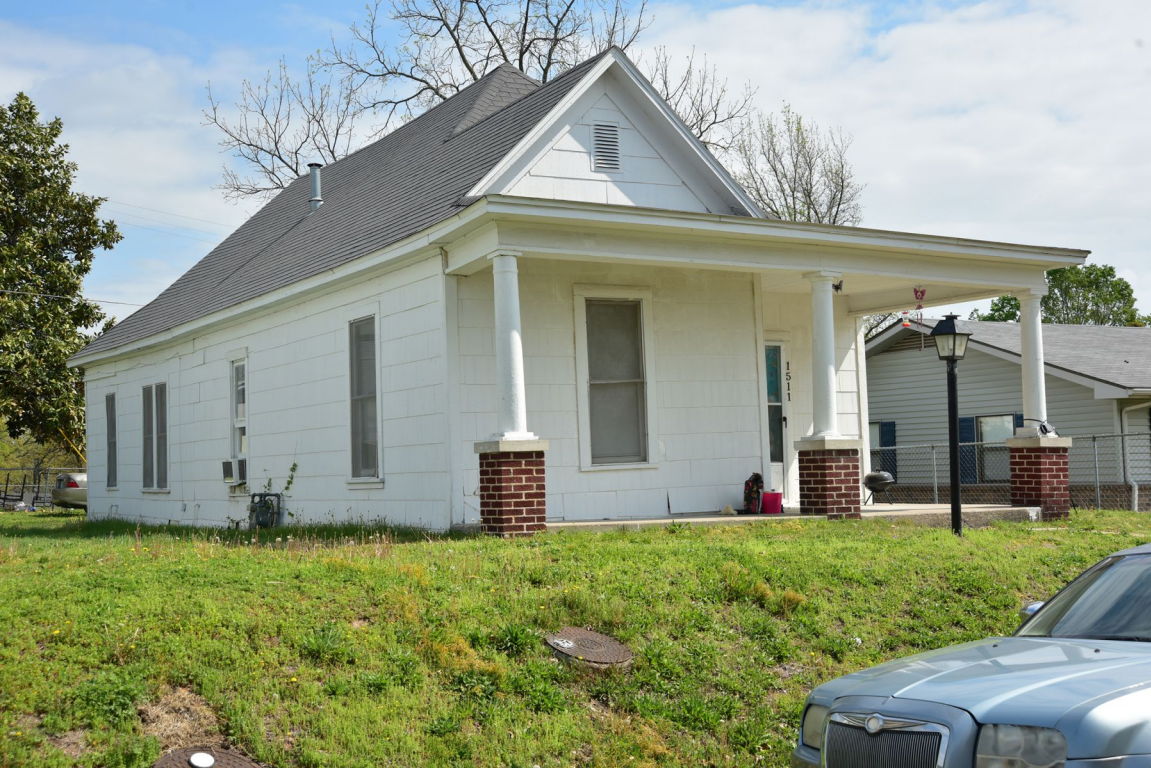
This one-story dwelling faces south and has a rectangular footprint. It features asbestos shingle cladding and hipped asphalt shingle roof. A gabled ell projects from the west end of the primary elevation. The foundation is not visible. The dwelling is two bays wide and four asymmetrical bays deep. A historic one-over-one wood window occupies the west bay. An entrance occupies the east bay; however, the door is not visible. A historic wood door with glazing is located in the east wall of the gabled ell. An open porch spans the primary elevation. The porch features a concrete foundation and flat roof. Wood Tuscan columns on square brick piers support the roof.

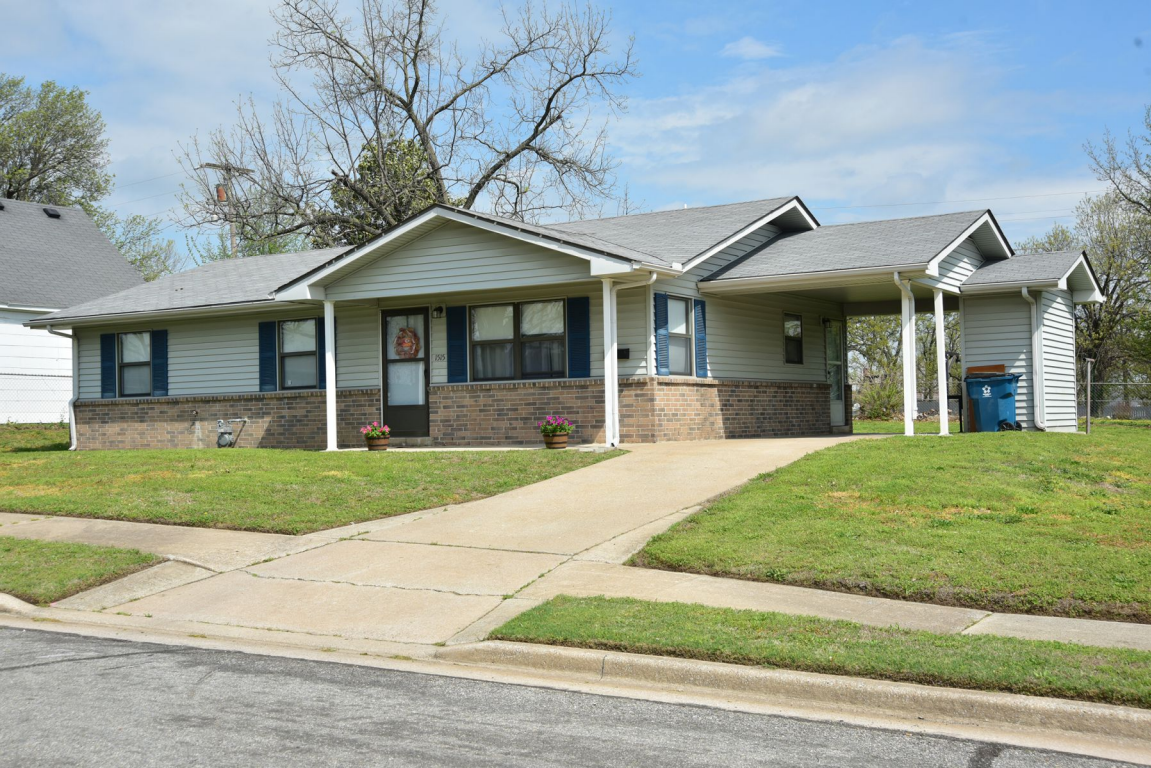
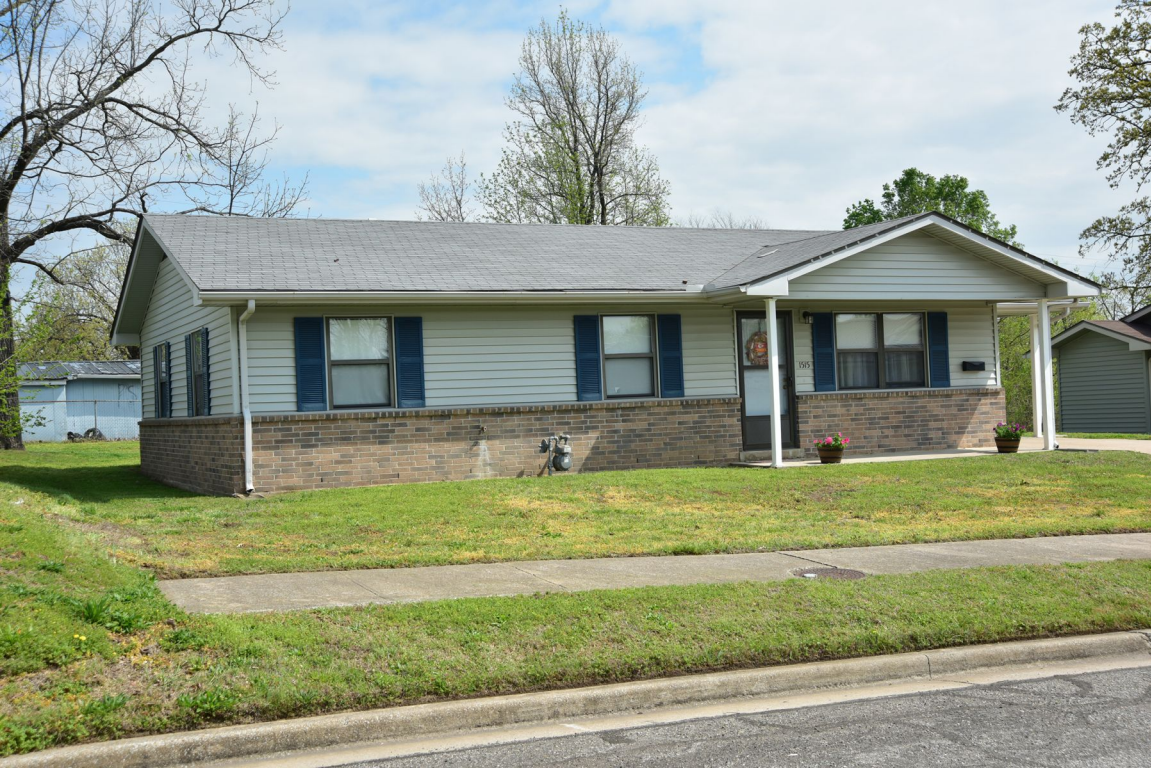
This one-story dwelling faces south and has a rectangular footprint. It has a concrete foundation and side-gable roof with asphalt shingles. Brick veneer clads the lower third of the dwelling while the remainder is vinyl-clad. The dwelling is four bays wide and three bays deep. A front-gable porch shelters the two east bays of the primary elevation. A wood door with metal storm door fills the second-from-east bay. One-over-one metal windows with false shutters define the remaining bays. A side-gable carport projects from the east elevation and shelters a secondary entrance. An enclosed storage area with gable roof is located at the east end of the carport.

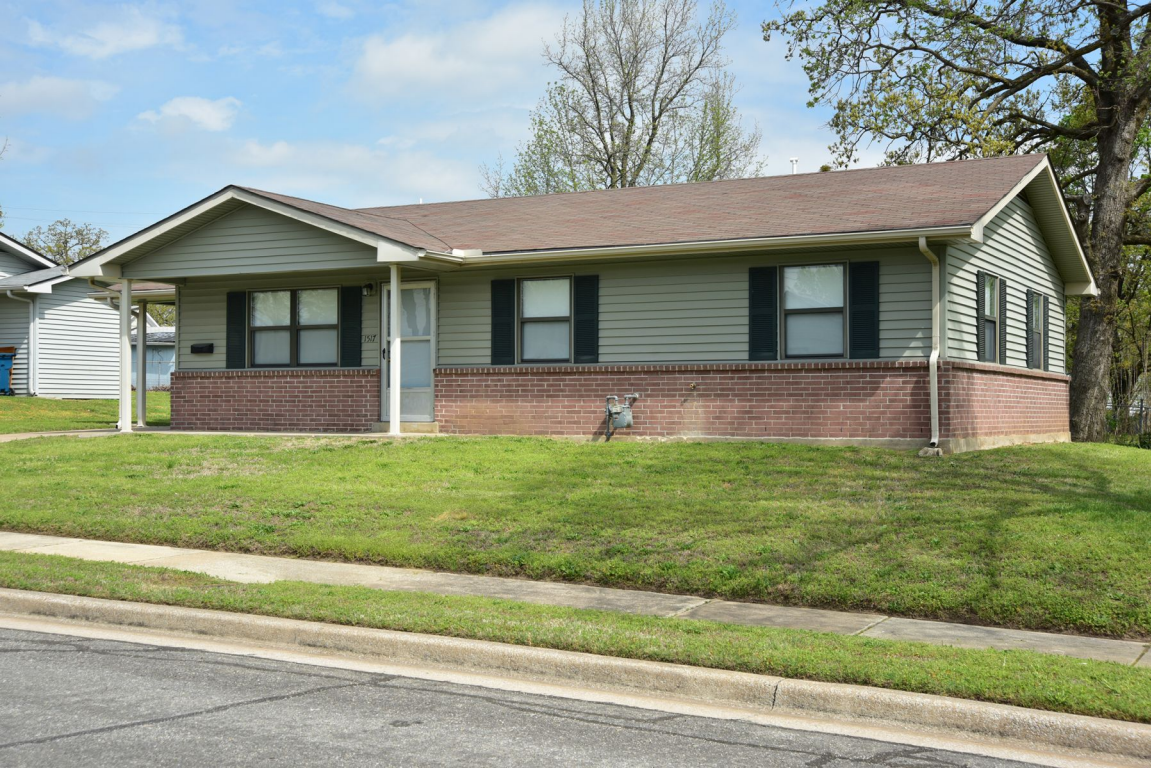
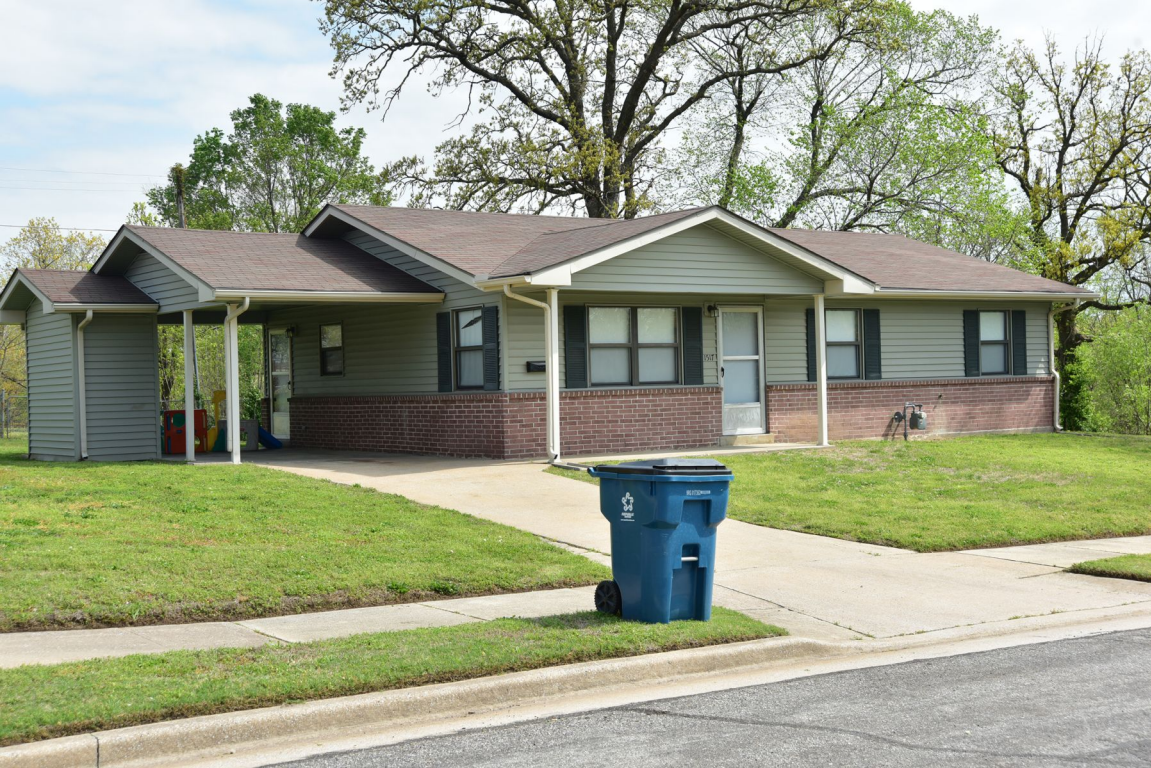
This dwelling is a mirror of the adjacent dwelling, 1515 E. Furnace Street. The one-story dwelling faces south and has a rectangular footprint. It has a concrete foundation and side-gable roof with asphalt shingles. Brick veneer clads the lower third of the dwelling while the remainder is vinyl-clad. The dwelling is four bays wide and three bays deep. A front-gable porch shelters the two west bays of the primary elevation. A wood door with metal storm door fills the second-from-west bay. One-over-one metal windows with false shutters define the remaining bays. A side-gable carport projects from the west elevation and shelters a secondary entrance. An enclosed storage area with gable roof is located at the west end of the carport.

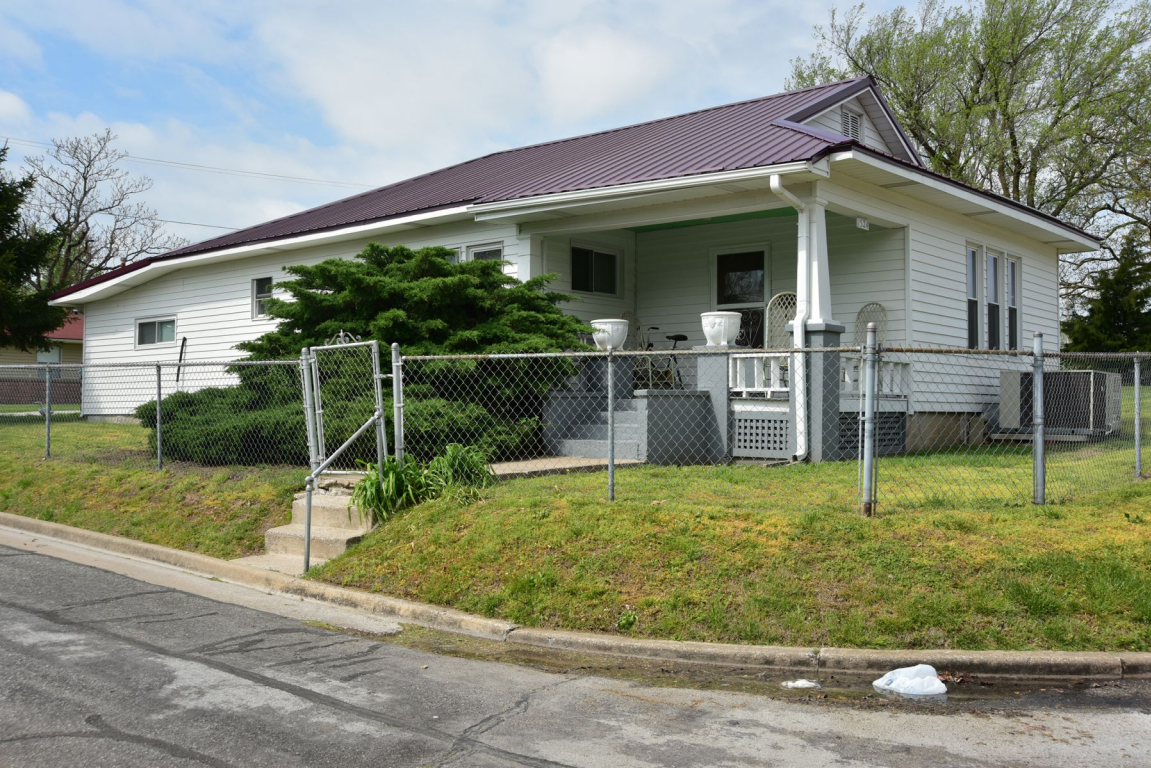
This one-story dwelling faces south and has a rectangular footprint. It features a concrete foundation, metal siding, and a corrugated metal roof. An enclosed porch with center gable is located at the south elevation. The porch enclosure is non-historic. A partial-width open porch shelters the east bay of the primary elevation. The front porch features a concrete foundation and stairs. Non-historic squared wood columns in concrete piers support the roof. A non-historic metal door is located in the east wall of the porch. A one-by-one sliding metal window occupies the east bay of the primary elevation while three narrow non-historic one-over-one vinyl windows characterize the west bay. No historic windows remain.
