MISSOURI DEPARTMENT OF NATURAL RESOURCES
STATE HISTORIC PRESERVATION OFFICE, P.O. Box 176, Jefferson City, MO 65102
ARCHITECTURAL/HISTORIC INVENTORY FORM

1. Survey number: JP-AS-006-093		2. Survey Name: East Town (Original Joplin) Historic Survey Phase 1	
3. County: JASPER		4. Address 1302	Street (name): E. Furnace Street
5. City: Joplin	Vicinity <input type="checkbox"/>	7. Township/Range/Section: T: R: S:	
8. Historic name (if known):		9. Present/other name (if known):	
10. Ownership: <input checked="" type="checkbox"/> Private <input type="checkbox"/> Public		11a. Historic use (if known): Domestic/Single Dwelling	11b. Current use: Domestic/Single Dwelling

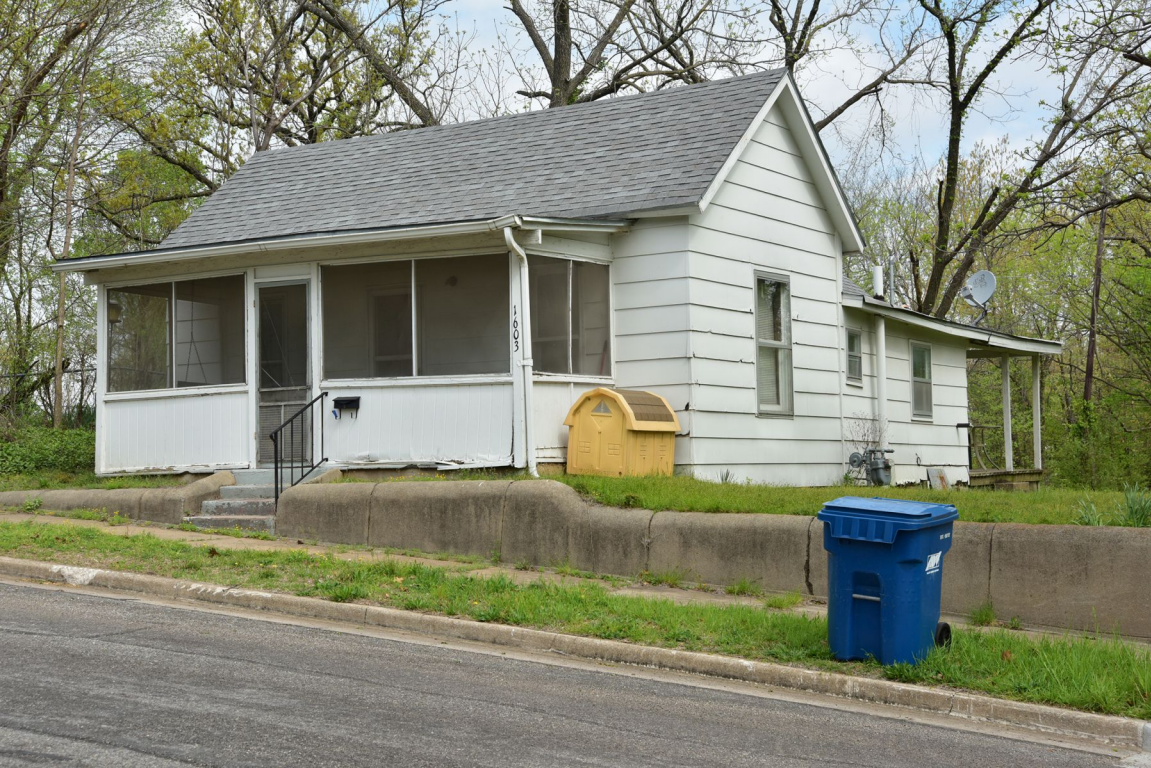
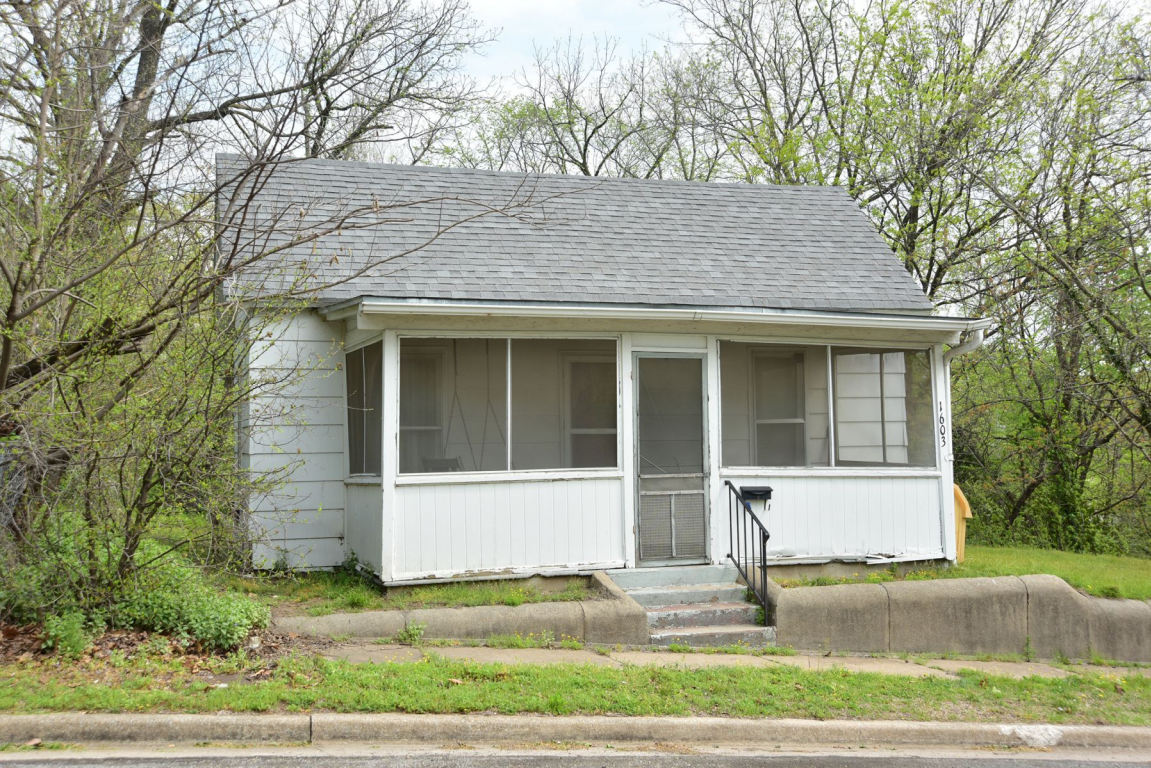
1603

This one-story dwelling faces south and has a rectangular footprint. It features a concrete masonry unit foundation, pressboard cladding, and asphalt shingle roof. The dwelling is three bays wide and three bays deep. An enclosed three-quarter width porch with a flat roof and concrete foundation is located at the primary elevation. The lower third of the porch features wood cladding while the upper portion features mesh screens. A wood door occupies the center bay of the primary elevation while historic one-over-one wood windows occupy the remaining bays.

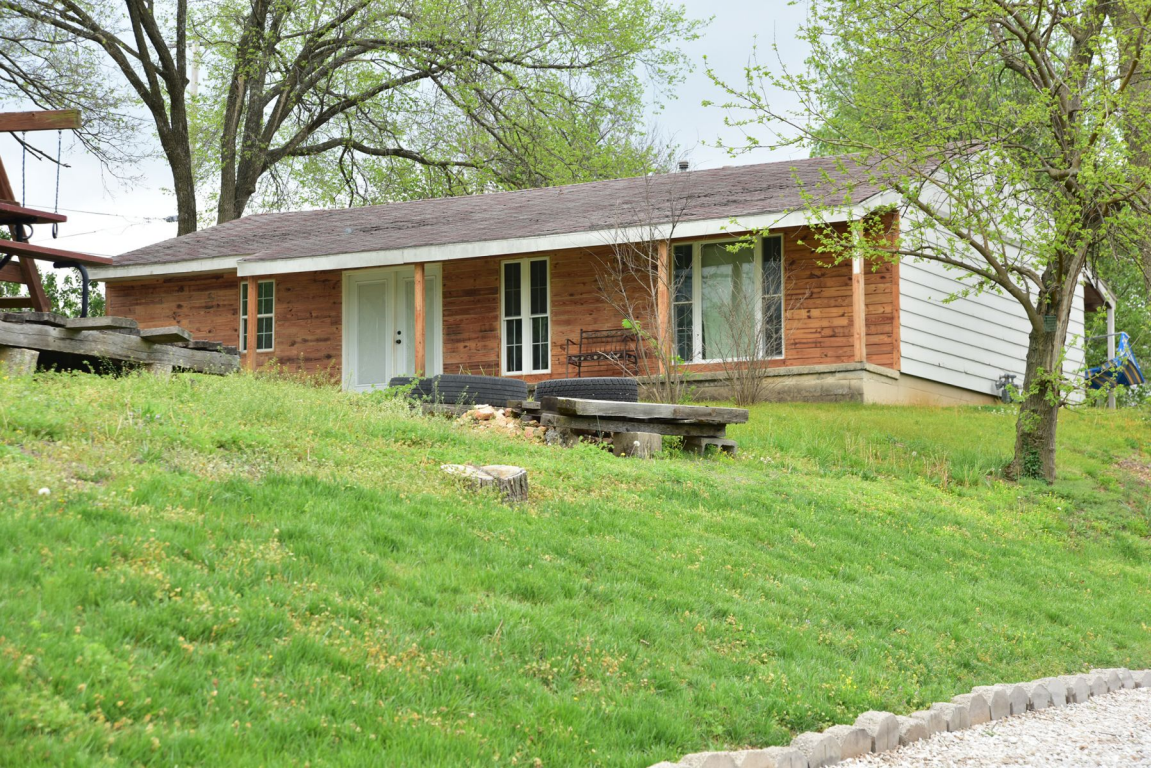
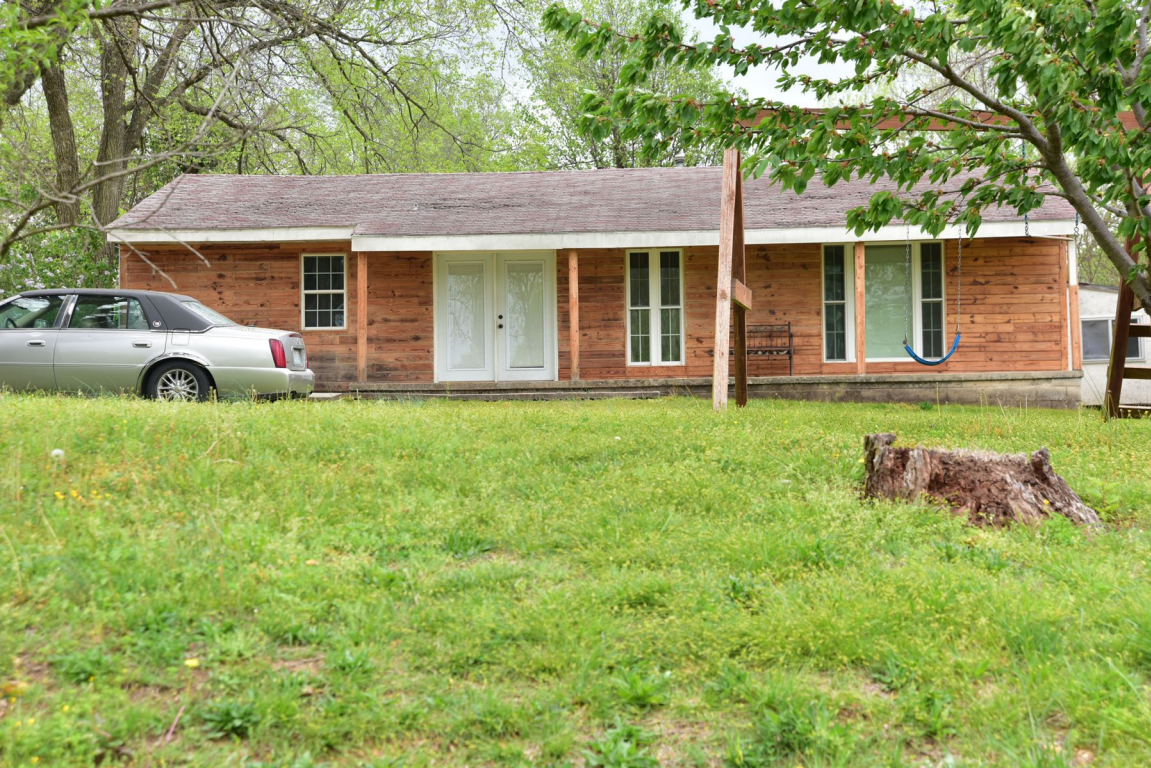
This one-story dwelling faces west and has a rectangular footprint. It features a concrete foundation, side-gable roof with asphalt shingles, and a combination of pressboard and non-historic wood plank siding (installed post-2013). The dwelling is four bays wide and two bays deep. A non-historic shed-roof porch shelters the south three bays. Paired, non-historic wood doors with glazing occupy the second-from-north bay. A vinyl tripartite picture window with occupies the south bay. The remaining bays feature four-over-four vinyl windows. The window openings have been enlarged since the building's initial construction.

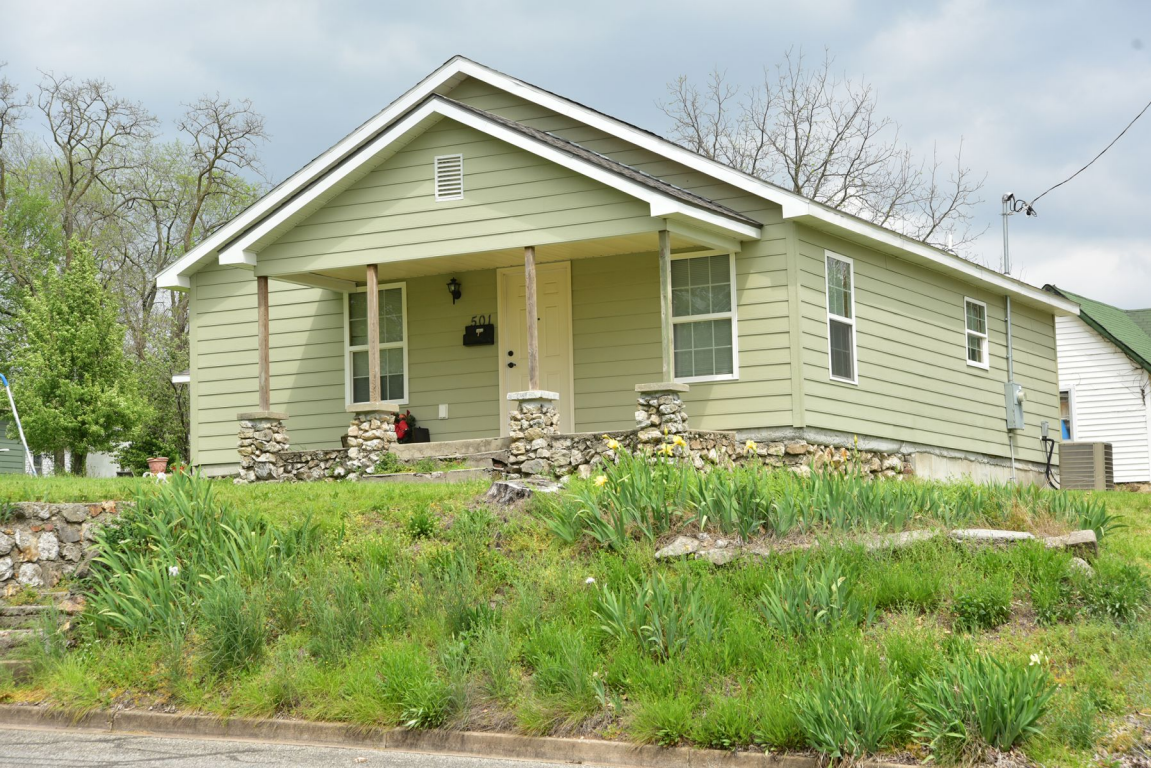
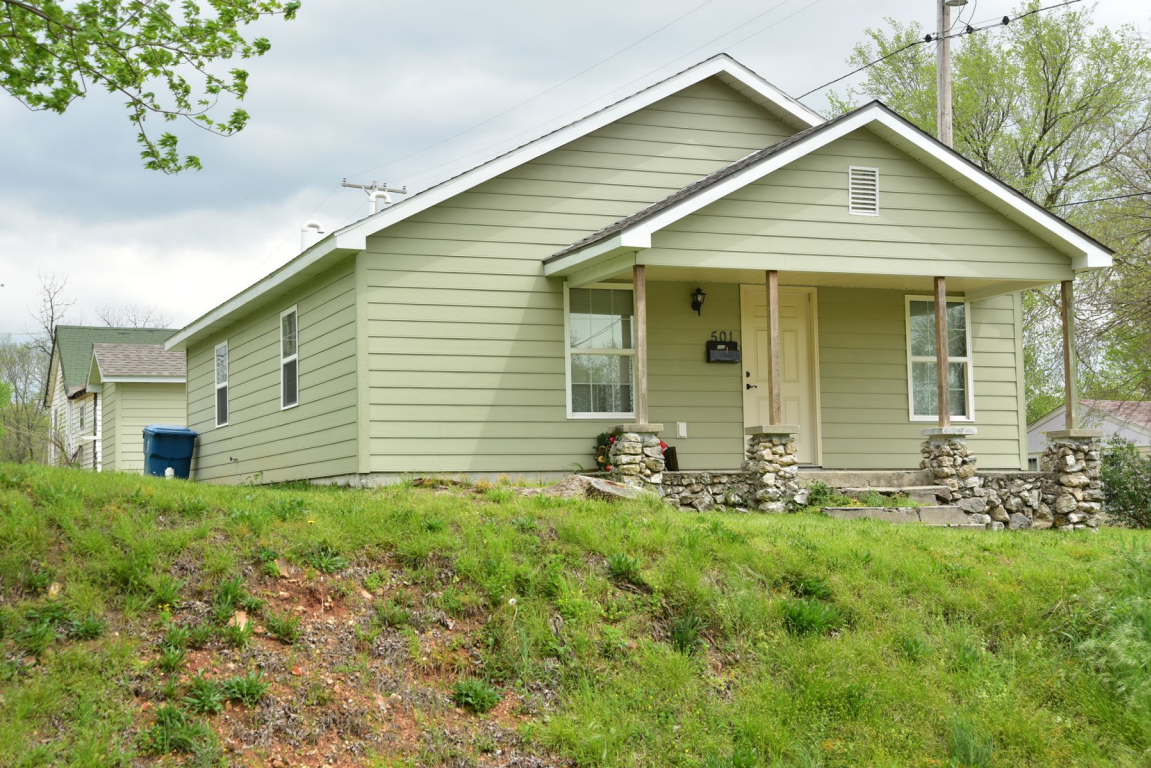
Rebuilt ca. 2017 - only concrete steps, stone retaining walls, and stone porch elements historic
This one-story dwelling faces west and has a rectangular footprint. It features a stone and concrete foundation and vinyl cladding. The front-gable roof features asphalt shingles. The dwelling is three bays wide and two asymmetrical bays deep. A front-gable porch shelters the primary elevation bays. Non-historic squared wood posts on stone piers support the porch roof. A non-historic wood door occupies the center bay while six-over-six vinyl windows occupy the remaining bays.

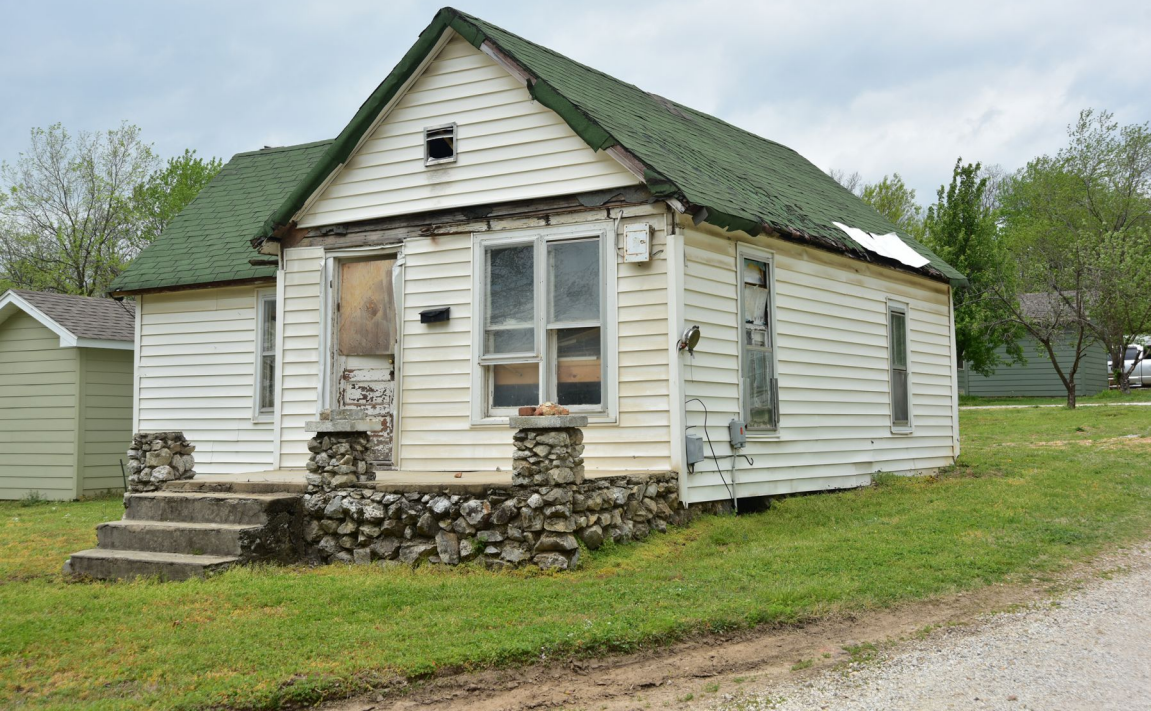
This one-story building faces south and has an L-shaped footprint. It features a field stone foundation and vinyl cladding. The roof features asphalt shingles and wood soffits. The dwelling is three bays wide and two bays deep. The north bay of the primary elevation recedes. A historic wood door occupies the center bay while historic one-over-one wood windows occupy the remaining bays. A concrete stoop with field stone piers is located at the primary elevation. The porch roof was removed post-2013.

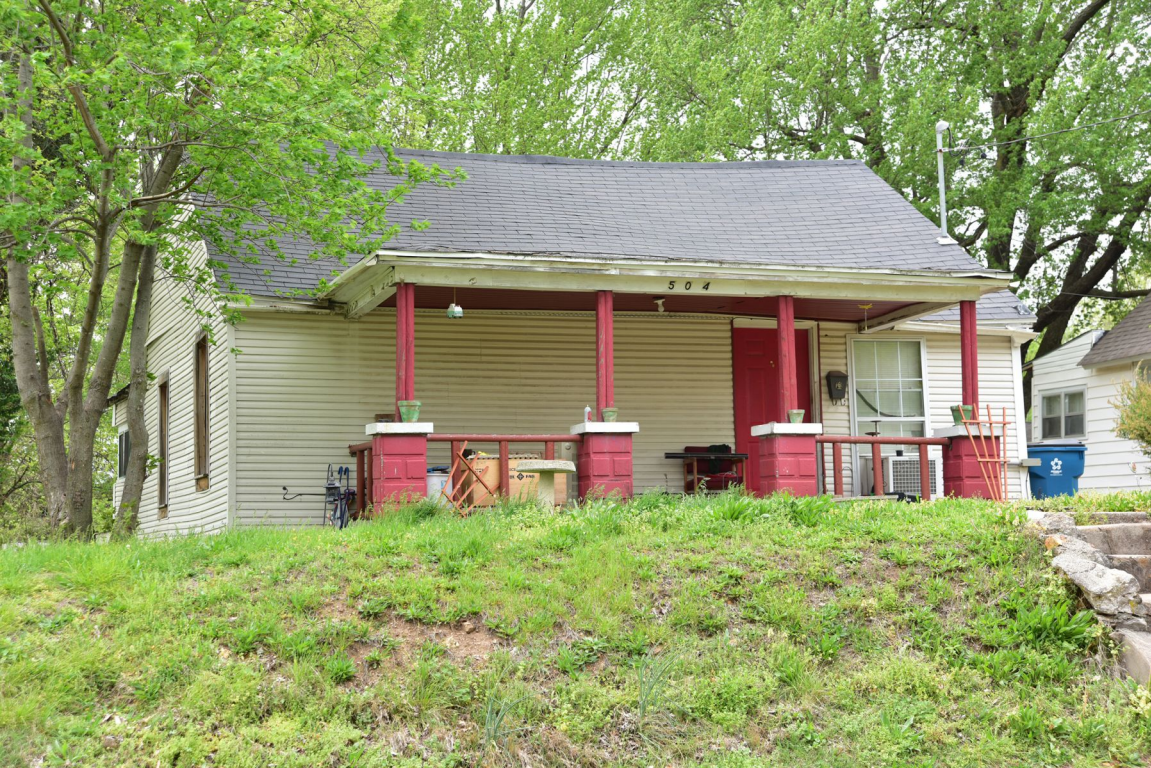
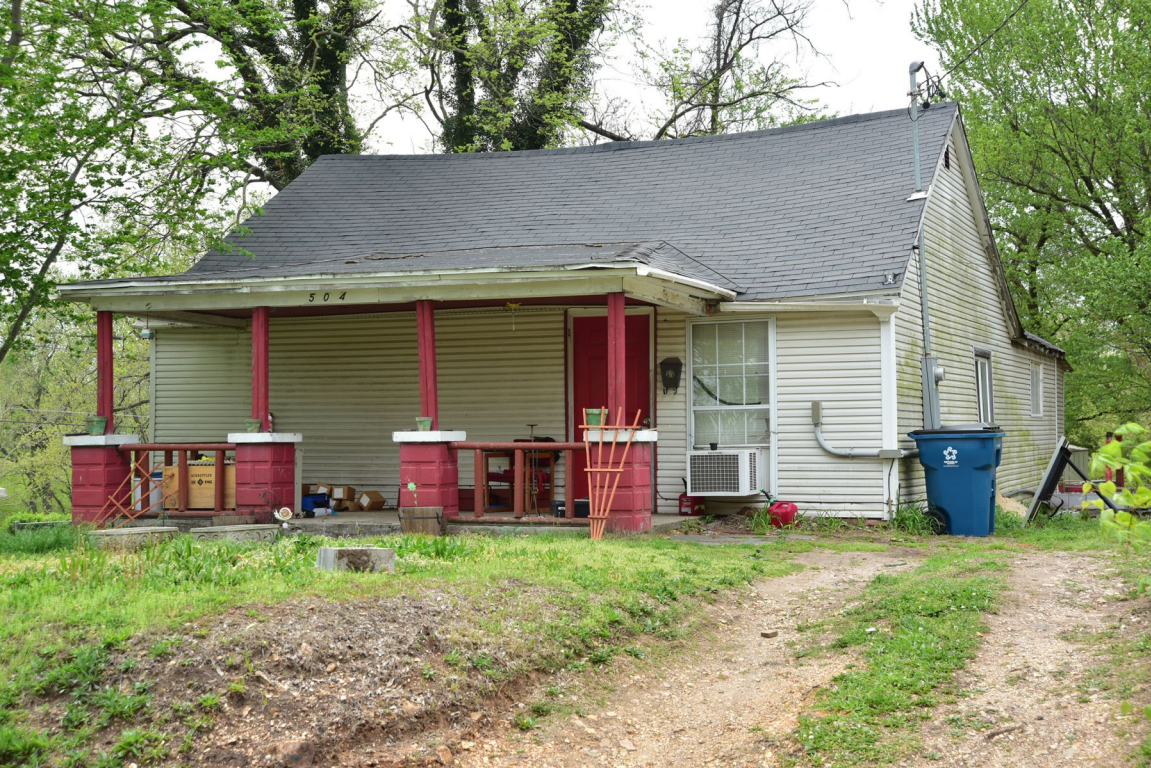
This one-story National Folk House dwelling faces east and has a rectangular footprint. It has a brick foundation and vinyl cladding. The side-gabled roof has asphalt shingles, wood soffits, and exposed rafter tails. The dwelling is two asymmetrical bays wide and three bays deep. An enclosed porch with vinyl cladding and mesh screening forms the third bay at the rear southwest corner of the house. A non-historic wood door occupies the south bay of the primary elevation while non-historic a six-over-six vinyl window occupies the north bay, both of which are located at the north end of the front (east) elevation. An open three-quarter width porch shelters the entrance. It has a concrete foundation and asphalt roof. Non-historic wood posts on concrete block piers support the roof. The wood balustrade is non-historic.

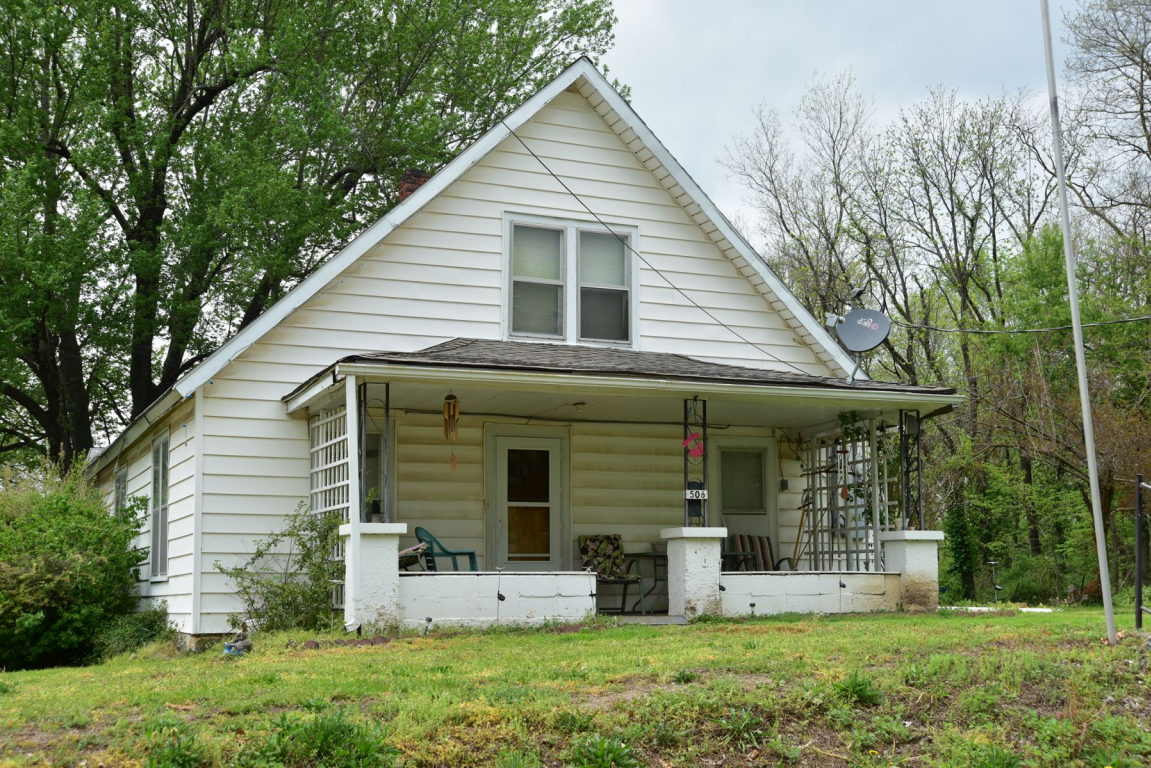
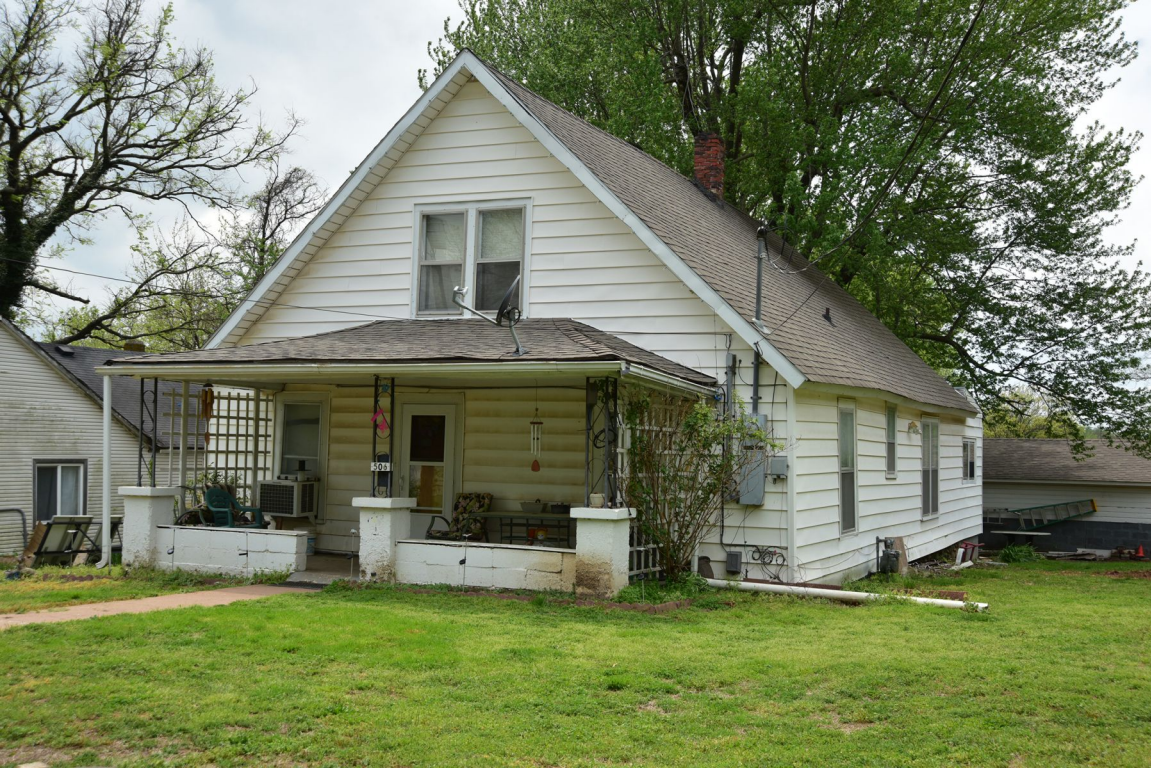
This dwelling faces east and has a rectangular footprint. It has a stone foundation and wide-profile metal cladding. The front-gable roof has asphalt shingles. A short brick chimney pierces the north slope of the roof and a pair of one-over-one wood windows is located at the gable end. The dwelling is three bays wide with single one-over-one wood windows flank a center entrance. An open, three-quarter width porch shelters the primary elevation bays. The porch has a hipped roof with asphalt shingles and a concrete foundation. Non-historic iron posts on stucco-clad piers support the porch roof. A mid-century wood door occupies the center bay while one-over-one wood windows fill the remaining bays.

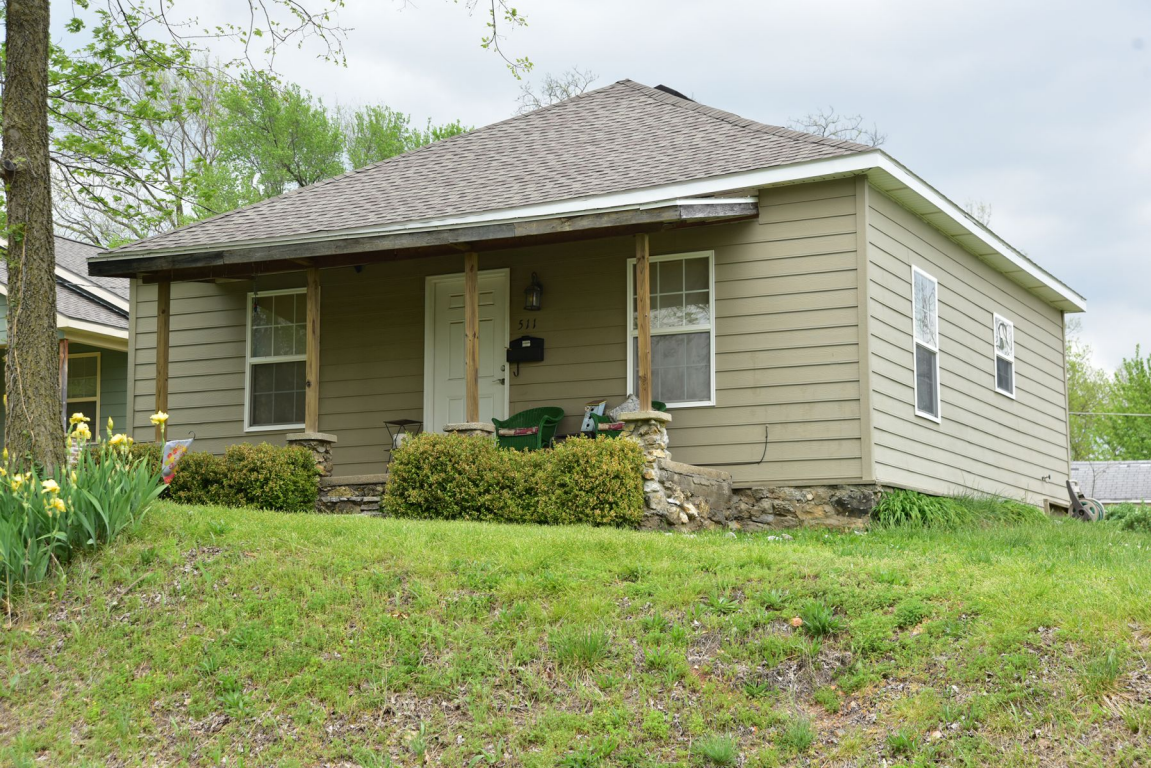
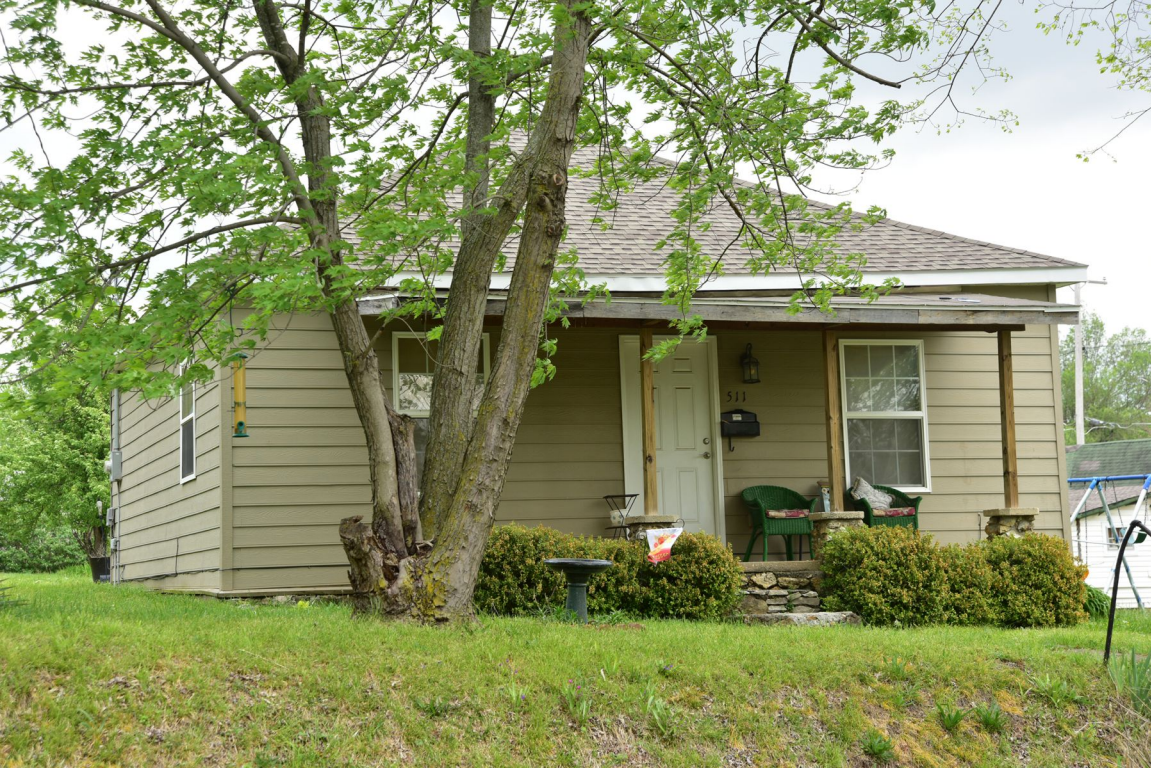
This one-story Pyramid Square Folk House faces west and has a rectangular footprint. It has vinyl siding and was built on the historic stone foundation that was extant. The pyramidal hipped roof has asphalt shingles. The dwelling is three bays wide and two bays deep. A non-historic wood door occupies the center bay of the primary elevation while six-over-six vinyl windows fill the remaining bays. An open, three-quarter width porch is located at the primary elevation. The porch has a stone foundation and shed roof. Non-historic squared wood posts on stone piers support the porch roof.

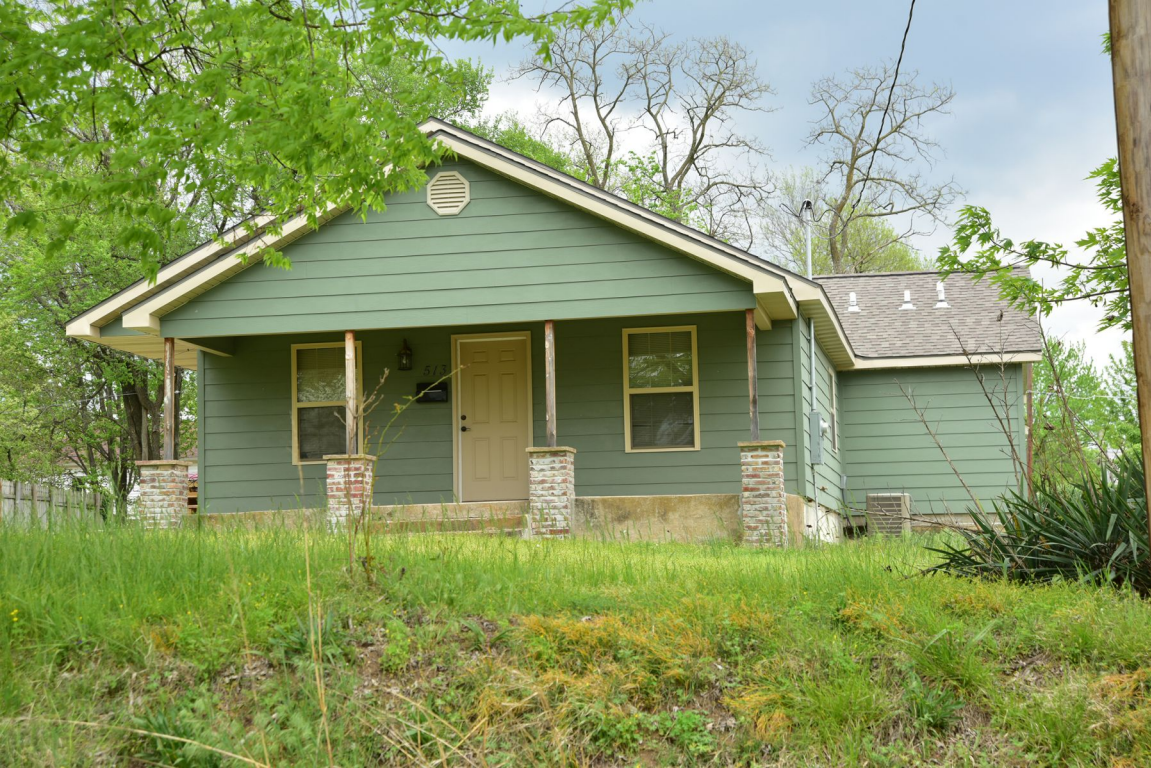
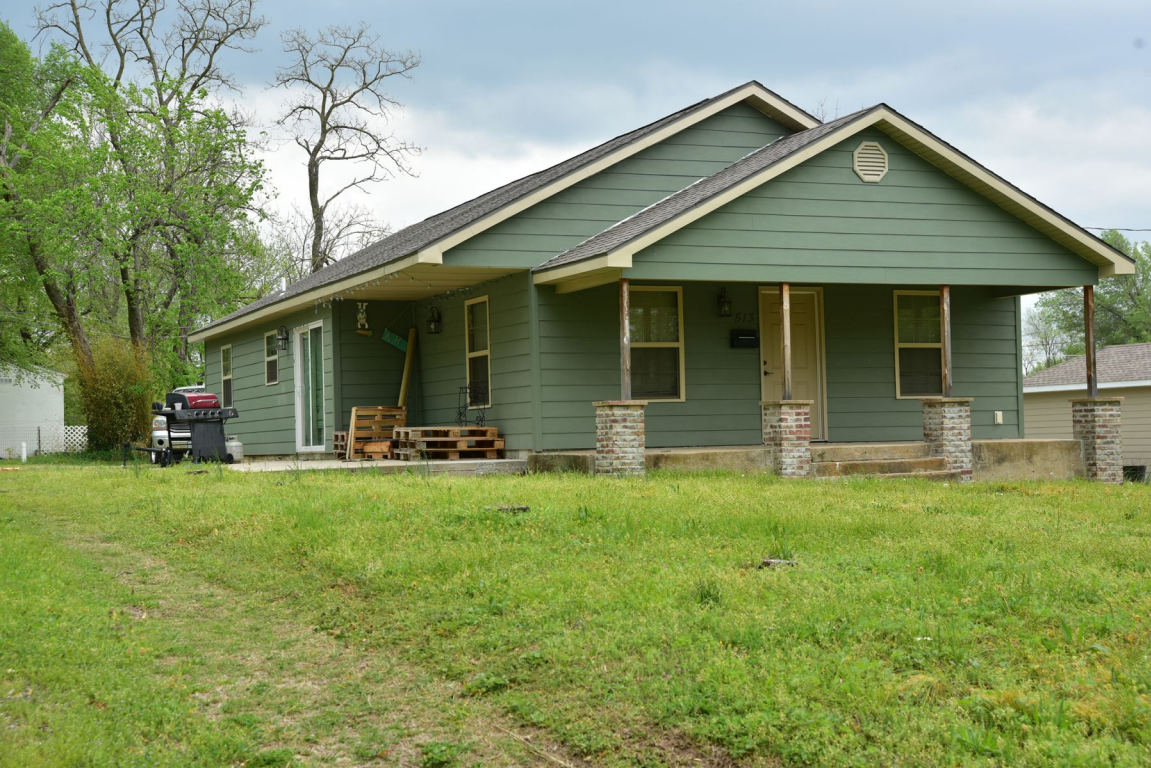
This one-story Bungalow dwelling faces west and has an L-shaped footprint. It has a concrete foundation and cementitious clapboard siding. The roof has asphalt shingles. The dwelling is three bays wide and four bays deep. A nested front-gable porch shelters the primary elevation bays. A non-historic wood door occupies the center bay while six-over-six vinyl windows occupy the remaining bays. The porch has a concrete foundation and its roof is supported by non-historic squared wood posts on historic brick piers.

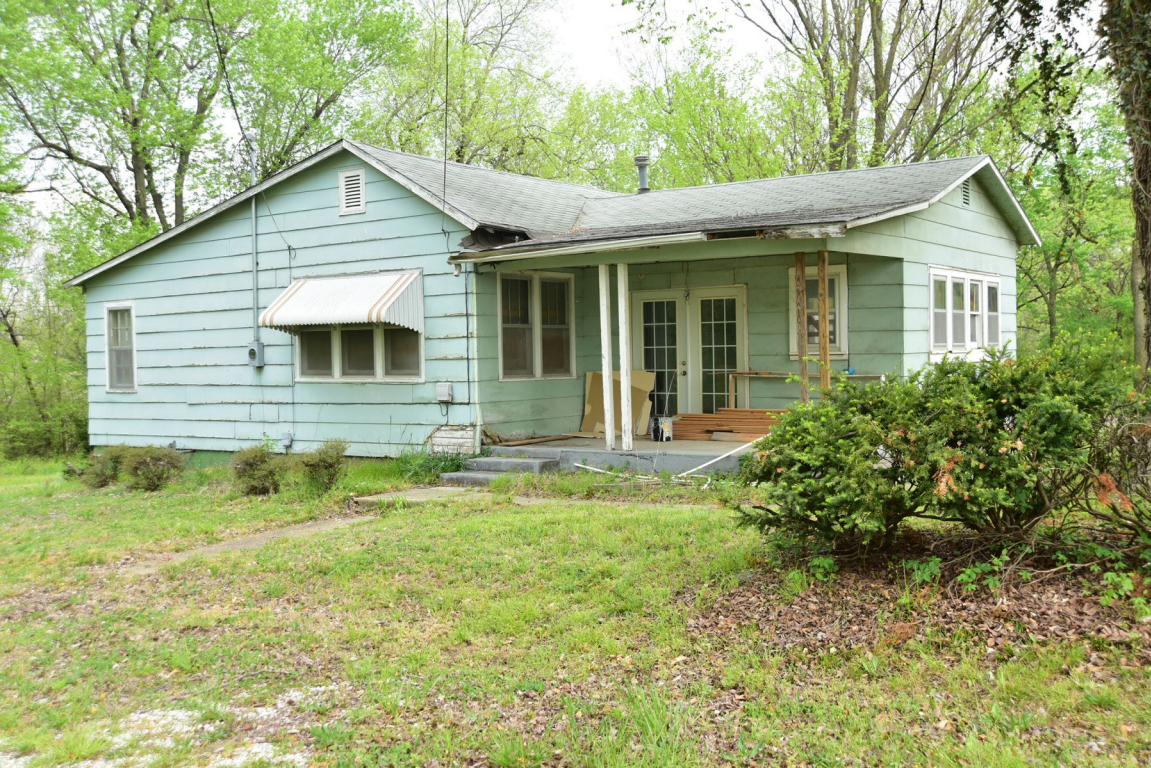
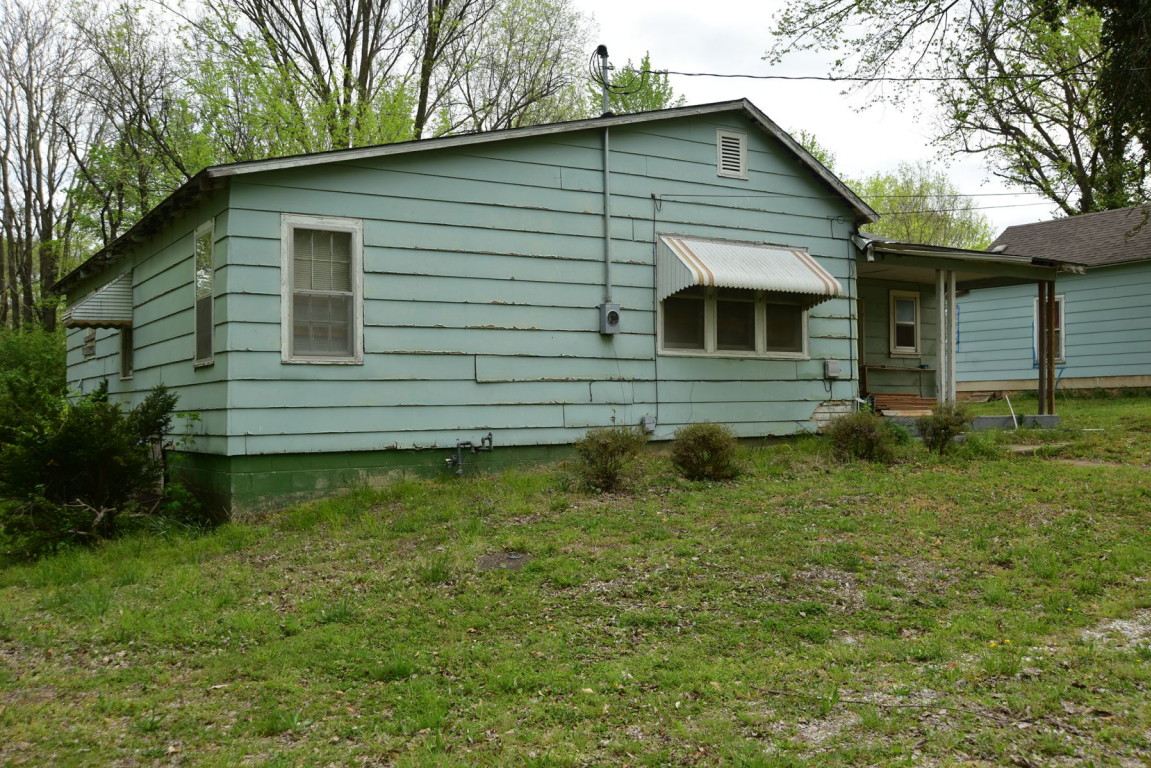
This one-story Gabled-El dwelling faces south and has an L-shaped footprint. It has a concrete block foundation and cementitious cladding over wood clapboard. The roof has asphalt shingles with wood soffits and fascia boards. It is four asymmetrical bays wide and three bays deep. The east two bays are recessed, creating a partial-width open porch. The porch has a concrete foundation and shed roof supported by non-historic wood posts. Non-historic French doors occupy the second-from-east bay. A historic six-over-six wood window occupies the westernmost bay while historic one-over-one wood windows occupy the remaining bays. Two historic three-over-one wood windows are located on the west wall of the porch.

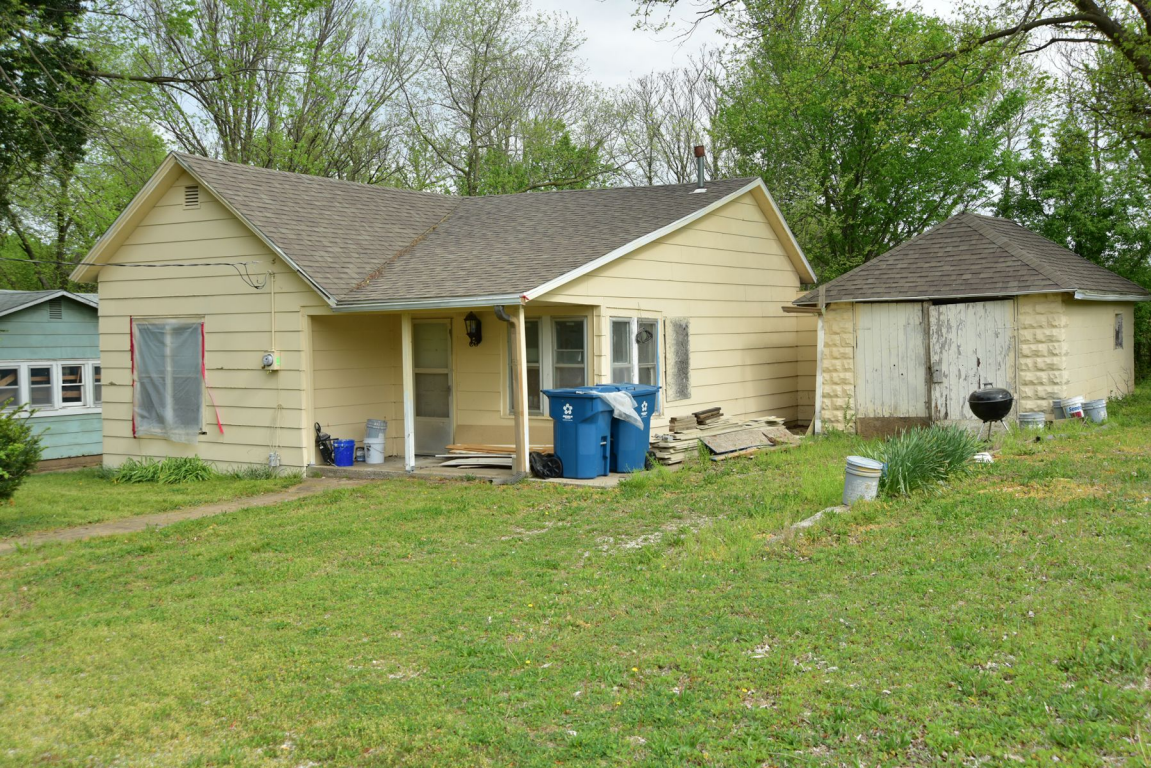
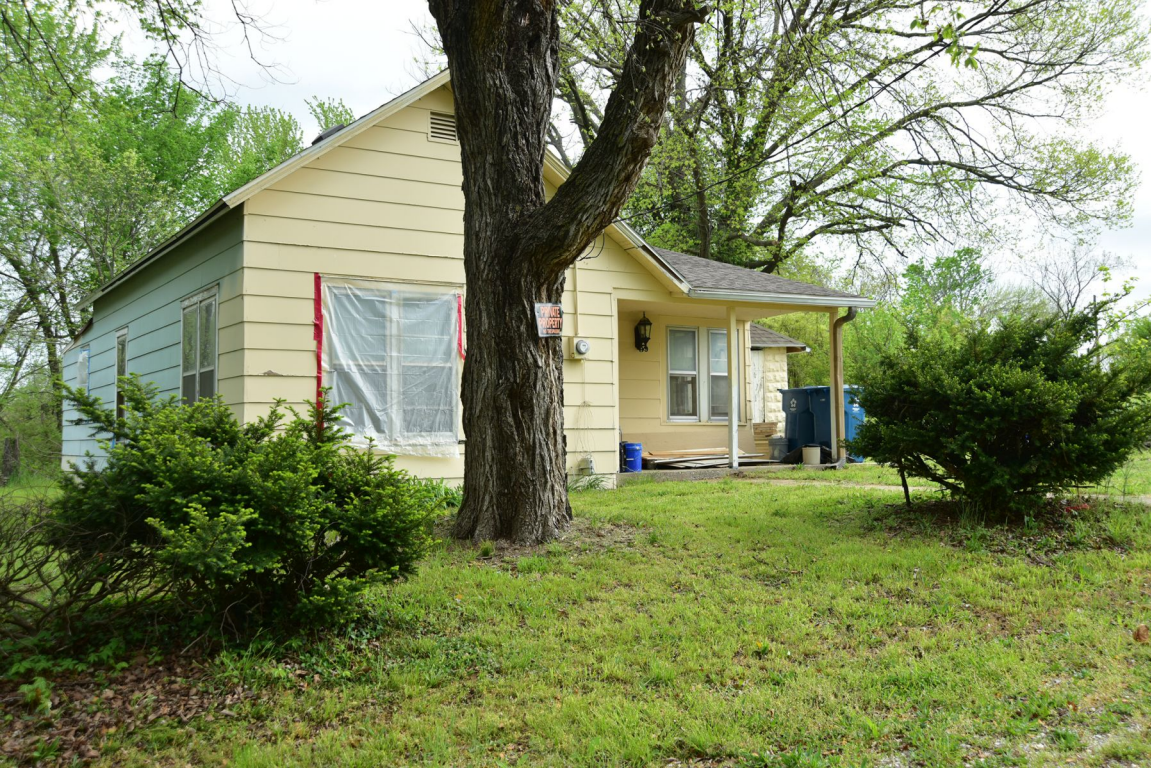
This Gabled-ElI dwelling faces south and has an L-shaped footprint. It has a concrete foundation and asphalt shingle roof. It is three bays wide and three bays deep. The east two bays recede, forming an open partial-width porch with a concrete foundation and shed roof supported by non-historic wood posts. A non-historic wood door occupies the center bay of the primary elevation while one-over-one wood windows occupy the remaining bays

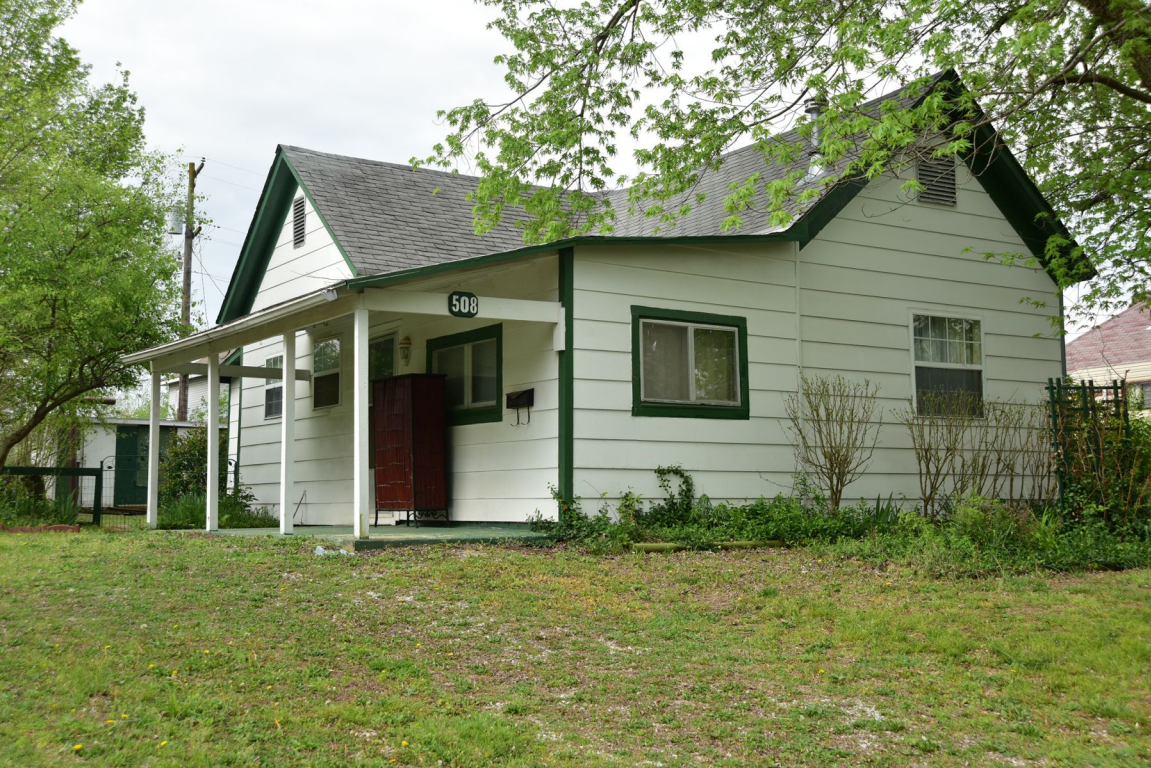
508

This Gabled-ElI dwelling faces north and has an L-shaped footprint. It has an asphalt shingle roof and cementitious cladding. It is five asymmetrical bays wide and two bays deep. A shed-roof porch with non-historic wood support posts and a concrete foundation shelters the north three bays of the primary elevation, two of which are a non-historic enclosed porch. A non-historic one-by-one window occupies the north bay while a non-historic door fills the second-from north bay. Six-over-six vinyl windows occupy the remaining bays.

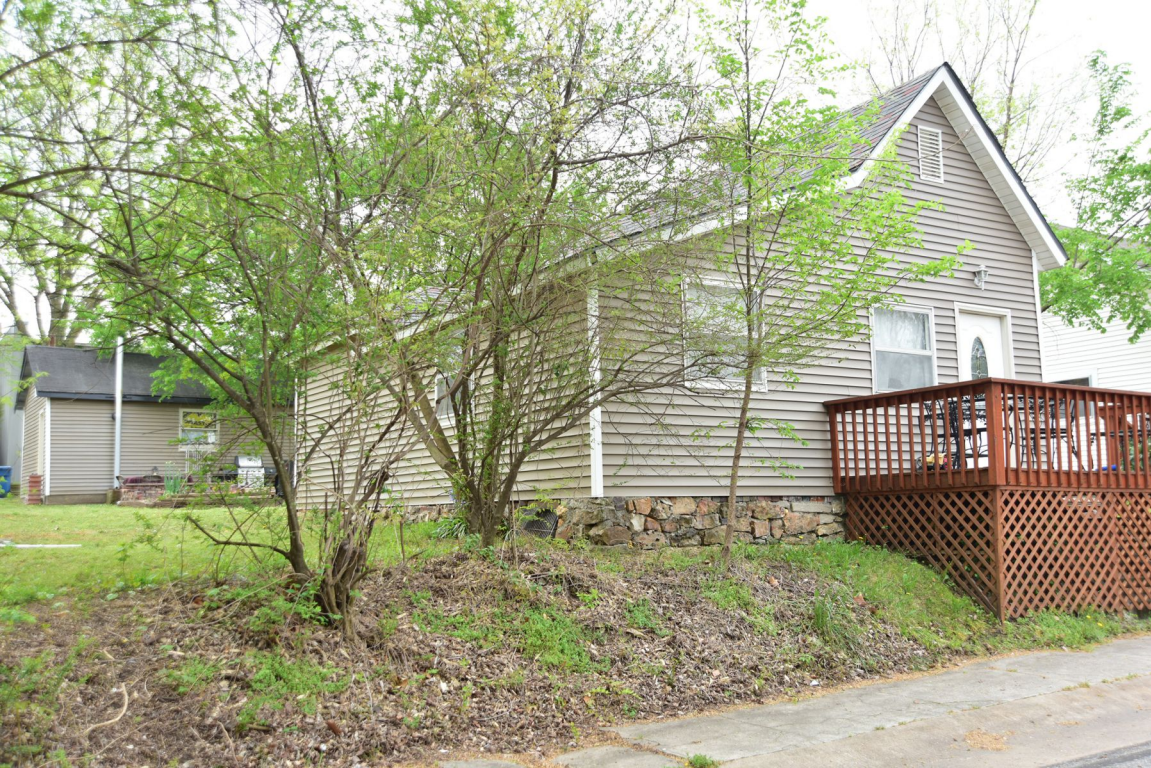
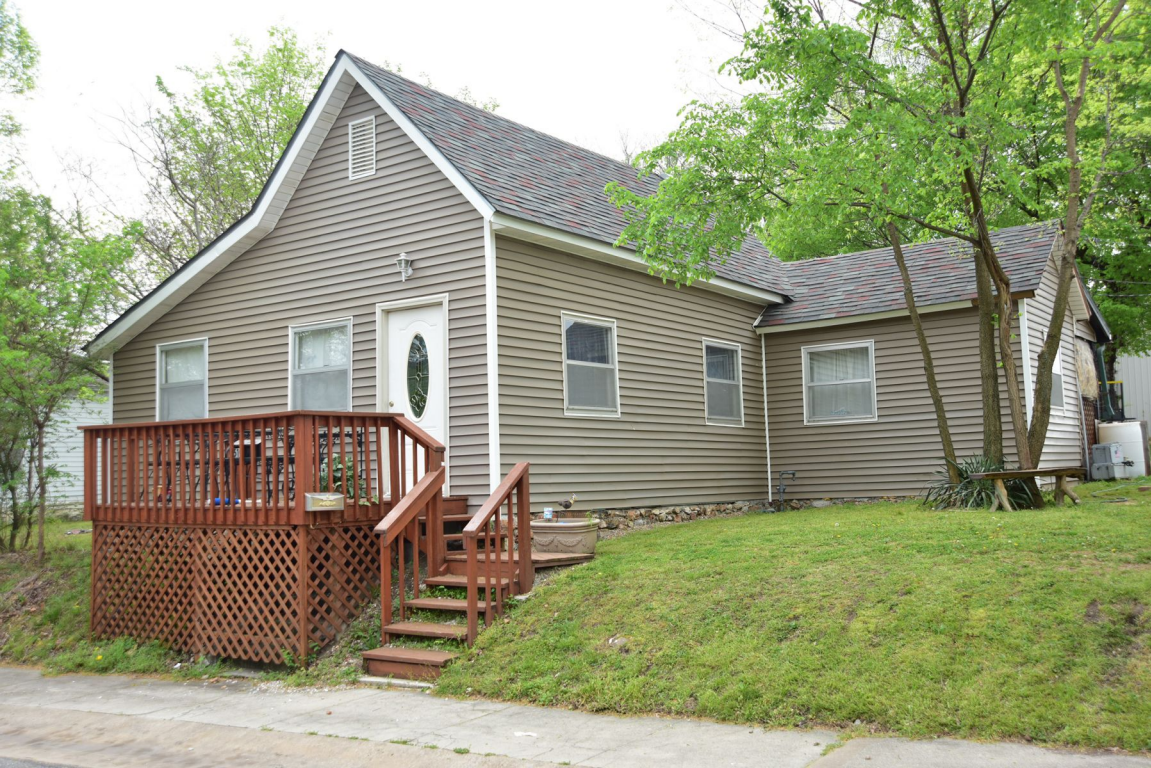
This Gabled-ElI dwelling faces north and has an L-shaped footprint. It has a stone foundation, vinyl cladding, and intersecting gable roof with asphalt shingles. The dwelling is three bays wide and three bays deep. The primary entrance features a non-historic door with glazing and a non-historic wood deck. The dwelling possesses one-over-one vinyl windows.

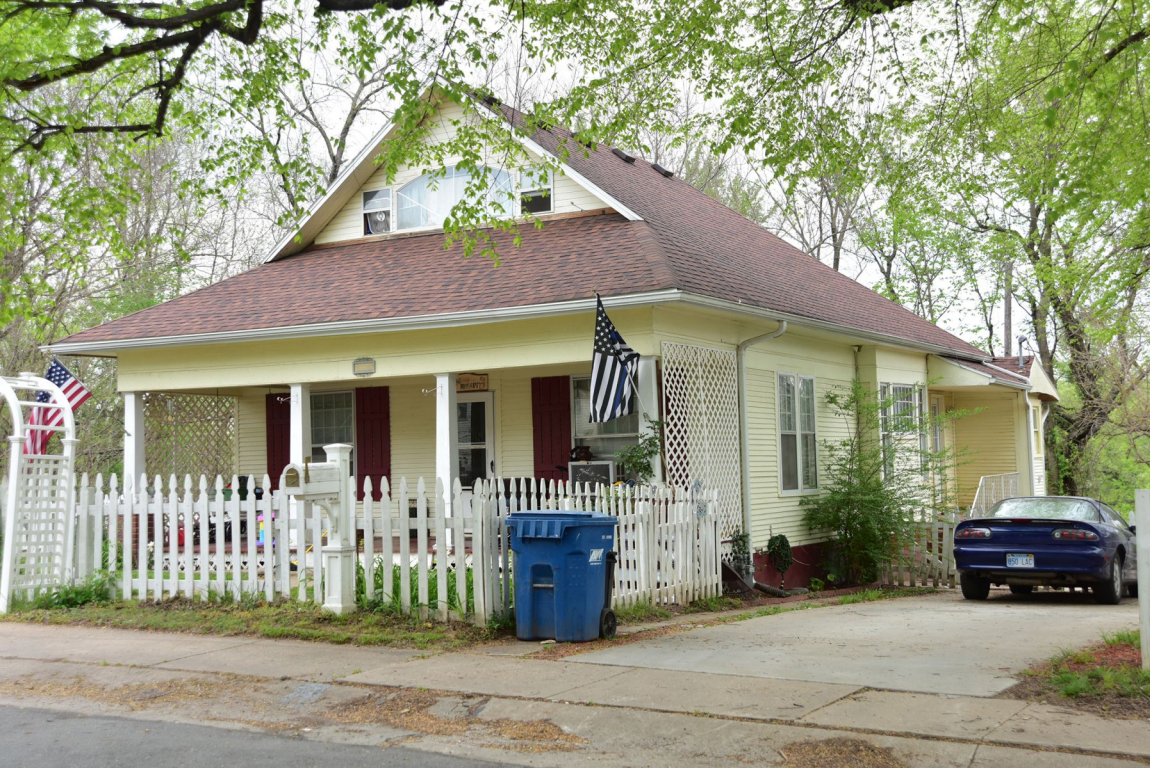
This bungalow dwelling faces south and has a rectangular footprint. It has a stone foundation, wood cladding, and asphalt shingle roof. It is three bays wide and three bays deep. An entrance occupies the center bay. The door was not visible at the time of survey. Six-over-one wood windows occupy the east and west bays. An open porch spans the primary elevation and shelters the bays. Tapered wood columns on brick piers support the porch roof and the foundation is not visible. A short segmental arch vinyl window flanked by small one-over-one vinyl windows occupies the gable peak.
