MISSOURI DEPARTMENT OF NATURAL RESOURCES
STATE HISTORIC PRESERVATION OFFICE, P.O. Box 176, Jefferson City, MO 65102
ARCHITECTURAL/HISTORIC INVENTORY FORM

1. Survey number: JP-AS-006-093		2. Survey Name: East Town (Original Joplin) Historic Survey Phase 1	
3. County: JASPER		4. Address 1302	Street (name): E. Furnace Street
5. City: Joplin	Vicinity <input type="checkbox"/>	7. Township/Range/Section: T: R: S:	
8. Historic name (if known):		9. Present/other name (if known):	
10. Ownership: <input checked="" type="checkbox"/> Private <input type="checkbox"/> Public		11a. Historic use (if known): Domestic/Single Dwelling	11b. Current use: Domestic/Single Dwelling

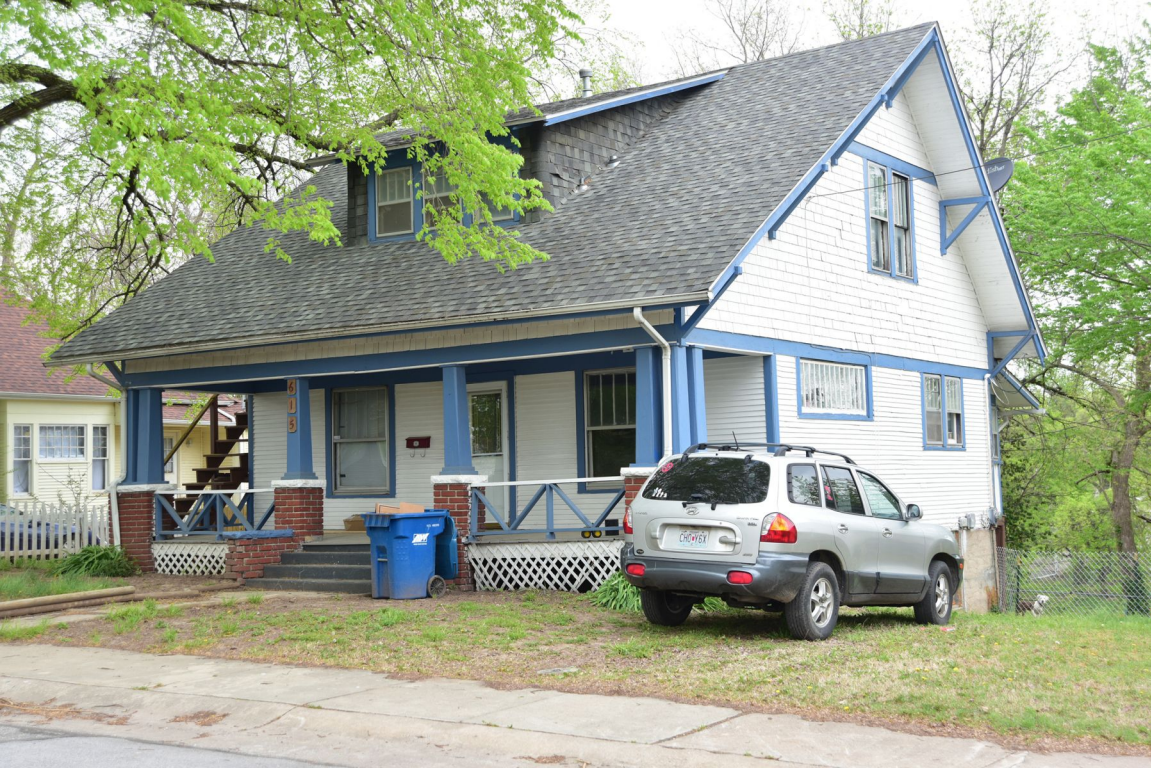
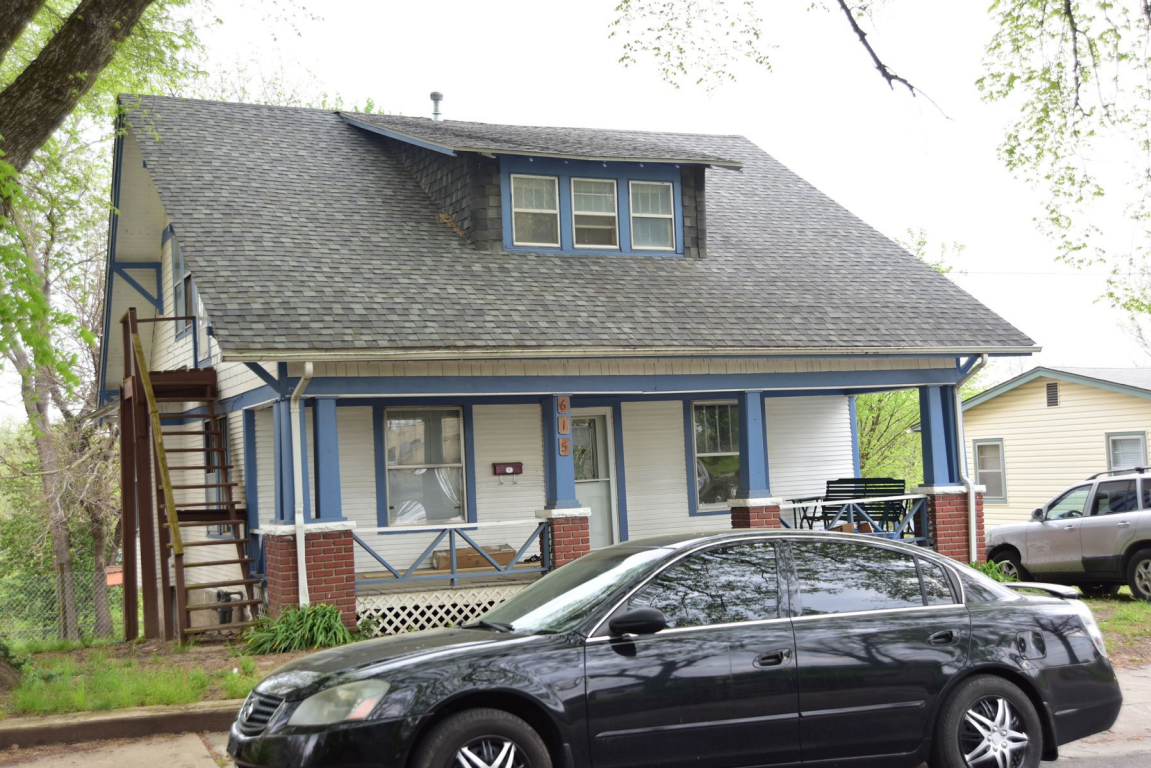
This Craftsman dwelling faces south and has a square footprint. It has a stone foundation and side-gable roof with asphalt shingles and knee brackets at the gable ends. A shed dormer with exposed rafter tails sits on the north slope and contains three historic four-over-one wood windows. Wood shingles clad the upper half of the dwelling whole wood clapboards clad the lower half. The dwelling is three bays wide and two bays deep. The roof extends to form an open, full-width porch at the primary elevation. Tapered wood columns on brick piers support the porch roof. A non-historic door with glazing occupies the center bay while historic five-over-one wood windows occupy the remaining bays.

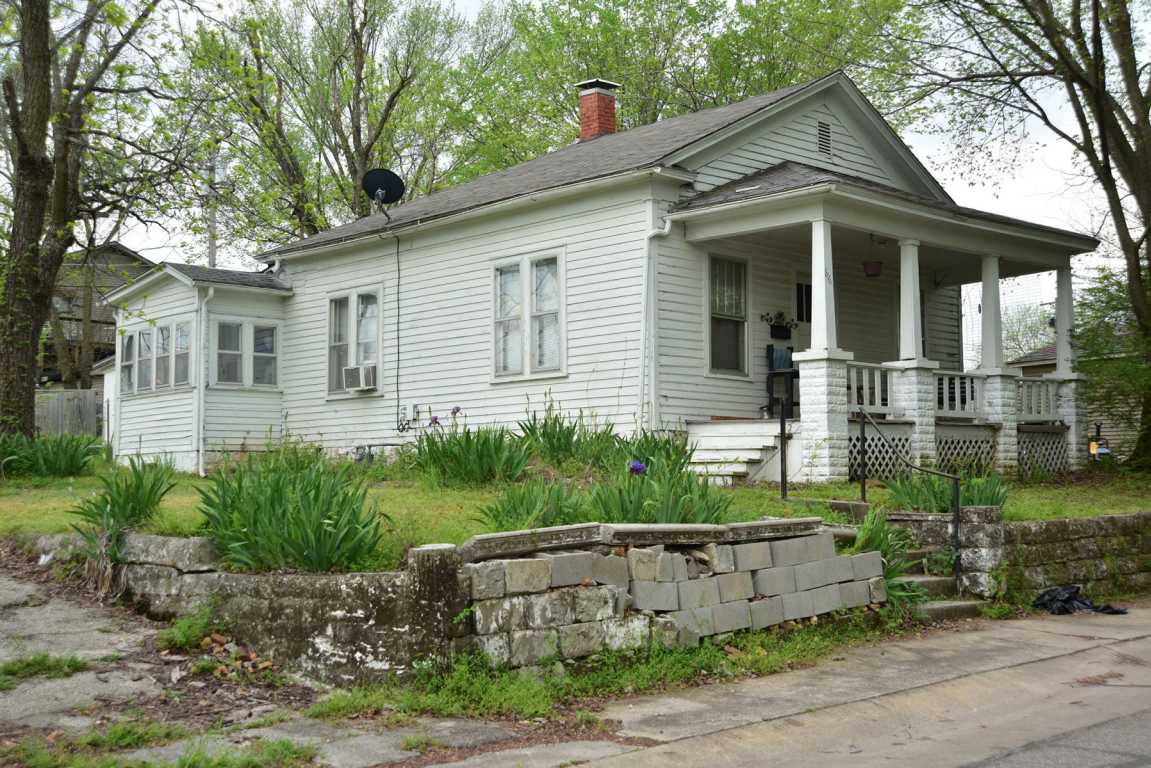
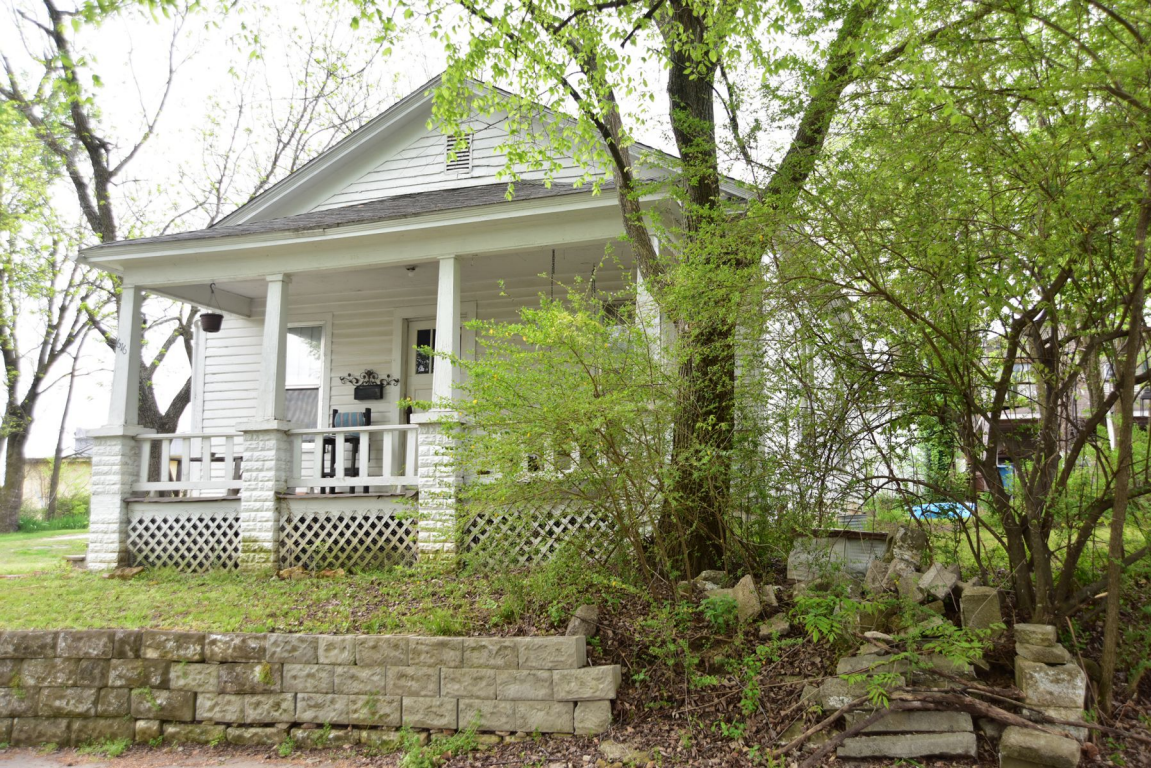
This Bungalow building faces north and has an L-shaped footprint. It has a stone foundation and wood clapboard cladding. The front-gable roof has asphalt shingles and a short brick chimney pierces the ridge. The dwelling is three bays wide. An enclosed porch projects from the rear of the east elevation. A hipped-roof porch shelters the primary elevation bays. Tapered wood columns on cast stone piers support the porch roof. A historic wood door with three-light glazing occupies the center bay while historic four-over-one wood windows occupy the remaining bays.

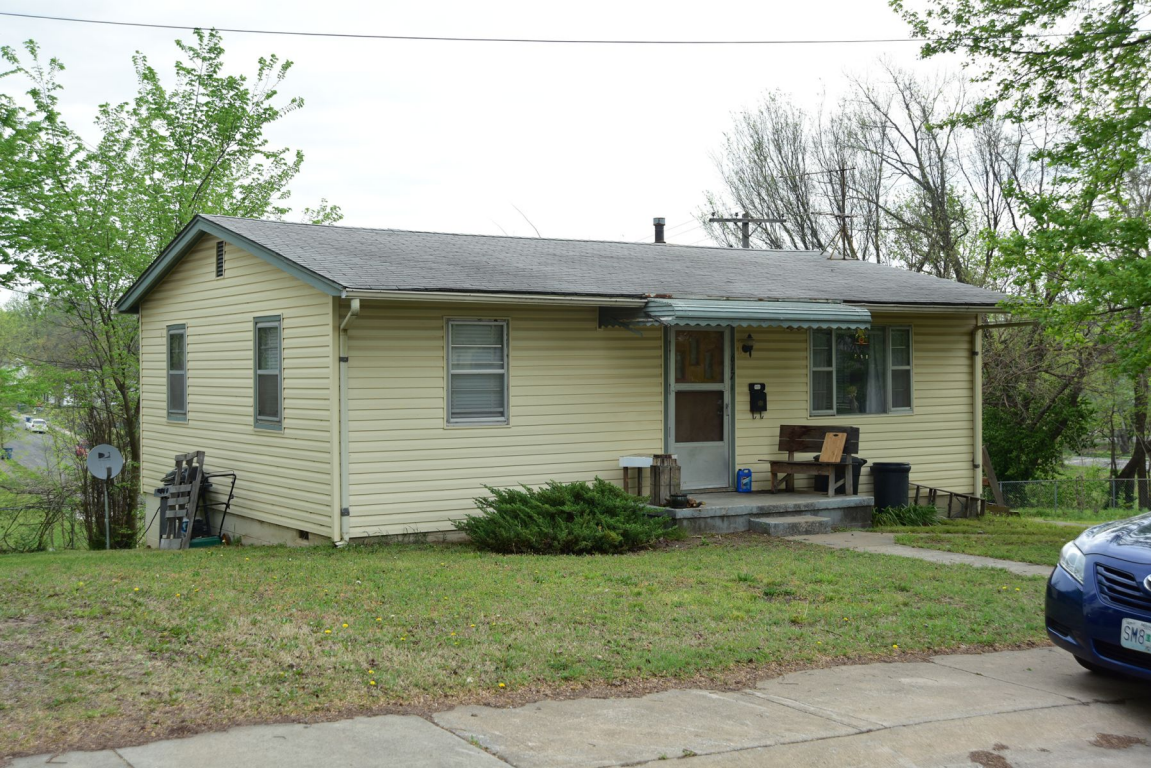
This Ranch dwelling faces south and has an L-shaped footprint. It has a concrete masonry unit foundation, vinyl cladding, and a side-gable roof with asphalt shingles. The dwelling is three bays wide and two bays deep. A mid-century wood door with three-light glazing occupies the center bay while historic two-over-two windows occupy the remaining bays. A metal awning shelters the concrete stoop.

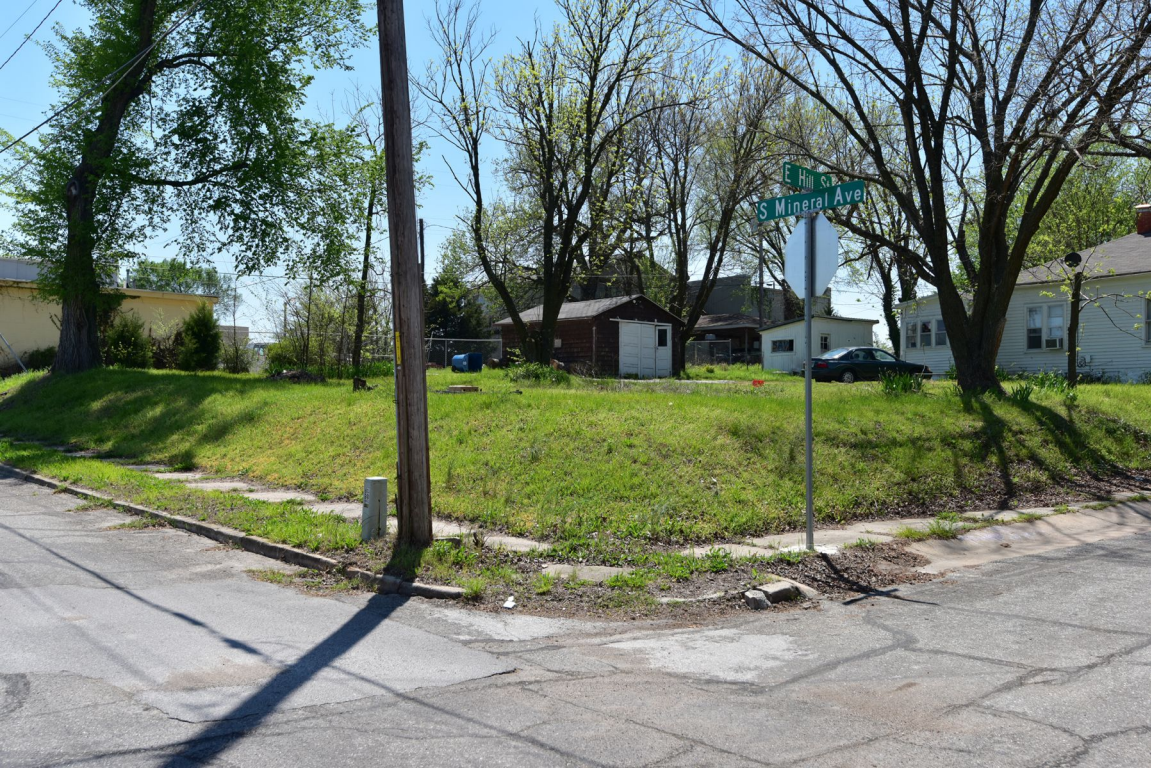
This grassy corner lot is vacant, dotted with mature deciduous trees.

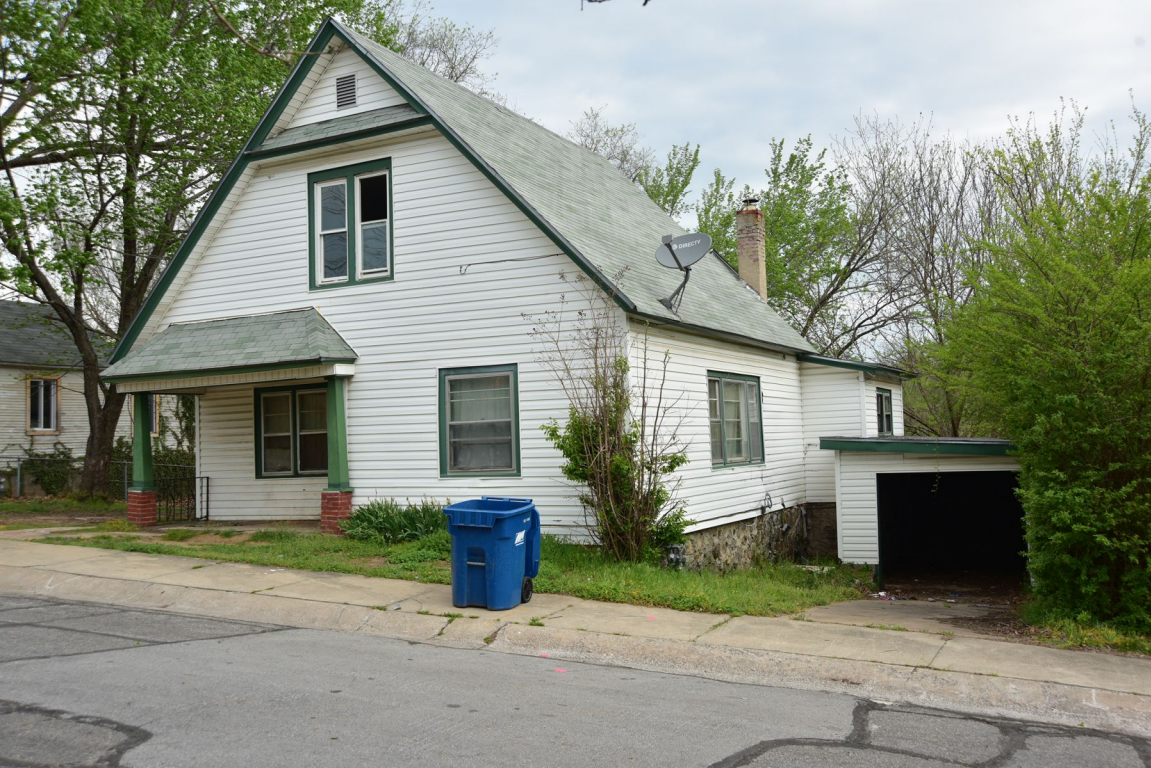
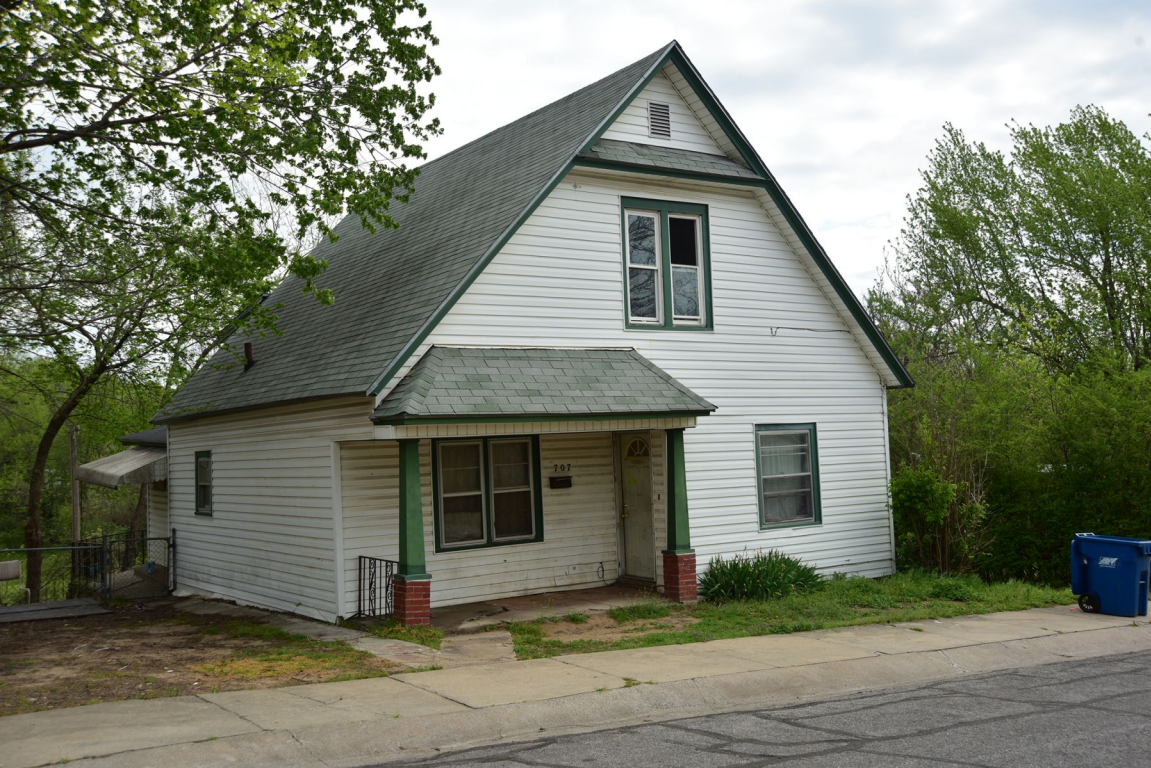
This Open Gable/Gambrel Front dwelling faces north and has an L-shaped footprint. It has a stone foundation and vinyl cladding. The front-gable roof has asphalt shingles. The dwelling is two bays wide and two bays deep. The west bay recedes, creating a partial-width porch. A hipped-roof porch shelters the west bay. It has a concrete foundation and tapered wood columns on brick piers support the roof. A pair of two-over-two wood windows occupies the west bay while a single two-over-two wood window occupies the east bay. A fiberglass door is located in the east wall of the porch. A pair of one-over-one wood windows occupies the single second-story primary elevation bay. A pent roof spans the gable above this bay.

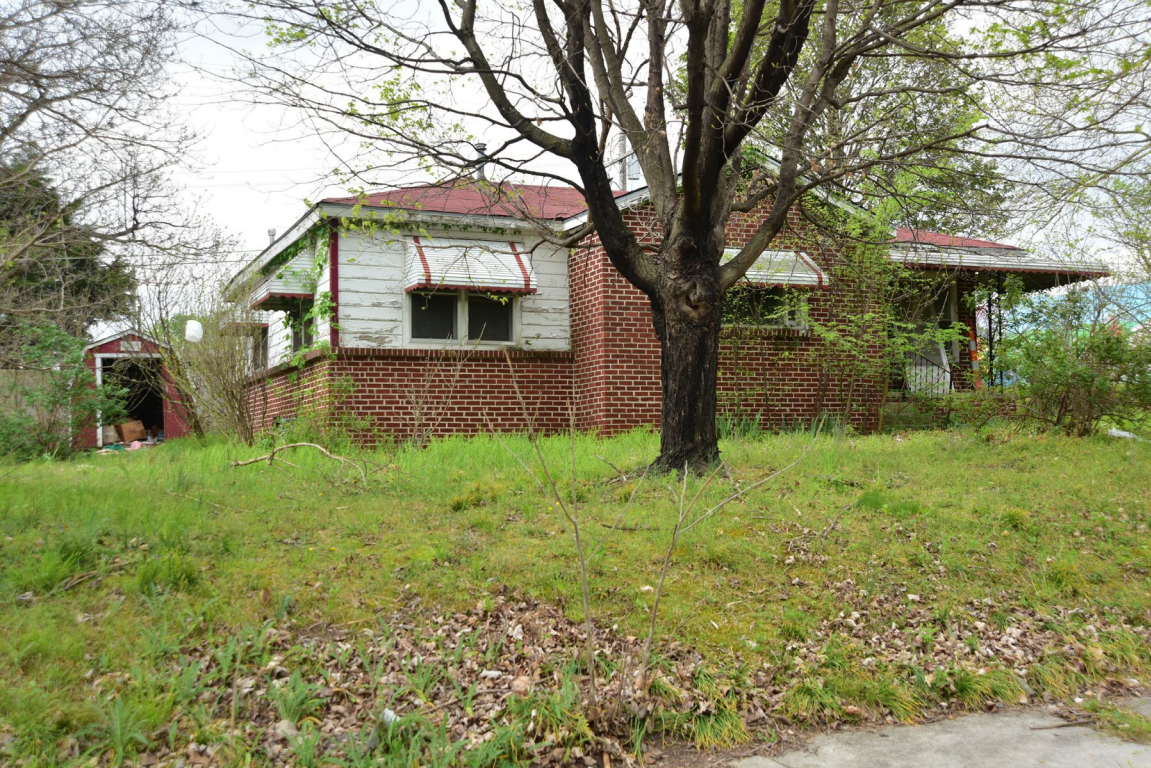
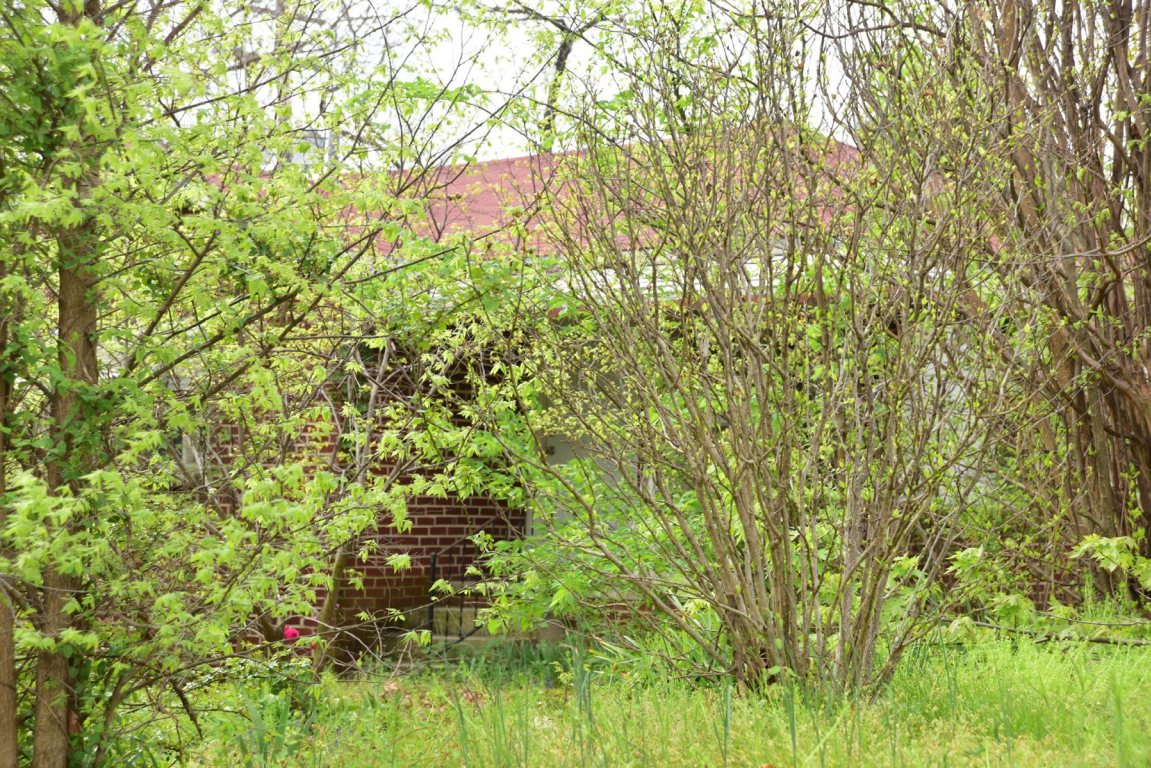
This dwelling faces north and has a rectangular plan. It has a concrete foundation, brick cladding, and an asphalt hipped roof. The dwelling is four bays wide. A pair of one-over-one wood windows with a metal awning occupies the first (east) bay and a tripartite wood picture window with a metal awning occupies the second bay. The second bay slightly projects from the elevation. The west two bays recede, creating a partial-width porch with a metal awning. A wood door occupies the third bay while a pair of one-over-one windows occupies the last bay.

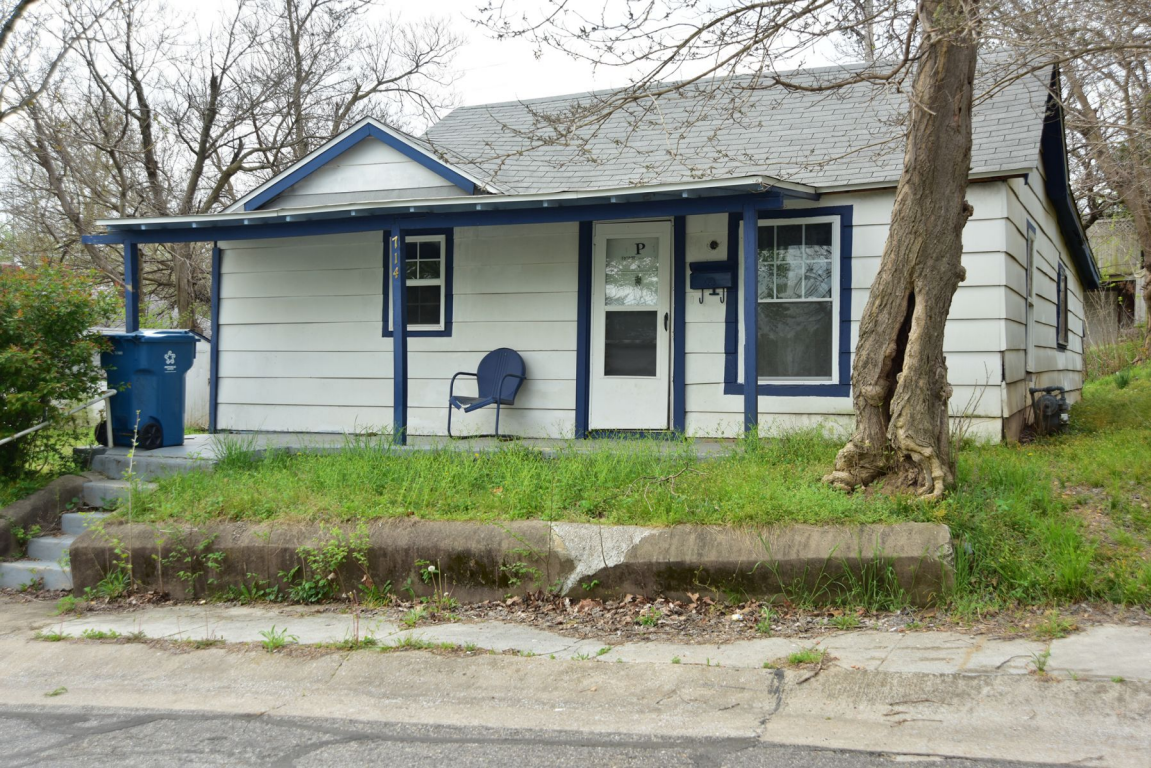
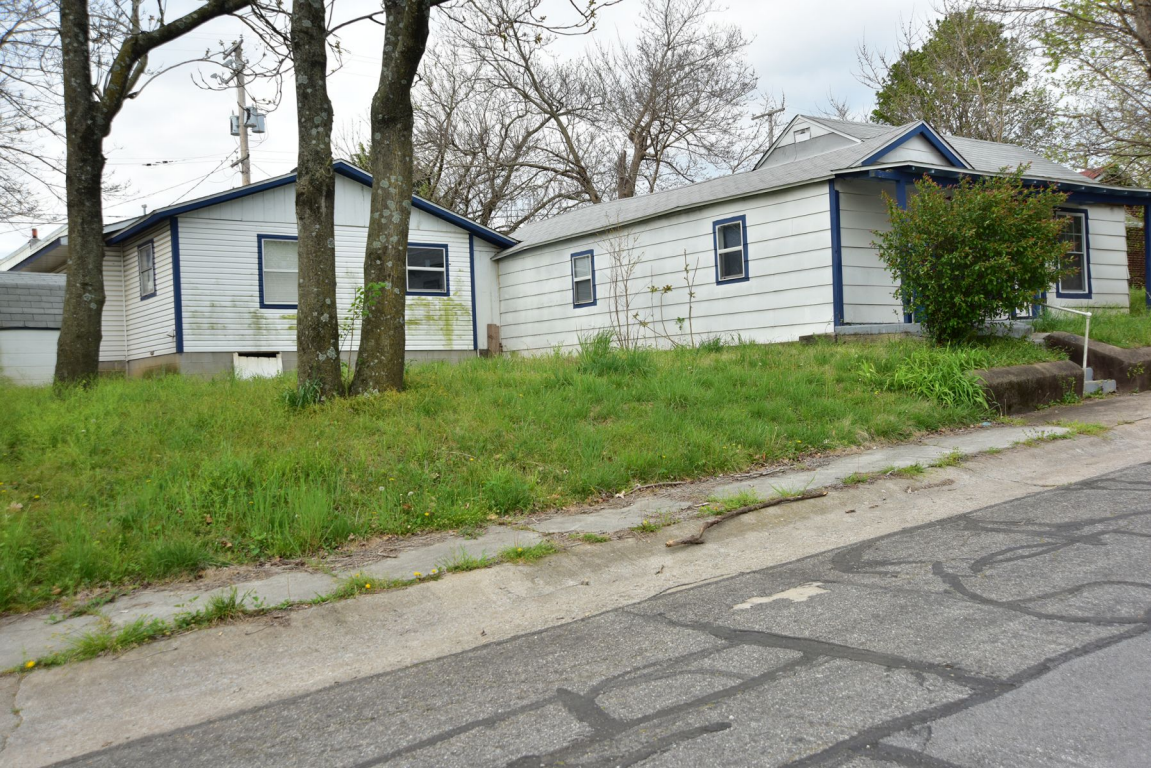
This National Folk House dwelling faces north with two large non-historic additions (c.1980) that create the L-shaped footprint. It has a concrete foundation and metal siding. The complex roof is asphalt. The dwelling is three bays wide and a non-historic door occupies the center bay. A six-over-six vinyl window occupies the east bay while a six-over-one vinyl window occupies the west bay. A non-historic flat-roof porch with concrete foundation shelters the bays. A narrow front-gable addition connects to the east side of the side-gable original building. A large front-gable addition projects from the southeast corner to form the L. It is two bays wide with vinyl cladding and a concrete masonry unit foundation.

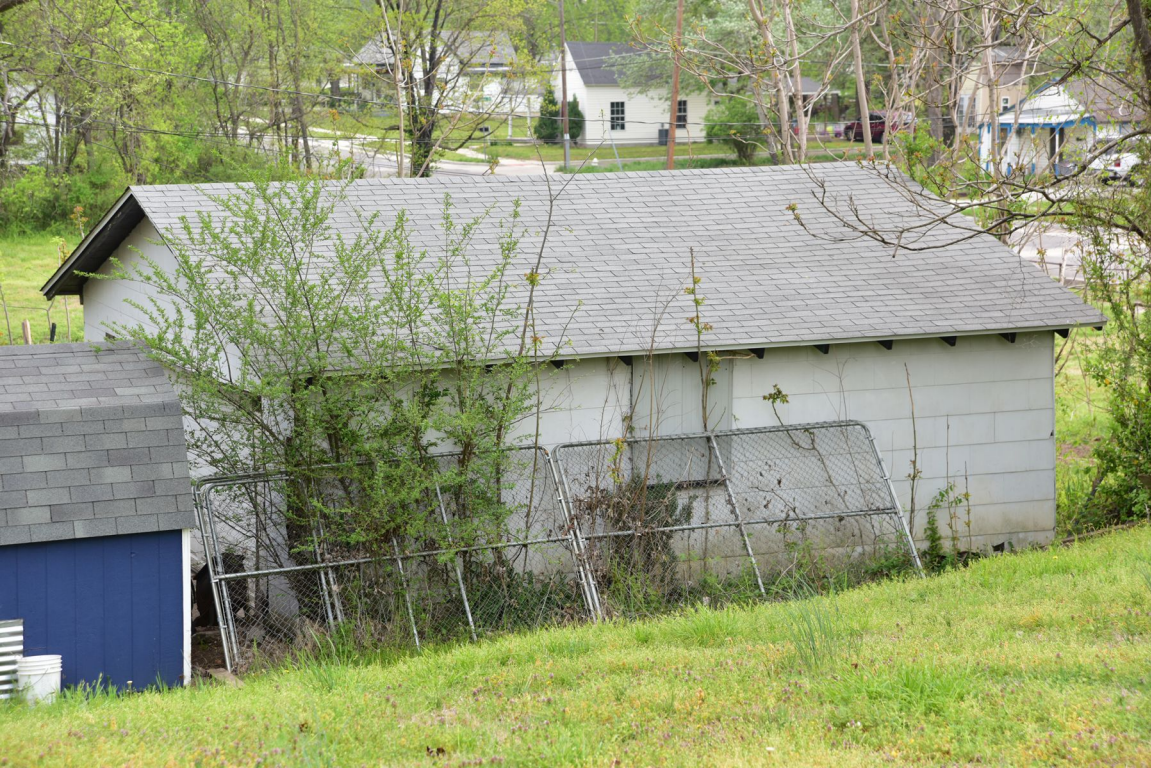
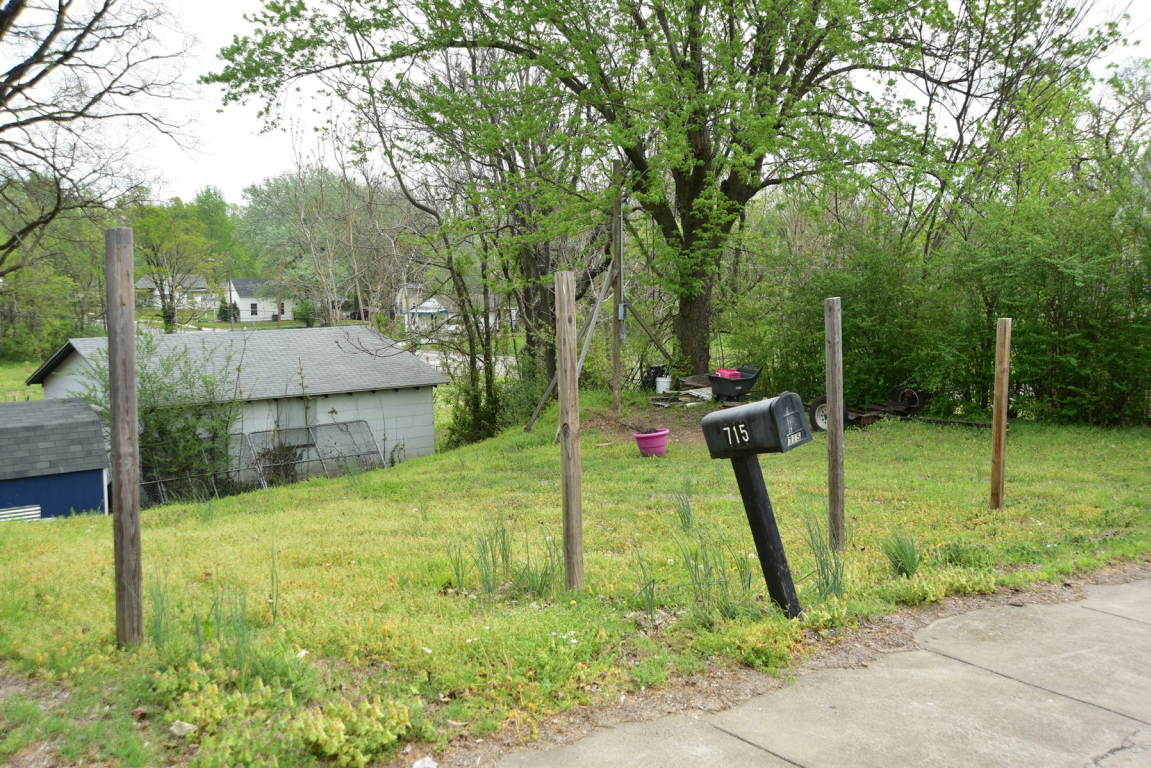
A side-gable garage with a square footprint is located at the rear of the lot. It has an asphalt roof with exposed rafter tails and asbestos shingle cladding. The foundation is not visible. An overhead garage door occupies the west elevation bay while a single window opening forms the south elevation bay. The window is boarded up.

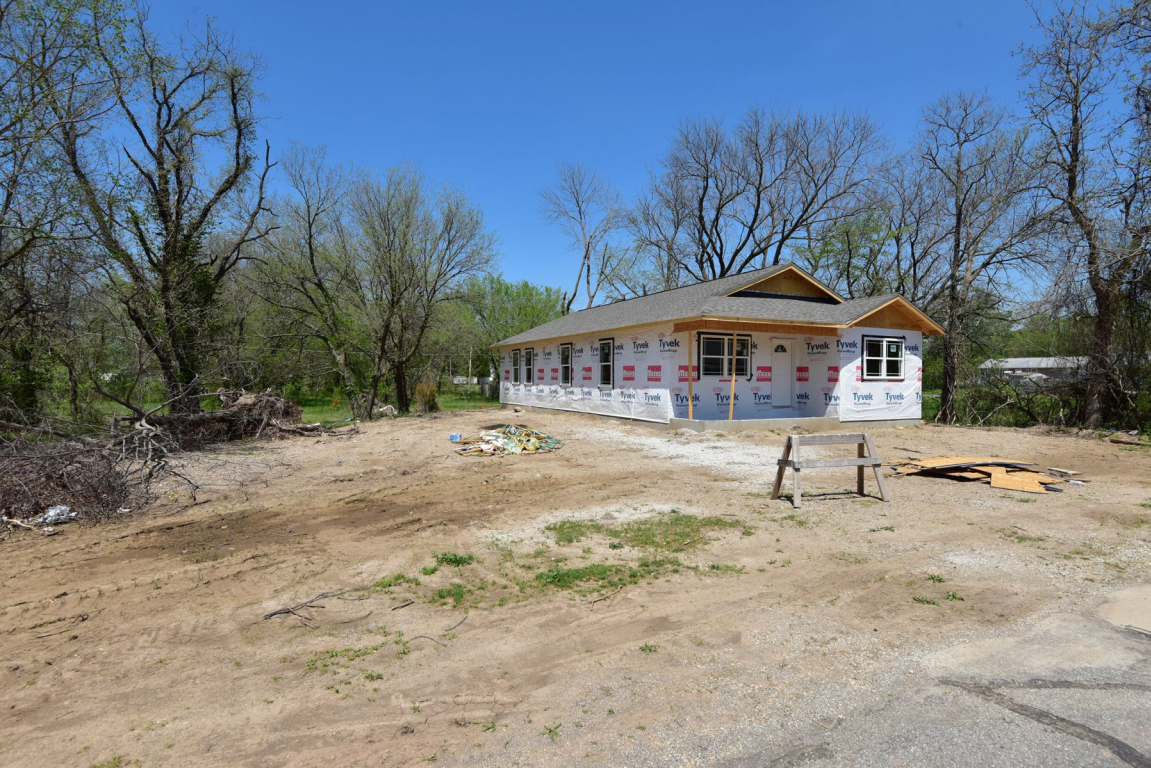
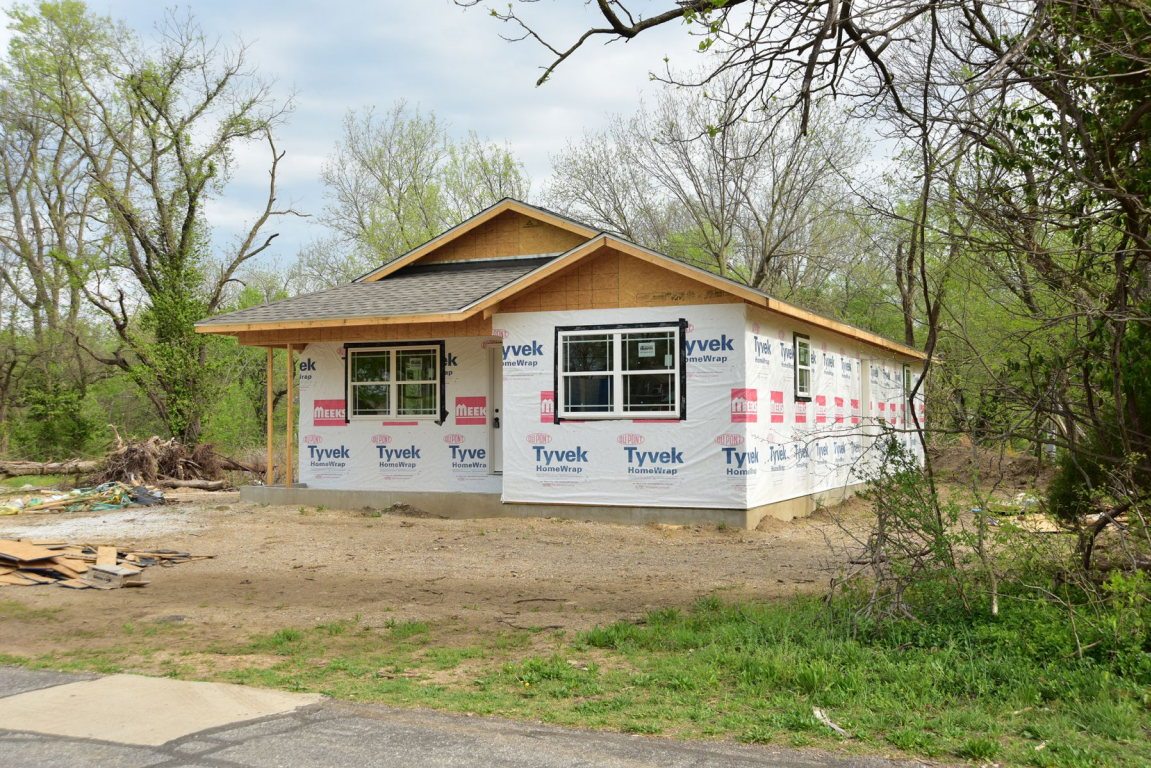
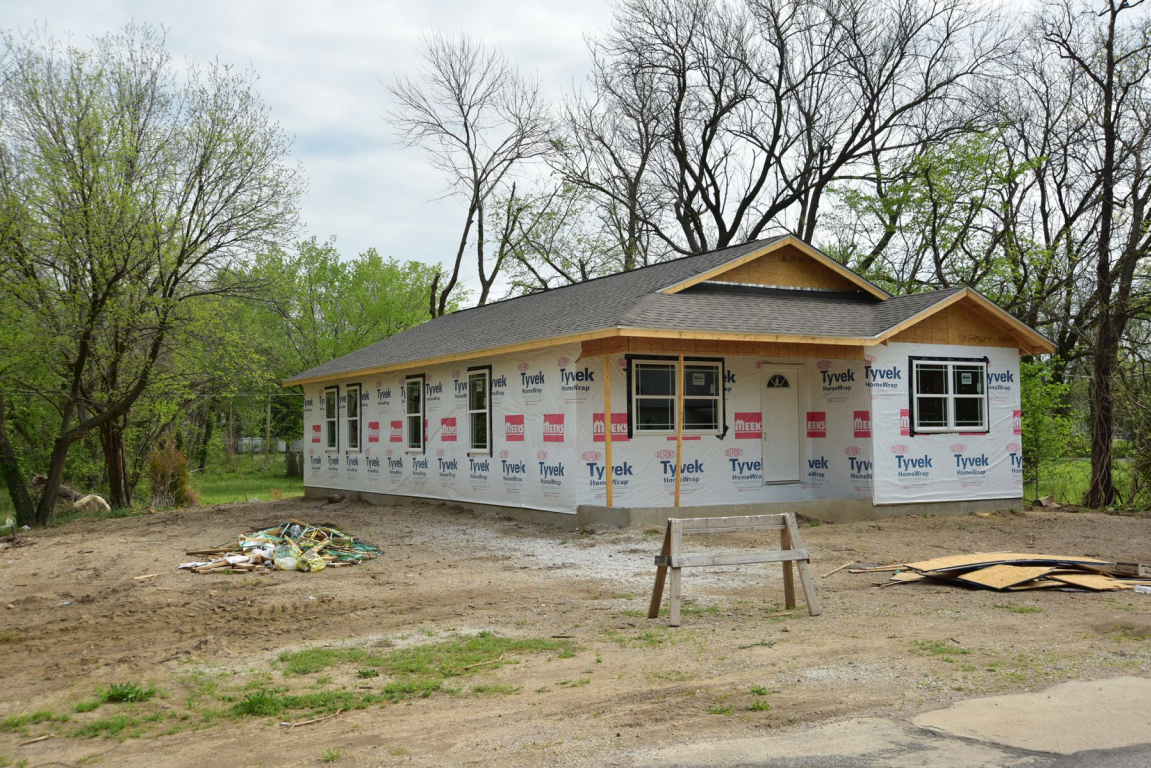
The construction of a single dwelling on this lot is in progress. This one-story rectangular dwelling has a concrete foundation and a gable-on-hip roof with asphalt shingles. The front (south) elevation has three bays. The west end center bays, containing a pair of windows and a door, are recessed under the partial-width porch. The narrow west bay, containing a pair of windows, projects slightly and has a gable roof. The windows are one-over-one vinyl windows with simulated craftsman style muntins. The concrete porch does not have any supports installed yet and there is no premanent siding yet.

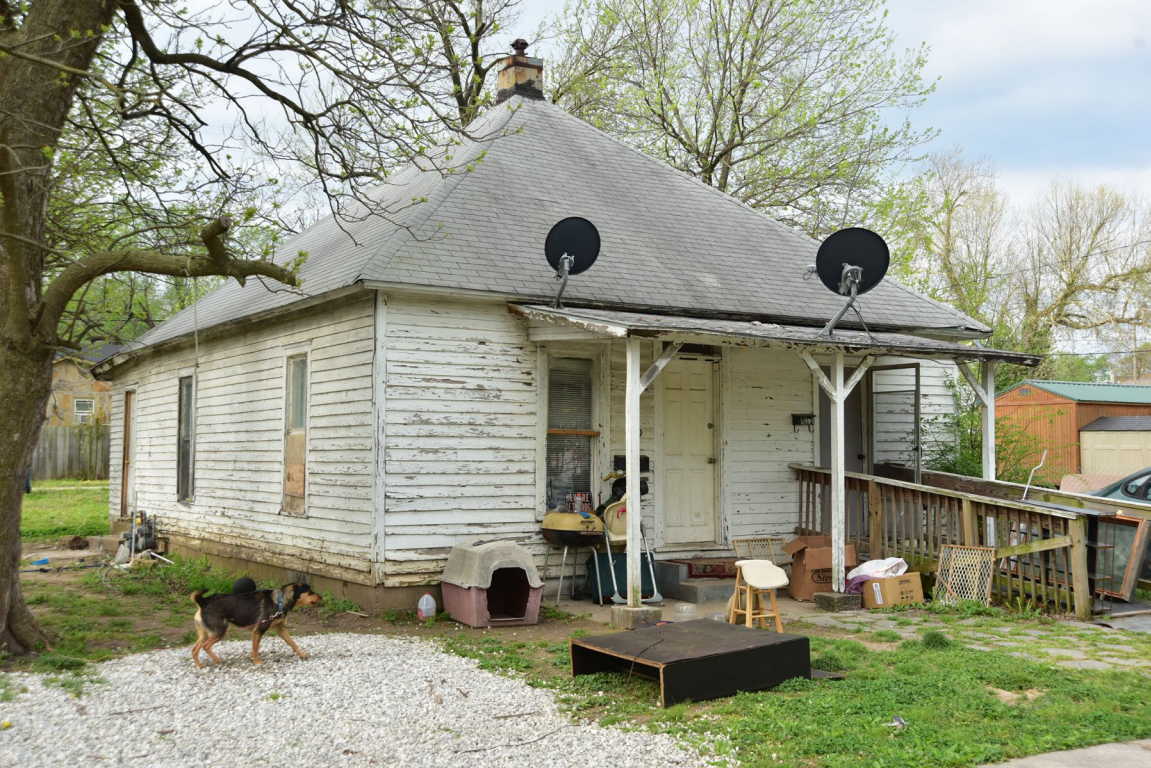
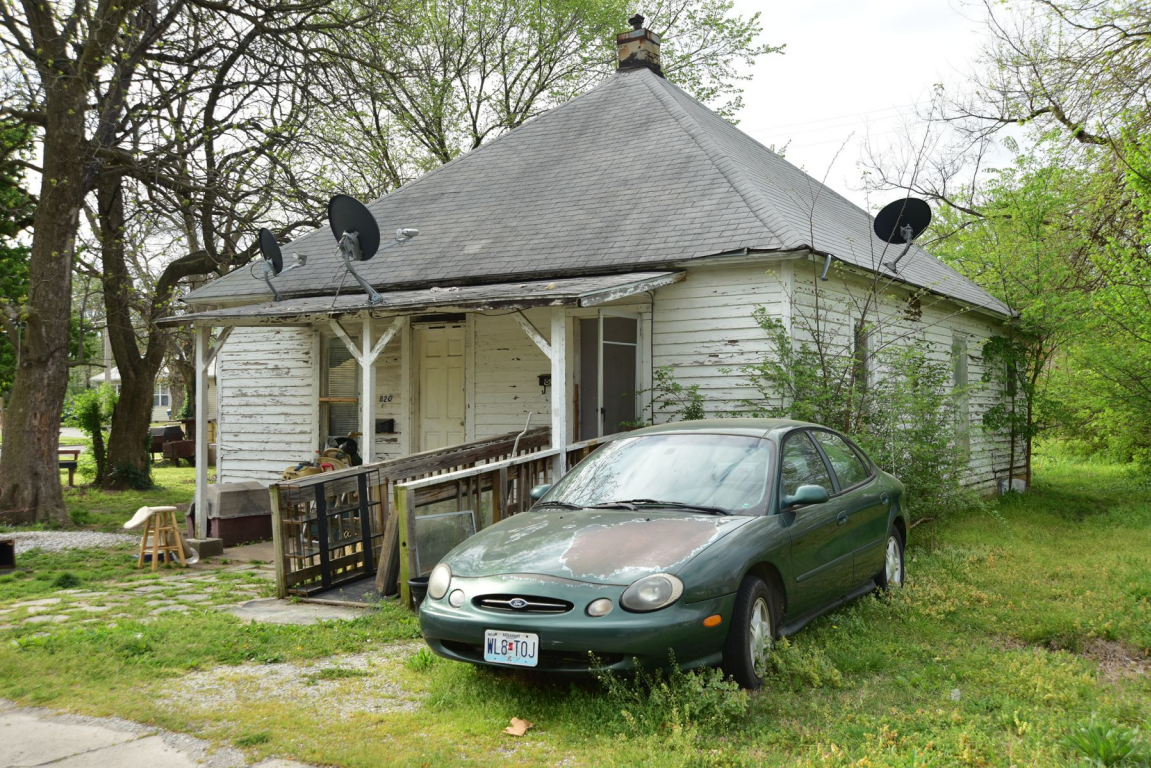
This Pyramid Square Folk House dwelling faces north and has a rectangular footprint. It has a concrete foundation and wood clapboard cladding. The pyramidal roof has asphalt singles and a short parged chimney pierces the peak. The dwelling is three bays wide and three bays deep. A historic one-over-one wood window occupies the east bay while a non-historic wood door occupies the center bay. The west bay has been altered to contain a non-historic wood door. A non-historic wood ramp leads to this entrance. A shed-roof shelters the bays. It has a concrete pad foundation. Wood posts with angle braces on short concrete bases support the roof. Historic one-over-one wood windows remain at the secondary elevations. All windows have historic trim and modest crown moldings.

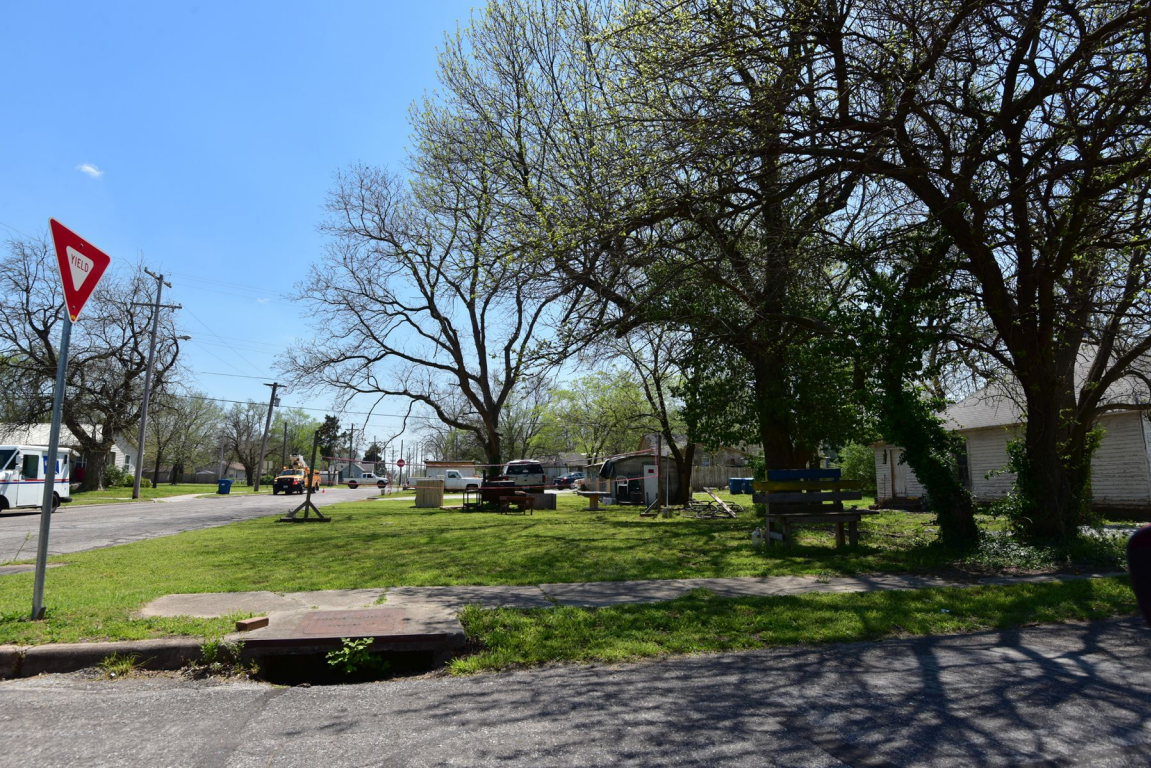
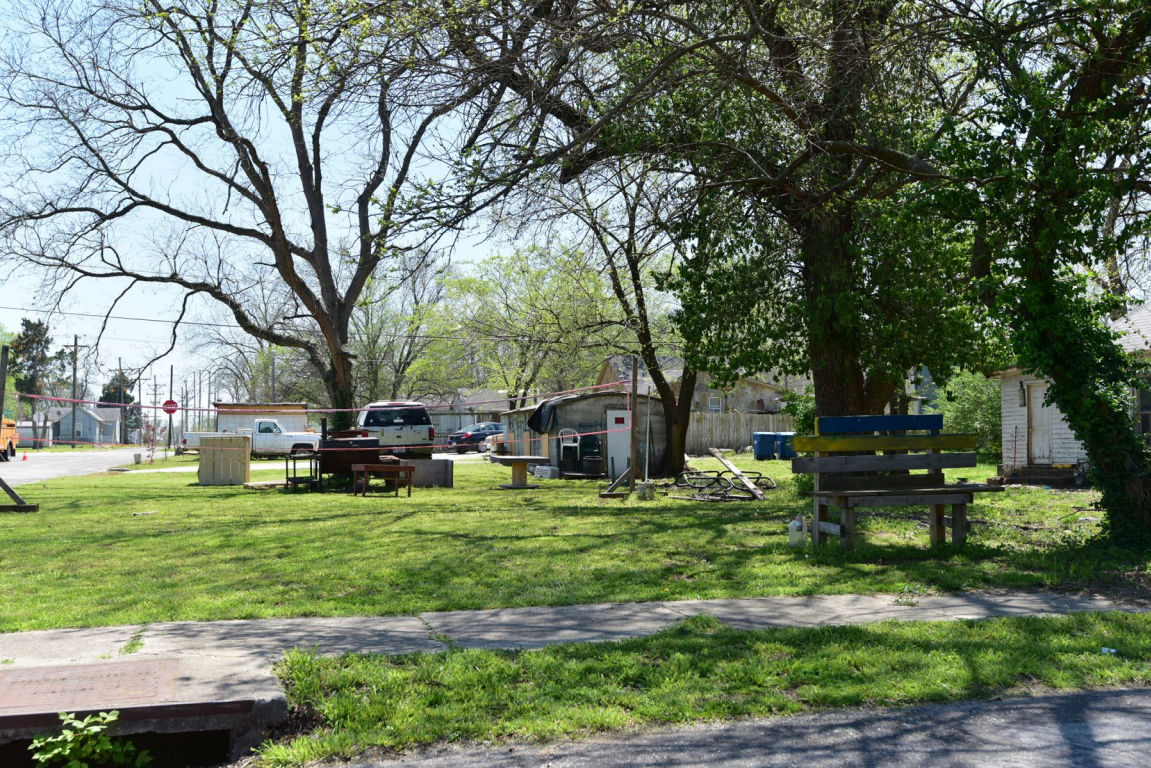
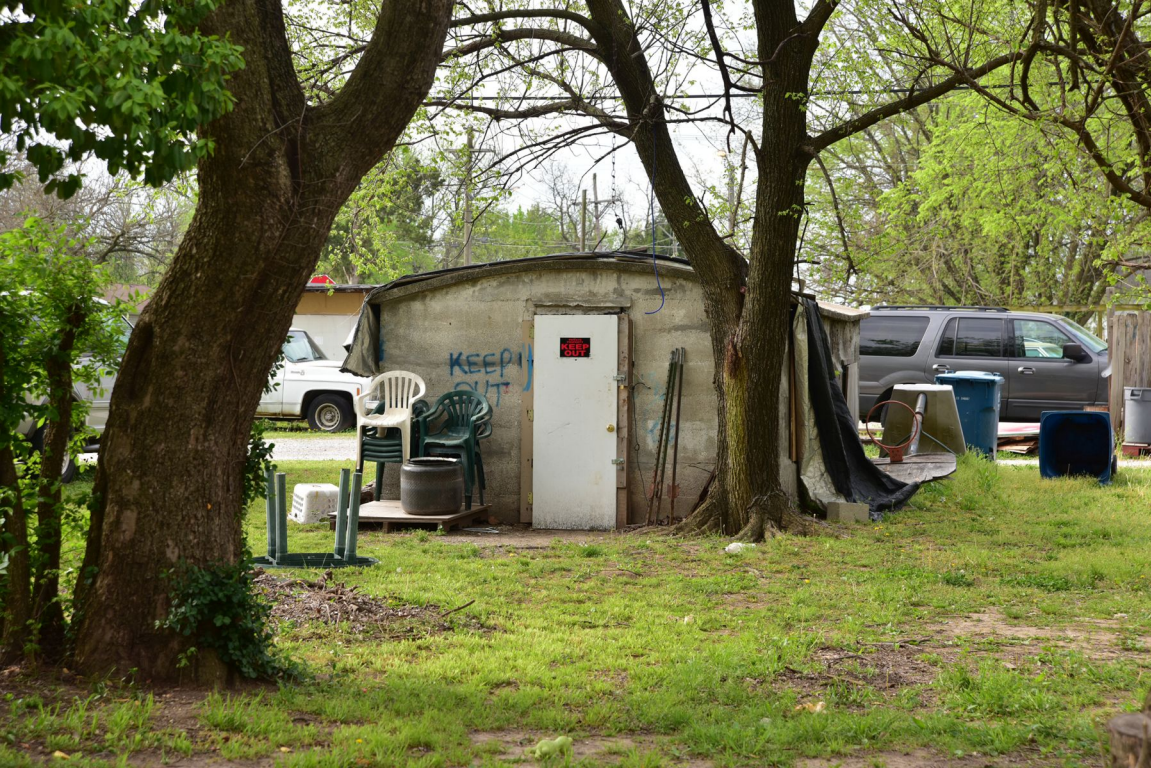
This grassy lot contains one concrete outbuilding with a barrel roof and rectangular footprint.

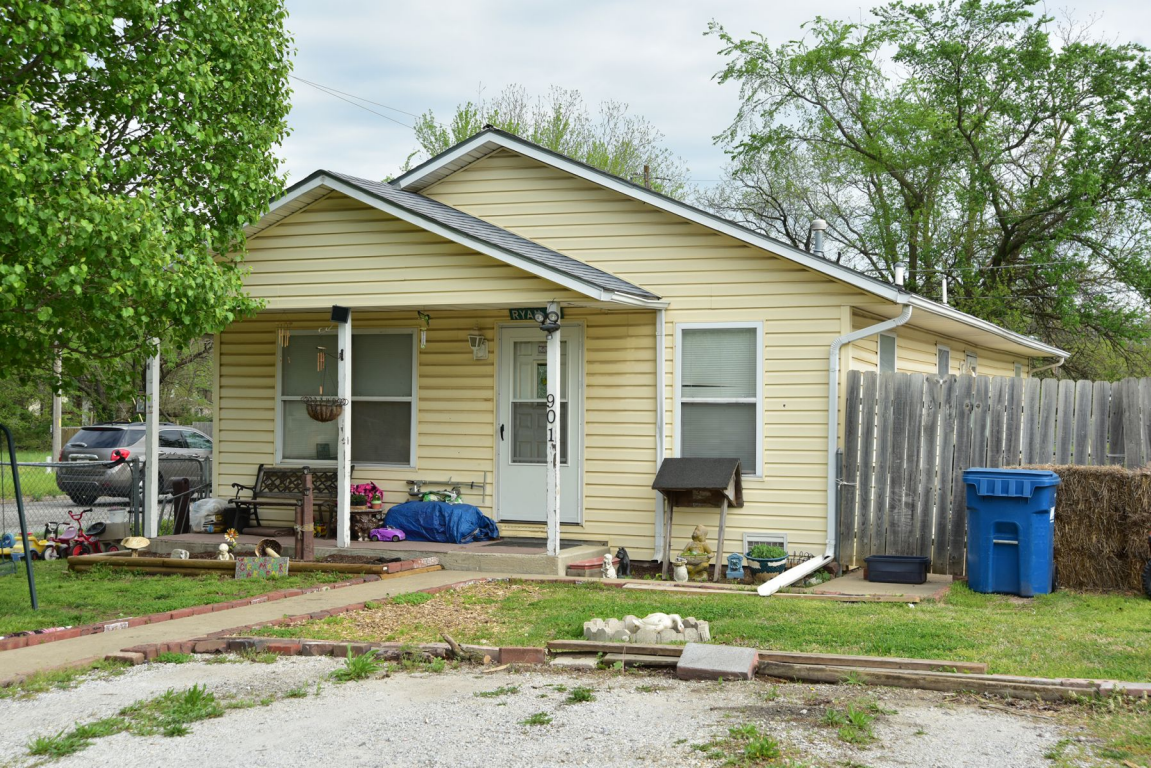
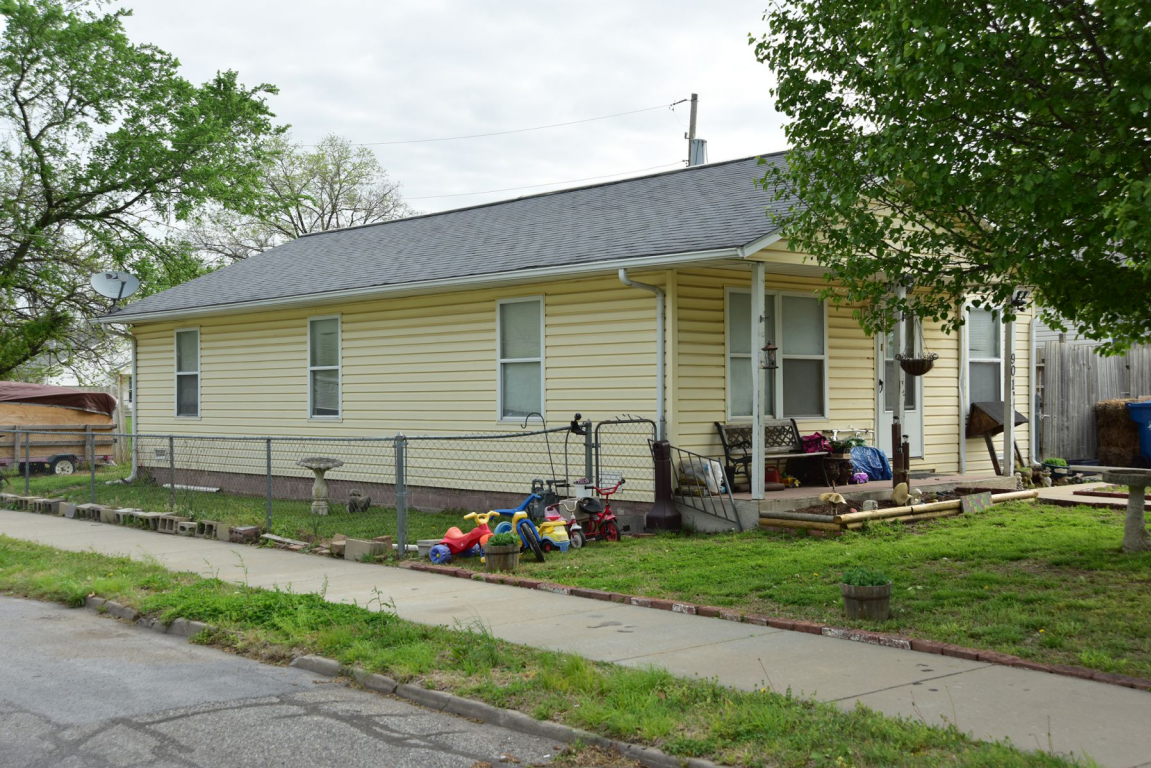
This Bungaloid dwelling faces south and has a rectangular footprint. It has a concrete masonry unit foundation, vinyl cladding, and a front-gable roof with asphalt shingles. The dwelling is three bays wide and four bays deep. A pair of one-over-one vinyl windows occupies the west bay while a single matching window occupies the east bay. A wood door with glazing occupies the center bay. A front-gable porch with a concrete foundation and wood support posts shelters the bays.
