MISSOURI DEPARTMENT OF NATURAL RESOURCES
STATE HISTORIC PRESERVATION OFFICE, P.O. Box 176, Jefferson City, MO 65102
ARCHITECTURAL/HISTORIC INVENTORY FORM

1. Survey number: JP-AS-006-093		2. Survey Name: East Town (Original Joplin) Historic Survey Phase 1	
3. County: JASPER		4. Address 1302	Street (name): E. Furnace Street
5. City: Joplin	Vicinity <input type="checkbox"/>	7. Township/Range/Section: T: R: S:	
8. Historic name (if known):		9. Present/other name (if known):	
10. Ownership: <input checked="" type="checkbox"/> Private <input type="checkbox"/> Public		11a. Historic use (if known): Domestic/Single Dwelling	11b. Current use: Domestic/Single Dwelling

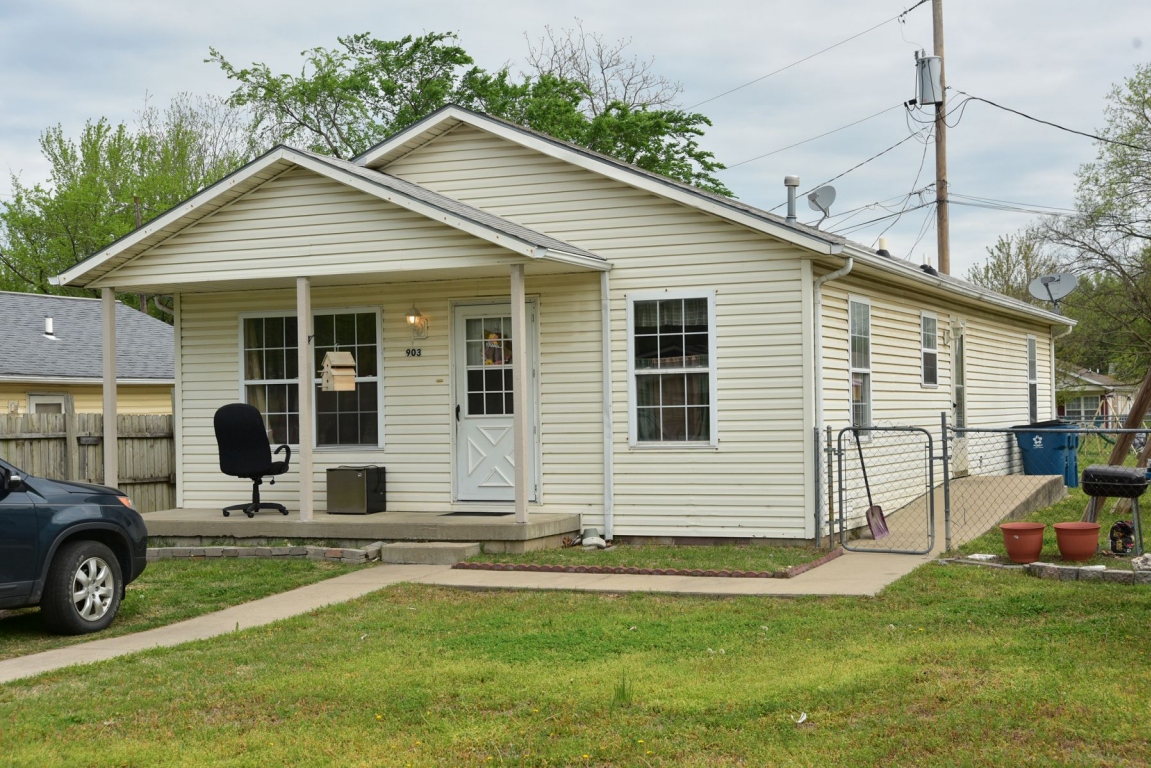
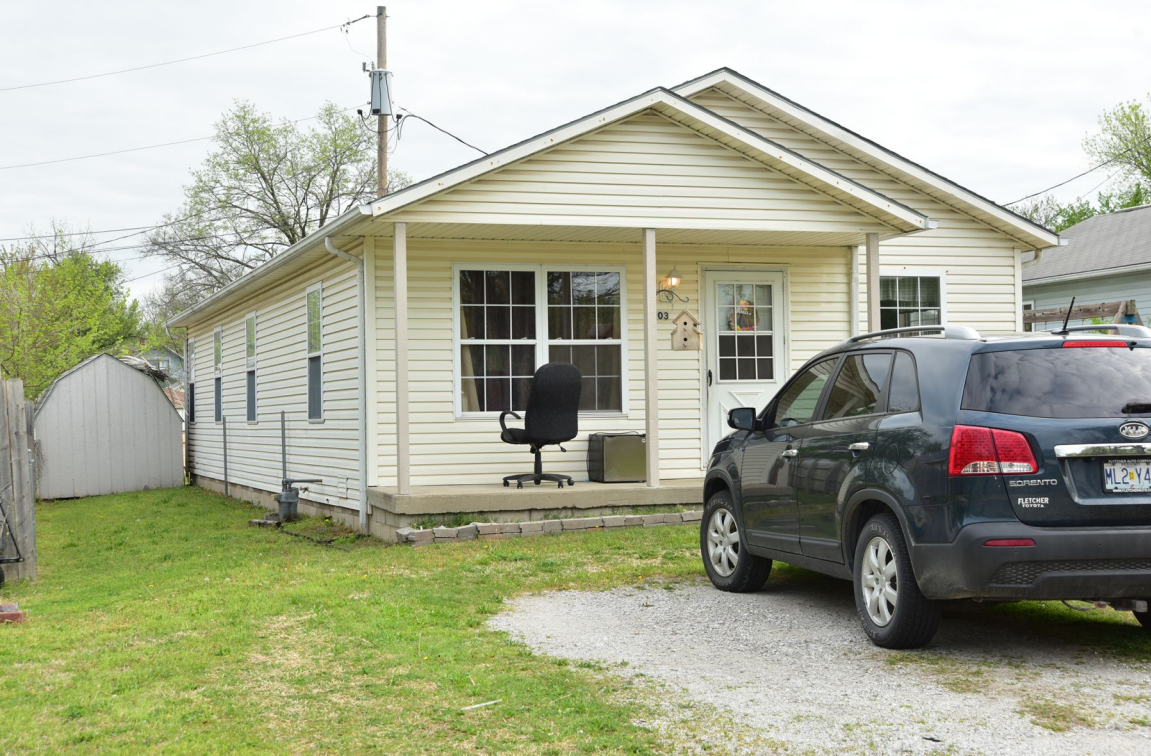
This one-story dwelling faces south. It has a concrete masonry unit foundation and a front-gabled roof with asphalt shingles. The exterior is clad with vinyl siding. A one-story, partial-width porch spans the west portion of the south façade. The porch has a front-gabled roof with vinyl cladding in the gable, a concrete foundation and slab, and square wood posts. The south façade has three bays. The west bay and center bays are sheltered under the porch. The west bay contains a pair of six-over-six vinyl windows. The center bay contains a fiberglass door with an aluminum storm door. The east bay contains a six-over-six vinyl window.

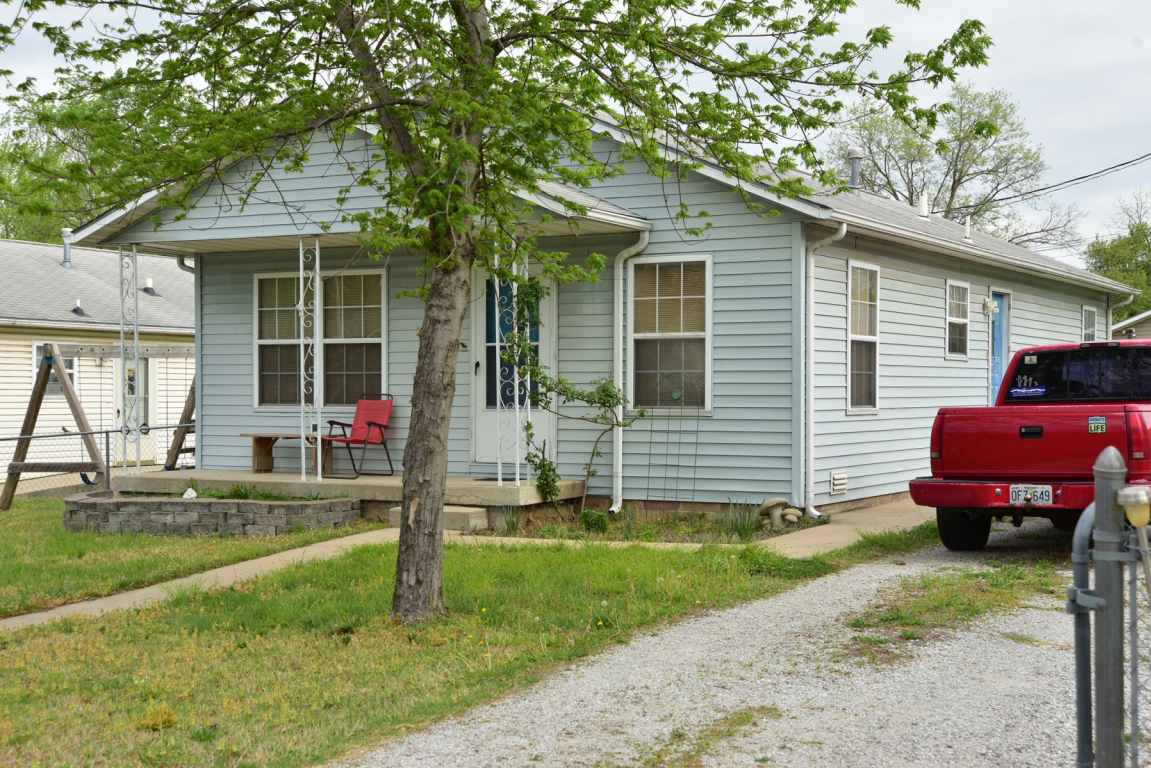
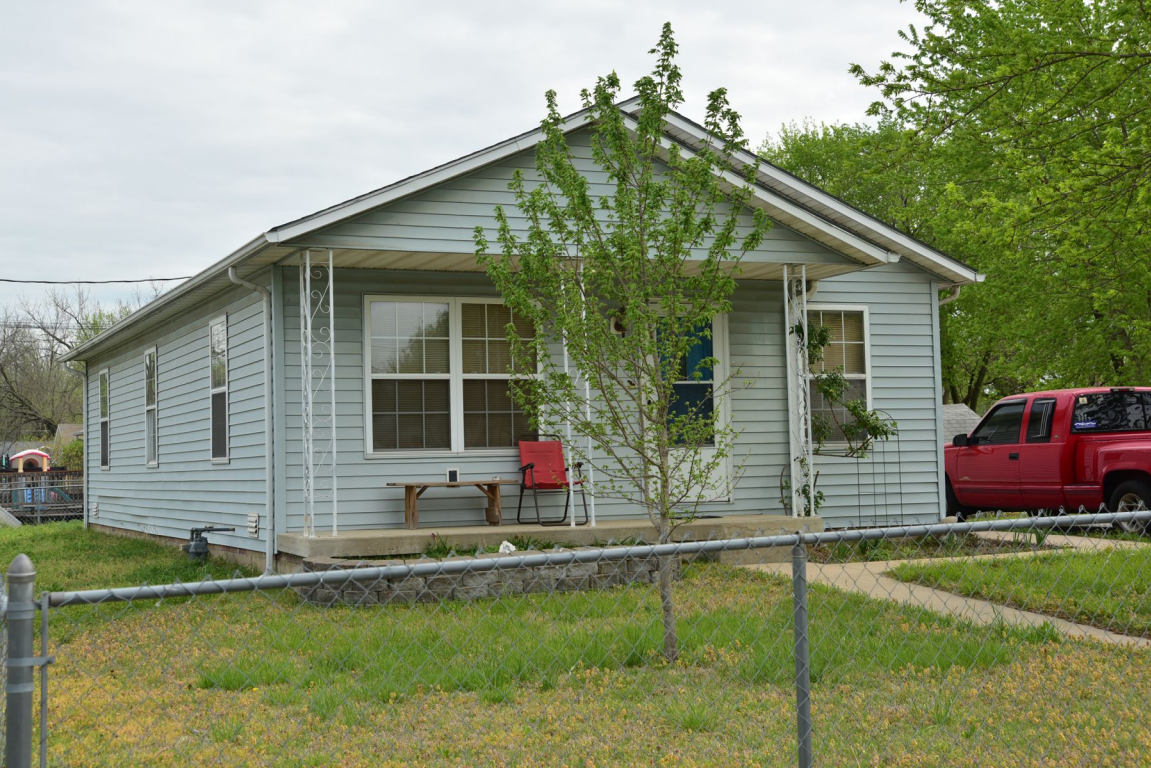
This one-story dwelling faces south. It has a concrete masonry unit foundation and a front-gabled roof with asphalt shingles. The exterior is clad with vinyl siding. A one-story, partial-width porch spans the west portion of the south façade. The porch has a front-gabled roof with vinyl cladding in the gable, a concrete foundation and slab, and shaped metal posts. The south façade has three bays. The west bay and center bays are sheltered under the porch. The west bay contains a pair of six-over-six vinyl windows. The center bay contains a wood paneled door with a pane of glazing and an aluminum storm door. The east bay contains a six-over-six vinyl window.

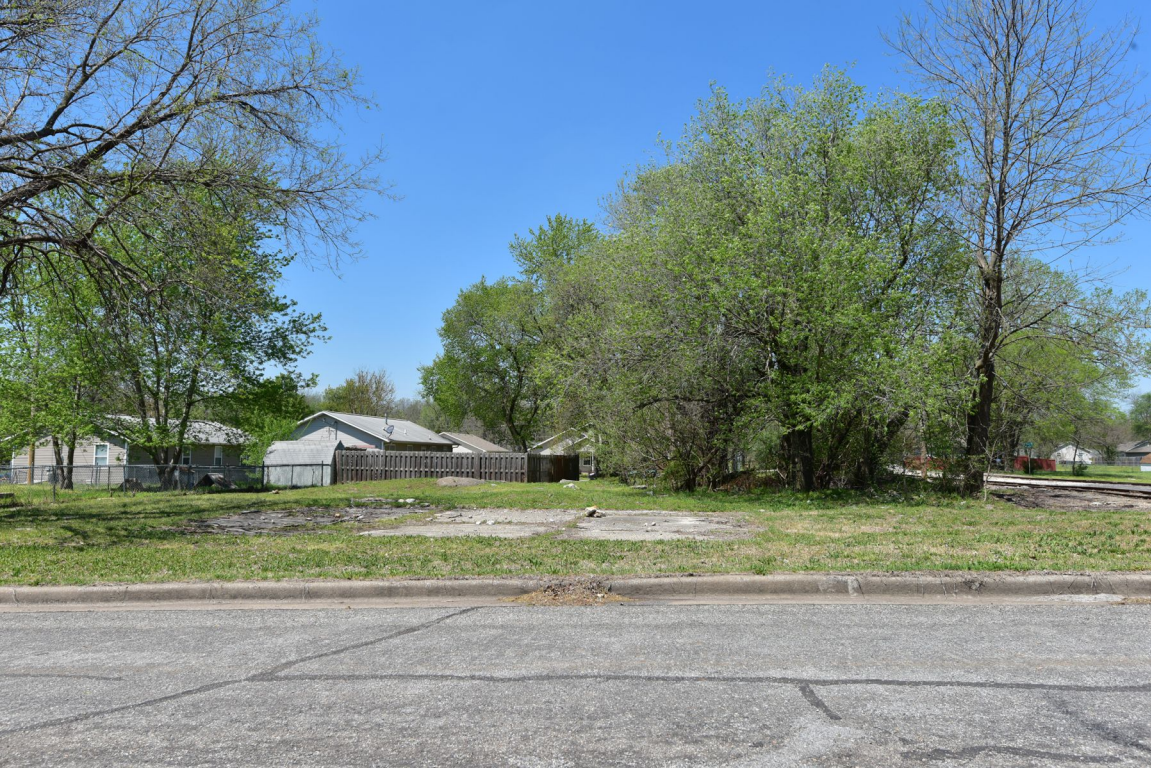
The lot is characterized by a grass lawn with a deteriorating concrete foundation. Deciduous trees are clustered at the northeast portion of the property. A large rectangular concrete pad fills part of the south end of the lot.

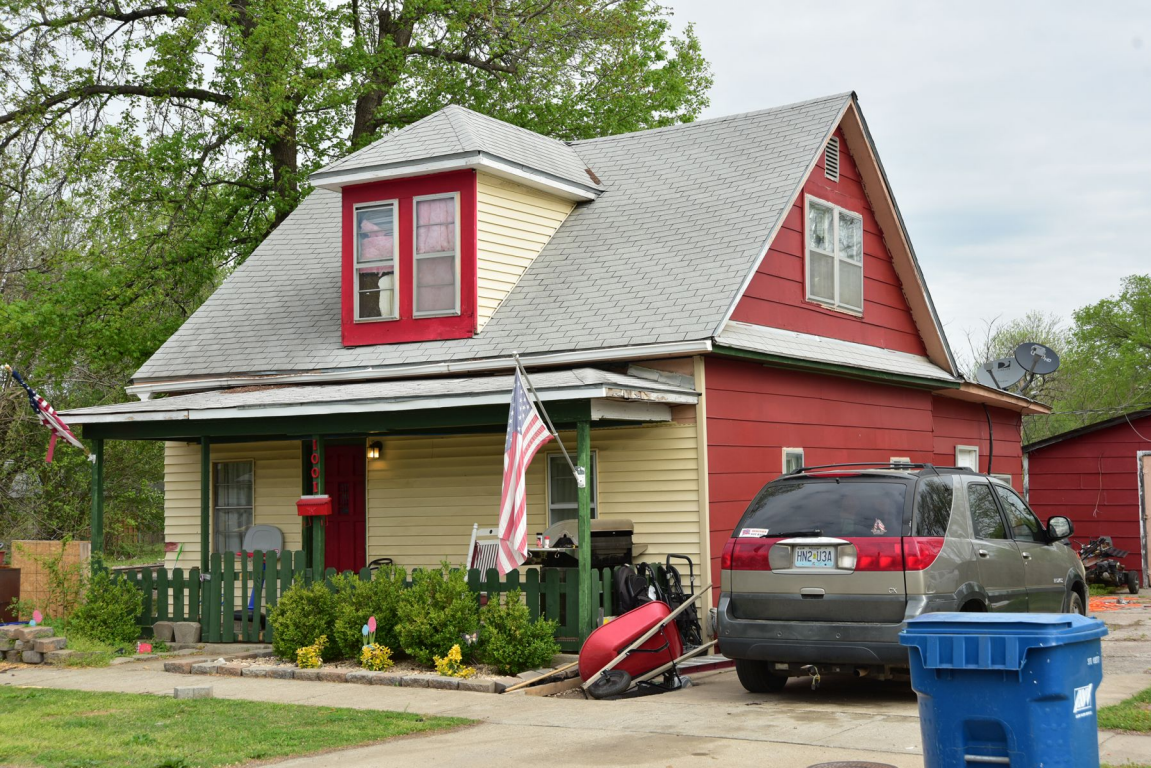
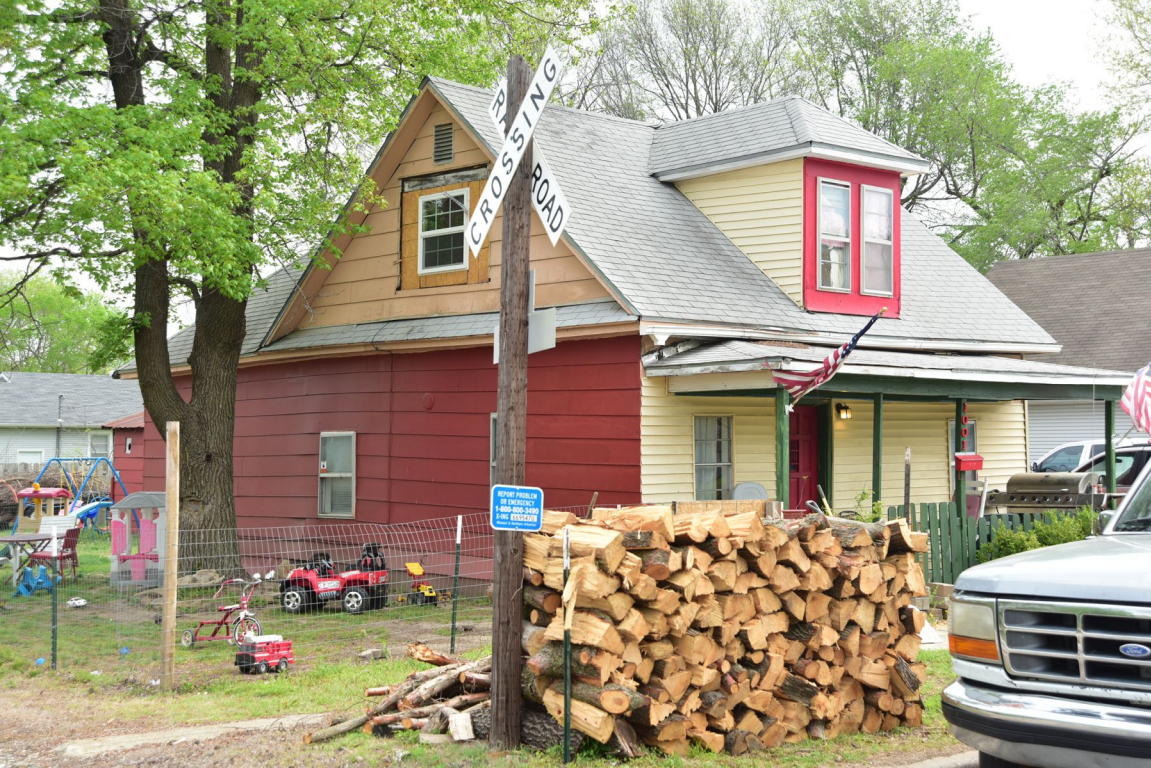
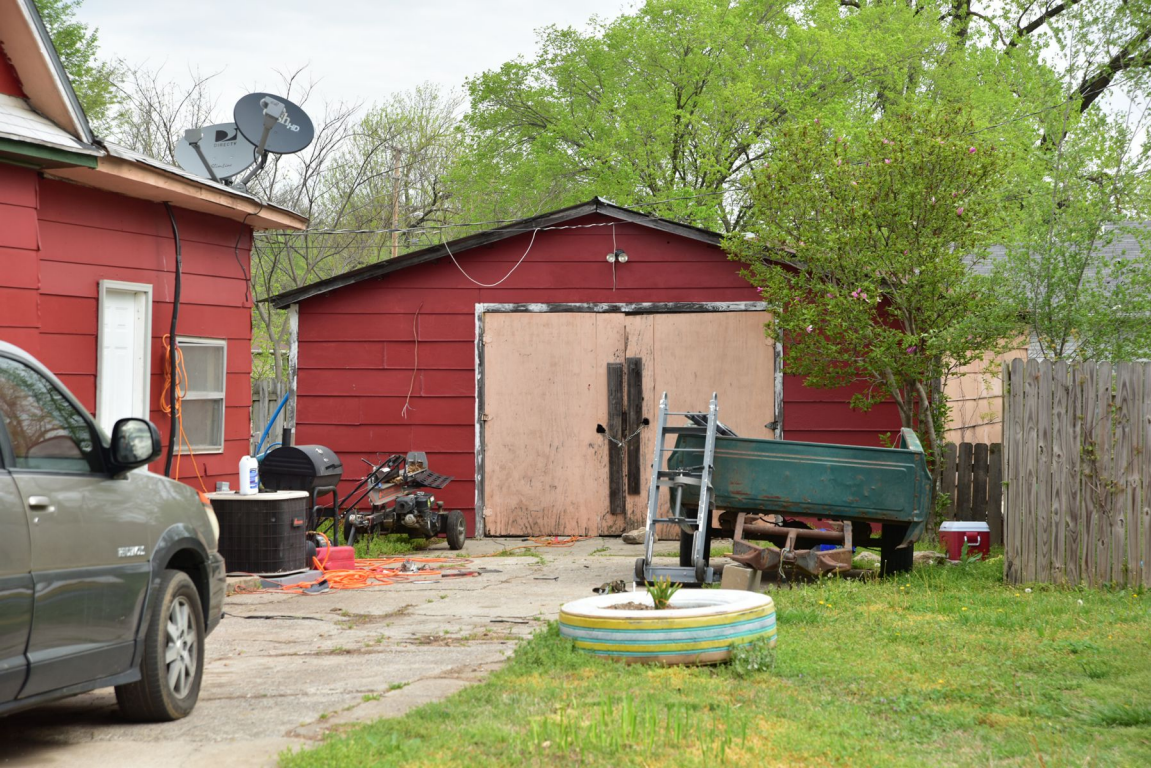
This one-and-a-half-story National Folk dwelling faces south. The foundation is not visible. It has a side-gabled roof with asphalt shingles. The south façade is clad with vinyl siding and the side elevations have asbestos shingles. A one-story, full-width porch with a hipped roof with asphalt shingles spans the south façade. The porch has a concrete slab foundation and non-historic wood support posts bridged with a short wood plank balustrade and gate. The south façade has three bays. The outer bays each contain a replacement two-over-two metal window with horizontal sash muntins. The siding and windows are historic alterations that date to c.1955. The center bay contains a paneled wood door. The south slope of the roof has a hipped-roof dormer with vinyl-clad sidewalls. The dormer contains a pair of replacement two-over-two metal sash windows with painted plywood surround.

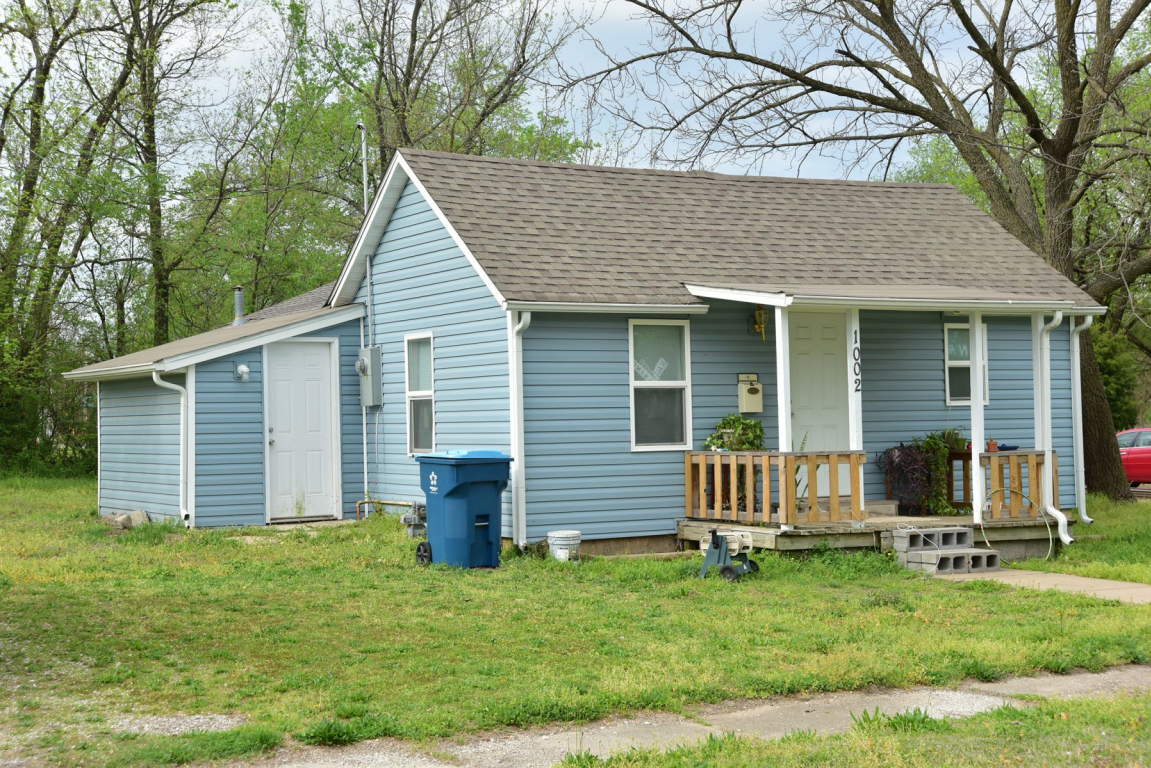
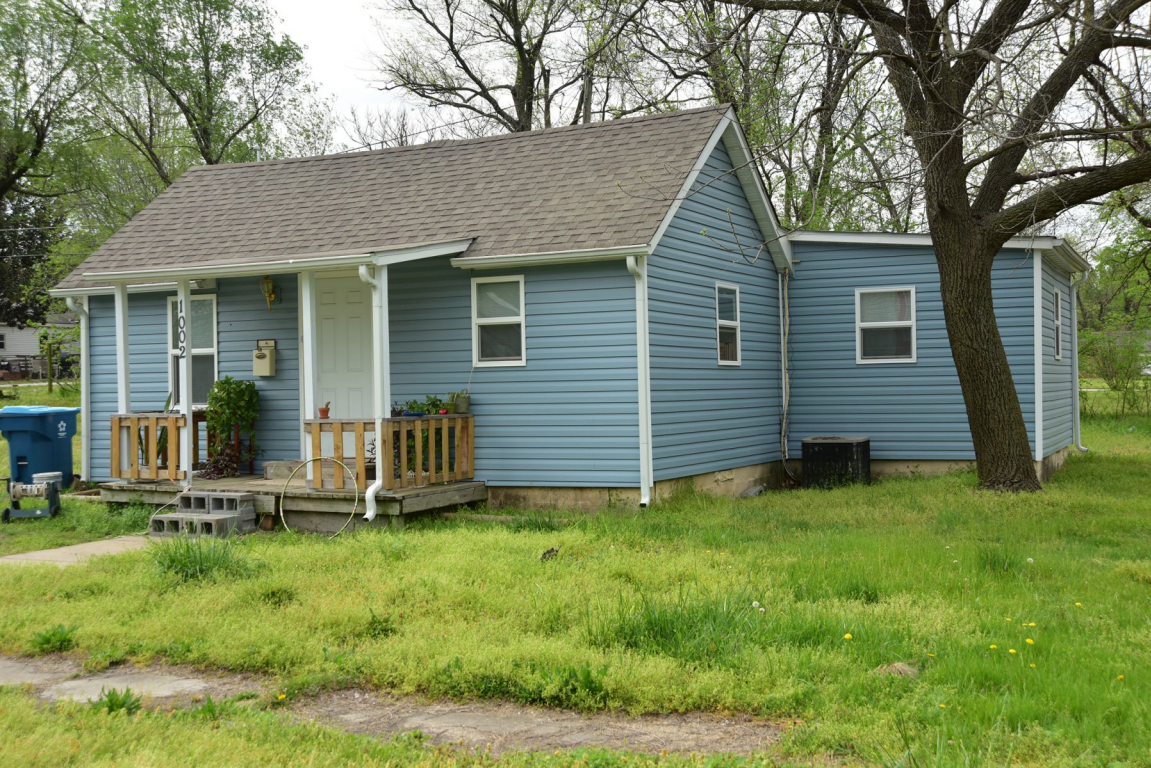
This one-story National Folk dwelling faces north and has a parged foundation and a side-gabled roof with asphalt shingles. The exterior is clad with vinyl siding. A one-story, partial-width porch with a shed roof with asphalt shingles spans the center of the north façade. The porch has a non-historic wood base with non-historic wood balustrade and square posts. The north façade has three bays. The outer bays each contain a replacement one-over-one vinyl window. The center bay contains a non-historic fiberglass door. Historic one-story shed-roof additions (c.1960) extend from the rear of the east and west elevations.

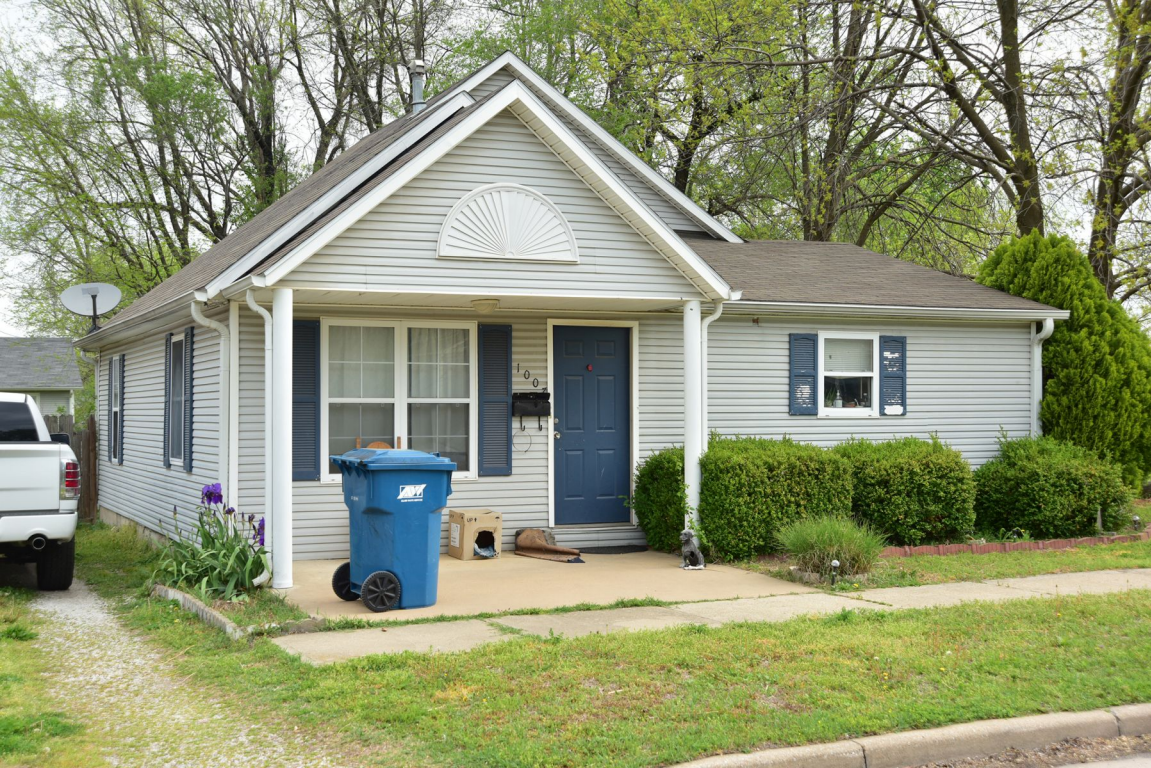
This one-and-a-half-story Gabled-ElI dwelling faces south. The foundation is not visible. It has a front-gabled roof with asphalt shingles. A non-historic one-story addition with a side-gabled roof with asphalt shingles fronts the south façade. The exterior is clad with vinyl siding. A one-story, partial-width porch with a front-gabled roof extends from the west end of the south façade. The porch has a poured concrete base and vinyl support posts. The gable is clad with vinyl siding and has a blind vinyl sunburst panel. The south façade has three bays; the west and center bays are sheltered beneath the porch. The west bay contains a pair of four-over-four vinyl windows with shutters. The center bay contains a non-historic fiberglass door. The east bay has a short one-over-one vinyl window with shutters. The half-story on the south façade, below the front-gabled primary mass of the dwelling, contains an octagonal vinyl window.

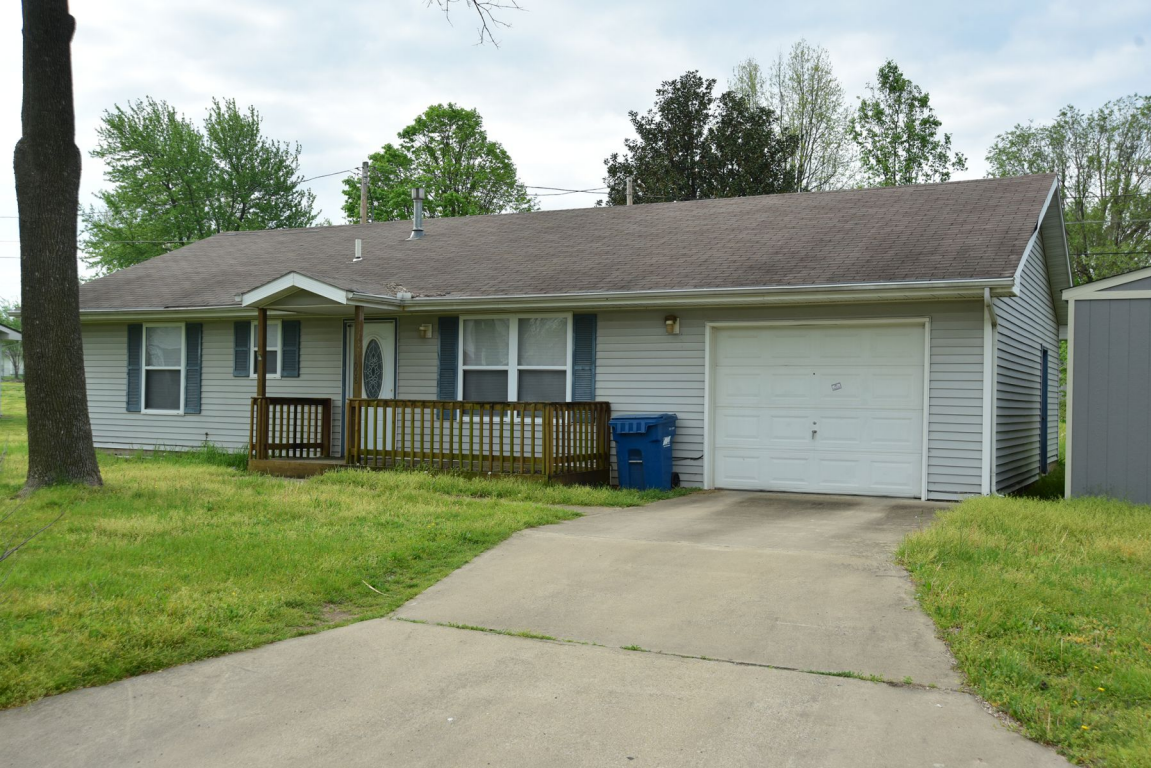
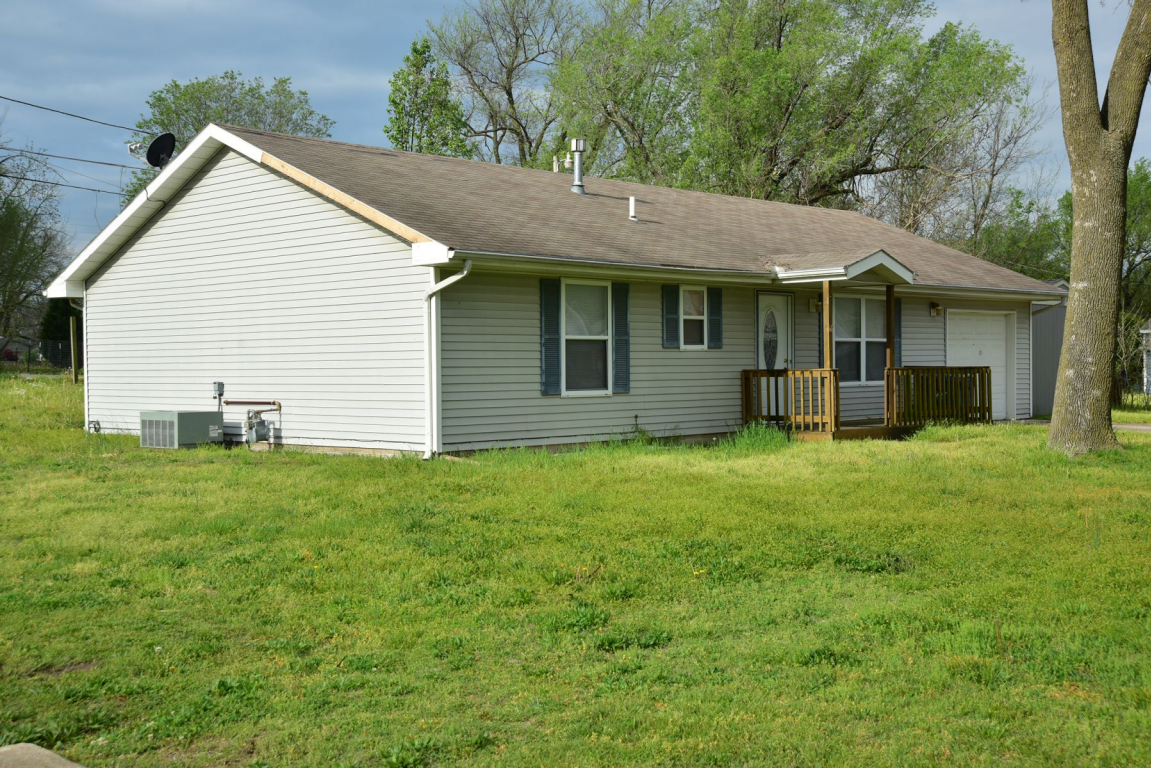
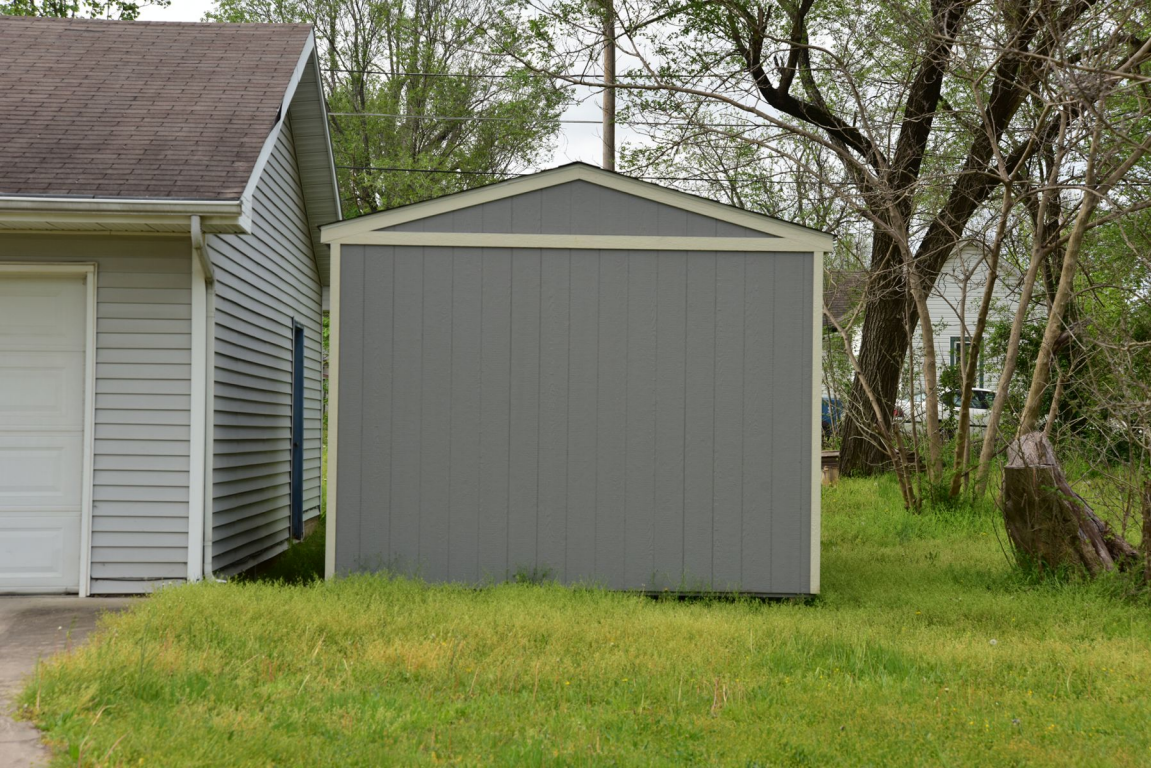
This one-story Ranch type house faces north. It has a concrete foundation and a side-gabled roof with asphalt shingles. The exterior is clad with vinyl siding. A one-story, partial-width porch spans the center of the north façade. The porch has a non-historic wood deck with wood balustrade, wood support posts, and a front-gabled hood over the dwelling's entrance. The north façade has five bays. The east bay contains a one-over-one vinyl window with shutters. The second bay from the east has a shorter one-over-one vinyl window with shutters. The third bay contains a fiberglass door with an oval art glass light. The fourth bay contains a pair of one-over-one vinyl windows with shutters. The fifth bay contains a one-car garage with a fiberglass paneled overhead rolling door.

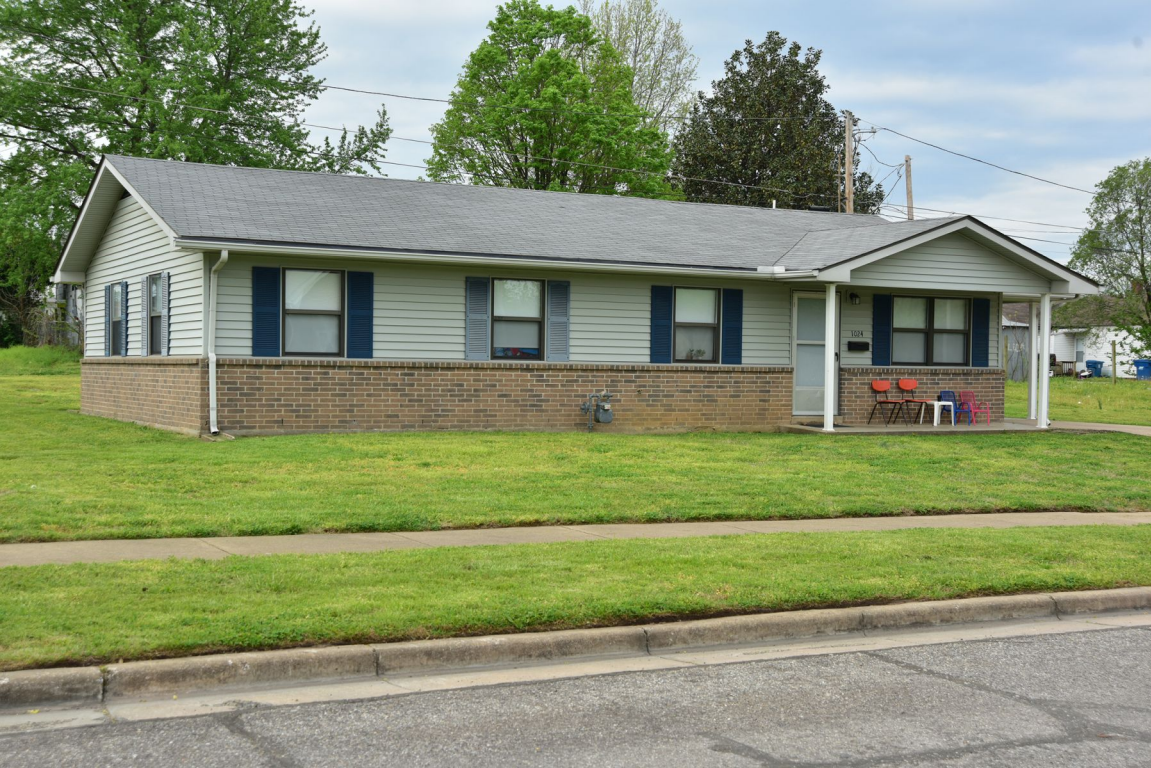
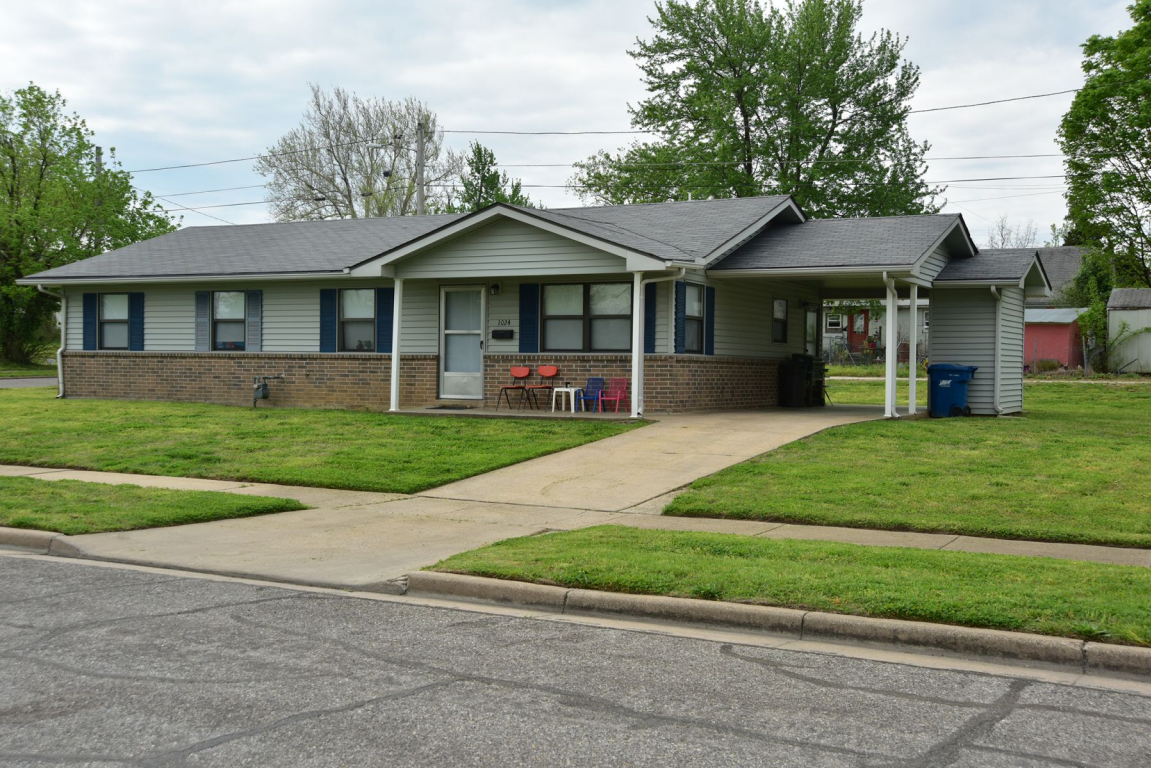
This one-story Ranch type house faces north. It has a poured concrete foundation and a side-gabled roof with asphalt shingles. The lower half of the exterior has brown brick veneer cladding and the upper half is clad with vinyl siding. A one-story, partial-width porch with a front-gabled roof with asphalt shingles and vinyl cladding in the gable spans the west portion of the north façade. The porch has a poured concrete slab and vinyl support posts. The north façade has five bays; the two west bays are sheltered by the porch. The three east bays each contain a one-over-one vinyl window with shutters. The fourth bay contains a wood door. The fifth (west) bay contains a pair of one-over-one vinyl windows with shutters. A carport with a side-gabled roof extends from the west elevation. The carport has metal support posts and an attached shed with vinyl siding.

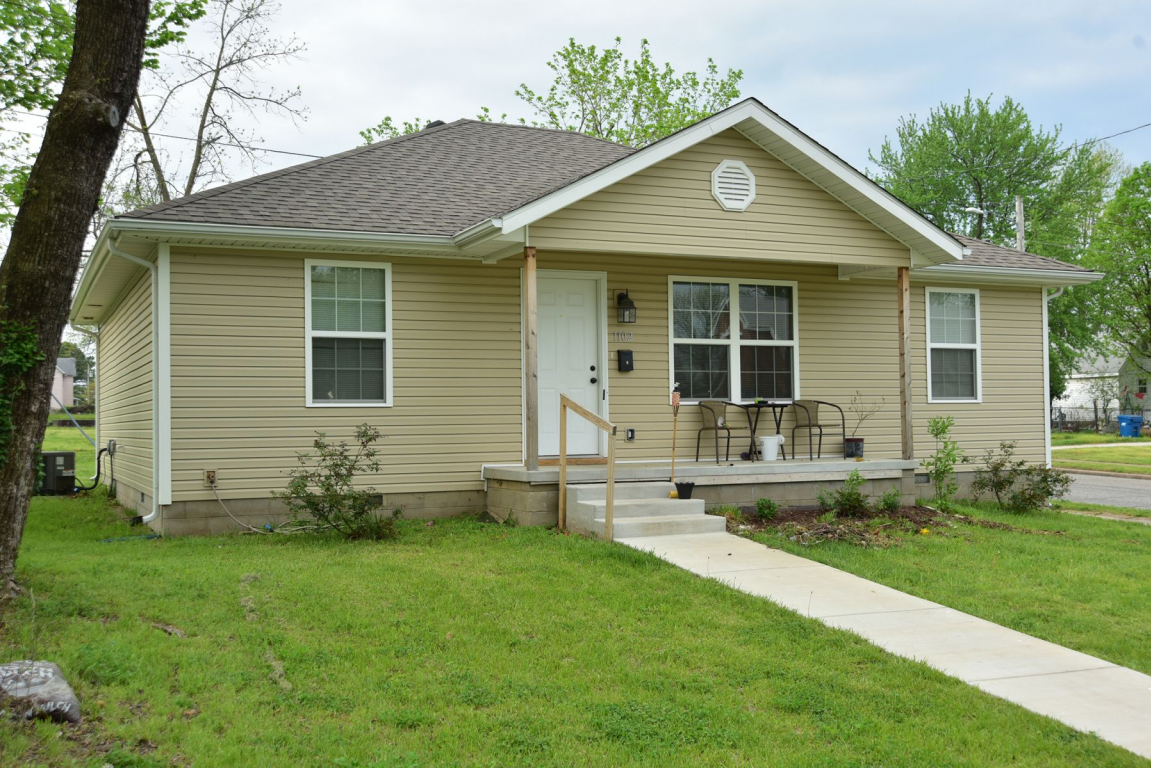
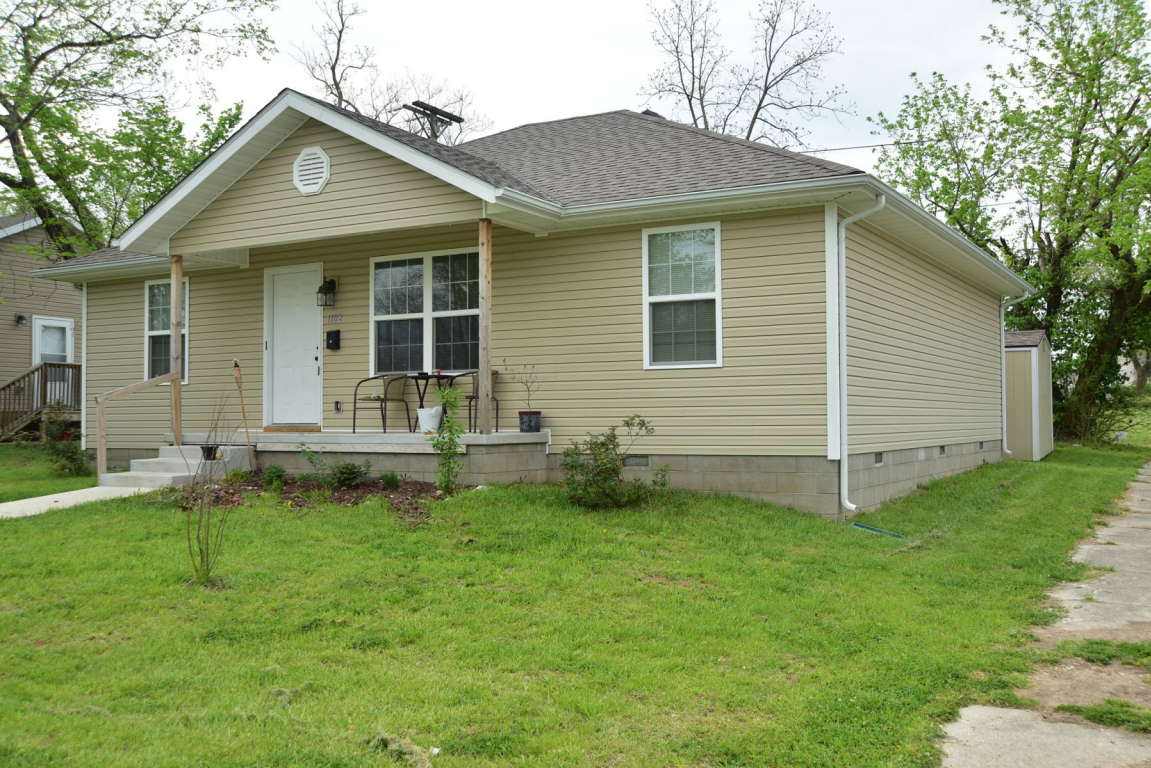
This one-story dwelling faces north. It has a concrete masonry unit foundation and a hipped roof with asphalt shingles. The exterior is clad with vinyl siding. A one-story, partial-width porch with a front-gabled roof with asphalt shingles and vinyl cladding in the gable spans the central portion of the north façade. The porch has a concrete masonry unit foundation and wood support posts. The north façade has four bays; the two center bays are sheltered by the porch. The east and west bays each contain a six-over-six vinyl window. The second bay from the east contains a fiberglass door. The third bay contains a pair of six-over-six vinyl windows.

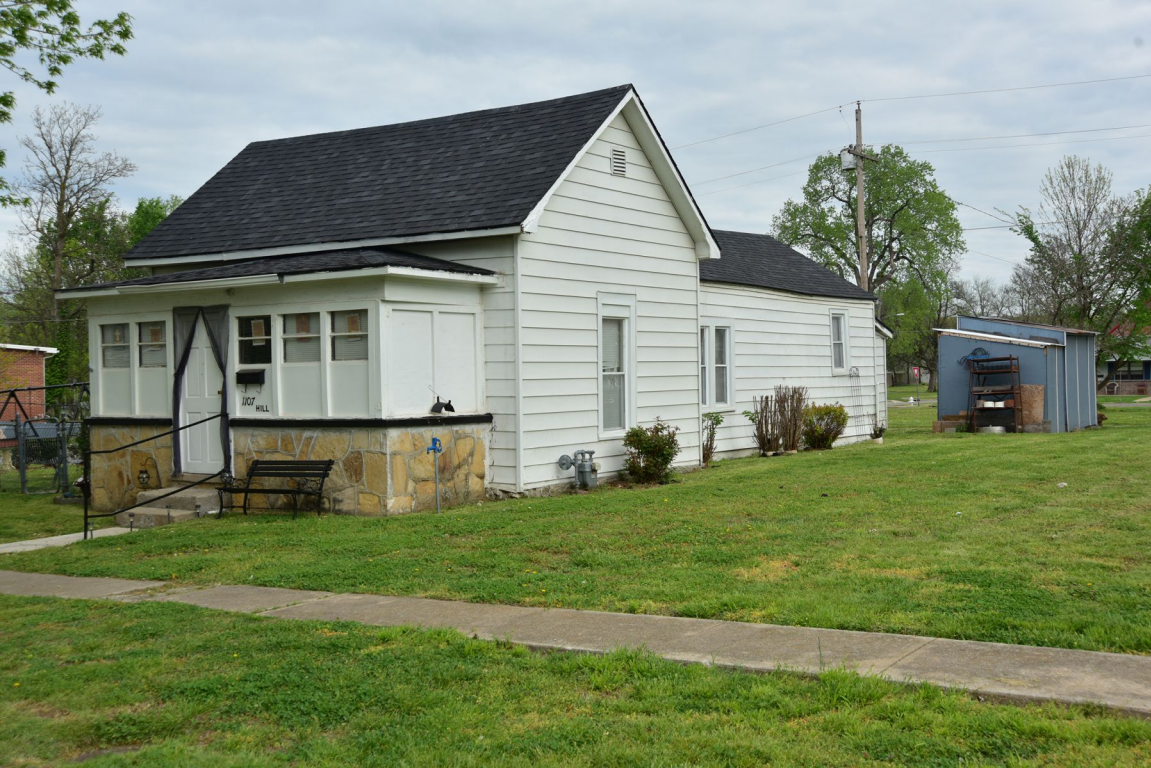
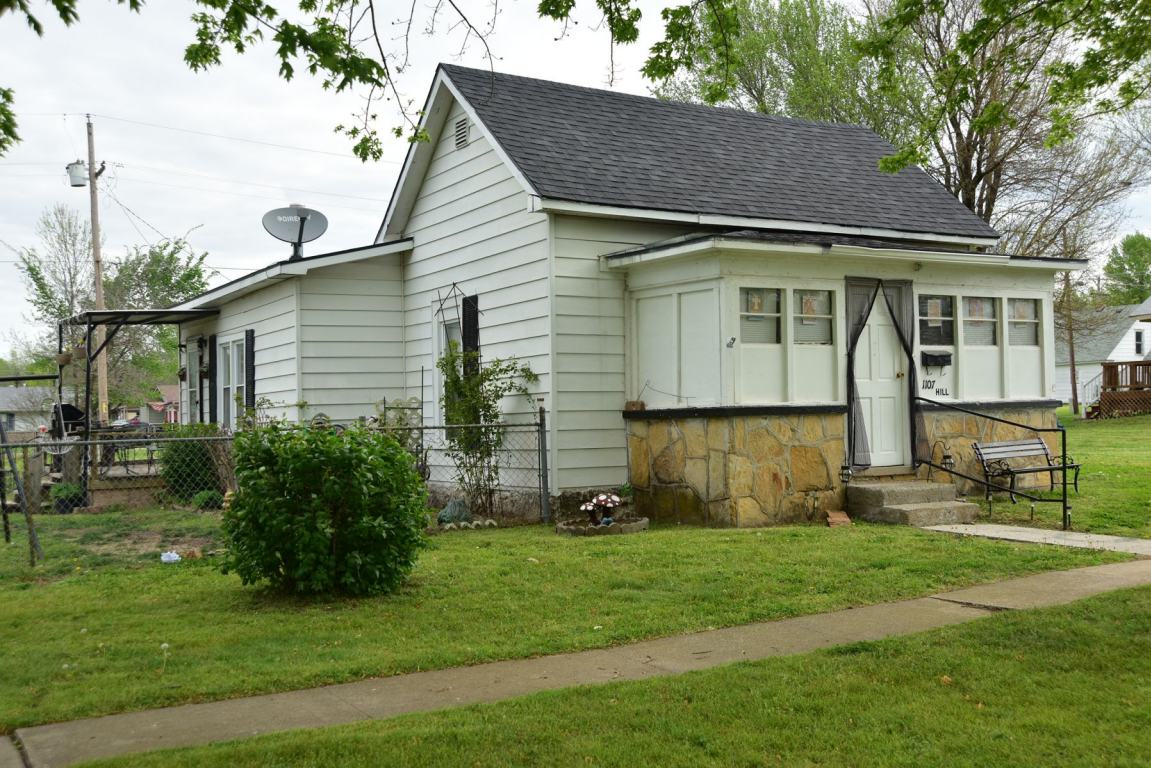
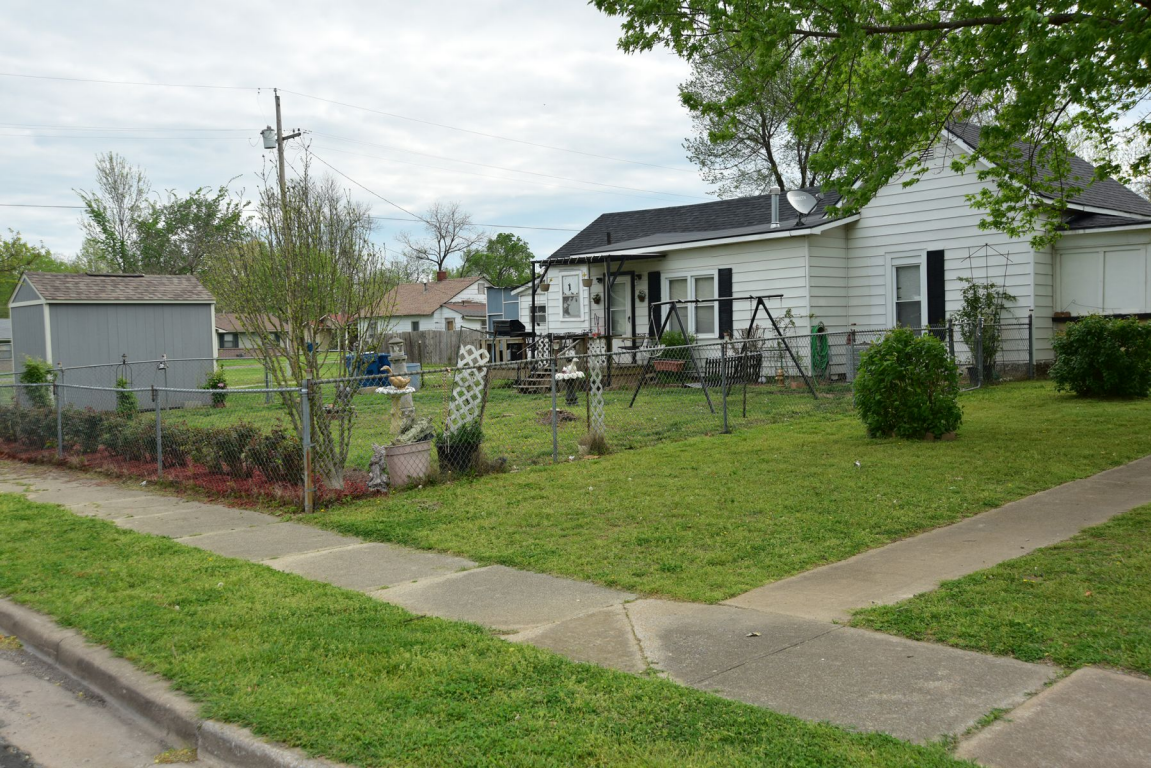
1107 HILL

This one-story National Folk dwelling faces south. It has a stone foundation and a side-gabled roof with asphalt shingles. The exterior is clad with metal siding. A one-story, full-width enclosed porch with a hipped roof with asphalt shingles spans the south façade. The porch has split-slab stone cladding on the lower half, and the upper half has fenestration openings with wood panels and two-light wood windows. A non-historic fiberglass door is centered in the south elevation of the porch.

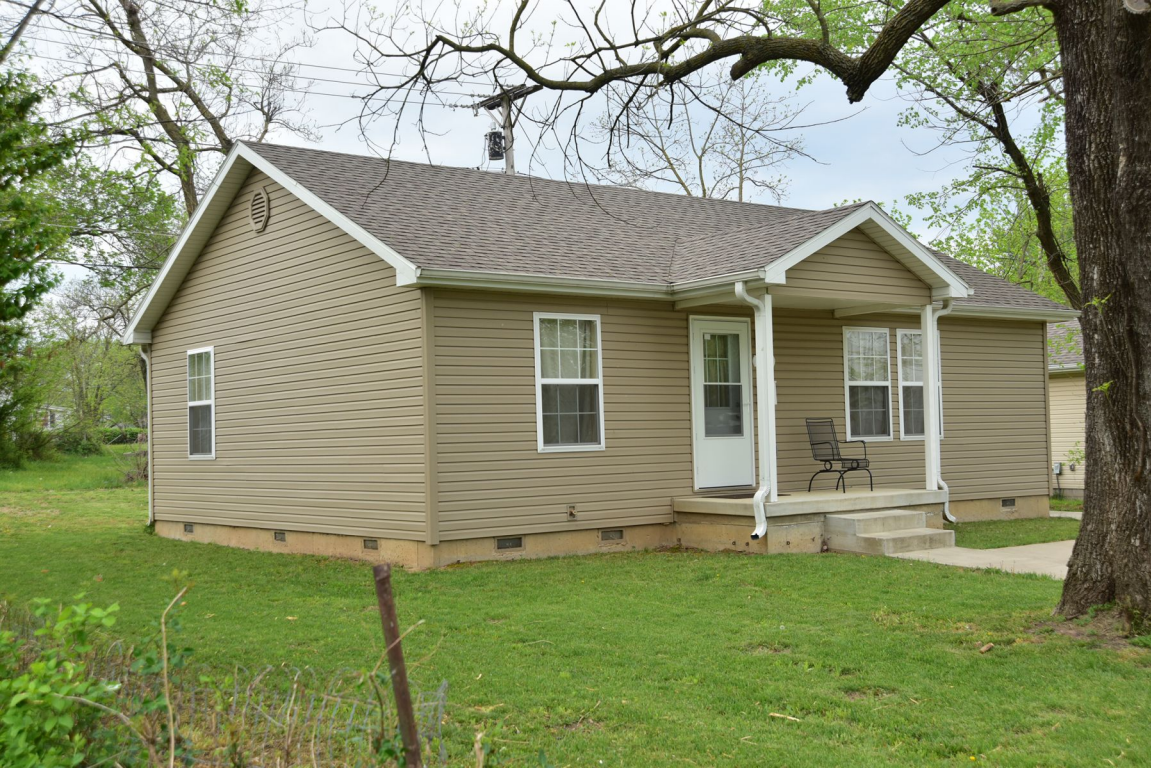
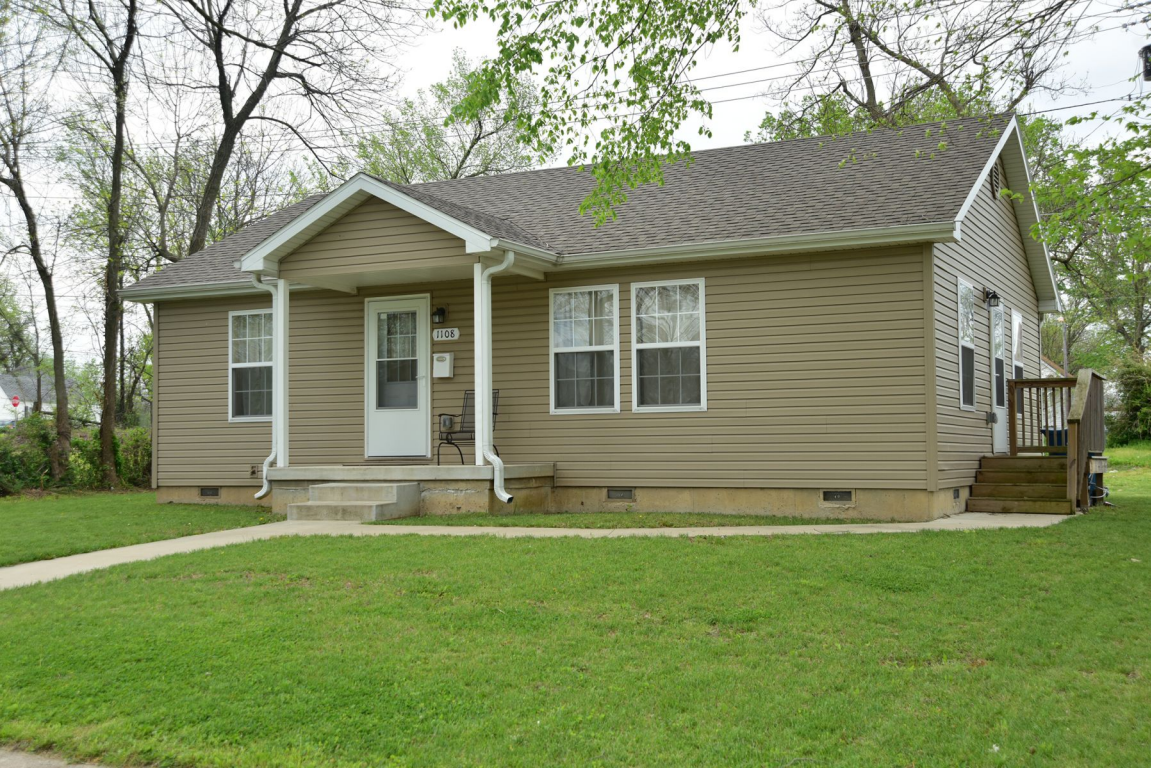
This one-story dwelling faces north. It has a concrete foundation and a side-gabled roof with asphalt shingles. The exterior is clad with vinyl siding. A one-story, partial-width porch with a front-gabled roof with asphalt shingles spans the center of the north façade. The porch has a concrete foundation and wood support posts. The north façade has four bays. The east bay and two west bays each contain a six-over-six vinyl window. The second bay from the east is sheltered under the porch and contains a fiberglass door with glazing with false muntins in the upper half, and an aluminum storm door.
