MISSOURI DEPARTMENT OF NATURAL RESOURCES
STATE HISTORIC PRESERVATION OFFICE, P.O. Box 176, Jefferson City, MO 65102
ARCHITECTURAL/HISTORIC INVENTORY FORM

1. Survey number: JP-AS-006-093		2. Survey Name: East Town (Original Joplin) Historic Survey Phase 1	
3. County: JASPER		4. Address 1302	Street (name): E. Furnace Street
5. City: Joplin	Vicinity <input type="checkbox"/>	7. Township/Range/Section: T: R: S:	
8. Historic name (if known):		9. Present/other name (if known):	
10. Ownership: <input checked="" type="checkbox"/> Private <input type="checkbox"/> Public		11a. Historic use (if known): Domestic/Single Dwelling	11b. Current use: Domestic/Single Dwelling

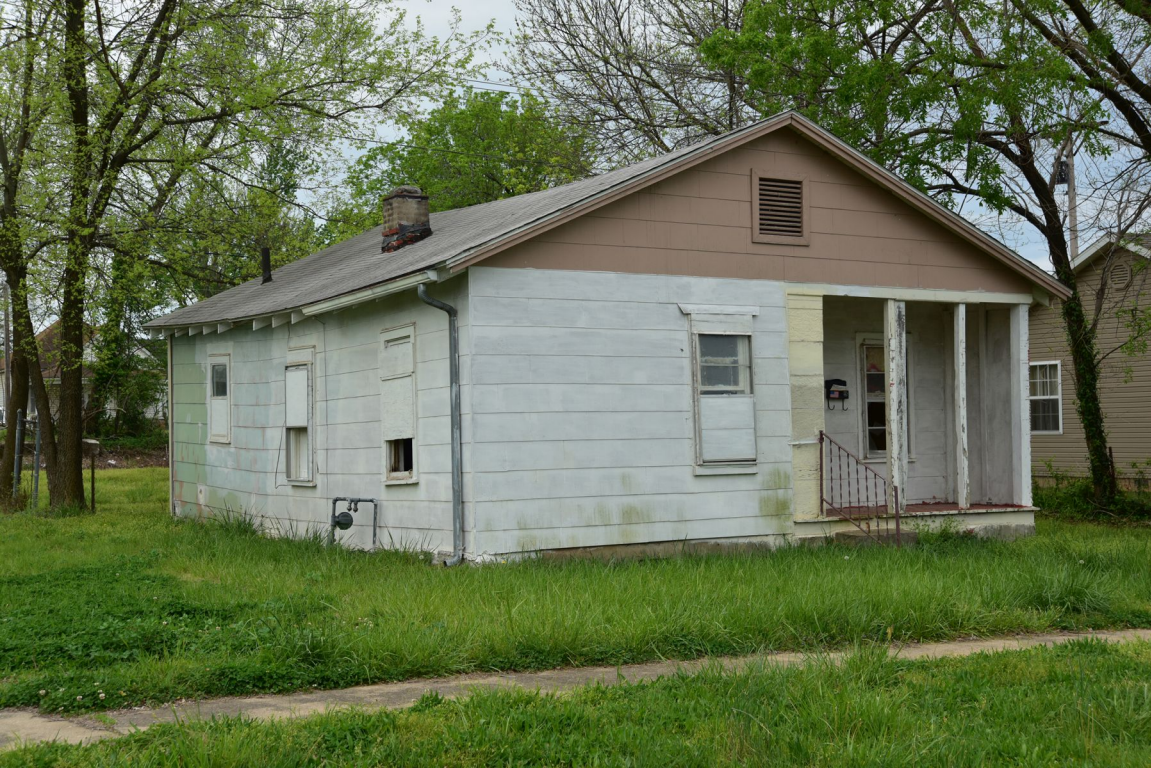
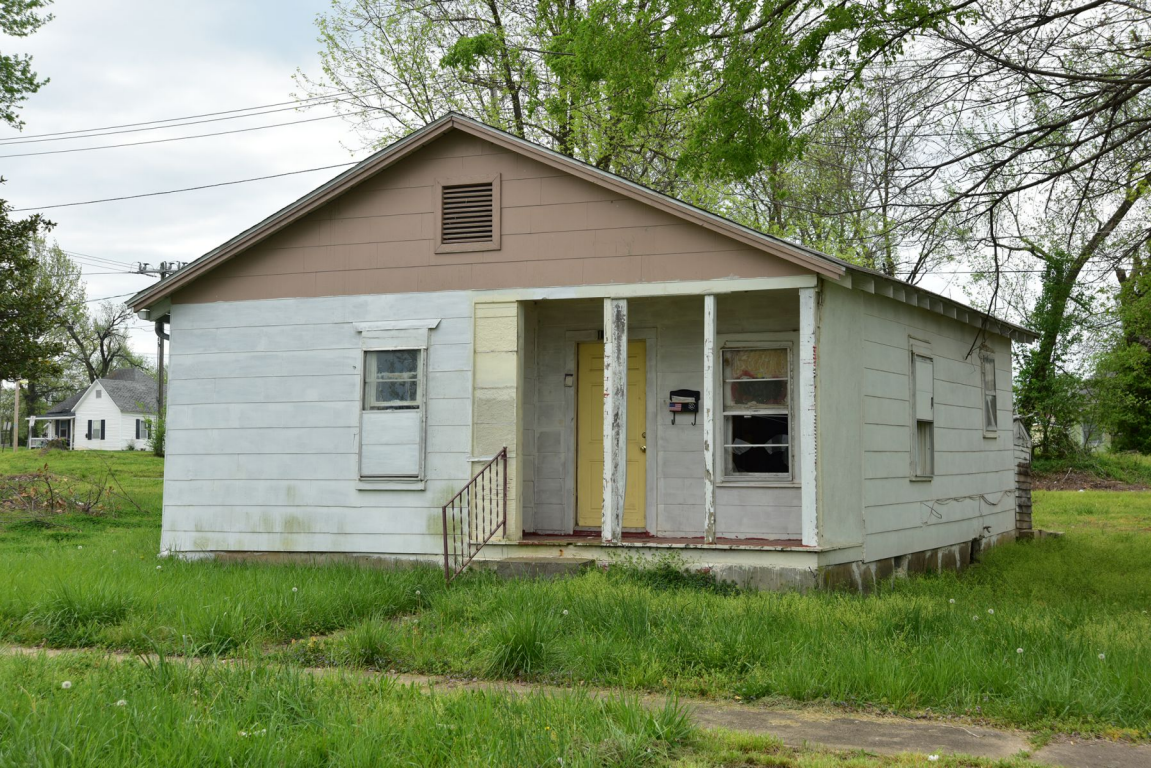
This one-story dwelling faces north. It has a parged foundation and a front-gabled roof with asphalt shingles and exposed rafter tails. The exterior is clad with asbestos siding. A one-story, partial-width recessed porch spans the west portion of the north façade. The porch has historic wood plank flooring and non-historic wood square posts. The north façade has three bays. The east bay contains a historic one-over-one wood sash window with an aluminum storm window. The center and west bays are under the recessed porch. The center bay contains a non-historic wood paneled door. The west bay contains a historic one-over-one wood sash window with an aluminum storm window. A square attic vent with wood trim and louvers pierces the wall below the roof gable on the north façade.

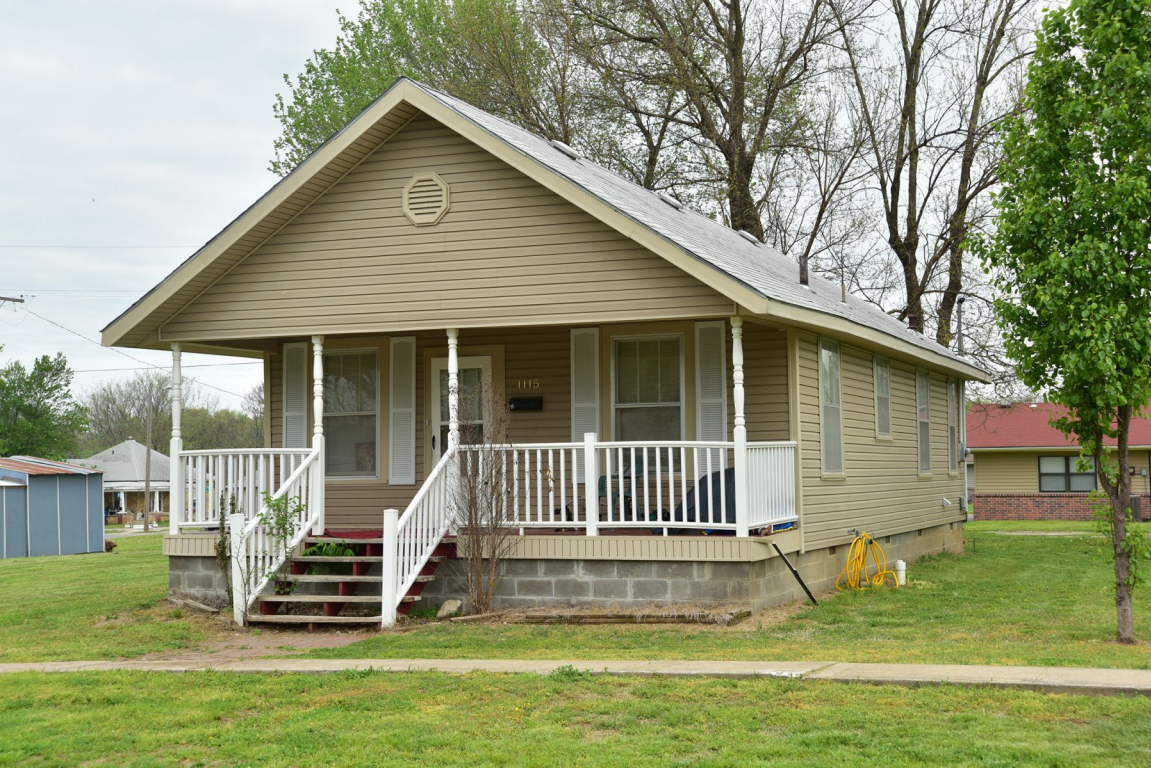
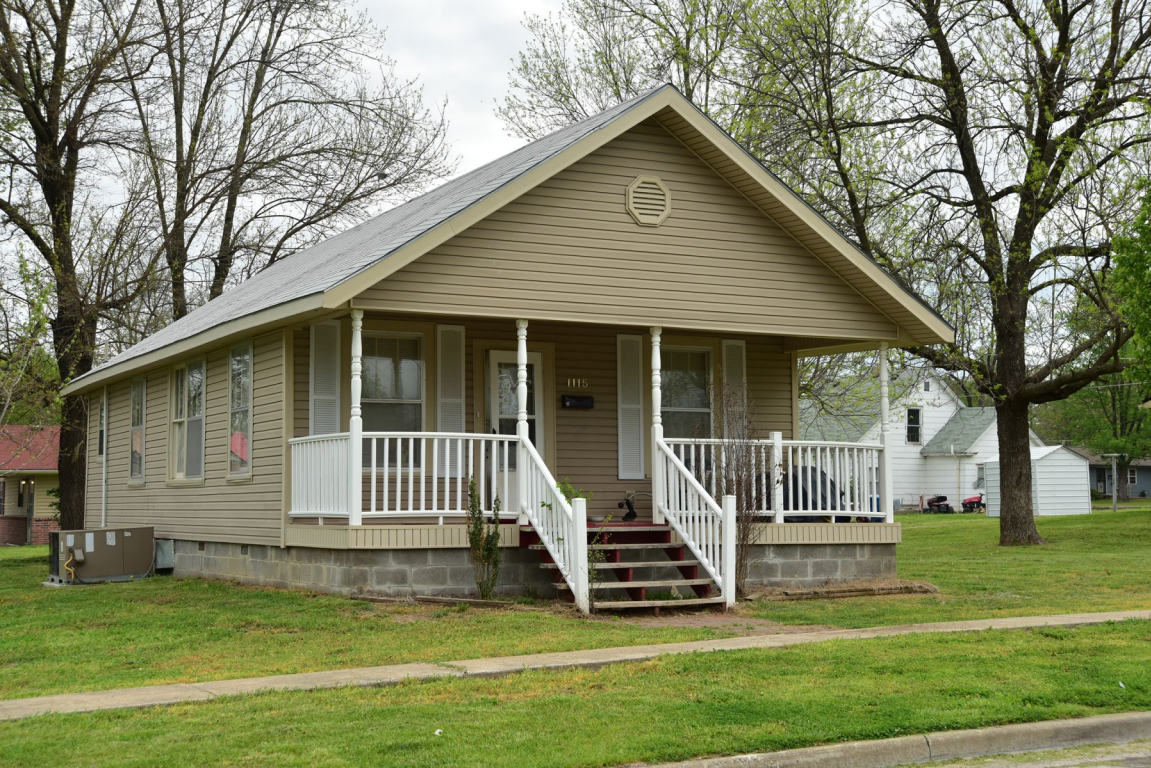
This resource may be a historic dwelling moved to this site c.2008. The windows appear to be historic 3/1 wood sash windows, but the foundation, siding, porch, and roof are either new or replacement materials.

This one-story dwelling faces south. It has a concrete masonry unit foundation and a front-gabled roof with asphalt shingles. The exterior is clad with vinyl siding. A one-story, full-width recessed porch spans the south façade. The porch has a concrete masonry unit foundation, vinyl balustrade, and vinyl posts simulating turned wood. The south façade has three bays. The outer bays each contain a three-over-one wood window with vertical muntins in the upper sash and a one-over-one aluminum storm window. Both windows have vinyl shutters. The offset center bay contains a non-historic wood door with nine-light glazing and an aluminum storm door. A vinyl octagonal attic vent pierces the wall below the roof gable on the south façade.

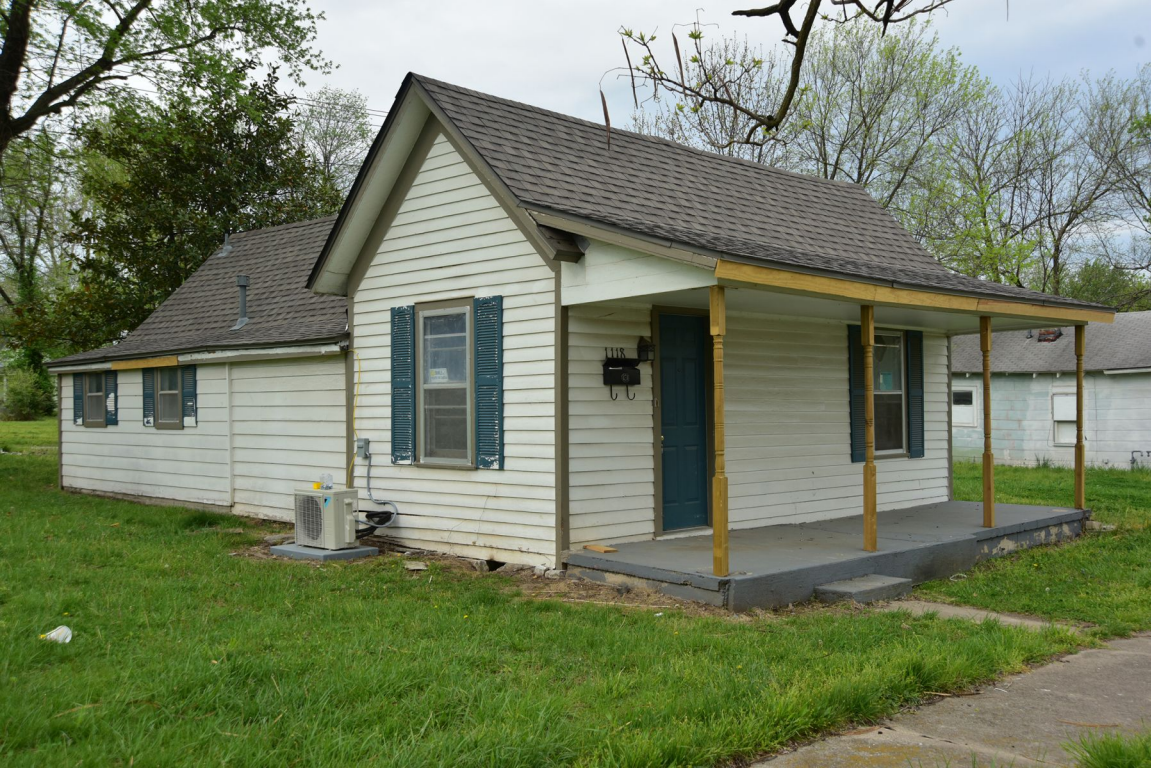
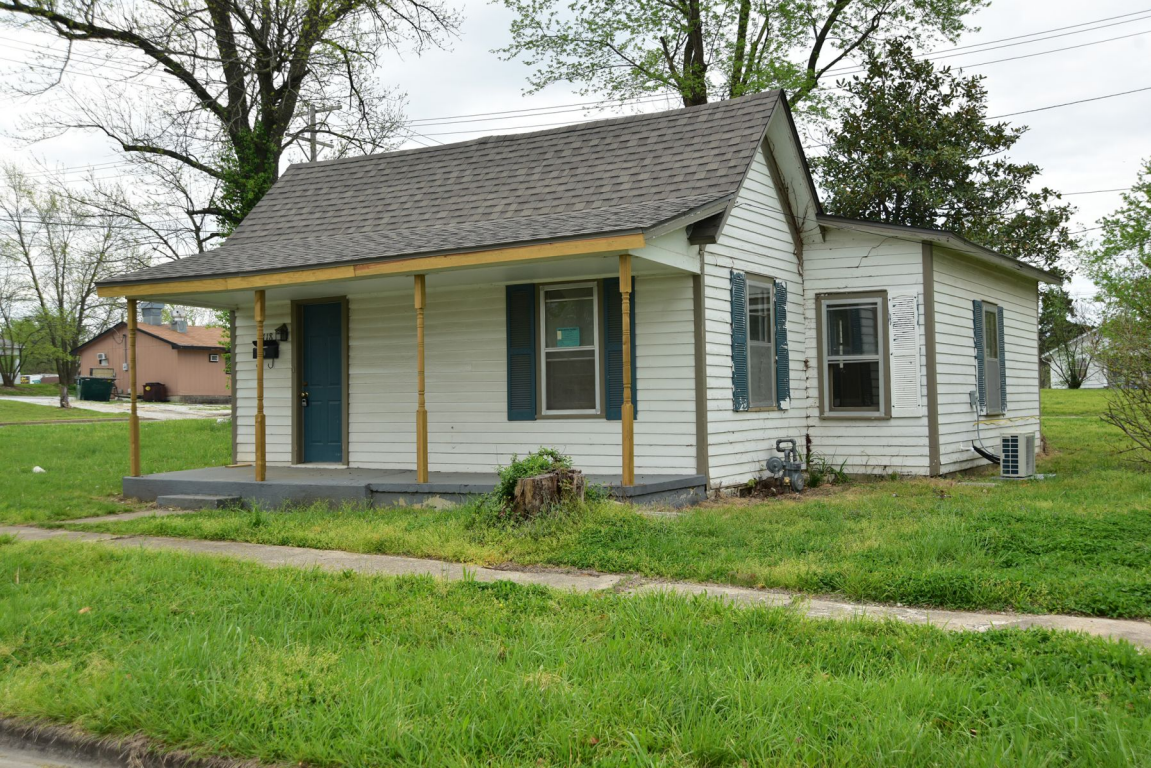
This one-story National Folk House faces north and has a rectangular footprint. It has a stone foundation, wood cladding, and an asphalt shingle roof. It is two bays wide and three bays deep. A non-historic wood door occupies the east bay while a historic one-over-one wood window occupies the west bay. A shed-roof porch shelters the bays. It has a concrete foundation and non-historic turned wood support posts. An enclosed porch projects from the southwest corner of the dwelling.

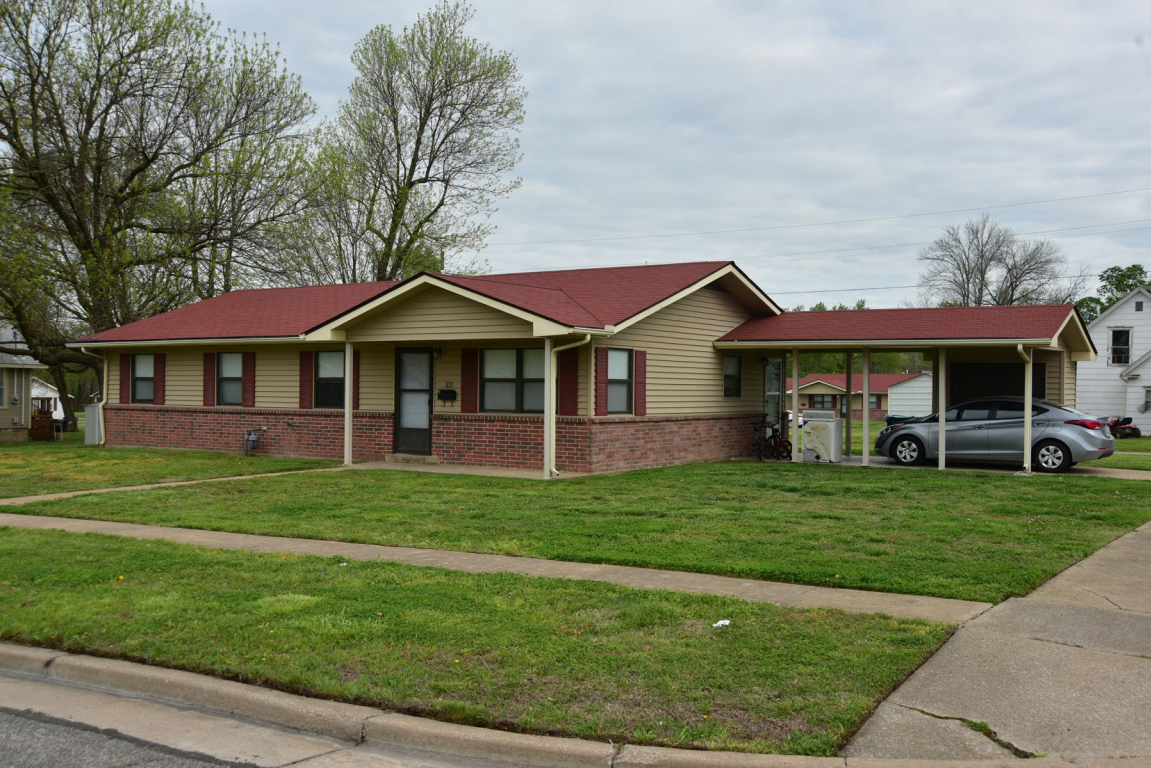
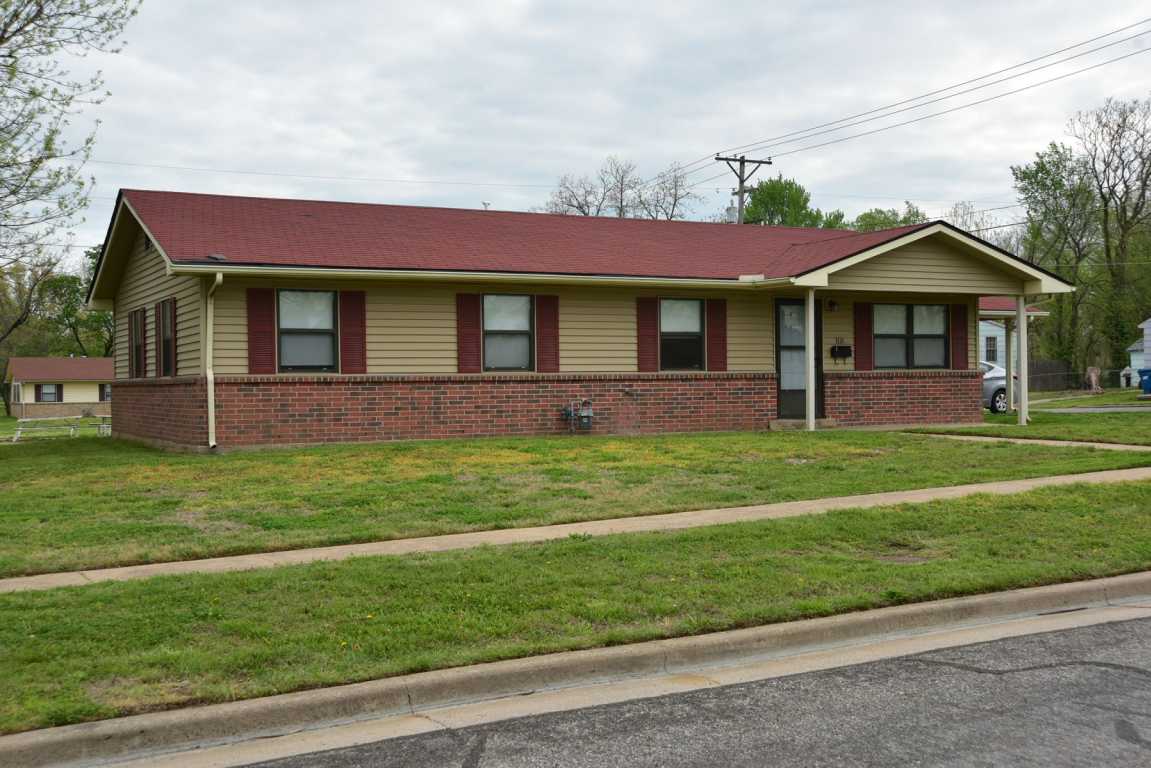
This one-story Ranch type house faces south. It has a poured concrete foundation and a side-gabled roof with asphalt shingles. The lower half of the exterior has red brick veneer cladding and the upper half is clad with vinyl siding. A one-story, partial-width porch with a front-gabled roof with asphalt shingles and vinyl cladding in the gable spans the east portion of the south façade. The porch has a poured concrete slab and vinyl support posts. The south façade has five bays; the two east bays are sheltered by the porch. The three west bays each contain a one-over-one vinyl window with shutters. The fourth bay contains a wood door. The fifth (east) bay contains a pair of one-over-one vinyl windows with shutters. A carport with a side-gabled roof extends from the east elevation. The carport has metal support posts and an attached shed with vinyl siding.

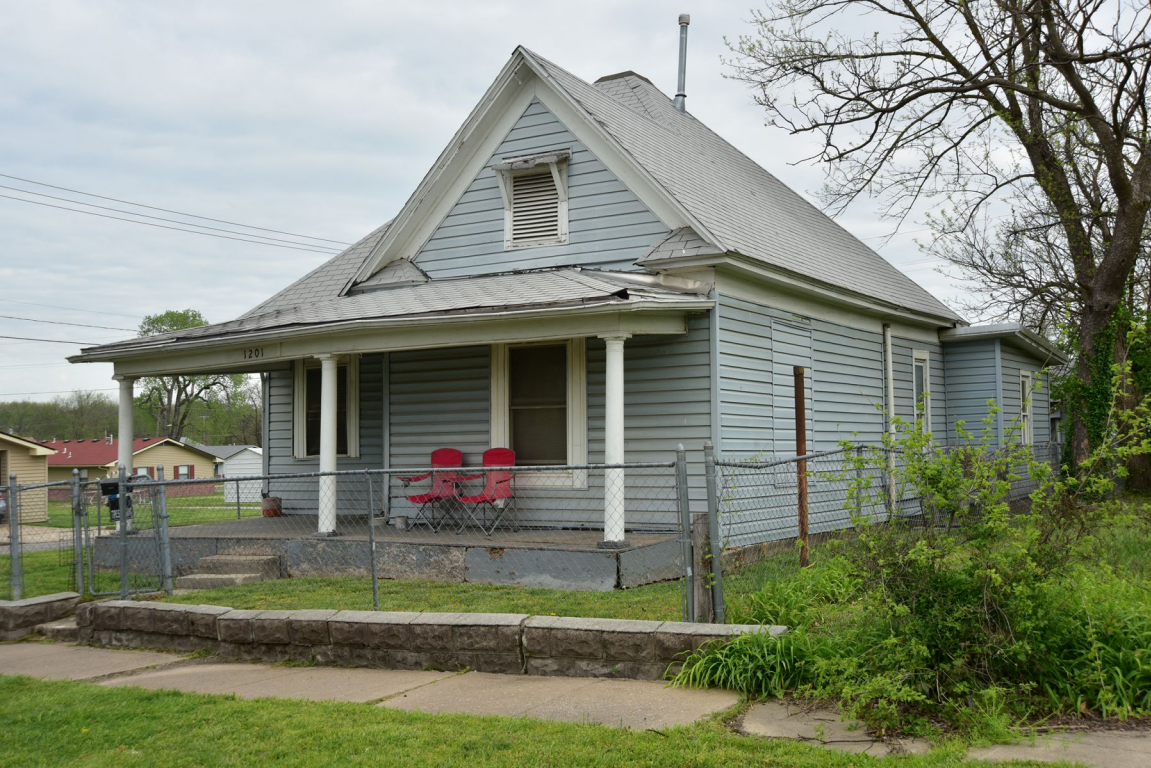
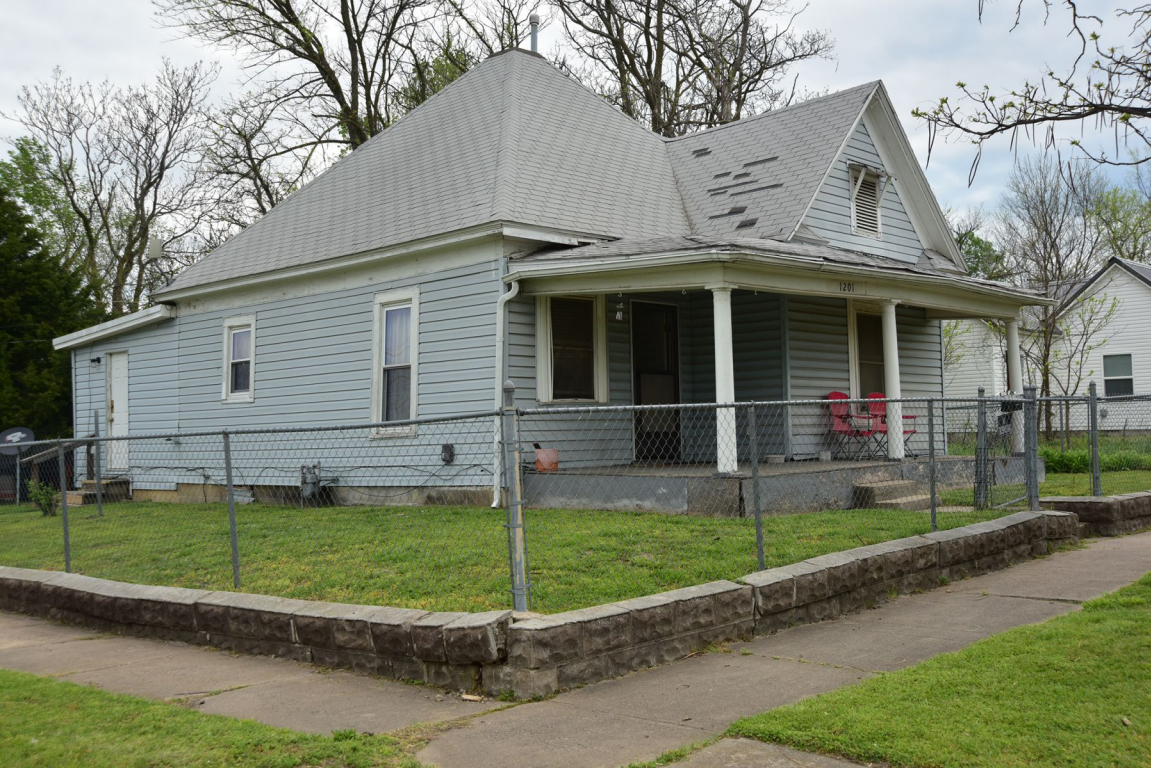
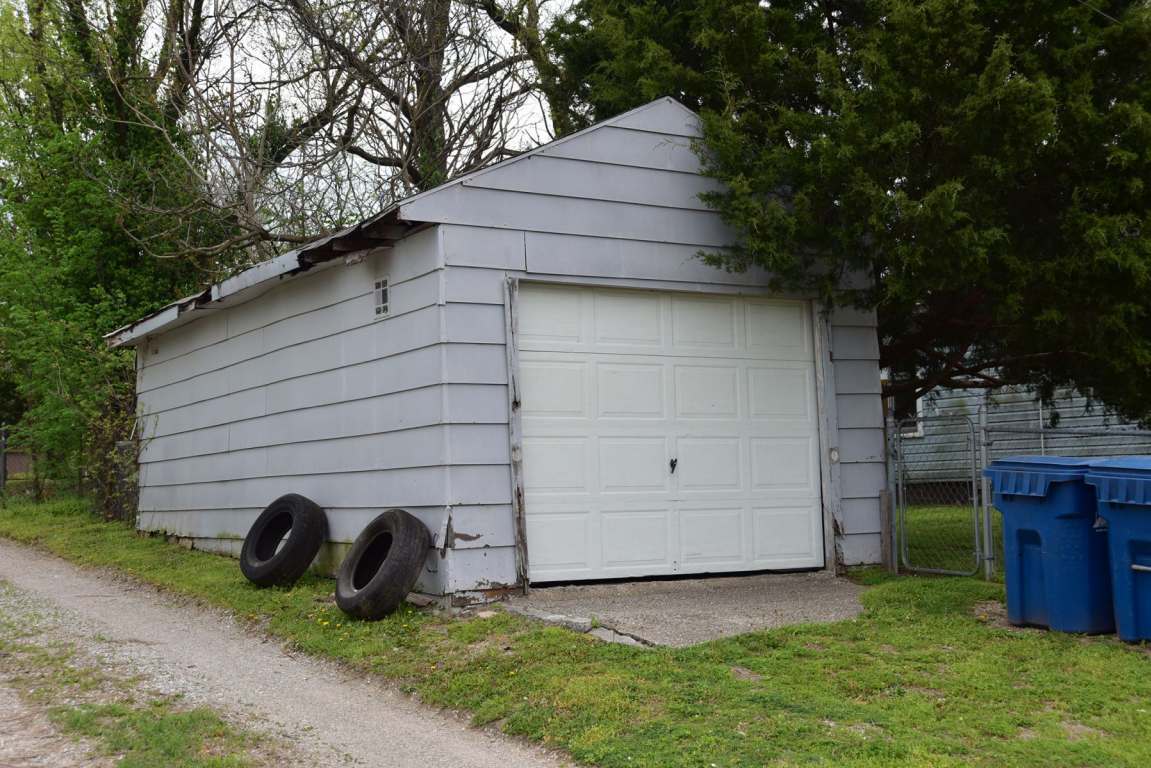
This dwelling faces south and has an L-shaped footprint. It has a concrete foundation and asphalt shingle roof. It has vinyl siding with wood soffits. It is three bays wide and three bays deep. A non-historic wood door occupies the center bay of the primary elevation while non-historic one-over-one wood windows occupy the remaining bays. An open porch with low-hipped roof and concrete foundations spans the primary elevation. Historic wood columns support the roof.

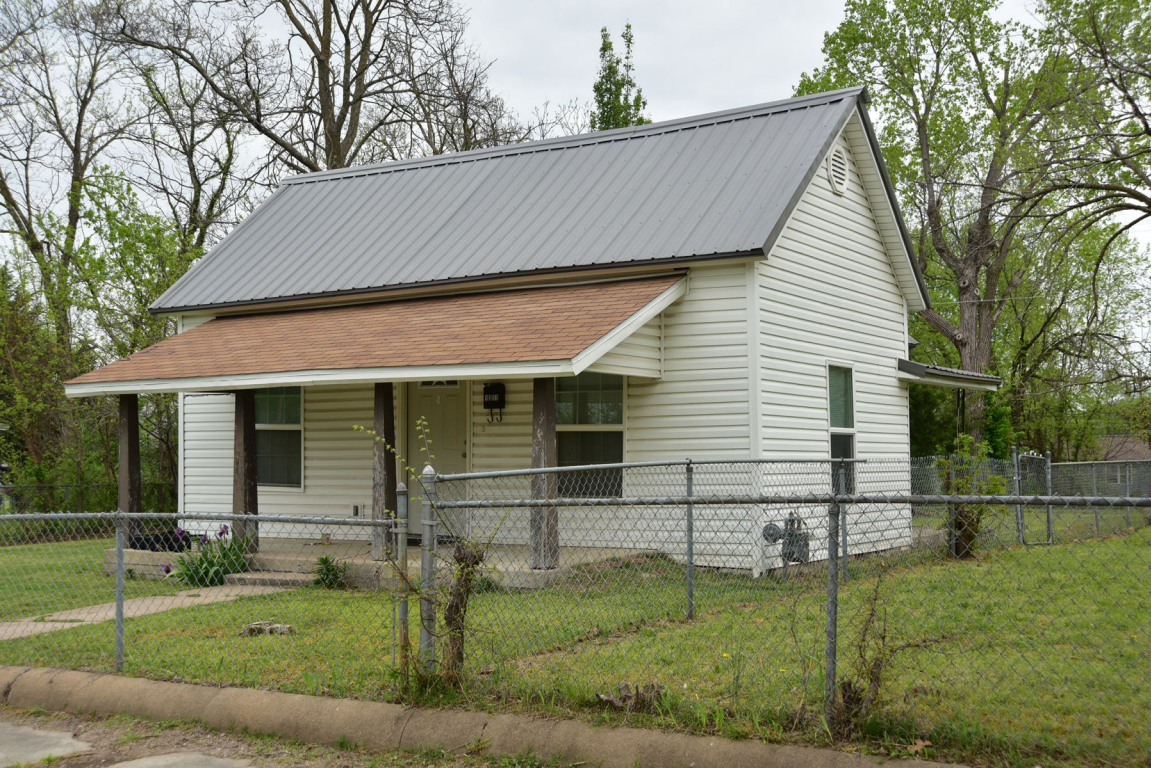
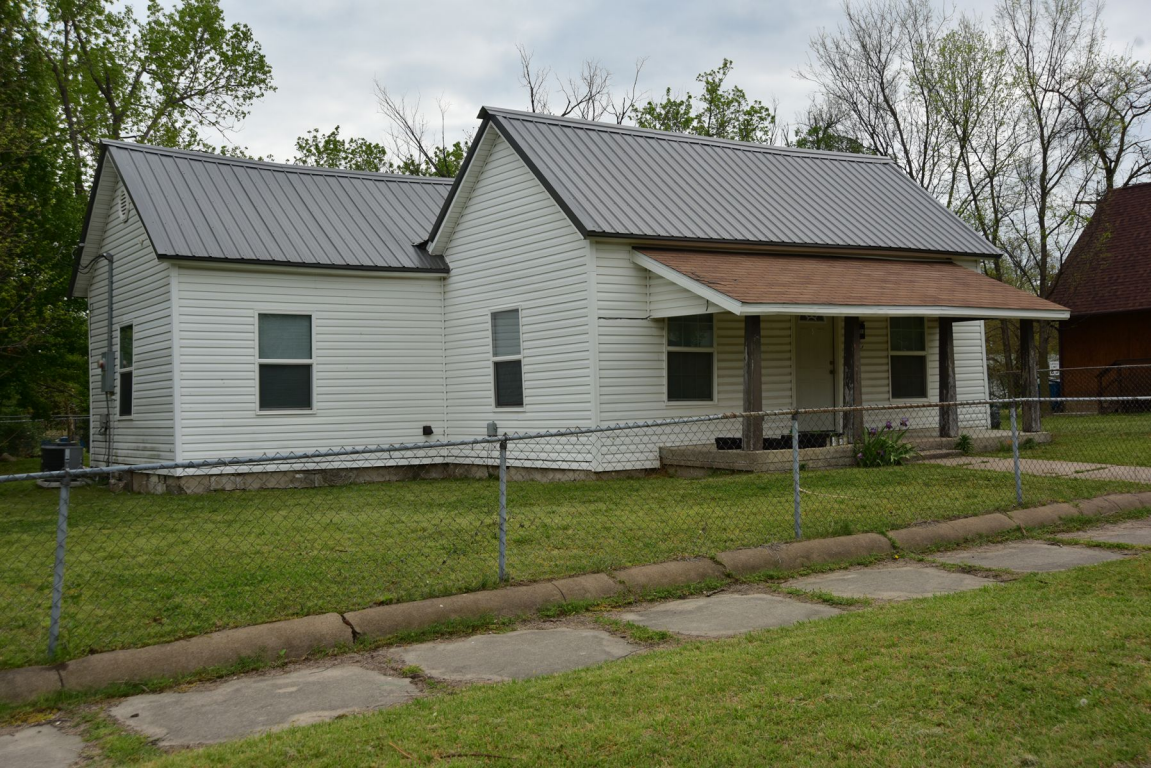
This one-story National Folk House dwelling faces south and has an irregular footprint, which is historic. It has a stone foundation and vinyl cladding. The shed-roof porch features asphalt shingles while the remainder of the roof has corrugated metal. The dwelling is four bays wide and two asymmetrical bays deep. A gabled projection at the west elevation forms the fourth bay. A shed-roof porch shelters the three east bays. It has a concrete foundation and tapered wood support posts. A non-historic fiberglass door occupies the second-from-east bay while six-over-six vinyl windows occupy the adjacent bays. All other windows are one-over-one vinyl.

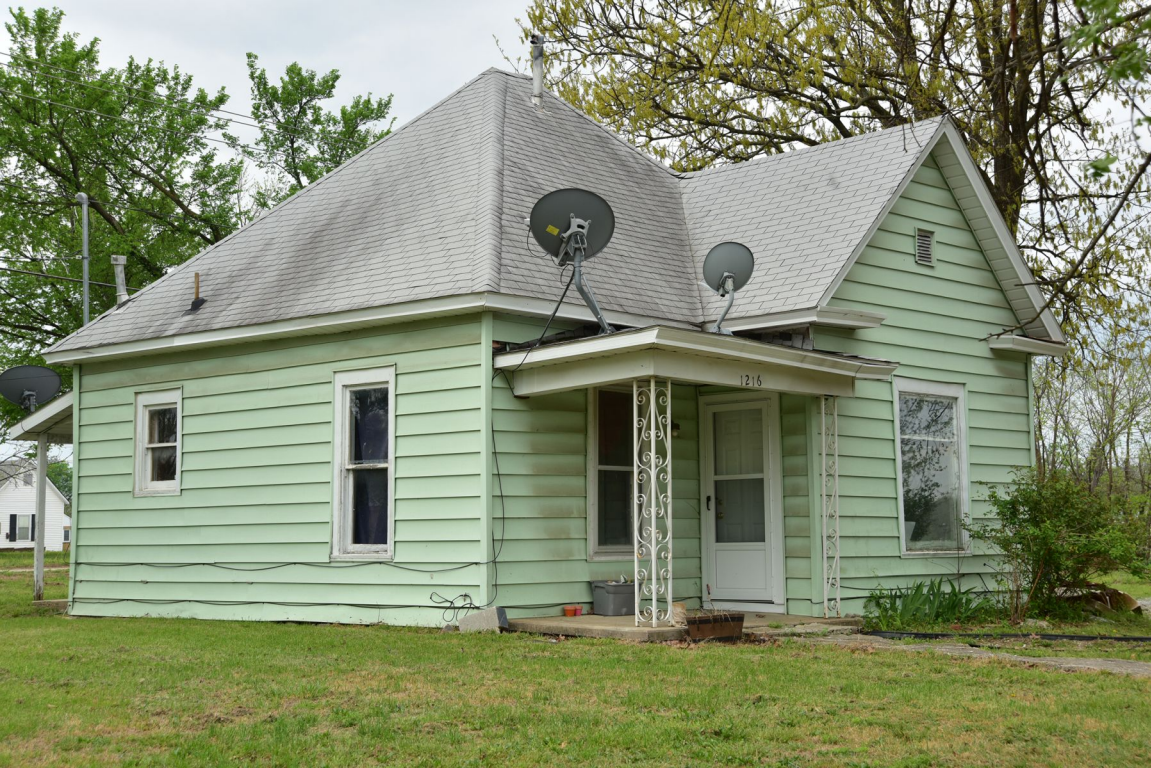
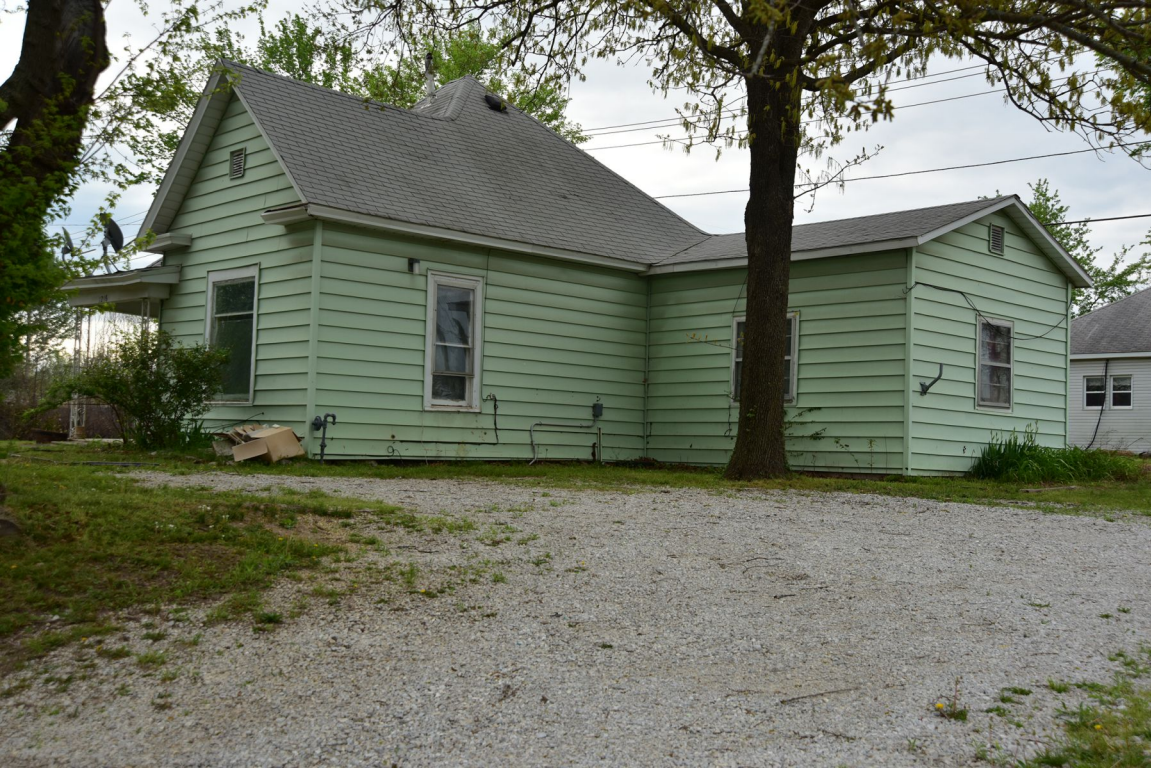
This dwelling faces north and has an L-shaped footprint. It has metal cladding and a pyramidal hipped roof with cross gables. The primary elevation cross-gable is characterized by a rectangular louver and cornice returns. The roof has asphalt shingles and the foundation is not visible. It is two bays wide and two bays deep. The east bay is recessed, creating a partial-width open porch. The porch has a concrete foundation and non-historic decorative metal support posts. Historic one-over-one wood windows occupy the bays while a non-historic wood door is located in the west wall of the cross-gabled ell.

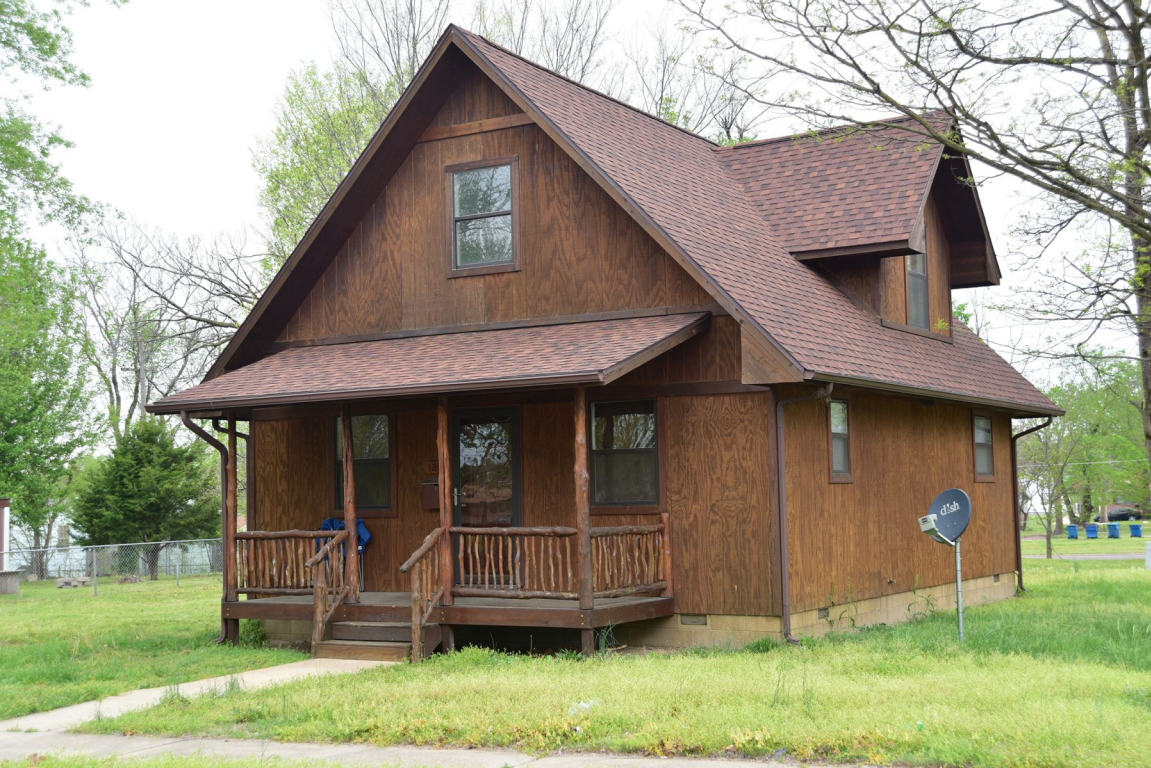
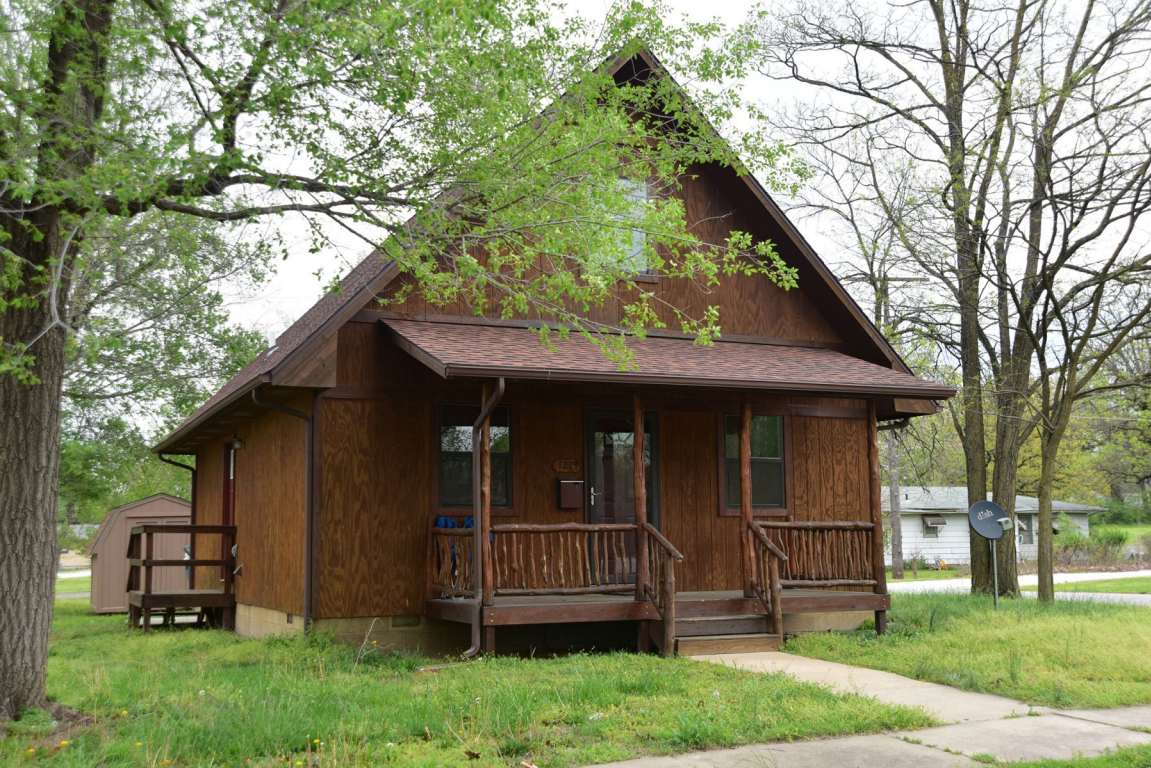
This Open Gable/Gambrel Front dwelling faces south and has a square footprint. It has a concrete masonry unit foundation and wood panel cladding. The front-gable roof has asphalt shingles and wide eaves. The dwelling is three bays wide and two bays deep. A three-quarter width open porch with a shed roof and wood floor is located at the primary elevation. It has raw wood support posts and balustrades. The dwelling has one-over-one metal windows and a wood door.

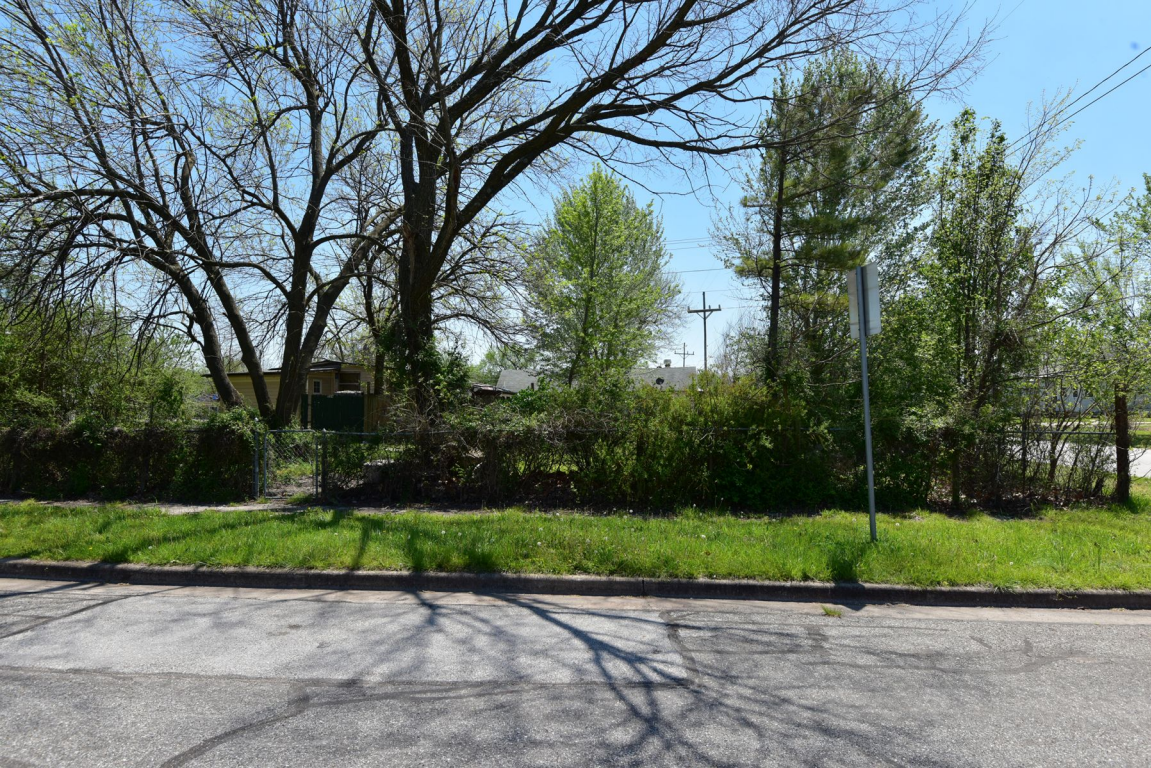
An outbuilding with an L-shaped footprint, pressboard cladding, one-over-one vinyl windows is located in the southeast corner. A wood privacy fence encircles the outbuilding. The fence displays the address "1304."

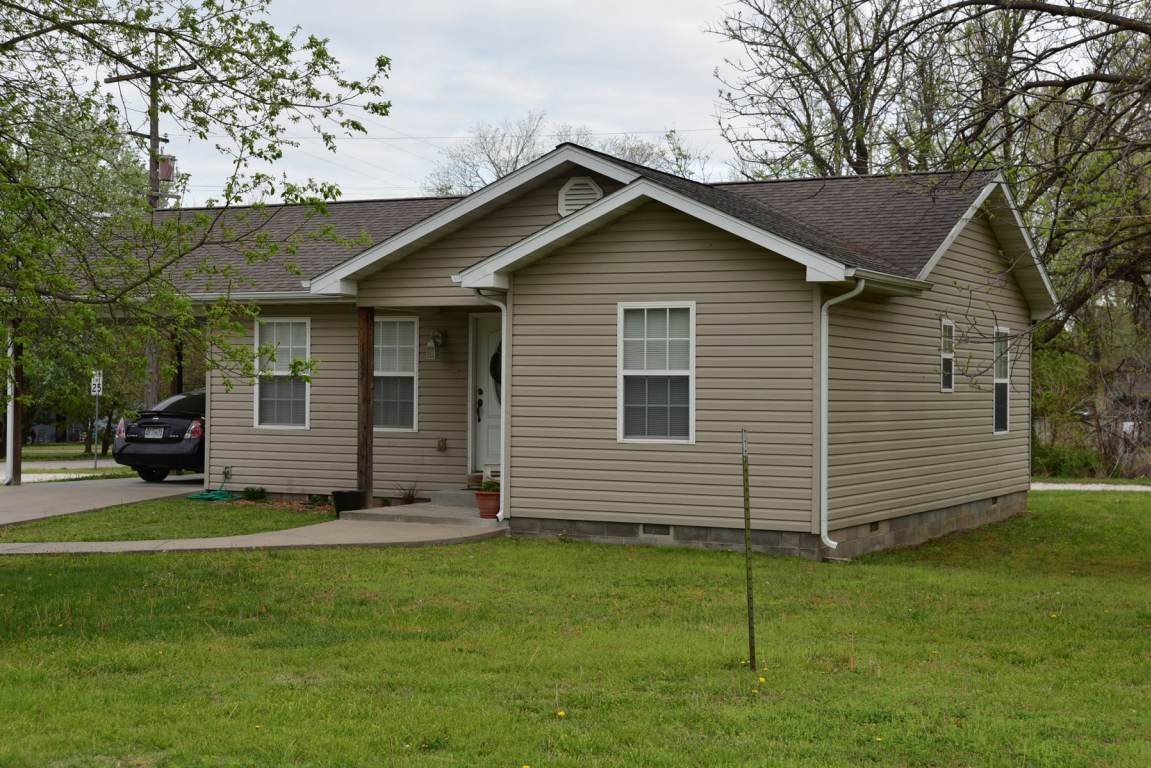
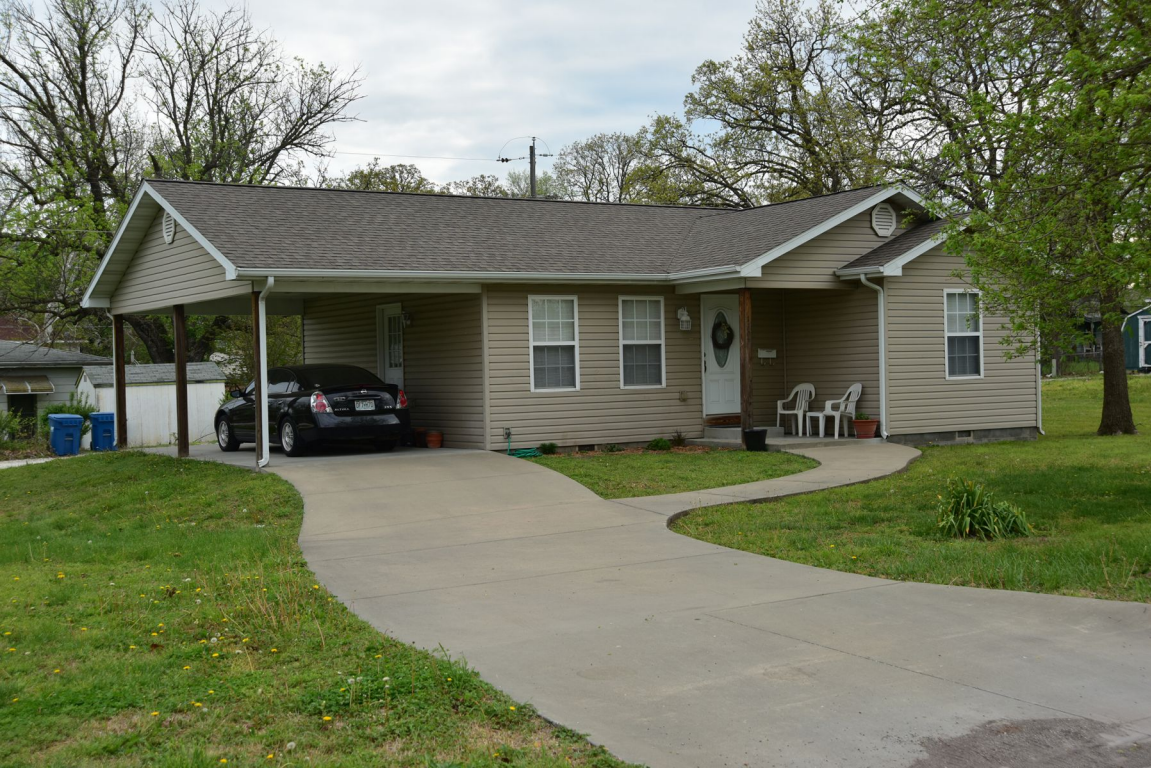
The dwelling fronts E. Hill Street to the south and is located in the east portion of the Survey Area. A concrete driveway leads to the carport while a concrete walkway leads to the front porch. An ornamental lawn with deciduous trees characterizes the landscaping. An east-west gravel alley abuts the north edge of the property. No outbuildings were observed.

This one-story Ranch dwelling faces south and has an L-shaped footprint. It is four bays wide and one bay deep. A wood door with oval glazing occupies the second-from-east bay while six-over-six vinyl windows occupy the remaining bays. A carport with wood support posts projects from the west elevation.
