MISSOURI DEPARTMENT OF NATURAL RESOURCES
STATE HISTORIC PRESERVATION OFFICE, P.O. Box 176, Jefferson City, MO 65102
ARCHITECTURAL/HISTORIC INVENTORY FORM

1. Survey number: JP-AS-006-093		2. Survey Name: East Town (Original Joplin) Historic Survey Phase 1	
3. County: JASPER		4. Address 1302	Street (name): E. Furnace Street
5. City: Joplin	Vicinity <input type="checkbox"/>	7. Township/Range/Section: T: R: S:	
8. Historic name (if known):		9. Present/other name (if known):	
10. Ownership: <input checked="" type="checkbox"/> Private <input type="checkbox"/> Public		11a. Historic use (if known): Domestic/Single Dwelling	11b. Current use: Domestic/Single Dwelling

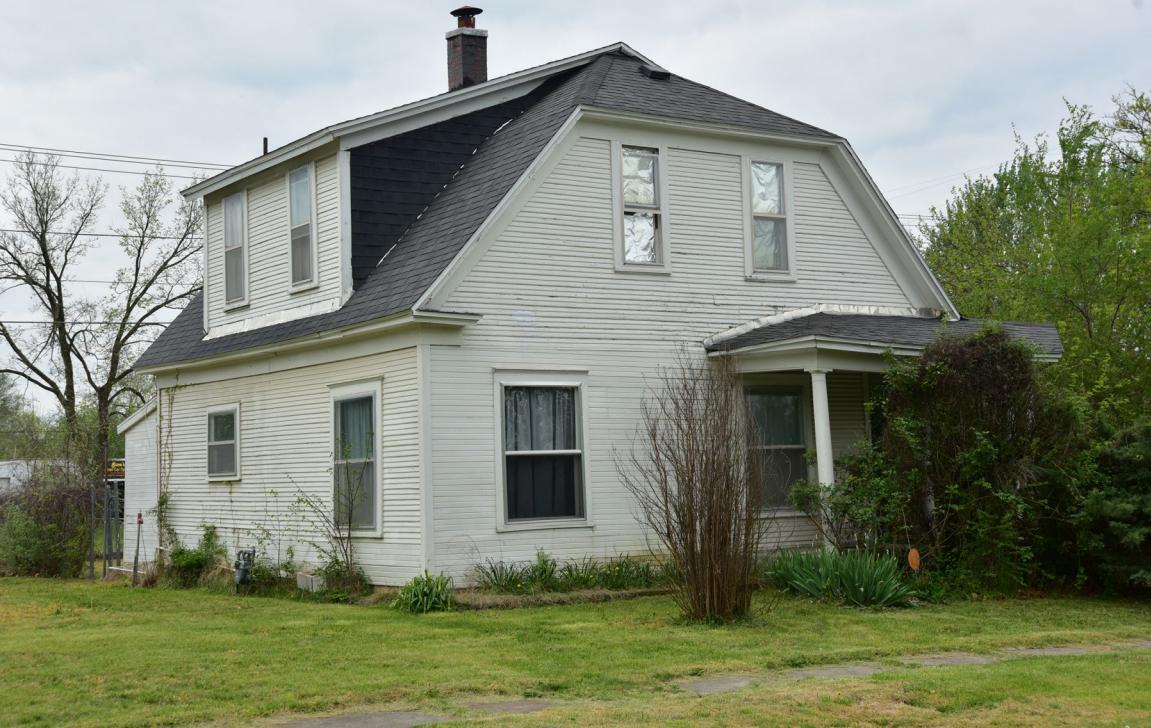
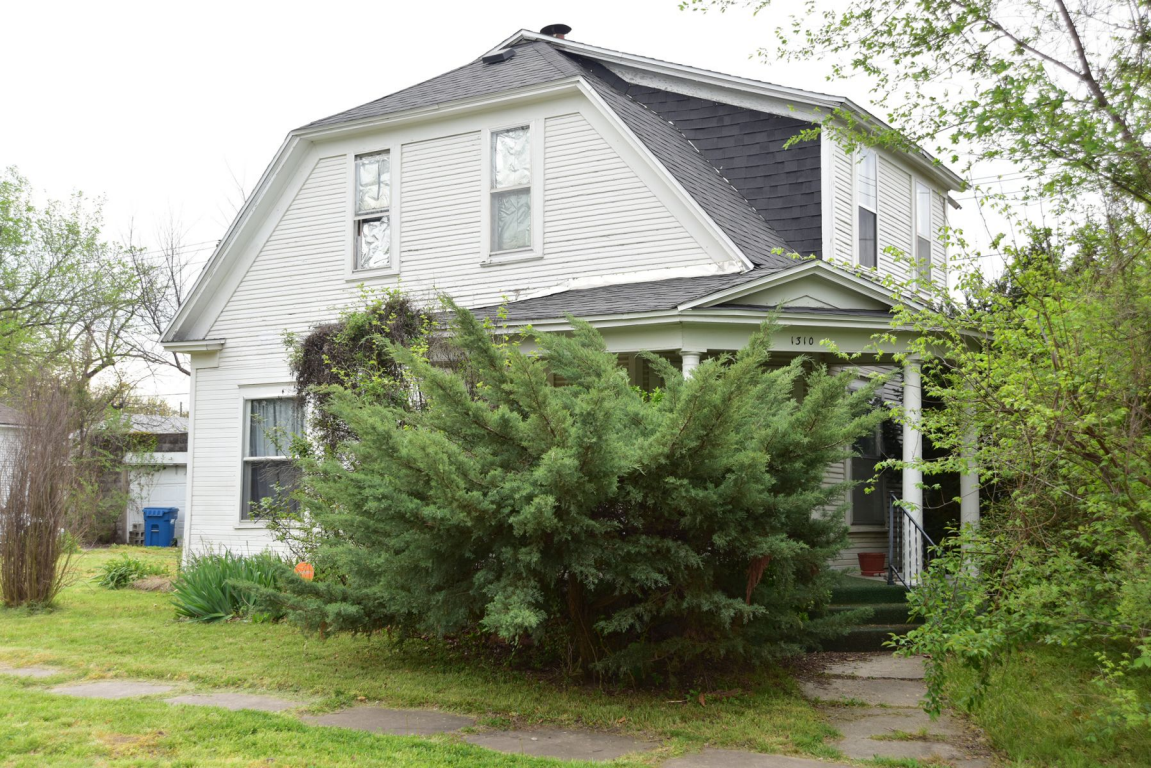
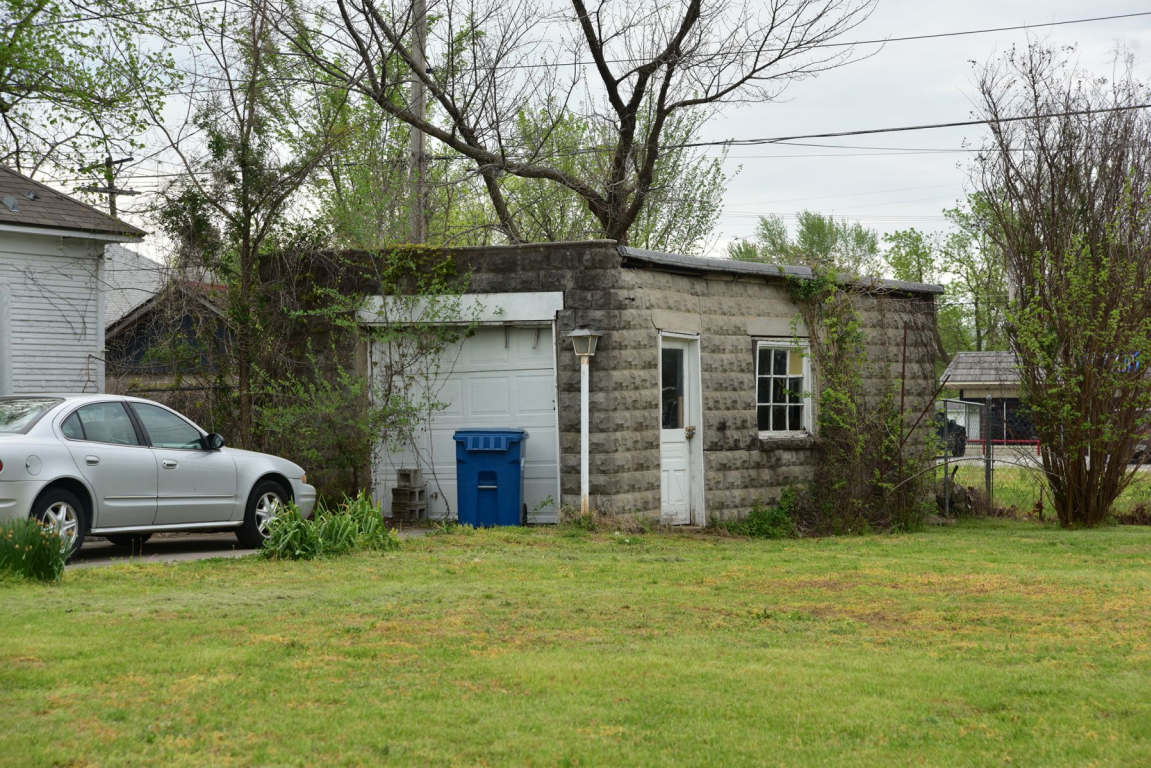
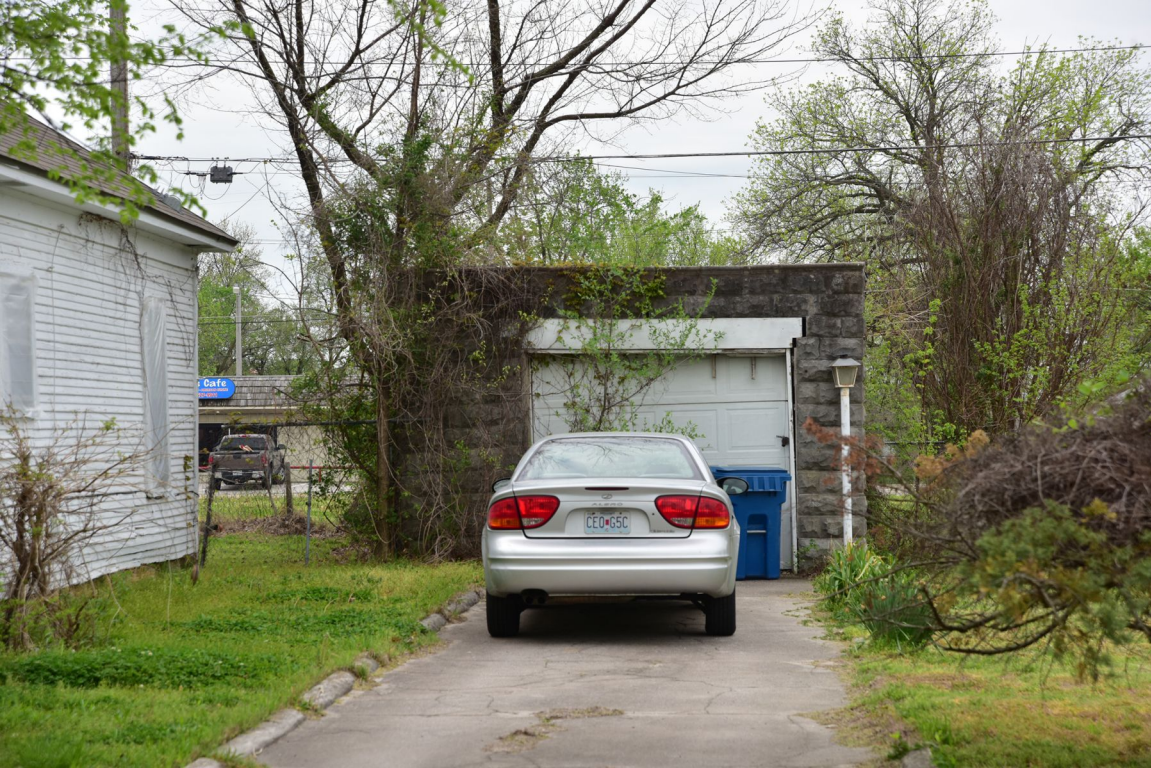
1310

This Open Gable/Gambrel Front dwelling faces north and has an irregular footprint. It has a stone foundation and wood clapboard cladding. The gable hipped roof has asphalt shingles. Shed-roof dormers are located on the east and west slopes of the roof. The dormer fronts have wood clapboard cladding while the sides have asphalt shingle. The dwelling is three bays wide and two bays deep. An enclosed porch with shed roof spans the south elevation. An open porch wraps around the northeast corner and features a small gablet and asphalt shingle roof. Wood Tuscan columns support the roof and the foundation is stone. The primary entrance is located at the northeast corner and has a non-historic wood door. Historic one-over-one wood windows occupy the remaining bays.

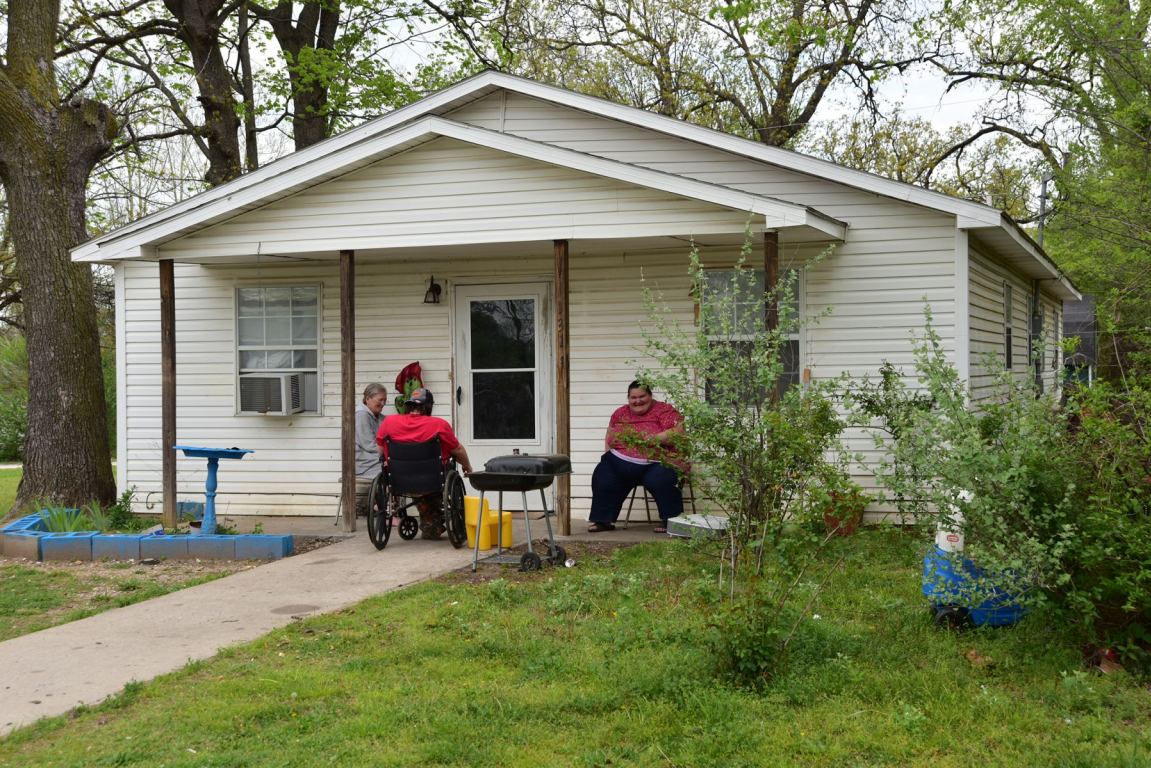
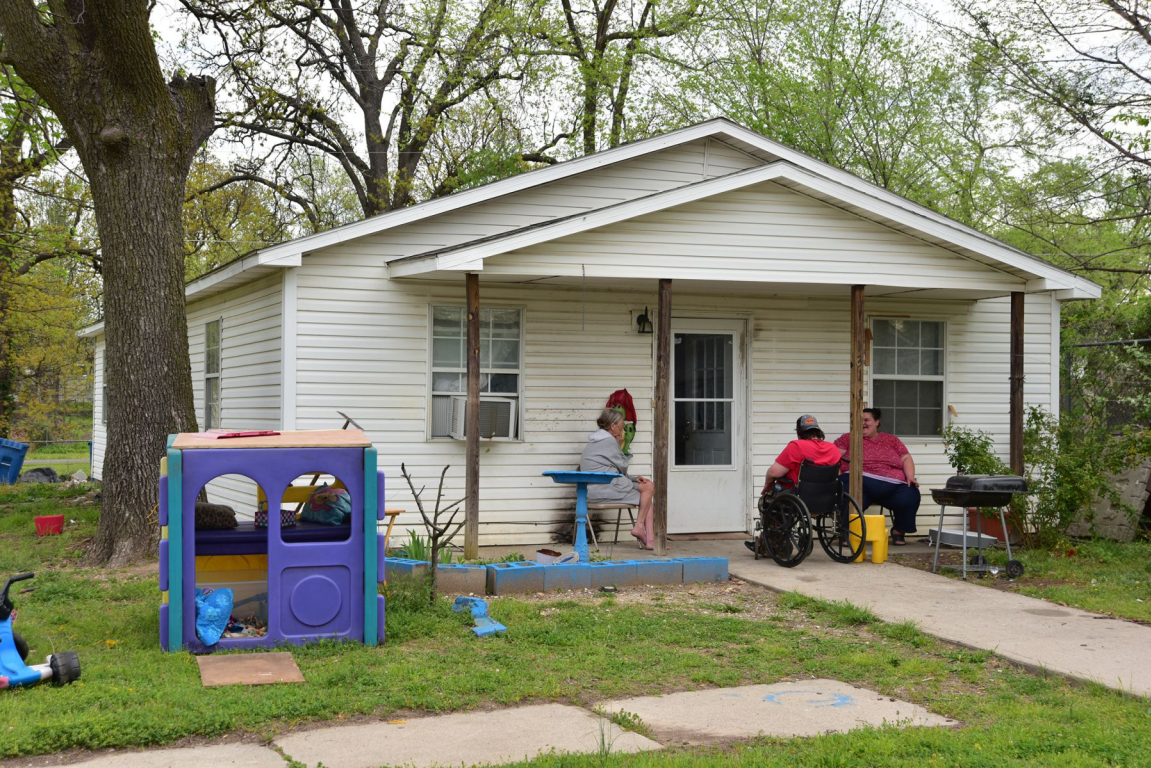
This one-story dwelling faces south and has a rectangular footprint. It has a concrete foundation and vinyl cladding. The front-gable roof has asphalt shingles. The dwelling is three bays wide and three bays deep. A non-historic wood door occupies the center bay of the primary elevation while six-over-six vinyl windows occupy the remaining bays. An open, three-quarter width porch with a concrete foundation and front-gable roof shelters the bays. Non-historic squared wood posts support the porch roof.

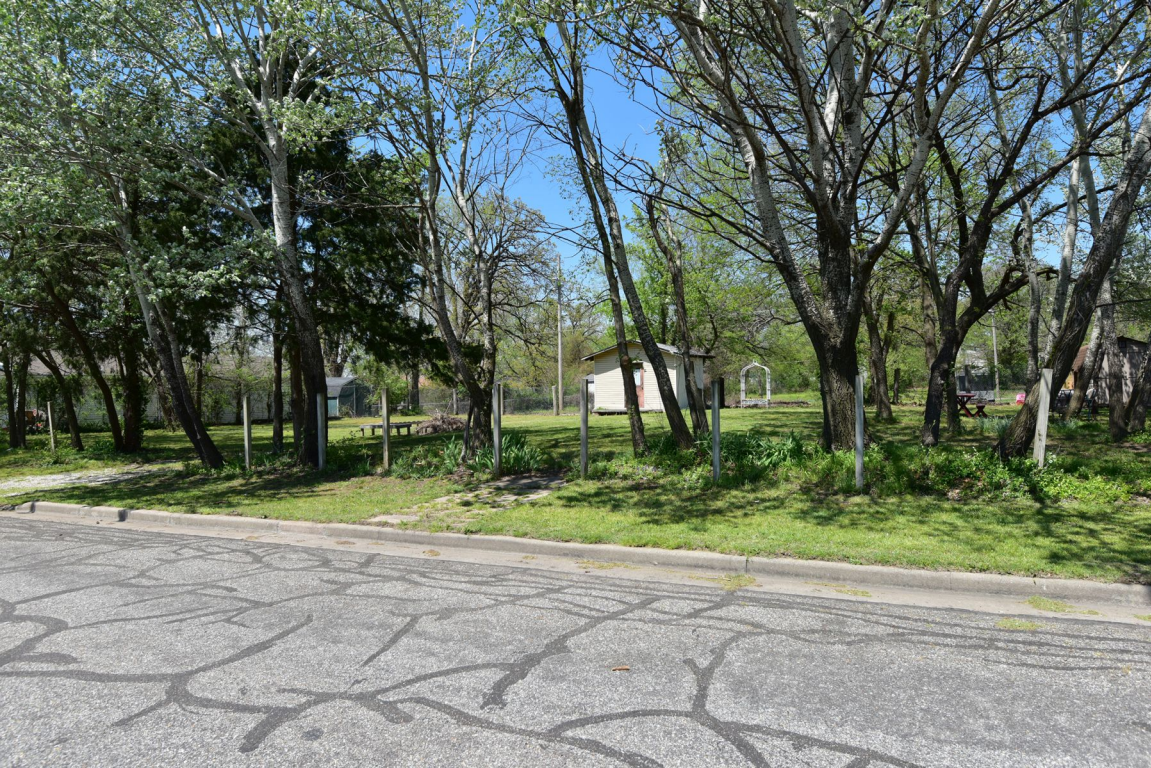
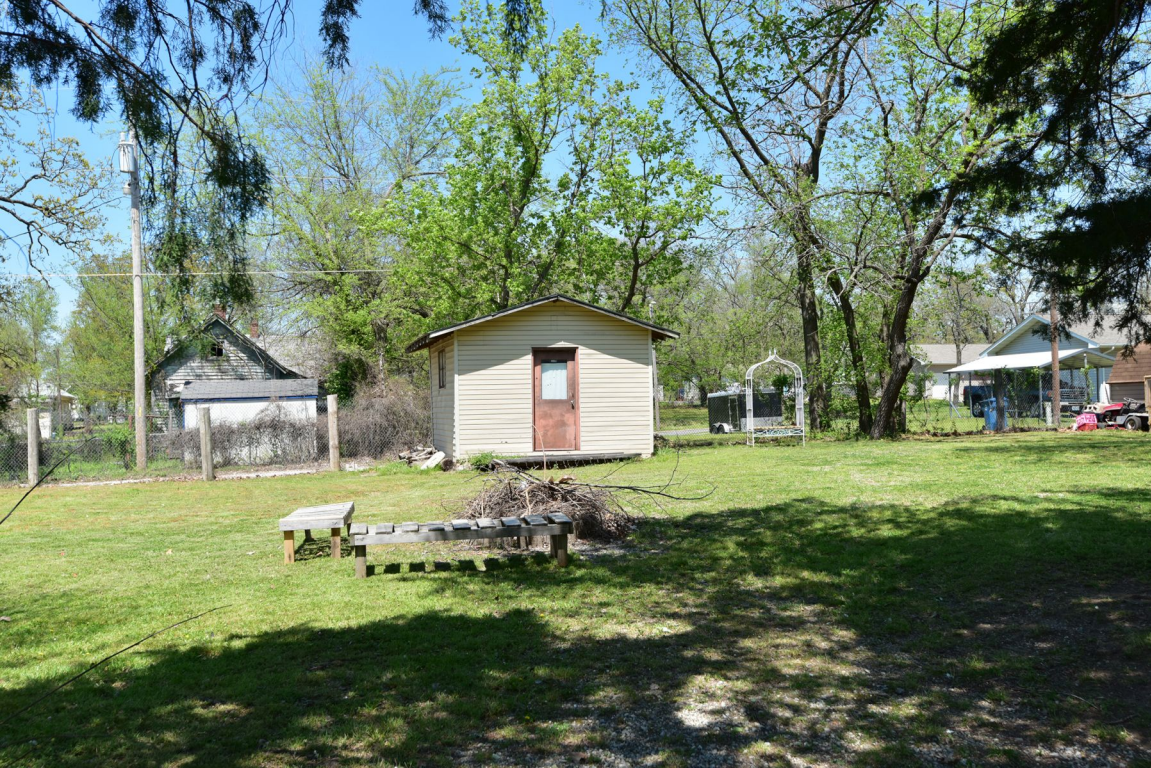
This lot fronts E. Hill Street to the south and is located in the east portion of the survey area. A large, open grass area bordered by mature deciduous trees characterizes the lot. Wood fence posts lines the south and west edges of the lot. A gravel drive is located at the west half of the south edge while a concrete walkway is located at the south half. An east-west gravel alley abuts the north edge of the property. A front-gable shed outbuilding with vinyl cladding is located at the rear of the lot. The roof features asphalt shingles and exposed rafter tails. A non-historic metal door with glazing occupies the primary elevation bay.

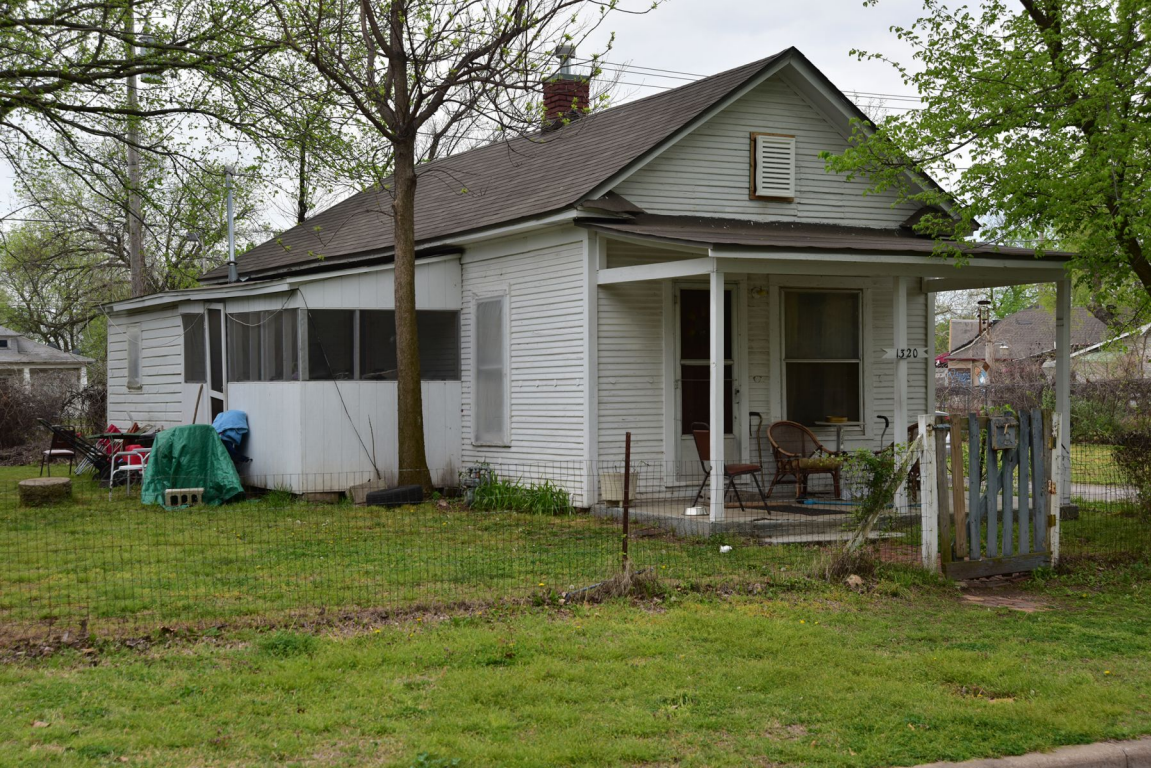
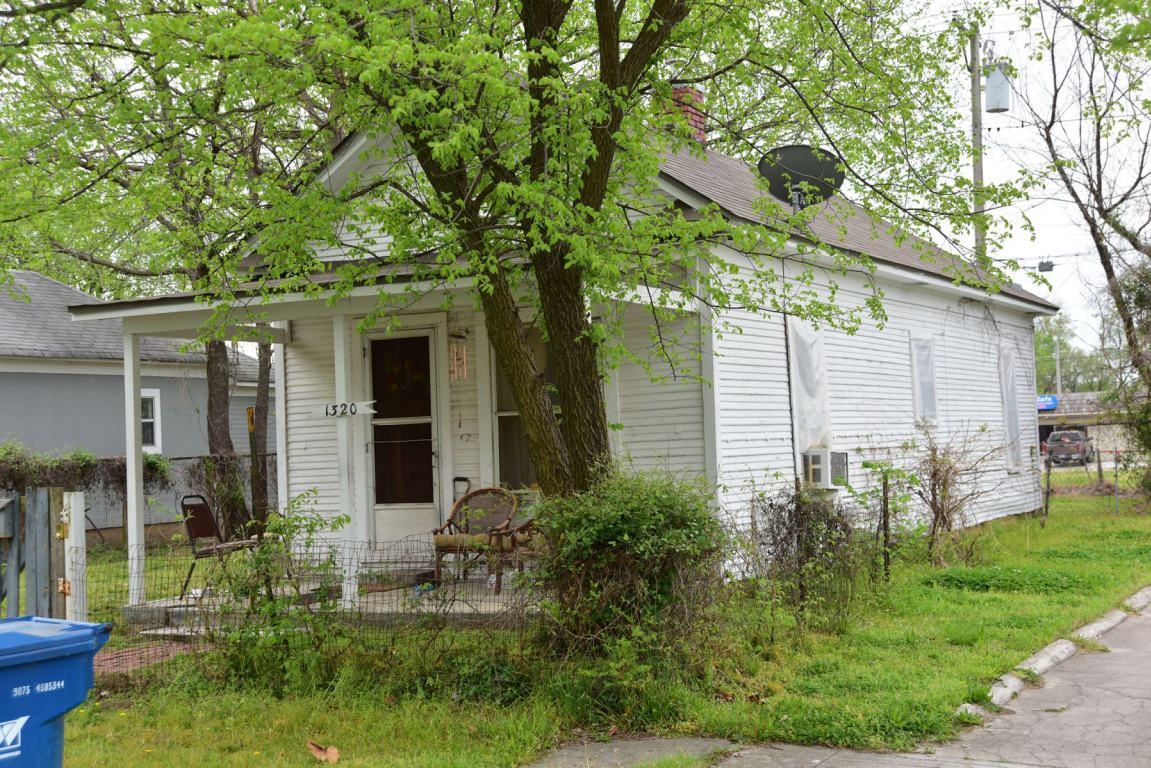
1320

The dwelling fronts E. Hill Street to the north and is located in the east portion of the Survey Area. An ornamental lawn with mature deciduous trees characterizes the landscaping. A non-historic chicken wire and metal post fence encircles the lawn. An east-west gravel alley abuts the north edge of the property. No outbuildings were observed.

This Shotgun dwelling faces north and has an L-shaped foot print. It has a stone foundation and wood clapboard cladding. The front-gable roof features asphalt shingles, brick straddle-ridge chimney, and a louver in the gable peak. A non-historic open porch with a concrete foundation and shed roof spans the width of the primary elevation. The dwelling is two bays wide and three bays deep. An enclosed porch with a shed roof and pressboard cladding projects from the east elevation. A non-historic wood door occupies the east bay of the primary elevation while a historic one-over-one wood window occupies the west bay.

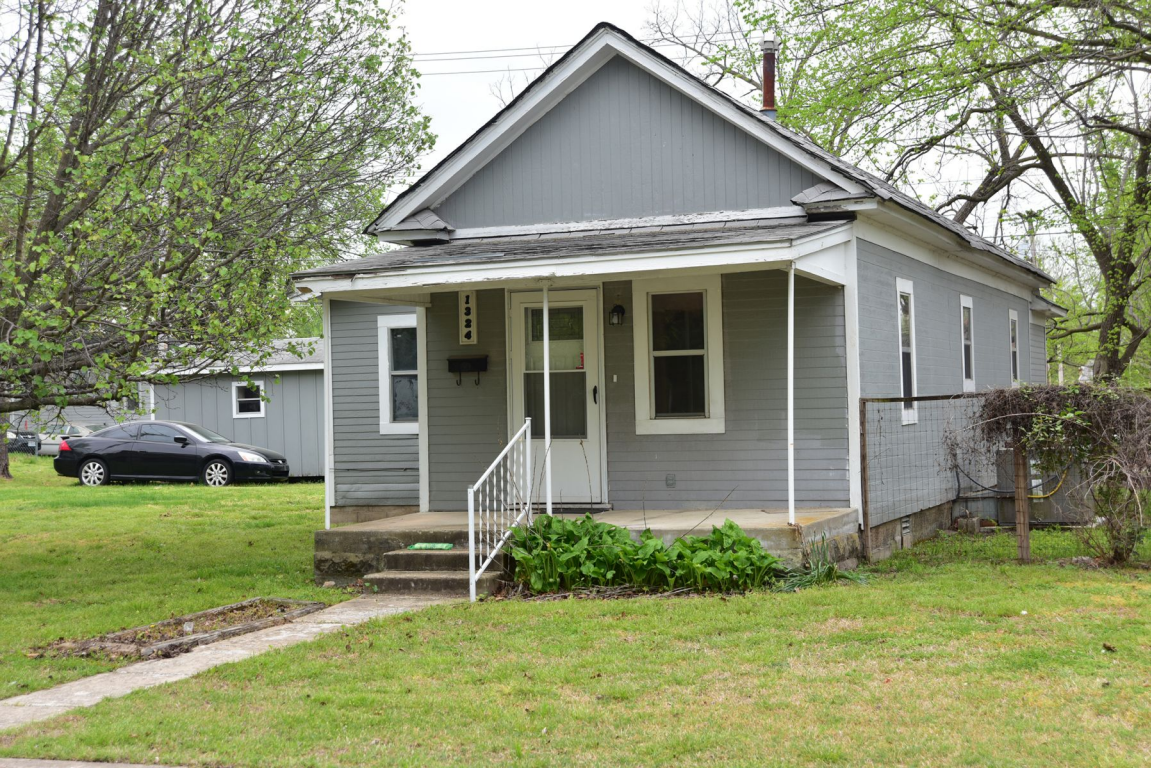
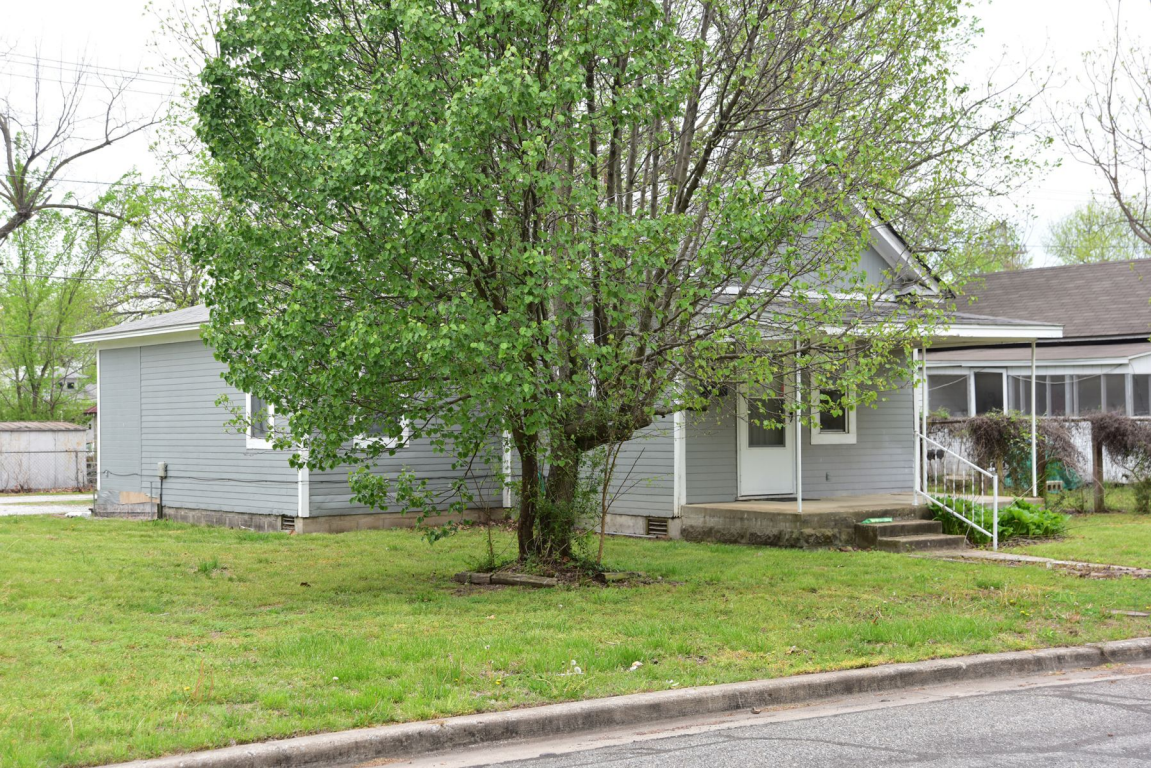
This Shotgun dwelling faces north and has a T-shaped footprint. It has a stone and concrete masonry unit foundation and wood cladding. The front-gable roof features asphalt shingles and cornice returns. A non-historic porch with a shed roof and concrete foundation spans the primary elevation and an enclosed porch addition projects from the east elevation. A non-historic wood door with glazing occupies the east bay of the primary elevation while a non-historic one-over-one vinyl window occupies the west bay.
