MISSOURI DEPARTMENT OF NATURAL RESOURCES
STATE HISTORIC PRESERVATION OFFICE, P.O. Box 176, Jefferson City, MO 65102
ARCHITECTURAL/HISTORIC INVENTORY FORM

1. Survey number: JP-AS-006-260		2. Survey Name: East Town (Original Joplin) Historic Survey Phase 1	
3. County: JASPER		4. Address 1506	Street (name): E. North Street
5. City: Joplin	Vicinity <input type="checkbox"/>	7. Township/Range/Section: T: R: S:	
8. Historic name (if known):		9. Present/other name (if known):	
10. Ownership: <input checked="" type="checkbox"/> Private <input type="checkbox"/> Public		11a. Historic use (if known): Domestic/Single Dwelling	11b. Current use: Domestic/Single Dwelling

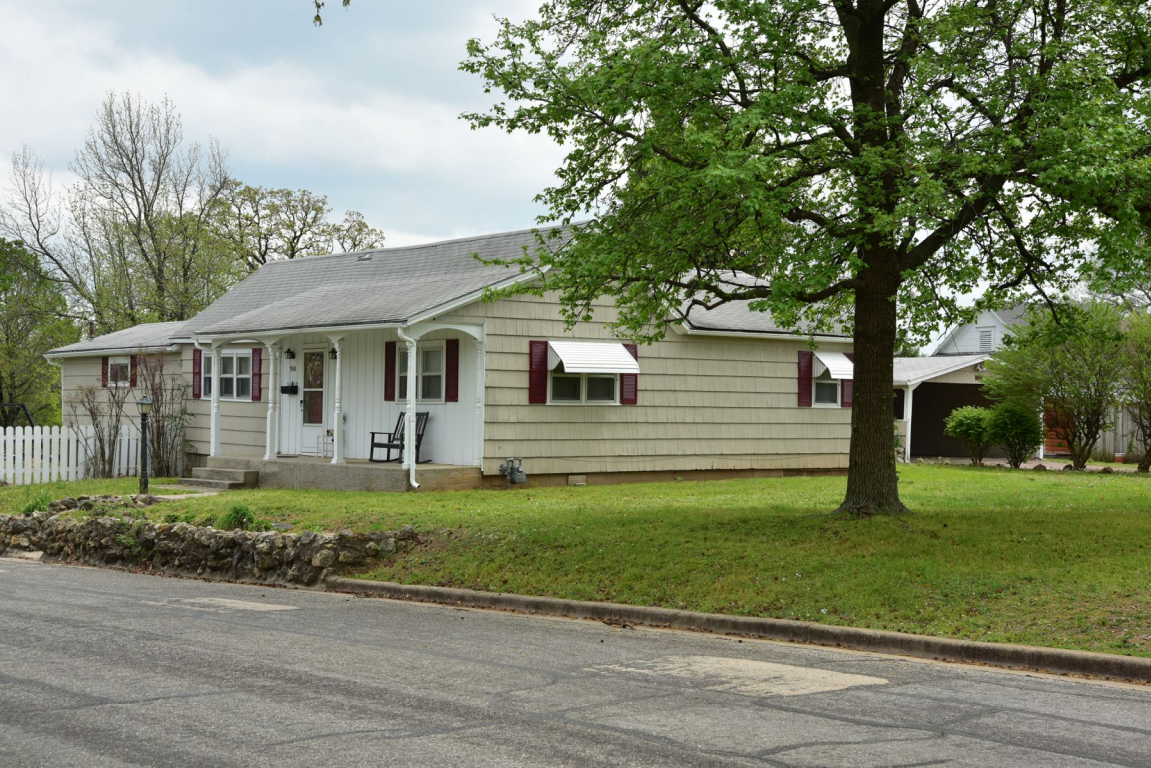
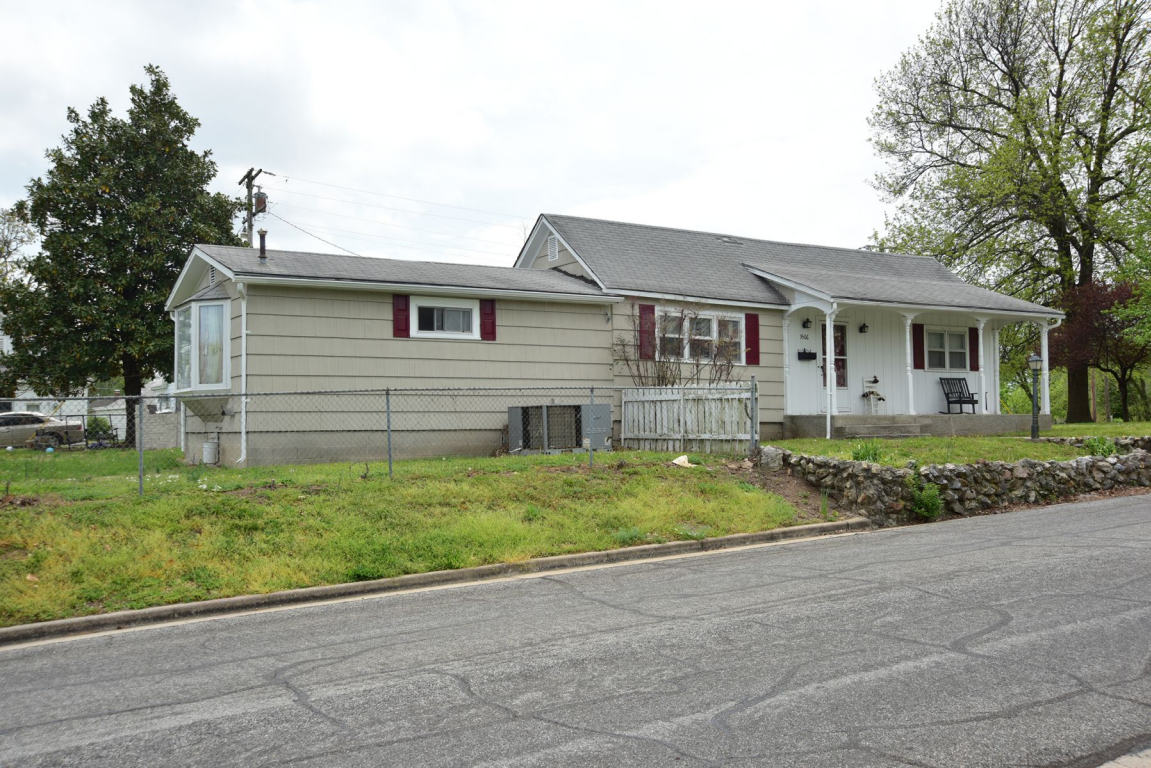
This Ranch dwelling faces north and has an L-shaped footprint. It has a concrete masonry unit foundation and asphalt roof. The west two bays of the primary elevation have wood cladding while the remaining of the dwelling has asphalt siding. The dwelling is four asymmetrical bays wide and two asymmetrical bays deep. A side-gabled addition contains the east bay, which includes a metal one-by-one sliding window. A pair of one-over-one wood windows occupies the west bay while a bank of three matching windows occupies the second-from-east bay. A non-historic wood door occupies the remaining bay. An open porch shelters the west two bays. It has a shed roof, concrete foundation, and non-historic turned wood support posts.

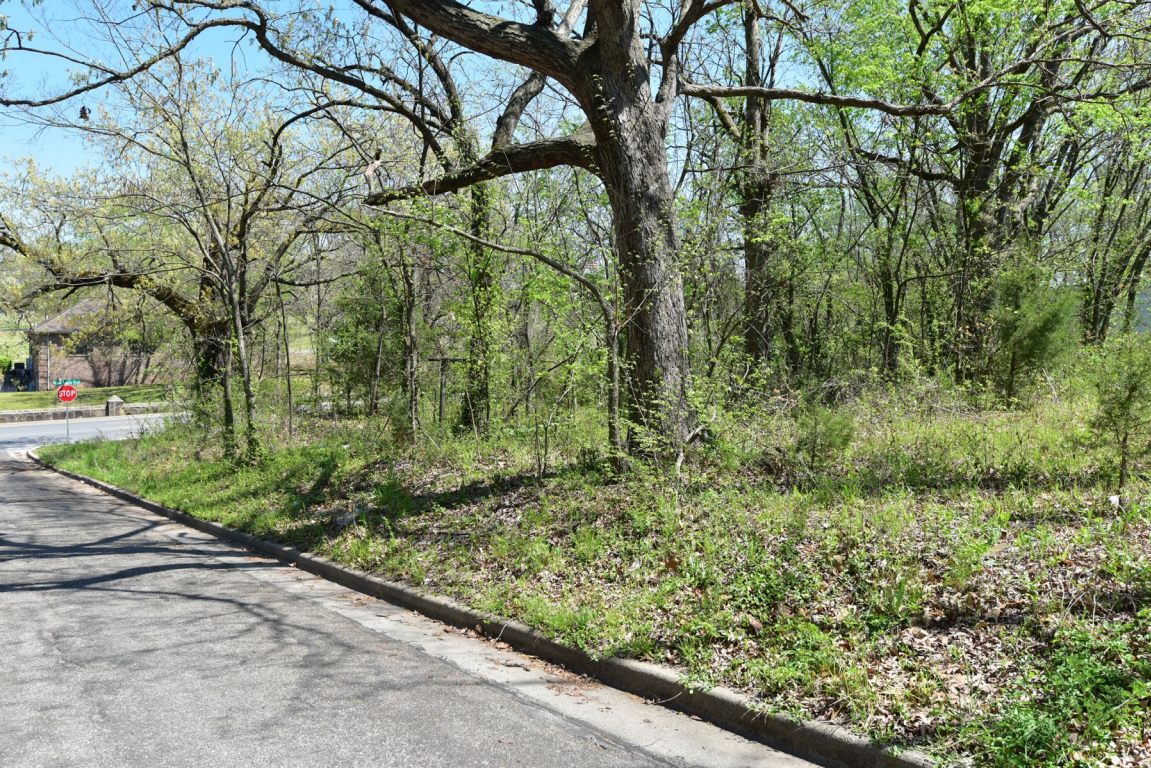
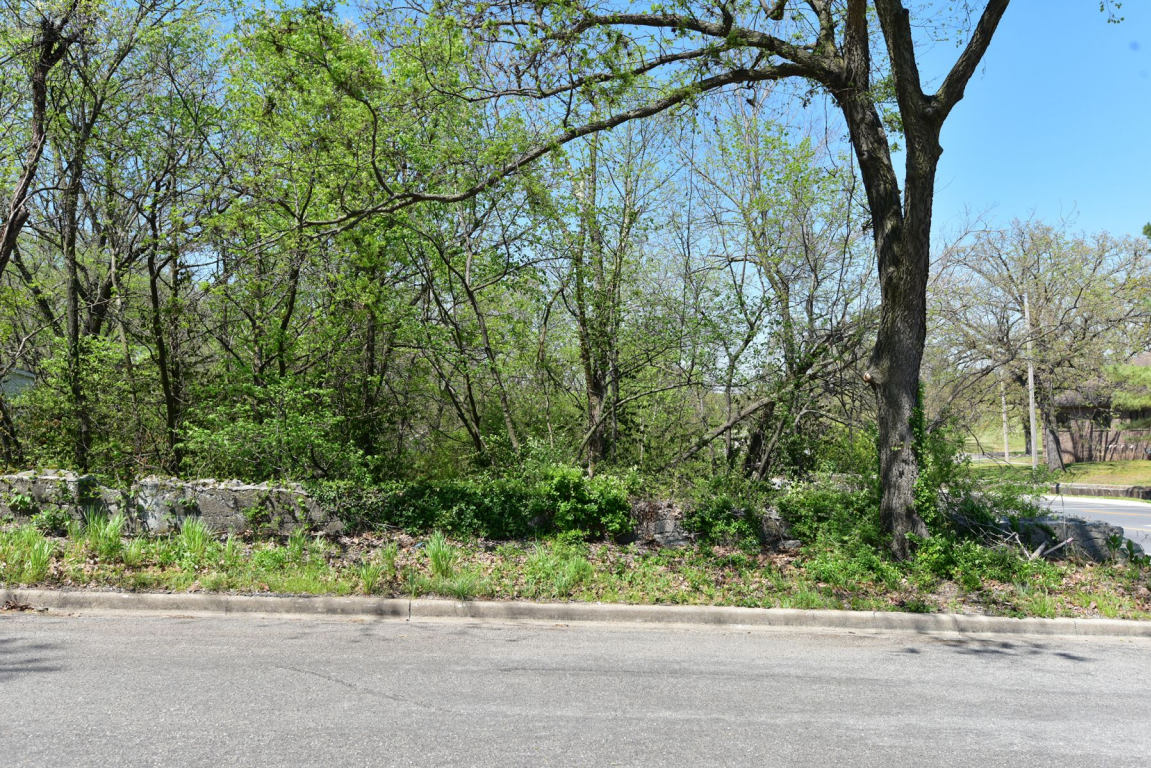
This vacant lot is heavily wooded. A parged retaining wall lines the corner.

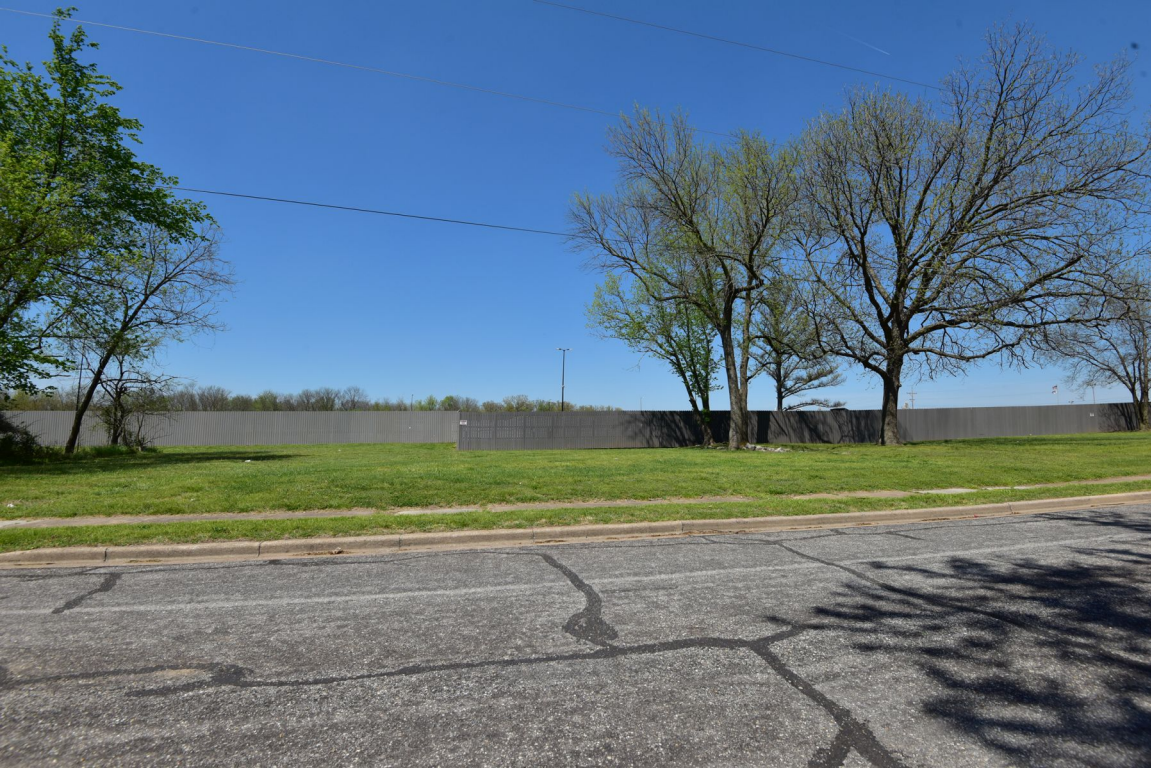
This grassy lot is vacant.

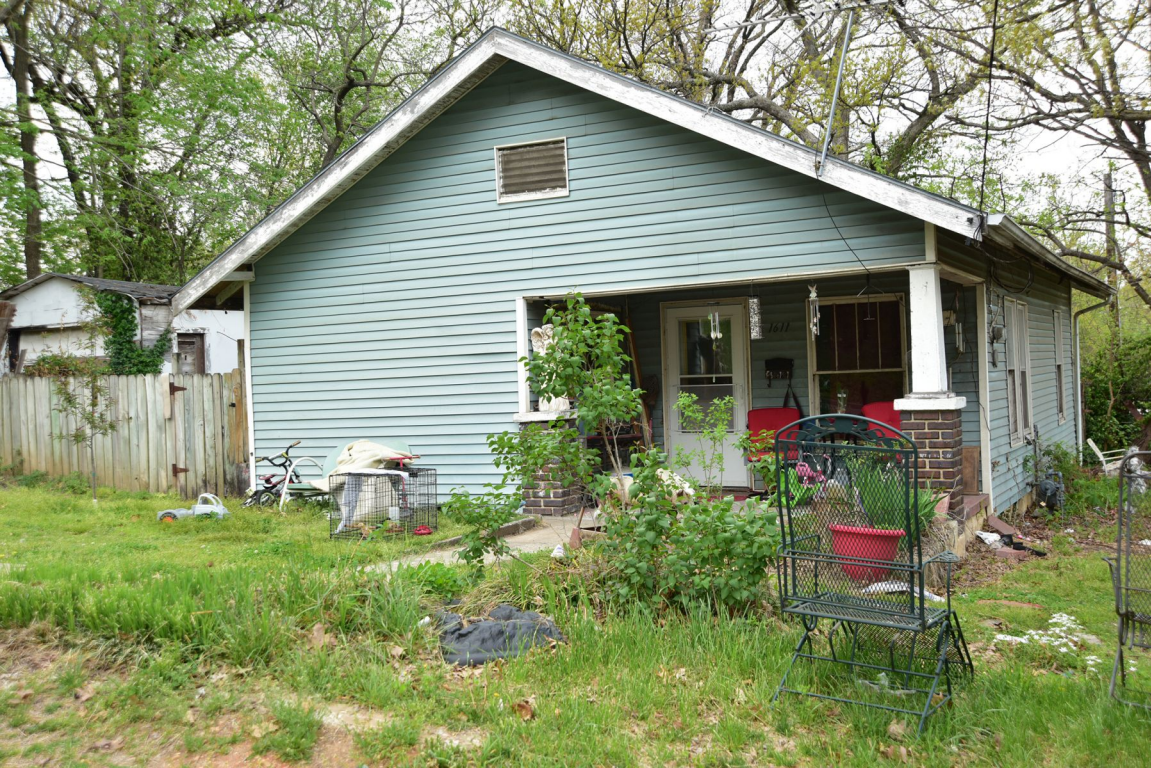
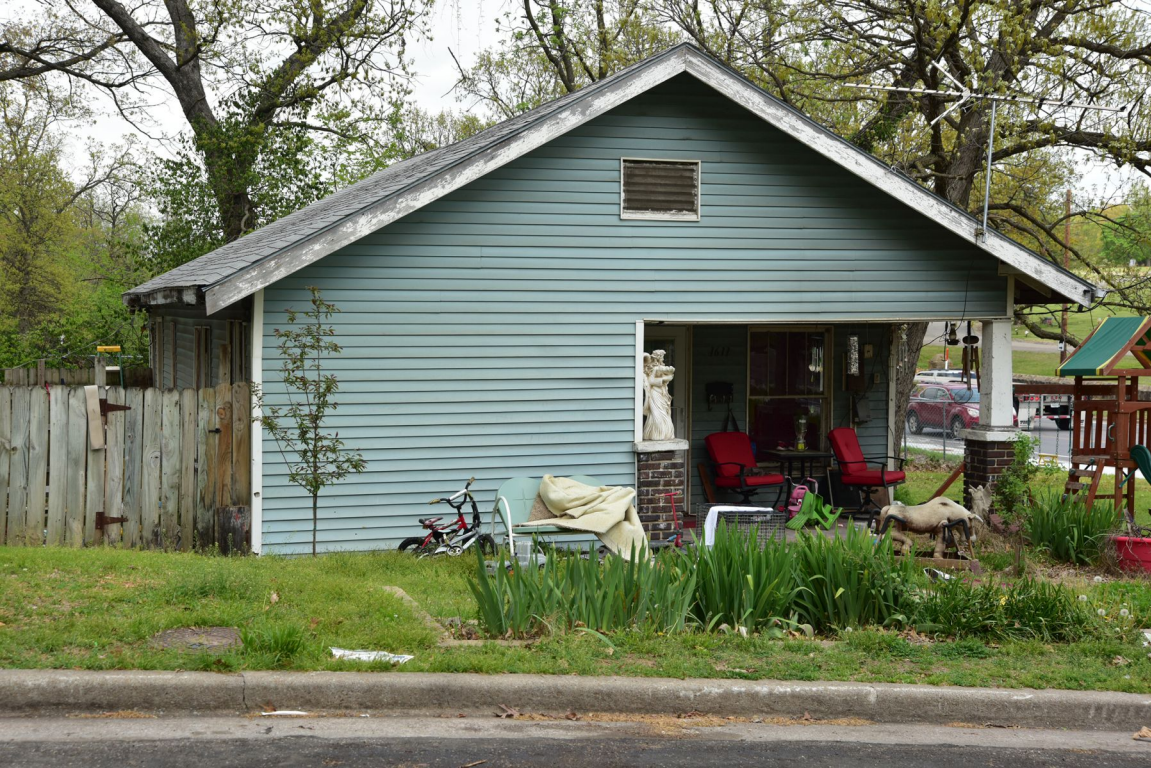
This bungalow dwelling faces south and has a rectangular footprint. It has a front-gable roof with asphalt shingles and wood fascia boards. The dwelling is vinyl-clad and the foundation is not visible. The dwelling is two asymmetrical bays wide and five asymmetrical bays deep. The primary elevation bays recede, creating a partial-width porch. The porch has a concrete foundation and brick piers. A tapered wood column on a pier supports the roof. A wood door with glazing occupies the west bay while a historic four-over-one wood window occupies the east bay. A matching window is located in the porch wall.

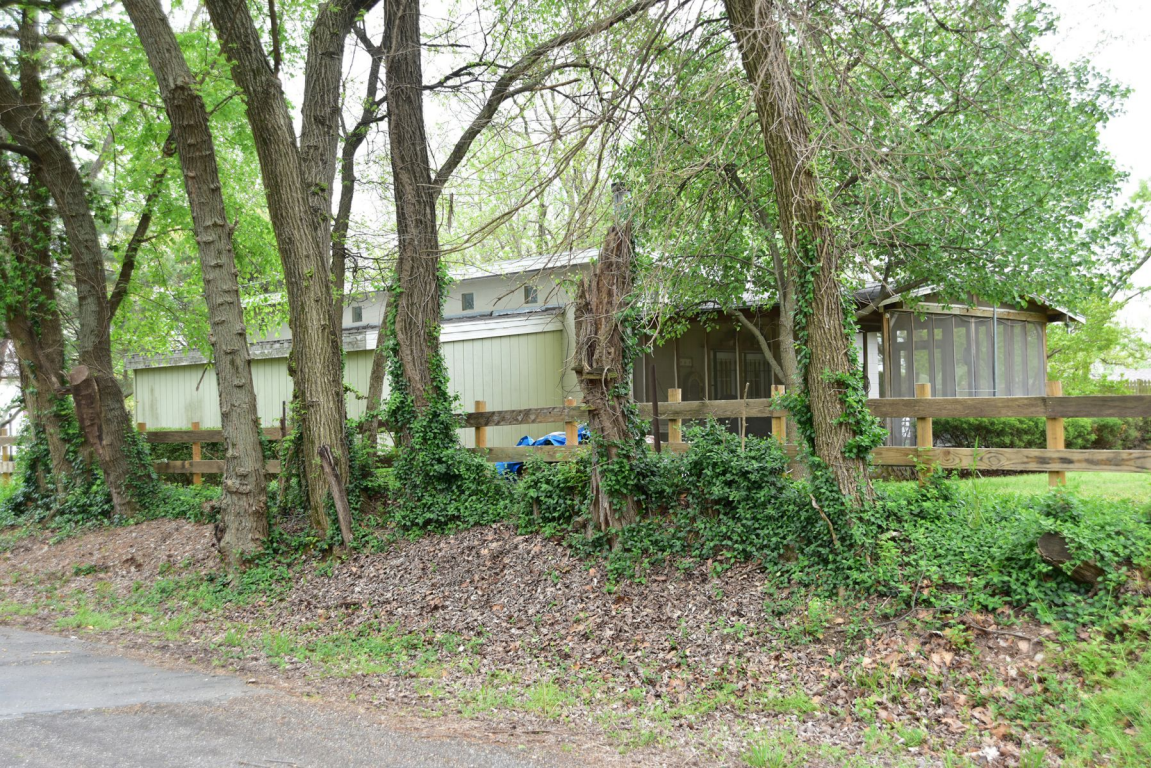
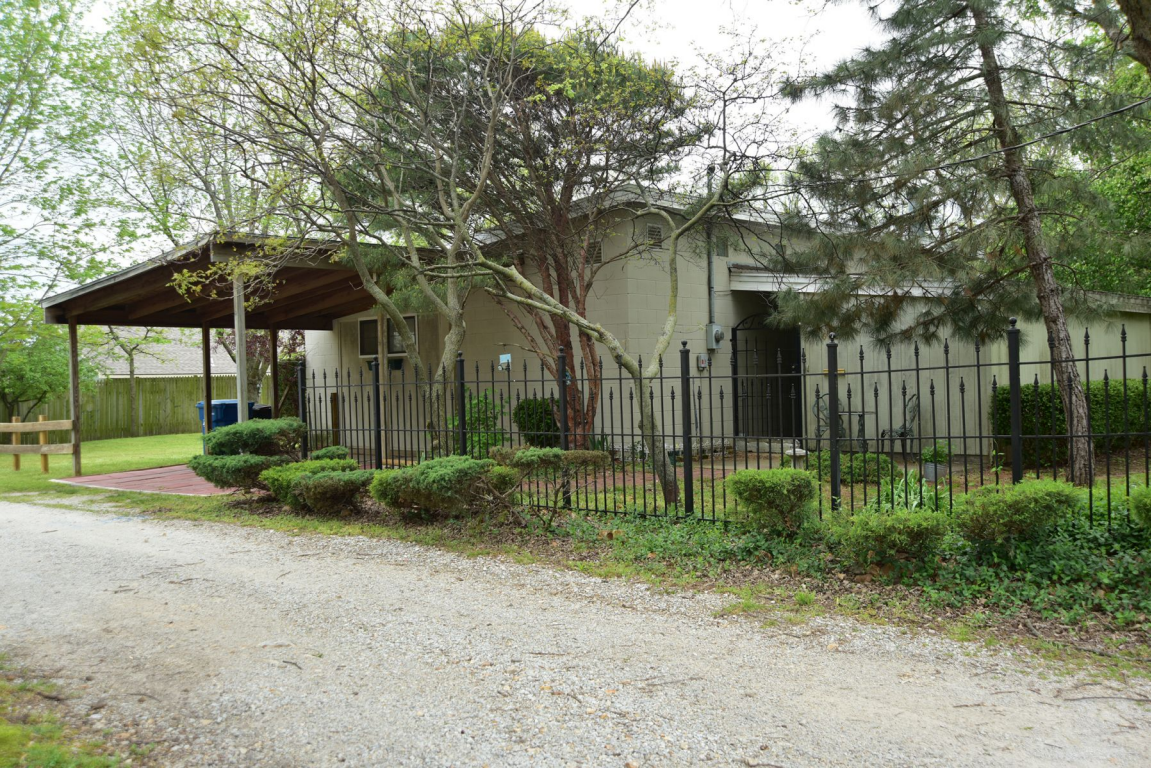
This Modern Movement dwelling faces east and has an irregular footprint. It has a concrete masonry unit foundation and walls. The shed roof has asphalt shingles. The dwelling is two bays wide. A shed-roof enclosed porch with wood cladding contains the second bay. The enclosed porch recedes and is slightly shorter than the main dwelling. The south bay contains a window while the north bay contains a recessed entry. Neither the door nor window are visible from the right-of-way. A row of small, square clerestory windows overlooks the enclosed porch. A wood frame carport with a flat roof shelters the south bay and a brick drive. A gable porch projects from the south elevation. It has an asphalt shingle roof and wood frame. Mesh screens enclose the porch.

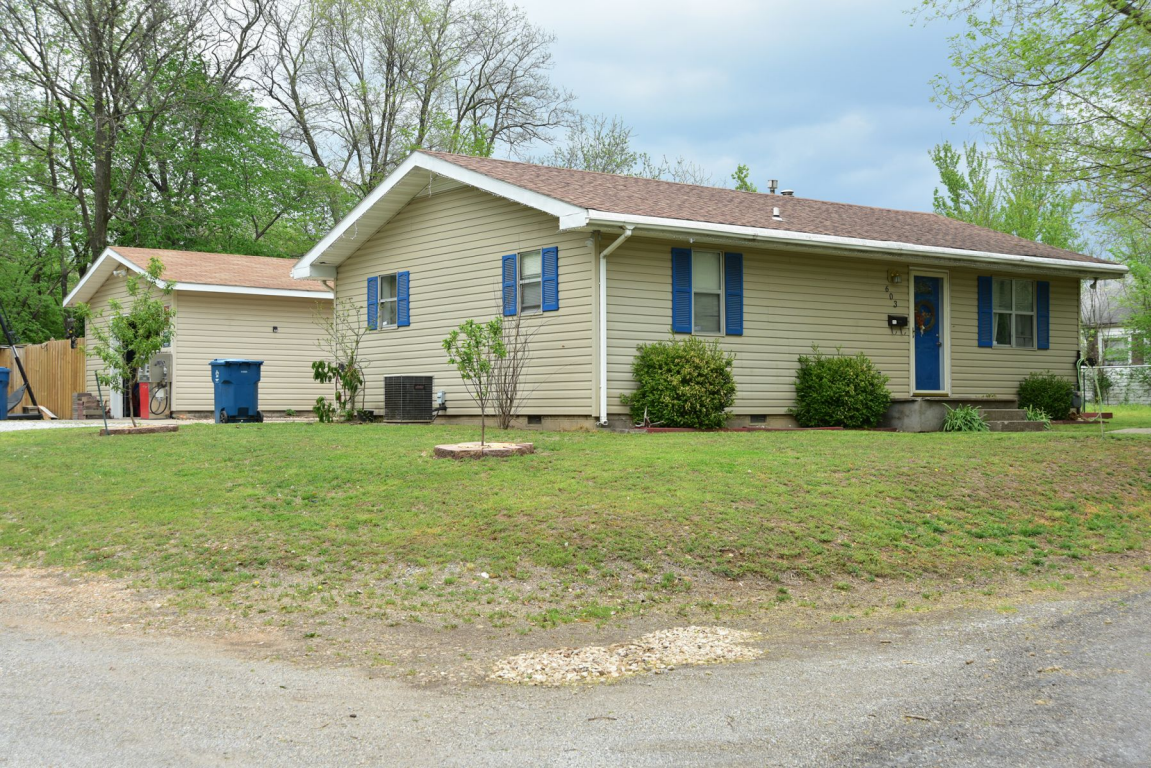
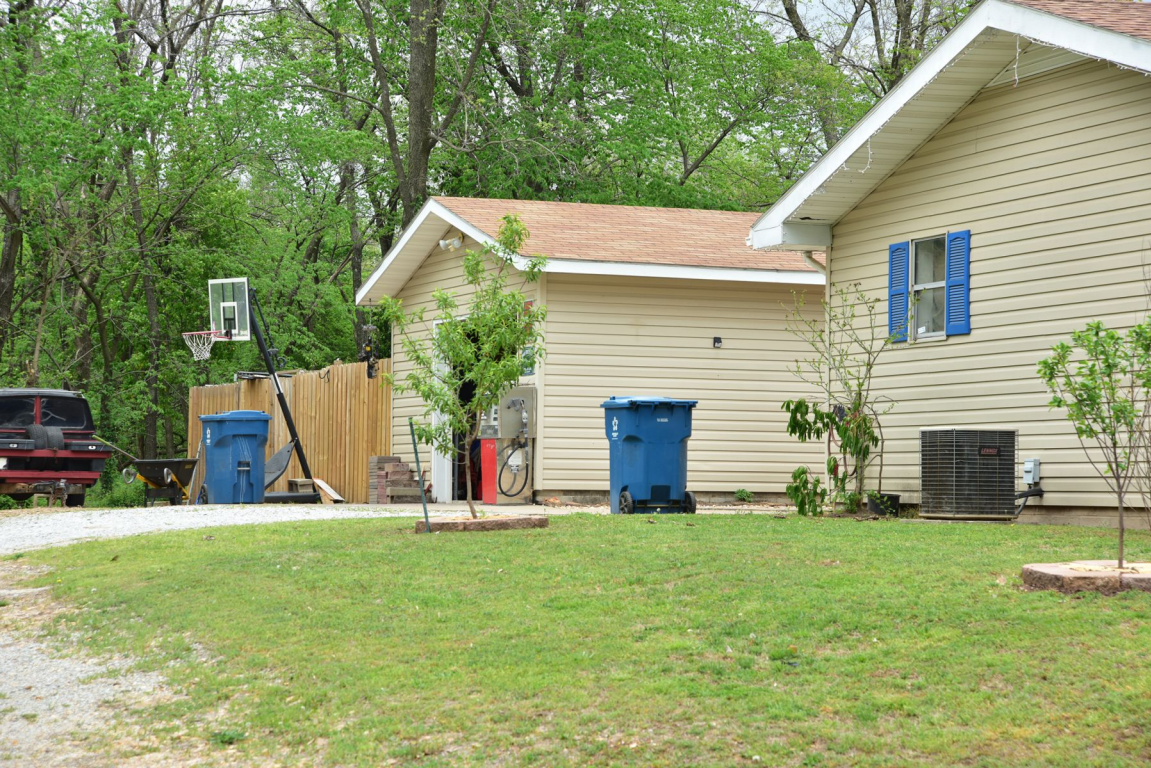
This Ranch dwelling faces south and has a rectangular footprint. It has a concrete masonry unit foundation and vinyl cladding. The side-gabled roof has asphalt shingles and wide eaves. The dwelling is three bays wide and two symmetrical bays deep. A non-historic wood door with glazing occupies the center bay. A single one-over-one vinyl window with false shutters occupies the west bay while a pair of one-over-one vinyl windows occupies the east bay. The dwelling has a concrete stoop porch.

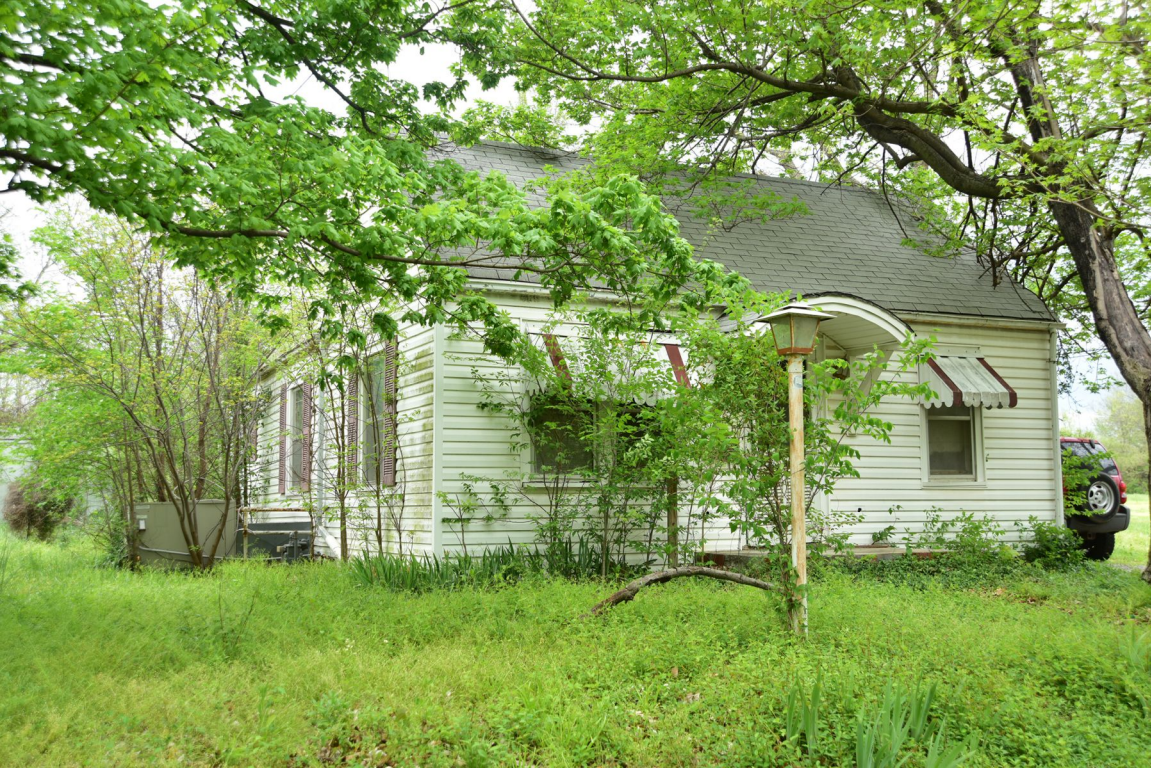
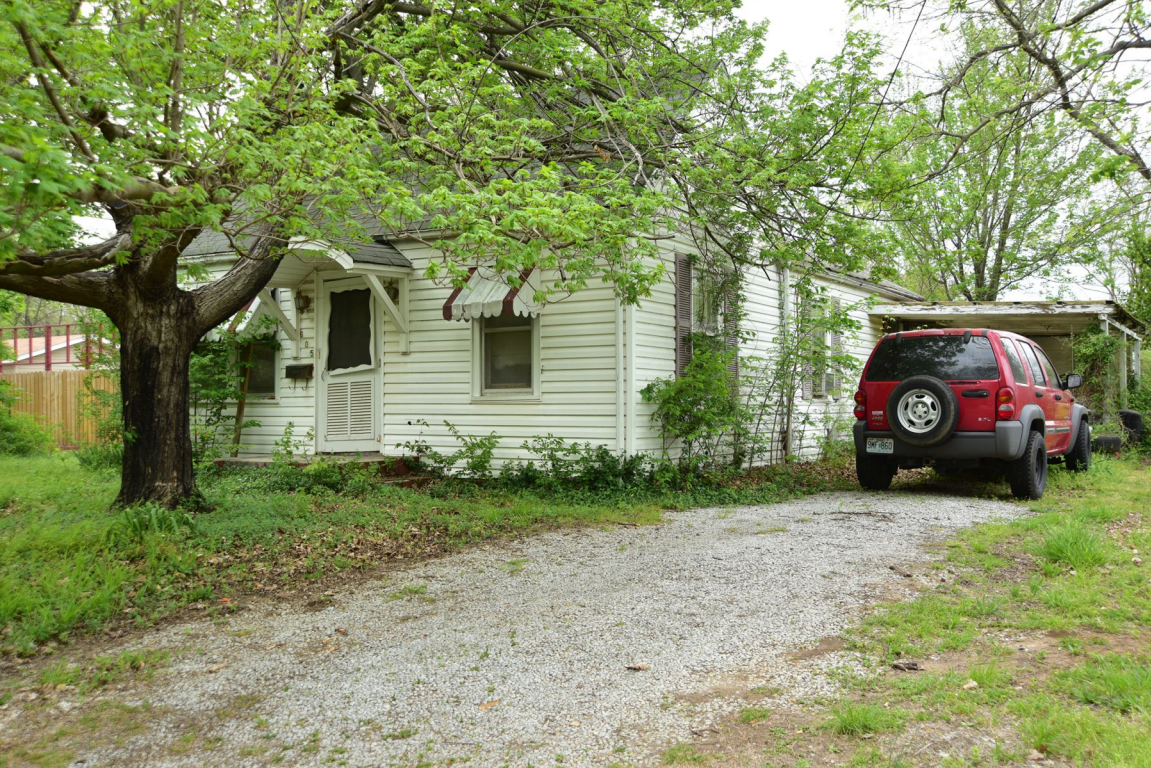
This one-story Minimal Traditional dwelling faces south and has an L-shaped footprint. It has an asphalt roof and vinyl cladding. The foundation is not visible. The dwelling is three bays wide and four bays deep. An enclosed porch forms the fourth bay. A wood door forms the center primary elevation bay. A pair of one-over-one wood windows with metal awnings occupies the west bay while a single matching window occupies the east bay. An arched roof with vinyl knee brackets shelters the entrance and parged brick stoop. A frame carport with exposed rafter tails projects from the east elevation. The north end of the carport is enclosed.

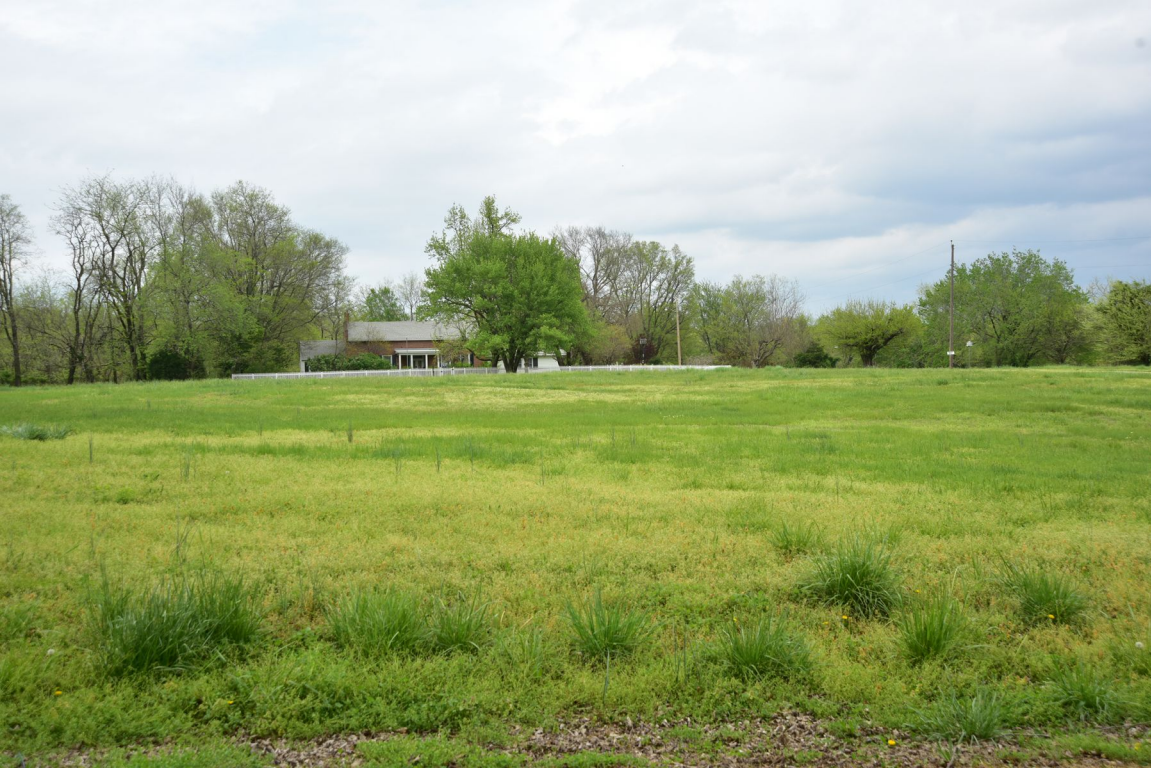
This Colonial/Georgian Revival dwelling faces south and has a rectangular footprint. It has a stone foundation, brick cladding, and a side-gable roof with asphalt shingles. Brick dentils line the primary elevation. The dwelling is five bays wide. Lower one-story side-gable additions with wide-profile vinyl cladding contain the first and fifth bays. Paired six-over-six vinyl windows with false shutters occupy each of these bays. A pair each of six-over-six windows with brick lintels occupy the second and fourth bays. A pair of historic wood doors with multi-light glazing occupies the center bay. The entrance features historic multi-light wood sidelights and a historic three-light wood transom. A historic open porch with wood columns shelters the entrance. The porch foundation is not visible. A stepped brick chimney is located between the original dwelling block and the east addition.

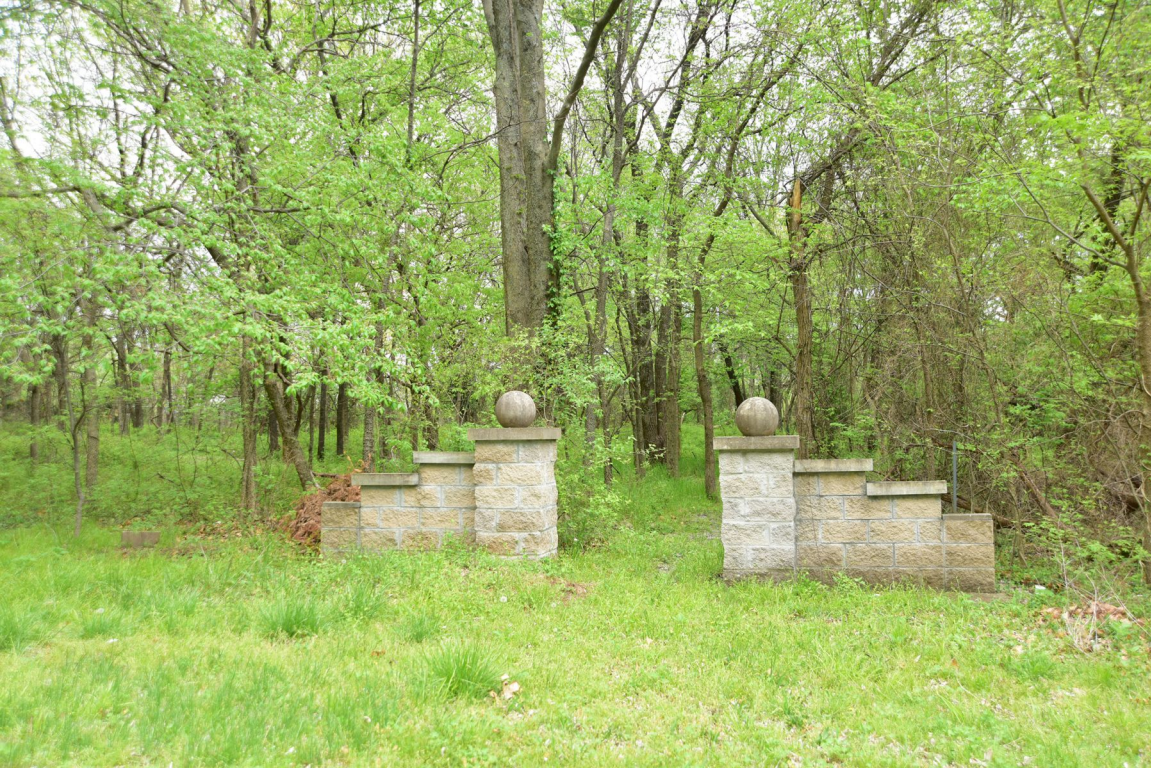
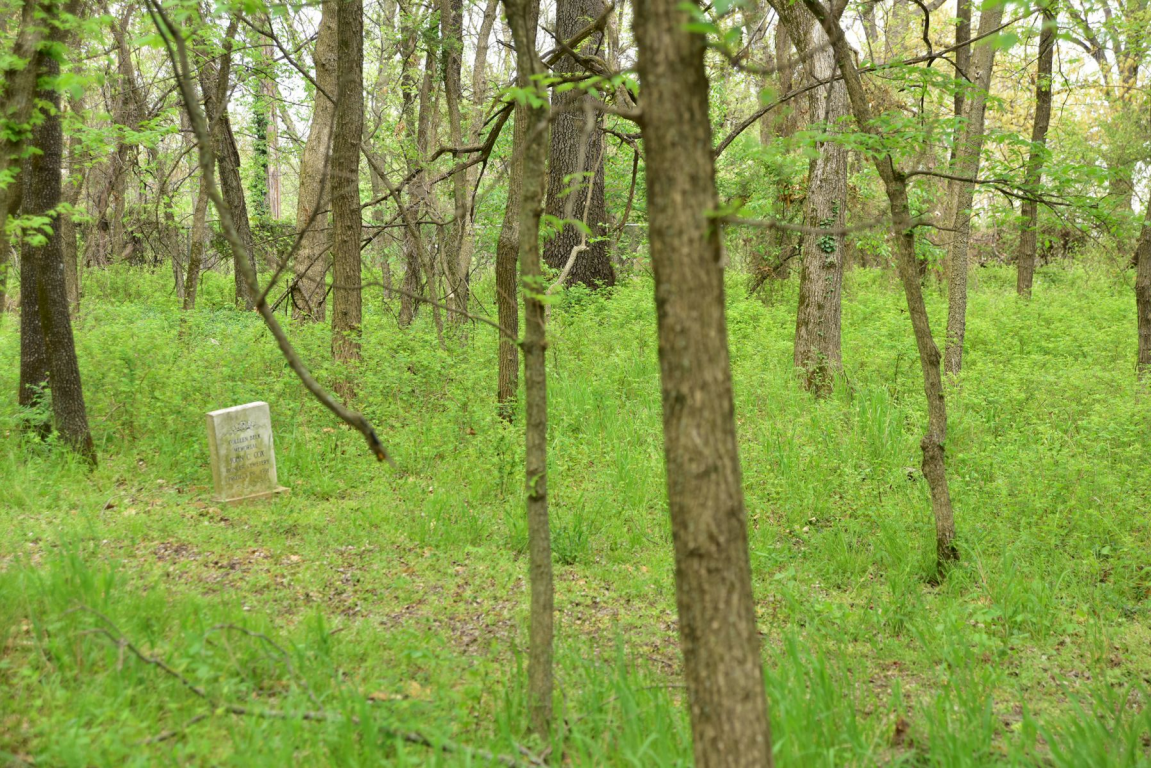
The Cox Cemetery faces west and is located in the northwest portion of the Survey Area. It has an L-shaped footprint and a deep setback. A chain-link fence encloses the cemetery. It is surrounded by dense woods and sporadically spaced mature trees characterize the cemetery grounds. A gravel trail west of the cemetery provides access to the fenced cemetery. Stepped stone piers with stone caps and spherical ornaments flank the trail at the trailhead. A decorative metal gate with stone piers is located at the end of the trail and provides access to the west edge of the cemetery. A gravel path loops through the cemetery.

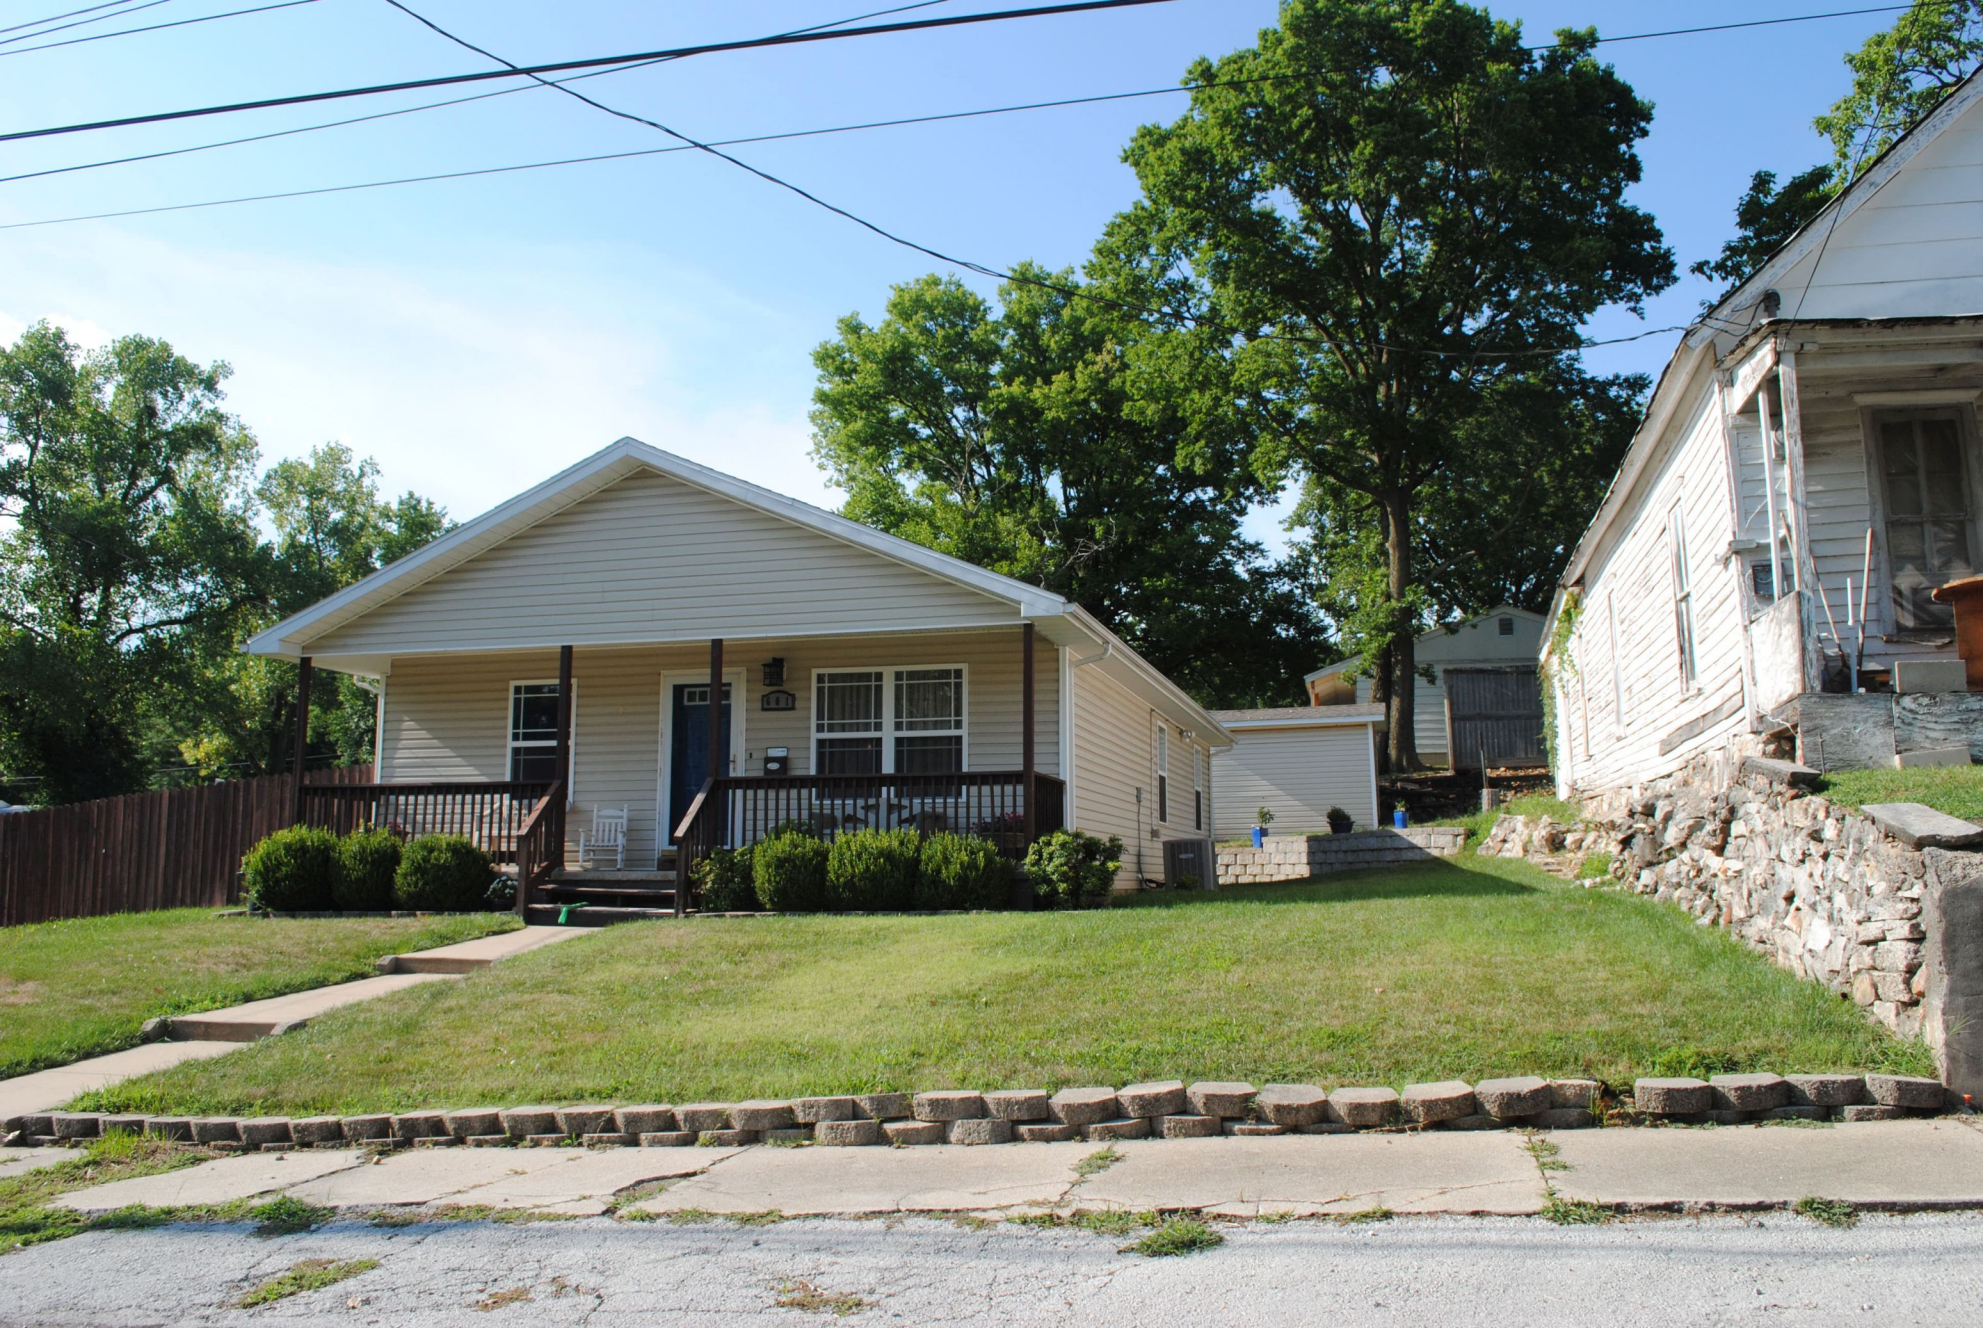
This bungaloid dwelling faces south and has a rectangular footprint. It has a concrete foundation, vinyl cladding, and a front-gable roof with asphalt shingles. It is three bays wide and three bays deep. Paired six-over-six vinyl windows occupy the east and west bays while a fiberglass door occupies the center bay. A full-width open porch shelters the bays. A secondary entrance is located in the center bay of the west elevation.

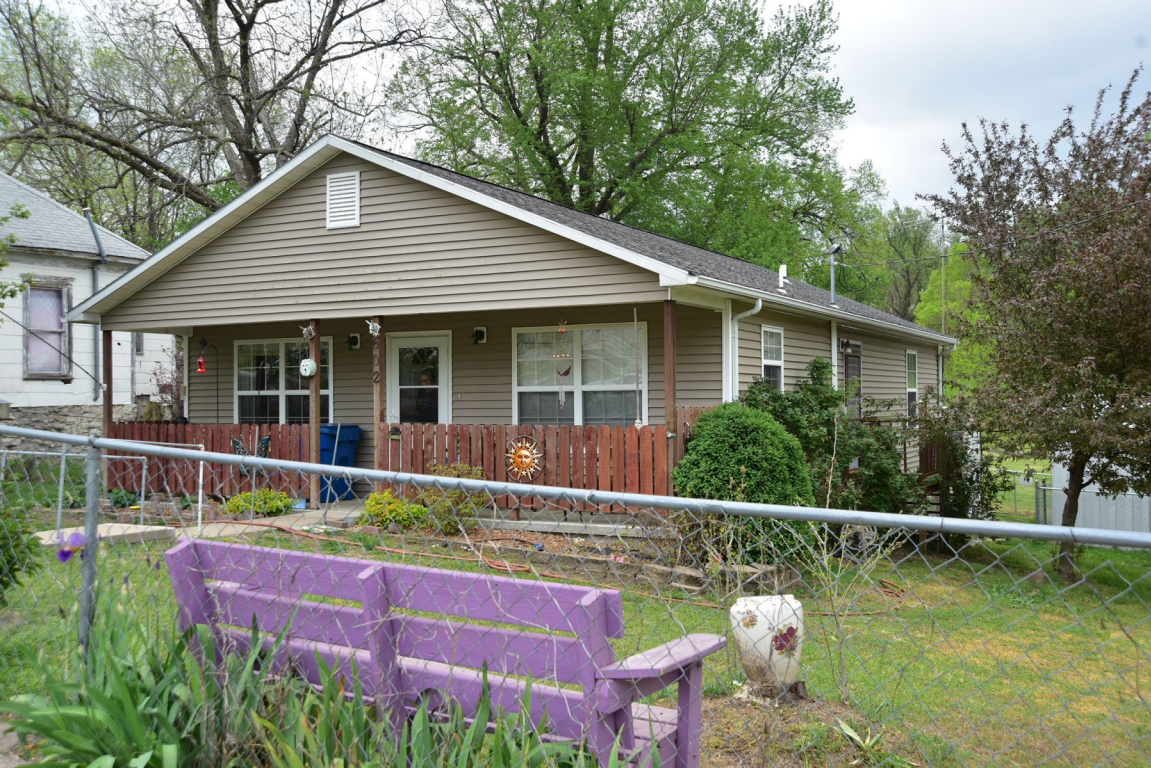
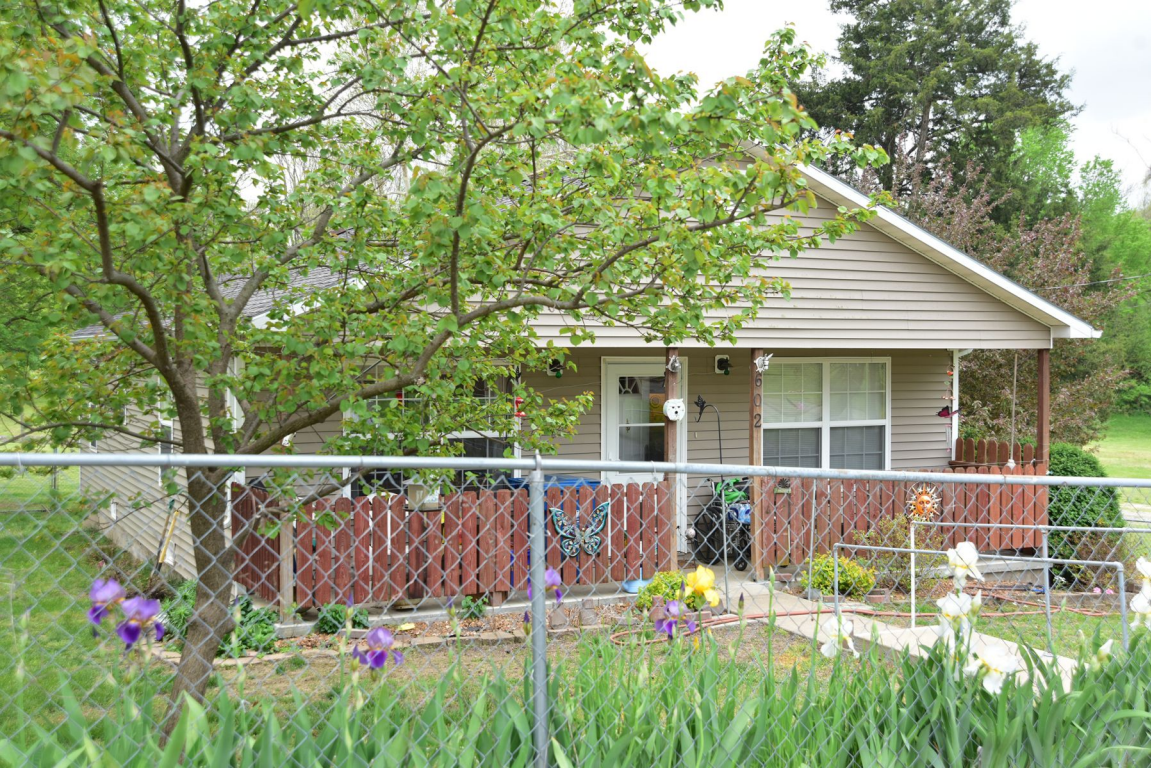
This bungaloid dwelling faces north and has a rectangular footprint. It has a concrete foundation, vinyl cladding, and a front-gable roof with asphalt shingles. It is three bays wide and three bays deep. Paired multi-over-multi vinyl windows occupy the east and west bays while a wood door with glazing occupies the center bay. A full-width open porch shelters the bays. A secondary entrance is located in the center bay of the west elevation

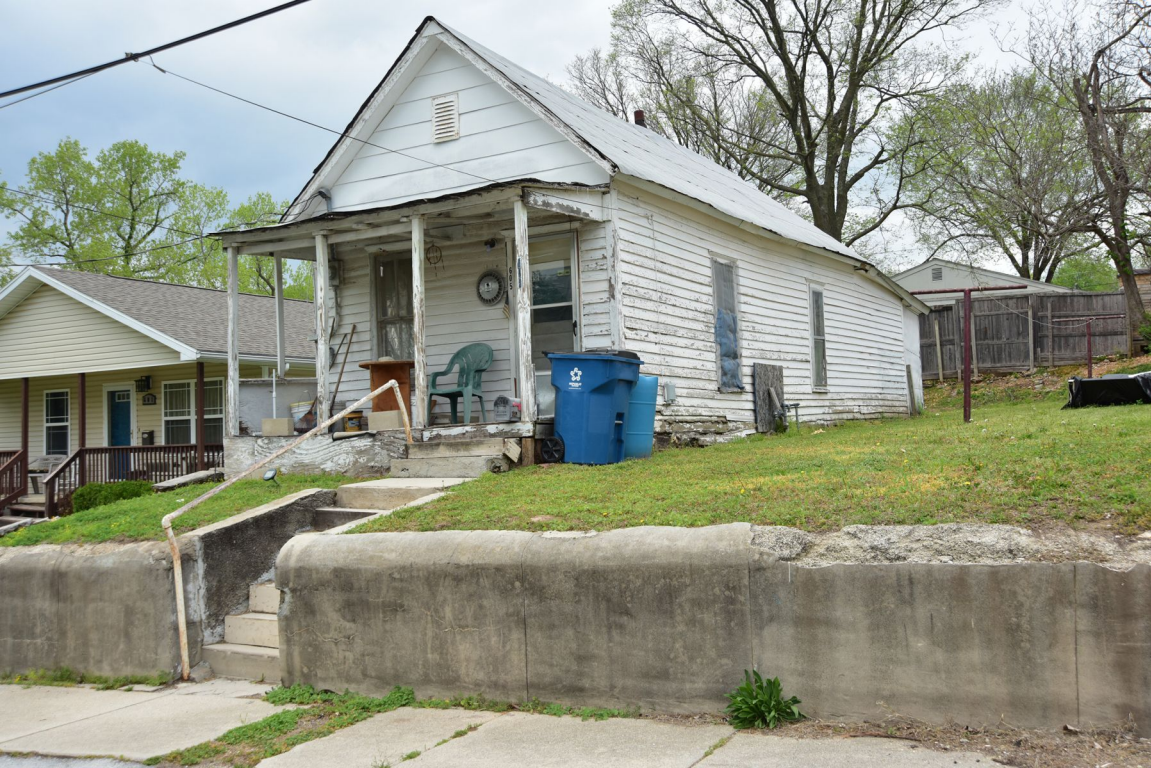
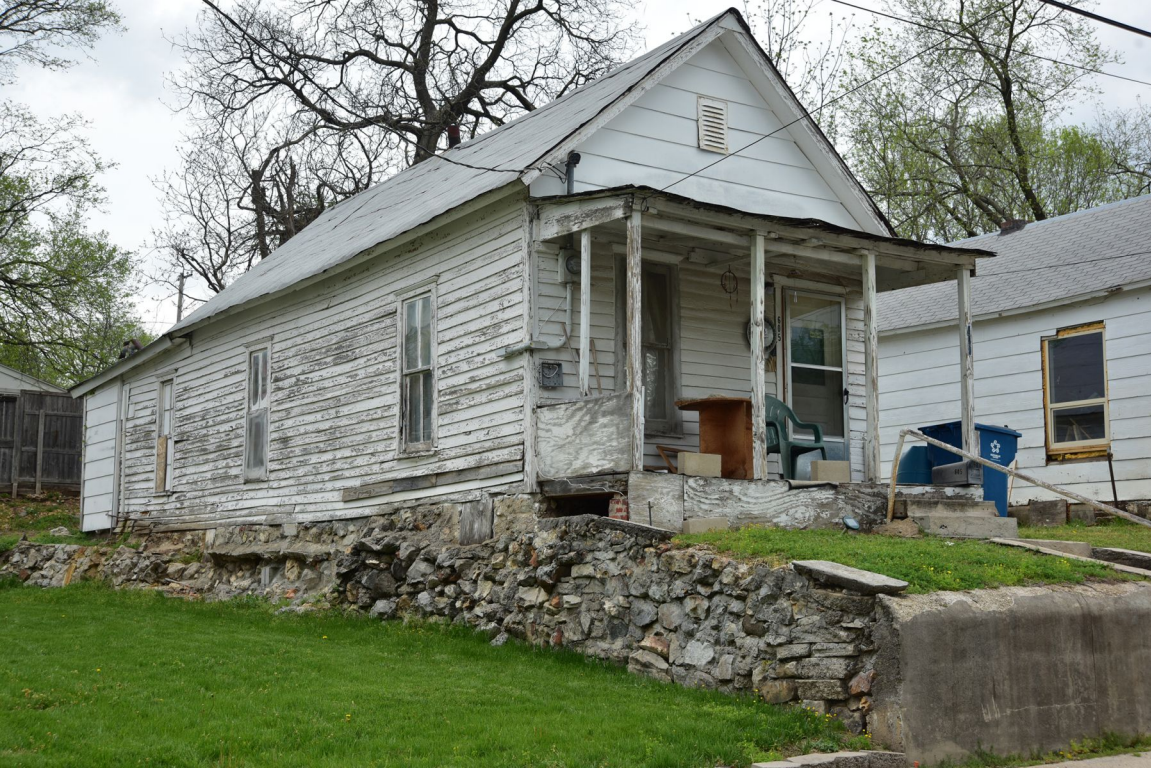
This Shotgun dwelling faces south and has a rectangular footprint. It has a stone foundation, wood clapboard cladding, and a front-gable roof with rolled asphalt. A shed-roof addition at the north elevation has wide-profile metal cladding. The dwelling is two bays wide and four bays deep. The rear addition forms the fourth bay. A historic wood door occupies the east bay of the primary elevation while a historic two-over-two wood window occupies the west bay. Matching windows define the secondary elevation bays. All windows have modest crown molding. An open porch spans the primary elevation. It has a shed roof and wood floor supported by brick piers. Wood posts support the porch roof.
