MISSOURI DEPARTMENT OF NATURAL RESOURCES
STATE HISTORIC PRESERVATION OFFICE, P.O. Box 176, Jefferson City, MO 65102
ARCHITECTURAL/HISTORIC INVENTORY FORM

1. Survey number: JP-AS-006-260		2. Survey Name: East Town (Original Joplin) Historic Survey Phase 1	
3. County: JASPER		4. Address 1506	Street (name): E. North Street
5. City: Joplin	Vicinity <input type="checkbox"/>	7. Township/Range/Section: T: R: S:	
8. Historic name (if known):		9. Present/other name (if known):	
10. Ownership: <input checked="" type="checkbox"/> Private <input type="checkbox"/> Public		11a. Historic use (if known): Domestic/Single Dwelling	11b. Current use: Domestic/Single Dwelling

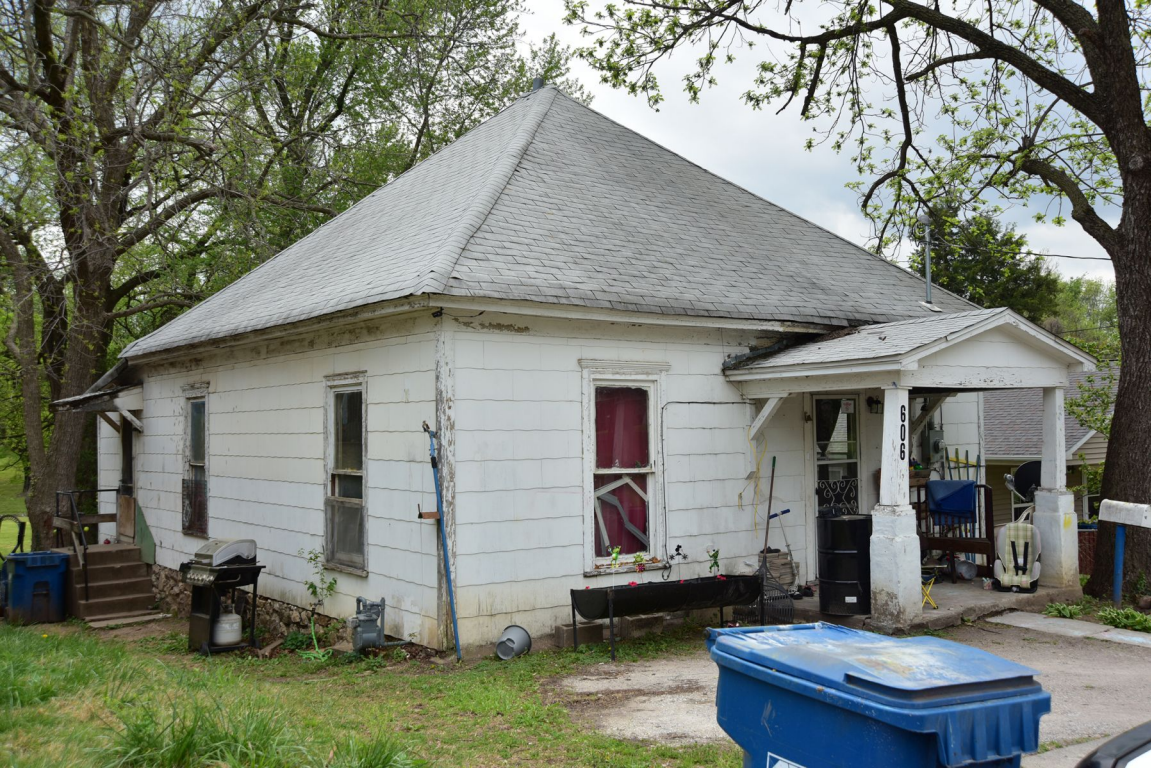
This Pyramid Square Folk House faces south and has a rectangular footprint. It has a stone foundation and asbestos shingle cladding. The pyramidal hipped roof has asphalt shingles and narrow eaves. The dwelling is two bays wide and three bays deep. An enclosed porch with a secondary entrance forms the third bay. A historic one-over-one wood window occupies the east bay of the primary elevation while an entrance occupies the west bay. The door was not visible at the time of survey. A front-gable porch with knee brackets and a concrete foundation shelters the entrance. Tapered wood columns on concrete piers support the porch roof. Historic one-over-one wood windows define the secondary elevation bays. All windows have historic wood trim and crown molding.

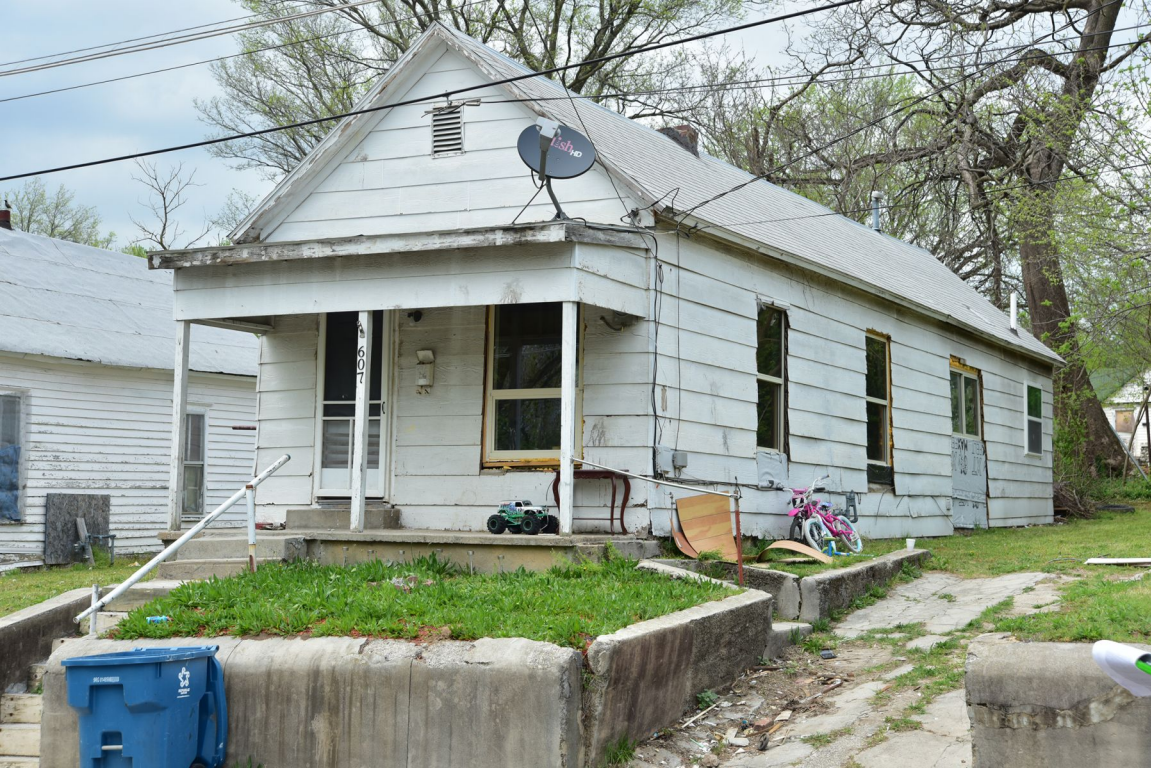
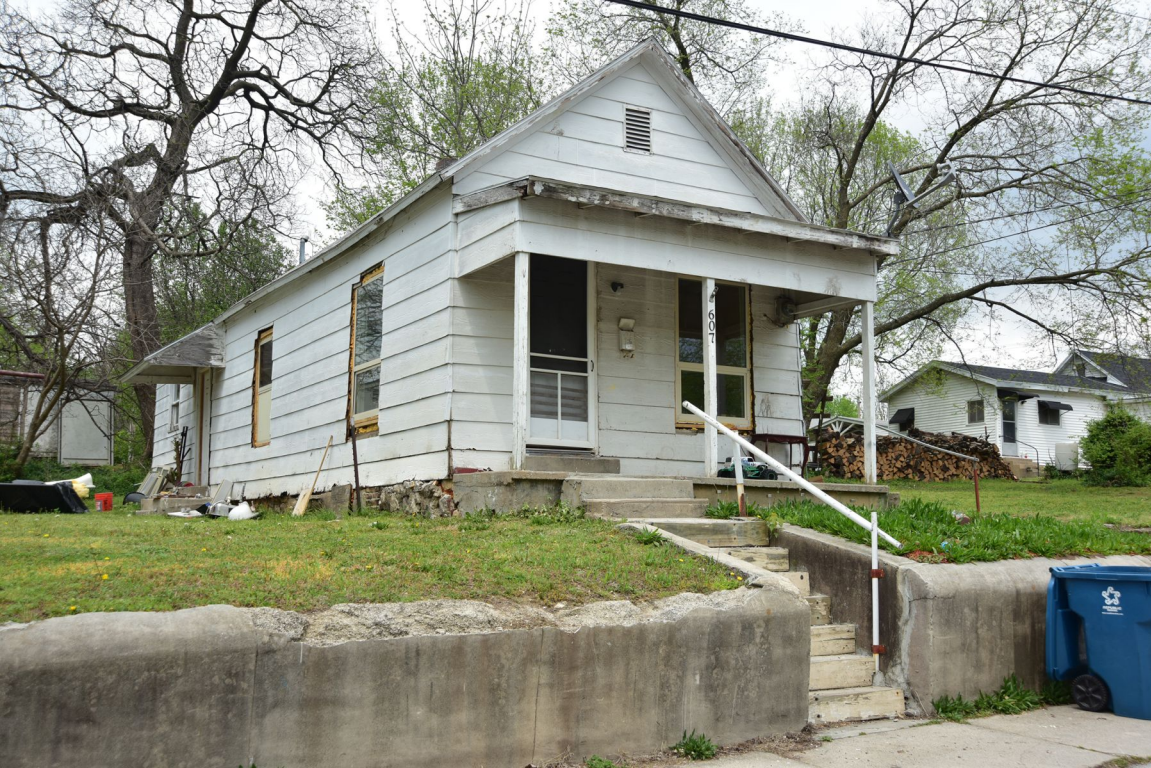
This Shotgun dwelling faces south and has a rectangular footprint. It has a stone foundation, pressboard cladding, and a front-gable roof with asphalt shingles. The dwelling is two bays wide and four bays deep. A non-historic wood door occupies the east bay of the primary elevation while a one-over-one vinyl window occupies the west bay. An open porch spans the primary elevation. It has a shed roof and concrete foundation. Wood posts support the porch roof. A secondary entrance with a shed awning occupies the third bay of the west elevation.

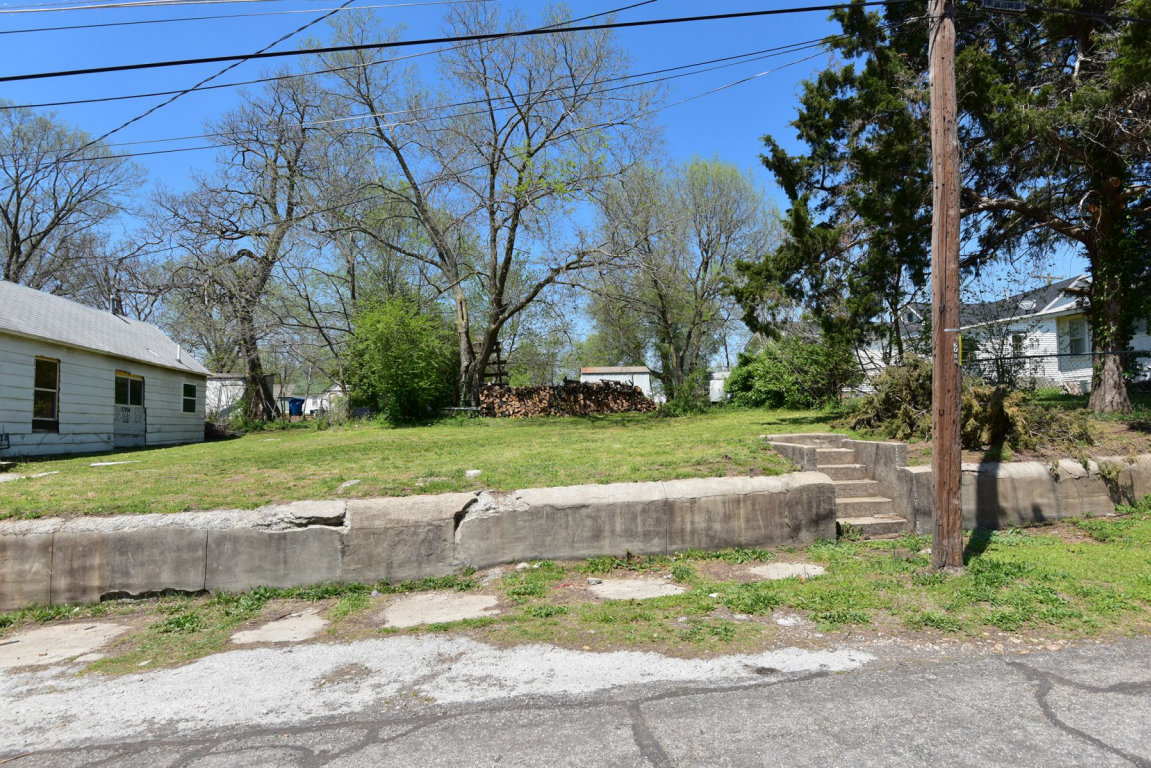
This grassy lot is vacant. A concrete retaining wall with concrete steps lines the south edge of the lot.

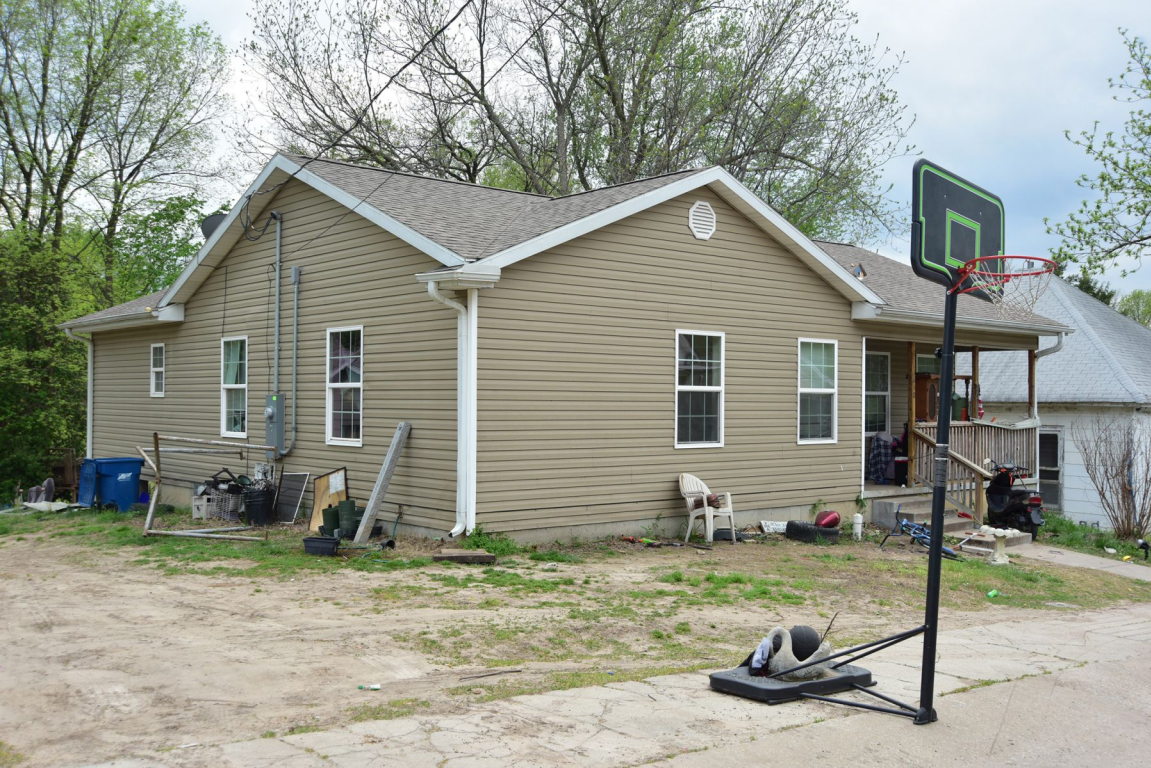
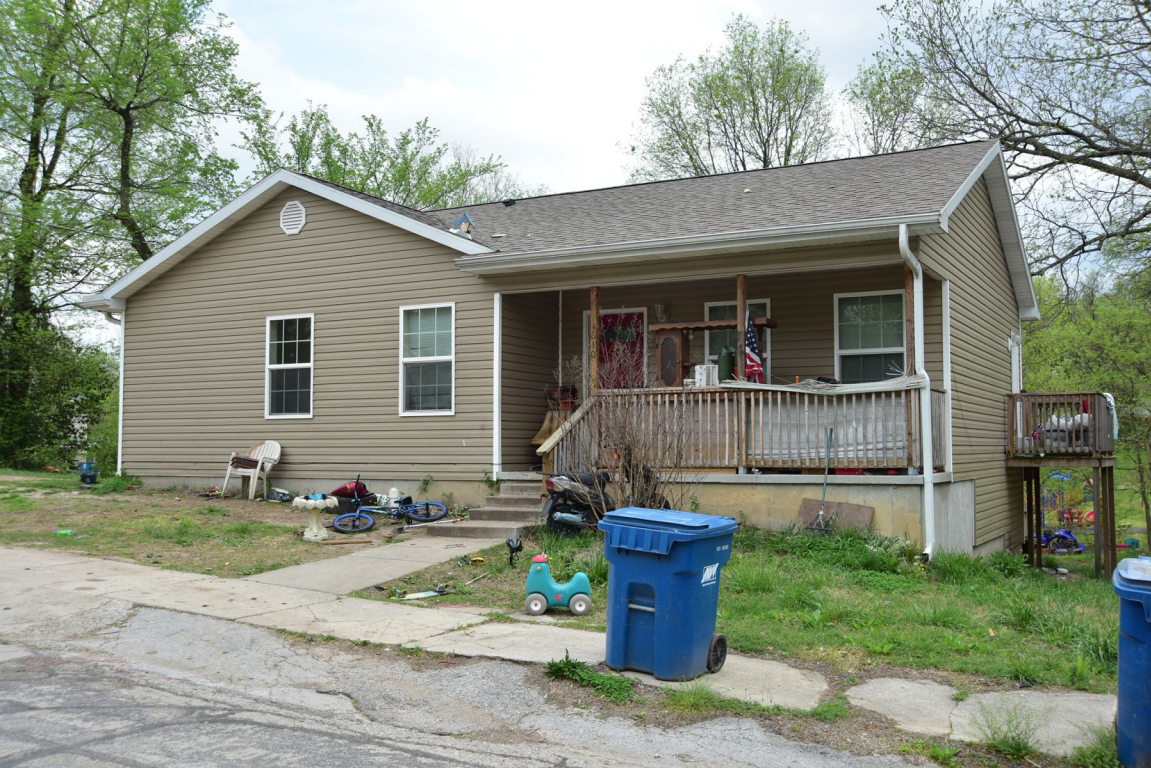
This dwelling faces north and has an L-shaped footprint. It has a concrete foundation, vinyl cladding, and asphalt shingle roof. The dwelling is five asymmetrical bays wide and three bays deep. The west three bays recede, creating a partial-width open porch. A fiberglass door occupies the center bay while six-over-six vinyl windows occupy the remaining bays

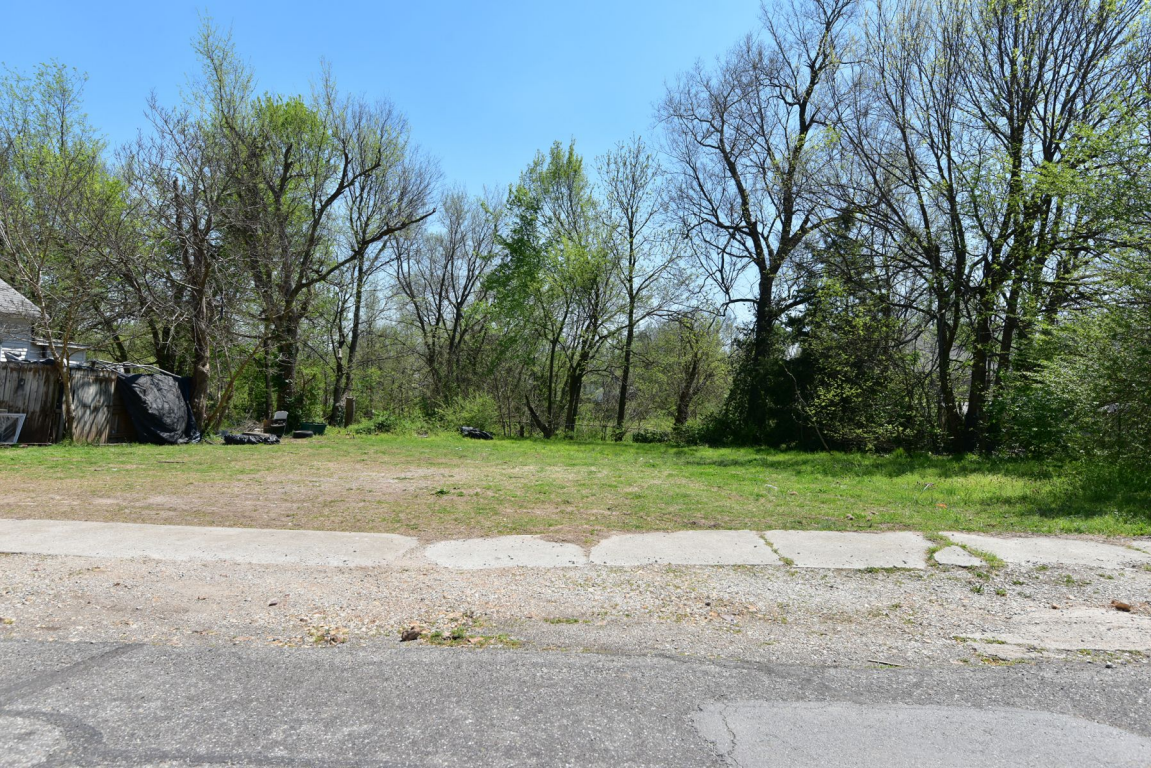
This grassy lot is vacant. A concrete sidewalk abuts the north edge of the lot.

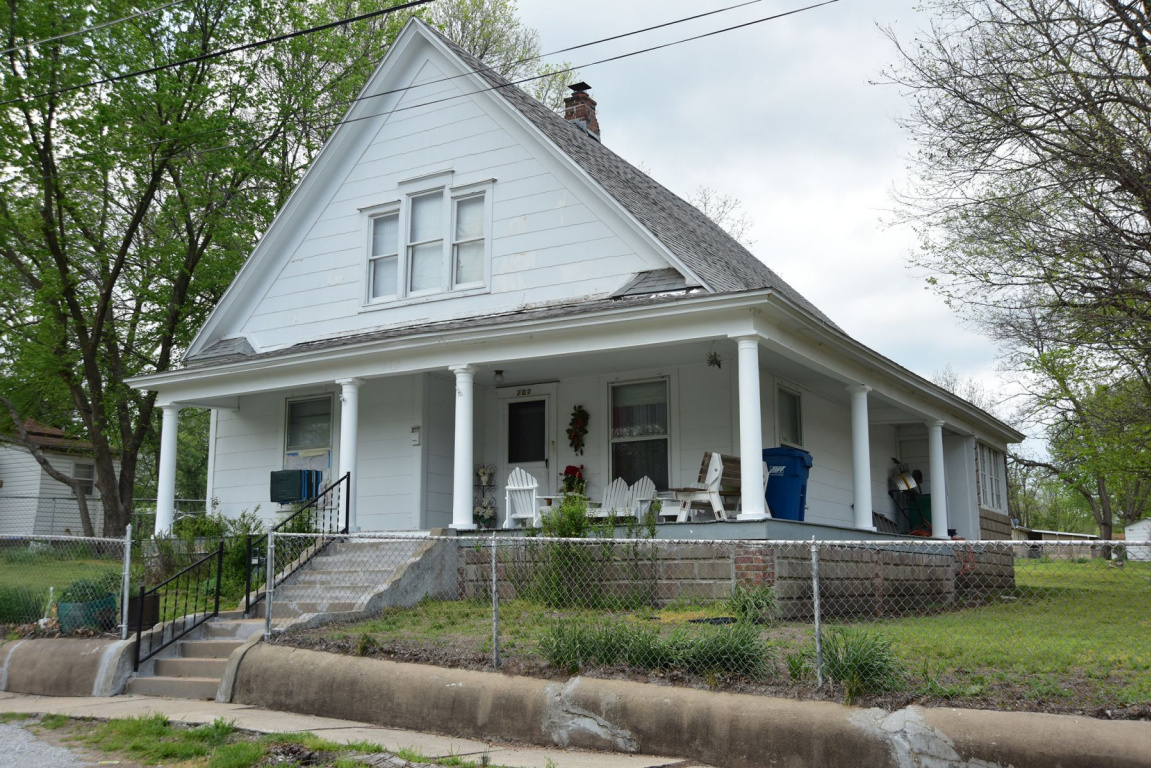
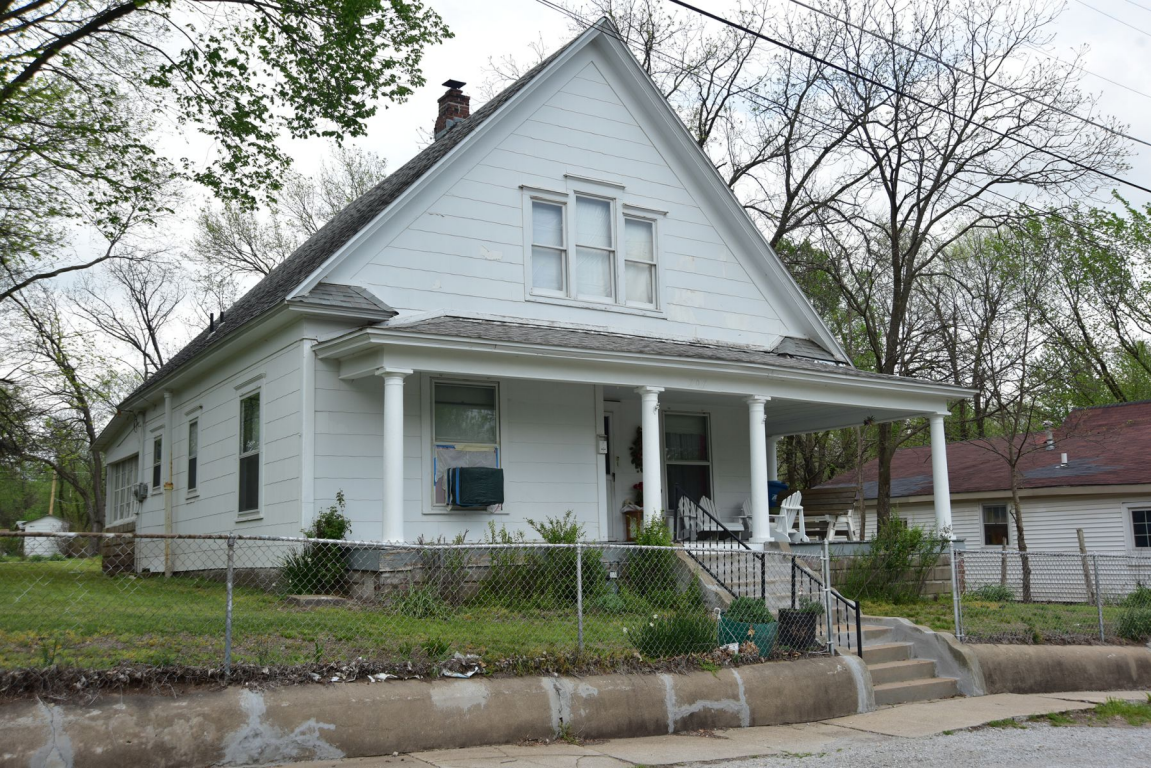
This Gothic Revival dwelling faces south and has a rectangular footprint. It has a concrete block foundation, asphalt shingle roof, and asbestos shingle cladding. A shed-roof verandah with wood columns wraps around the primary and east elevations. The dwelling is three bays wide and four bays deep. An enclosed porch with a shed roof and concrete block cladding forms the fourth bay. One-over-one wood windows occupy the east and west bays of the primary elevation while a historic wood door with glazing and crown molding occupies the center bay. The west bay projects slightly. A historic wood tripartite window occupies the gable peak. The west elevation windows have crown molding.

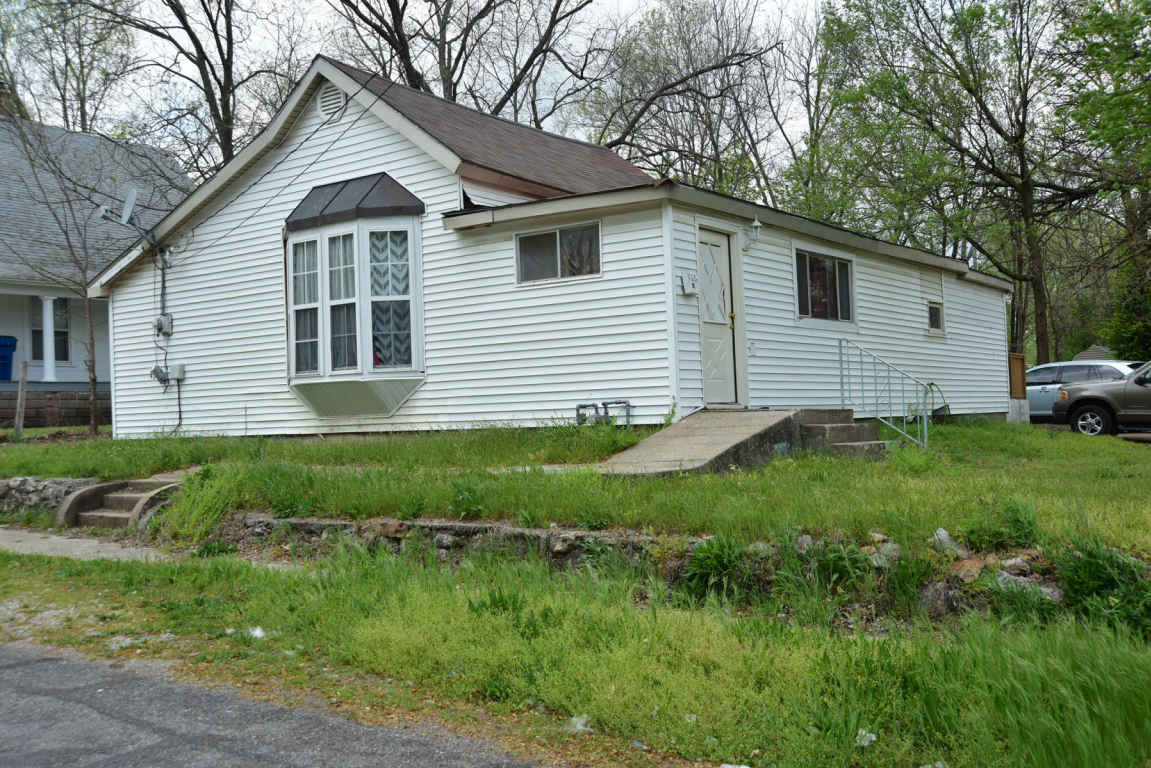
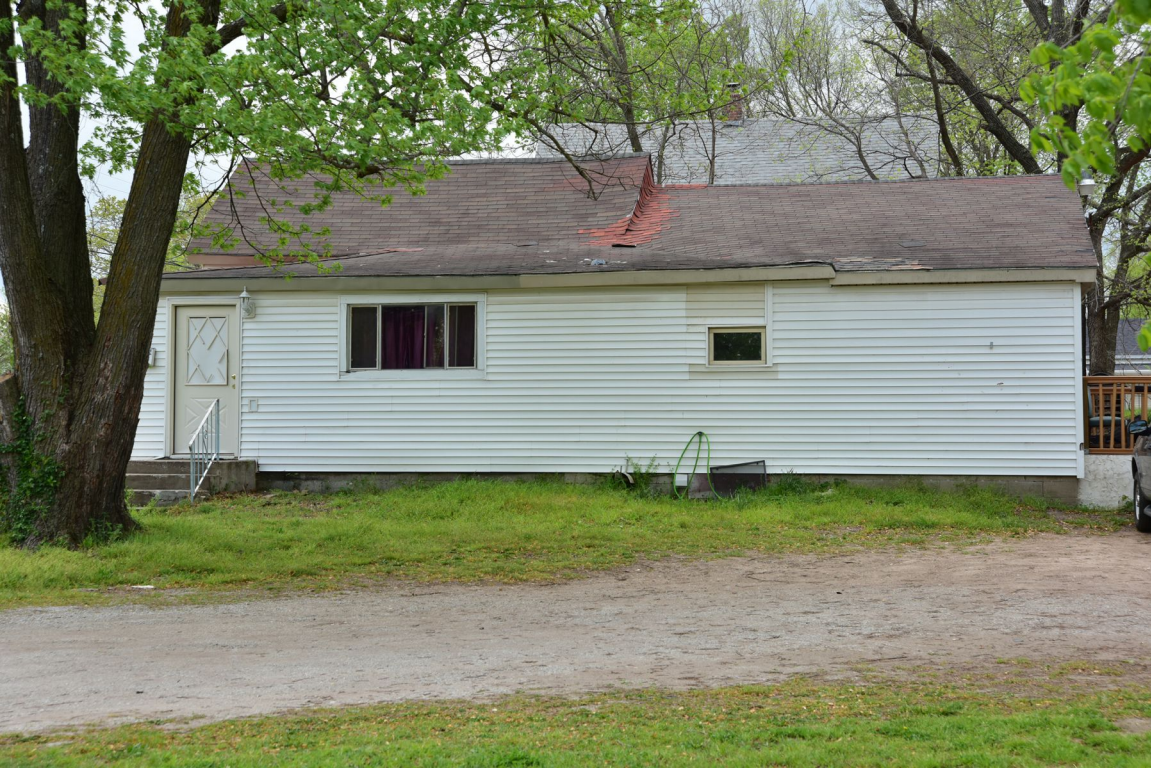
This dwelling faces south and has a square footprint. It has a concrete foundation, vinyl cladding, and asphalt shingle roof. The dwelling is two asymmetrical bays wide and three bays deep. An enclosed porch with a shallow hipped roof forms the second bay of the primary elevation and spans the length of the east elevation. A non-historic four-part bay window with four-over-four vinyl segments occupies the west bay of the primary elevation while a one-by-one metal window occupies the east bay. A non-historic wood panel door occupies the first bay of the enclosed porch. The adjacent bay contains a tripartite metal picture window.

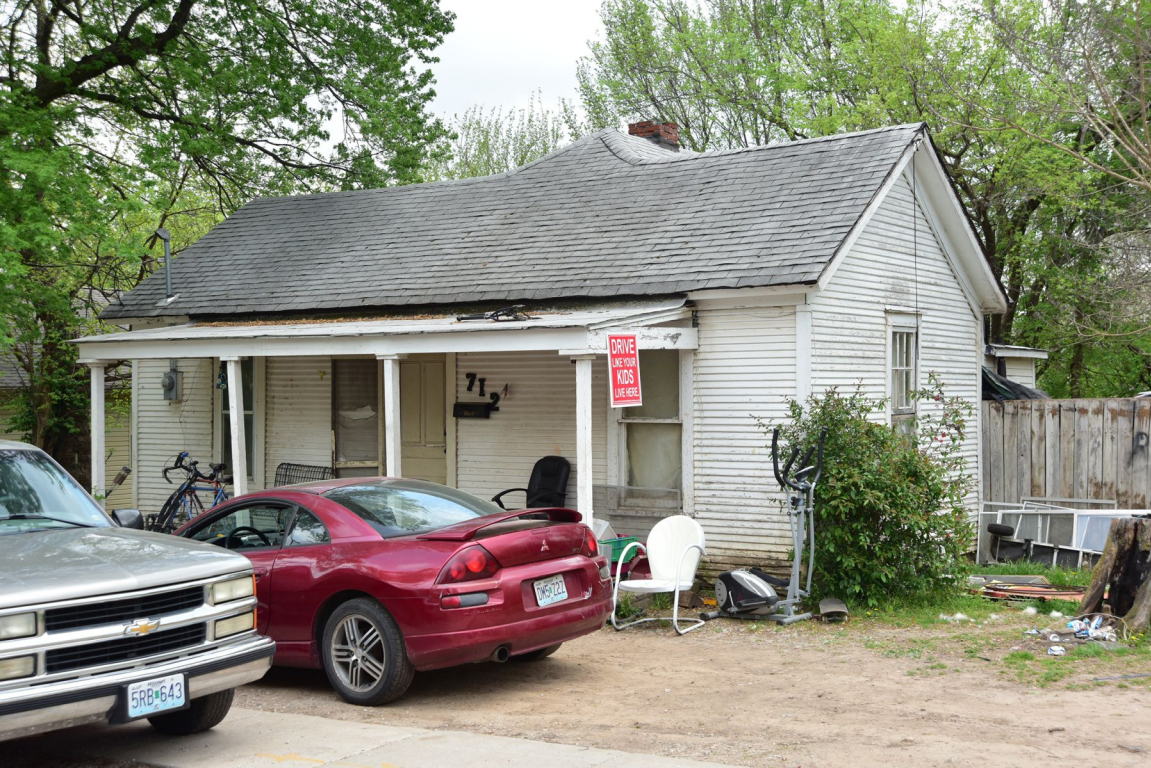
This National Folk House dwelling faces north and has a rectangular footprint. It has a concrete foundation, historic wood clapboard cladding, and an asphalt roof. The dwelling is three bays wide and four asymmetrical bays deep. A non-historic open porch shelters the primary elevation bays. It has a shed roof, concrete foundation, and squared wood posts. A historic wood door occupies the center bay while narrow one-over-one wood window occupy the remaining bays. A shed-roof addition projects from the east bay and retains historic six-light wood windows while the west gable-end retains a historic six-over-six wood window.

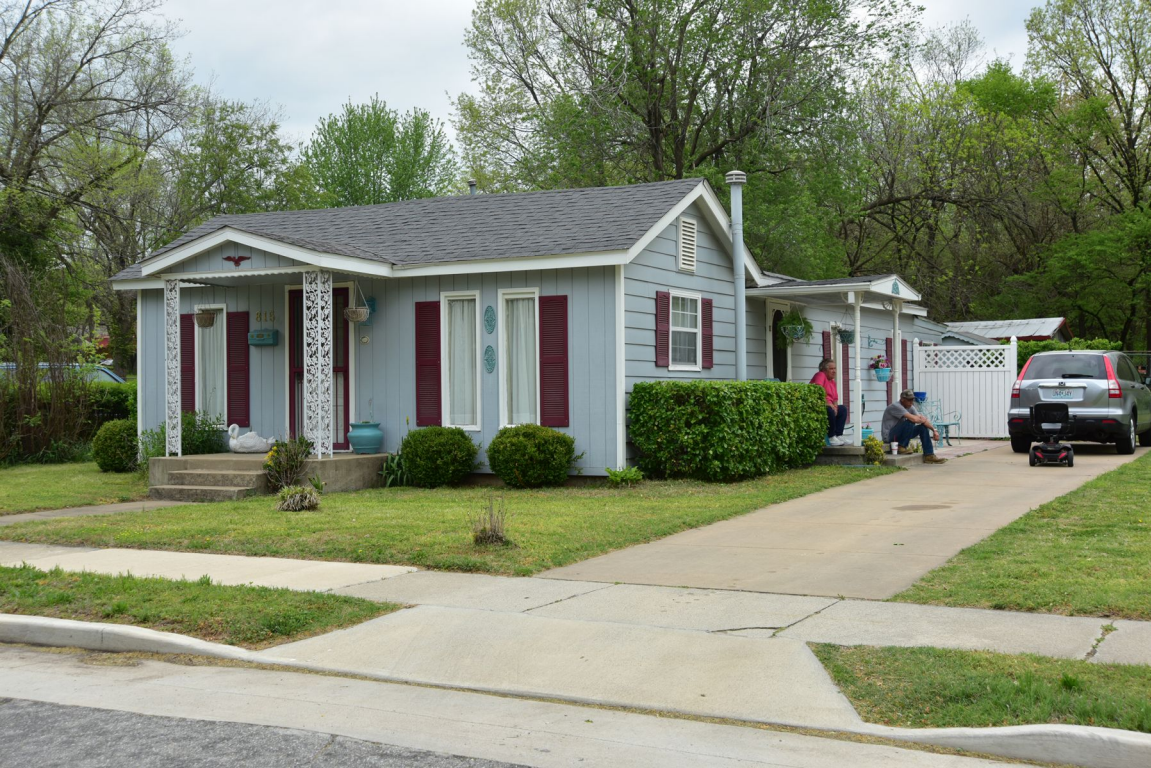
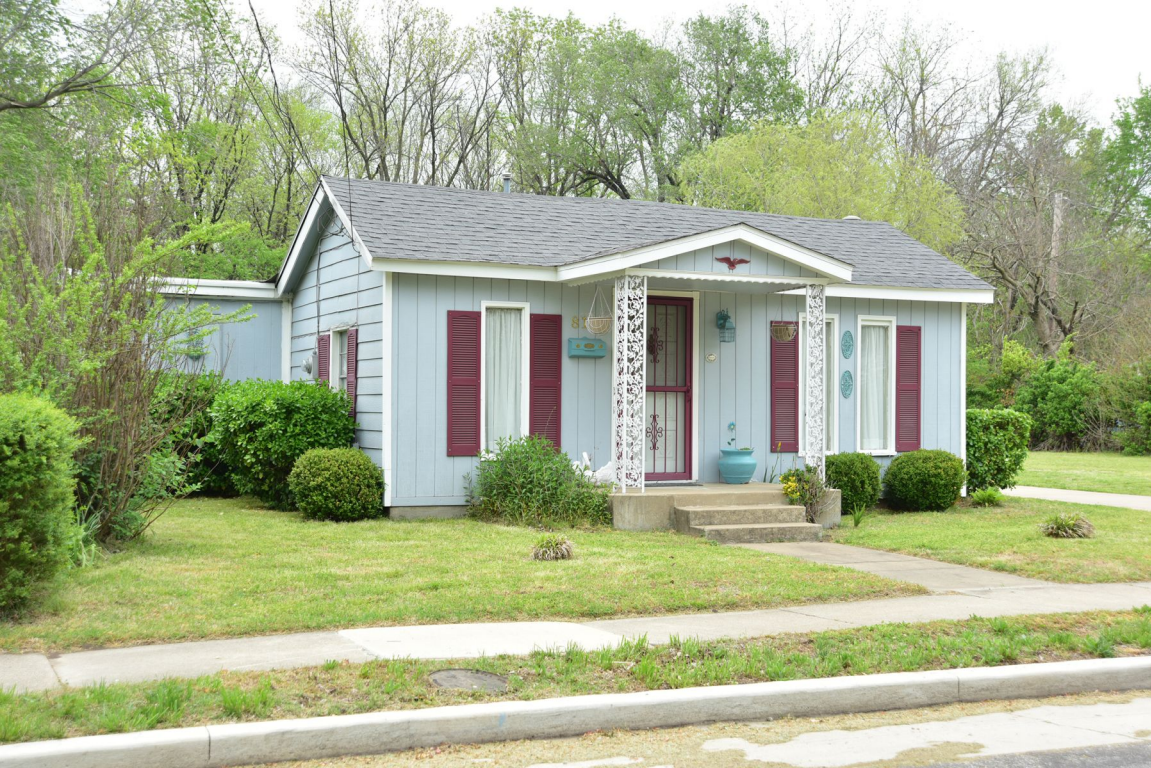
This Minimal Traditional dwelling faces south and has an irregular footprint. It has a concrete foundation, asphalt shingle roof, and wood cladding. The dwelling is four bays wide and five bays deep. A mid-century wood door with decorative panels occupies the second bay while narrow one-light vinyl windows with false shutters occupy the remaining bays. A front-gable porch with a concrete foundation and decorative metal support posts shelters the entrance. A secondary entrance with an open porch is located in the second bay of the east elevation.

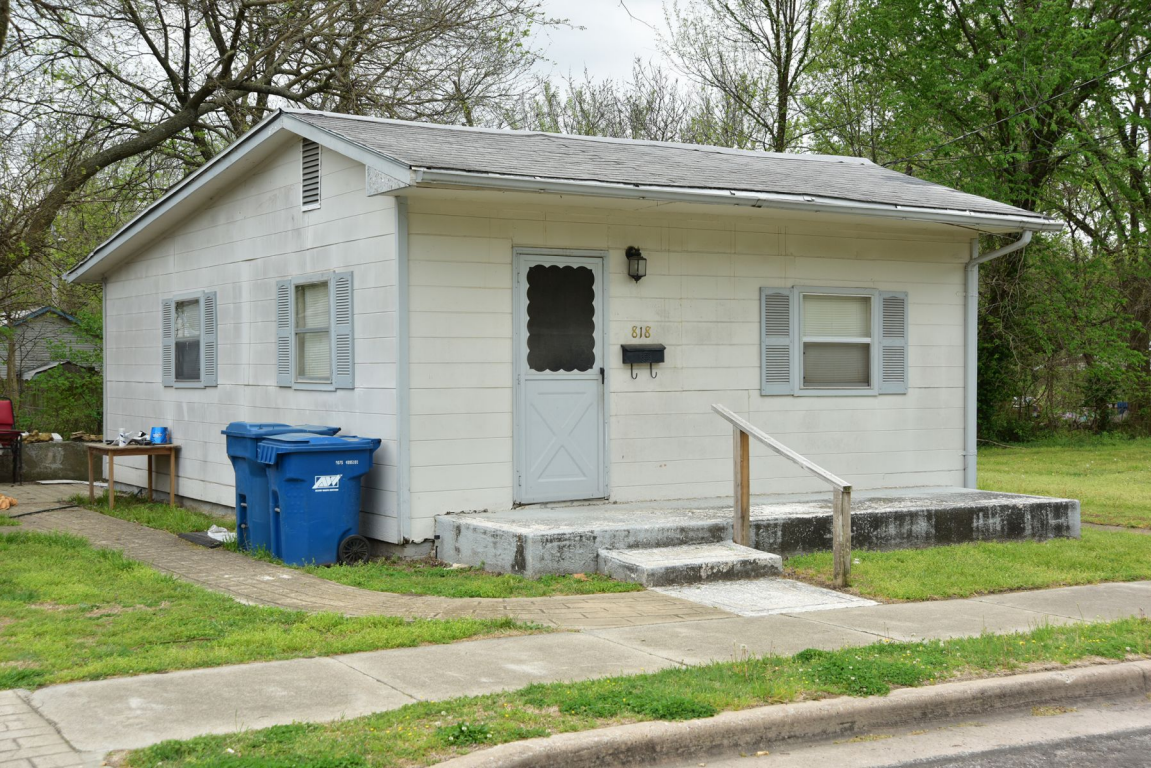
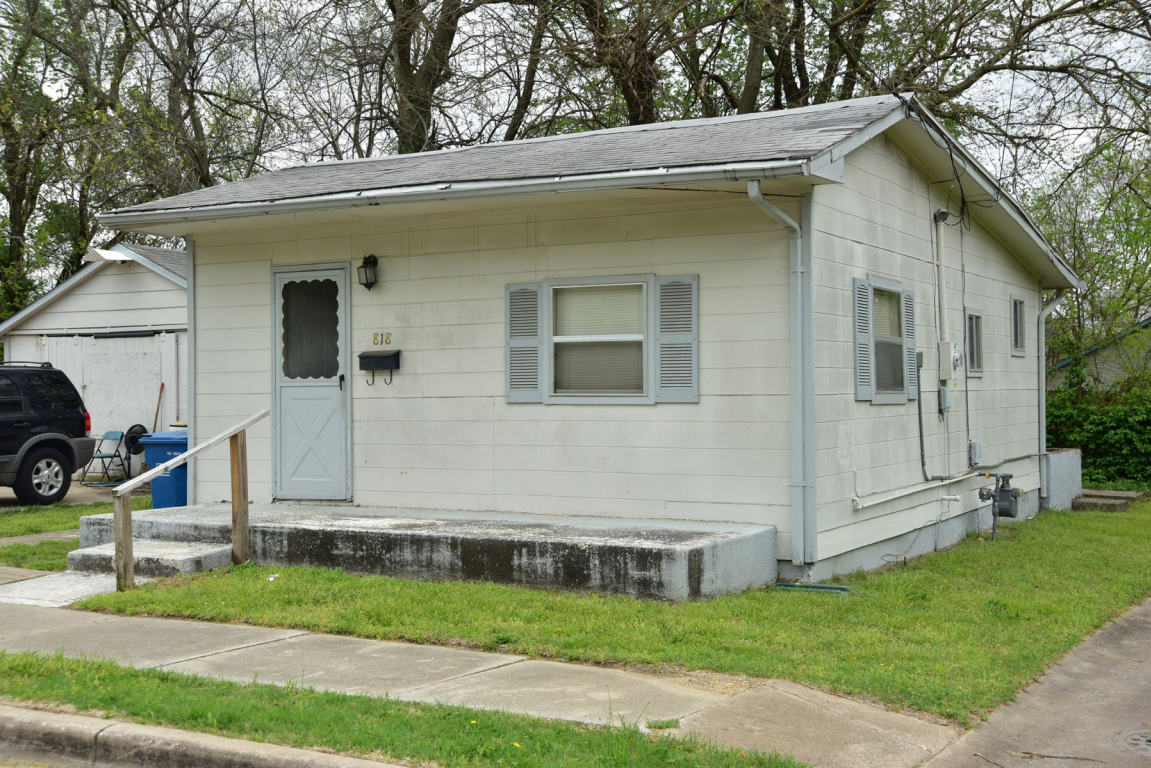
This dwelling faces north and has a rectangular footprint. It has a stone foundation and pressboard cladding. The front-gable roof is asymmetrical and has asphalt shingles. The dwelling is two bays wide and three bays deep. A non-historic wood door occupies the east bay of the primary elevation and a one-over-one metal window with false shutters occupies the west bay. The roof overhangs to shelter the bays and a full-width concrete porch foundation.

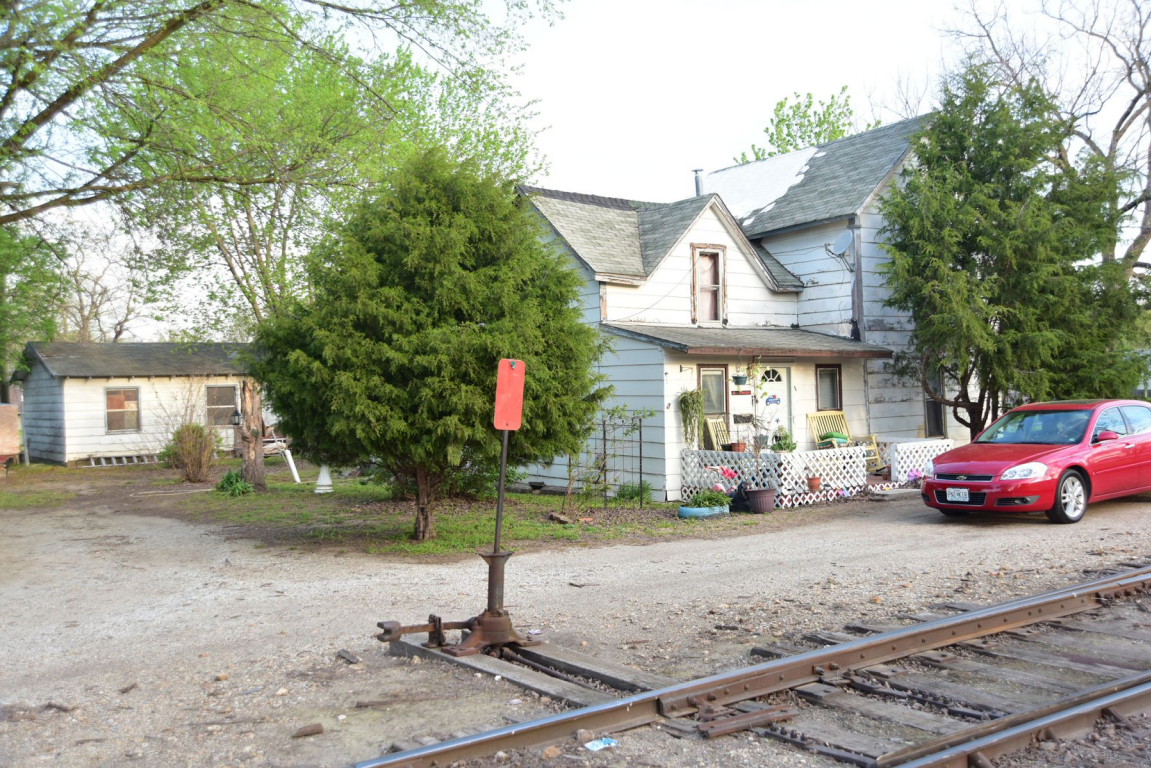
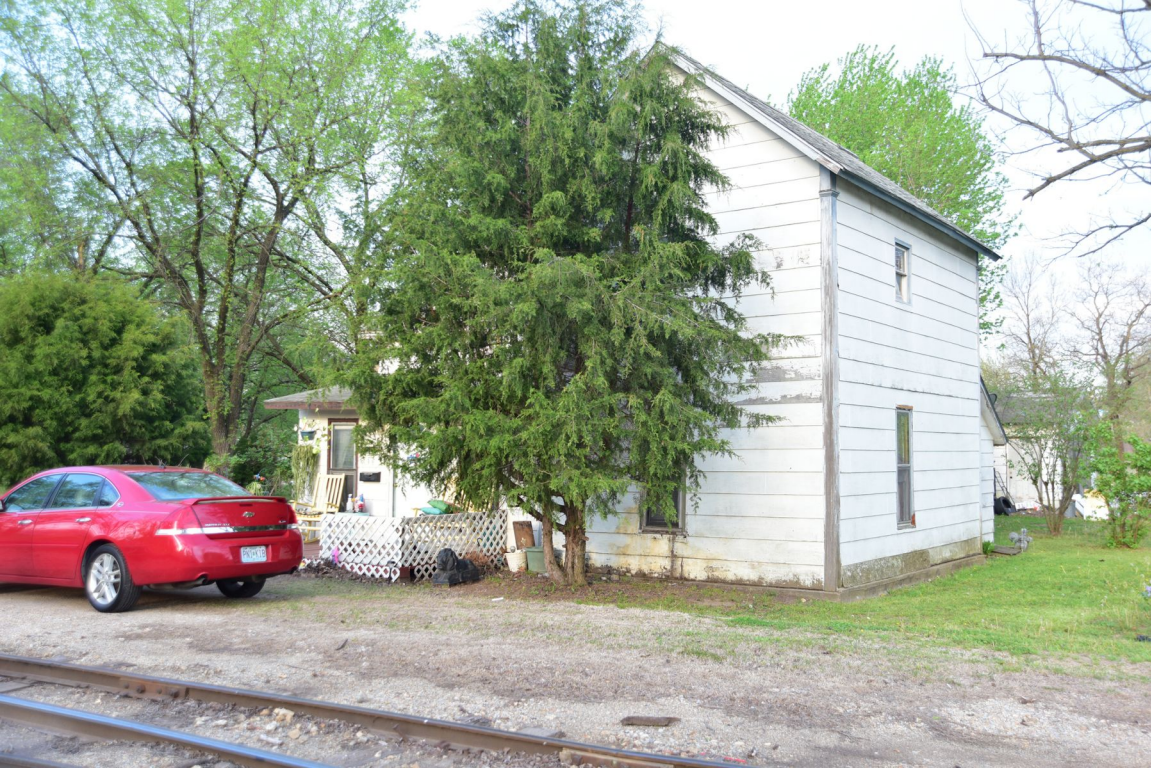
This Gothic Revival dwelling faces east and has a rectangular footprint. It has a stone foundation and asphalt shingle roof. The cladding is pressboard and wood. The dwelling is four bays wide and two bays deep. An enclosed porch with a shed roof contains the first three bays. A non-historic fiberglass door occupies the second bay while one-over-one metal windows occupy the remaining bays. Historic one-story additions extend from the rear elevation.

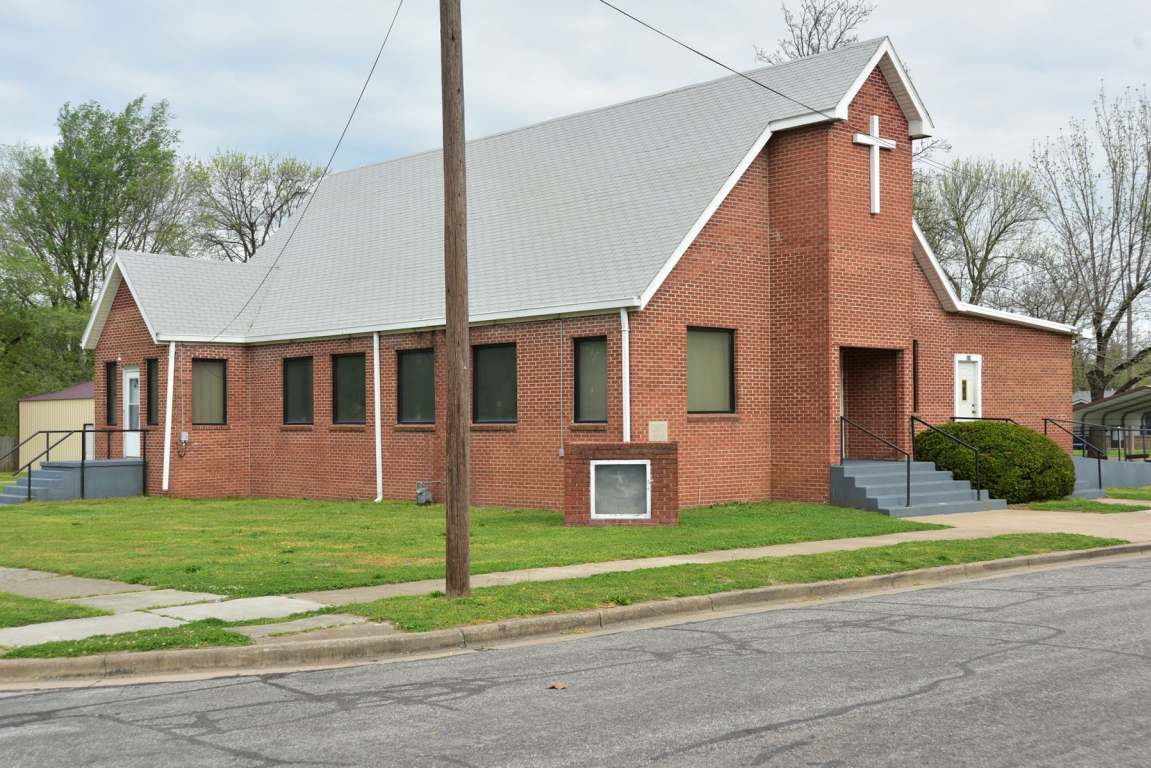
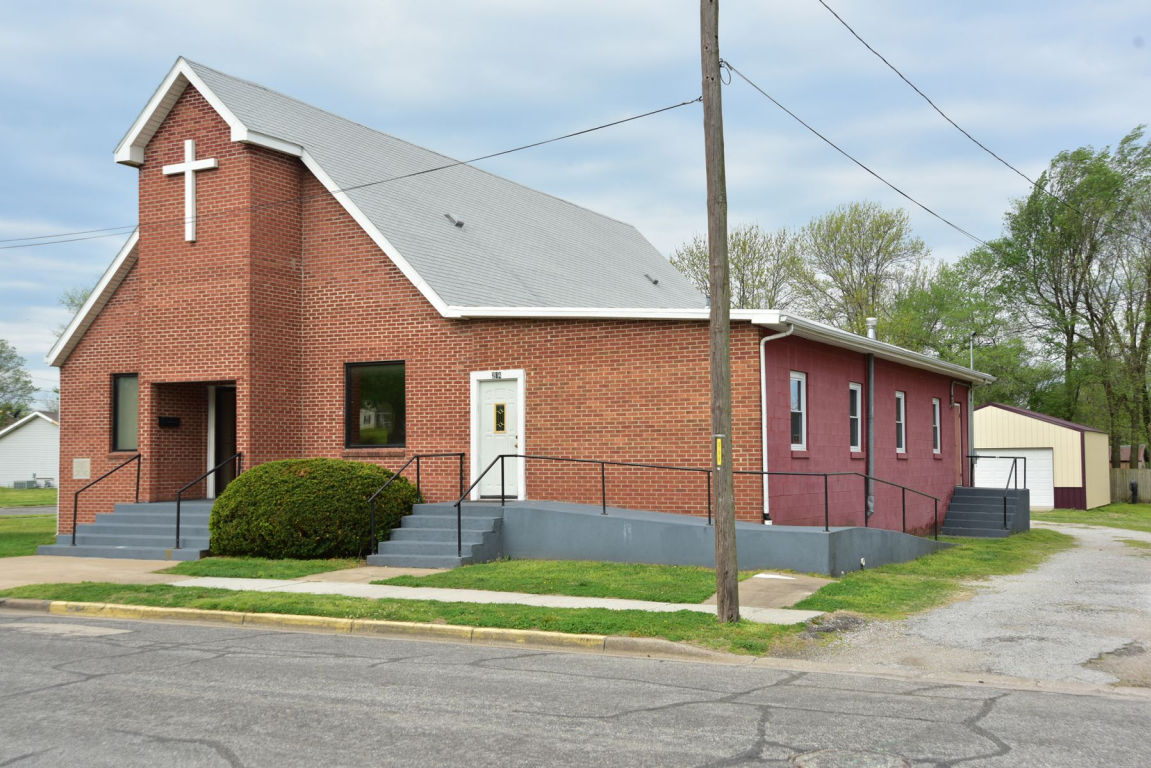
This church faces east and has a rectangular footprint. It has a brick foundation and asphalt roof. The south half of the church has a front-gable roof while c.1980 the north addition has a shed-roof. The north elevation has concrete masonry unit cladding while the other elevations have brick. The church is four asymmetrical bays wide and six bays deep. One-light fixed metal windows occupy the first and third bays of the primary elevation while a non-historic wood door with glazing occupies the fourth bay. A set of paired metal doors with glazing defines the primary entrance at the second bay. A squared brick tower shelters the primary entrance. The tower projects from the primary elevation and spans the height of the church, terminating at the gable peak. A front-gable projection at the south elevation contains a secondary entrance and one-light fixed metal windows. A secondary entrance also occupies the rear bay of the north elevation. Concrete stairs with metal pip railings are located at all entrances. A concrete ramp wraps around the northeast corner of the church.

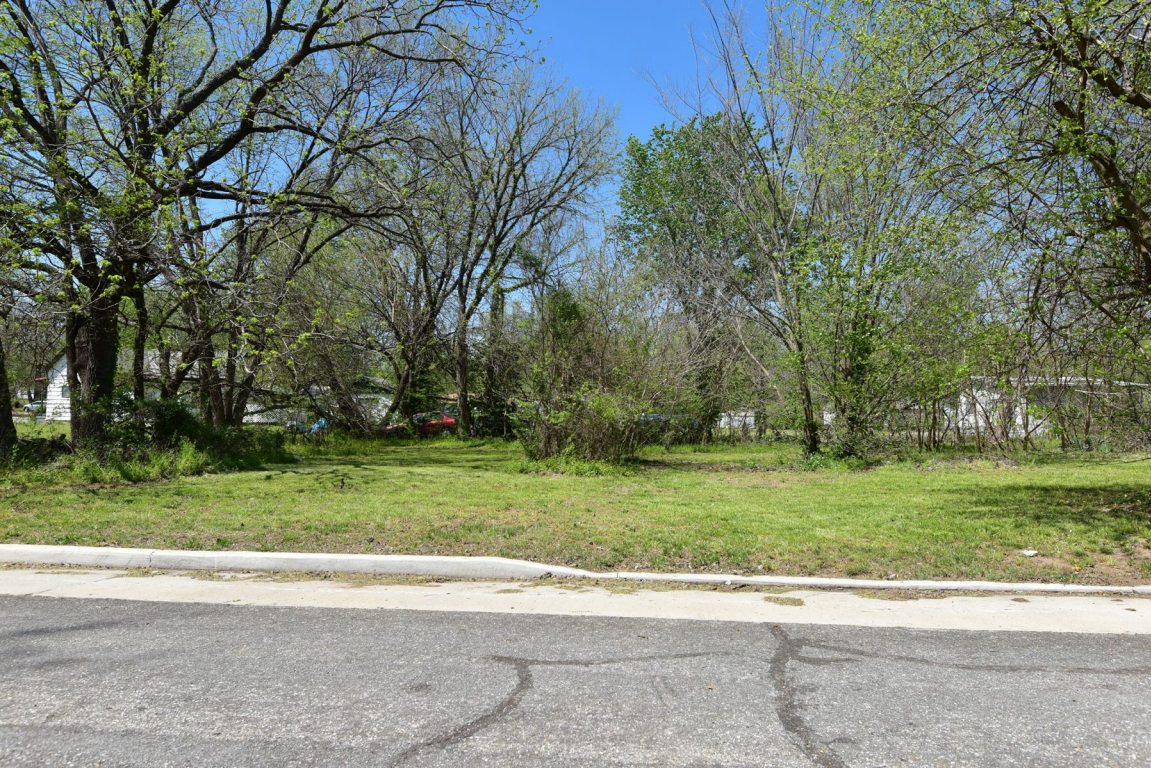
This is a vacant lot characterized by grassy areas, trees, and scrub.

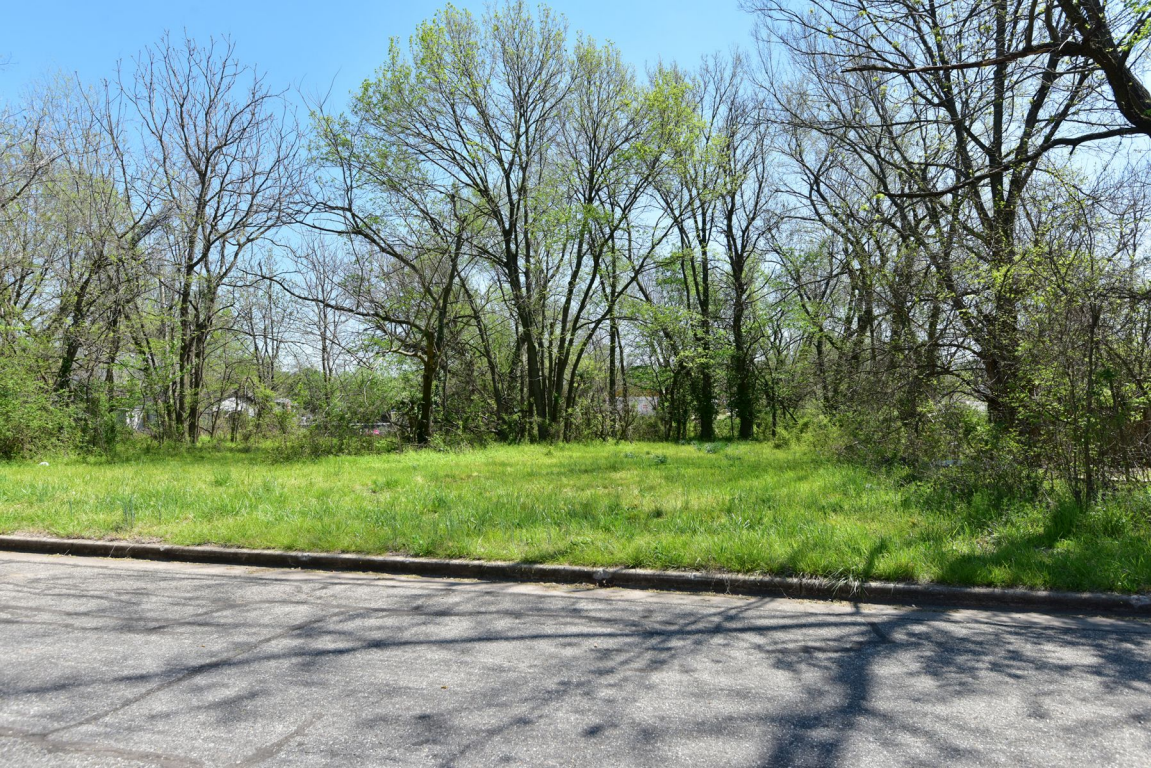
This is a vacant lot characterized by grassy areas, trees, and scrub.
