MISSOURI DEPARTMENT OF NATURAL RESOURCES
STATE HISTORIC PRESERVATION OFFICE, P.O. Box 176, Jefferson City, MO 65102
ARCHITECTURAL/HISTORIC INVENTORY FORM

1. Survey number: JP-AS-006-260		2. Survey Name: East Town (Original Joplin) Historic Survey Phase 1	
3. County: JASPER		4. Address 1506	Street (name): E. North Street
5. City: Joplin	Vicinity <input type="checkbox"/>	7. Township/Range/Section: T: R: S:	
8. Historic name (if known):		9. Present/other name (if known):	
10. Ownership: <input checked="" type="checkbox"/> Private <input type="checkbox"/> Public		11a. Historic use (if known): Domestic/Single Dwelling	11b. Current use: Domestic/Single Dwelling

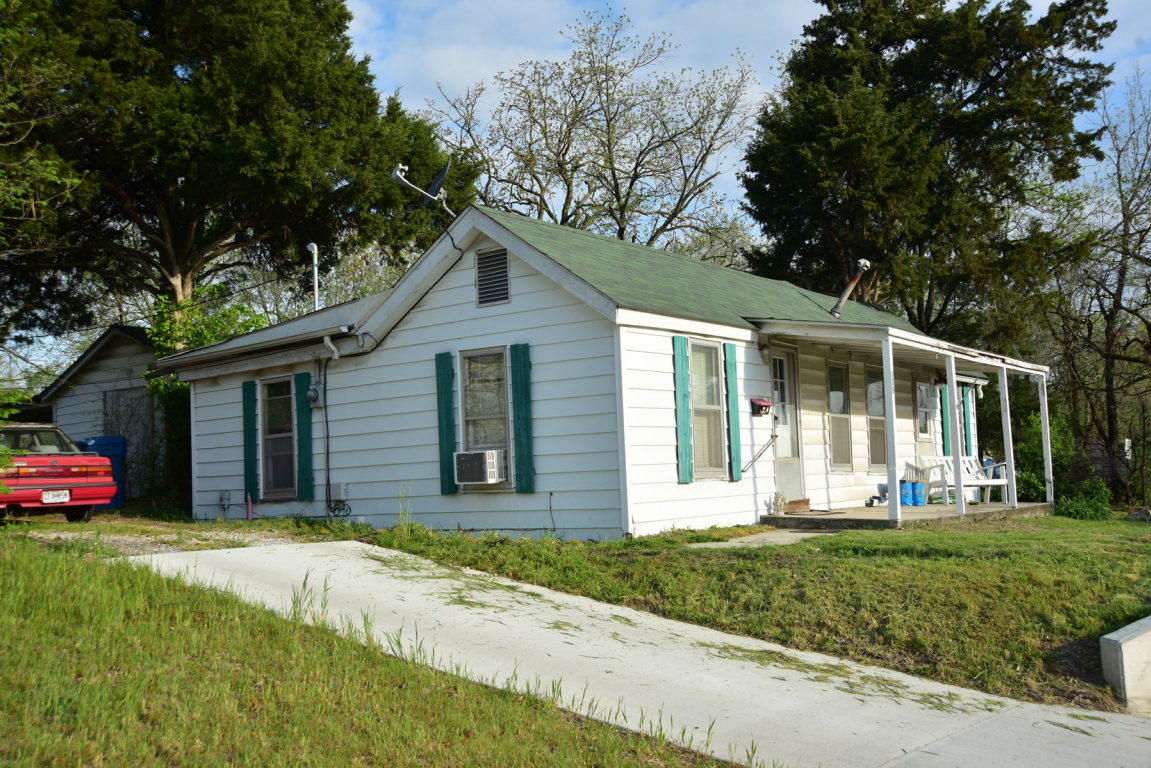
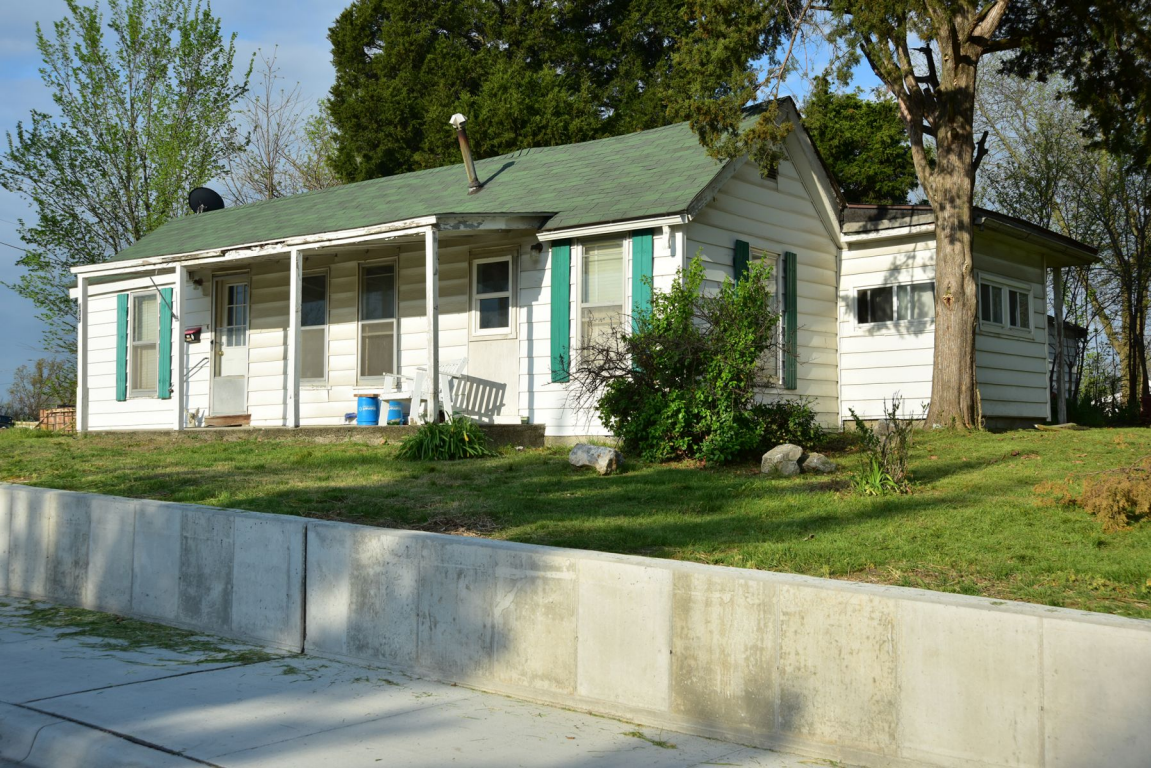
This dwelling faces east and has a rectangular footprint. It has wide-profile vinyl cladding and an asphalt roof. The foundation is not visible. An addition at the north elevation has a concrete foundation. The dwelling is six bays wide and two bays deep. A non-historic wood door with nine-light glazing occupies the second bay while one-over-one vinyl windows fill the remaining bays. The fifth bay has been shortened. A shed-roof porch shelters the center four bays. It has a concrete foundation and square wood support posts. A shed-roof addition projects from the rear of the north elevation. It has vinyl cladding and banks of one-by-one vinyl windows define its bays.

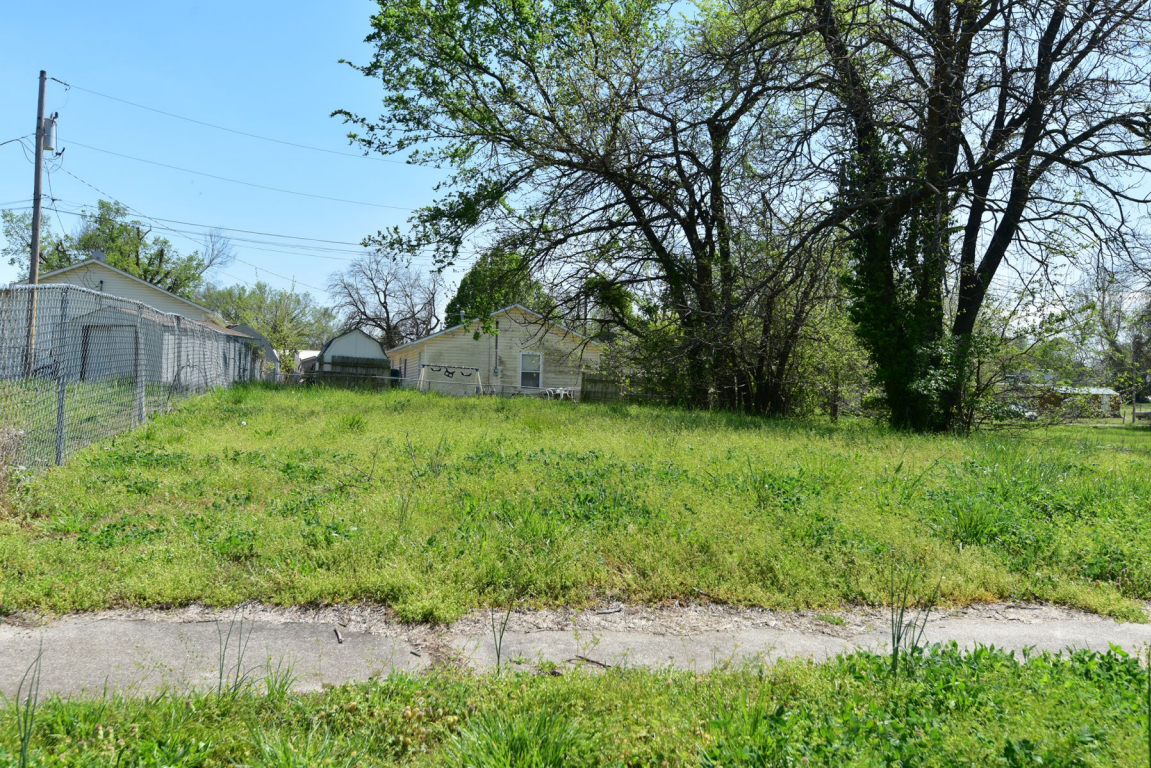
This grassy lot is vacant.

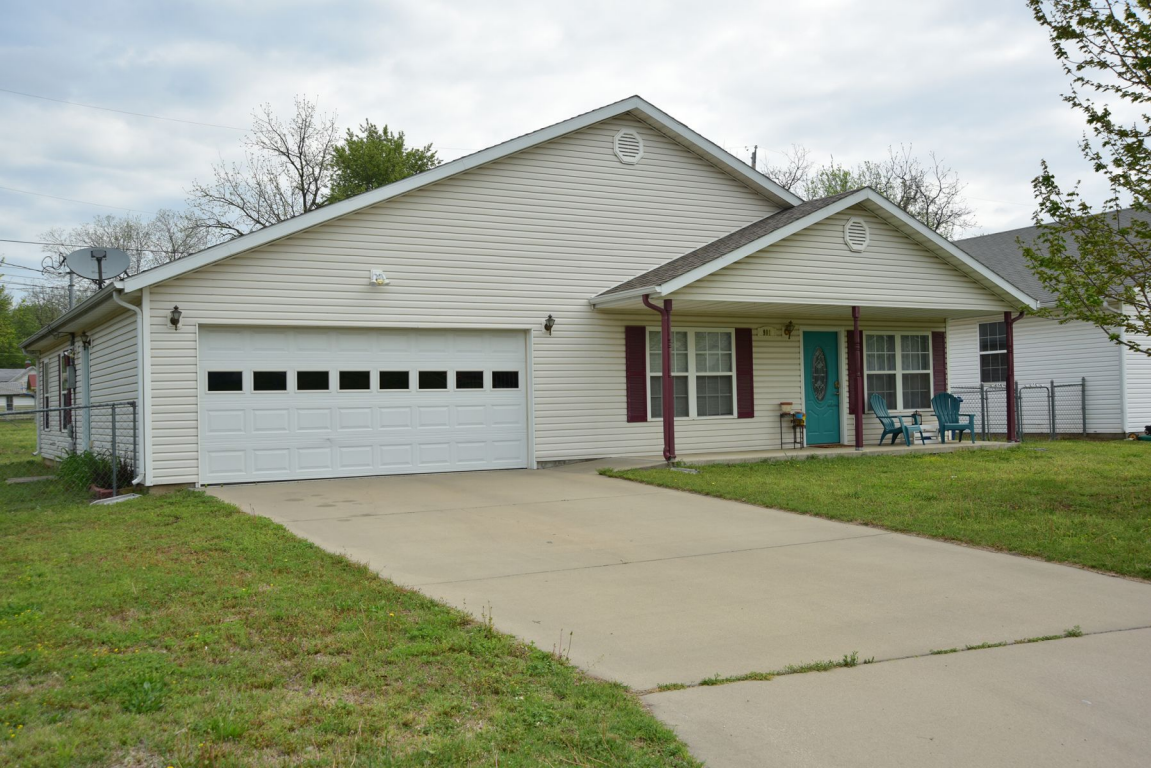
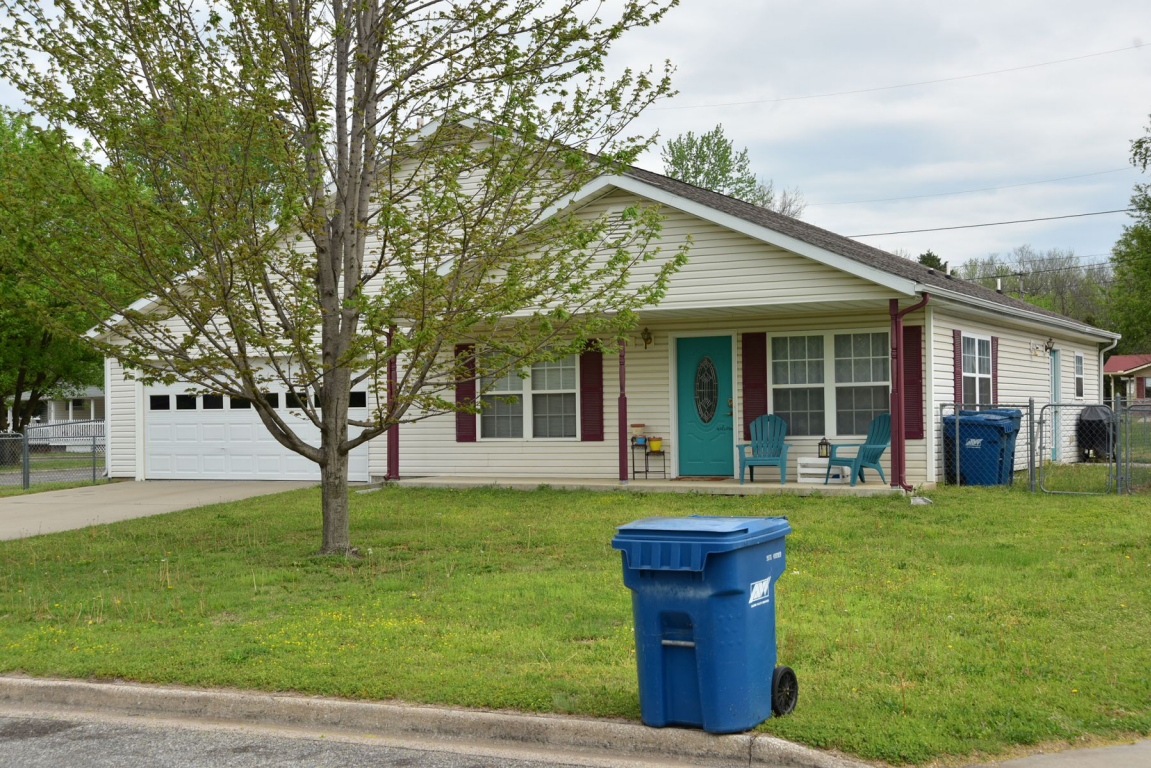
This dwelling faces south and has an L-shaped footprint. It has as concrete foundation, vinyl cladding, and a front-gable roof with asphalt shingles. It is four bays wide and three bays deep. A two-car overhead garage door occupies the first bay while a wood door with glazing occupies the third bay. Six-over-six vinyl windows fill the remaining bays. A front-gable roofed porch shelters the east three bays.

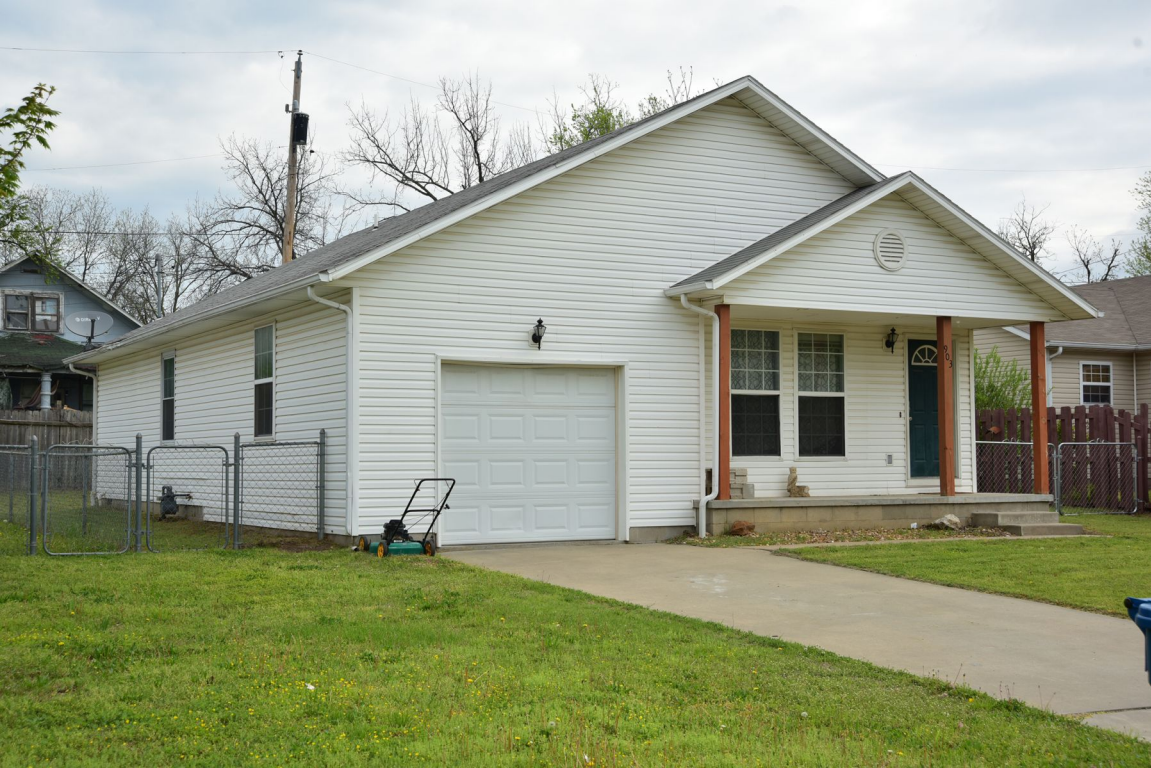
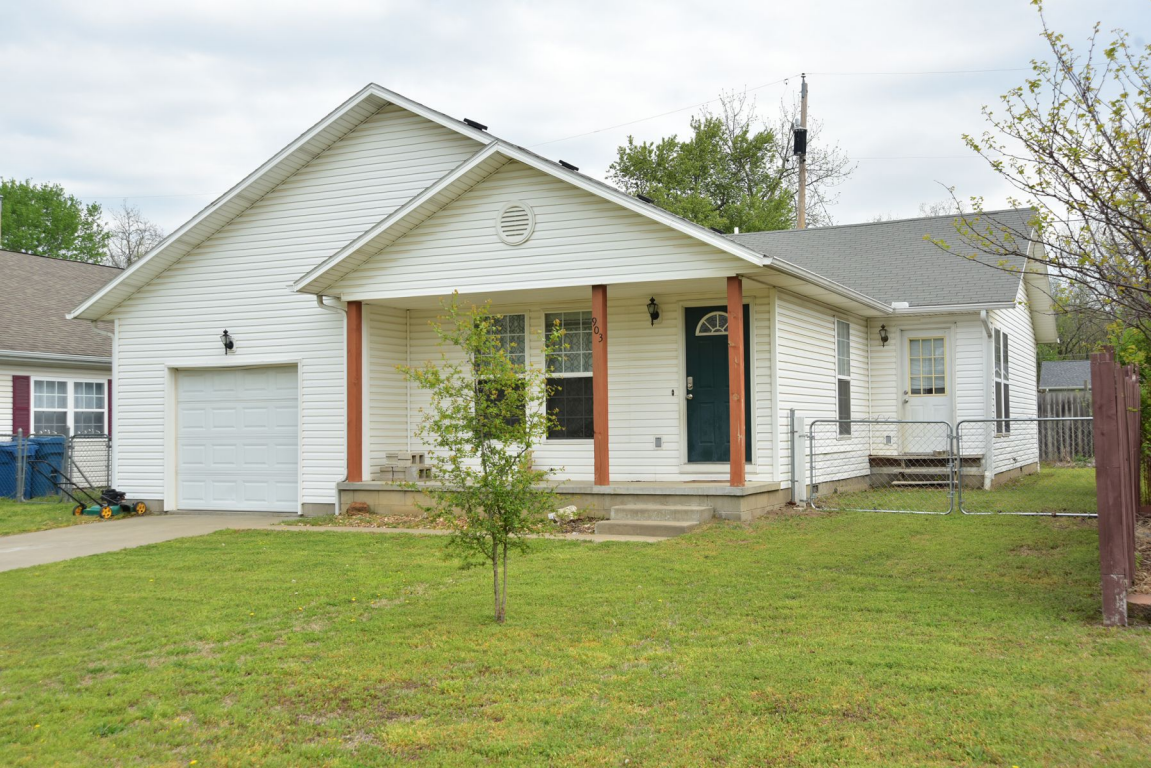
This dwelling faces south and has an L-shaped footprint. It has as concrete foundation, vinyl cladding, and a front-gable roof with asphalt shingles. It is three bays wide and two bays deep. A one-car overhead garage door occupies the first bay while a wood door with glazing occupies the third bay. A pair of six-over-six vinyl windows fills the center bay. A front-gable roofed porch shelters the east two bays.

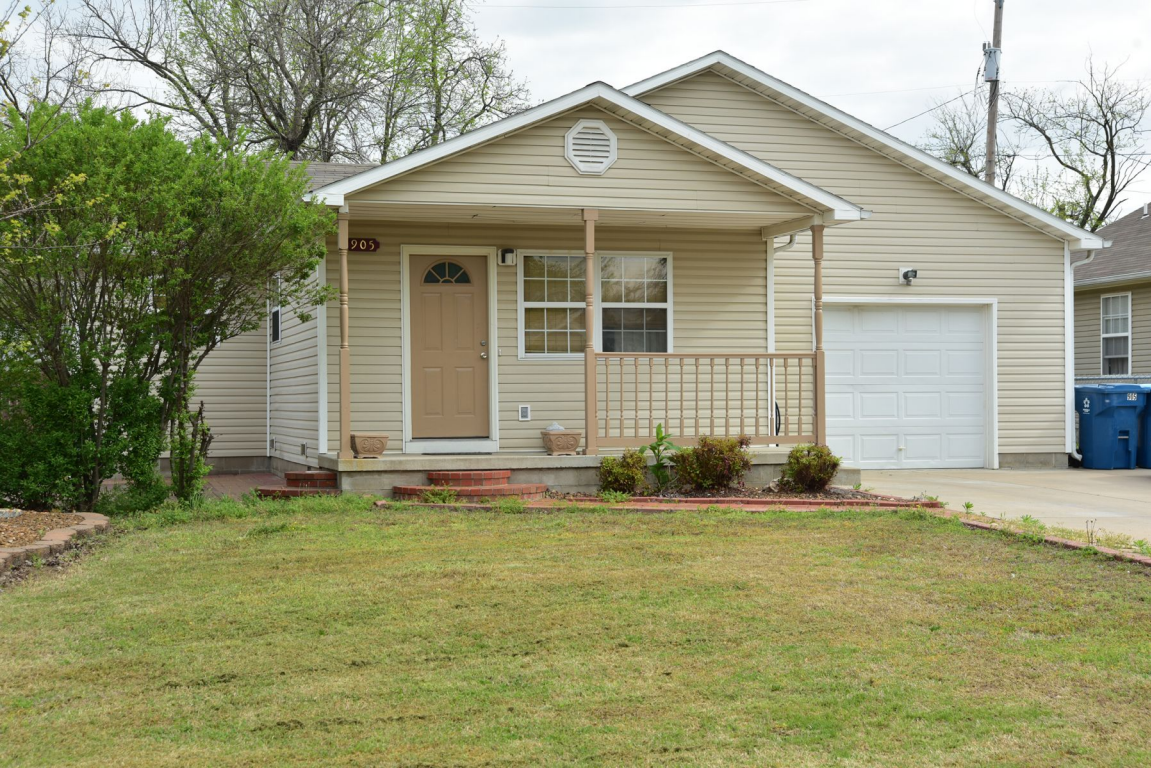
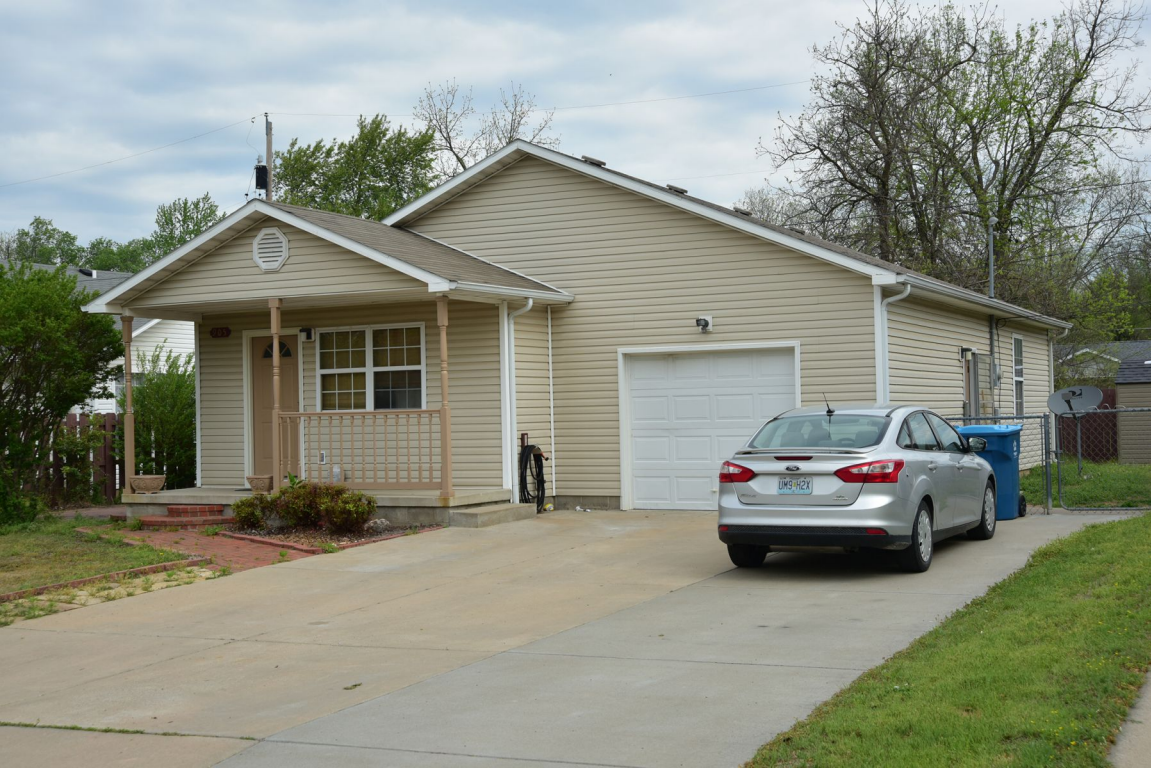
This dwelling faces south and has an L-shaped footprint. It has as concrete masonry unit foundation, vinyl cladding, and a front-gable roof with asphalt shingles. It is three bays wide and two bays deep. A one-car overhead garage door occupies the third bay while a wood door with glazing occupies the first bay. A pair of six-over-six vinyl windows fills the center bay. A front-gable roofed porch shelters the west two bays.

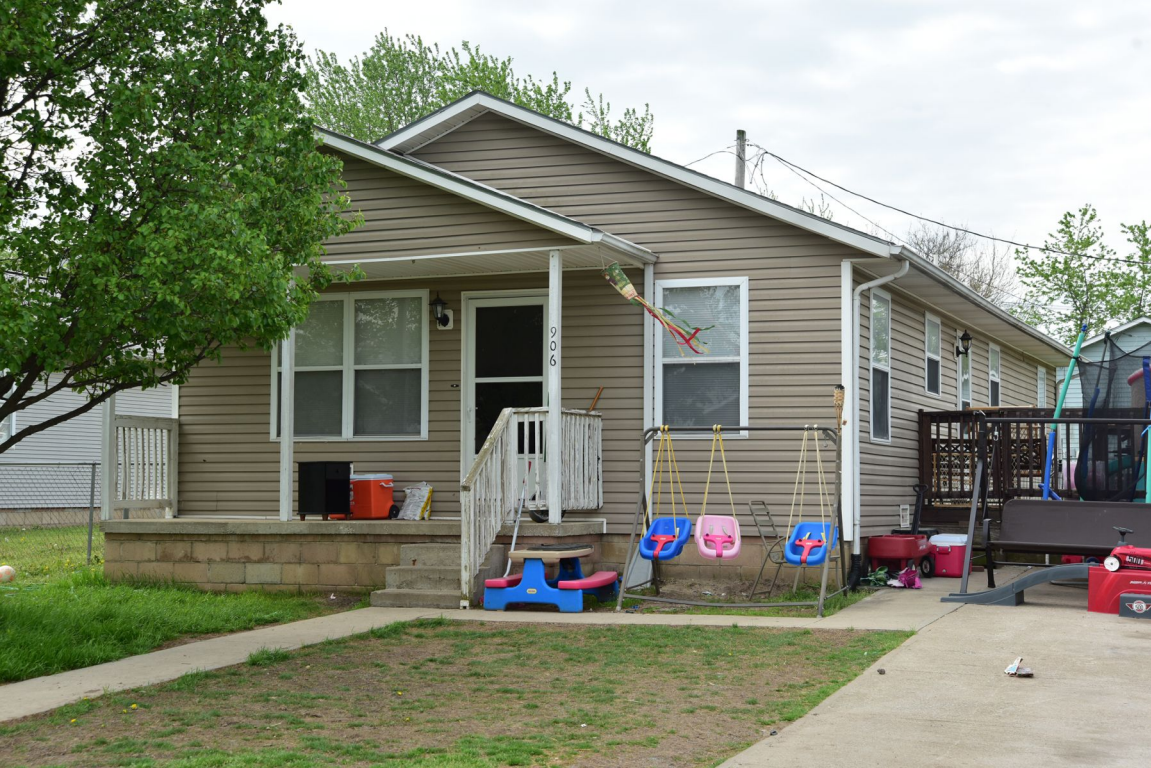
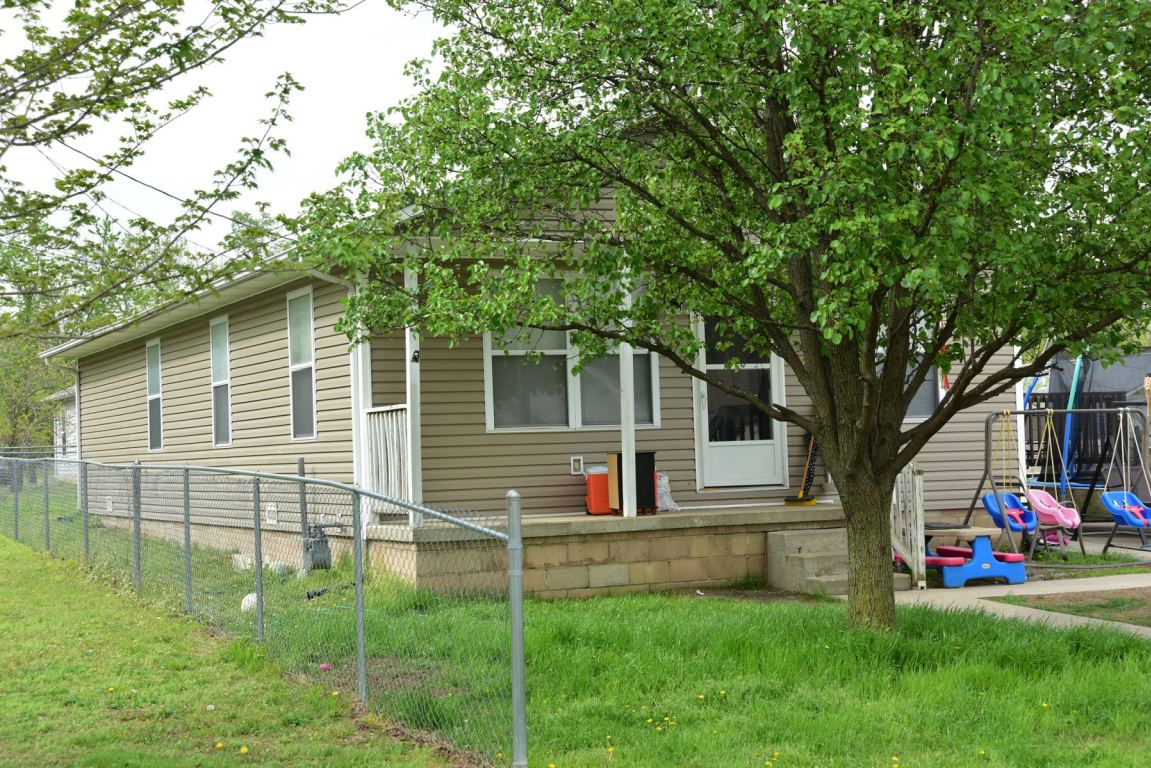
This dwelling faces north and has rectangular footprint. It has as concrete masonry unit foundation, vinyl cladding, and a front-gable roof with asphalt shingles. It is three bays wide and five bays deep. A wood door with glazing occupies the center bay while one-over-one vinyl windows occupies the remining bays. A front-gable roofed porch shelters the east two bays.

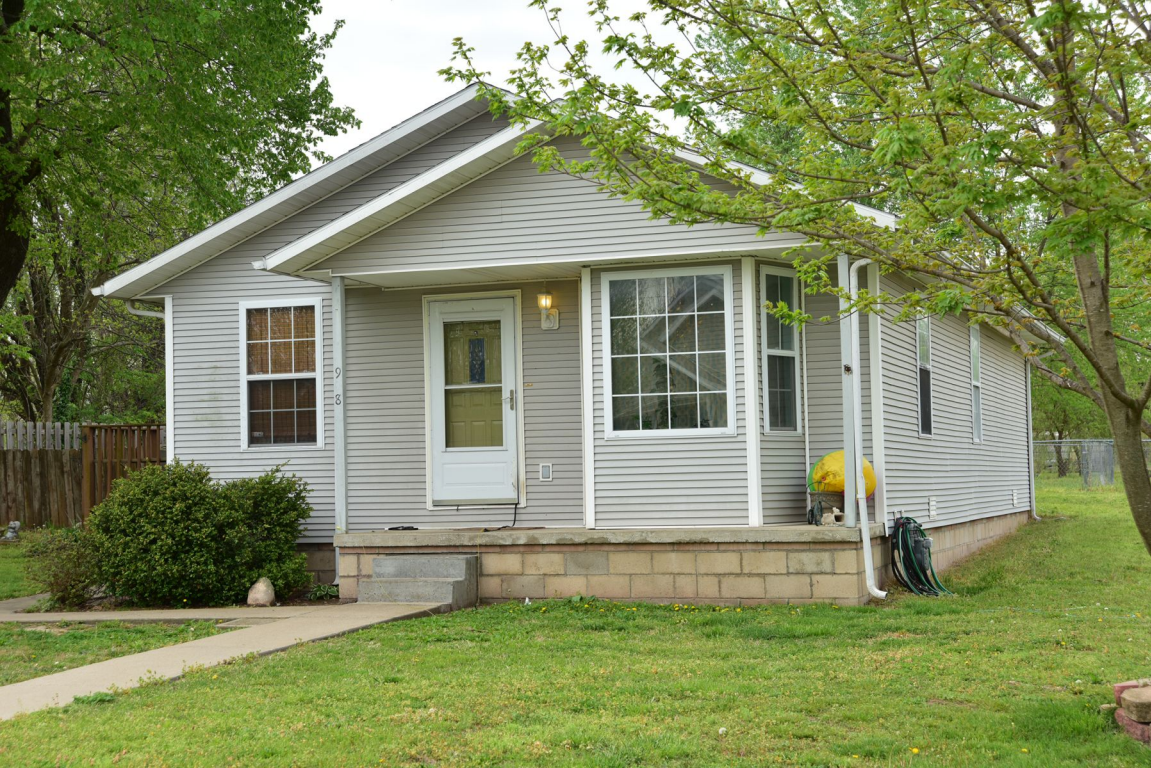
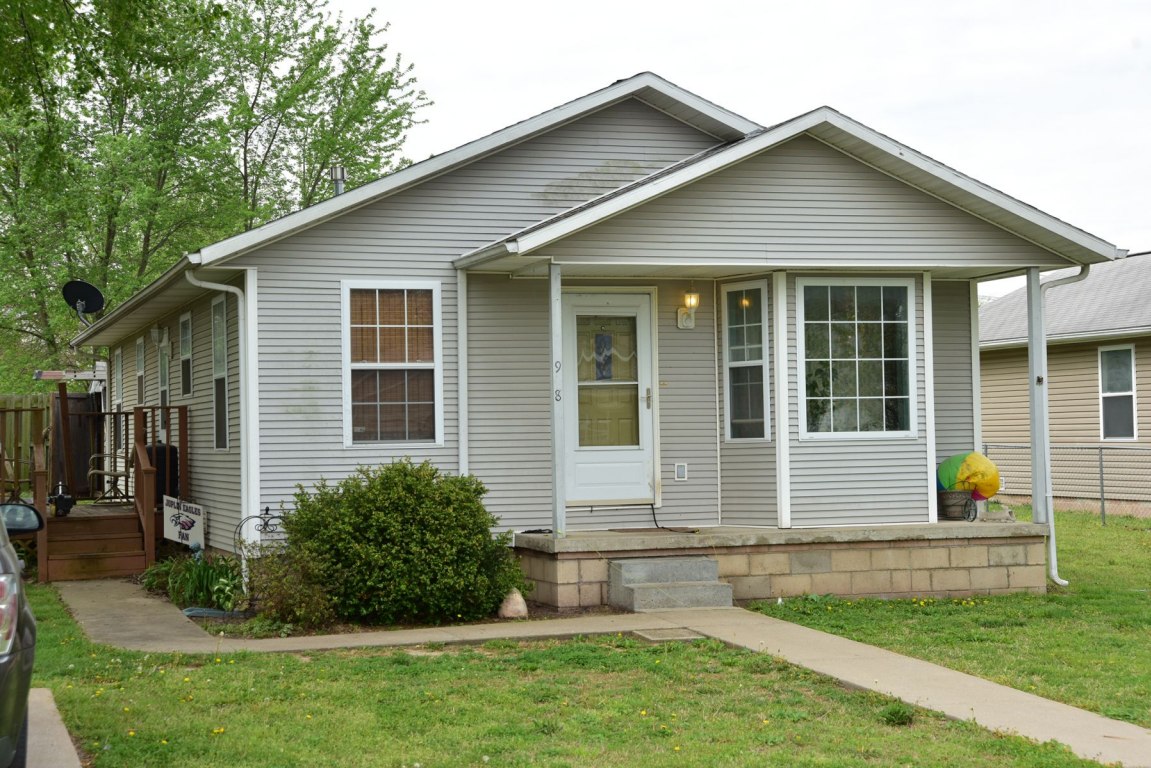
This dwelling faces north and has rectangular footprint. It has as concrete masonry unit foundation, vinyl cladding, and a front-gable roof with asphalt shingles. It is three bays wide and five bays deep. A wood door with glazing occupies the center bay while a six-over-six vinyl windows occupies the east bay. A vinyl bay window with fifteen-light center and four-over-four side segments occupies the west bay. A front-gable roofed porch shelters the west two bays.

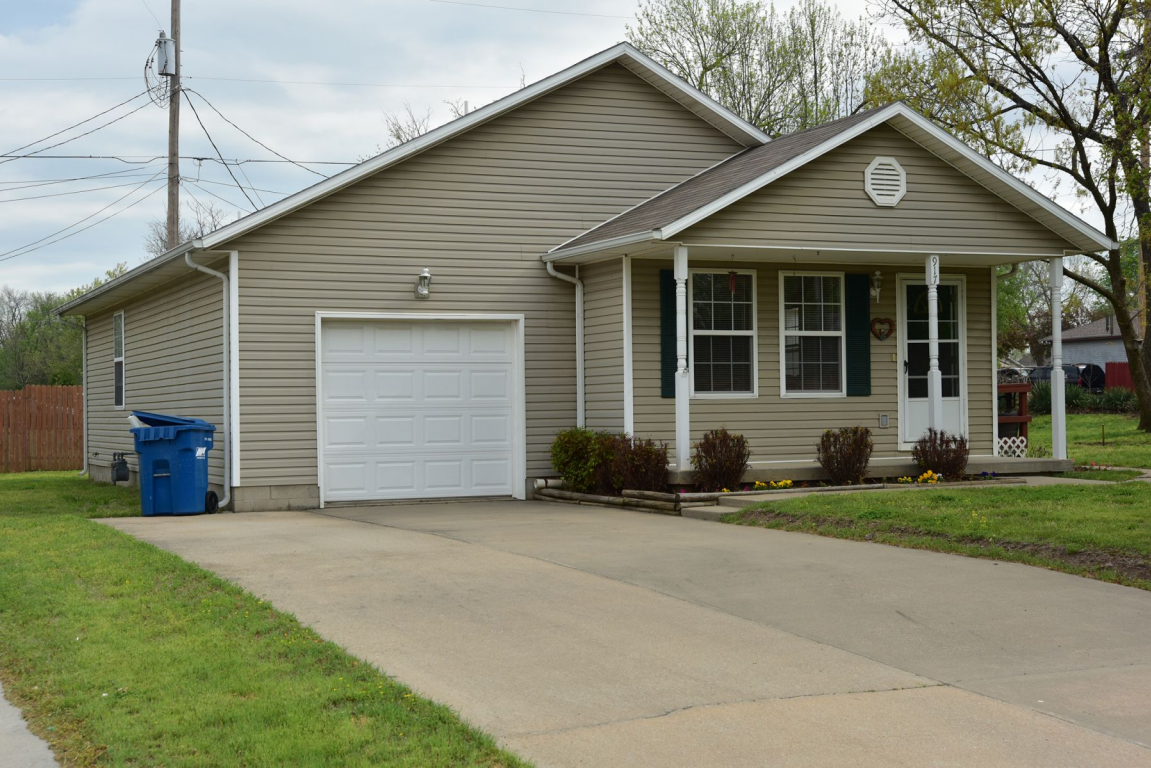
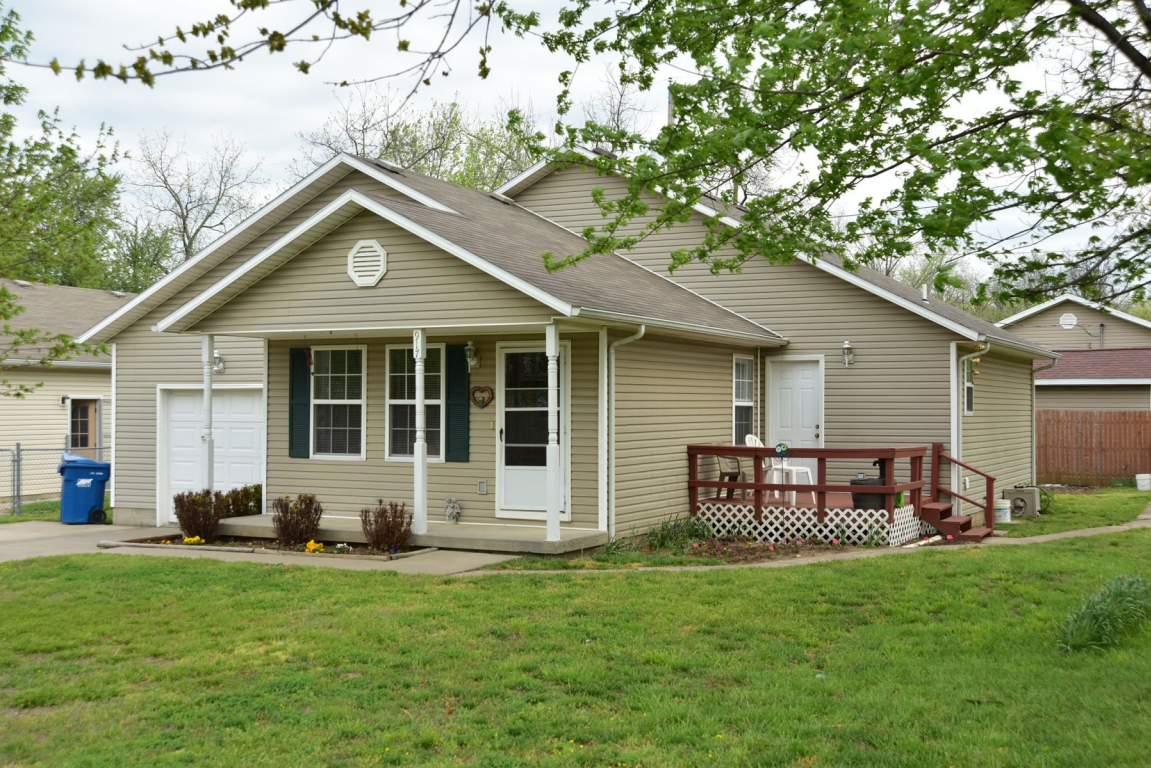
This dwelling faces south and has an L-shaped footprint. It has as concrete foundation, vinyl cladding, and a front-gable roof with asphalt shingles. It is three bays wide and two bays deep. A one-car overhead garage door occupies the first bay while a wood door with glazing occupies the third bay. A pair of six-over-six vinyl windows fills the center bay. A front-gable roofed porch shelters the east three bays.

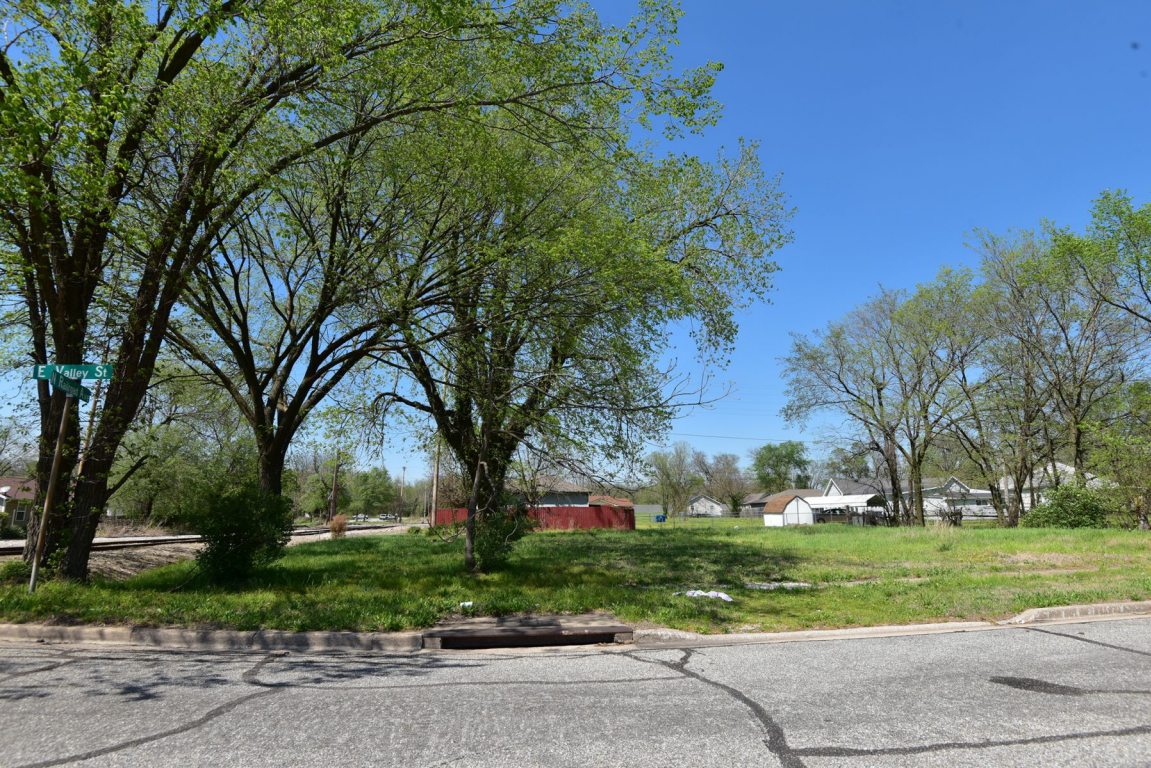
This grassy lot is vacant.

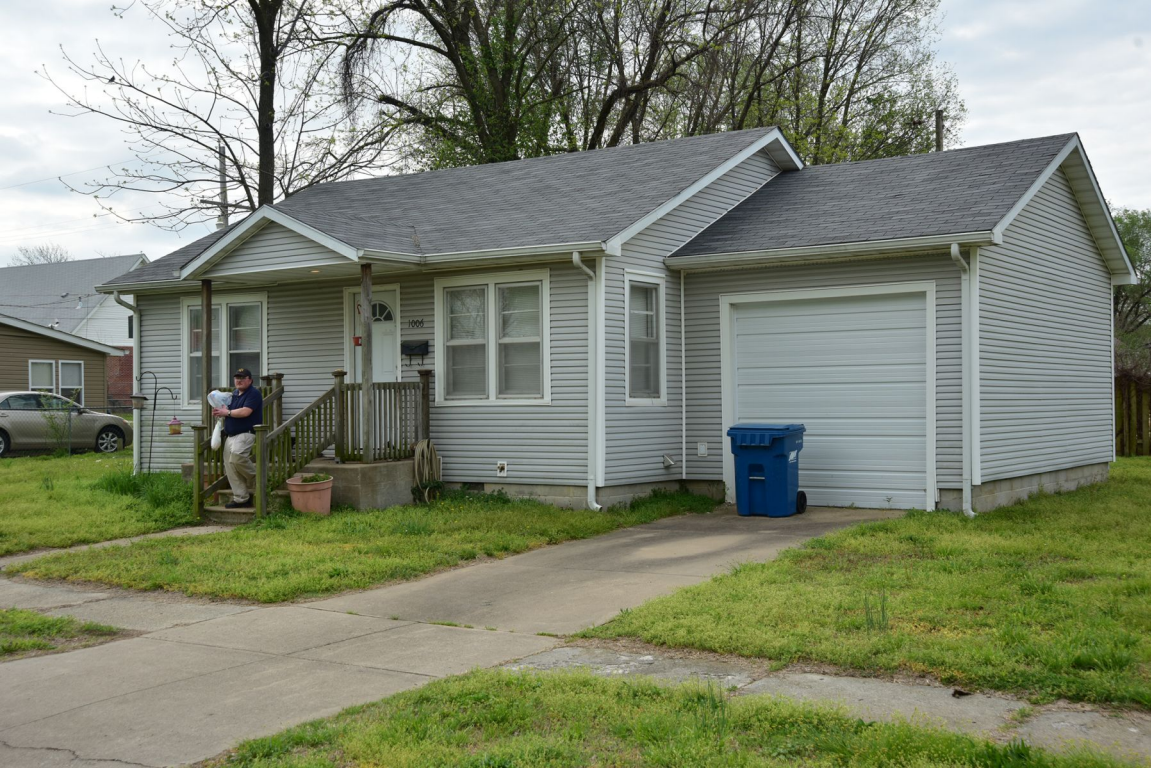
This dwelling faces north and has rectangular footprint. It has as concrete masonry unit foundation, vinyl cladding, and a side-gable roof with asphalt shingles. It is four bays wide and two bays deep. A wood door with glazing occupies the second bay while a one-car overhead garage door occupies the fourth bay. Pairs of two-over-two wood windows occupy the remaining bays. A front-gable roofed porch shelters the entrance bay.

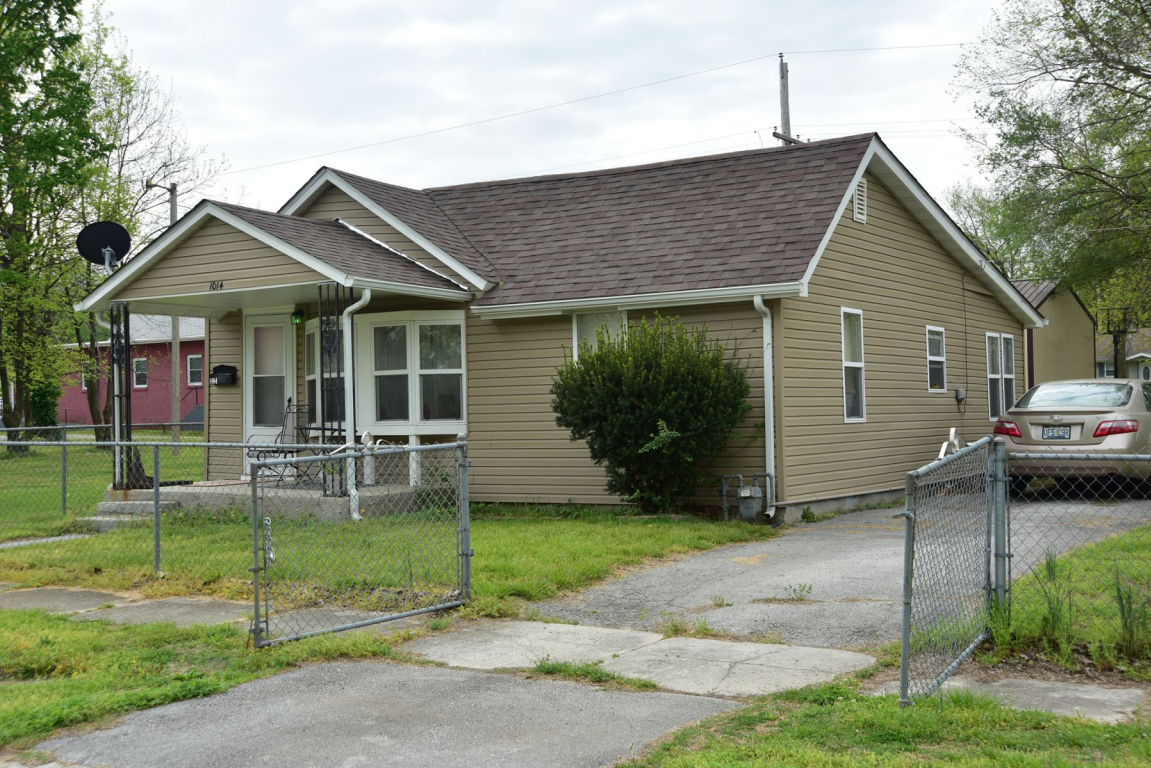
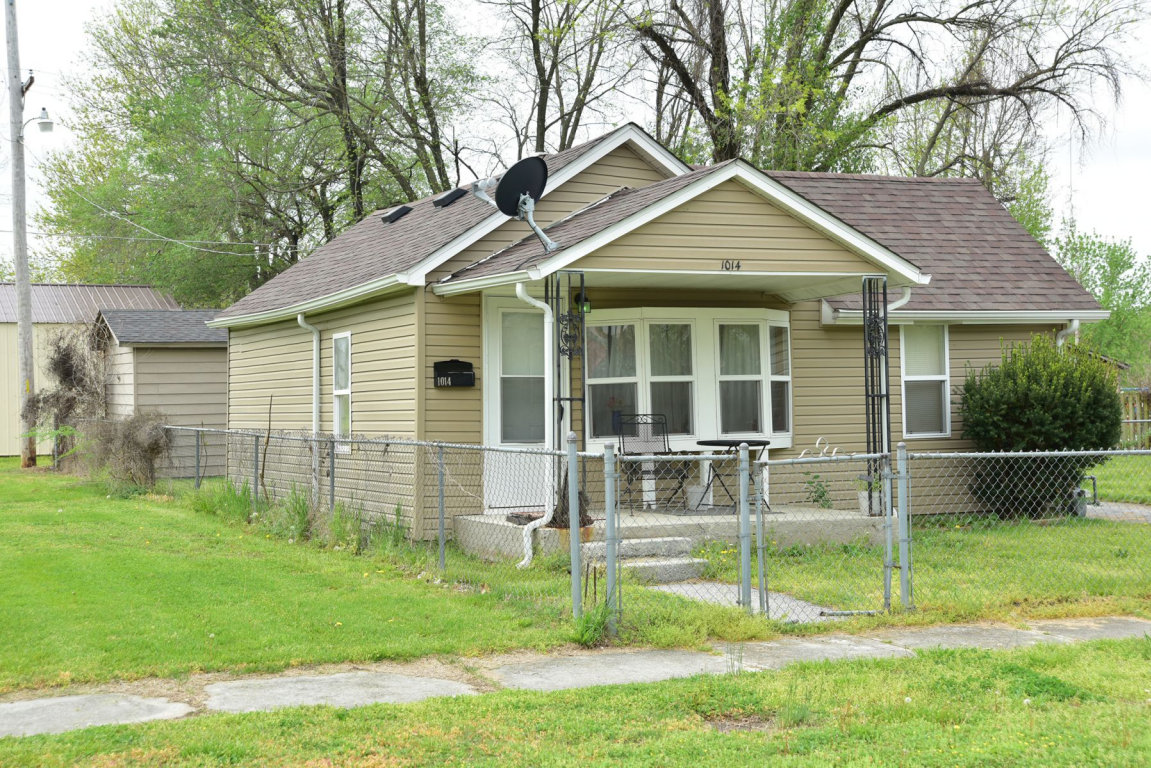
This bungalow dwelling faces north and has rectangular footprint. It has a concrete foundation, vinyl cladding, and asphalt shingle roof. It is three bays wide and two three bays deep. A wood door with glazing occupies the east bay while a one-over-one vinyl window occupies the west bay. A four-part vinyl bay window with one-over-one segments occupies the center bay. A front-gable roofed porch shelters the east two bays.

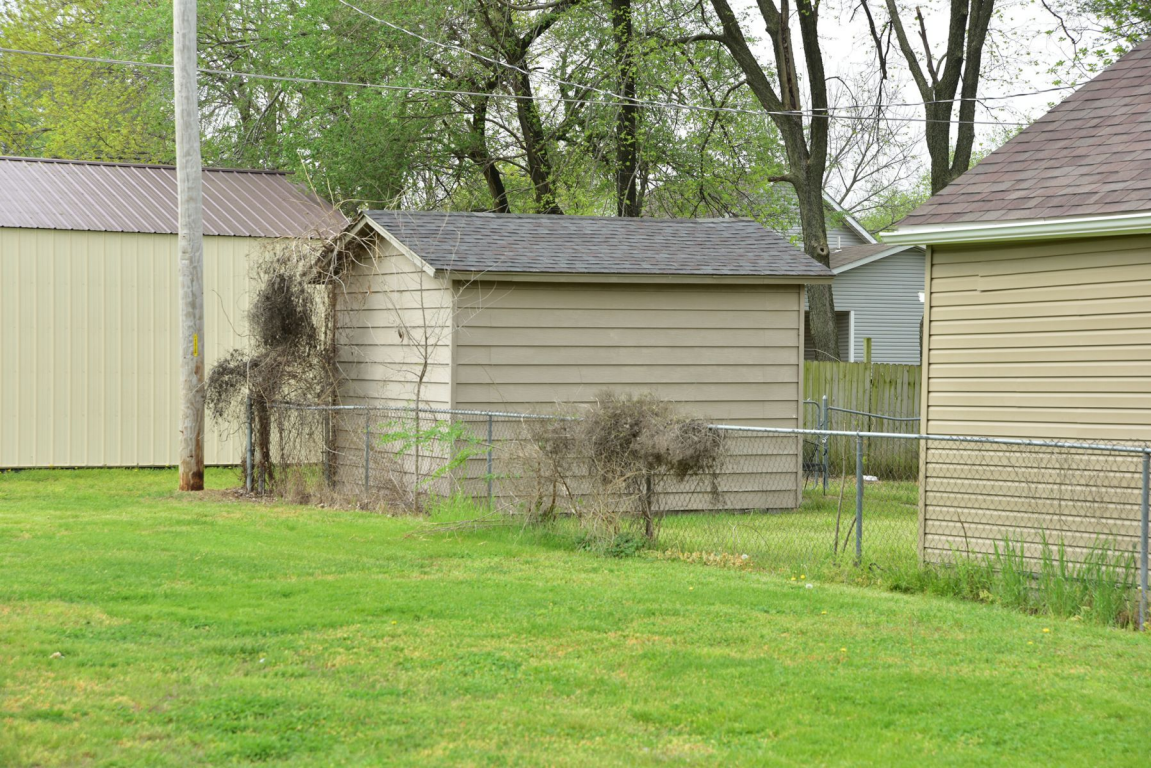
This dwelling faces south and is in the central portion of the Survey Area. It has an ornamental lawn and concrete driveway. No outbuildings were observed.

This one-story Ranch type house faces south. It has a poured concrete foundation and a side-gabled roof with asphalt shingles. The lower half of the exterior has brick veneer cladding and the upper half is clad with vinyl siding. A one-story, partial-width porch with a front-gabled roof with asphalt shingles and vinyl cladding in the gable spans the west portion of the primary elevation. The porch has a poured concrete slab and vinyl support posts. The primary elevation has five bays; the two west bays are sheltered by the porch. The three east bays each contain a one-over-one metal window with shutters. The second-from-west bay contains a wood door. The west bay contains a pair of one-over-one metal windows with shutters. A carport with a side-gabled roof extends from the east elevation. The carport has vinyl support posts and an attached shed with vinyl siding.

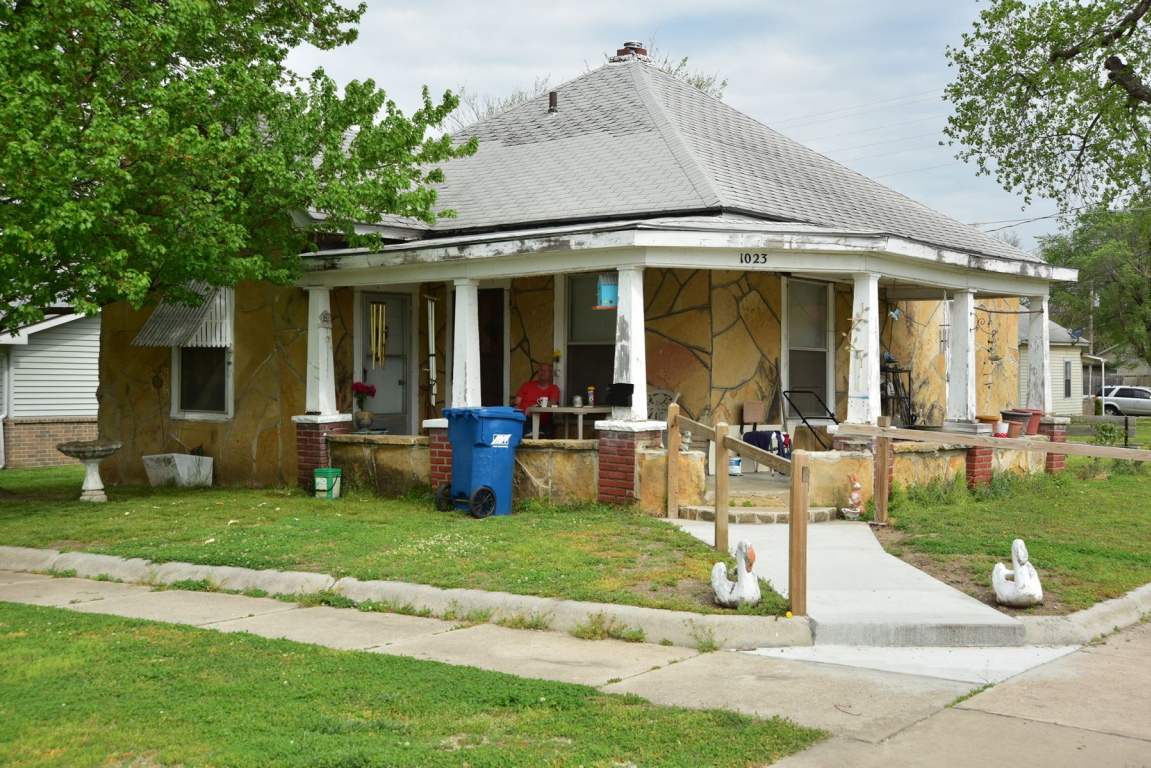
This Pyramid Square Folk House dwelling faces south and has a square footprint. It has a stone foundation and split-slab fieldstone cladding. The pyramidal hipped roof has asphalt shingles and a cross gable is located in the southwest corner. A short brick chimney pierces the roof peak. A verandah wraps around the southeast corner. It has split-slab field stone walls and brick piers. Tapered wood columns top the piers and support the roof. The dwelling is three bays wide and two bays deep. Historic one-over-one wood windows occupy the east and west bays while a wood door occupies the center bay. A second entrance is located in the east wall of the cross-gable projection. Both doorways have historic wood trim. An enclosed porch projects from the north elevation.

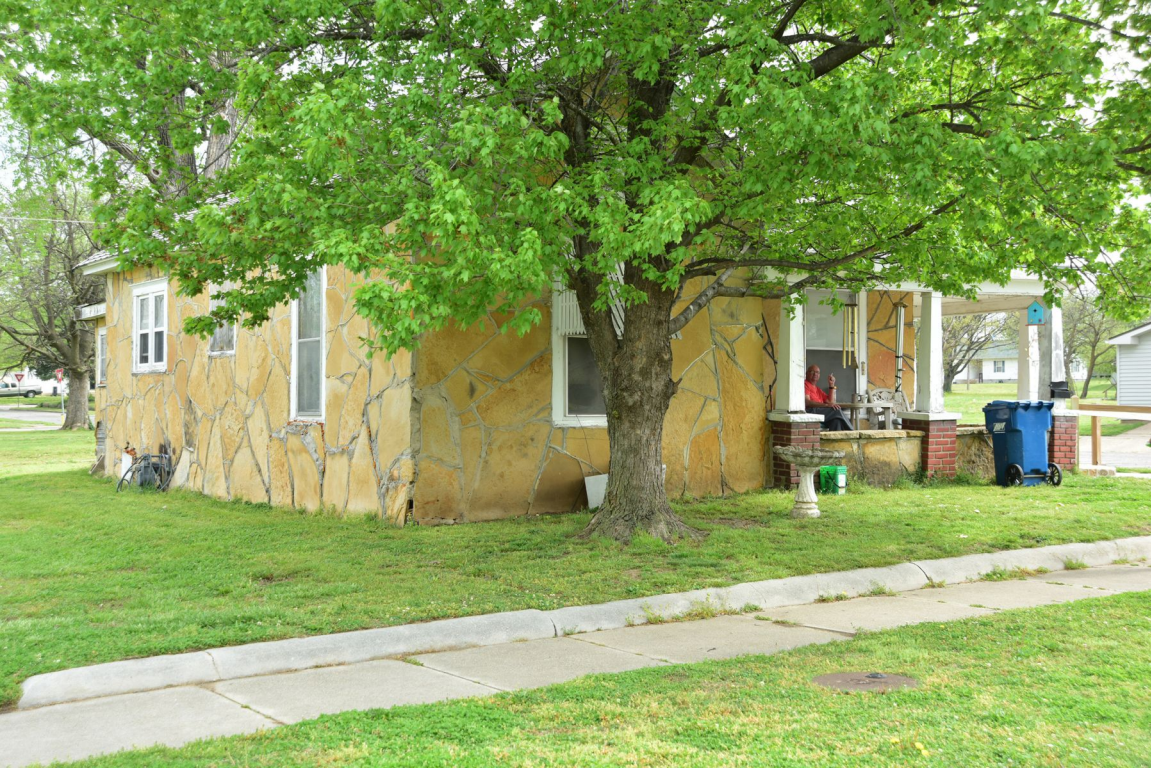
1023

This dwelling faces south and is in the central portion of the Survey Area. Concrete sidewalks abut the south and east edges of the property. A large deciduous tree is in the southwest corner of the ornamental lawn. No outbuildings were observed.

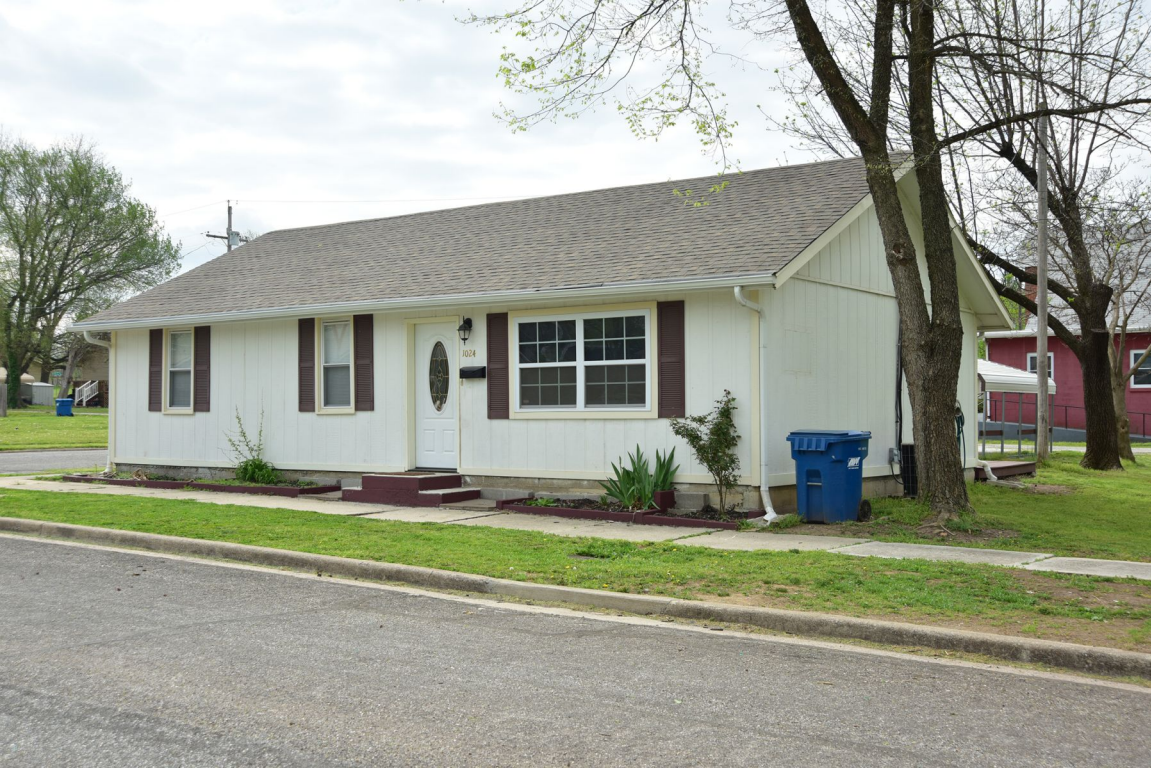
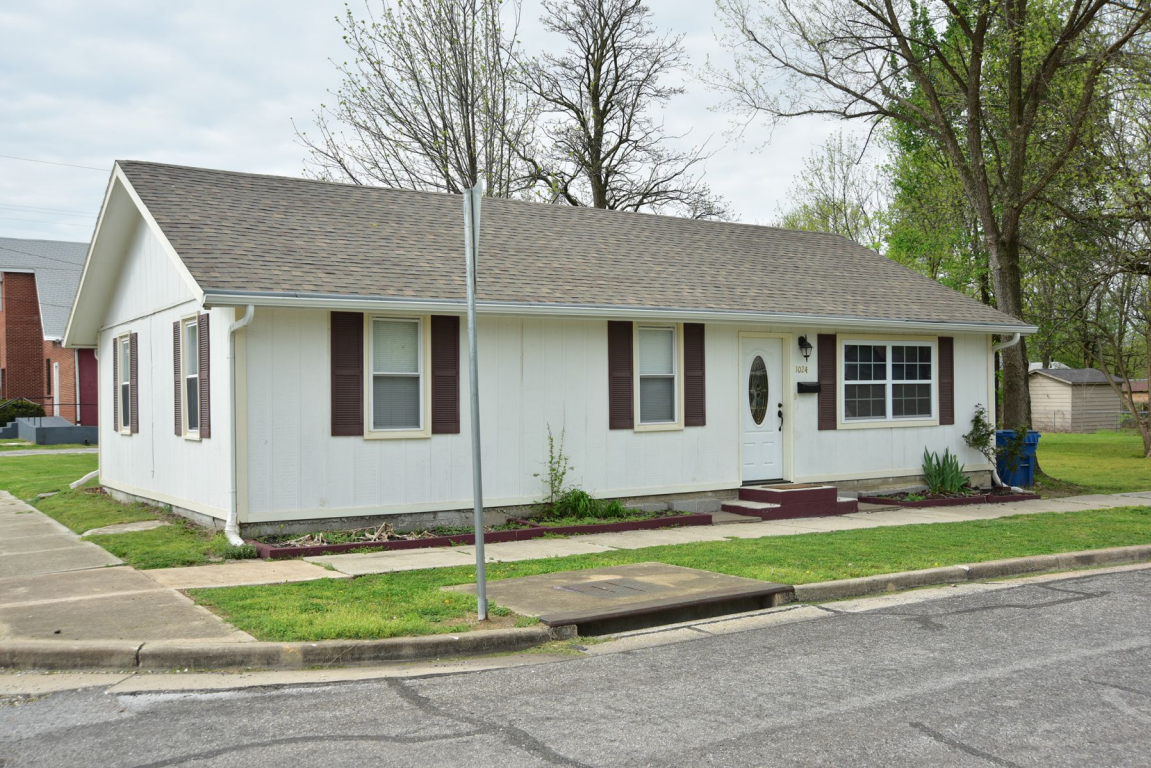
This Ranch dwelling faces north and has a rectangular footprint. It has a concrete masonry unit foundation, wood cladding, and a side-gable roof with asphalt shingles. It is four bays wide and two bays deep. A set of paired, six-over-six vinyl windows occupies the first bay while a wood door with glazing occupies the second bay. One-over-one vinyl windows occupy the remaining bays. All windows have false shutters. The entrance has a concrete stoop.
