MISSOURI DEPARTMENT OF NATURAL RESOURCES
STATE HISTORIC PRESERVATION OFFICE, P.O. Box 176, Jefferson City, MO 65102
ARCHITECTURAL/HISTORIC INVENTORY FORM

1. Survey number: JP-AS-006-260		2. Survey Name: East Town (Original Joplin) Historic Survey Phase 1	
3. County: JASPER		4. Address 1506	Street (name): E. North Street
5. City: Joplin	Vicinity <input type="checkbox"/>	7. Township/Range/Section: T: R: S:	
8. Historic name (if known):		9. Present/other name (if known):	
10. Ownership: <input checked="" type="checkbox"/> Private <input type="checkbox"/> Public		11a. Historic use (if known): Domestic/Single Dwelling	11b. Current use: Domestic/Single Dwelling

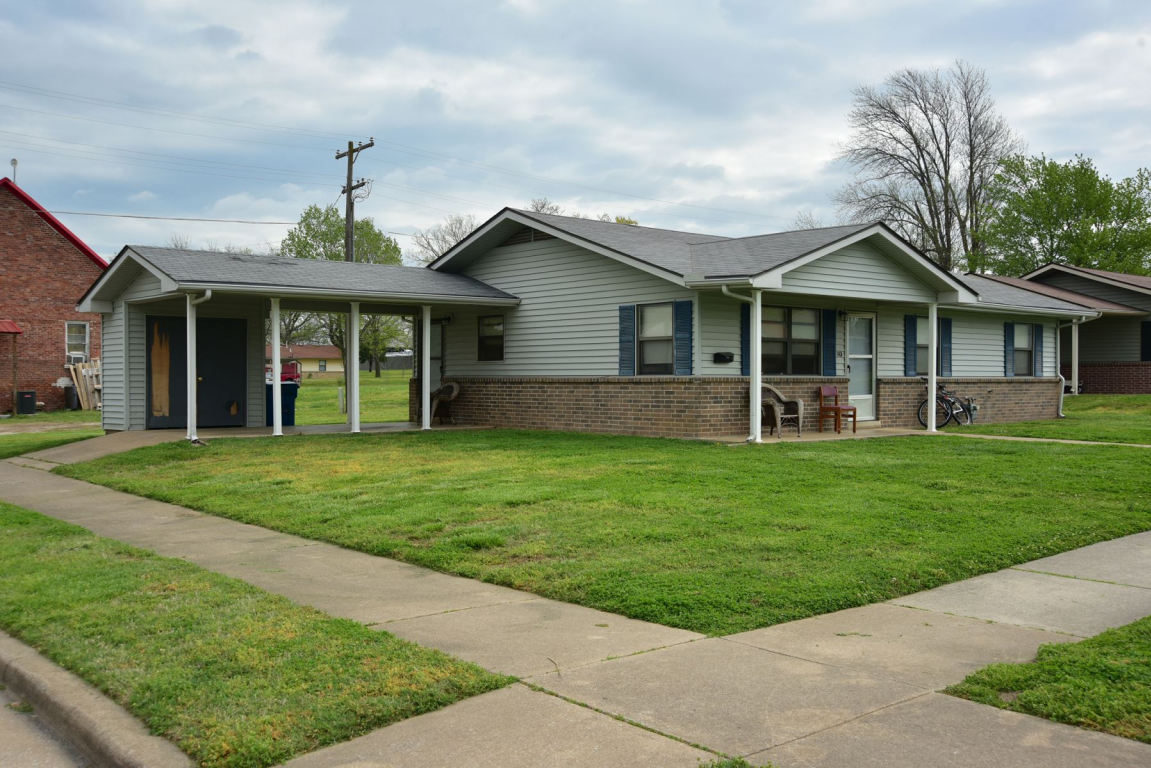
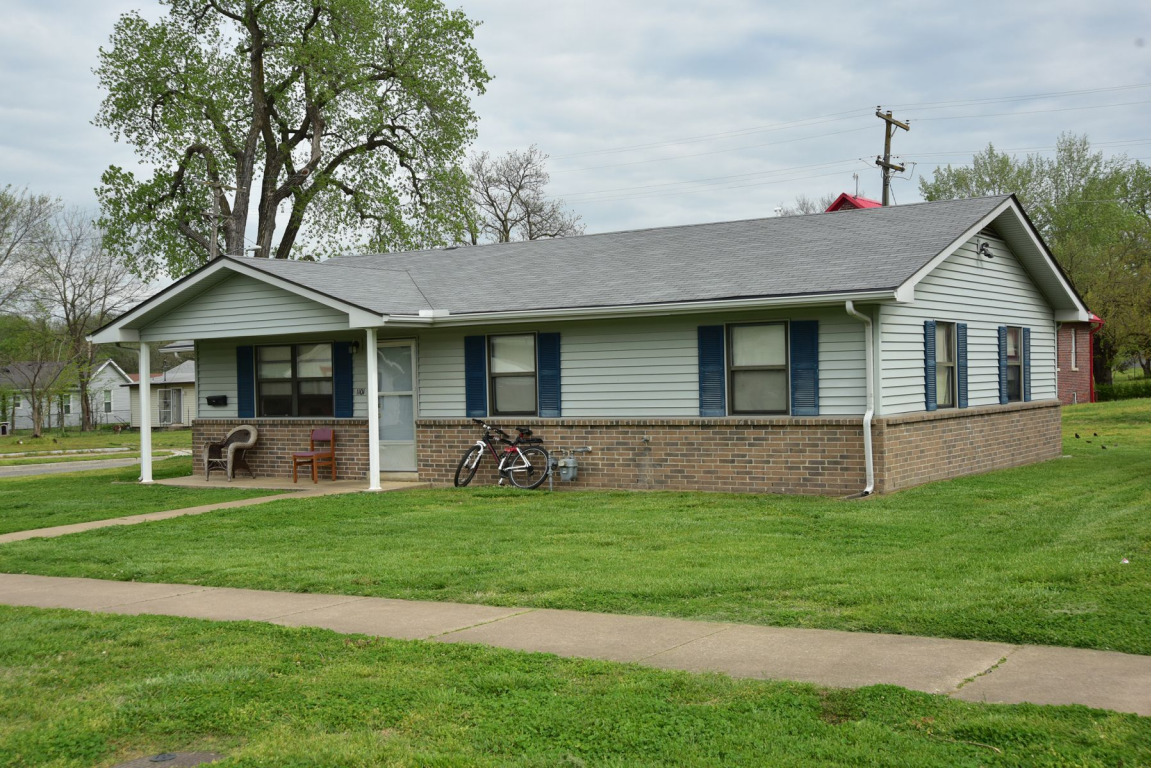
This one-story Ranch type house faces south. It has a poured concrete foundation and a side-gabled roof with asphalt shingles. The lower half of the exterior has brick veneer cladding and the upper half is clad with vinyl siding. A one-story, partial-width porch with a front-gabled roof with asphalt shingles and vinyl cladding in the gable spans the west portion of the primary elevation. The porch has a poured concrete slab and vinyl support posts. The primary elevation has four bays; the two west bays are sheltered by the porch. The two east bays each contain a one-over-one metal window with shutters. The second-from-west bay contains a wood door. The west bay contains a pair of one-over-one metal windows with shutters. A carport with a side-gabled roof extends from the east elevation. The carport has vinyl support posts and an attached shed with vinyl siding.

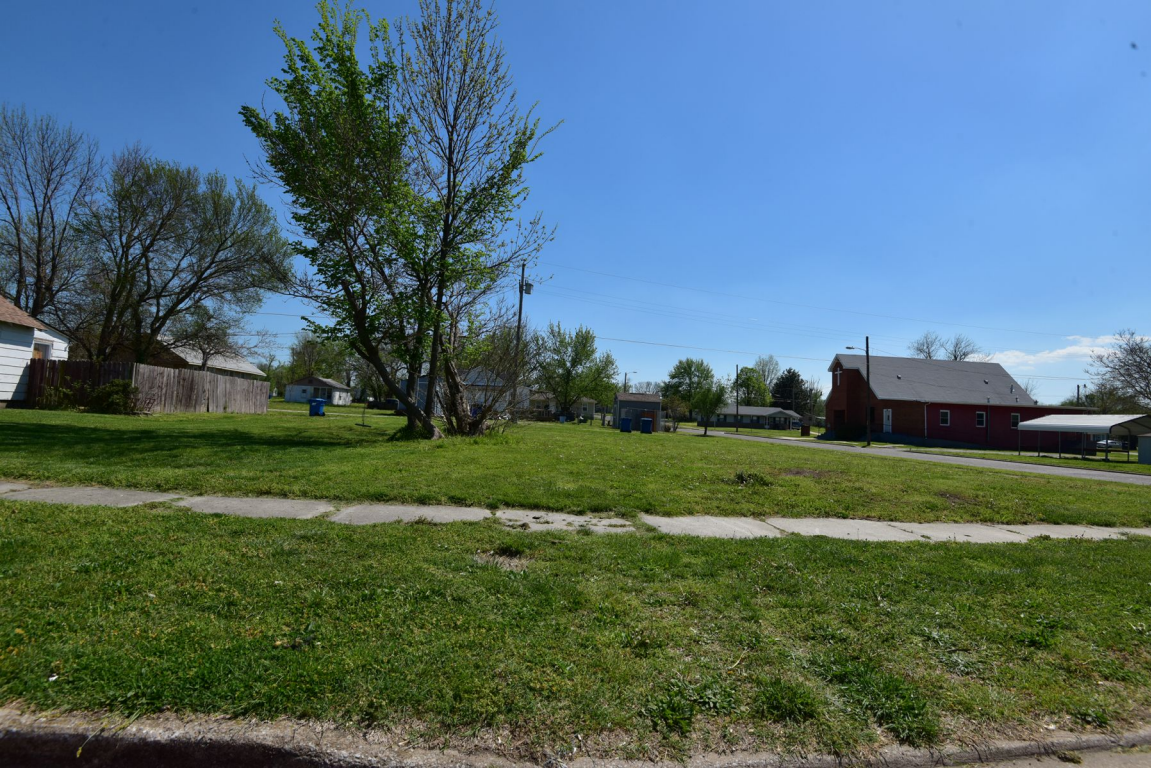
This grassy lot is vacant. A concrete sidewalk abuts the north and west edges of the property.

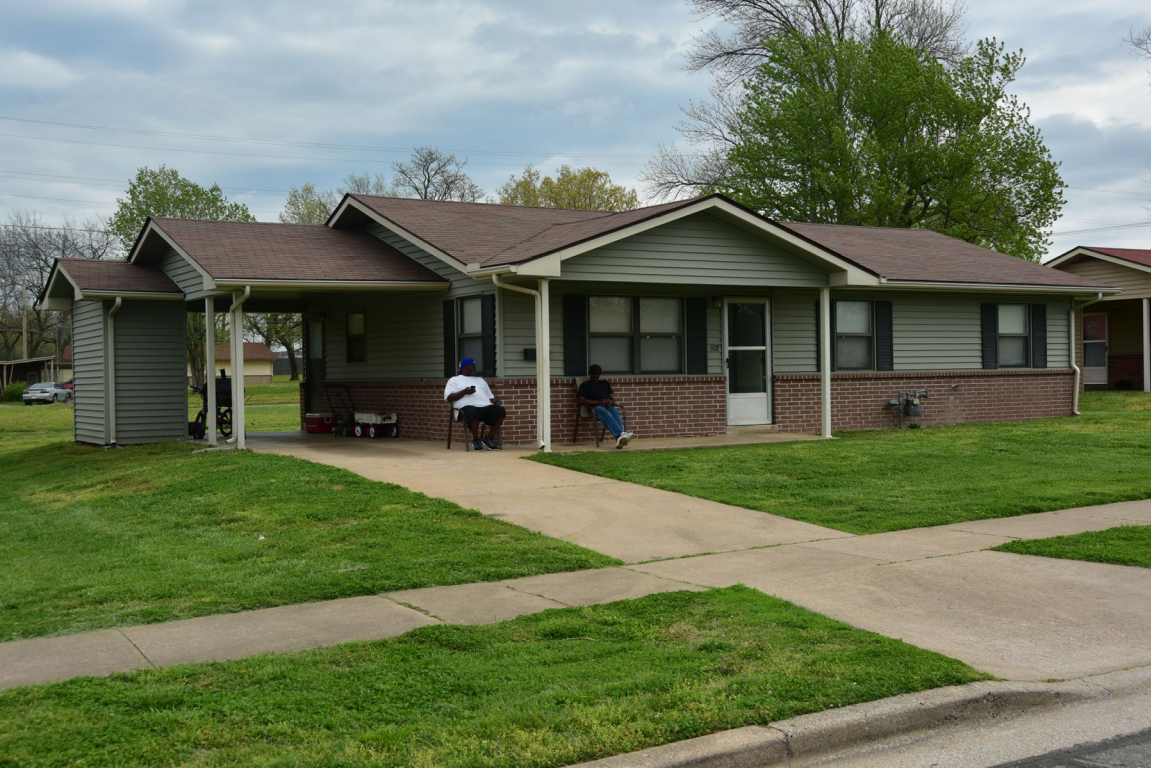
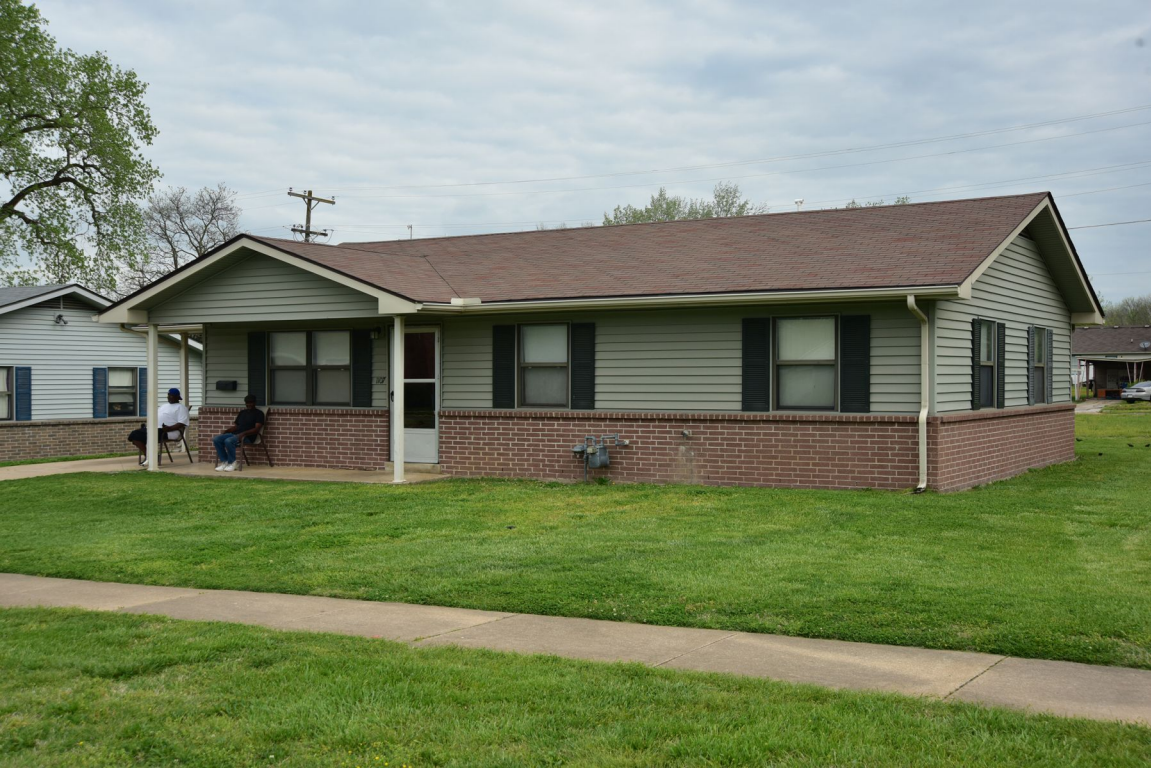
This one-story Ranch type house faces south. It has a poured concrete foundation and a side-gabled roof with asphalt shingles. The lower half of the exterior has brick veneer cladding and the upper half is clad with vinyl siding. A one-story, partial-width porch with a front-gabled roof with asphalt shingles and vinyl cladding in the gable spans the west portion of the primary elevation. The porch has a poured concrete slab and vinyl support posts. The primary elevation has four bays; the two west bays are sheltered by the porch. The two east bays each contain a one-over-one metal window with shutters. The second-from-west bay contains a wood door. The west bay contains a pair of one-over-one metal windows with shutters. A carport with a side-gabled roof extends from the east elevation. The carport has vinyl support posts and an attached shed with vinyl siding.

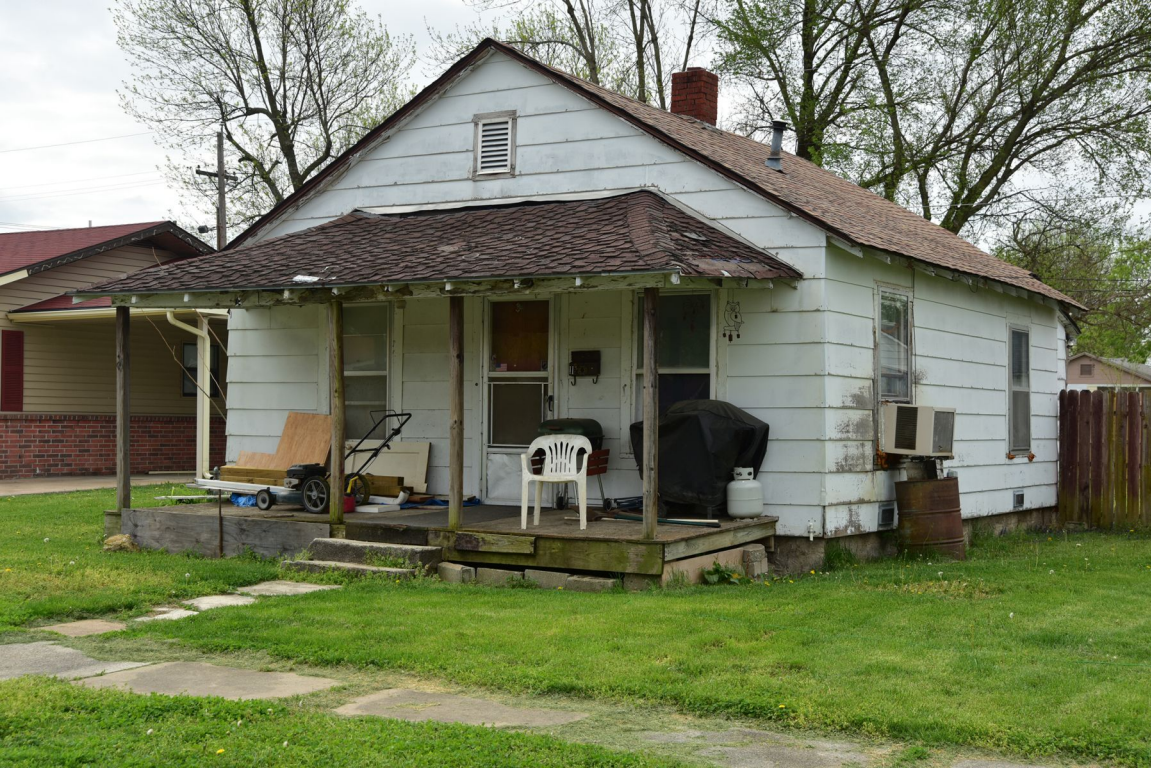
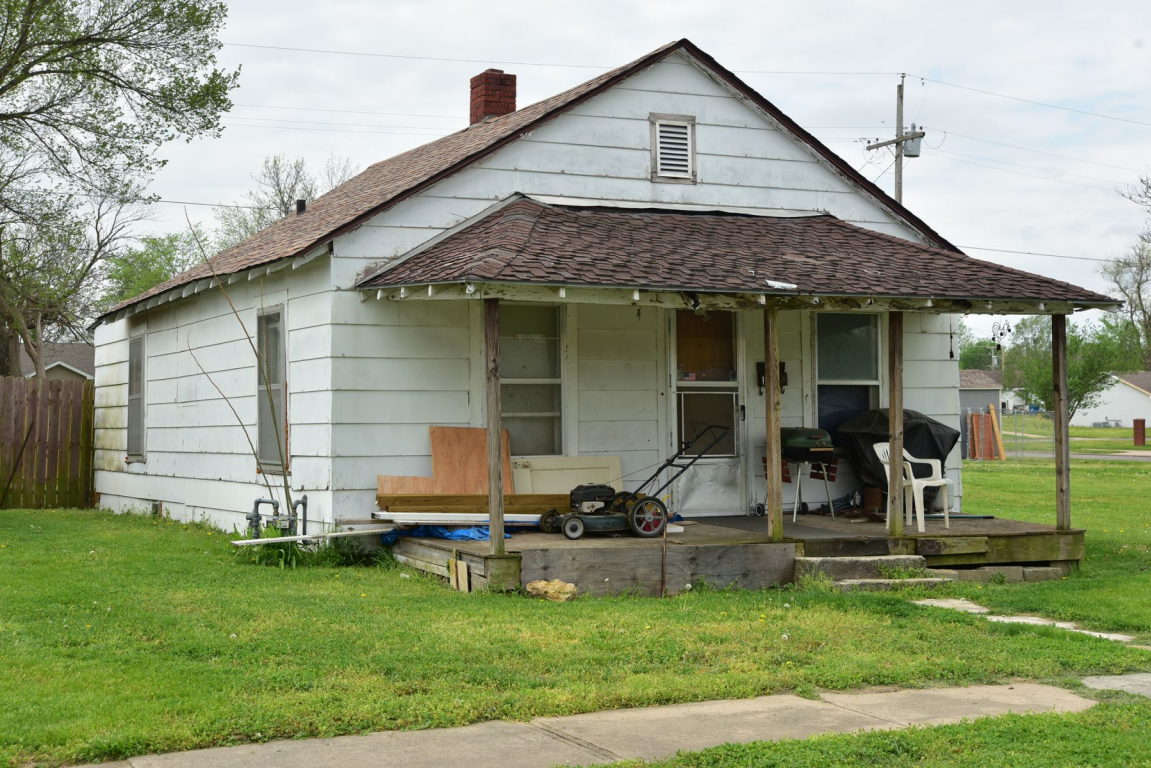
This one-story bungaloid dwelling faces north and has a rectangular footprint. It has a parged stone foundation and cement hardboard cladding, likely installed during the 1940s. The front-gable roof has asphalt shingles and exposed rafter tails. A short, straddle-ridge brick chimney pierces the center of the roof. The dwelling is three bays wide and two bays deep. A non-historic wood door occupies the center bay historic one-over-one wood windows occupy the remaining bays. An open, three-quarter width porch shelters the primary elevation bays. The porch has a hipped roof with asphalt shingles and exposed rafter tails. Non-historic squared wood posts support the roof and the porch foundation is not visible.

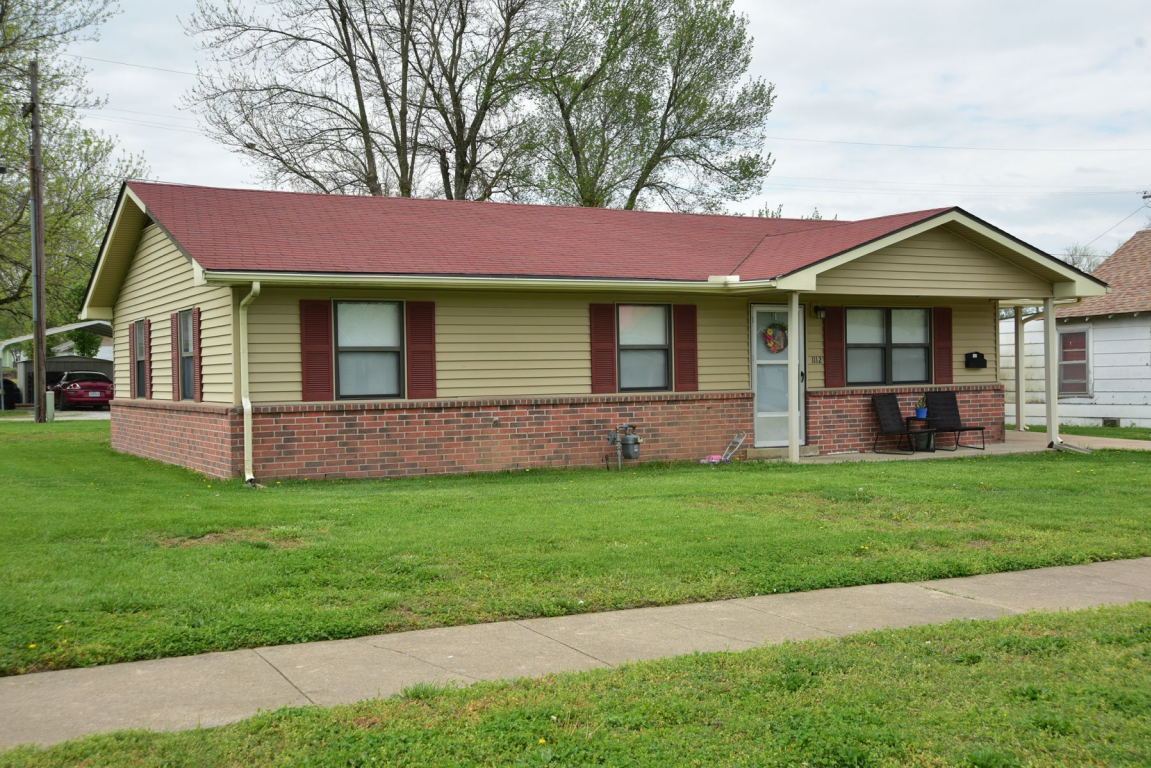
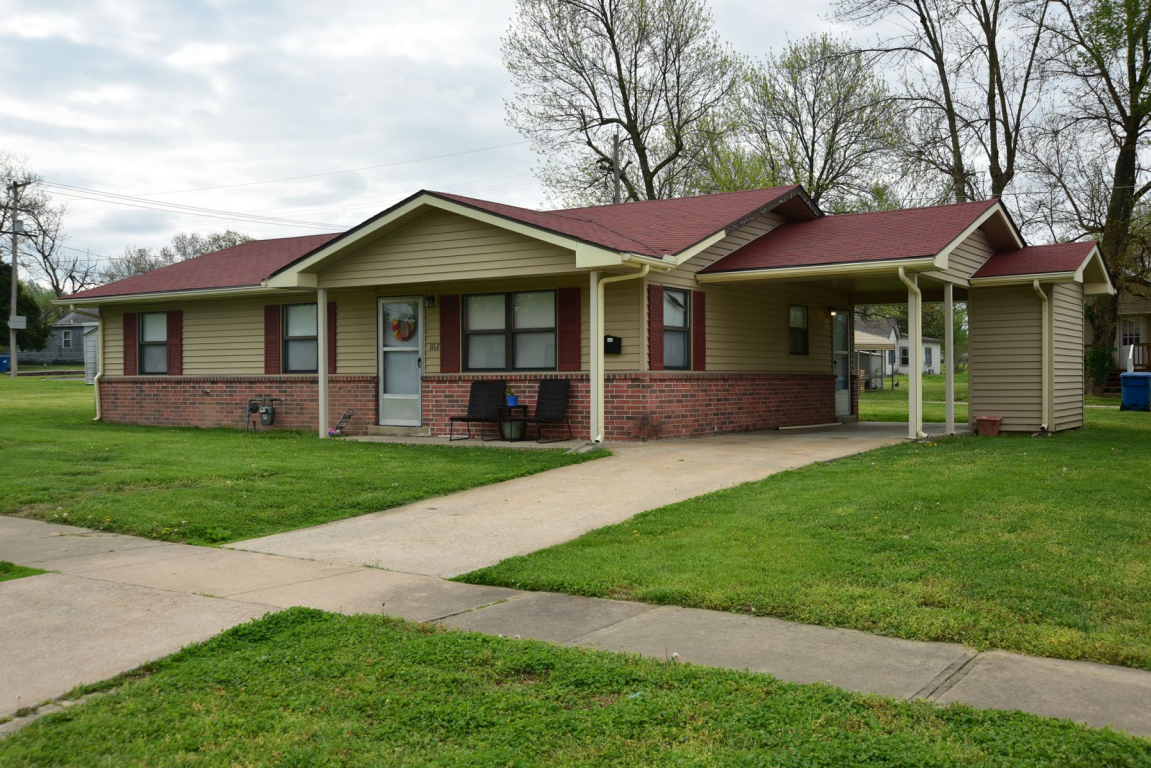
This one-story Ranch type house faces north. It has a poured concrete foundation and a side-gabled roof with asphalt shingles. The lower half of the exterior has brick veneer cladding and the upper half is clad with vinyl siding. A one-story, partial-width porch with a front-gabled roof with asphalt shingles and vinyl cladding in the gable spans the west portion of the primary elevation. The porch has a poured concrete slab and vinyl support posts. The primary elevation has four bays; the two west bays are sheltered by the porch. The two east bays each contain a one-over-one metal window with shutters. The second-from-west bay contains a wood door. The west bay contains a pair of one-over-one metal windows with shutters. A carport with a side-gabled roof extends from the east elevation. The carport has vinyl support posts and an attached shed with vinyl siding.

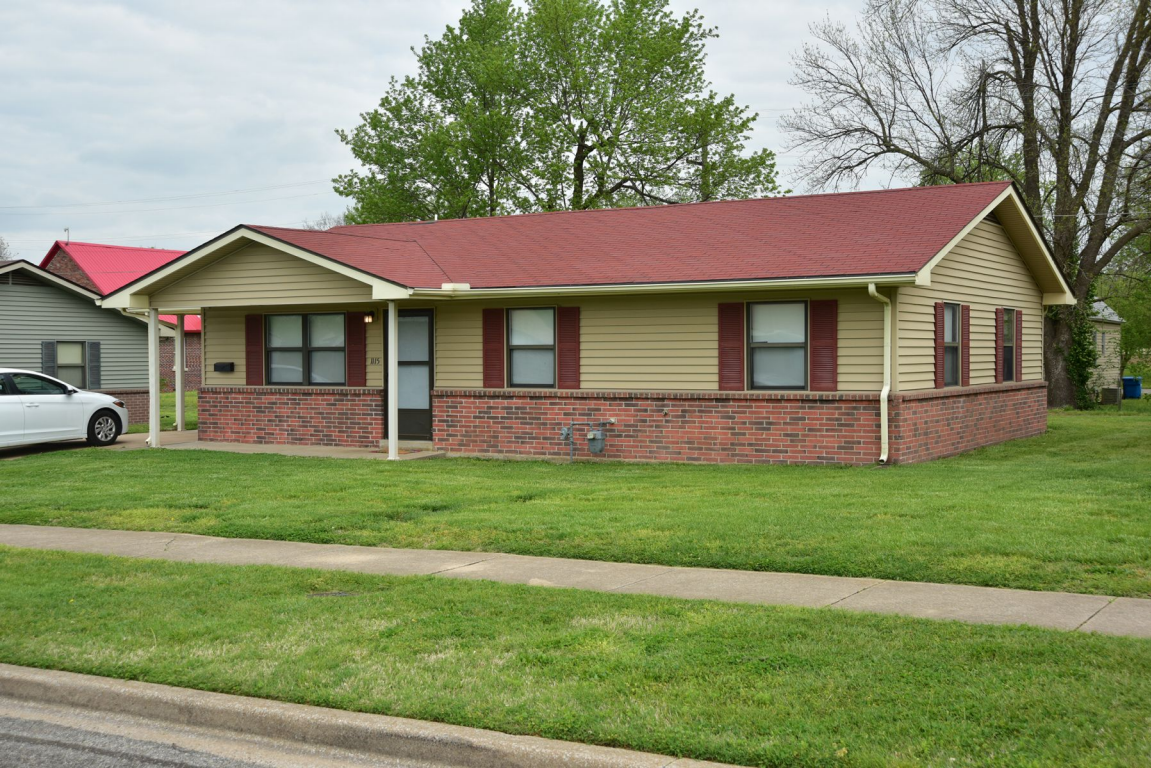
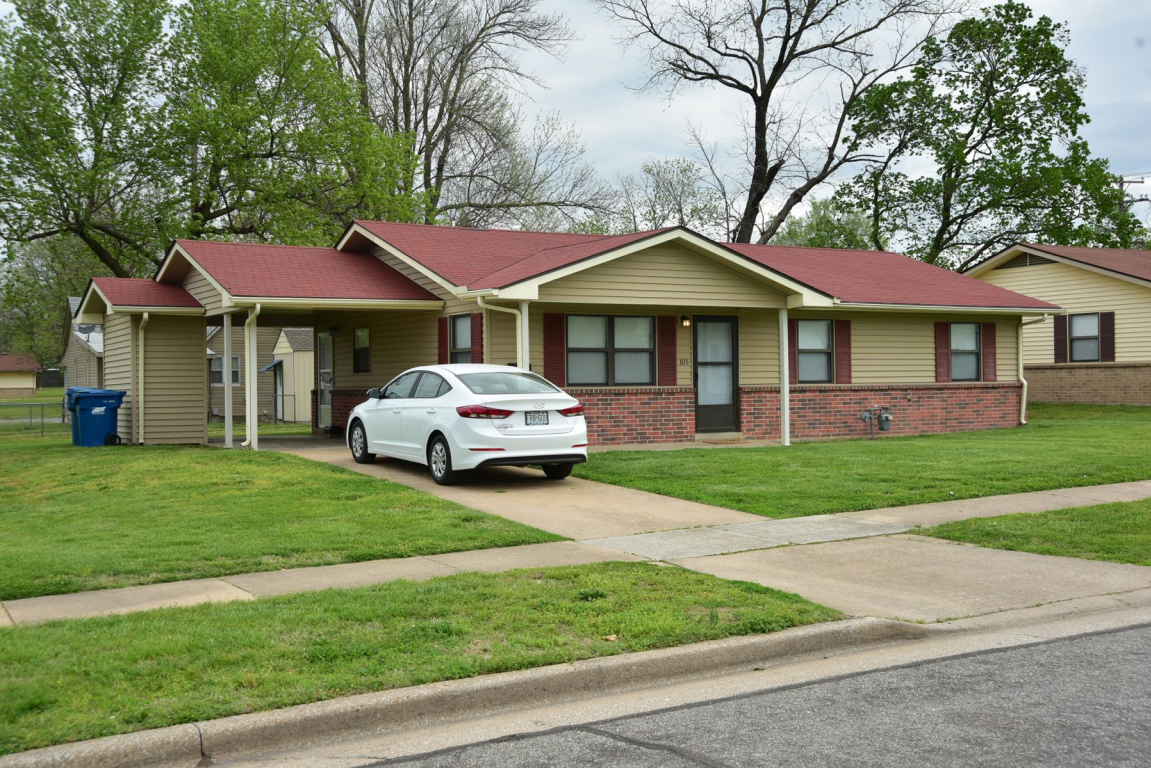
This one-story Ranch type house faces south. It has a poured concrete foundation and a side-gabled roof with asphalt shingles. The lower half of the exterior has brick veneer cladding and the upper half is clad with vinyl siding. A one-story, partial-width porch with a front-gabled roof with asphalt shingles and vinyl cladding in the gable spans the west portion of the primary elevation. The porch has a poured concrete slab and vinyl support posts. The primary elevation has four bays; the two west bays are sheltered by the porch. The two east bays each contain a one-over-one metal window with shutters. The second-from-west bay contains a wood door. The west bay contains a pair of one-over-one metal windows with shutters. A carport with a side-gabled roof extends from the east elevation. The carport has vinyl support posts and an attached shed with vinyl siding.

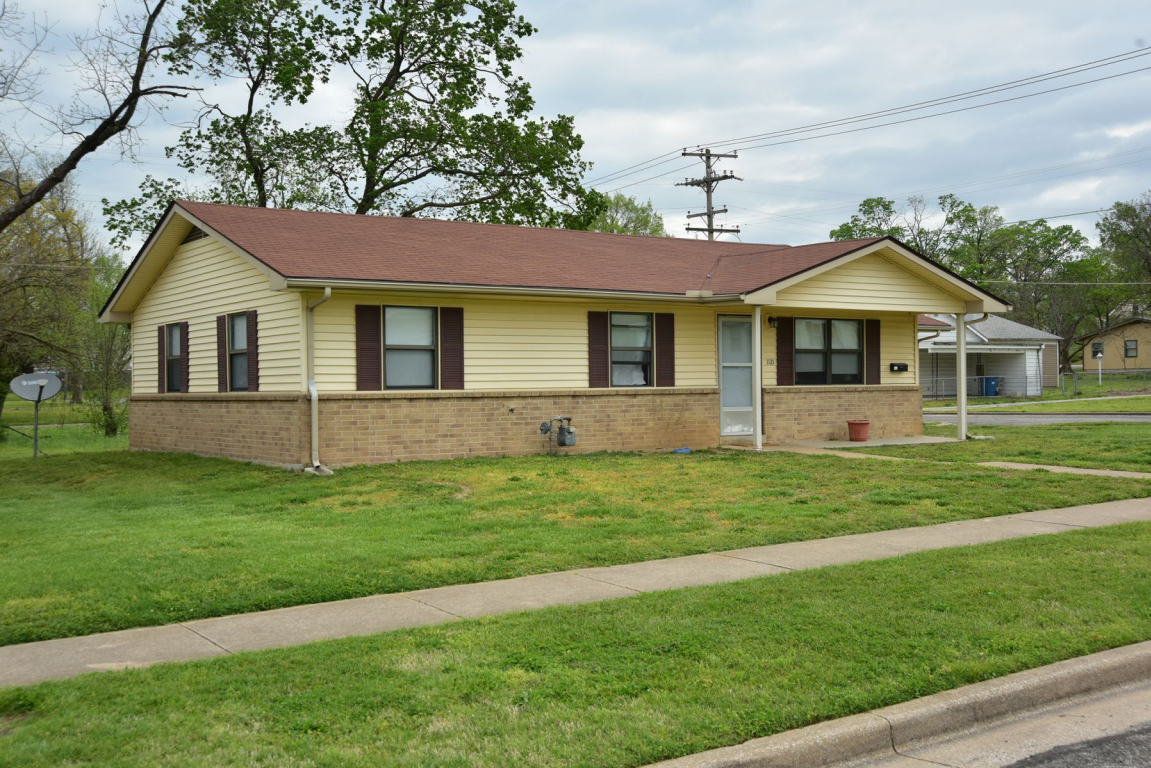
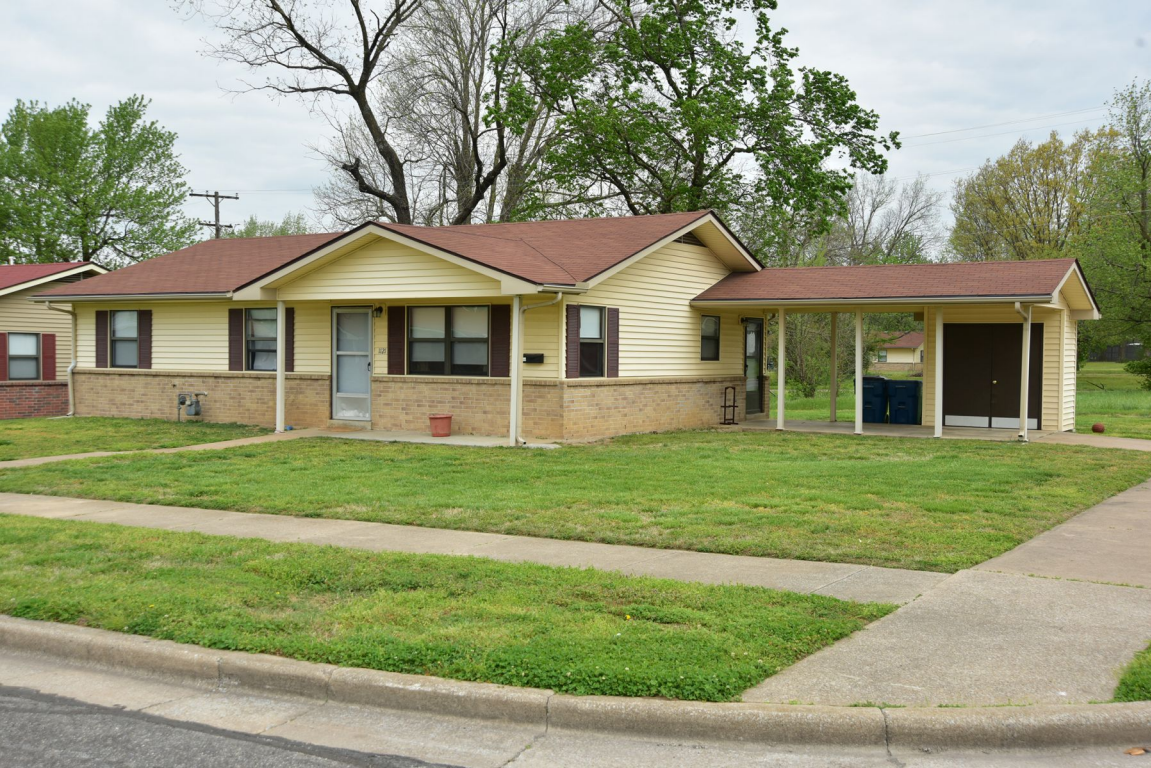
This one-story Ranch type house faces south and has an L-shaped footprint. It has a poured concrete foundation and a side-gabled roof with asphalt shingles. The lower half of the exterior has brick veneer cladding and the upper half is clad with vinyl siding. A one-story, partial-width porch with a front-gabled roof with asphalt shingles and vinyl cladding in the gable spans the east portion of the primary elevation. The porch has a poured concrete slab and vinyl support posts. The primary elevation has four bays; the two east bays are sheltered by the porch. The two west bays each contain a one-over-one metal window with shutters. The second-from-east bay contains a wood door. The east bay contains a pair of one-over-one metal windows with shutters. A carport with a side-gabled roof extends from the east elevation. The carport has vinyl support posts and an attached shed with vinyl siding.

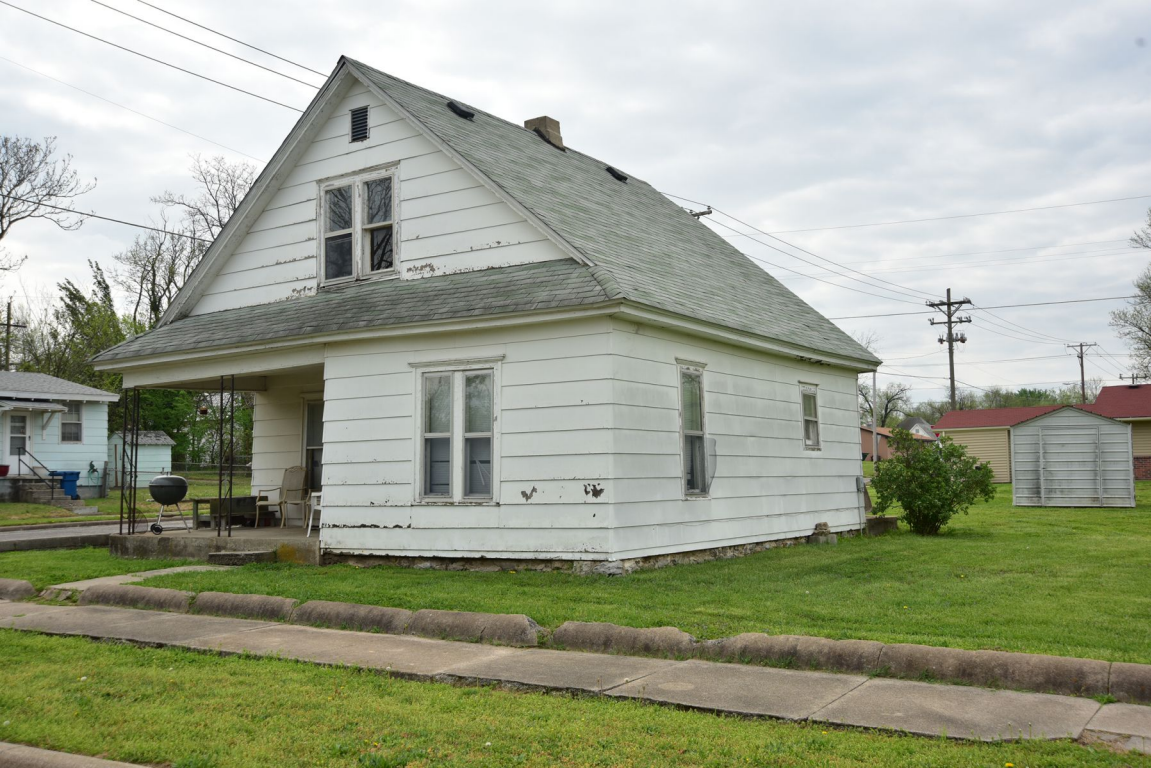
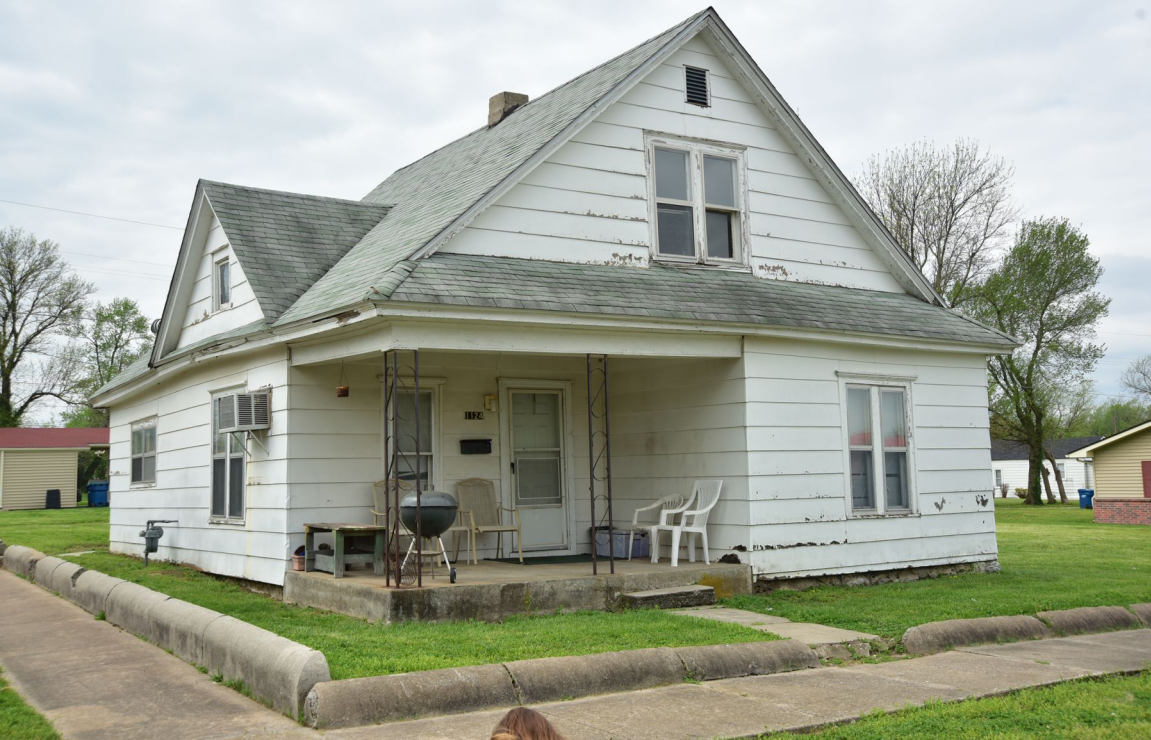
This dwelling faces north and has an L-shaped footprint. It has a stone foundation and cementboard siding. The front-gable roof has asphalt shingles and narrow eaves. A gabled dormer with a historic one-light wood window sits on the east slope. A pair of historic one-over-one wood windows occupies the north gable end. The dwelling is three bays wide. The east two bays recede, creating a partial-width open porch. The porch has a concrete foundation and decorative metal support posts. An asphalt shingle pent spans the elevation at this level. A historic one-over-one wood window occupies the east bay and a non-historic wood door occupies the center bay. A pair of historic one-over-one wood windows occupies the west bay. The windows have modest crown molding.

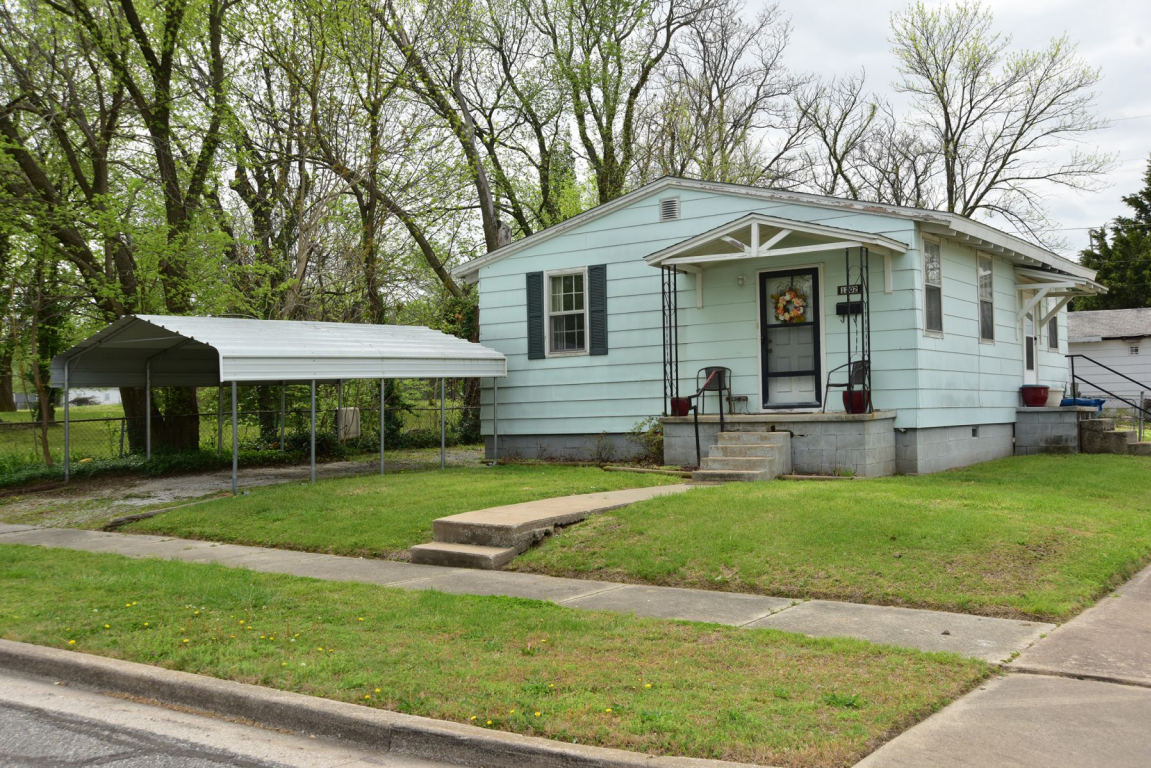
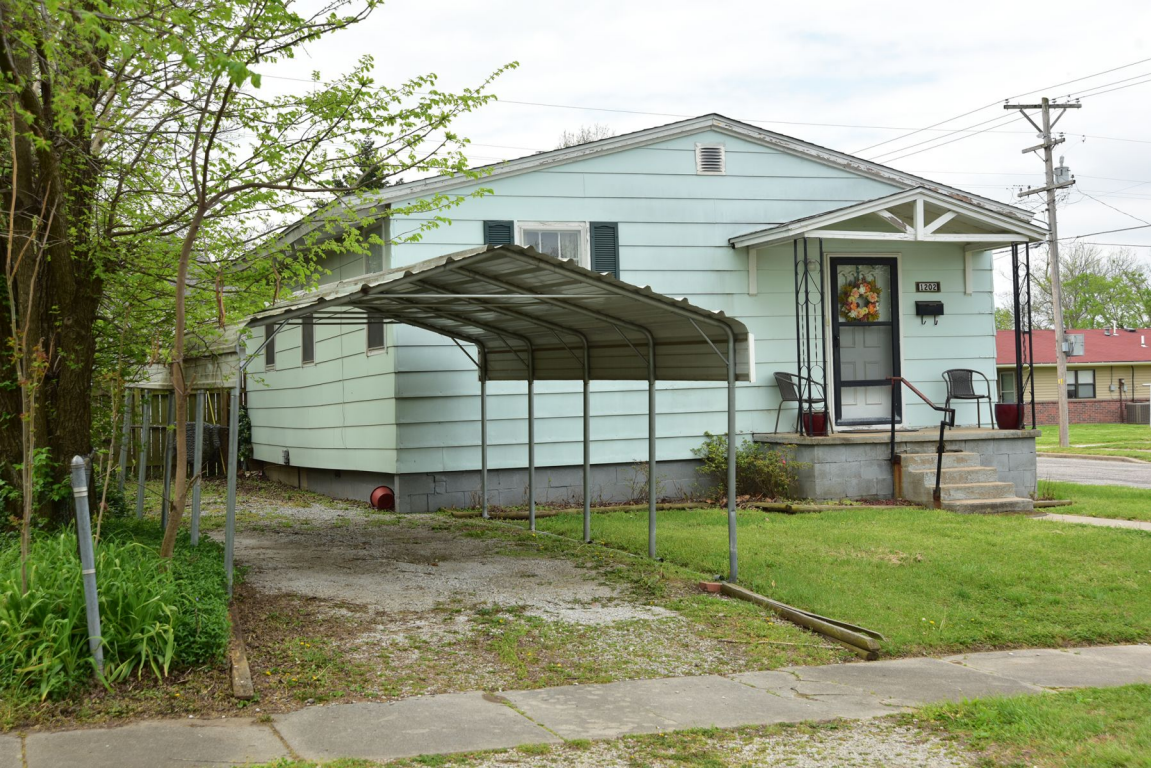
This dwelling faces north and has a square footprint. It has a concrete masonry unit foundation and historic hardboard cladding. The front-gable roof has asphalt shingles and exposed rafter tails. The dwelling is two bays wide and four bays deep. A front-gable porch shelters the west bay. It has a concrete masonry unit foundation and decorative metal support posts. Angled bracing occupies the gable. A non-historic wood door occupies the west bay while a six-over-six wood window with false shutters occupies the east bay. A secondary entrance with a concrete masonry unit stoop occupies the third bay of the west elevation.

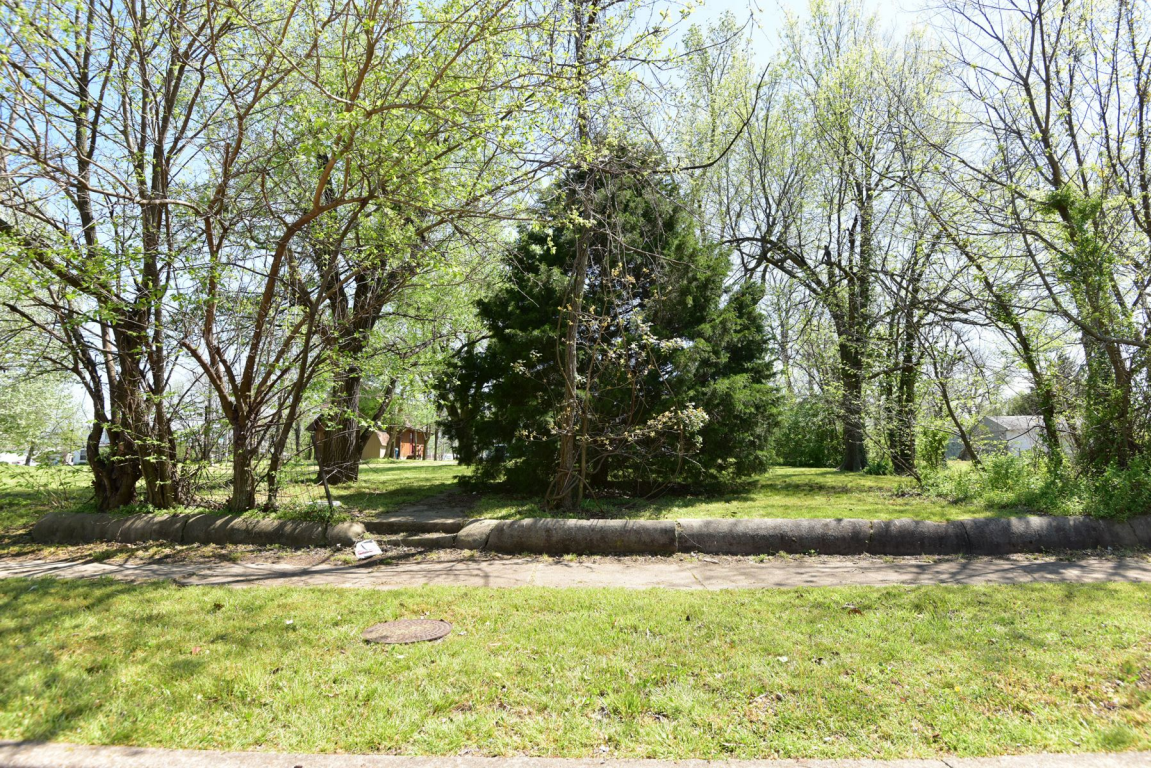
This grassy lot is vacant. A low concrete retaining wall with concrete steps lines the north edge of the lot.

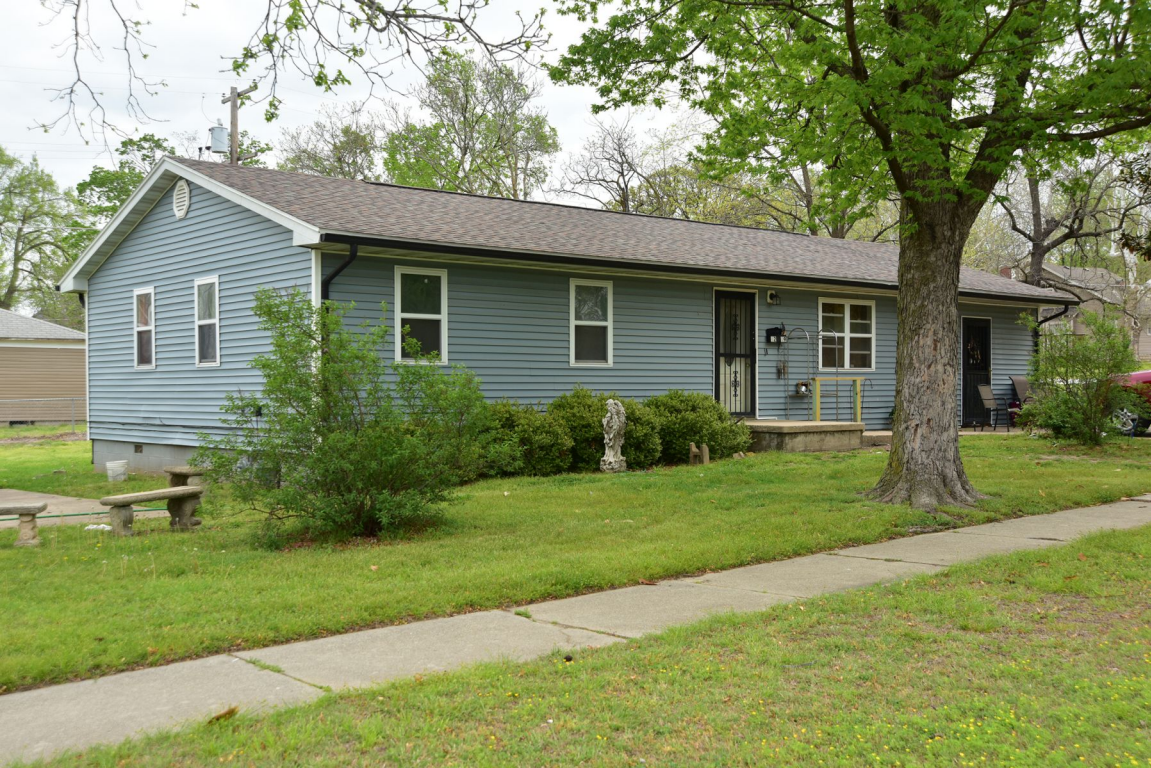
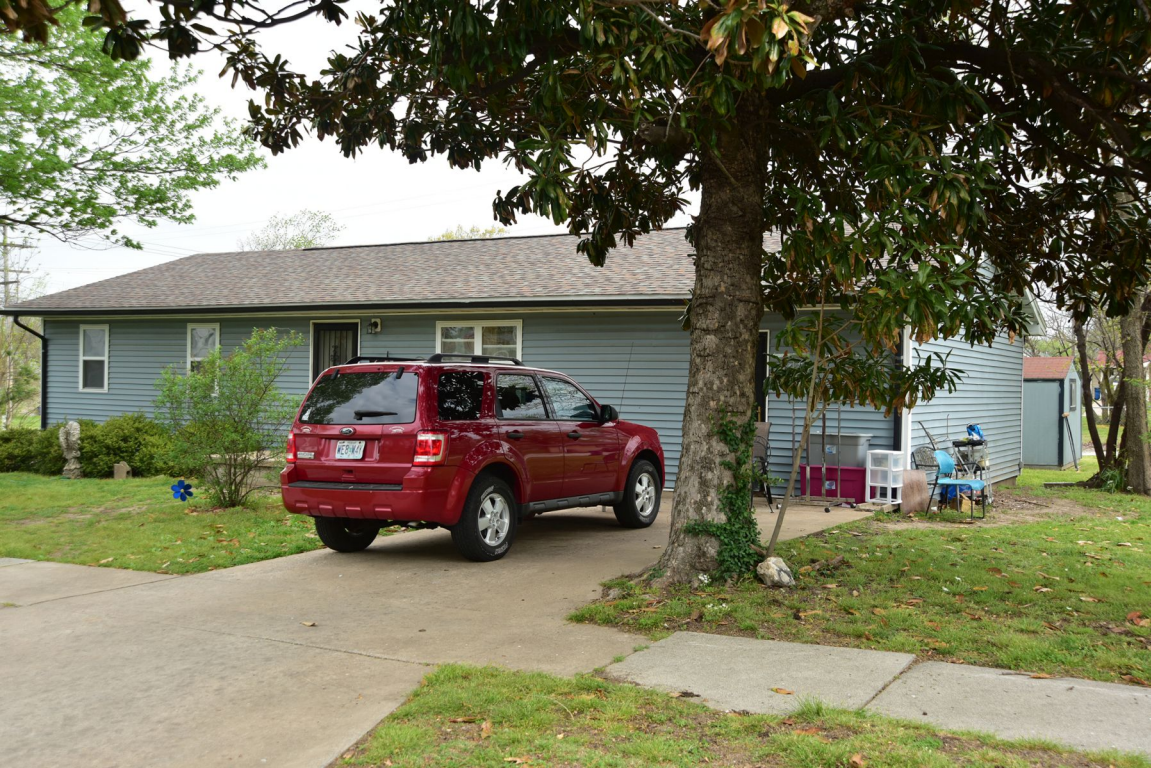
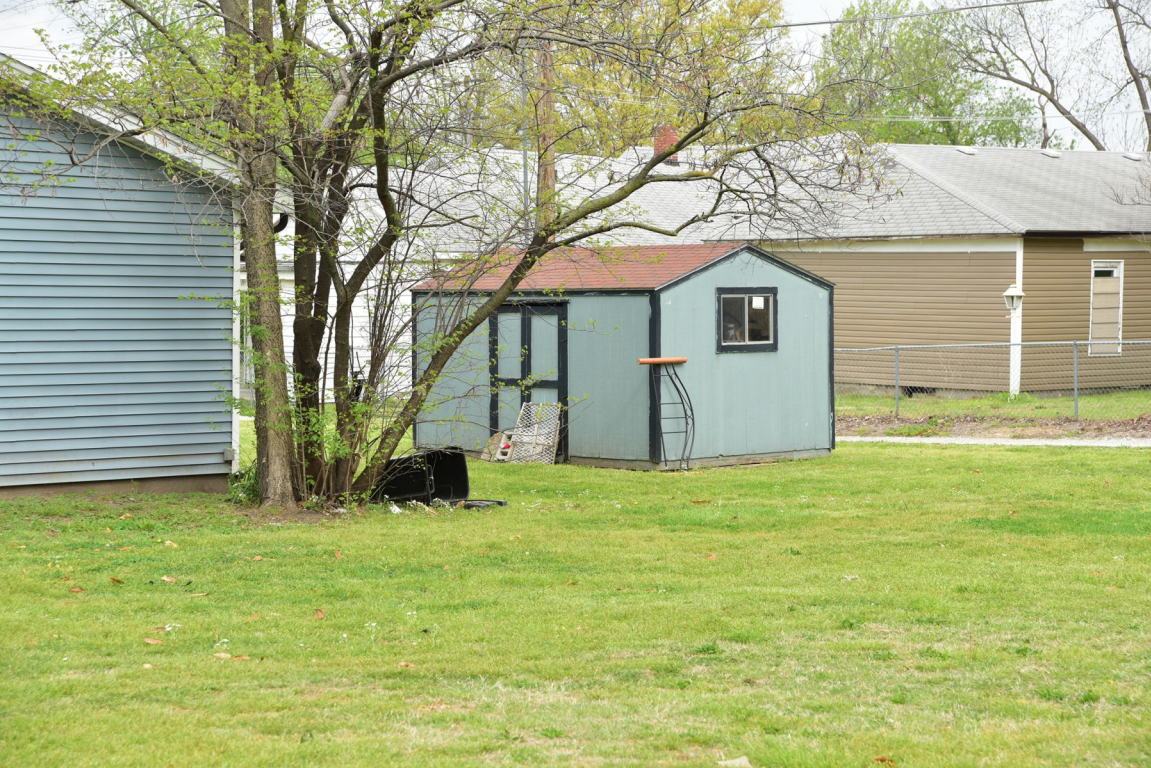
This Ranch dwelling faces south and has a rectangular footprint. It has a concrete masonry unit foundation and vinyl cladding. The side-gabled roof has asphalt shingles. The dwelling is five bays wide and two asymmetrical bays deep. A wood door with glazing occupies the center bay while one-over-one wood windows occupy the west two bays. A pair of one-over-one wood windows occupies the second-from-east bay while a secondary entrance occupies the east bay.
