MISSOURI DEPARTMENT OF NATURAL RESOURCES
STATE HISTORIC PRESERVATION OFFICE, P.O. Box 176, Jefferson City, MO 65102
ARCHITECTURAL/HISTORIC INVENTORY FORM

1. Survey number: JP-AS-006-260		2. Survey Name: East Town (Original Joplin) Historic Survey Phase 1	
3. County: JASPER		4. Address 1506	Street (name): E. North Street
5. City: Joplin	Vicinity <input type="checkbox"/>	7. Township/Range/Section: T: R: S:	
8. Historic name (if known):		9. Present/other name (if known):	
10. Ownership: <input checked="" type="checkbox"/> Private <input type="checkbox"/> Public		11a. Historic use (if known): Domestic/Single Dwelling	11b. Current use: Domestic/Single Dwelling

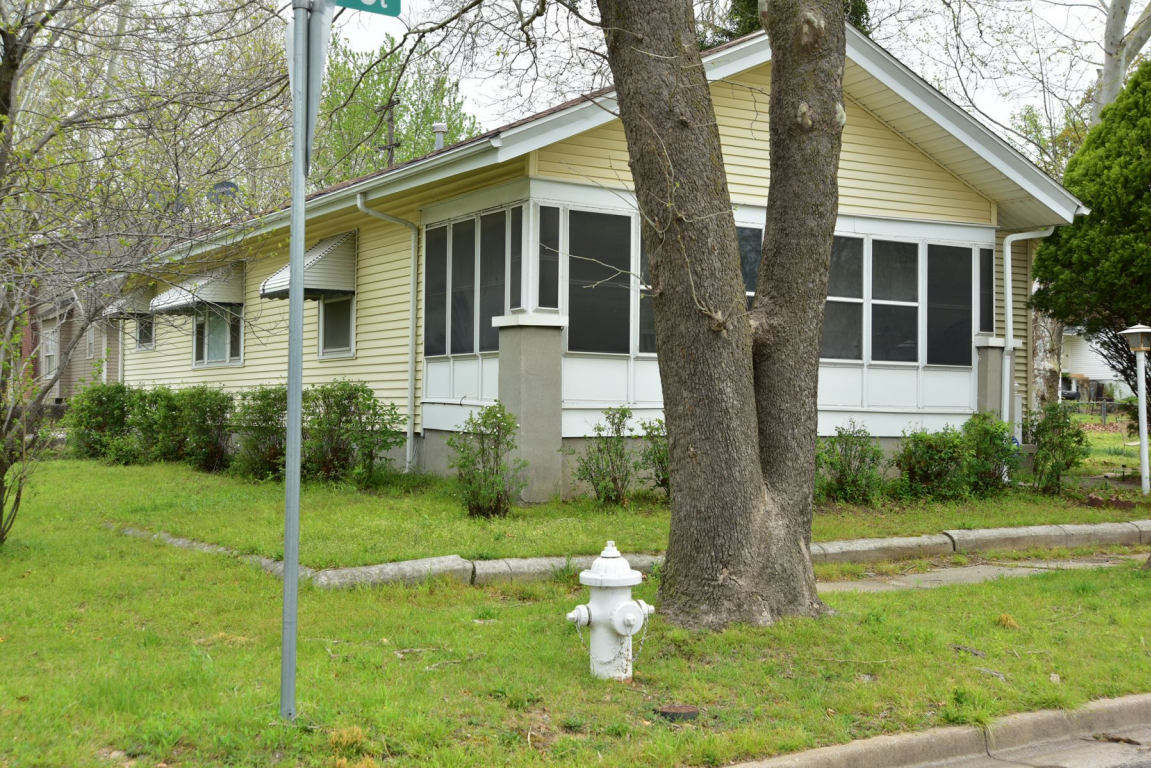
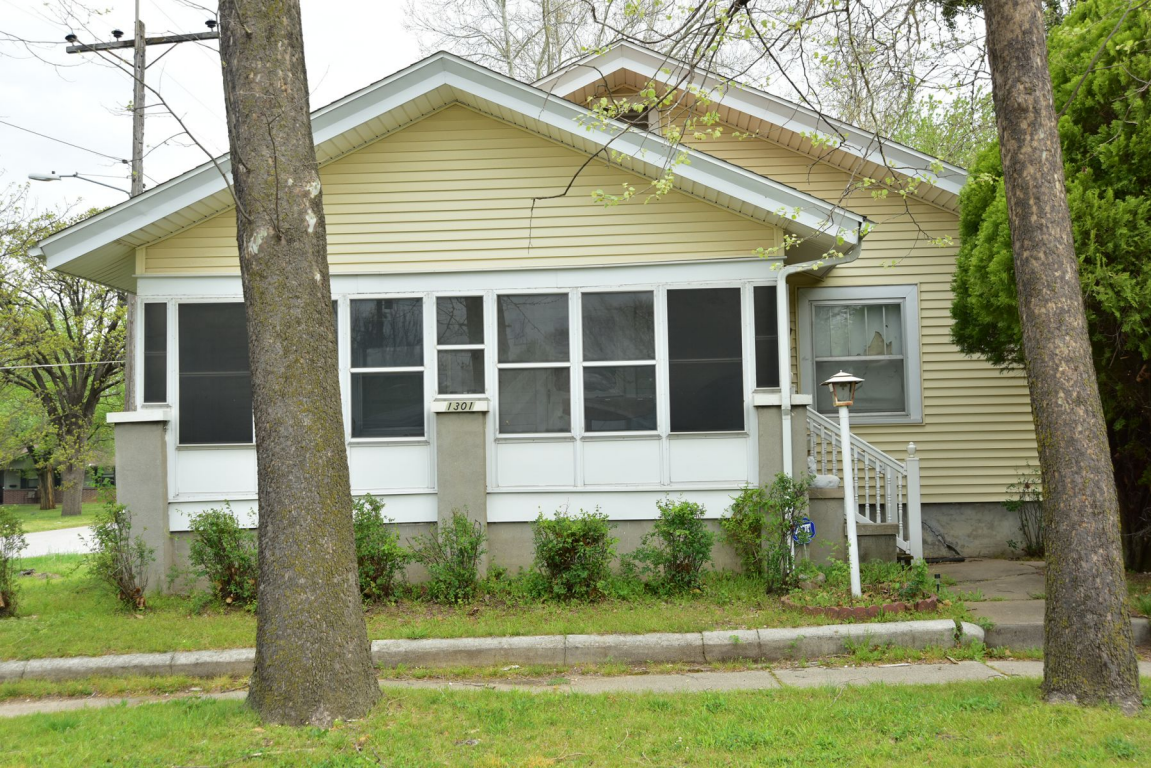
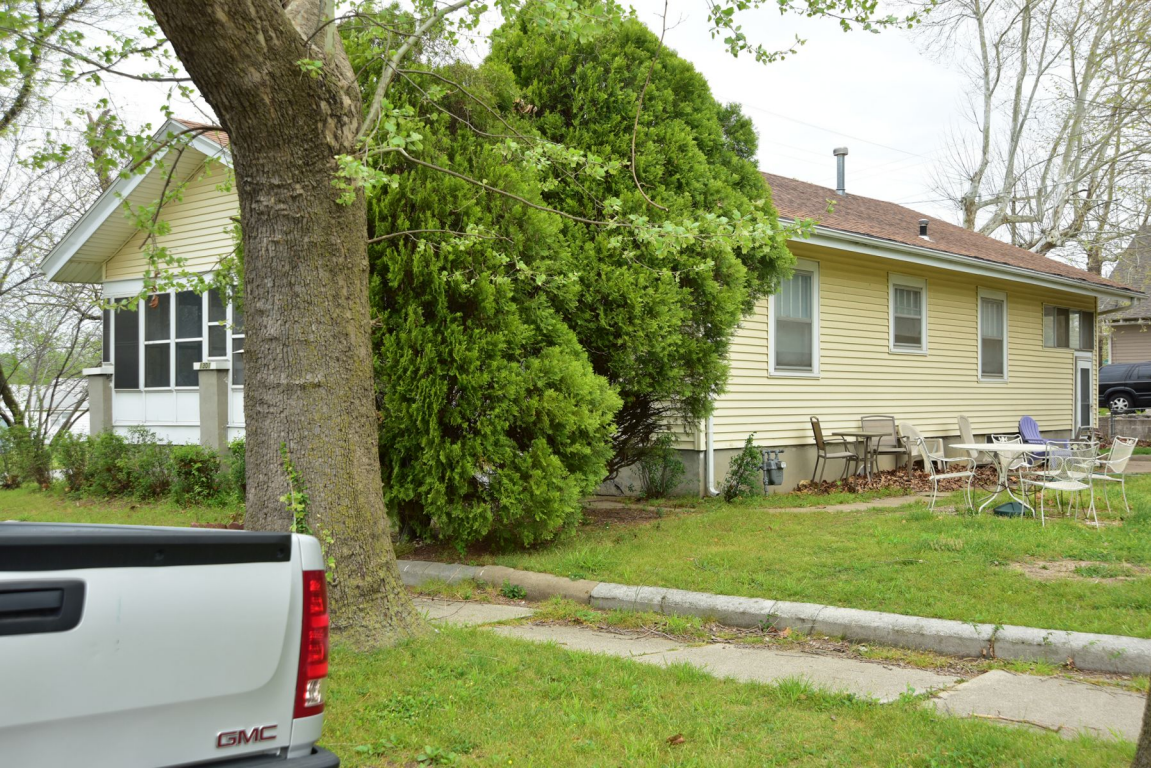
This bungalow dwelling faces south and has a rectangular footprint. It has a parged stone foundation and vinyl cladding. The front-gable roof has asphalt shingles. The dwelling is three bays wide and four bays deep. An enclosed porch obscures the west two bays. It has a front-gable roof, vinyl cladding, and a parged foundation and piers. A continuous band of windows wraps around the porch. A historic five-over-one wood window occupies the east bay.

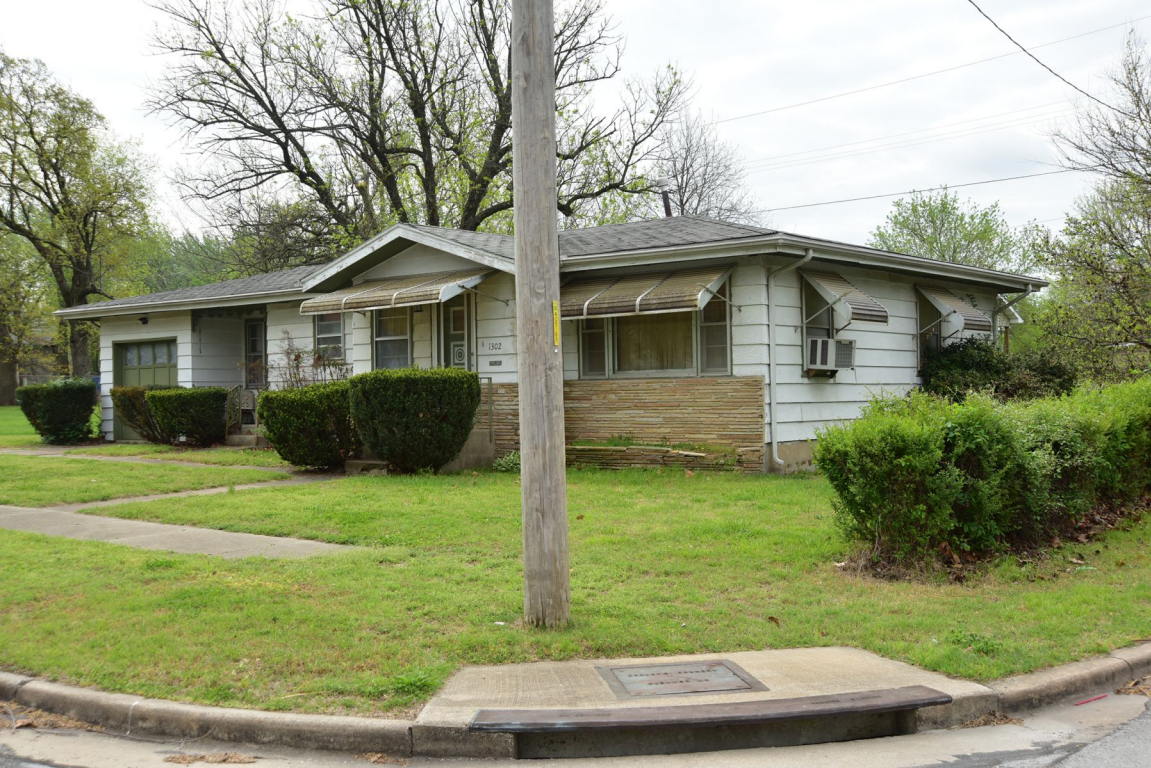
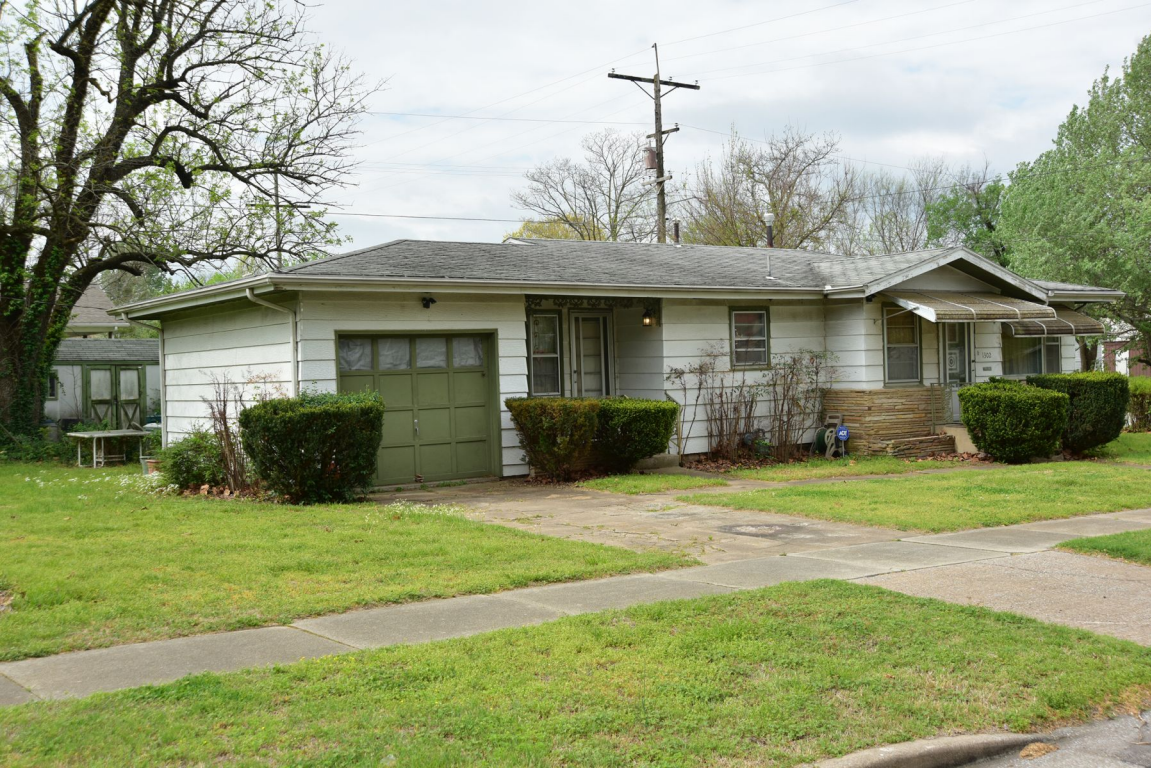
This Ranch dwelling faces south and has a rectangular footprint. It has a concrete foundation and metal cladding. Stone veneer clads the lower third of the west portion of the primary elevation. The low hipped roof has asphalt shingles and a front-gable wall dormer is located at the primary elevation. The dwelling is five bays wide and two bays deep. A single-car historic wood garage door with panels occupies the first (east) bay. The second bay recedes and contains historic two-over-two wood window and secondary entrance. A historic two-over-two wood window occupies the third bay while a historic tripartite wood picture window occupies the last bay. The fourth bay projects slightly and has a front-gable roof. A historic two-over-two window and historic wood door occupy this bay. Metal awnings shelter the two west bays. The fourth-bay entrance has a concrete stoop with decorative metal railings.

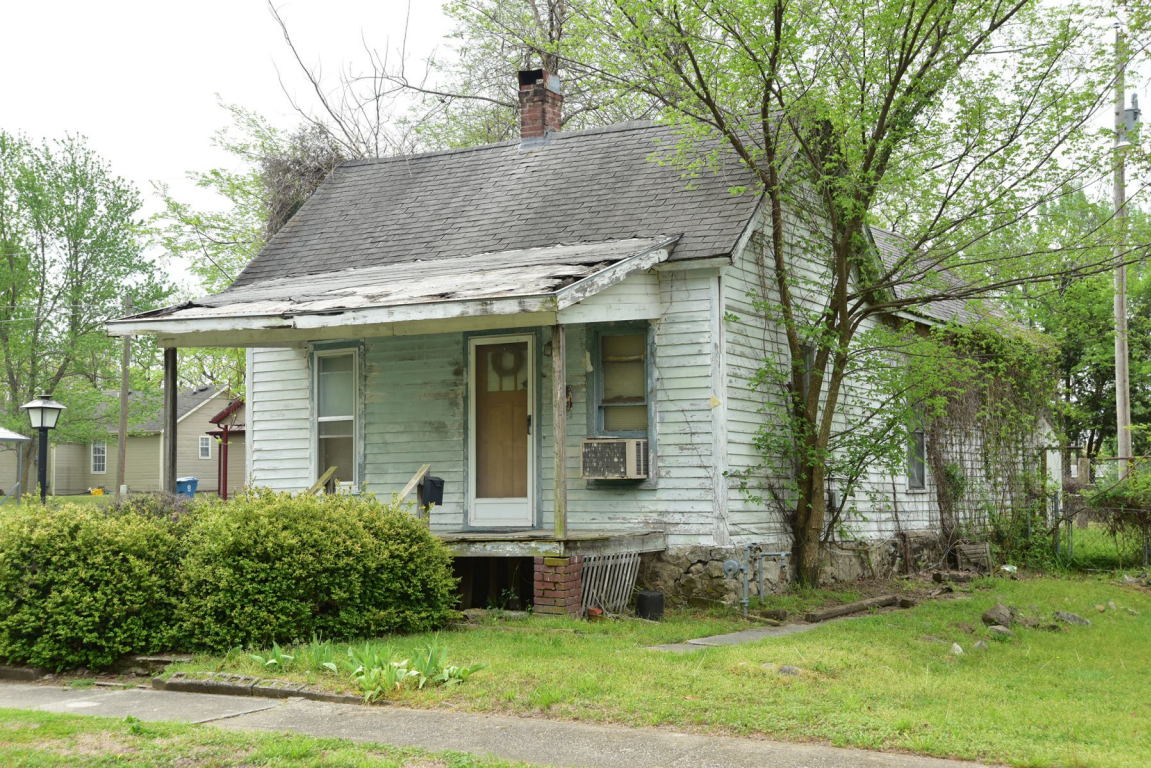
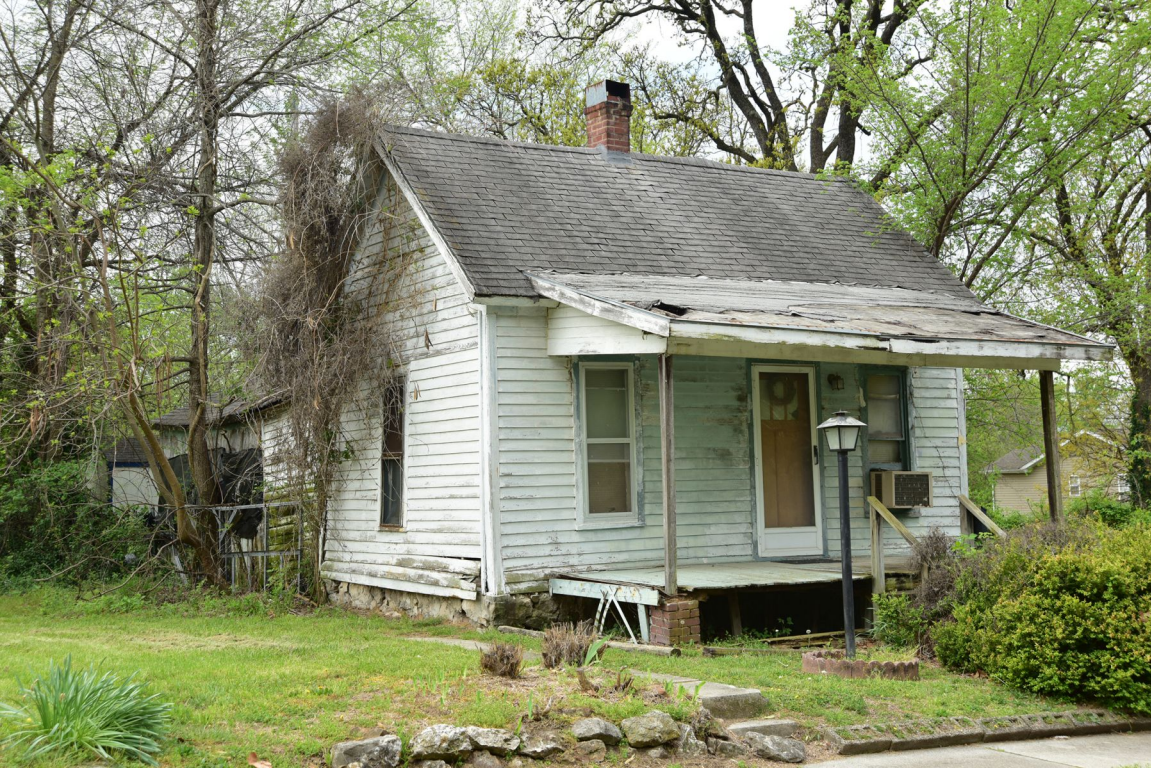
This National Folk House dwelling faces north and has a rectangular footprint. It has a stone foundation and wood clapboard cladding. The intersecting-gable roof has asphalt shingles and a brick straddle-ridge chimney. The dwelling is three bays wide. A historic wood door with three-light glazing occupies the center bay while one-over-one wood windows occupy the remaining bays. A shed-roof porch shelters the bays. Brick piers support the wood floor and square wood posts support the roof. Non-historic wood stairs provide access to the porch. Historic one-over-one wood windows occupy the secondary elevation bays.

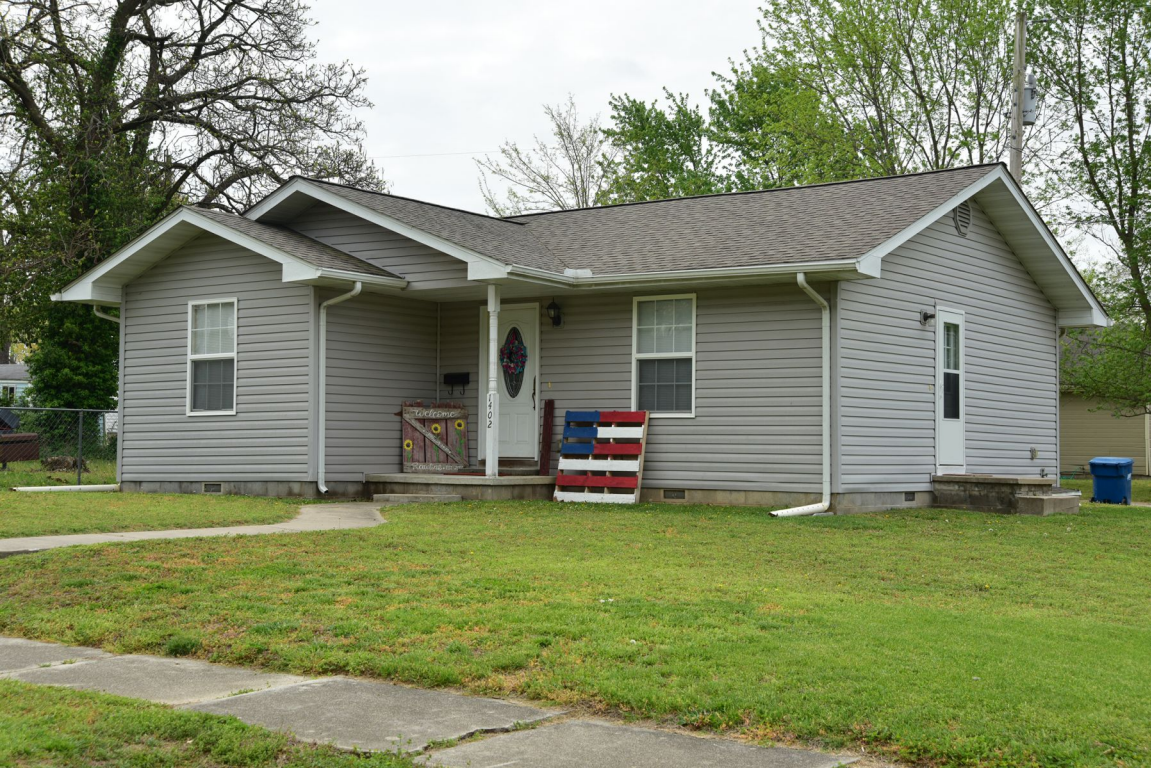
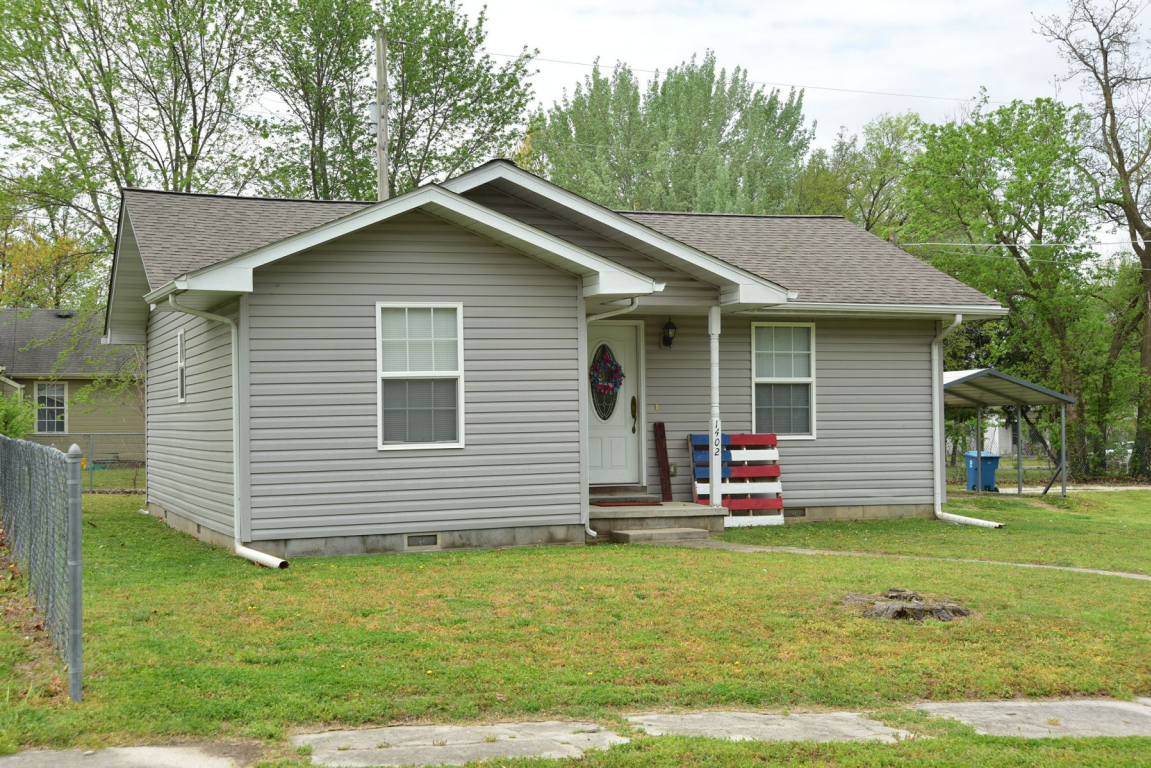
This dwelling faces north and has a rectangular footprint. It has a concrete masonry unit foundation and vinyl cladding. The roof features asphalt shingles and wide eaves. The dwelling is three bays wide and one bay deep. A nested gable ell contains the west bay. A wood door with glazing occupies the center bay while six-over-six vinyl windows occupy the remaining bays. The projecting gable shelters the entrance bay, creating a partial-width open porch. The porch has a concrete foundation and turned wood support post. A secondary entrance with a concrete stoop occupies the west elevation bay.

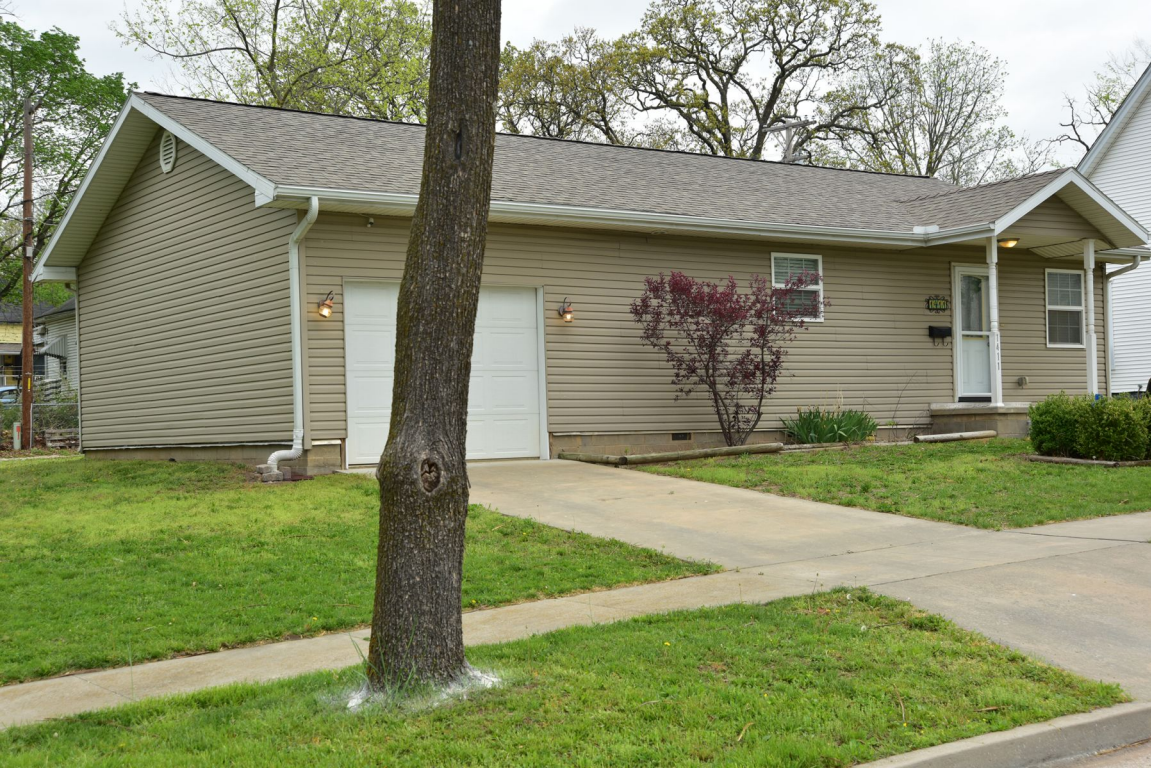
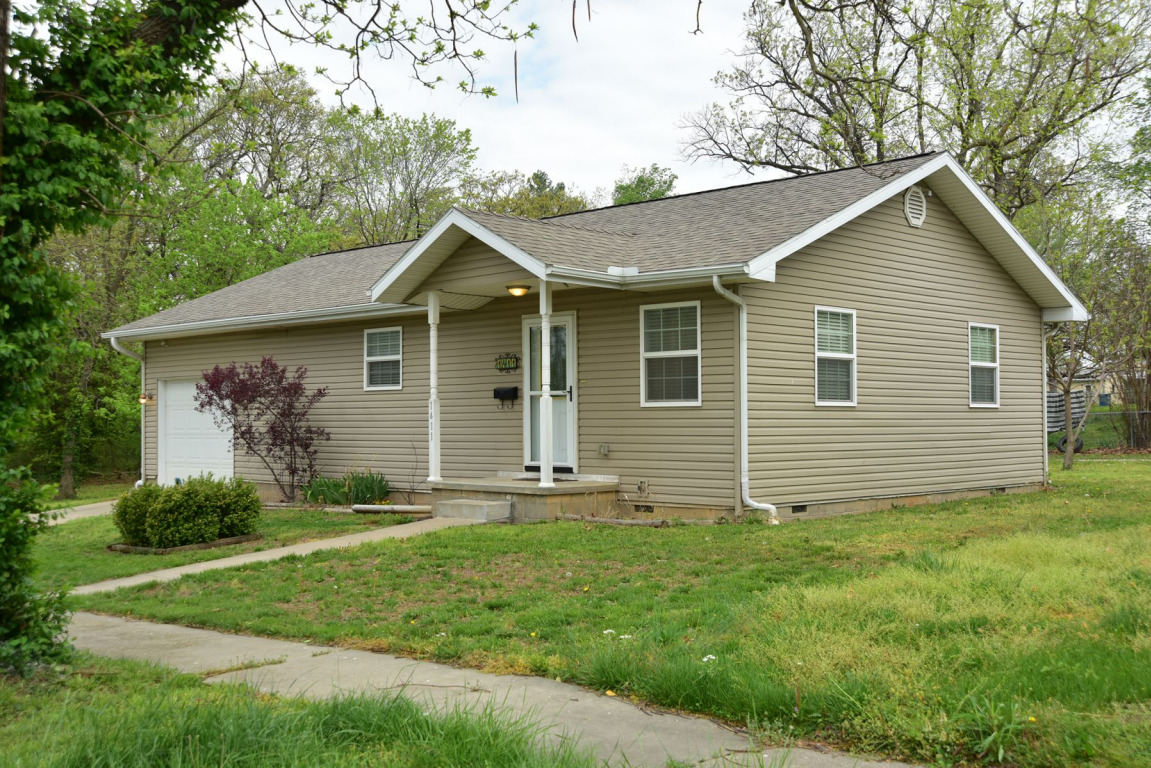
This Ranch dwelling faces south and has a rectangular footprint. It has a concrete masonry unit foundation and vinyl cladding. The side-gable roof has asphalt shingles. The dwelling is four bays wide and two asymmetrical bays deep. A one-car overhead garage door occupies the first (west) bay while six-over-six vinyl windows occupy the second and fourth bays. A wood door occupies the center bay and is sheltered by a front-gable porch roof. The porch has a concrete masonry unit foundation and turned wood posts support the roof.

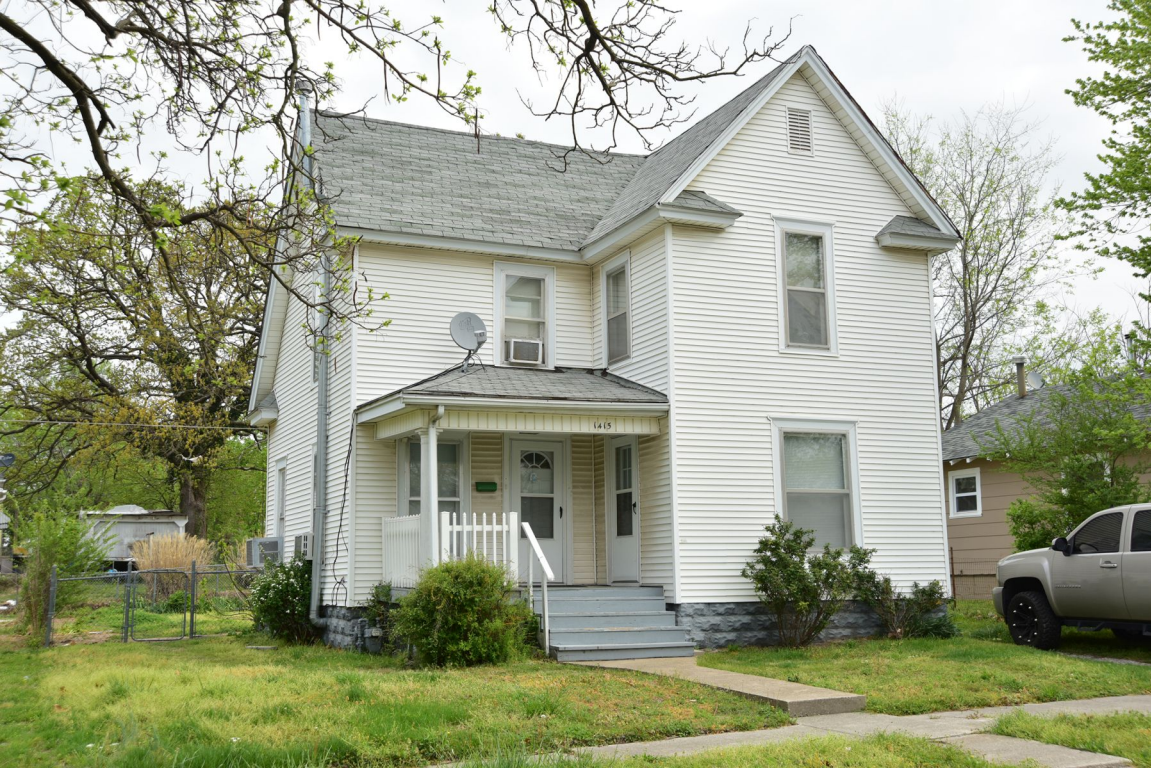
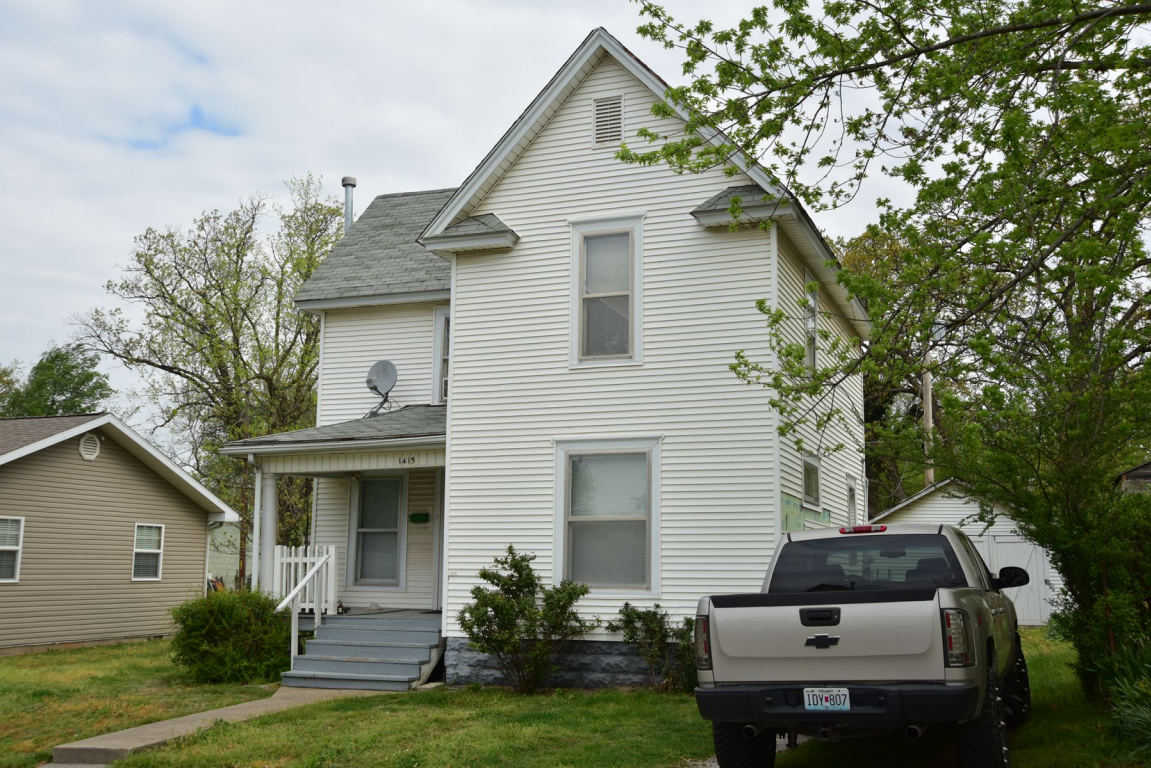
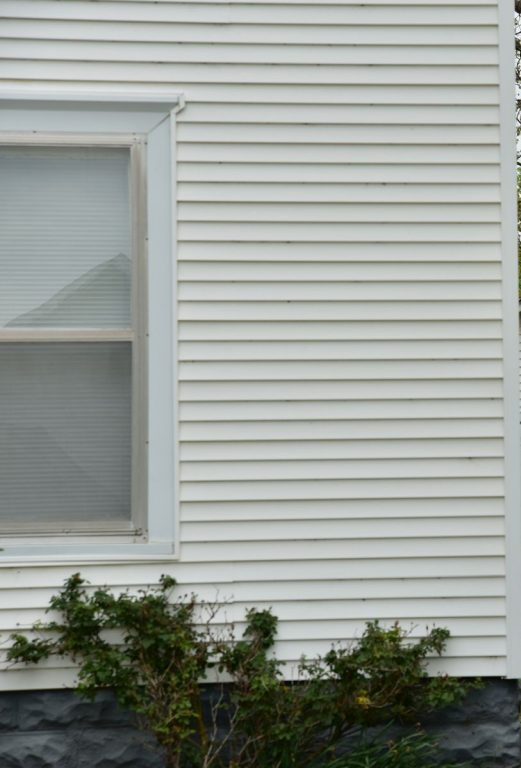
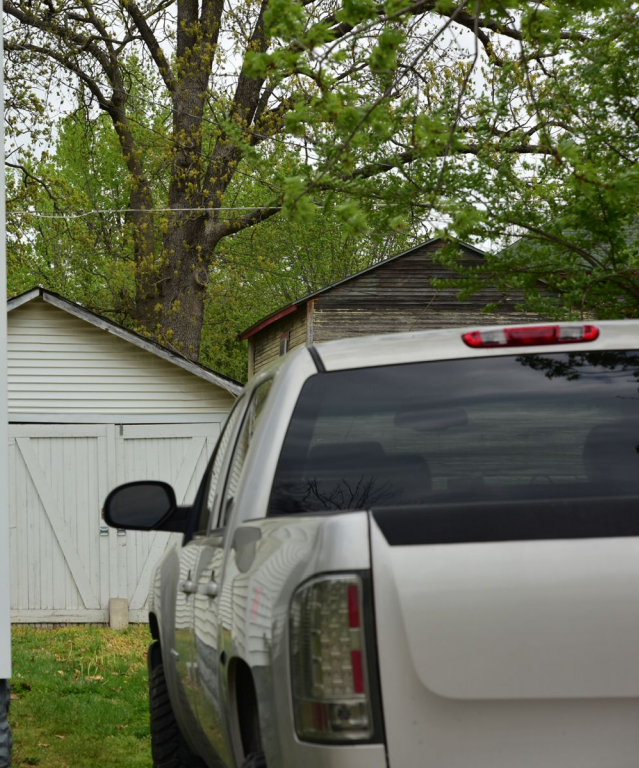
This dwelling faces south and has a square footprint. It has a concrete block foundation and vinyl cladding. A gabled ell projects from the side-gable roof. The roof has asphalt shingles and cornice returns characterize the gable ends. The dwelling is three bays wide and two bays deep. A hipped-roof porch shelters the west two first-story bays of the primary elevation. A wood column supports the roof and the foundation is not visible. The porch has vinyl balusters. A fiberglass door occupies the center bay while historic one-over-one wood windows occupy the remaining bays. A secondary entrance is located in the west wall of the gabled ell. The second-story primary elevation bays contain historic one-over-one windows.

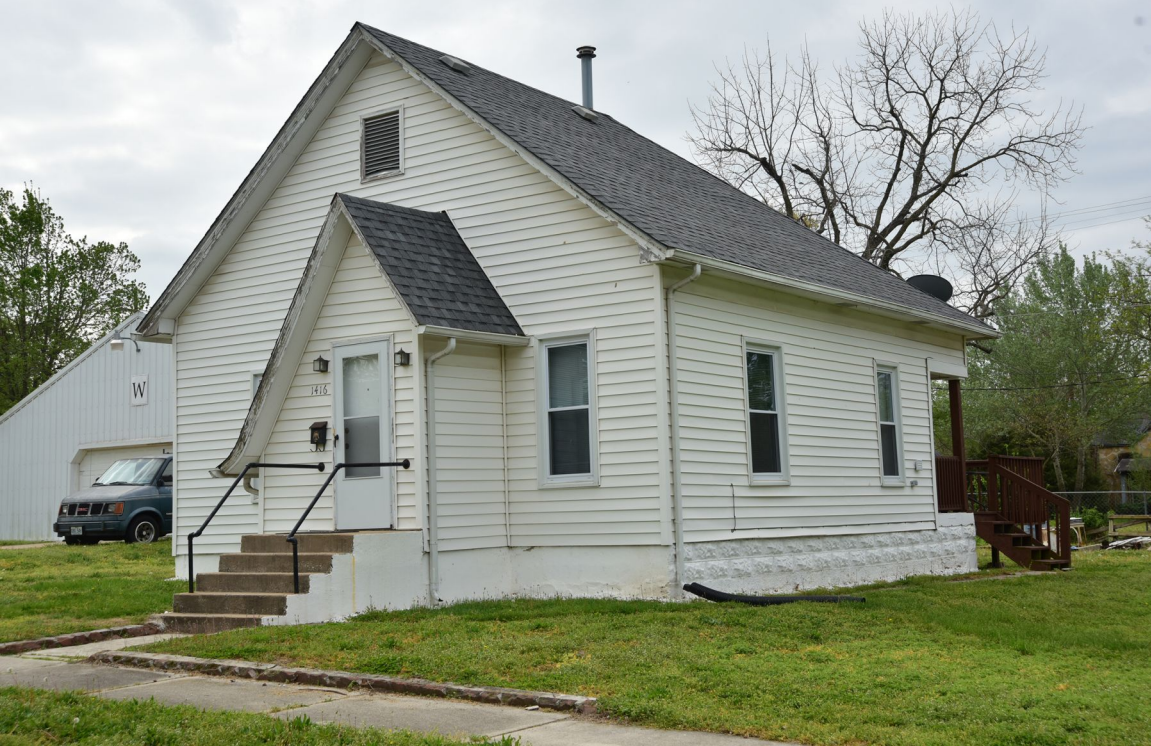
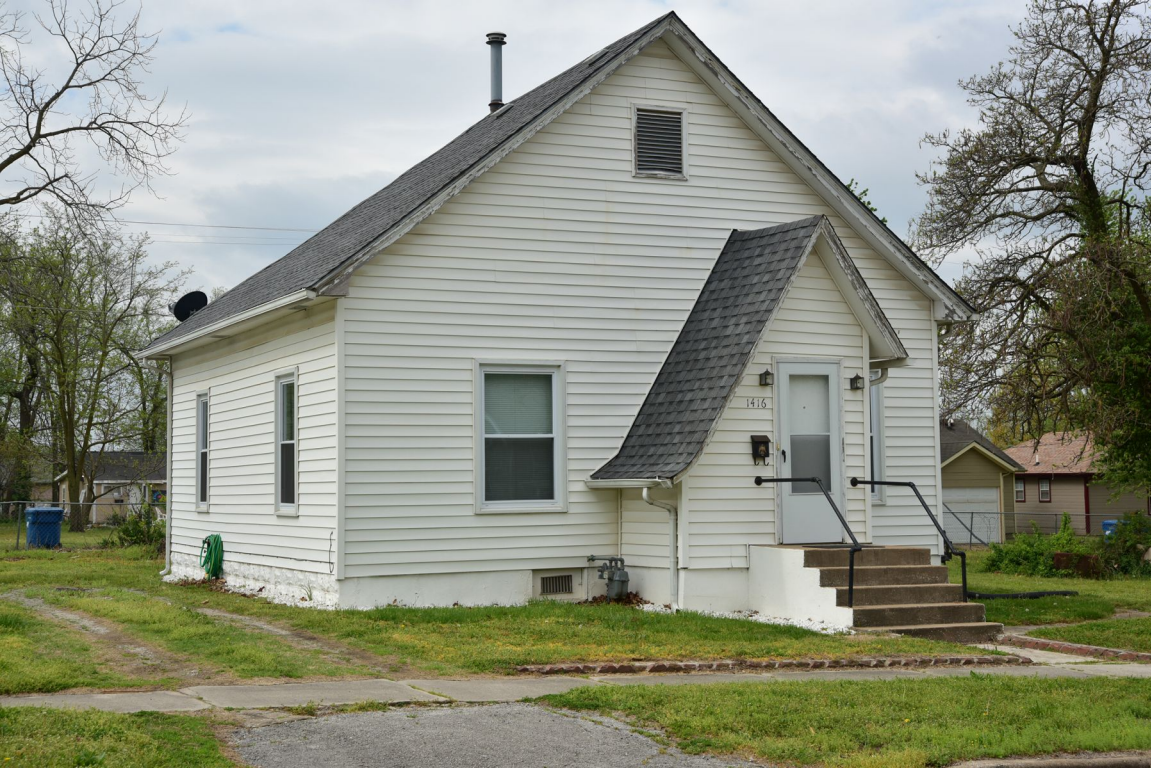
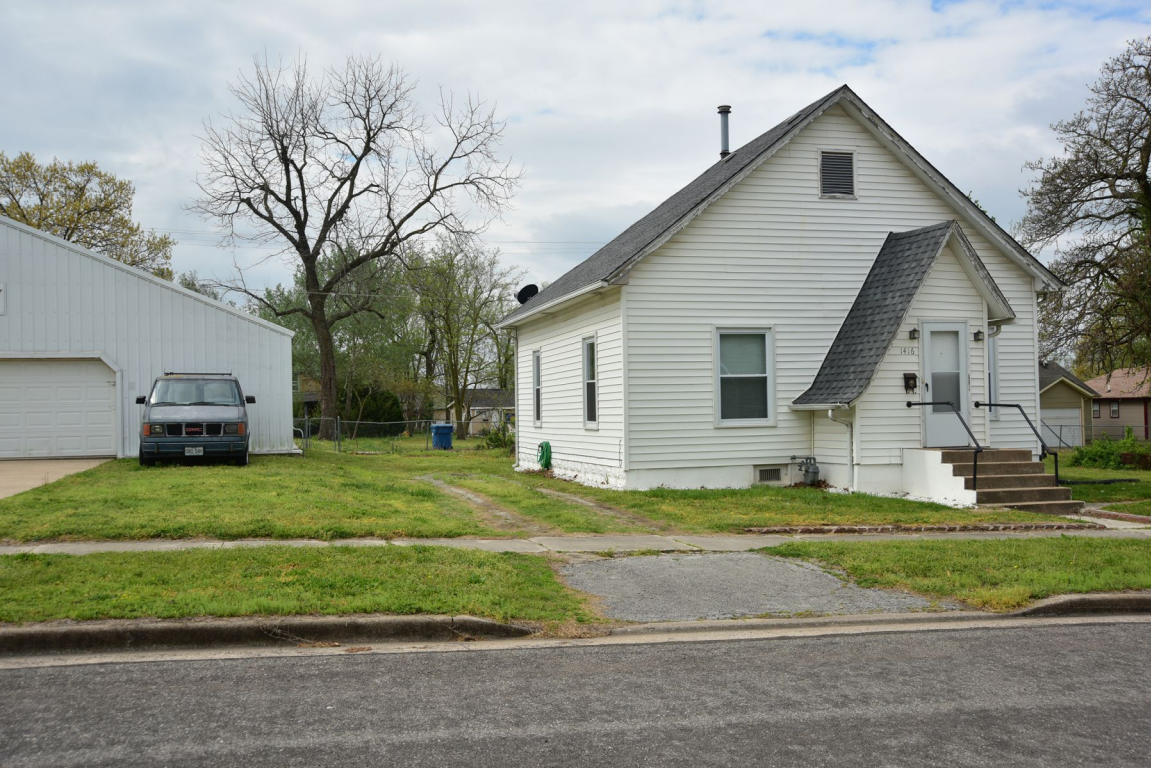
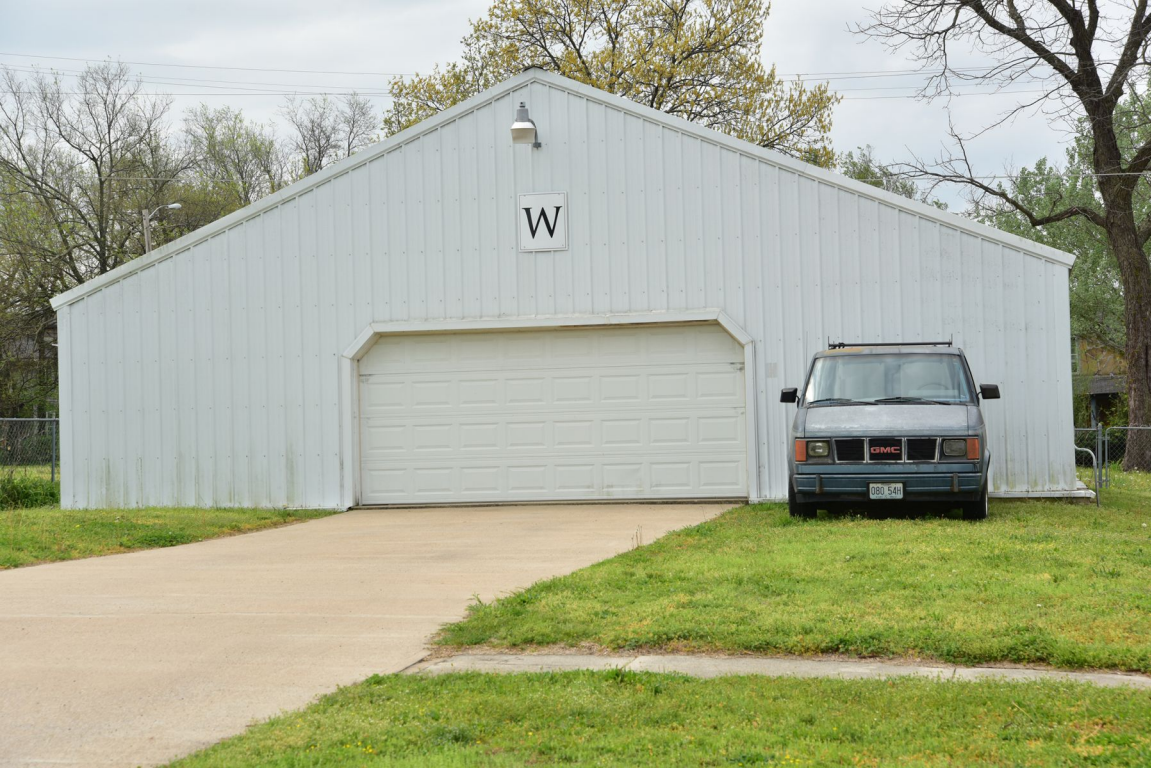
This dwelling faces north and has a square footprint. It has a concrete block foundation, vinyl cladding, and an asphalt shingle roof. The dwelling is three bays wide and two bays deep. An enclosed entrance with an asymmetrical gable roof and wood door occupies the center bay. One-over-one vinyl windows occupy the remaining bays. The dwelling has a concrete stoop with metal pipe railings.

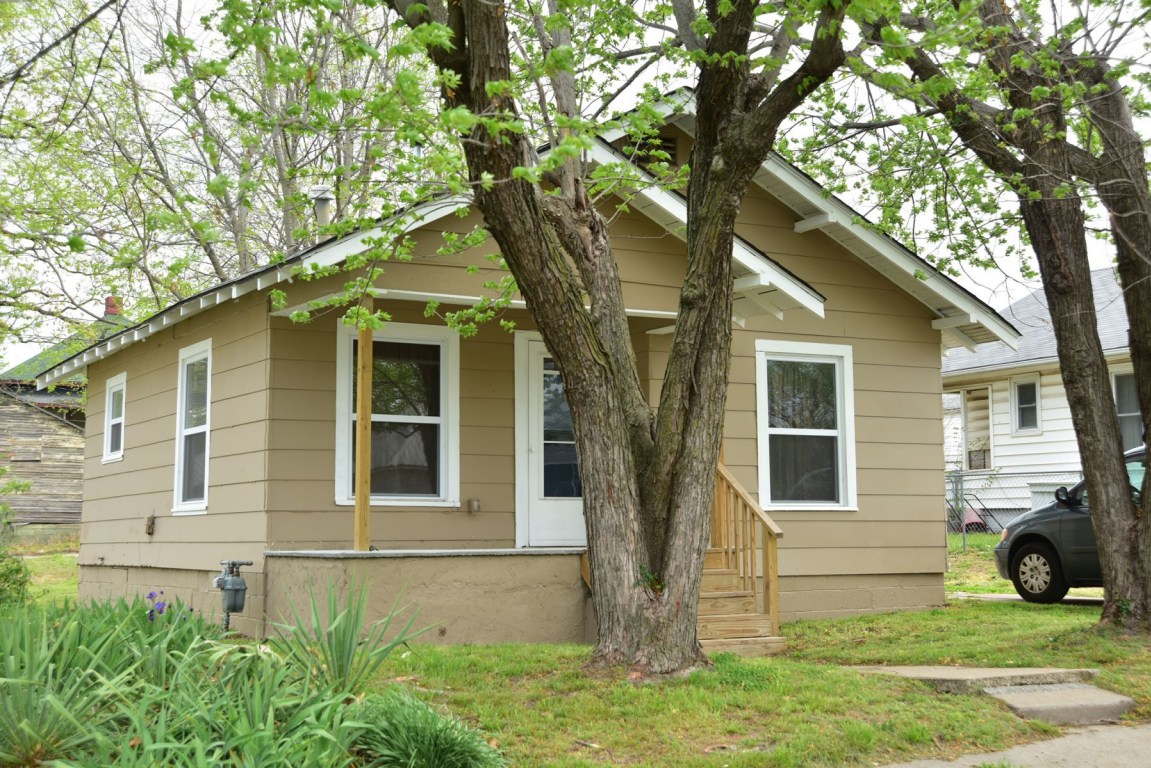
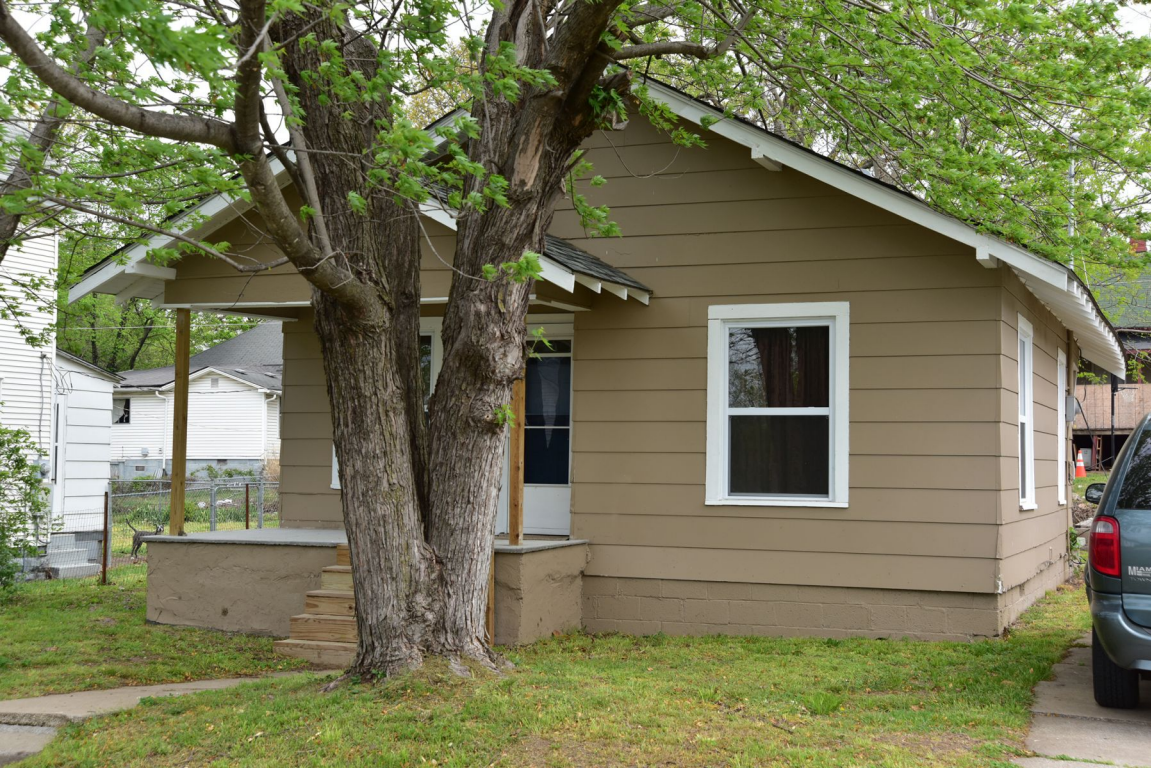
This bungalow dwelling faces south and has a square footprint. It has a concrete masonry unit foundation and hardboard cladding. The front-gable roof has asphalt shingles and exposed rafter tails. The dwelling is three bays wide and three bays deep. A front-gable porch roof with exposed rafter tails shelters the west two bays. The porch has a parged foundation and non-historic squared wood support posts. A non-historic wood door with glazing occupies the center bay. Non-historic one-over-one vinyl windows occupy the east and west bays.

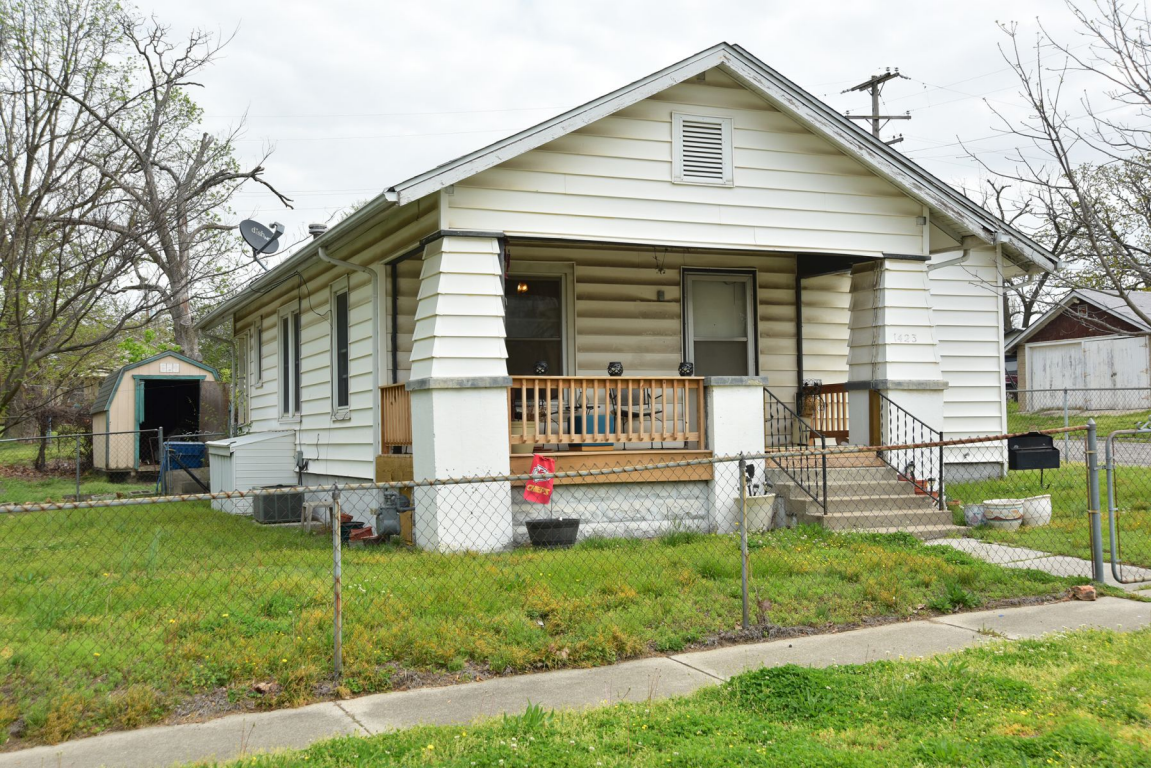
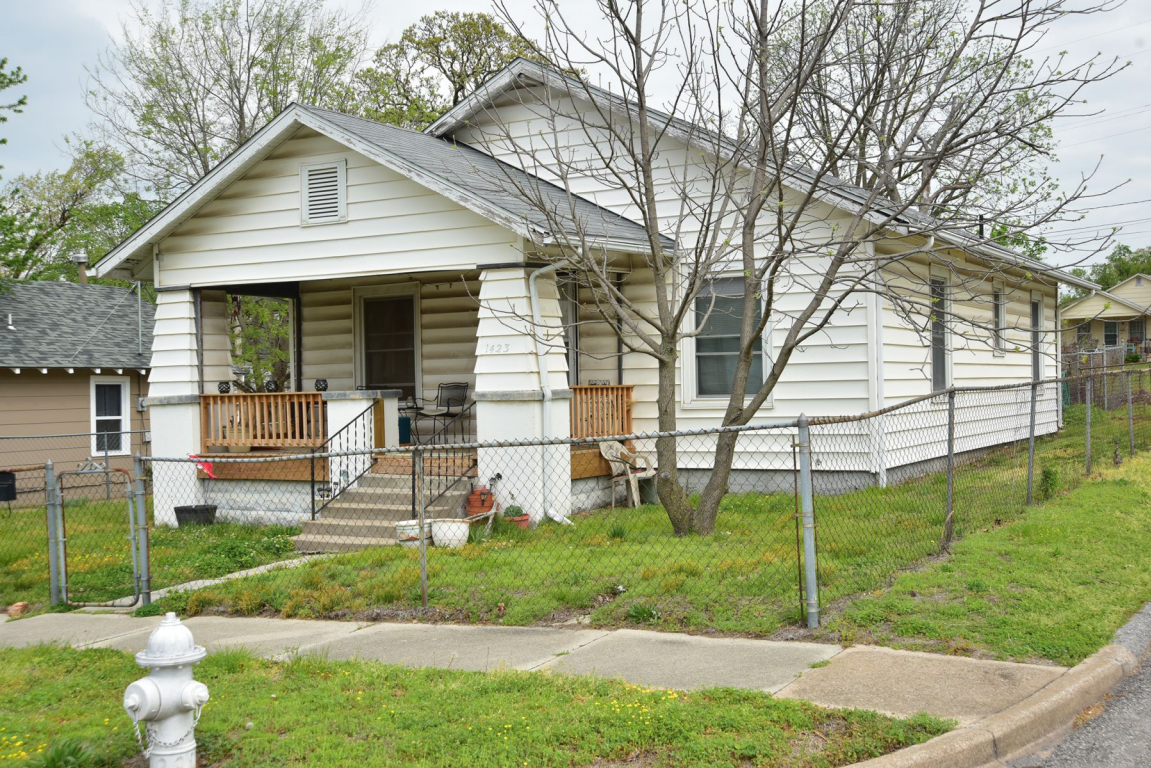
This bungaloid dwelling faces south and has a rectangular footprint. It has a concrete block and concrete masonry unit foundation and wide-profile vinyl cladding. The front-gable roof has asphalt shingles. The dwelling is three bays wide and three bays deep. An open, front-gable roof porch shelters the west two bays. The porch has a concrete block foundation and non-historic matchstick balustrade. Tapered, vinyl-wrapped columns on concrete piers support the roof. A wood door occupies the center bay while one-over-one wood windows occupy the remaining bays.

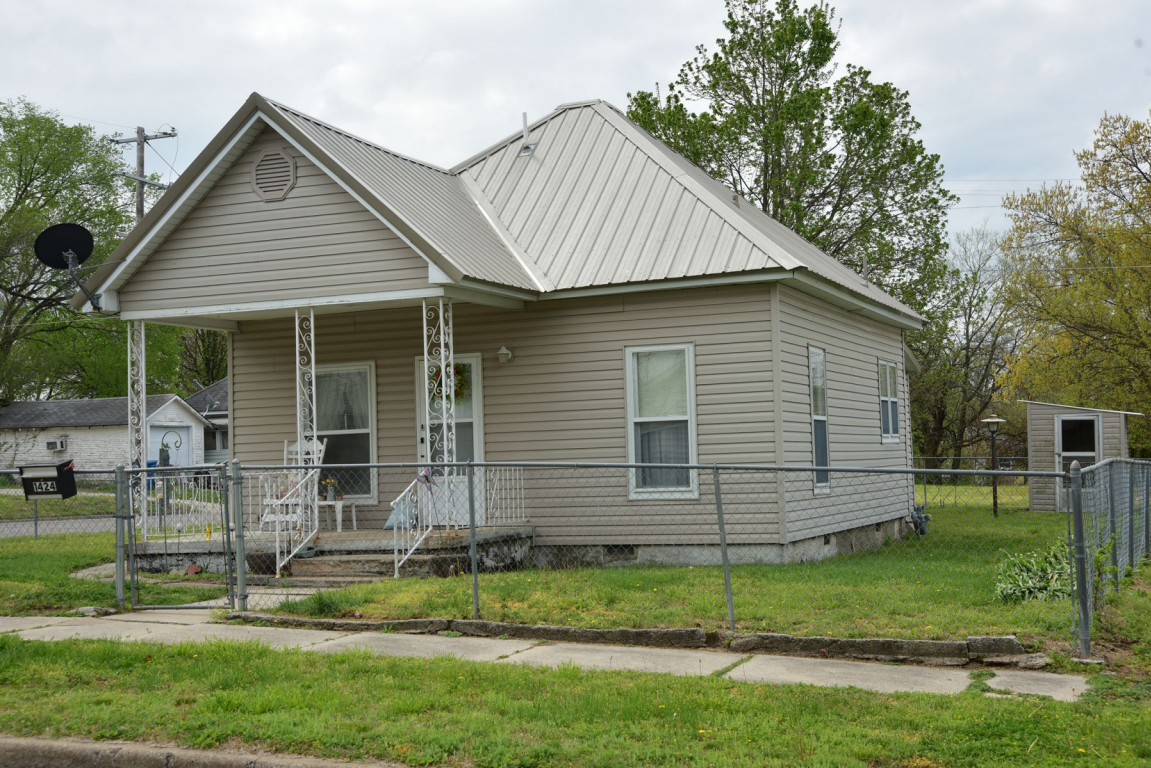
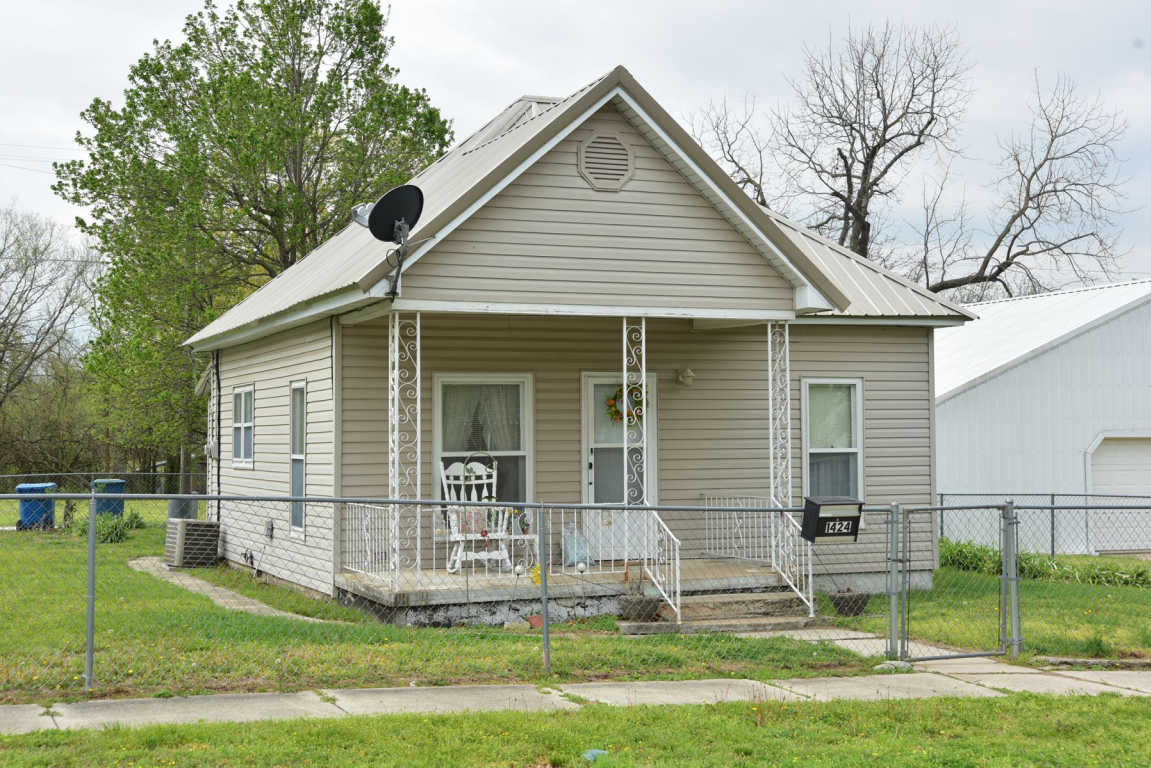
This Pyramid Square Folk House dwelling faces north and has a rectangular footprint. It has a parged stone foundation and vinyl cladding. The pyramidal hipped roof features corrugated metal cladding and narrow eaves. The dwelling is three bays wide and three bays deep. An enclosed porch with a shed roof forms the fourth bay. A non-historic front-gable porch roof shelters the east two bays. It has a concrete foundation and decorative metal support posts and railings. A non-historic wood door occupies the center bay while historic one-over-one wood windows occupy the remaining bays.
