MISSOURI DEPARTMENT OF NATURAL RESOURCES
STATE HISTORIC PRESERVATION OFFICE, P.O. Box 176, Jefferson City, MO 65102
ARCHITECTURAL/HISTORIC INVENTORY FORM

1. Survey number: JP-AS-006-260		2. Survey Name: East Town (Original Joplin) Historic Survey Phase 1	
3. County: JASPER		4. Address 1506	Street (name): E. North Street
5. City: Joplin	Vicinity <input type="checkbox"/>	7. Township/Range/Section: T: R: S:	
8. Historic name (if known):		9. Present/other name (if known):	
10. Ownership: <input checked="" type="checkbox"/> Private <input type="checkbox"/> Public		11a. Historic use (if known): Domestic/Single Dwelling	11b. Current use: Domestic/Single Dwelling

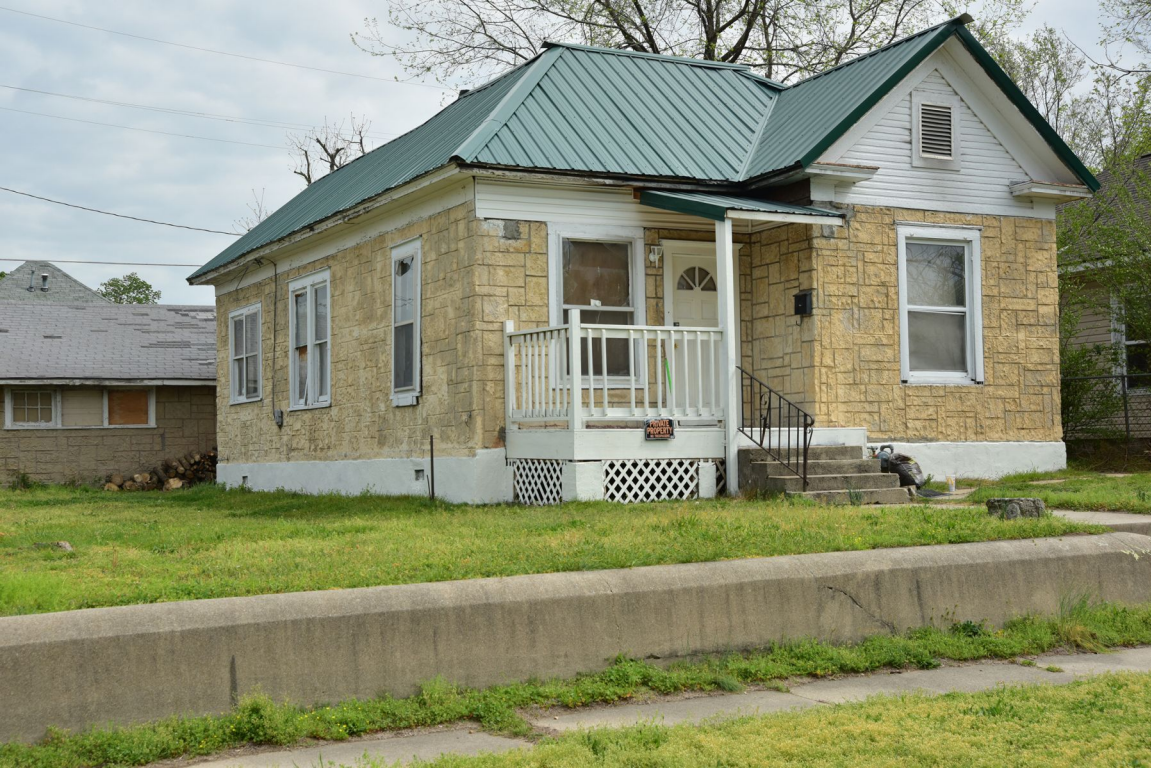
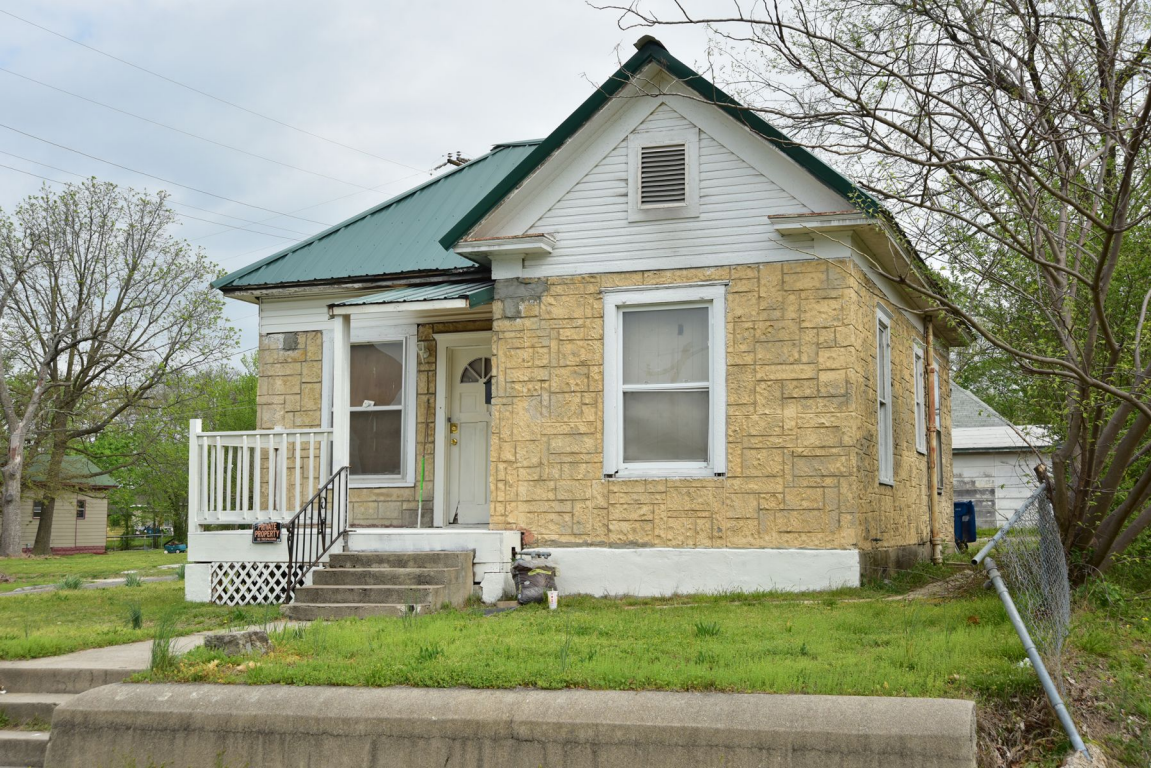
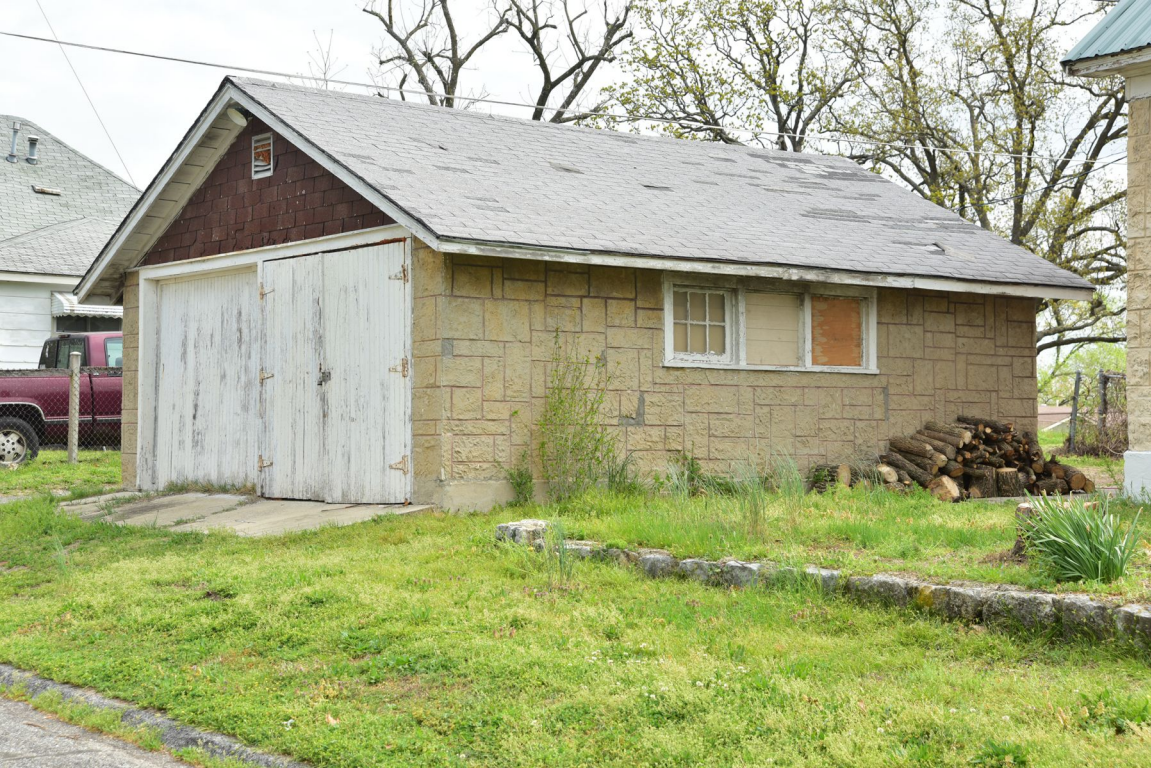
This dwelling faces south and has a rectangular footprint. It has a parged foundation and metal roof. The siding is stucco that is scored and painted to look like stone and appears to be historic, although this cannot be confirmed. The roof has wood soffits and cornice returns characterize the gable-end. The gable has wood clapboard cladding. A wide wood frieze is present at the east and west elevations. The dwelling is three bays wide and three bays deep. A gabled-ell contains the east bay. A fiberglass door occupies the center bay. A one-over-one wood window occupies the west bay while a one-over-one vinyl window occupies the east bay. The windows have historic wood trim. A non-historic, open porch spans the west two bays. It has a wood floor and matchstick balustrade. The corrugated metal shed roof shelters the center bay only.

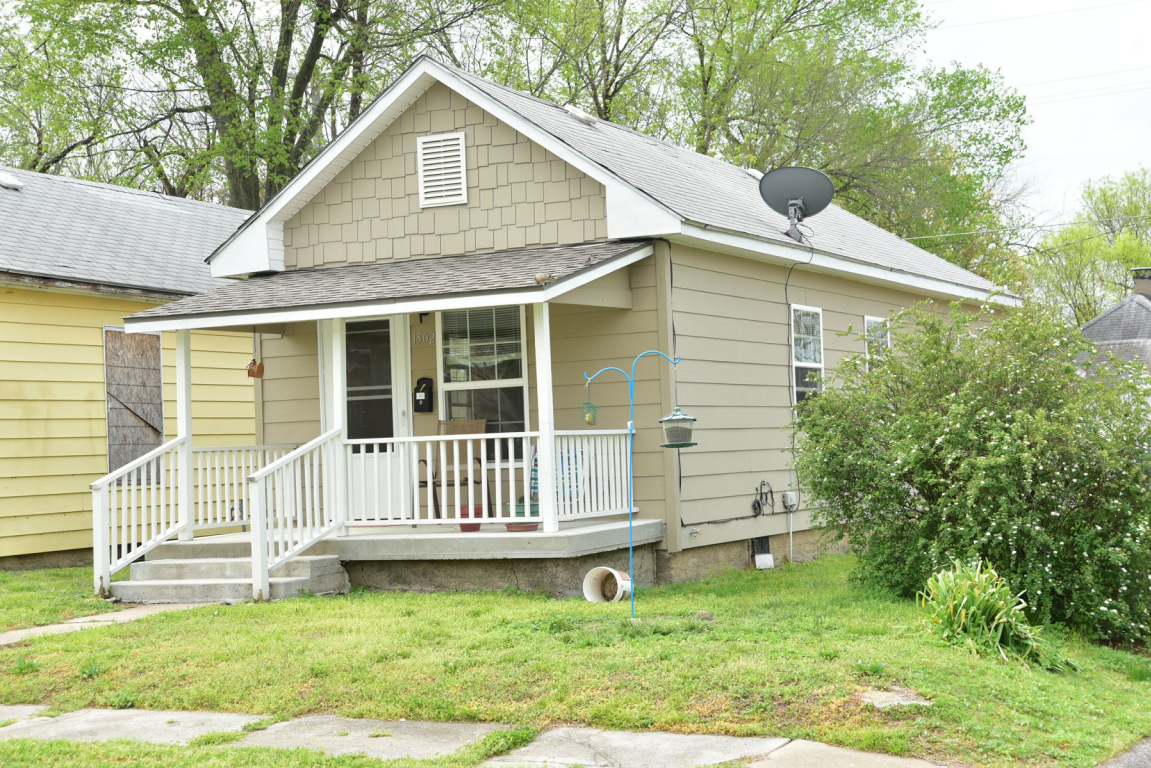
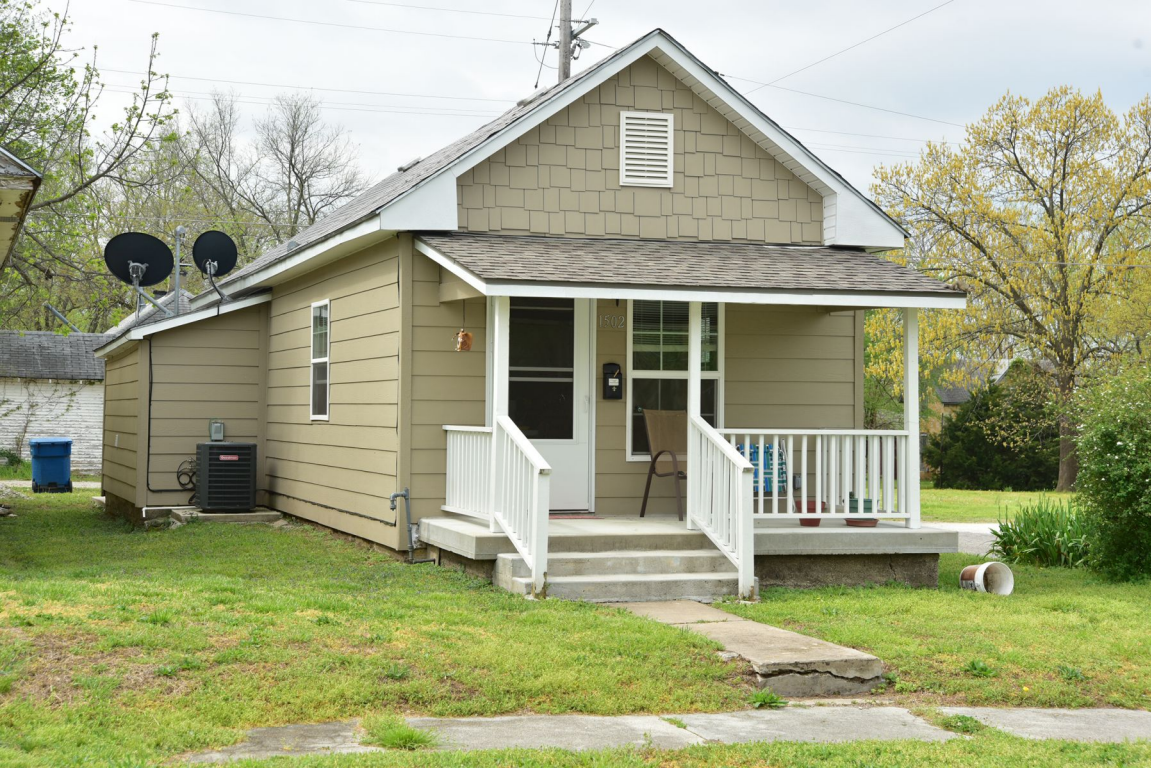
This Shotgun dwelling faces north and has a rectangular footprint. It has a concrete foundation and cementitious siding. The front-gable roof has asphalt shingles. The dwelling is two bays wide and three bays deep. A non-historic porch with a shed roof and concrete foundation shelters the primary elevation bays. The porch has wood roof support posts and a vinyl balustrade and stair railings. A six-over-six vinyl window occupies the west bay while an entrance occupies the east bay. The door is not visible. An enclosed porch with shed-roof projects from the east elevation. The porch enclosure is an alteration.

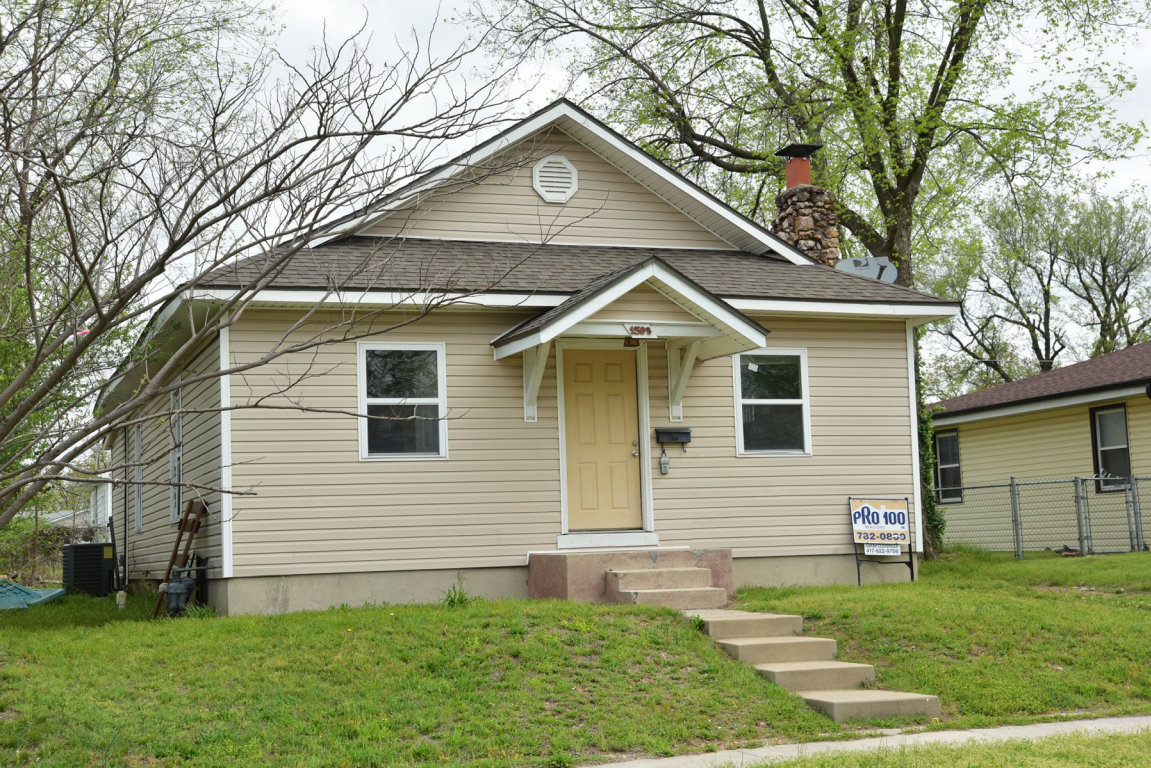
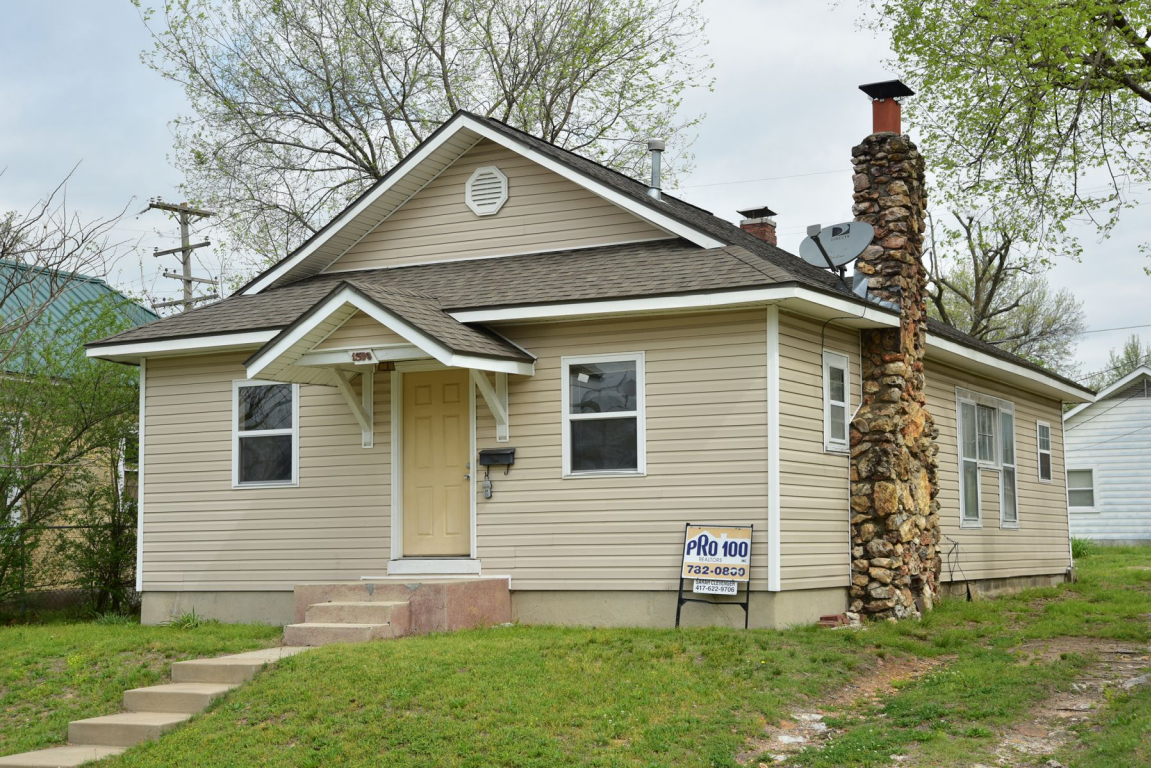
This bungalow dwelling faces south and has a rectangular foundation. It has a concrete masonry unit foundation. The south third of the foundation is parged. The dwelling has vinyl cladding and the roof has asphalt shingles. A stone exterior chimney is located on the east elevation. A historic full-width front porch has been enclosed. The dwelling is three bays wide and three bays deep. A non-historic wood door occupies the center bay while one-over-one vinyl windows occupy the east and west bays. A front-gable roof with knee brackets shelters the concrete stoop.

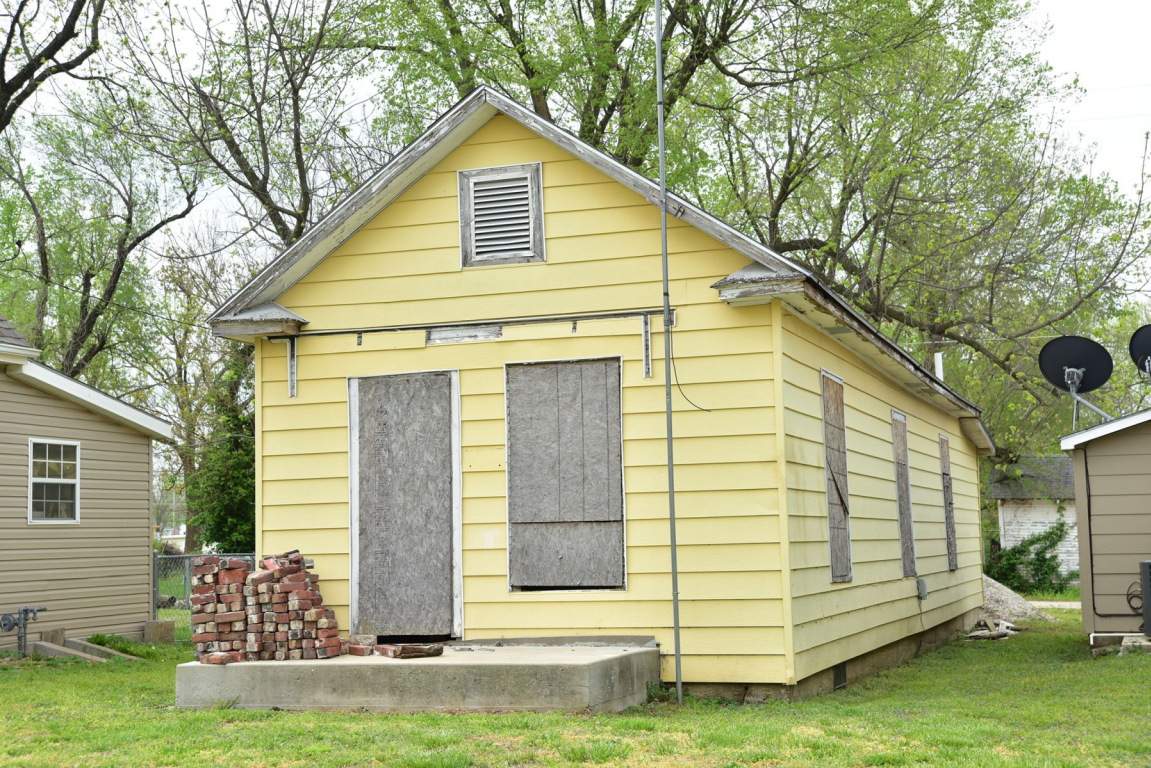
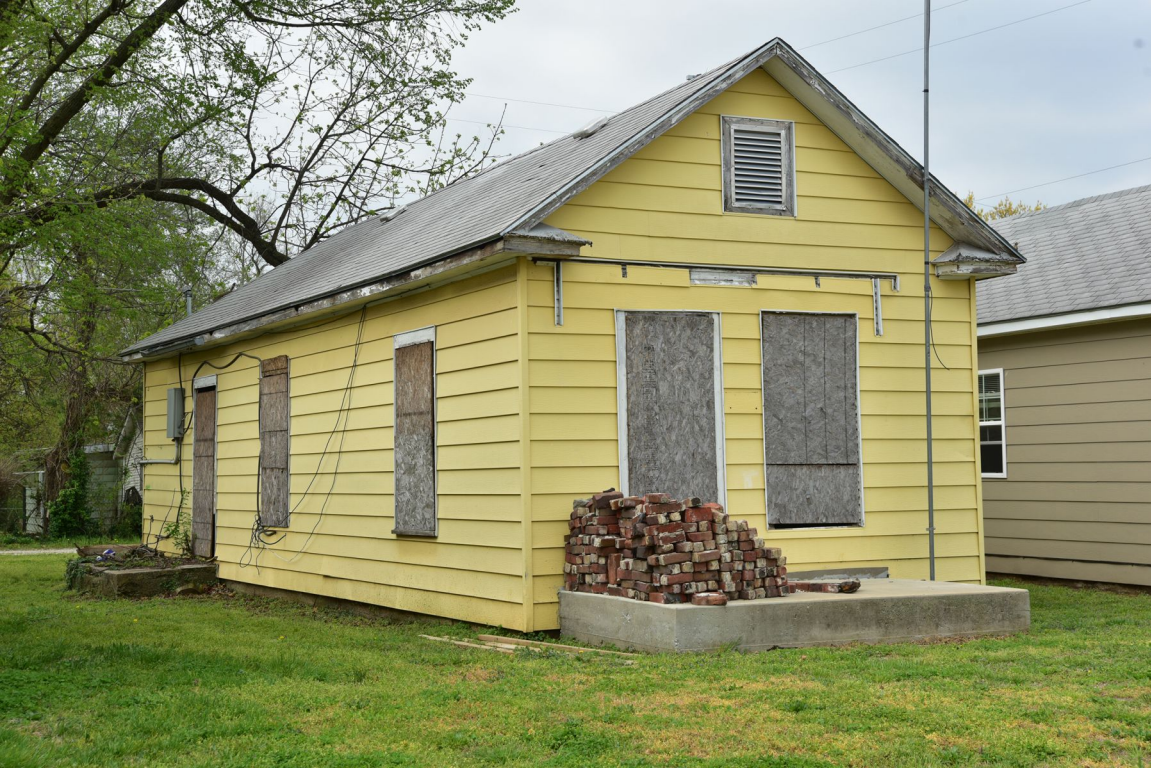
This Shotgun dwelling faces north and has a rectangular footprint. It has a concrete foundation and metal siding over wood clapboards. The front-gable roof has asphalt shingles with wood fascia boards and soffits. The dwelling is two bays wide and three bays deep. The bays are boarded up, although the historic one-over-one wood windows may be intact beneath the plywood. The front porch has been removed. A concrete stoop is located at the rear bay of the east elevation.

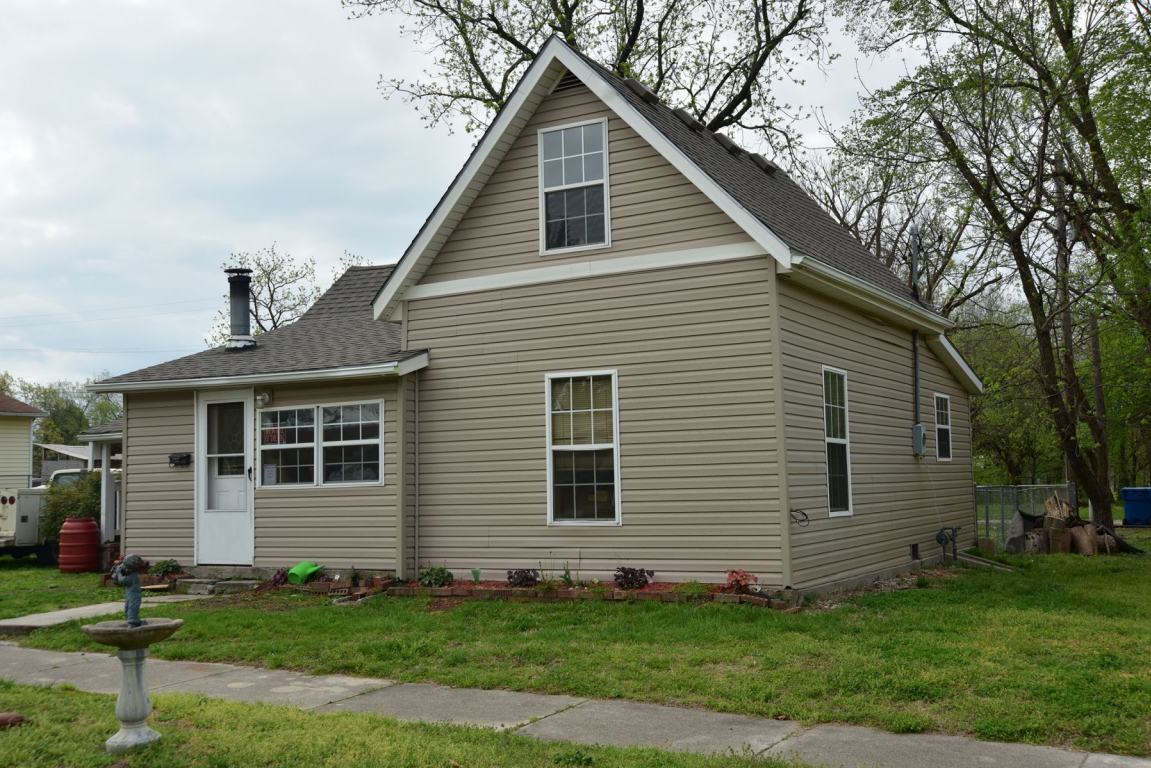
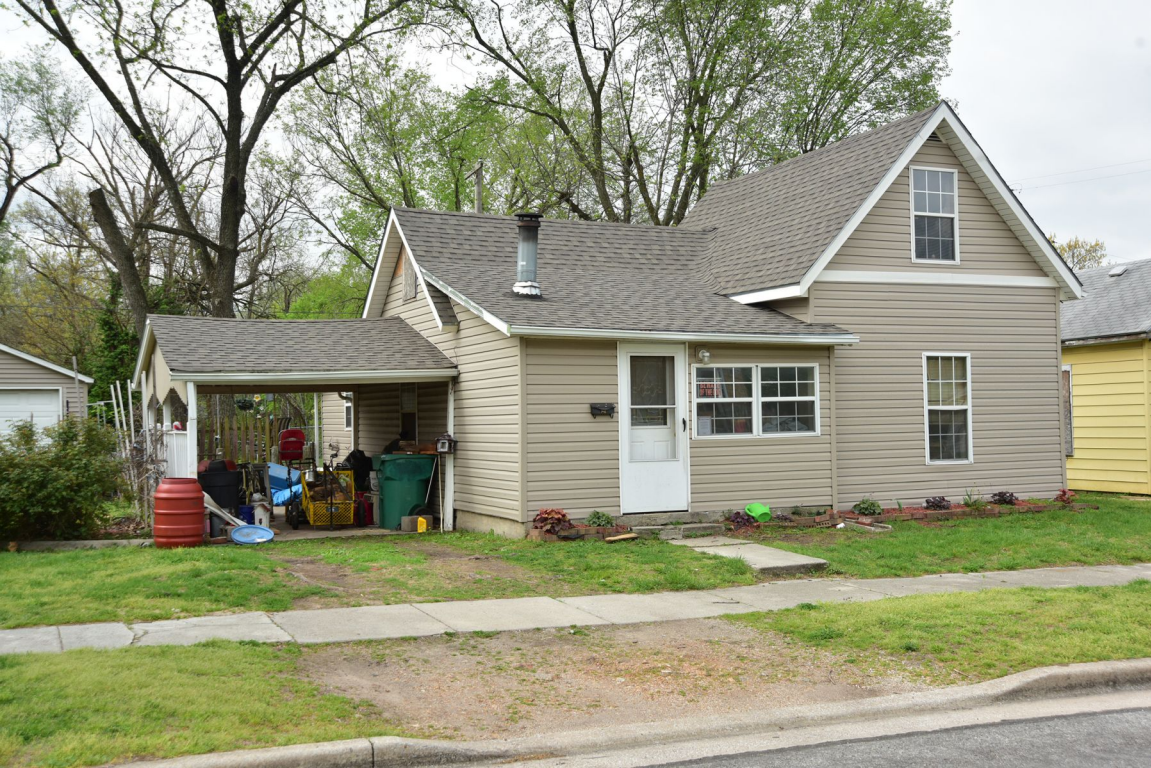
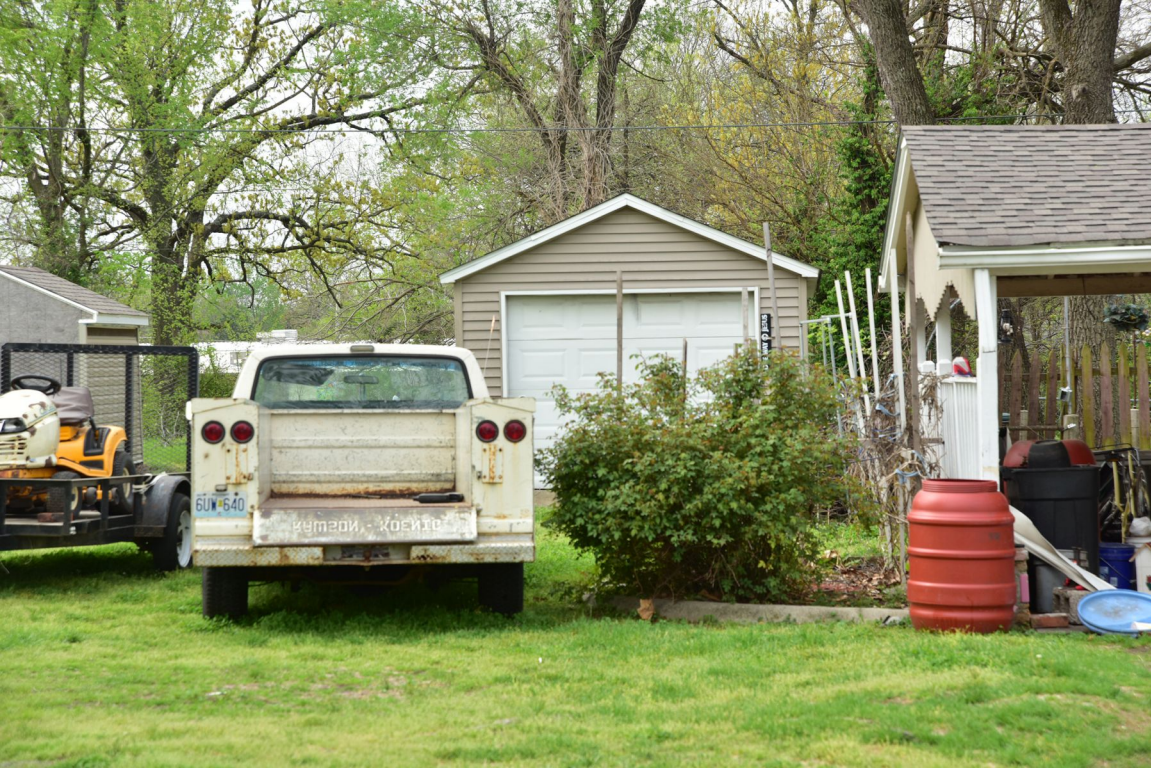
This Gabled-El dwelling faces north and has a rectangular footprint. It has a parged foundation, vinyl siding, and an asphalt shingle roof. The dwelling is three bays wide and two bays deep. A non-historic enclosed porch contains the east two bays. The porch enclosure is an alteration. A non-historic wood door with glazing occupies the first (east) bay while a pair of six-over-six vinyl windows occupies the second bay. The third bay and gable-end contain a single six-over-six vinyl window each. A non-historic side-gable carport projects from the east elevation.

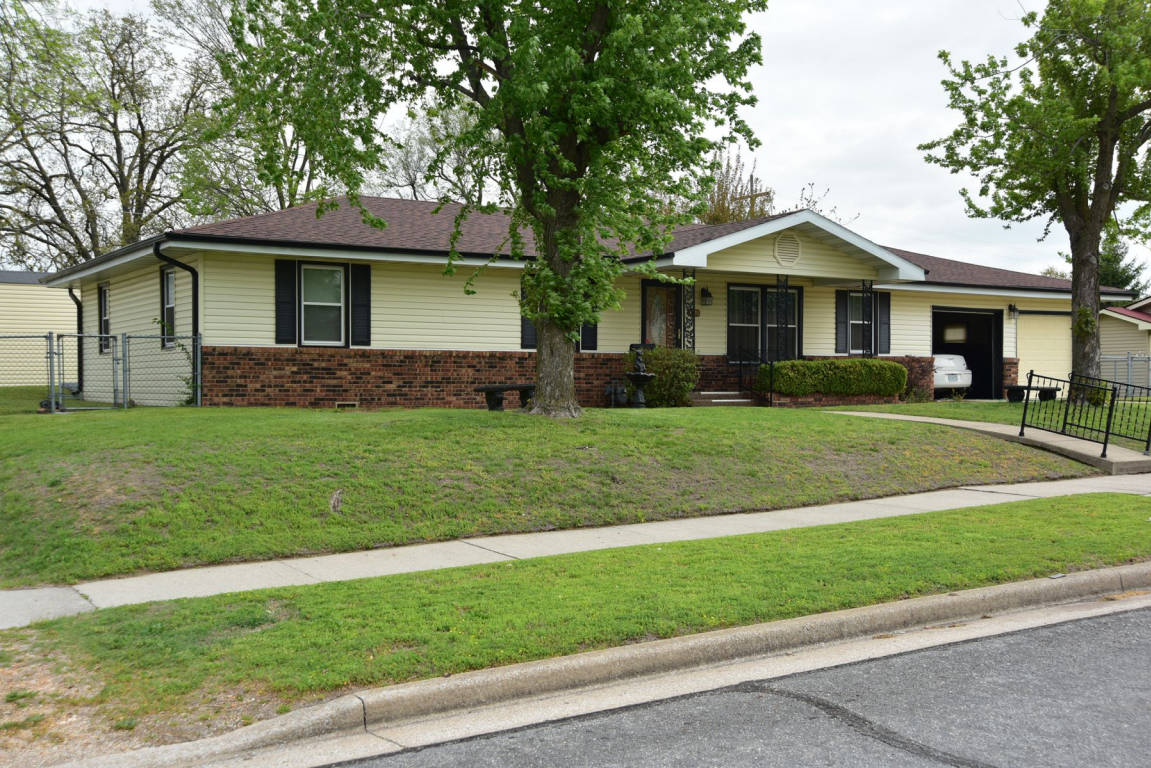
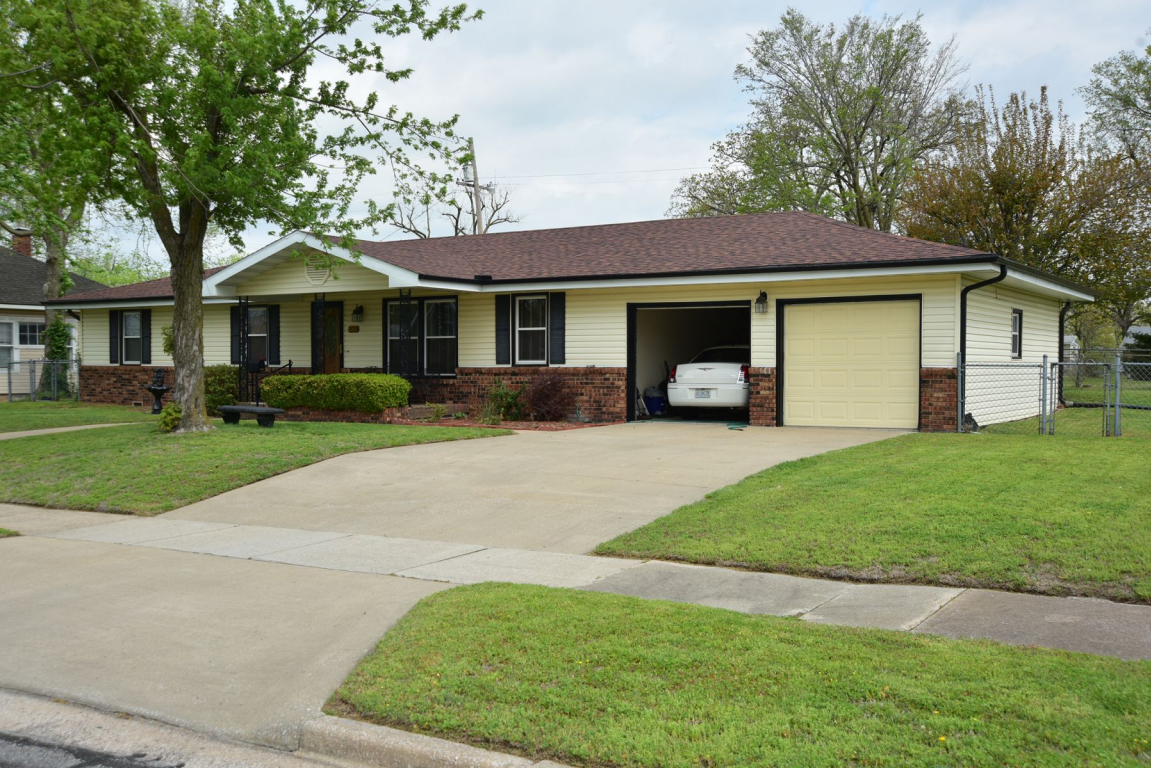
This Ranch dwelling faces south and has a T-shaped footprint. It has a concrete foundation and asphalt shingle roof. Brick veneer clads the lower third of the dwelling while the upper two-thirds is vinyl-clad. The dwelling is seven bays wide and two bays deep. Overhead garage doors occupy the two east bays. Single one-over-one wood windows with false shutters occupy the first (west), second, and third bays. A pair of one-over-one wood windows occupies the fourth bay and a wood door with glazing occupies the center bay. A front-gable porch with decorative metal support posts shelters the third and fourth bays. A shed-roof addition with a broad brick chimney projects from the north elevation.

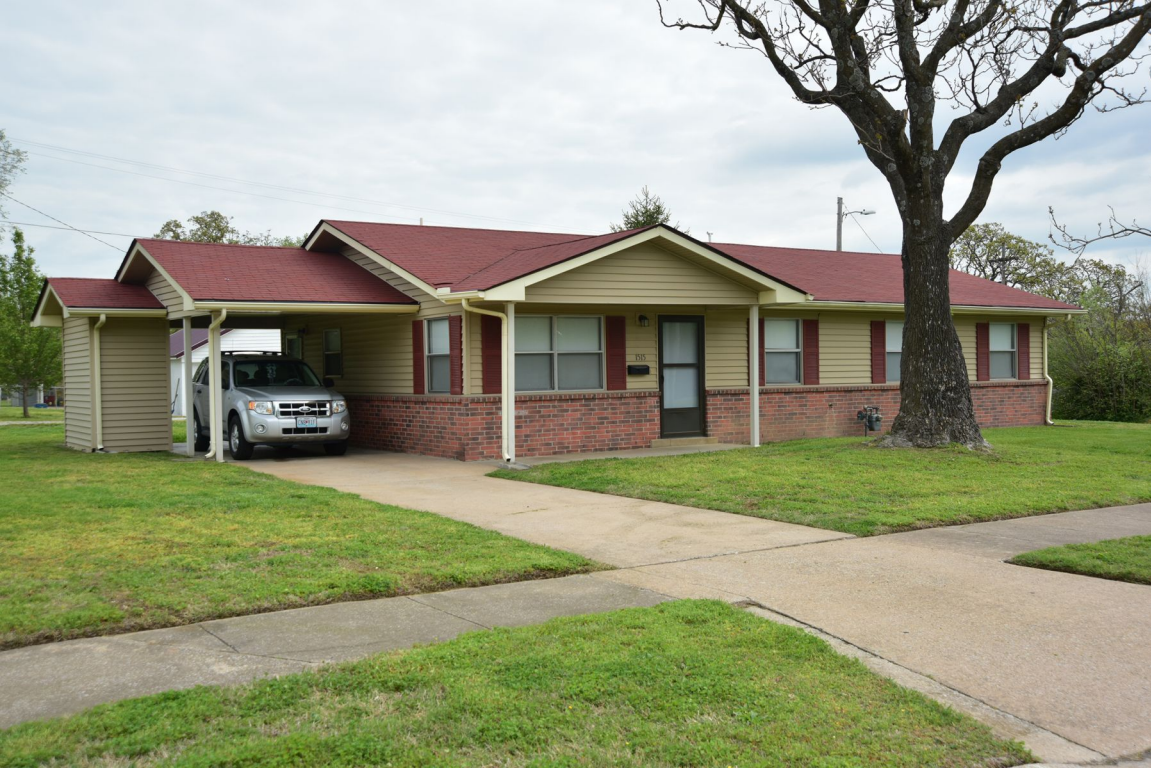
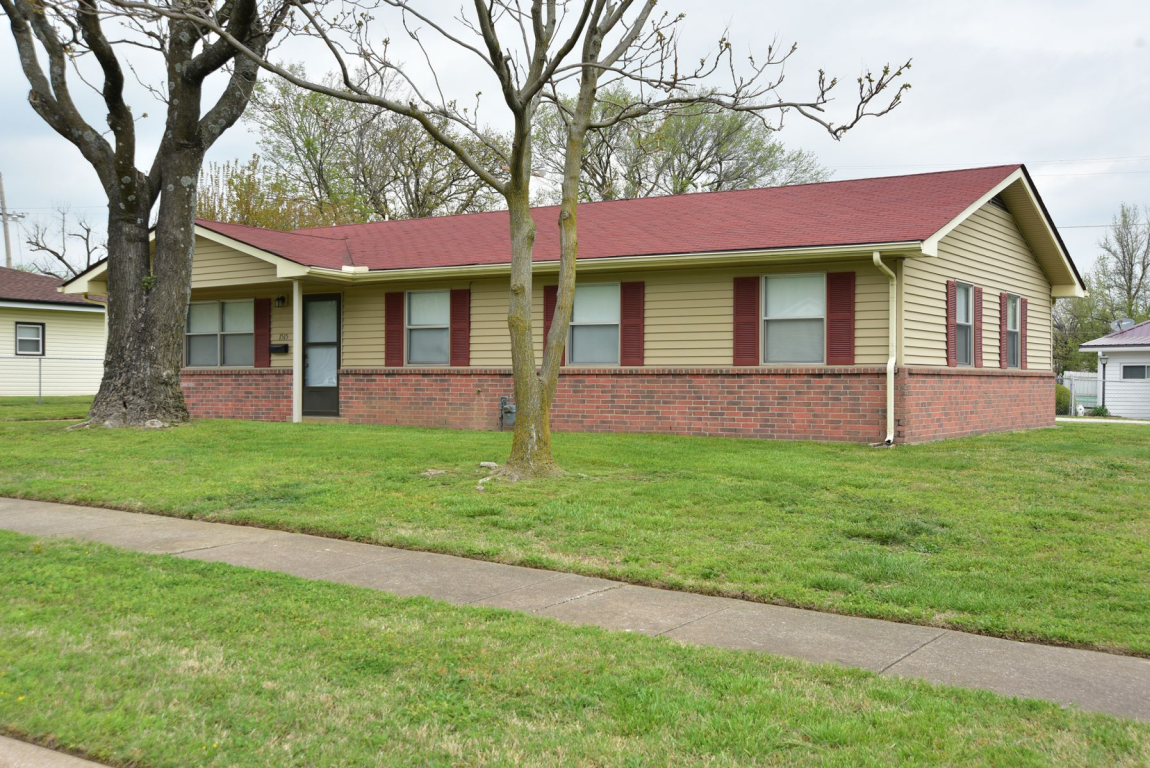
This one-story Ranch type house faces south and has rectangular footprint. It has a poured concrete foundation and a side-gabled roof with asphalt shingles. The lower half of the exterior has brick veneer cladding and the upper half is clad with vinyl siding. A one-story, partial-width porch with a front-gabled roof with asphalt shingles and vinyl cladding in the gable spans the west portion of the primary elevation. The porch has a poured concrete slab and vinyl support posts. The primary elevation has five bays; the two west bays are sheltered by the porch. The three east bays each contain a one-over-one metal window with shutters. The second-from-west bay contains a wood door. The west bay contains a pair of one-over-one metal windows with shutters. A carport with a side-gabled roof extends from the west elevation. The carport has vinyl support posts and an attached shed with vinyl siding.

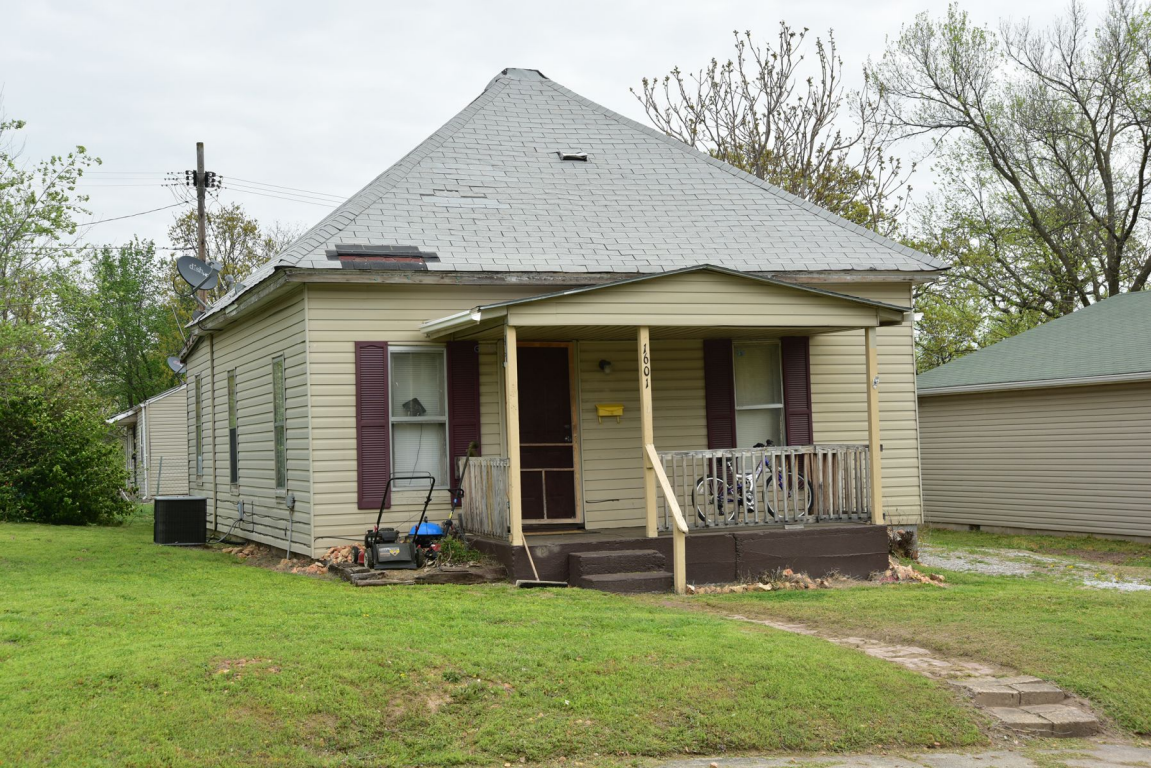
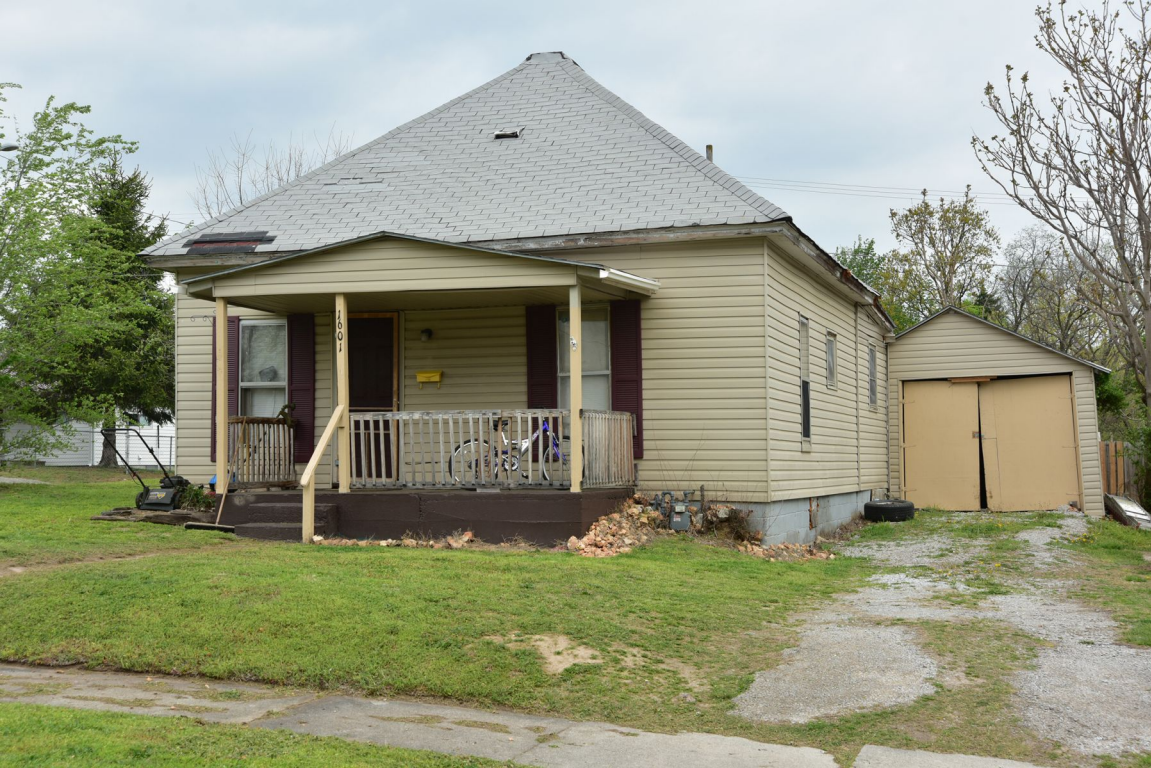
This Pyramid Folk House dwelling faces south and has a rectangular footprint. It has a concrete masonry unit foundation and vinyl cladding. The pyramidal hipped roof has asphalt shingles with wood fascia boards and soffits. The dwelling is three bays wide and three bays deep. A non-historic front-gable porch with a concrete foundation and matchstick balustrade shelters the two east bays. A non-historic wood door occupies the center bay and one-over-one wood windows with false shutters occupy the remaining bays. A garage addition is attached to the northeast corner of the dwelling. It has a front-gable roof and vinyl cladding. The foundation is not visible. A pair of non-historic plywood doors occupies the single bay.

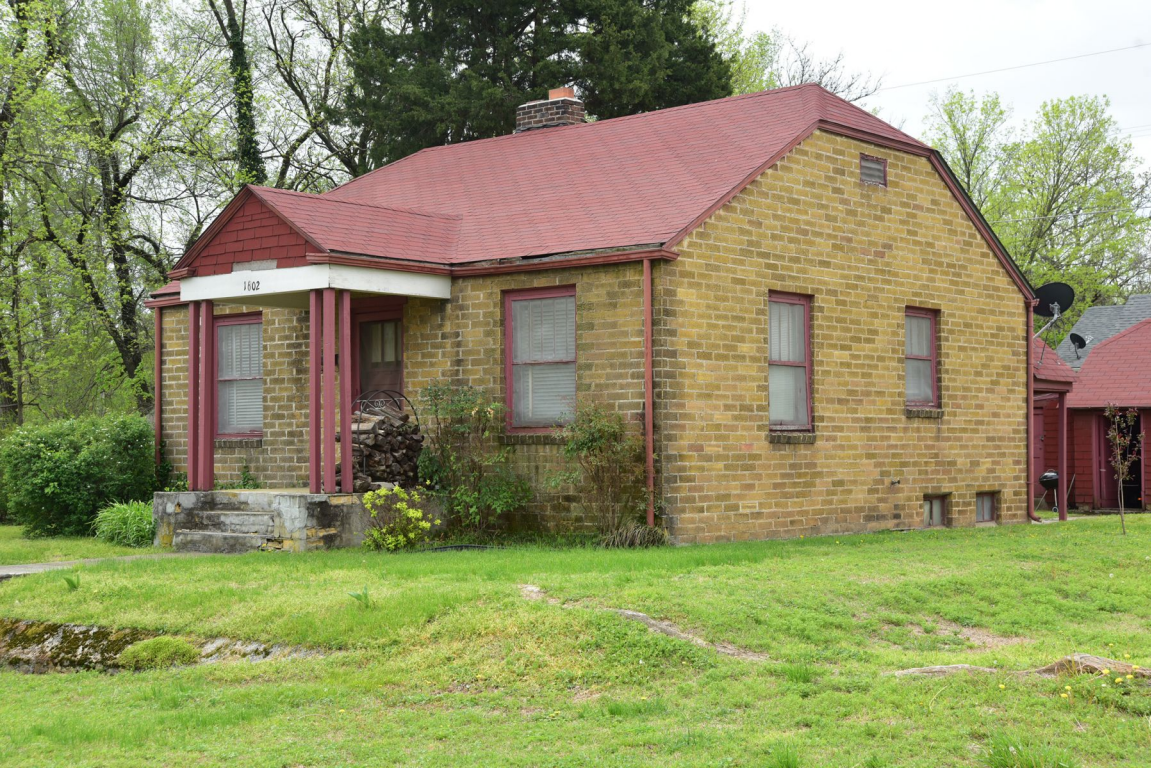
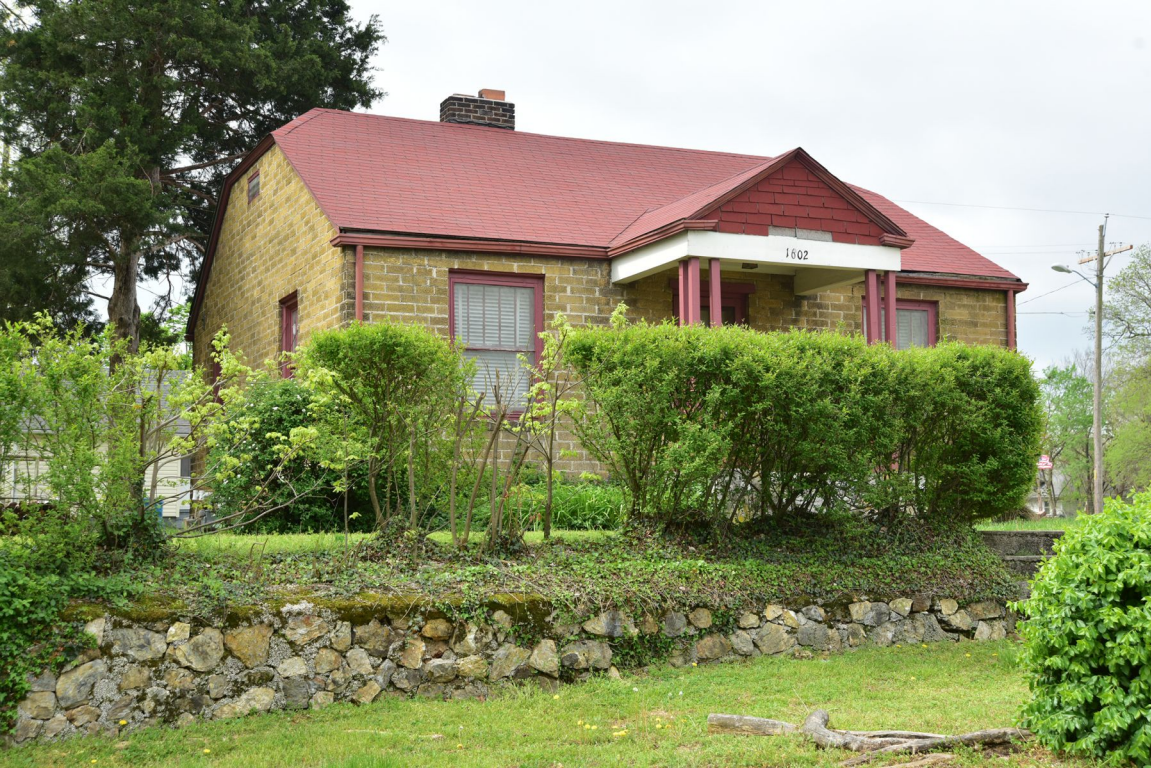
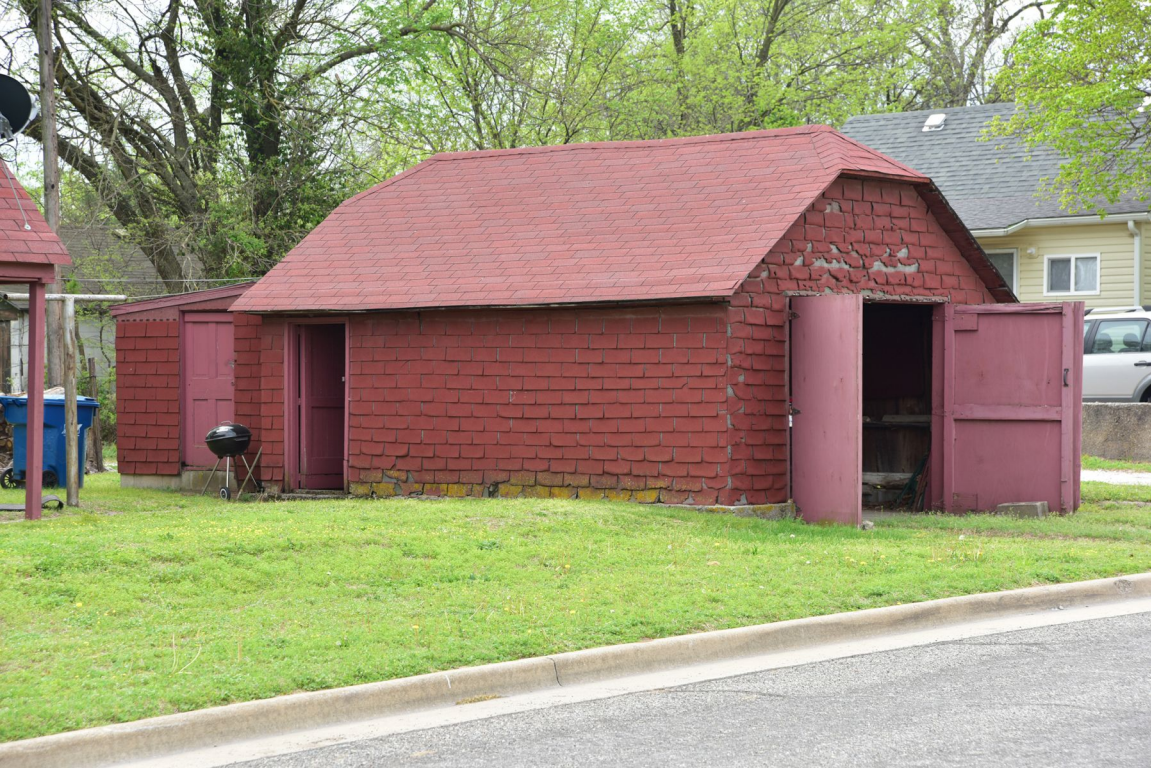
This Minimal Traditional dwelling faces north and has a square footprint. It has a hipped-gable roof with asphalt shingles. A short, broad brick chimney pierces the center of the roof. It is brick-clad and the foundation is not visible. The dwelling is three bays wide and two bays deep. A historic wood door with three-light glazing occupies the center bay while historic five-over-one wood windows with header brick sills occupy the east and west bays. A front-gable porch shelters the entrance bay. It has a parged stone foundation and wood support posts arranged in sets of three. Historic four-over-one and one-by-one wood windows are present at the secondary elevations.

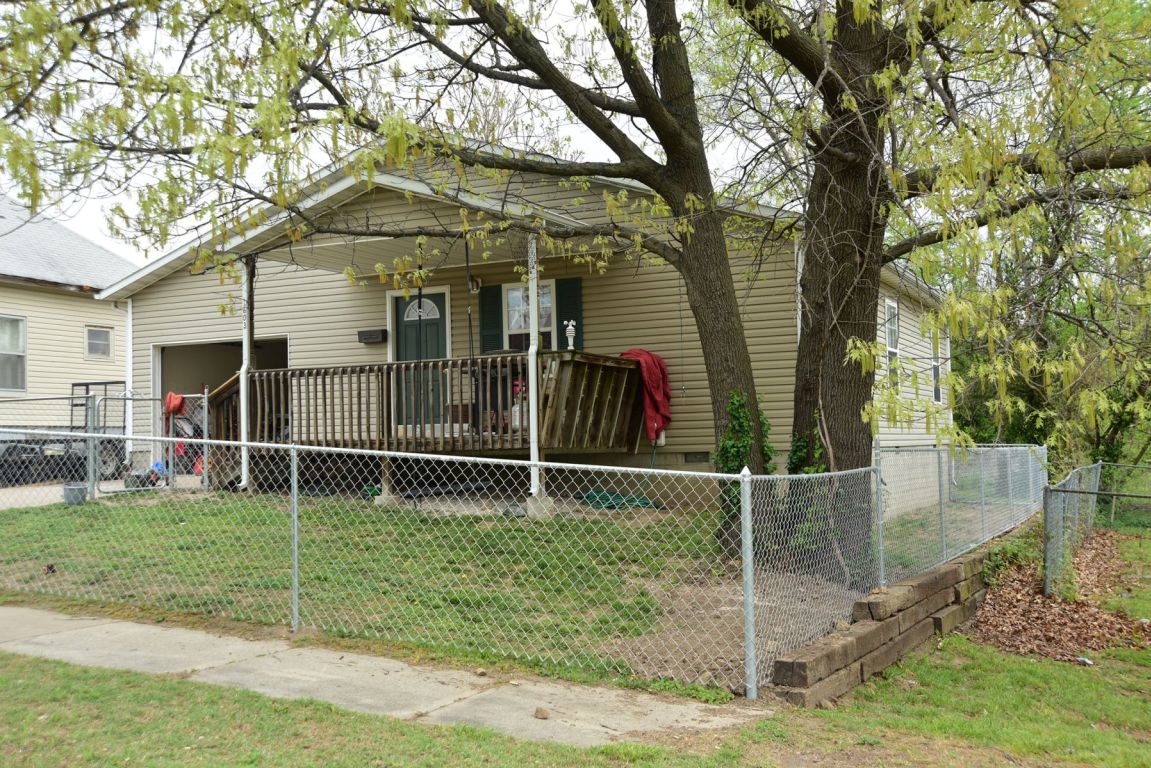
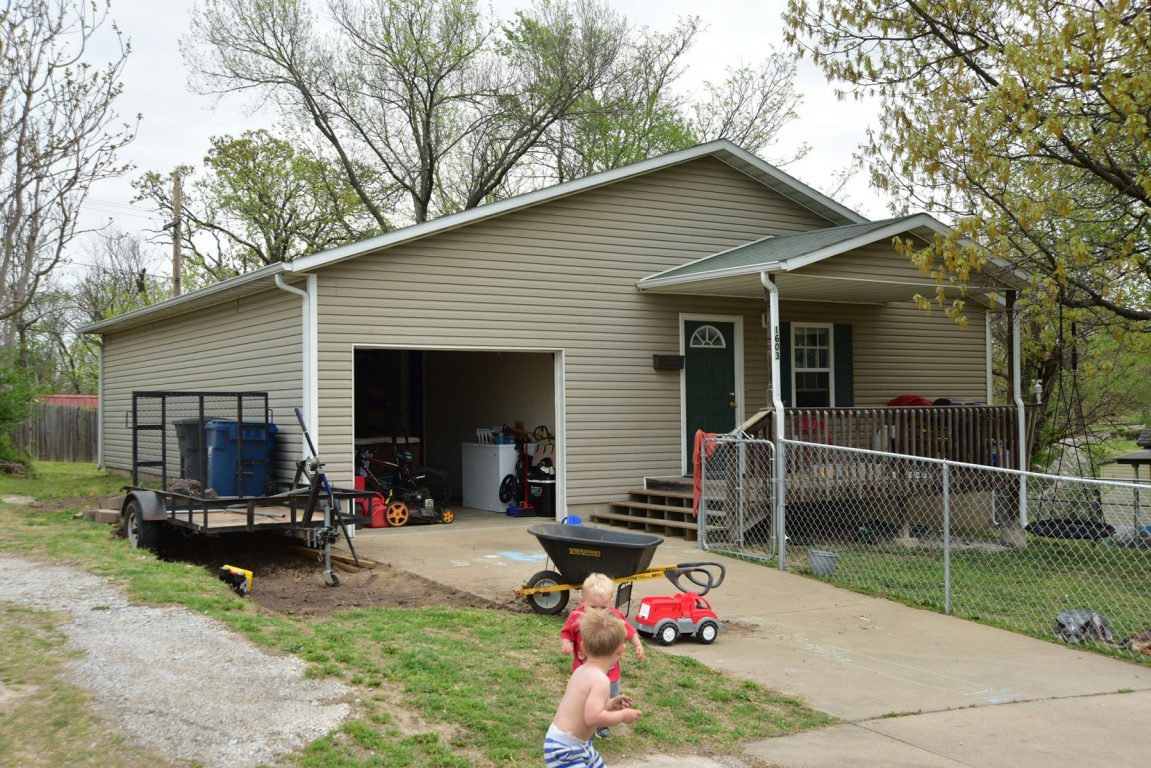
This bungaloid dwelling faces south and has a square footprint. It has a concrete masonry unit foundation, vinyl cladding, and asphalt shingle roof. The dwelling is three bays wide and three days deep. A front-gable porch shelters the east two bays. An overhead garage door occupies the west bay. The door was not visible at the time of survey. A fiberglass door occupies the center bay while a six-over-six vinyl window occupies the east bay.
