MISSOURI DEPARTMENT OF NATURAL RESOURCES
STATE HISTORIC PRESERVATION OFFICE, P.O. Box 176, Jefferson City, MO 65102
ARCHITECTURAL/HISTORIC INVENTORY FORM

1. Survey number: JP-AS-006-260		2. Survey Name: East Town (Original Joplin) Historic Survey Phase 1	
3. County: JASPER		4. Address 1506	Street (name): E. North Street
5. City: Joplin	Vicinity <input type="checkbox"/>	7. Township/Range/Section: T: R: S:	
8. Historic name (if known):		9. Present/other name (if known):	
10. Ownership: <input checked="" type="checkbox"/> Private <input type="checkbox"/> Public		11a. Historic use (if known): Domestic/Single Dwelling	11b. Current use: Domestic/Single Dwelling

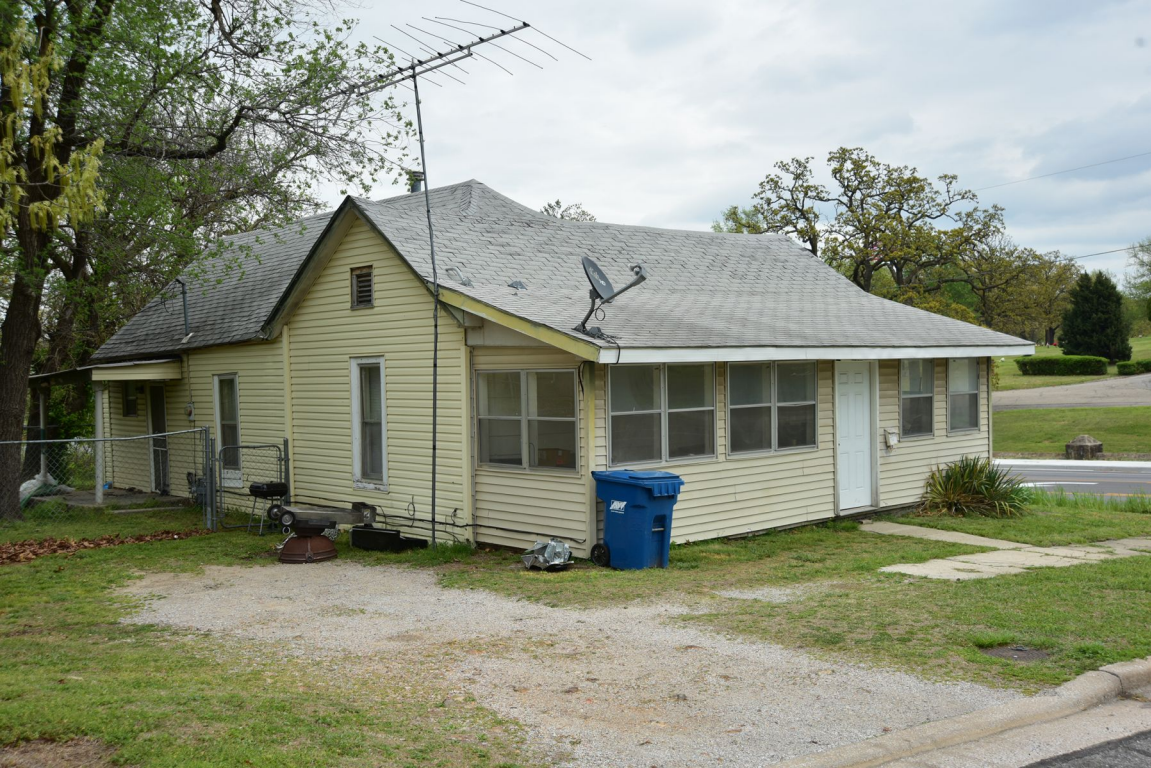
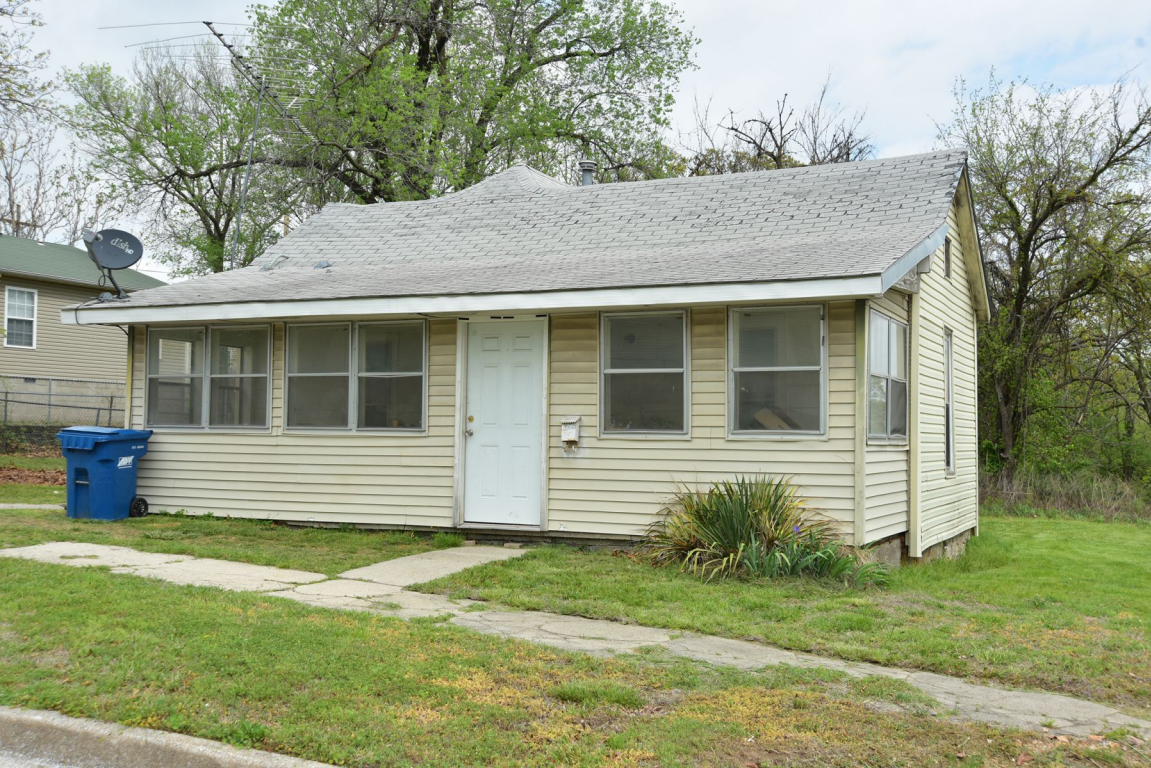
This National Folk House dwelling faces south and has an L-shaped footprint. It has a stucco foundation, vinyl cladding, and asphalt roof. An enclosed porch spans the primary elevation and is an alteration. It is five bays wide. Paired, one-over-one metal windows occupy the first and second bays while a non-historic wood door occupies the center bay. One-over-one metal windows fill the remaining bays. One-over-one wood windows remain at the secondary elevations and historic wood louvers are located in the east and west gable ends. A shed roof porch shelters a secondary elevation at the west elevation.

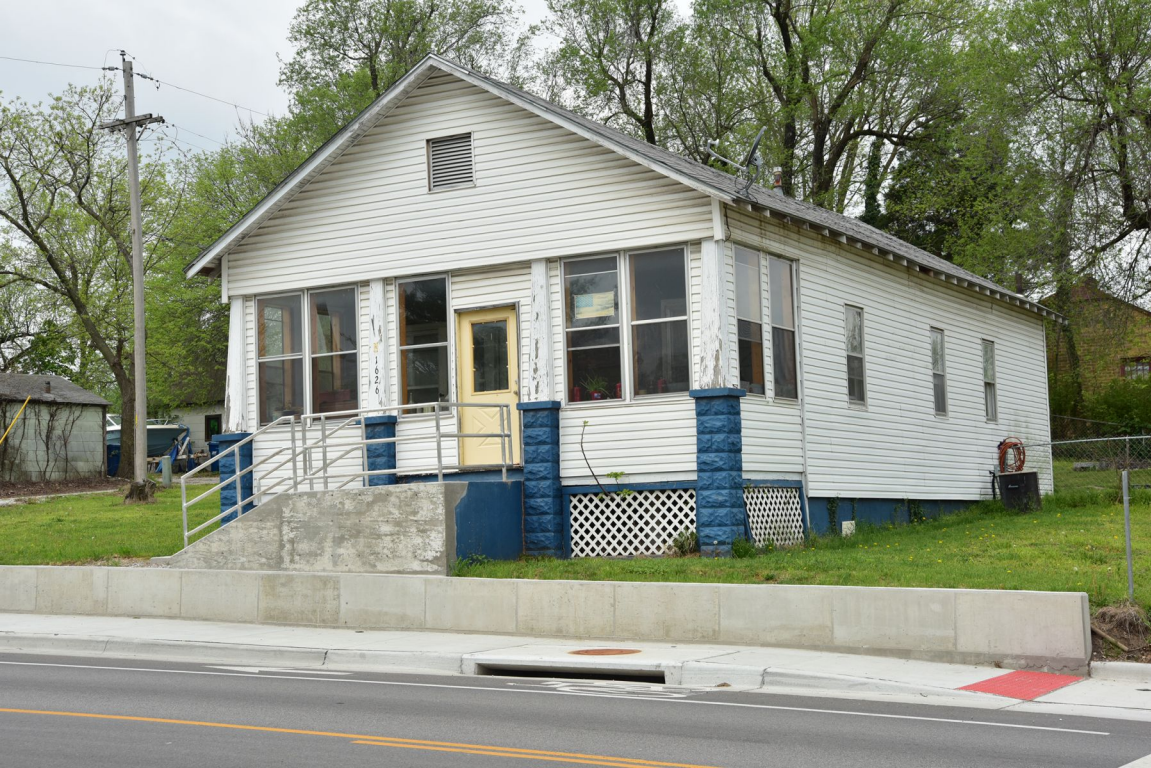
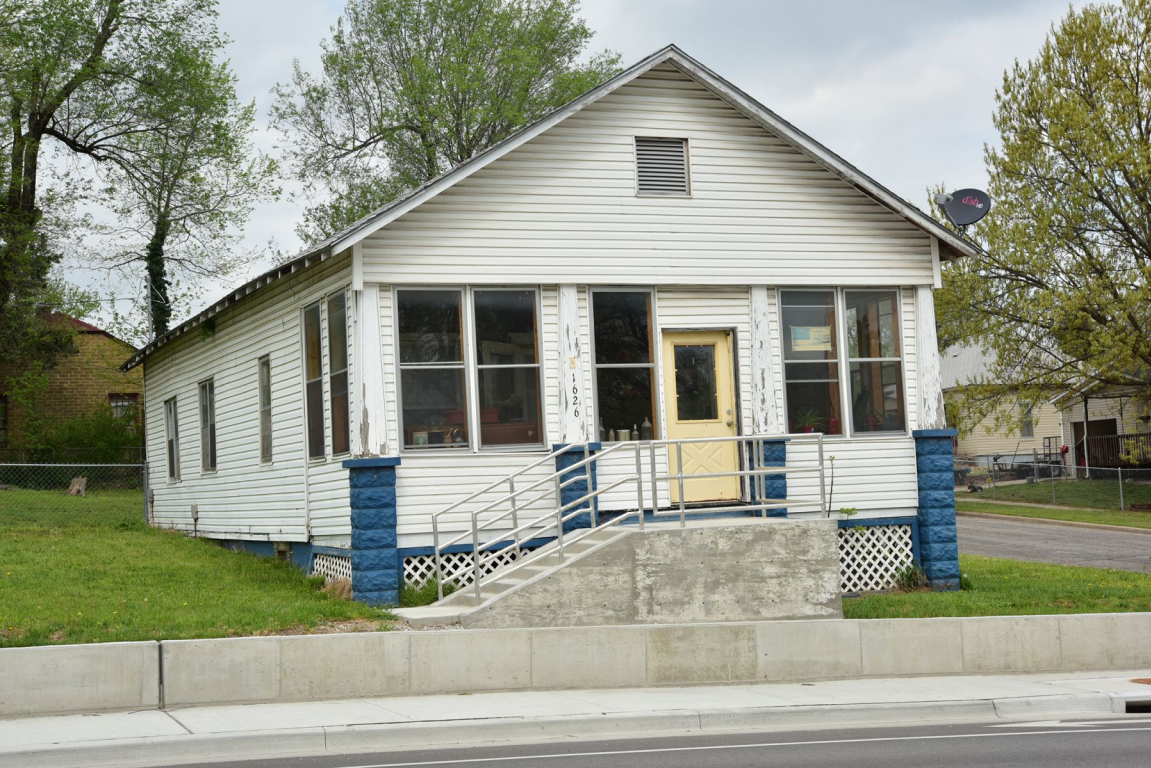
This bungalow dwelling faces east and has a rectangular footprint. It has a parged foundation and vinyl cladding. The front-gable roof has asphalt shingles and exposed rafter tails. An enclosed porch spans the primary elevation. The porch enclosure is an alteration. It is three bays wide. Historic tapered wood columns on concrete block piers delineate the bays. The center bay includes a non-historic wood door with one-light glazing. A one-over-one metal window sits to the right of the door. Vinyl infill fills the rest of the bay. Paired one-over-one metal windows and vinyl infill occupy the first and third bays. A modern concrete ramp with metal railings abuts the enclosed porch.

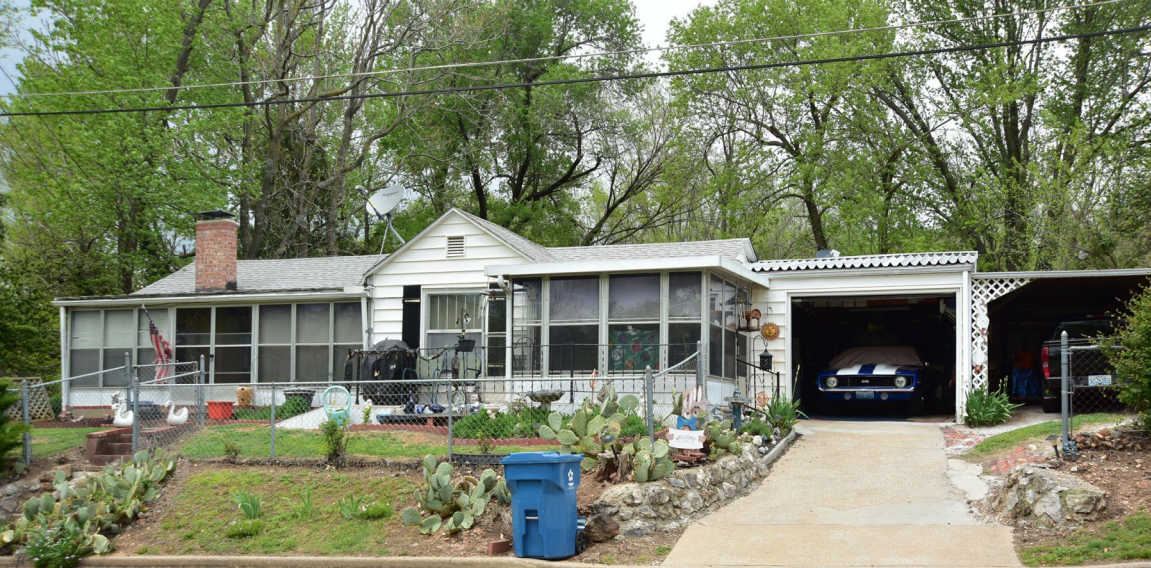
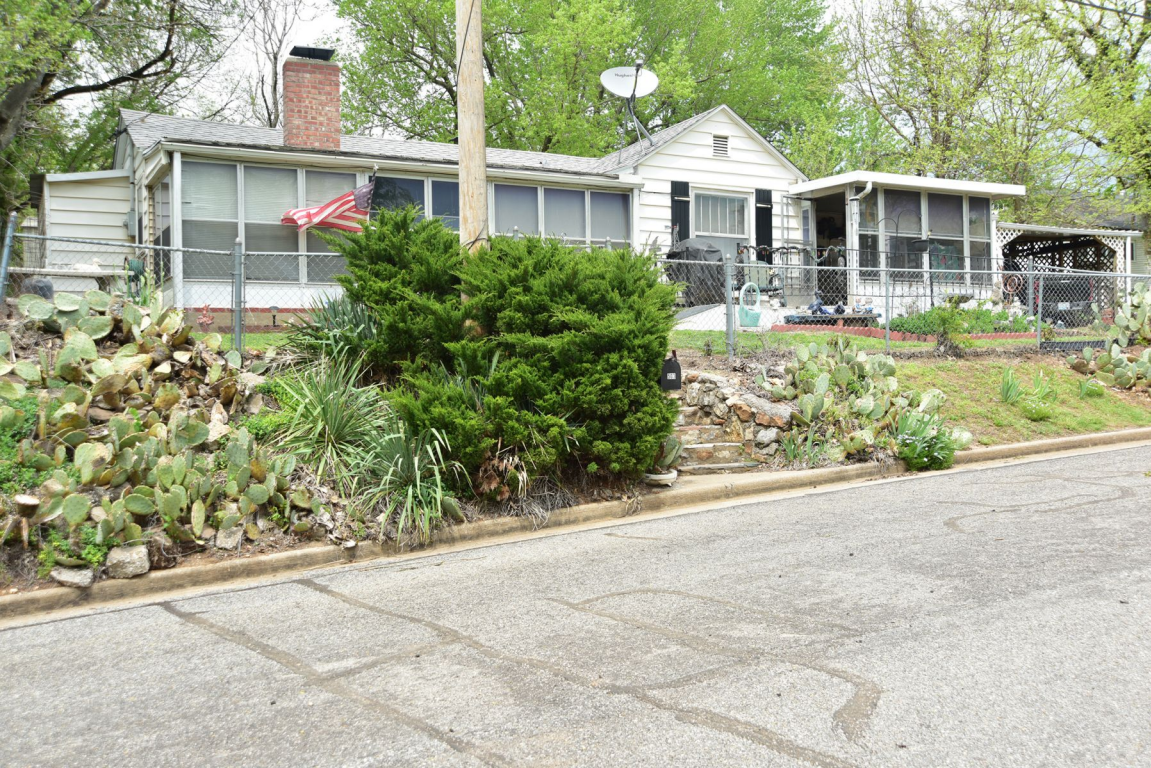
This Ranch dwelling faces south and has an irregular footprint. It has metal cladding and an asphalt shingle roof. The foundation is not visible. A broad brick chimney pierces the roof at the west end of the primary elevation. The dwelling is four bays wide. Enclosed porches define the first (west) and third bays. The enclosed portions are an alteration. The first bay features a band of eight one-over-one metal windows. A historic six-over-one wood window with false shutters occupies the center bay. A flat-roof enclosed porch with a continuous band of one-over-one metal windows projects from the elevation and defines the third bay. A single-car garage with a corrugated metal roof occupies the fourth bay. A frame carport projects from the east elevation.
