MISSOURI DEPARTMENT OF NATURAL RESOURCES
STATE HISTORIC PRESERVATION OFFICE, P.O. Box 176, Jefferson City, MO 65102
ARCHITECTURAL/HISTORIC INVENTORY FORM

1. Survey No. JA-AS-092-001		2. Survey name: 3100 Block of Troost Avenue 2019	
3. County: Jackson		4. Address (Street No.) 3100	Street (name) Troost Avenue
5. City: Kansas City	Vicinity: <input type="checkbox"/>	6. Geographical Reference:	7. Township/Range/Section: T: R: S:
8. Historic name (if known): Wirthman Building		9. Present/other name (if known):	
10. Ownership: <input checked="" type="checkbox"/> Private <input type="checkbox"/> Public		11a. Historic use (if known): Commerce/Trade: Business	11b. Current use: Landscape-Parking Lot

1. Survey No. JA-AS-092-002		2. Survey name: 3100 Block of Troost Avenue 2019	
3. County: Jackson		4. Address (Street No.) 3101	Street (name) Troost Avenue
5. City: Kansas City	Vicinity: <input type="checkbox"/>	6. Geographical Reference:	7. Township/Range/Section: T: R: S:
8. Historic name (if known): Westover Building		9. Present/other name (if known):	
10. Ownership: <input checked="" type="checkbox"/> Private <input type="checkbox"/> Public		11a. Historic use (if known): Commerce/Trade: Bus

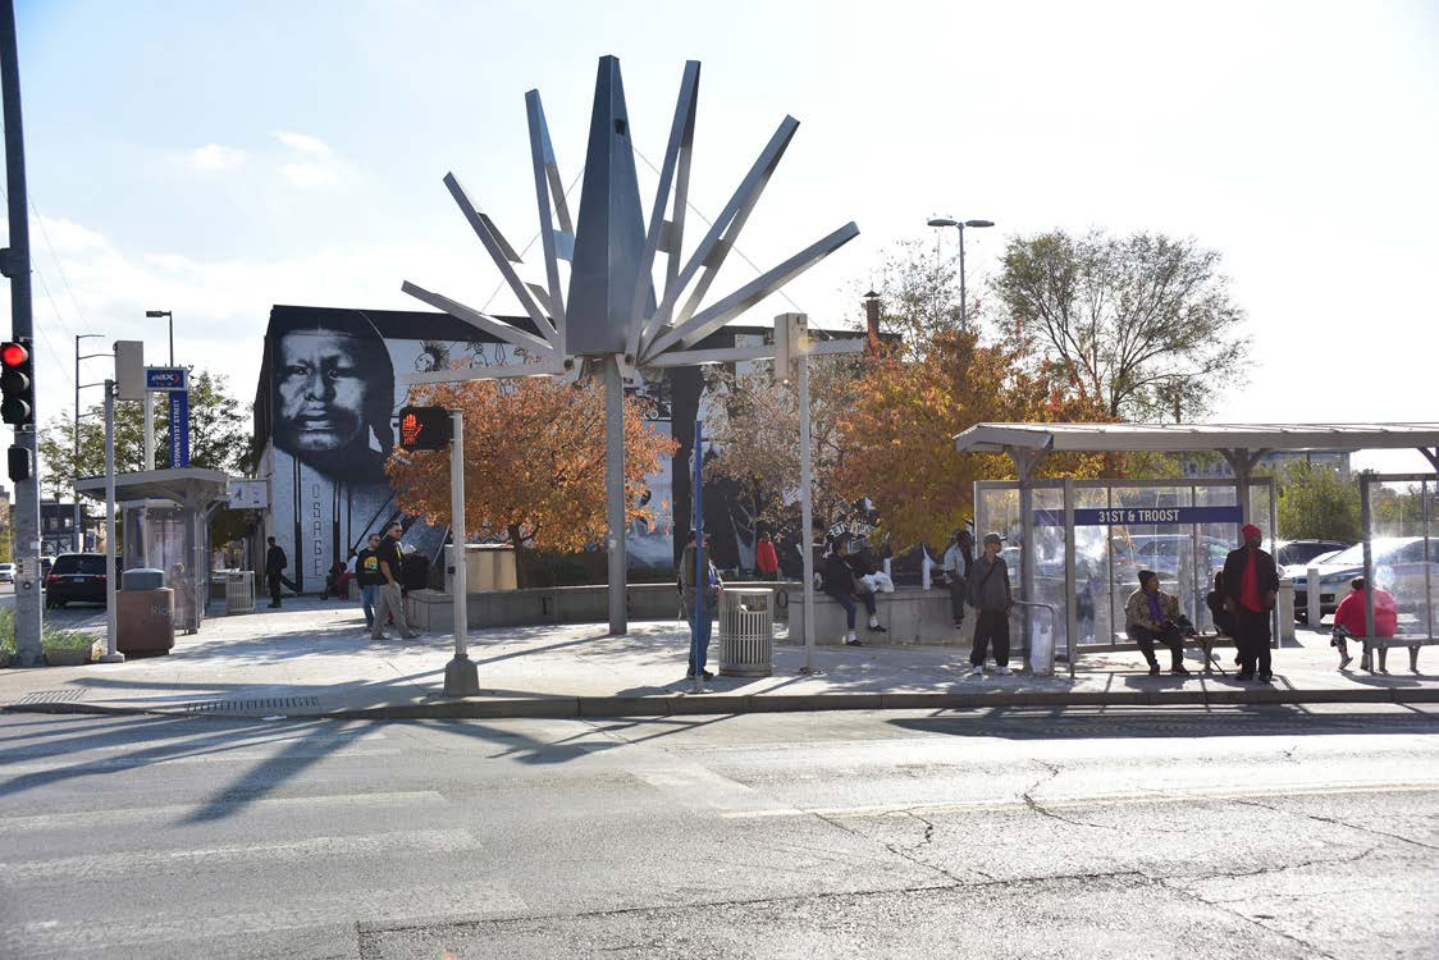
3100 Troost Avenue is a paved surface parking lot on a corner lot. Non-historic bus shelters line the east edge which fronts Troost Avenue, and the north corner. Low concrete walls separate the parking lot from the bus shelters and public sidewalk. A large, non-historic metal art piece occupies the northeast corner of the parcel.

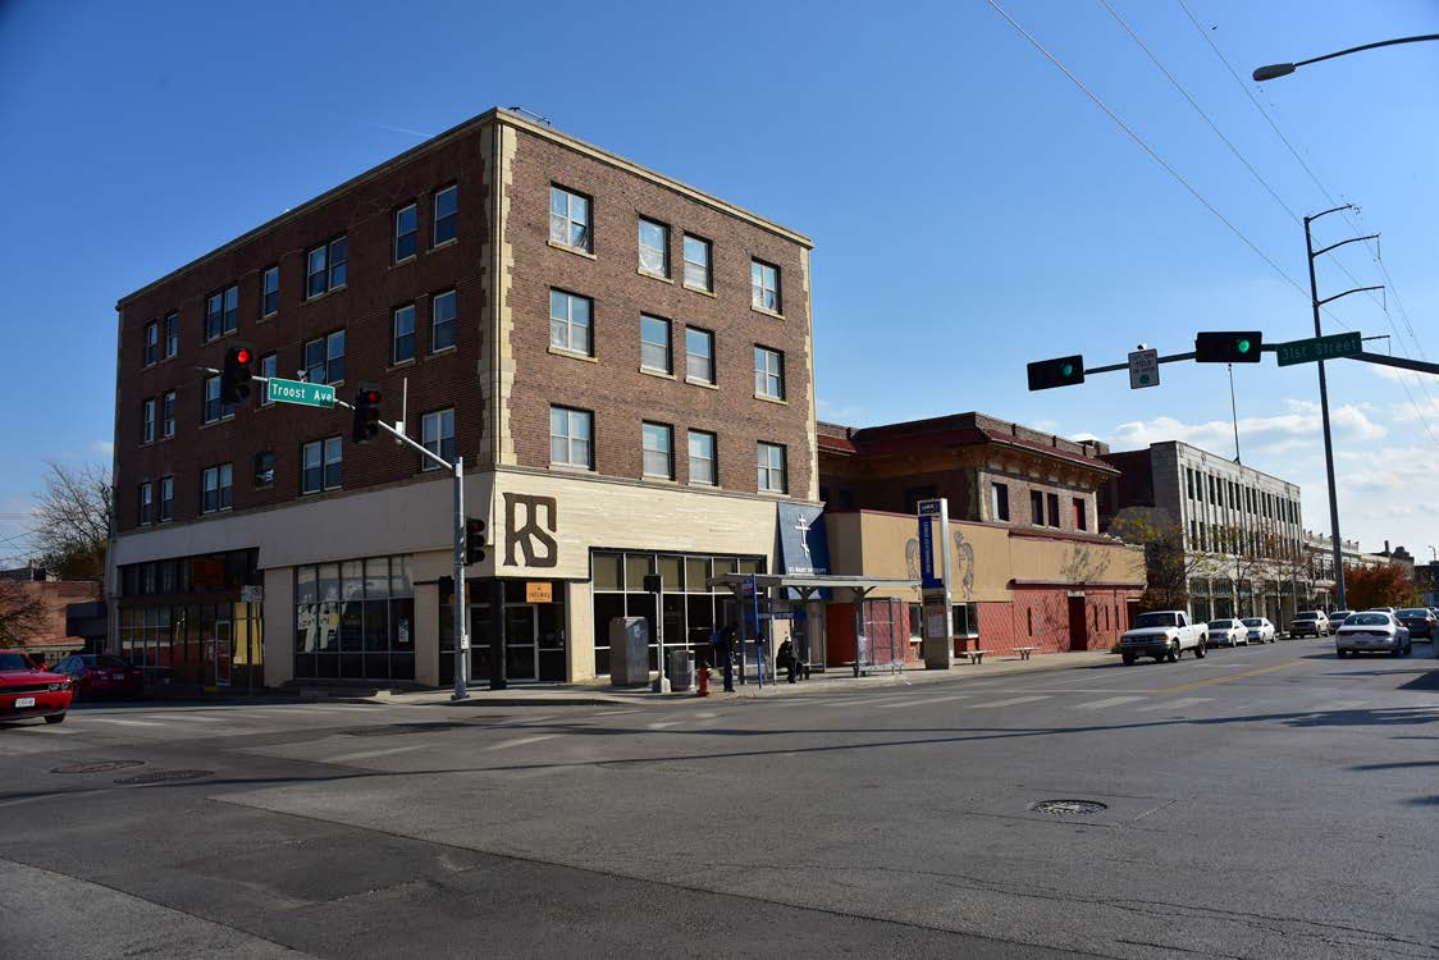
The Westover Building is a four-story two-part commercial block with a flat roof and brick cladding. An elevator doghouse is centered on the south edge of the roof. The first story is clad with non-historic painted wood sheathing. A terra cotta stringcourse divides the first and upper stories. Terra cotta quoins accent the corners above the strong course. A simple terra cotta cornice and concrete cap accent the roofline. The northwest corner is canted and contains the primary entrance. A non-historic anodized aluminum storefront system with paired doors occupies the entrance. The canted entrance is slightly recessed and round pillar supports the overhang. Large non-historic anodized aluminum fifteen-light display windows flank the corner entrance and pierce the north and west elevations. A secondary pedestrian entrance pierces the first story at the south end of the west elevation. A large ten-part storefront occupies the east half of the north elevation. The east-five parts are non-historic anodized aluminum while the west ten are painted with a slightly different pane sizes. Seven pairs of eight-light historic wood windows are located above. A narrow, asphalt-clad awning separates the historic windows from the storefront below. Regularly punched fenestration characterizes the upper stories. Four asymmetrical bays organize the west elevation. The outer two bays contain paired 1/1 windows with wide mullions with the center two bays are single 1/1 windows. Five asymmetrical bays organize the north elevation upper stories. The bays contain single and paired 1/1 windows. the windows are non-historic aluminum with historic terra cotta sills. Most windows have non-historic aluminum storm windows. A small, one-story formed painted masonry building with a flat roof extends from the rear. A pedestrian entrance pierces the north elevation. The ell is located on the adjacent irregularly shaped parcel and connects to the adjacent building at 3105-3109 Troost Avenue. It does not appear historically related to the Westover Building. It is unknown if an interior connection exists or if the ell and Westover Building are currently related.

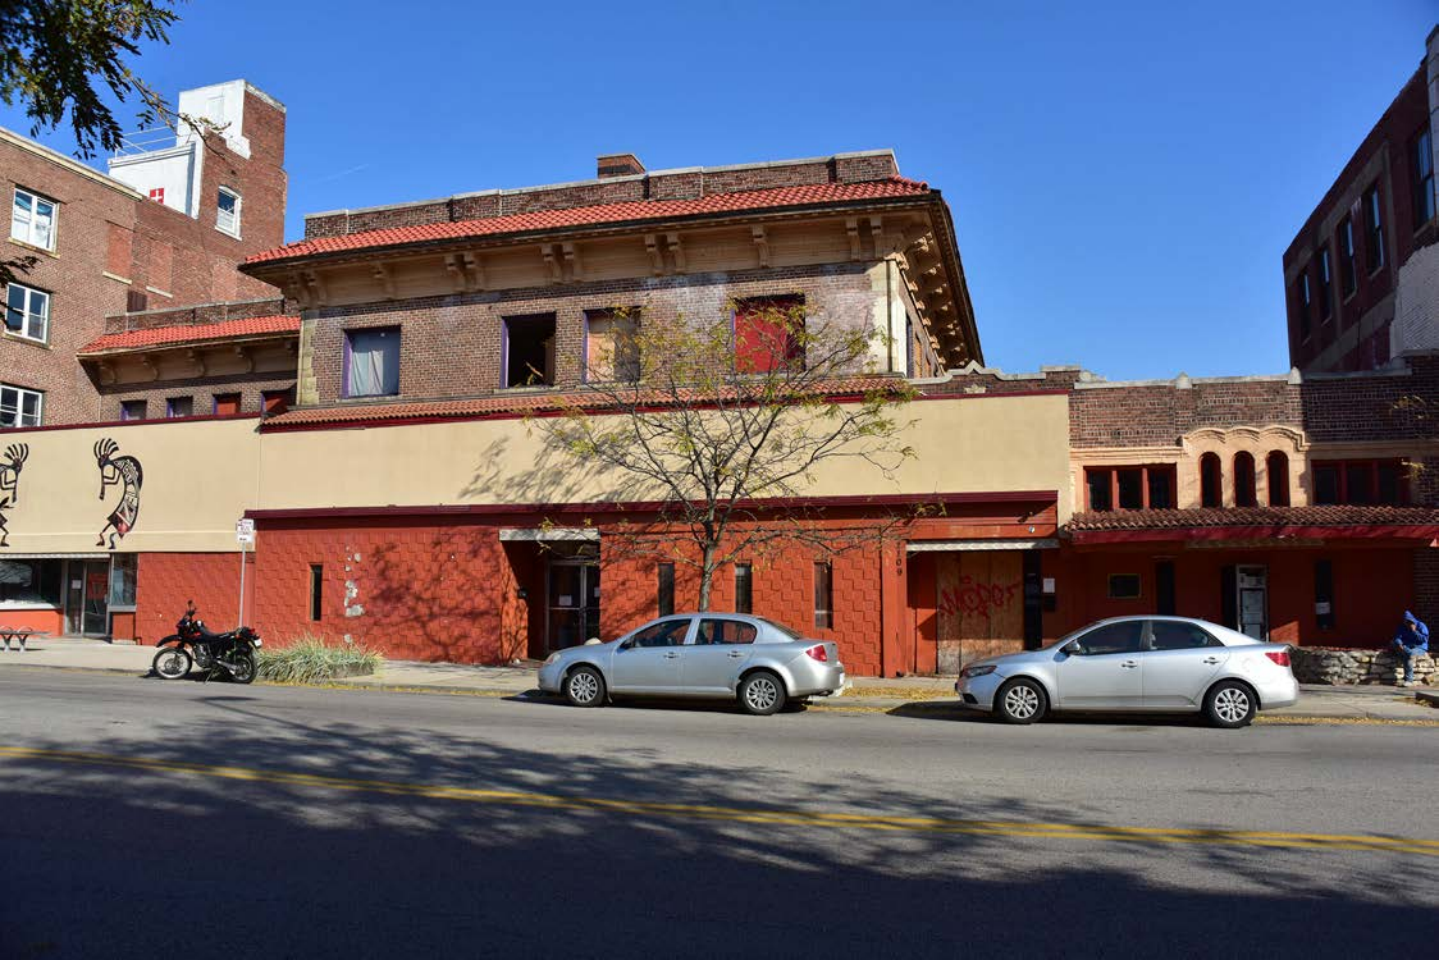
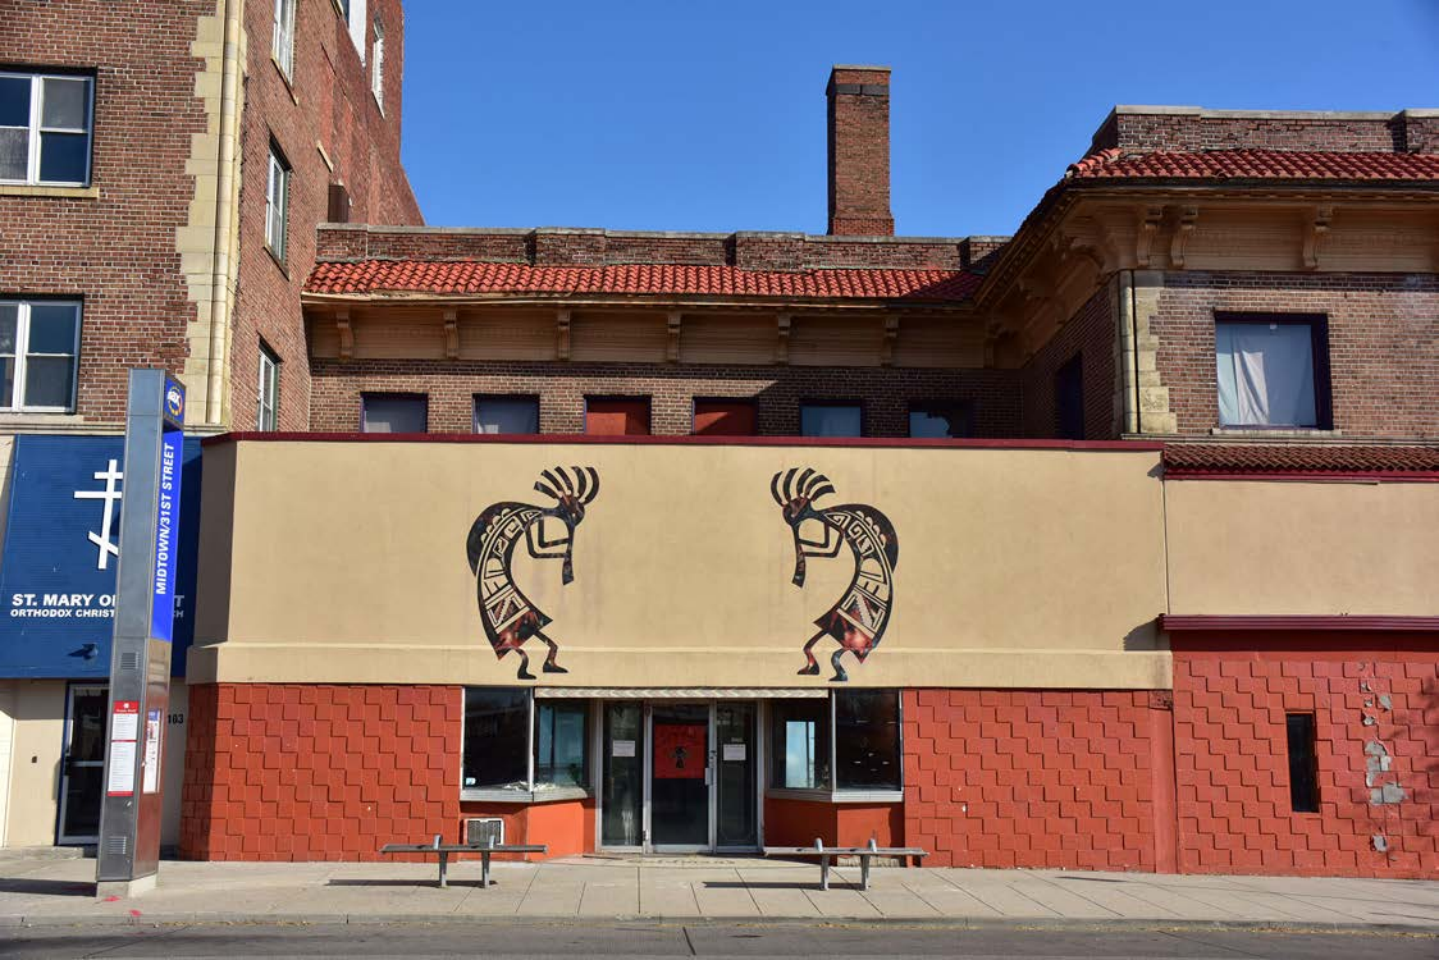
3105-3109 is a two-story Italianate building with an irregular plan, brick cladding, and mansard roof. A brick parapet encircles the center portion of the roof while the wide eaves are tile. A wide frieze with egg and dart molding, brackets, and modillions accents the eaves. The north third of the building recedes dramatically. A one-story addition with a flat roof fills the recession. Concrete in a textured checkerboard pattern clads the lower half while EFIS clads the top half. A mid-century storefront with a recessed entrance is centered on the addition and defines the first primary elevation bay. The entrance contains an anodized aluminum door with glazing and sidelights. Stucco-clad angled bulwarks flank the entrance and support large single-pane fixed display windows. The textured concrete and EFIS cladding continue onto the center block and enclose a former porch. The enclosed porch contains the next five bays. A recessed entrance with paired anodized aluminum doors with glazing defines the third-from-north bay. Narrow, rectangular fixed metal windows define the second and fourth through sixth bays. A 1923 one and one-half-story brick ell contains the south five bays. Much of the original primary elevation has been obscured through cladding alterations. The porch enclosure continues onto the ell to form a recessed storefront. The doorway is boarded and only a non-historic single-pane sidelight is visible. The storefront defines the seventh bay. A small, square fixed window defines the eighth bay. A pedestrian entrance defines the tenth bay and contains an anodized aluminum door with glazing. Narrow, rectangular fixed windows define the remaining two bays. A tile awning shelters the south four bays and abuts nine, narrow window bays above. The center three are arched while the outer six are rectangular. The first and third window bays contain historic none-light windows. The remaining bays contain fixed single-pane windows that appear non-historic. Eroded terra cotta pilasters, arches, and pronounced trim accent the window bays. The ell wraps around the two-story block at the rear. Ten window bays organize the second story of the two-story block. Most windows are absent or boarded. Non-historic single-pane fixed windows fill approximately one-half of the second-story bays.

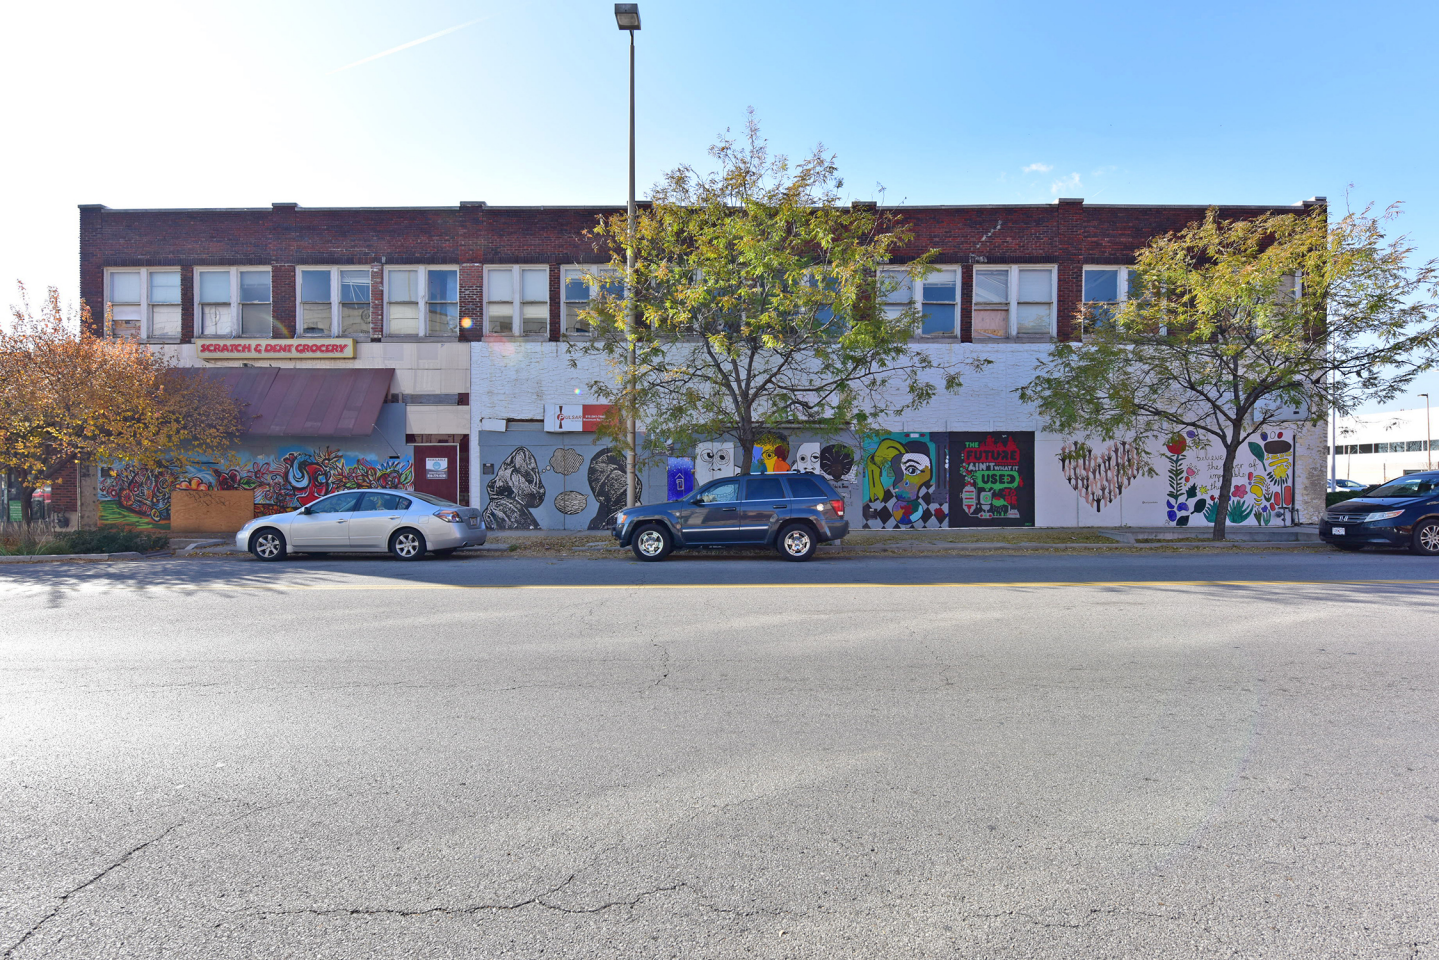
The Bradford Building was constructed c. 1922 and initially advertised space for a drug store. In 1925 tenants included a music store, florists, candy shop, restaurant, and photography studio. A fire destroyed the second story and many first-story storefronts in 1959. Several retail shops and offices occupied the building at that time. The first-story storefronts and second-story windows likely date to this period in association with repairs following the fire. City building permits for \$90,000 to "repair fire damage to business building" were issued June 25, 1959.

The Bradford Building is a two-story, two-part commercial block building with a flat roof and brick cladding. Non-historic stucco and architectural glass clad the first story. Six mid-century storefronts organize the first story. Plywood boards with painted murals cover the store fronts, however the mid-century storefronts remain intact behind the boards. The storefronts are deeply recessed. Anodized aluminum frames contain large single pane display windows in similar configurations. Single or paired anodized aluminum doors with glazing and transoms access the interior at each storefront. Brick pilasters define the second-story bays. Each second-story bay contains two sets of paired 1/1 historic wood windows with wide mullions and corresponds to a storefront below. The windows have concrete sills and a continuous soldier brick lintel spans each bay above the window openings. A narrow concrete cap lines the parapet at the primary and south elevations. Non-historic pressed wood sheeting covers the parapet at the north elevation. The north elevation was historically a party wall and thus lacks fenestration. A two-story ell with an irregular plan extends from the rear elevation at the south half. The date of construction is unknown; however, the ell appears in the 1925 City Atlas. A small, two-story addition with a square plan projects from the rear elevation at the north end. Building permits and the 1951 Sanborn Map indicate it was constructed c. 1950-1951. A third, two-story addition abuts this addition to the south and was constructed between 1951 and 1963.

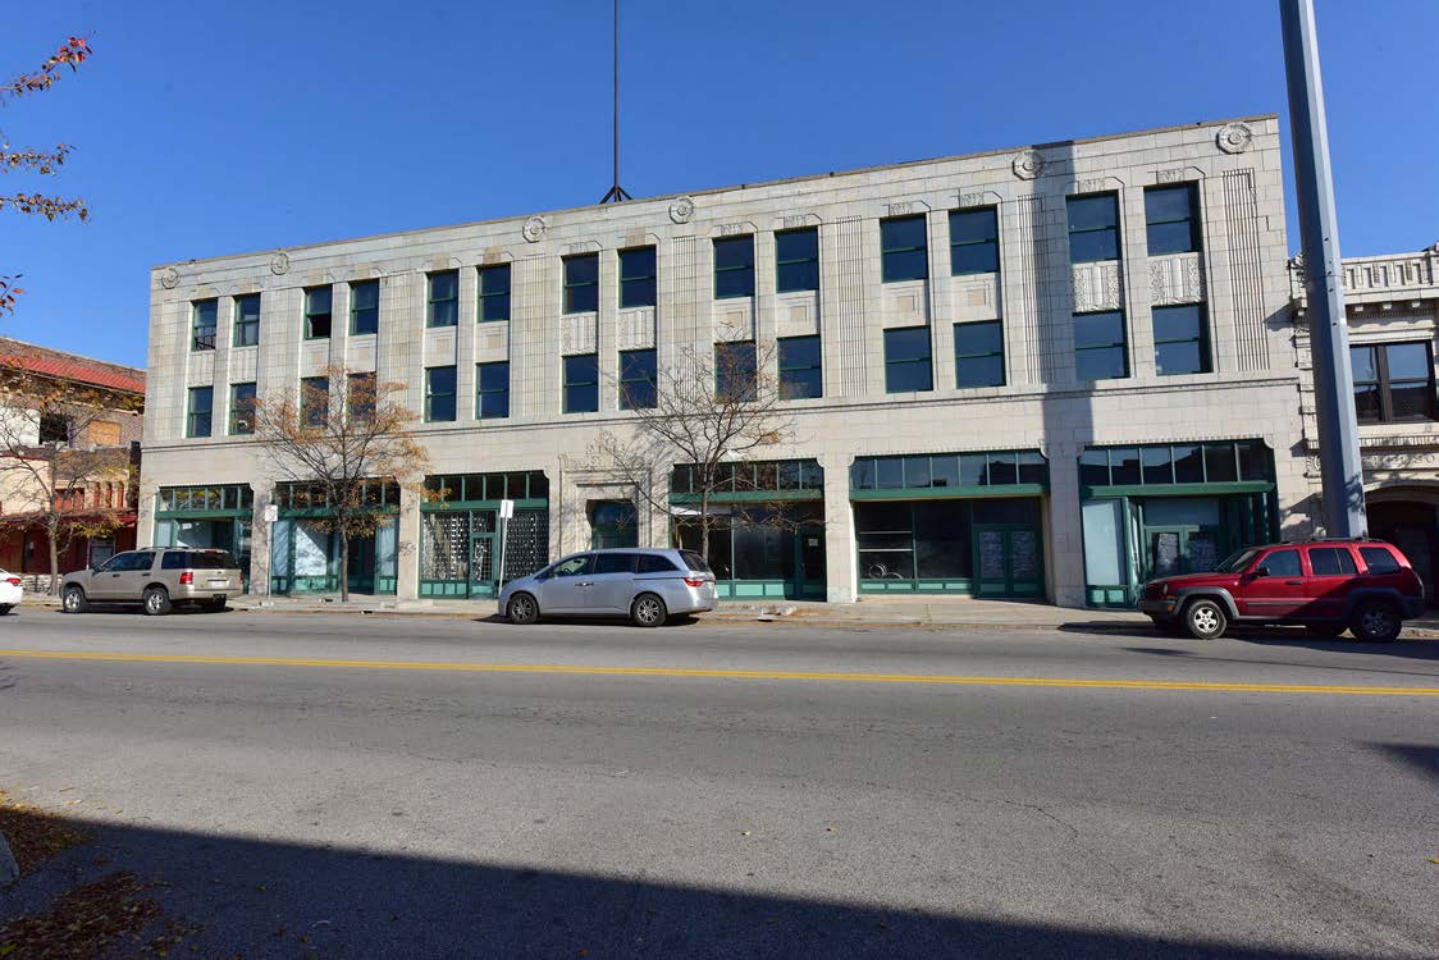
The Shankman Building at 3115-3123 Troost Avenue is a three-story Art Deco two-part commercial block. Terra cotta clads the primary elevation while brick clads the secondary elevations. Six storefronts flank a center entrance at the first floor. All excepting the third from north are recessed. The c. 1990 storefronts are non-historic; however, they fill historic openings. Elaborate terra cotta filigree and floral motifs accents the center entrance. Seven window bays organize the upper stories. Each bay contains two 1/1 non-historic windows. Spandrel panels separate the two upper stories. The outer two and center bay heavily spandrel panels are heavily ornamented with filigree while concentric square motif ornaments the remaining spandrels. Medallions and bas relief floral motif ornaments accent the third story bays and cornice. The Shankman Building was listed on the National Register of Historic Places, January 29, 2018 under Criterion C for Architecture and does not appear significantly altered since listing. See Spencer, Brenda and Michelle. "Shankman Building." National Register of Historic Places Registration Form. Spencer Preservation, Wamego, Kansas. January 29, 2018 for a complete description

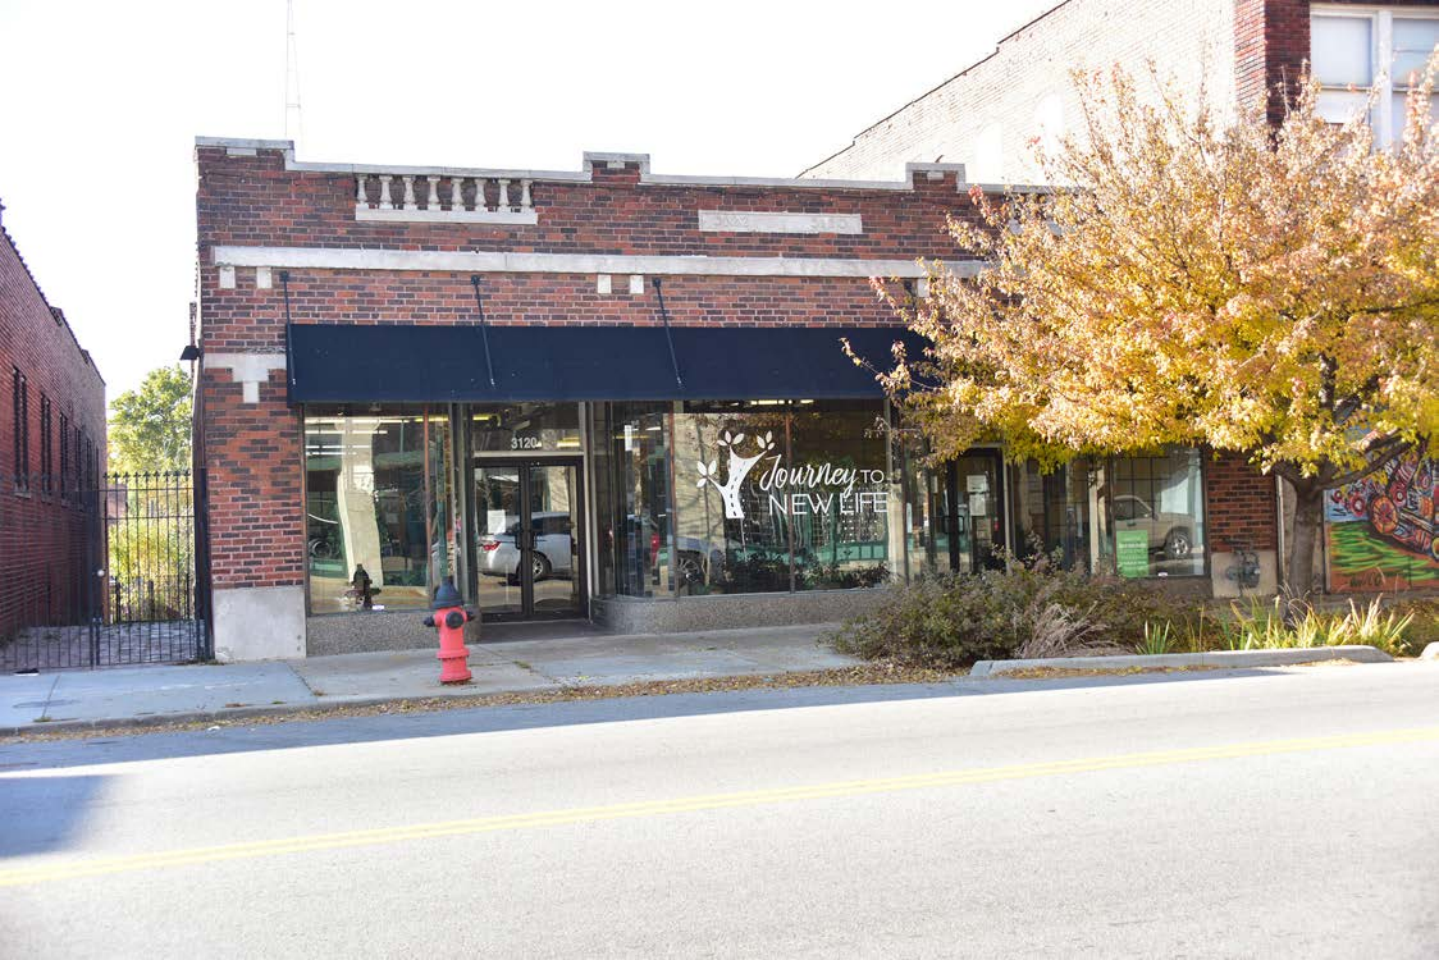
The F.W. Woolworth Building is a one-story, one-part commercial block with restrained neoclassical ornament at the parapet, cast stone stringcourse, and a crenellated parapet. Two storefronts organize the primary elevation. Each contains non-historic paired aluminum doors. Anodized aluminum fixed transoms top each doorway and are c. 1960 alterations. Bronze frames contain large single-glazed storefront windows with curved corners at each entrance. Narrow vertical panes form each corner. The storefronts sit on terrazzo-clad bulkheads. The F.W. Woolworth Building was listed on the National Register of Historic Places May 6, 2005. See Schwenk, Sally F. "F.W. Woolworth Building." National Register of Historic Places Registration Form. Historic Preservation Services, Inc. Kansas City, Missouri. May 6, 2006 for a detailed description. Alterations to the building since listing include replacement entrance doors, removal of one dividing strip in the south storefront window, and installation of an awning. The F.W. Woolworth Building does not appear significantly altered.

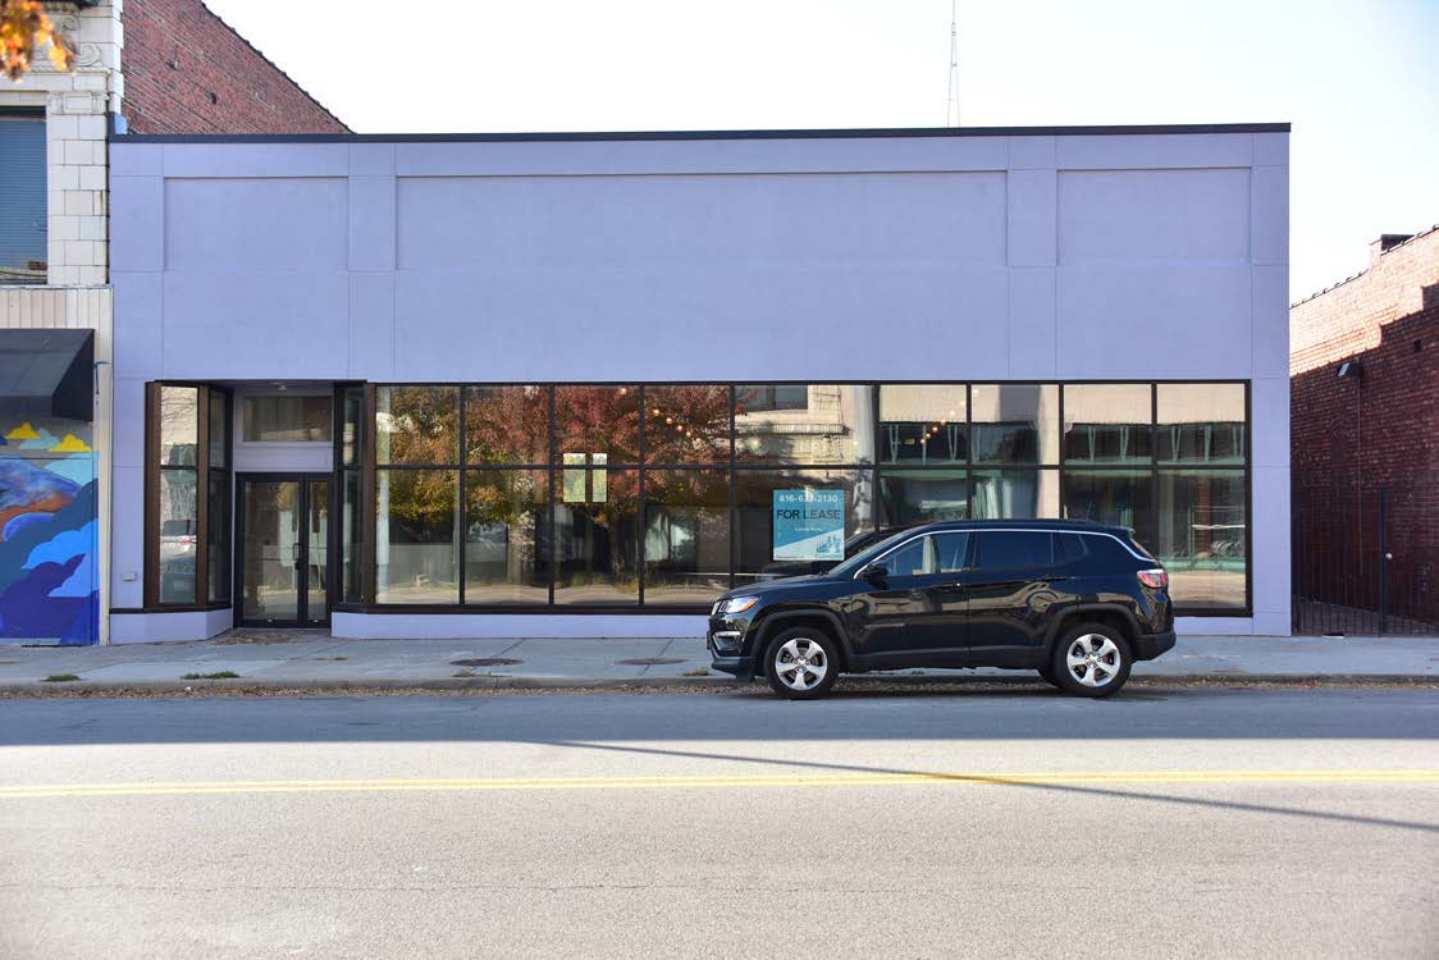
3124-3126 Troost Avenue is a one-story one-part commercial block with a flat roof and EFIS cladding at the primary elevation. Non-historic metal coping caps the primary elevation while tile coping lines the secondary elevations. The cladding is a c. 2019 alteration and was recently applied. A non-historic fourteen-part aluminum storefront spans the primary elevation and is an alteration dating to the same period. The entrance is recessed and composes the third storefront part. It contains a non-historic aluminum door with glazing and a single-pane sidelight. A historic, fixed wood transom window is located above. The transom corresponds to a second storefront historically present at that location. Recessed panels above the storefront visually divide the upper half of the elevation into three segments. The north elevation retains historic brick cladding and regular punched fenestration pierces the elevation. A permit for \$4000 was issued to S.S. Kresge Co. and builder J. Killwortm in 1935 to construct a steel and brick addition. The non-historic cladding obscures the addition.

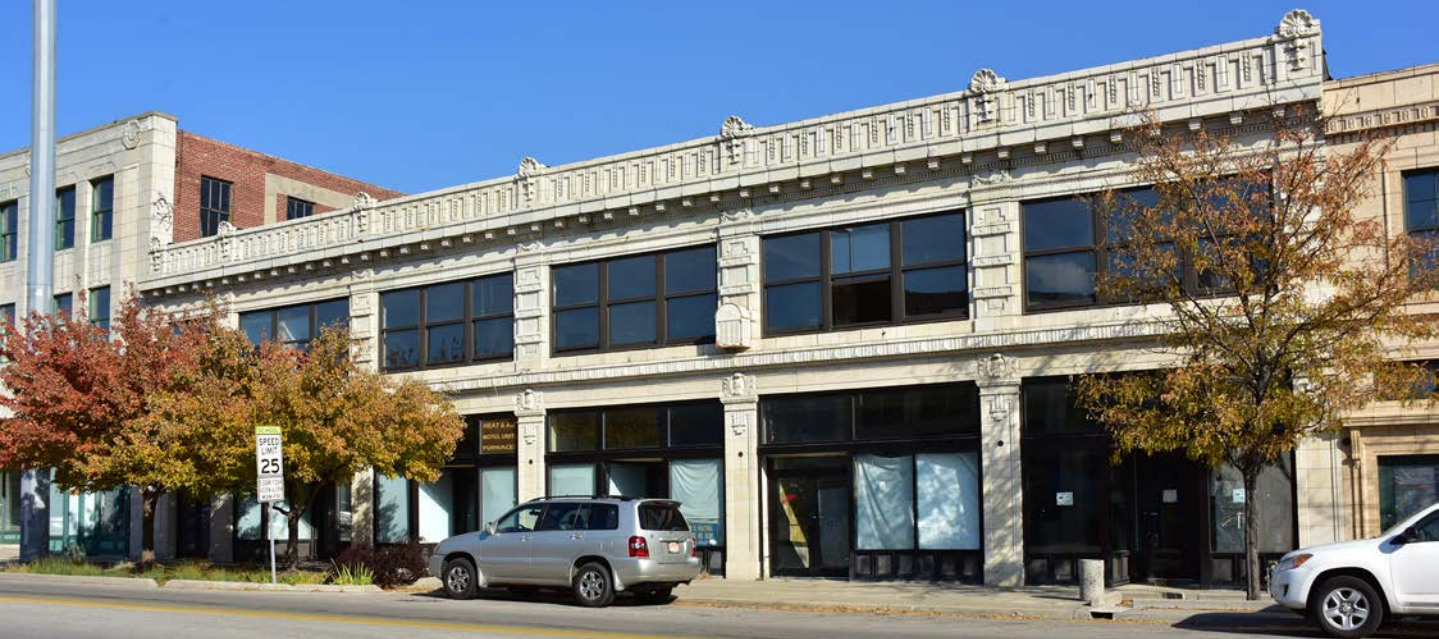
The Michelson Building is a two-story two-part commercial block with a flat roof and terra cotta cladding. Six bays organize the first story. A pedestrian entrance defines the north bay. It contains paired, non-historic aluminum doors with a fixed transom and accesses a stairway to the second story. Non-historic aluminum storefronts define the south six bays. Three-ganged non-historic 1/1 aluminum windows define the upper story bays which are in line with the storefront. Paired 1/1 matching windows define the north bay directly above the pedestrian entrance. The store fronts, pedestrian entrance doors, and second-story windows are c. 1990 alterations. Although alterations, they fill historic openings. Terra cotta cladding ornamented with Beaux Arts Classicism and Art Deco inspired motifs characterizes the design at both stories. An elaborately ornamented cornice spans the primary elevation only. The Michelson Building was listed on the National Register of Historic Places January 29, 2018. It does not appear altered since listing. See Spencer, Brenda and Michelle. "Michelson Building." National Register of Historic Places Registration Form. Spencer Preservation, Wamego, Kansas. January 29, 2018 for a detailed description.

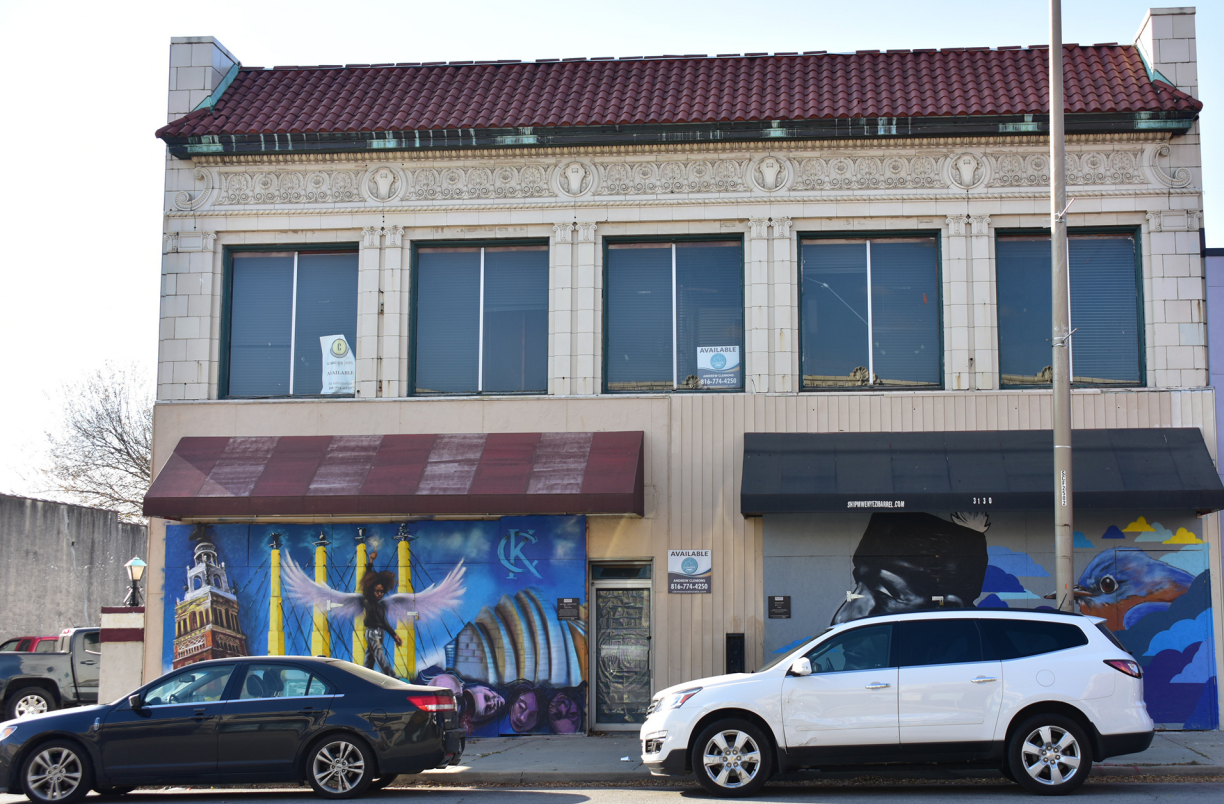
Alterations to the Grimme Building include replacement storefronts, second-story windows, and the application of stucco panel and wood cladding at the first story. The south storefront is a historic alteration. Tax Assessor photographs suggest the storefront post-dates 1939. The north storefront is a c. 2014 non-historic alteration. While non-historic, it fills the historic opening and retains mid-century tile walls. Vertical muntins were applied to the second-story windows between 1980 and 2014. Although non-historic, the muntins divide non-historic single-pane windows to create a configuration more complimentary to the historic configuration. While non-historic cladding is applied to the first story, the second story retains historic terra cotta cladding and Beaux Arts ornament. The Grimme Building retains its historic form, character-defining terra cotta ornament, distinctive south storefront, much historic material. Consequently, the Grimme Building retains good integrity. This resource would be contributing resource to the potential 3100 Block of Troost Avenue historic district. The district is eligible for listing under Criterion A in the area of Commerce as the remaining intact block of the historic commercial corridor and represents a period of transition from residential to commercial development in the block. The period of significance is 1908-1970, capturing the beginning of commercial development on the block through its decline.

The Grimme Building is a two-story Beaux Arts commercial block. Non-historic stucco panels and vertical pressed wood clad the south and north halves, respectively, of the primary elevation. Terra cotta clads the second story. The first story is two bays wide. Storefronts define the bays and are currently boarded, however they remain intact behind the plywood boards. The south storefront (3132) is a deeply recessed mid-century storefront. Distinctly curved, large, single pane display windows with aluminum frames flank a center entrance. Narrow aluminum muntins divide the windows. Concrete bulwarks support the display windows. The north bulwark rises several inches higher than the left and slightly truncates the display windows. Wide aluminum trim accents the display windows at the bottom edge. The center entrance contains an aluminum door with glazing and a wide horizontal muntin which contains the door handle. A narrow, fixed transom tops the door. Simple aluminum trim surrounds the door and transom. Large rectangular terrazzo tile flooring and synthetic ceiling tiles complete the storefront finishes. A recessed secondary entrance abuts the curved display windows to the north and contains an anodized aluminum door with glazing and a narrow, fixed transom. The north storefront (3130) is a four-part non-historic aluminum system. The entrance defines the south part and contains a door with glazing and large fixed transom. The north-three parts are large, single-pane fixed display windows. The storefront is recessed, and historic small-scale mid-century tile clads the recessed walls. Non-historic aluminum-framed fabric awnings shelter each storefront. Five bays organize the second story. Non-historic 1 by 1 fixed windows with narrow, vertical anodized aluminum muntins define the bays. Paired terra cotta pilasters with ornate capitals separate the bays. An elaborate frieze with an alternating floral motif, medallions, egg and dart and rope moldings, and curved bracket ends ornaments the primary elevation. A copper cornice tops the ornate frieze. Tile extends from the parapet to the cornice, visually mimicking a mansard roof.

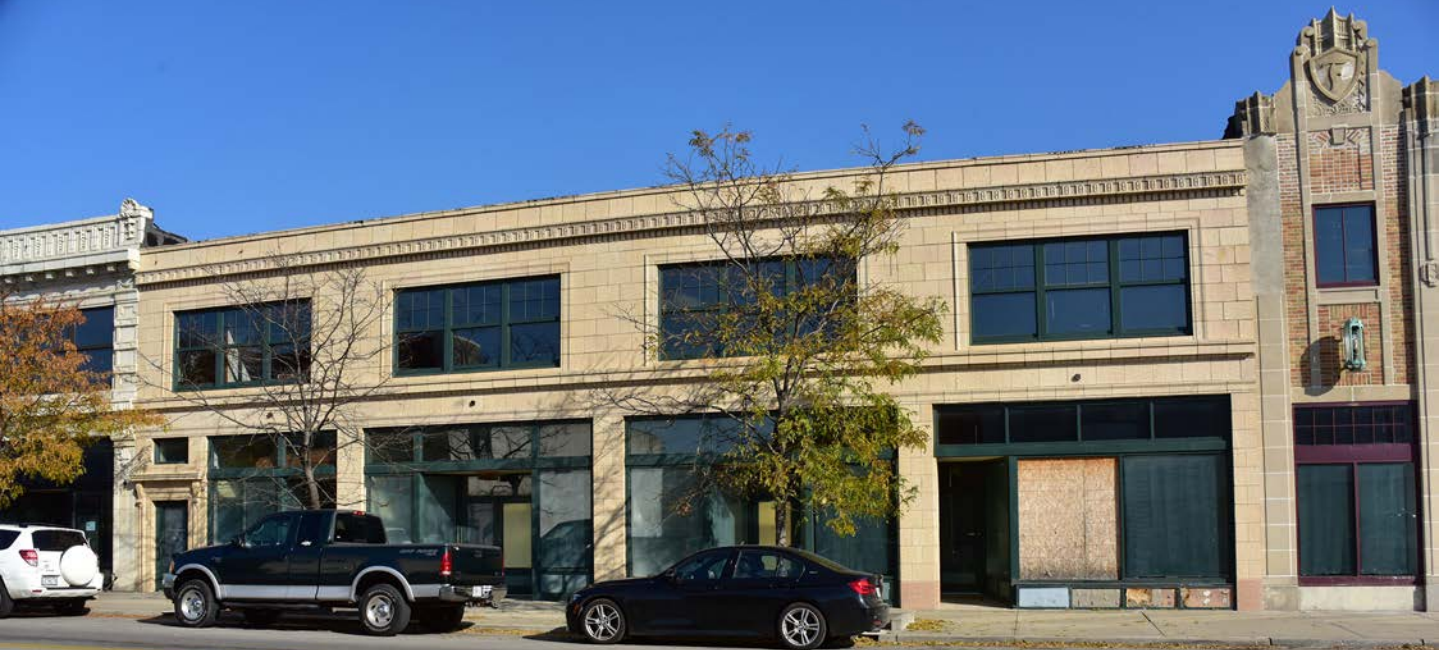
Alterations to the Harkness Building include c. 1990 non-historic windows and storefronts. While non-historic, they fill historic openings. The storefronts replace mid-century anodized-aluminum storefronts and mimic the historic configuration. The second-story windows replace glass block and brick infill installed 1966-67 and are complimentary in style to the building. The Harkness Building retains good integrity. This resource would be contributing resource to the potential 3100 Block of Troost Avenue historic district. The district is eligible for listing under Criterion A in the area of Commerce as the remaining intact block of the historic commercial corridor and represents a period of transition from residential to commercial development in the block. The period of significance is 1908-1970, capturing the beginning of commercial development on the block through its decline.

The Harkness building is a two-story, two-part commercial block with restrained neoclassical influences, a flat roof, and terra cotta cladding. Five bays organize the first story. A pedestrian entrance defines the first bay. It contains a non-historic aluminum door with glazing. Narrow pilasters flank the door and a simple entablature with classical brackets tops the entrance. A non-historic fixed transom pierces the elevation above the entablature. Non-historic aluminum storefronts define the remaining first-story bays. The storefronts are simple with large fixed display windows and fixed transoms. The entrances are deeply recessed. The center two storefronts have center entrances while the first and fourth storefront entrances are offset south and north, respectively. A terra cotta stringcourse bisects the building. Four bays organize the second story. Each bay contains three-ganged 6/1 non-historic aluminum windows. Simple terra cotta trim surrounds each bay. A narrow dentilled cornice spans the primary elevation.

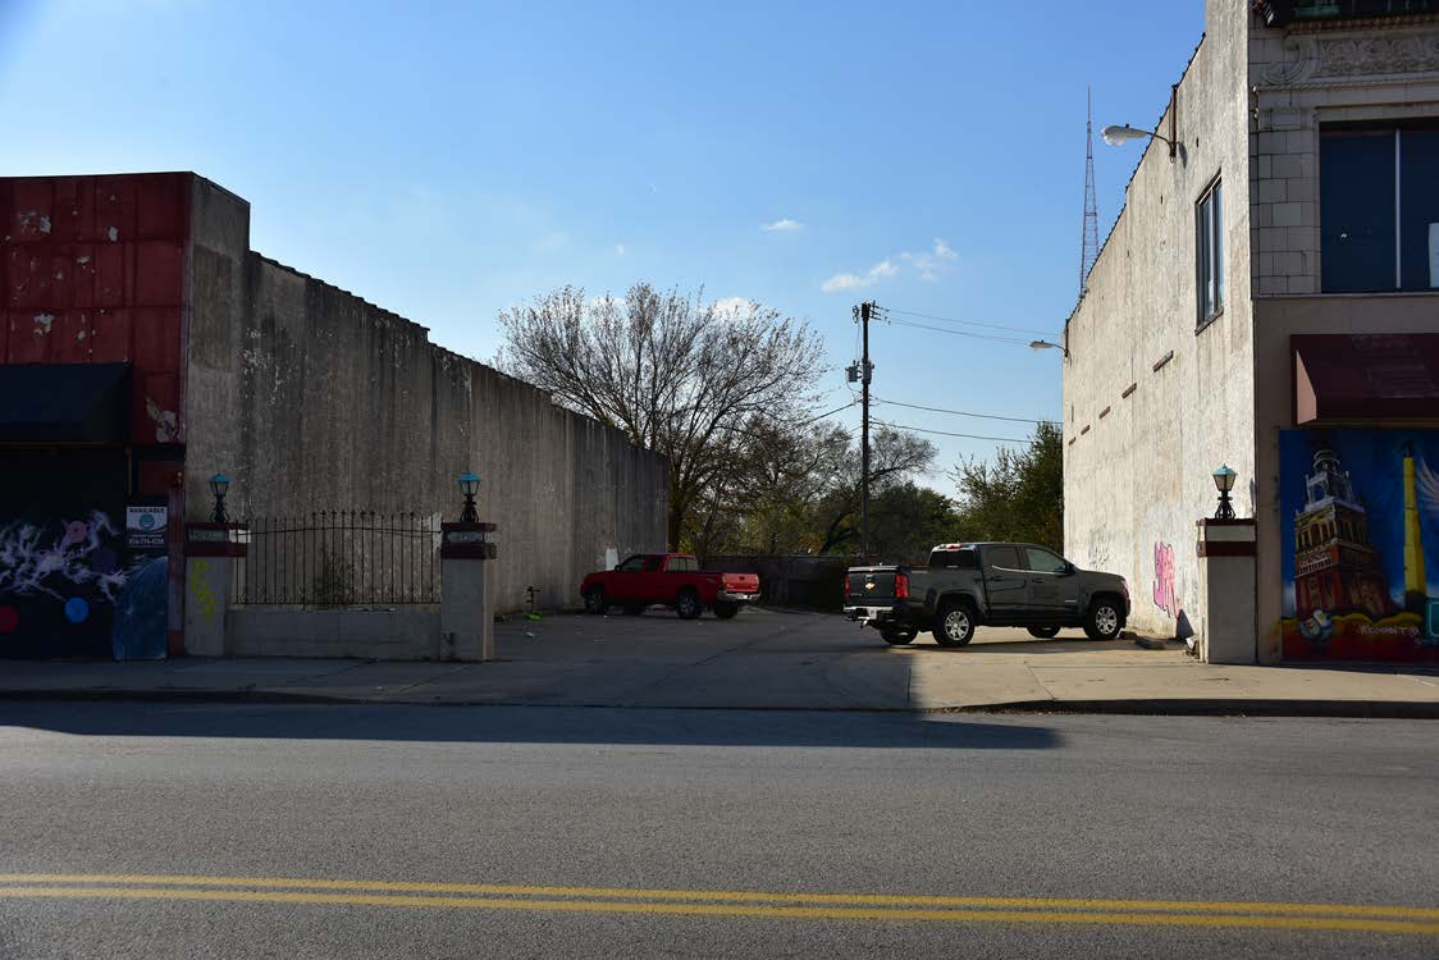
3136 Troost Avenue is a concrete paved surface parking lot. It is rectangular in plan. A curb cut access the parking lot at the east edge. A low concrete wall with concrete piers and metal fencing is located south of the curb cut and partially encloses the lot. A matching concrete pier is located at the northeast corner. The remaining portion of the north wall was demolished in 2019. Lanterns top all three concrete piers.

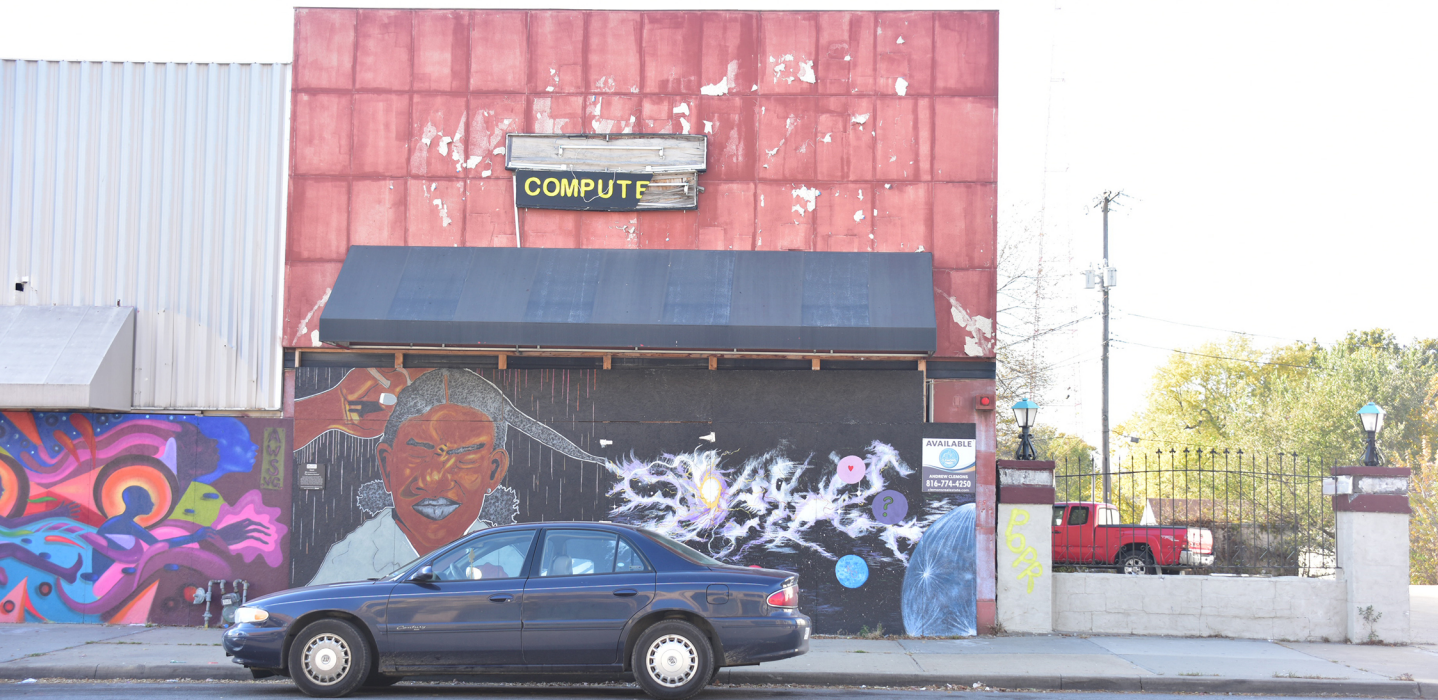
3142 Troost Avenue is a one-story one-part commercial block building. The roof is flat. The north parapet is stepped with tile coping. Non-historic stucco panels clad the primary elevation. A historic storefront is centered on the primary elevation. While the storefront is currently boarded, it remains intact. The storefront is deeply recessed and extends several feet. The storefront entrance contains a pair of anodized aluminum doors with glazing. A continuous sidelights and glazing system surround the doors. Large single-pane fixed display windows with fixed transoms flank the entrance. Elongated, aluminum framed display windows on low concrete bulwarks extend east from the entrance. Large single pane display windows with vertical muntins fill the north display window frame. The south frame glazing is absent. Historic metal trim accents the bulwarks below each window. Historic recessed circular lighting extends the length of each display window. Terrazzo flooring and synthetic ceiling tiles complete the storefront finishes. A non-historic aluminum-framed fabric awning shelters the storefront. Non-historic stucco clads the north elevation. This elevation was historically a party wall and thus lacks fenestration.
