MISSOURI DEPARTMENT OF NATURAL RESOURCES
STATE HISTORIC PRESERVATION OFFICE, P.O. Box 176, Jefferson City, MO 65102
ARCHITECTURAL/HISTORIC INVENTORY FORM

1. Survey No. JA-AS-092-001		2. Survey name: 3100 Block of Troost Avenue 2019	
3. County: Jackson		4. Address (Street No.) 3100	Street (name) Troost Avenue
5. City: Kansas City	Vicinity: <input type="checkbox"/>	6. Geographical Reference:	7. Township/Range/Section: T: R: S:
8. Historic name (if known): Wirthman Building		9. Present/other name (if known):	
10. Ownership: <input checked="" type="checkbox"/> Private <input type="checkbox"/> Public		11a. Historic use (if known): Commerce/Trade: Business	11b. Current use: Landscape-Parking Lot

1. Survey No. JA-AS-092-002		2. Survey name: 3100 Block of Troost Avenue 2019	
3. County: Jackson		4. Address (Street No.) 3101	Street (name) Troost Avenue
5. City: Kansas City	Vicinity: <input type="checkbox"/>	6. Geographical Reference:	7. Township/Range/Section: T: R: S:
8. Historic name (if known): Westover Building		9. Present/other name (if known):	
10. Ownership: <input checked="" type="checkbox"/> Private <input type="checkbox"/> Public		11a. Historic use (if known): Commerce/Trade: Bus

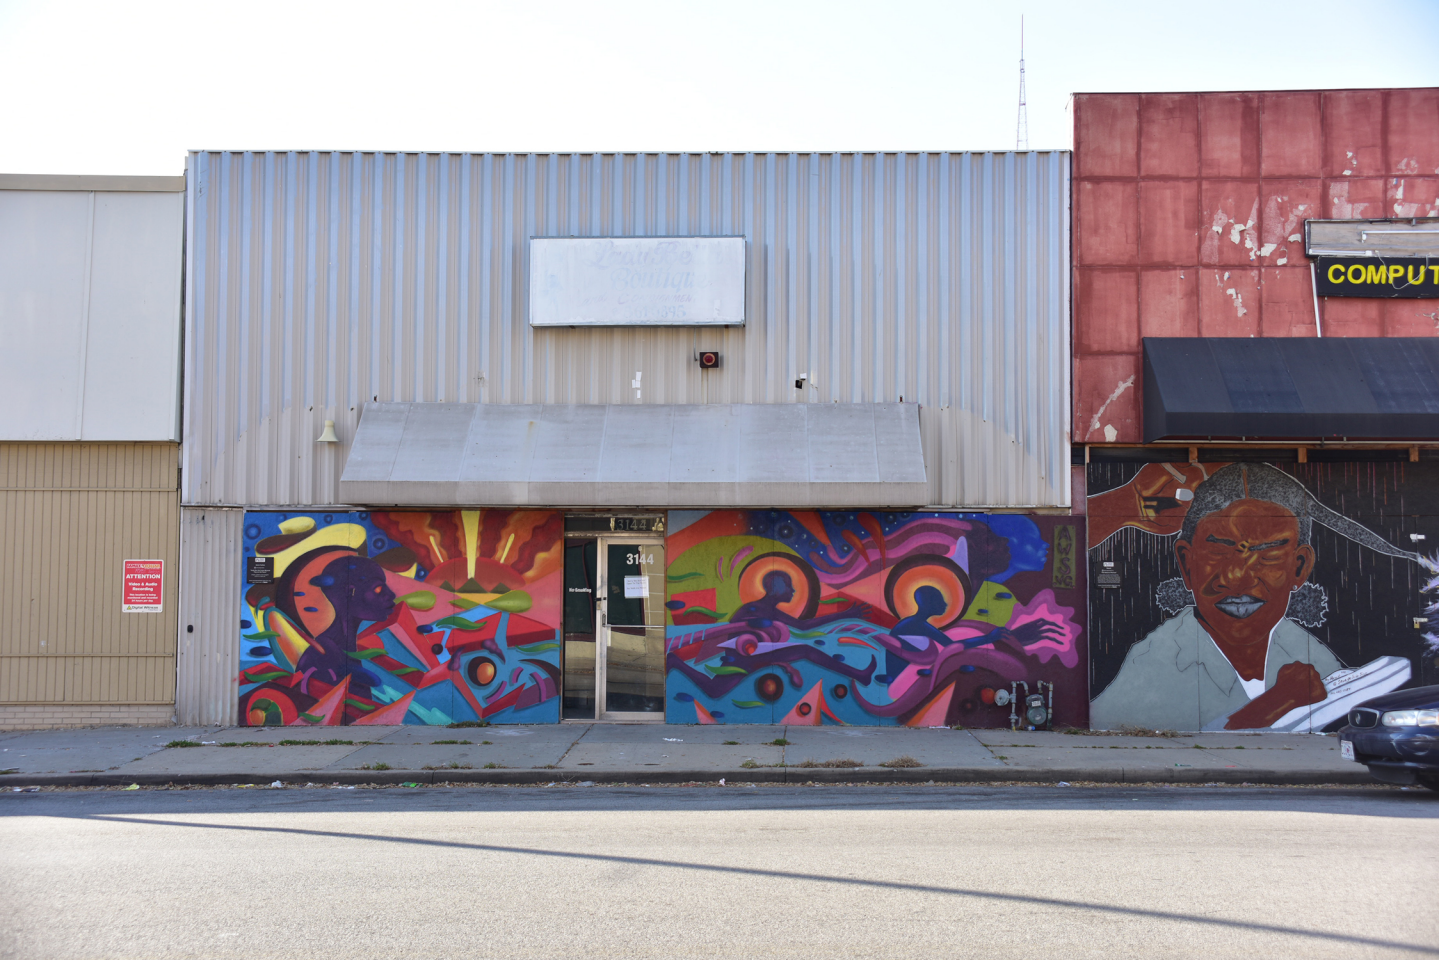
Alterations to 3144 Troost Avenue include a replacement storefront and the application of non-historic corrugated metal cladding to the primary elevation. While the storefront is currently boarded, it remains intact beneath plywood boards. Building permits indicate the resource was remodeled in 1967 and the extant storefront may date to this period. The application of non-historic cladding significantly compromises the integrity of the resource. It consequently retains poor integrity. Non-historic alterations compromise the integrity of the resource. It would not be contributing resource in the potential 3100 Block of Troost Avenue historic district. The district is eligible for listing under Criterion A in the area of Commerce as the remaining intact block of the historic commercial corridor and represents a period of transition from residential to commercial development in the block. The period of significance is 1908-1970, capturing the beginning of commercial development on the block through its decline.

3144 Troost Avenue is a one-story, one-part commercial block building with a flat roof and non-historic corrugated aluminum cladding. A seven-part anodized aluminum storefront is centered on the primary elevation. While the storefront is currently boarded, it remains intact. The primary entrance is centered in the storefront system and contains a single anodized aluminum door with glazing. Single-pane sidelights flank the door. A narrow, fixed transom extends from sidelight to sidelight. Single pane fixed storefront windows with vertical aluminum muntins flank the entrance. Low brick bulwarks support the display windows. A non-historic aluminum-framed fabric awning is centered above the storefront and shelters the center two-thirds. An aluminum framed sign is centered above the awning on the primary elevation.

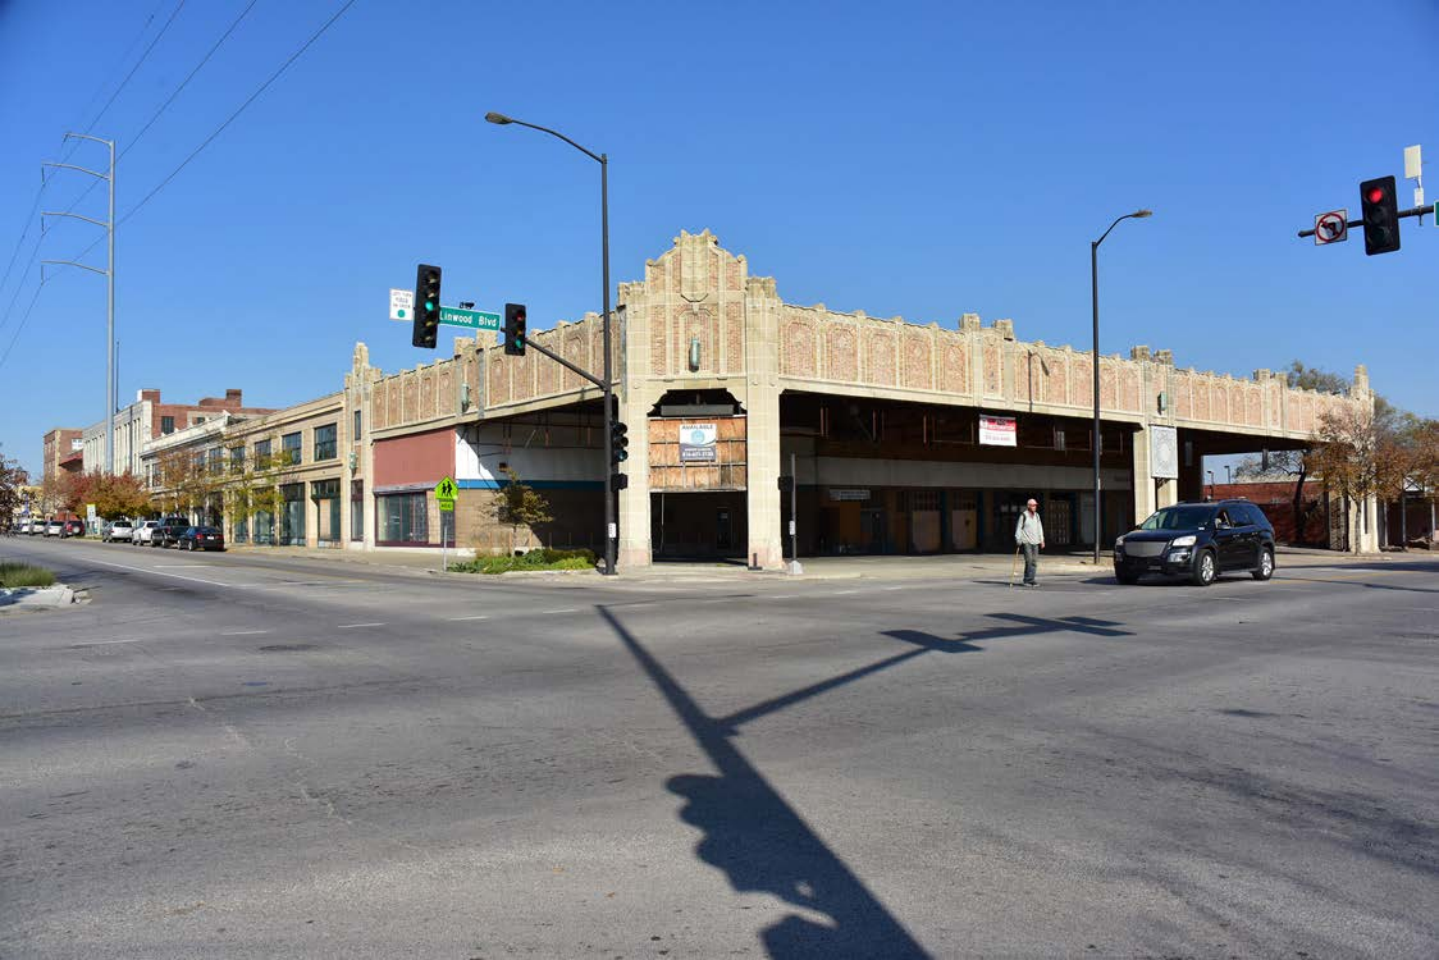
Alterations to the Firestone Building include replacement windows, vehicular bay doors, and pedestrian entrance doors. The filling station pumps and equipment are no longer extant. The Firestone Building does not otherwise appear substantially altered and retains good integrity. This resource would be a contributing resource to the potential 3100 Block of Troost Avenue historic district. The district is eligible for listing under Criterion A in the area of Commerce as the remaining intact block of the historic commercial corridor and represents a period of transition from residential to commercial development in the block. The period of significance is 1908-1970, capturing the beginning of commercial development on the block through its decline.

The Firestone Building is a two-story auto service building with an L-shaped plan and flat roof. A high canopy projects spans the south elevation. A distinctive high parapet lines the west, south, and approximate south-third of the rear elevation of the building and attached canopy and is a character-defining feature. Small-scale brick panels with segmental arch details and geometric motif terra cotta ornament clad the parapet. Narrow terra cotta and brick pilasters with Art Deco caps separate the brick panels. Wide terra cotta pilasters with highly stylized caps accent the west and south parapet elevations at regular intervals. Brick panel arches between these pilasters contain terra cotta keystones. Paired, wide terra cotta pilasters and elaborate scrolled panels accent the northwest, southwest, and southeast corners of the parapet. The northwest and southeast corners contain stylized "F" terra cotta ornaments and the southwest canopy corner is canted. The south elevation is deeply setback under the canopy and contains the primary entrances. It is eleven bays wide. Pedestrian entrances and associated storefronts define the third and fifth bays respectively. A non-historic aluminum door with glazing fills the third bay and the fourth contains a partially boarded anodized-aluminum storefront. Non-historic, undersized, fixed windows define the first, second, and fourth bays. Vehicular entrances define the remaining bays and contain overhead doors in a variety of materials and forms. Boards or similar material obscure most overhead doors. The west elevation is two bays wide and fronts Troost Avenue. A non-historic two-light window with a vertical muntin and twelve-light transom defines the north bay. A six-part non-historic fixed display window system defines the south bay. Synthetic sheeting covers the transom above. A non-historic two-light window with vertical muntin is located above the north bay and is positioned between the parapet and south bay transom.

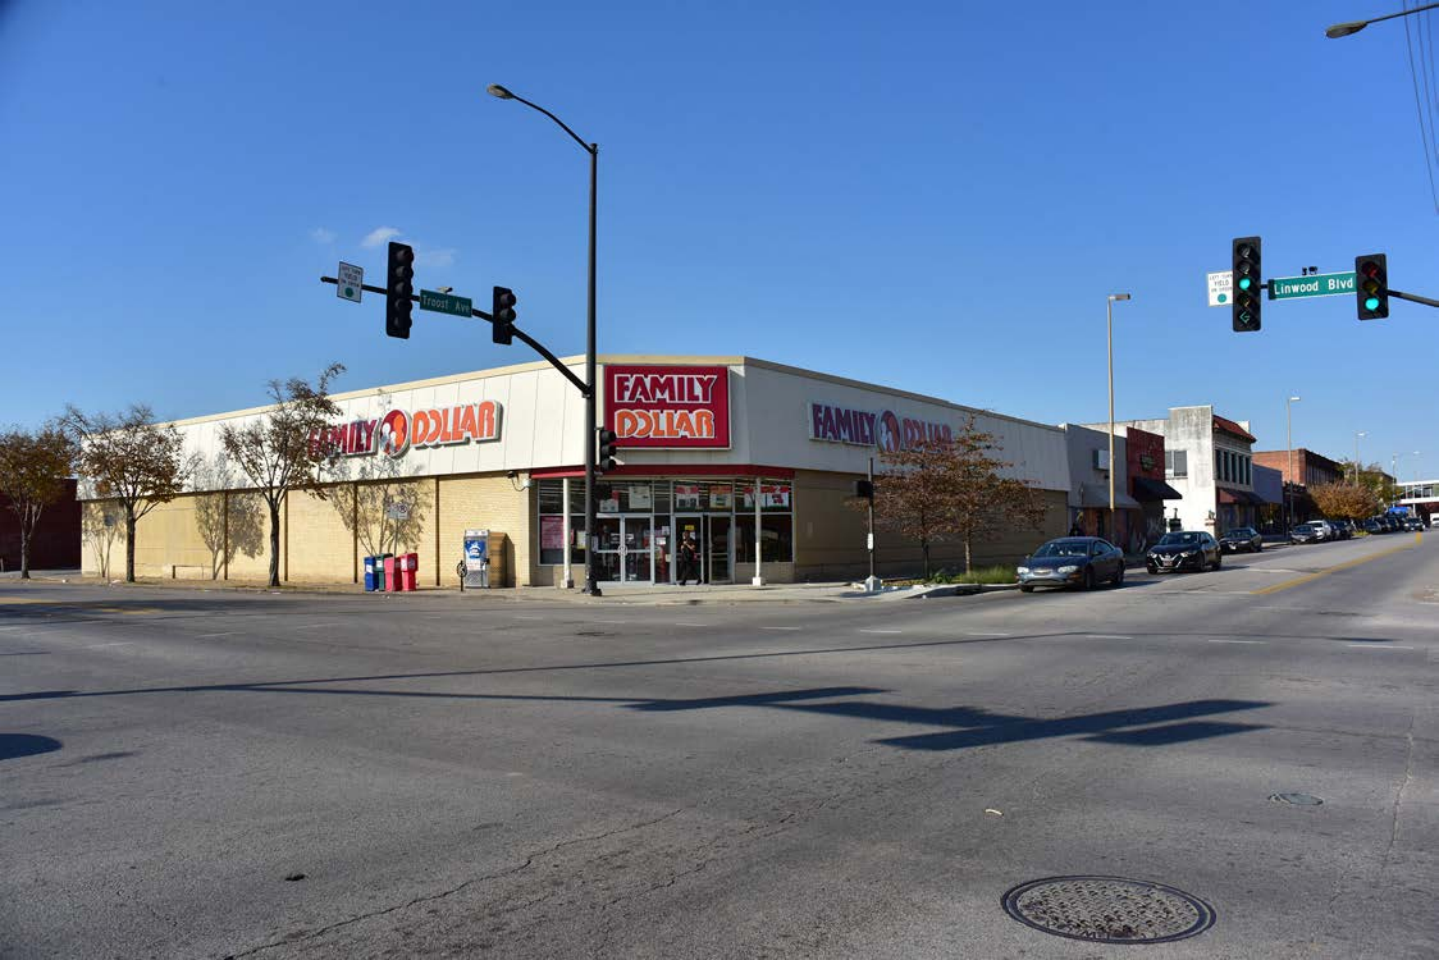
3156 Troost Avenue was constructed 1940-1941. Building permit 15959 was issued to Hugo Brecklein and builder W.K. Martin Cont. Co. for \$27,000 November 4, 1940. The Scott ten cent store was an early tenant and occupied the building through the 1950s. In 1948 a building permit was issued to Scott Stores and Schumuger (?) Con. Co to erect a large addition and to remodel the existing structure. Permits issued in 1959 note alterations to the primary elevation, infill of windows with brick, and replacement aluminum doors.

3156 Troost Avenue is a one-story, one-part commercial block building with a rectangular plan and flat roof. Non-historic pressed wood siding clads the east elevation while the south and west elevations are brick. A wide non-historic aluminum parapet wraps around the south and west elevations. The southeast corner is canted and contains the single bay. A non-historic five-part anodized aluminum storefront defines the bay and is slightly recessed. The storefront contains two pairs of aluminum doors with glazing. A narrow, fixed window separates the pairs. Fixed display windows define the outer storefront parts. Brick bulkheads support the outer display windows. The roof extends over the recessed storefront to shelter the entrance. Two metal columns set in square concrete bases support the overhang.
