HISTORIC INVENTORY

1 No 73		4 Present Name(s) Kennedy Theater	
2 County Adair		5 Other Name(s)	
3 Location of Negatives NEMO Regional Planning Comm.		Kennedy Country Opry 0273	
6 Specific Location Corner of Elson and McPherson		16 Thematic Category	
7 City or Town Kirksville If Rural, Township & Vicinity		17 Date(s) or Period 1920	
8 Site Plan with North Arrow

KENNEDY THEATRE

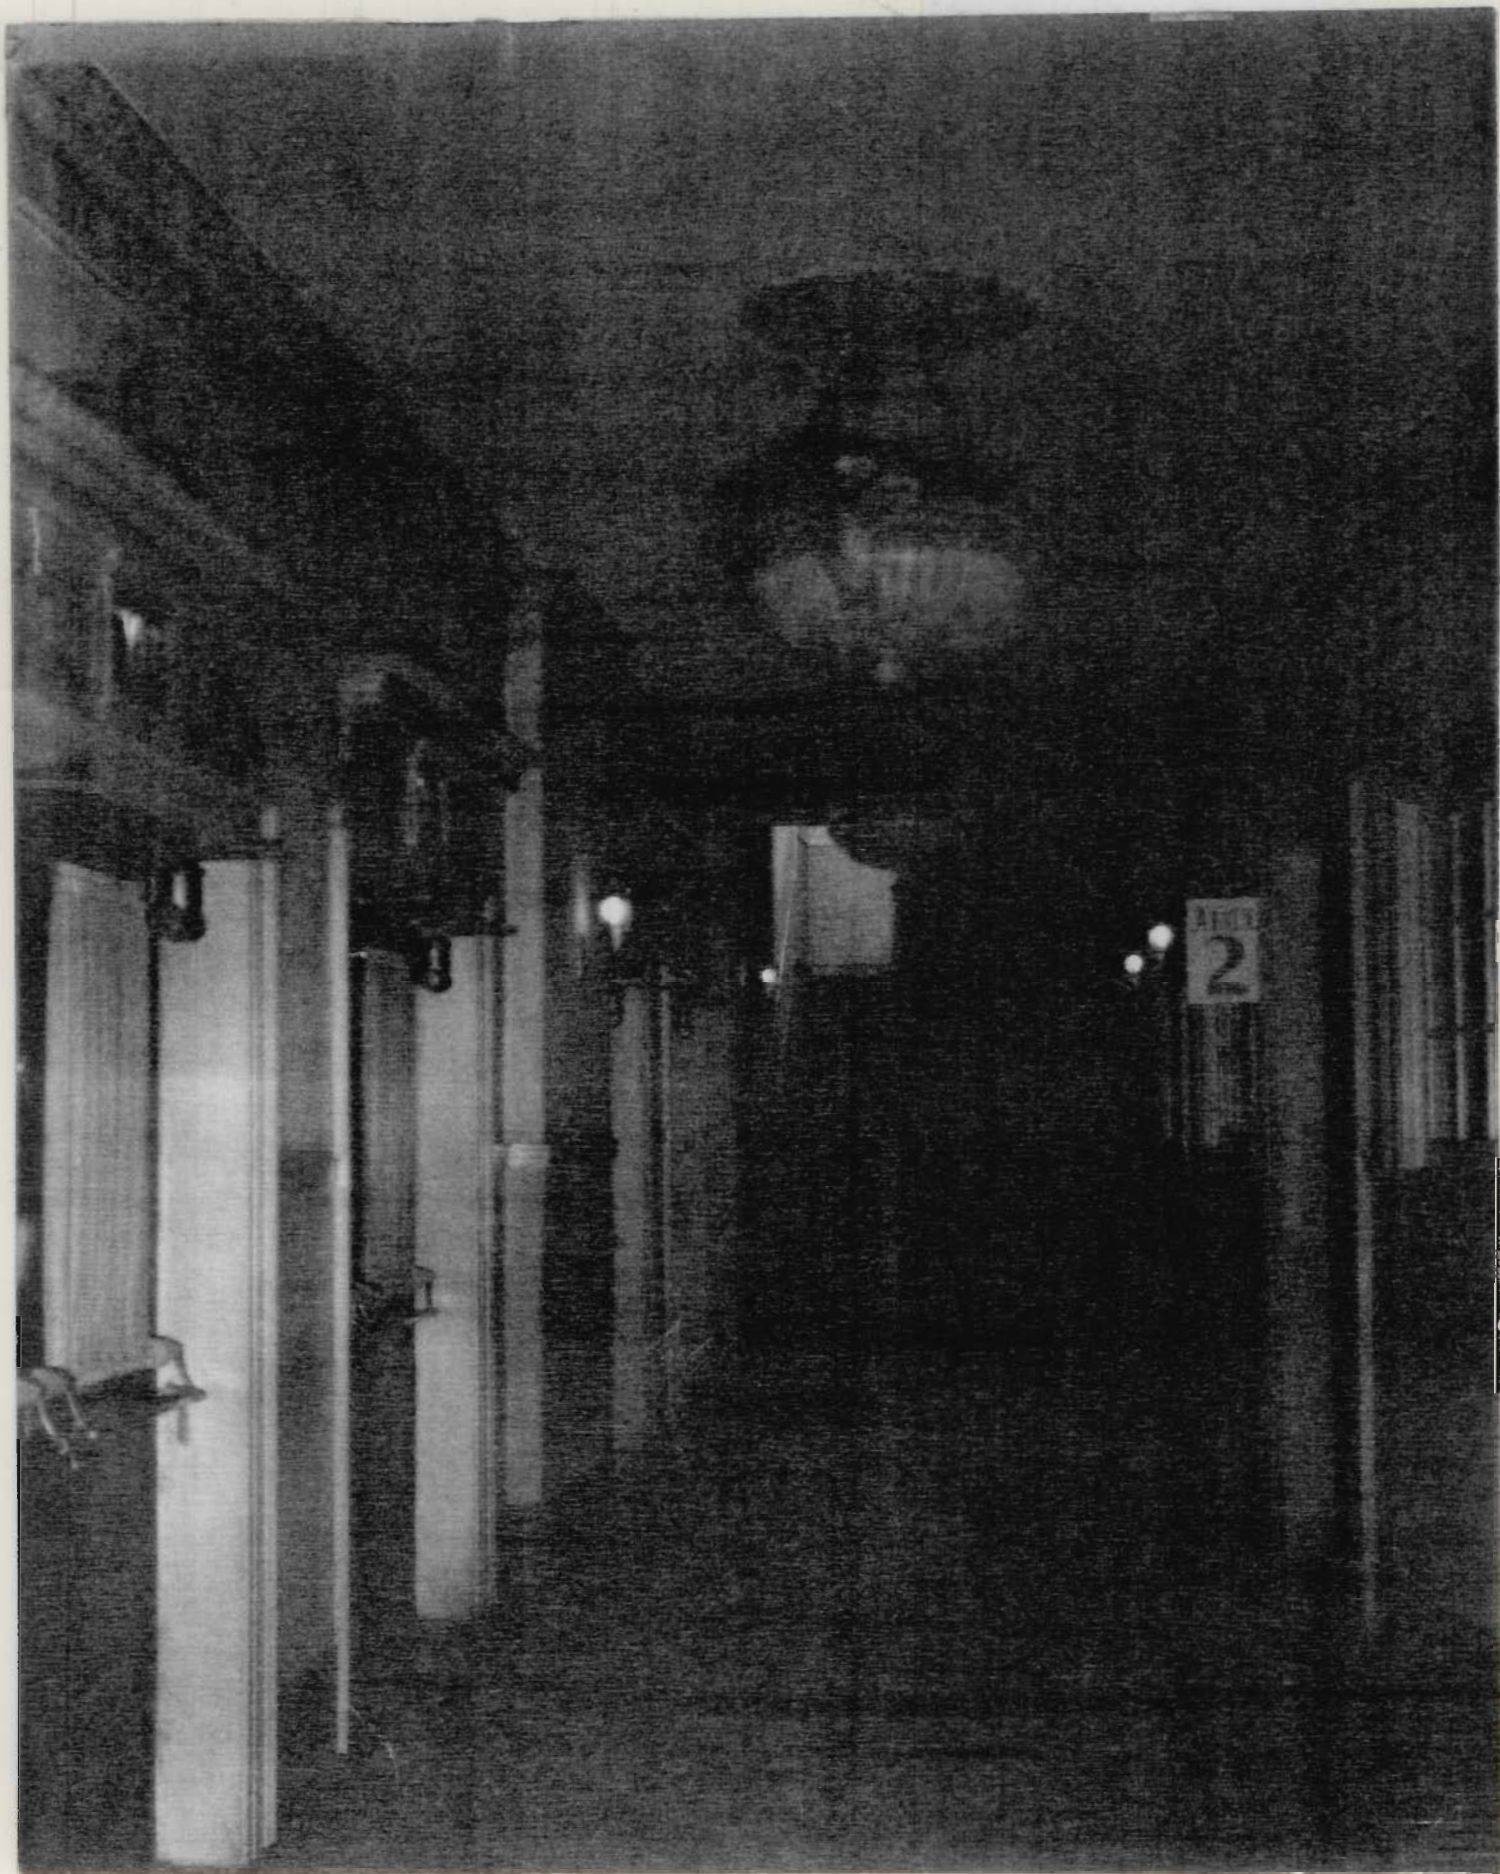
INTERIOR VIEWS
KENNEDY THEATRE
— KIRKSVILLE —

42 Further Description of Important Features The facade of the theater shows influence from both the Beaux-Arts and Art Deco periods. The Art Deco influence can be seen in the angular capstone found on the parapets on the north and west sides of the theater. The building also has a Renaissance Revival flavour, this becomes much more evident on the interior surfaces. The main facade, and that of the north, is composed of brown, textured brick and glazed ceramic tile. The lower story of the main facade consists of various shop fronts, an apartment entrance, the theater entrance, and glass movie poster cases. The latter two are not original, but the others are almost entirely intact. The main entrance is now a triple door (cont)

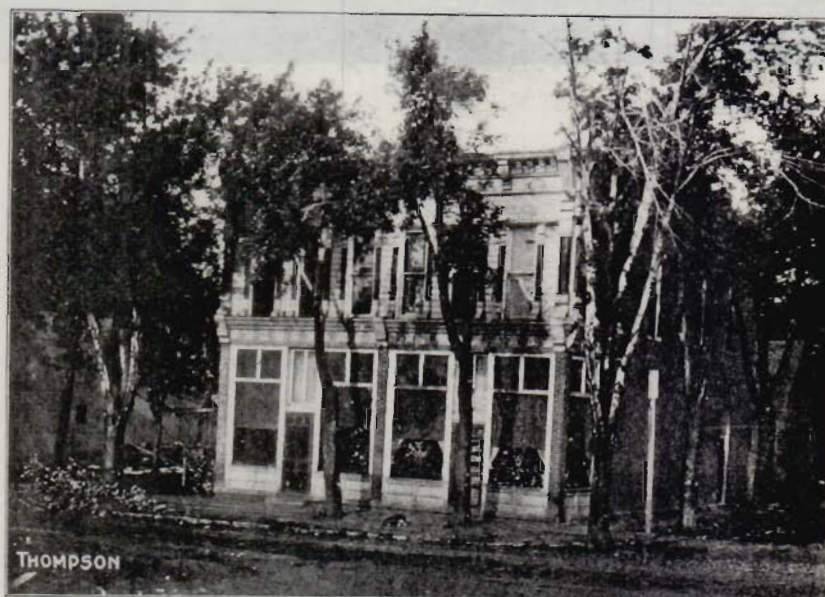
LESLIE HOTEL.—Owned by T J Dockery.

42. resemble rusticated stone, above it is a heavily molded cornice with brackets. Half sunbursts alternate with the brackets. The interior of the structure has been altered somewhat. During their use as a taxi service and a bus terminal, two of the first story rooms were walled off. Despite various changes in ownership the structure retains it's original windows, woodwork, and doors. The main stair is of oak. The floor in this area is of pink and white marble tile. The ceilings are of pressed tin.

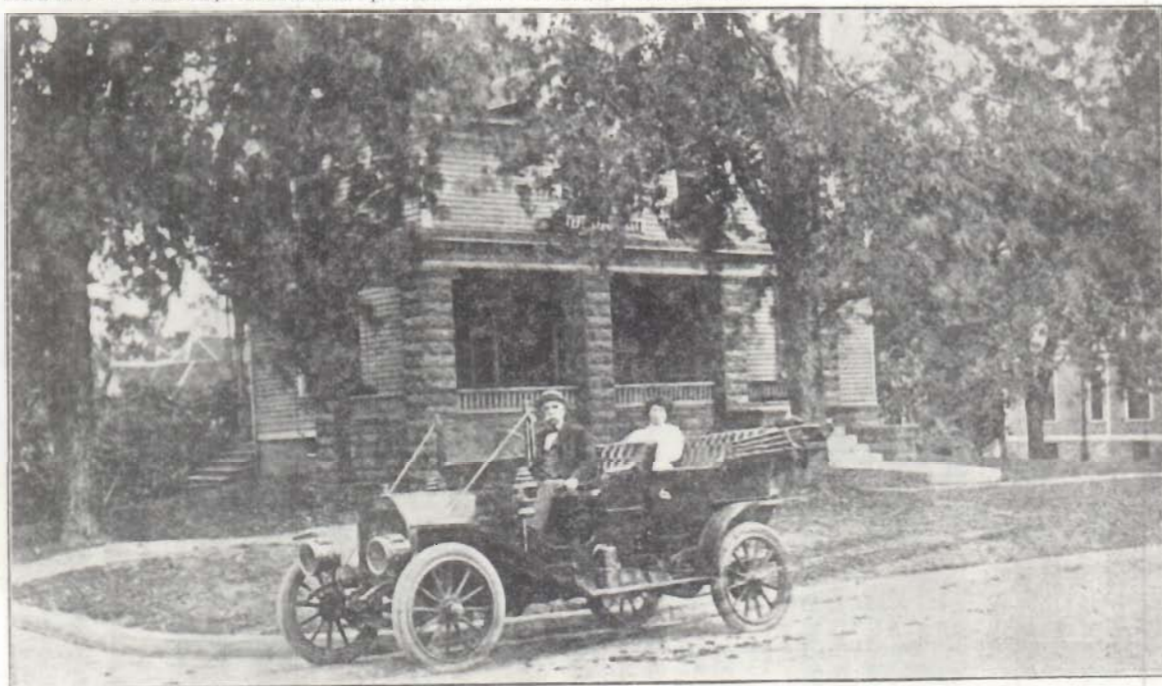
Residence of S. M. Pickler, Kirksville; Mr. and Mrs. Pickler in their Auto in the foreground

42. this, like a transom over the lower bay window, was stained glass. The upper courses of the tower are of tin, the battlements are now missing. The south side of the house once had another single story bay window. The north side of the house has a large addition (1 story) which is used as a salon. The interior of the structure retains its walnut railed stair and some wood work.

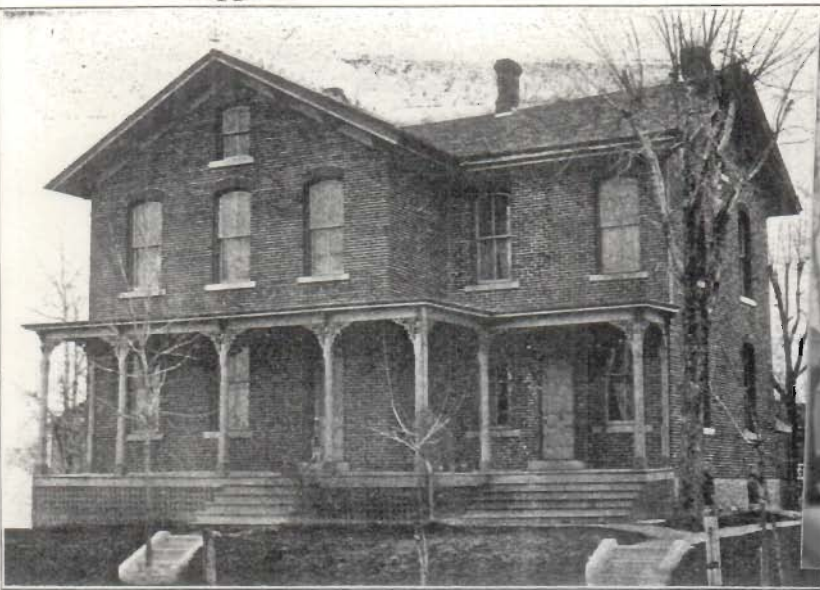
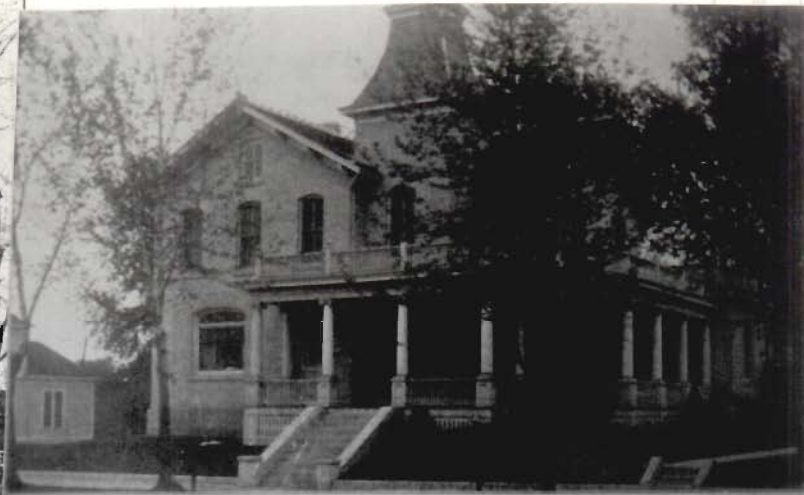
Residence of H. Selby, Kirksville

He was married August 30, 1895, to Ella Clay of Clark County, MO. They had seven children. His eldest son, Paul O. Selby, was a noted local historian and professor at NMSU. Hiram Selby passed away in 1934, his wife in 1947. After their deaths, the house passed out of the family, and was converted into apartments. During that time the house deteriorated considerably: the towers roof and the dining rooms stained glass windows disappeared.

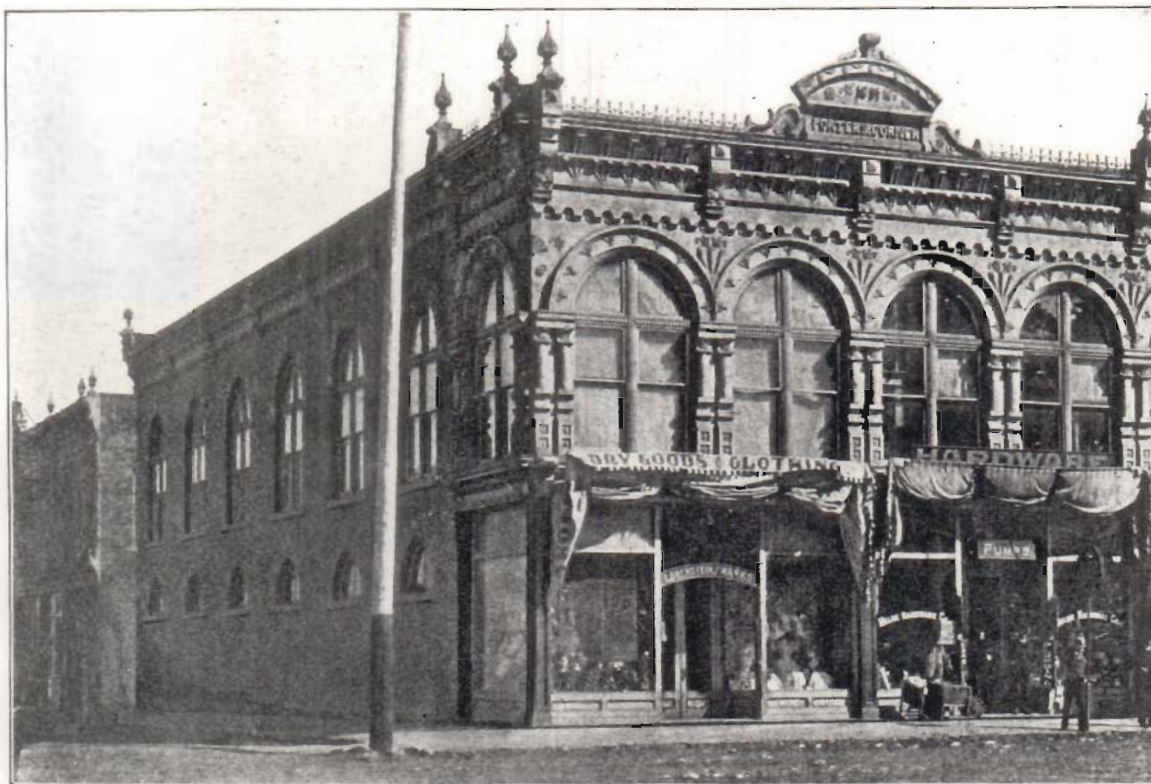
JOHN L. PORTER'S CORNER.
Lowenstein & Marks—Dry Goods, Clothing, Cloaks, Etc.

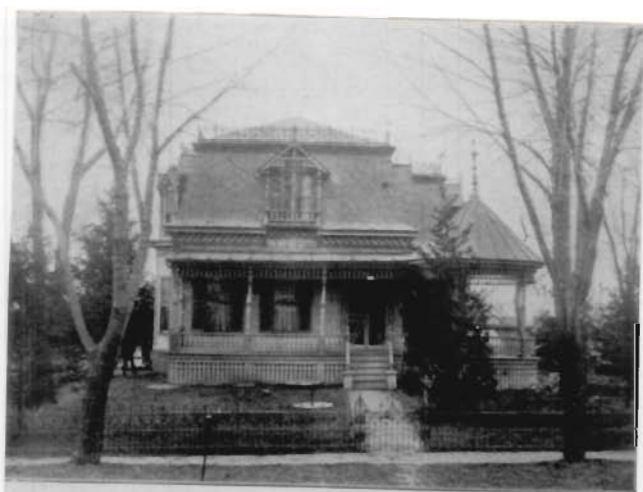
Residence of Thomas J. Dockery, Kirksville

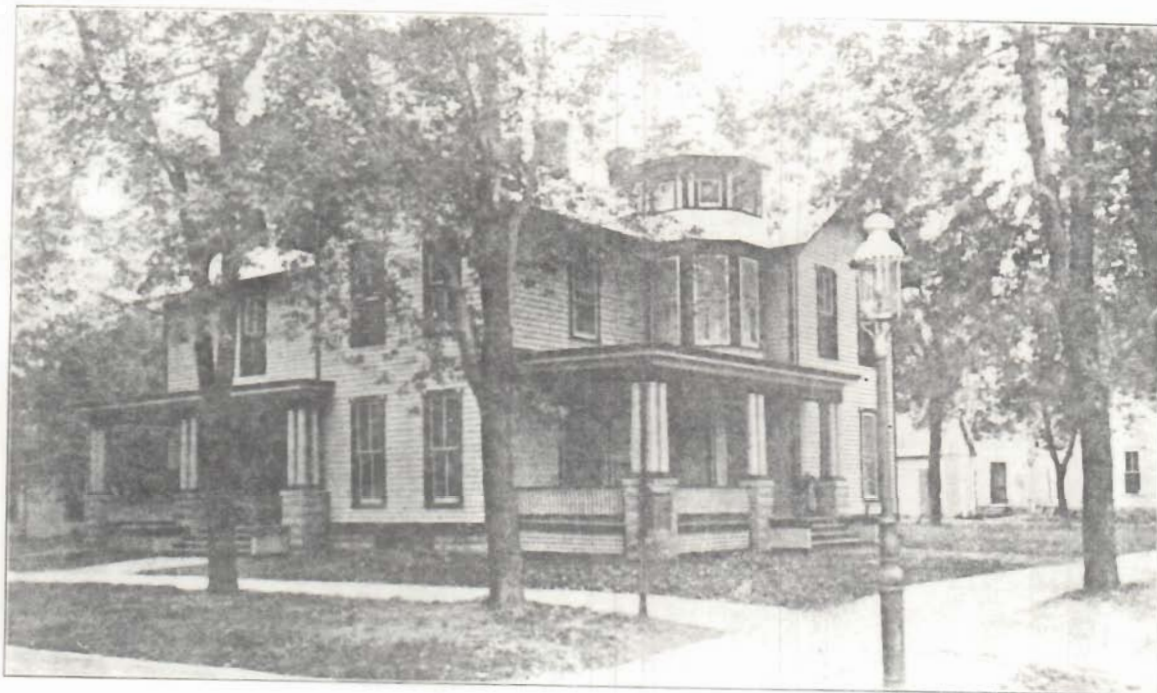
Residence of C. C. Gardner, Kirksville

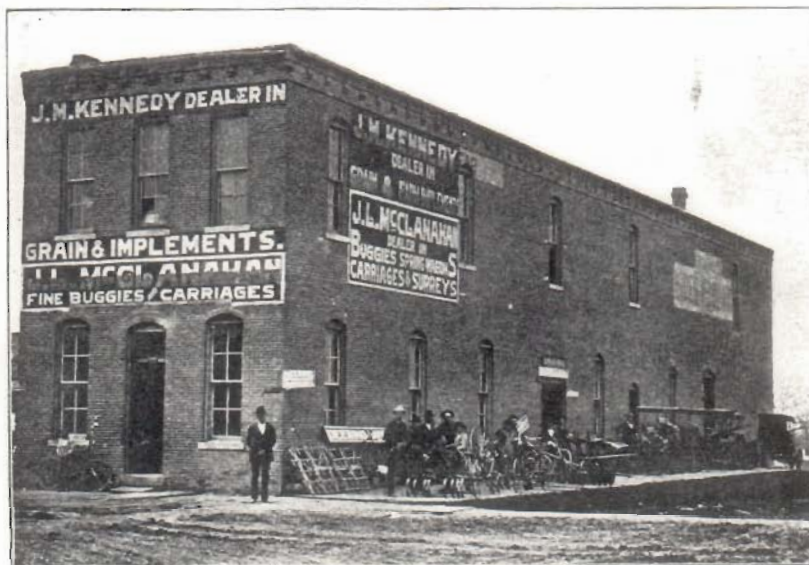
J. M. KENNEDY'S MAMMOTH IMPLEMENT HOUSE.
J. L. McCLANAHAN'S CARRIAGE EMPORIUM.

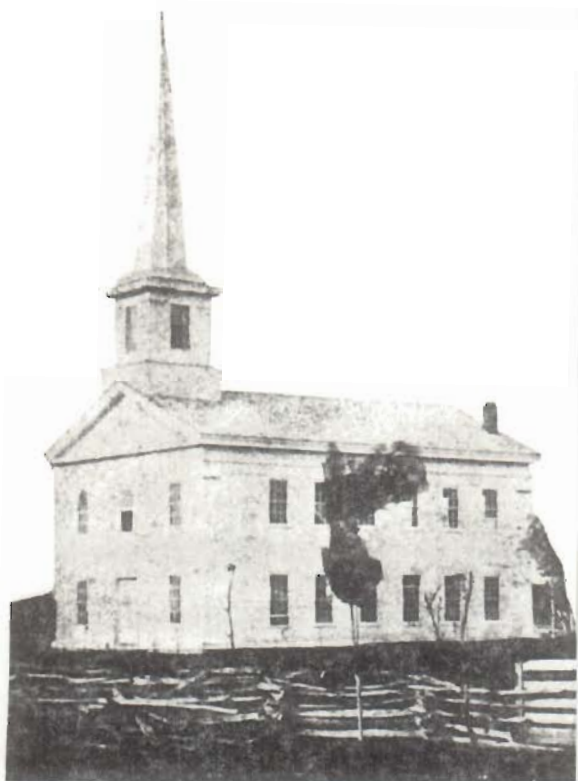
CUMBERLAND ACADEMY.

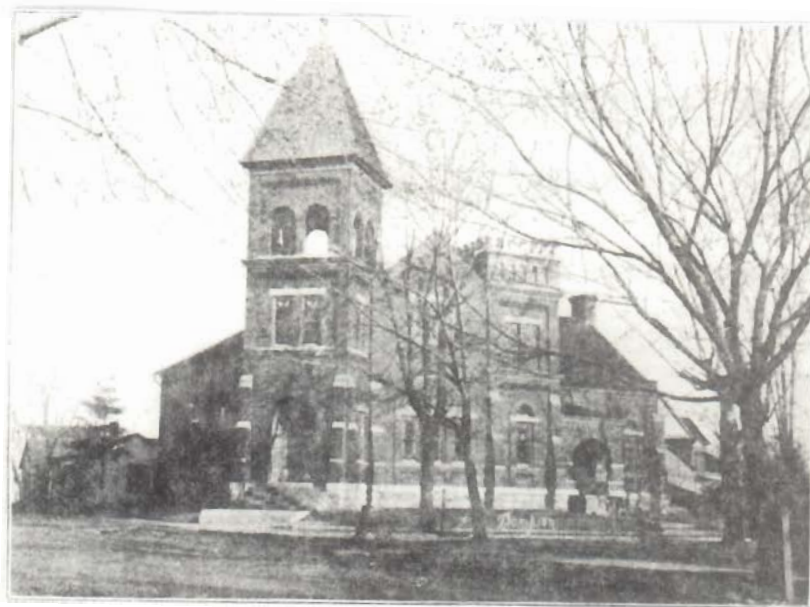
C. P. CHURCH, KIRKSVILLE.
(Presbyterian since the union in 1906.)

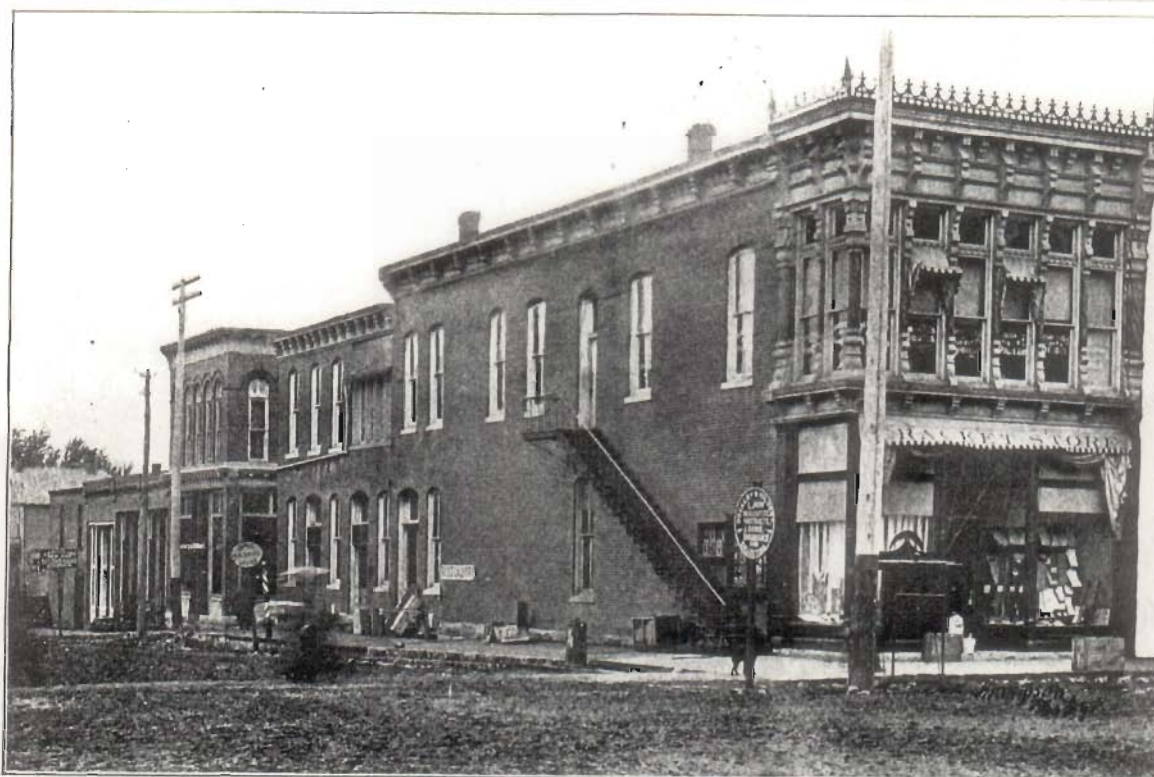
T. J. DOCKERY BLOCK.

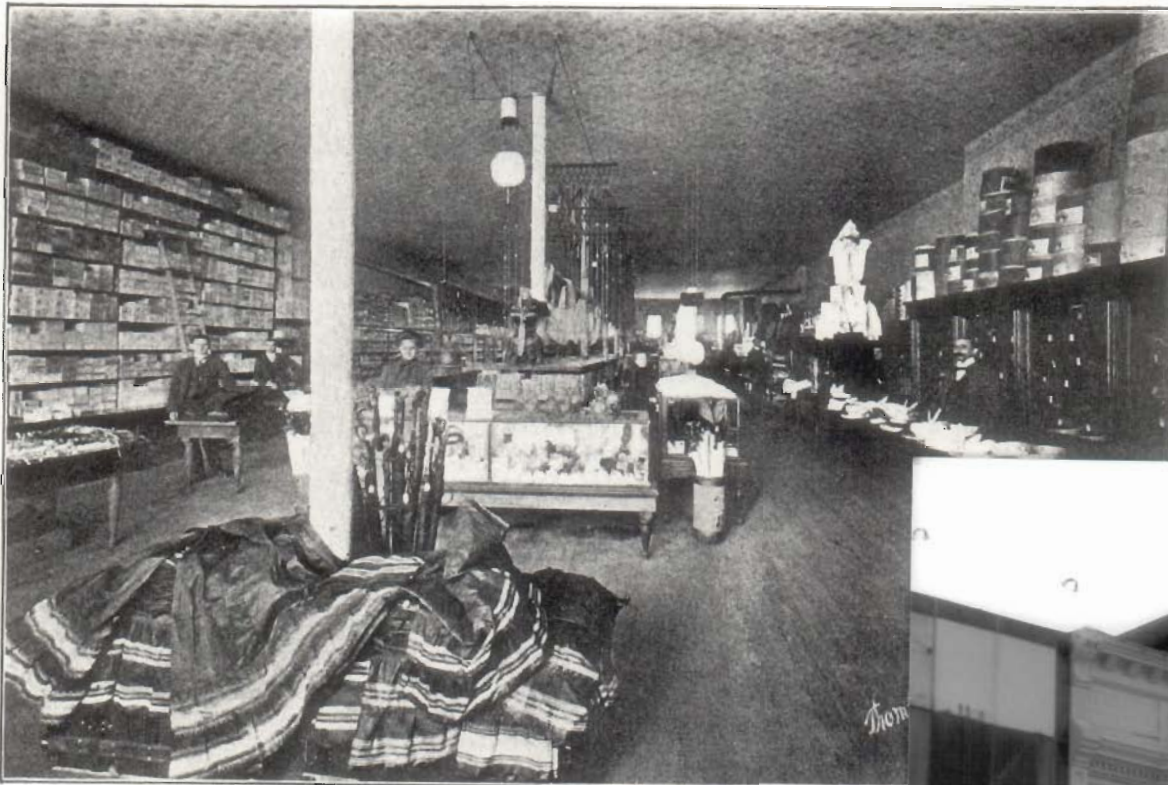
GRAND LEADER, RYON AND GOODWIN PROPRIETORS, 111 and 113

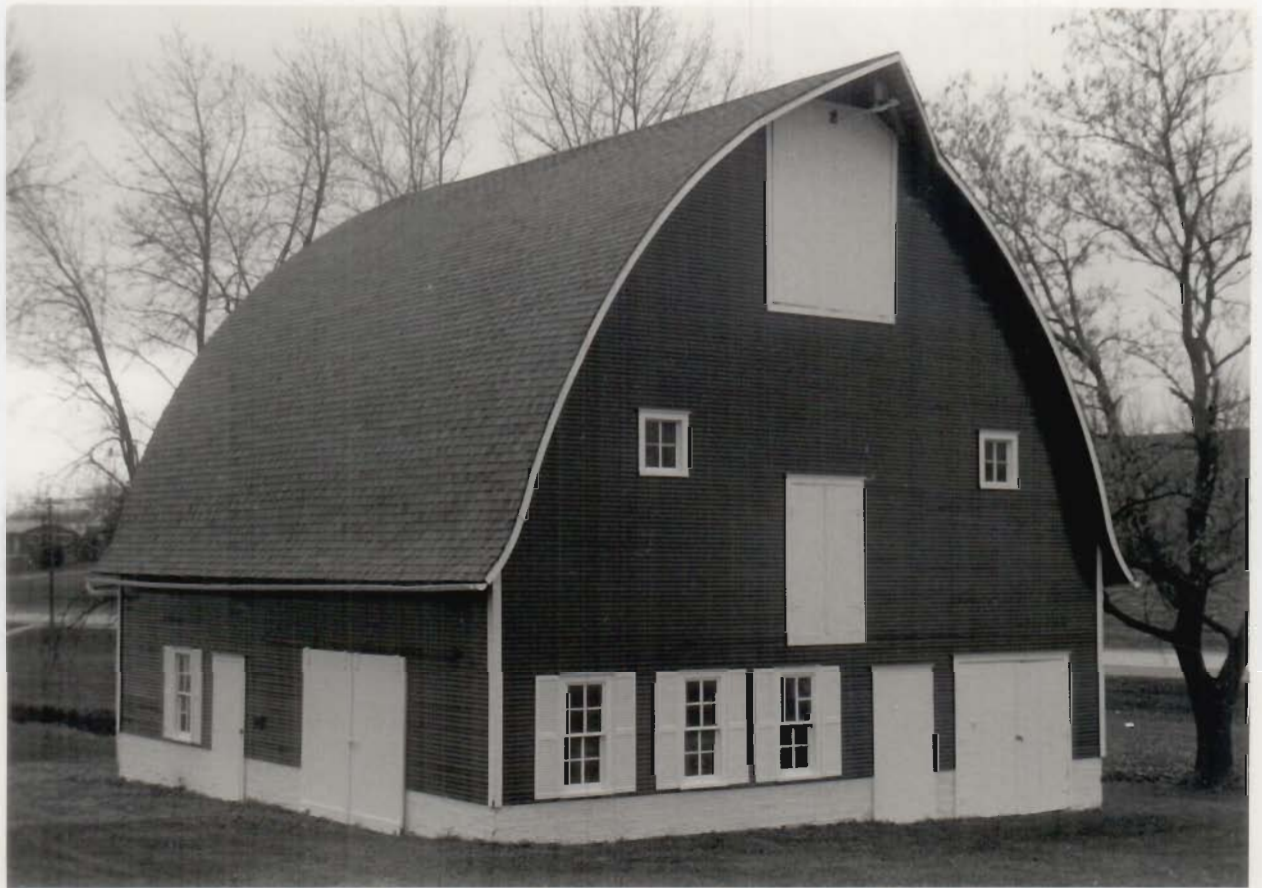
The Red Barn has just been painted and its trim and foundation were painted white. On the north side is an entrance, a haymow door, and two small haymow windows. On the west there are four windows with the sills rest on the hollowtile wall below. The south end of the barn has an entrance, and two haymow windows, and a haymow door. The east side has double doors, a single door,

and one window. The outer cladding of the barn is made up of 4 inch wide sheathing. Plastic shutters on the ground floor windows are a recent addition.

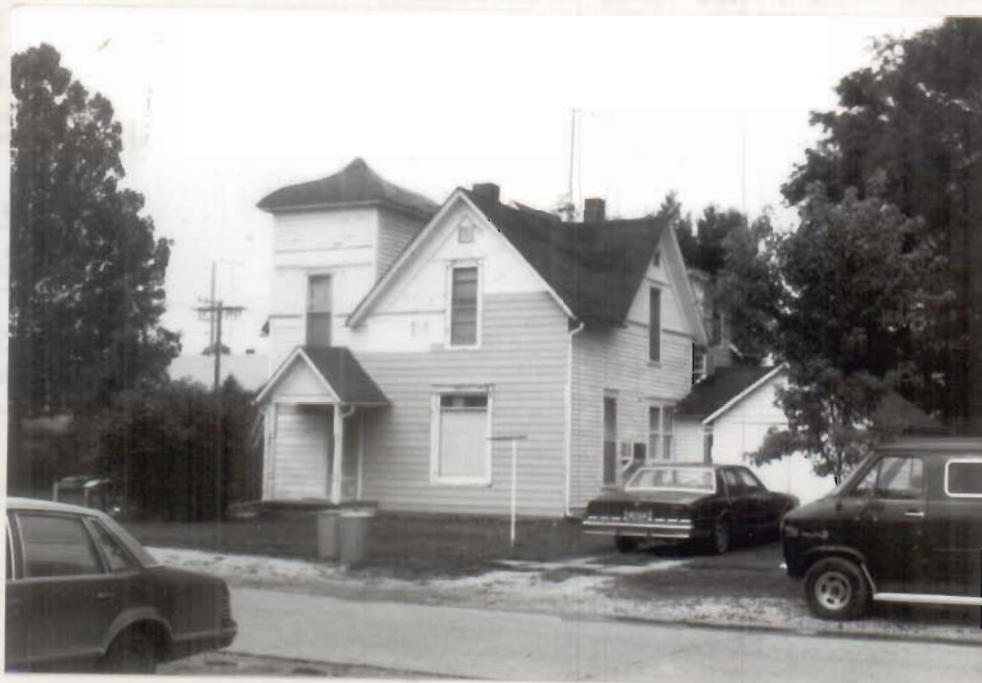
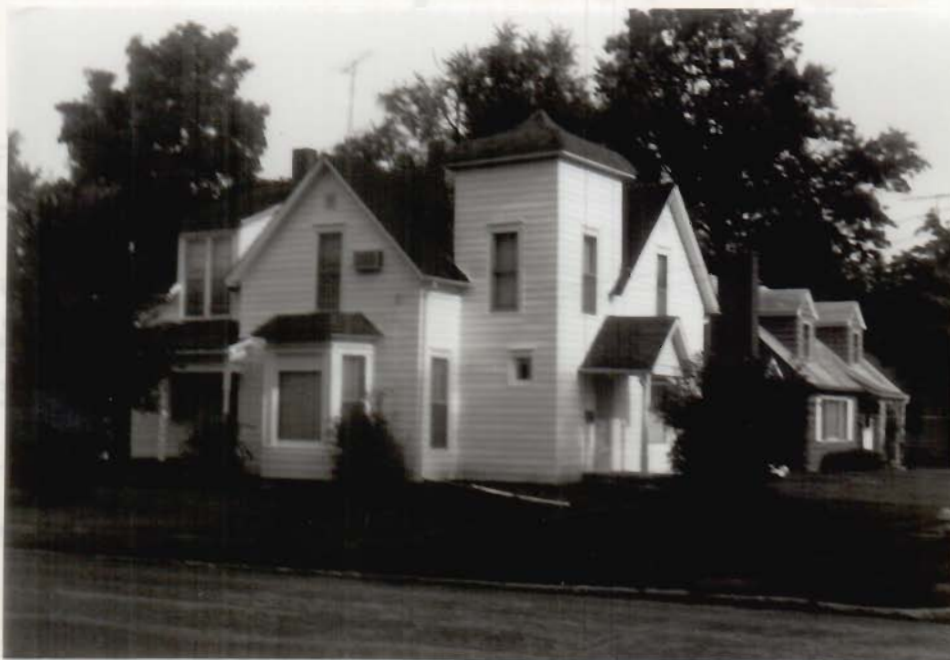
42. Further Description of Important Features The main facade of the house has a tower and a large gable end. The single leaf main entrance is in the tower. It is sheltered by a modern stoop. The stoop has turned posts which were probably taken from an earlier, original porch. The gable end is lighted by an oversized window. A band of multicoloured stained glass is set above the window. The gable is lighted by a single l/l window. A course of fishscale shingles extends from eave level to the top of the window. The remainder of the gable is faced with diamond shingles. The adjoining tower is also faced with shingles. It is lighted by a l/l window. The tower is topped by a low, re-curved roof. The south side of (cont.)

42. the house is very similar, having another gable and showing the other side of the tower. The north side of the house has a large central gable, decoratively faced. Some of the windows on this elevation have been changed to 6/6. A small addition connects the house to a c. 1940 frame garage directly north of the house. The interior of the structure was modernized when it was divided into apartments. The house is currently being re-sided. This process will cover most of it's details.
43. reason as up until the 1940's many of the adjoining lots were vacant, and adjacent to the property was the two hundred acre Brashear farm, these surroundings would have to be considered almost rural.

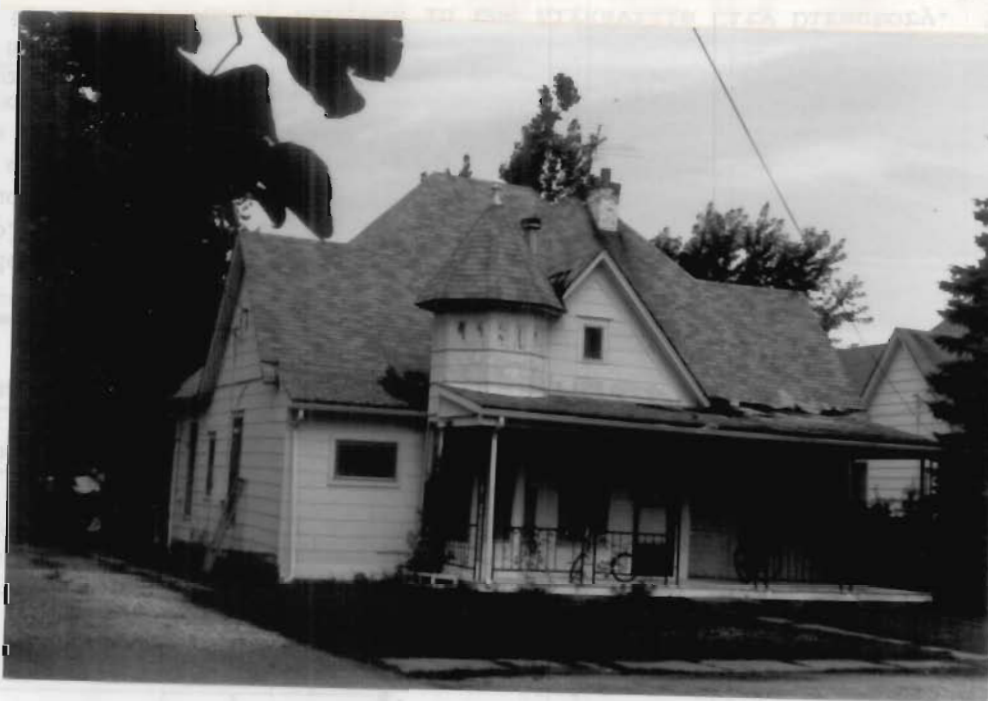
42. window. The tower has an upper most course of paneled tin, it is octagonal, and is surmounted by a wooden finial. Since the house has been re-sided most other architectural details have been lost. The interior of the house has been modernized. It has none of it's original features.
43. that it shows the large number of variations that the simple pyramid-roofed house could assume. In this example side gables greatly extend it's facade and a tower adds further surface interest.

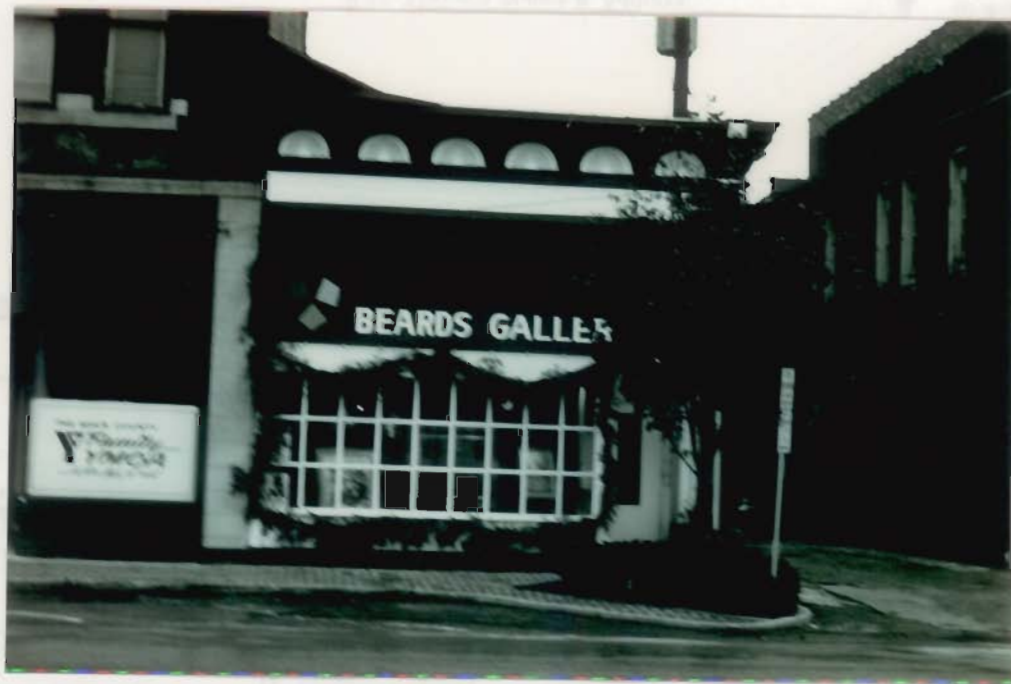
42 Further Description of Important Features Originally the building was entered by a central double leaf door. This door was deeply set and flanked by large 4-paned display windows. The front of the building was embellished with cast iron pilasters and a heavy, elaborate entablature. The front has since been radically changed. The windows and doors have been removed and replaced with modern ones. The door is now single leaf and is set on the west side of the front. The remainder of this facade is occupied by a large multi-pane display window. During these renovations the cast iron pilasters, except two, were replaced by wooded turned half posts. There is also modern brickwork on this facade. The original entablature (cont)

The interior of the building has been entirely remodeled. Only some of the rear storage areas retain their original appearance.

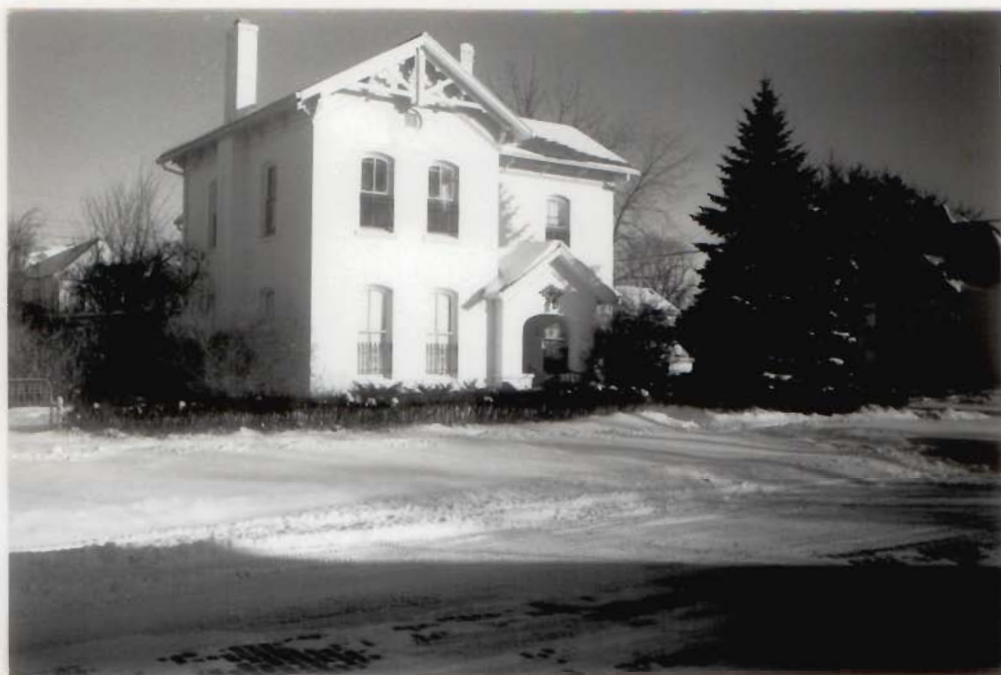
42. front facade. It had 4 chamfered posts of Halianate design. A three bay window is on the East gable facade. This bay replaces an earlier semi-hexagonal one. Also on the East side of the house is a two-story frame addition (c. 1940). The windows on the exterior of the house now have wrought iron grills.

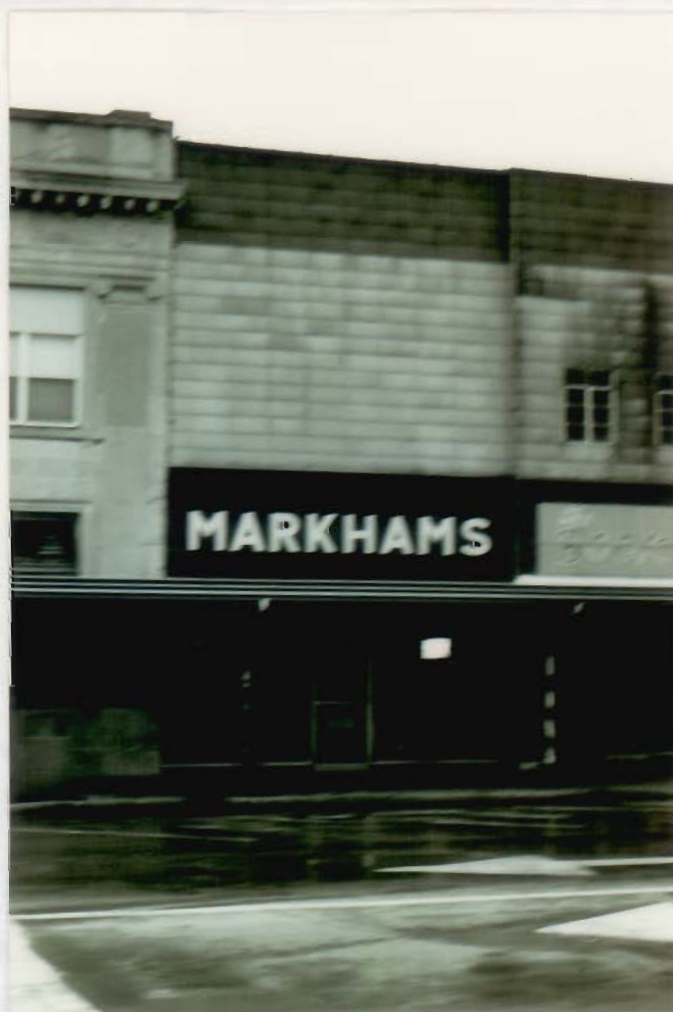
40. Visible from Public Road? Yes <input checked="" type="checkbox"/> No <input type="checkbox"/>	
		41. Distance from and Frontage on Road Adjacent	
42. Further Description of Important Features The original facade on both stories have been replaced by modern ones. Traces of the second story 1880's facade may remain beneath the modern one on the second story. The main floor now is fronted by plate glass and aluminum. Above it are morano glass panels upon which are painted the stores name. The second story is clad by composition siding. The facade is shaded by an aluminum awning. No original fixtures remain on the interior.			
43 History and Significance Since it's construction in the 1880's until the 1940's the building has always held dry good businesses. In 1914 the store also sold carpet. In 1946 the building was purchased by Beulah and Ila Markham who opened a children's clothing store. This store is operated yet today by Mrs. Markham and her daughter Joan Sorrel. The store is almost certainly on the site of an ante-bellum structure which burned c. 1890. It is assumed that (cont.)

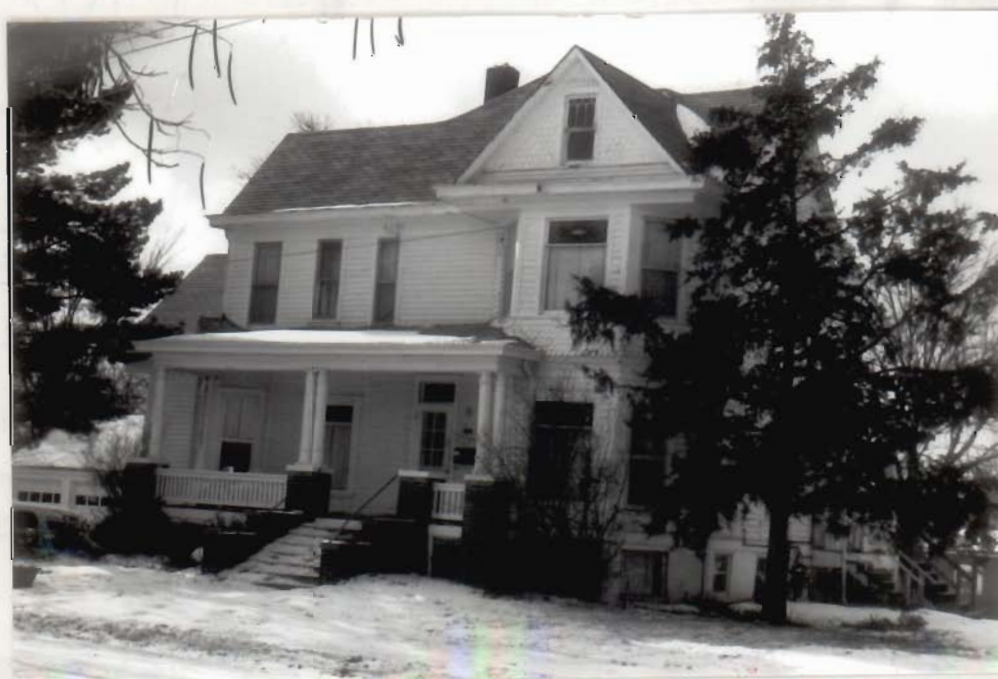
42. Further Description of Important Features The house shows a single story porch and a large gable end with cutaway corners on it's front facade. The porch is supported by paired ionic posts set upon brick piers. These piers replace older wooden ones. It shades a single leaf door, part of the gable end and on the south end of the house a square bay window. It also shelters an over-sized window with a stained glass transom. The gable end of the house has similiar windows on each level. The cutaway surfaces have simple 1/1 lights. A course of round shingles marks the floor line between the two main stories. The gable ends of the house are rounded shingles and lighted by small 1/1 windows. There is a small, (cont)

42. original porch on the north side of the house, it has turned posts. At the rear, a large modern stair rises to the second story sunporch which now serves as an apartment entrance. The south side of the house has a large modern addition.

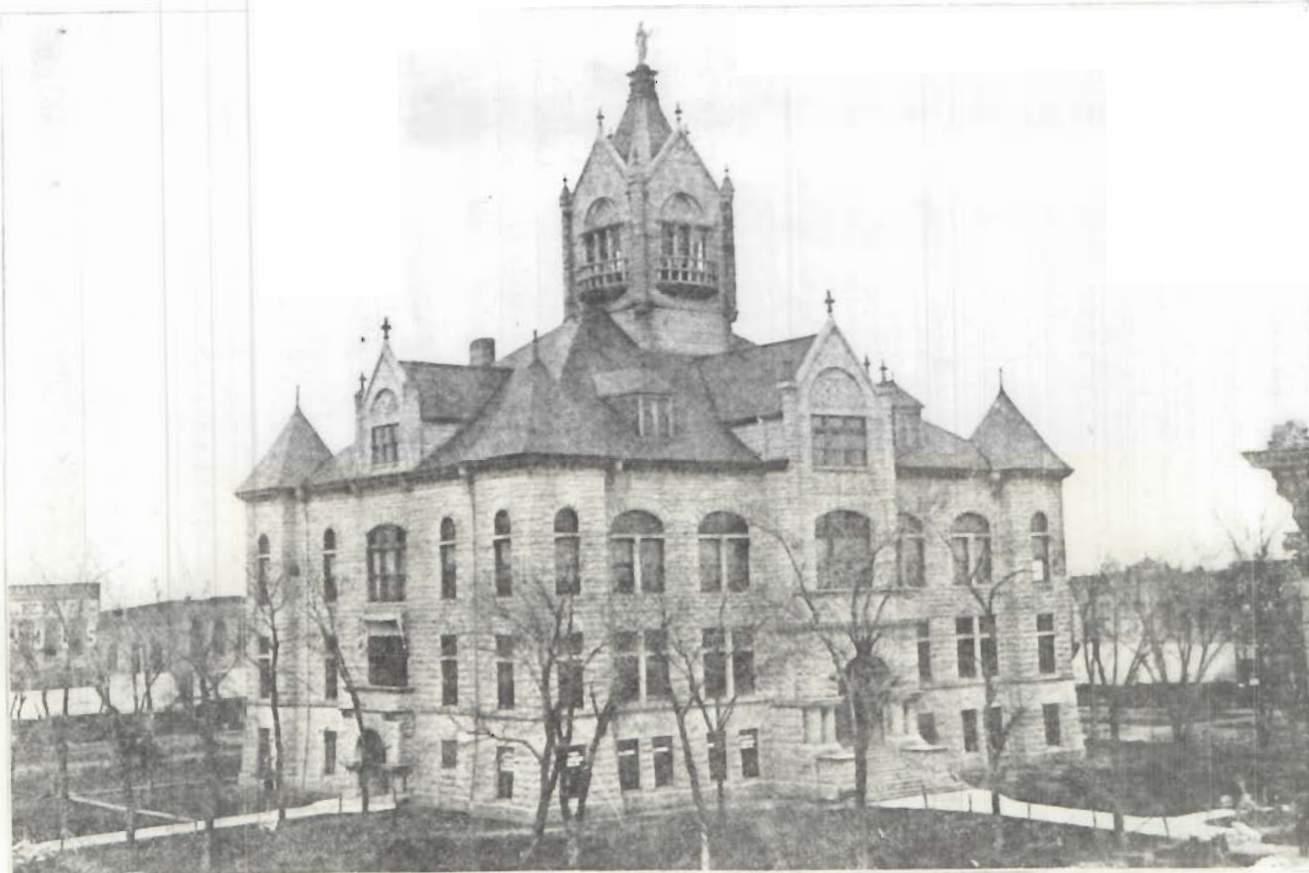
THE PRESENT ADAIR COUNTY COURT HOUSE.
Built in 1898-99. The trees here have been cut down since this picture was taken.
