National Register of Historic Places Registration Form

historic name Krog, Albert, House

street & number 1395 West Main Street [N/A] not for publication

Summary: The Albert Krog House, at 1395 West Main Street, in Washington, Missouri is a one and one-half story brick central passage house with a stone foundation, a side facing gable roof, and a dentiled cornice. It has a symmetrical five-bay facade, with a central front door, and wide double hung windows which are topped with brick jack arches. There is a distinct seam in the brickwork to one side of the front door; it appears that the house originally had a three bay, side entry facade, which was expanded to its present form at a very early date. There is a large vaulted brick cellar under the east part of the house, which is the newer section. The house is representative of Property Type B. Vernacular Missouri-German, Subtype: Central Passage, and meets the registration requirements set forth in the MPS Cover document "Historic Resources of Washington, Missouri." The oldest part of the house was built ca. 1850, and the expansion occurred before 1868. There have been no other major changes to the house since that time, and the

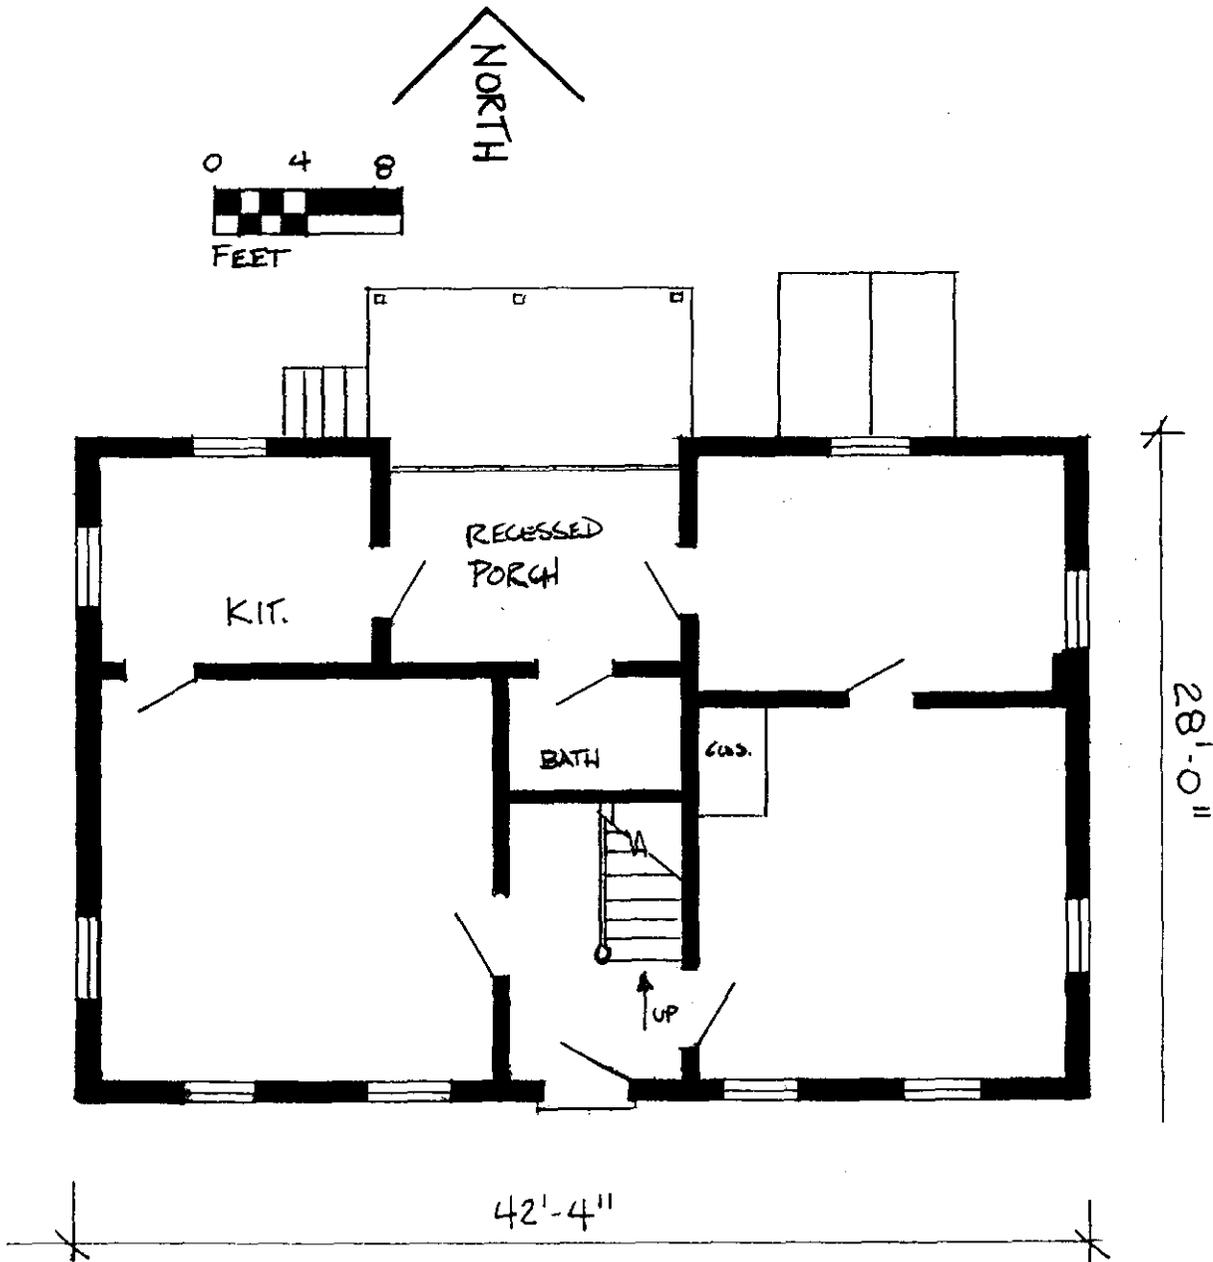
Figure One. Floorplan. Drawn by Debbie Sheals.

The interior of the house is largely unchanged from the period of significance. The front door opens to a small stair hall. There are four main rooms and a small modern bath on the main floor. It appears that the center hallway at one time ran the depth of the house, and that it was closed off from the front when the bathroom was installed. (See Figure One.) The front hallway provides access to each of the front rooms, and each of those rooms has a door to the room behind it. Each of the rear rooms has a door which leads to the recessed back porch. The bathroom door has a transom and a segmental arched top, and the kitchen door has a segmental arched top, but no transom. The door to the east rear room has a transom and a jack arched top.

All of the doors in the house have four panels, and all are early or original. Most retain what appears to be the original hardware. The interior finishes throughout the ground floor are largely intact. All wall and ceiling plaster is in place, as is most interior woodwork. (See photos 5-7.) The doors and windows are all topped with wide pedimented trim which has a thin band of molding along the top of the pediment. In the west part of the house, the molding on the trim follows the slant of the pediment. In the eastern rooms, the molding is straight. (See photo 7.)

tapered octagonal newel post, and the hand railing curves down over the newel post in a small scroll. (The railing and newel post are almost identical to those found on the Casper Kruse house, at 202 Stafford Street.) The stairs lead to the largest of the two second floor rooms, which is over the original part of the house. That room has wood floors, and the ceiling and short walls were plastered at an early date. (Some of the plaster and lath are now missing.) The window in the west wall has flat pedimented trim which is narrower and simpler than that below. Both dormers light the west room. There is a door east of the stairs which opens to an unfinished storage area.

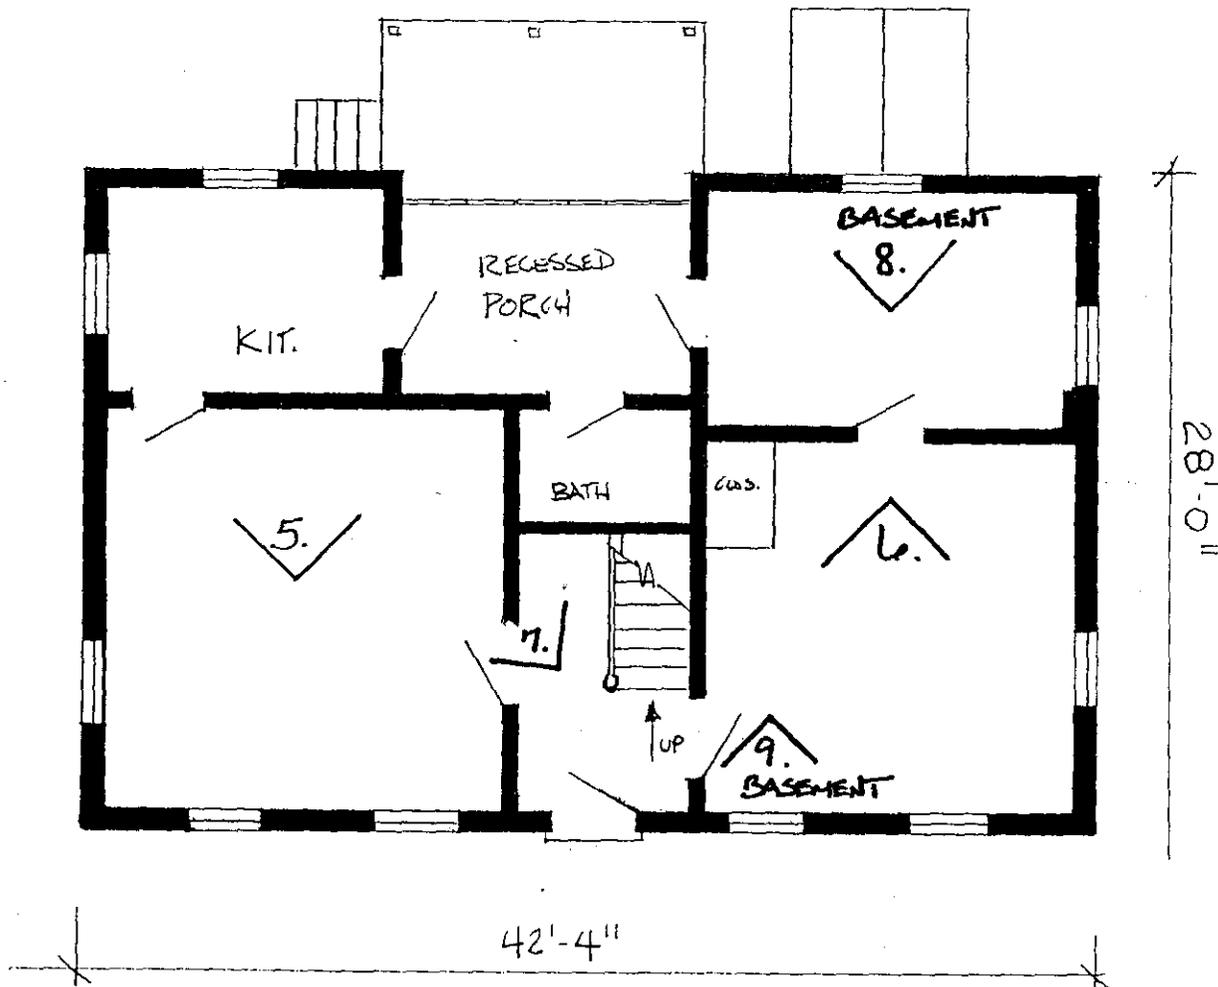
Photo Key.

See photo key for description of camera angle.
