United States Department of the Interior  
National Park Service  
**National Register of Historic Places  
Registration Form**

historic name Kruse, Casper, House  
other names/site number Stumpe, Wilhelmina, House

street & number 202 Stafford Street [N/A] not for publication  
city or town Washington [N/A] vicinity  
state Missouri code MO county Franklin code 071 zip code 63090-2307

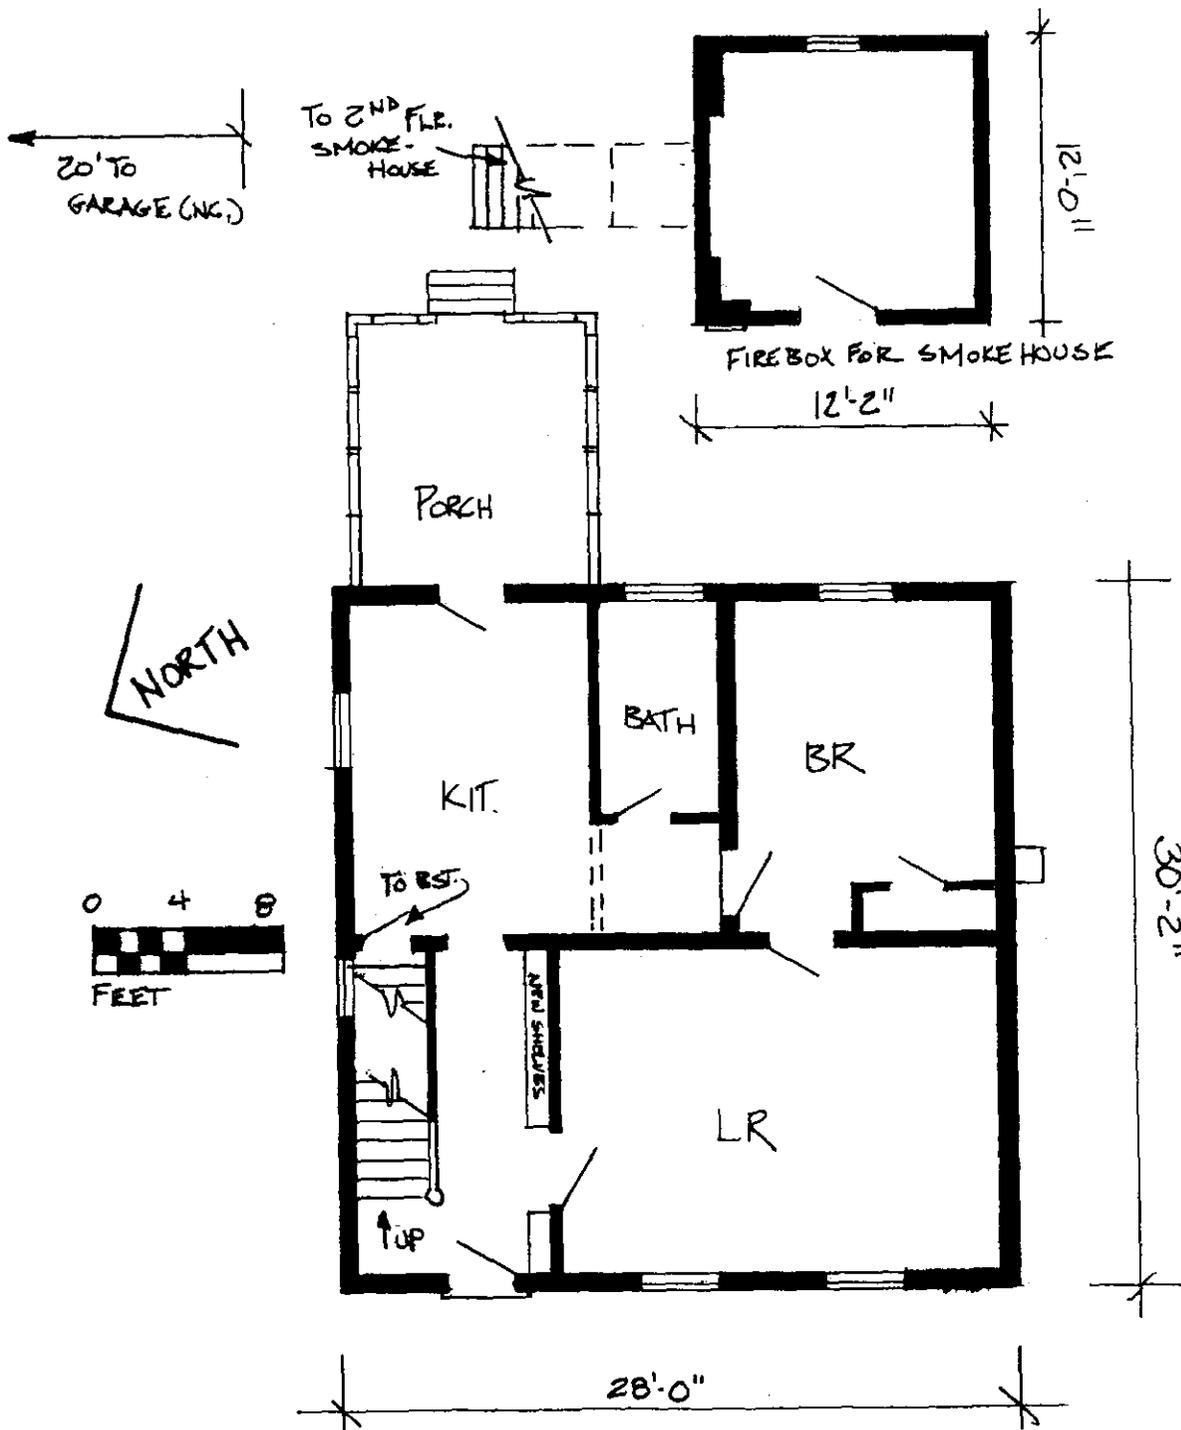
Figure One. First Floor Plan. Drawn by Debbie Sheals.

The interior of the house is little changed. Neither the plan nor the interior finishes have seen significant changes. The front door opens onto a narrow stair hall. (See photo 6.) The hall features a straight-run staircase which leads to the second floor bedrooms. The painted newel post has a tapered polygonal base, and the handrail curves down over the newel post in a small scroll. (The railing and newel post are almost identical to those in the Albert Krog house, at 1395 West Main Street.) The hall also contains a door to the kitchen, which is at the rear of the house, and one to the front parlor, which is opposite the stair hall at the front of the house. There is a bedroom in the far corner of the house which has doors to both the kitchen and the parlor. The kitchen was partitioned at an early date to add a bathroom between it and the back bedroom. (See Figure One, floorplan.)

The kitchen also contains a door to the basement stairs, which are directly beneath the main staircase. The basement consists of two large open rooms, with a 17-inch thick wall beneath the bearing wall above. There is also a doorway on the south wall of the basement which leads to a set of steps which are set into a well on the outside of the building. The second floor of the house contains two small bedrooms which have slanted ceilings which follow the slope of the roof.

Most interior millwork is in place throughout the house. The doors and windows of the main floor have simple pedimented trim with narrow bands of molding along the top edges. (See photos 6 and 7.) The molding follows the slope of the pediment tops. Many of the doors have four panels, and most are early or original. The second floor millwork is much simpler, and consists primarily of plain flat boards. (See photo 8.) Most of the original plaster walls are intact and in good condition, as are the wood floors.

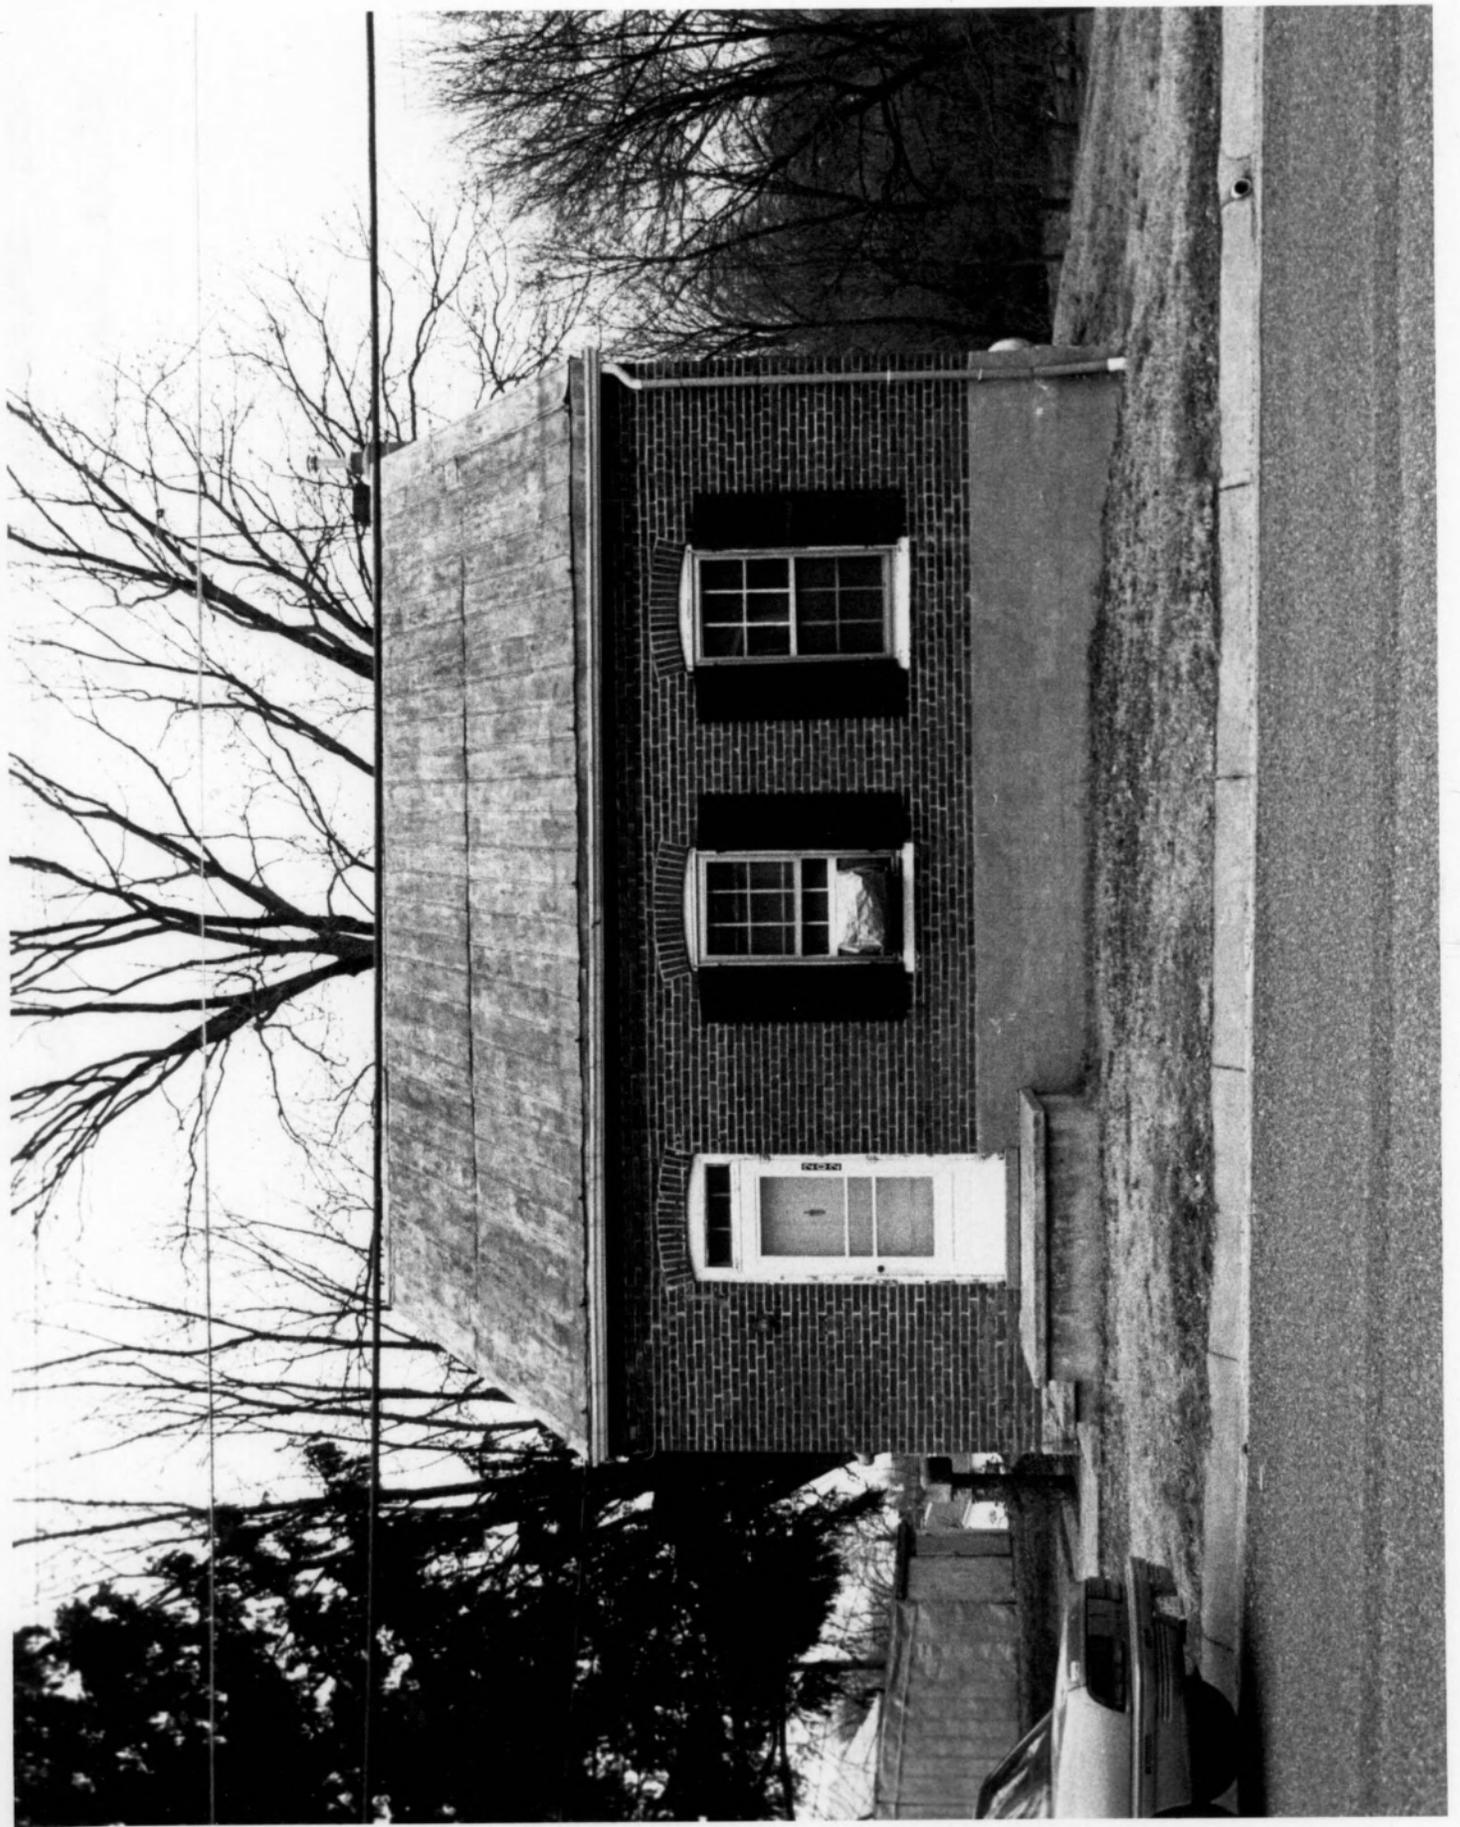
1. Facade, west elevation.
2. South elevations, house and smokehouse.
3. Southeast corners.
4. Northeast corners.
5. North elevations, with garage.
6. Interior, stair hall and back door.
7. Living room, looking to hallway.
8. Second floor, looking to stairs.
9. Interior, second floor of smokehouse, with smoke register.

The house is very much intact, inside and out. The original form and patterns of fenestration are little changed, and from the street it appears today much as it did in the 1860s. The six-over-six windows are original or very early. The interior is also little changed. Almost all original pedimented door and window trim is in place and in good condition, as are most early wood floors. The house is one of the more intact examples of the Side Entry subtype in the study group, and the smokehouse is an unusual and highly intact early outbuilding. Both are representative examples of the Missouri-German building tradition of the nineteenth century.

The house itself utilizes the common form of a Missouri-German Side Entry house. It is one story tall, with a side-facing gable roof and a three-bay facade. The roof is sheathed with early standing seam metal roofing. The doorway is set to the side of the facade, and the two front windows have early or original louvered shutters. (See photo 1.) The door is topped with a short three-light transom. There is a small concrete stoop in front of the doorway, and the lower part of the front wall is stuccoed with concrete.

The house has red brick walls laid in a common bond, and the door and window openings are all topped with slightly flared segmental brickwork arches. The arches are composed of sailor bricks, and the windows have six-over-six sash which are early or original. Both the front and back walls have dentiled cornices. The cornices contain several stepped rows, with dentils which are made up of single sailor bricks. The dentils are close to the top of the cornices, and there are two more stepped courses below them. The dentils end about eight inches from the ends of the walls, and the stepped courses continue to the very edge. There is one internal corbeled brick chimney on the south side of the roofline.
