Summary Report
Architectural and Historical Survey
La Grange, Lewis County, Missouri

Project No. 29-96-11100-422

July 15, 1997

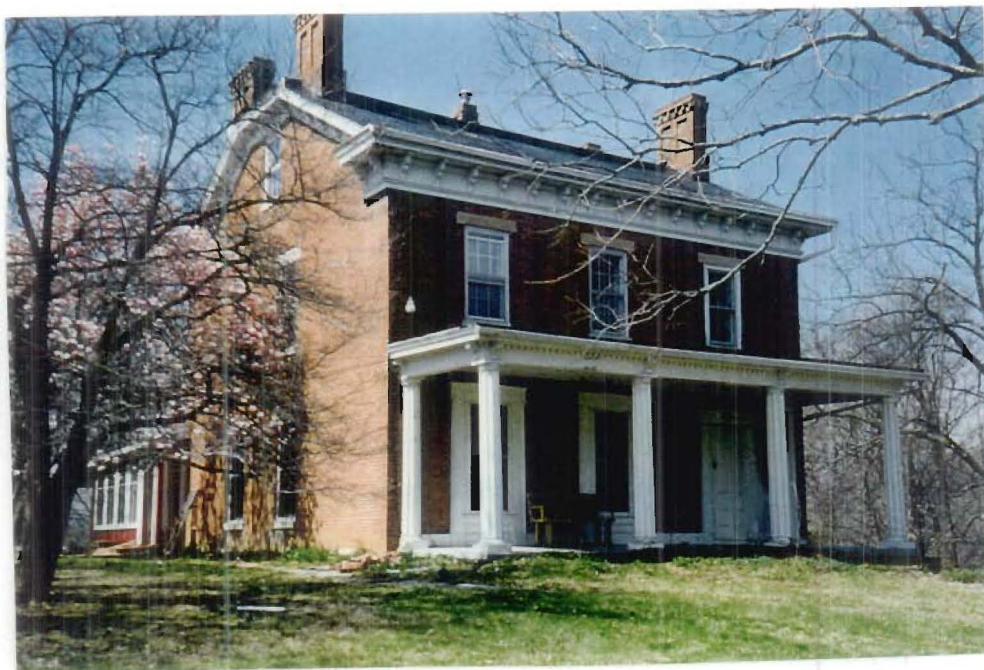
Cover photo:
Survey Property 165/9, the C. R. Browning House, ca. 1873.

One of the largest and most intact houses from this period was reportedly built for a man who made his living as a railroad promoter. The C. R. Browning house, 165/9, is located in the southern part of town, on the bluff near the Riverview cemetery. (See cover photo.) The ca. 1873 house stands as one of the best late examples of Greek Revival architecture in the survey group. It is a 2-1/2 story, three bay, brick house with a full front porch and Greek Revival style millwork. The house, which faces the river valley, is well-built and in excellent condition. A close look at construction techniques shows that it was built with two main elevations. The front, or east, side, and the south wall, which is the one approached from town, are more elegantly appointed than the north and west walls. Both walls feature a running bond in the brickwork, a refinement usually reserved for only the front walls of the finer houses in the survey area. Also, the windows of those two walls have tooled stone sills and lintels, while those of the other elevations are of wood.

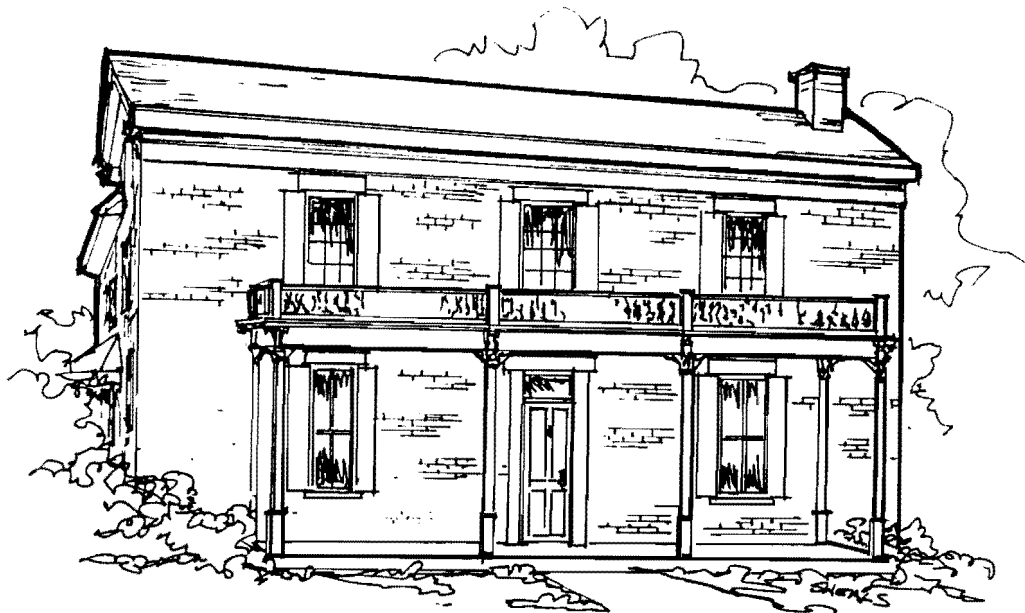
Figure Five. Survey property 66/6, a ca. 1860 brick I-house.

I-houses are by definition one room deep and at least two rooms wide, with the wide part of the house set parallel to the road to create the broadest possible facade. One and two story rear kitchen ells were common, either as part of the original house or a later addition.²⁸ The term "I" house was coined by geographer Fred Kniffen in the 1930s, based on his observation that the builders of such houses in Louisiana often came from Illinois, Indiana, and Iowa. Also, as he noted, "the 'I' seems a not inappropriate symbol in view of the tall, shallow house form it describes."²⁹

I-houses were commonly built in Kentucky, Tennessee and Virginia, and the form moved west with settlers from those areas. The popularity of such houses in La Grange is not surprising, as a large number of the area's settlers (including Saunders) were from those states.³⁰ Although I-houses are essentially vernacular buildings, it is very common to see them embellished with high-style characteristics. Most of the ante-bellum I-houses in La Grange were built in the Greek Revival style. Notable examples of I-houses in La Grange include survey properties 85/5, 125/7, 66/6, 180A/9 and 181/9.

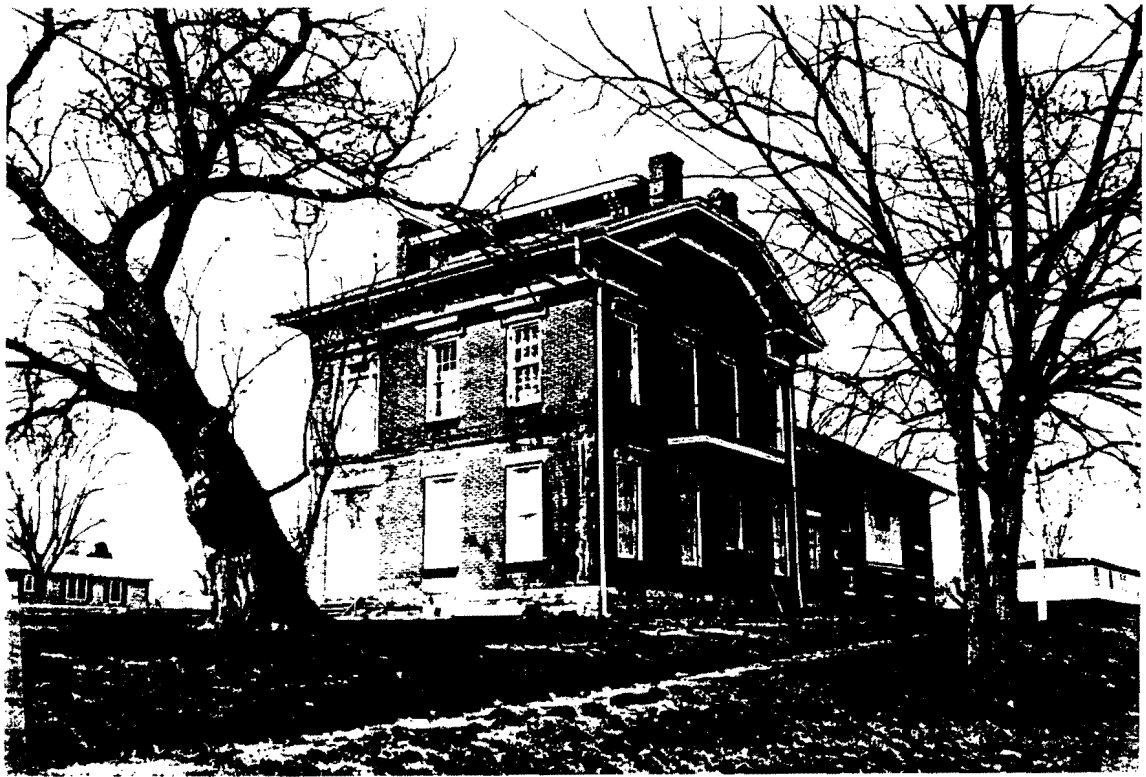
Figure Seven. Survey Property 86/5, the John M. Cashman House, built 1858.

Cashman and his wife Susan bought the land for their new house in 1856, and began laying the foundation in 1858. The local paper made note of the construction project in August of that year, proclaiming that the house, "when completed will be the finest family residence in La Grange." That claim holds true today. Even in a state of partial restoration, and missing a front porch, the Cashman House is still one of the most impressive buildings in La Grange, and the largest high style ante-bellum residential property in the survey group.

It is a large, two and one half story, side hall brick house with a bracketed cornice. A wide clerestory window on the roof is bracketed to match the cornice line, and appears to offer an impressive view of the Missouri River Valley. The multi paned windows are topped with tooled limestone sills, and many have ornamental cast iron sills as well. Matching tooled limestone blocks run along the water table on two sides of the house. The millwork of the full formal door surrounds is some of the finest in the survey group, and was probably of the highest quality in town when the house was built. The house has been extended

rearward over the years; part of the rear ell may have originally been a detached outbuilding.

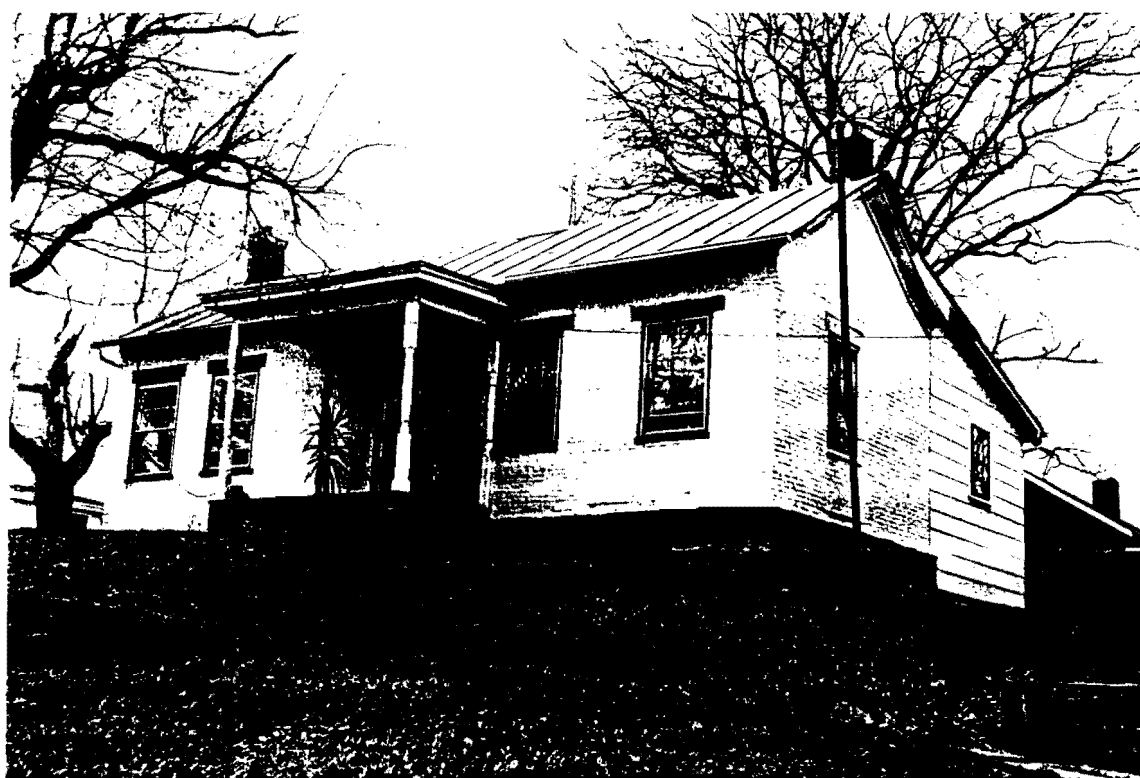
Figure Eight. Survey Property 162/9, the William Gunther House, ca. 1860.

Hall and Parlor houses were popular in La Grange, and throughout the country, especially before the turn of the century. Approximately 10% of the survey properties can be categorized as Hall and Parlor houses, and there is evidence that they originally accounted for a larger percentage of the housing stock. (The small size inevitably leads to expansions and major alterations, resulting in fewer intact historic examples.) Hall and Parlor houses in the survey group range in date from ca. 1849 to ca. 1940. Some of the more intact examples of this house type are found in the southern part of town, including 187/11, 196/11, and 162/9, below.

Hall and Parlor houses have two rooms of uneven size set side by side beneath a gable roof. The front door generally opens into the "hall," which is the larger of the two rooms. Like I-houses, the broadest part of the house is set parallel to the road, and rear ells are common, either as original rooms or later additions. The small house type was popular in all parts of the state, and was built by British-Americans as well as German-Americans. Missouri Germans were much more likely to build such houses of brick, and many of the town's earliest small brick houses appear to be the work of German-American craftsmen.⁵⁸

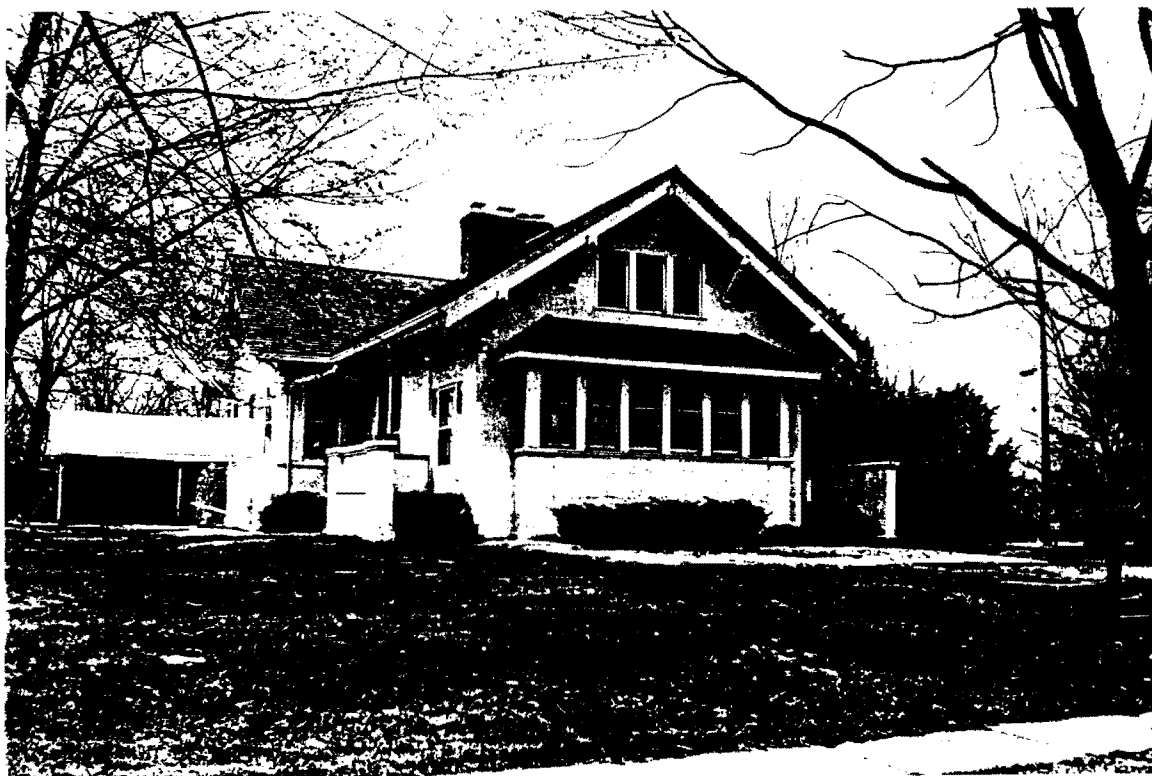
Figure Sixteen. The Wilbur Lake House, a 1920s Bungalow.

and gable end shakes are intact and in good condition. The house was built by or for Benjamin C. Klusmeyer, who became the youngest first class postmaster in the country when he was awarded that post in La Grange in the late 1890s. Other notable bungalows in the survey group include 81/4 and 87/4, both of frame, and 92/6, an especially well-crafted stone example.
