**SHPO Note for Marlborough Village Historic Resources Survey, Kansas City, Jackson County**

# Marlborough Village Historic Resources Survey

## City of Kansas City, Missouri

June 2016

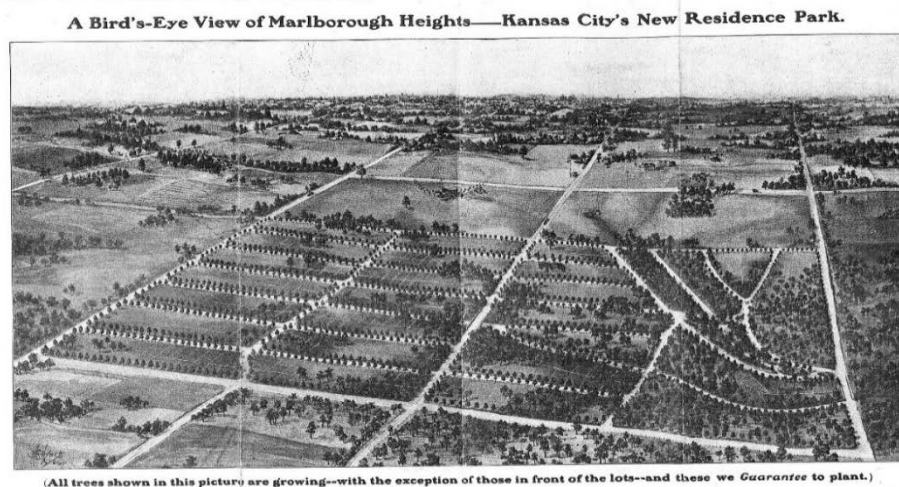
Figure 2. Bird's Eye View, Marlborough Heights, 1907 Advertisement.

lots, electric lights, city water services, and an electric streetcar line that connected the garden suburb to the city center (Figure 2).<sup>6</sup> The residents of Marlborough Heights and the other subdivisions that followed shortly thereafter supported the businesses that operated in Marlborough Village. Marlborough Heights became part of Kansas City when the city limits were extended to 79<sup>th</sup> Street in 1909, while the Marlborough Village commercial center and later developments south of E. 79<sup>th</sup> Street were not annexed until 1947.

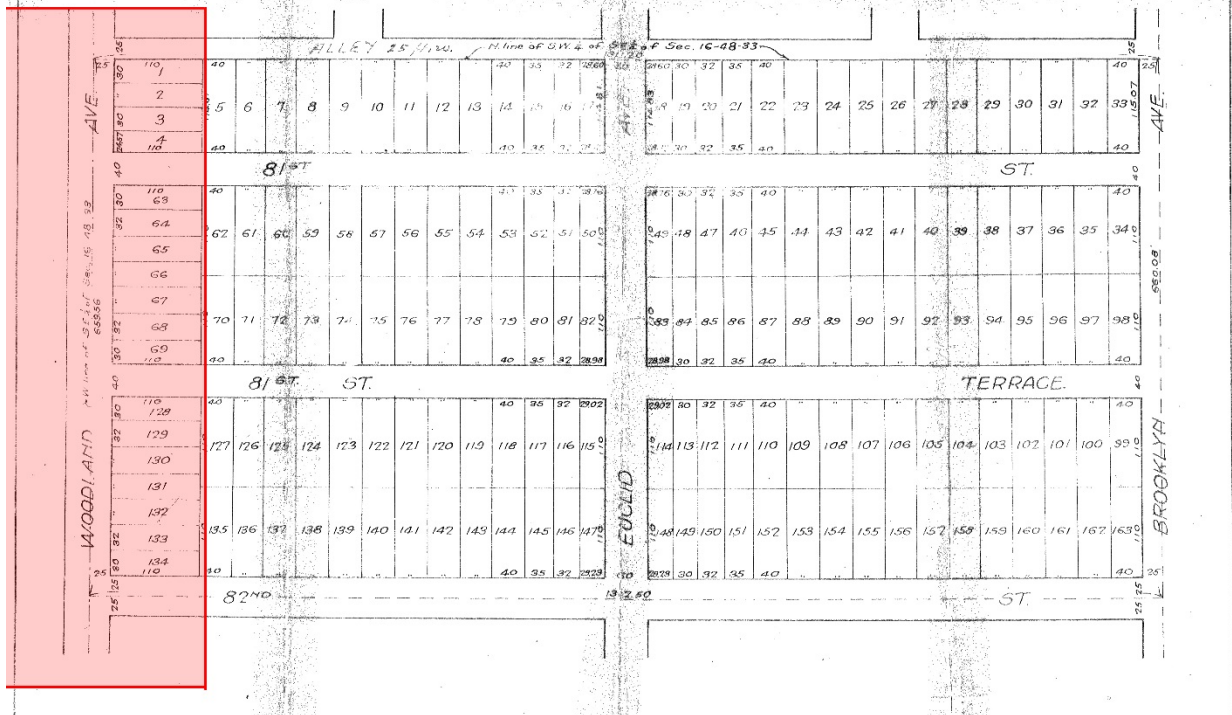
Figure 7. Marlborough Plaza Plat, 1911. Marlborough Village shown in red.

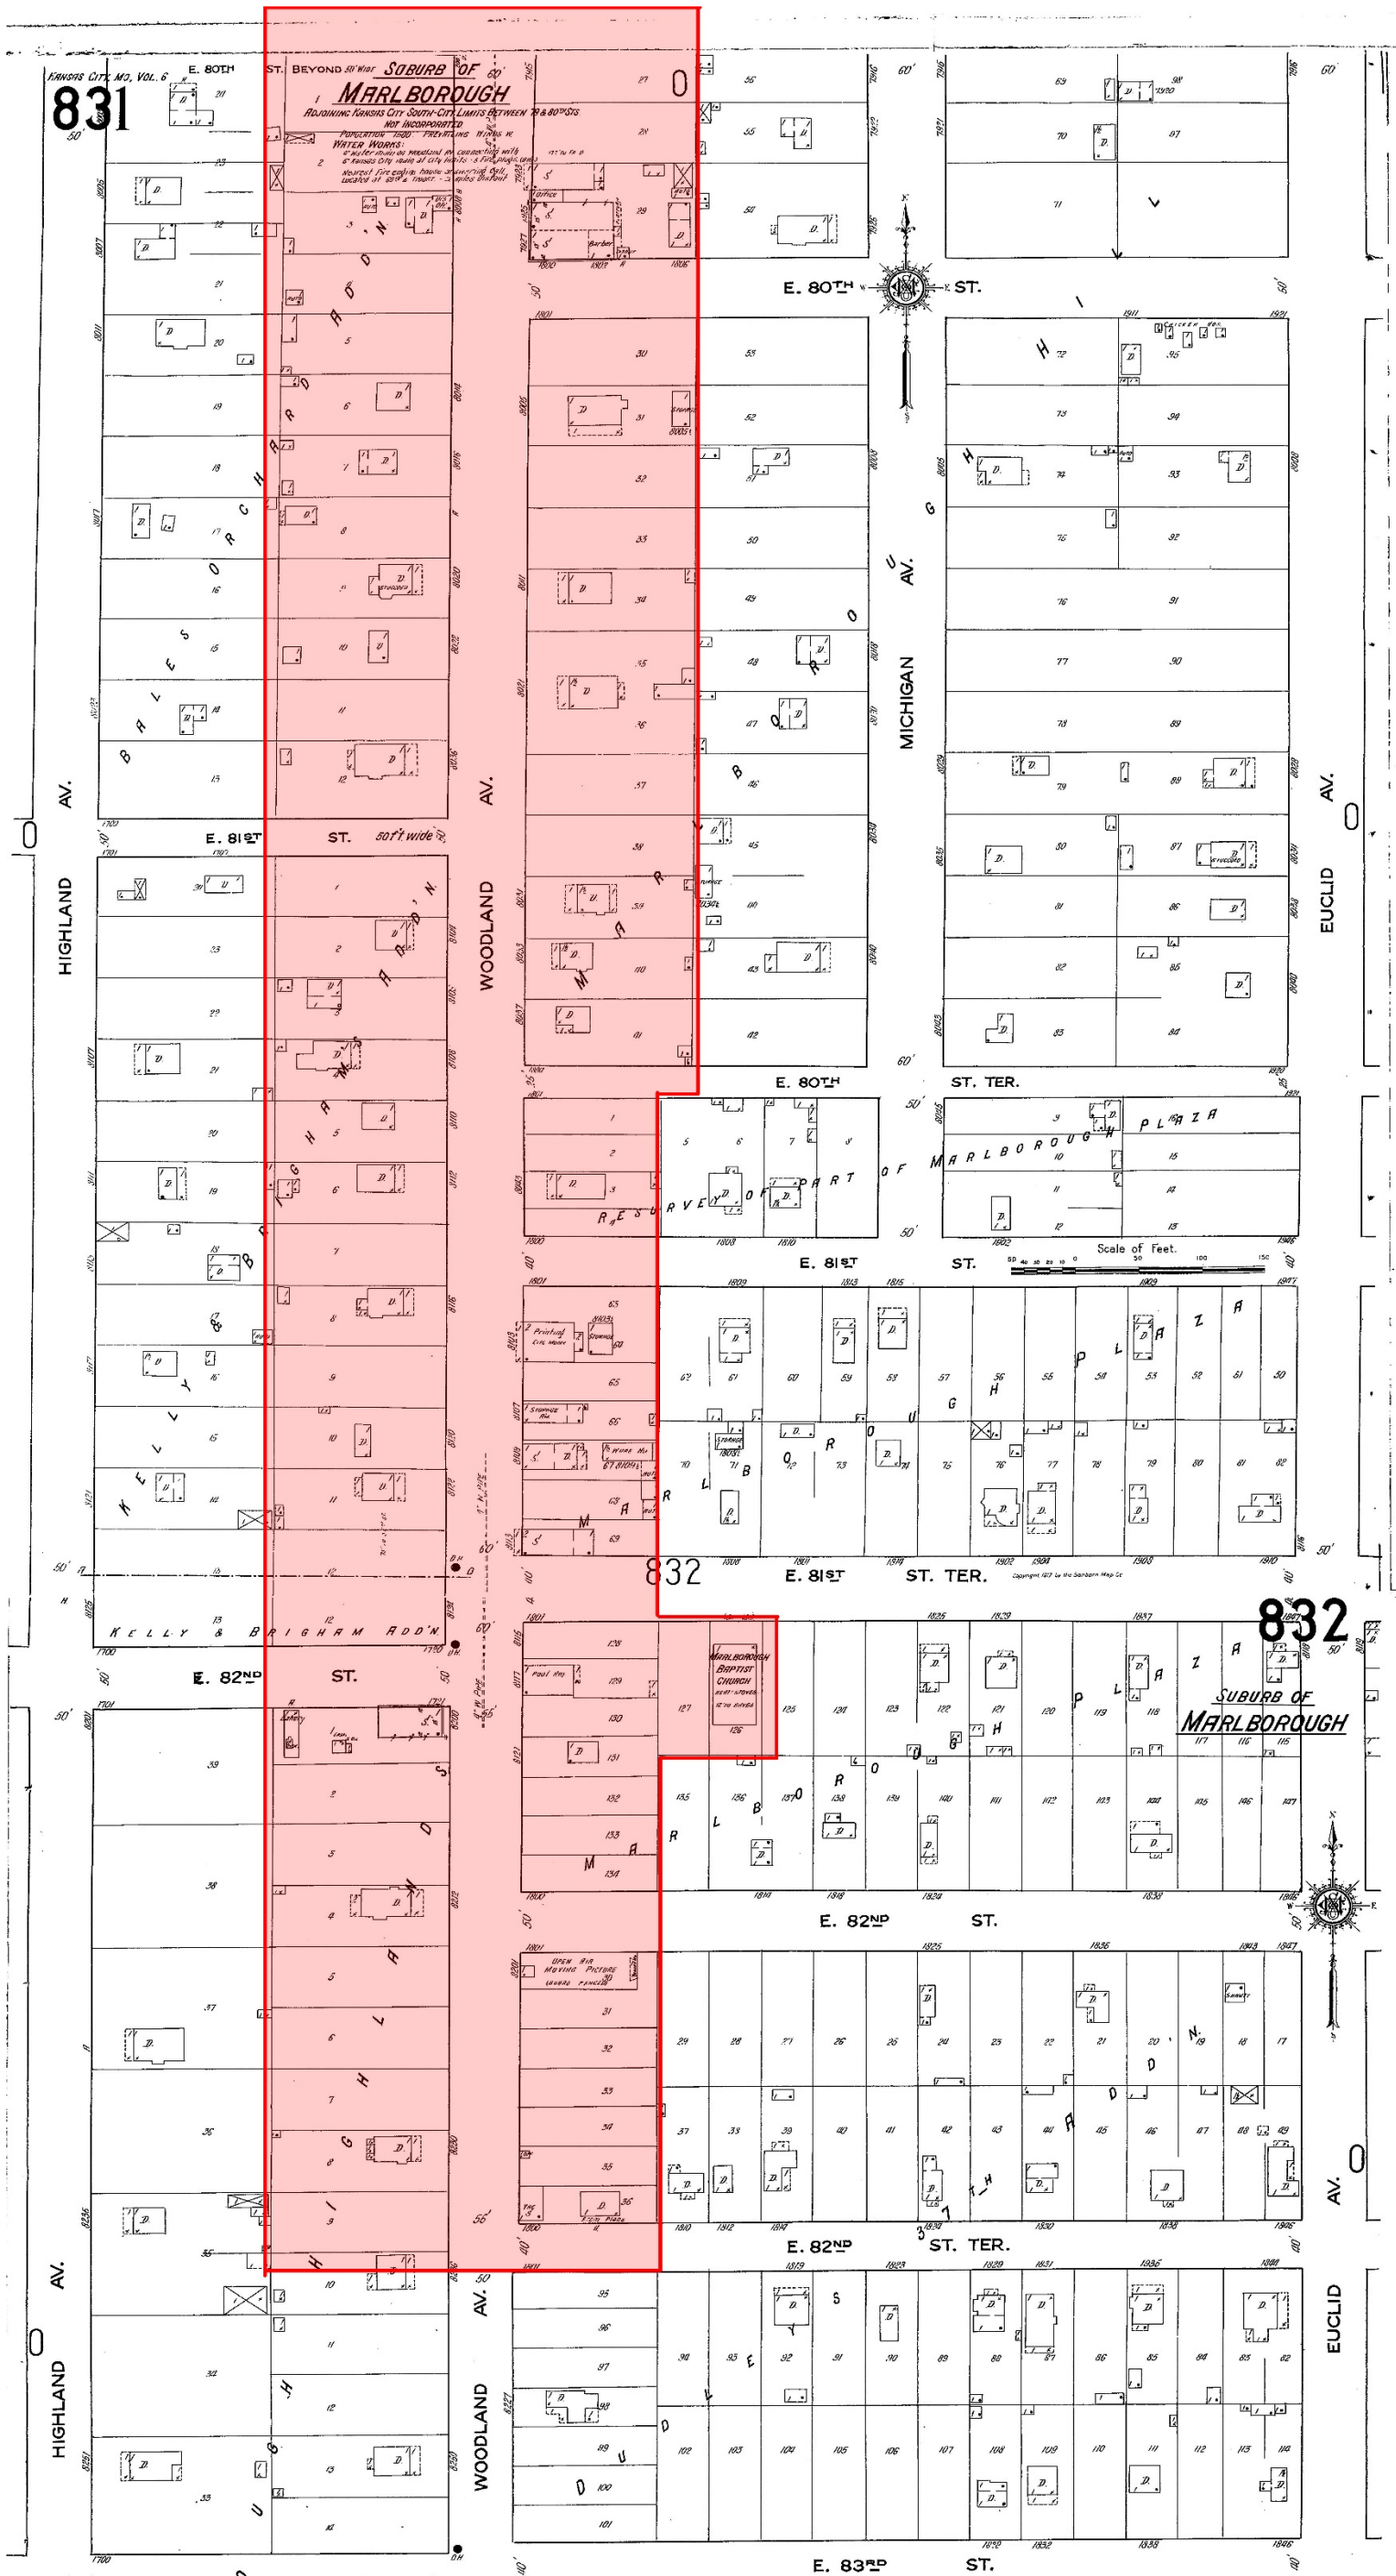
Figure 10. 1917 Sanborn Map. Marlborough Village shown in red.

Marlborough Village developed along Woodland Avenue (The Paseo) between E. 79<sup>th</sup> Street and E. 82<sup>nd</sup> Street, with its hub at the corner of Woodland and 80<sup>th</sup> Street. The 1917 Sanborn map (*Figure 10*) labels the area “the Suburb of Marlborough” and shows long, narrow buildings that housed three stores, a cobbler’s shop, and a barbershop densely packed in the lot at the northeast corner of Woodland Avenue and E. 80<sup>th</sup> Street. Commercial buildings south of E. 80<sup>th</sup> Street were generally detached and constructed on separate lots. Four additional retail shops occupied lots on the east side of Woodland Avenue between E. 81<sup>st</sup> Street and E. 81<sup>st</sup> Terrace. Wood frame or brick buildings housed these commercial businesses (*Figures 11-15*). While most buildings were one-story, the buildings at 8103 Woodland Avenue and 8113 Woodland Avenue were two stories. A property identified as “Open Air Motion Pictures” occupied the southeast corner of E. 82<sup>nd</sup> Street and Woodland Avenue.<sup>12</sup> Small one-story frame houses of varying sizes and with irregular setbacks were interspersed among the businesses on both sides of Woodland Ave, although not every lot was developed.<sup>13</sup> Marlborough was still developing in the early 1920s, when the city directory listed a garage, grocery store, drugstore, restaurant, and bank as the local businesses.<sup>14</sup>

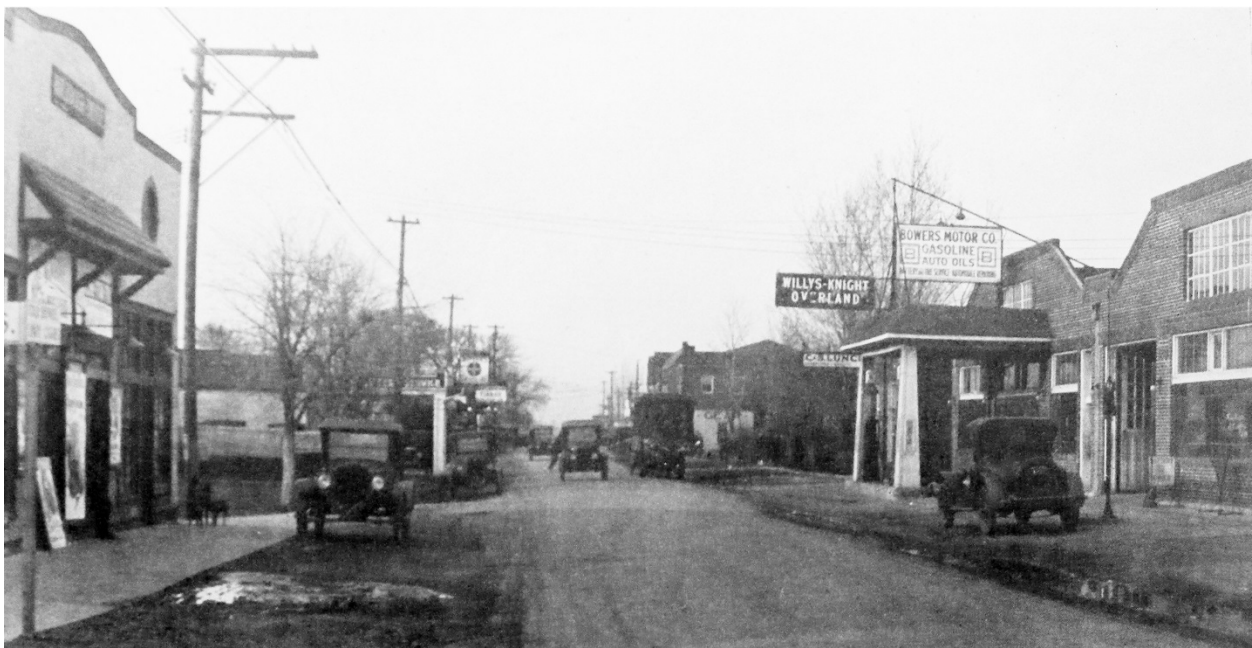
*Figure 11. Marlborough Business District, looking north on Woodland Avenue between 80<sup>th</sup> and 81<sup>st</sup> Streets, 1926. The 1930 Kansas City Directory lists the Bowers Motor Co (the building on the right) at 8025 Woodland Avenue.*

A second building boom in the mid to late 1920s grew the population of Marlborough, creating demand for a more-developed commercial district with more-substantial brick buildings. By the late 1920s, Marlborough's commercial district had expanded to meet the needs of the surrounding community. Early commercial buildings in Marlborough Village were one-story brick structures with shaped parapets typical of the period. Large display windows with transoms and gable-end windows let in natural light. Canopied service stations fronted Woodland Avenue (*Figure 11*). A 1926 account describes "Marlborough [as] a town to itself," advertising its location as far enough from the city to be an exurban retreat, but close enough to travel easily into Kansas City by streetcar.<sup>15</sup> An associated photograph shows a bustling commercial center filled with automobile-related and light-industrial resources as well as retail stores. A one-story brick building at 8016 Woodland Avenue, built c. 1925, housed an auto-sales and service shop. Industrial buildings at 8021 and 8025 Woodland Avenue, built c. 1925, housed a tin shop and metal wire manufacturing shop. A general store at 8101 Woodland Avenue and a grocery store and butcher shop at 8107-8109 Woodland Avenue opened in c. 1925 and 1926, respectively (*Figure 12*). These buildings are all extant.<sup>16</sup> Filling stations at 7907 Woodland, built c.1934 and demolished in 1958, and 8040 Woodland, built c.1925, supplied gasoline to neighborhood automobiles. The latter became a store and operated as a hamburger stand in the 1970s; it is extant. A grocery store at 8204 Woodland opened c. 1925 in a building with brick walls and iron structural columns. The building was demolished in 1998.<sup>17</sup>

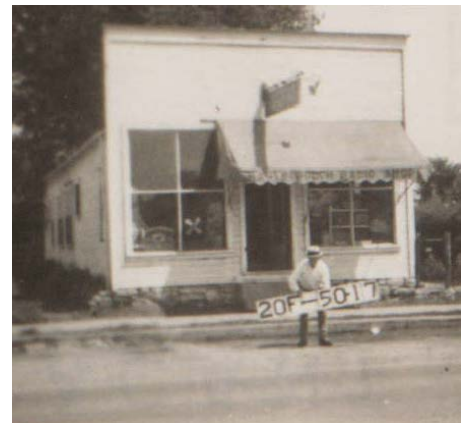
Figure 13. Radio Repair Shop, 8115 Woodland Avenue (The Paseo). 1940 tax assessment photograph.

While businesses that supported basic community needs, such as drugstores, general stores, carpenter shops, paint stores, and a radio repair shop, were established during this time, businesses associated with the social life of Marlborough residents opened as well (*Figure 13*). The large two-story brick buildings at 8001 and 8007 Woodland Avenue housed retail stores on the first floor and halls for social clubs, such as the Independent Order of Odd Fellows (IOOF) and the Masons (AF & AM), on the second floor. These buildings are extant. A movie theater at 8100 Woodland Avenue (The Paseo) also provided entertainment to local residents. The two-story front façade of the movie theater is extant; the rear portion of the building was altered in the late 1950s.<sup>22</sup>

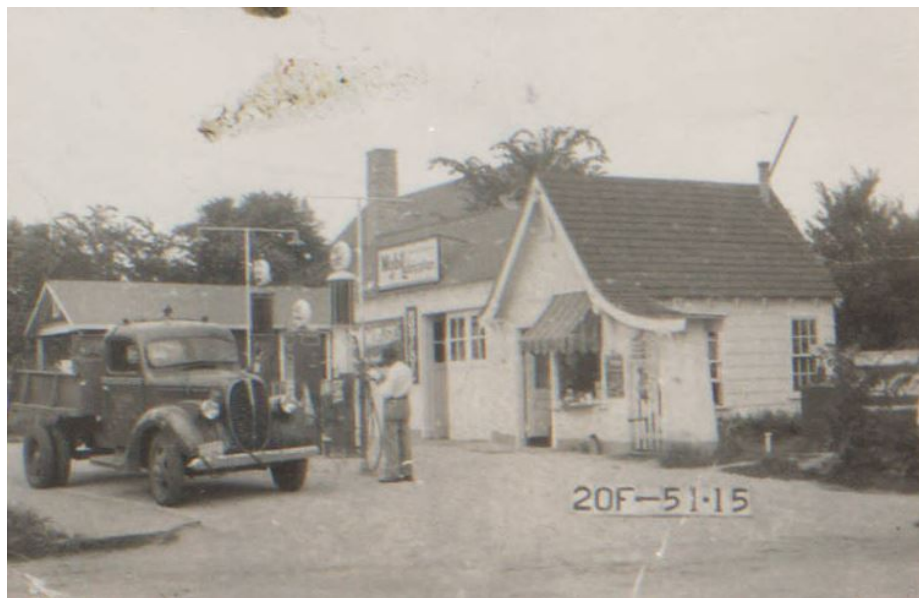
*Figure 14. Filling Station, 8135 Woodland Avenue (The Paseo). 1940 tax assessment photograph.*

As the popularity and availability of the automobile grew, so did the presence of automobile-related businesses in Marlborough Village (*Figure 14*). The 1951 Sanborn Map shows eight automobile-related resources along Woodland Avenue (The Paseo) between E. 79<sup>th</sup> Street and E. 82<sup>nd</sup> Street (*Figure 15*). Three of these were filling stations. The others were a parking lot at 7931 Woodland Avenue, a used car sales lot at 8010 Woodland Avenue, an auto sales and service garage at 8016 Woodland Avenue, a garage at 8035 Woodland Avenue, and an auto repair shop at 8101 Woodland Avenue, which opened in a new concrete block building.<sup>23</sup> Of these, only the service garage at 8016 Woodland Avenue (The Paseo) and the auto repair shop at 8101 Woodland Avenue (The Paseo) are extant.

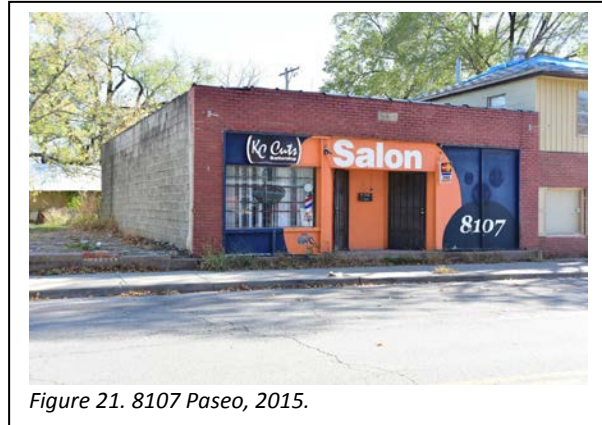
Figure 21. 8107 Paseo, 2015.

The One-Part Commercial Block building has only a single story and is a simple cube with a decorated façade. In several examples, multiple storefronts with separate entrances occupy one building and a cornice or parapet spans the width of the façade. The storefront of **8107 Paseo** was altered, but the commercial function remains clear (*Figure 21*).

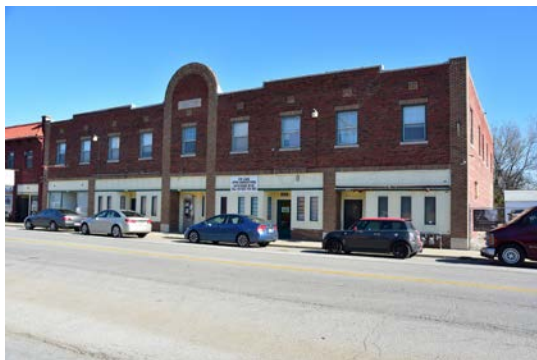
Figure 22. 8007 Paseo, 2015.

Slightly more complex than their one-story cousins, Two-Part Commercial Block buildings are typically two to four stories in height, although the Survey Area contains buildings none taller than two stories. They have a clear visual separation of use between the first-story customer service/retail space and the upper-story office, meeting room, or residential uses. Similar to One-Part Commercial Block buildings, the styling of the first story focuses on the storefront glazing and entrance(s). The design of the upper stories identifies the building's architectural influences. Good examples of Two-Part Commercial Blocks in the Survey Area include **8001 Paseo** and **8007 Paseo**. (*Figures 22 and 23*). Alterations include the infill of the storefront openings and the replacement of the second story windows. Shaped or tiled parapets, patterned brickwork, and stone lintels ornament the buildings.

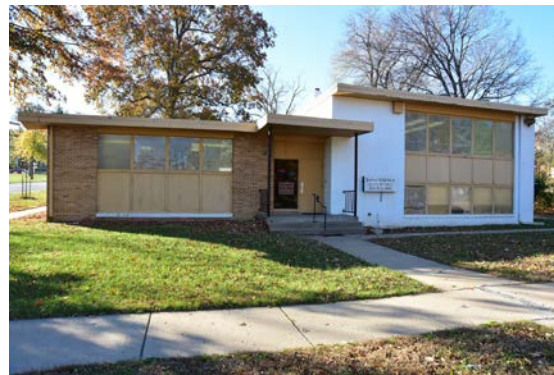
Figure 24. 7800 Paseo, 2015.

dimensional objects that defined space. Parking lots on one or all four sides of a building became dominant defining features of the commercial landscape, relegating the building to the role of back drop.<sup>30</sup> The healthcare clinic at **7800 Paseo** is an excellent example of a mid-twentieth century Free-Standing Commercial Block. (Figure 24). Brick and concrete block along with ribbon windows and an open stoop express the simple Modern Movement features.

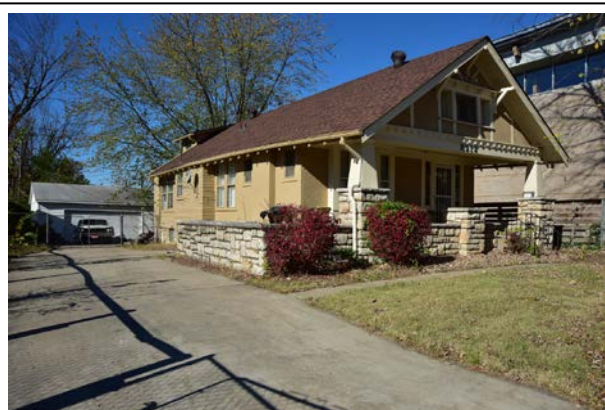
*Figure 25. 8212 Paseo, 2015.*

Craftsman houses date from circa 1905 through 1930. Most evolved from the early designs of Charles Sumner Greene and Henry Mather Greene who practiced architecture in California from 1893 to 1914. The Greene's designed both elaborate and simple bungalow houses that incorporated elements inspired by the English Arts and Crafts movement and by Asian architecture. Popularized by architectural magazines and builder pattern books, the one-story Craftsman house became popular nationwide during the early decades of the twentieth century as the most fashionable style for a smaller house. Identifying features include low-pitched roofs; wide eave overhangs, often with exposed roof rafters; decorative beams or braces under gables; and full- or partial-width porches supported by square piers.<sup>32</sup> Three resources represent the Craftsman style in varying degrees, making it the most common stylistic expression in the Survey Area. The low-pitched roof with exposed rafter tails, front gabled porch, and multi-light double-hung windows with vertical muntins on the house at **8212 Paseo** clearly exemplify Craftsman design (*Figure 25*).
