UNITED STATES DEPARTMENT OF THE INTERIOR  
NATIONAL PARK SERVICENATIONAL REGISTER OF HISTORIC PLACES  
INVENTORY -- NOMINATION FORM

Martin Hotel

Morgan County Historical Museum

### MARTIN HOTEL

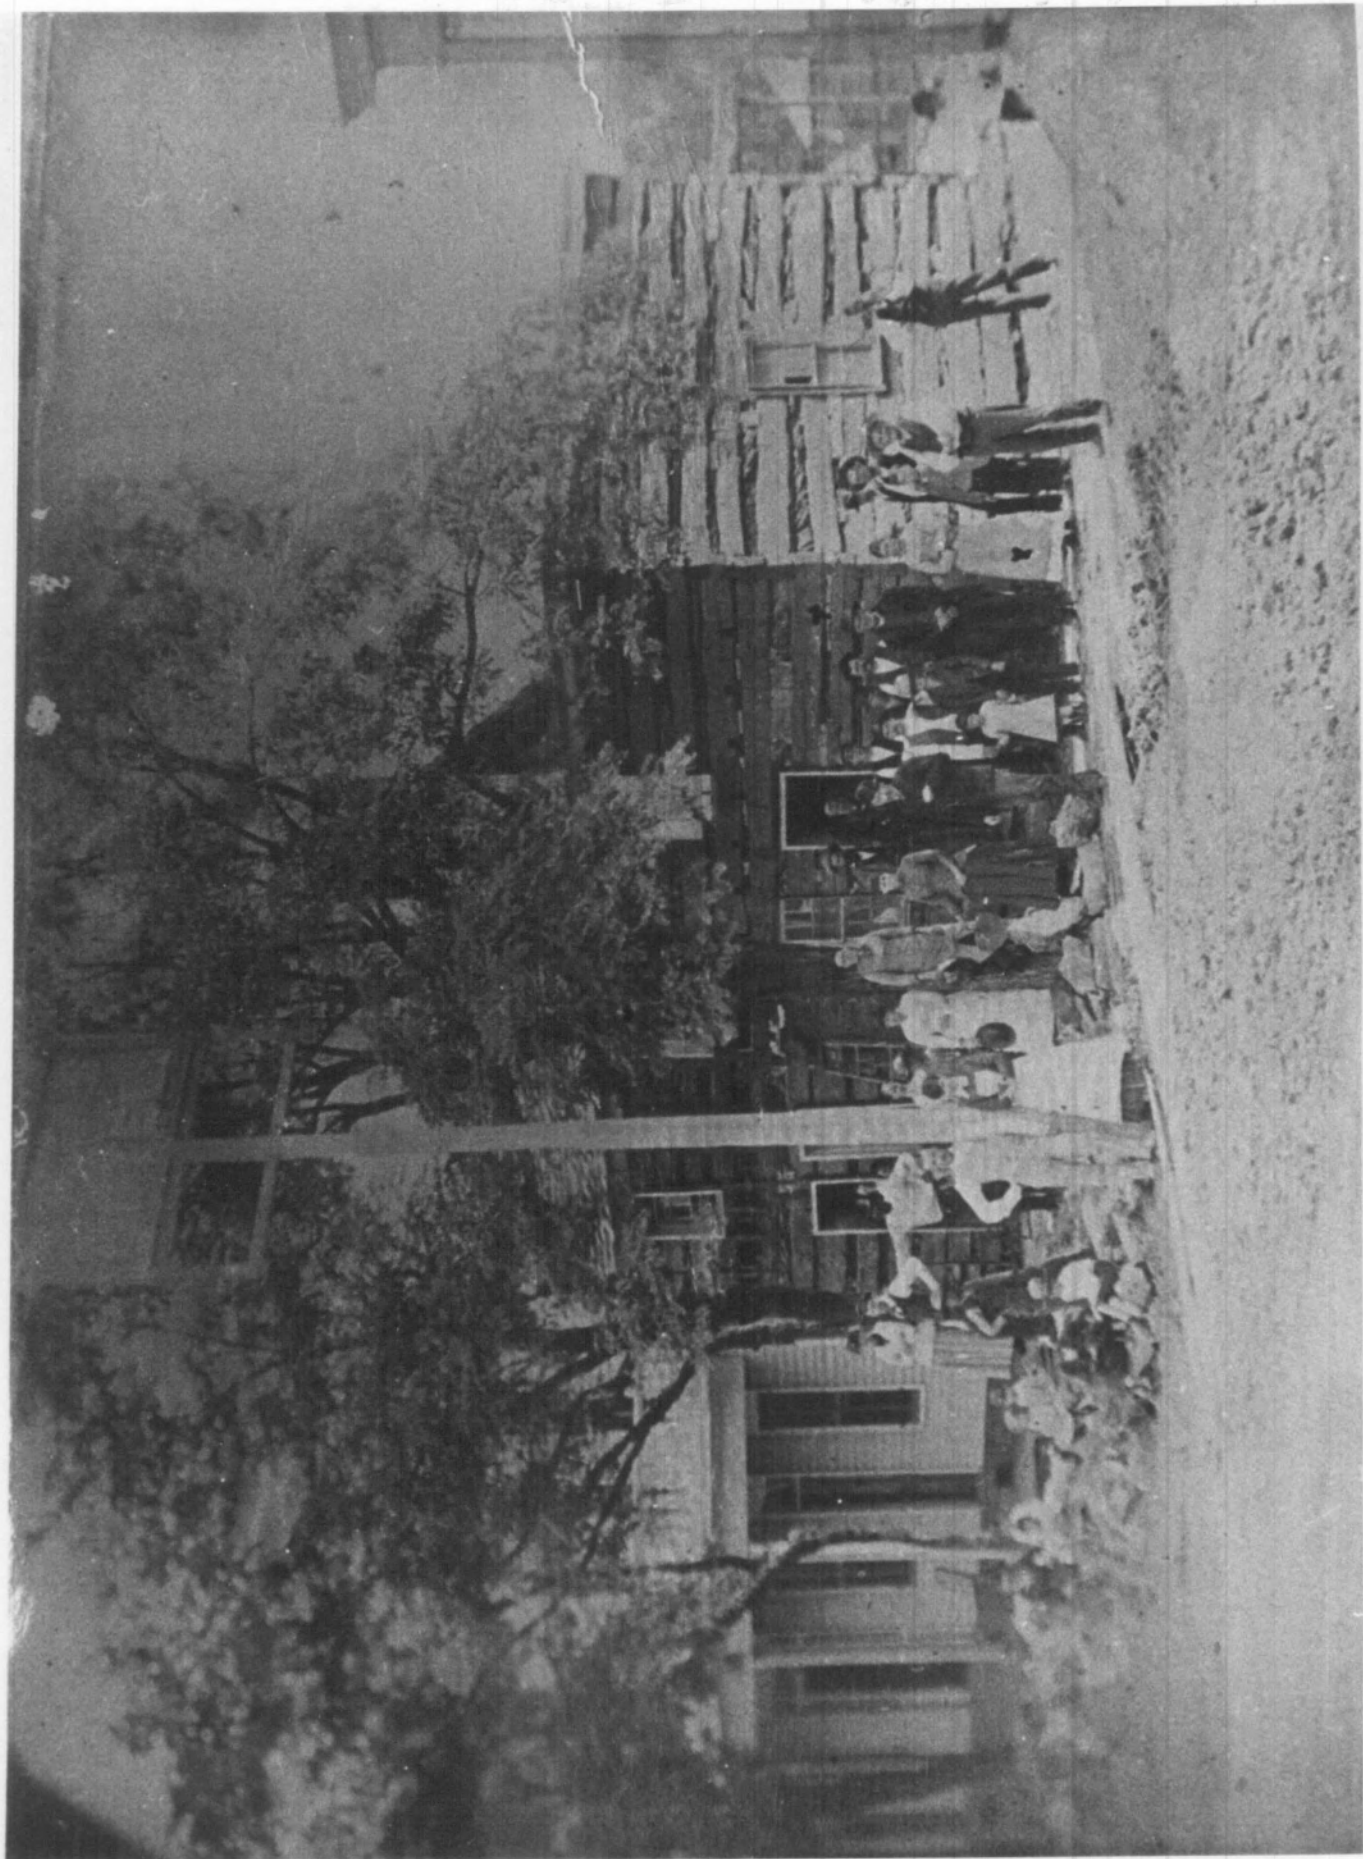
The first log Martin Hotel, photo  
circa 1880. 1877 frame building  
can be seen adjoining the log  
structure.

In 1877, the frame Martin Hotel building was erected. An early photograph (photograph #1) suggests that the original log building adjoined the new frame one and may have continued to be used until being dismantled to make way for the brick building. The photograph appears to have been taken during this dismantling.

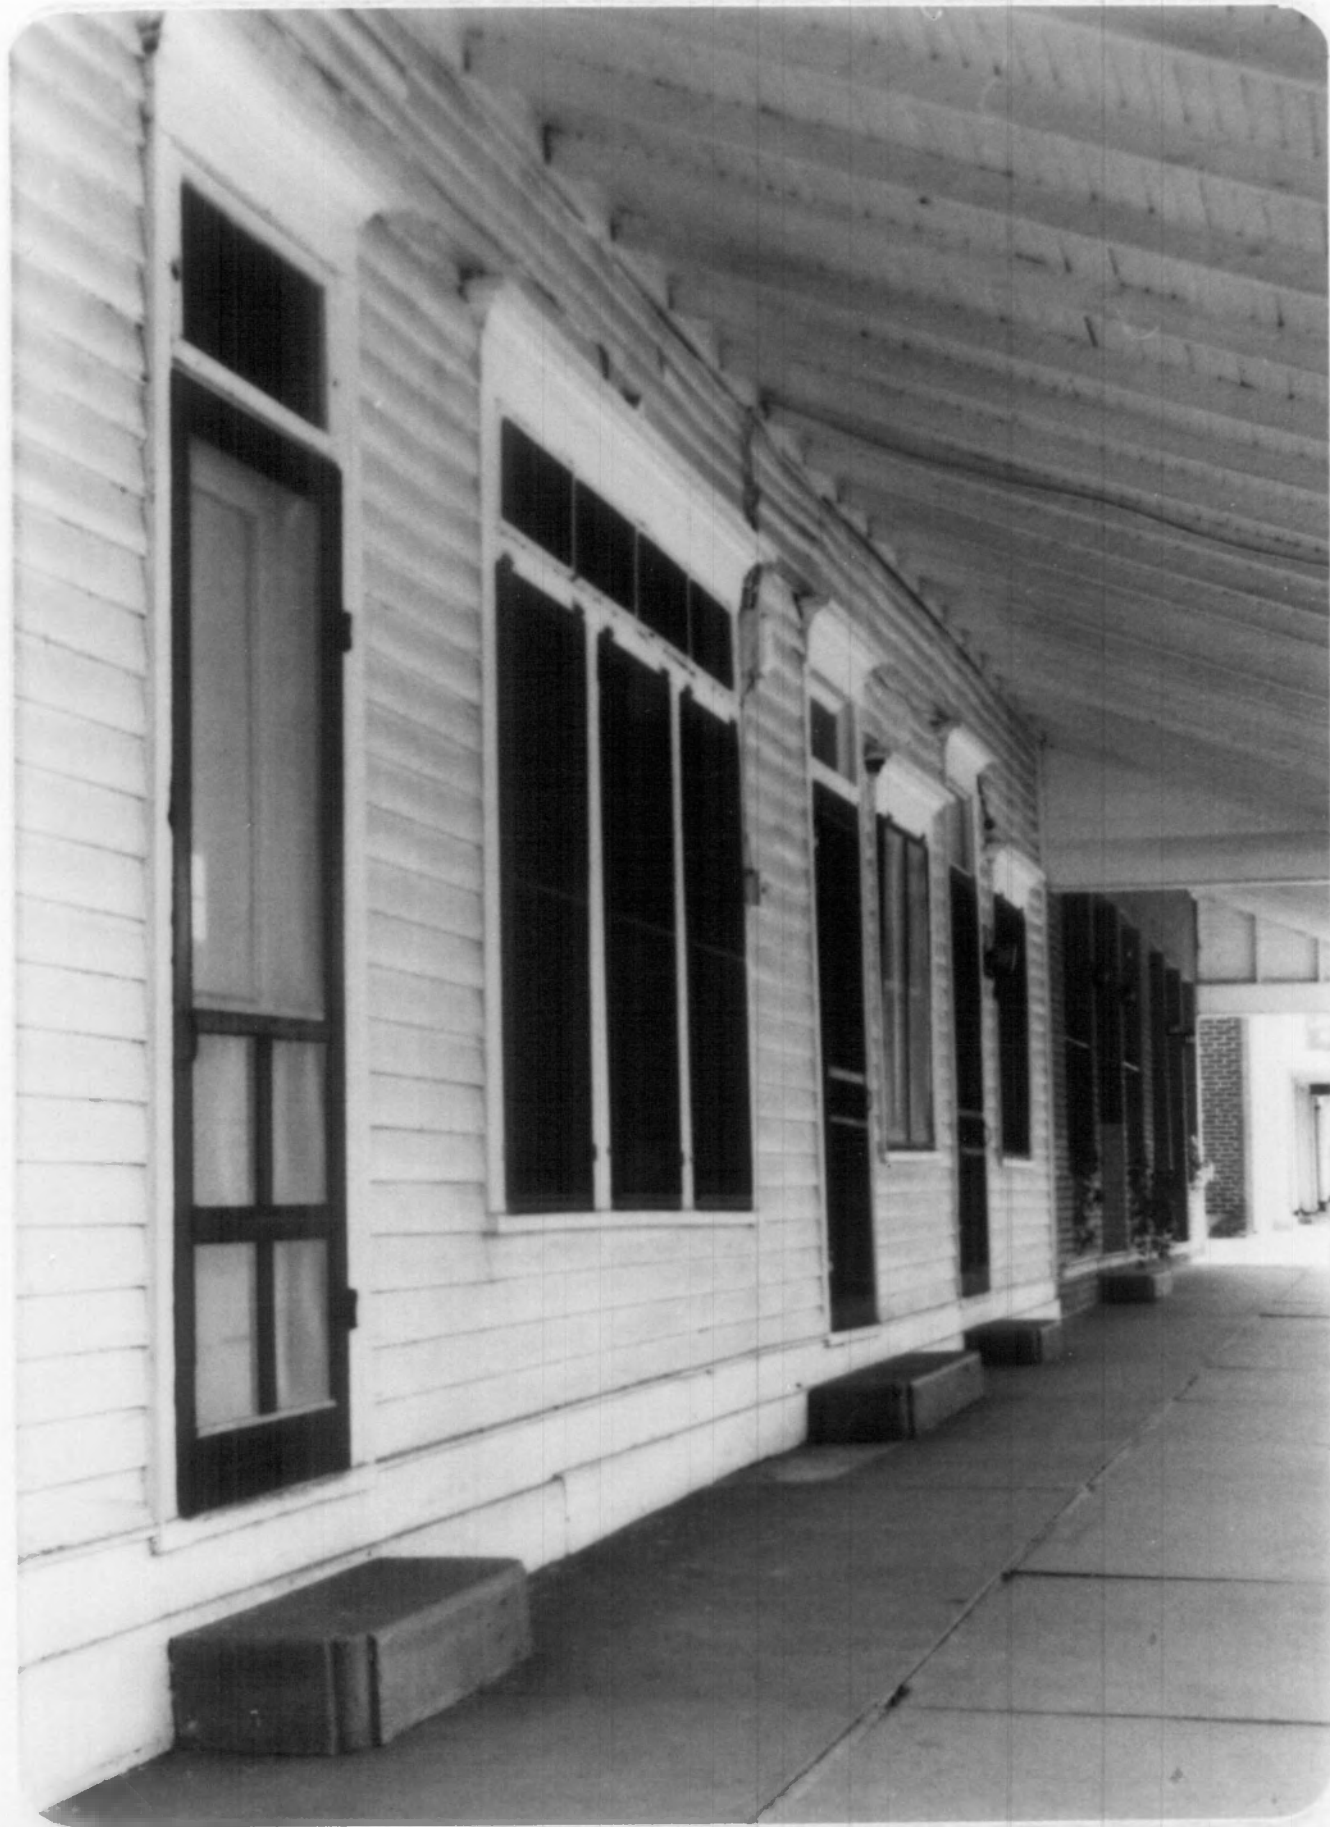
MARTIN HOTEL #3  
Versailles, Mo.  
Photographer: Harold Lampe  
September, 1977  
Cadmenton, Mo.  
Copy Neg. Loc.: Dept. of Natural Resources,  
P.O. Box 176, Jefferson City, Mo. 65101

Front west facade, view beneath lean-to  
porch, frame structure on the left

The lean-to porch is supported by seven equally spaced wooden columns; the roof has an approximate 4 X 12 pitch and is covered with asbestos shingles. The construction is exposed underneath; this porch extends across the entire front facade with the porch line being approximately one foot lower than that of the lean-to porch of the brick building which it joins. There are three entrances, with concrete stoops in front of each doorway of the primary facade. The three doors are all single-leaf, with four wooden panels and glass overhead transoms. These doors have the same style lintels as the second floor windows.

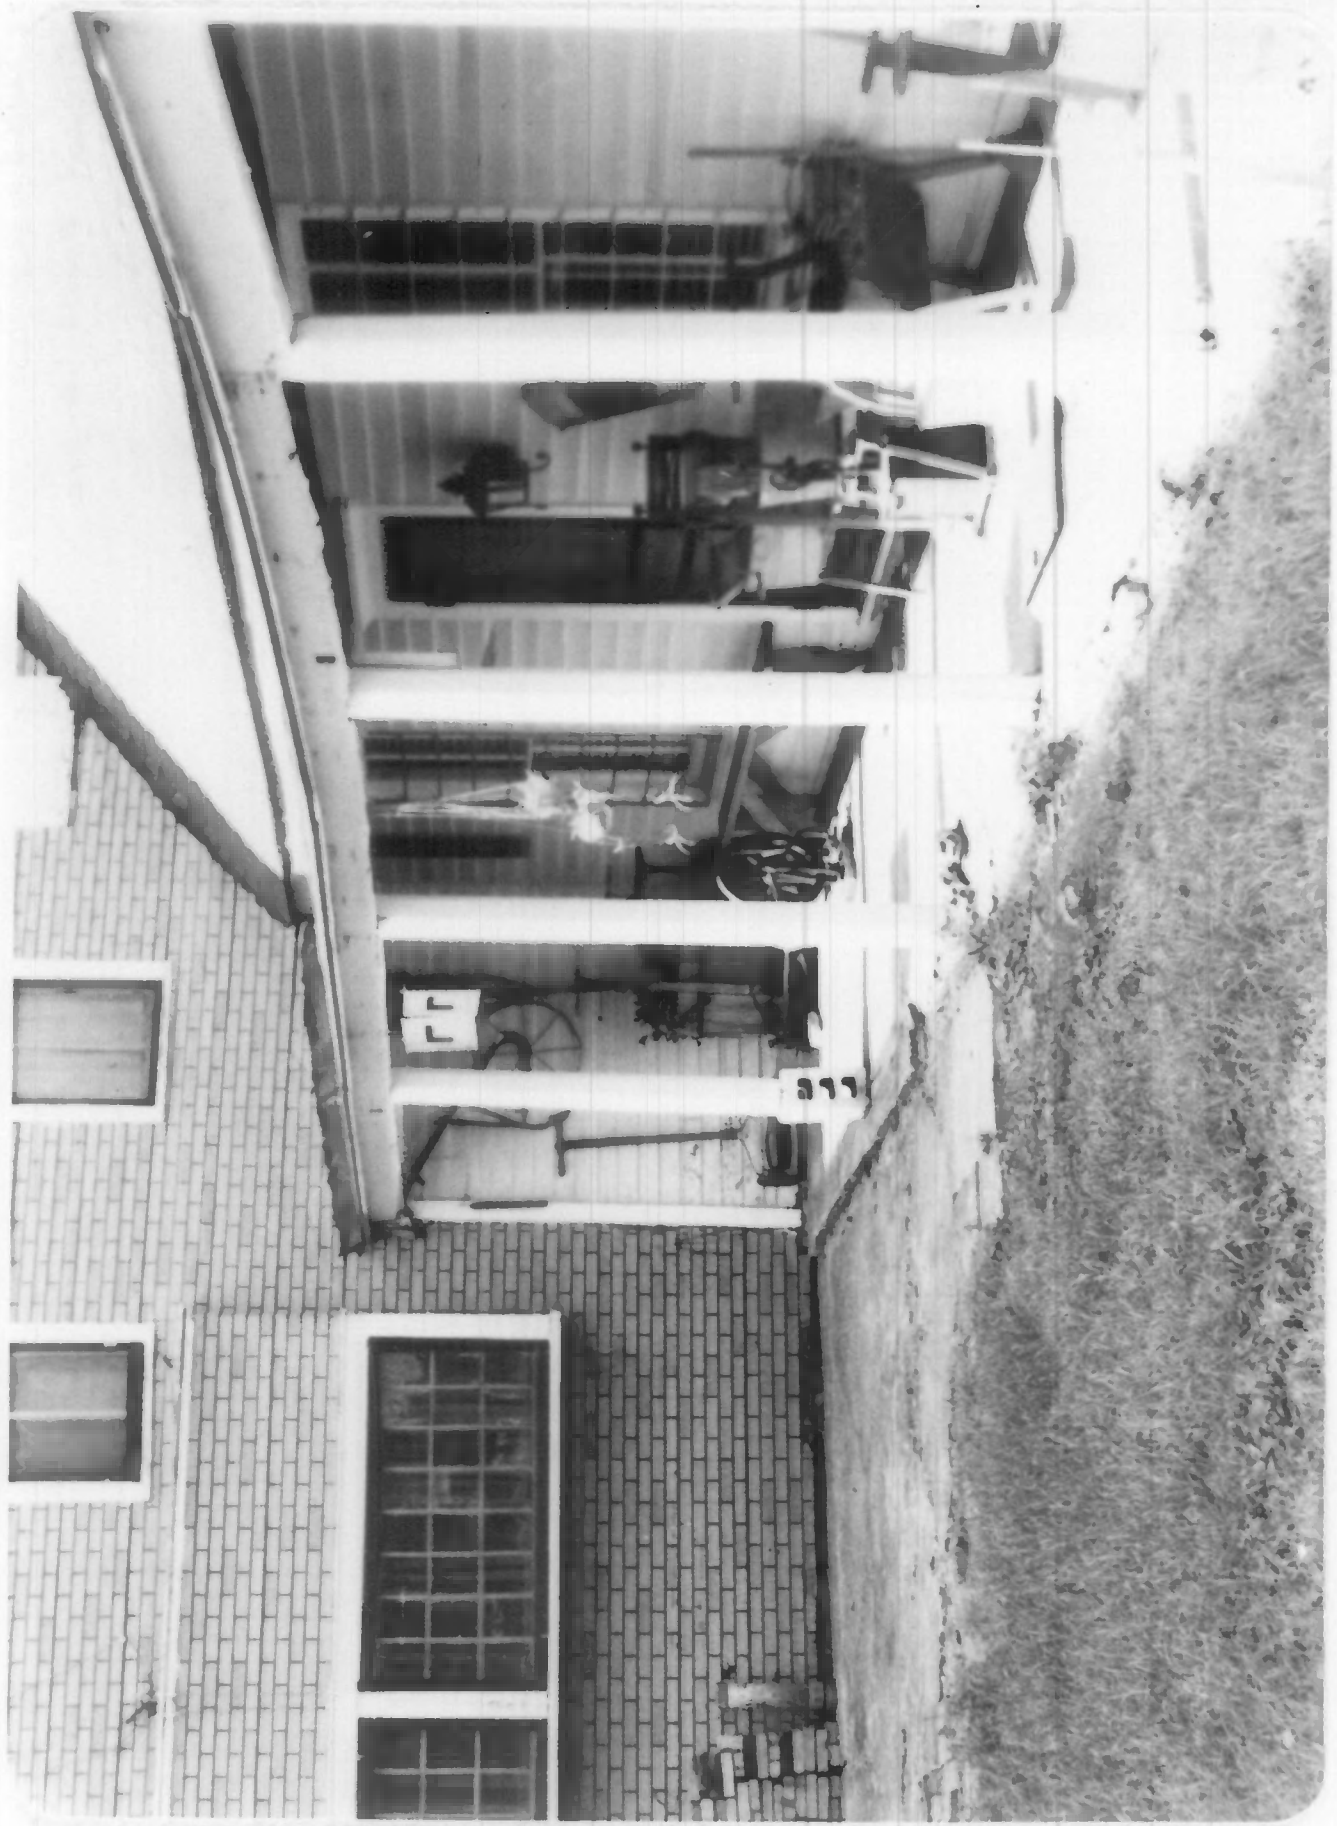
MARTIN HOTEL #5  
Versailles, Missouri  
Photographer: Harold Lampee  
September, 1977  
Cadmenton, Mo.  
Copy Neg. Loc.: Dept. of Natural Resources  
P.O. Box 176, Jefferson City, Mo. 65101

Frame building, east facade, showing porch on the south side of the library addition

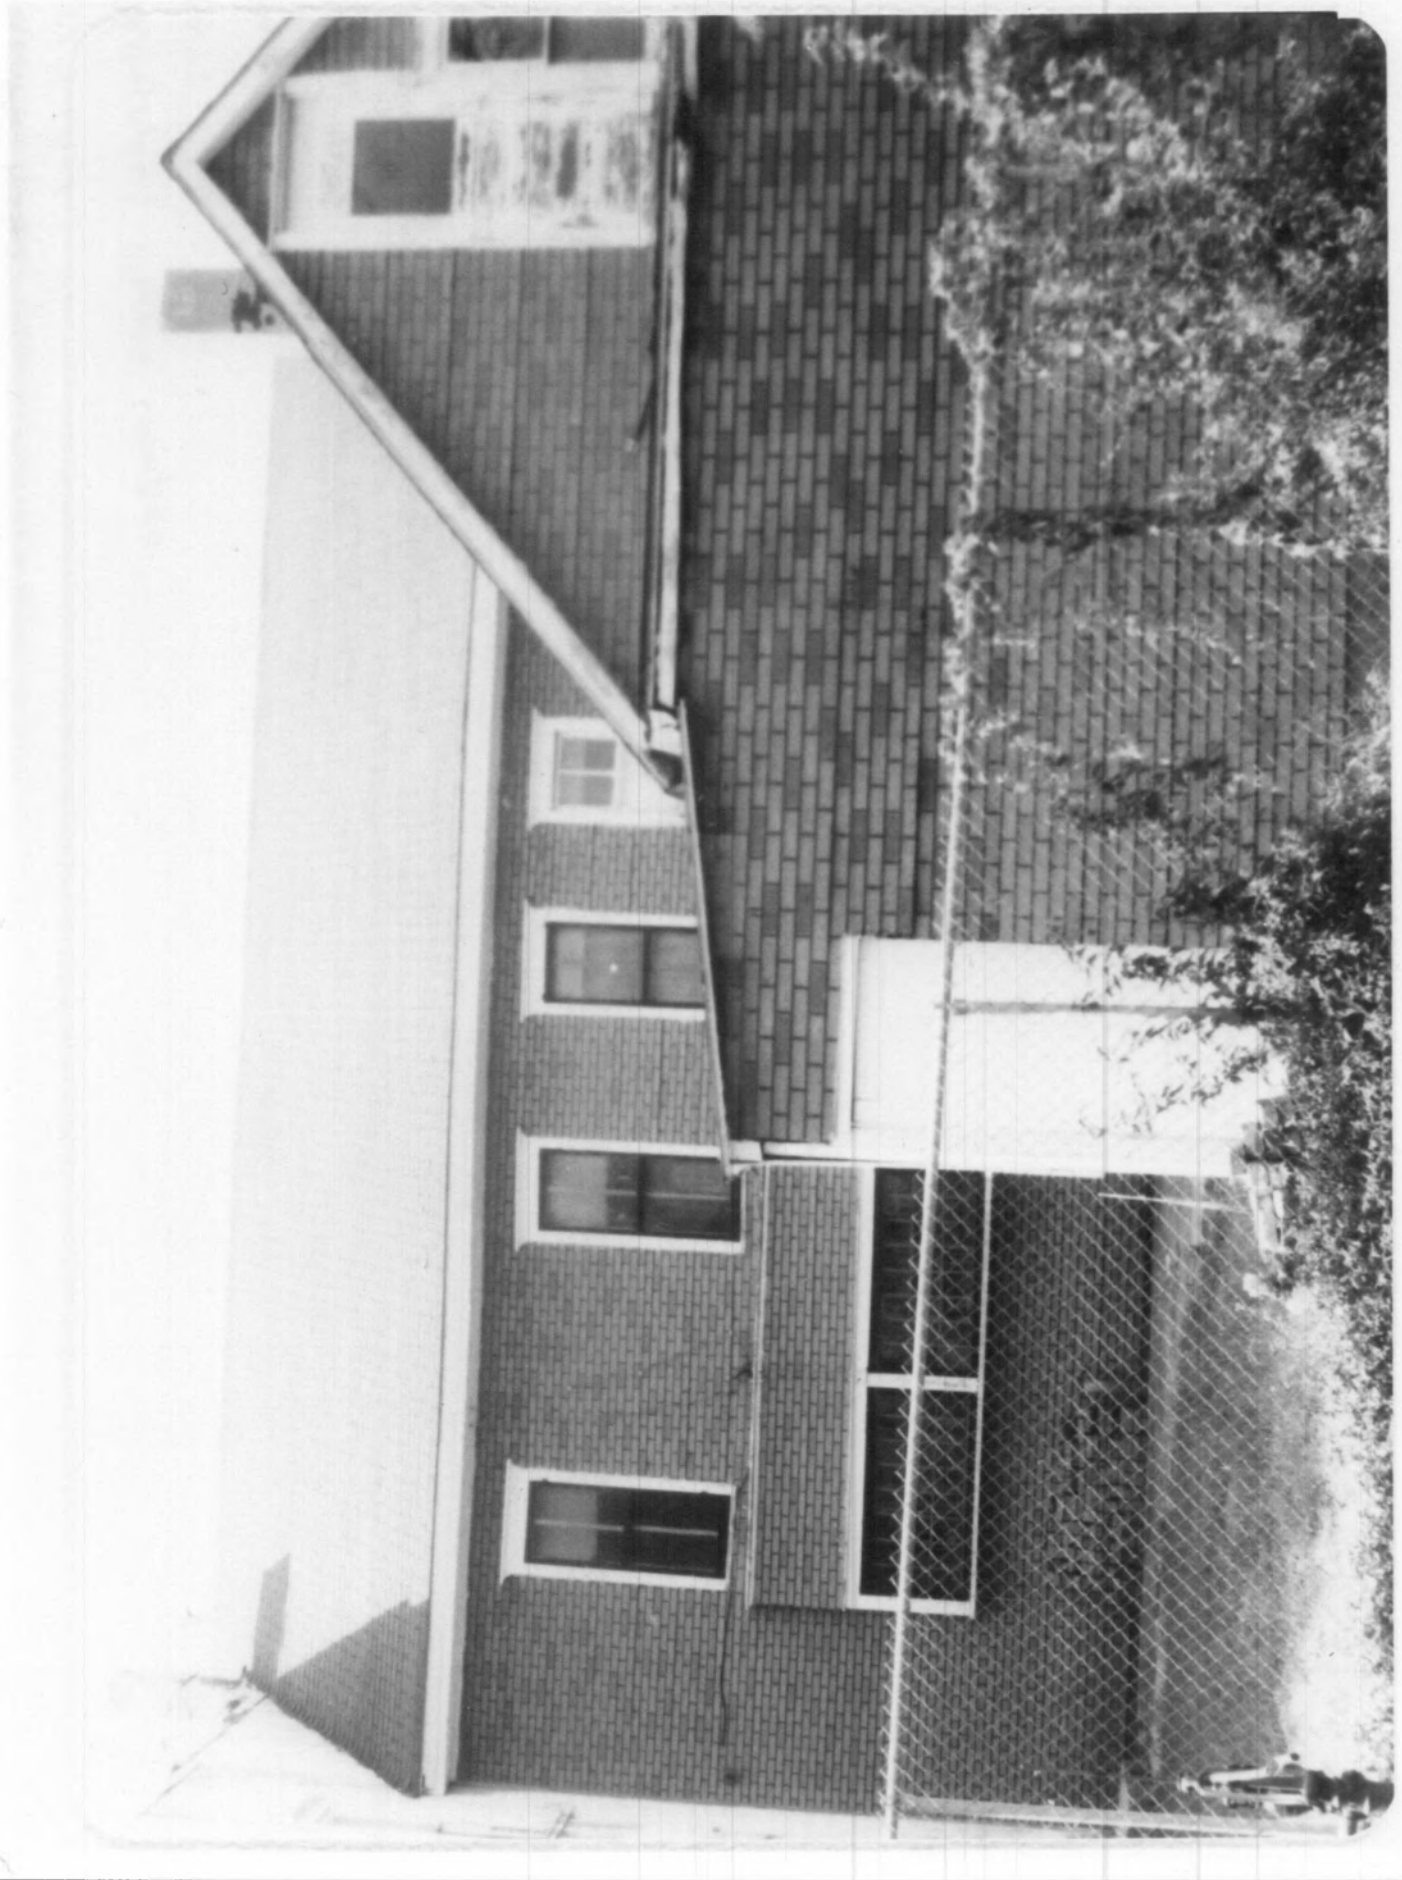
MARTIN HOTEL #6  
Versailles, Mo.  
Photographer: Harold Lampe  
September, 1977  
Cadmon, Mo.  
Copy Neg. Loc.: Dept. of Natural Resources  
P.O. Box 176, Jefferson City, Mo. 65101

Frame building, east facade, showing rear  
view of library addition.

The east facade has four windows on the second story, a shallow paired sash oriel window on the first, and has been covered with simulated brick asbestos siding. The library addition, connected to the frame building on its east facade, has on its north wall a 4' X 5' porch and a 6' X 12' poured concrete vault. This vault, of recent construction, houses documents and papers belonging to the Historical Society. The east facade of the library addition has a small room adjoined, used as a kitchen; a small porch in turn is affixed to the kitchen. On the east facade of the library addition, at the attic level, are a small four-over-four light double hung window, and a single leaf door with one light. This door once opened onto an outside stairway. This facade has also been covered with the same simulated brick asbestos siding found elsewhere. One brick chimney penetrates the roofline at midpoint. A covered lean-to porch with an approximate slope of 2 X 12 runs the entire length of the south facade, facing the courtyard. The porch is supported by four square wooden columns. The facade has two double hung windows separated by a six panel single leaf wooden door. Another door leads to the kitchen and to the porch at the rear of the library addition. The wall treatment on this portion of the building is bevel wood siding painted white, and the door and windows have the same entablature as the others of this building.

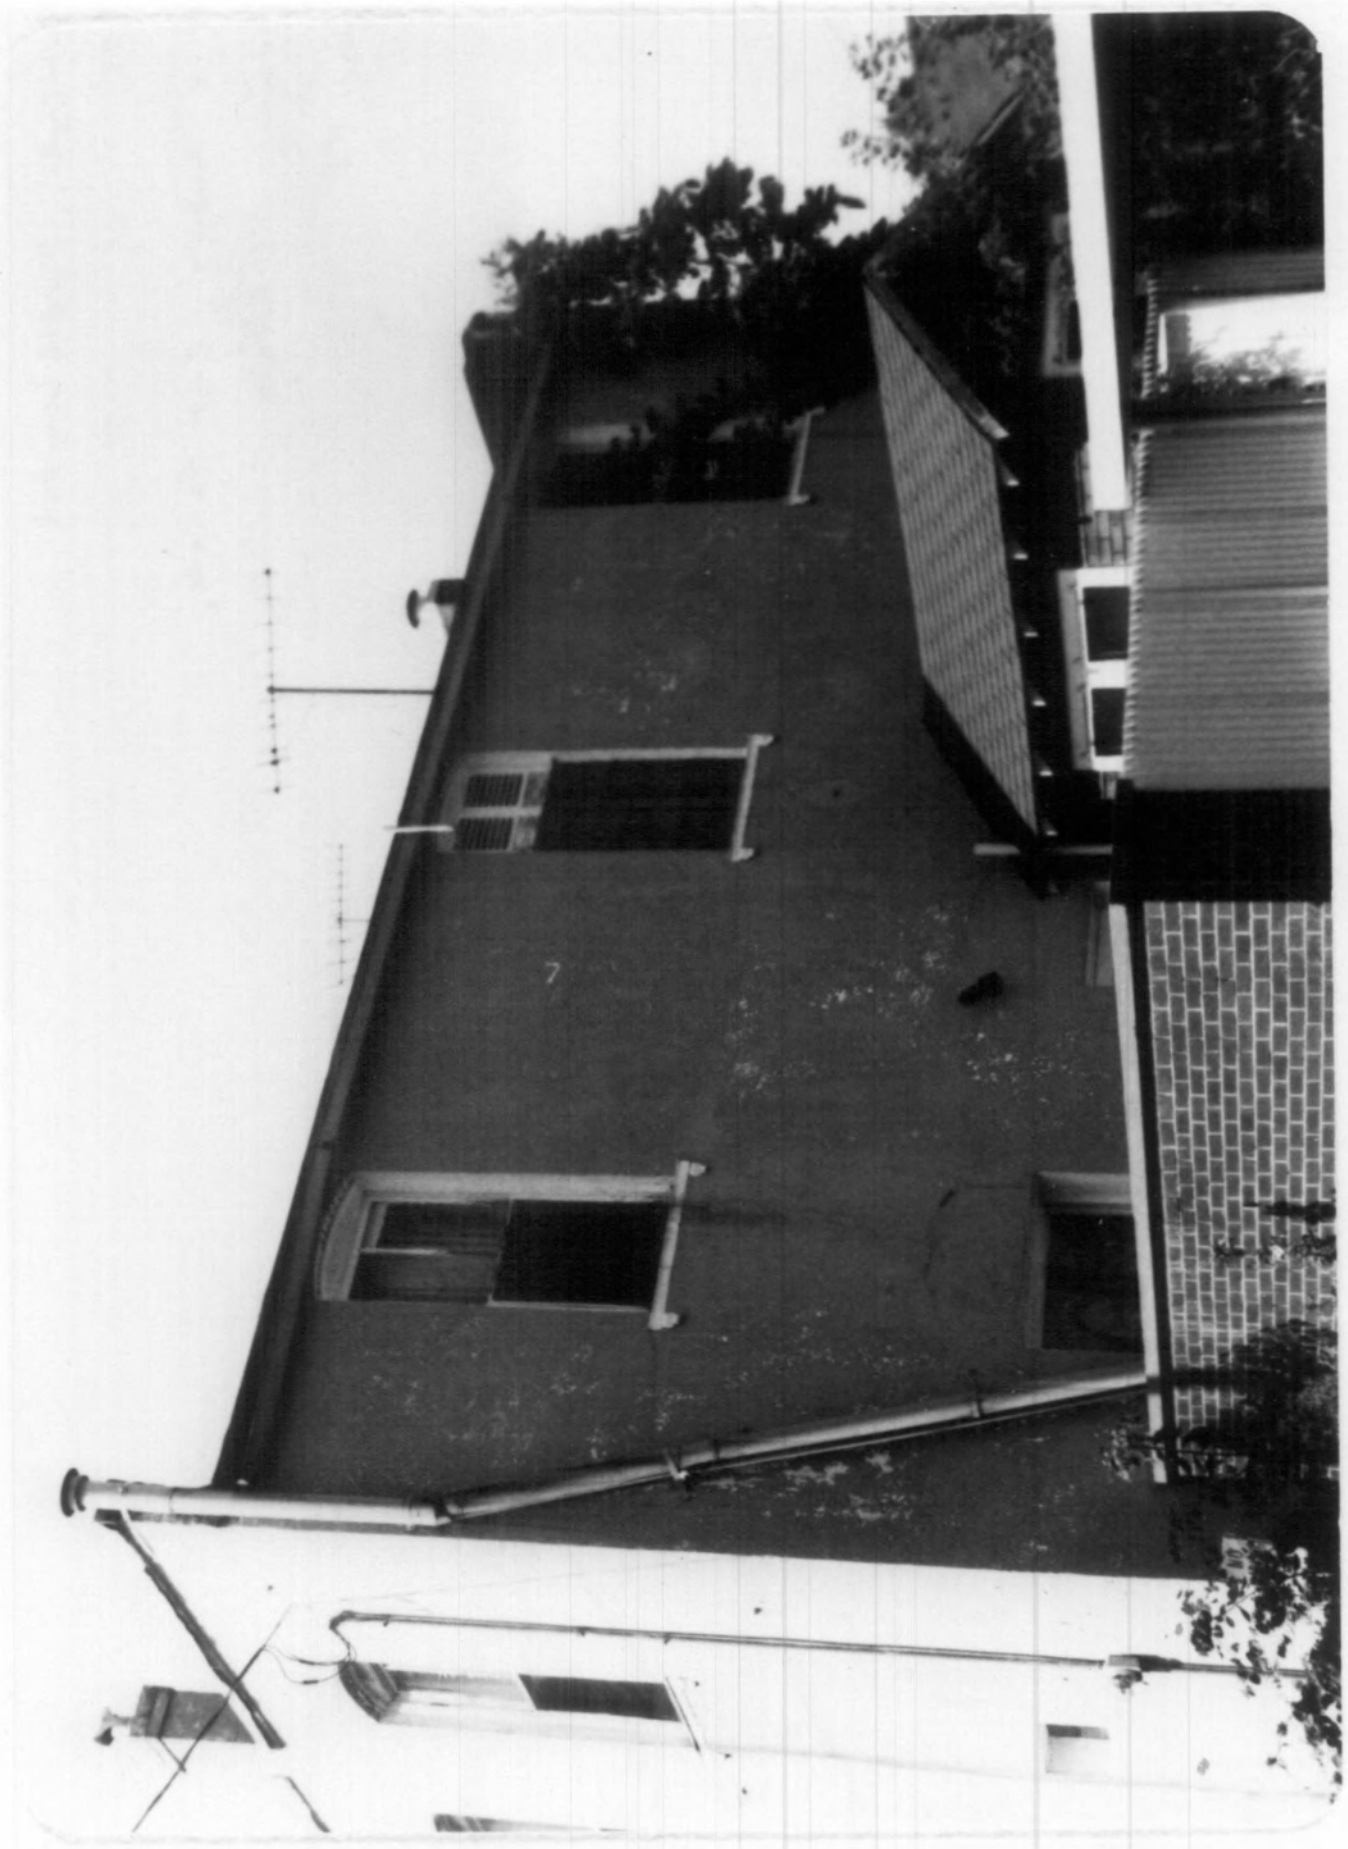
MARTIN HOTEL #8

Brick building, east facade, showing  
"old kitchen" addition.

window, one doorway onto a fenced yard, and a later addition of a small frame 9' X 12' kitchen covered with simulated brick asbestos shingles on all three sides. This addition has two small double hung windows on both the south and east facades. The north facade, facing the courtyard, has four two-over-two light double hung windows on the second floor and two windows on the first floor separated by a single entry door of a later date. There are three brick chimneys atop a stepped parapet on this facade also.
