MISSOURI OFFICE OF HISTORIC PRESERVATION
ARCHITECTURAL/HISTORIC INVENTORY SURVEY FORM

11
NORTH BROADWAY INDUSTRIAL SURVEY II
2217 N. FIRST FACING SW

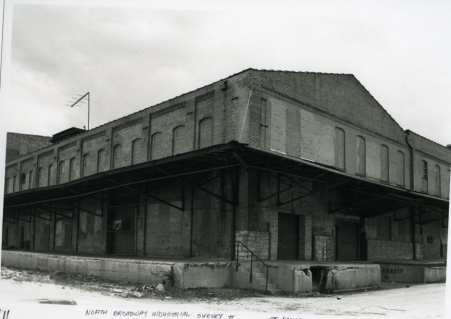
31. Further description of important features: Double-rowlock segmentally arched windows with stone sills are infilled; recessed panels topped with dentilling divide them into pairs on the east elevation. A concrete loading dock with a frame and iron overhang extends both lengths of the building. The western part of the L is flat-roofed.

32. History and Significance: The Ranken & Fritsch Foundry Company took out a building permit in 1888 for \$3,000 for a one-story foundry building. The building was later bought by the Foundry Inv. Co. who took out permits to alter the building in 1908 (for \$350 and \$1800) and in 1916 (for \$2600). The original building probably was gabled, with the flat-roofed portion coming at one of the later dates, along with the upper story.

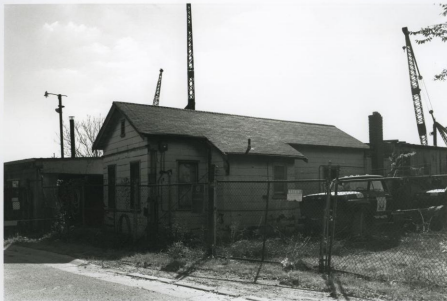
NORTH BROADWAY INDUSTRIAL SURVEY II
4023 N. FIRST
FACING SW

31. Further description of important features: Openings have double-rowlock segmental arches, many of which are infilled with brick. North roofline is slightly stepped.

32. History and Significance: The Herman Oak Leather Co. took out the permit for \$3,500 to build this building in 1918 as part of his tannery complex. The company had been operating in this city block since 1888; a frame tannery building was in use across the street by Herman 1886. The complex is still in use as a tannery today.

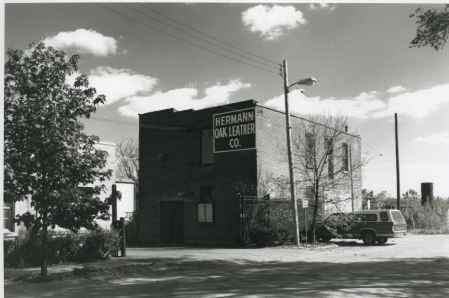
NORTH BROADWAY INDUSTRIAL SURVEY II
402B-30 N. FIRST
FACING SE

31. Further description of important features: A series of small vents with tiny stone hoods runs across the building at the attic; a corbelled cornice extends below. Original arches of second-story windows appear to have been altered; they now have flat arches and brick sills, with the same one-over-two-over-one horizontally hinged panes as are found in the building (cont'd. below)

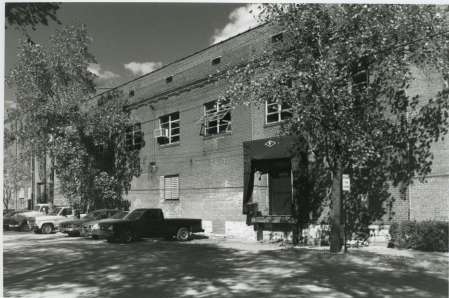
#145
NORTH BROADWAY INDUSTRIAL SURVEY II
4044 N. FIRST
FACING NE

32. History and Significance: to the north. First-story openings have been infilled with brick; double-rowlock segmental arches are still visible. A loading dock bay is located in the south end. The building is attached to a one-story building on the north and a newer brick building on the south. The permit for this building was taken out by Herman Koenitzer in 1901 for \$4,000 for a warehouse for his Herman Oak Leather tannery, a concern still operating on this site.

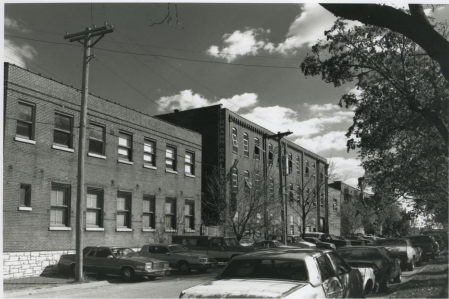
NORTH BROADWAY INDUSTRIAL SURVEY II
4054 N. FIRST
FACING SE

31. Further description of important features: Parapeted gable end is stepped with a slant on the north side and straight on the south; center and south sections have corbelled brick cornices. Double rowlock segmentally arched windows with stone sills are mostly infilled with brick or concrete block. Round arches top the two outside bays in the primary elevation. Loading dock on north side.

32. History and Significance: Smith, Beggs & Ranken were given a building permit for a \$4,000 storehouse in 1881. No firm by this name could be located, although the foundry of Ranken & Fritsch was located adjoining this building after 1888. C. H. Beggs and David Ranken were two St. Louisans of money and position about this time and possibly funded the undertaking for speculation.

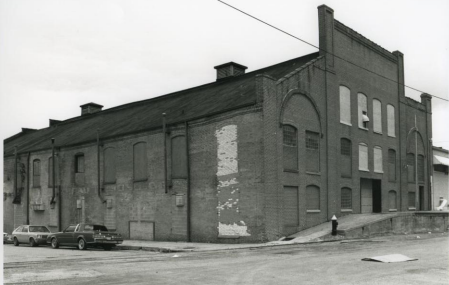
#10
NORTH BROADWAY INDUSTRIAL SURVEY II
2234 N. SECOND
FACING SE

31. Further description of important features: Building has a corbeled cornice and a small parapet on the north elevation. Double rowlock segmental arches and brick sills; almost all windows have been infilled in the western half of this building. Small pedimented entry of buff terra cotta at the n.w. corner has acanthus leaf-panels and reads, "BILT WELL MILL WORK."

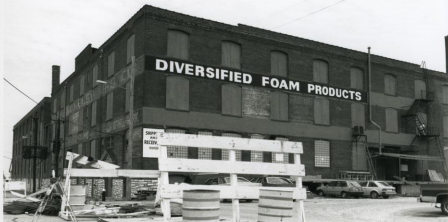
#56
NORTH BROADWAY INDUSTRIAL SURVEY II
3014 N. 2ND
FACING NE

31. Further description of important features: A cast-iron column and framing remain at the southeast corner; concrete block infill has obliterated the original windows of the entrance. A cast-iron sill and first-story lintel course (s. & e. elevations) also remain. The other entrances and windows have flat arches and are infilled with wood or CMU. A garage bay is (cont'd. below)

32. History and Significance: located at the north end of the front elevation. A corbelled cornice beneath the wide overhanging eaves is the main ornament left on the building. The permit for this "store & dwelling" was taken out by William A. Meinhart in 1910. It appears that the original plan housed two residential units, judging from the two rear doors and the reference to the building being a "double" in the building permit.

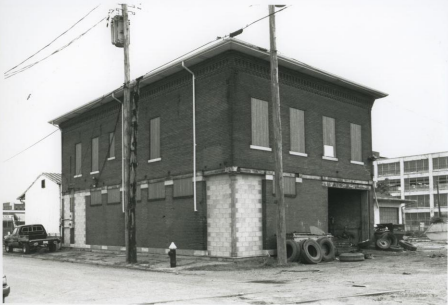
NORTH BROADWAY INDUSTRIAL SURVEY II
3201-03 N. SECOND
FACING NW

31. Further description of important features: A round-arched, recessed entrance draws the visual interest of this facade. Double-rowlock segmentally-arched windows have been infilled with glass brick and small windows; brick sills. A one-story CMU addition is located at the rear. The building is connected to a larger, newer commercial building.

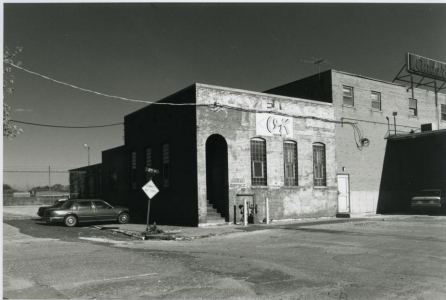
156
NORTH BROADWAY INDUSTRIAL SURVEY II
4138 N. SECOND
FACING SE

31. Further description of important features: Terra cotta coping rims the flat roofline of this functional building. Windows have flat arches, the larger of which at the first story have been enframed with concrete and sized down with brick infill. Some bricked-in segmentally-arched openings are visible; it is probable that the other windows were originally segmentally (cont'd. below)

32. History and Significance: arched as well. Several sliding loading dock doors. The permit for this building was taken out in 1907 by the Union Cooper-age Co. for \$5,000. The company was established in 1862 and incorporated in 1886. Their frame factory stood on this site at least as early as 1883 (see Hopkins map). They built kegs, half barrels and barrels, well buckets, harvest kegs, and "patented all wood and porcelain enameled water coolers," according to their city directory listing. Here in 1930, they were gone by 1940.

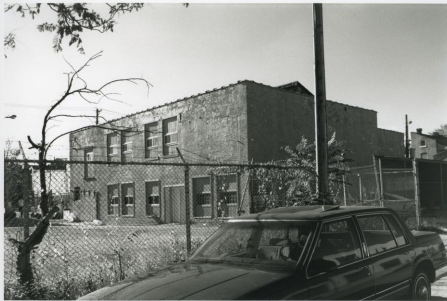
NORTH BROADWAY INDUSTRIAL SURVEY II
4205 N. SECOND
FACING NW

31. Further description of important features: North and south walls have parapeted chimneys. Windows have segmental soldier arches and stone sills. Two-over-two window panes. Two dormers. Two centered, transomed entrance doors, one of which is missing stone steps. Denticulated brick cornice. Rear wood porch.

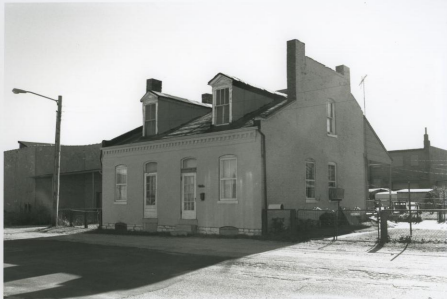
#161

32. History and Significance: The permits for this city block go back as early as 1876, and no permit was recorded for this house. It is fairly clearly not on the 1875 Compton & Dry map, however; hence the c. date of 1875. (It does appear on the 1883 Hopkins map.) The building seems to have always been a residence.

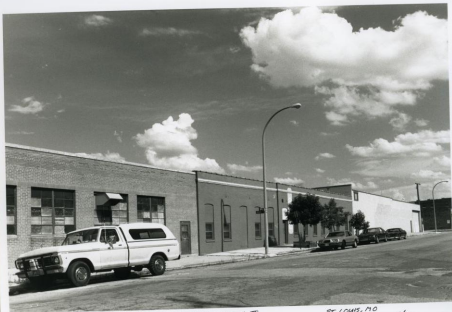
#3
NORTH BROADWAY INDUSTRIAL SURVEY II
2214-24 N. 9th
FACING SE

31. Further description of important features: This building appears to have been built in two or three sections, although only one permit was found. The north section features arched stone lintels and stone sills above; brick segmental arches and stone sills can be found below and in the remaining part of the building. Extensive brick infill has changed former stable door openings.

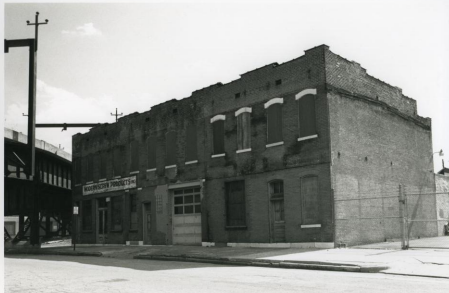
#2
NORTH BROADWAY INDUSTRIAL SURVEY II
2307-11 N. 9th
FACING SW

32. History and Significance: A \$600 building permit was taken out in 1877 by William Paschedag to build a two-story stable. The building was owned during the 1920s - early 1940s by W. Doane of the Doane Carton Co. Doane used the building as a factory for his carton-manufacturing business. Later alteration permits indicate that the upper floor was also used as a residence during the early 20th century.

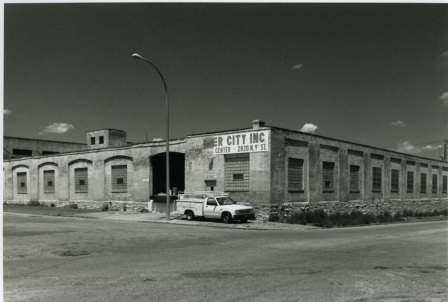
#48
NORTH BROADWAY INDUSTRIAL ENTRY II
2820 N. NINTH
FACING NE

31. Further description of important features: Original large window bays have been infilled with brick and glass block. Those on the west elevation have triple-rowlock elliptical arches; those on the south have flat arches. Rubble-stone foundation. Building adjoins 2820 N. Ninth (#49).

32. History and Significance: Herman J. Benderschied built this building in 1900 for \$4,000 as a cabinet factory for the Benderschied Manufacturing Co. By 1924, he had moved his residence to Los Angeles, still retaining his presidency in the company. By the 1930s, the company had begun to specialize in drugstore fixtures. The Great Western Box Co. occupied the building in 1943, followed by a succession of light manufacturing concerns.

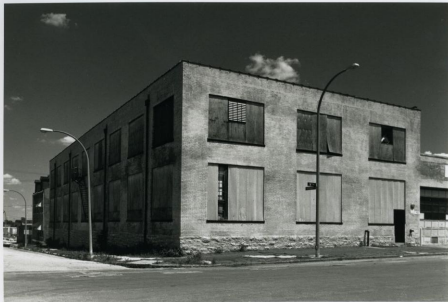
#49
NORTH BROADWAY INDUSTRIAL SURVEY II
2820 N. NINTH
FACING SE

31. Further description of important features: The picturesquely-gabled roof of this building appears to be shingled in metal tiles. The north gable end and the east chimney base have raised brick roundels. Openings have soldier course lintels, multipane windows. Elliptically-arched main (east) entrance. Concrete block addition on the south side. Gas pumps remain on east side.

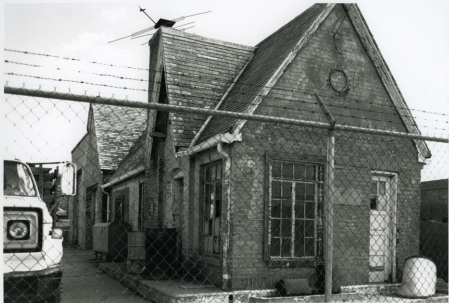
NORTH BROADWAY INDUSTRIAL SURVEY II
2923-25 N. NINTH
FACING SW

31. Further description of important features: Segmentally arched windows have brick sills and replacement one-over-one panes. Centered parapet. Corbelled brick cornice. Terra cotta coping. First-story openings include a garage bay, apparently original, with a rosette-studded iron lintel. Center first-story window infilled. A stucco wash covers the building.

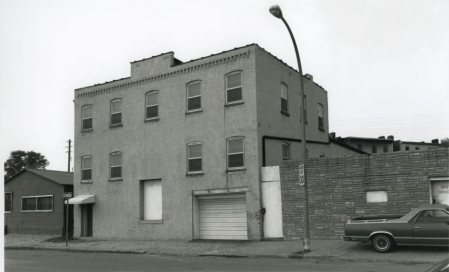
#67
NORTH BROADWAY INDUSTRIAL SURVEY II
3105-07 N. NINTH
FACING W-SW

31. Further description of important features: A corbeled brick cornice bands the building. Terra cotta coping. Garage bay is round-arched. Building appears to have been damaged by fire.

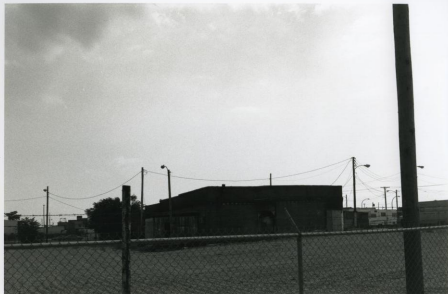
#75
NORTH BROADWAY INDUSTRIAL SURVEY II
3116-18 N. NINTH
FACING SE

31. Further description of important features: Two upper stories have windows with multipane industrial metal sash and no arches; first-story windows in the front elevation have double-rowlock segmental arches; all have brick sills. A loading dock with double wood doors is located at the southeast corner of the front elevation. Dark headers distinguish the brickwork on (cont'd below)

32. History and Significance: the front elevation. Simple corbelled brick cornice. Terra cotta coping. No building permit could be found for this building.

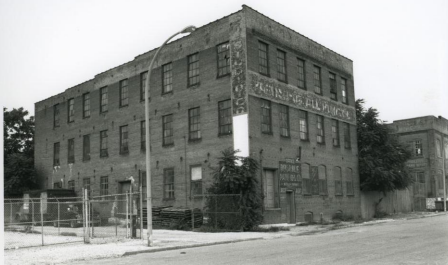
NORTH BROADWAY INDUSTRIAL SURVEY II
3183-37 N. NINTH
FACING NW

31. Further description of important features: Two-story piers are connected by corbelled brick banding at either end. Paired windows (some infilled with wood) have multipane industrial double-hung sash, segmental soldier arches and wood tympana incised with scrollwork (Ninth St. elevation). Parapet is stepped.

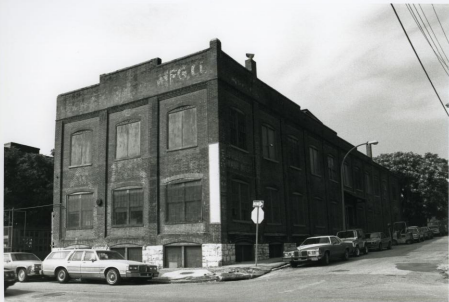
NORTH BROADWAY INDUSTRIAL SURVEY II
3145-51 N. NORTH
FACING SW

31. Further description of important features: A cast-iron storefront marked Christopher & Simpson occupies the southeast corner of this building. Corinthian columns remain, although the original window configuration has been altered. Windows have segmental soldier arches and stone lugsills; those on the primary elevation have stone keystones. Corbelled brick cornice. All (cont'd. below)

32. History and Significance: openings infilled. Parapeted brick chimneys on north and south walls. Two dormers. Rear, one-story brick addition is much newer and connected by a transitional passageway. Henry Bauer took out the permit for this building in 1883 for \$4,700.

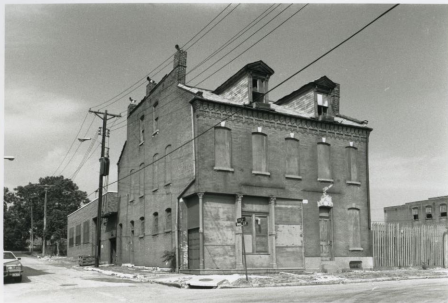
NORTH BROADWAY INDUSTRIAL SURVEY II
32.03 N. NINTH
FRING NW

31. Further description of important features: Pilasters divide the facade into sections. Windows have double-rowlock segmental arches. A round arch heads the entry at the south end of the primary elevation. Corbelled brick cornice on primary elevation. Decoratively-incised wood tympana survive on some windows. Several loading dock bays around the building.

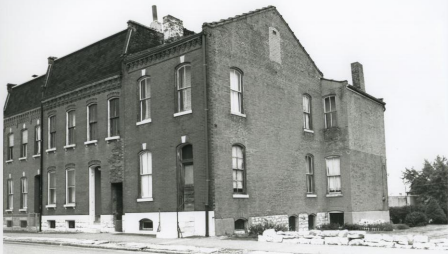
NORTH BROADWAY INDUSTRIAL SURVEY II
2314 N. NINTH (RIGHT)
PACING NE

31. Further description of important features: Corbelled brick cornice. Openings have segmental brick soldier arches, the ones on the front elevation with stone keys. Two-over-two, double-hung wood sash, stone sills. Attic window bricked in. Shared commonwall with 3316 N. Ninth (#97). Rear ell has flounder roofline. House is built directly on sidewalk line; stone steps.

32. History and Significance: S. Gang took out the permit for this house in 1877 for \$1,700. It has always been a residence.

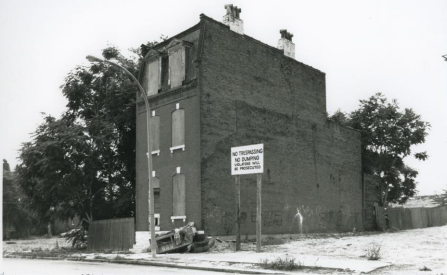
NORTH BROADWAY INDUSTRIAL SURVEY II
3315 N. NINTH
FACING SW

23. Foundation material: stone	24. Roof type/material: mansard/slate	
25. No. Bays: Front 2 Side 2	25. Wall treatment: red brick	
26. Plan shape: rectangular	27. Changes: Addition? yes Altered? yes

28. Exterior condition: poor	29. Open to public? no	
30. Other Surveys in which included: St. Louis Harbor Historic Properties Reconnaissance, 1987, U.S. Army Corps of Engineers survey (partially incl.)

31. Further description of important features: The front elevation of the 3rd story is a mansard roofline covered with hexagonal slate tiles and inset with two dormers with carved wood frames and cornices. Below, a corbelled cornice and frieze of ornamental pressed brick extend across the front. Front elevation openings are segmentally soldier arched with stone keystones (cont'd. below)

32. History and Significance: and stone lugsills. Doorway appears to have been recessed. No openings on the north elevation. Stone water table. House is built right on the sidewalk line with stone steps. A flat-roofed, two-story rear addition has a one-story frame addition on it.

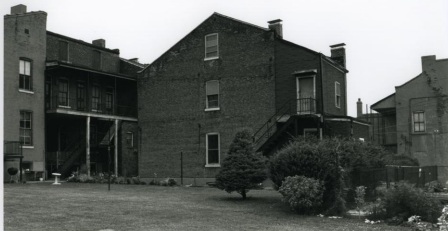
NORTH BROADWAY INDUSTRIAL SURVEY II
3316 REAR NORTH NINTH
FACING N-NW

23. Foundation material: stone	24. Roof type/material: side gable	
25. No. Bays: Front 2 Side 1	25. Wall treatment: red brick	
26. Plan shape: rectangular	27. Changes: Addition? yes Altered?

28. Exterior condition: good	29. Open to public? no	
30. Other Surveys in which included: St. Louis Harbor Historic Properties Reconnaissance, 1987, U.S. Army Corps of Engineers survey (partially incl.)

31. Further description of important features: This "alley house" has a front elevation that actually faces west, right into the rear of 3316 N. Ninth (#97). Windows have double-rowlock segmental arches, stone sills and six-over-six or two-over-two panes. A rear frame addition 1 and 2 stories in height is covered with brick-look asphalt siding.

32. History and Significance: The building appears on the 1875 Compton & Dry map. No permit was found.

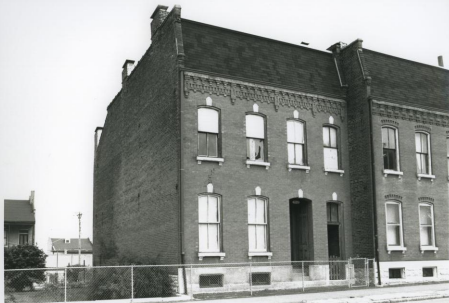
NORTH BROADWAY INDUSTRIAL SURVEY II
3310 N. NINTH
FACING SE

23. Foundation material: limestone	24. Roof type/material: mansard/asph.	
25. No. Bays: Front 4 Side 0	25. Wall treatment: red brick	
26. Plan shape: rectangular	27. Changes: Addition?	Altered? yes

28. Exterior condition: good	29. Open to public? no	
30. Other Surveys in which included: St. Louis Harbor Historic Properties Reconnaissance, 1987, U.S. Army Corps of Engineers survey (partially incl.)

31. Further description of important features: The original mansard was probably slate-covered. Elaborately corbelled cornice. Segmental soldier arches have shaped stone keys; bracketed stone lugsills. Two-over-two double-hung wood sash. Recessed, wood-paneled entrance. Narrow passageway through to rear is transomed. Slight setback from sidewalk.

32. History and Significance: The only permit for a mansarded dwelling in this city block was taken out by Joe Mettig on 7/3/1888 for \$3,400. That sum is about double the standard single dwelling cost, and about equal to the usual cost of a double; based on this information, it appears that #97 and #98 were built from the same permit.

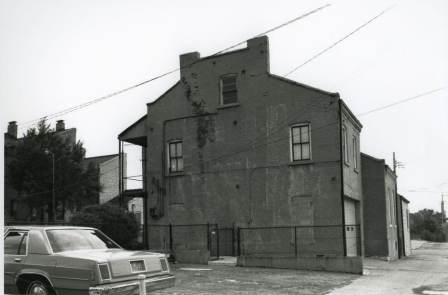
NORTH BROADWAY INDUSTRIAL SURVEY II
3320 REAR N. NINTH
FACING NW

23. Foundation material: stone		24. Roof type/material: side gable
25. No. Bays: Front 2	Side 2	25. Wall treatment: concrete wash
26. Plan shape: rectangular		27. Changes: Addition? Altered? yes

28. Exterior condition: good		29. Open to public? no
30. Other Surveys in which included: St. Louis Harbor Historic Properties Reconnaissance, 1987, U.S. Army Corps of Engineers survey (partially incl.)

31. Further description of important features: Owner says brick is covered with a special concrete wash mixture done initially c. mid-1940s and periodically redone. Segmentally arched windows have stone sills. Dentilled cornice. Some openings infilled with CMU. Garage bay dominates east elevation; possibly indicates early use as a carriage house/stable/servant's (cont'd. below)

32. History and Significance: quarters, although the latter is somewhat unlikely in this German-Irish working class neighborhood. Building appears on the 1875 Compton & Dry map. No permit was found.

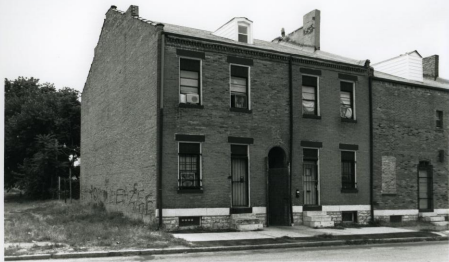
#92

32. History and Significance: Repair work to the primary facade, mostly at the second-story level, was done with an inappropriate variegated brick (the facade of the house adjoining to the north was completely redone with this brick, in the process rendering it totally without integrity - see photo, right). W. Wilhelmy took out the single permit for this double dwelling in 1876 for \$7,000.

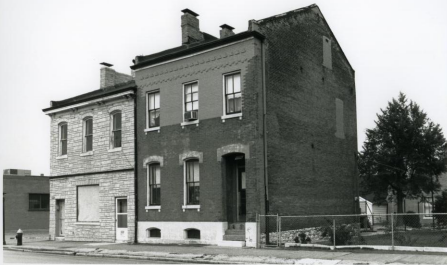
99
NORTH BROADWAY INDUSTRIAL SURVEY II
3324 N. NINTH (RIGHT)
FACIN S NE

23. Foundation material: limestone	24. Roof type/material: side gable	
25. No. Bays: Front 3 Side 1	25. Wall treatment: red brick	
26. Plan shape: rectangular	27. Changes: Addition?	Altered? yes

28. Exterior condition: fair	29. Open to public? no	
30. Other Surveys in which included: St. Louis Harbor Historic Properties Reconnaissance, 1987, U.S. Army Corps of Engineers survey (partially incl.)

31. Further description of important features: A pair of parapeted chimneys is located atop the commonwall between this building and the one adjoining it to the north. A profiled (metal?) cornice is located above what appear to be the remnants of a corbelled cornice; much of the upper part of the primary facade has had replacement brickwork done. Upper story front windows (cont'd. below)

32. History and Significance: have flat arches; lowers have shaped stone arches. Two-over-two double-hung wood sash; stone lugsills with brackets. Recessed entrance. Side windows have been bricked in. Building appears on the 1875 Compton & Dry map. No building permit found.

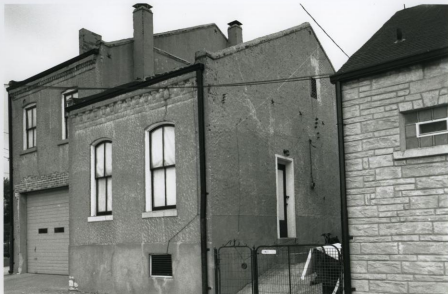
NORTH BROADWAY INDUSTRIAL SURVEY II
3324 REAR N. NINTH (CENTER)
FACING SW

23. Foundation material: stone		24. Roof type/material: side gable
25. No. Bays: Front 2	Side 3	25. Wall treatment: concrete wash
26. Plan shape: rectangular		27. Changes: Addition? Altered? yes

28. Exterior condition: good		29. Open to public? no
30. Other Surveys in which included: St. Louis Harbor Historic Properties Reconnaissance, 1987, U.S. Army Corps of Engineers survey (partially inci.)

31. Further description of important features: This brick alley house was, like #102 next to it, covered with a "special" concrete wash mixture by the owner c. mid-1940s. Segmentally-arched windows have stone sills, two-over-two panes. Dentilled brick cornice. Side entrance.

32. History and Significance: This house is clearly on the 1875 Compton & Dry pictorial map of St. Louis. No permit could be found.

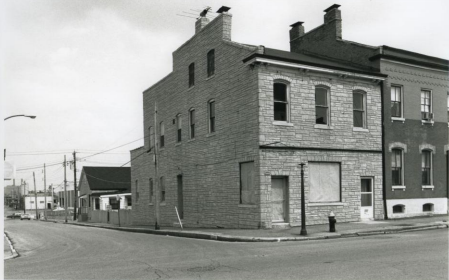
#100
NORTH BROADWAY INDUSTRIAL SURVEY II
832.8 N. NINTH
FACING SE

23. Foundation material: stone	24. Roof type/material: side gable	
25. No. Bays: Front 3 Side 7	25. Wall treatment: permastoned	
26. Plan shape: rectangular	27. Changes: Addition? yes Altered? yes

28. Exterior condition:	29. Open to public? no	
30. Other Surveys in which included: St. Louis Harbor Historic Properties Reconnaissance, 1987, U.S. Army Corps of Engineers survey (partially incl.)

31. Further description of important features: Although the building has been entirely encased in permastone (c. 1946), attempts were made to retain the major architectural elements; windows still have segmental arches and stone sills; paired, scrolled brackets remain at the simple wood cornice. The side parapet retains its chimneys. Large front openings may have been part (cont'd. below)

32. History and Significance: of a storefront. Rear two-story and one-story additions. This building appears on the 1875 Compton & Dry map. It was used as a saloon at least c. 1904 when M. Mummer took out a permit for a minor alteration.

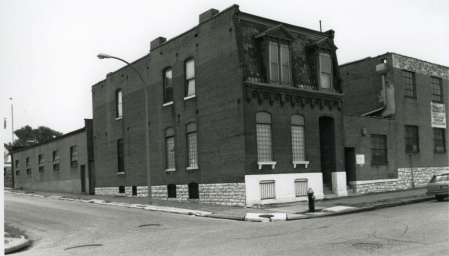
NORTH BROADWAY INDUSTRIAL SURVEY II
3401 N. NINTH (CENTER)
FACING NW

23. Foundation material: limestone	24. Roof type/material: mansard/slate	
25. No. Bays: Front 3 Side 3	25. Wall treatment: red brick	
26. Plan shape: rectangular	27. Changes: Addition? yes Altered? yes

28. Exterior condition: good	29. Open to public? no	
30. Other Surveys in which included: St. Louis Harbor Historic Properties Reconnaissance, 1987, U.S. Army Corps of Engineers survey (partially incl.)

31. Further description of important features: The front elevation features a mansard roof with hexagonal slates; two dormers have wooden sunburst designs in their pediments. Below, a corbelled cornice features ornamental pressed brick. Windows have segmental soldier arches, stone sills (with ornamented brackets in the case of the primary elevation). Recessed doorway. Four of (cont'd. below)

32. History and Significance: the first-story windows have been infilled with glass brick & regular brick; the others have replacement panes. A one-story addition adjoins the building to the north. It in turn is attached to the south side of 3405 N. Ninth (#94). A rear ell addition of #94 extends across the rear of this property, directly connected to this building only by a passageway.

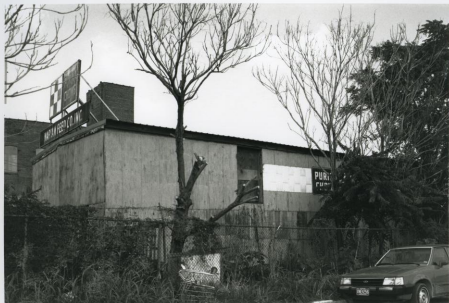
#117 NORTH BROADWAY INDUSTRIAL SURVEY II
3804 N. NINTH
FACING NE

31. Further description of important features: Frame building is covered with corrugated iron. Window infilled. Roof gable has very slight slope.		
32. History and Significance: The Thielling Moulding Co. took out the 1899 permit for this building to be used as a wagon shed. An early 20th century edition of the Sanborn maps says it was used for hay storage. More recently it has been used by a feed company for storage.

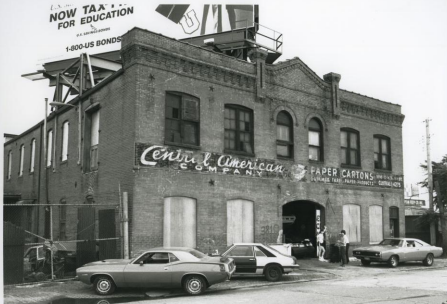
NORTH BROADWAY INDUSTRIAL SURVEY II
 3810-14 N. NINTH
 FACING SE

23. Foundation material: stone		24. Roof type/material: flat	
25. No. Bays: Front 6 Side		25. Wall treatment: red brick	
26. Plan shape: L		27. Changes: Addition? yes Altered? yes

28. Exterior condition: fair		29. Open to public? limited	
30. Other Surveys in which included: St. Louis Harbor Historic Properties Reconnaissance, 1987, U.S. Army Corps of Engineers survey (partially incl.)

31. Further description of important features: A gabled parapet flanked by colonettes bears a corbelled cornice. Centered at the second story are two windows with round-arched pressed-brick hoods. Remaining windows feature triple rowlock segmental arches (mostly double rowlock on side elevations). Remnants of a corbeled cornice can be seen between the two stories on (cont'd. below)

32. History and Significance: the front elevation. Most openings have been infilled; original windows appear to have had multipane industrial sash. The Theiling Moulding Co. (later, Theiling-Lothmann) (see brief history attached) took out three major building permits relating to this building. The first was in 1894 for a one-story factory at \$3,600; the second was in 1898 for a \$2,500 moulding mill of unspecified height. The third was in 1907 for a "2-story addition to warehouse" for \$5,924, facing Bremen, clearly the n-s ell portion.

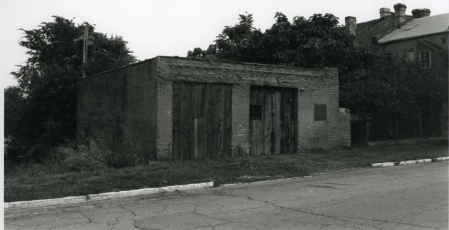
#124

31. Further description of important features: A corbelled cornice extends across the front elevation. Terra cotta coping. Two wood garage doors.		
32. History and Significance: F. Bartchoer had this stable built in 1912 for \$1,000. It was intended to be used by residents of 827-29 and 831-33 Bremen. In later years it almost certainly served as an automobile garage.

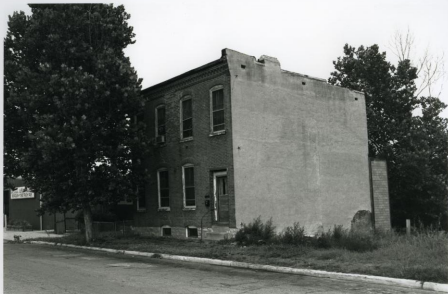
NORTH BROADWAY INDUSTRIAL SURVEY II
3916-18 N. NINTH
FACING NE

23. Foundation material: limestone		24. Roof type/material: flat
25. No. Bays: Front 4 Side		25. Wall treatment: red brick
26. Plan shape: rectangular	27. Changes: Addition? yes Altered? yes

28. Exterior condition: good		29. Open to public? no
30. Other Surveys in which included: St. Louis Harbor Historic Properties Reconnaissance, 1987, U.S. Army Corps of Engineers survey (partially incl.)

31. Further description of important features: Corbelled cornice. Segmental soldier arches. Two-over-one panes appear not to be original. Wood sills. Entrance has a flat header arch; curved brick form its jambs. A stucco wash covers the south wall. Rear one-story frame addition.

32. History and Significance: This building was one of a pair of adjoining flats listed on a permit taken out by Pauline McMillan in 1893 for \$5,500 for the both. The other building was attached to this one on the south side and has been demolished, which is the reason for the stucco coverup.

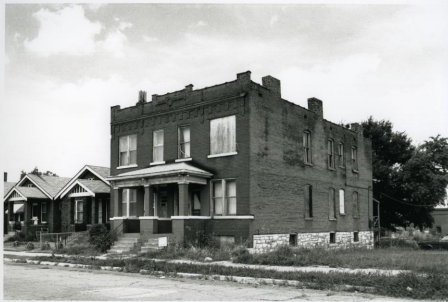
NORTH BROADWAY INDUSTRIAL SURVEY II
4000-02 N. NINTH
FACING NE

23. Foundation material: limestone		24. Roof type/material: flat	
25. No. Bays: Front 4 Side 4		25. Wall treatment: red brick	
26. Plan shape: rectangular		27. Changes: Addition? Altered? yes

28. Exterior condition: fair/poor		29. Open to public? no	
30. Other Surveys in which included: St. Louis Harbor Historic Properties Reconnaissance, 1987, U.S. Army Corps of Engineers survey (partially incl.)

31. Further description of important features: A stepped parapet features a raised brick design in its pediment. A copper cornice across the building's front elevation surmounts brick corbelling that "drips" down at intervals into a brick soldier lintel course. First-story front windows have flat soldier arches; side windows have double-rowlock segmental arches. (cont'd. below)

32. History and Significance: Stone sills on the front elevation; wood on the side. Windows are replacements or boarded. Square brick pillars support a hipped porch roof with profiled brackets. Double entrances. Rear wood porch. P. J. Mays took out the permit for this \$5,500 tenement in 1912 and built it himself. No information could be found on Mays. The building appears to have always been used as a residence.

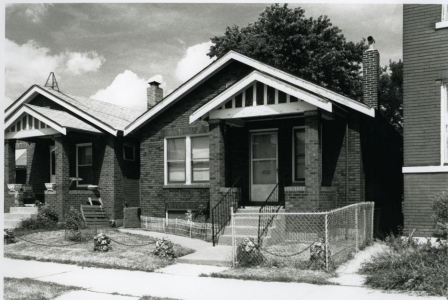
#127
NORTH BROADWAY INDUSTRIAL SURVEY II
4006 N. NINTH
FACING NE

23. Foundation material: concrete		24. Roof type/material: end gable	
25. No. Bays: Front 3 Side		25. Wall treatment: textured brick	
26. Plan shape: rectangular		27. Changes: Addition? Altered?

28. Exterior condition: good		29. Open to public? no	
30. Other Surveys in which included: St. Louis Harbor Historic Properties Reconnaissance, 1987, U.S. Army Corps of Engineers survey (partially incl.)

31. Further description of important features: Flat soldier arches over openings. Brick pillars support porch roof with wood Craftsman detailing. Chimney in south wall. Well-maintained.

32. History and Significance: This building and the three to its north (#128-130) were all listed on a single building permit taken out by E. Cantanne in 1926 for a total of \$12,000.

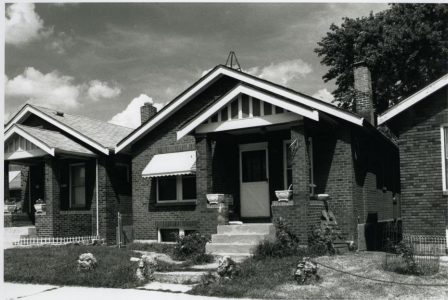
NORTH BROADWAY INDUSTRIAL SURVEY II
4008 N. NINTH
FACING NE

23. Foundation material: concrete		24. Roof type/material: end gable	
25. No. Bays: Front 3 Side		25. Wall treatment: textured brick	
26. Plan shape: rectangular		27. Changes: Addition? Altered?

28. Exterior condition: good		29. Open to public? no	
30. Other Surveys in which included: St. Louis Harbor Historic Properties Reconnaissance, 1987, U.S. Army Corps of Engineers survey (partially incl.)

31. Further description of important features: Soldier arch lintel courses over openings. Brick pillars support gabled porch roof with Craftsman detail. Chimney in south wall. Brick sills. Virtually identical to #127, 129 & 130.

32. History and Significance: Four nearly identical buildings were listed on a single permit for \$12,000 taken out in 1926 by E. Cantanne, who also built them. They are all excellently maintained.

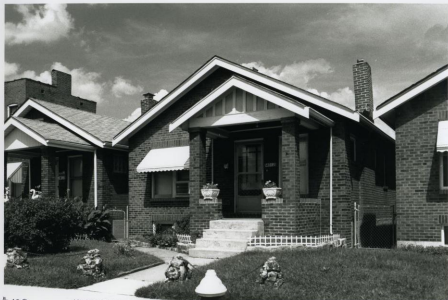
NORTH BROADWAY INDUSTRIAL SURVEY II
4012 N. NINTH
FACING NE

23. Foundation material: concrete		24. Roof type/material: end gable	
25. No. Bays: Front 3 Side		25. Wall treatment: textured brick	
26. Plan shape: rectangular		27. Changes: Addition? Altered?

28. Exterior condition: good		29. Open to public? no	
30. Other Surveys in which included: St. Louis Harbor Historic Properties Reconnaissance, 1987, U.S. Army Corps of Engineers survey (partially incl.)

31. Further description of important features: Square brick columns support a gabled wood porch roof with Craftsman detailing. Soldier lintel courses over openings; brick sills. Chimney in south wall. Excellently maintained.

32. History and Significance: E. Cantanne took out the permit for four nearly identical houses in 1926, which he built himself for a total of \$12,000. They are #127-130 of this survey, and they remain virtually unchanged.

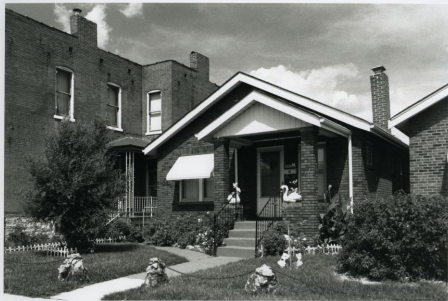
NORTH BROADWAY INDUSTRIAL SURVEY II
4014 N. NINTH
PACING NE

23. Foundation material: concrete	24. Roof type/material: end gable	
25. No. Bays: Front 3 Side	25. Wall treatment: textured brick	
26. Plan shape: rectangular	27. Changes: Addition?	Altered? yes

28. Exterior condition: good	29. Open to public? no	
30. Other Surveys in which included: St. Louis Harbor Historic Properties Reconnaissance, 1987, U.S. Army Corps of Engineers survey (partially incl.)

31. Further description of important features: The gable end of the wood porch roof has been altered from the original Craftsman detailing; otherwise, this house is virtually identical to the three houses to its south. Soldier lintel courses and brick sills. Square brick porch pillars. Chimney in south wall. Excellently maintained.

32. History and Significance: This house is one of four listed on a single building permit taken out in 1926 for \$12,000 by E. Cantanne, who also built the houses himself. The other three are #127-129 of this survey.

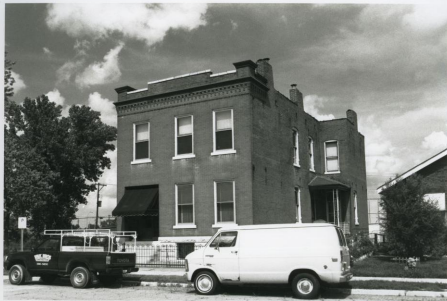
NORTH BROADWAY INDUSTRIAL SURVEY II
4018 N. NINTH
FACING NE

23. Foundation material: stone		24. Roof type/material: flat
25. No. Bays: Front 3 Side 3		25. Wall treatment: red brick
26. Plan shape: L		27. Changes: Addition? Altered? yes

31. Further description of important features: White terra cotta coping along parapeted roofline; a profiled metal cornice surmounts a corbelled cornice. A stringcourse of ornamental pressed brick crosses the building below the corbeling; brick, corbelling and cornice all return at the corners. Brick jack arches. Stone sills. Double-rowlock segmentally arched windows (cont'd. below)

32. History and Significance: on side elevation. Quarry-faced stone water table. Recessed entrance is obscured by a canvas awning. Replacement panes. A small wood and metal porch is located in the corner formed by the rear ell. Apparently original wrought iron fence. The permit for this building was taken out by Fred Kraft in 1908 for \$5,500. It has apparently always been a residence.

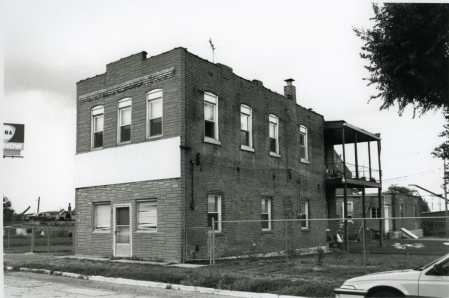
NORTH BROADWAY INDUSTRIAL SURVEY II
4040 N. NINTH
FACING NE

31. Further description of important features: Parapeted front elevation has had ye olde permastone treatment. A painted, corbelled brick cornice has the look of having been applied to the permastone. A sheet of corrugated metal has been attached to the front between stories. Segmentally arched windows on front and sides have been reduced with infill for replacement windows (cont'd. below)

32. History and Significance: Modern openings at first story front. Rear two-story wood porch. Although no permit was recorded for this building, John Laskowitz took out a \$1,300 permit for an addition to a store and flat on 8/17/1908. He hired C. Gescheit for the construction. F. Laskowitz built the one-story workshop (visible at the rear of the property in the photo) with a permit dated 7/31/1905 for \$800. The Laskowitz family occupied the house at least through 1940, apparently using part of it as a store.

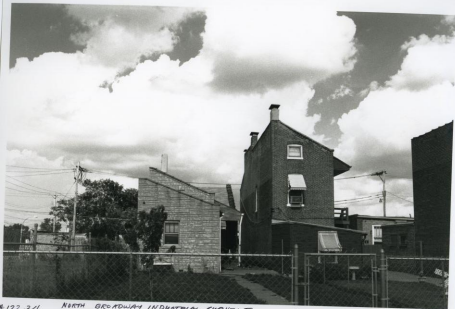
133-34

31. Further description of important features: This alley house has two completely different elevations (see photo #133-34): the east elevation that faces the alley is side-gabled with parapeted chimneys, while the west elevation is a flounder with a flounder addition. All but the north elevation have been covered with permastone; the north side has been stuccoed. Windows (cont'd. below)

32. History and Significance: in the east elevation are segmentally arched while those in the western addition have rectangular openings. A wood and metal overhang creates a porch/patio on the south side of the rear addition. This building is on the 1875 Compton & Dry pictorial map as well as the 1883 Hopkins map. It predates building permits for this block (1877). It has apparently always been used as a residence.

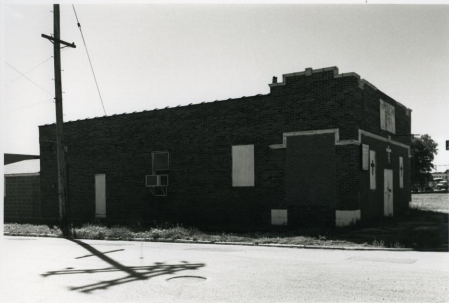
417
NORTH BROADWAY INDUSTRIAL SURVEY II
2524 N. 10th
FACING SE

31. Further description of important features: Stepped, terra cotta-coped parapets top the front of this building. The original storefront has been infilled with brick. A terra cotta course echoes the parapet lines above the openings. Windows have brick sills. A small rear addition (1974) is attached to the east end of the building.

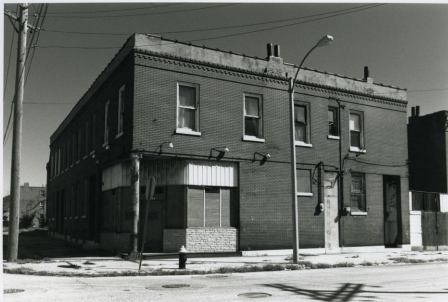
25

31. Further description of important features: Brick egg & dart and dentilled cornice above raised string course. Above cornice, concrete veneer replaces the former profiled cornice (see #26). One-over-one windows have no arches, stone sills; most first-story and several second-story are infilled. Corner cast-iron front is all enclosed except for the Globe Foundry column. Small rear shed.

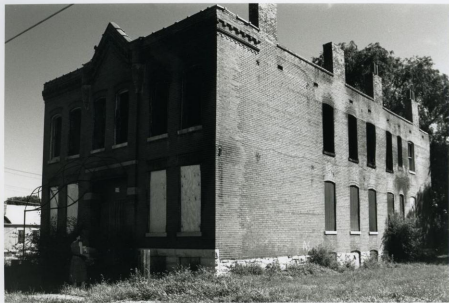
#29

31. Further description of important features: This building was recently gutted by fire. Second-story front elevation windows have gauged brick arches; first-story windows have flat arches with splayed sandstone. All front elevation openings have pressed-brick jambs. Side windows have double-rowlock segmental arches; all windows have stone sills. Centered peaked (con't. below)

32. History and Significance: parapet emphasizes the slightly projecting center bay; carved sandstone colonnettes further highlight this feature. Sandstone banding highlights the entrance pilasters. Limestone water table. The building permit for this residence was taken out in 1897 by H. Wedig for \$4,250.

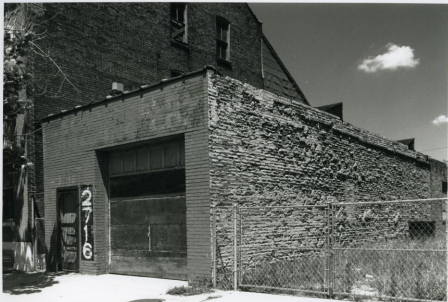
#41

31. Further description of important features: The primary opening in the front elevation of this building is an overhead garage door bay; a regular door is the only other opening. Neither have arches. Terra cotta coping. This building was originally an addition to a warehouse now demolished; this is reflected by the non-stricken mortar joints on the south wall.

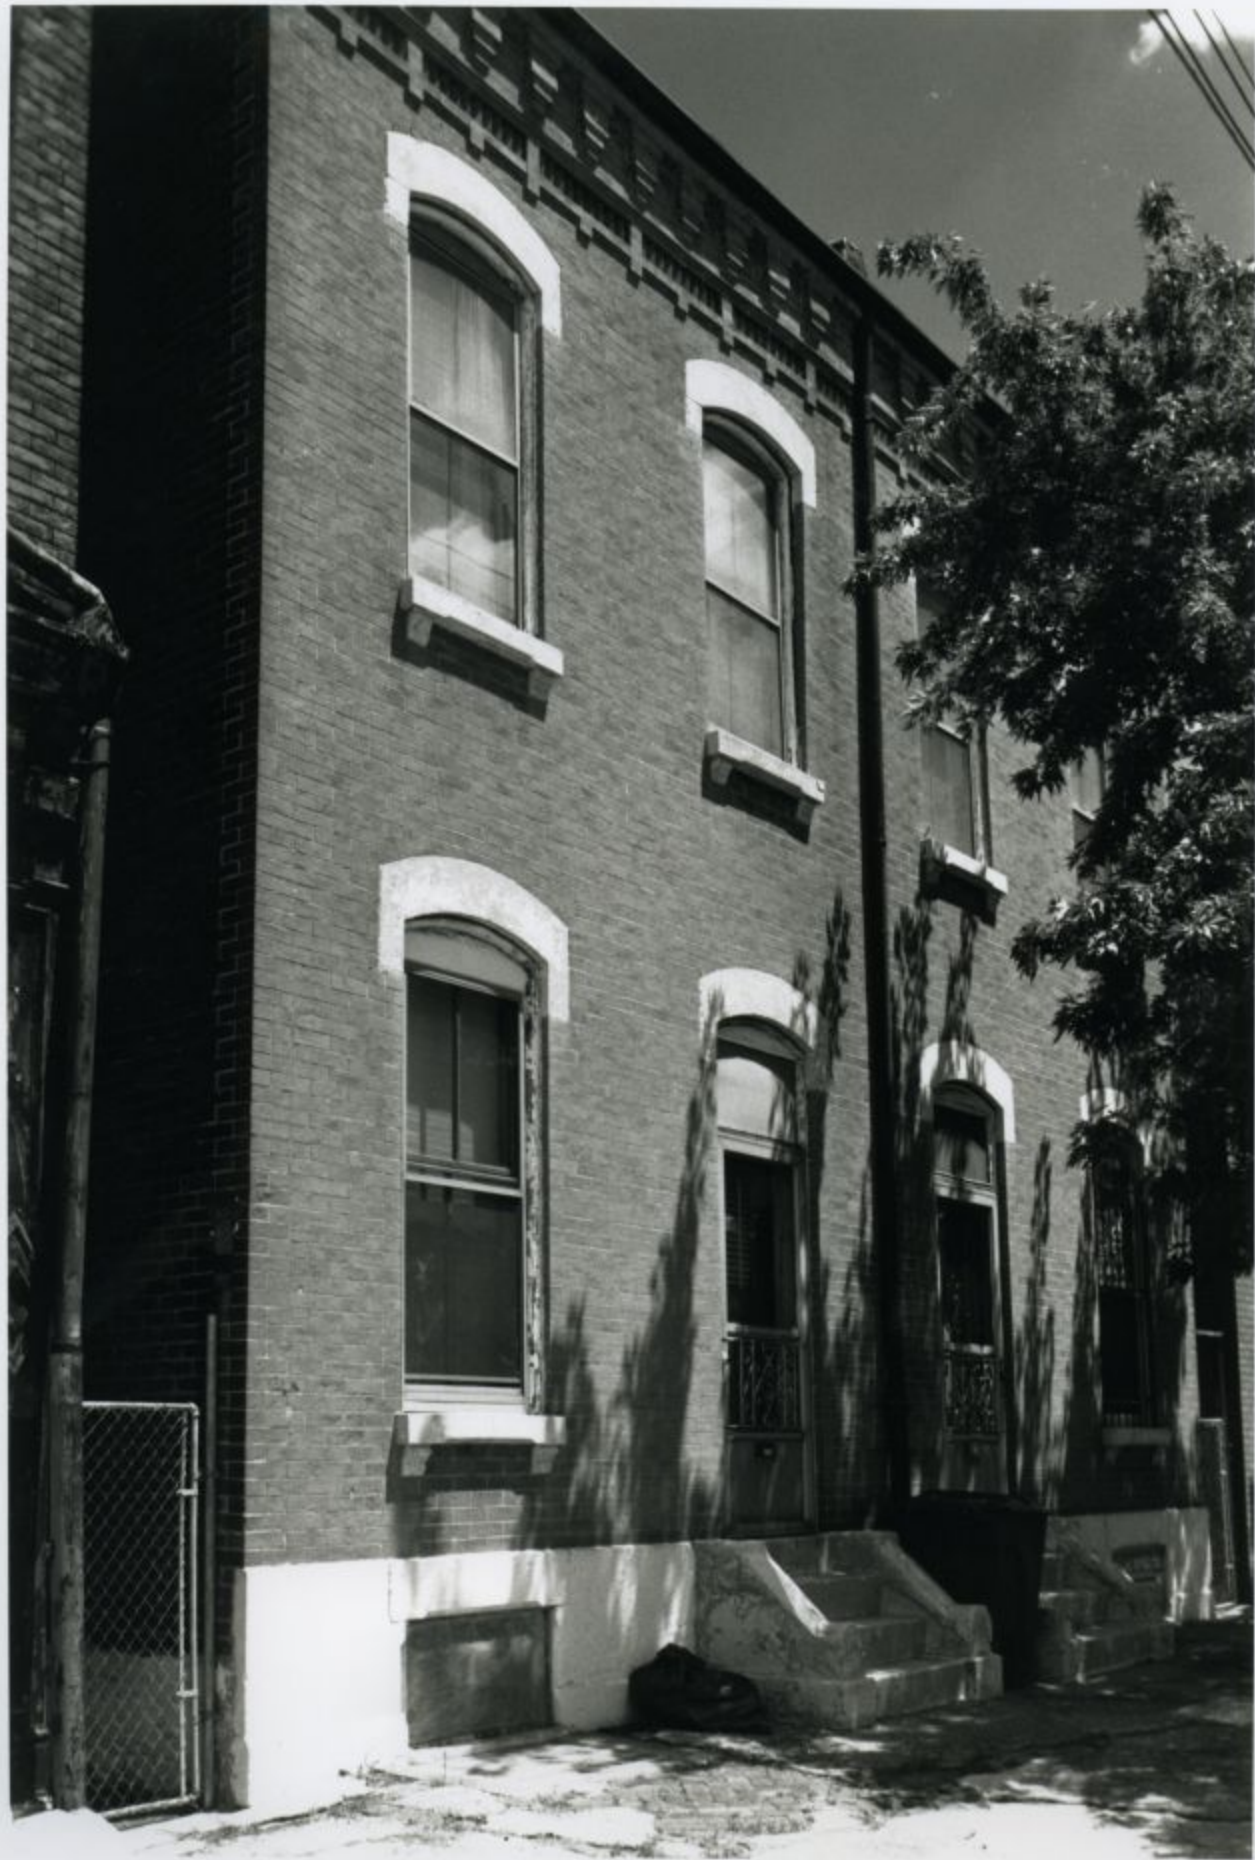
#42

31. Further description of important features: Windows of the primary elevation have shaped stone lintels and stone lugsills. Two-over-two windows are probably replacements. Elaborately corbelled cornice. Parapeted chimneys. Building fronts directly on sidewalk; front stone steps have stone side walls.

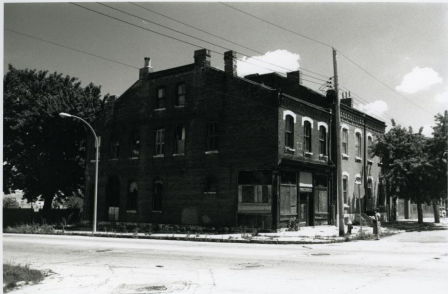
#43

31. Further description of important features: Primary elevation features shaped stone lintels and stone lugsills, elaborately corbelled cornice and a cast-iron storefront headed with a wood cornice. The display windows of the storefront appear to be in their original configuration, although they have been boarded up. Side openings are segmentally arched with the (cont'd. below)

32. History and Significance: exception of a round-arched recessed entryway near the rear of the building, which probably provided access to upper units for residential use. Windows are two-over-two, double-hung wood sash. Parapeted chimneys. Building appears to have had fire damage. The permit for this building was taken out by C. Schawback/Schoenbach/Schoenbeck (there is great inconsistency in the recorded permits) for \$2,400 in 1879 to build a "store & dwelling." Its use was apparently consistent with this until its vacancy.

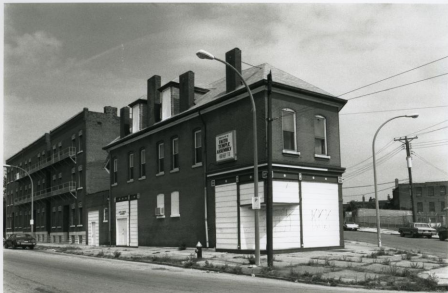
#58

31. Further description of important features: This building is located on a peninsula, necessitating its odd shape. Windows are segmentally arched on the 11th St. elevation; gauged brick arches are on the corner & 9th St. elevations. First-story openings have been infilled, including the corner cast-iron store-front by St. Louis Architectural Iron. Stone sills have egg & (cont'd below)

32. History and Significance: dart ornamental brick directly beneath. One-story rear addition attaches the building to 1111-13 Branch. H. Bressler took out the permit for this building in 1907 for \$7,000. He hired General Contractor Bernhardt Wussler to do the construction. The pair teamed up on two other tenement buildings in this city block at the same time (#59 & 60). No information could be found on Bressler; he evidently built the buildings as speculation or investment. Wussler was active in many parts of the city c. 1900.

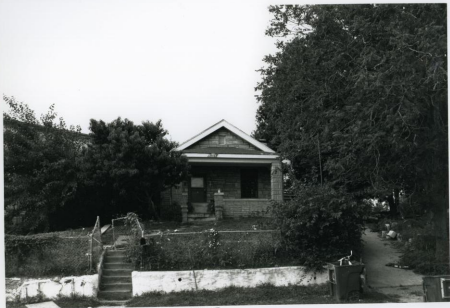
#61
NORTH BROADWAY INDUSTRIAL SURVEY II
3115 N. ELEVENTH
FACING W

31. Further description of important features: An open porch is located across the gable end of this house. A rear ell is attached to the rear. The exterior is covered with permastone.

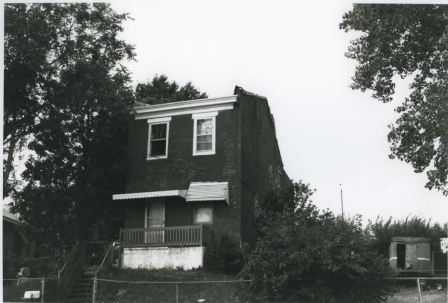
#62
NORTH BROADWAY INDUSTRIAL SHADY II
3119 N. ELEVENTH
FACING W

31. Further description of important features: Plain wood cornice. Replacement windows have flat wood lintels. First-story window heads obscured by metal awnings. Concrete block porch with wood railing of late-20th century vintage.

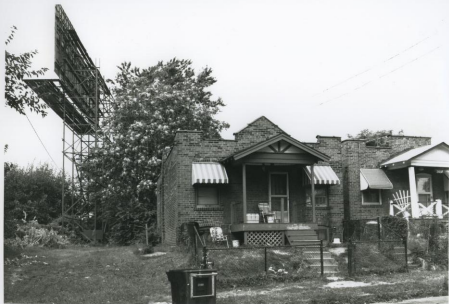
#63

31. Further description of important features: Variegated "tire track" textured red & mixed brick is trimmed with terra cotta coping. Shaped parapet. Double-rowlock segmentally arched windows have brick sills. Gabled wooden front porch.

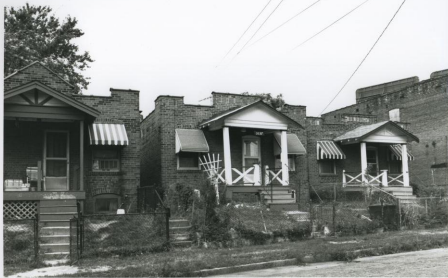
#64

31. Further description of important features: Variegated "tire track" textured red & mixed brick is trimmed with terra cotta coping. Shaped parapet. Double-rowlock segmentally arched windows have brick sills. Gabled wooden front porch.

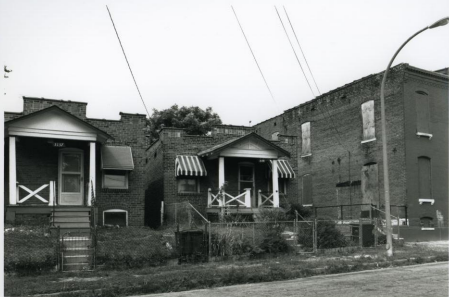
#65

31. Further description of important features: Variegated "tire track" textured red & mixed brick is trimmed with terra cotta coping. Shaped parapet. Double-rowlock segmentally arched windows have brick sills. Gabled wooden front porch.

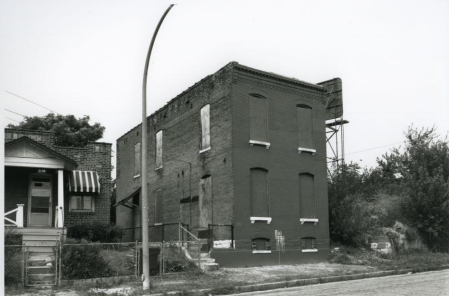
66

31. Further description of important features: Windows have segmental soldier arches, rounded pressed-brick jambs and stone lugsills with brackets. Corbeled cornice. Quarry-faced foundation. Openings are all infilled with wood. An unusual feature of this building is the side entrance.

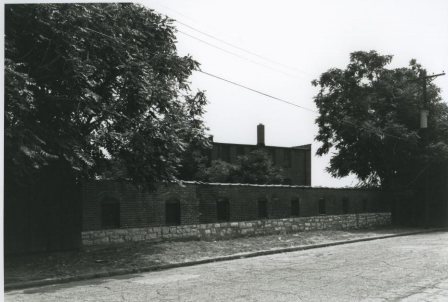
#69

31. Further description of important features: This building is unusual in that the only part of it visible from the street appears basementlike. The interior height is actually the equivalent of about 1-1/2 stories due to the slope of the site. Double-rowlock segmentally arched windows are spaced at regular intervals just above the stone "foundation" (really a (cont'd. below)

32. History and Significance: retaining wall). A permit was taken out for a wagon shed and stone retaining wall in 1900 by the Yerkes & Finan Woodworking Machine Company for \$450. The company also owned the factory next door at 3145-51 N. Ninth (#70).

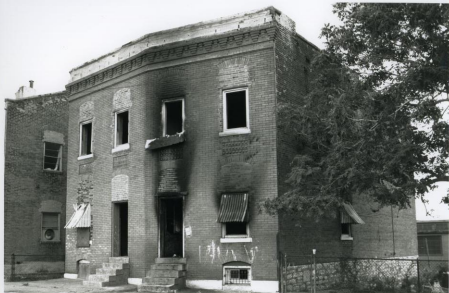
#71 NORTH BROADWAY INDUSTRIAL SURVEY II
3156-58 N. ELEVENTH
FACING NE

32. History and Significance: building had just been substantially burned in a fire the night before the photo was taken. W. C. Richardson took out the building permit for this duplex in 1884 for \$5,000. The building has always been a residence.

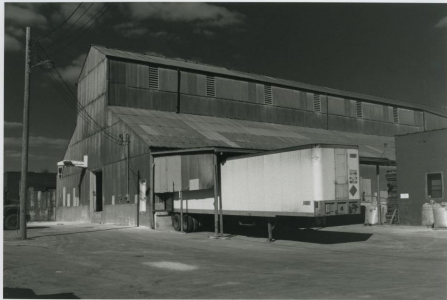
152

31. Further description of important features: This building has a monitor roof with corrugated fiberglass clerestory. High concrete foundation gives way to complete sheathing with corrugated iron. Loading bay in gable end and west end of south elevation.

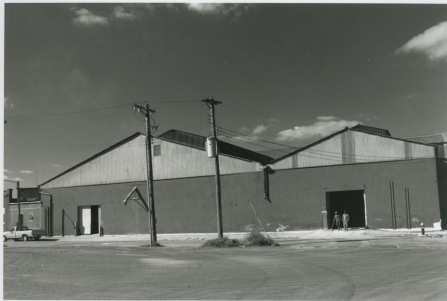
#151

31. Further description of important features: Roofline has two end gables, each surmounted by a gable of the same pitch to provide a clerestory (sheathed with corrugated fiberglass - see photo #150 for better view). Gable ends covered with corrugated iron. All original openings have been bricked in with the exception of two large garage bays.

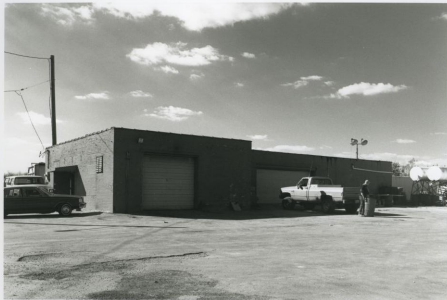
#149

31. Further description of important features: Side openings in this building are overhead garage-door bays. Original front elevation openings have been infilled with brick and wood. Terra cotta coping.

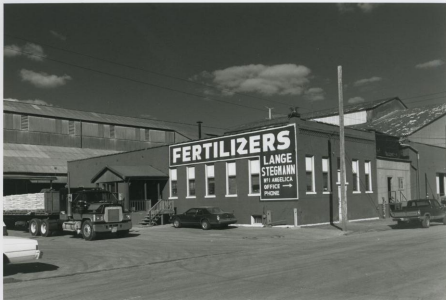
NORTH BROADWAY INDUSTRIAL SURVEY II
21 ANGELICA
FACING NE

31. Further description of important features: This building is set on a diagonal to the corner, with a projecting center entrance pavilion highlighted by a panelled terra cotta cornice. Double brick string cornice courses extend across the wings. Flat arches, stone sills; one-over-one panes. Centered entrance is reached by either of a pair of flanking steps.

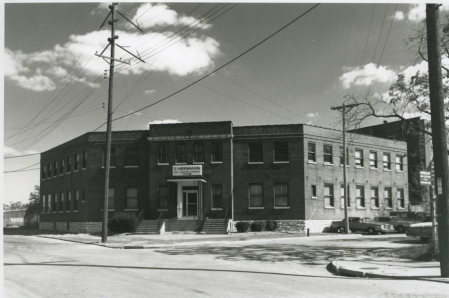
NORTH BROADWAY INDUSTRIAL SURVEY II
88 ANGELICA
FACING SE

31. Further description of important features: Building has an awninglike roof on the north and west sides, covered in asphalt shingles and supported by heavy wood brackets. Window arches are obscured by this feature. Terra cotta coping. One-story brick rear ell addition.

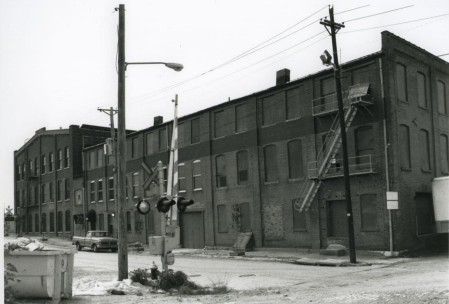
NORTH BROADWAY INDUSTRIAL SURVEY II
47 BRANCH
FACING NW

31. Further description of important features: Windows have triple-rowlock segmental arches, stone sills, and three-over-three horizontally-hinged sash. Piers divide the building into recessed panels that are topped with corbelling. Some windows infilled with brick. Terra cotta coping. Southwest & southeast corners and small parapet rise above the roofline. Building is (cont'd. below)
