MISSOURI OFFICE OF HISTORIC PRESERVATION
ARCHITECTURAL/HISTORIC INVENTORY SURVEY FORM

11
NORTH BROADWAY INDUSTRIAL SURVEY II
2217 N. FIRST FACING SW

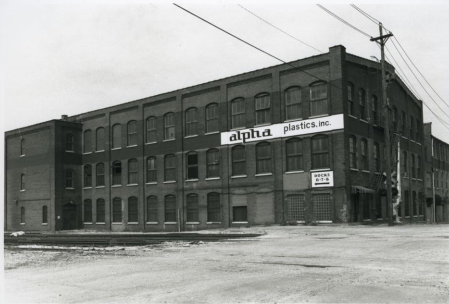
NORTH BROADWAY INDUSTRIAL SURVEY II
59 BRANCH
FACING NE

31. Further description of important features: This is actually two separate, identical buildings being counted as one unit. Gauged brick arches and stone sills with egg & dart molding beneath highlight the 6-over-6 double-hung wood sash windows. Inset wood panels with diamonds throughout are new additions. Elaborately corbeled cornice. Stone water table; quarry-faced (cont'd below)

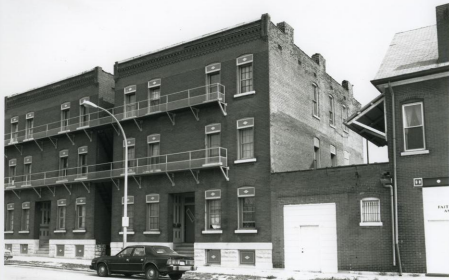
NORTH BROADWAY INDUSTRIAL SURVEY II
1111-13 BRANCH
FACING N

31. Further description of important features: This triple tenement building is of the same design as #59. Gauged brick arches and stone sills with egg & dart molding beneath highlight 6-over-6 double-hung wood sash. Inset wood panels with diamonds are recent additions. Elaborately corbeled cornice. Stone water table. Quarry-faced foundation. Recessed doorways. New metal balcony.

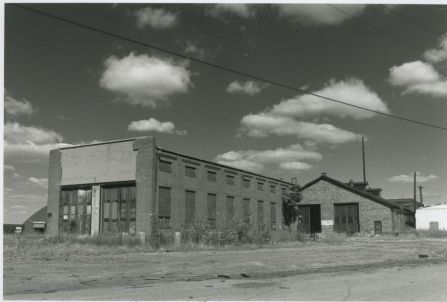
#148
NORTH BROADWAY INDUSTRIAL SURVEY II
37 BREMEN
FACING NE

31. Further description of important features: A concrete loading dock with a wood and metal fixed awning spans the Bremen St. elevation of this building. All windows are boarded; they have double-rowlock segmental arches and brick sills.

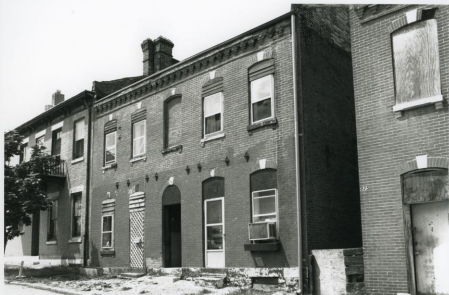
122

31. Further description of important features: A corbelled cornice crosses the top of this building. A round-arched center gangway provides the entrance to an open hall to the rear stairs. The other openings are segmentally arched with stone keys and bracketed lugsills. Building fronts directly on sidewalk. Some rebuilding of the front facade is in evidence. Window arches (cont'd. below)

32. History and Significance: are infilled. Replacement windows have metal sash. Building has commonwall with 831-33 Bremen (#121). No permit was found for this building. It does not appear on the 1875 Compton & Dry map but seems to be on the Hopkins 1883 map.

NORTH BROADWAY INDUSTRIAL SURVEY II
827-29 BREMEN (CENTER)
FACING NW

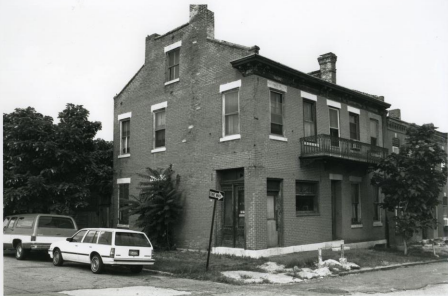
#121
NORTH BROADWAY INDUSTRIAL SURVEY II
891-33 BALEMEN
FACING NE

31. Further description of important features: Flat stone lintels and stone sills highlight original openings. A profiled wood cornice features carved brackets and dentils; it returns at the sides. Parapeted chimneys on west elevation. Very fine, original iron balcony with iron brackets. Southwest corner has been altered; it apparently was used as a commercial (cont'd. below)

32. History and Significance: entrance for a business in the building. A brick corner pillar, punched-in window, and Queen Anne style wooden doors belie a later alteration. Residence shares commonwall with 827-29 Bremen (#122); the chimneys on that wall feature corbelling. No permit was evidently issued on this building due to its early date. It does not appear on the Compton & Dry 1875 map, although it is on the 1883 Hopkins. A rear frame addition of indeterminate age extends from the rear, obscured by foliage.

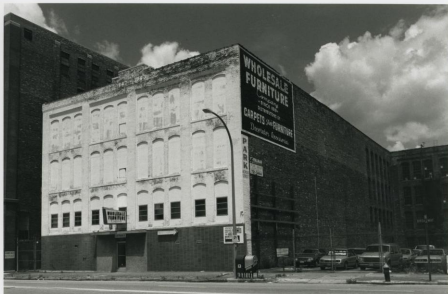
#4

31. Further description of important features: First-story facade extensively altered. "1847-1903" inscribed across centered stepped parapet. Triple-row-lock segmentally-arched windows have stone sills, are divided into pairs or triples by pilasters & brick corbelling. All openings on front elevation infilled to some degree. Rear & side windows have original multipanining.

NORTH BROADWAY INDUSTRIAL SURVEY II
2204-10 N. BROADWAY
FACING NE

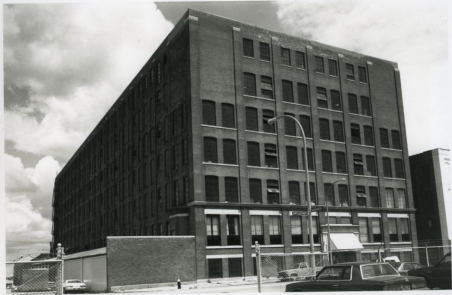
#5
NORTH BROADWAY INDUSTRIAL SURVEY II
2212-20 N. BROADWAY
FACING SE

31. Further description of important features: Stone-capped pilasters divide the triple-rowlock segmentally-arched windows into pairs. Stone lintels above 1st & 2nd story windows; stone sills. Stone cornice across front above 2nd story. Paneled pilasters support stone entablature over entrance. Original windows in floors 3-7 have multiple industrial panes.

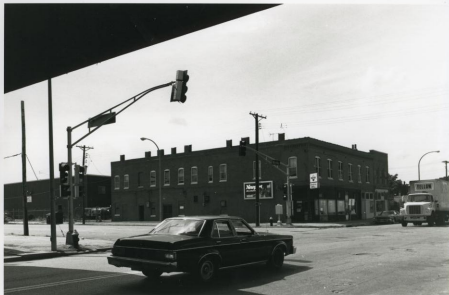
#13

31. Further description of important features: Triple-rowlock segmentally arched windows have stone sills and modernized panes; many first-story openings are infilled. A deeply-corbelled cornice returns for the width of one bay. A cast-iron storefront by Globe Iron & Foundry Co. is mostly intact, distinguished by sunbursts, with rosettes across the lintel beam.

NORTH BROADWAY INDUSTRIAL SURVEY II
2401 N. BROADWAY
FACING NW

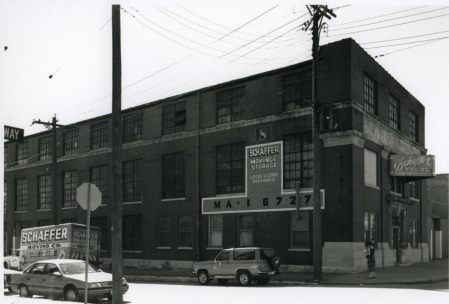
8 16
NORTH BROADWAY INDUSTRIAL SURVEY II
2422-24 N. BROADWAY
PACINA SE

31. Further description of important features: This building was originally only two stories; a third was added above the stone sillcourse with guttae, probably in 1920. Tooled stone extends midway up the first floor, returning at the sides. Stone forms the pilaster capitals and sills as well. Original windows are multipane industrial metal sash; some one-over-one (cont'd. below)

32. History and Significance: replacements have been made. The interior has millwork construction with iron/steel columns; interior walls are of vitreous brick. A one-story garage (1941) is attached to the south side of the building. The original permit for a cold storage building was taken out for \$27,000 in 1903 by J. Ogden Armour. Condie Bray Glass Co. apparently added the third floor for \$12,000 in 1920. The Pernoud Carpet Co. owned the building in the 1930s, followed by rug companies in the 1950s, a box company, and Schaffer Moving Co.

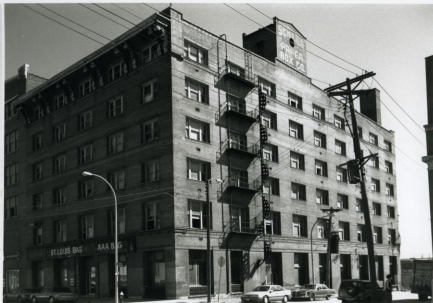
22

31. Further description of important features: Chicago-style tripartite windows have continuous lintel and sill soldier courses for horizontal emphasis. Prominent, overhanging, bracketed copper cornice. Stylized classical piers at entry. Metal grillwork at base of first story windows. Pink granite entry steps and foundation facing.

NORTH BROADWAY INDUSTRIAL SURVEY I
2500 N. BROADWAY
FACING NE

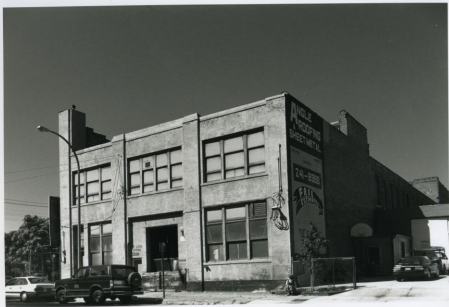
#20

31. Further description of important features: The three recessed bays of the primary elevation are topped by a (concrete?) parapet of probably 1940s vintage. Utilitarian windows are horizontally hinged and have concrete sills. Center bay is a loading dock/garage door bay. The rear elevation is three stories, with all openings infilled save a garage bay. Rear windows have soldier arches.

NORTH BROADWAY INDUSTRIAL SURVEY II
2507-N N. BROADWAY
FACING SW

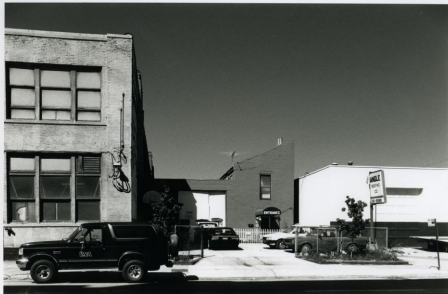
#21

31. Further description of important features: A single, stone-linteled window punctuates the flounder section's primary elevation; warehouse doors open in the flat-roofed section. The 1875 Compton & Dry map shows a diverse group of buildings in the immediate area, including the mixed gabled-front-with-flounder-rear style found throughout the north side. Although no permit could (con't. below)

32. History and Significance: be found earlier than 1886, it is likely that this building is a remnant of the earlier era. A permit taken out by Louise Becker on 6/23/1886 for two adjoining tenements probably incorporated this building. No other permits could be found from 1886 to 1970, when a demolition permit was issued to wreck a "2 story factory & warehouse." The tenements had probably been turned into industrial buildings before their demise left the smaller building standing alone.

NORTH BROADWAY INDUSTRIAL SURVEY II
2513 N. BROADWAY
FACING W

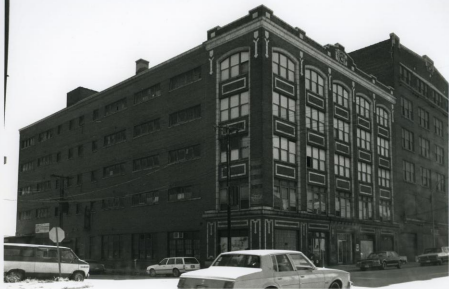
24

31. Further description of important features: Extensive use of cream-colored terra cotta trim highlights the building's pier & spandrel system. Triple windows of the primary elevation appear to have been modified in all but the 2nd story. A green terra cotta panel over the entry reads "OLIVER" and the shaped parapet features a center terra cotta insignia of a capital O (cont'd. below)

32. History and Significance: with a plow and shield motif. Mortar is rose-colored. First-story display windows have glass brick, wood or plate glass in-fill. The \$75,000 building permit for this warehouse was taken out by the Oliver Chilled Plow Co. in 1911, specifying that the building be "fireproof." The company became the Oliver Farm Equipment Co., makers of tractors and other farming implements sold nationwide. They used the building until its sale to United Bags in 1960. The architects were from Pittsburgh, builder from Indiana.

NORTH BROADWAY INDUSTRIAL SURVEY II:
2516 N. BROADWAY
FACING SE

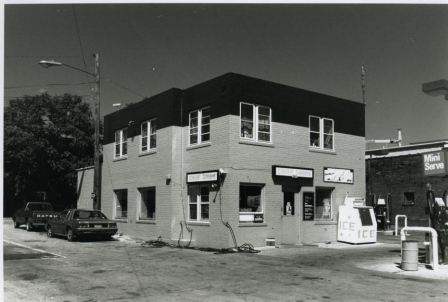
31

31. Further description of important features: Paired windows have brick sills and soldier course lintels. Some first-story windows have been replaced with single panes. Terra cotta coping.

NORTH BROADWAY INDUSTRIAL SURVEY II
2601 N. BROADWAY
FACING NW

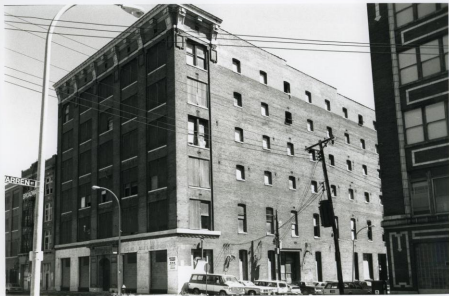
32
NORTH BROADWAY INDUSTRIAL SURVEY II
2604-06 N. BROADWAY
FACING NE

31. Further description of important features: Pier & spandrel system is used on the primary elevation, with almost all the original paired windows infilled with wood. The vertical emphasis of the facade is heightened by huge, nearly vertical terra cotta paneled brackets. Piers terminate below the cornice with Craftsman raised brickwork panels. A stylized classical front (cont'd. below)

32. History and Significance: entry features paneled pilasters supporting an elliptical arch. Raised letters of grey terra cotta above the entrance read, "KINGMAN." Four loading docks are located on the south elevation. Kingman took out an \$85,000 permit in 1906 for this warehouse; the permit mentions the St. Louis Implement Co. Leonard Hillis took out a \$10,000 permit to "repair fire damage to warehouse." Artophone occupied the building in 1947.

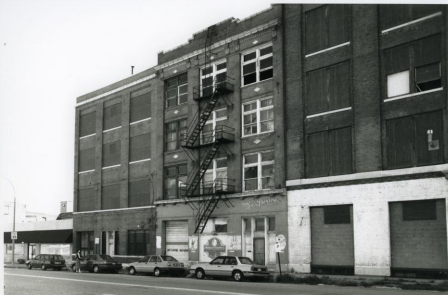
#33

31. Further description of important features: White terra cotta is used to highlight the facade, including coping on the stepped parapet, diamond insets in the spandrels, and profiled cornices at the first and fourth stories. Paired, transomed windows have soldier-course lintels. First-story facade has been altered with a north bay garage door and infilling of the center bay.

NORTH BROADWAY INDUSTRIAL SURVEY II
2608 N. BROADWAY (CENTER)
FACING NE

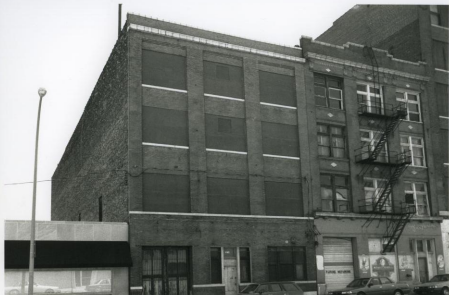
34

31. Further description of important features: All upper-story openings in the primary facade have been boarded up; they are recessed and feature stone sills. White terra cotta cornice and coping. Stone water table. North garage bay appears to be original.

NORTH BROADWAY INDUSTRIAL SURVEY II
2614 N. BROADWAY (CENTER)
FACING E-SE

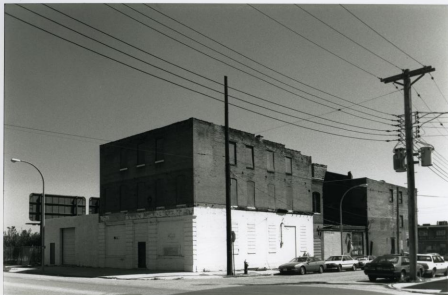
#47 NORTH BROADWAY INDUSTRIAL SURVEY II
8700-04 N. BROADWAY
FACING NE

31. Further description of important features: All openings in the front portion of the building have been infilled with wood or masonry. Rusticated brickwork defines the first-story storefront. 1st & 2nd story windows have segmental arches, stone sills. 3rd story windows have no arches. Modern CMU 1-story addition to the north; one-story brick addition connects the rear (cont'd. below)

32. History and Significance: 1941 addition to the front part. Rear addition has windows with no arches and brick sills, flat roof, terra cotta coping. The Schwarzschild & Switzberger Co., apparently a short-lived meat market, took out the \$25,000 building permit for this building in 1903; they were gone by 1917. The M. Holtzman Metal Co. occupied the building by 1924, owning it through the early 1950s. It has since been a textile waste warehouse, package liquor store confectionery and now is a warehouse for paper products.

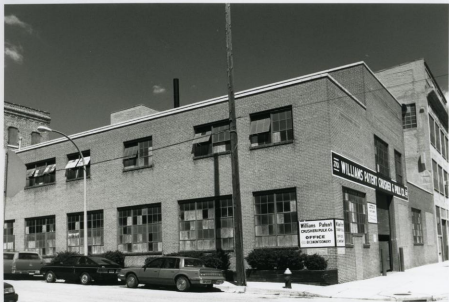
#45 NORTH BROADWAY INDUSTRIAL SURVEY II
2701 N. BROADWAY
PACIFIC NW

31. Further description of important features: Windows have brick sills and multipane industrial metal sash; openings have no arches. White terra cotta coping. Primary elevation has several brick-in openings.

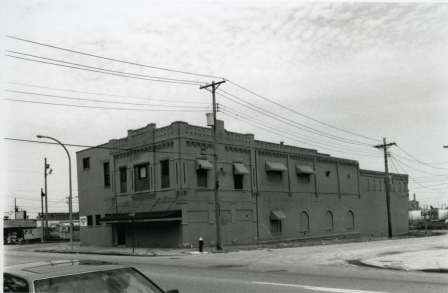
#54

31. Further description of important features: A stepped parapet is high-lighted with rows of recessed square panels; below, a string course of quarry-faced stone tops brick corbelling divided by pilasters. Windows have quarry-faced flat stone lintels in the front part of the building. The original storefront has been infilled with masonry; an oval Moderne-style (cont'd below)

32. History and Significance: window has been punched into the west elevation. Quarry-faced stone banding remains on pilasters. First-story side windows have round, pressed-brick arches. A rear 1917 cooler addition has only a row of tiny segmentally arched windows near the roofline. A brick addition is located on the north side. The active and inactive building permits for this city block have been mixed together with the loss of some. An 1892 demo permit for this site is never followed by a building permit. Meat companies here since 1917.

NORTH BROADWAY INDUSTRIAL SURVEY II
2900 N. BROADWAY
SPRING NE

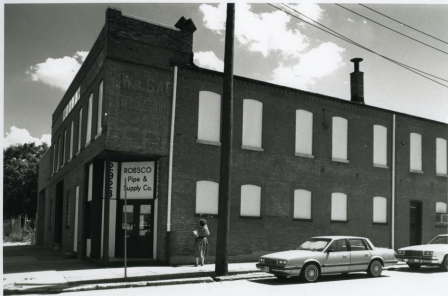
#53
NORTH BROADWAY INDUSTRIAL SURVEY II
2917-23 N. BROADWAY
FACING SW

31. Further description of important features: Windows have segmental soldier arches with stone sills; they have all been infilled with corrugated material or glass brick. Angled cast-iron storefront has a single column. Corbelled brick cornice. Stepped parapet at front is coped with white terra cotta. One-story 1904 warehouse addition to south; concrete block rear addition to west.

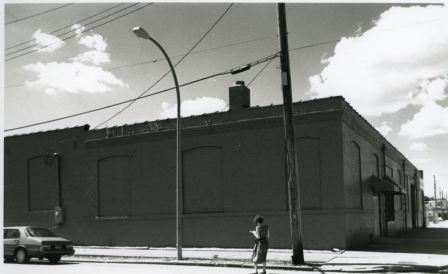
#55

31. Further description of important features: Triple-rowlock segmental arches top openings on the east and south elevations. Corbelled brick cornice. Raised brick sill string course. Terra cotta coping. Windows have been infilled with brick.

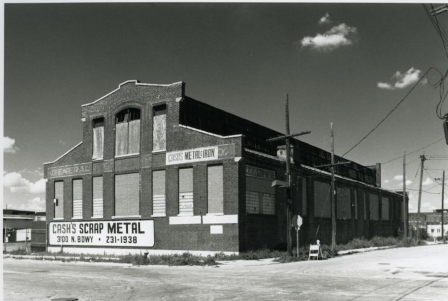
77
NORTH BROADWAY INDUSTRIAL SURVEY II
300 N. BROADWAY
FACING NE

31. Further description of important features: The center of this building is raised to a 2-story height with a monitor roofline. Terra cotta coping rims the parapet. A double-rowlock segmental soldier arch dominates the upper center bay of this building, which was originally used as a foundry. Windows have all been infilled. Stone sills on front elevation.

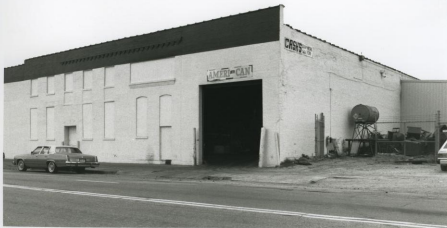
78

31. Further description of important features: A corbelled brick cornice is centered on the building. Flat and segmentally-arched windows are all infilled. Large garage bay in south end of front elevation. Plain parapet with terra cotta coping. New addition adjoins building on the north.

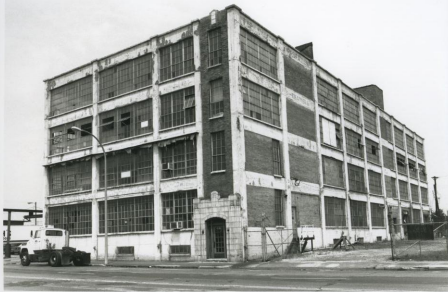
80
NORTH BROADWAY INDUSTRIAL SURVEY II
3228 N. BROADWAY
FACING NE

31. Further description of important features: Bays of multipane industrial metal sash windows make up the bulk of the walls of this building. A buff terra cotta Art Deco entrance in the southwest corner projects somewhat from the face of the building; it is surmounted by nine-over-six windows, one per story, and topped by a tiny inset shield at the roofline. Some of the (cont'd. below)

32. History and Significance: bays have been infilled with brick. The permit for this building was taken out by the Con Fero Paint Company in 1929. The building cost \$55,000.

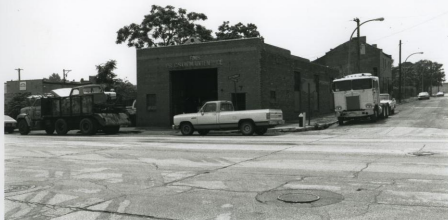
#76
NORTH BROADWAY INDUSTRIAL SURVEY II
3237 N. BROADWAY
FACING SW

31. Further description of important features: Soldier course banding (one of which is buff-color) relieves the facade. A large garage bay dominates the front elevation. A tiny, pointed parapet of glazed white brick is centered, flanked by white terra cotta coping. The primary facade shows evidence of being a replacement of the original.

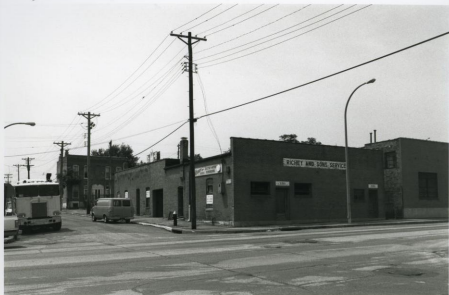
105

31. Further description of important features: Front elevation has a new brick veneer applied with new fenestration. Side openings have double-rowlock segmental arches, most infilled. Terra cotta coping.

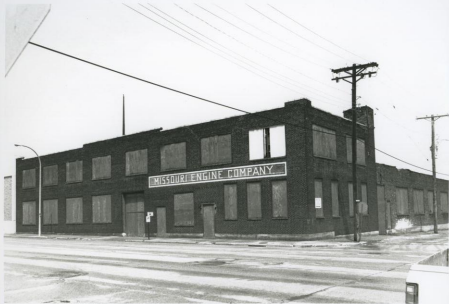
#107

31. Further description of important features: All openings on the west and south elevations have been infilled with wood. Brick sills, flat arches. White terra cotta coping along roofline that has parapeting at corners and center front. One-story, six-bay rear addition predates main building.

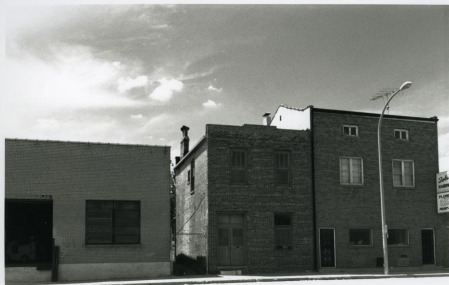
106

31. Further description of important features: The facade of this building has been covered with a variegated brick veneer. Front elevation windows have no arches, brick sills and have a three-over-one Craftsman double-hung wood sash pane configuration. Double wood doors are transomed. Side window is segmentally arched; smaller, square window is punched in. Short stepped parapet.

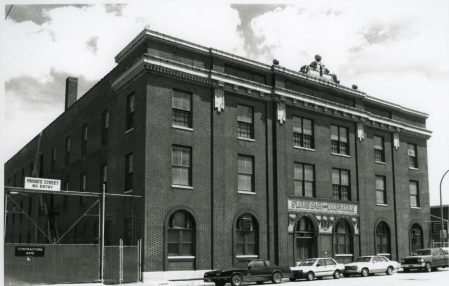
#109

31. Further description of important features: A white terra cotta cornice is surmounted by a scroll & ball pediment. A second t.c. cornice features dentil-ling at the sides and modillions in the center; t.c. shield ornaments mark the pilasters just below. The facade is laid in a checkerboard pattern using dark cull headers. First-story openings have large round arches; (cont'd. below)

32. History and Significance: those above have flat arches; side windows are segmentally arched. All front elev. windows have brick sills. Above the first-story center openings is a large t.c. panel: "ST. LOUIS SASH and DOOR WORKS." Below, amid t.c. swags and ornamentally-bricked round arches, is the date 1906. See attached for information on the company, who occupied the building at least through 1940.

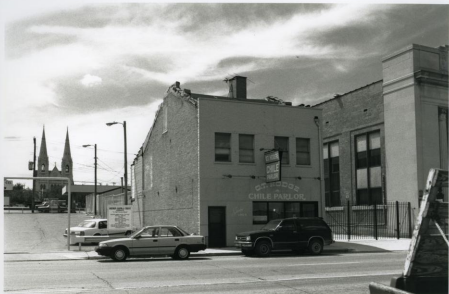
III
NORTH BROADWAY INDUSTRIAL SURVEY II
3523 N. BROADWAY
FACING W-NW

31. Further description of important features: The front of this building has been altered, perhaps more than once; a building permit to "change front of store" was issued in 1906 to Mr. Kupperschmidt. The front as it is today was probably redone later in this century. Openings have flat arches and brick sills. Side openings infilled with brick. CMU rear addition.

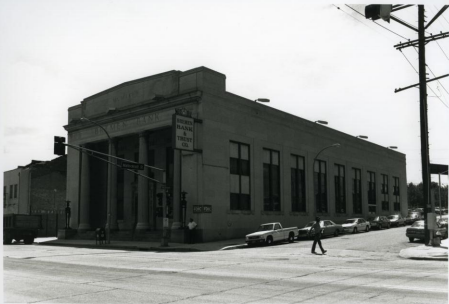
#112

31. Further description of important features: Four fluted stone corinthian columns support a stone entablature engraved "BREMAN BANK." Above the profiled and denticulated cornice on the shaped parapet are engraved "MCMXXVII." Four stone steps lead up to the entrance. Stone griffins are carved above the doorway, which is flanked by carved classical figures. Above the (cont'd. below)

32. History and Significance: front bays are stone shield and swag carvings. Massive side windows are eight-paned. Art Deco metal lamps flank the building front. Rear and south side elevations are not covered with stone, exposing the brick. The Breman Bank has been in continuous operation at this location since 1927.

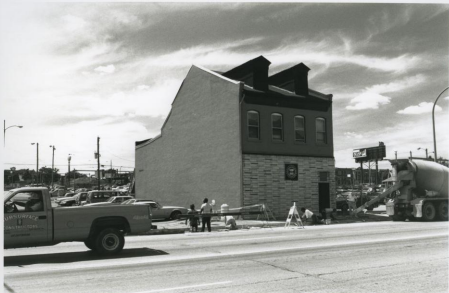
#114
NORTH BROADWAY INDUSTRIAL SURVEY II
3607 N. BROADWAY
FACING NW

31. Further description of important features: The first story of this building has been covered with permastone, obscuring the original fenestration. The second-story windows have segmental arches and replacement panes. The two dormers have been infilled. A one-story brick rear addition is flat-roofed.

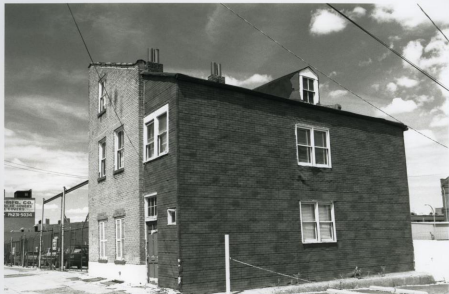
113

31. Further description of important features: This building is a two-bay brick flounder with a brick-look asphalt-shingled two story addition. Original windows had brick jack arches; two have been altered to flat arches. Functional wood shutters at the first floor. A transomed wood doorway is located in the frame portion. A dormer faces south in the frame section. (cont'd. below)

32. History and Significance: A two-story wood porch is located across the brick half of the east elevation. It is not possible to be certain whether this building appears on the 1875 Compton & Dry pictorial map; it is on the 1883 Hopkins map. No building permit could be found for it. Since this photo was taken, Mallinckrodt has cordoned it off and has removed some of the roofing around the dormer. It appears that they have plans to demolish the building.

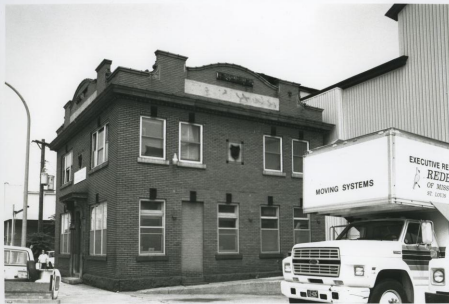
119

31. Further description of important features: A curvilinear parapet with terra cotta coping tops the building; on each elevation, a terra cotta "log" ornament is embedded in the parapet (part of one missing). Profiled terra cotta cornice has egg & dart molding just beneath. Windows have header lintel courses with terra cotta keystones. At the second story on each (cont'd. below)

32. History and Significance: elevation is a rectangular inset with a terra cotta shield with the letter N. Entrance has ornate, bracketed terra cotta surround. The metal-sided building behind this office has shaped parapets that echo those of this building. Because the siding is new, it is impossible to tell whether the parapets are old or new. Charles Naber's Sons operated a lumber/building materials business at this location into the 1940s. No permit could be found for this building, which Naber was using in the teens, at least.

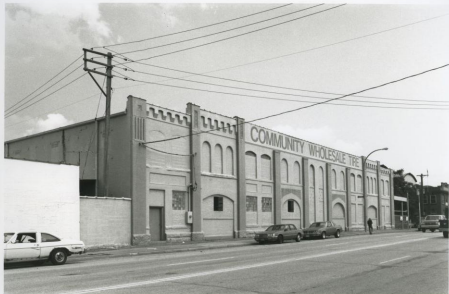
#120

31. Further description of important features: Stepped, terra cotta-coped parapet. Piers divide the facade into bays; various types of ornamental pressed brick blocks are inset at the terminations of the six tallest piers. Openings are variously segmentally-, elliptically- or round-arched; they have all been infilled with brick, glass brick or CMU.

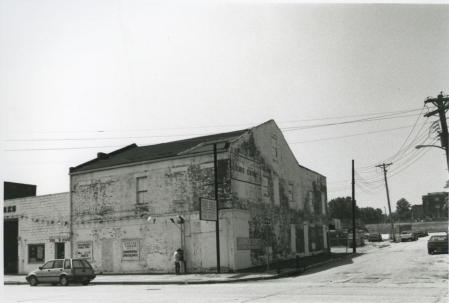
#116
NORTH BROADWAY INDUSTRIAL SURVEY II
3749 N. BROADWAY
FACING W-SW

31. Further description of important features: Most of the openings in this building have been infilled with brick. Flat stone lintels are visible. Corner storefront is bricked in; the stone or concrete corner pillar is still in place. Rear of building has a flat roof; 1959 south side addition is CMU.

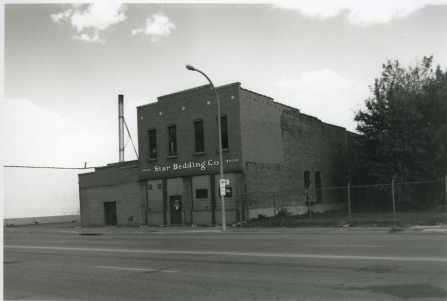
#138

31. Further description of important features: A stepped parapet has white terra cotta coping and white diamond insets. Side and upper-story windows have double-rowlock segmental arches and brick sills. The first-story storefront has been infilled with glass brick; two panelled cast-iron pillars remain. A 1904 one-story addition to the north mimicks the roofline of the (cont'd. below)

32. History and Significance: larger portion. A plain, painted brick addition of one story is attached to the building at the north side. Frederick L. Kayser took out the permit for this building as part of his tannery in 1908 for \$2,650. He owned the Kayser Raw Hide Co., formerly the Kayser & Nils Raw Hide Co. and, later, the Kayser Tanning Co. The one-story storeroom and office was built in 1904, and the large rear addition was built in two parts in 1927 by Wahlert & Guntzler ("est. 1848; buyers of all kinds of feathers and raw wool").

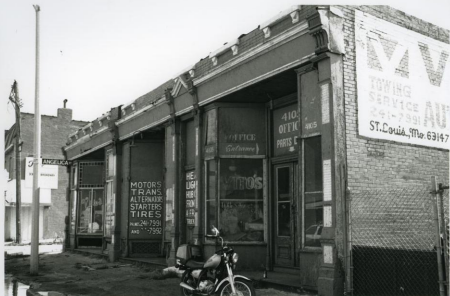
#155

31. Further description of important features: This building was originally two stories in height (note stone sills) and the two adjoining buildings on the north that were included in the building permit have been demolished. However, the remaining cast-iron storefront is such a wonderful specimen of the art that it is included in this survey. Paneled columns feature fields (cont'd. below)

32. History and Significance: of tiny pyramids, fluting, and bands of hemispheres. Corner column is gridded like a hand grenade. Capitals have floral motifs and rosette medallions. Quatrefoil grillwork below several display windows. Original transomed, wood-panelled double doors, some with Eastlake carving above. Southernmost display bay features Queen Anne windows. No casting imprint. Sidewalk is gone and building has been allowed to deteriorate. Permit was taken out in 1888 for \$12,000 for 3 adj. bldgs. by Louis Kohrmel = no info.

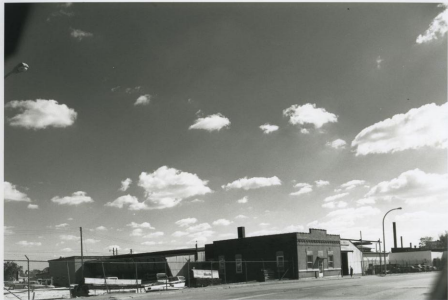
* 140
NORTH BROADWAY INDUSTRIAL SURVEY II
4006 N. BROADWAY
FACING SE

31. Further description of important features: Parapeted cornice with heavy terra cotta coping. Large corbelled brick cornice. Front windows have jack arches with brick keys; these have been partially infilled to fit smaller new windows. A stone sill course crosses the front of the building. Side windows have double-rowlock segmental arches adn stone sills and are (cont'd. below)

32. History and Significance: all infilled. The permit for this building was taken out in 1904 by P. Gruner & Bros. for \$2,000. The firm was a lumber company; the property is still a lumberyard.

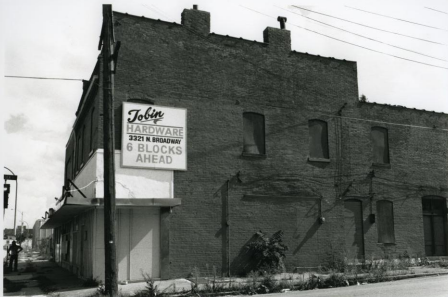
#136

31. Further description of important features: The mansard on this building has asphalt shingles and boarded dormer windows (traffic prohibited a better photo). Corbelled cornice. Double rowlock segmental arches and stone sills on the windows, which are all infilled. Original corner storefront has been altered and infilled with aluminum & wood. Terra cotta coping. (cont'd. below)

32. History and Significance: Portions of building on the south and rear have flat roofs. Building is attached to 812 Angelica (#135) by means of a small passageway. The permit for this "wareroom and wagon house" was taken out in 1880 by A. Ralive. No name for the business was given and Ralive could not be traced. During the 1930s and 1940s, at least, the building was used as a meat store and grocery store.

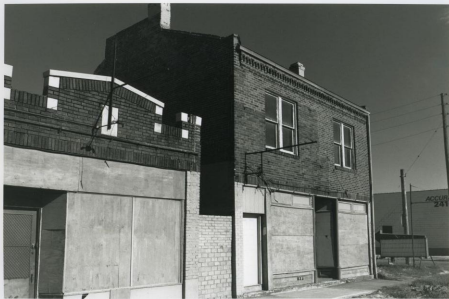
157

31. Further description of important features: Front of building has a denticulated brick cornice. Parapeted chimneys in side walls. Front elevation has apparently been altered, probably in 1926 when neighboring store (#158) was built. Windows have flat arches and brick sills and soldier course extends above storefront, none of which are characteristic of a (cont'd. below)

32. History and Significance: building of this age. Storefront was probably all cast-iron; only iron pillars remain; the front has been infilled with wood. The 1876 permit for this building was taken out by D. P. Zeipe for a store and dwelling. The building was used as a furniture store during the 1930s.

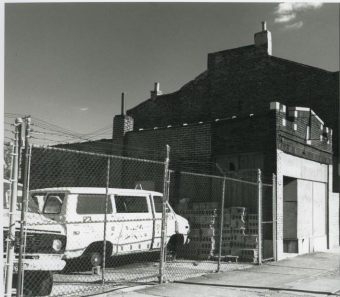
#150

31. Further description of important features: A parapeted front roofline is highlighted with white vitreous brick. A soldier course extends across the building above the storefront. Storefront has been infilled with wood. Terra cotta coping. See photo #157 for closer view.

32. History and Significance: The permit for this building was taken out by L. Rubin in 1926 for a \$3,000 store. City directories offer no clue as to which of several L. Rubins this might have been. The 1930 city directory lists the occupant of the building as the Western Union Telegraph Co. The 1940 city directory says the building was the "Branch Dispensary No. 1 Hospital Division." It has been used for storage in recent years.

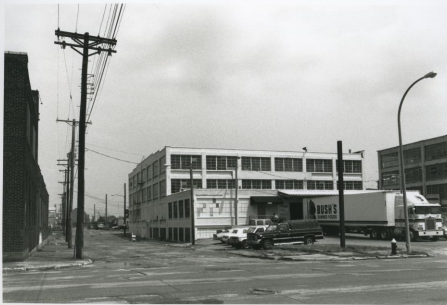
81 NORTH BROADWAY INDUSTRIAL SURVEY II
210 BUCHANAN
FACING SE

31. Further description of important features: This building was built as two separate entities; the older part is one-story and the newer, three. A loading dock now obscures about half of the west elevation of the older part. A low stepped parapet distinguishes the primary (north) elevation of the newer part. Multipane industrial metal sash windows are separated (cont'd. below)

32. History and Significance: horizontally by recessed panels. Some window infill. Foster Brothers Manufacturing Co. took out a permit for a one-story fireproof foundry for \$11,000 in 1906. This was followed by the three-story fireproof manufacturing building behind it, built by the same company in 1909 for \$35,000.

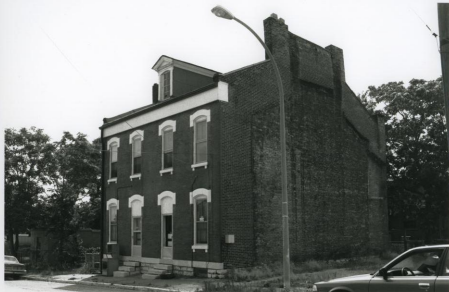
#74

31. Further description of important features: Shaped stone arches head window openings, which also have bracketed stone lugsills. Replacement panes. Single dormer. Parapeted chimneys in east and west walls. Plain wood cornice probably replaces more ornate original. Stone water table. Building fronts directly on sidewalk. Adjoining residence on west side (cont'd. below)

32. History and Significance: recently demolished; building "shadow" is markedly present on the west wall. The permit for this duplex was taken out in 1877 by T. Sparks. The building has always been used as a residence.

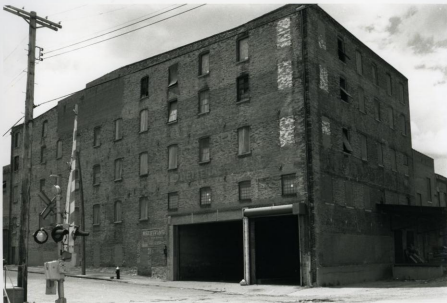
#9
NORTH BROADWAY INDUSTRIAL SURVEY II
N CLINTON
FACING NW

31. Further description of important features: Remaining original windows have segmental arches and stone sills; most are infilled with wood or brick. South elevation has had much replacement brick. A loading dock fronts the east elevation while two garage bays open in the south wall's east end. The Ranken & Fritch or Fritz Foundry took out a building permit in 1890 for (cont. below)

32. History and Significance: \$2,000 for a two-story foundry at this address. The company were no longer in business by the early 20th century. In 1944, the Hard Broad Fab. Co. took out a permit for \$1,000 to alter a "5-story factory." No permit appears in between to indicate when the additional three stories were built. The Monroe Realty & Inv. Co. spent \$35,000 in 1948 to alter a "five-story storage and sales grocery warehouse."

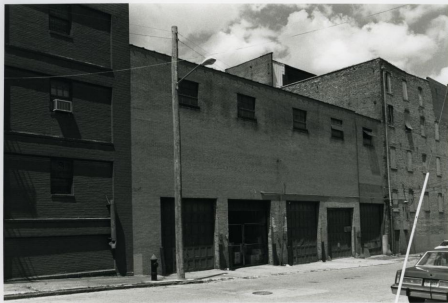
#8

31. Further description of important features: Five garage bays with no arches are located across the ground level. Five 6-over-3 horizontally-hinged windows with brick sills and no arches are located near the roofline. Terra cotta coping.

32. History and Significance: The site of this building was included in the late 1900 demolition permit taken out by Thomas & Kelly. No building permit was entered for this building, although a permit dated 2/17/1908 was taken out by Foundry Inv. Co. to alter a factory/warehouse for \$4,000. They additionally took out a permit in 1936 to alter a garage at this address. The original building was evidently one story, because a 1954 permit by Wetterow Grocery Co. was for \$18,000 to add a "one story second floor addition to garage."

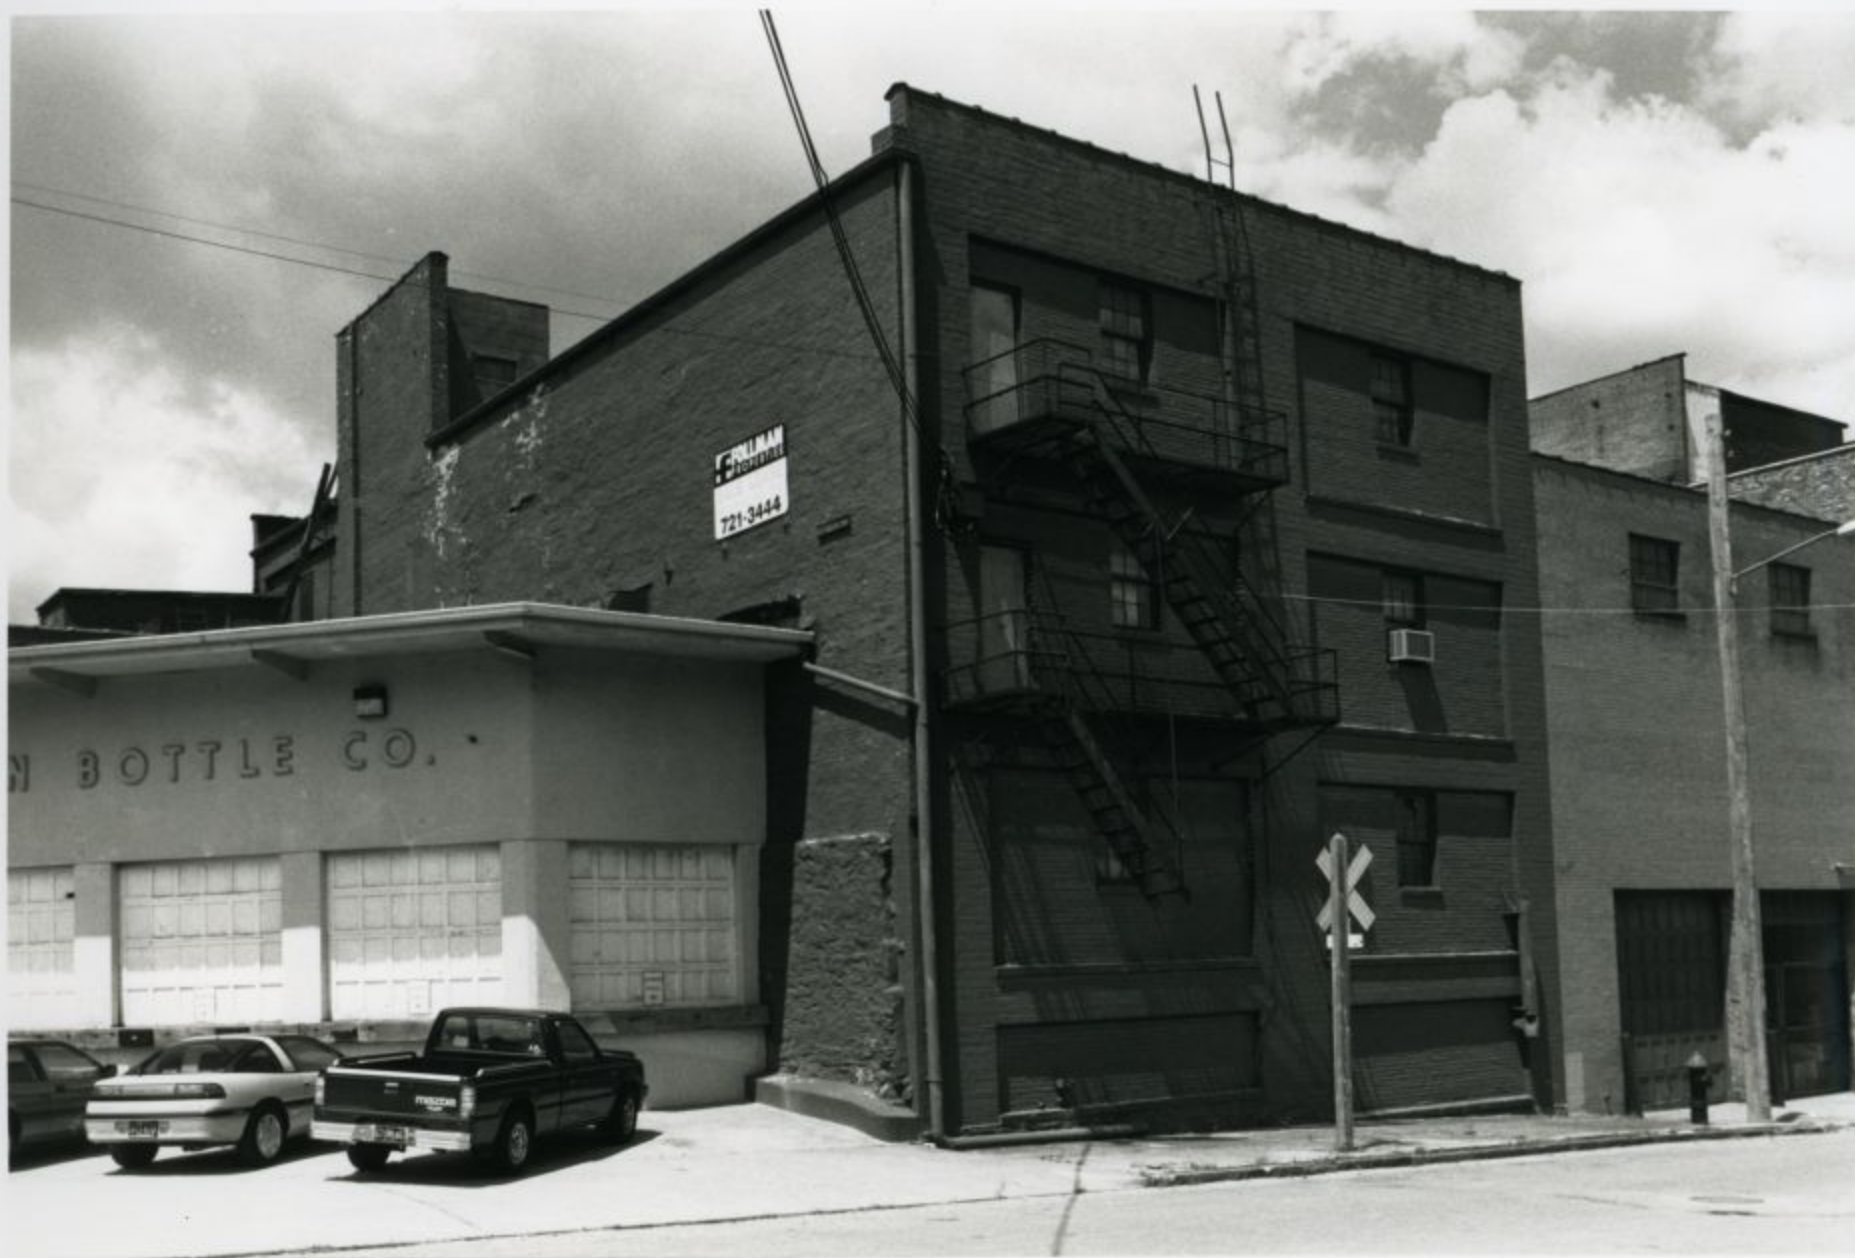
#7

31. Further description of important features: Small, 6 over 6 windows are punched into the recessed panels formed by a rectangular brick grid on the primary elevation. The recessed panels appear to be infilled larger windows. Terra cotta coping. A short corner wall on the roof appears to allow access to the roof itself.

32. History and Significance: Although no building permit could be found for this building, there is a demolition permit for this address by Thomas & Kelly (about whom no information could be located) in December, 1900.

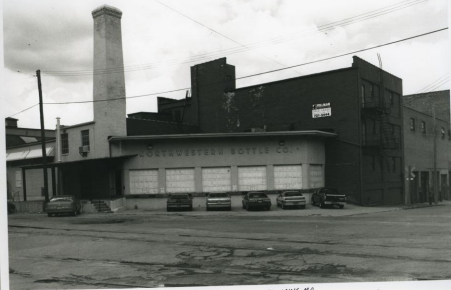
#6

31. Further description of important features: This building is built at an angle across the northeast corner of Clinton and N. Second. Roll-up garage doors predominate across the primary elevation. A shaped brick chimney rises above the building, topped with brick corbelling. Windows are of the multipane industrial type.

32. History and Significance: An \$18,000 permit for this building was taken out in 1922 by the Reardon Company. Reardon was a manufacturer of glue. It appears that their interest in this building disappeared c. early 1930s.

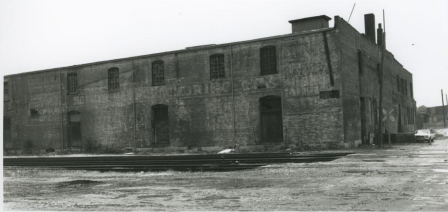
85

31. Further description of important features: The majority of the openings on this building are double- or triple-rowlock segmentally arched. A stepped parapet with terra cotta coping is located across the north elevation. Five loading dock bays are spaced across the east elevation, in close proximity to the railroad.

32. History and Significance: The Joseph Hefner Realty Co. took out the building permit for this warehouse in 1901 for \$27,000. The company hired noted architect E. C. Klipstein to complete the job.

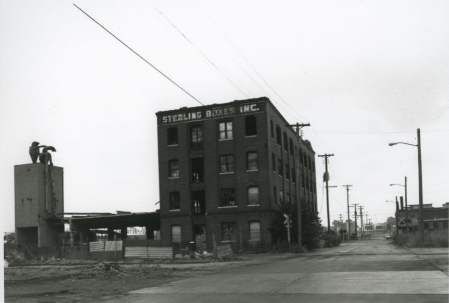
#86

31. Further description of important features: Inner bays are recessed, set off by piers; they are headed by segmental arches. Remaining bays have individual double-rowlock segmentally-arched windows with stone sills. Between the first and second stories is a stringcourse of projecting corbelled brickwork. Corbelled cornice. Terra cotta coping. One-story rear (north) (cont'd. below)

32. History and Significance: addition is now mostly demolished; a concrete hopper stands north of the addition. The building permit was taken out in 1898 by F. Christen & Son for \$6,000. The firm made leather bellows; a painted sign, "Christen & Sons, Mfrs. of Blacksmith Bellows" is still faintly visible on the east elevation. Beginning around 1930, the Sterling [wood] Box company occupied the building concurrently with the Christen company. The building has been the victim of vandals and neglect and is in danger of total destruction.

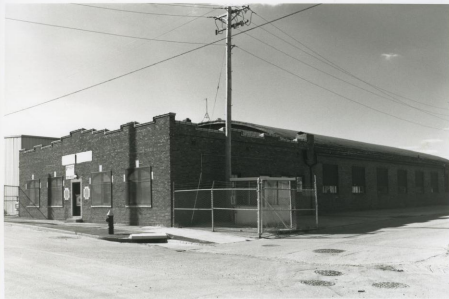
166
NORTH BROADWAY INDUSTRIAL SURVEY II
105 FERRY
FACING NW

31. Further description of important features: The multi-stepped parapet is coped with white terra cotta. Four round-arched windows across the front elevation are obscured by square screens mounted over them. Flanking the doorway are two white terra cotta medallions with round centers infilled with red brick. Side windows have flat soldier arches and brick sills. (cont'd. below)

32. History and Significance: Attached to the rear of the building is a one-story brick-walled addition with a quonset hut roofline. Puritan Oil took out the permit to build the \$15,000 office in 1927. By 1948, the building belonged to the Walsh Refractories Corporation, who built the rear addition for \$30,000.

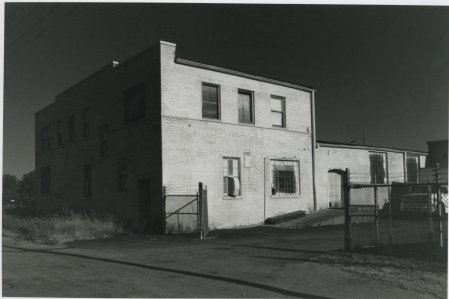
164

31. Further description of important features: A front short parapet has terra cotta coping. Soldier lintel and sill courses at second story. Rear loading door has double-rowlock segmental arch; from inset of door it can be seen that the walls are unusually thick, probably relating to its original function as part of a chemical works. Rear part of the building is one story.

32. History and Significance: The Grasselli Chemical Company took out the permit to build a one-story, \$8,000 chemical works in 1906, hiring the Kellerman Construction Co. to do the job. Grasselli sold the building to Du Pont between the beginning of 1935 and the end of 1936, when Du Pont took out a \$4,750 permit to alter and add to the building. The second-story sill course probably hides the break between stories.

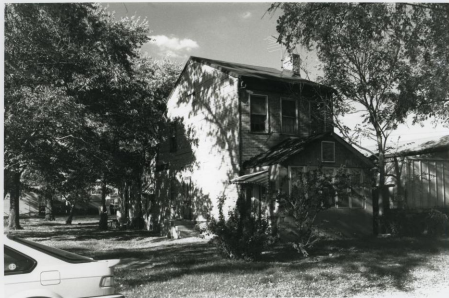
#165

31. Further description of important features: This frame house has rolled roofing and brick-look asphalt siding. Wood-framed rectilinear windows are six-over-six. Building is very narrow. One-story concrete block and frame gabled, enclosed front porch. One-story frame rear porch. West side entrance appears to be original.

32. History and Significance: Although Ferry at Second is not clearly delineated, it appears that this building and the two that formerly adjoined it to the east are shown on the 1875 Compton & Dry map. The three frame buildings are definitely on the 1883 Hopkins map; only this building remains of the three. No permits could be found for frame buildings for Ferry in this city block; permits in general for the north side of Ferry only go back to c. 1879.

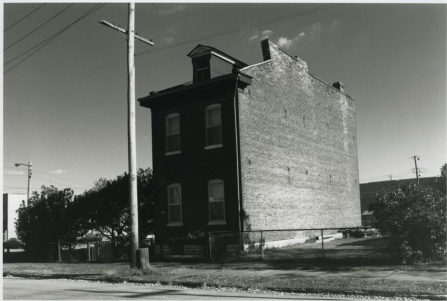
#160
NORTH BROADWAY INDUSTRIAL SURVEY II
206 FERRY
FACING SE

31. Further description of important features: Windows have segmental soldier arches and stone lugsills; panes are two-over-two. West wall is blind. The wood cornice was once ornamented with scrolled wood brackets, which are now all gone except for a pair on each side. Single dormer. Two-story wood porch at rear. Parapeted chimneys in west wall only.

32. History and Significance: George Summer took out the permit to build this residence in 1876 for \$1,800. It has been in residential use since then.

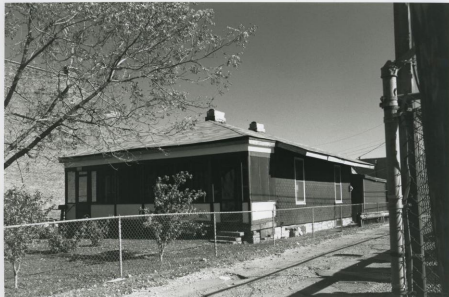
#159 NORTH BROADWAY INDUSTRIAL SURVEY II
210-12 FERRY
FACING SE

31. Further description of important features: This frame house has a hipped roof with asphalt shingles and brick-look asphalt siding. A screened porch extends the width of the front elevation with two entrance doors corresponding to the real entrances. Wide overhanging west eave; east elevation has a normal width eave. Rear frame addition.

32. History and Significance: This frame house is clearly shown on the Hopkins map of 1883; it doesn't seem to be on the 1875 Compton & Dry map, although the buildings in the vicinity are rather jumbled together, and the original roof may have been different - possibly end-gabled - before the porch was put on. The foundation of the porch is rather rickety and suggests that it is a later addition. This house is something of an anomaly in St. Louis city proper; it is not unlike owner-built housing along both sides of the Mississippi above Alton, Ill.

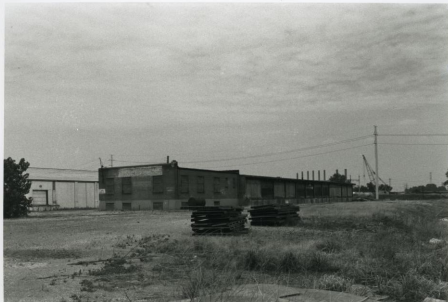
89
NORTH BROADWAY INDUSTRIAL SURVEY II
3150 HALL
FACING NE

31. Further description of important features: A three-by-five bay brick section extends to the west; a section of 12 loading dock bays is covered with corrugated iron and extends to the east. Windows have been infilled; they have flat arches. A small parapet rises at the east and west ends of the brick section.

32. History and Significance: The Mississippi Valley Storage Co. took out the permit for this warehouse/storage building for \$10,000 in 1898. The building took advantage of its location in the midst of railroad sidings.

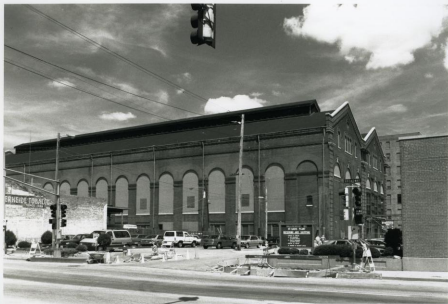
NORTH BROADWAY INDUSTRIAL SURVEY II
201-07 MALLINCKRODT
FACING NE

31. Further description of important features: The twin gables of this building have small monitor roofs. Enormous round-arched bays corresponding to about three stories in height are separated by banded piers down the length of the west side; these have all been infilled. Pressed brick and corbelling ornament the cornice. Stone keys in the round arched bays across (cont'd. below)

32. History and Significance: the south end. Bull's-eye windows in the gable ends are of pressed brick, as are the round arches of smaller windows running across either gable. Brick quoining on south elevation. See attached about Mallinckrodt and architect Isaac Taylor.

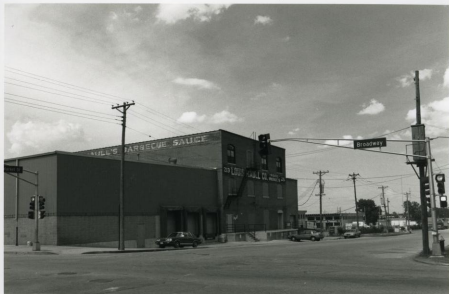
NORTH BROADWAY INDUSTRIAL SURVEY II
 215-19 N. MARKET
 FACING NE

31. Further description of important features: 1st & 2nd story triple rowlock elliptically-arched windows have stone sills and are infilled. Remaining non-filled windows have divided transoms and 2-over-2 panes. A concrete loading dock extends the length of the front. Terra cotta cornice. Building is flanked by new additions on its east and west elevations.

32. History and Significance: L. Maull took out a permit to build a two-story factory for \$31,000 in 1918. The loading platform was built in 1923 for \$2,000. In 1924, Maull got a permit to built a \$6,000 addition to the factory; since no building height is listed as is customary, it is probable that this permit was for the third story. The interior of the building was damaged by fire in 1959 and 1974, causing extensive repairs to be made. The Maull Company, makers of barbecue sauce and other products, is nationally-known.

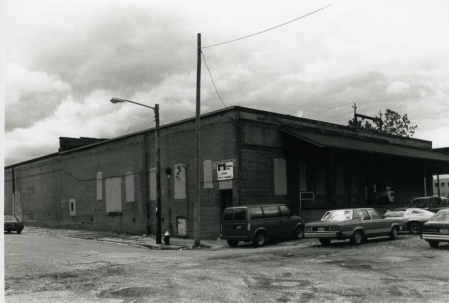
NORTH BROADWAY INDUSTRIAL SURVEY II
111-19 MONROE
FACING NW

31. Further description of important features: Double-rowlock segmentally arched windows are infilled with brick and concrete block. A concrete loading dock with a frame and iron roof is located along the east elevation.

32. History and Significance: A.F.W. Luehrmann built this warehouse in 1910 for \$8,000. He took out permits for very minor alterations to it in 1918 and 1920. It seems likely that the building suffered damage along the roofline at some point, because Mary H. Luehrmann took out a \$3,000 permit to repair the warehouse in 1948 and newer brick can be seen along the cornice line. August F.W. Luehrmann was the president of the Luehrmann Hay and Grain Company, which he located in this building through at least c. 1950.

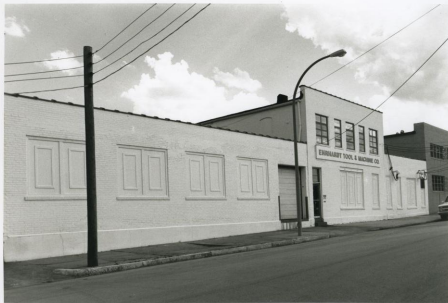
NORTH BROADWAY INDUSTRIAL SURVEY II
908-12 MOURCE
FACING SW

31. Further description of important features: First-story windows have flat arches, brick sills and are infilled. Second-story windows are top-hinged. Terra-cotta coping. Second-story side windows are segmentally arched. Garage bay in primary elevation. 1962 and 1967 additions to the west and south are of concrete block.

32. History and Significance: The original building permit was taken out by Hannibal Brothers in 1893 for \$3,000. Herman and Louis Hannibal operated an ice company next door at 914 Monroe through the mid-1920s, using this building to stable their horses.

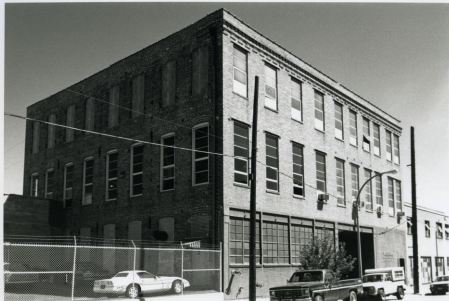
NORTH BROADWAY INDUSTRIAL SURVEY II
BIT-19 MONTGOMERY
FACING NE

31. Further description of important features: South elevation features cast-iron lintels, brick sills, and a corbelled brick cornice. Second-story and third-story front elevation windows appear to have replacement sash; remaining side windows are infilled with masonry or wood. First-story windows are multi-pane metal sash. Side windows have triple-rowlock segmental (cont'd. below)

32. History and Significance: arches. Simple cast-iron framing by Christopher & Simpson iron works. Terra cotta coping. A one-story ell of more recent vintage extends from the northwest corner. The Williams Patent Crusher & Pulverizer Co. took out a building permit for the warehouse in 1908. M. F. Williams operated his business in this city block at least as early as 1898, and probably before. The company has expanded to include the bulk of the block.

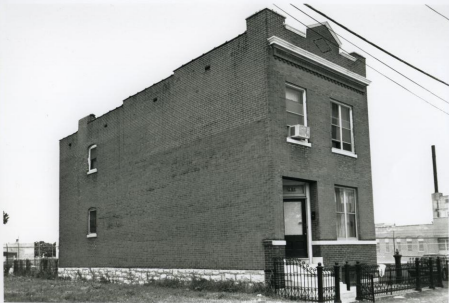
NORTH BROADWAY INDUSTRIAL SURVEY II
911 MONTGOMERY
FACING NE

31. Further description of important features: Openings have soldier arches and stone sills. Entrance is angled. Stone water table above contrasting brick below first-story window. Shaped parapet has green vitreous brick diamond-shaped inset. Simple cornice above dentilled band of ornamental pressed brick. Outstanding short wrought-iron fence.

32. History and Significance: Louis Zwick took out the permit for this residence in 1910 for \$4,000. Zwick was a St. Louis City Inspector working out of City Hall; his place of residence was on the other side of the city. His position may have led to his filling out the building permit form for a friend; it is also possible that he built the house on speculation.

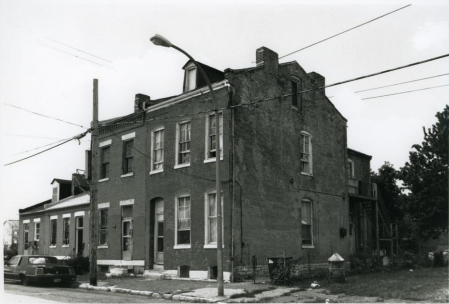
NORTH BROADWAY INDUSTRIAL SURVEY II
913 MONTGOMERY, RIGHT
FACING NW

31. Further description of important features: Segmentally arched windows have stone sills; two-over-two double-hung sash are probably not original. Doorway is segmentally arched, slightly recessed. Single dormer. East wall has parapeted chimneys. Rear ell has a relatively new wooden two-story deck/porch. House fronts directly on sidewalk and shares a common wall with 915 Montgomery.

32. History and Significance: This building predates recorded building permits for this city block. It appears on Plate 50 of the 1875 Compton & Dry publication; it has been in continuous residential use.
