MISSOURI OFFICE OF HISTORIC PRESERVATION
ARCHITECTURAL/HISTORIC INVENTORY SURVEY FORM

11
NORTH BROADWAY INDUSTRIAL SURVEY II
2217 N. FIRST FACING SW

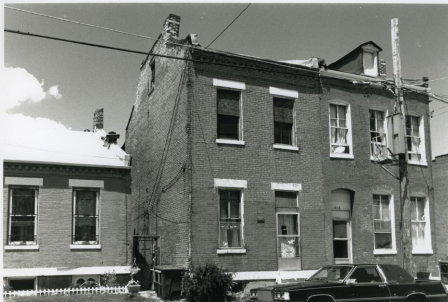
NORTH BROADWAY INDUSTRIAL SURVEY II
913-15 MONTGOMERY; 915, CENTER
FACING NE

31. Further description of important features: Openings have flat stone lintels; windows have stone sills. Upper windows partially boarded; doorway has been partially infilled with wood. West wall is parapeted with chimneys. Stone water table. Building fronts directly on sidewalk. It shares a common wall with 913 Montgomery.

32. History and Significance: This building predates the building permit record for this city block. It appears on Plate 50 of the 1875 Compton & Dry book. It has been in residential use since built.

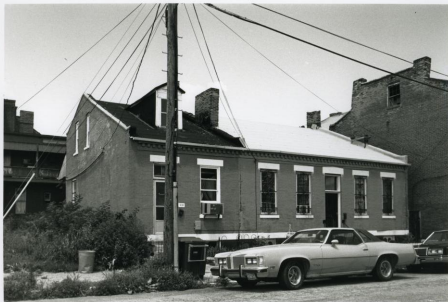
NORTH BROADWAY INDUSTRIAL SURVEY II
917-19 MONTGOMERY
FACING NE

31. Further description of important features: This house is really two buildings together. All but one of the primary elevation's openings have flat stone lintels; the remaining one has a shaped stone lintel. Side windows are segmentally arched. All windows have stone sills. Stone water table. Single dormer in west section. Dentilled cornice. East section has parapeted chimneys.

32. History and Significance: These adjoining houses predate the requirement of building permits; however, they clearly appear on Plate 50 of Compton & Dry (1875). They have been in continuous residential use ever since.

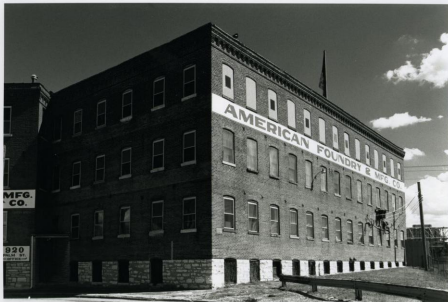
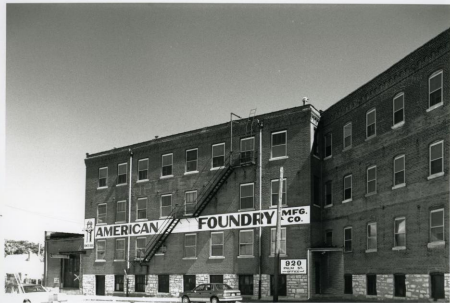
#51A

31. Further description of important features: Note: this site has 2 photos. This factory building has a corbelled cornice. Windows in the western section (photo #51a) have double rowlock segmental arches; some have been infilled with wood or corrugated fiberglass. This portion is set at an angle to the eastern segment (photo #51b); a rock-faced covered entrance is located (cont'd. below)

32. History and Significance: in the odd angle formed by the unusual orientation of the two parts of the factory to each other. The cornice on this part matches that of the western part, but the windows have flat arches. A small, one-story addition is attached to the east part of this building. The factory was built in 1910 for \$10,742 by F. W. Hanpeter of the Hanpeter Furniture company. Only one permit exists, and it is not known why the two segments were built at such odd angles. American Foundry moved into the building after 1940.

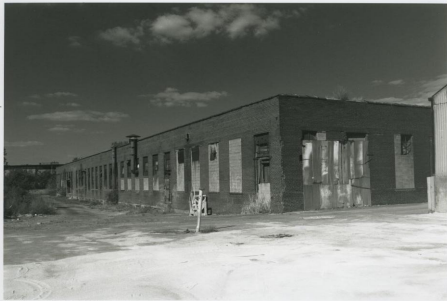
NORTH BROADWAY INDUSTRIAL SURVEY II
#2 PENROSE
FACING NE

31. Further description of important features: The photo shows the west and south elevations of the western portion of this factory; the remainder is inaccessible. The entire factory is one story with terra cotta coping. Windows have brick soldier arches and brick sills and originally had multipane industrial metal sash. CMU or wood has been used to infill many (cont'd. below)

32. History and Significance: of the openings.
The St. Louis Basket & Box Company took out a permit in 1919 for two, one-story factories to be built for \$1,000 (apparently apiece). This section of the complex is one of those specified. St. Louis Basket & Box operated in this location until the 1930s. The building appears to be vacant; because Penrose is privately cordoned off, this cannot be confirmed and the north elevation could not be photographed.

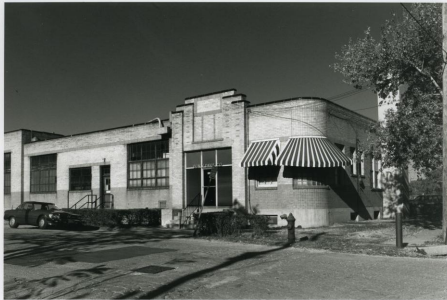
NORTH BROADWAY INDUSTRIAL SURVEY II
181 PENROSE
FACING NE

31. Further description of important features: The entrance pavilion to this building projects slightly and features a Deco stepped parapet highlighted with highly glazed dark terra cotta coping. Soldier courses of red brick provide visual interest above the entrance and in banding around the building. The southwest corner of the building is curved and has a glass (cont'd. below)

32. History and Significance: brick window. Other windows are double-hung wood sash (south end) and multipane metal sash (north of entrance). Attached to the north is a 1944 factory building done in the same colors of brick but of strictly functional rectilinear design. The permit was issued to the Grasselli Chemical Co. in 1931 for a \$3,000 office. The attached factory was built by present owner Don V. Davis & Co.

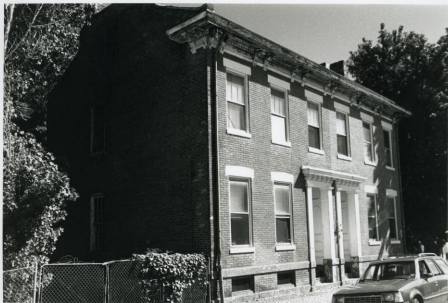
NORTH BROADWAY INDUSTRIAL SURVEY II
911-13 WARREN
FACING NE

31. Further description of important features: Returning at the corners, a wood cornice is supported by paired, scrolled brackets separated by wood denttilling. Upper windows feature flalt stone lintels; lowers have shaped stone lintels; all have stone sills. A double recessed entrance features wood pilasters supporting a bracketed wood cornice. Entrances have (cont'd. below)

32. History and Significance: 6-paneled walls and ceiling. Paired parapeted chimnies intact on the south elevation. Stone water table. Side windows are segmentally arched with original 6-over-6 double-hung wood sash. No building permit was filed for this duplex.

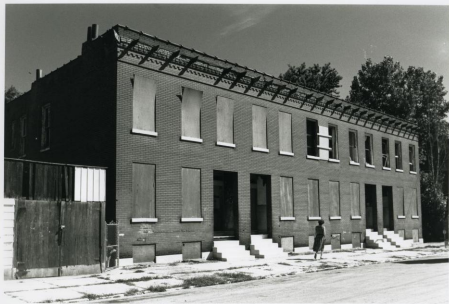
NORTH BROADWAY INDUSTRIAL SURVEY II
917. 23 WARREN
FACING NE

31. Further description of important features: This building features the same egg & dart and dentilled cornice as 2600 N. Tenth (#25); the wood supports for the (metal?) profiled cornice now missing are still in place, however. Openings have no arches. Stone sills. Most windows have been boarded. Two pairs of recessed doorways provide access to the four-family building.

32. History and Significance: No building permit was found for this building; however, next to it (#25) is a building of very similar cornice and opening design, material use and general appearance. It is probable that this building was included in the 1901 permit H. Clark took out for \$7,000 flats built by Christopher Frieling.

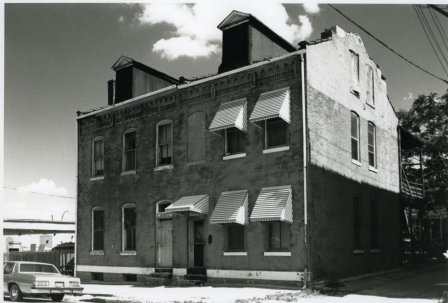
50 NORTH BROADWAY INDUSTRIAL SURVEY II
812-14 WRIGHT
FACING SE

31. Further description of important features: Windows have segmental soldier arches and stone sills; most have two-over-two double-hung wood sash. An elaborately corbelled brick cornice highlights the roofline. Two dormers. Side walls have parapeted chimneys; west side chimneys have been removed. Two, transomed entrances. Stone water table. Building is really (cont'd. below)

32. History and Significance: two mirror-image residences with a common wall. They were together on the same building permit taken out by A. Manewal in 1882 for \$4,600 for the pair. The building has been used as a duplex throughout its history.
