ARCHITECTURAL/HISTORIC INVENTORY FORM

1. Survey No. SL-AS-036-001		2. Survey Name: Architectural Survey of Old Ferguson West	
3. County: St. Louis		4. Address: 1 Carson Rd.	
5. City: Ferguson	Vicinity: <input type="checkbox"/>	6. UTM:	7. Township/Range/Section
8. Historic name (if known):		9. Present/other name (if known): Whistle Stop	
10. Ownership: <input type="checkbox"/> Private <input checked="" type="checkbox"/> Public		11. Historic use (if known): TRANSPORTATION/rail-related	11. Current use: COMMERCE/restaurant & RECREATION/museum

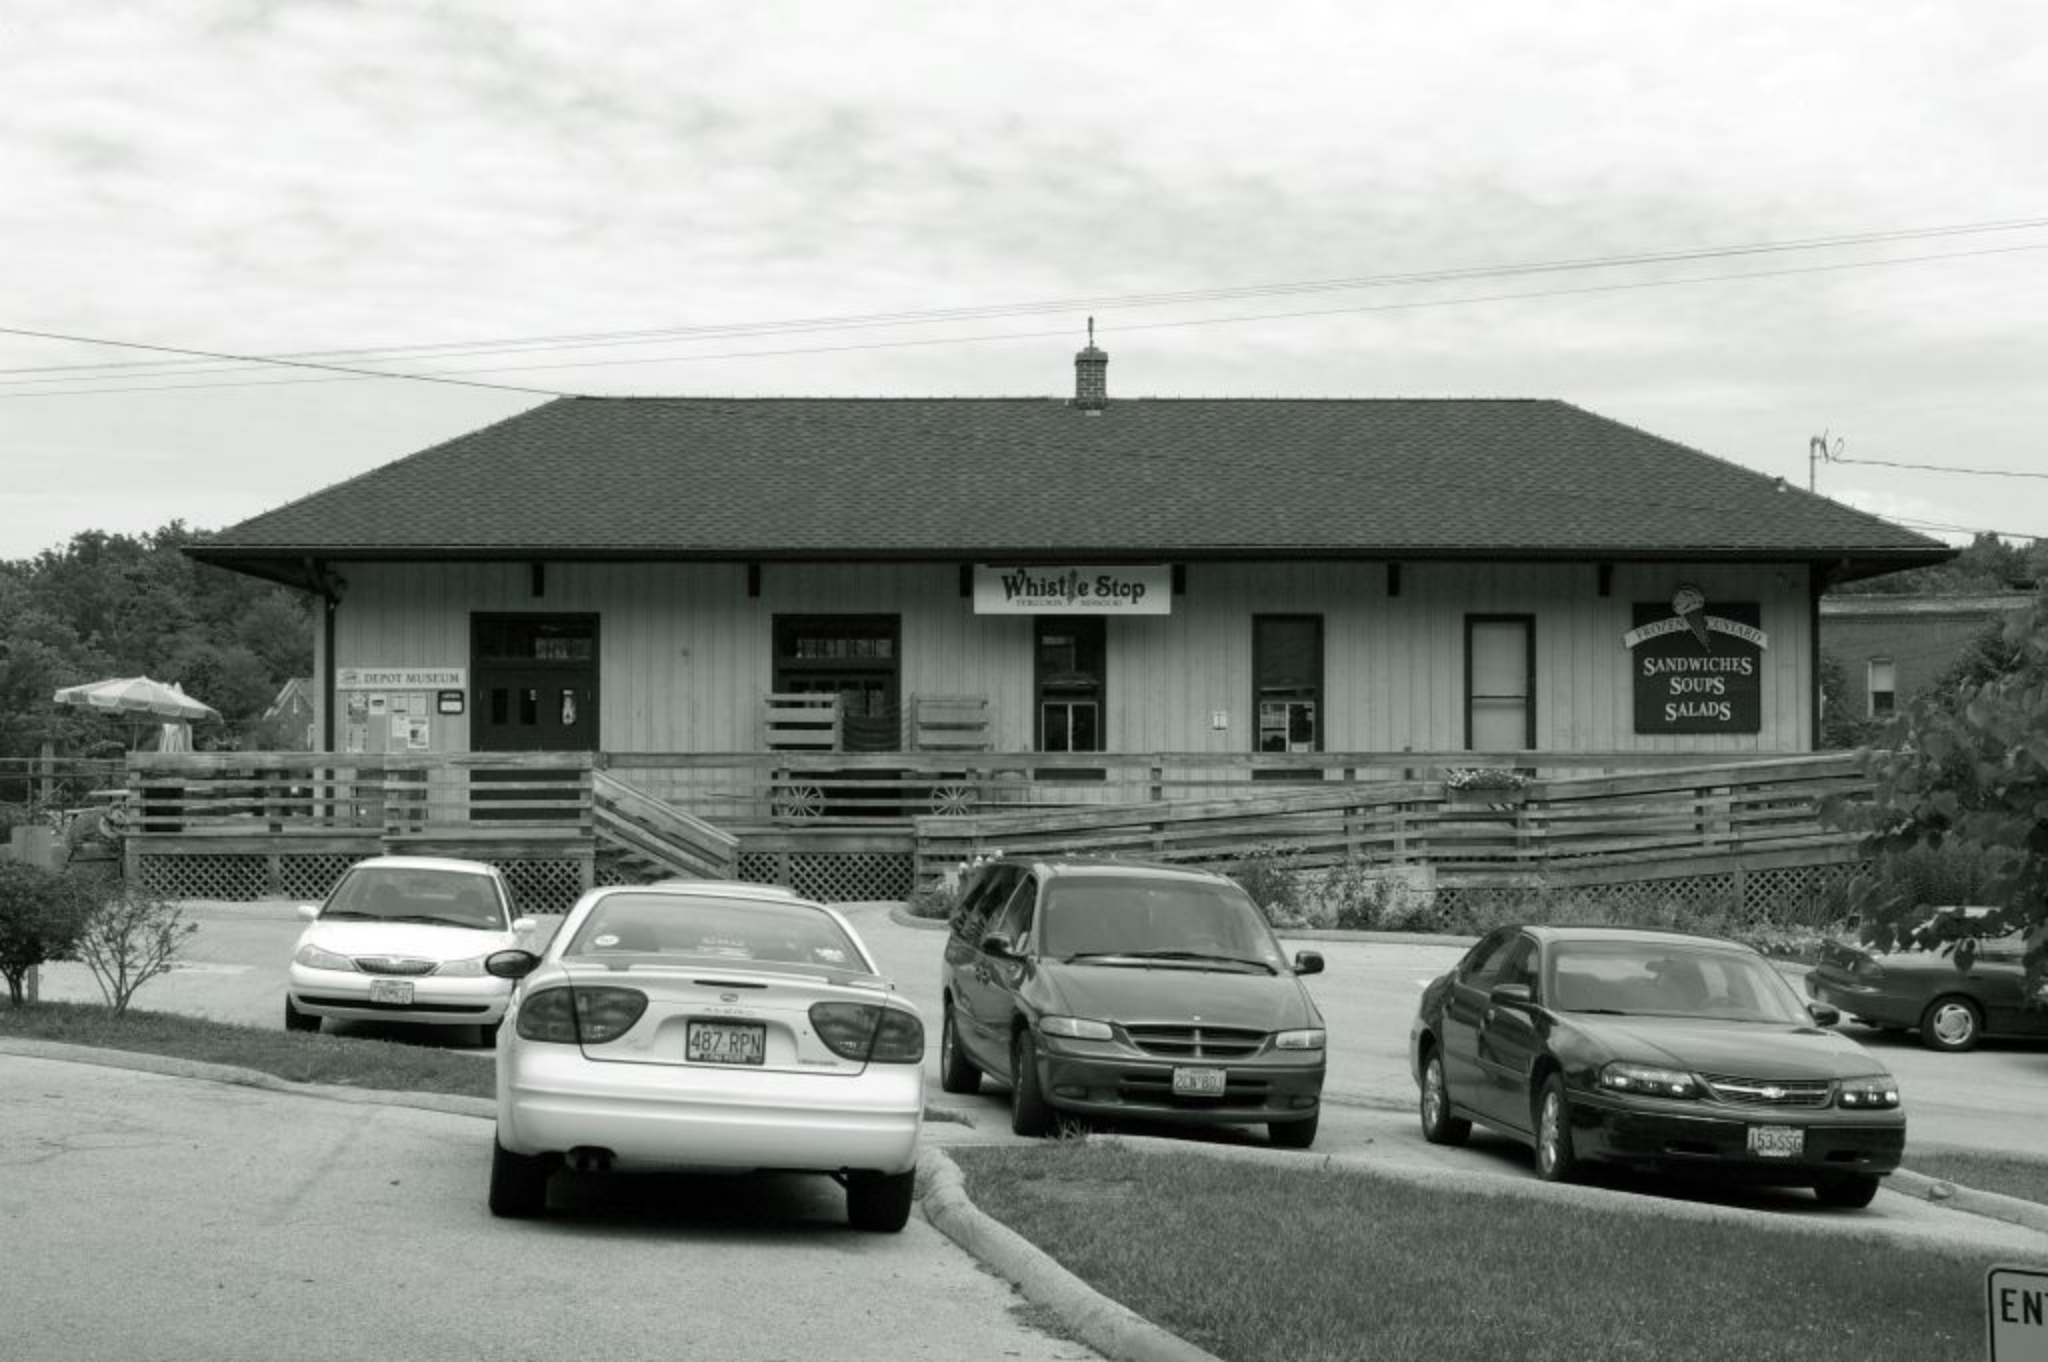
2009 survey: Noted that the concrete block foundation, the wooden wheelchair accessible ramp/entry deck are later alterations. Historic photos show the depot with a gabled roof, not the current hipped roof, which seems to indicate that the construction date based upon these photos may be in error and the depot or at least its roof may have been rebuilt at a later date. The stylistic details with the knee braced hipped roof is characteristic of late nineteenth or early twentieth century frame depots.

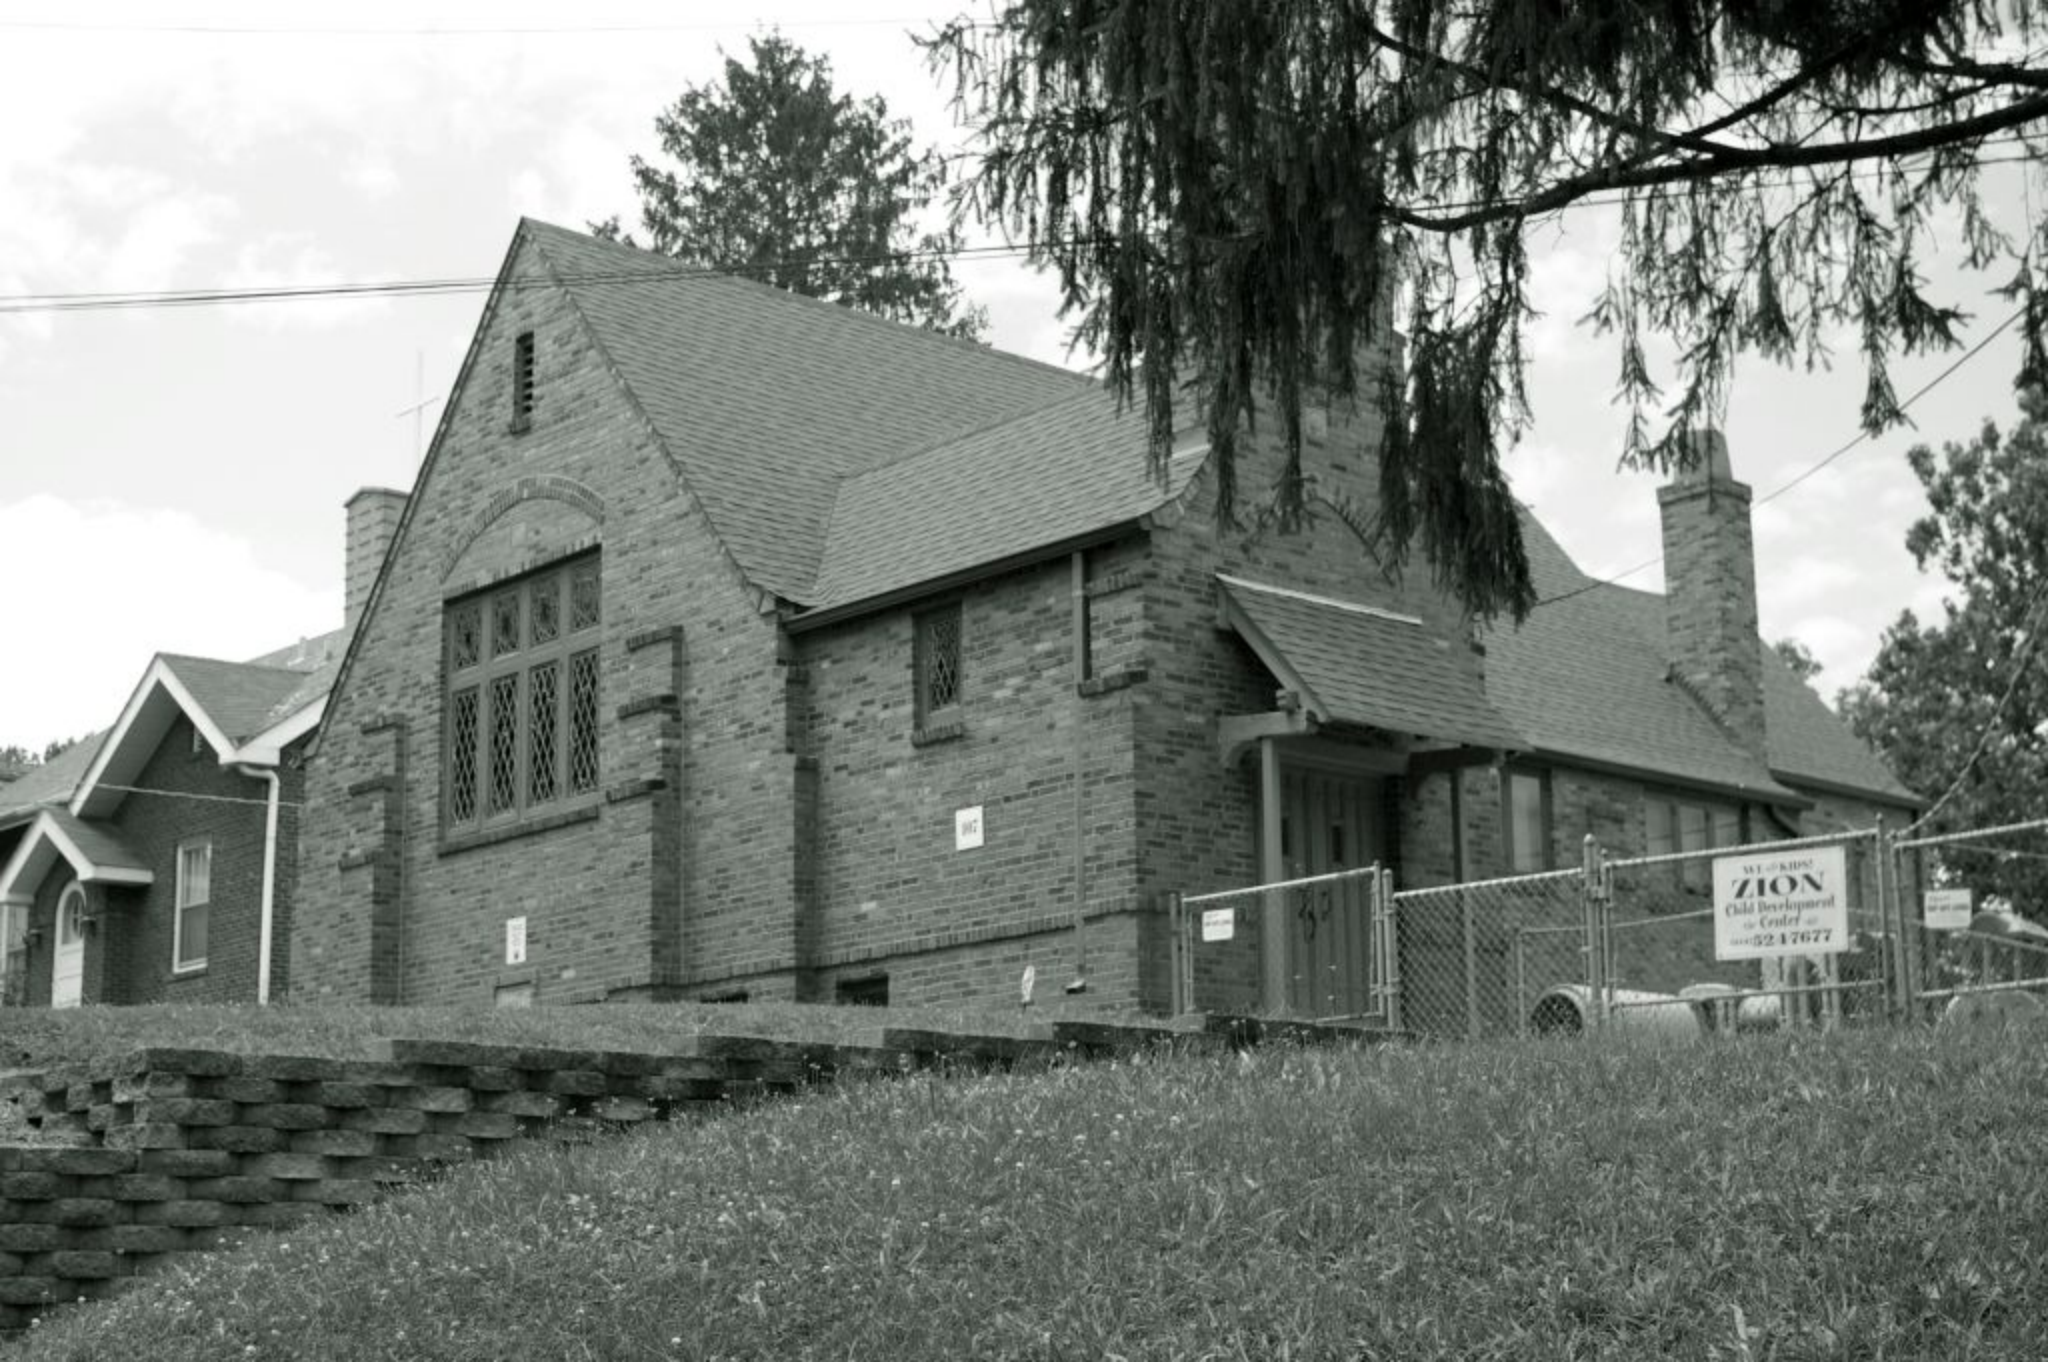
2009 Survey Update: Retains original stained glass windows.

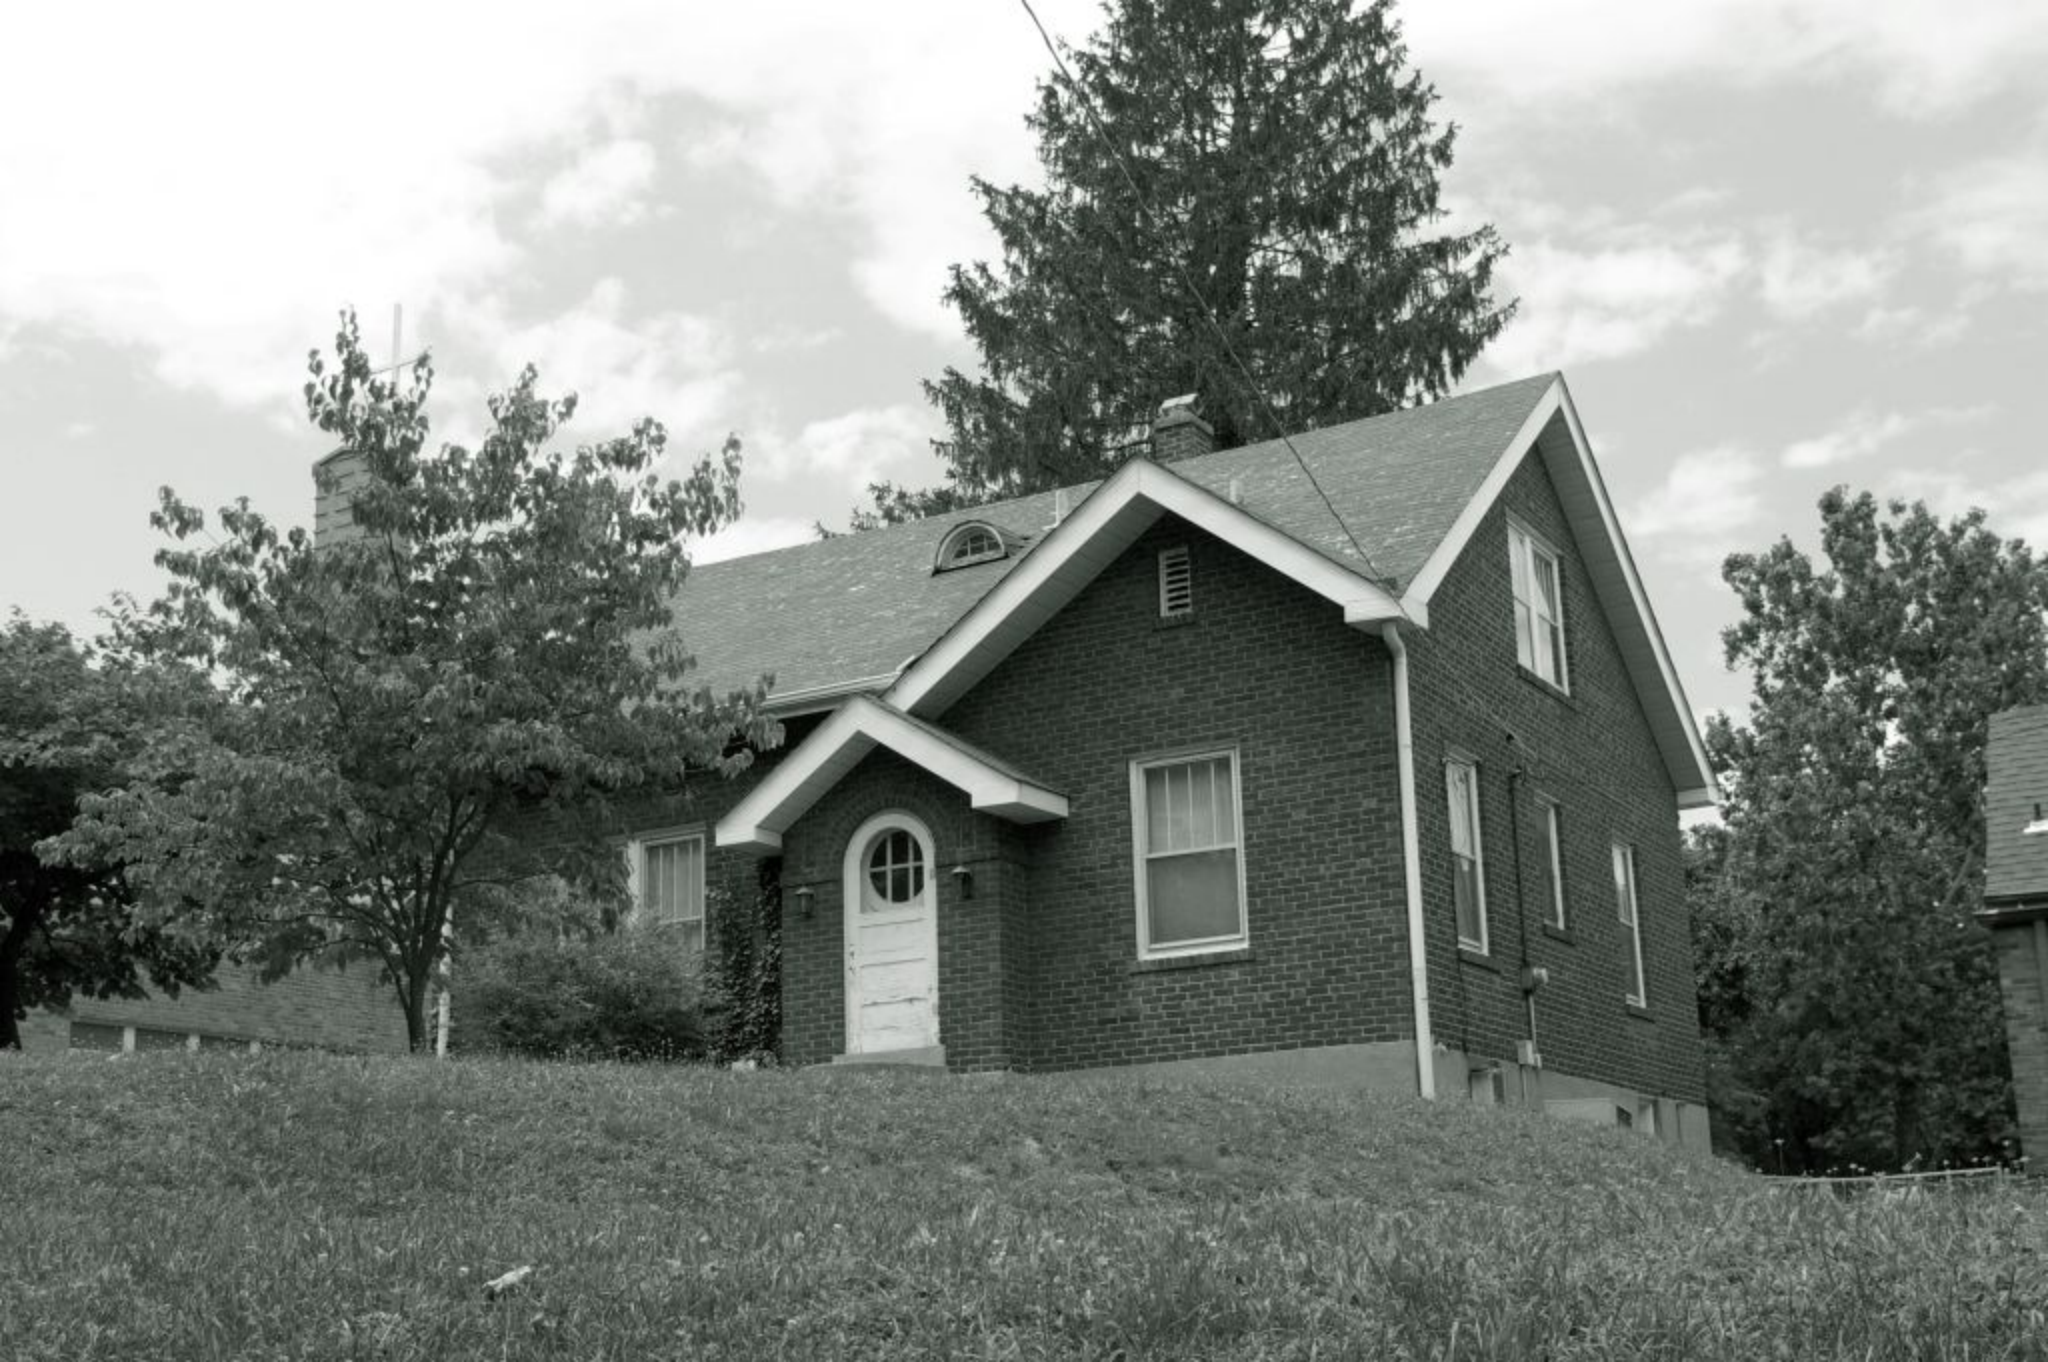
2009 Survey Update: The house retains its original wood plank, round arched door and 4 over 1 wood windows.

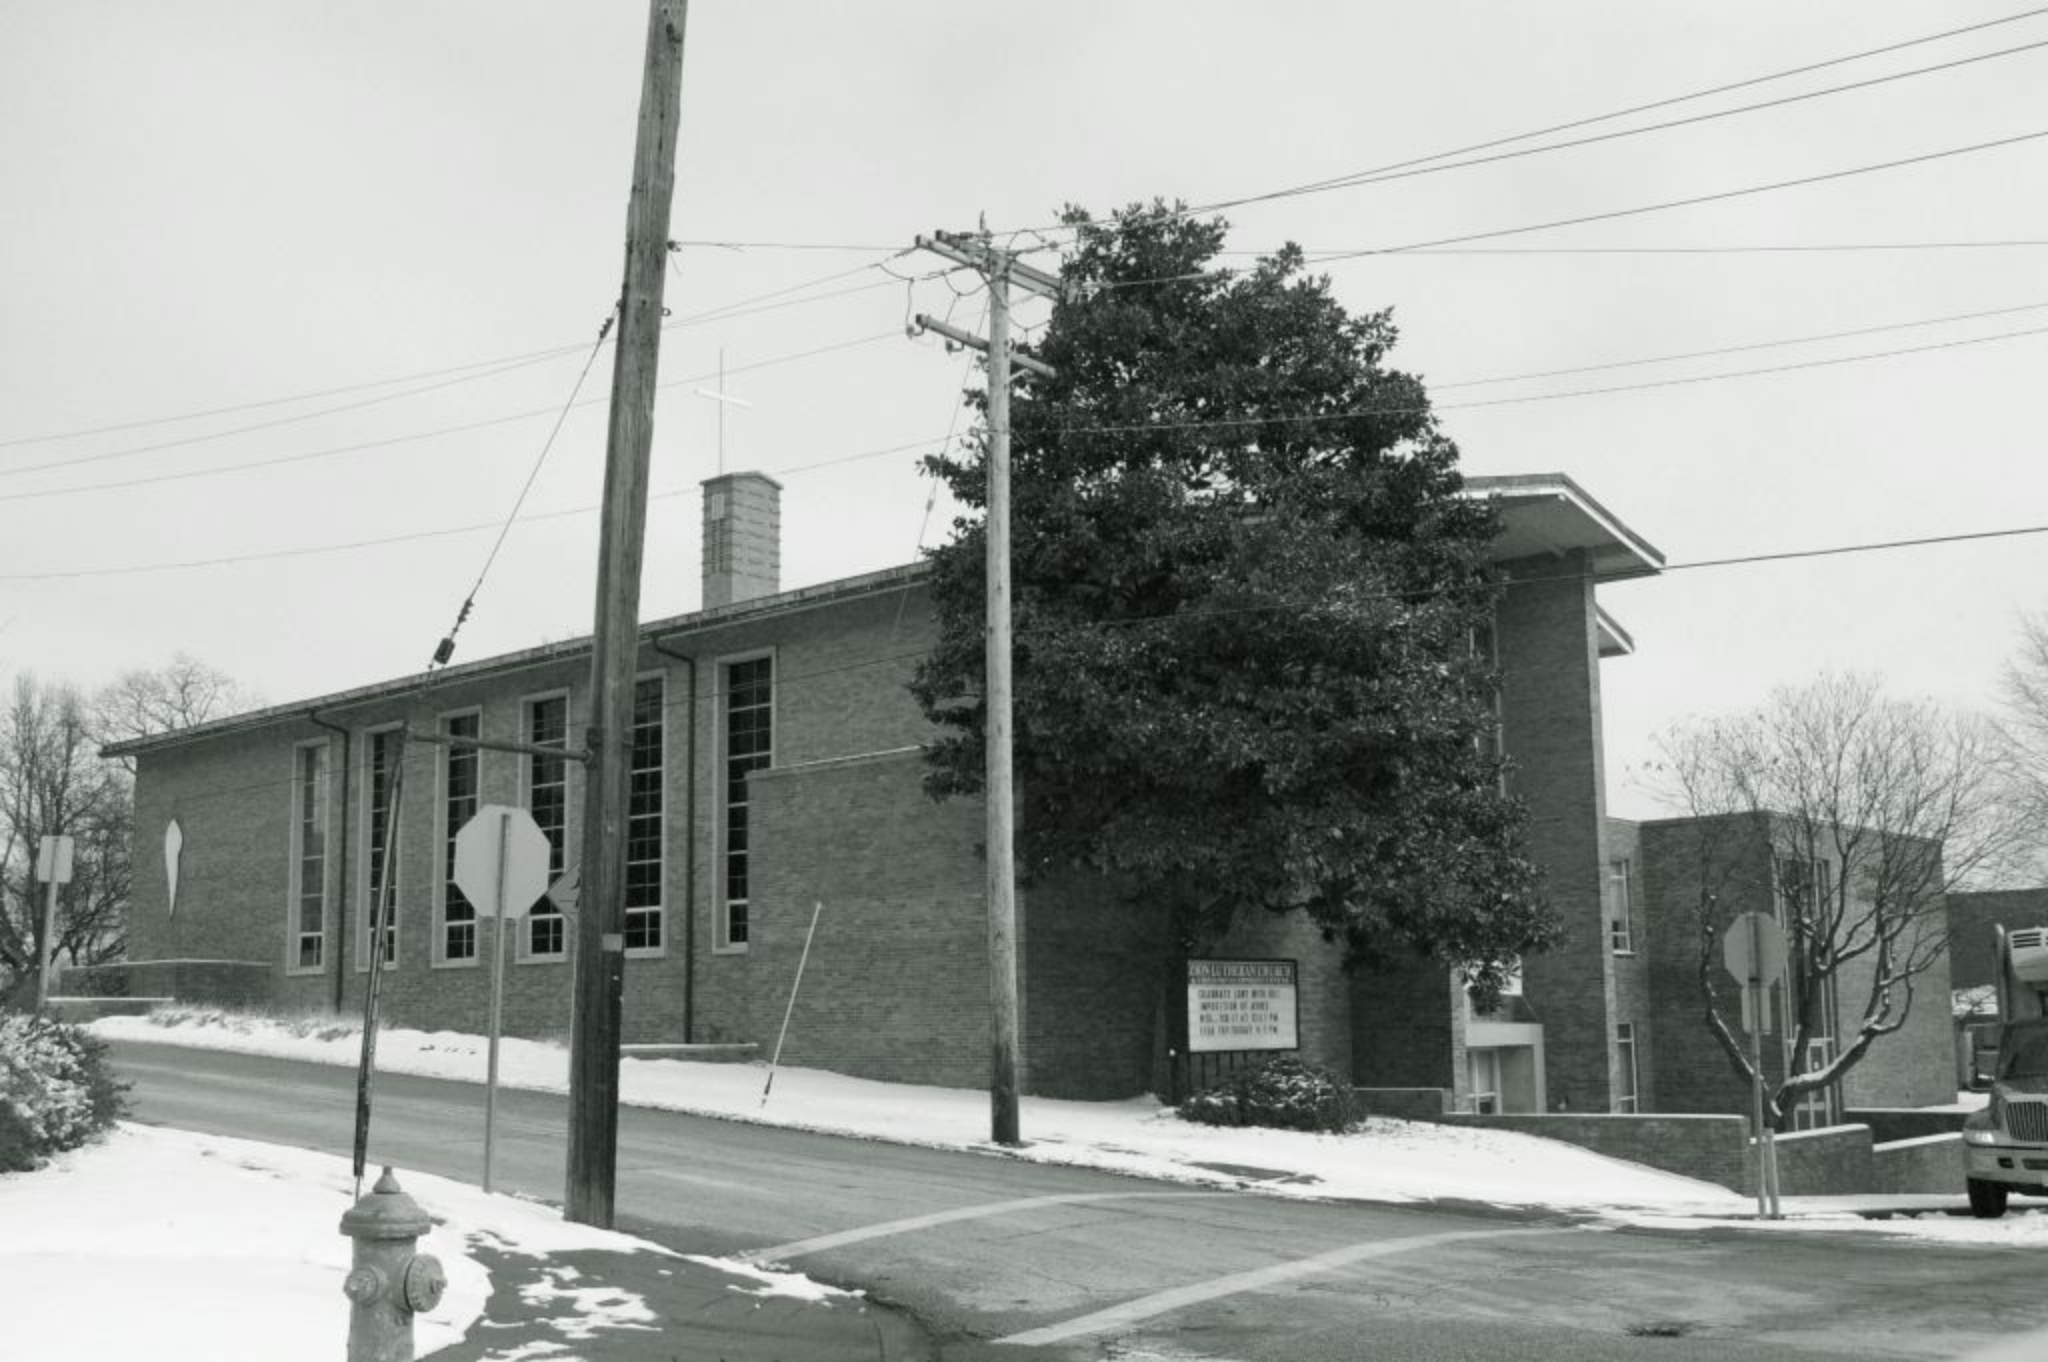
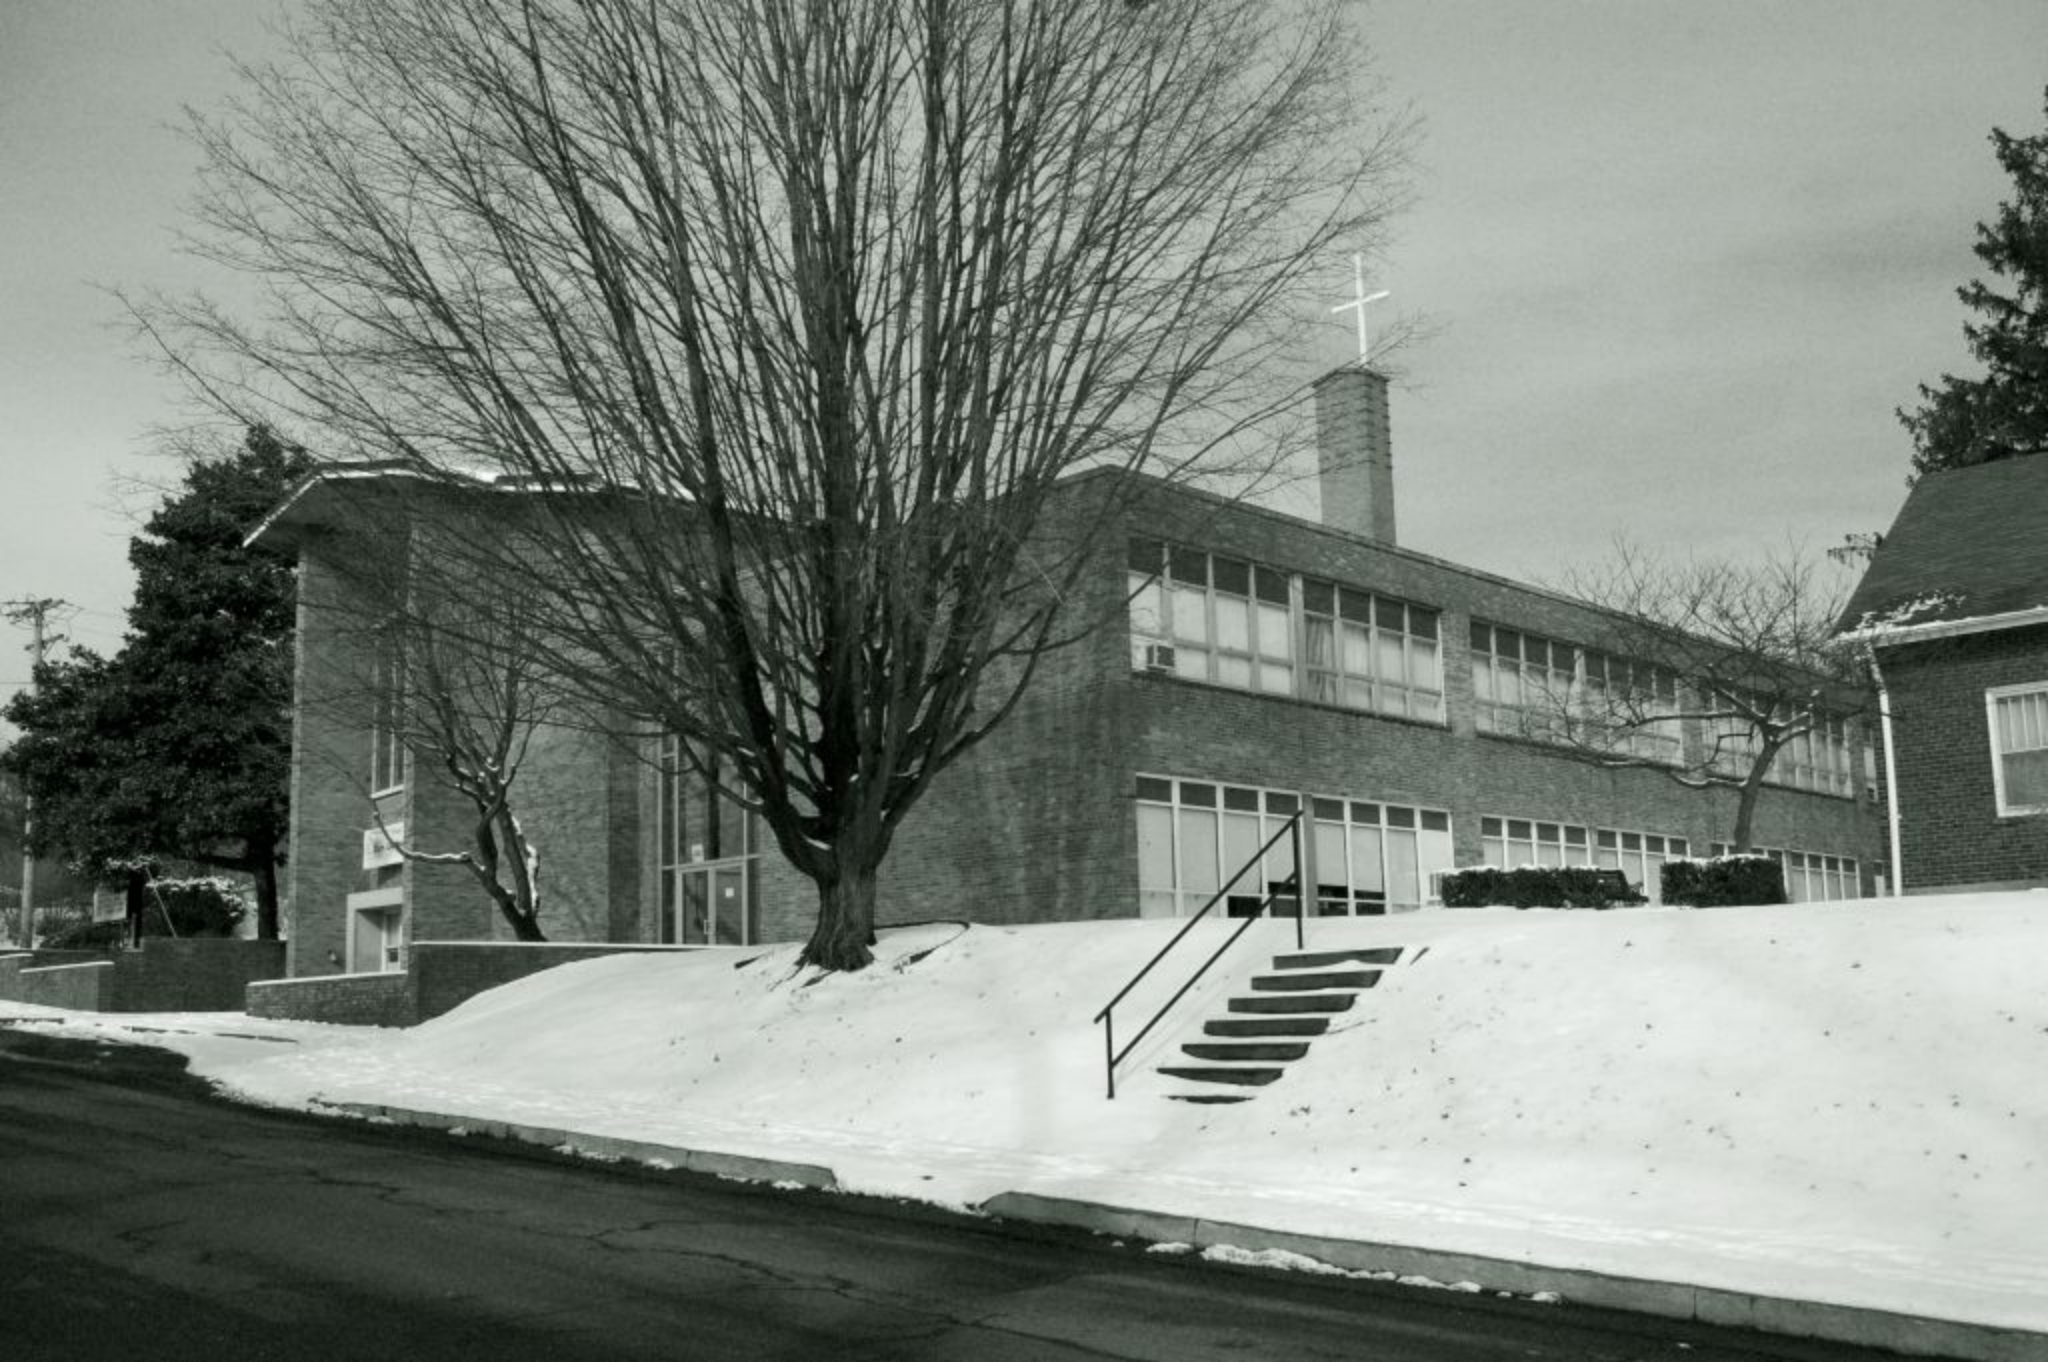
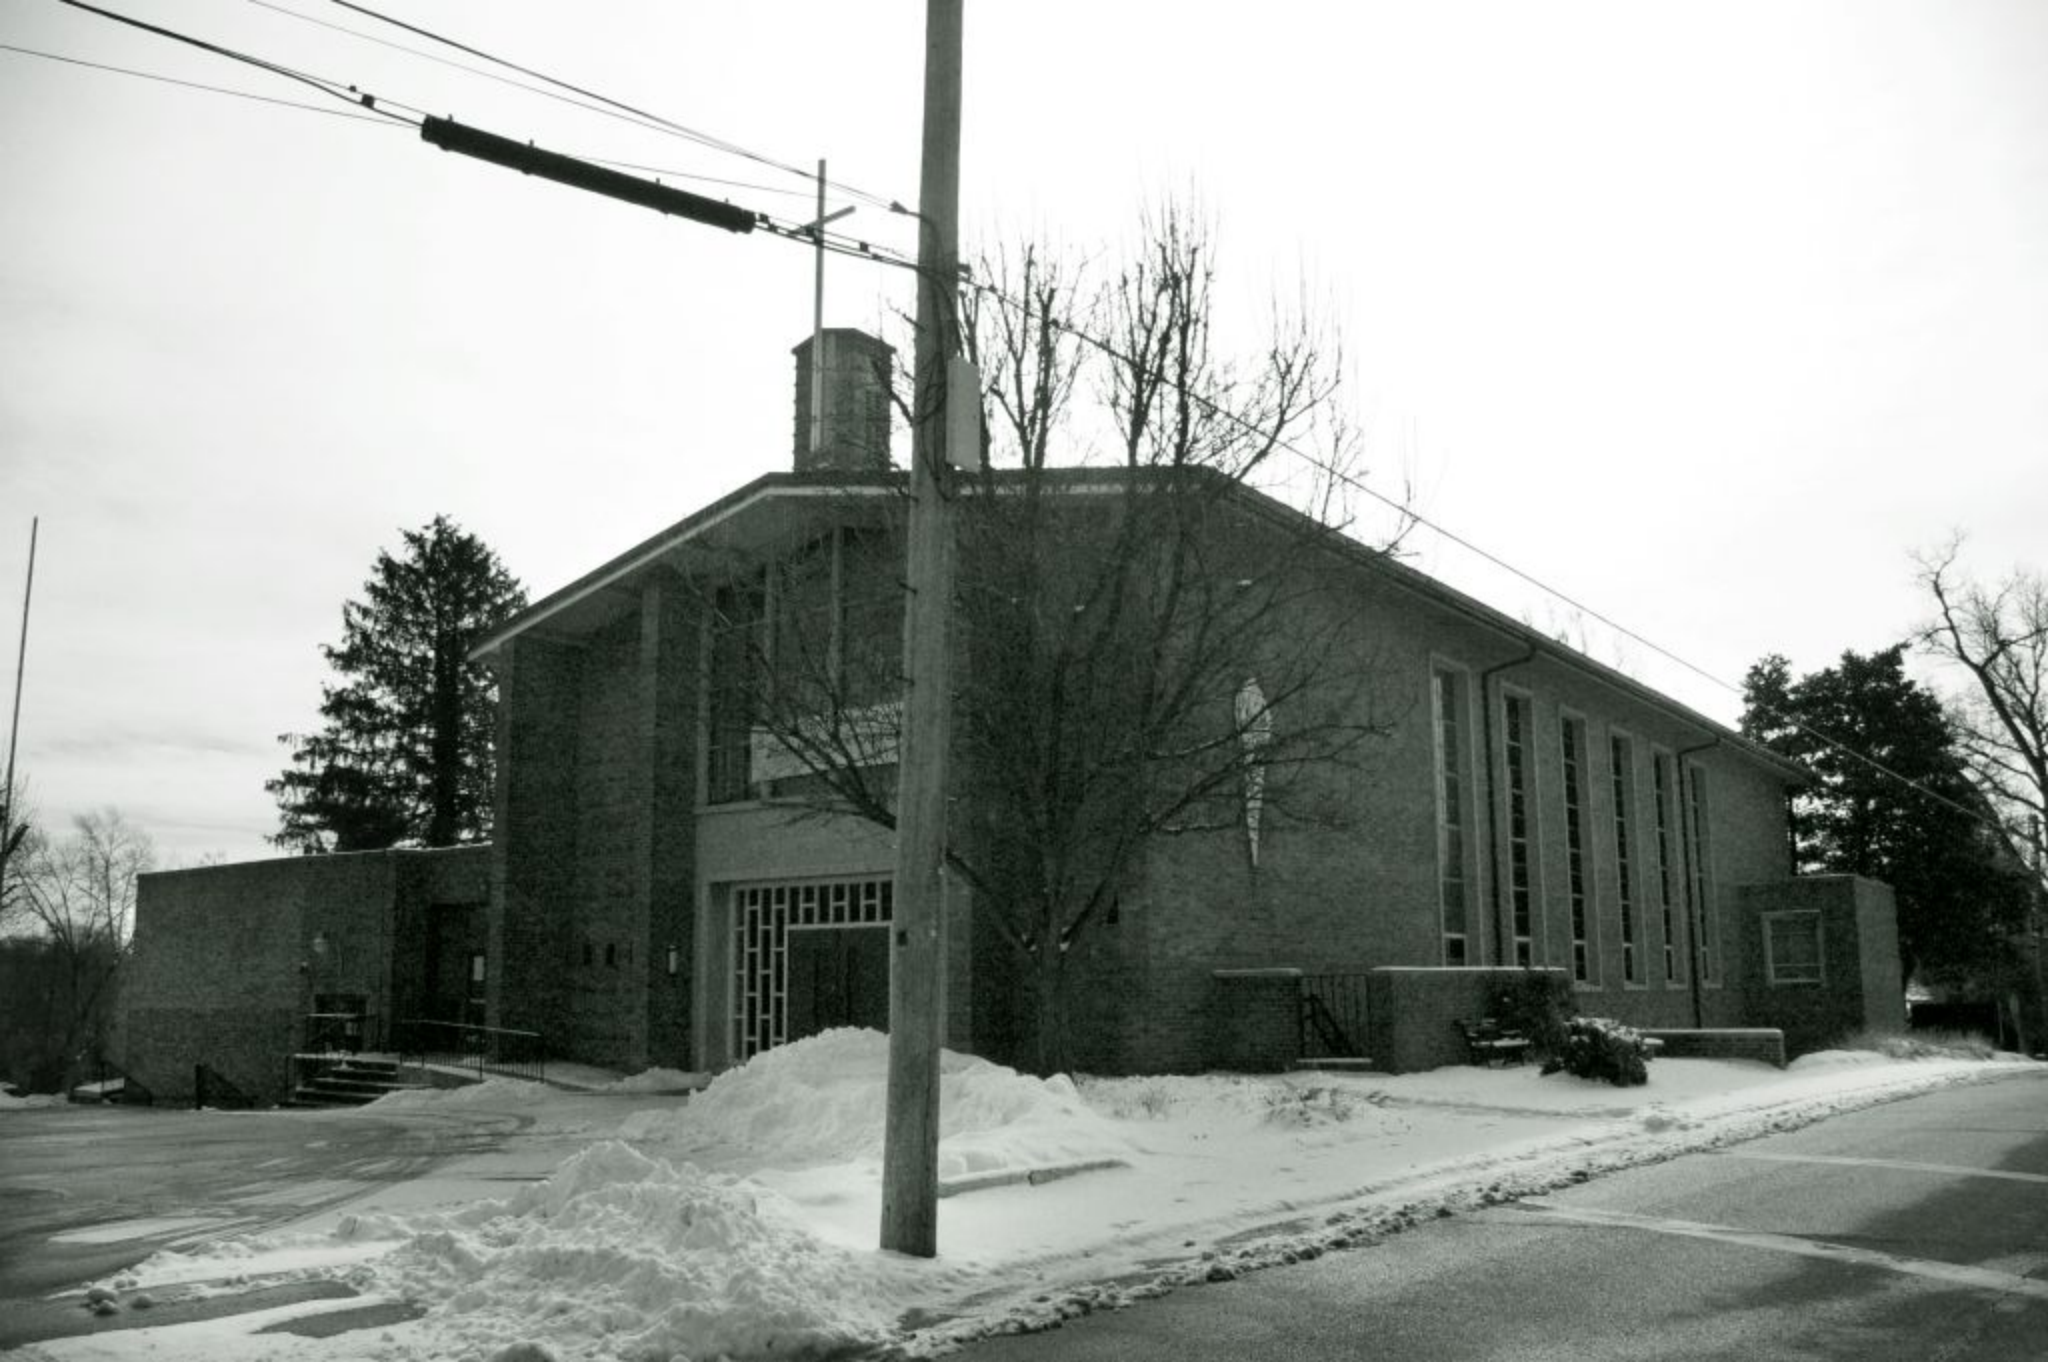
Finished in 1957 according to the cornerstone, this salmon-colored brick church is one of several post-war Modern churches in Ferguson. The main sanctuary is a two story rectangular building with a shallow pitched gabled roof with a square, brick belfry reminiscent of a tall chimney, off-set to the east side, with a simple cross anchored to its north face. The building is located on a sloped lot, and the upper or main level is much taller than the lower level. Both the main façade and the elevation facing the parking lot on the north side are divided into three simple bays, separated by buttress-like brick piers. The brick piers on either side of the central bay on the facade project forward with the roof extending over this section. The upper level of both the front and rear center bay are spanned by a window wall divided both vertically and horizontally into panels of glass but on the front, these are abstract stained glass. The outer bays on both the front and rear are brick, but on the rear, the brick pattern has rhythmic alterations of projecting brick to texture these bays as well as several tiny, deeply recessed windows. The side elevations have a series of simple slender windows divided horizontally into six glass panels and framed by simple concrete surrounds, similar to the divisions on the front and rear windows. On the lower level of the facade, the center bay has a rectangular, concrete frame around a bank of windows and full light entry doors with a brick retaining wall creating an entry courtyard out to the public sidewalk. Adjacent on the east side of the sanctuary is a flat roofed two story classroom wing, with its own two story glass entry on the facade with a slightly recessed bay of hopper windows between this entry and the sanctuary. On the rear, this classroom wing is unadorned except for the paired full light doors with sidelights and transoms.

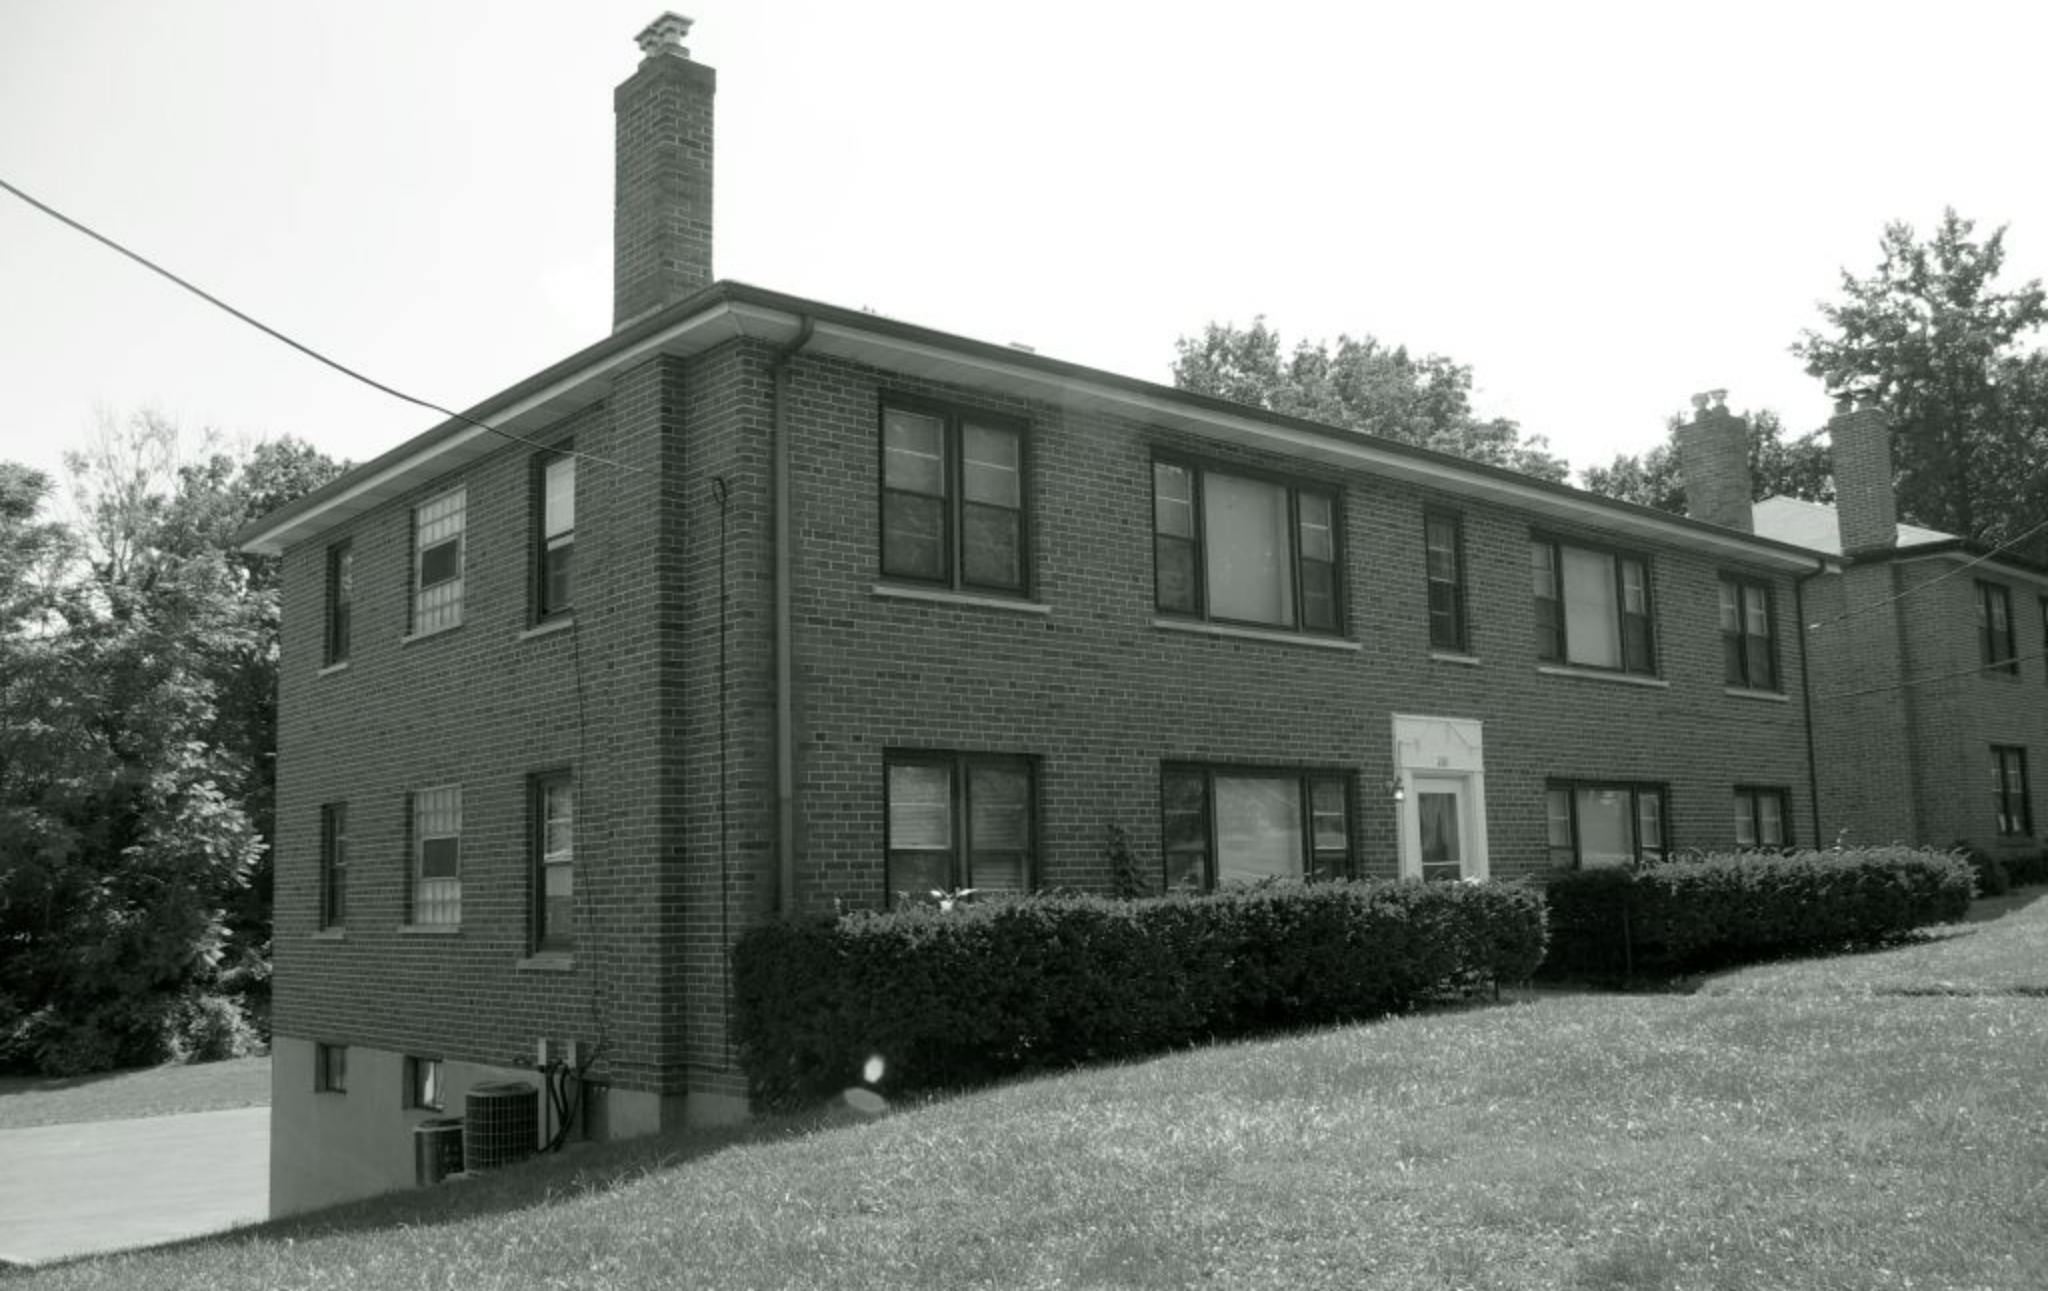
This two story, brick apartment building has a shallow pitched, asphalt shingle, hipped roof with tall, brick, interior chimneys positioned on each side. The facade is divided into five bays with 2 over 2, horizontal-light sashed windows paired in the outer bays, flanking a plate glass window in the two inner bays, and as a single window above the central entry. The simple entablature and pilaster strips of the entry are accentuated with molding in the shape of a pediment within the entablature. The 2 over 2 windows and the diamond light wood door are Streamline Modern features, while the other features are commonly associated with Georgian Revival houses. The slope of the hillside makes the poured concrete basement visible on the side and rear elevations. On the side elevations, the original glass block, vented (bathroom) windows are positioned in the central of the three bays. The only visible alterations are the installation of 1 over 1 combination storm screens and the vents on top of the chimneys.
