ARCHITECTURAL/HISTORIC INVENTORY FORM

1. Survey No. SL-AS-036-001		2. Survey Name: Architectural Survey of Old Ferguson West	
3. County: St. Louis		4. Address: 1 Carson Rd.	
5. City: Ferguson	Vicinity: <input type="checkbox"/>	6. UTM:	7. Township/Range/Section
8. Historic name (if known):		9. Present/other name (if known): Whistle Stop	
10. Ownership: <input type="checkbox"/> Private <input checked="" type="checkbox"/> Public		11. Historic use (if known): TRANSPORTATION/rail-related	11. Current use: COMMERCE/restaurant & RECREATION/museum

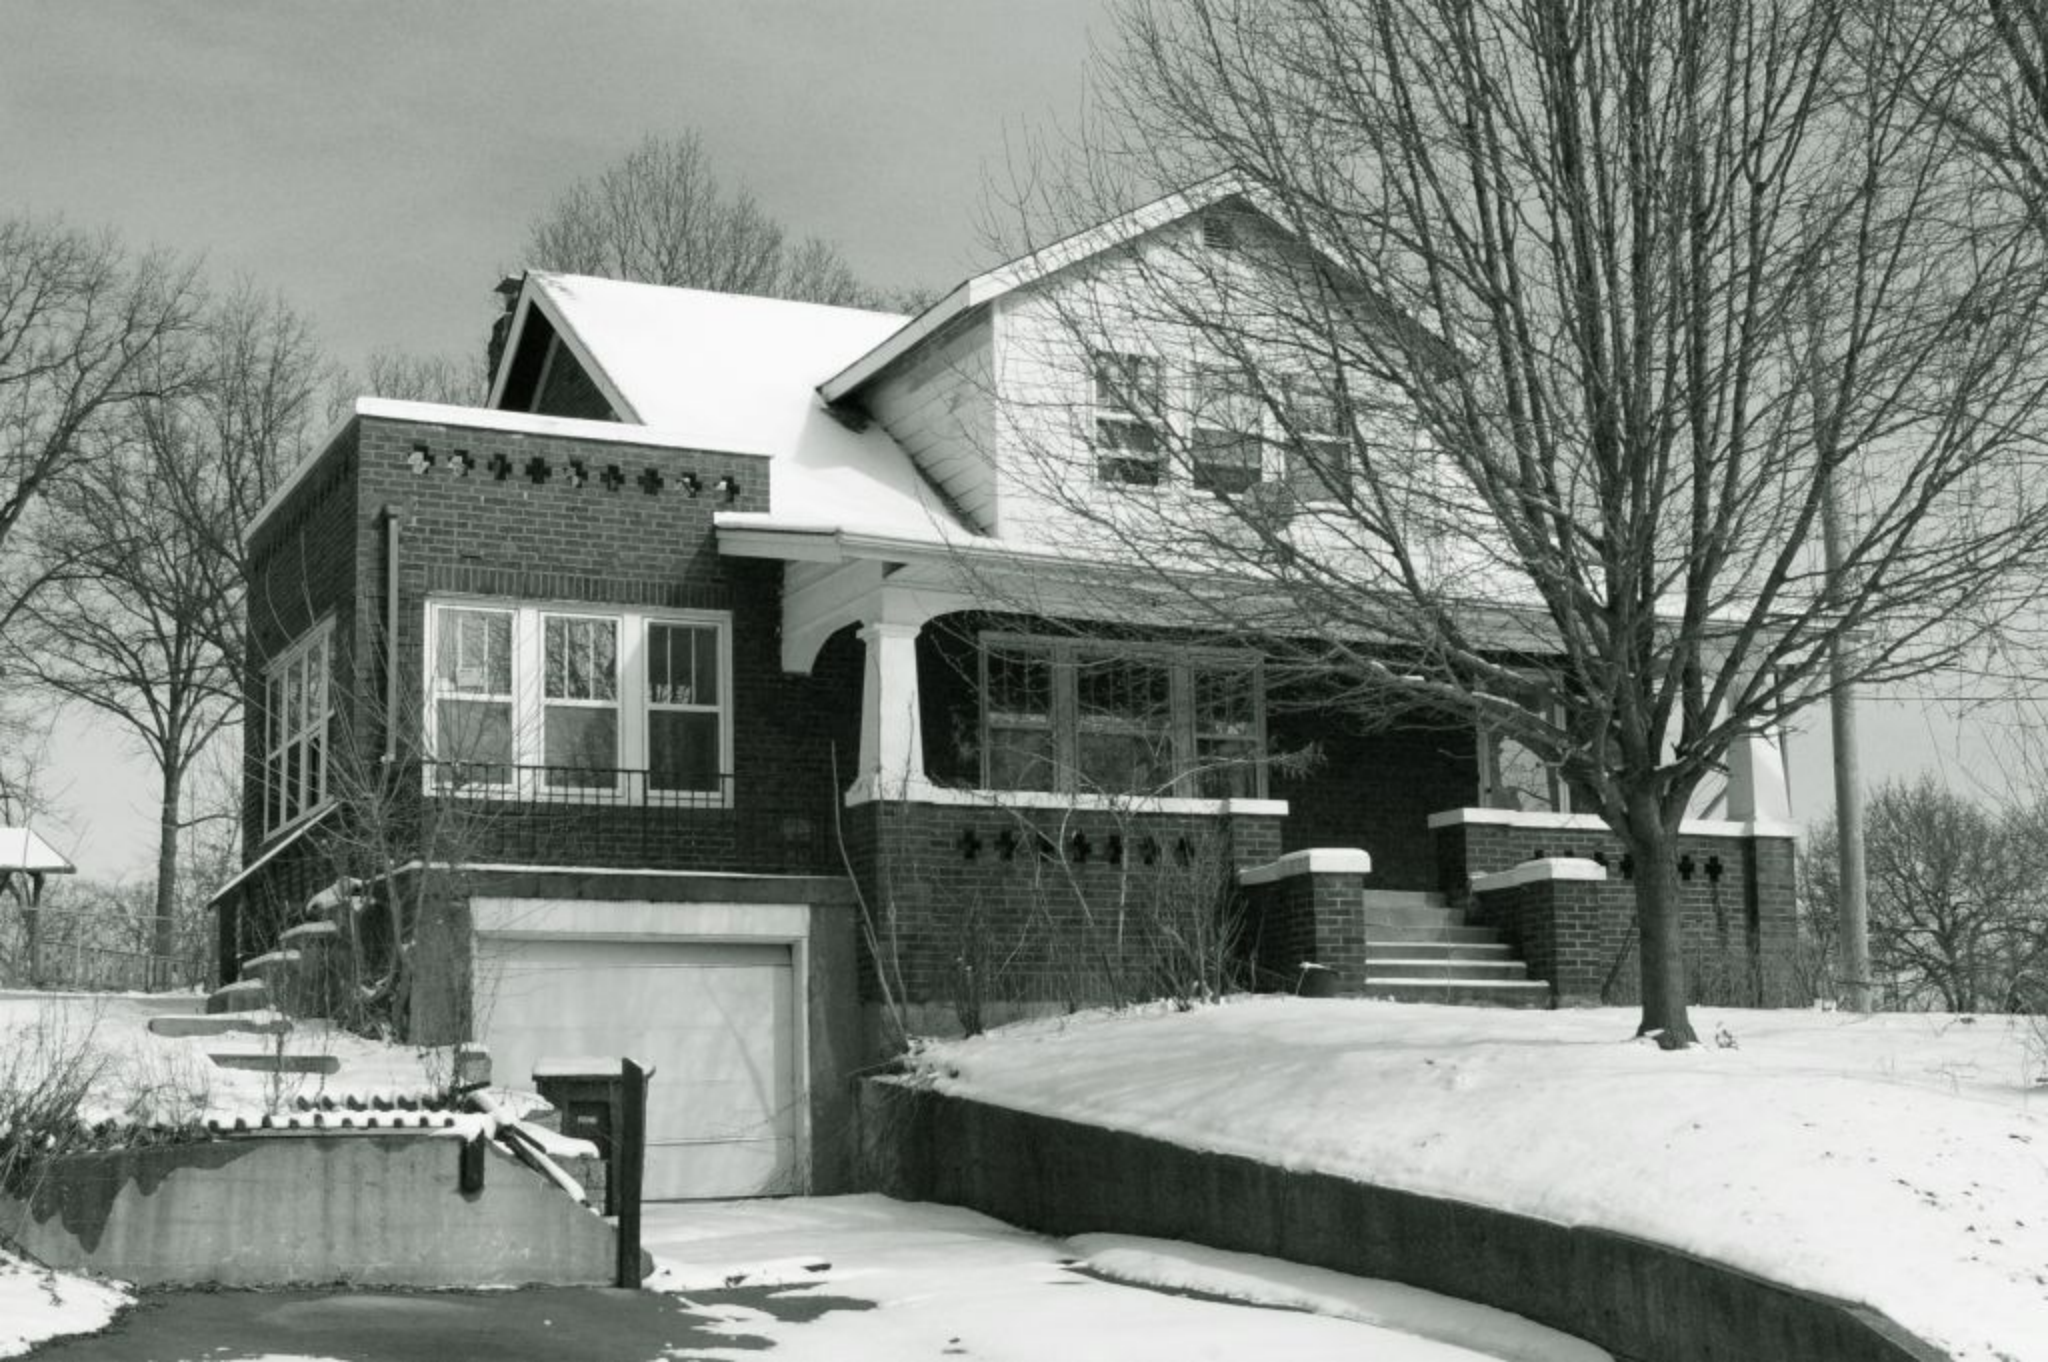
This 1.5 story, side gabled, brick house has wide eaves with open rafters. It has a large, central dormer on the facade with three 4 vertical light upper sashed wood windows, which retains the open rafters but has replacement, wider aluminum siding. The full width, shed roofed porch is supported by tapered posts at each corner that rest on the pierced brick half wall railing with centered concrete steps with brick side walls. The first floor of the facade has a triple window with vertical lights in each upper sash window. With the window positioned to the west, the original entry door is near the east end of the facade. The door appears to be the original, lighted wooden door but it is currently covered by a plywood panel and has a full light storm door. The porch eaves have been enclosed with aluminum. Attached on the west side is a flat roofed, pierced parapet, brick, one story sunroom with banks of 3 over 1 sashed windows. Below the sunroom is a basement level garage. The garage door faces the street with concrete retaining walls on the driveway. The garage appears on the 1931 fire insurance map so even if it is not original to the building, it dates at least from that time.

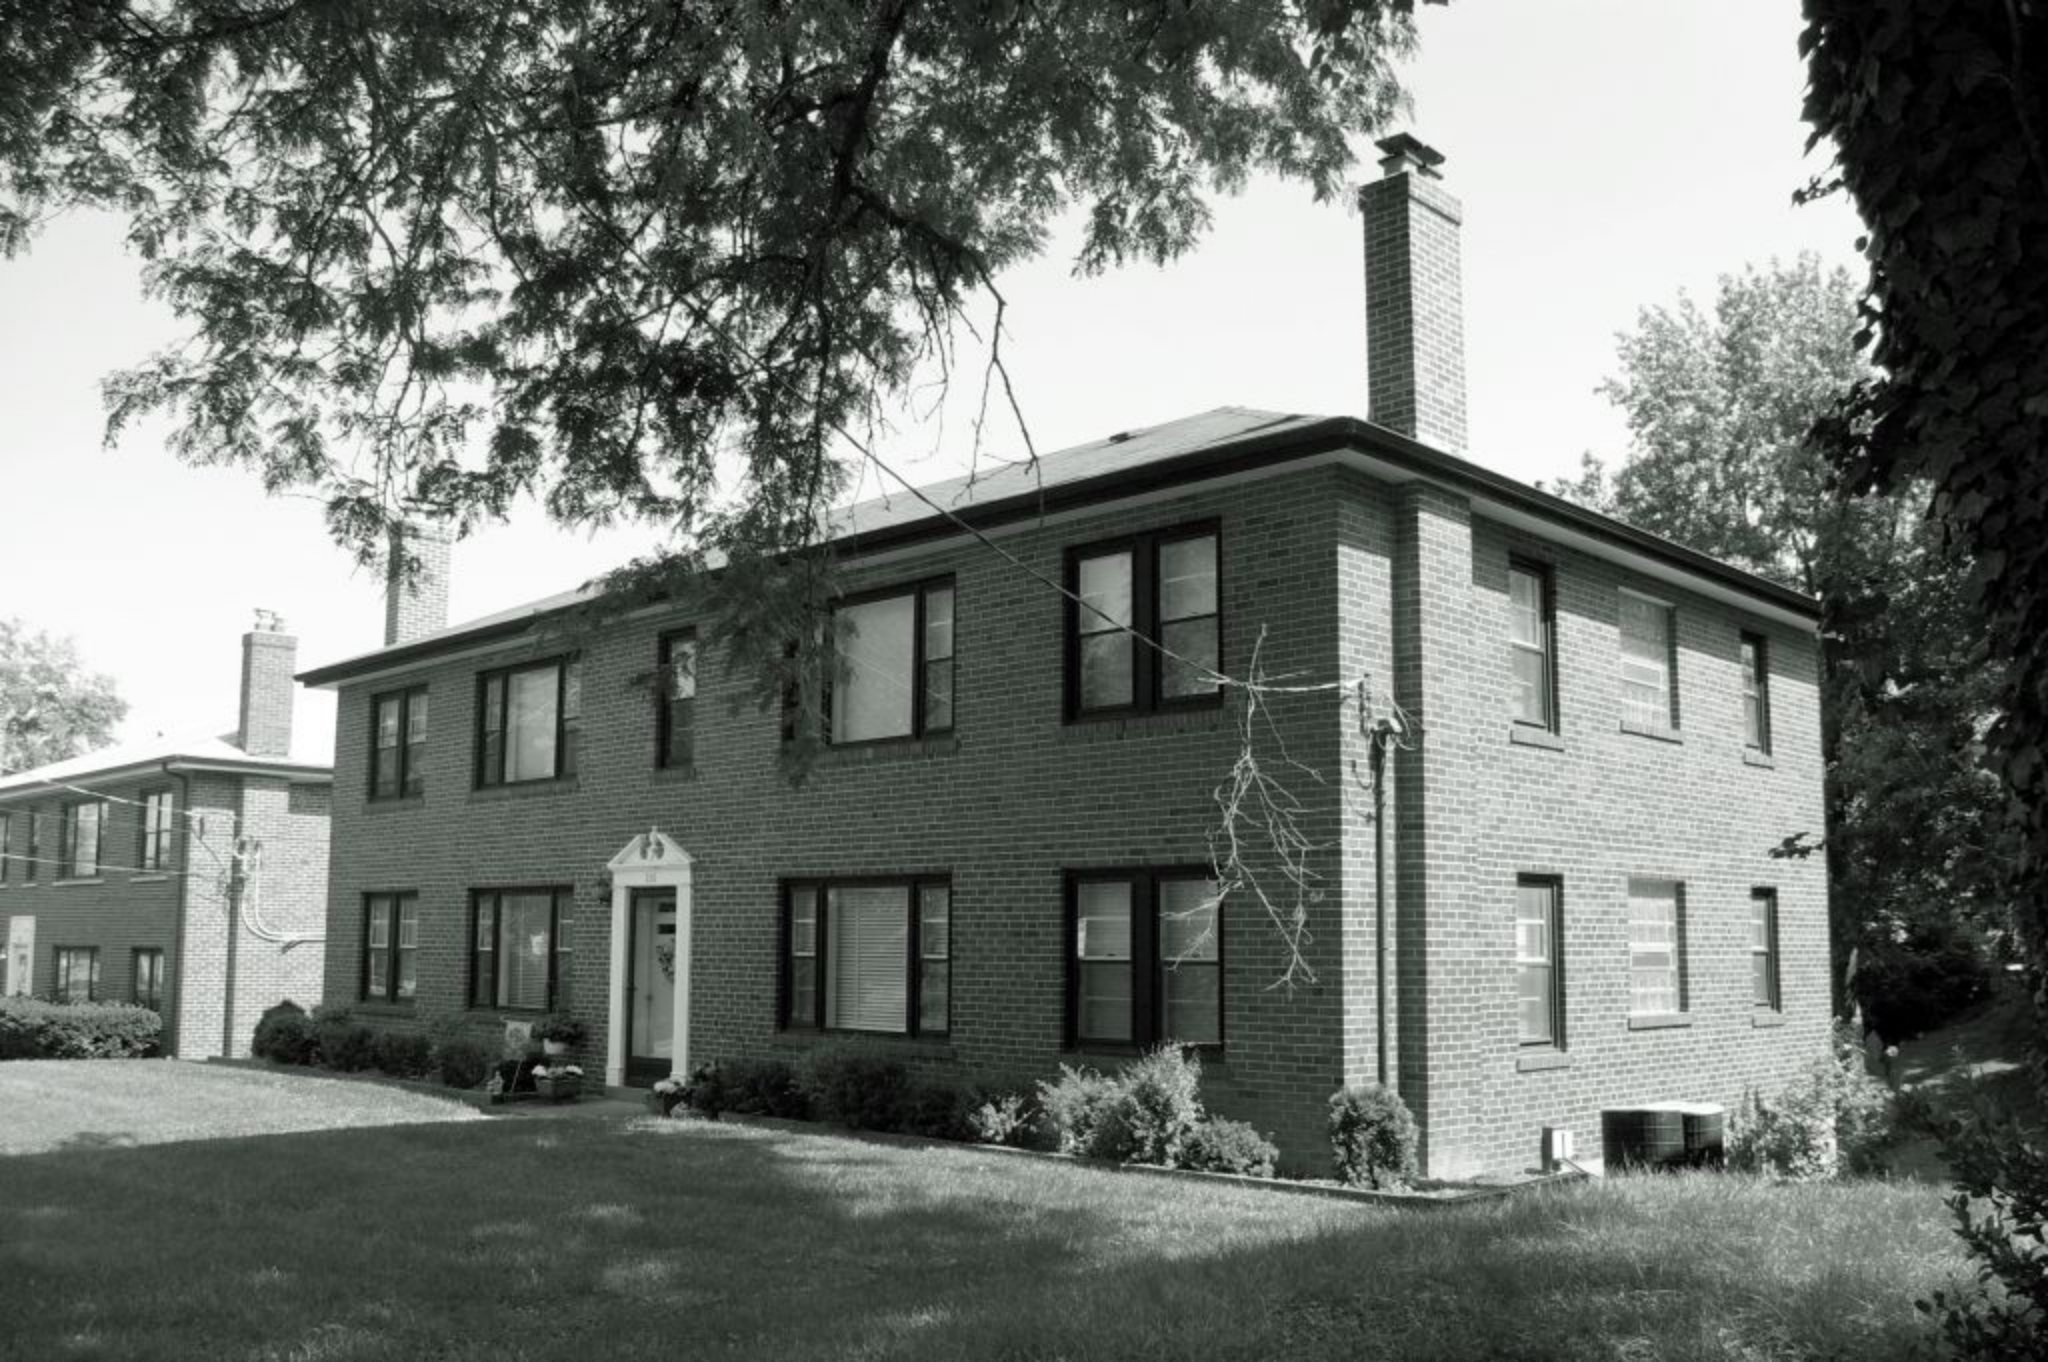
This two story, brick apartment building has a shallow pitched, asphalt shingle, hipped roof with tall, brick, interior chimneys positioned on each side. The facade is divided into five bays with 2 over 2, horizontal-light sashed windows paired in the outer bays, flanking a plate glass window in the two inner bays, and as a single window above the central entry. The entry is accentuated by a broken pediment with urn and pilaster strips. The 2 over 2 windows and the two-horizontal light wood door are Streamline Modern features, while the other features are commonly associated with Georgian Revival houses. The slope of the hillside makes the poured concrete basement visible on the side and rear elevations. On the side elevations, the original glass block, vented (bathroom) windows are positioned in the central of the three bays. The only visible alterations are the installation of 1 over 1 combination storm screens (and a storm door) and the vents on top of the chimneys.

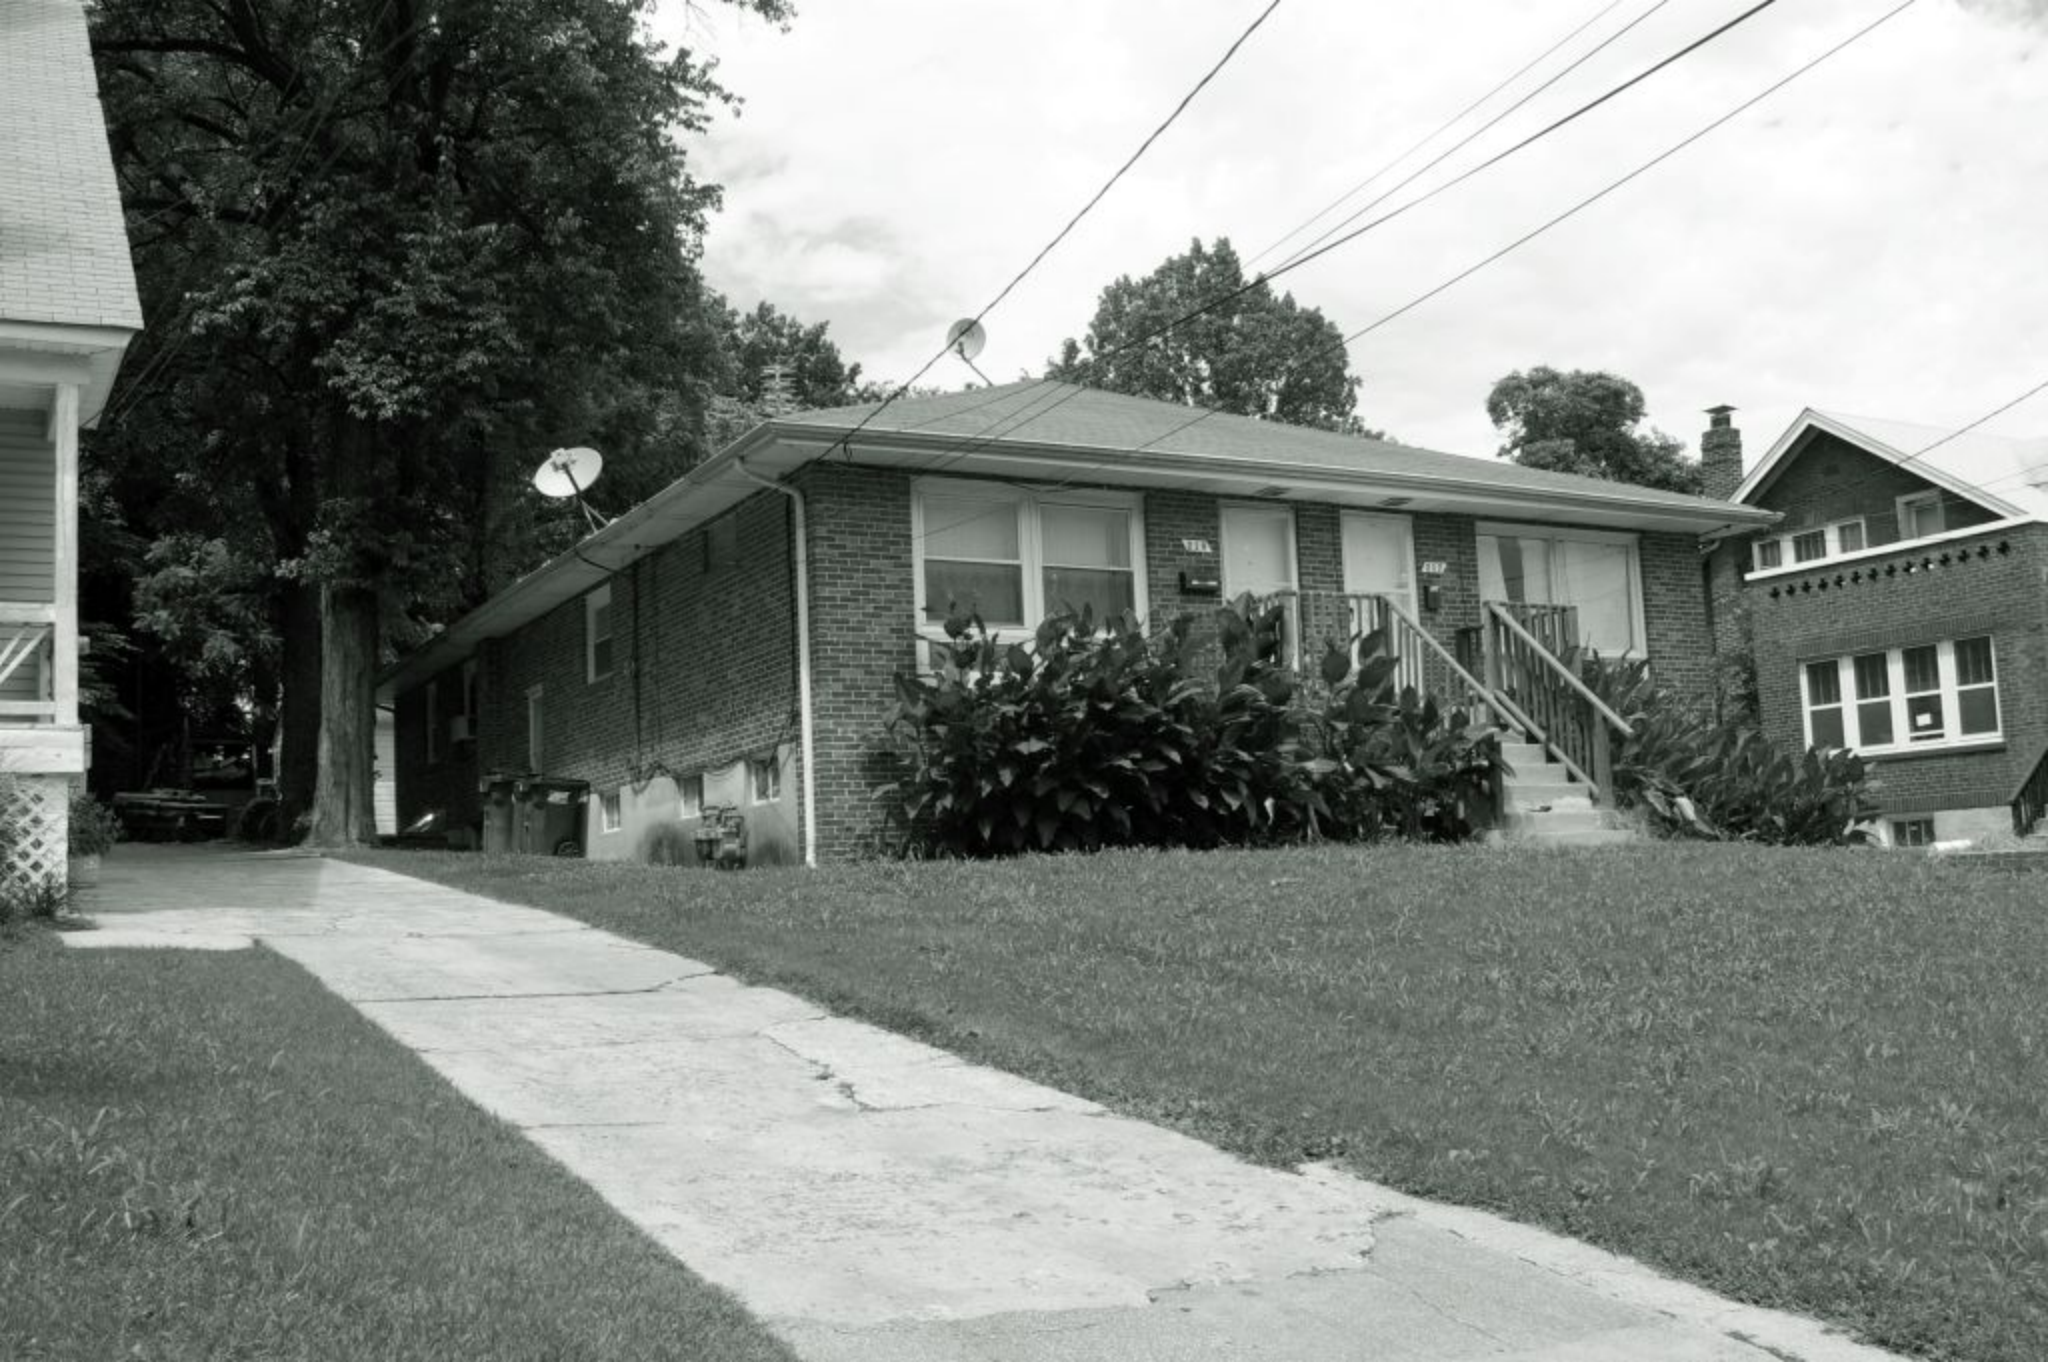
This simple, Mid-Century Modern, one story, hipped roof duplex building has wide, enclosed eaves and a symmetrical facade with the original concrete stoop leading up to the central bay where there are two entry doors, both simple slab doors. To the east, the bay has paired metal windows each with a tall fixed window above the hopper window. In the west bay, the paired metal sashed windows are positioned above the hopper windows. The entry stoop has been modified with the addition of a high wood railing around the stoop and steps. Given the date of construction, the vented soffit may be original and the slab doors and hopper windows are common to mid-century construction as well.

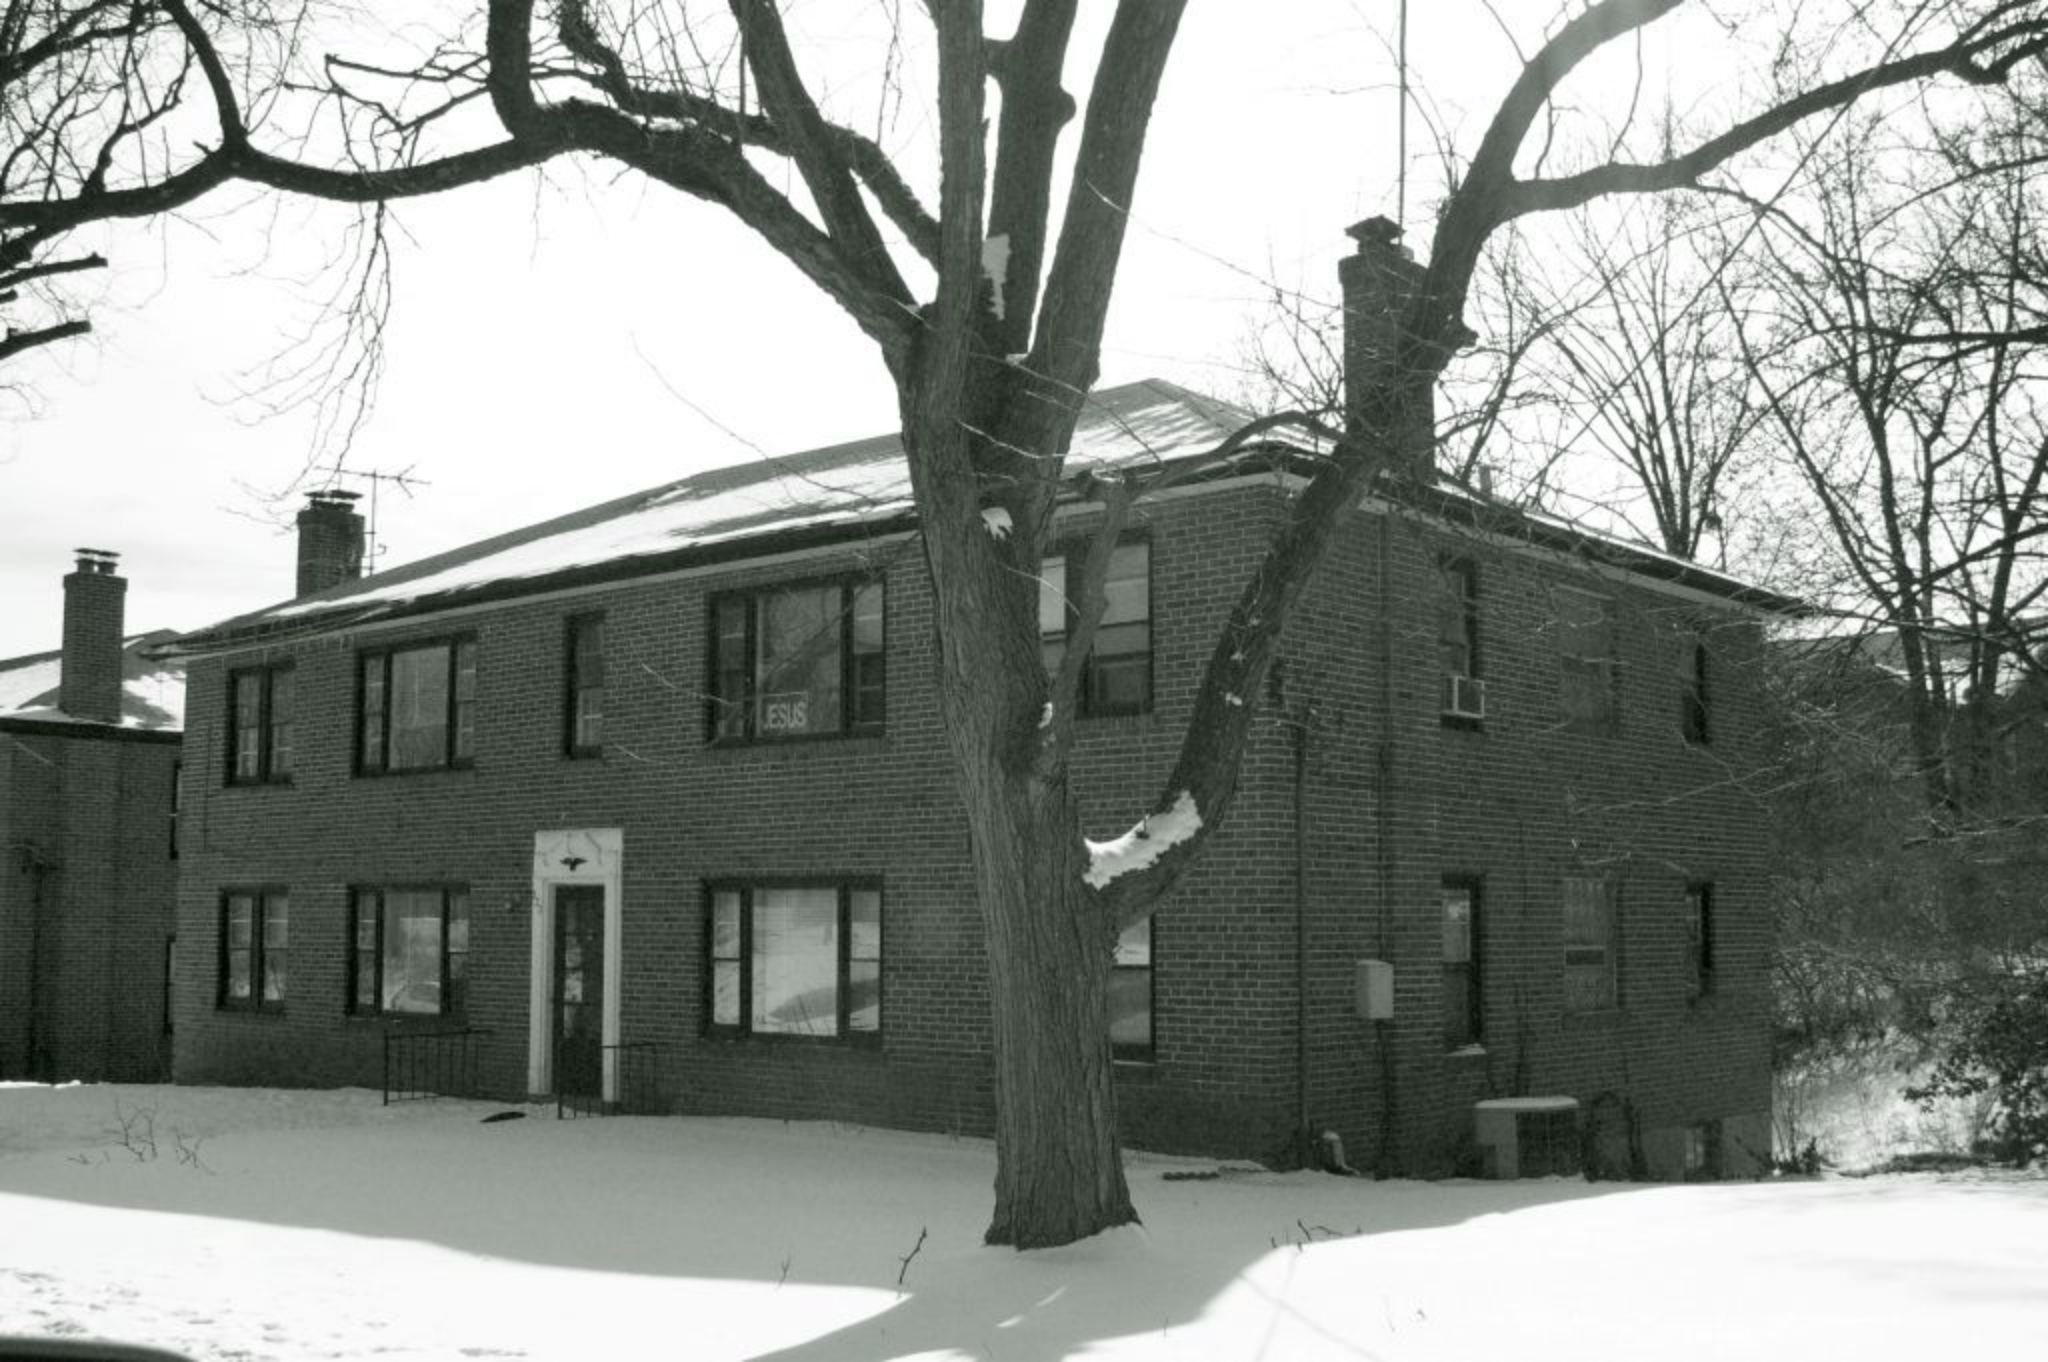
This two story, brick apartment building has a shallow pitched, asphalt shingle, hipped roof with tall, brick, interior chimneys positioned on each side. The facade is divided into five bays with 2 over 2, horizontal-light sashed windows paired in the outer bays, flanking a plate glass window in the two inner bays, and as a single window above the central entry. The entry has a simple entablature and pilaster strips. The 2 over 2 windows and the simple wood door are Streamline Moderne features, while the other features are commonly associated with Georgian Revival houses. The slope of the hillside makes the poured concrete basement visible on the side and rear elevations. On the side elevations, the original glass block, vented (bathroom) windows are positioned in the center of the three bays. The only visible alterations are the installation of 1 over 1 combination storm screens (and storm door) and the vents on top of the chimneys.

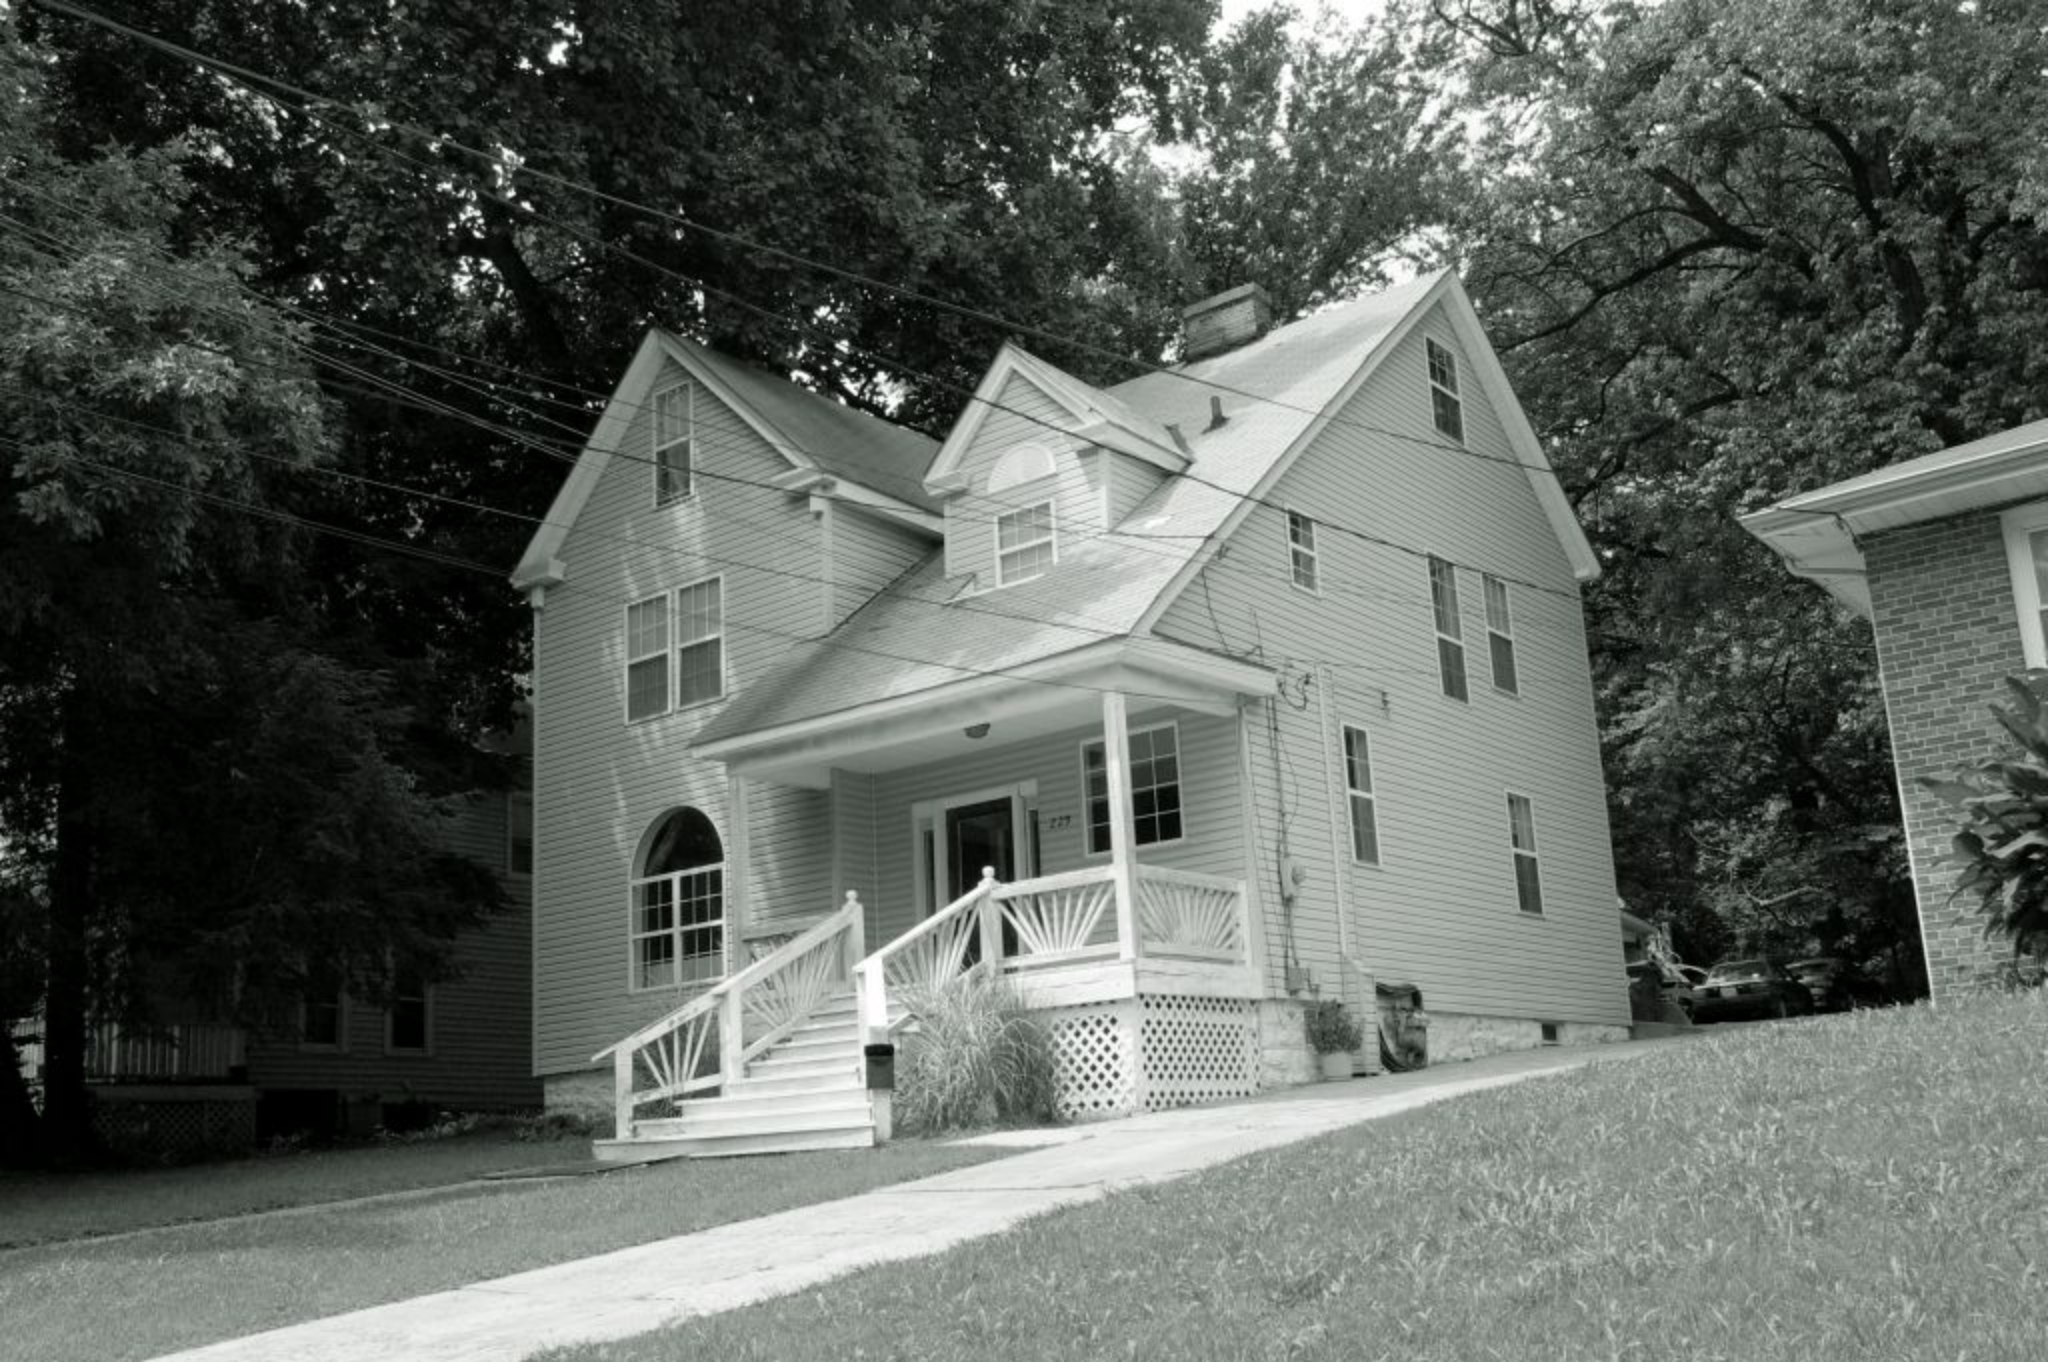
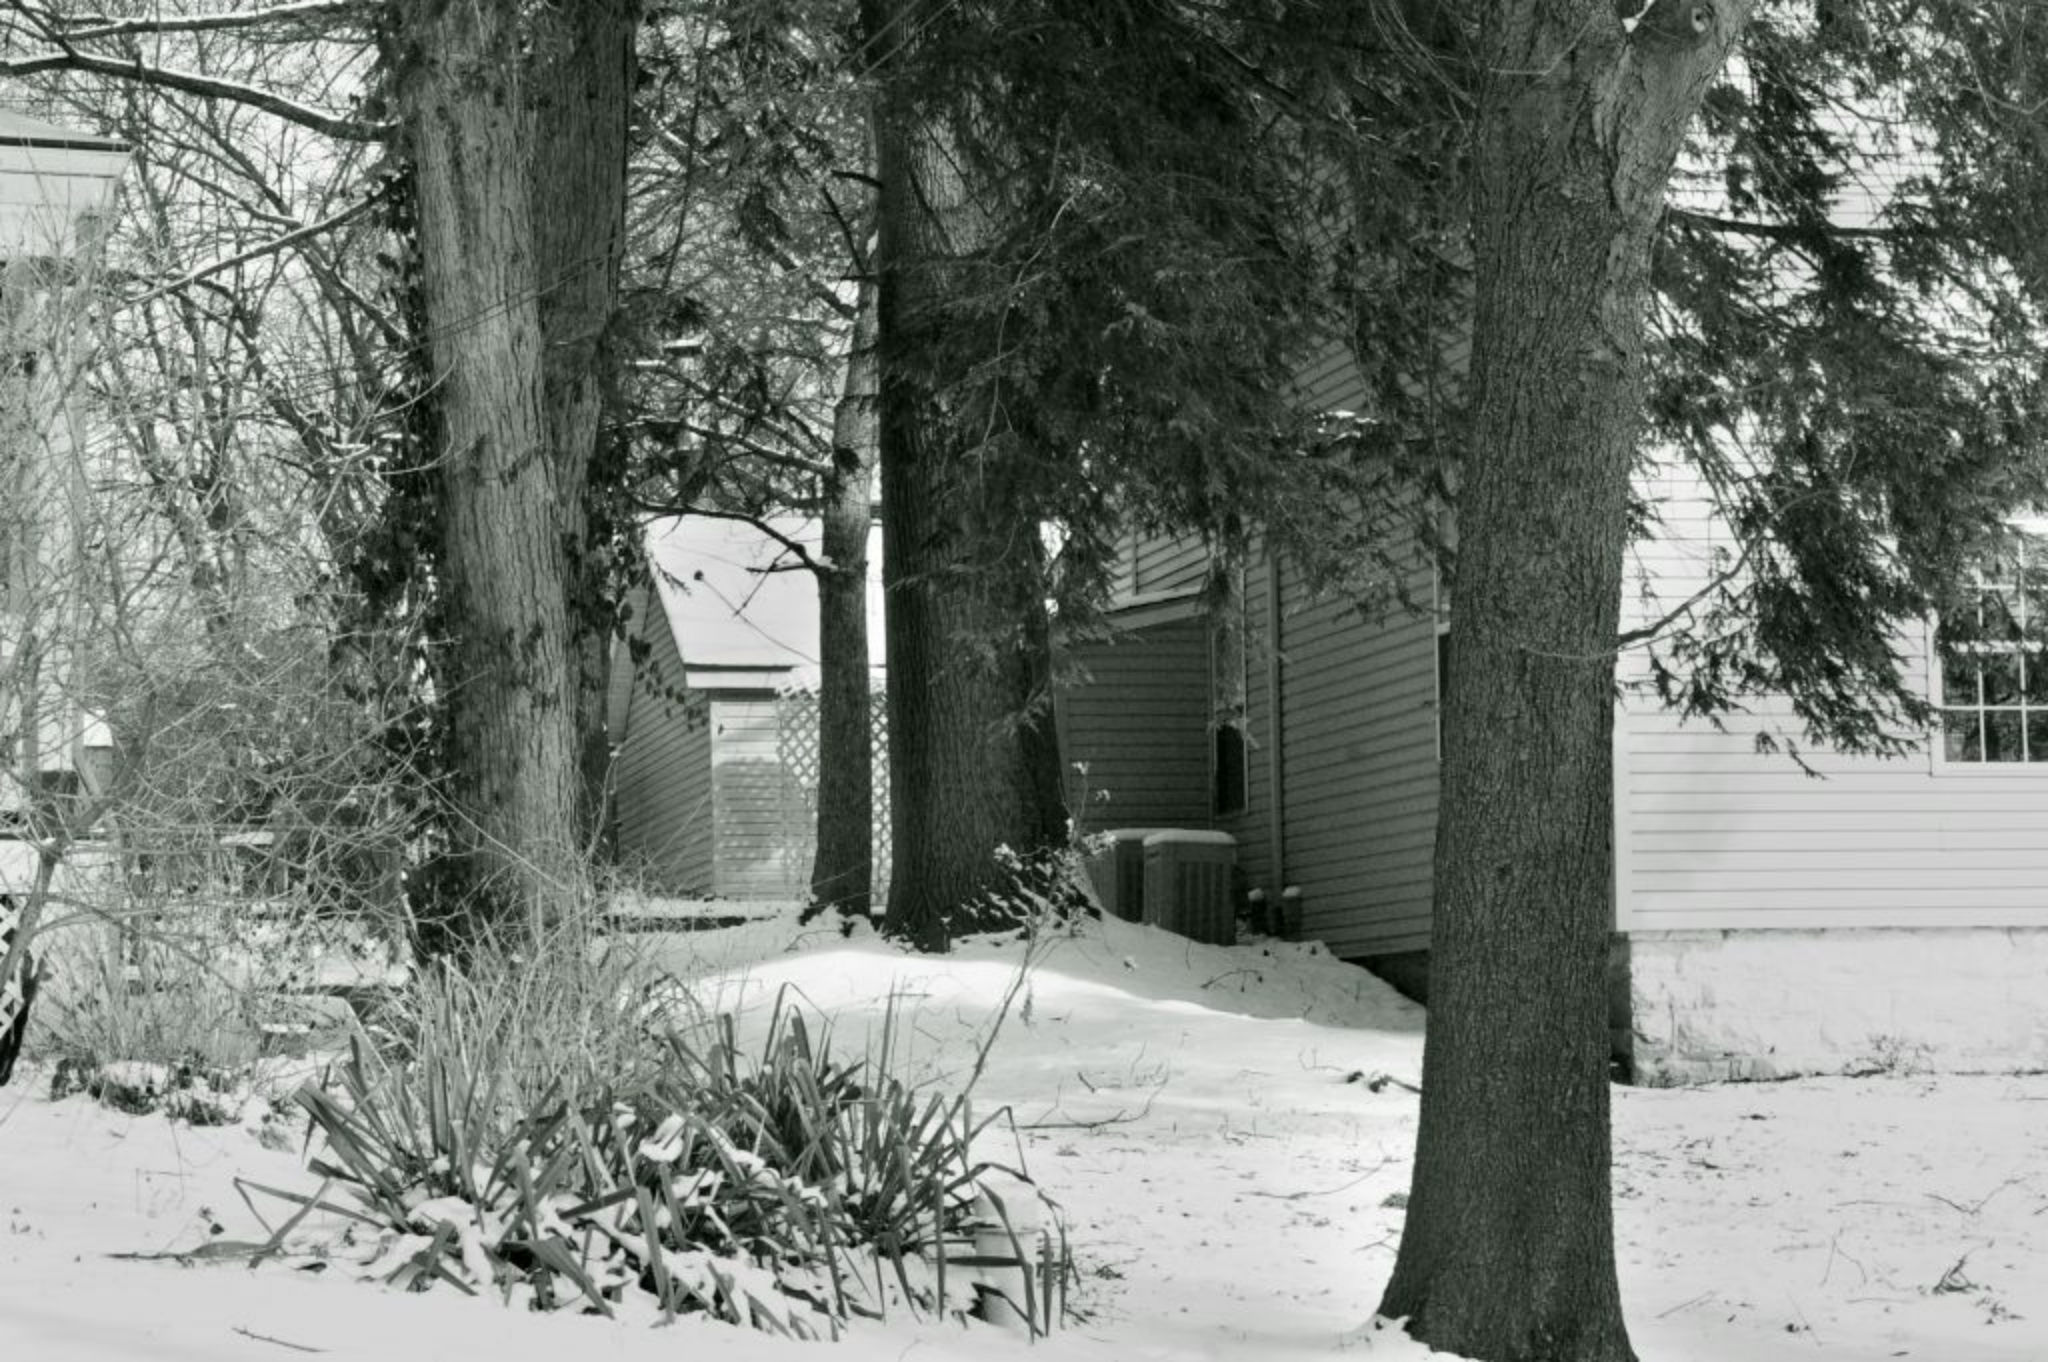
2009 Survey Update: Since the 1983 survey, the replacement asbestos siding has been replaced with vinyl siding and the windows have been replaced with vinyl windows, changing the front window into an arched top opening and altering the window light pattern. In addition, the porch railings and support have been altered, but the original features are clearly evident in the 1983 survey photo.

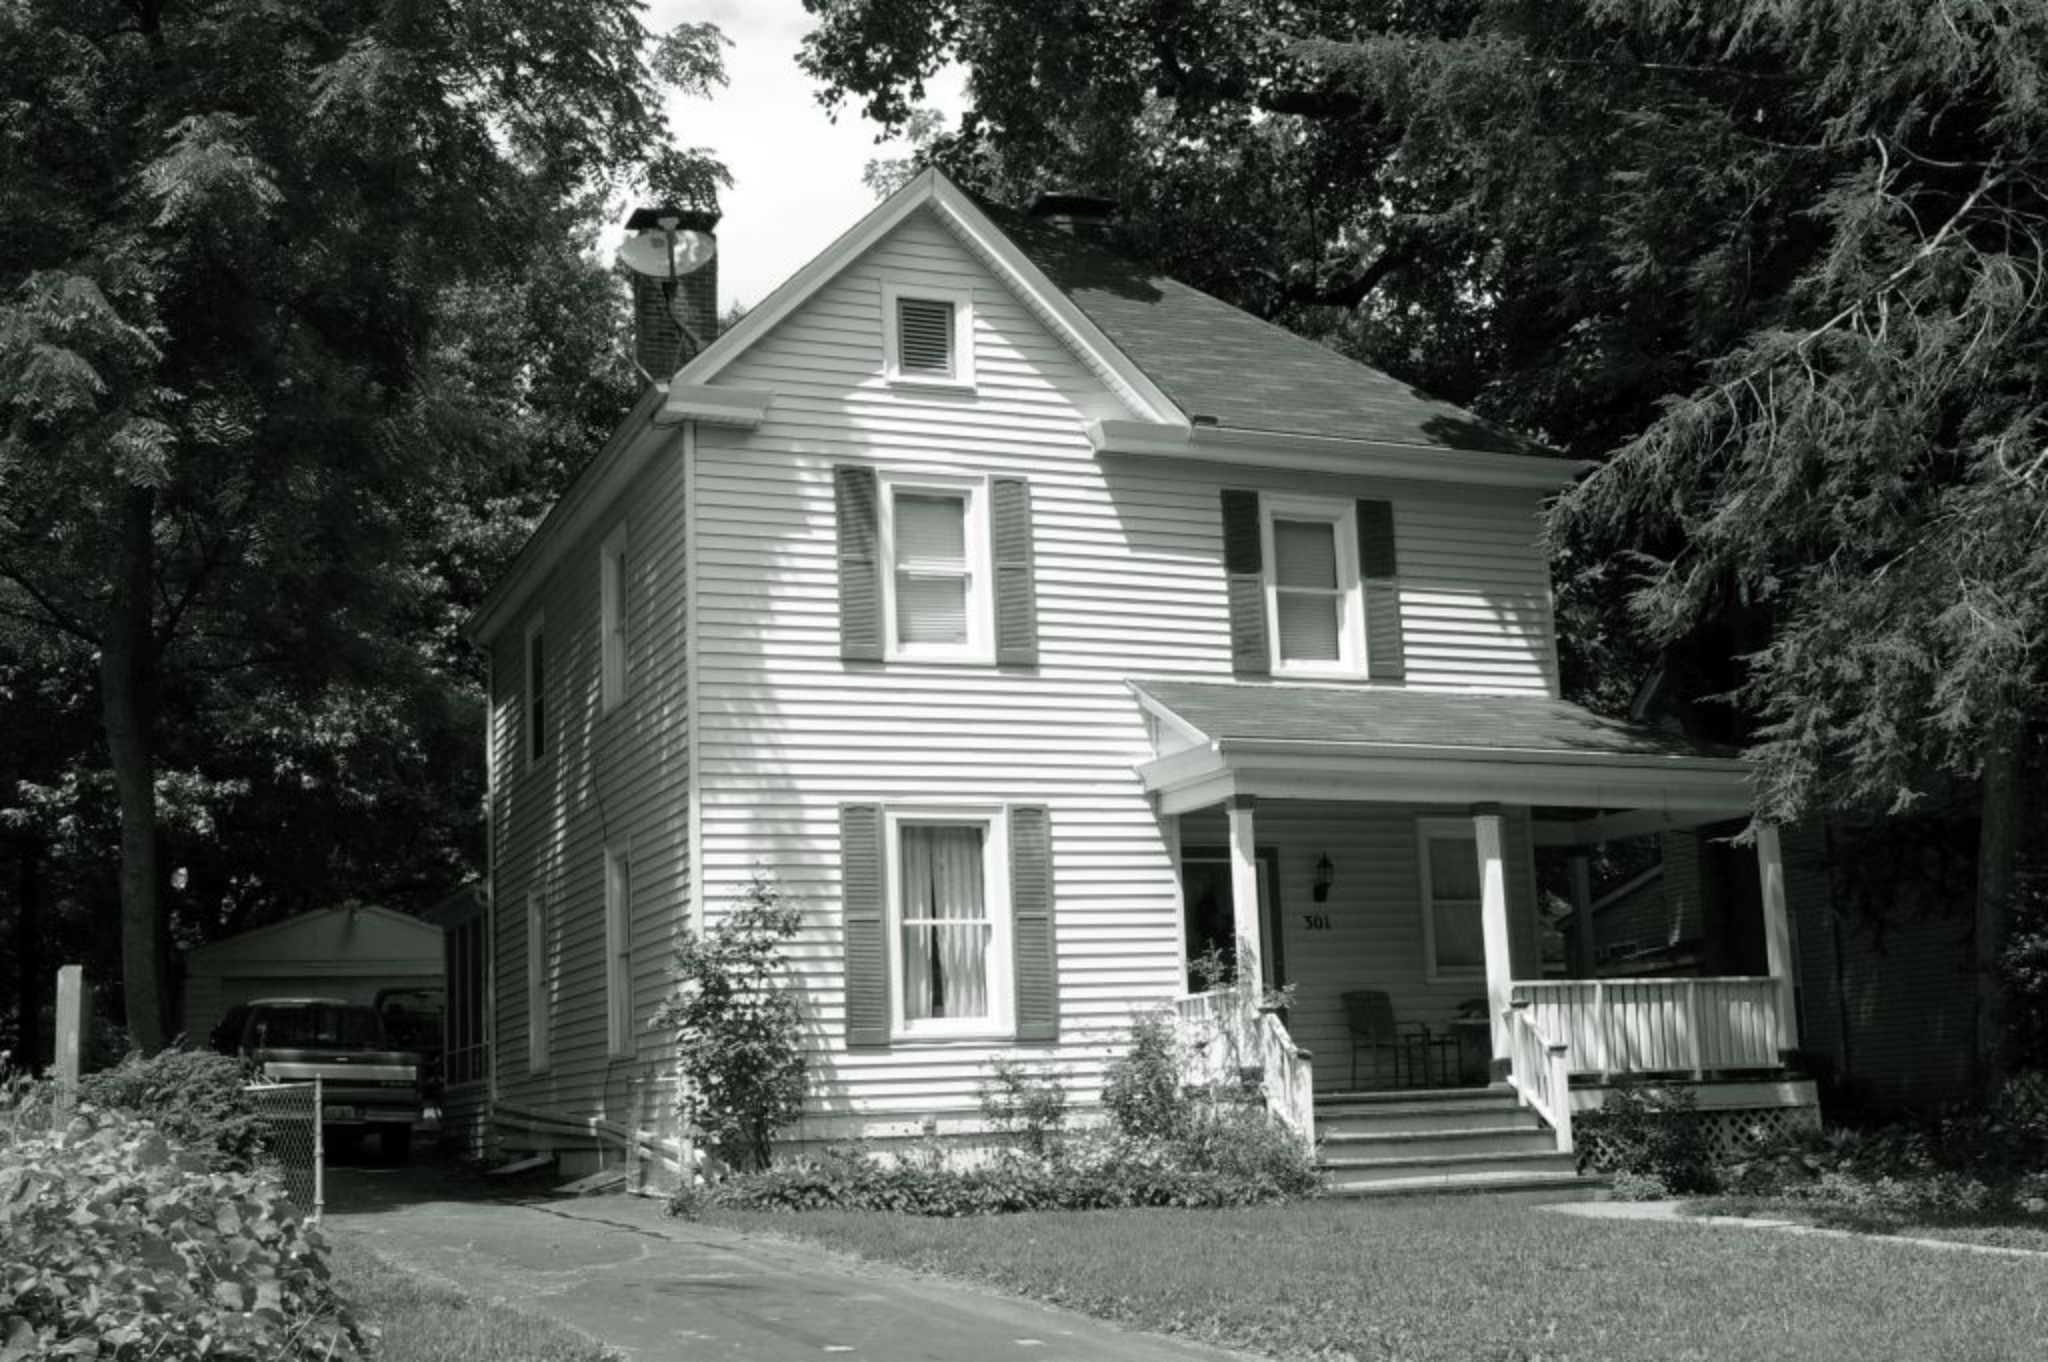
2009 Survey Update: The wider aluminum siding has been replaced since the 1983 survey with a vinyl siding more in proportion to the original wood siding. The porch railings have also been replaced since the 1983 survey with 2x4 railings and balusters.
