ARCHITECTURAL/HISTORIC INVENTORY FORM

1. Survey No. SL-AS-036-001		2. Survey Name: Architectural Survey of Old Ferguson West	
3. County: St. Louis		4. Address: 1 Carson Rd.	
5. City: Ferguson	Vicinity: <input type="checkbox"/>	6. UTM:	7. Township/Range/Section
8. Historic name (if known):		9. Present/other name (if known): Whistle Stop	
10. Ownership: <input type="checkbox"/> Private <input checked="" type="checkbox"/> Public		11. Historic use (if known): TRANSPORTATION/rail-related	11. Current use: COMMERCE/restaurant & RECREATION/museum

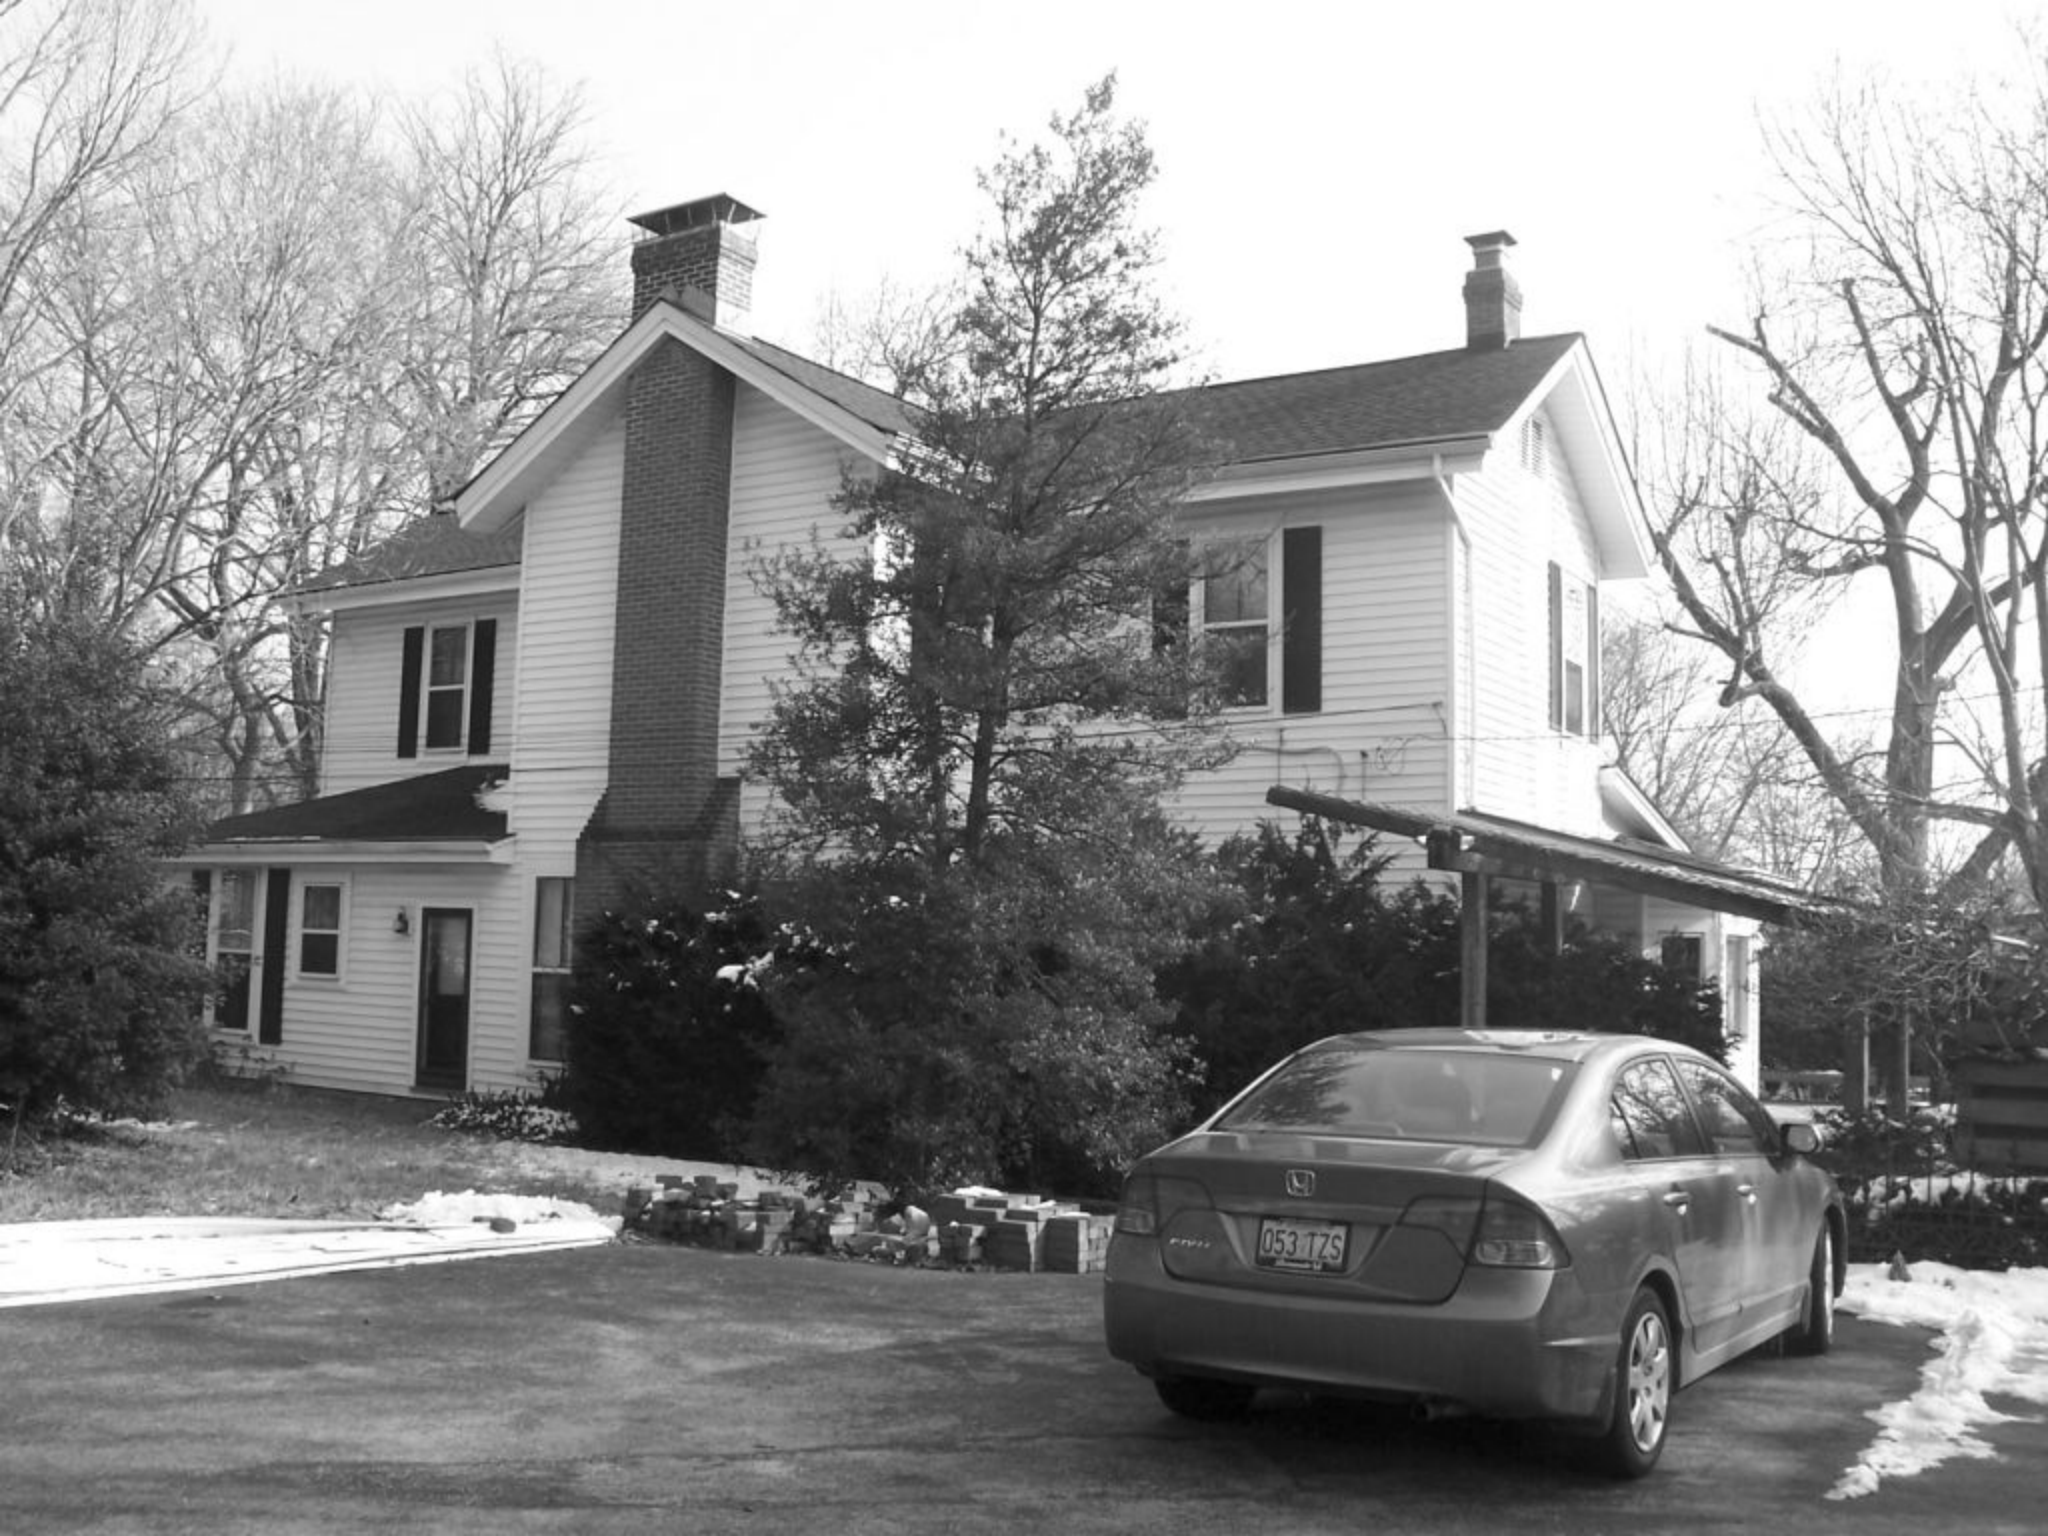
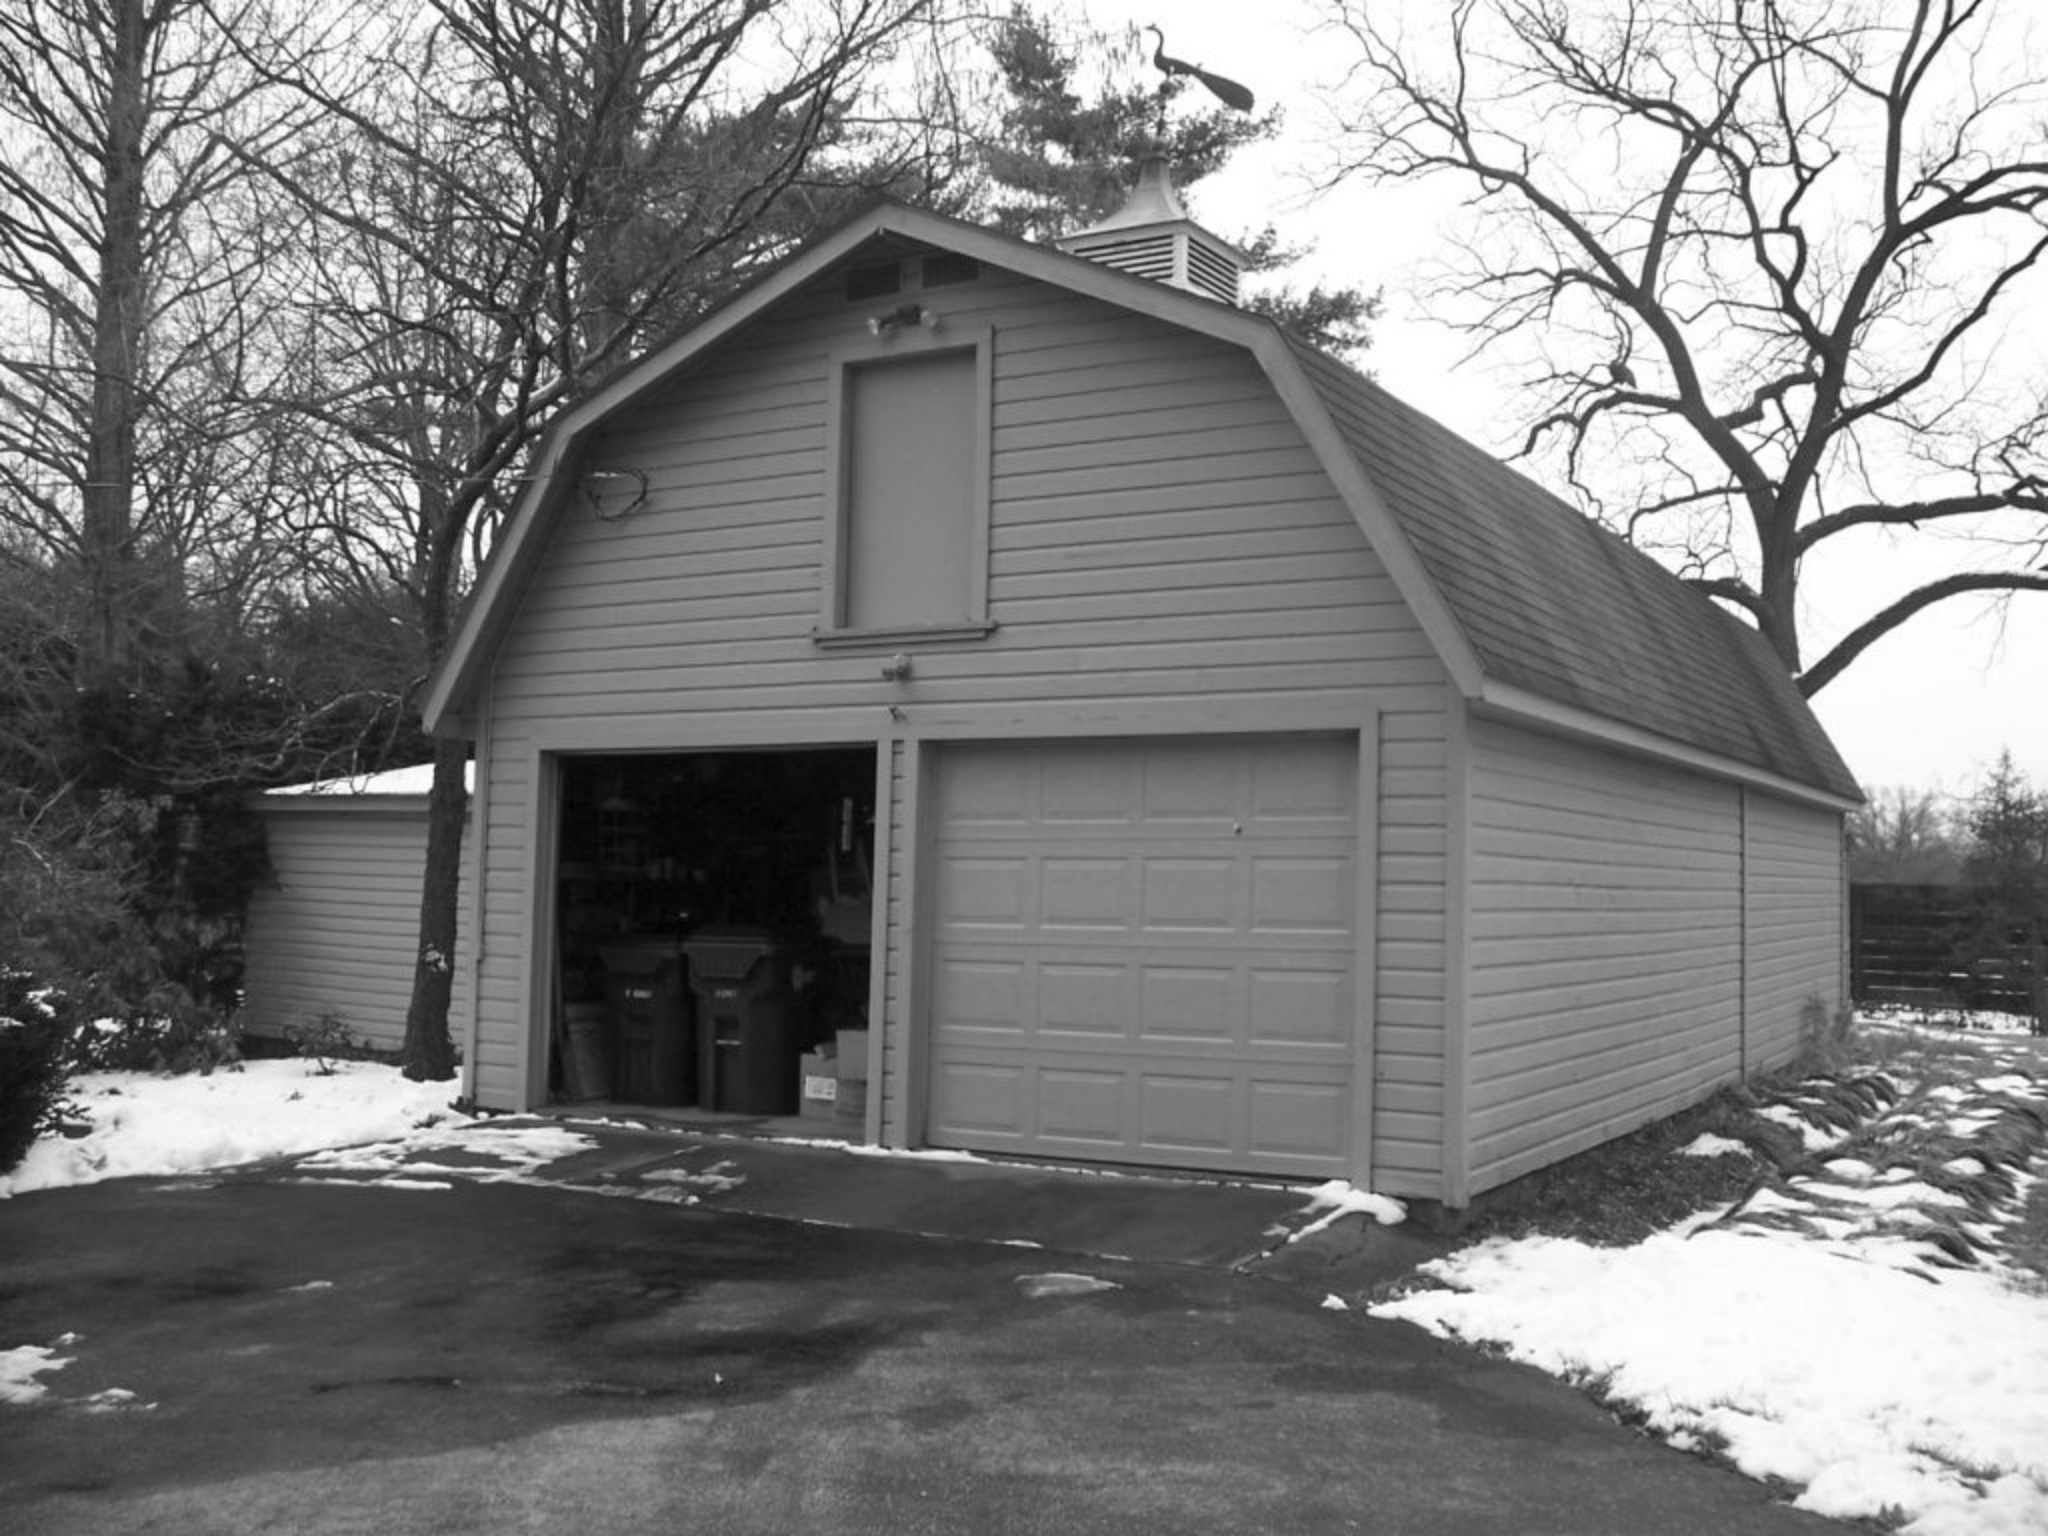
2009 Survey Update: The siding on the house appears to have been replaced with vinyl siding since the 1983 survey, which identified the siding as aluminum. The wrap-around porch visible on the 1931 and 1950 fire insurance maps has been removed or partially removed and enclosed.

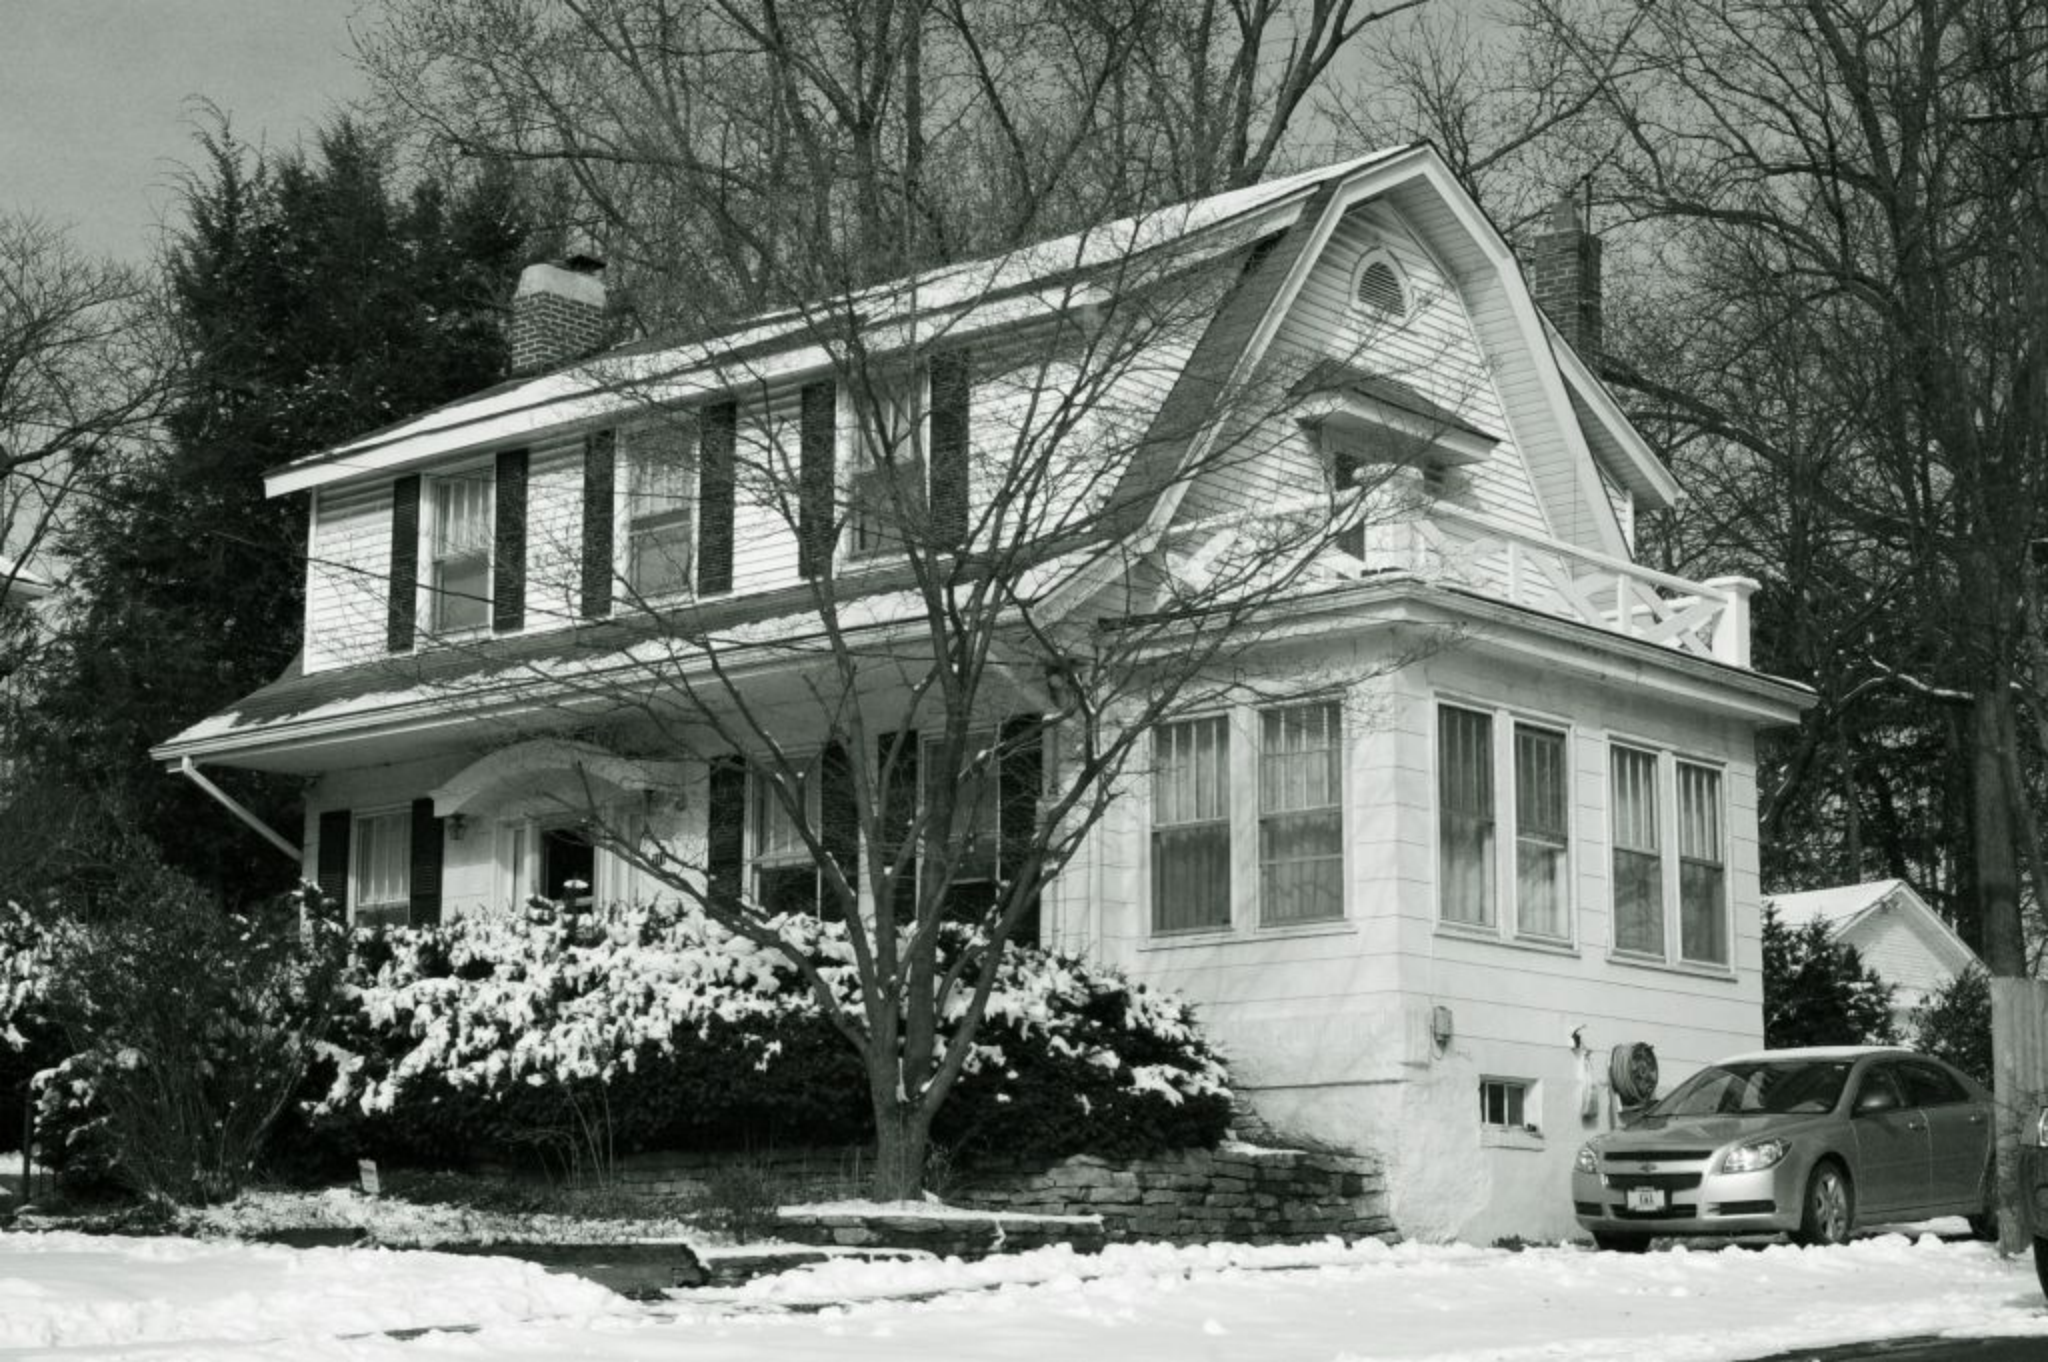
This side gambrel roofed, two story house has painted brick walls on the first floor with a full length shed roofed dormer on the facade. The facade is divided into four bays (plus one additional bay for the sunroom wing on the west side). The entry is located in the second bay from the west with an arched top roof (and what appears to be original Colonial style pendant lantern porch lights at each end) over the sidelighted wood paneled door and entry stoop. There is a brick end wall chimney on the west elevation and a one story sunroom on the east end, which is clad with wider wood siding. The windows are generally 4 over 1 sashed windows with decorative shutters, but the sunroom windows are not shuttered. The walls of the shed dormer have been clad with vinyl siding and the house has aluminum storm screens, but these alterations do not drastically change the appearance of the house.

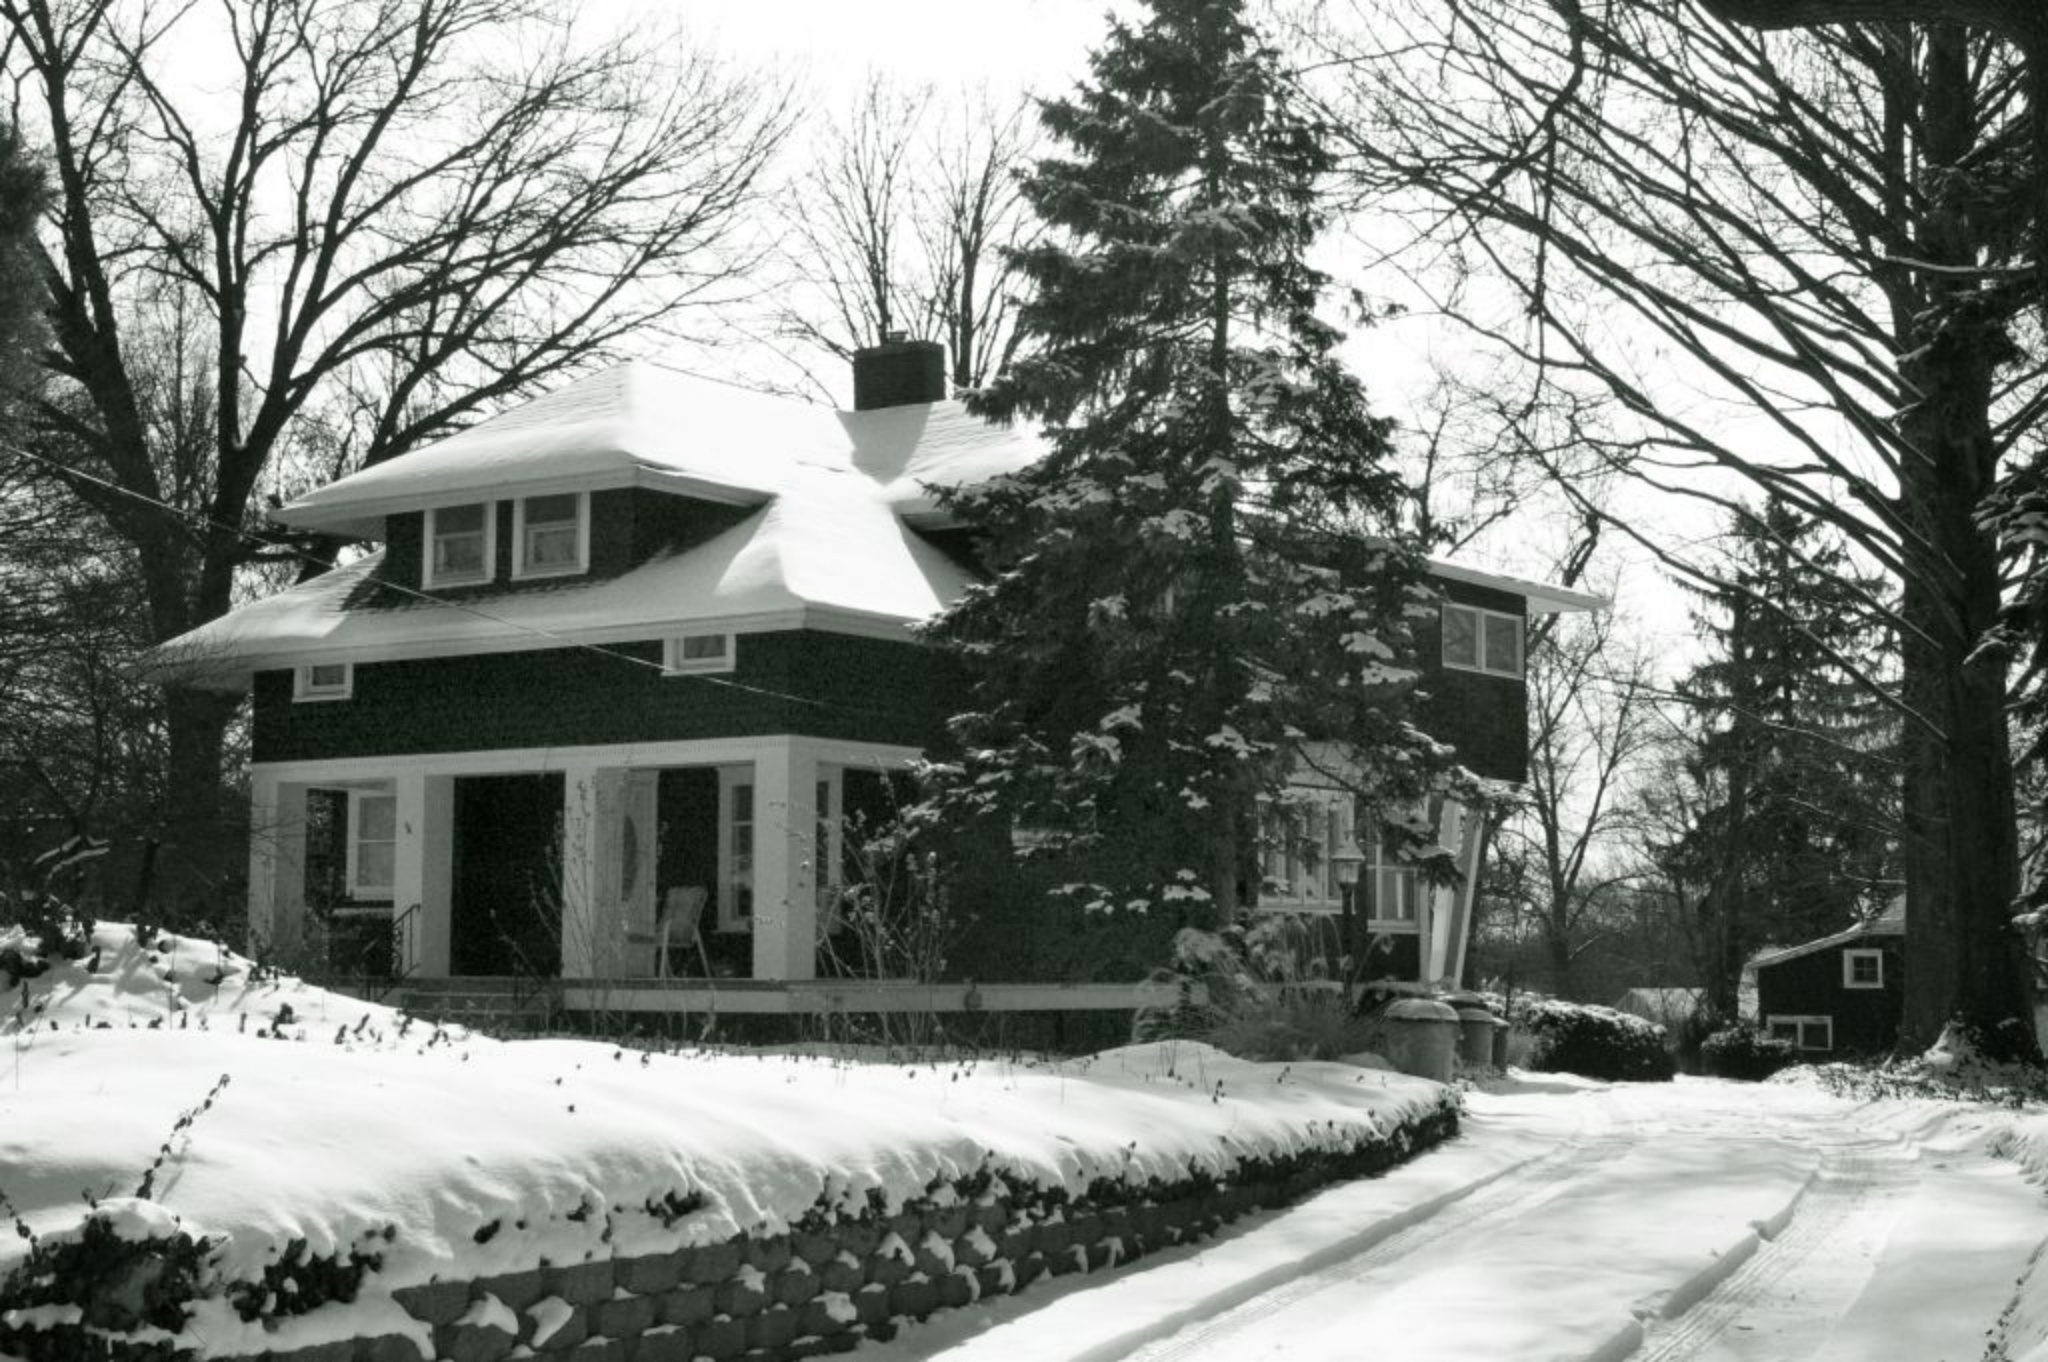
2009 Survey Update: The front door has been replaced with a newer door with art glass. The cantilevered wing on the west side is a post-1950 addition since it does not appear on the fire insurance map.

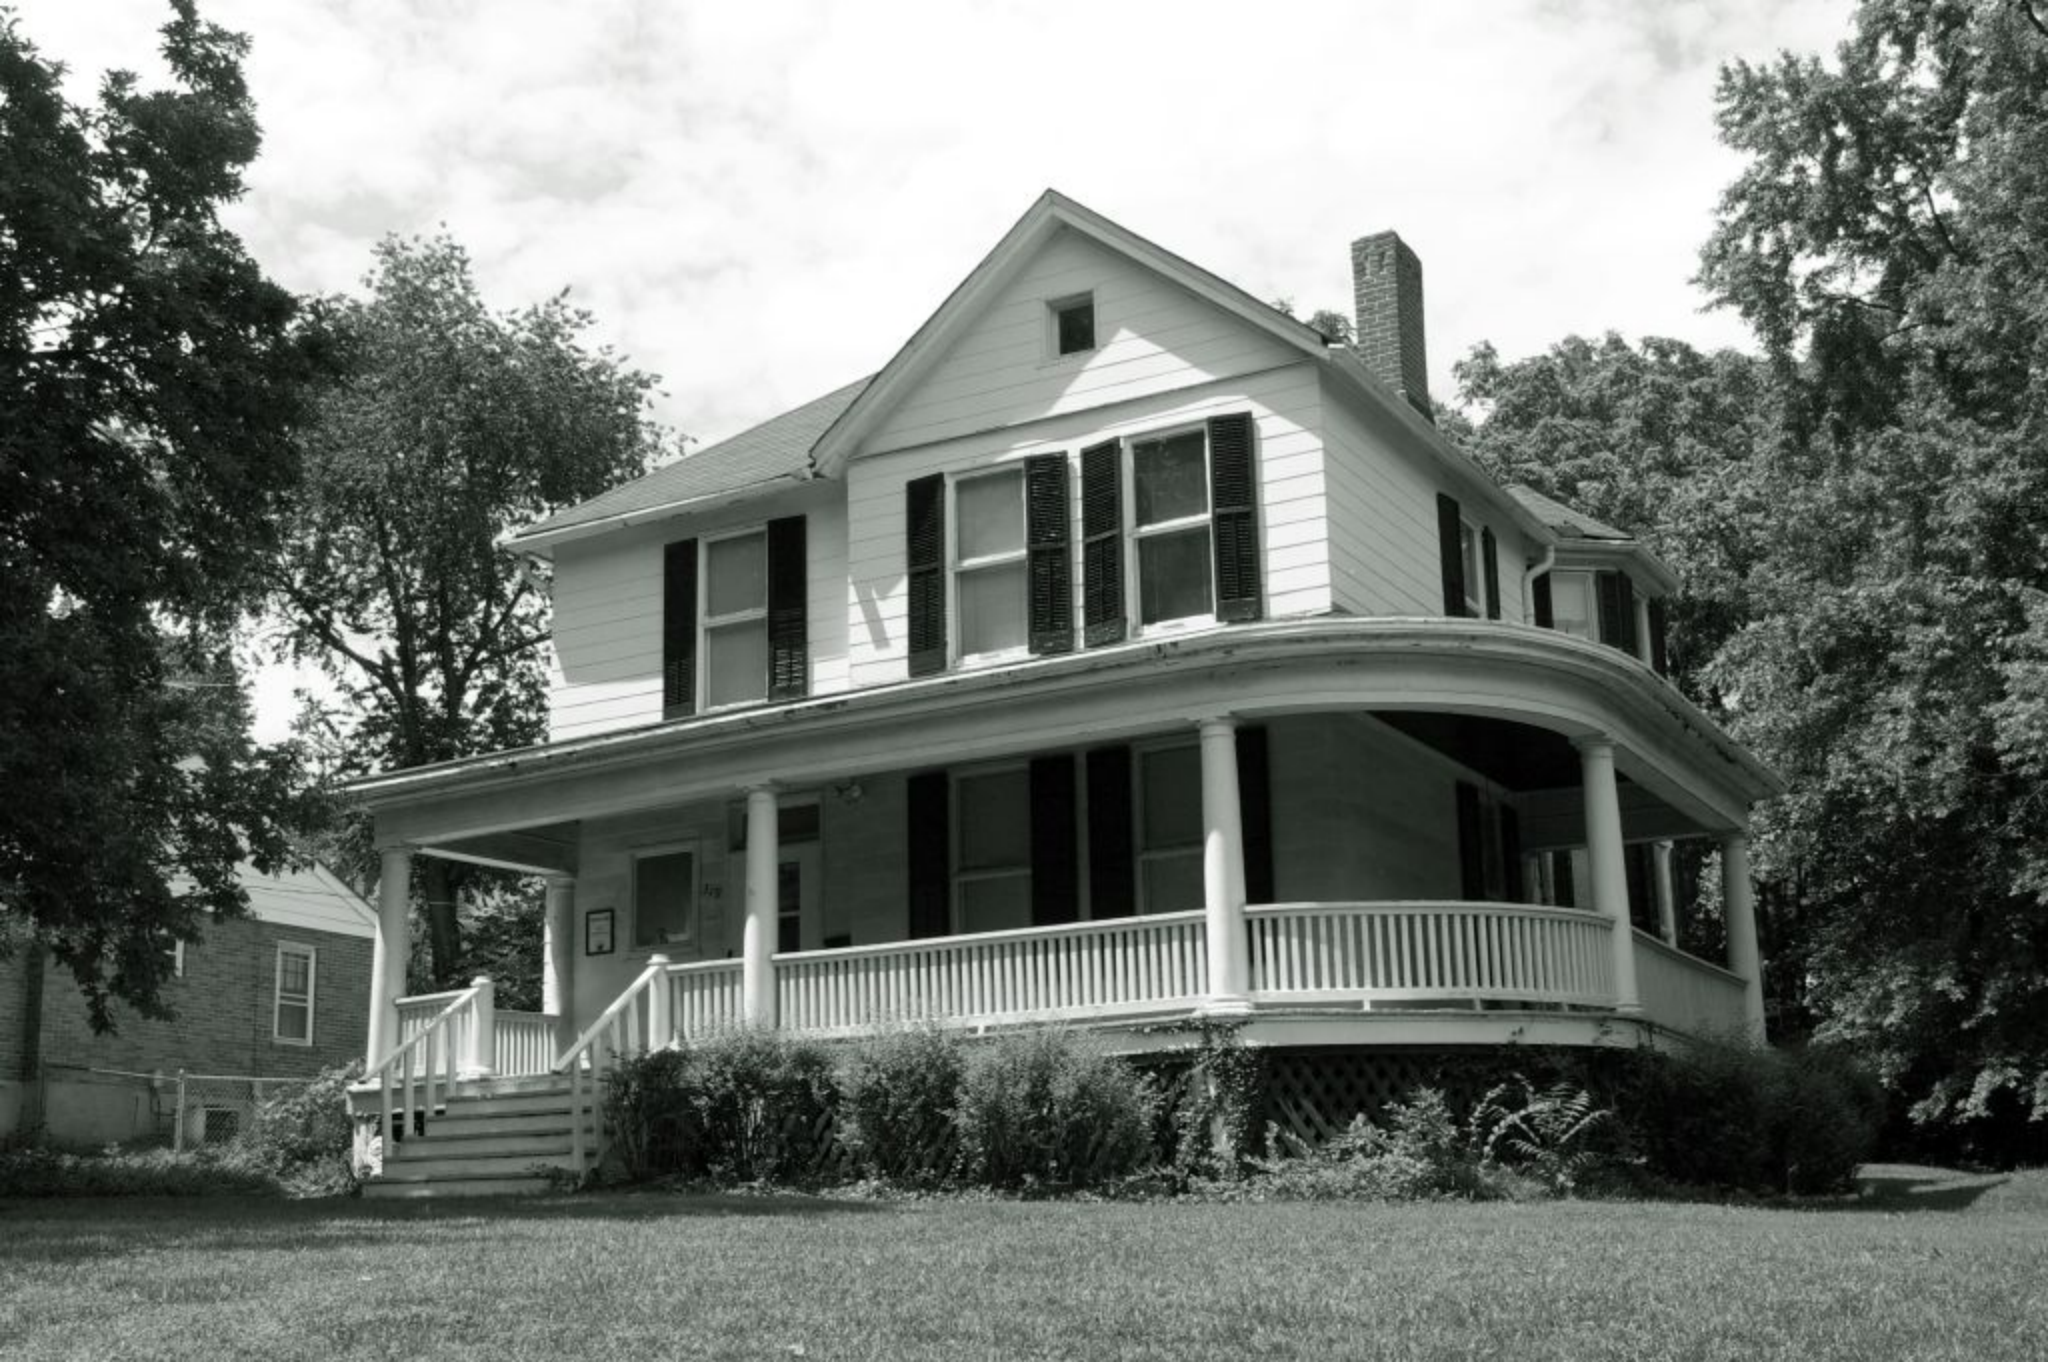
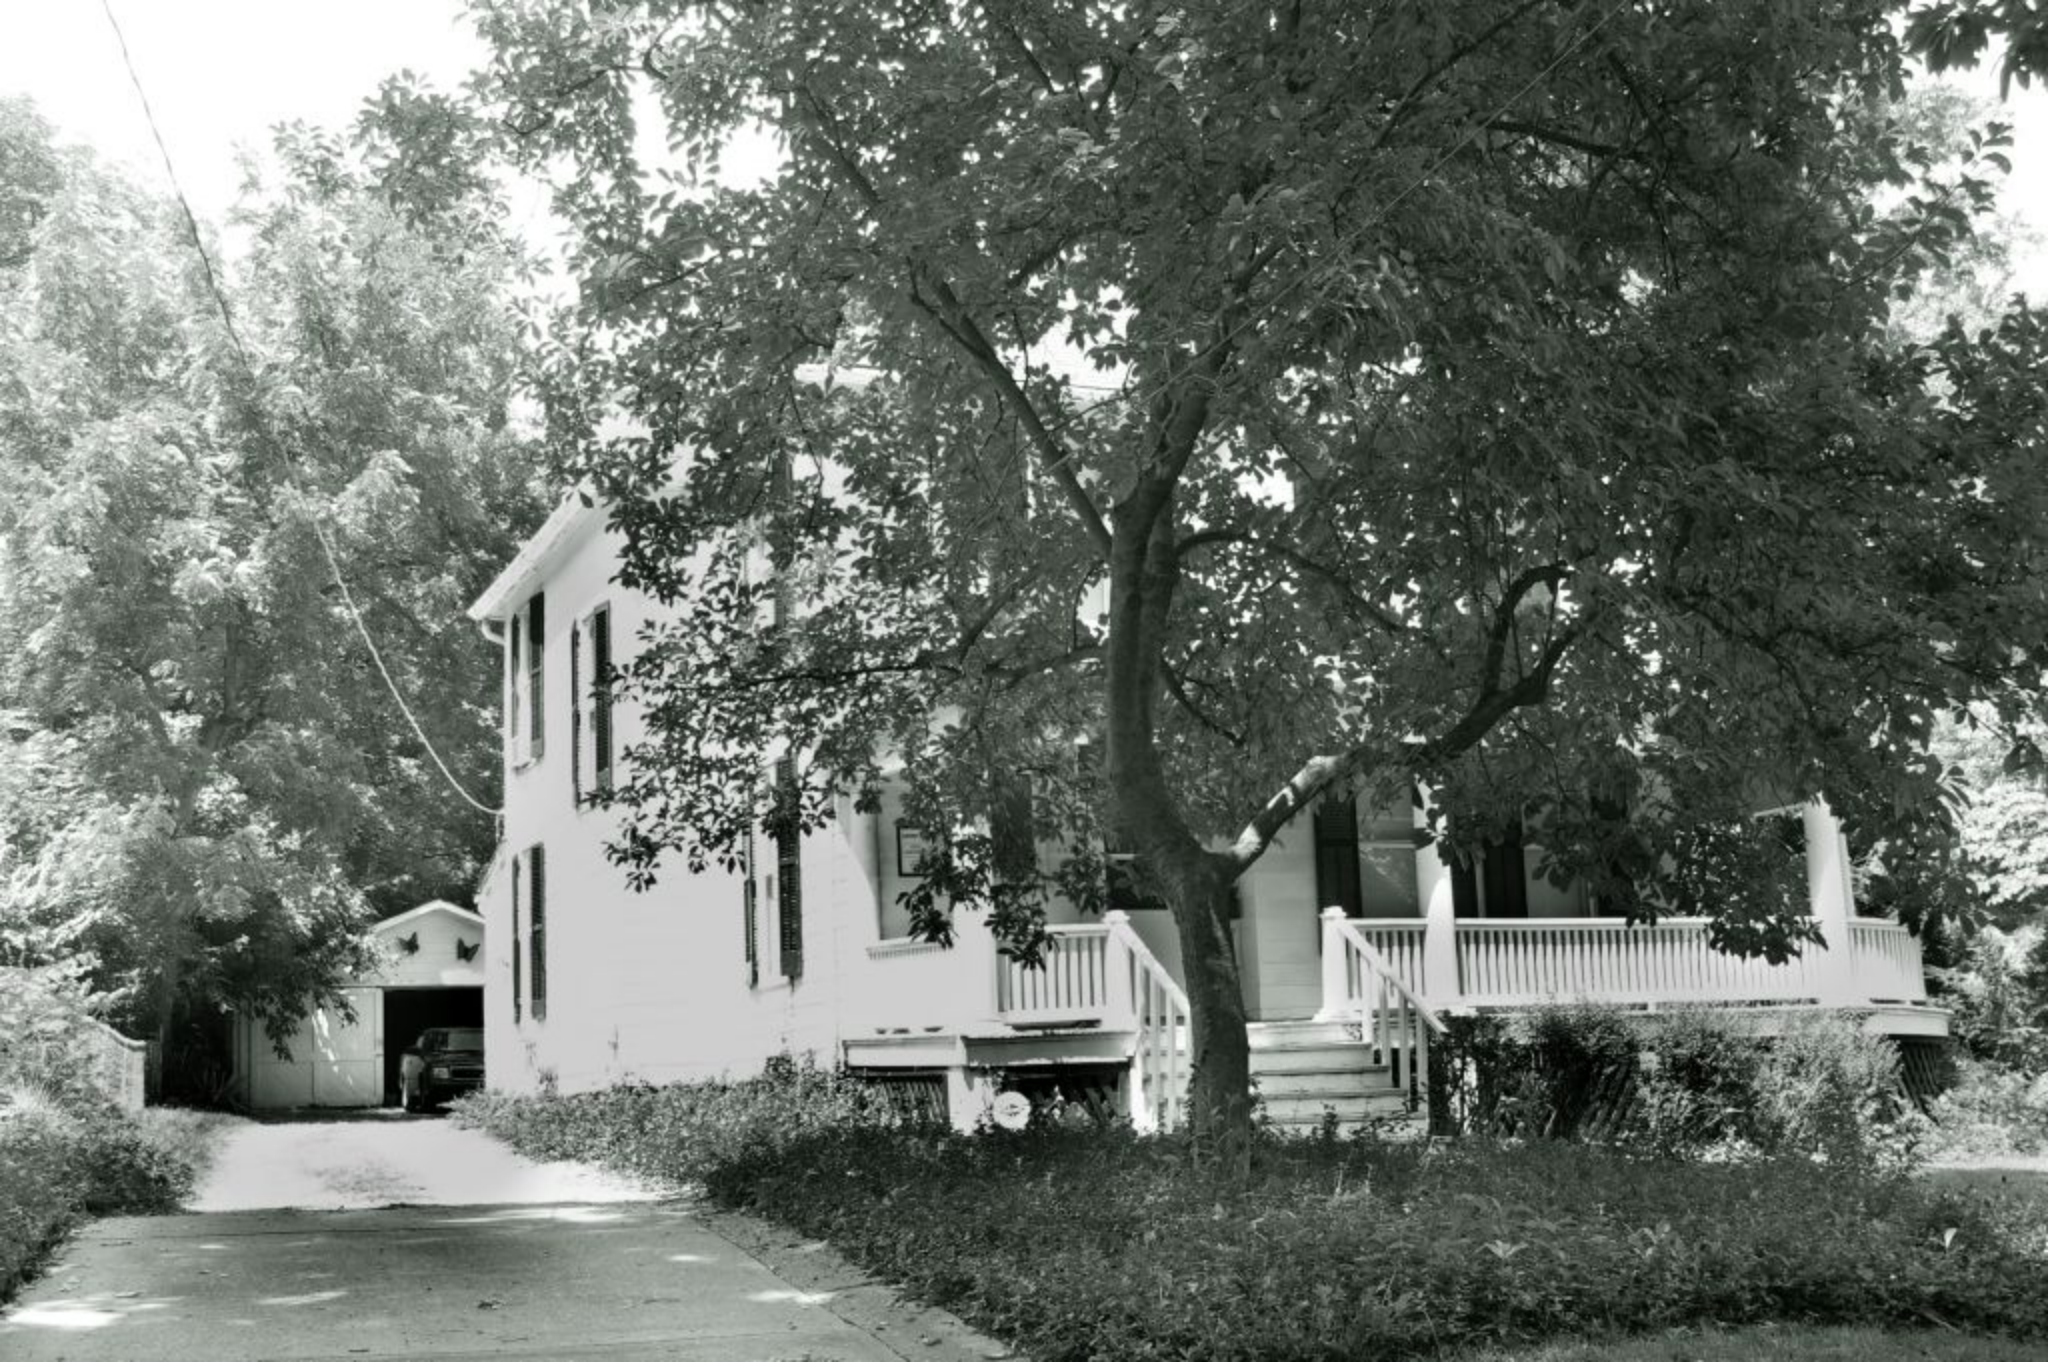
2009 Survey update: The wooden front steps have had railings added since the 1983 survey and the chimney has been shortened.

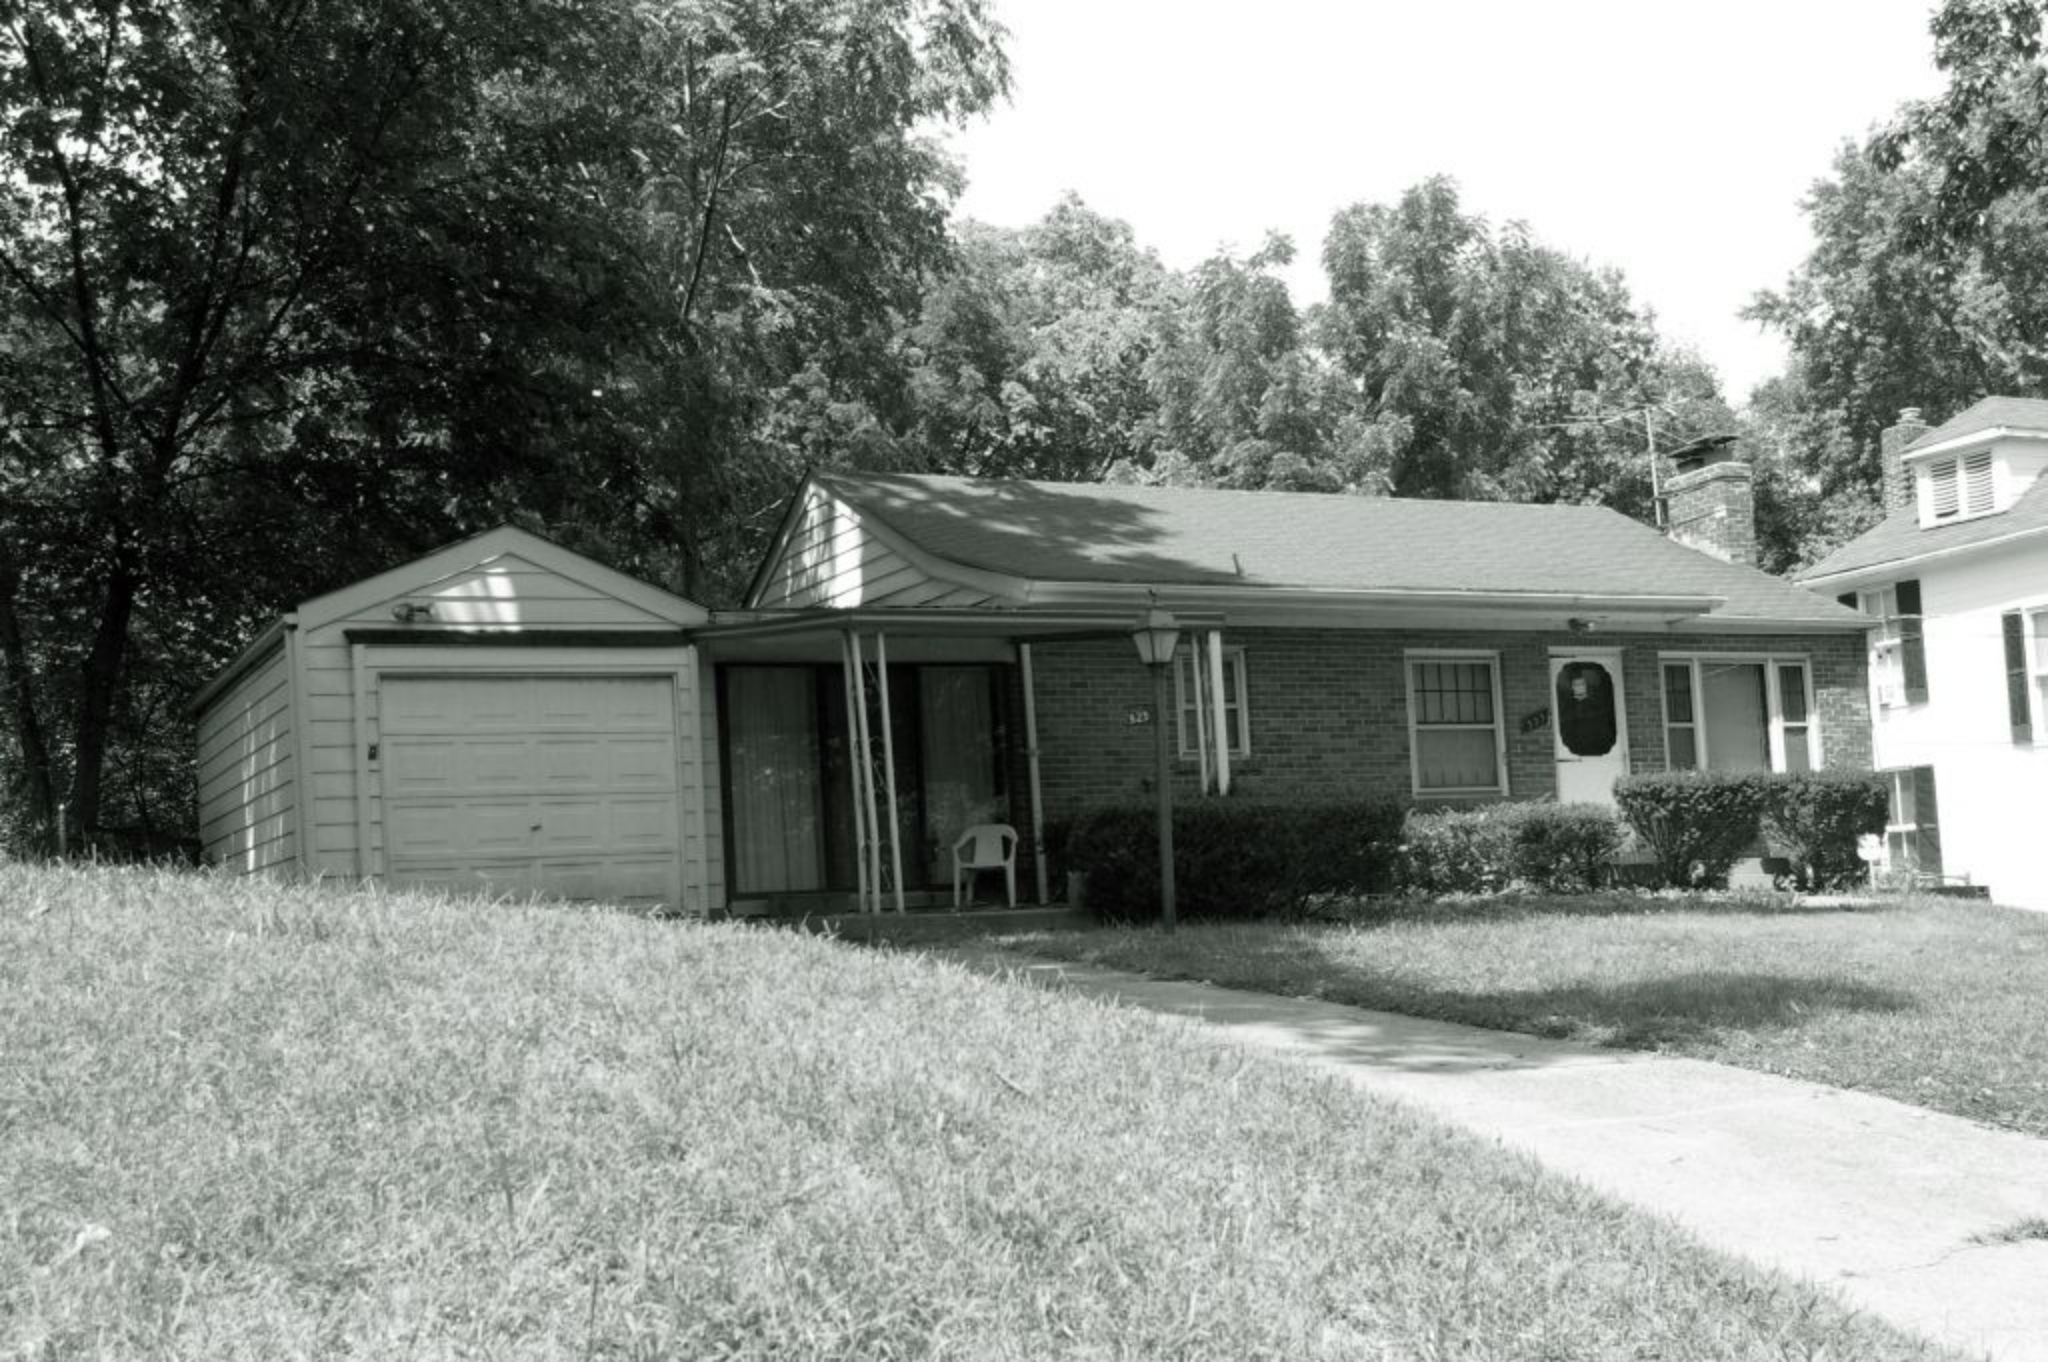
This side gabled, one story, brick house has a flat roofed, enclosed breezeway connecting the main house to the end gabled, one car garage. There is an end wall, broad, brick chimney on the east elevation. Clustered on the east half of the facade are a picture window to the east and a multipaned, 10 over 10, sashed window to the west of a simple, paneled entry door and low concrete stoop with steps leading to the west side. The roof extends slightly starting at the door and extending to the west end of the facade to cover the sidewalk and stoop. The picture window combines a plate glass window flanked by narrow, 4 over 4, sashed windows. On the west end of the main house facade is a 6 over 6 wood sashed window. The gable ends are clad in aluminum siding, which may be original to the building. The flat roofed breezeway connecting to the garage is probably original to the design, a popular feature in the early 1950s, but it has been enclosed with patio doors and has a metal patio now positioned in front that is supported by wrought iron corner posts. The end gabled garage retains what is probably the original aluminum siding but has a replacing metal overhead door.
