ARCHITECTURAL/HISTORIC INVENTORY FORM

1. Survey No. SL-AS-036-001		2. Survey Name: Architectural Survey of Old Ferguson West	
3. County: St. Louis		4. Address: 1 Carson Rd.	
5. City: Ferguson	Vicinity: <input type="checkbox"/>	6. UTM:	7. Township/Range/Section
8. Historic name (if known):		9. Present/other name (if known): Whistle Stop	
10. Ownership: <input type="checkbox"/> Private <input checked="" type="checkbox"/> Public		11. Historic use (if known): TRANSPORTATION/rail-related	11. Current use: COMMERCE/restaurant & RECREATION/museum

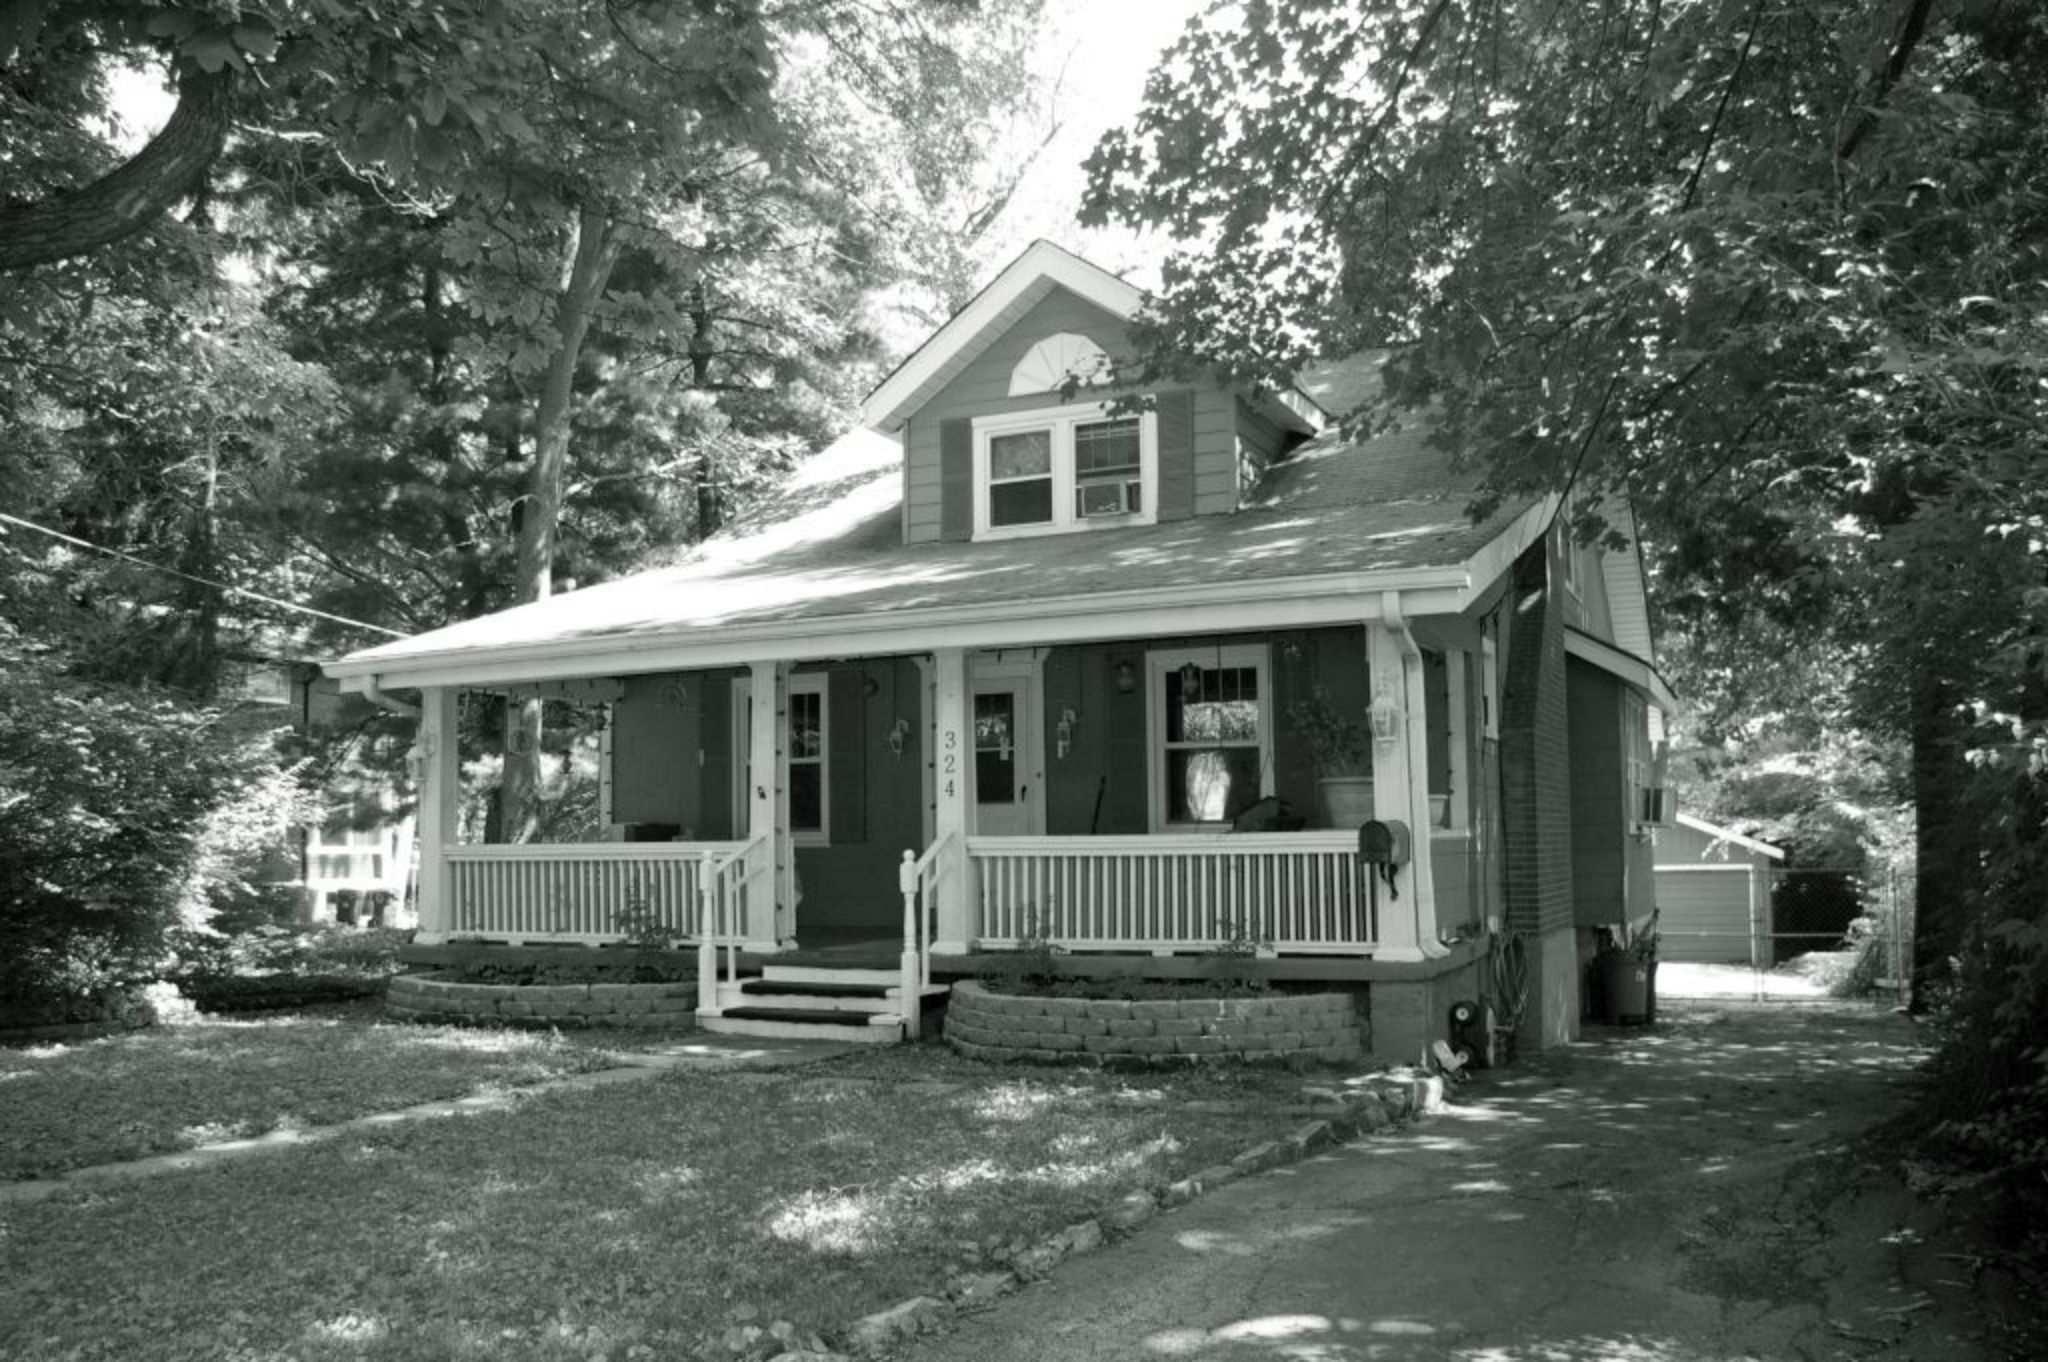
2009 Survey Update: Since the 1983 survey, the enclosure on the front porch has been removed and a simple wood railing installed on the facade of the porch, utilizing the original square wooden porch columns. The railings on either side of the front steps have turned balusters, the shutters, and the applied fanlight over the dormer windows are recent additions, not in keeping with the Craftsman detailing of this bungalow.

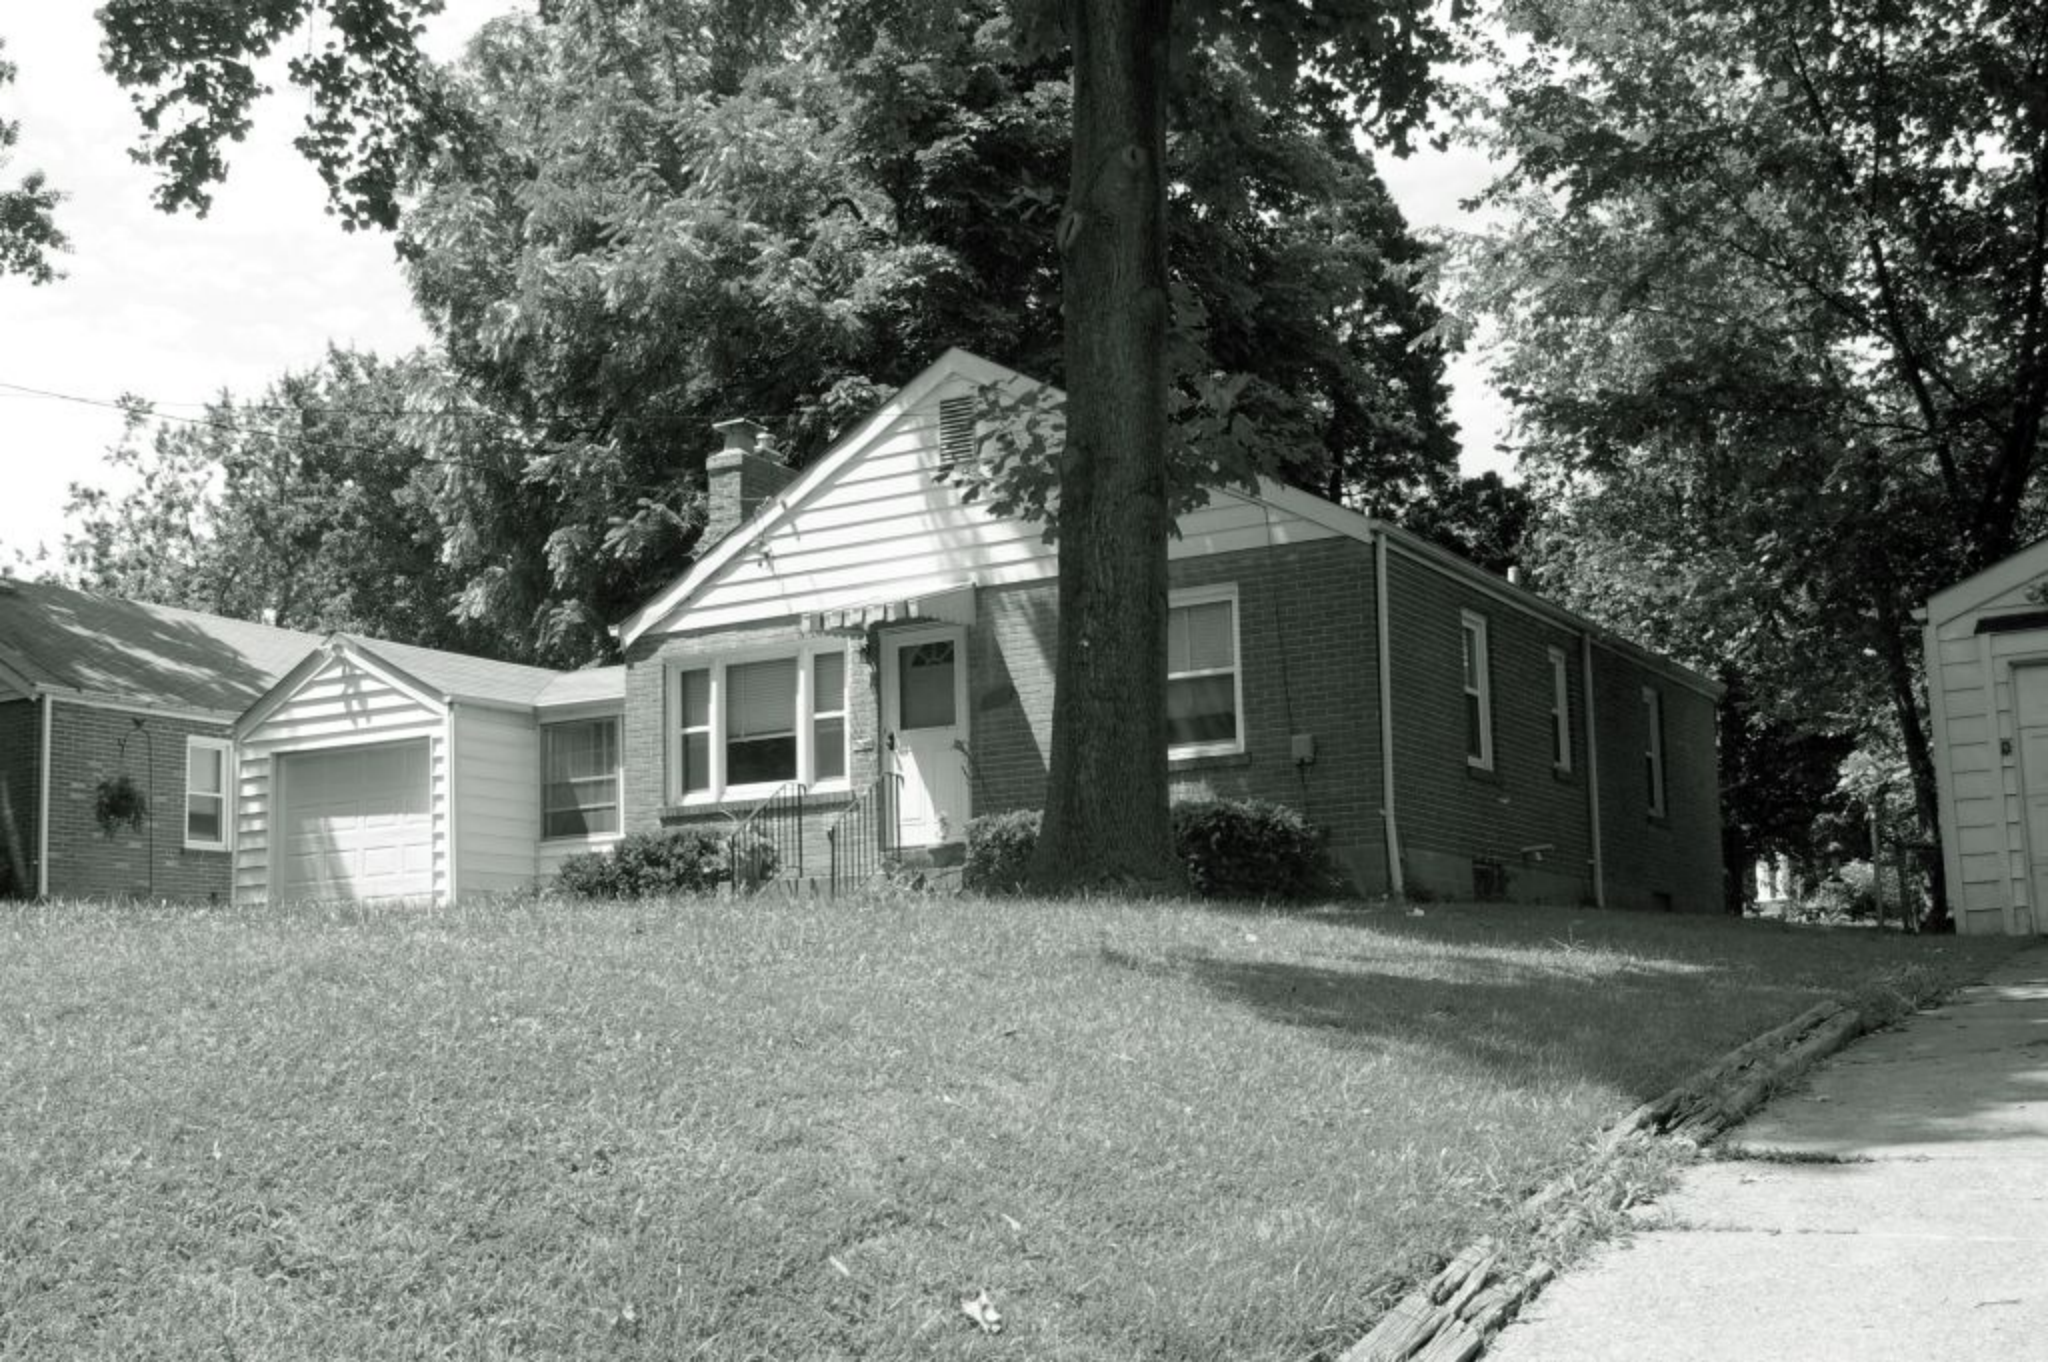
This simple, end gabled, one story brick house has aluminum siding in the gable ends (which is probably original) and on the one car, end gabled garage which is connected to the main house by a side gabled, slightly recessed breezeway. The entry is centered in the main facade with a fanlight, paneled door that has an aluminum storm door and metal awning added over the simple concrete entry stoop, which retains its metal railings on the stairs. The windows are 1 over 1 sashed windows, mostly the original wood windows but some appear to be replacement vinyl windows. There is a large sashed window to the east of the entry and a picture window to the west comprised of a plate glass window flanked by narrow sashed windows. There is an end wall brick chimney between the house and breezeway. The aluminum sided breezeway has banks of casement windows that are now covered with aluminum storm screens. The garage has a replacement overhead door facing the street. The composition created by the garage, breezeway and main house and their roofline variations creates a simple Minimal Traditional design.

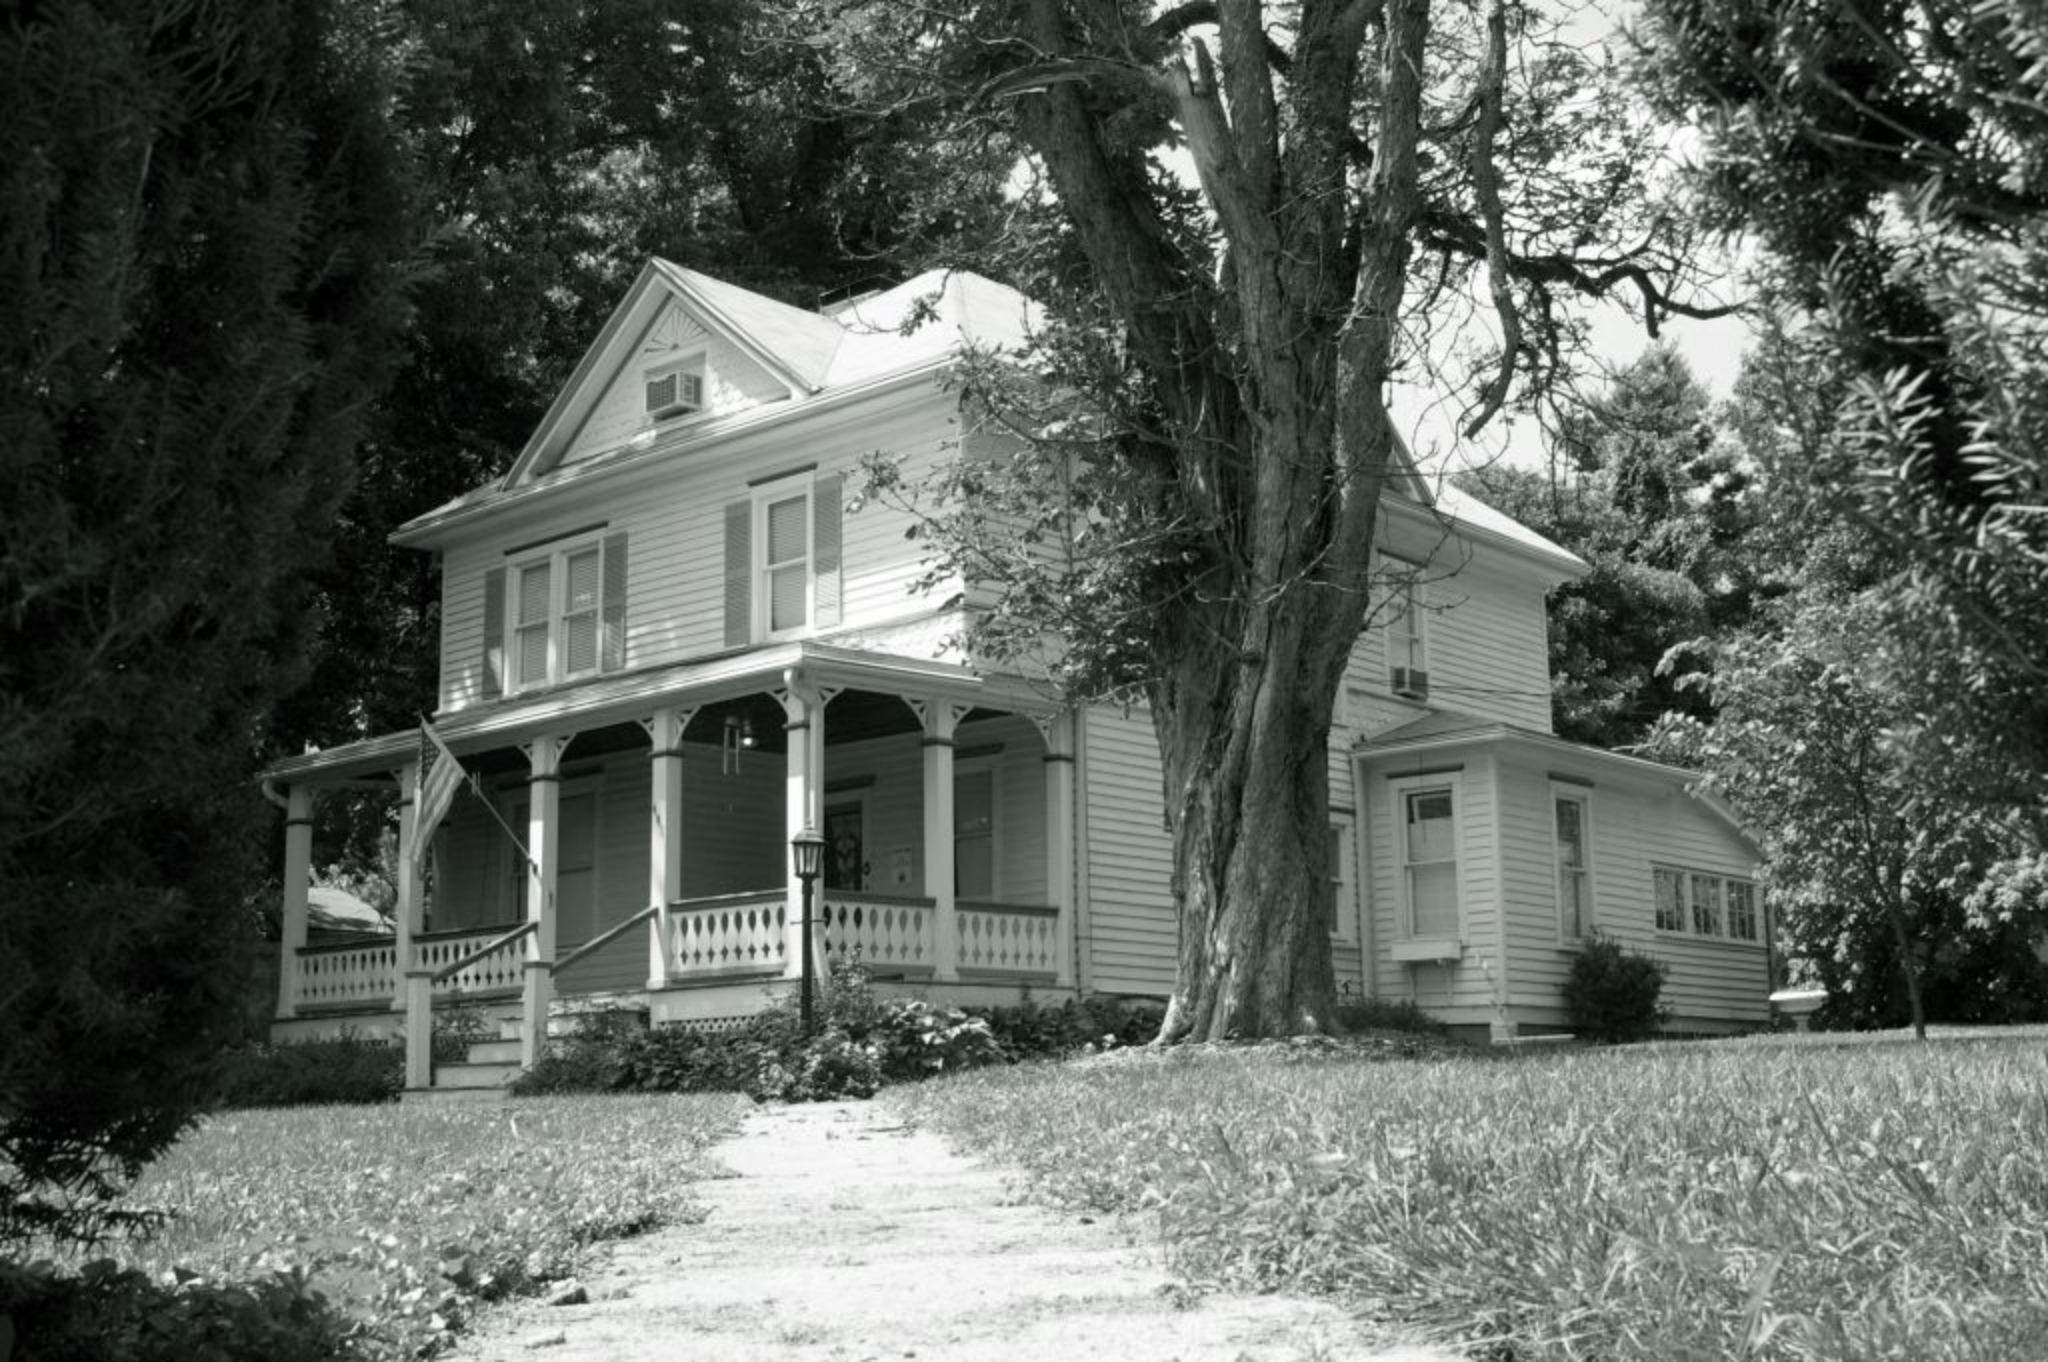
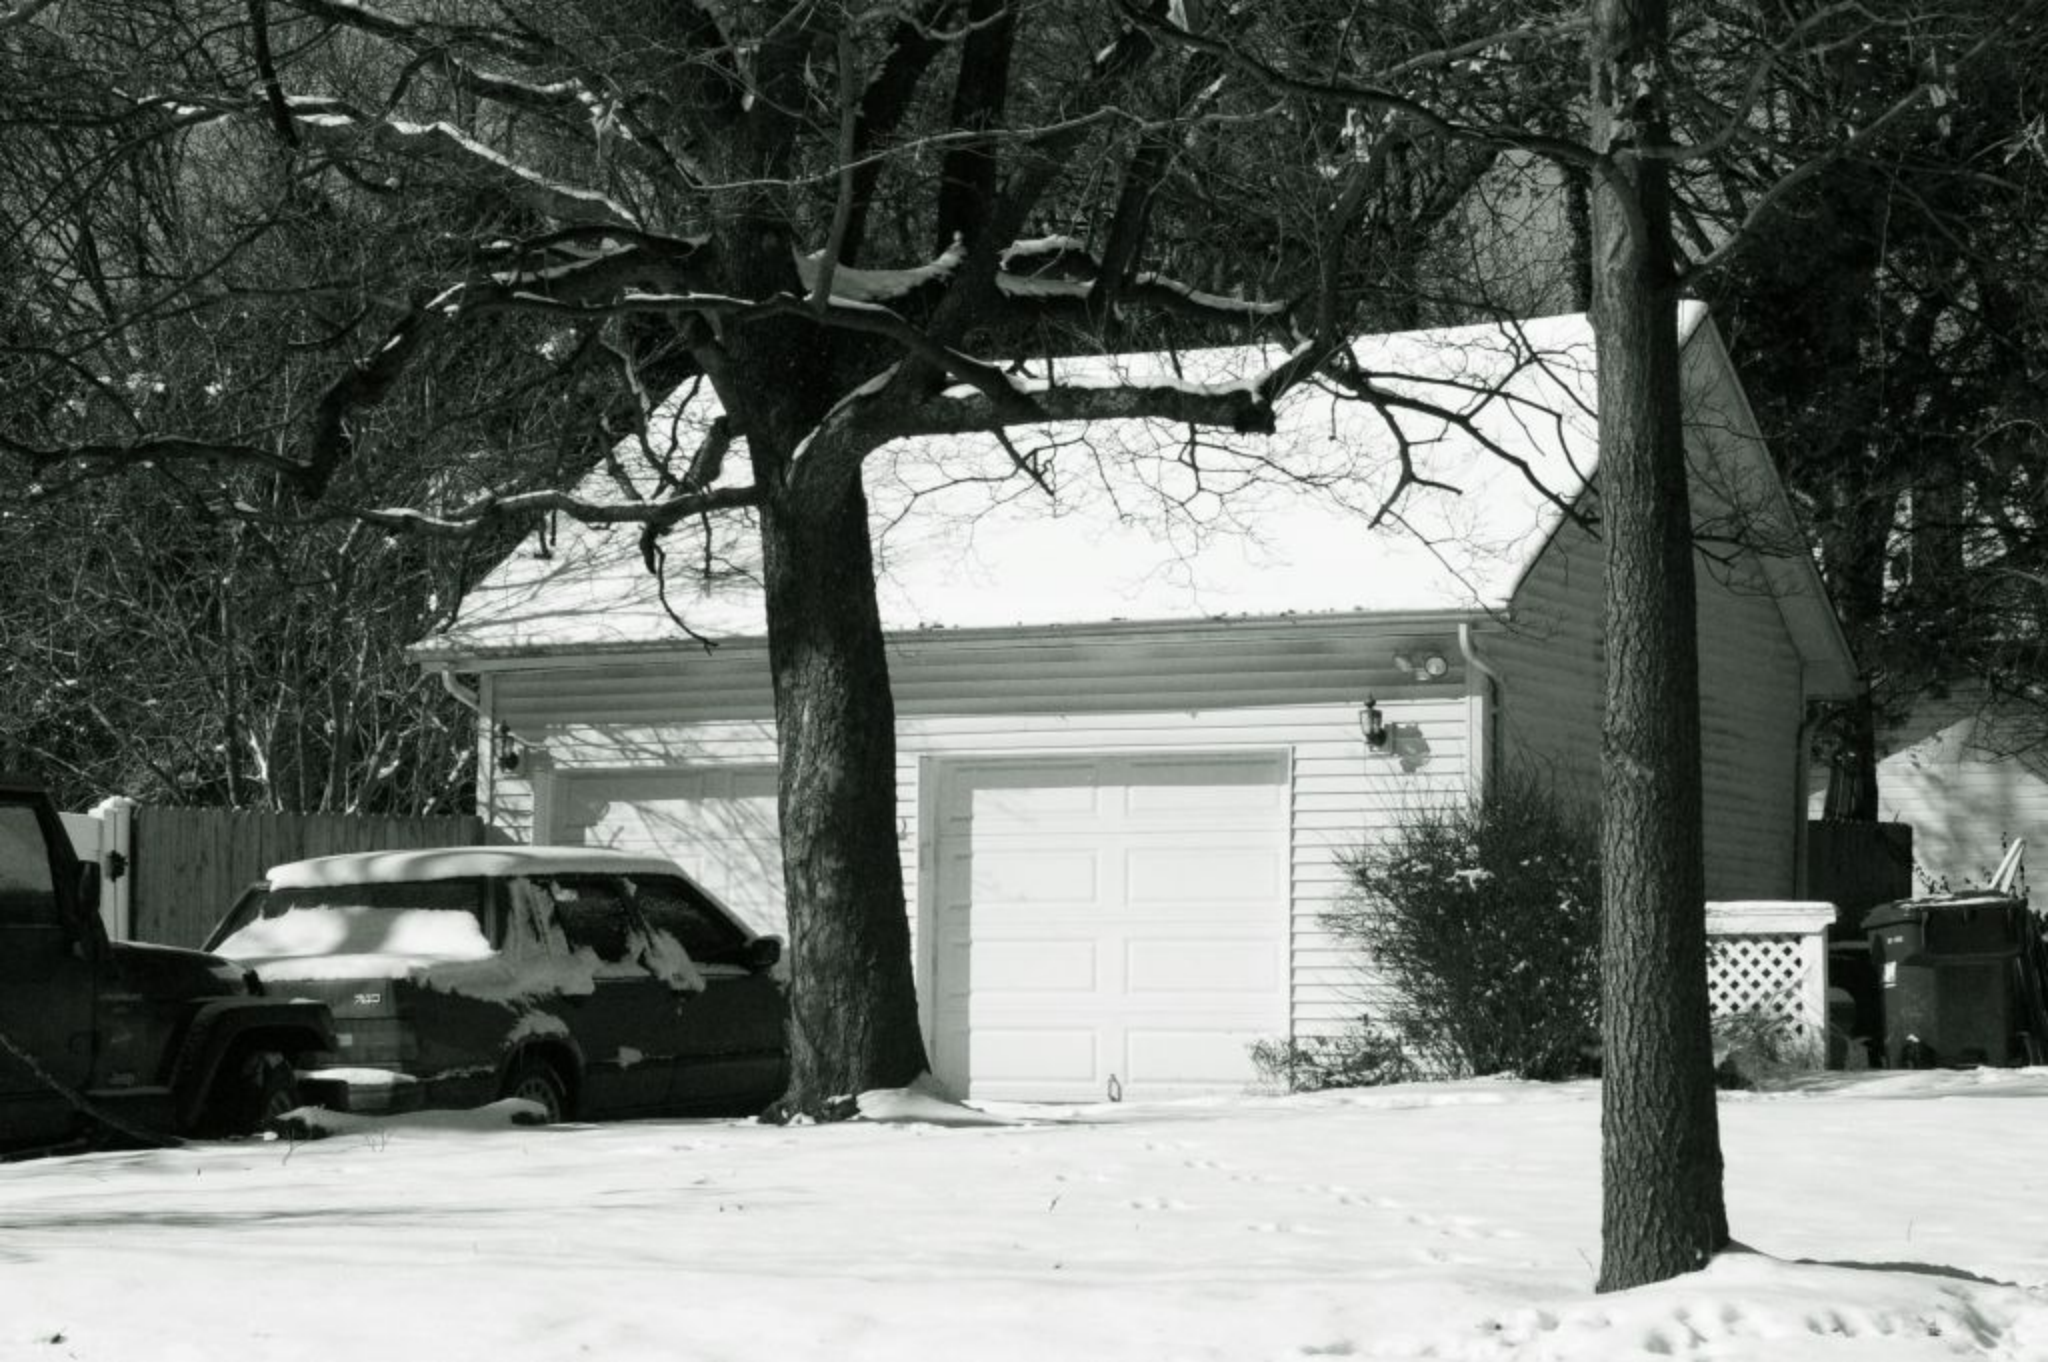
2009 Survey Update: Since the 1983 survey, the screened-in porch has been returned to its open porch configuration and the railing reinstalled utilizing a pierced design. The original porch posts have been retained but it is unclear whether the spindlework at the top of the posts is original or not, although it is in keeping with the Queen Anne design. The addition on the east side, near the rear pre-dates the 1931 fire insurance map.

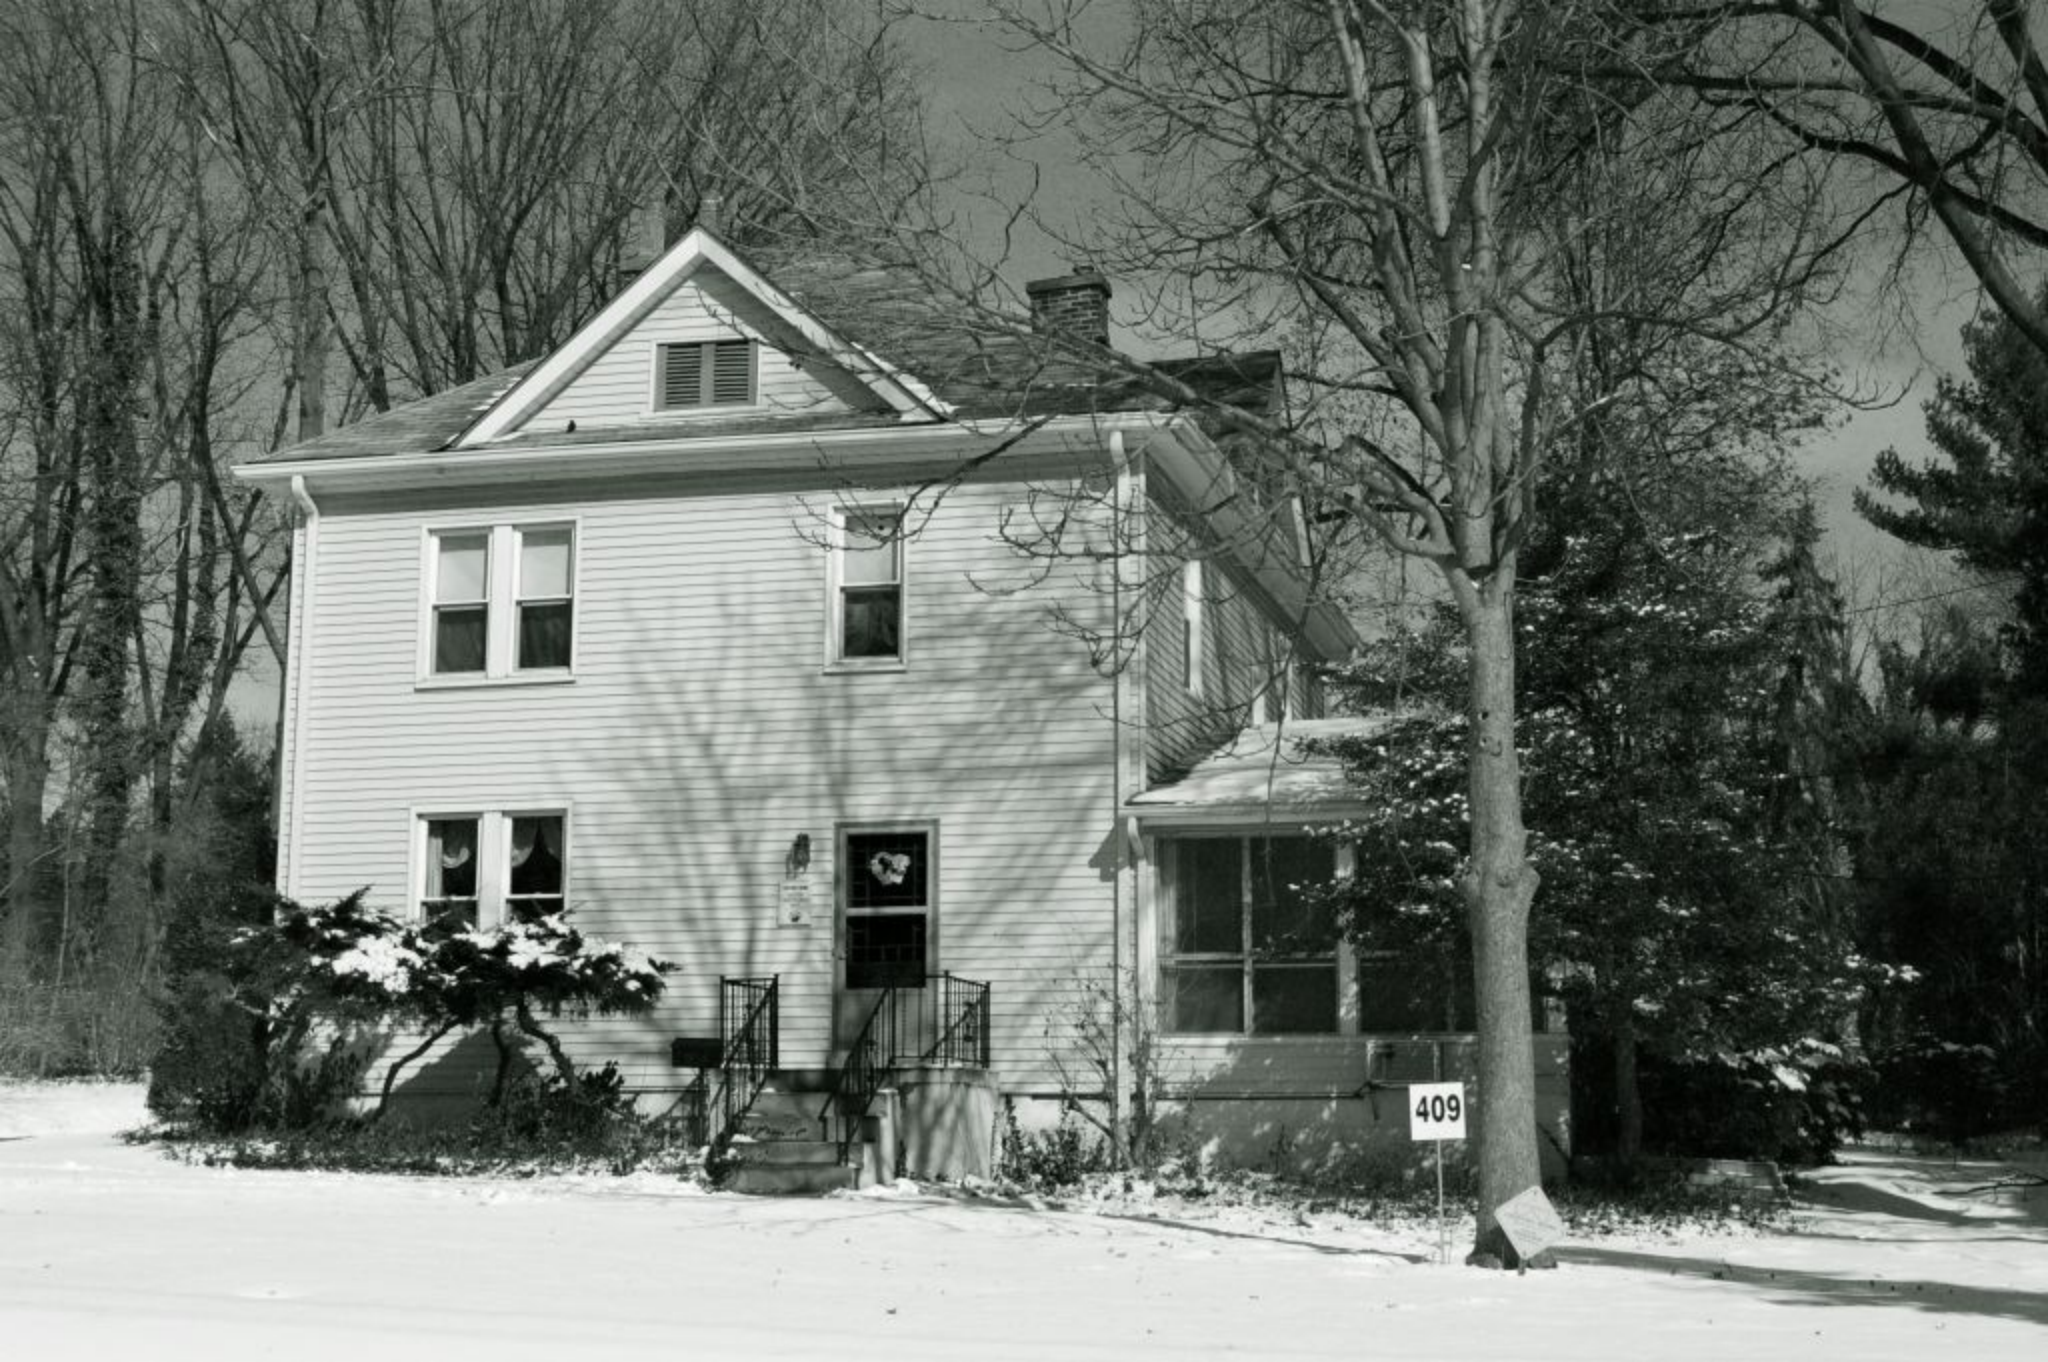
2009 Survey Update: Since the 1983 survey, the aluminum siding has been replaced with vinyl siding. The full width porch was removed after 1951 based upon the fire insurance map, which also seems to indicate that the wing on the east side was added after that date also, although there is a smaller one story wing near the rear showing on the map, which may still be intact behind the newer wing.

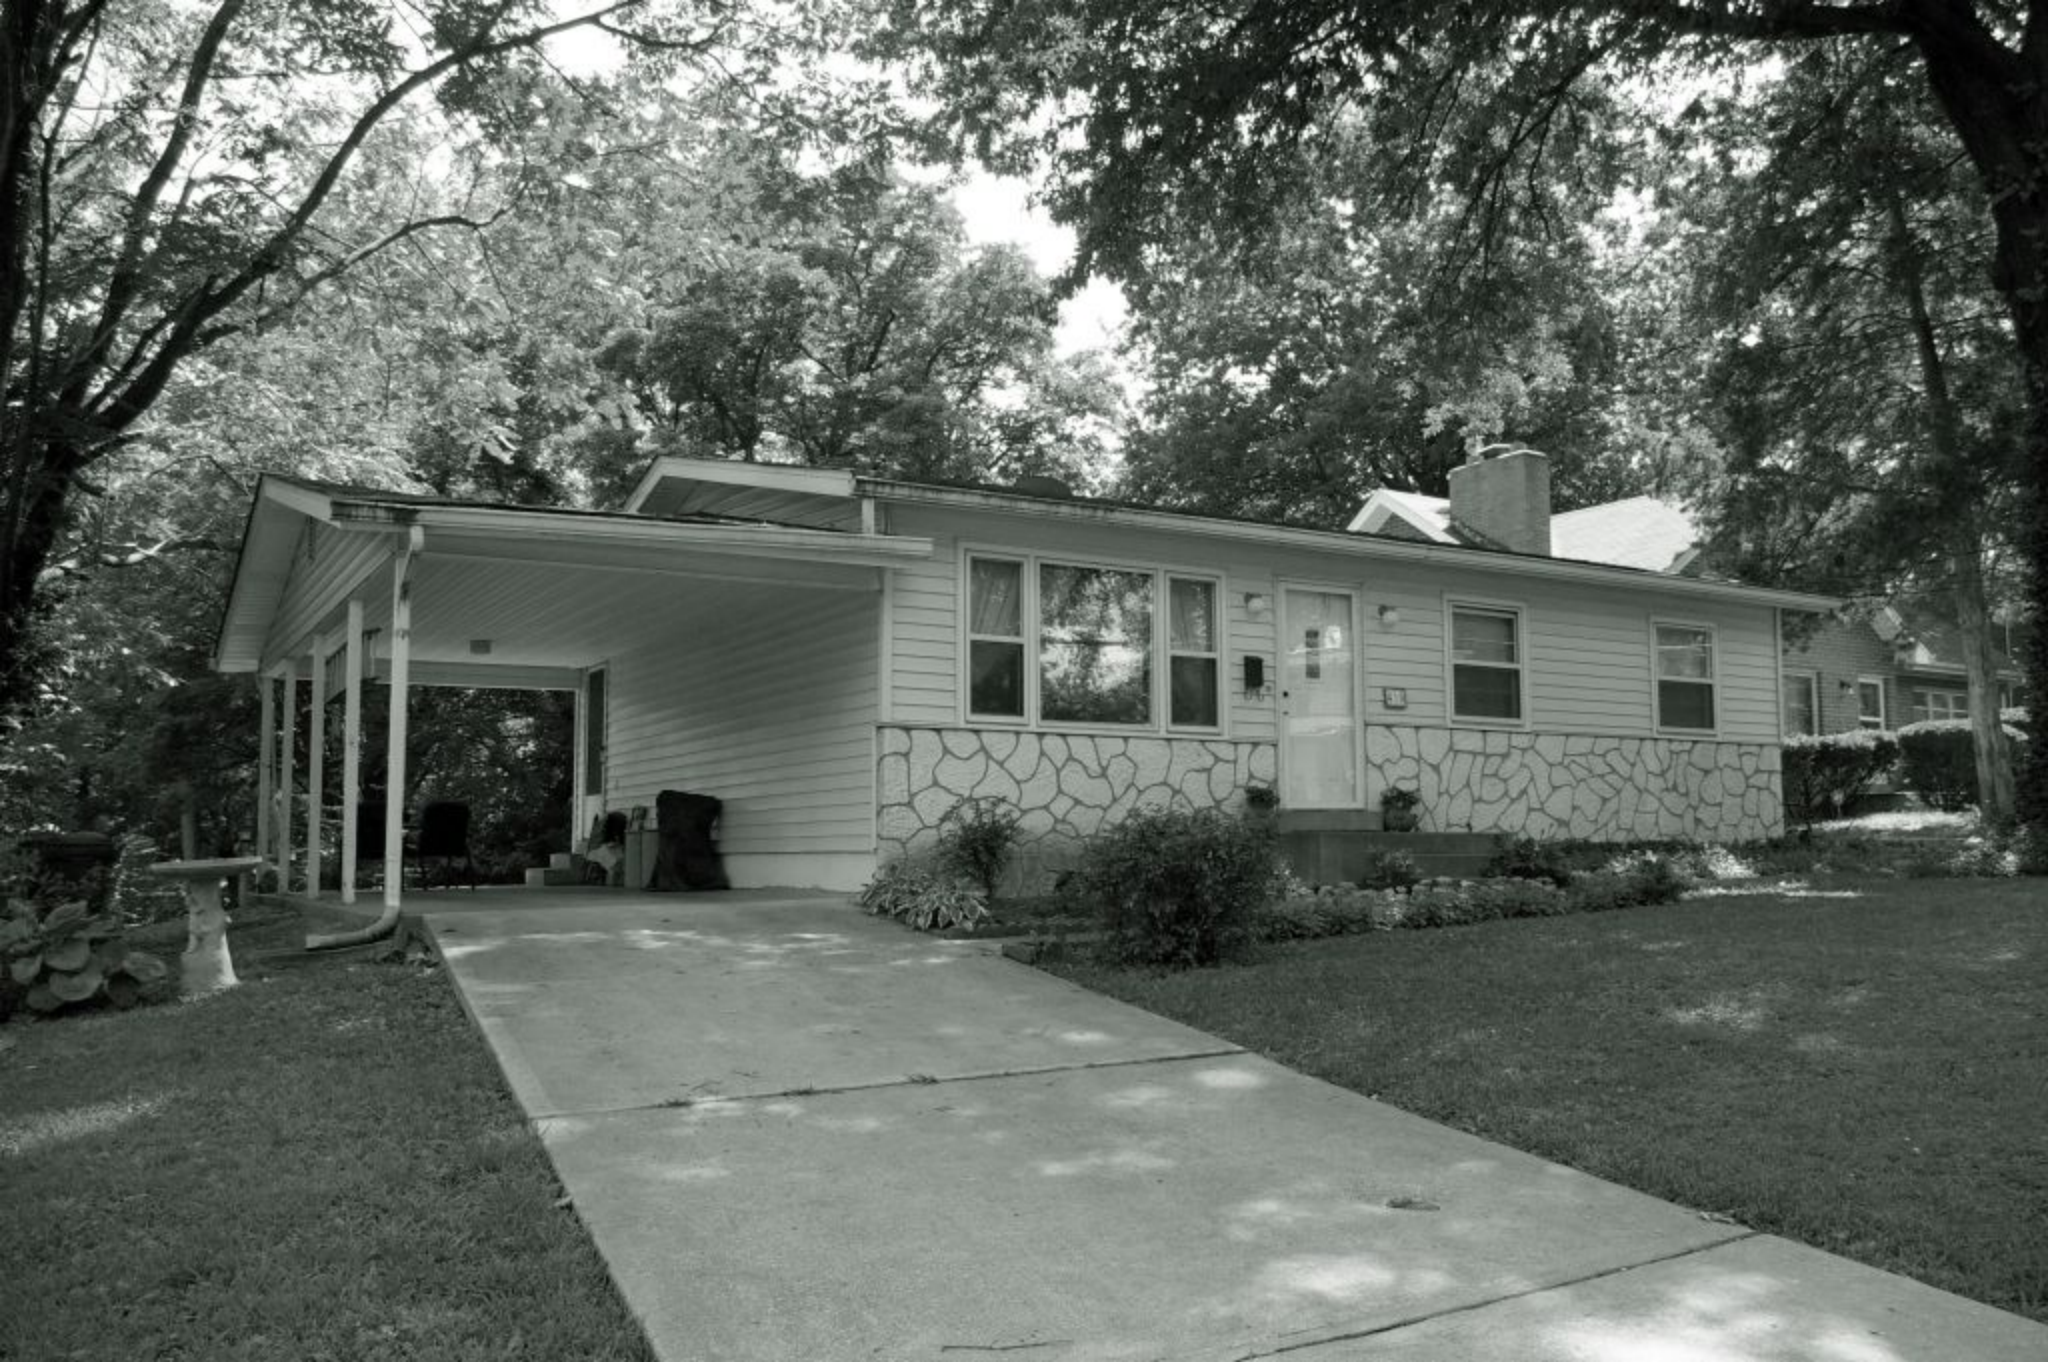
This one story, side gabled, modest Ranch house has been modified with vinyl siding above the window sills and faux stone veneer on the walls below. It appears to retain its original windows covered with storm windows 1 over 1 windows flanking the picture window in the west bay, directly west of the simple entry with its metal replacement door. There are two single window units in the east two bays, which are 2 over 2, horizontally lighted sashed windows. On the west side of the house there is a side gabled carport supported by simple posts along the west end.

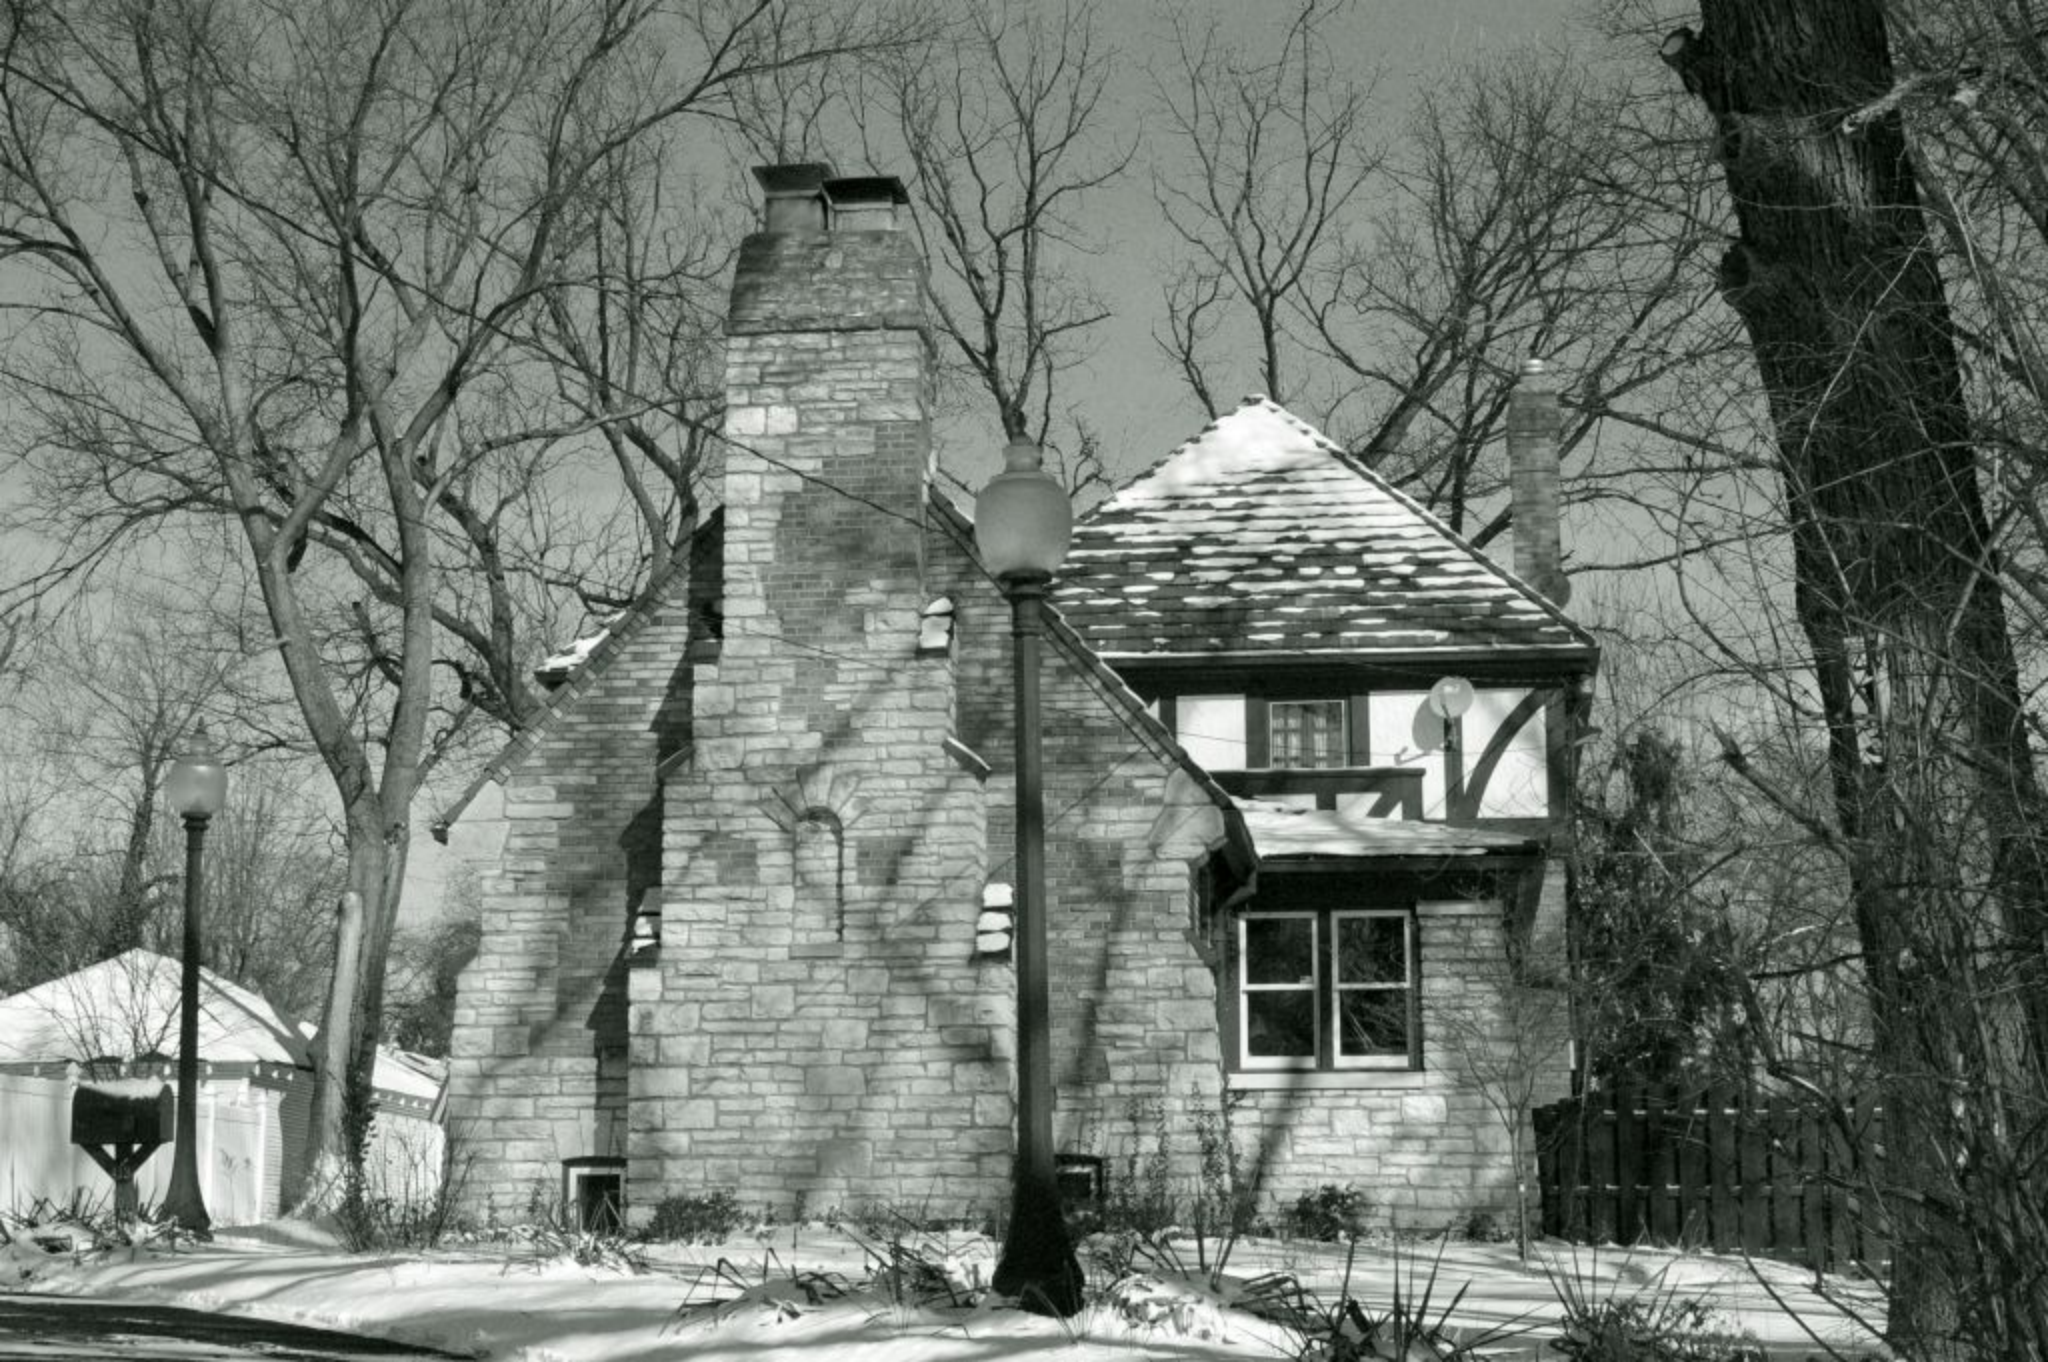
2009 Survey Update: Since the 1983 survey it appears that some windows have either been replaced with vinyl windows or that substantial vinyl storm screens have been added. According to the fire insurance map of 1931, there is a basement level garage in this house.
