ARCHITECTURAL/HISTORIC INVENTORY FORM

1. Survey No. SL-AS-036-001		2. Survey Name: Architectural Survey of Old Ferguson West	
3. County: St. Louis		4. Address: 1 Carson Rd.	
5. City: Ferguson	Vicinity: <input type="checkbox"/>	6. UTM:	7. Township/Range/Section
8. Historic name (if known):		9. Present/other name (if known): Whistle Stop	
10. Ownership: <input type="checkbox"/> Private <input checked="" type="checkbox"/> Public		11. Historic use (if known): TRANSPORTATION/rail-related	11. Current use: COMMERCE/restaurant & RECREATION/museum

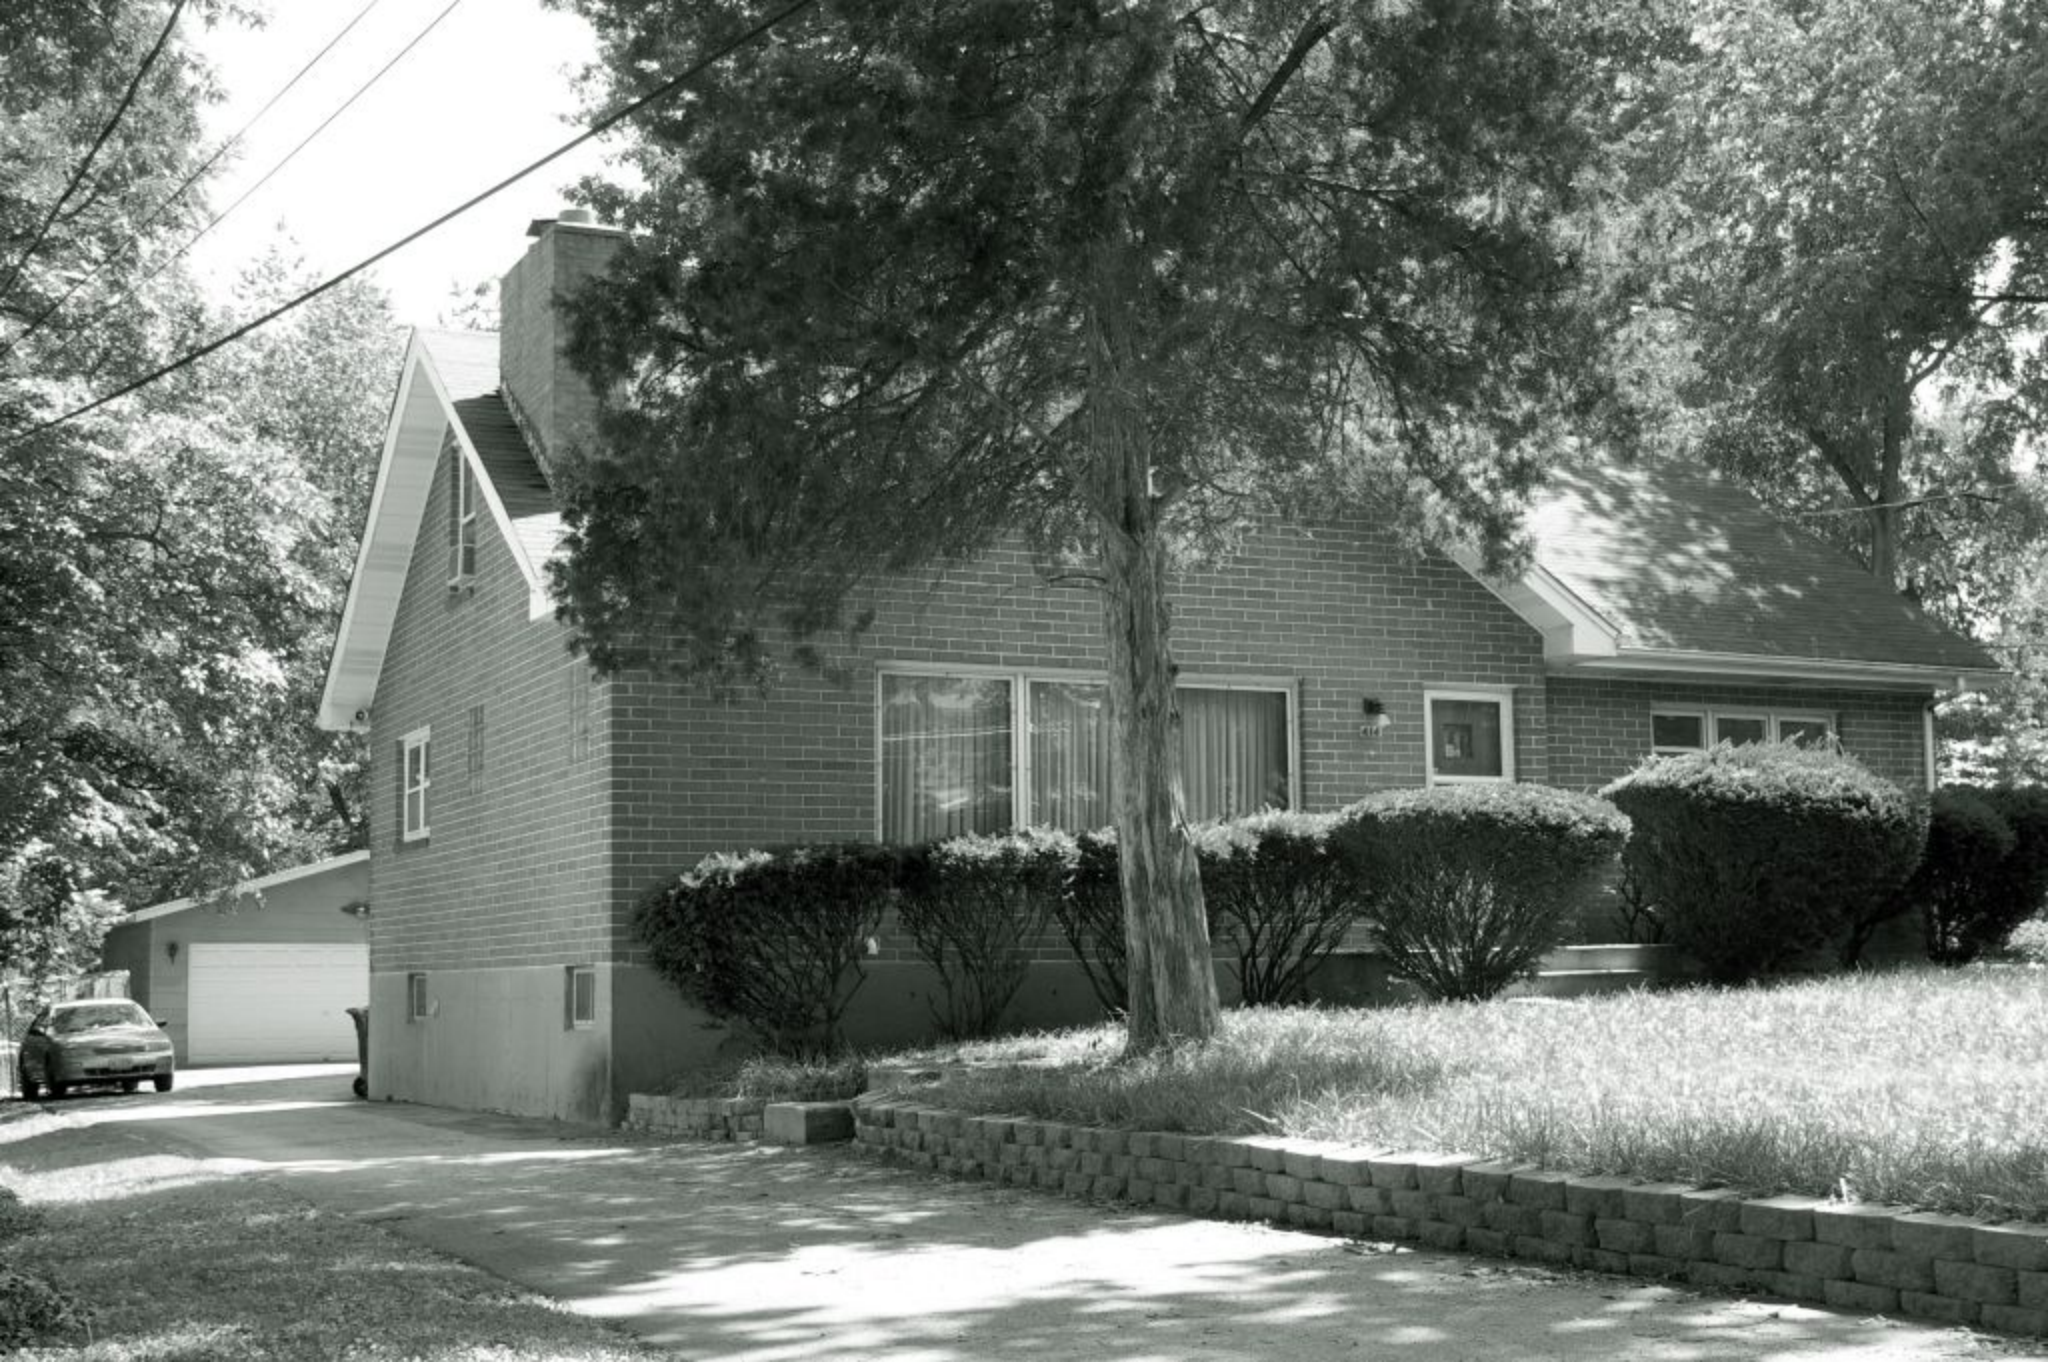
This 1.5 story, red brick, Minimal Traditional house with a simple design and limited detailing. The design is lower, with broader eave overhangs, with the prominent side gable intersected by the broad cross gable on the east half of the facade. The simple entry has a simple small light in the wood door which is located toward the center of the facade with a large picture window centered in the cross gabled bay below a single 1 over 1 sashed window. To the west of the cross gabled bay, here is a triple, 1 over 1 sashed window. There is a simple, shallow concrete entry stoop leading toward the street. On the east elevation is a broad, brick, end wall chimney. The large picture window has replacement aluminum sashes, probably changing the light pattern as well.

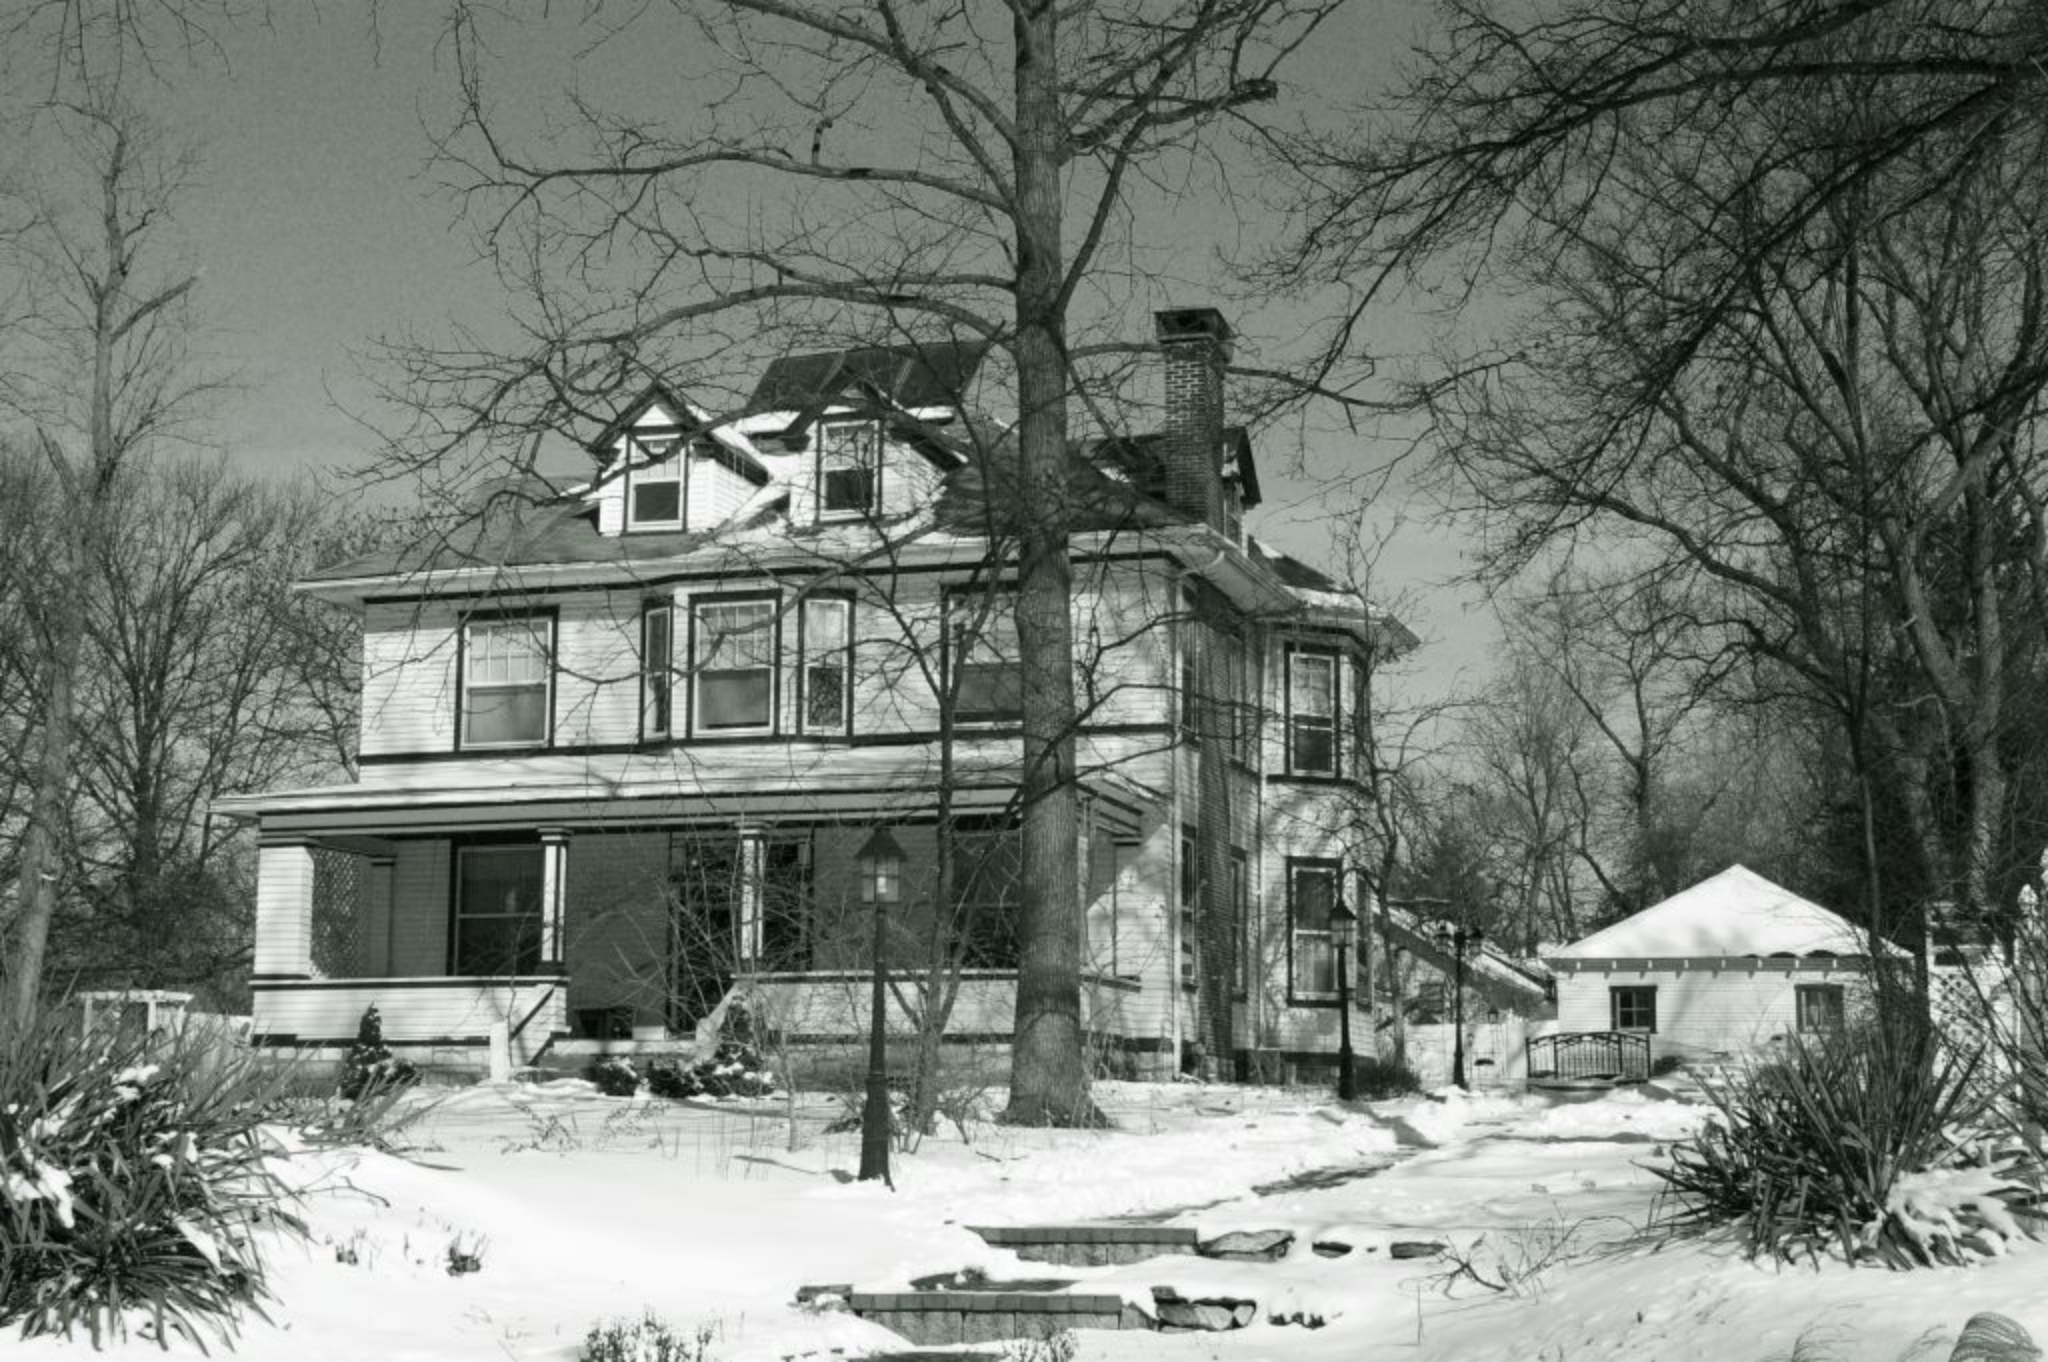
2009 Survey Update: Since the 1983, solar panels have been mounted on the roof above the paired dormers facing the facade. Storm screens have also been added.

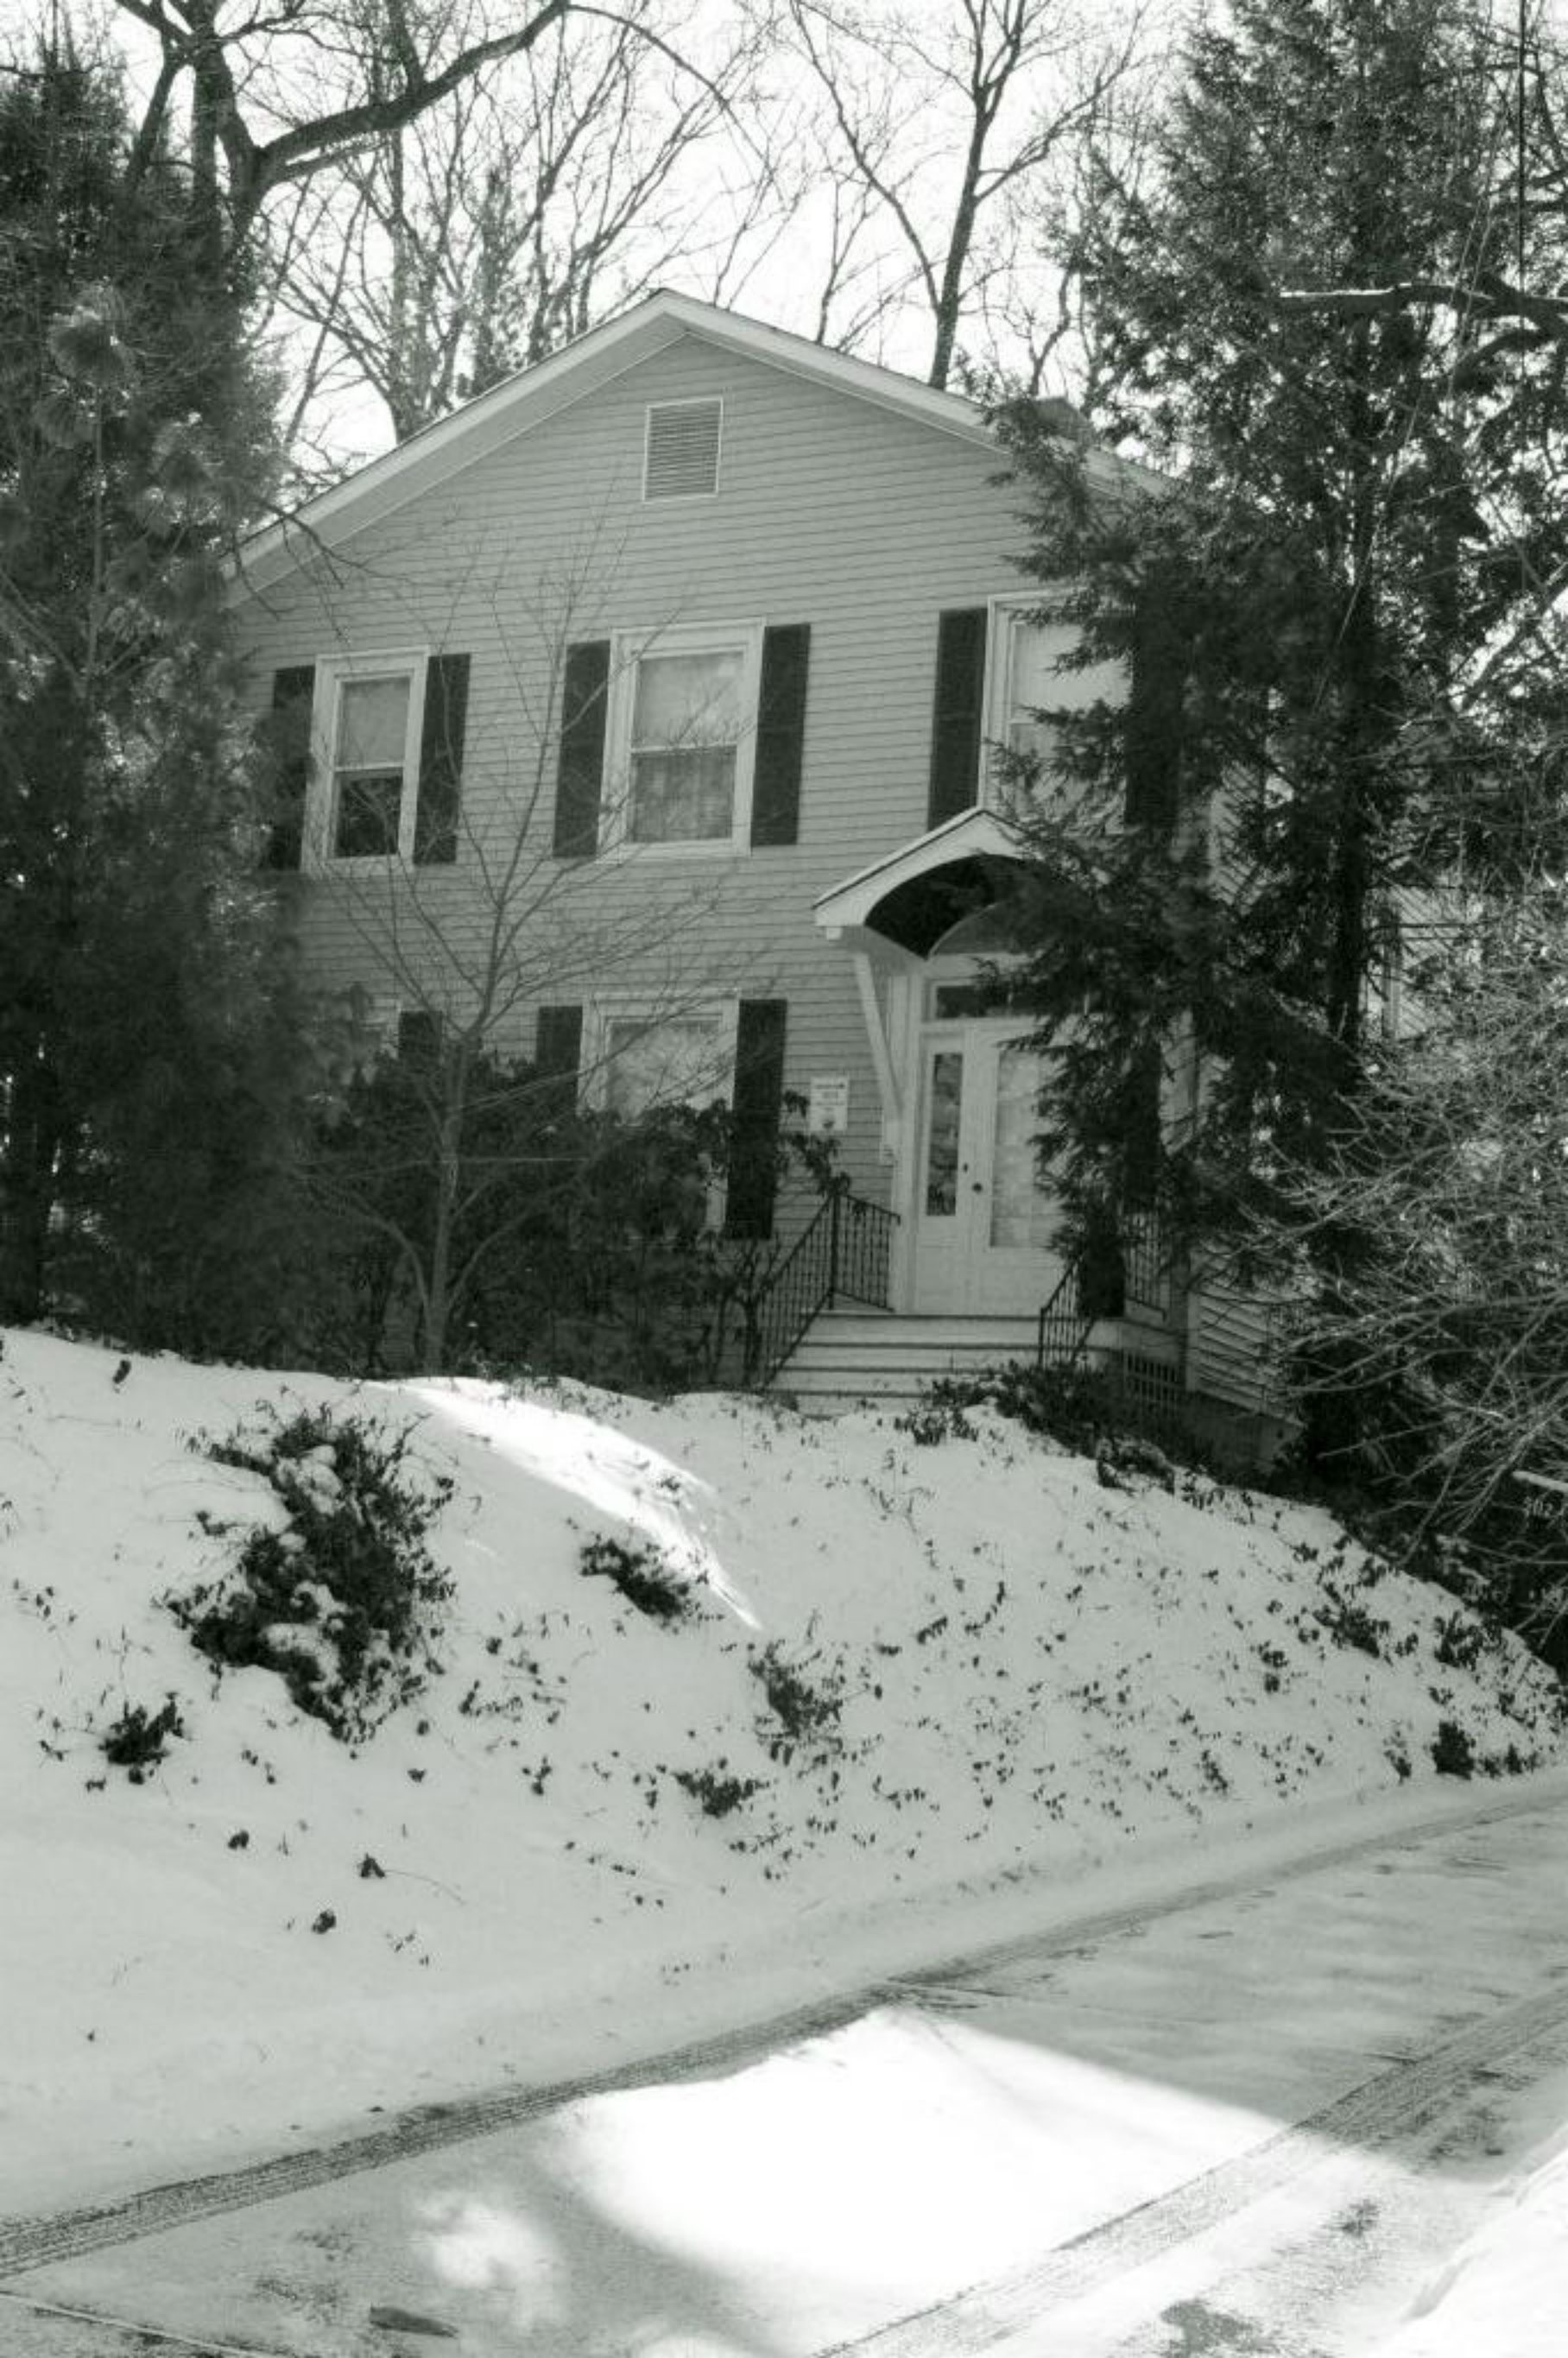
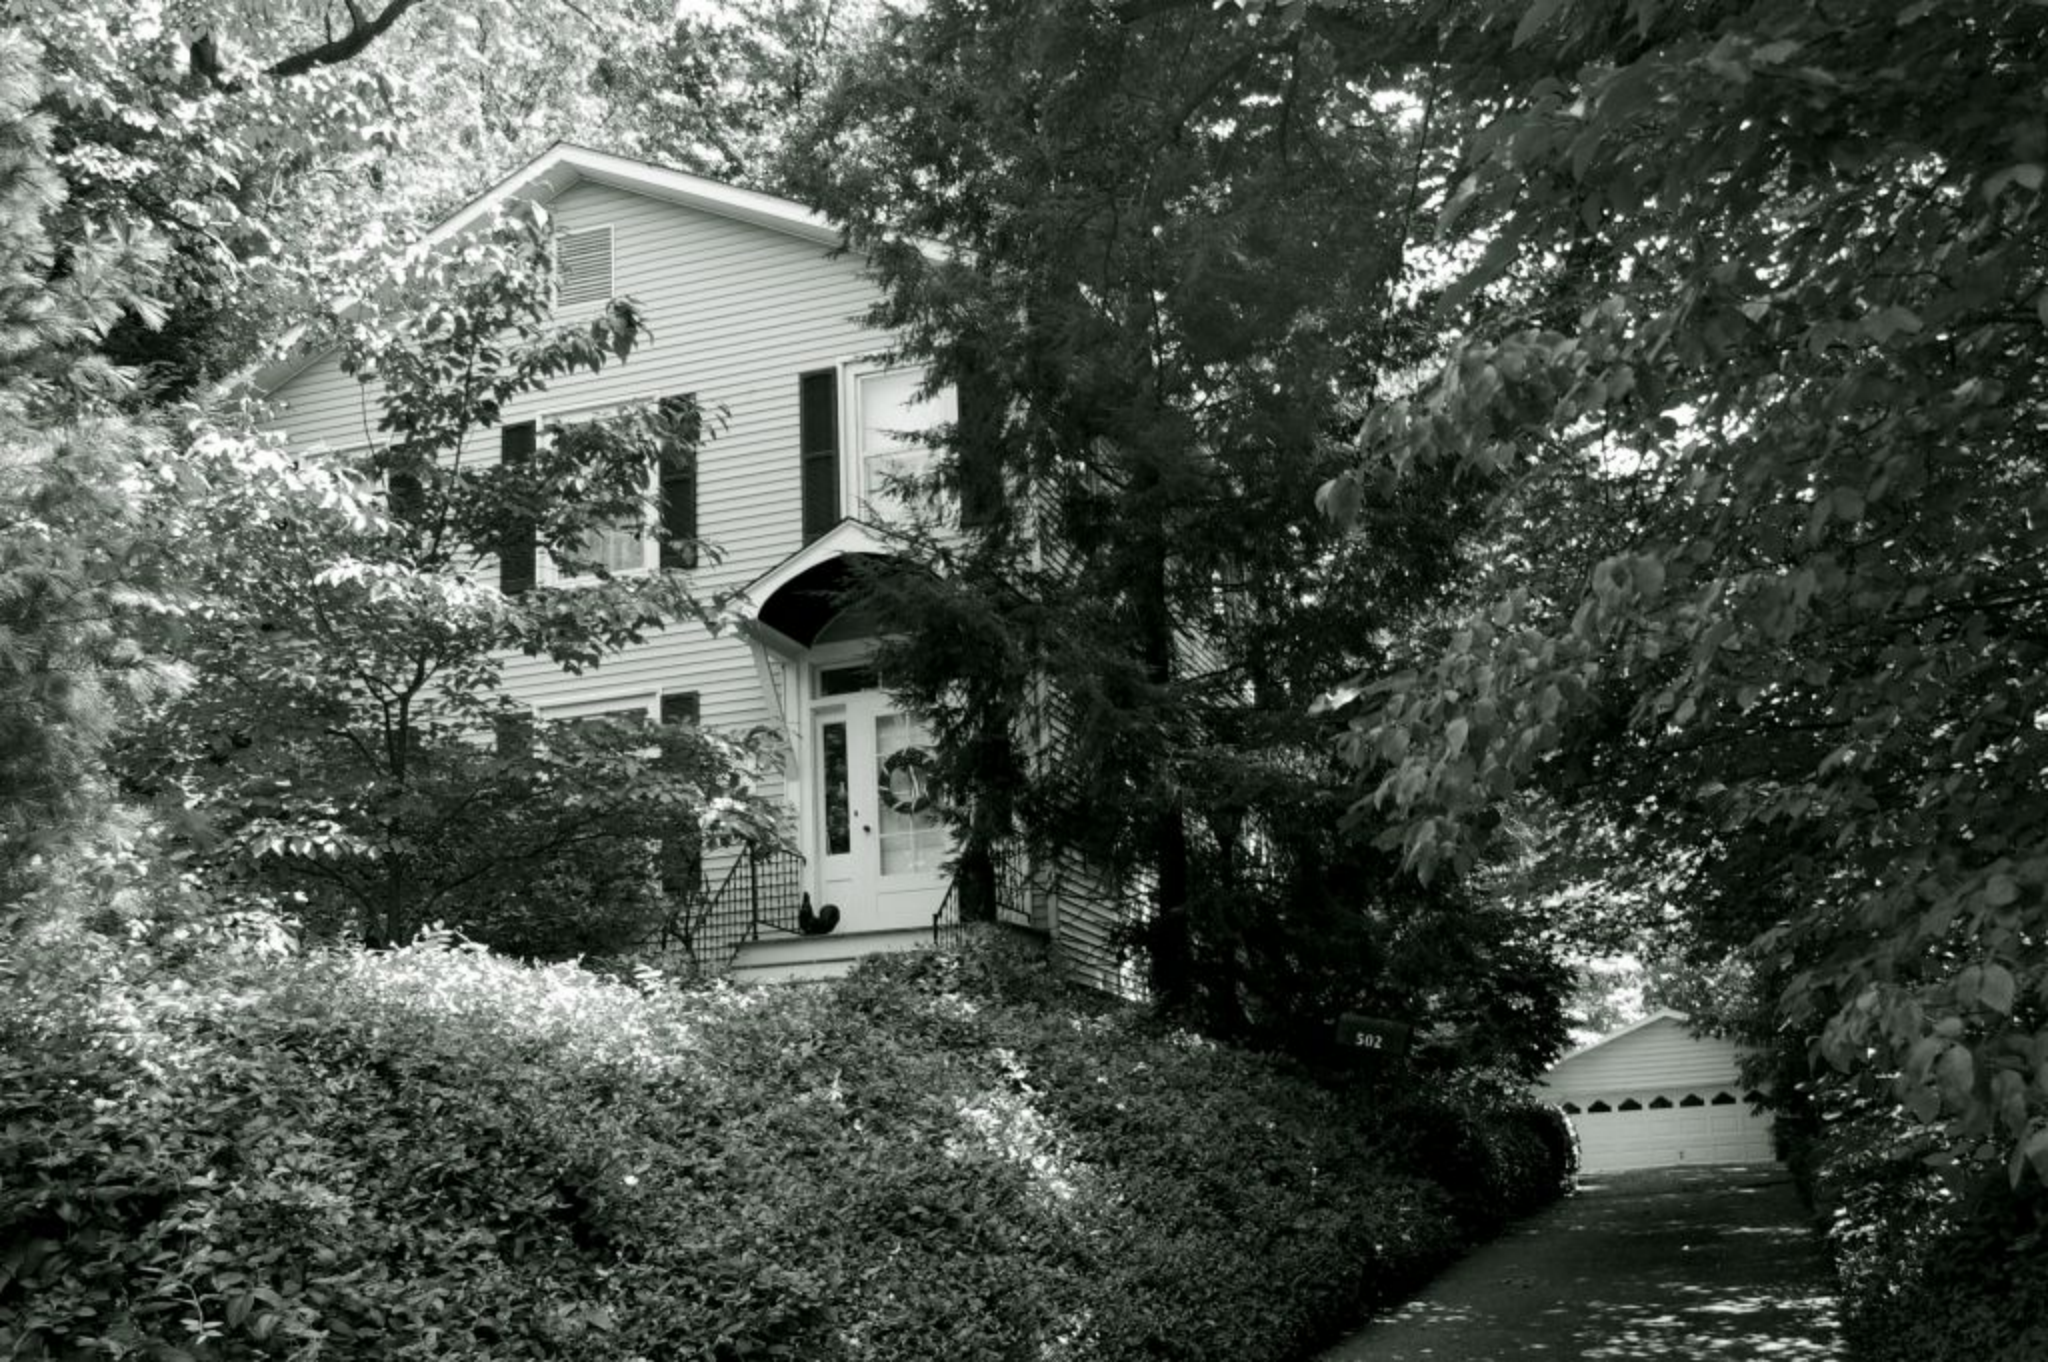
2009 Survey Update: Since the 1983 survey, the house has been resided with vinyl siding and has newer storm windows but retains the original wood sashed windows and the siding did not cover the casing around the windows.

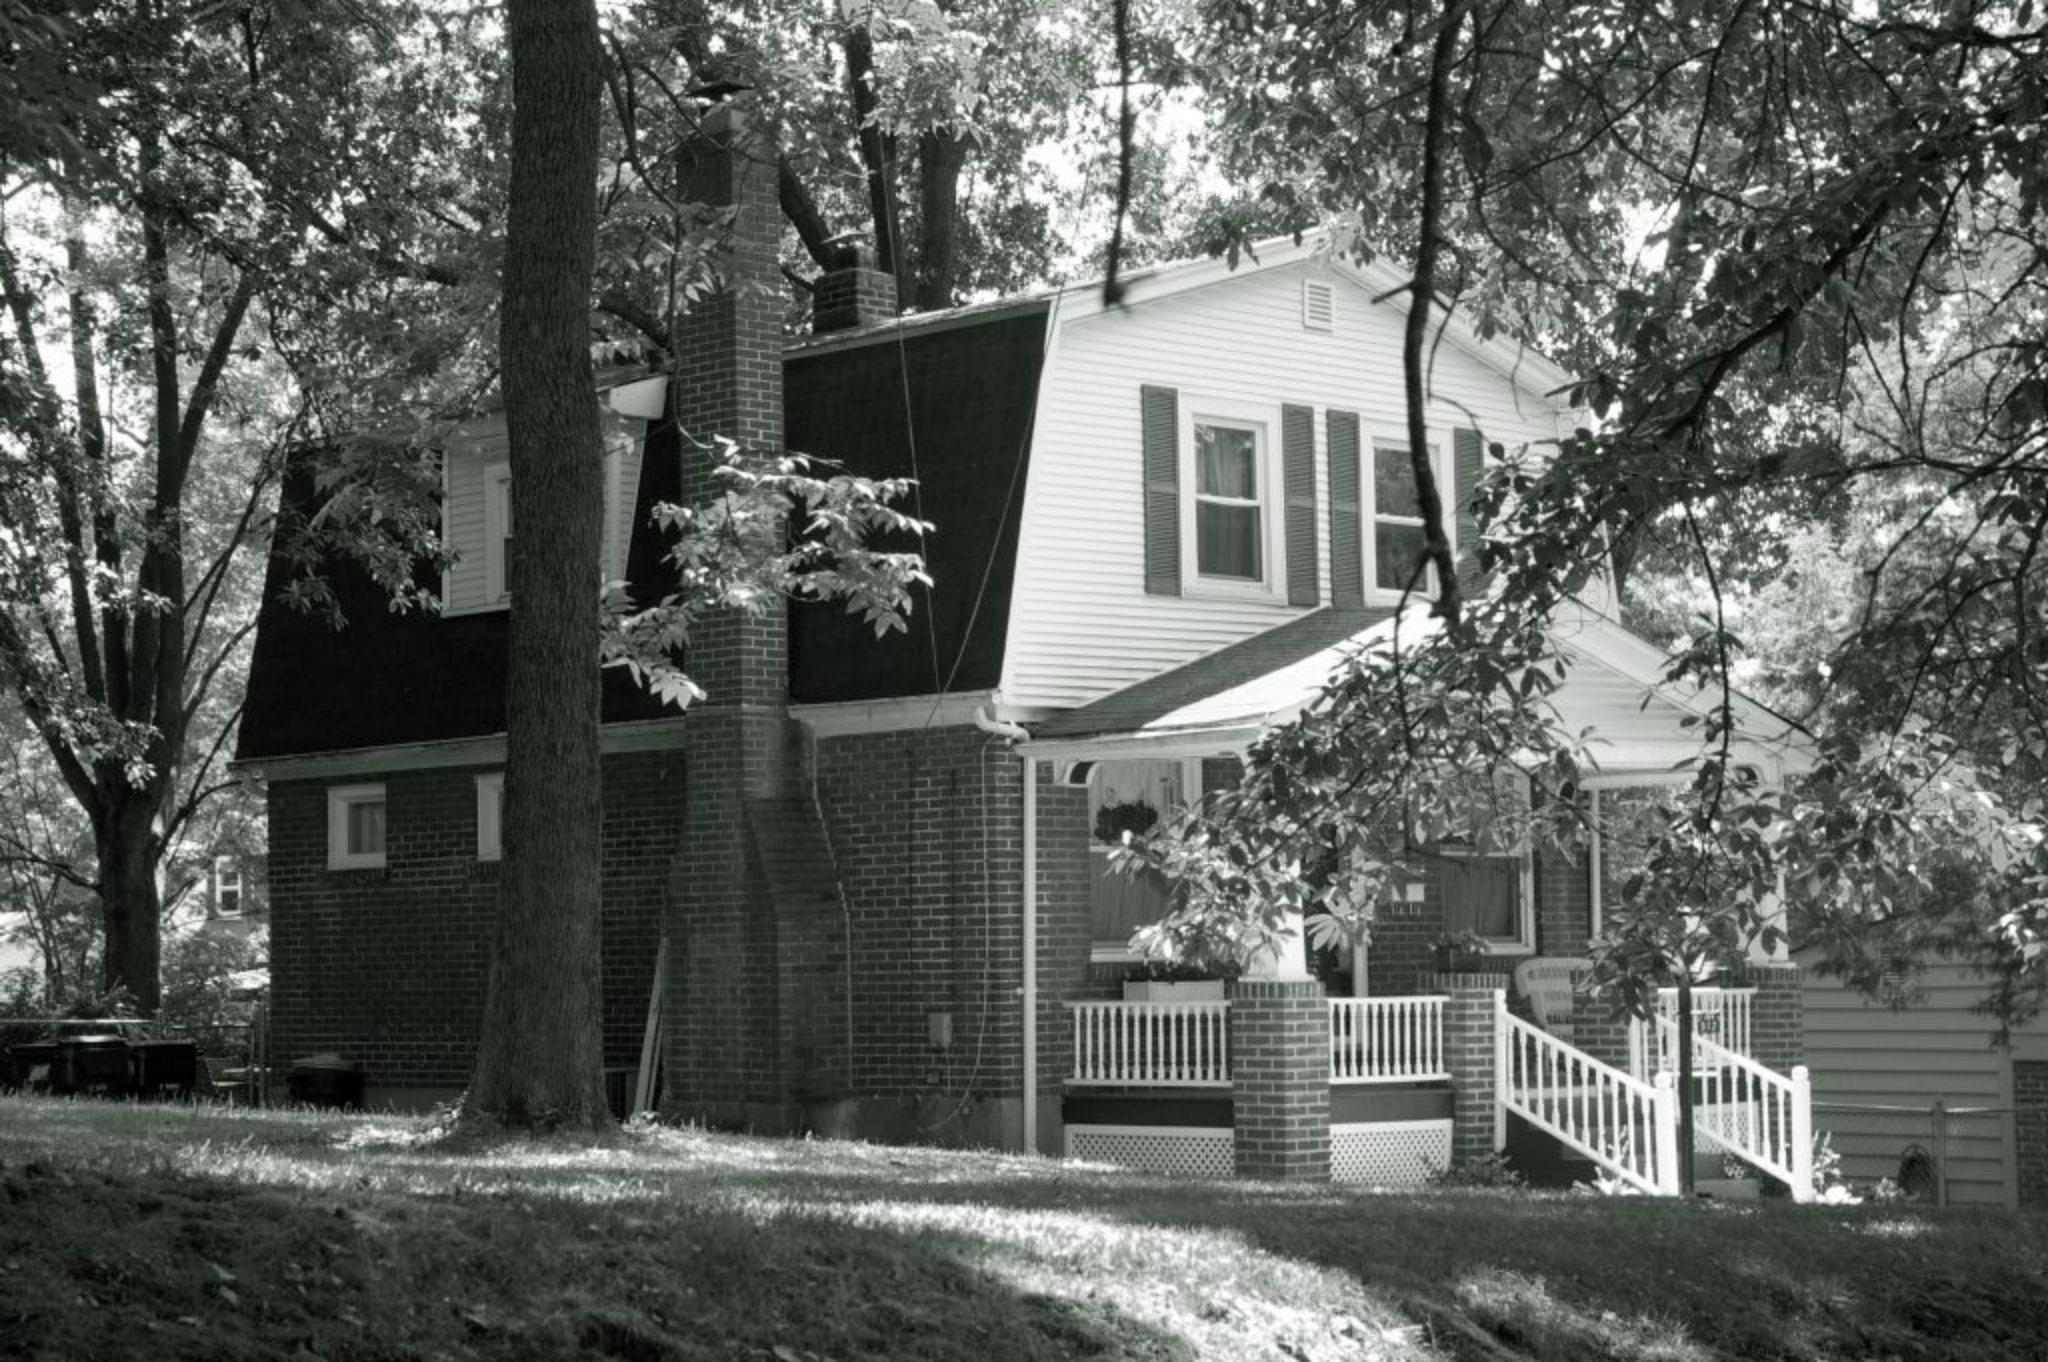
This appears to have originally been a one story Craftsman bungalow, but a second floor addition with a gambrel roof has been added behind what was probably the original full width gabled roofed porch. The facade is still divided into three bays with the entry door in the center bay and the tapered, square, wood columns at the corner of the porch rest on the outer two of the four brick piers. The porch railing has been replaced with a new turned baluster railing and the windows have been replaced with vinyl windows. The gable end of the porch has been clad with vinyl siding to match the walls of the new second story.

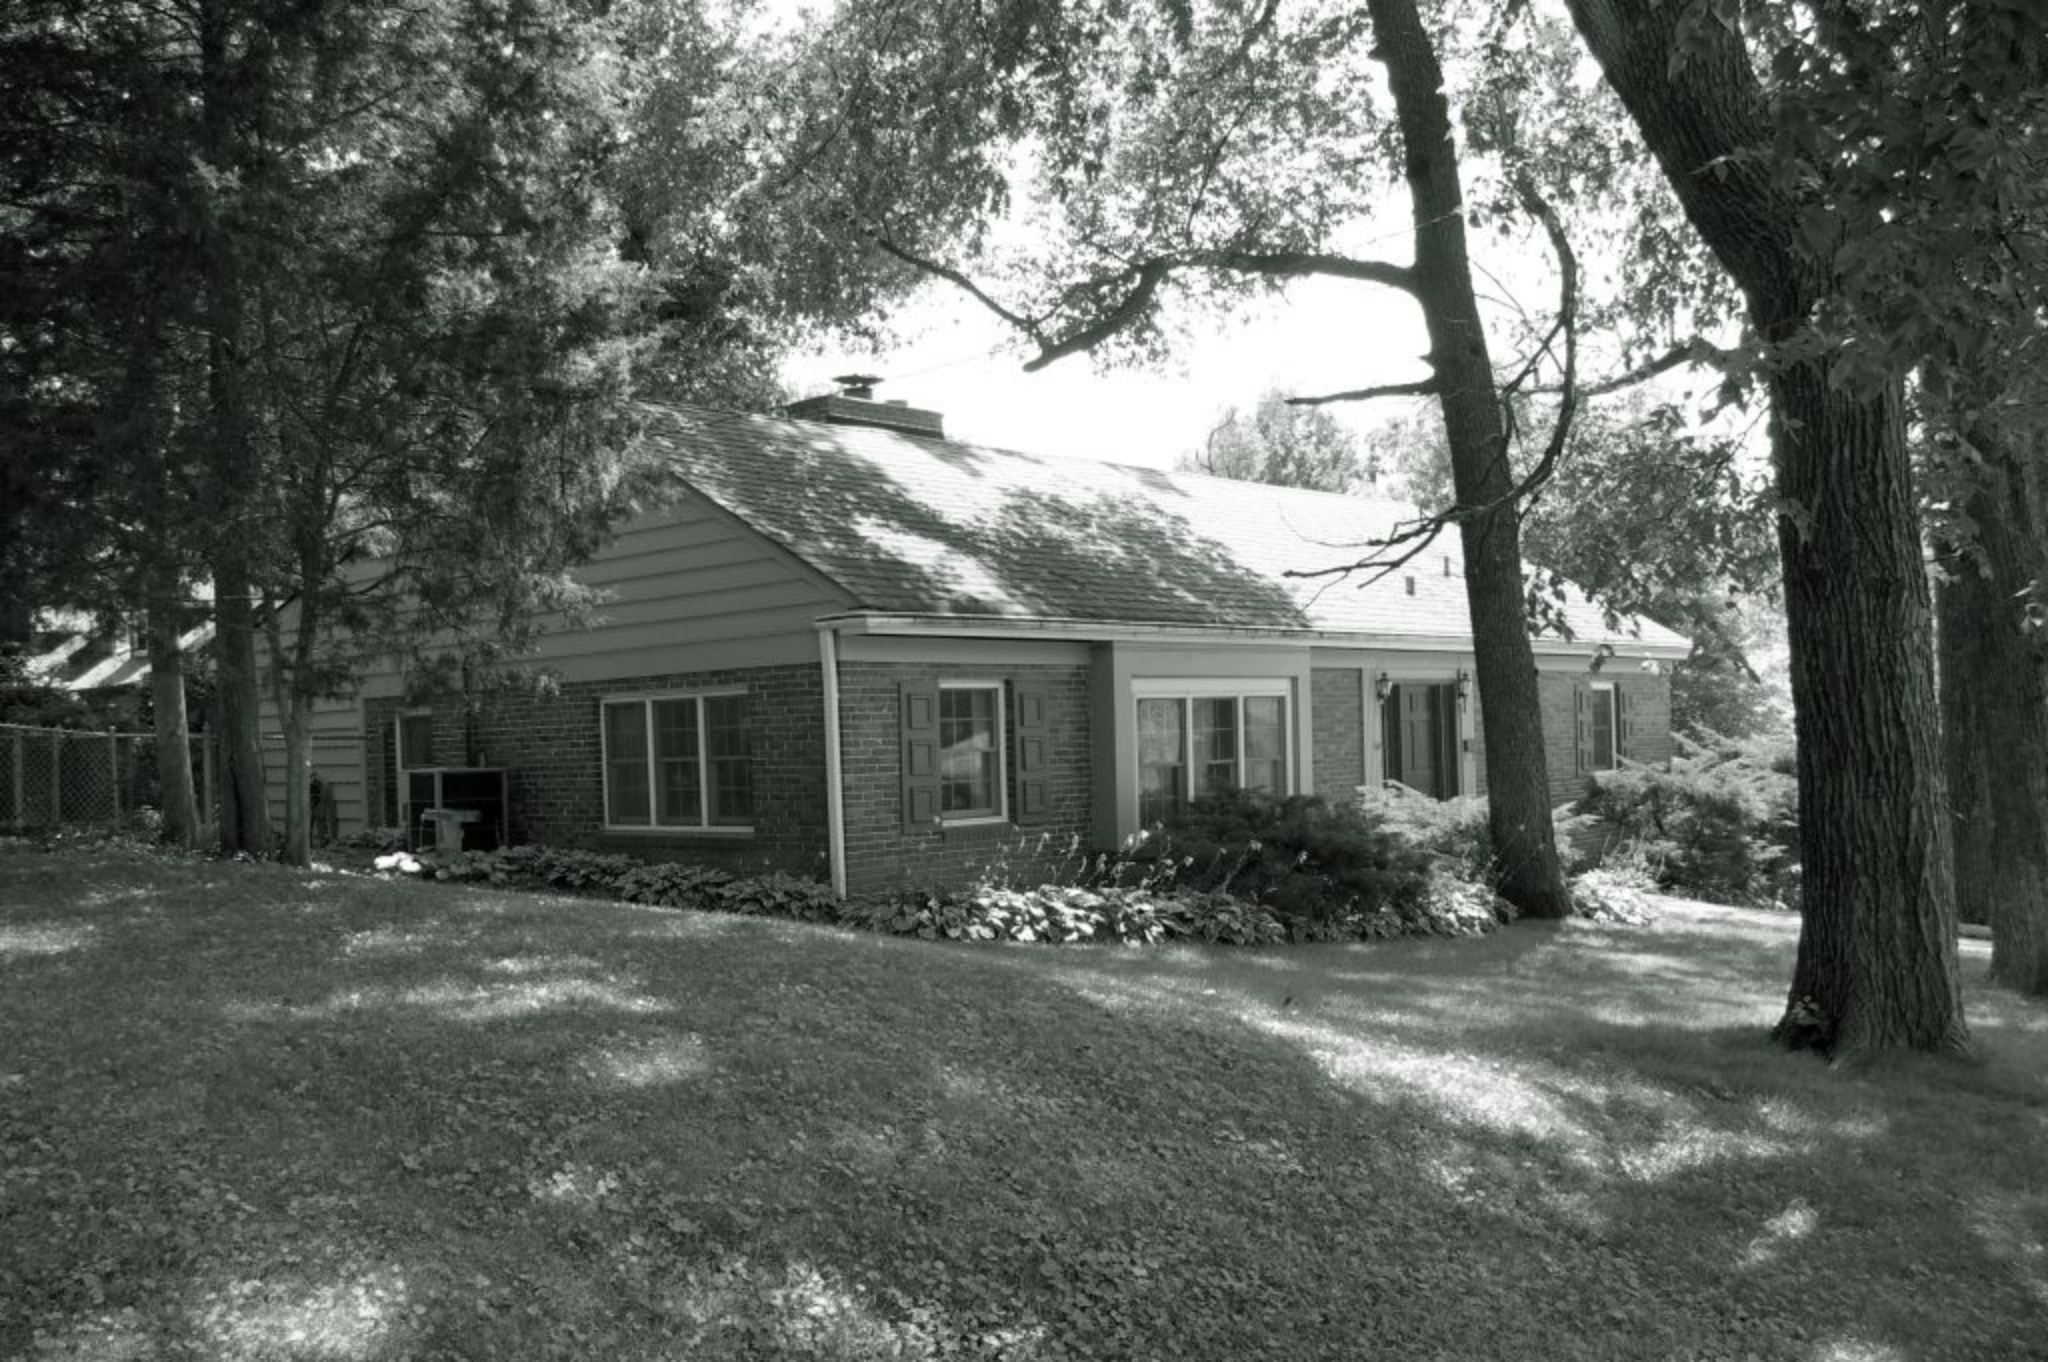
This shallow pitched, side gabled, one story, brick house has a simple design common to Minimal Traditional designs. The facade is divided into four bays with 6 over 6 wood sashed windows with decorative shutters in the outer two bays. The second bay from the east end is a flattened bay window with a triple window unit of 6 over 6 sashed windows while the other bay has an entry framed by fluted pilaster strips around the sidelighted wood paneled door and concrete entry stoop. At the back of the house is an attached garage clad in aluminum siding, as are the gable ends (the siding may be original given the date of construction).

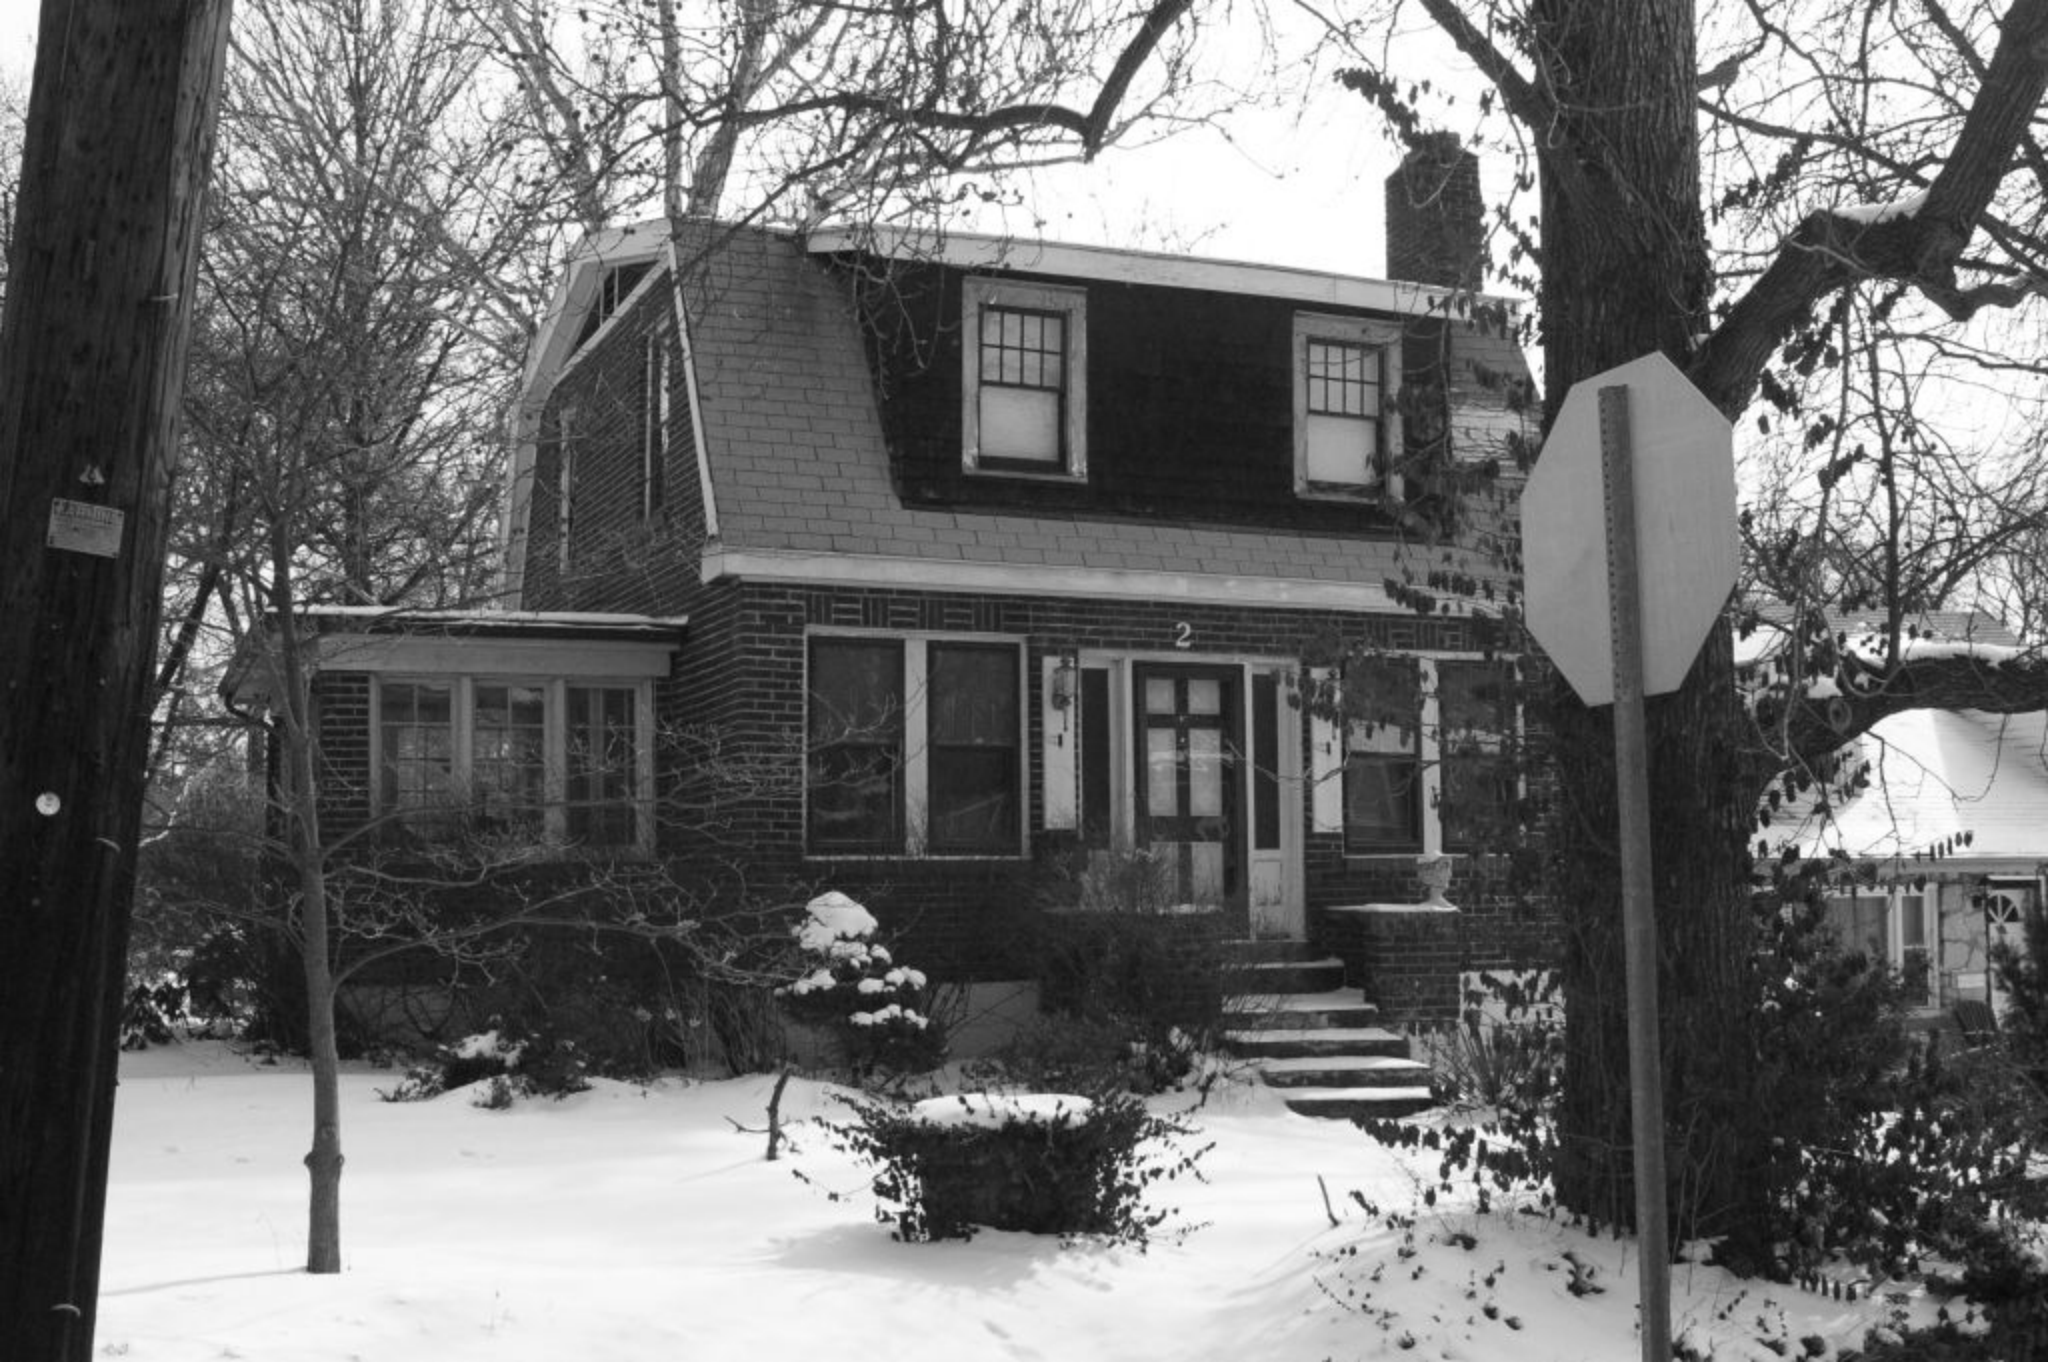
This 1.5 story, side gambrel roof, brick house has wood shingles in the shed dormer on the facade. Although it faces Carson it is addressed on Clark. There are two 8 over 1 wood sashed windows in the dormer and similar paired windows on either side of the central entry with its side lights and wood 6-panel door. The concrete stoop has brick half walls. The front windows have decorative basketweave pattern brick linels and contrasting red brick sills. On the west elevation facing Clark, there is a stained glass window. The one story, flat roofed sunroom on the east side is original to the design since it is clearly indicated on the 1931 fire insurance map. Metal storm windows and a full view storm door have been added.
