ARCHITECTURAL/HISTORIC INVENTORY FORM

1. Survey No. SL-AS-036-001		2. Survey Name: Architectural Survey of Old Ferguson West	
3. County: St. Louis		4. Address: 1 Carson Rd.	
5. City: Ferguson	Vicinity: <input type="checkbox"/>	6. UTM:	7. Township/Range/Section
8. Historic name (if known):		9. Present/other name (if known): Whistle Stop	
10. Ownership: <input type="checkbox"/> Private <input checked="" type="checkbox"/> Public		11. Historic use (if known): TRANSPORTATION/rail-related	11. Current use: COMMERCE/restaurant & RECREATION/museum

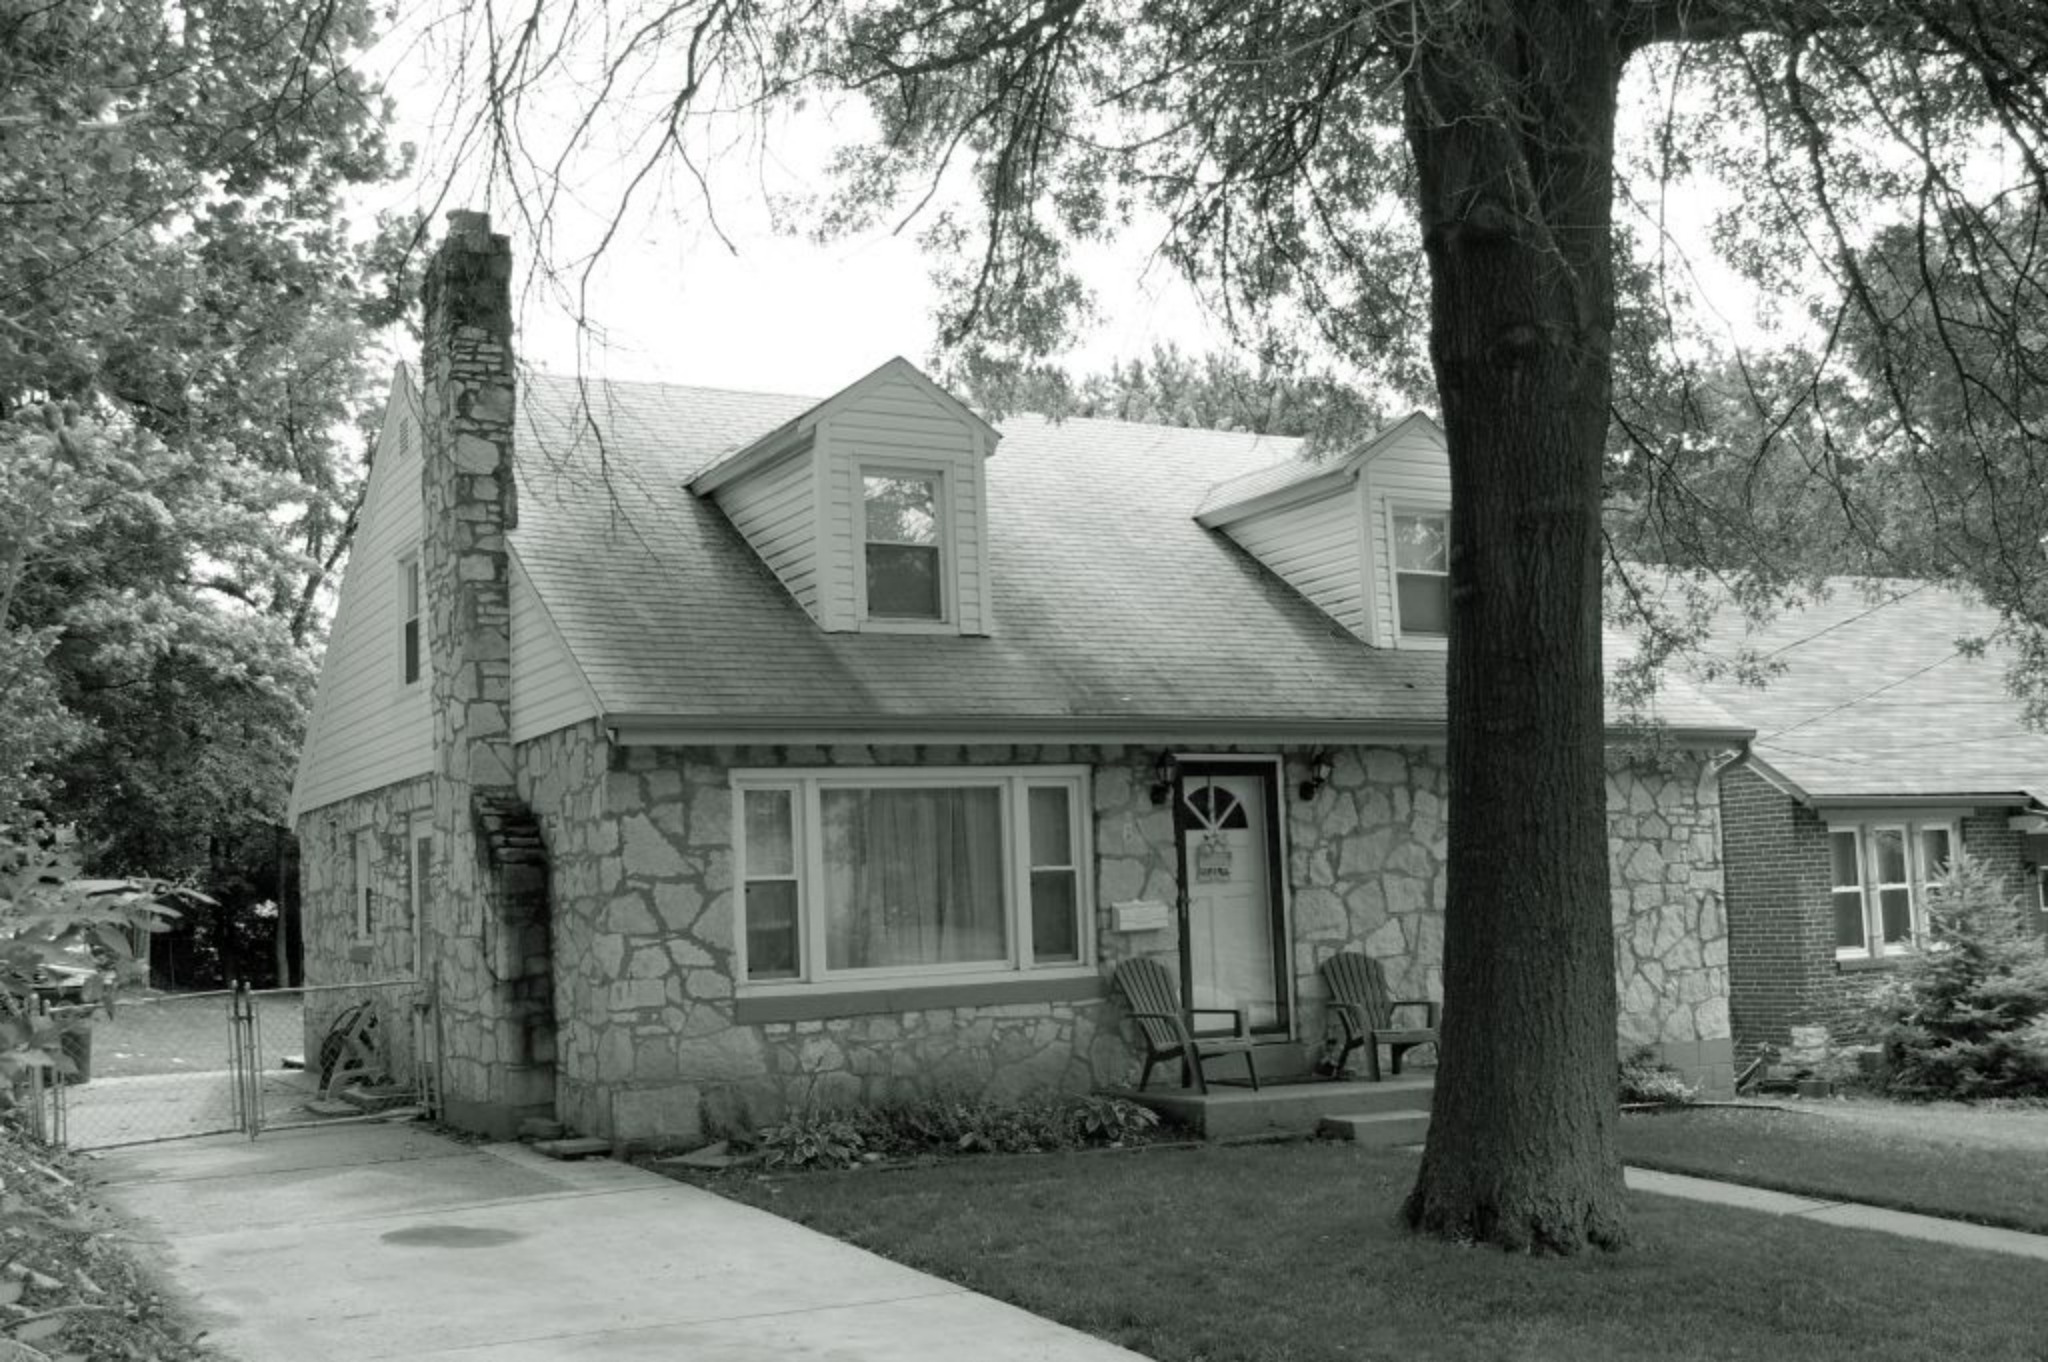
This 1.5 story, rubble limestone, Cape Cod style house has a pair of gabled dormers with 1 over 1 windows on the facade. The first floor is divided into three bays with a large picture window consisting of 1 over 1 sashed windows flanking the plate glass window positioned in the north bay and a simple entry door centered on the facade. There is a shallow concrete stoop in front of the original wood paneled door which incorporates a half-round fanlight. On the north side of the house is a stone end wall chimney and a secondary entry door accessible to the adjacent driveway. The house has storm windows, a full light storm door, and replacement vinyl siding on the dormers and gable ends.

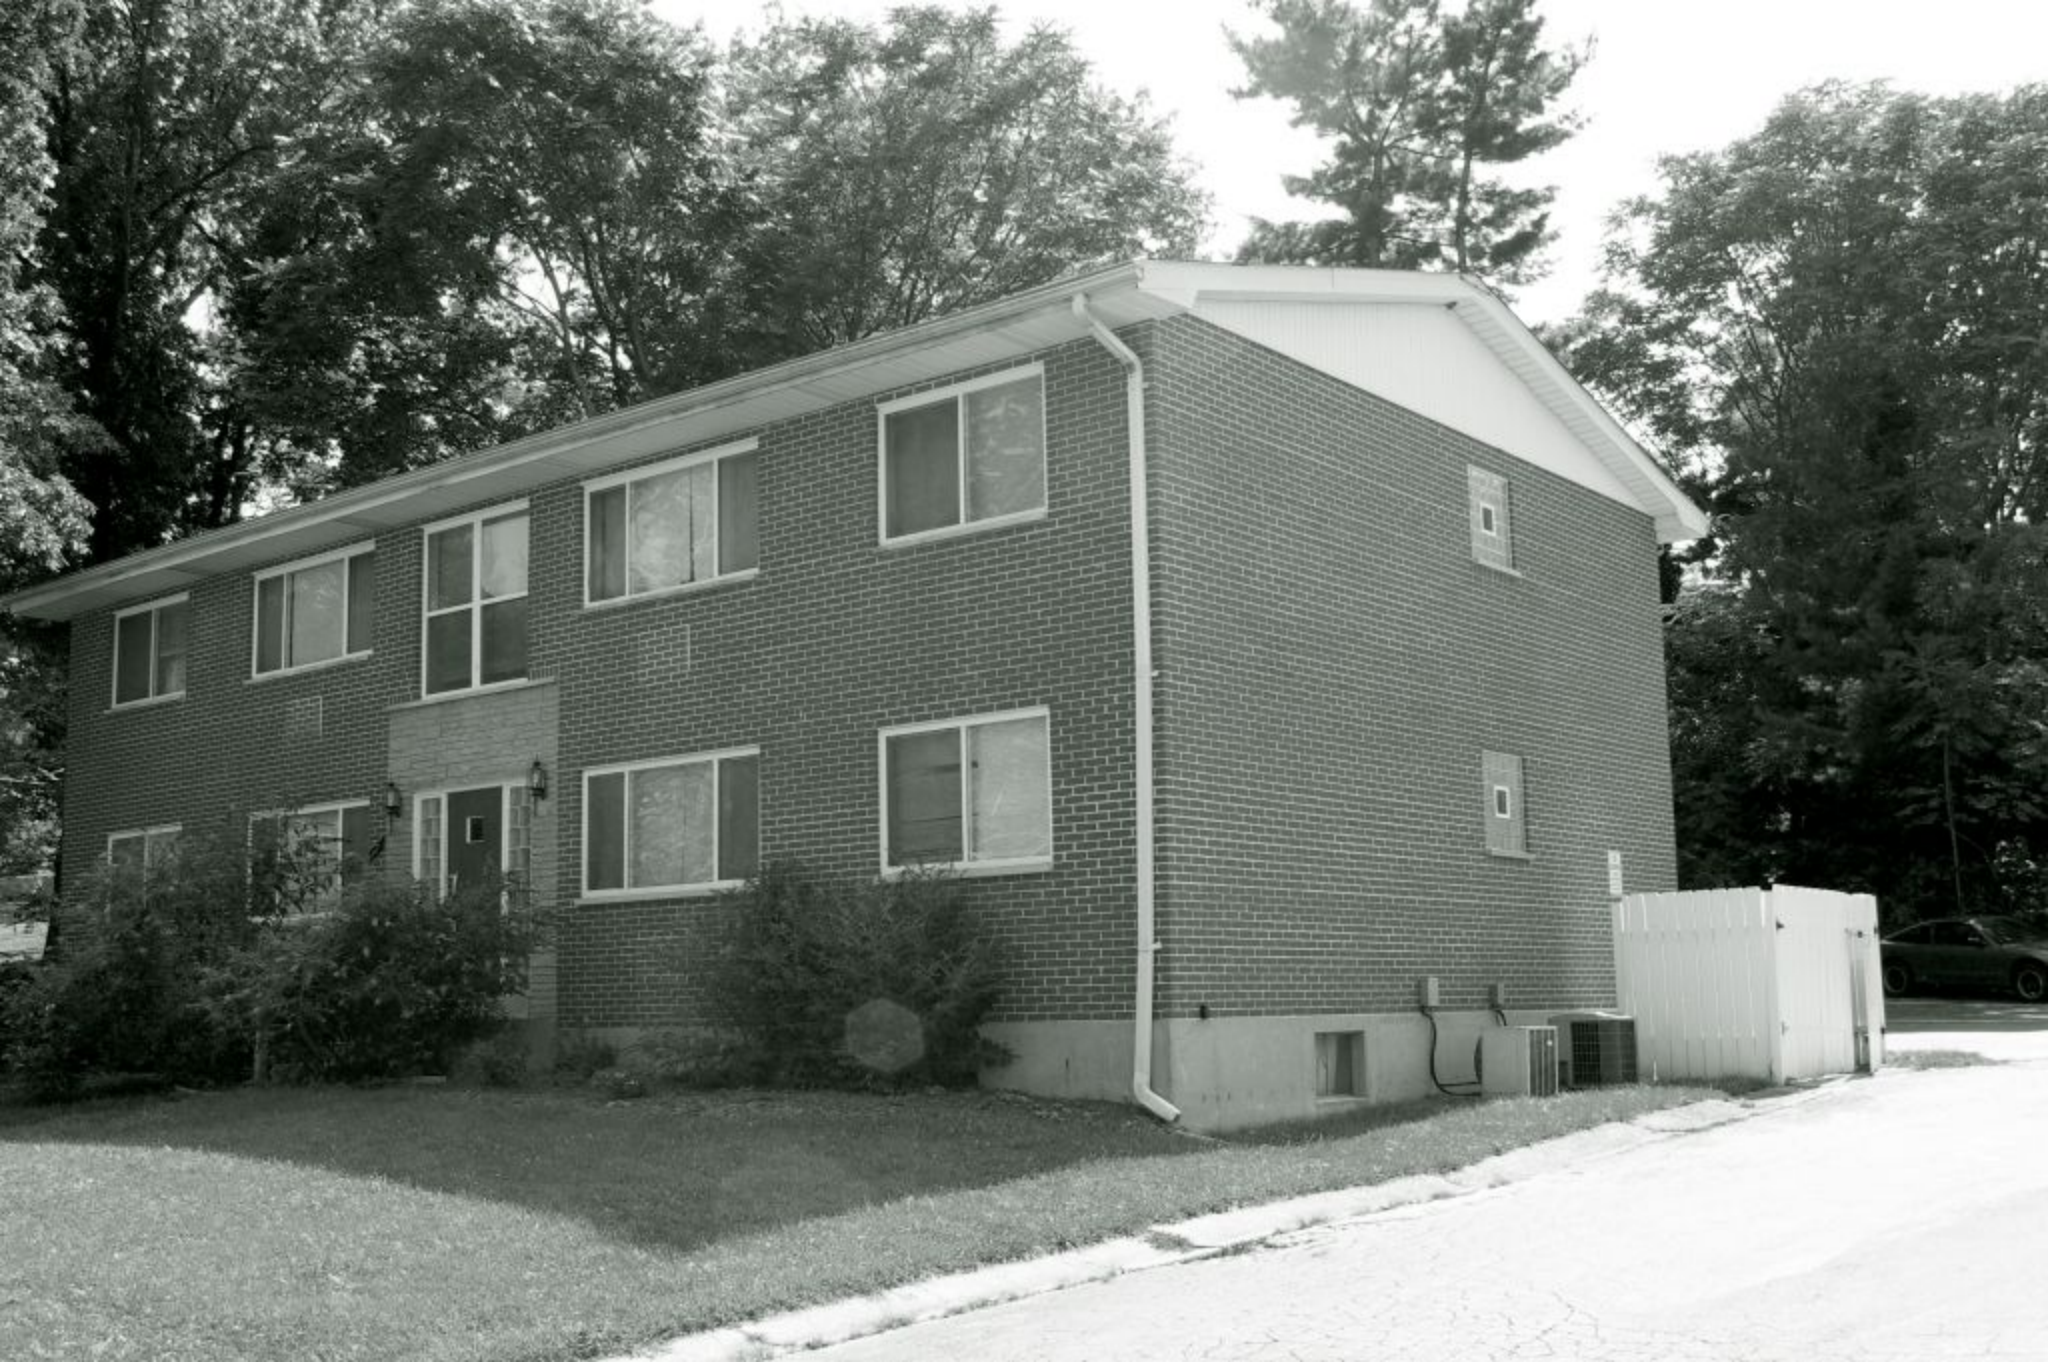
This two story, red brick, shallow side gabled, apartment building has a symmetrical facade with five vertical bays, the outer two of which are 2 light sliding windows and the others are window units with single light casement windows flanking a large plate glass window. The center bay is framed by ashlar limestone around the doorway, extending up to the second floor window. The entry is a simple wood door with a small square light and it is flanked by glass block side lights. Glass block also is used on the bathroom windows on the side elevations. The windows appear to be vinyl replacement windows.

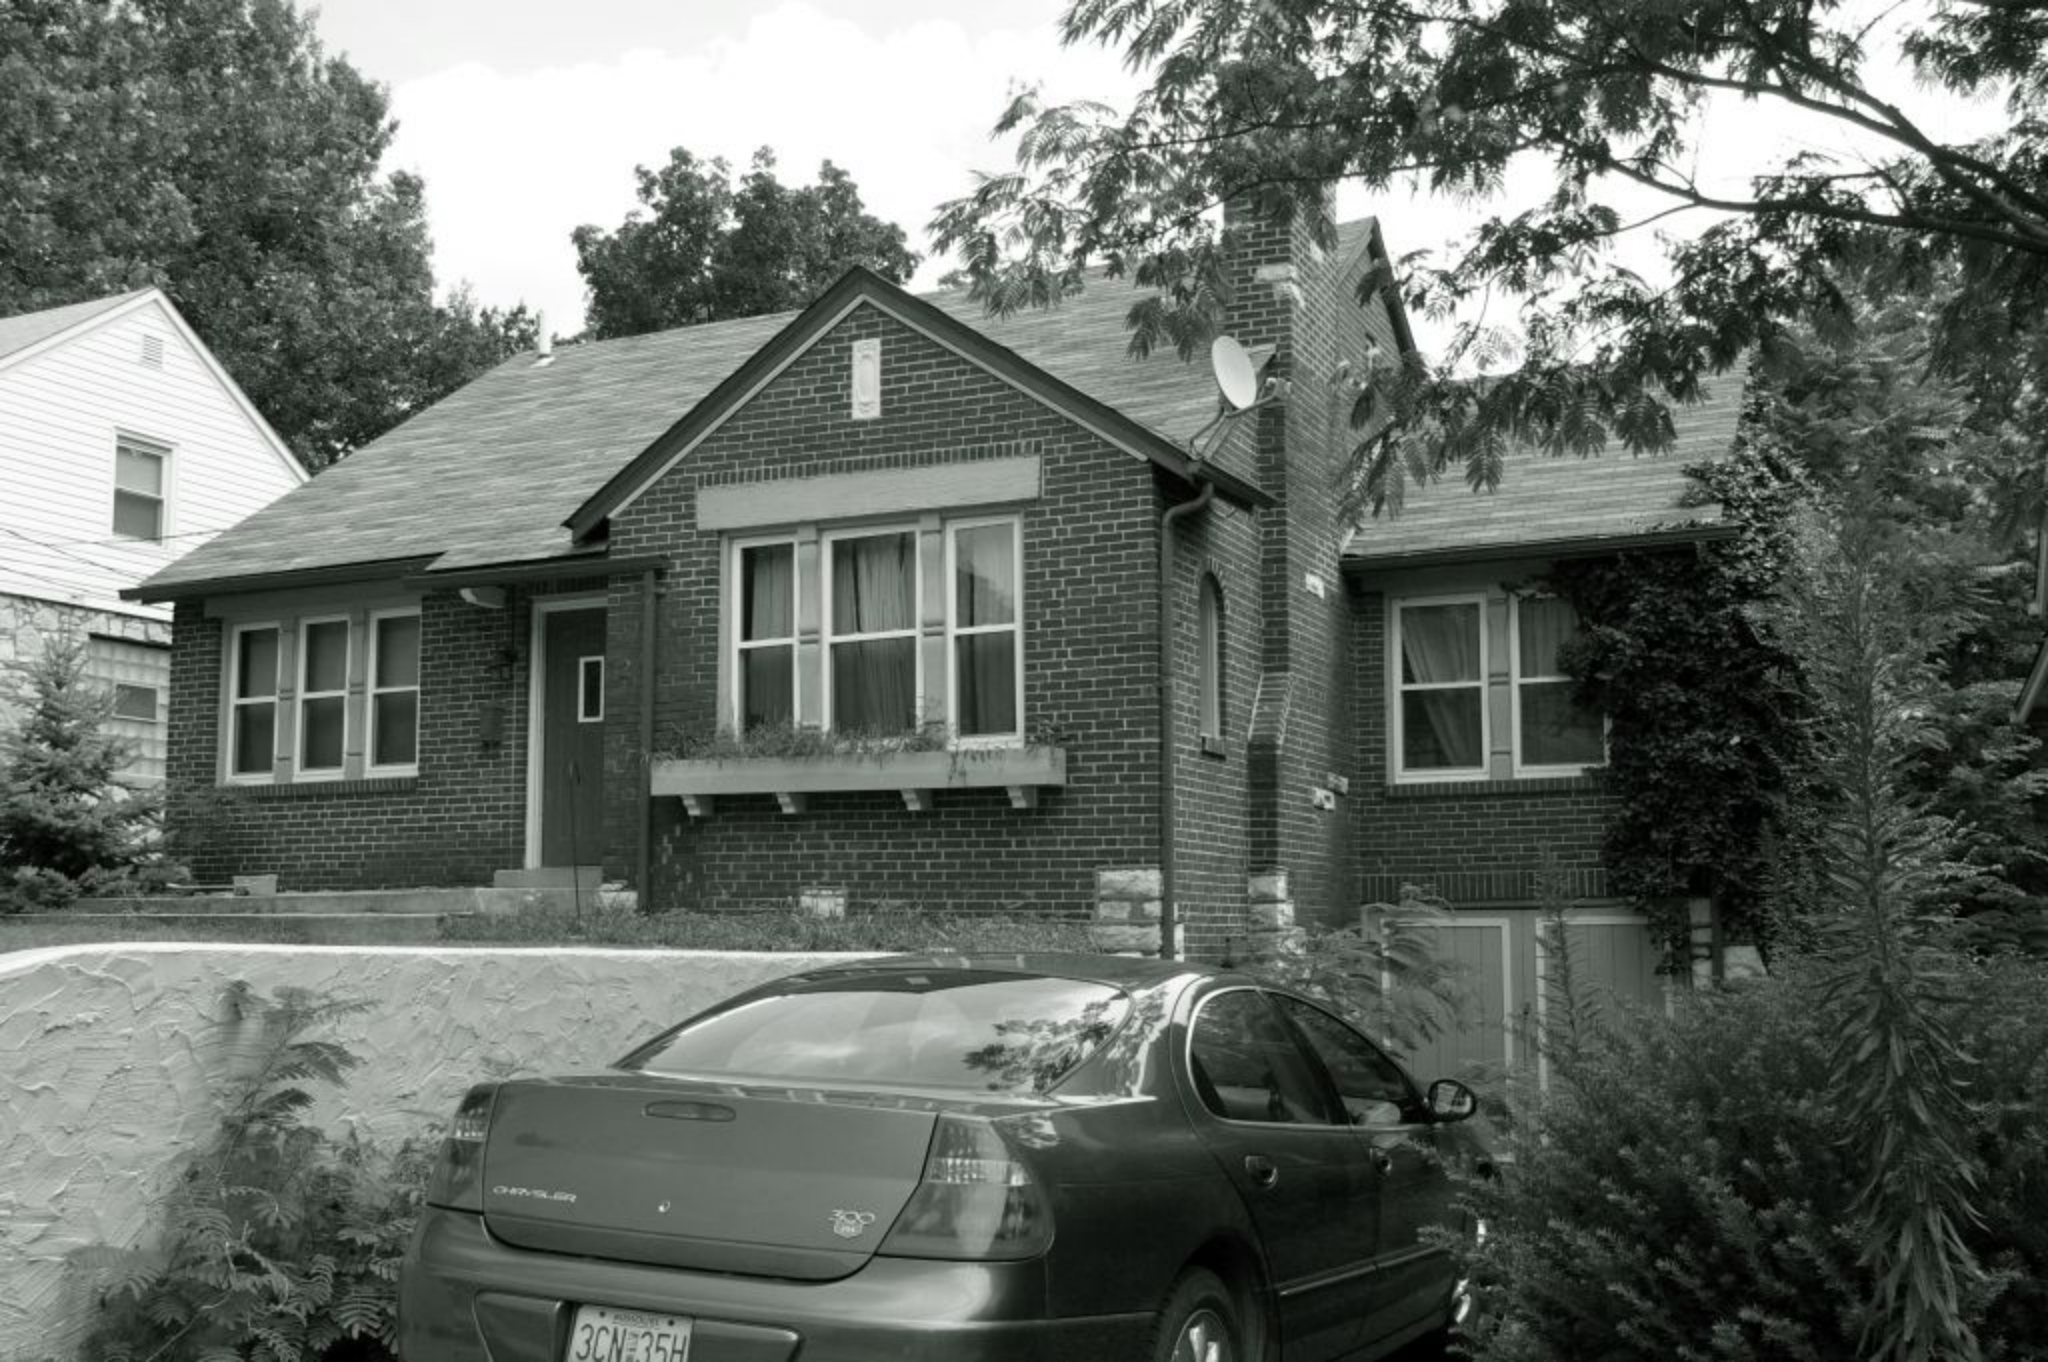
This one story, red variegated brick, Minimal Traditional style house has a side gabled, asphalt roof with an intersecting gable adjacent to the small shed roof extension over the entry door. Recessed back from the main facade is a shorter, side gabled wing with paired 1 over 1 windows over a basement level garage that retains its original swinging, paired, vertical board doors. On the south side of the house in front of the garage wing is a stepped, end wall, brick chimney with scattered stone details more reminiscent of Tudor Revival designs. At the foundation are more scattered limestone details, another Tudor Revival feature. To the north of the entry bay and in the gabled bay are triple window units, and like the ones over the garage, here are turned pilaster strips at each mullion and there are flat limestone lintels. The gable bay also has a large planter box below the windows. There is a driveway and retaining wall cut deep into the front lot leading from the garage. The windows appear to be vinyl replacements and the front door appears to be a newer metal paneled door.

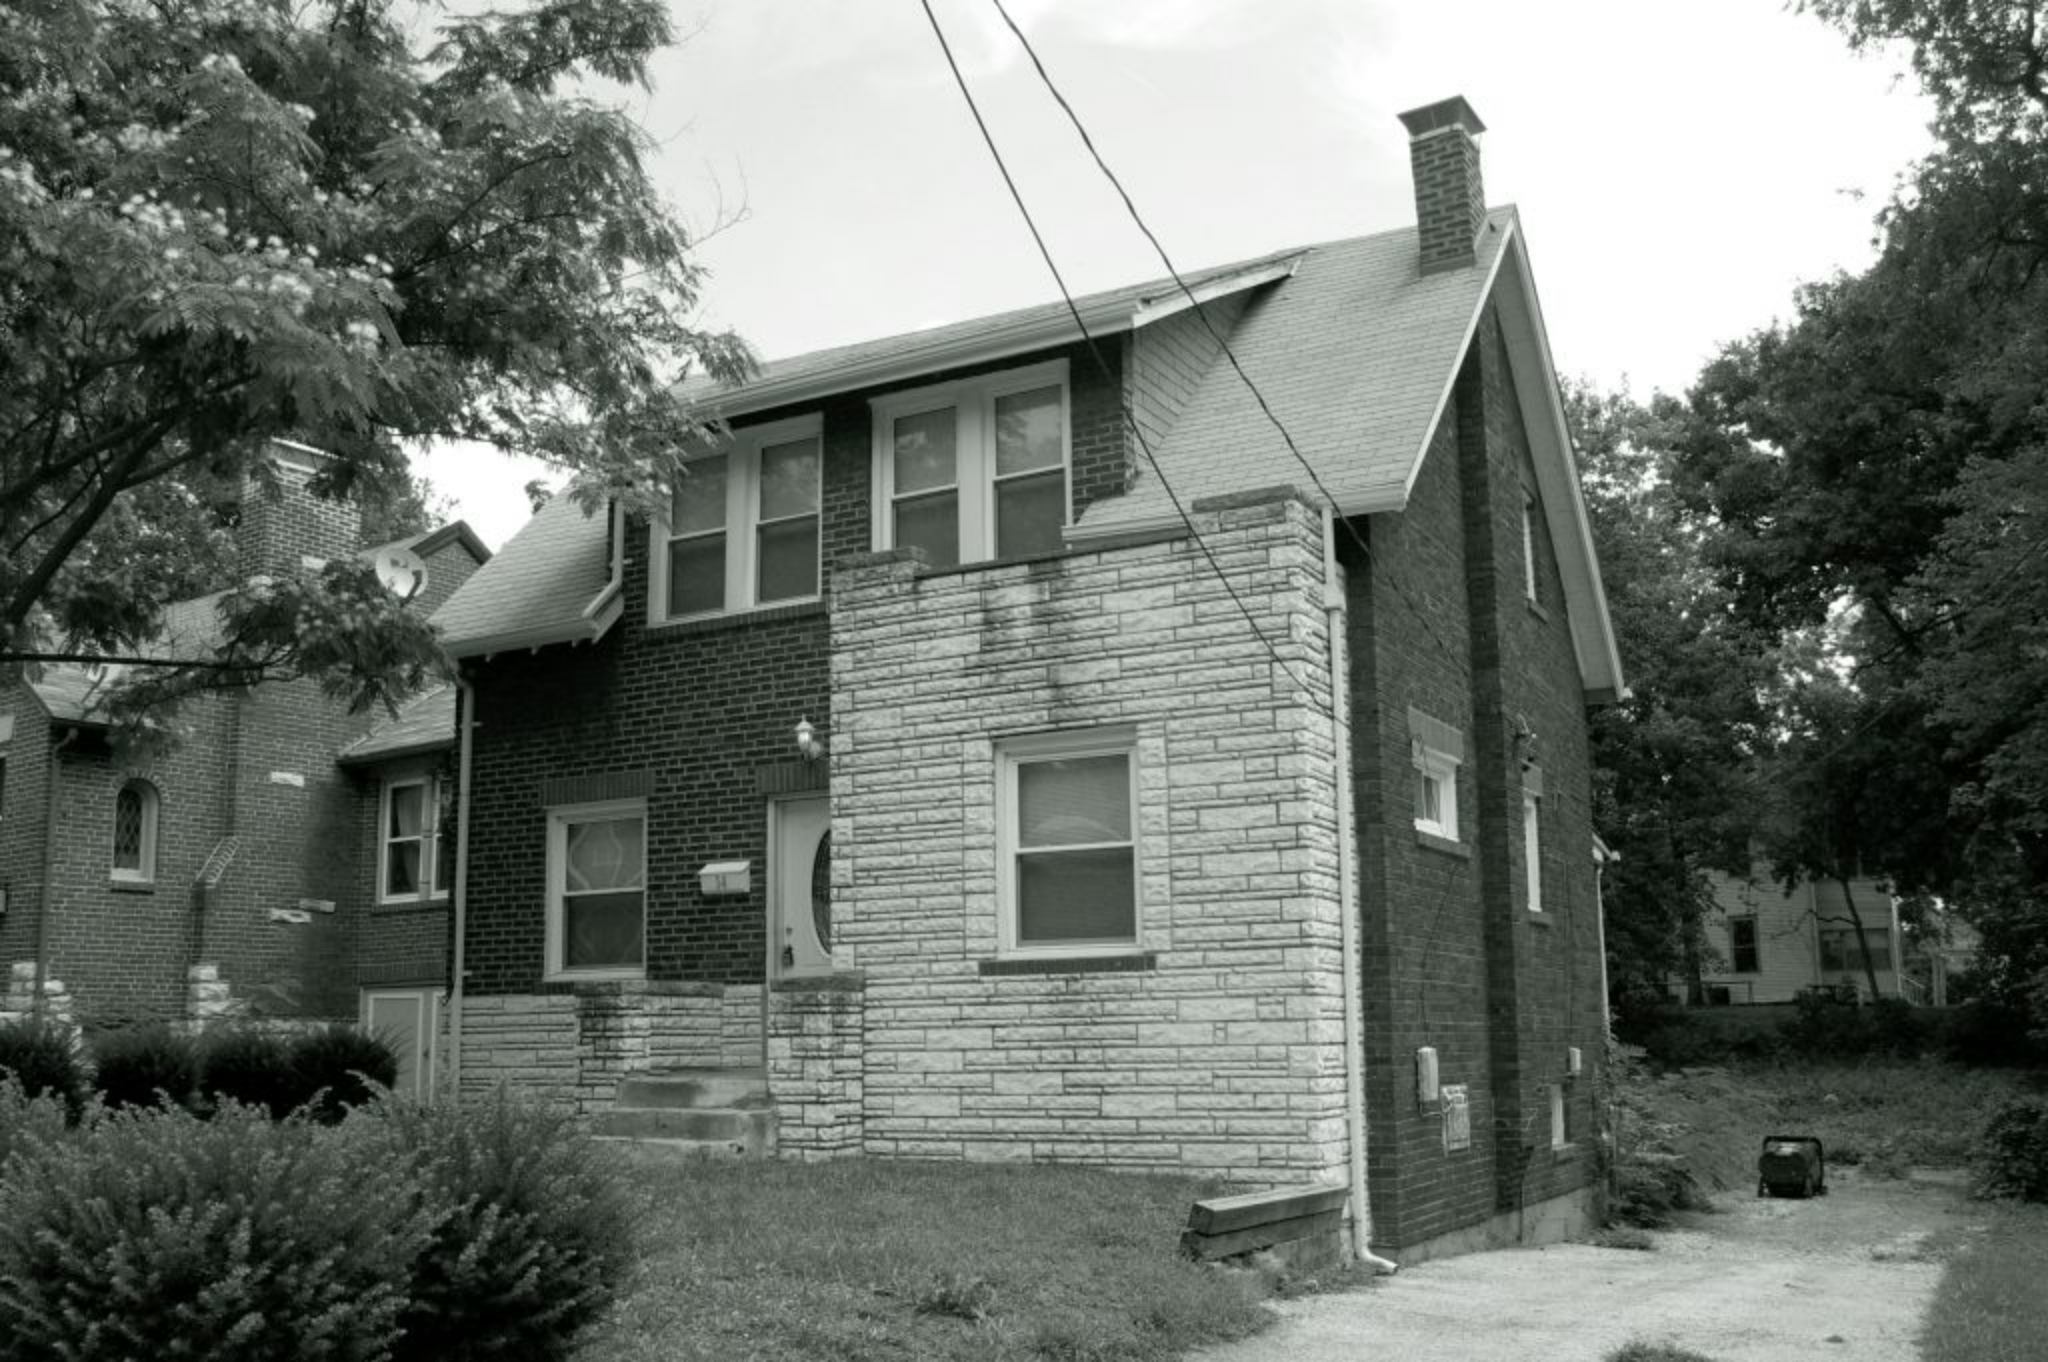
This 1.5 story, dark red brick, side gabled house has asphalt shingles and a broad shed dormer with two pairs of 1 over 1 sashed windows facing the facade. On the rear of the house is a one story shed roofed wing. Between 1926 and 1930, the owners had the facade updated (it is shown on the 1931 fire map), utilizing Tudor Revival deailing, creating a small addition on the facade for a parapet, flat bay with a single 1 over 1 sashed window. This bay, the walls below the sill height and the adjacent porch half walls were all veneered with an ashlar pattern faux limestone. The windows and door have red brick sills and soldier course lintels. The facade is divided into three vertical bays on the first floor: the parapet flat bay, the central entry door and stoop, and a single 1 over 1 sashed window. There is an end wall chimney piercing the roof on the south side. The door is a replacement metal door with an oval light. Windows appear to be vinyl replacement sashes.

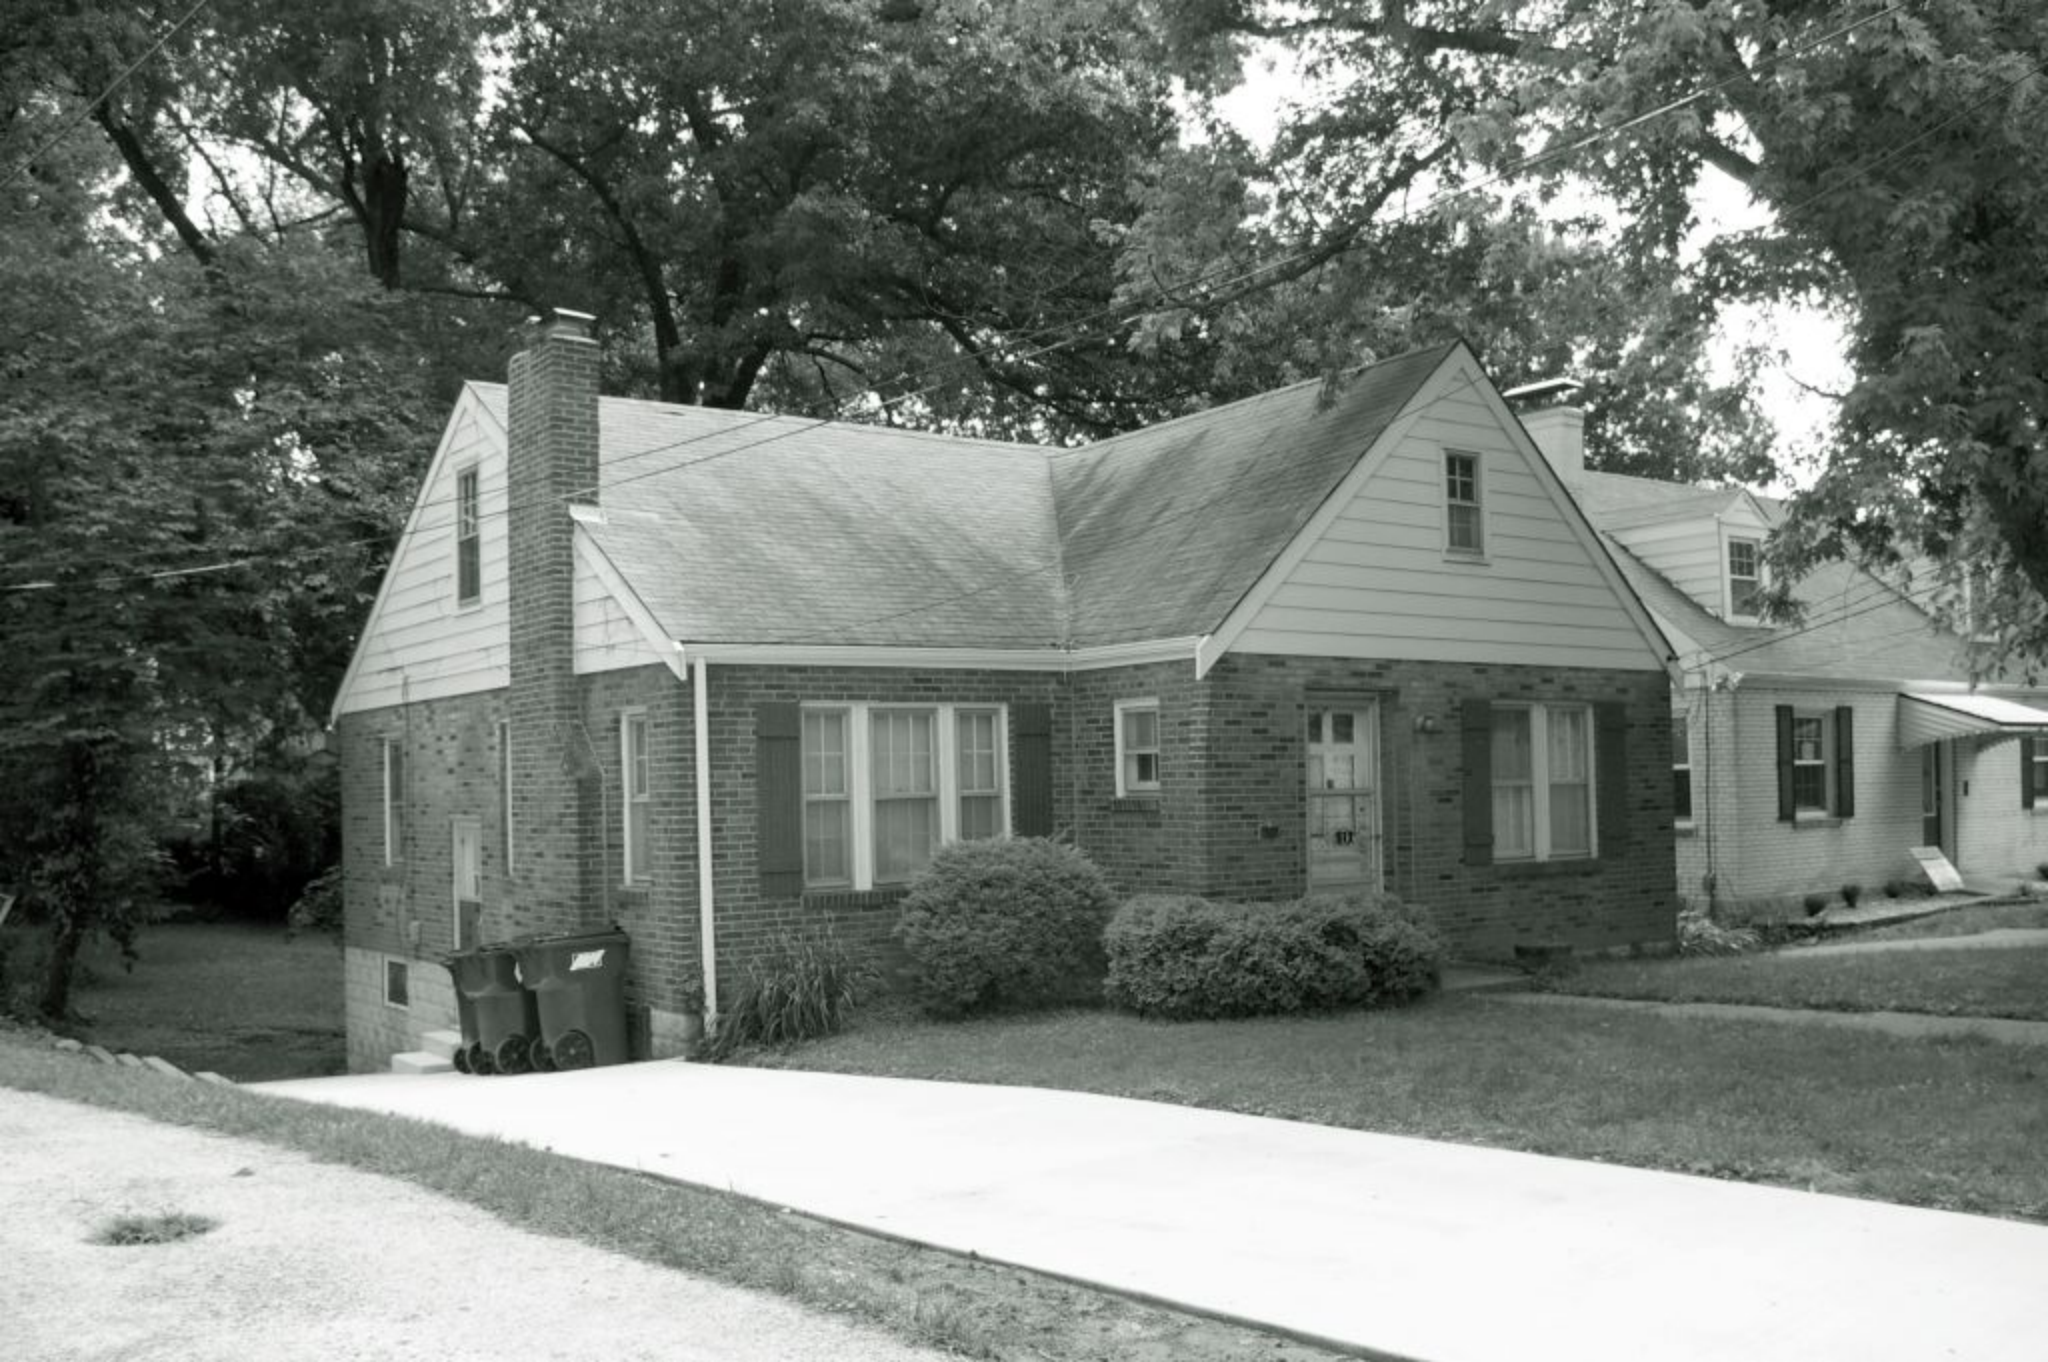
This 1.5 story, Minimal Traditional design house has an asphalt, low pitched, side gabled roof with a cross gable on the facade. The facade is divided in half by the projecting cross gable with a triple, shuttered window unit in the north bay with 4 over 4 wood sashed windows flanking the 6 over 6 sashed window. In the cross gable bay, there is a paired window unit with 6 over 6 sashed windows and near the center, the simple entry door opening and shallow concrete stoop. The door is a wood paneled door with two lights in the upper panels. There are single sashed, multipaned windows in each gable end, except the south side has two, different sized windows in the gable end. There is a brick, end wall chimney on the north side elevation in front of a secondary entry door with concrete steps leading down to the adjacent driveway. The faux stone foundation is clearly visible on the south side. The wider siding in the gable ends appear to be replacement aluminum siding, and there are metal storm screens on the windows.

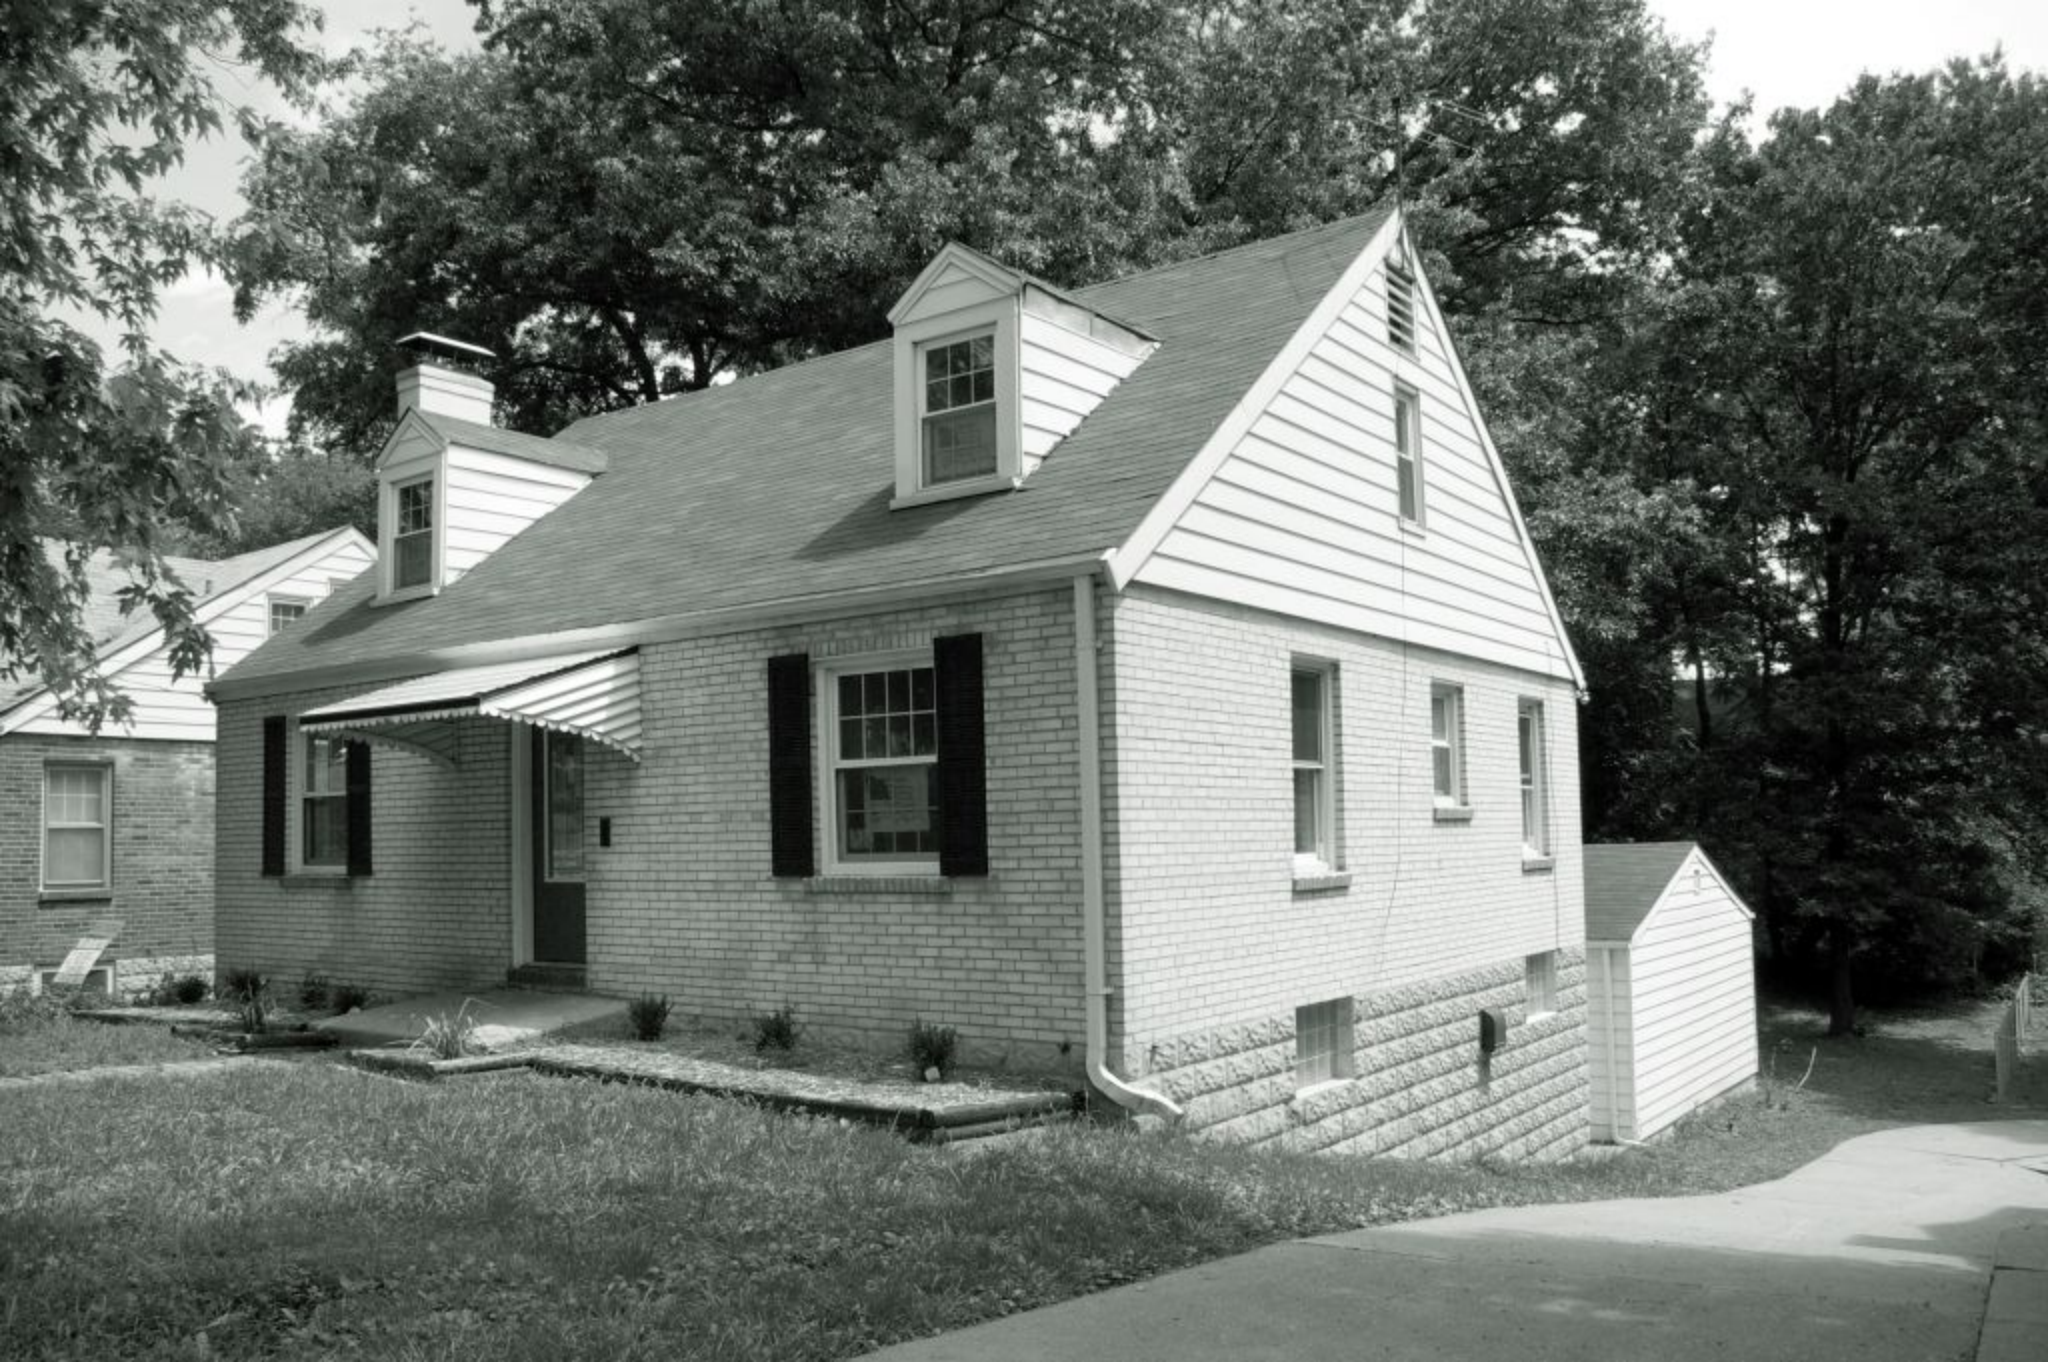
This 1.5 story, side gabled, cream colored brick house has a faux stone foundation that is clearly visible on the side elevation. The house has an asphalt roof with two gabled dormers positioned over the outer two bays of the main facade, which have multipaned sashed windows with shutters. The dormers and gable ends are clad in aluminum siding. The center bay has a simple entry door with a shallow concrete entry pad. The door appears to be a newer metal door with a rectangular art glass light and there is a nonhistoric aluminum awning over the door. On the north side is a brick, exterior chimney with a newer metal chimney cap. Behind the chimney is a secondary entry door with a set of concrete steps leading down to the driveway, but the old steps have been overlaid with a wooden porch and railing. According to the fire insurance map there is a garage in the basement of the house, but that cannot be confirmed since its entry was at the back of the house. The windows appear to be multipaned vinyl replacement sashed windows.

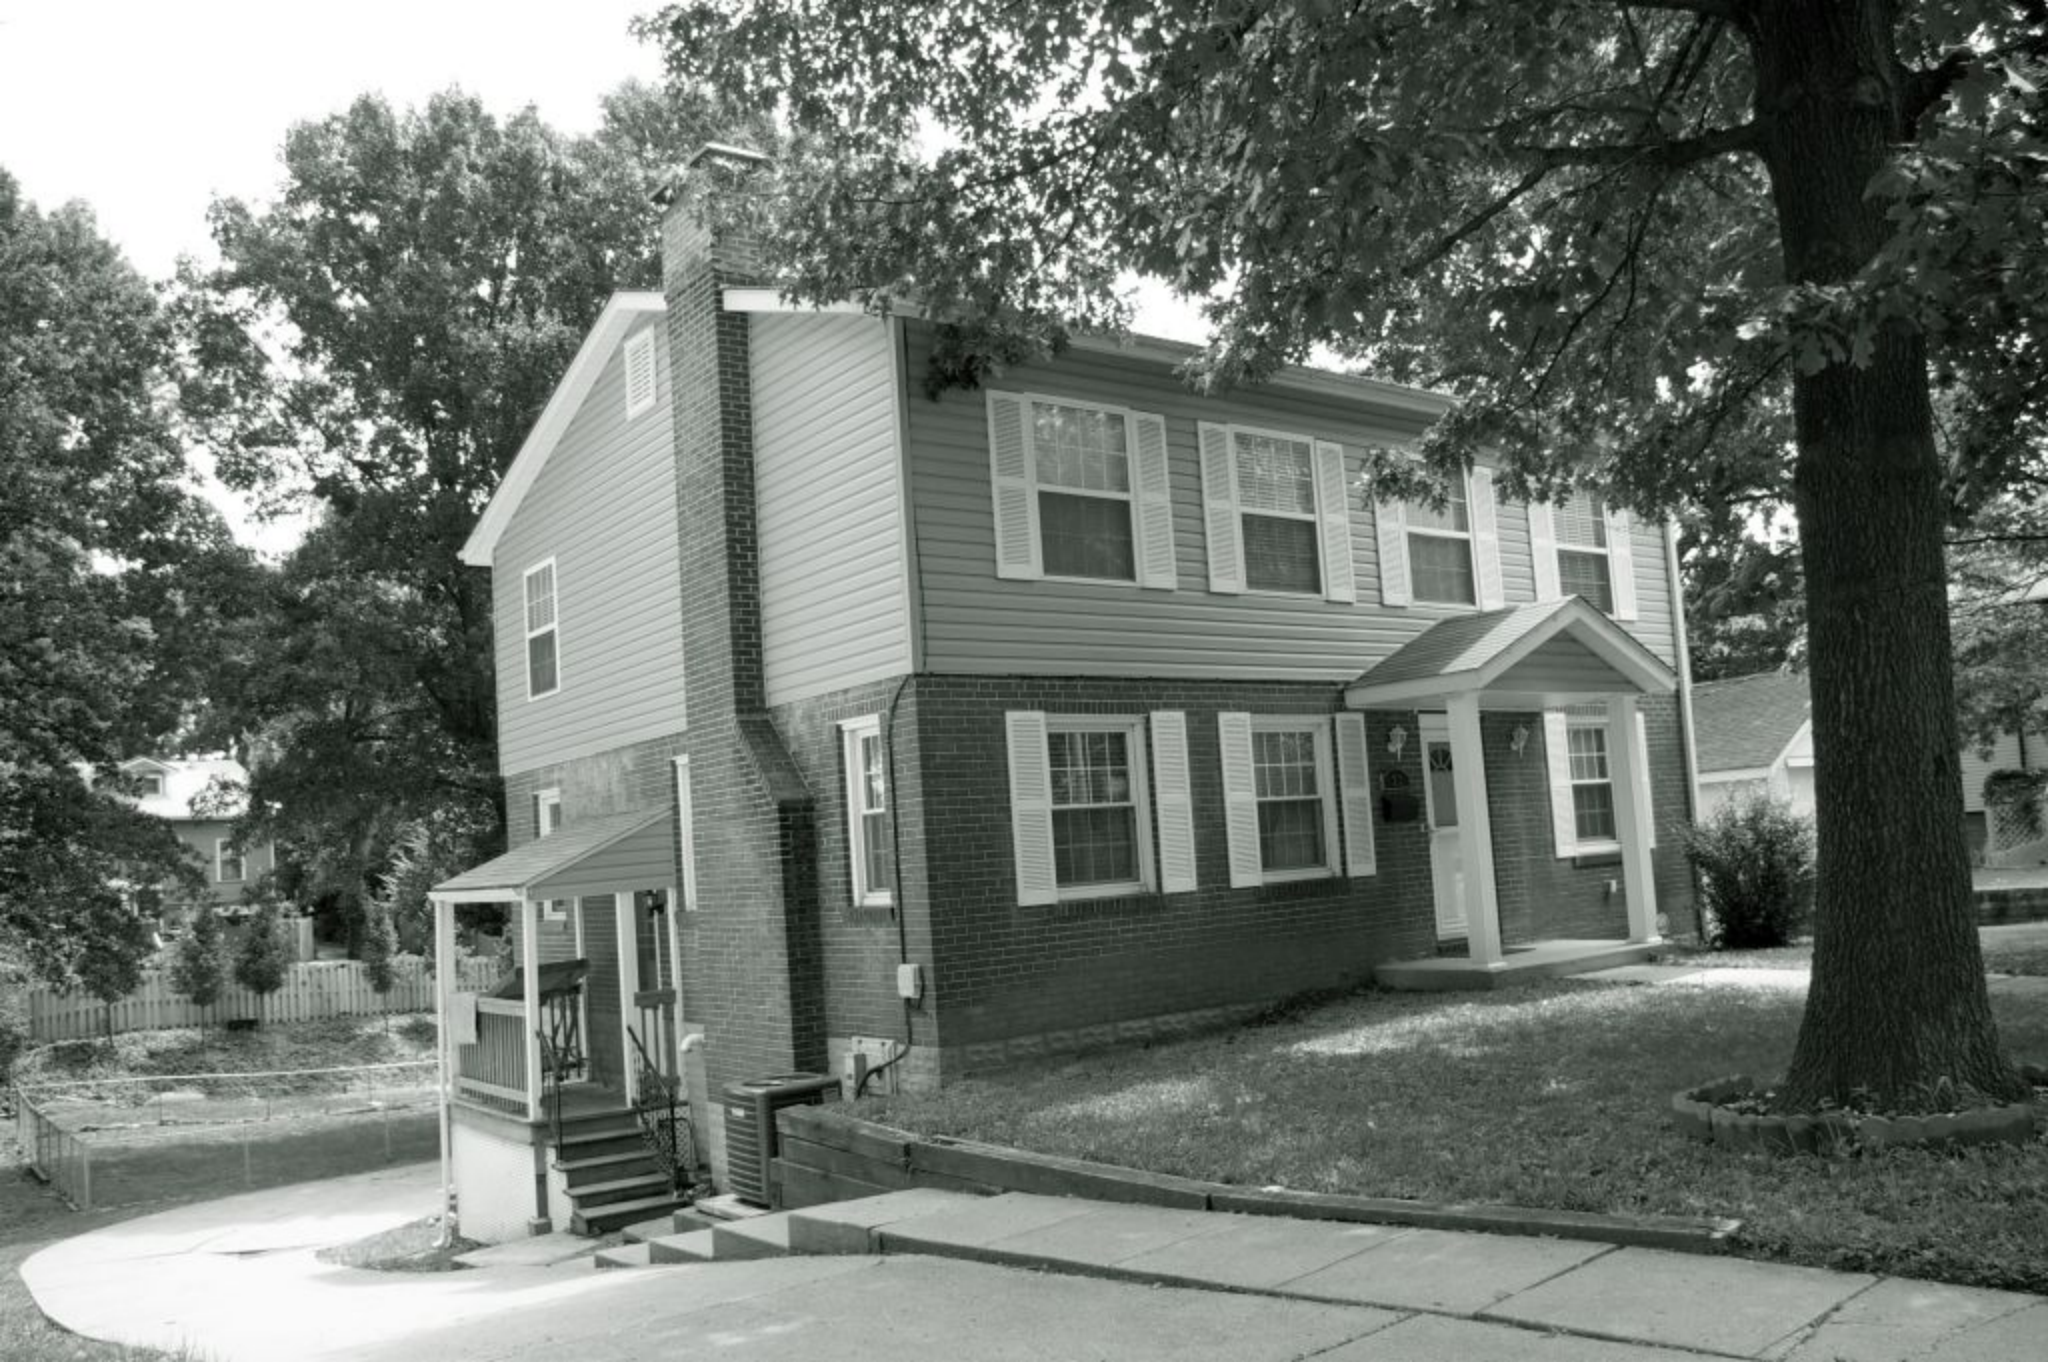
This two story, side gabled house was originally a one story house as indicated by the change in the brick on the chimney and the use of a modern pitched side gable roof and vinyl siding on the second floor above the original first floor red brick walls. This is confirmed by the indication that it was a one story house on the 1950 fire insurance map. The facade is now four bays wide with multipaned vinyl sashed windows with shutters on both levels except for the one bay where there is a simple metal door with glass light which is covered by a gabled roof porch with simple square corner posts resting on what was probably the original entry stoop (without a covered porch) given the other buildings in the subdivision development which were all Cape Cod or Minimal Traditional designs.
