ARCHITECTURAL/HISTORIC INVENTORY FORM

1. Survey No. SL-AS-036-001		2. Survey Name: Architectural Survey of Old Ferguson West	
3. County: St. Louis		4. Address: 1 Carson Rd.	
5. City: Ferguson	Vicinity: <input type="checkbox"/>	6. UTM:	7. Township/Range/Section
8. Historic name (if known):		9. Present/other name (if known): Whistle Stop	
10. Ownership: <input type="checkbox"/> Private <input checked="" type="checkbox"/> Public		11. Historic use (if known): TRANSPORTATION/rail-related	11. Current use: COMMERCE/restaurant & RECREATION/museum

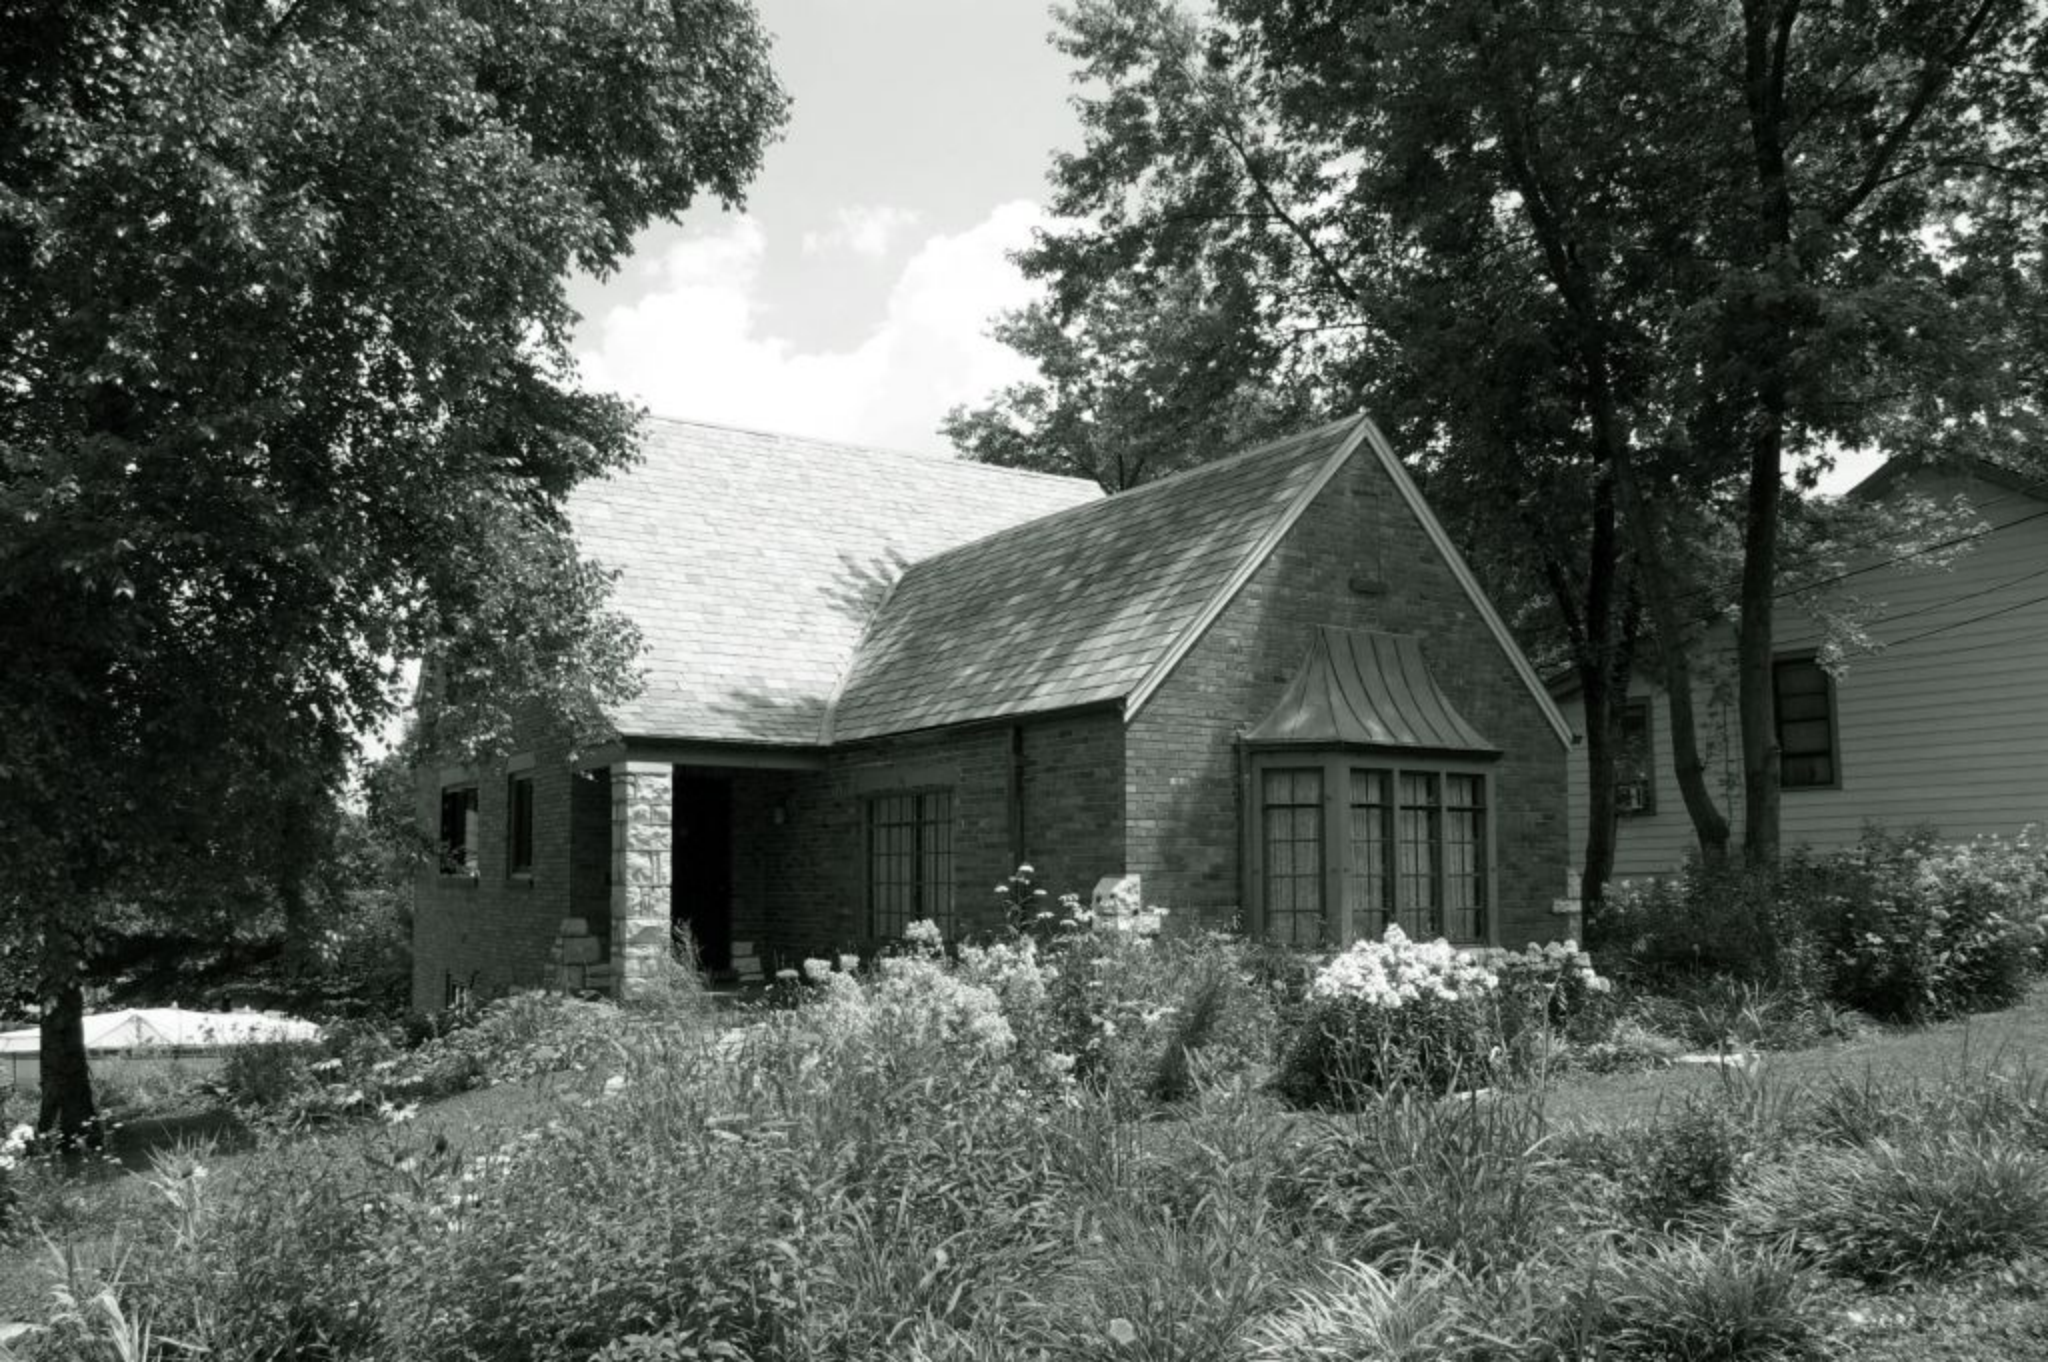
This 1.5 story, side gabled, multicolored brick, Tudor Revival house is deceptively large since the front facade consists of only two bays, one the 1 story, cross gabled wing that has a canted bay window resting on a limestone foundation and facing the street. The other bay consists of a corner recessed entry supported by a square limestone column. The roof is slate and most of the original windows are steel, transomed, multipane casements. Other Tudor Revival features include the limestone wrapping up the corners of the brick walls from the foundation and the massive exterior chimney on the south side of this bay. Since it is positioned on a corner lot that slopes downhill toward the rear, from Wesley, the rear of the house appears to be 2.5 stories high with a one story, side gabled, matching brick, two car garage connected at the northwest corner of the house at the basement level. The rear of the house has a large shed roofed wall dormer and most of the windows on the north side and rear elevation appear to be aluminum replacements with tinted glass.

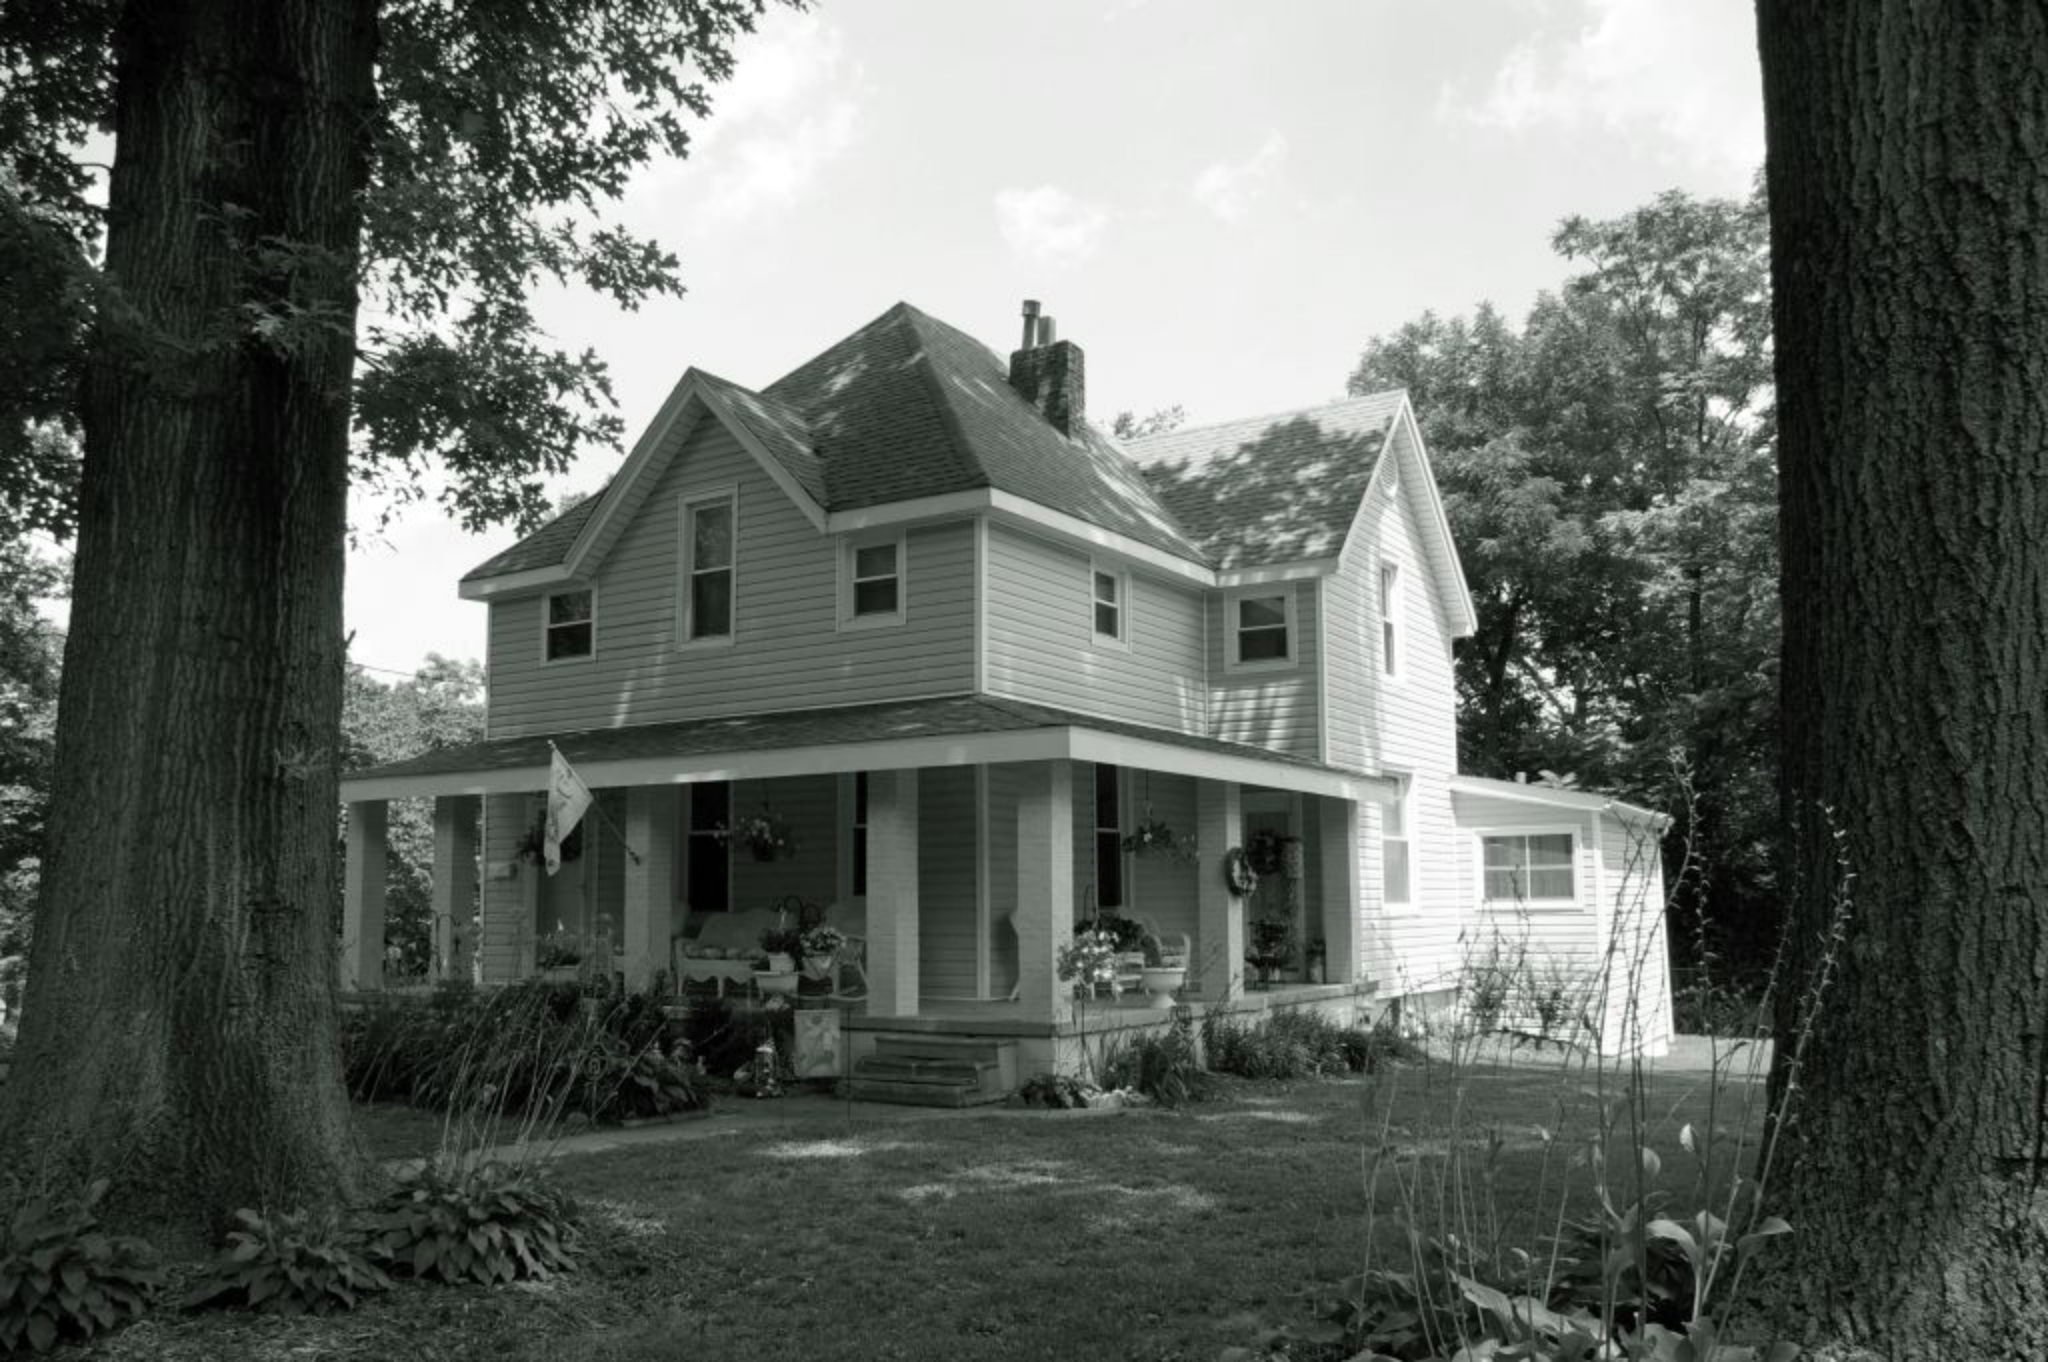
2009 Survey Update

2009 Survey Update: In recent years the house has been resided with vinyl siding and has new vinyl, 1 over 1 windows. The posts supporting the wrap around porch are brick. There is a one story addition on the rear, visible from the front as it extends out on the south side of the house.

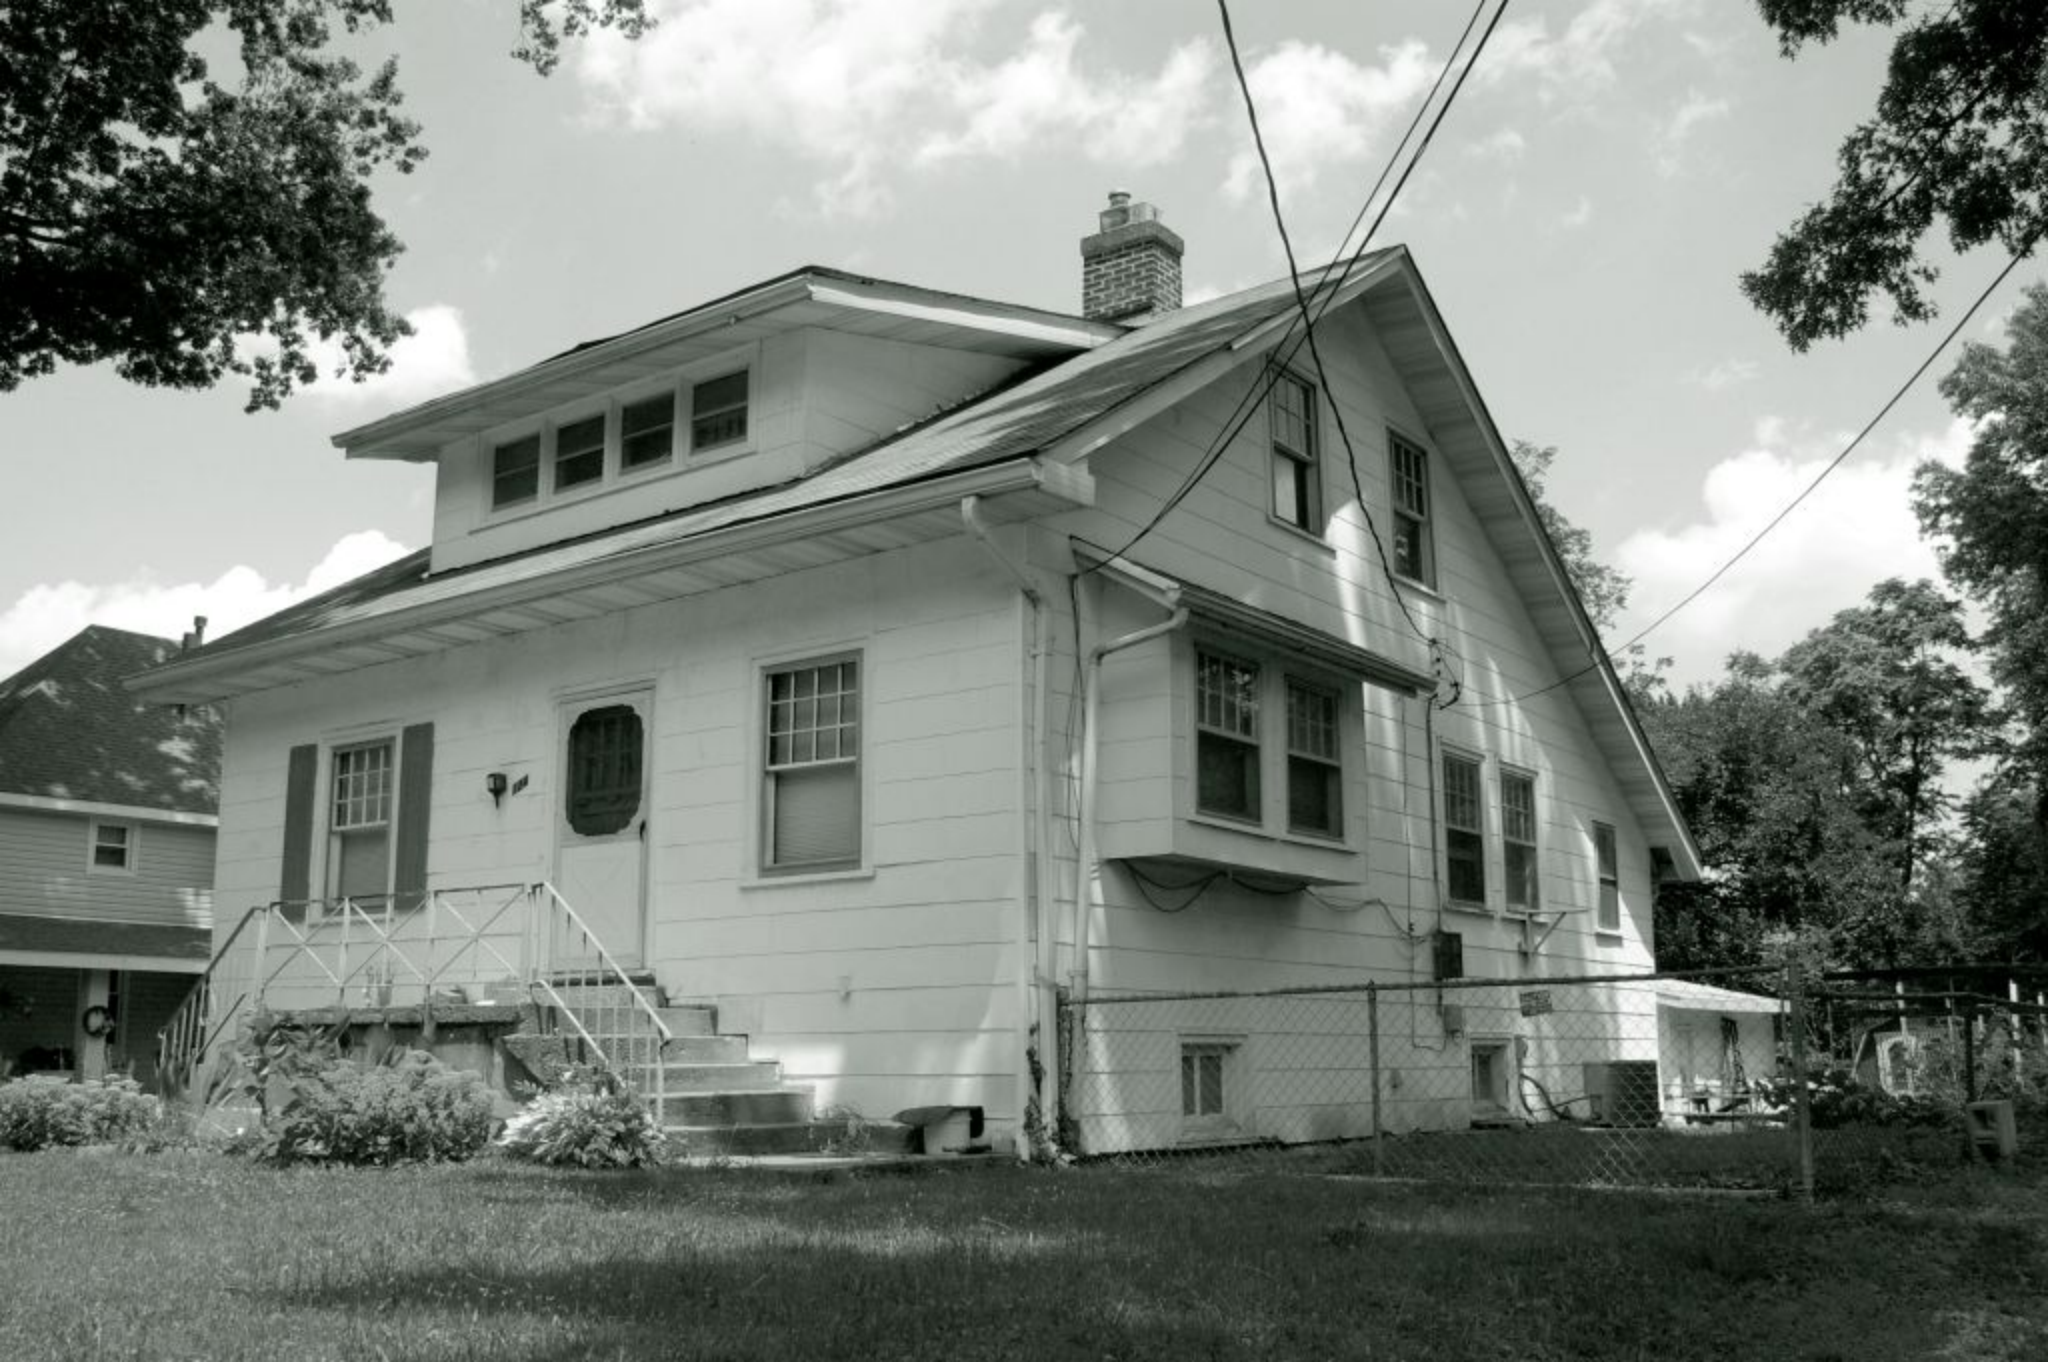
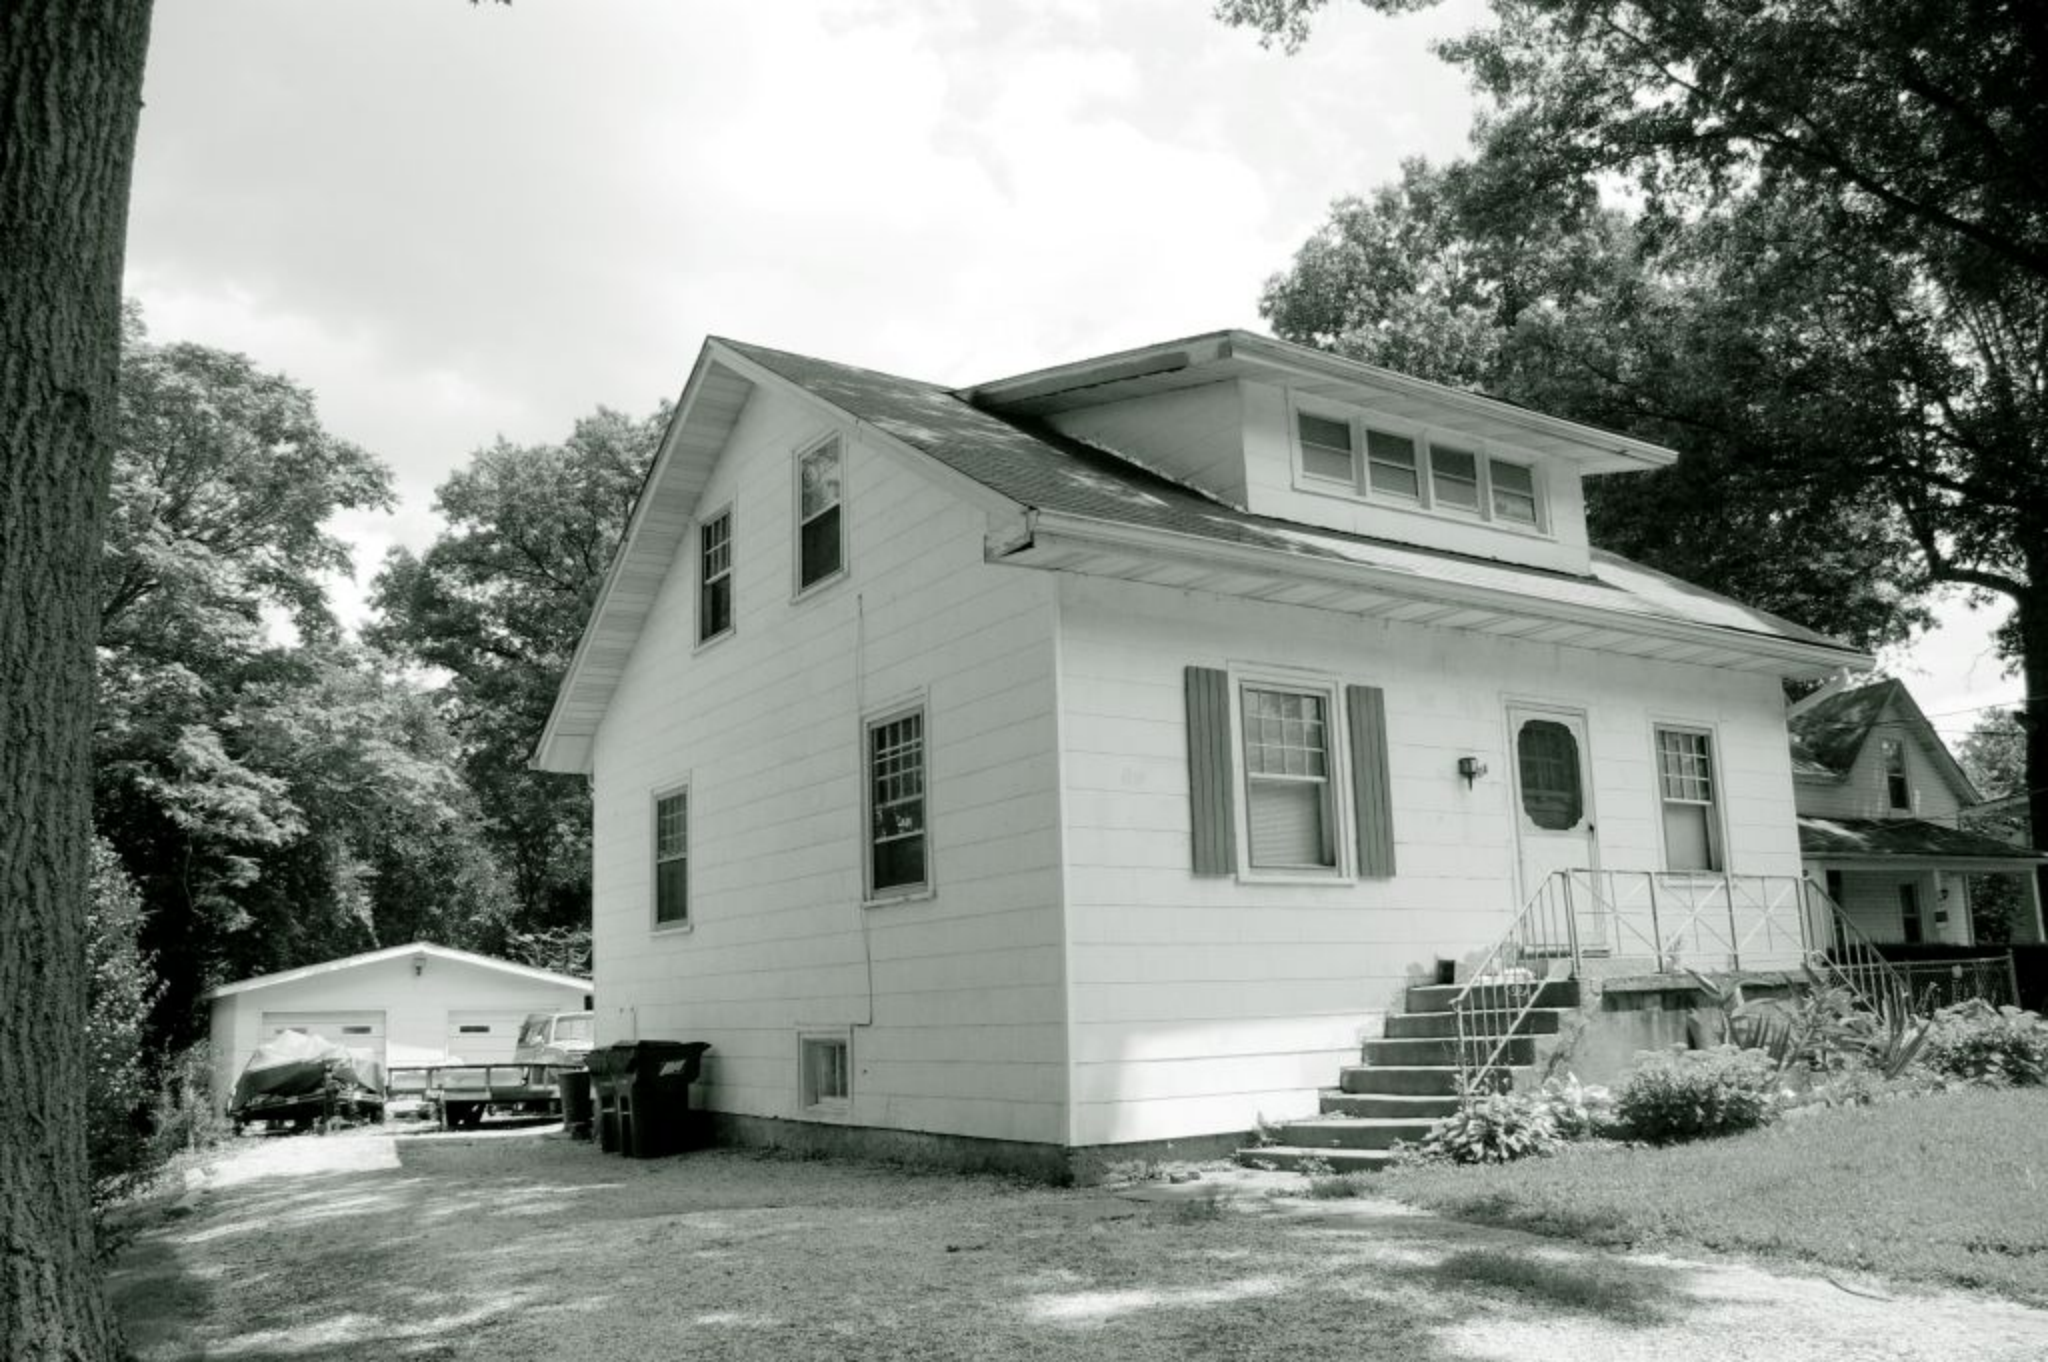
This 1.5 story, side gabled bungalow has a large shed dormer that has wide eaves like the main house. The facade is divided into three bays with wood 12 over 1 sashed windows flanking the simple wood door. The house has been altered drastically, with asbestos siding, aluminum covering what were probably open rafters, storm windows, and a storm door. The front entry stoop with stairs on either side is a post-1950 replacement of what was a one story partial width covered porch according to the 1950 fire map and building features (especially the asymmetrical roofline) which indicates that it used to have a roofed porch positioned under the higher eave on the facade. There is still a shed roofed, oriel window on the south side.

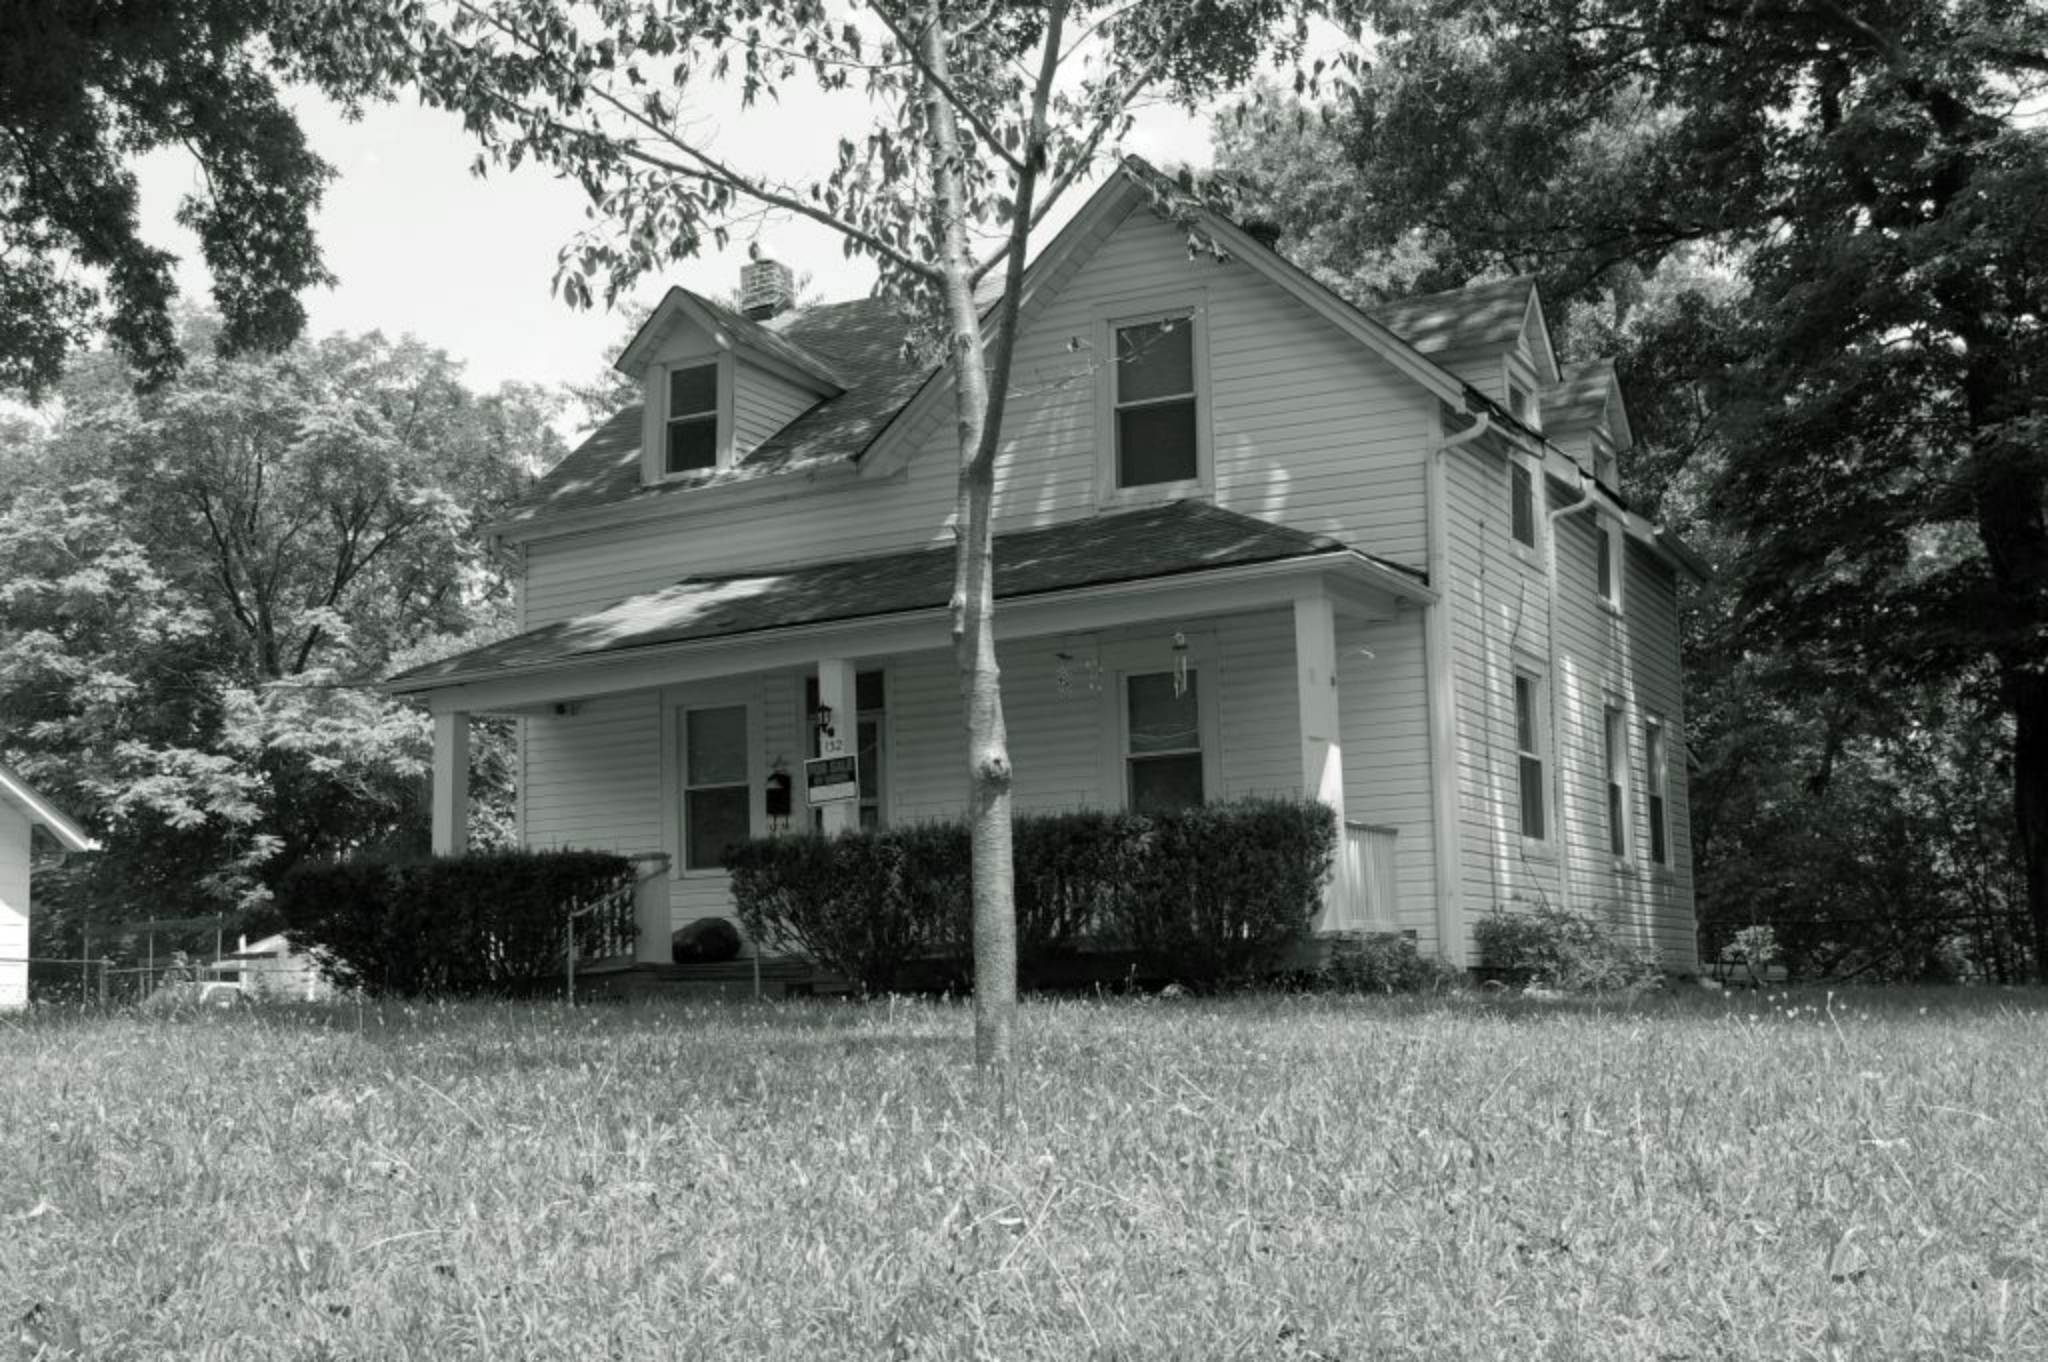
2009 Survey Update: Since the previous survey, the aluminum siding has been replaced with vinyl siding, but it still retains the old wood sashed windows and porch railing.

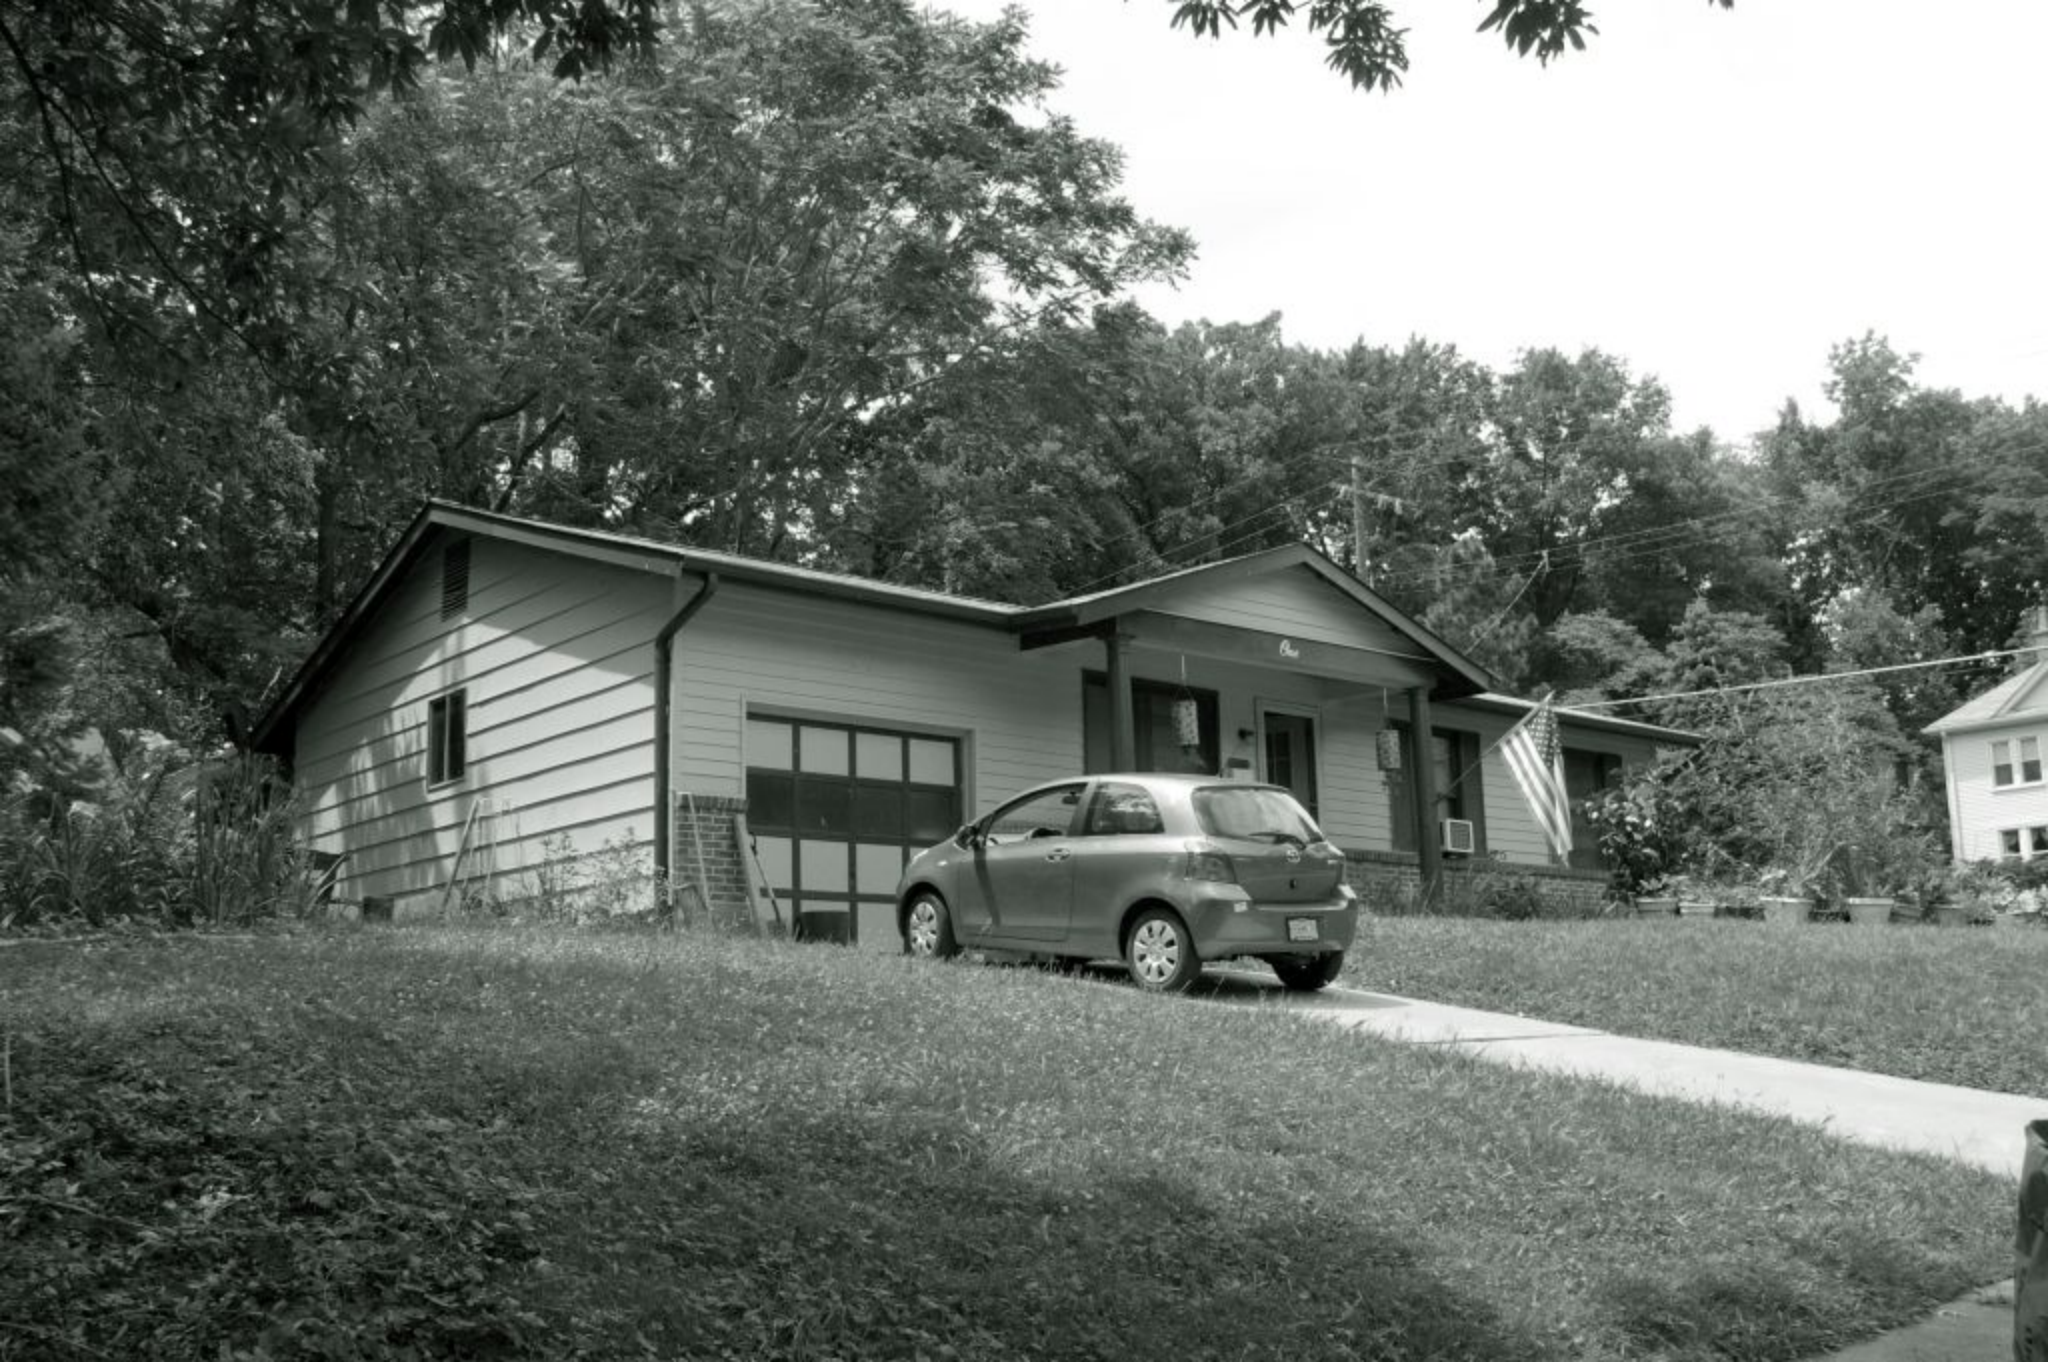
This simple Ranch, one story, side gabled house with its wide eaves and cross gable over the entry porch retains the original brick at the base of the facade but what was probably originally aluminum siding elsewhere (and still evident on the side elevations) has been partially replaced with narrow vinyl siding. The four bay facade incorporates the original paneled garage door in the south bay next to the entry bay with the gabled roof supported by the simple wood posts and poured concrete porch floor with a large plate glass picture window next to the simple entry door. The other two bays have shuttered, 1 over 1 sashed windows. The door has a full light storm door and the plate glass window appears to be a replacement while the original wood windows have metal storm screens.

note: the house is a simple ranch design.

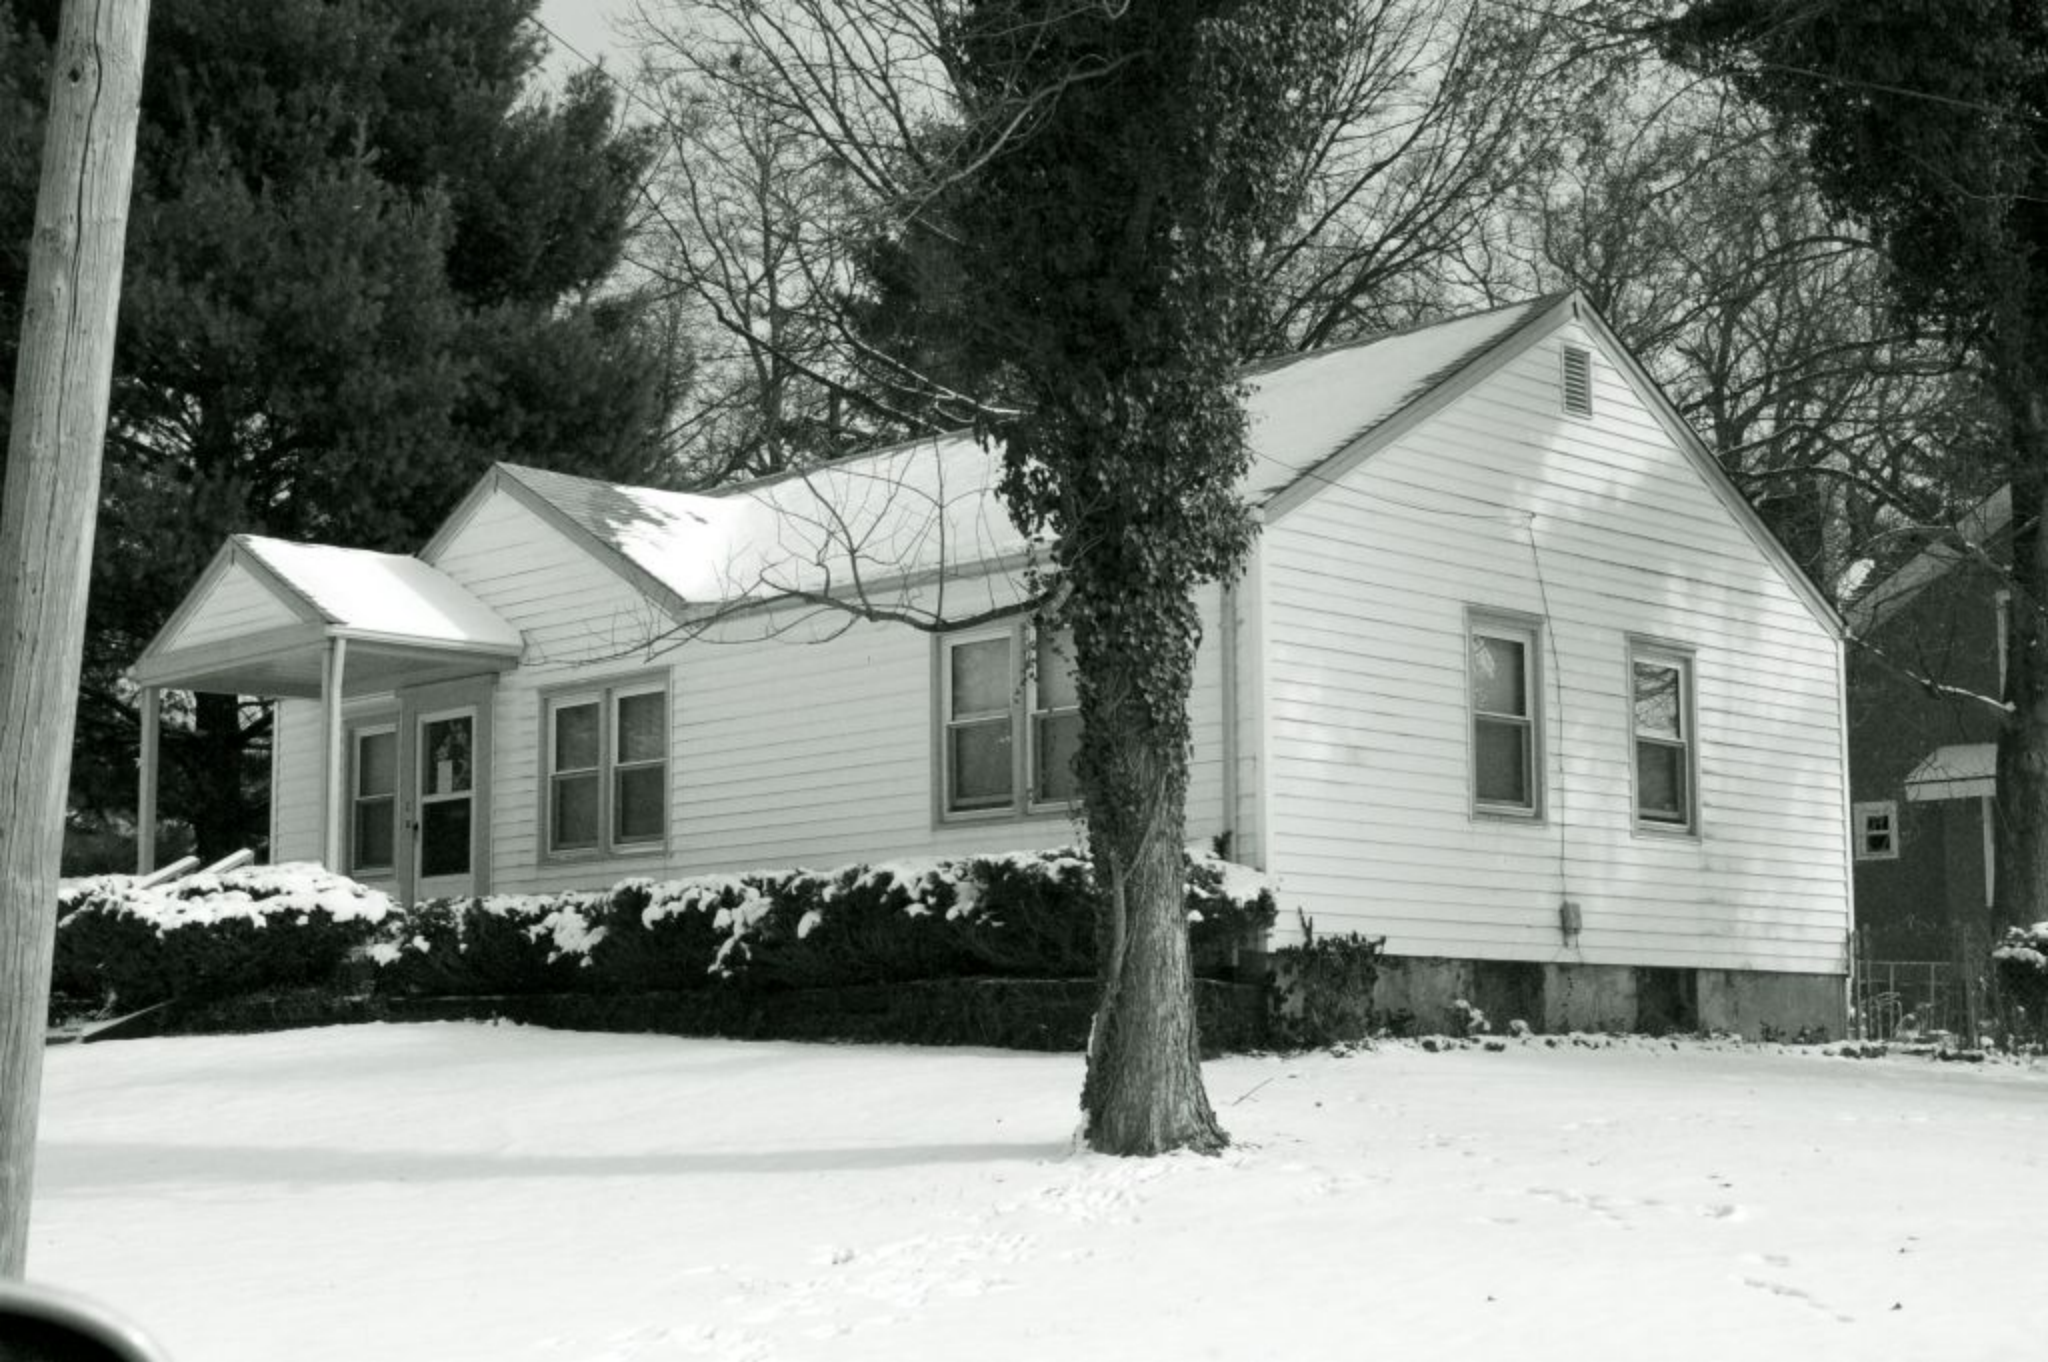
This simple, Minimal Traditional house has a shallower pitched side gabled roof with a cross gable over the entry bay and adjacent bay of windows. In front, spanning the simple entry door and the adjacent sashed window is a small gabled entry porch supported by square corner posts on a low concrete base. The adjacent bay has paired 1 over 1 sashed windows and at the far south end of the facade there is another pair of sashed windows. The house has had vinyl siding and newer vinyl windows installed in recent years, but it retains the original form and elements that distinguish as a Minimal Traditional design. There is a breezeway connection to the attached garage on the rear.
