ARCHITECTURAL/HISTORIC INVENTORY FORM

1. Survey No. SL-AS-036-001		2. Survey Name: Architectural Survey of Old Ferguson West	
3. County: St. Louis		4. Address: 1 Carson Rd.	
5. City: Ferguson	Vicinity: <input type="checkbox"/>	6. UTM:	7. Township/Range/Section
8. Historic name (if known):		9. Present/other name (if known): Whistle Stop	
10. Ownership: <input type="checkbox"/> Private <input checked="" type="checkbox"/> Public		11. Historic use (if known): TRANSPORTATION/rail-related	11. Current use: COMMERCE/restaurant & RECREATION/museum

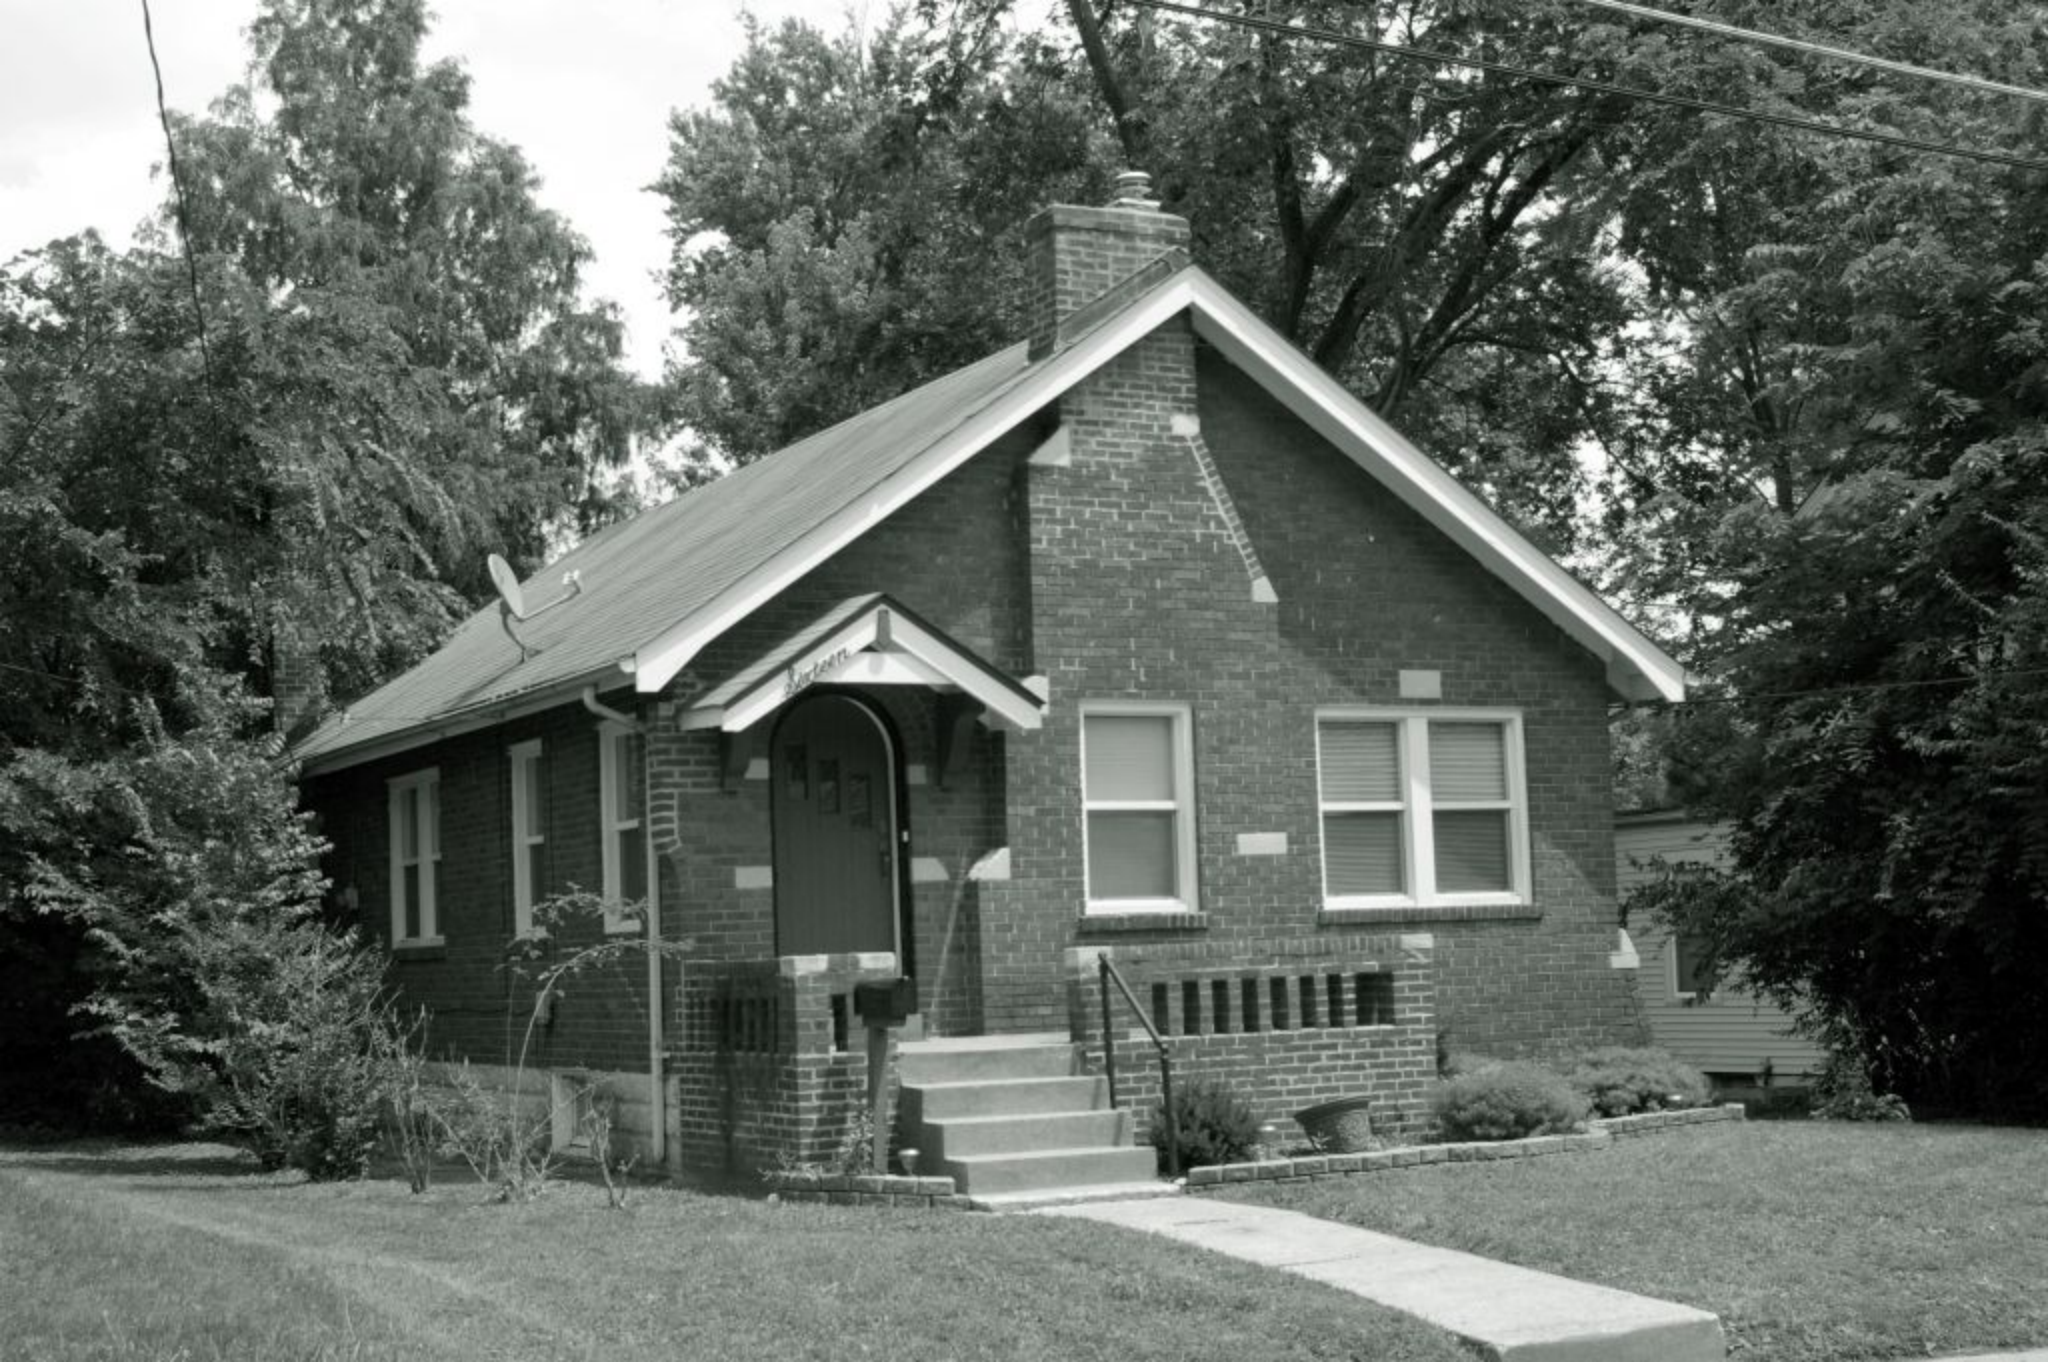
This one story, end gabled, red brick Tudor Revival house has a shallower pitched roof than normally associated with this style, but has details that are distinctly associated with this style. The center bay has an end wall chimney with sloped side that includes a sashed window in the face of the chimney, there are scattered stones as decorative details on the chimney and elsewhere on the facade, the bay to the north of the chimney has a gabled roof covering the entry stoop and the round arched wood plank door, and the pierced brick half wall railings of the entry stoop extend across both the entry and chimney bay, and there is a small brick and stone wing wall on the south corner of the facade. To the south of the chimney, the other facade bay has paired sashed windows. The windows have been replaced however with vinyl 1 over 1 windows, impacting the historic integrity of what was probably originally a more elaborate window pattern. Unfortunately, the chimney and entry porch have been repointed with nonmatching mortar.

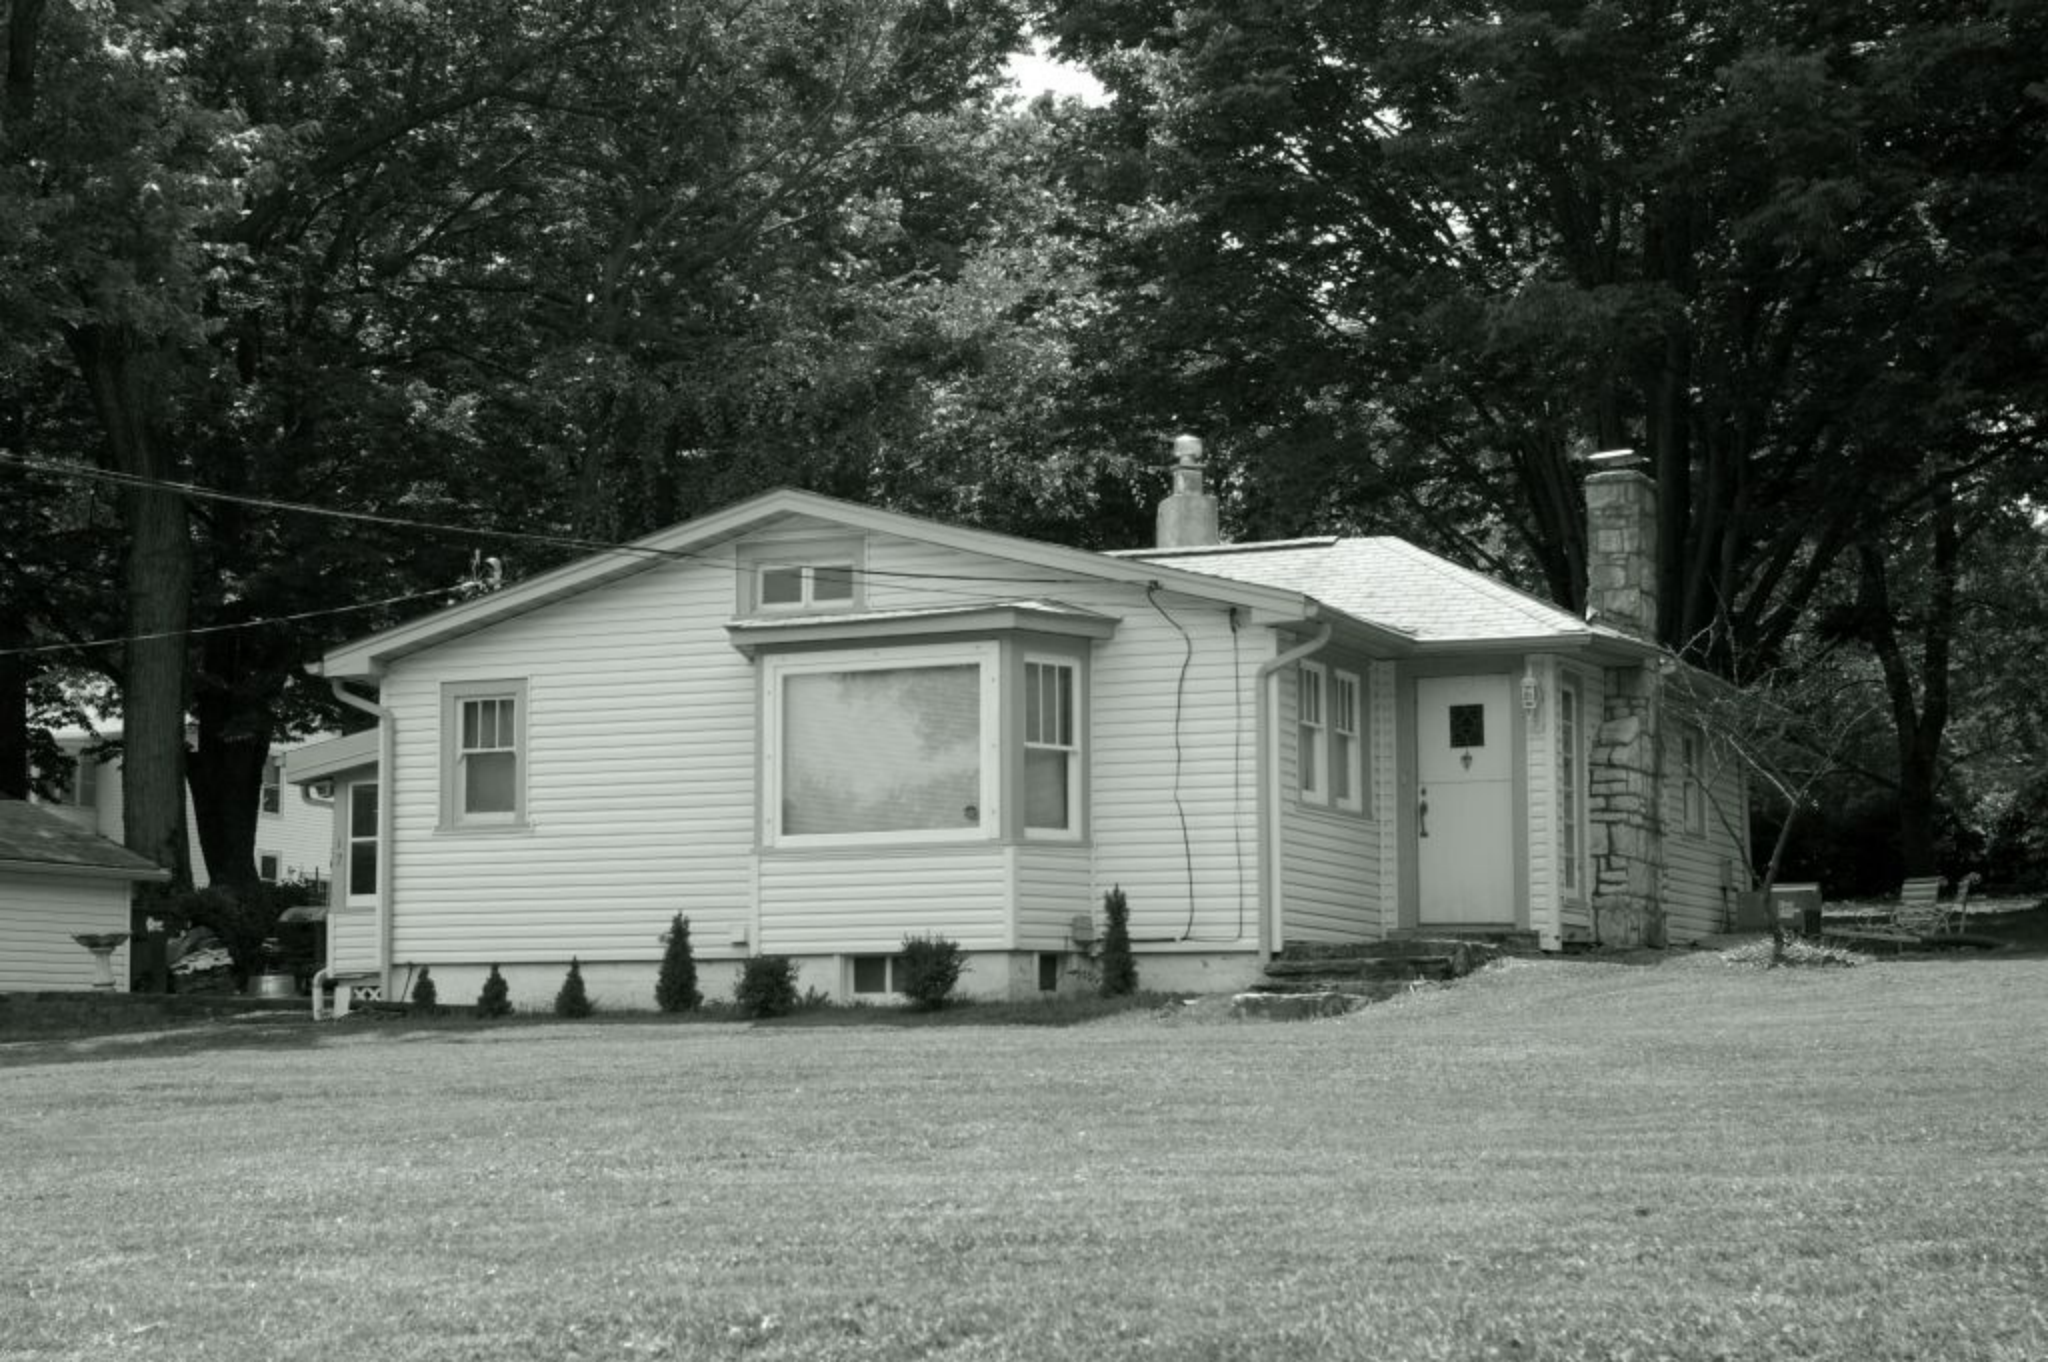
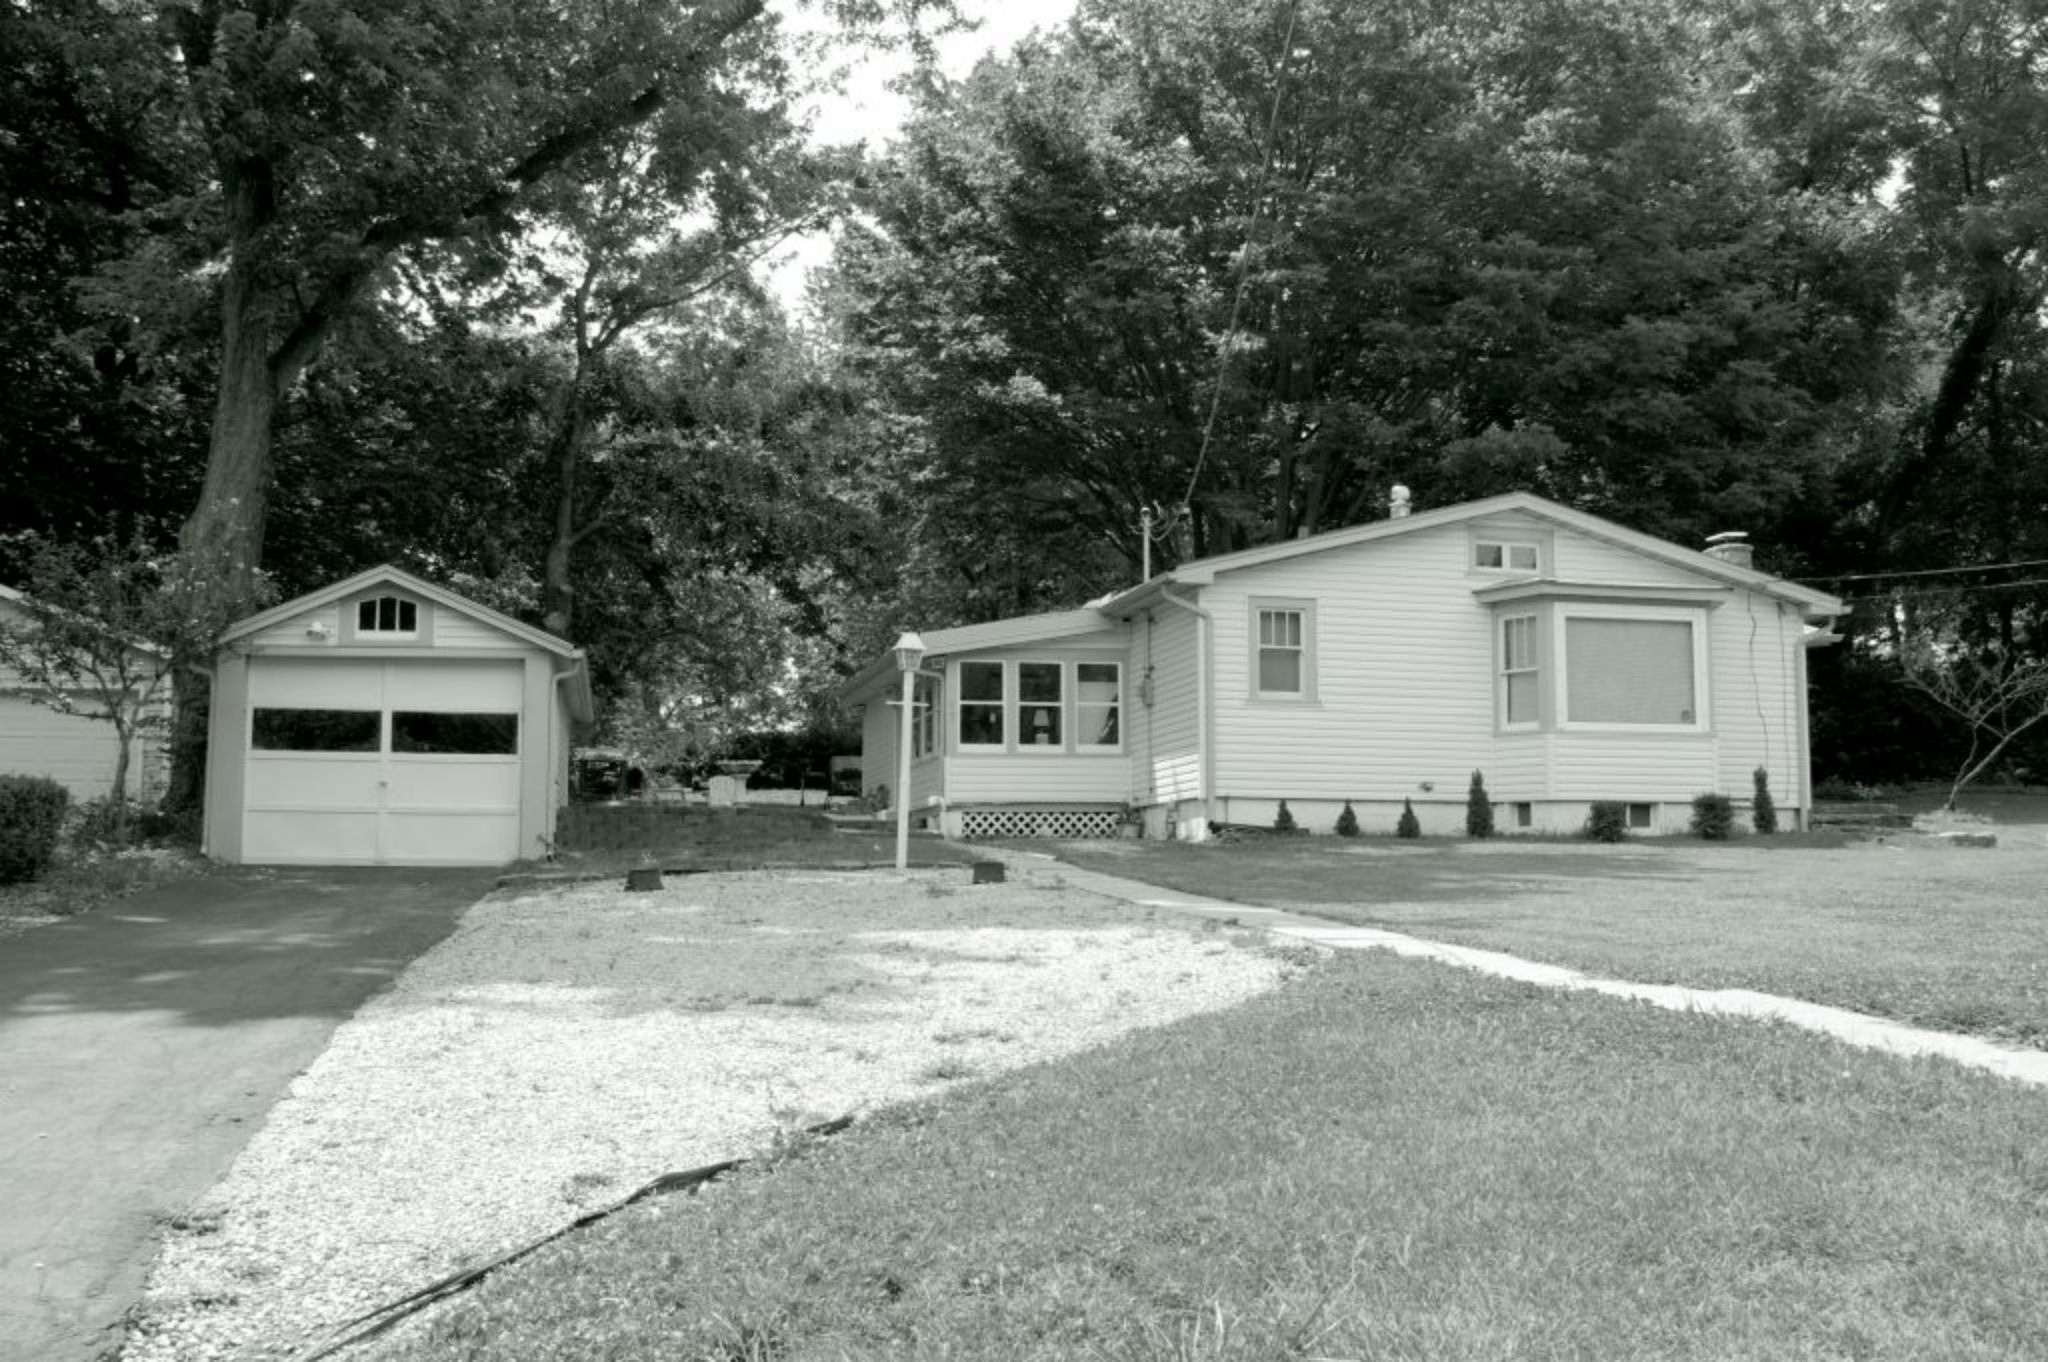
This one story house has been modified over the years but appears to have originally been a Craftsman bungalow in design given the remaining broad cross gabled wing on the front and the 3 over 1 windows, both distinctive features of this style. However, the main house is a flattened hipped roof with a side-shed roofed sunroom on the south side. The facade is divided into four bays across the facade with the cross gabled front wing incorporating two of these bays, the south one with the 3 over 1 window and the north one with a canted gable bay with similar sashed windows on each side and a replacement, plate glass window across the facade. Above there is the typical 2-light attic window often seen in simple bungalows. The sunroom is recessed behind this front gabled wing on the south side and in the hipped portion, recessed on the north side is the simple entry door and stoop. Some windows have been replaced with vinyl 1 over 1 windows and the house has newer vinyl siding which makes it difficult to identify the original elements, but it appears that the original porch is missing on the front and that the house may have been built in two stages (hipped roof separate from the gabled section).

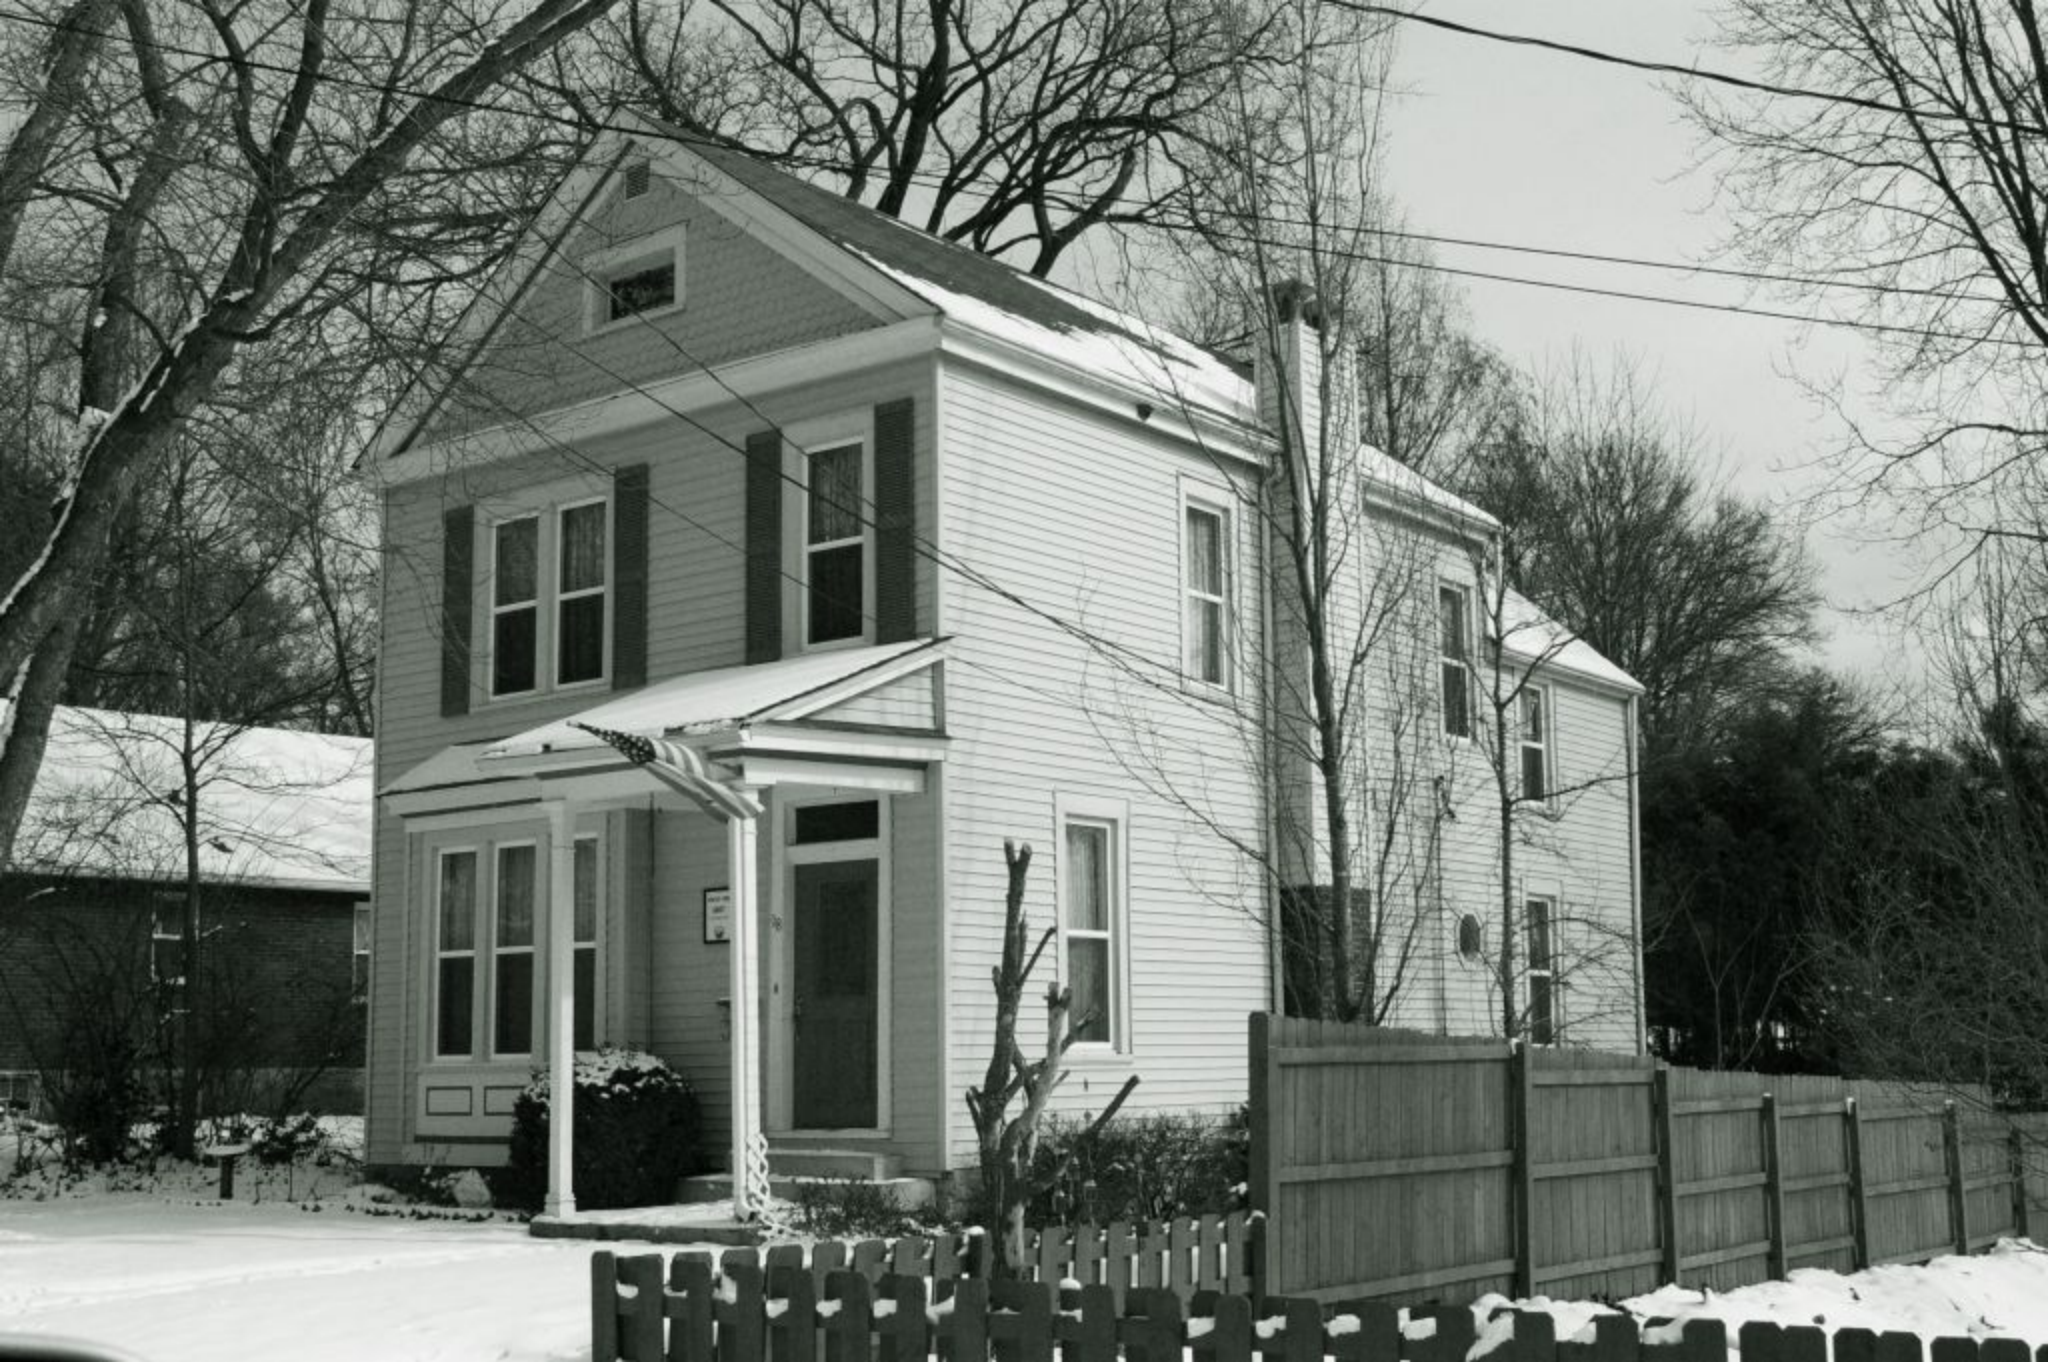
2009 Survey Update: Since the previous survey, the siding identified as asphalt shingles has been replaced with vinyl siding, but the fishscale shingles in the gable end were retained. The new vinyl siding carefully maintained the window trim exposure and decorative details below the front bay window as well and since the siding seems to more closely approximate the original siding rather than the asphalt siding, the house actually now appears more like it did historically. The original 1 over 1 windows have been replaced with new vinyl sashed windows. The small shed roofed porch may be a replacement because the fire insurance maps in both 1931 and 1950 show there was a wrap-around porch at this corner.

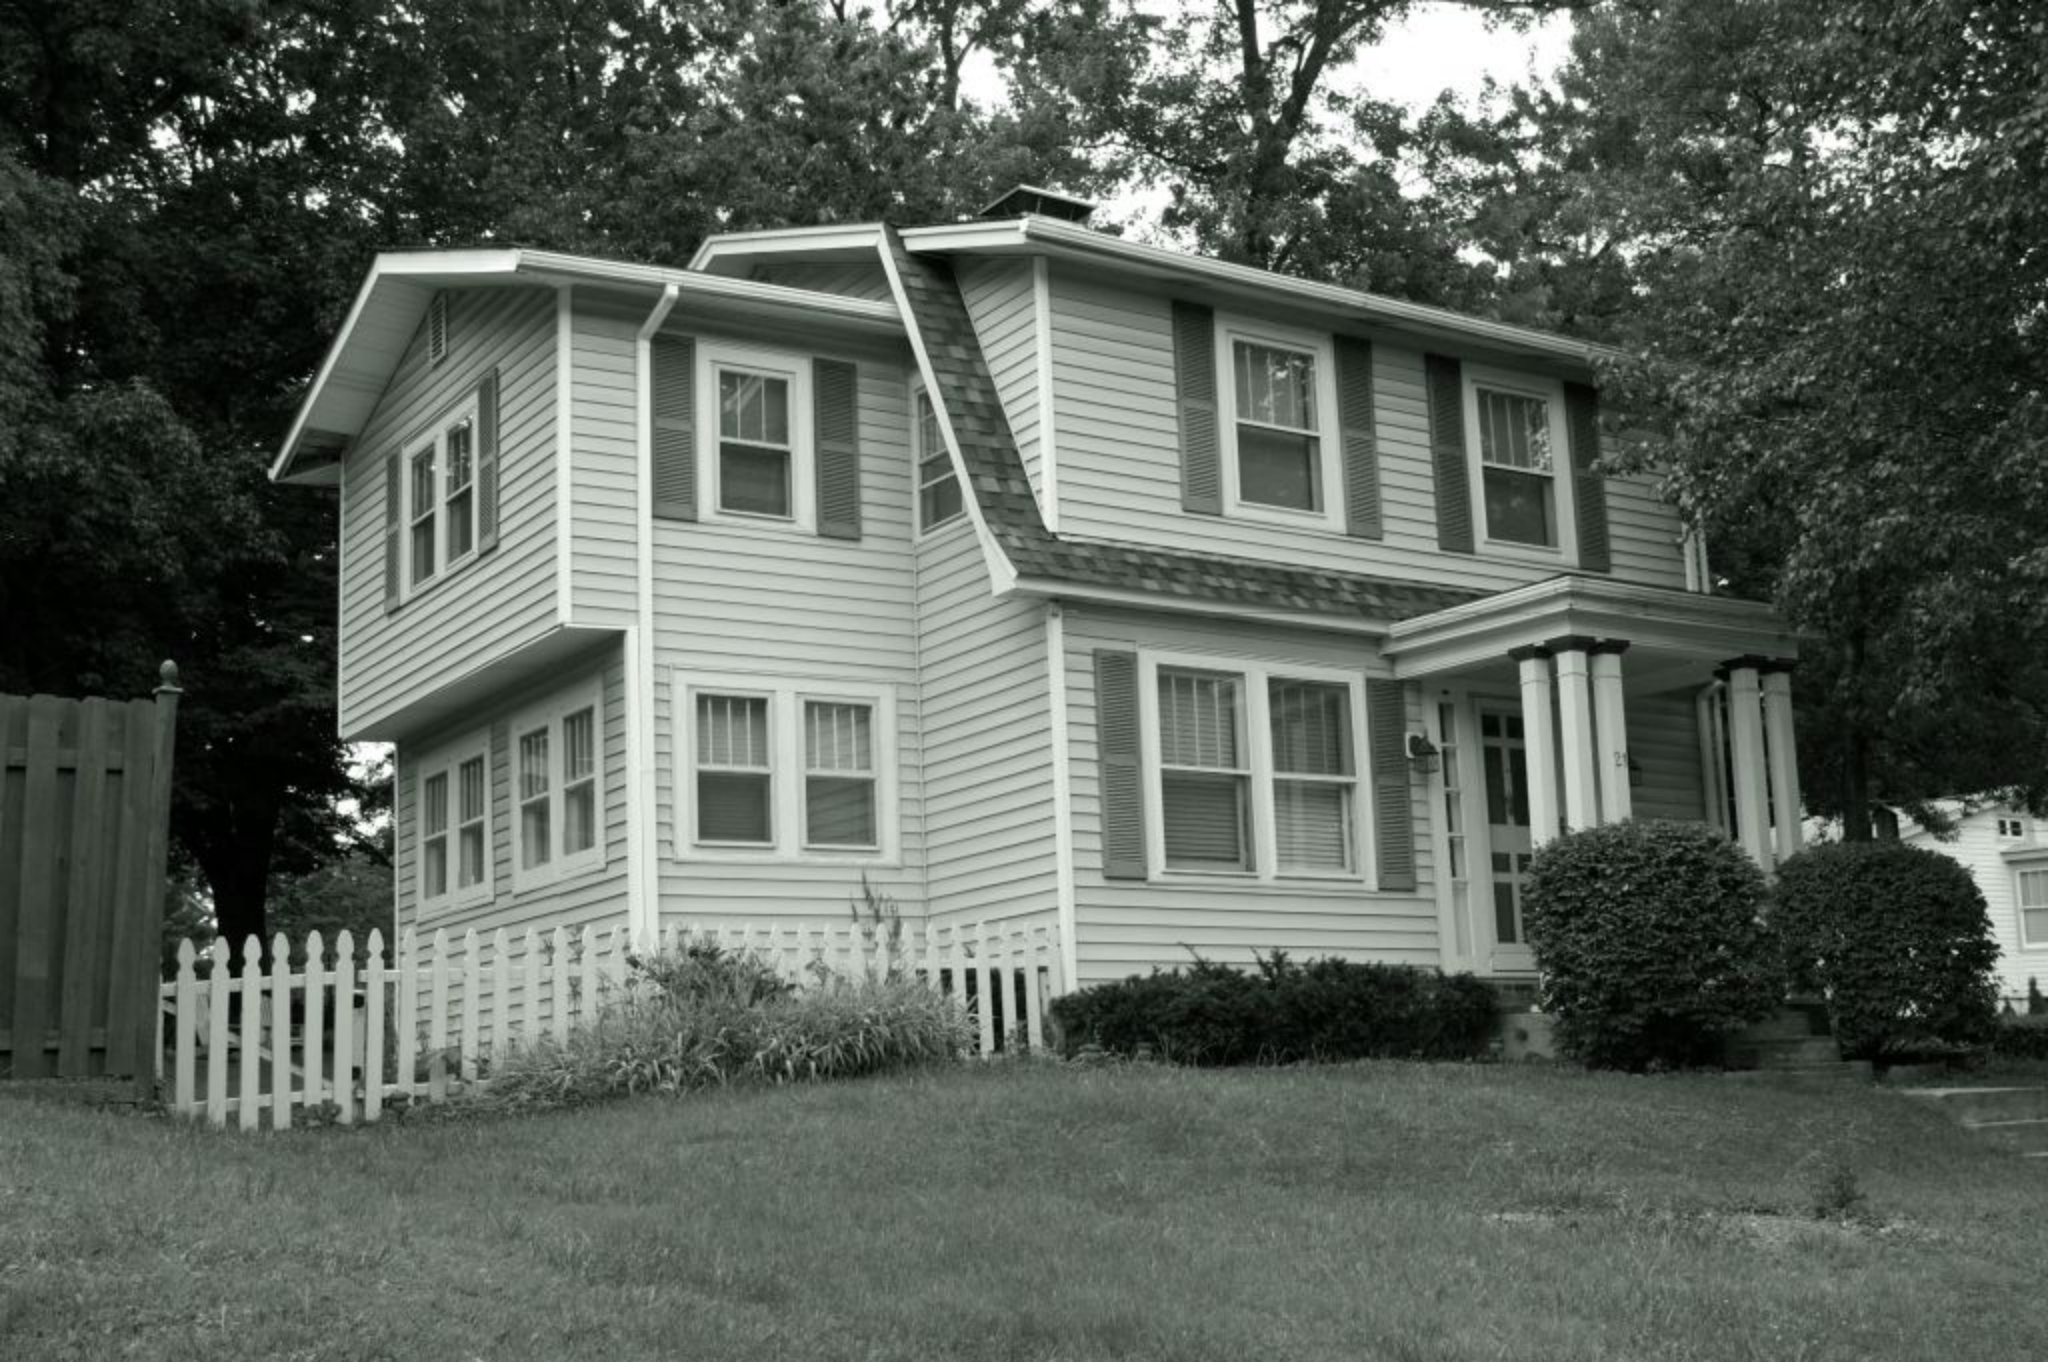
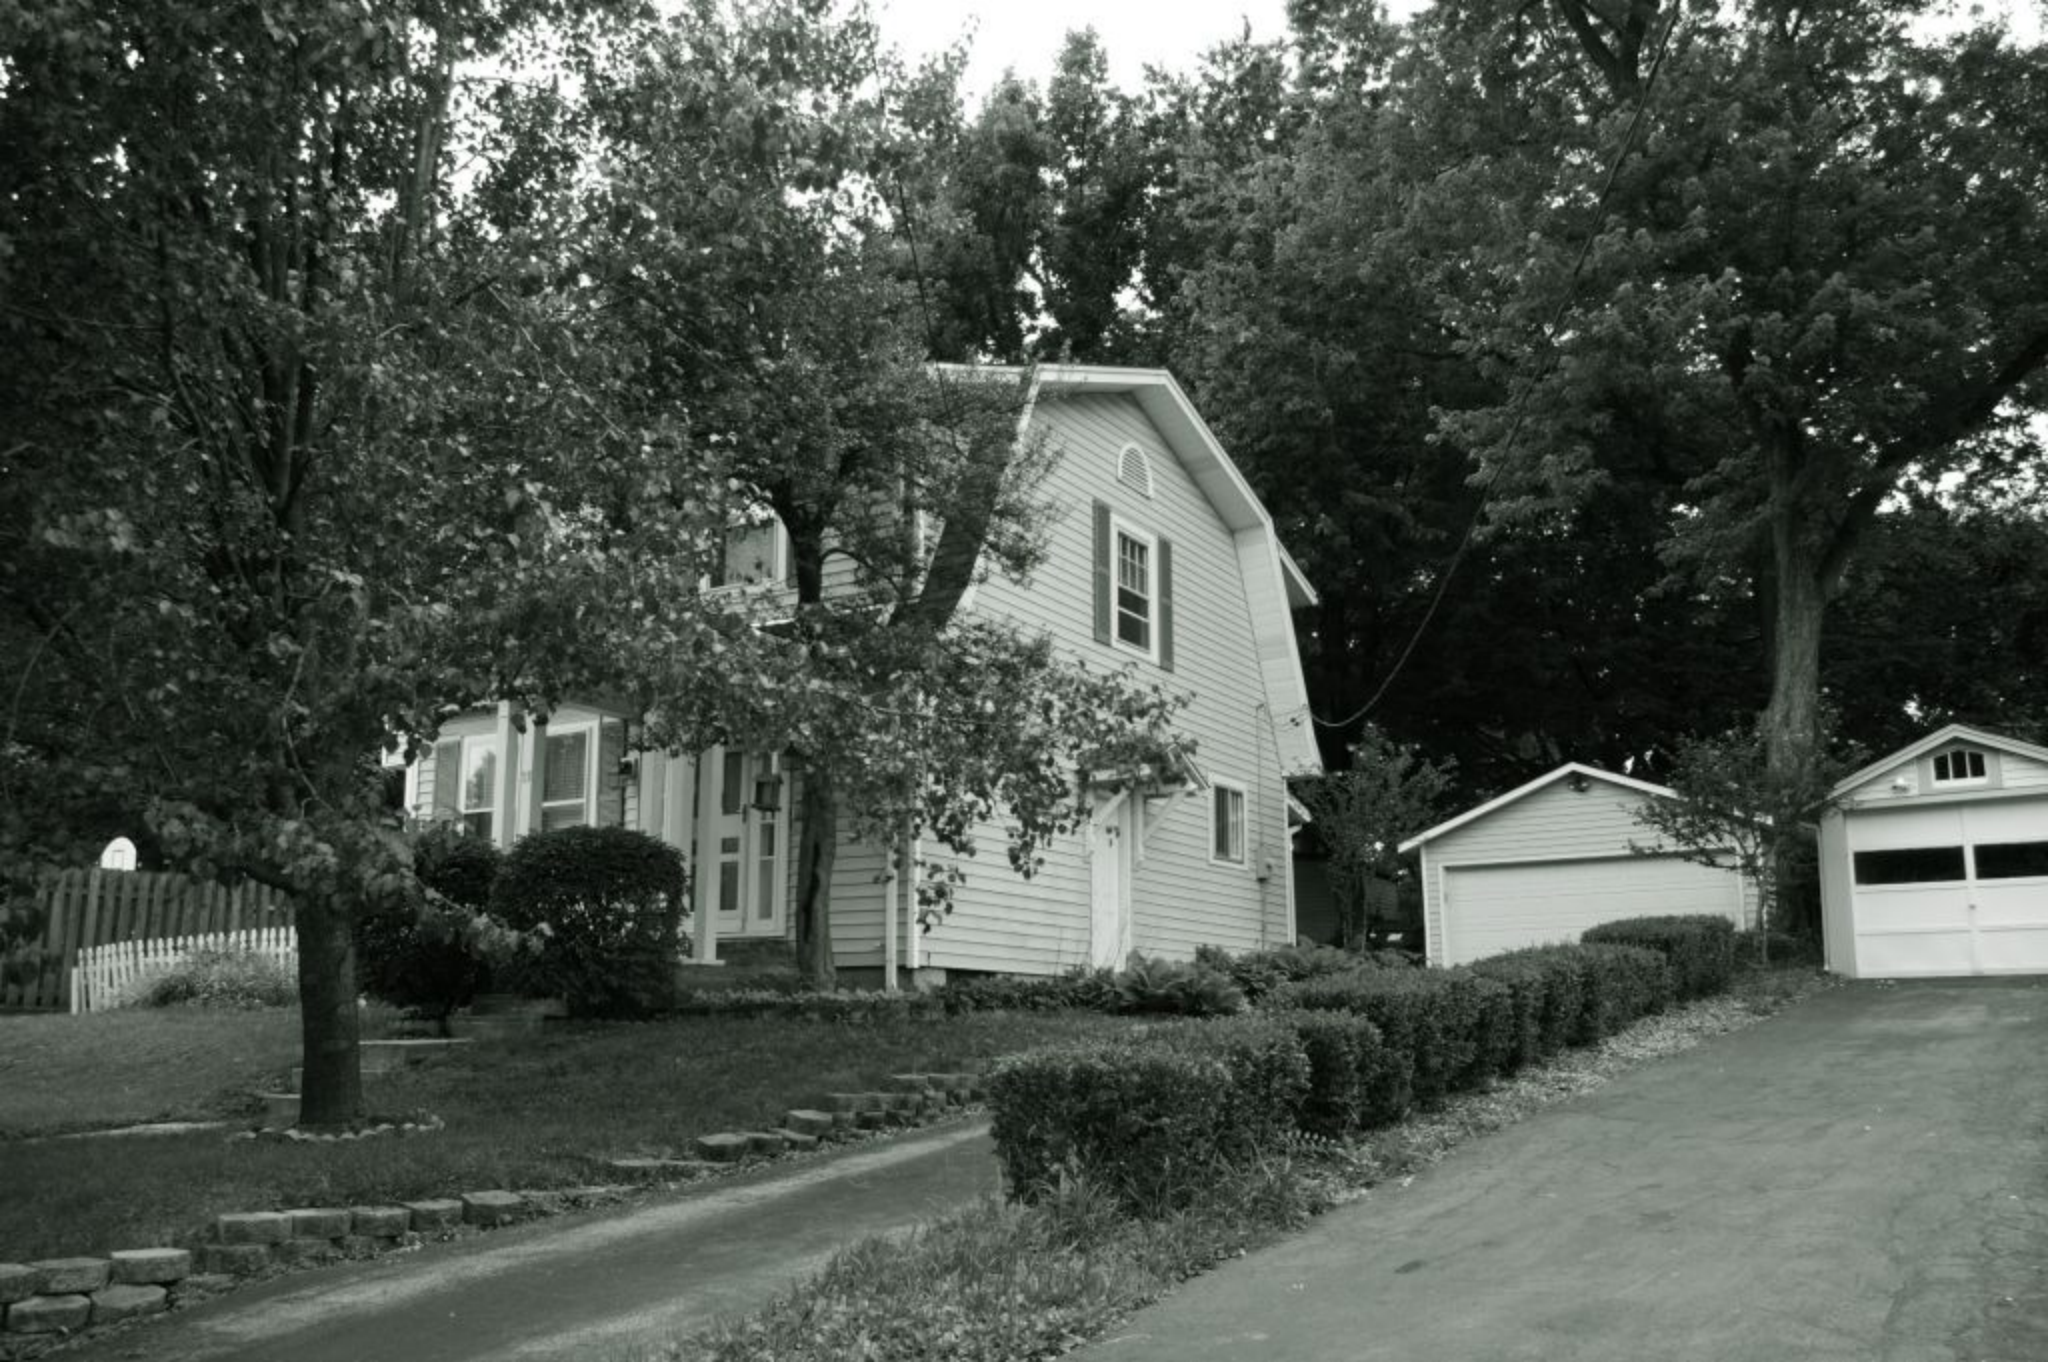
This two story, frame, Dutch Colonial Revival house has a large shed dormer on the facade with two windows in the dormer. To the south of the main house is a two story side gabled roof wing with a second floor overhang facing south. The first floor of the facade has paired windows in the south bay and a flat roofed portico in the east bay. This portico has clusters of three square stylized columns at each outer corner supporting the entablature and roof of the portico. The entry door is the original paneled wood door with simple sidelights. The upper sashes of the original wood windows have vertical muntins and most facade windows have shutters, another Colonial Revival feature. An indication of the arrival of the automobile in importance, there is a knee braced gabled roof over a side entry door on the north side to access the adjacent driveway. The house has been re-sided with vinyl siding in recent years and there are storm windows on most windows.

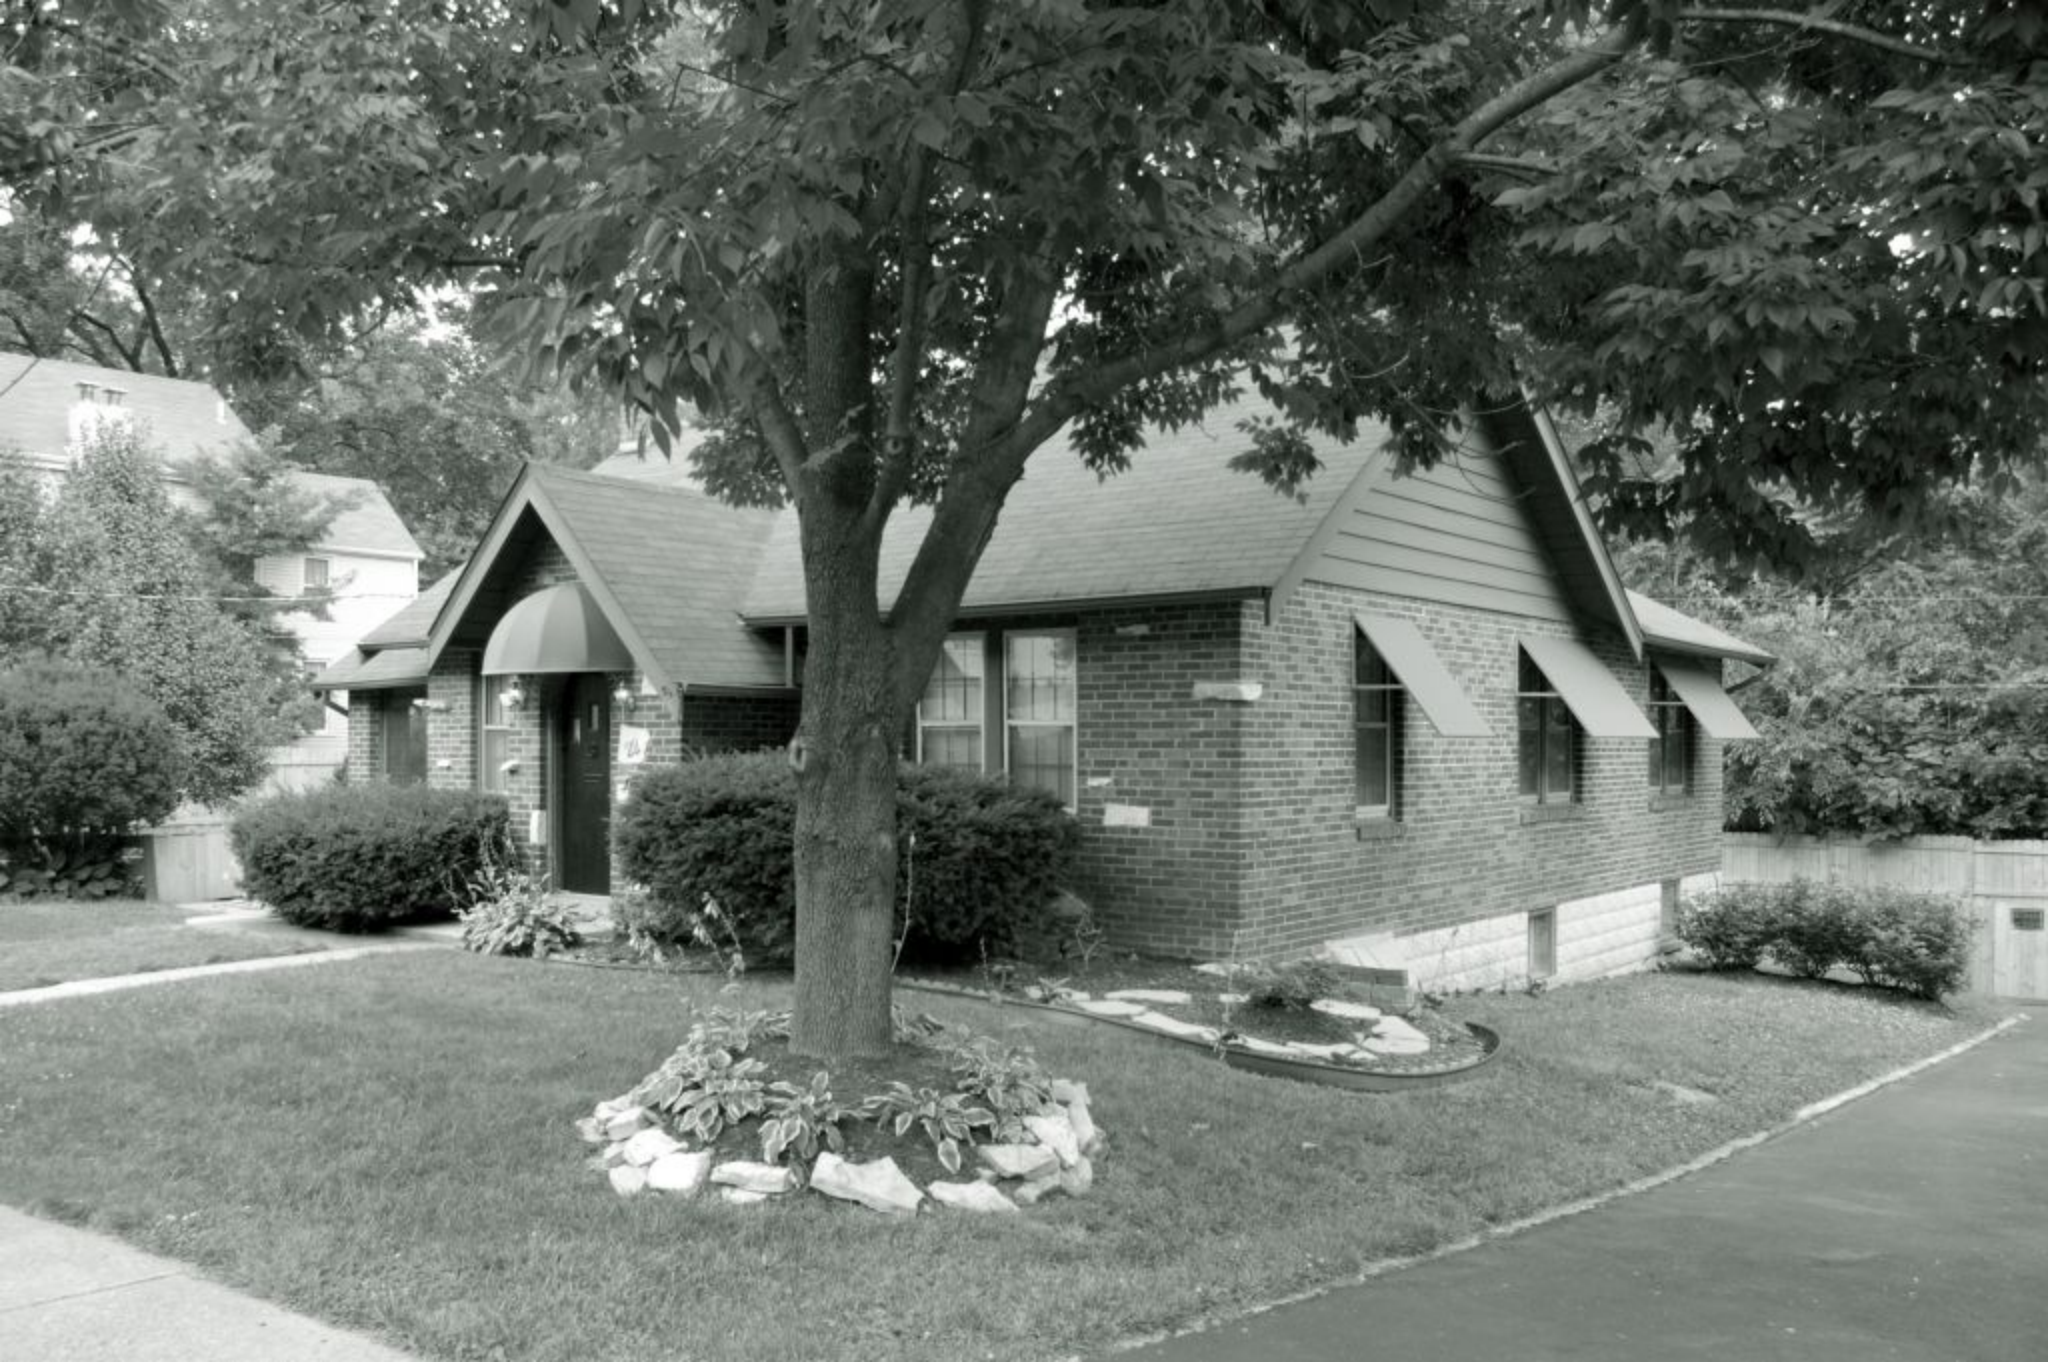
This one story, side gabled house is a good example of a Minimal Traditional design that still shows strong influences of the Tudor Revival style. It has a lower pitched roof and profile than Tudor Revival houses but it still has a more complex roofline with a lower side gabled wing to the north of the main three bay facade. Unlike Tudor Revival designs, the main facade is symmetrical with a cross gabled entry vestibule centered on the facade and with the flanking bays having paired, 6 over 6 wood sashed windows with aluminum storm screens. The entry door is a wood plank door with a round arched top and there are scattered stones on the brick facade, more Tudor Revival details. Unlike Tudor Revival designs, the gable ends have simple wood siding and the chimney is nestled between the north wing and main roof at the ridge. There is a garage in the basement accessed from the rear of the house and the driveway on the south side of the property. Besides the aluminum storm screens, the only visible alteration is the use of awnings on the south windows and over the entry door, which obscure the details of the vestibule.
