ARCHITECTURAL/HISTORIC INVENTORY FORM

1. Survey No. SL-AS-036-001		2. Survey Name: Architectural Survey of Old Ferguson West	
3. County: St. Louis		4. Address: 1 Carson Rd.	
5. City: Ferguson	Vicinity: <input type="checkbox"/>	6. UTM:	7. Township/Range/Section
8. Historic name (if known):		9. Present/other name (if known): Whistle Stop	
10. Ownership: <input type="checkbox"/> Private <input checked="" type="checkbox"/> Public		11. Historic use (if known): TRANSPORTATION/rail-related	11. Current use: COMMERCE/restaurant & RECREATION/museum

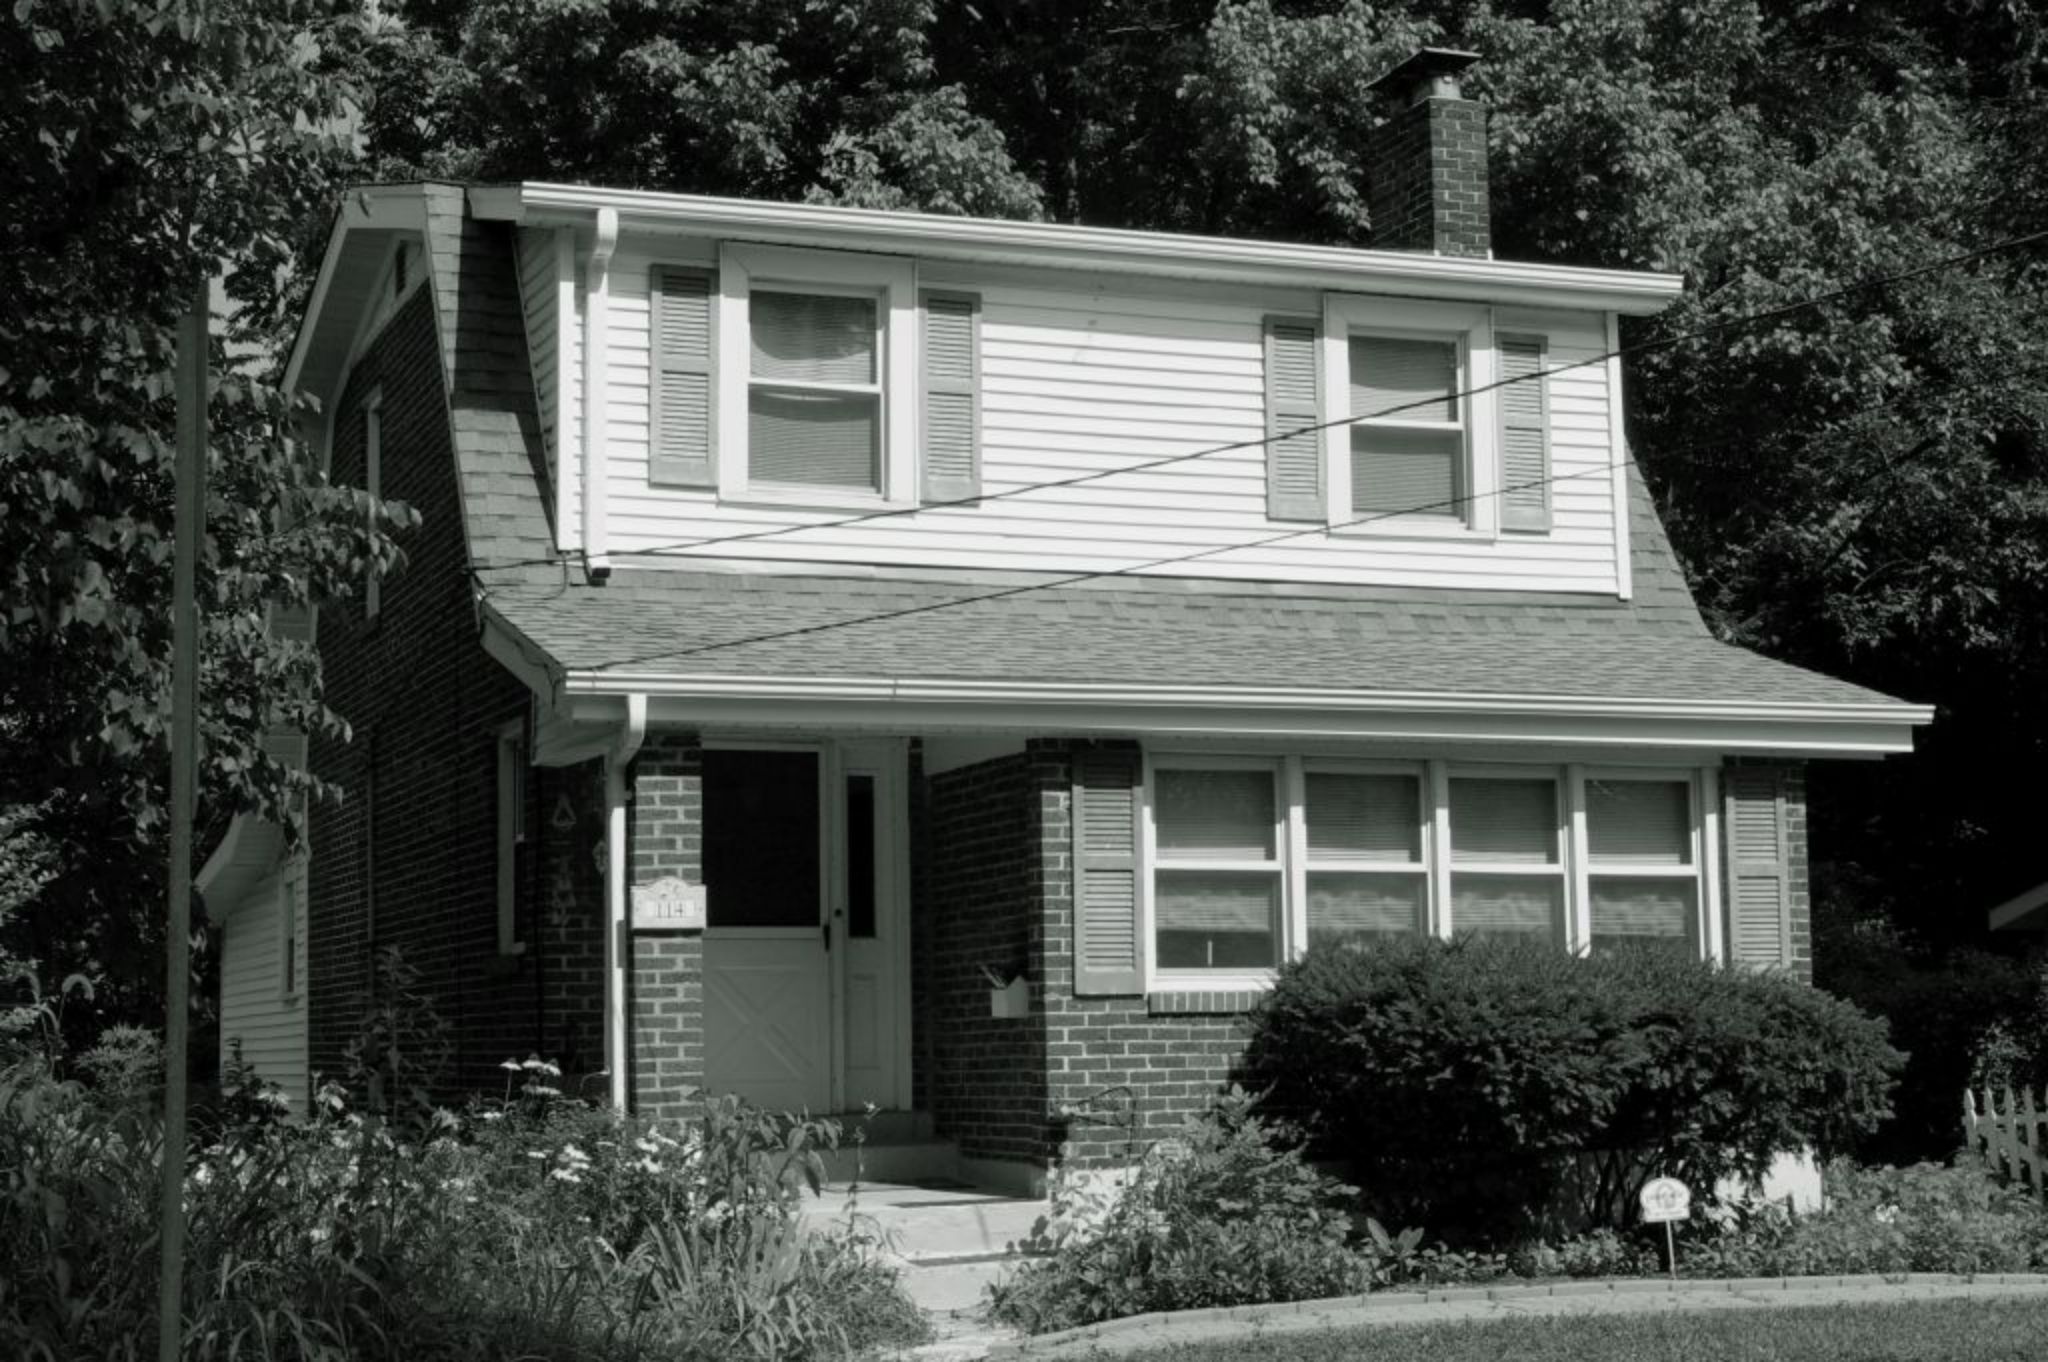
This two story, bellcast gambrel roofed, brick house has a concrete foundation and a two bay facade. There is a large shed dormer spanning the facade with shuttered 1 over 1 wood windows (with storm screens) and shutters. Below, there is a recessed porch in the north corner which creates a partially open porch with a brick corner pier and brick half wall railing along the side of the concrete porch floor. The rest of the first floor facade is spanned by a cluster of four 1 over 1 wood windows which are flanked by shutters as well. On the south side of the house is an end wall brick chimney that pierces through the roof and behind the chimney is a hipped roof, flat bay window. The bay, soffits, and dormer have been clad in vinyl siding.

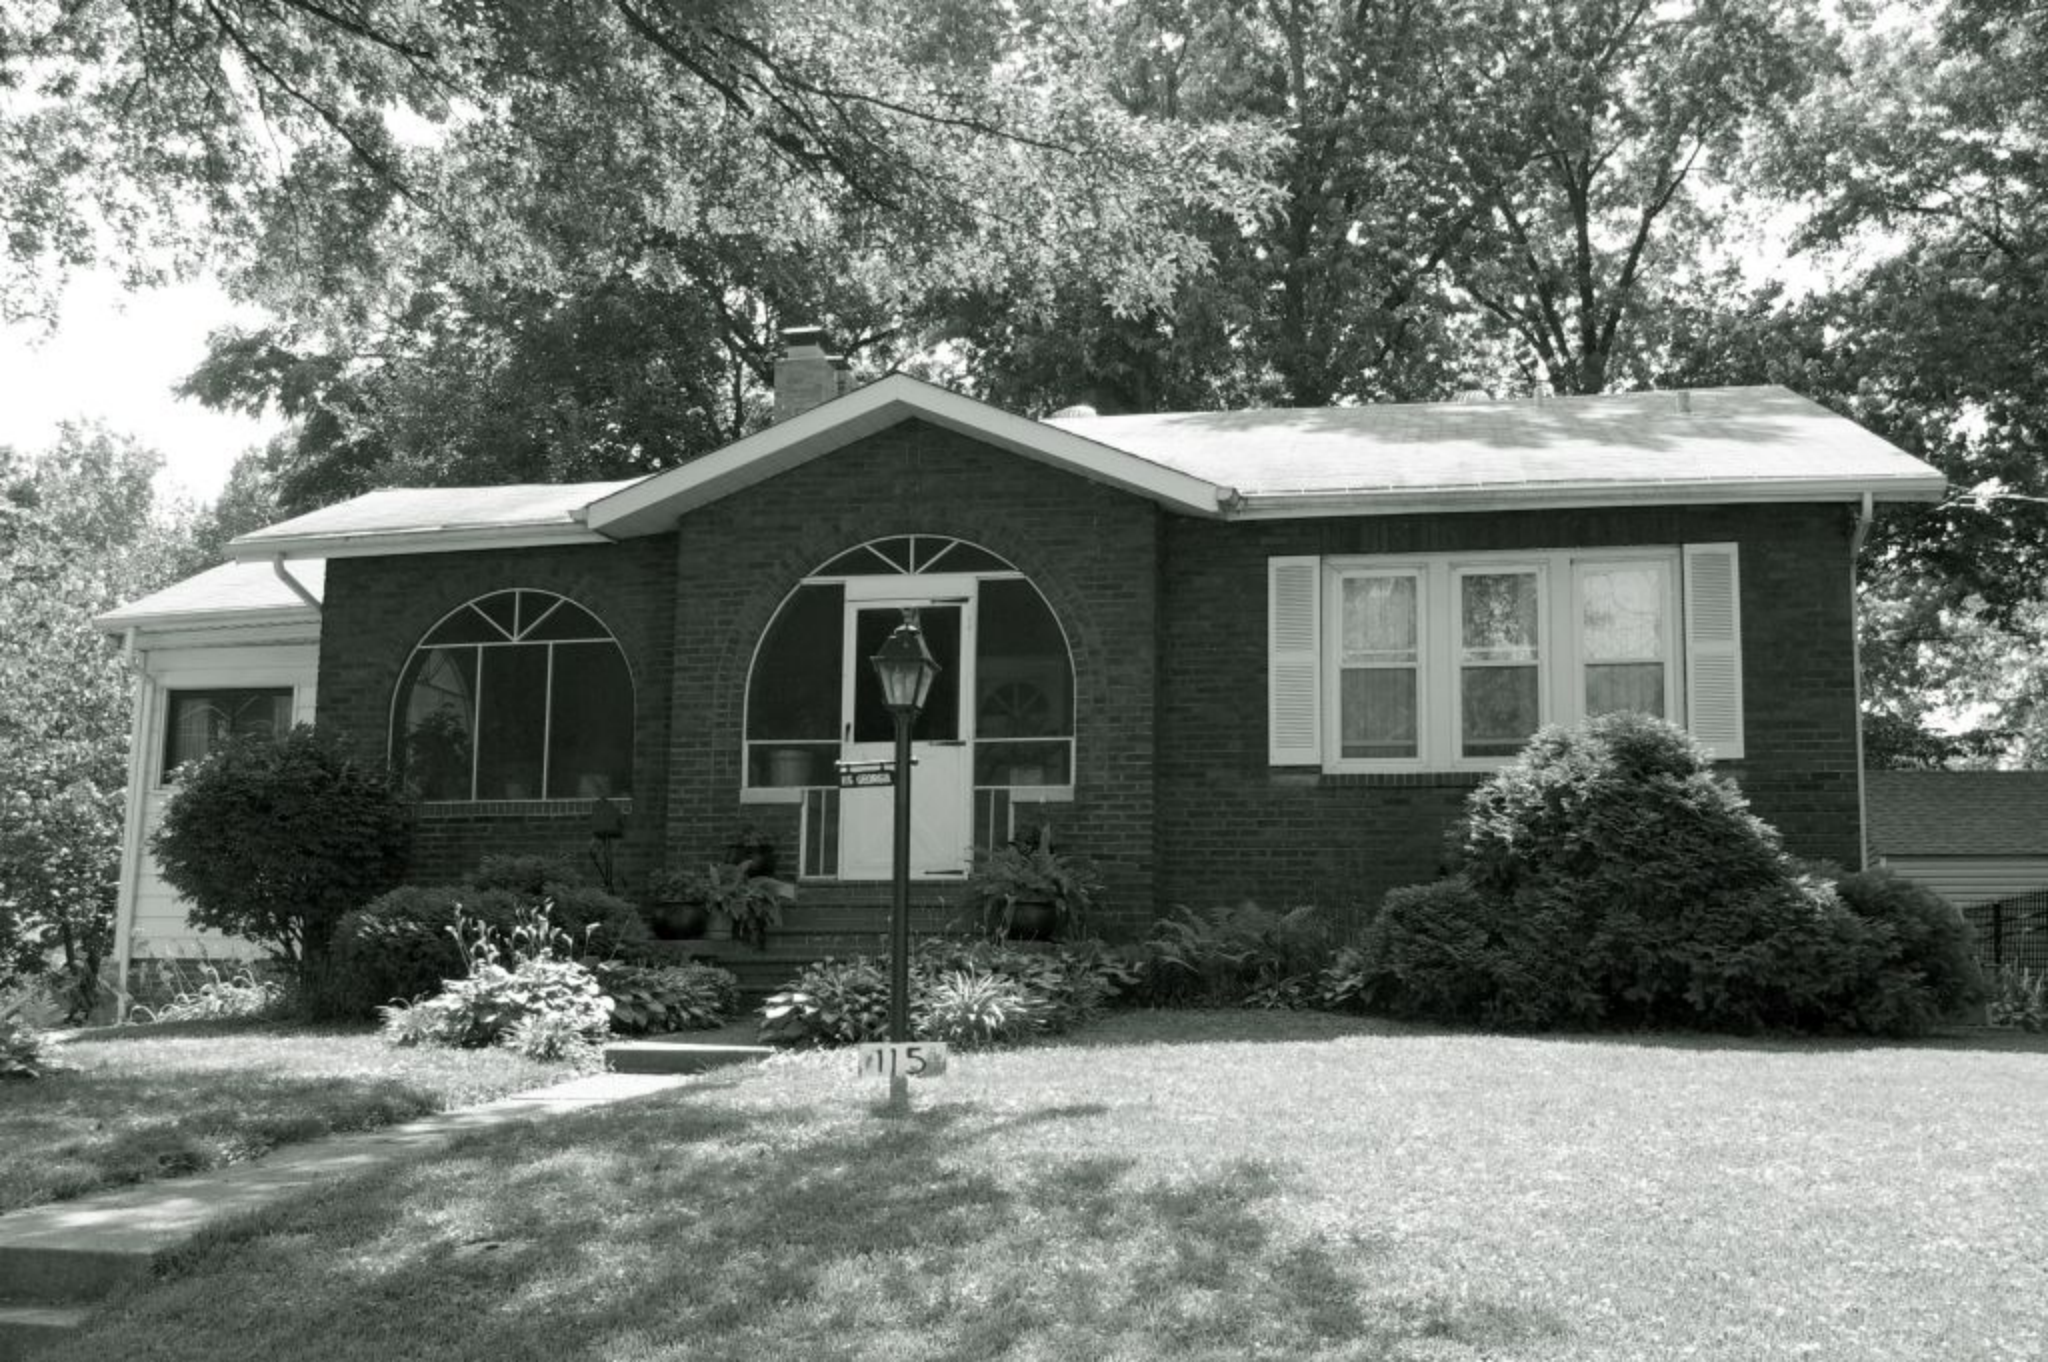
115 GEORGIA

This shallow pitched, side gabled roof with wide eave, brick house is basically a Craftsman bungalow, but the round arched openings of the entry and the sunroom are highly unusual. The original facade is basically three bays with the entry arch to the recessed porch and entry in the center bay and the round arch opening of the sunporch in the south bay while the north bay has a cluster of three sashed windows. Most likely the shutters on these windows is not original and they appear out of character to the house design. A small side gabled wing on the south side appears to have been original to the house, but the enclosure on the first floor appears to be a newer addition with aluminum siding with a basement level entry to the garage (the older, brick portion) which is at grade because of the downhill slope of the land and appears to be a two story wing as a result. The upper level of this wing has rectangular window openings, but there is another round arched opening to the sunporch in front of this wing. The entry and sunporch openings have been enclosed with screens.

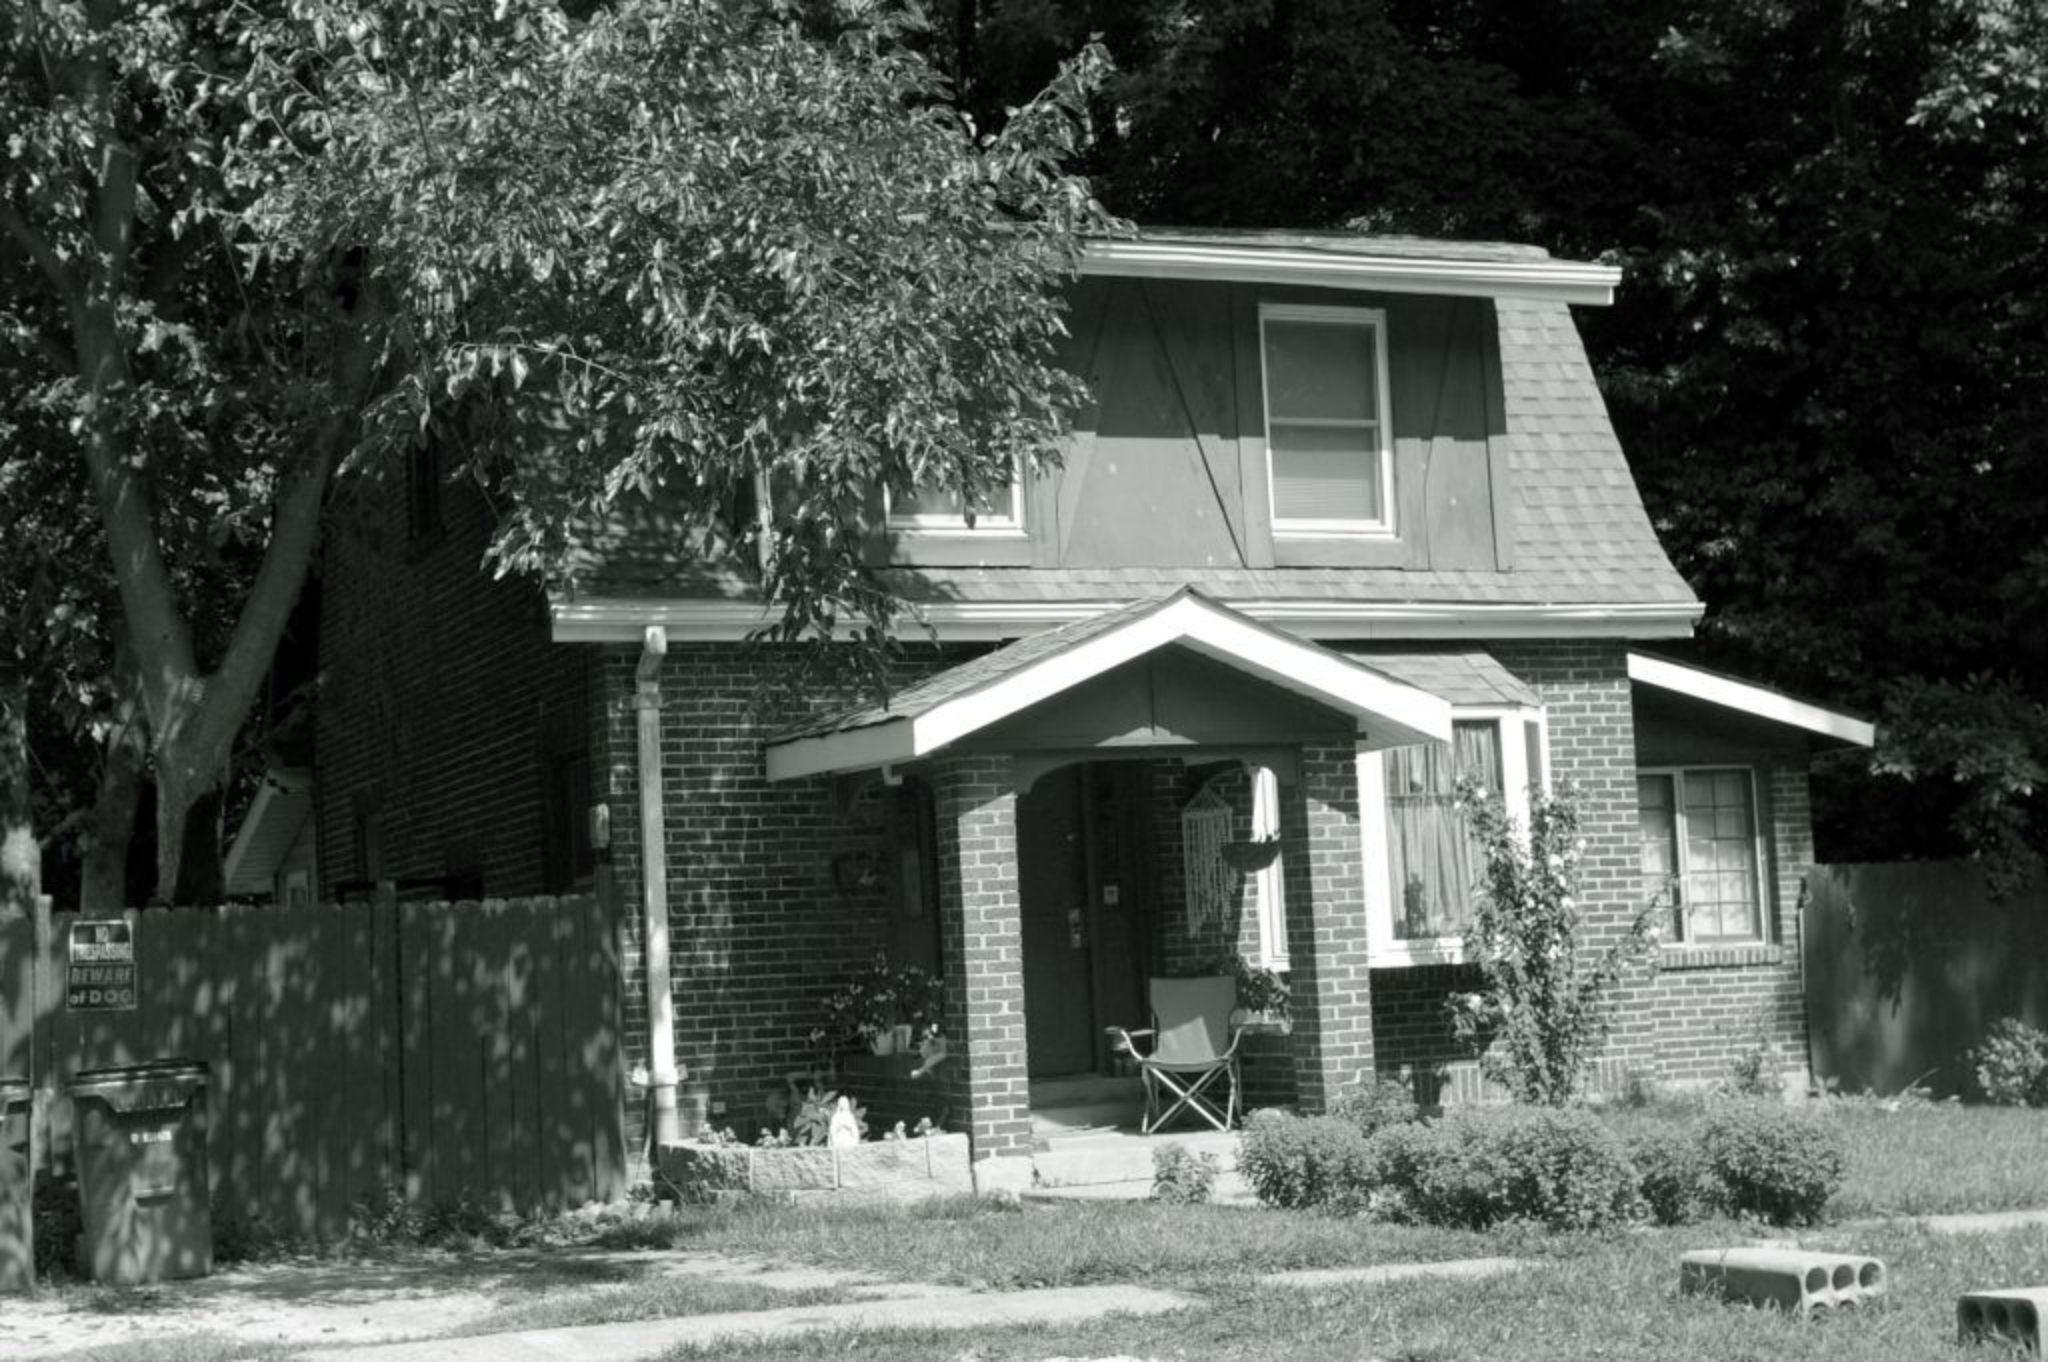
This small, two bay wide, Dutch Colonial Revival house has a shed dormer with half-timbered stucco that spans the facade and has two 1 over 1 wood sashed windows with storm screens. The house is brick, and there is a gabled porch roof supported by corner brick piers on top of a low concrete floor that leads to the replacement metal door in the north bay of the facade with a canted oriel window in the other facade bay. On the south side of the house is a small one story, sunroom wing with a shed roof and wood, 10-light casement windows. On the back of the house there is a shed roofed wing that may have originally been an open porch but is now enclosed with siding.

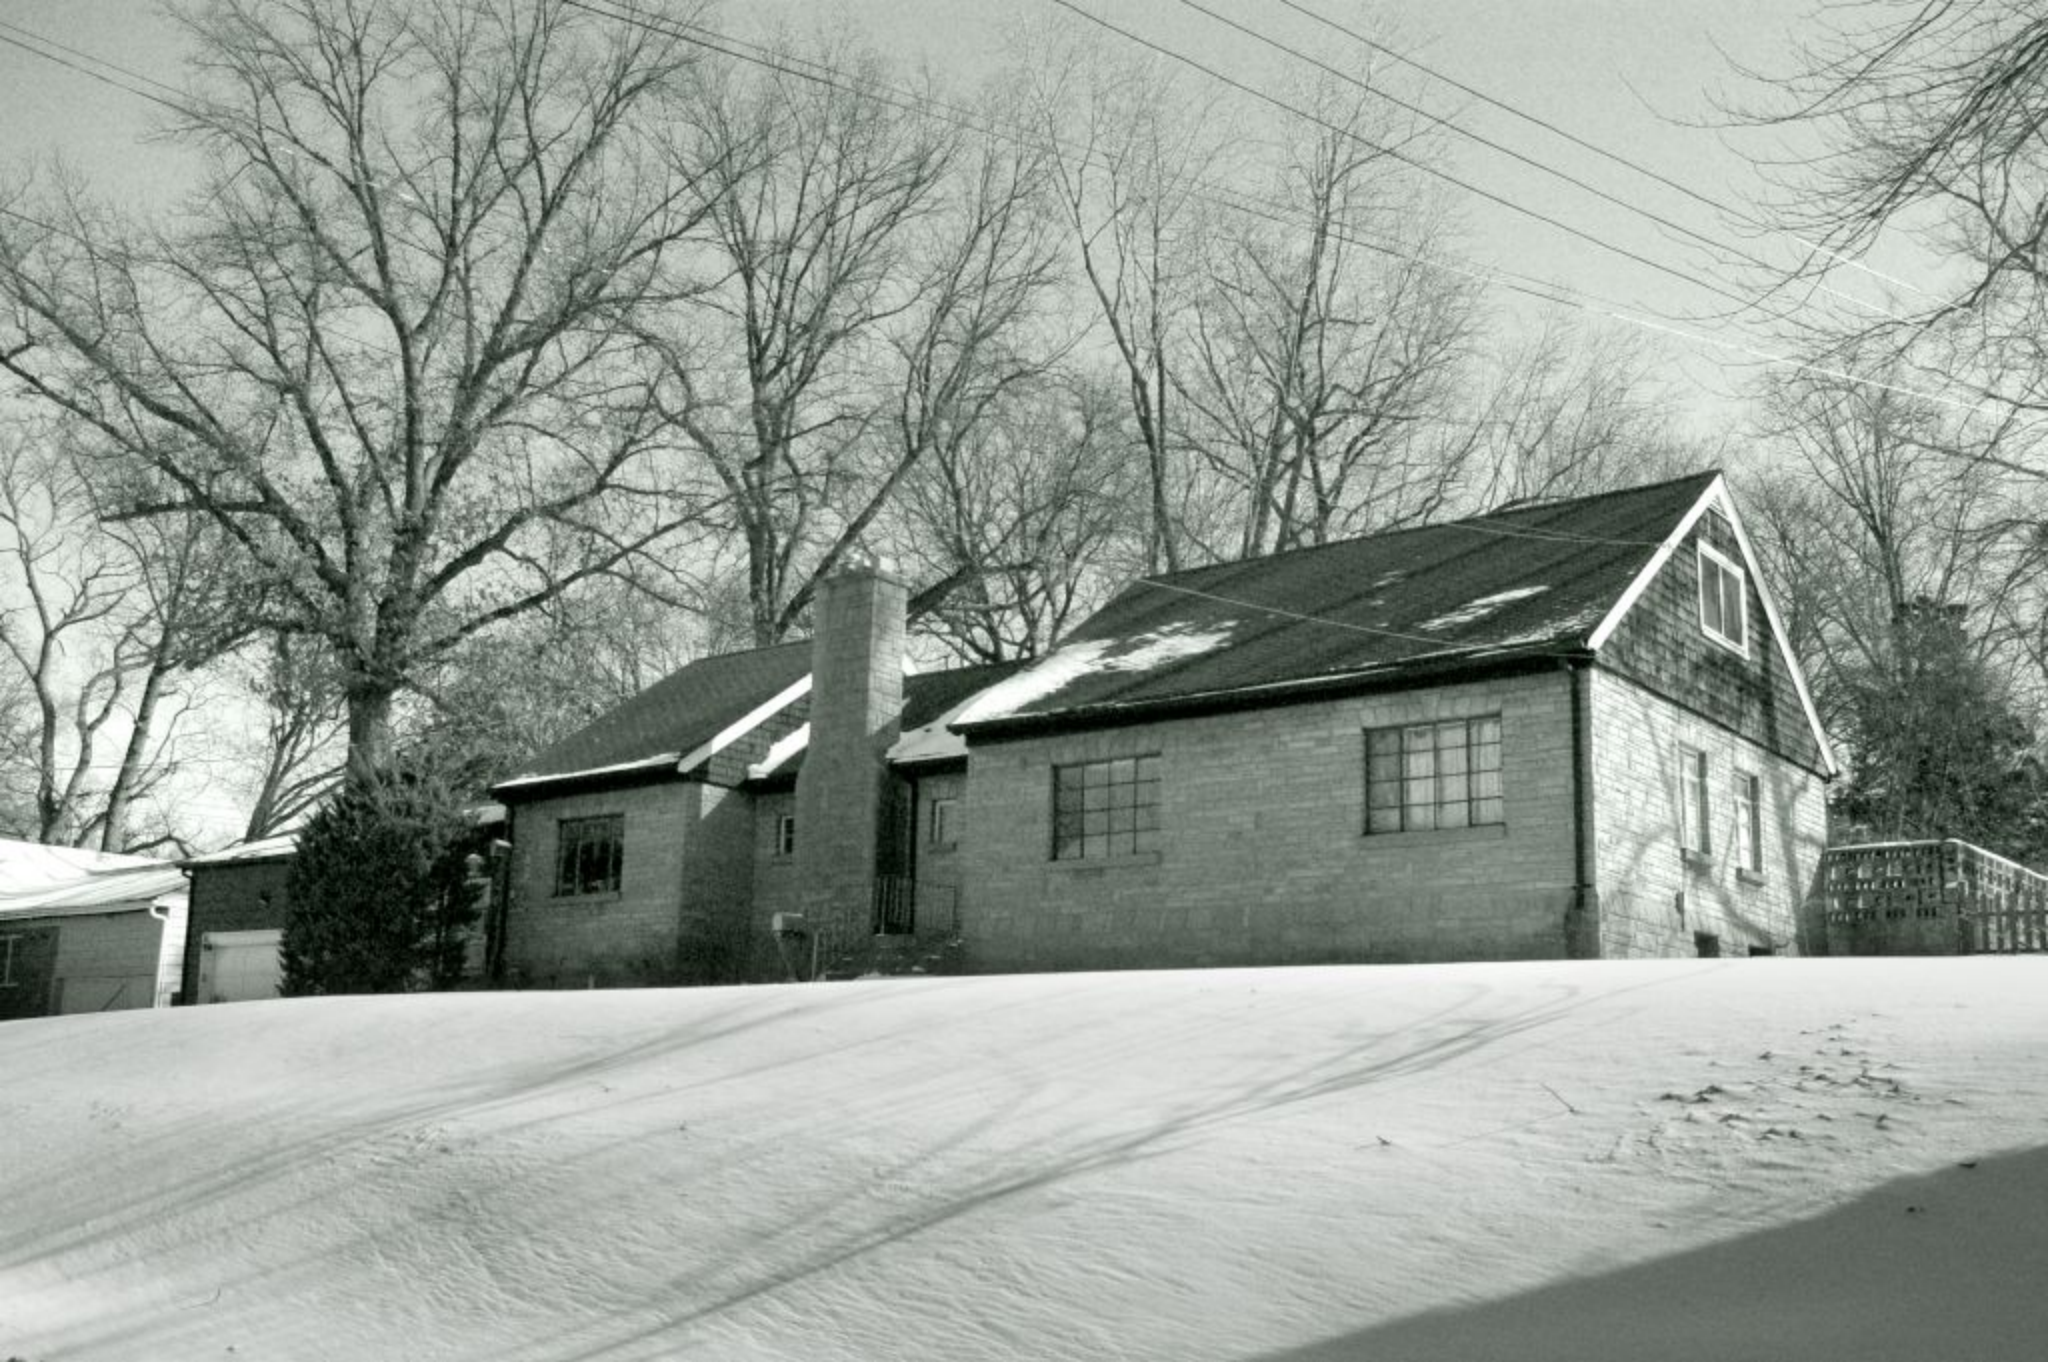
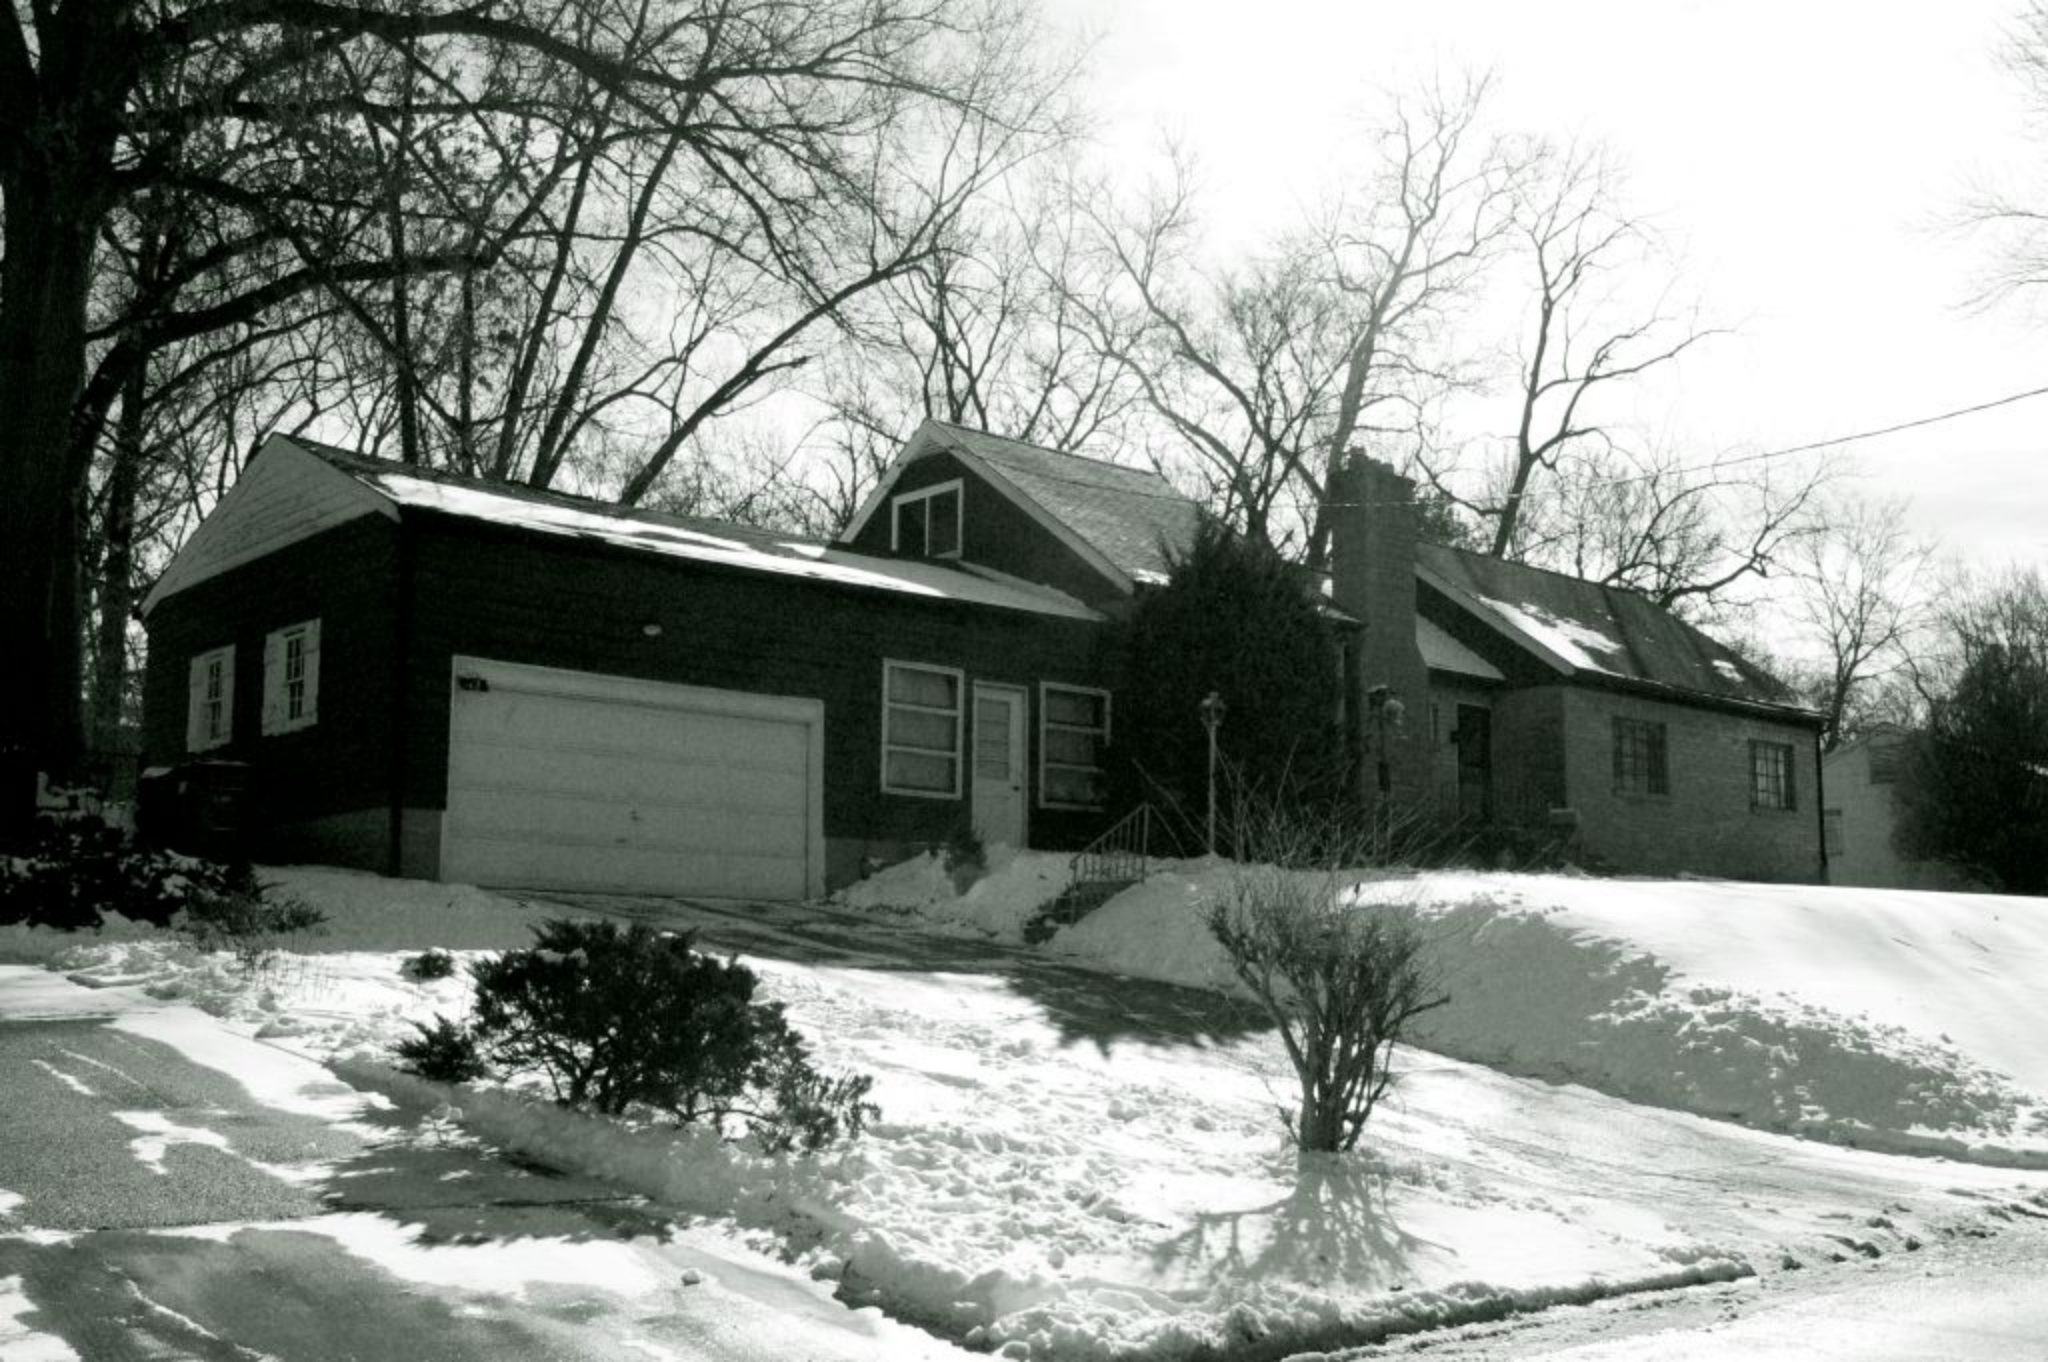
This 1.5 story, side gabled, sandstone house is not only unusual for its use of a stone veneer but also for its roofline and composition. It has what for other houses of this era would be a breezeway between the house and garage, with a shorter, one story side gabled roof, but this is actually the main entry to the house with a large sandstone exterior chimney positioned next to a simple entry door with a shallow stoop, all in this 1 story bay. To either side of the chimney is a small casement window. In the 1.5 story section to the south of the entry bay, there are two bays with two pairs of multipaned steel casement windows and the 1.5 story section to the north of the entry bay has another casement window. The gable ends (including those facing the 1 story bay) are clad with wood shingle siding and the south elevation has paired wood windows in the gable end and two paired steel casement windows on the first floor. On the north end of the house is an attached, side gabled, two car garage with wide wood lap siding and a newer overhead door. The garage wing is obviously older, but it may not be original to the design. South of the garage door in this wing there are horizontally light windows on either side of a three-horizontal light wood door, which are commonly associated with 1950s designs.

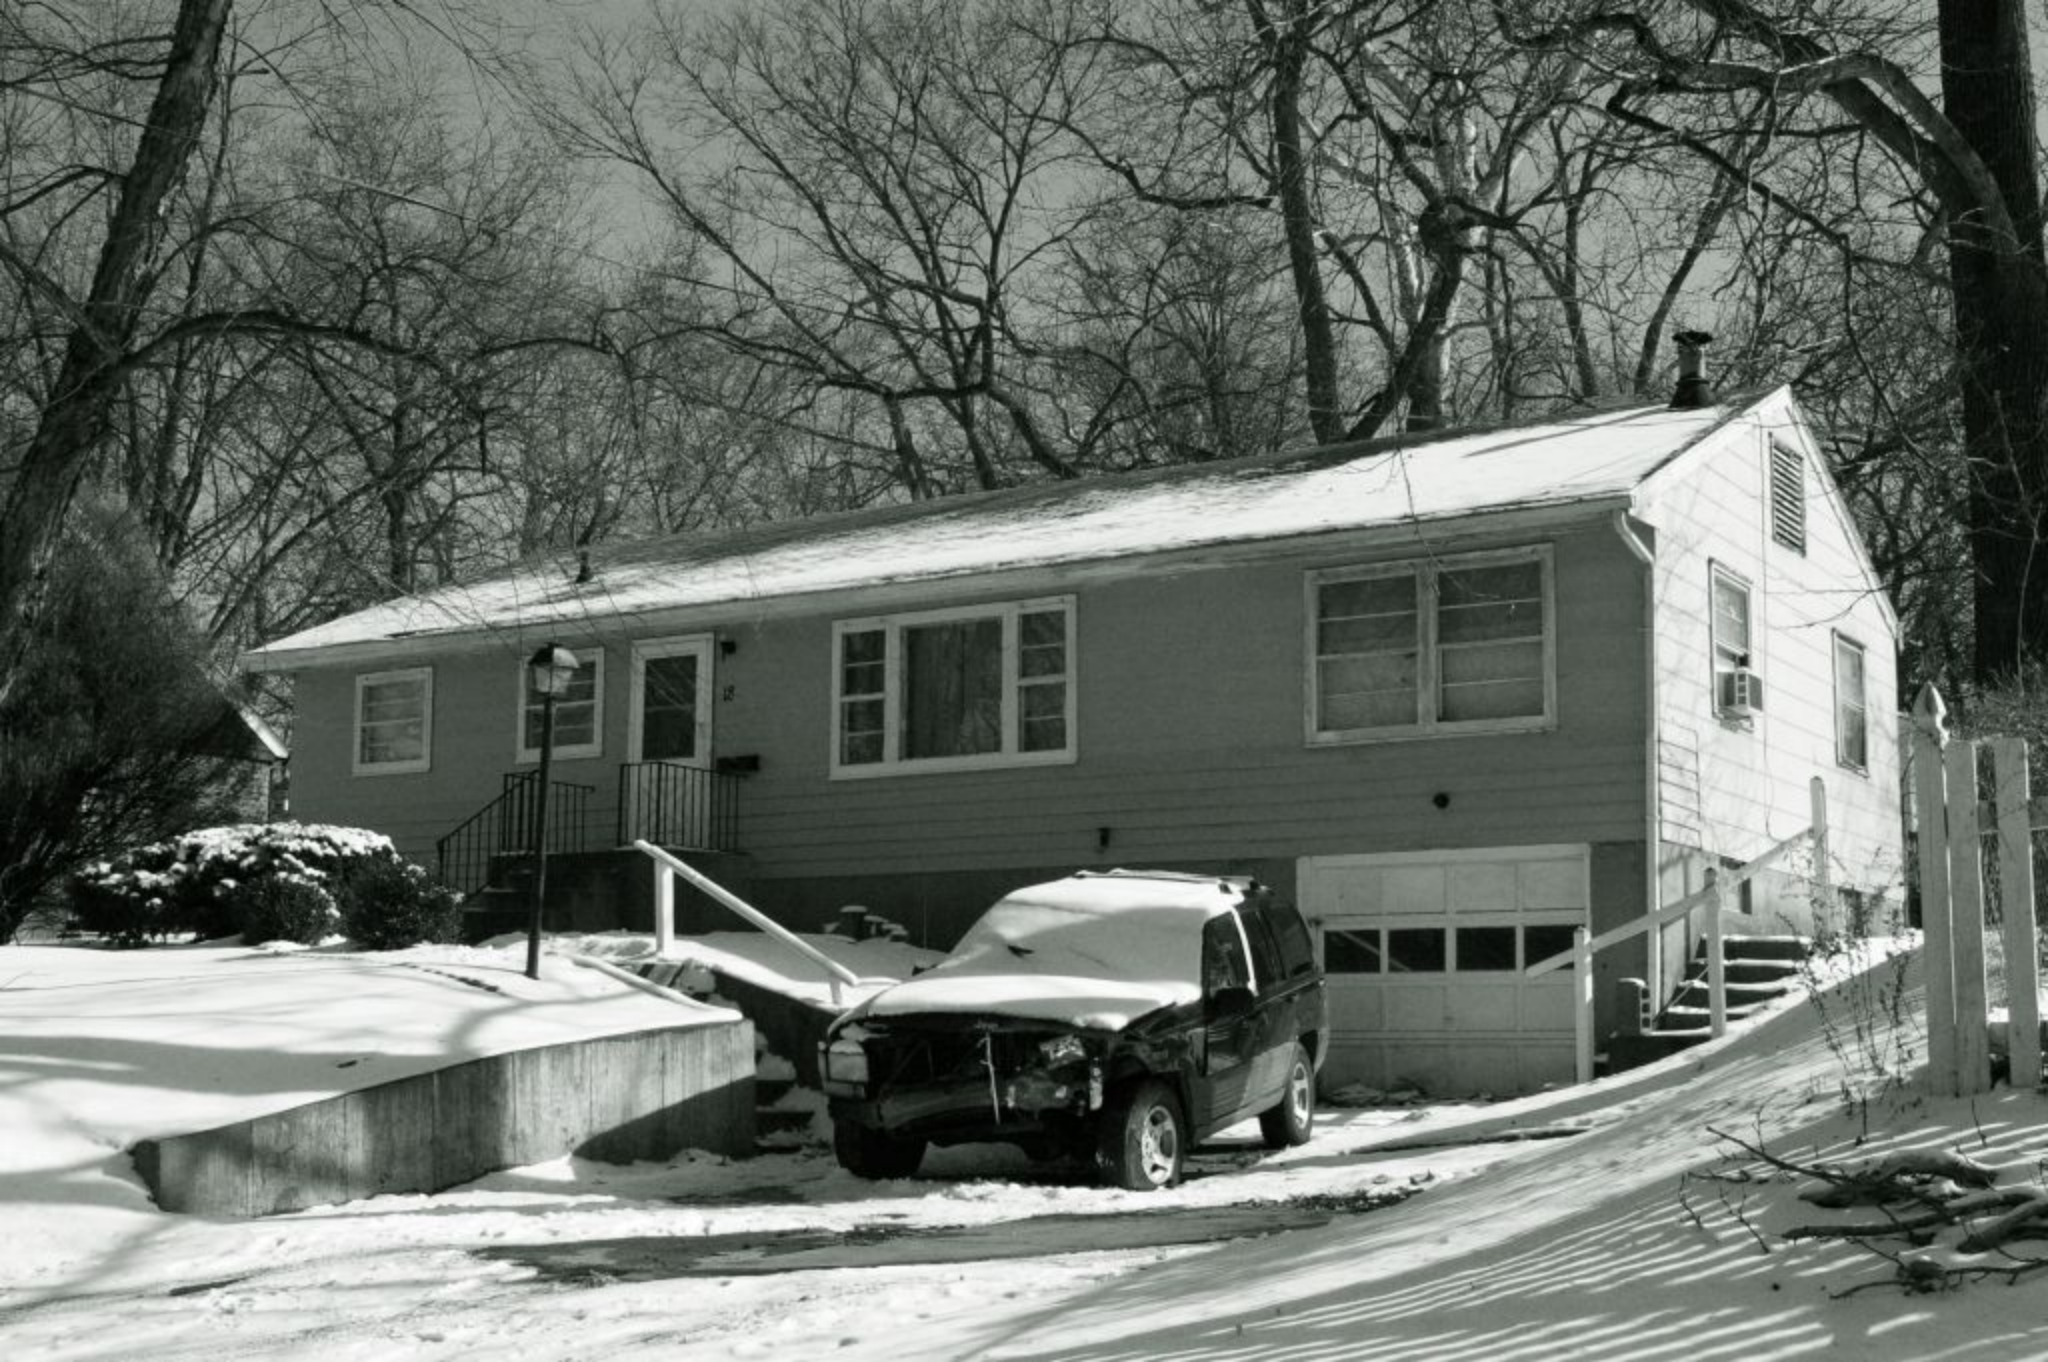
This 1 story Ranch house has asbestos shingle siding on most walls, which has been painted yellow to blend with a band of wood lap siding that stretches across the facade below the window sills. The four bay facade is positioned on a hillside so that there is a shallow concrete retaining wall along the driveway to the facade entry to the basement level garage which still retains its original wood paneled overhead door. The basement level is simple concrete. The garage is located in the south bay and above there are paired, 2 over 2 horizontally lighted, wood sashed windows. The next bay north has narrow 2 over 2 sashed windows flanking the plate glass picture window and adjacent is the entry bay with a simple doorway and a concrete stoop that has metal railings. Next to the door is another 2 over 2 sashed window and there is a matching window in the north bay. These horizontally lighted windows are a distinctive 1950s feature as is the wood paneled garage door and the asbestos shingle siding. Except for the paint on the asbestos siding and storm screens and storm door, this is a rare example of an unaltered frame Ranch house in Ferguson.

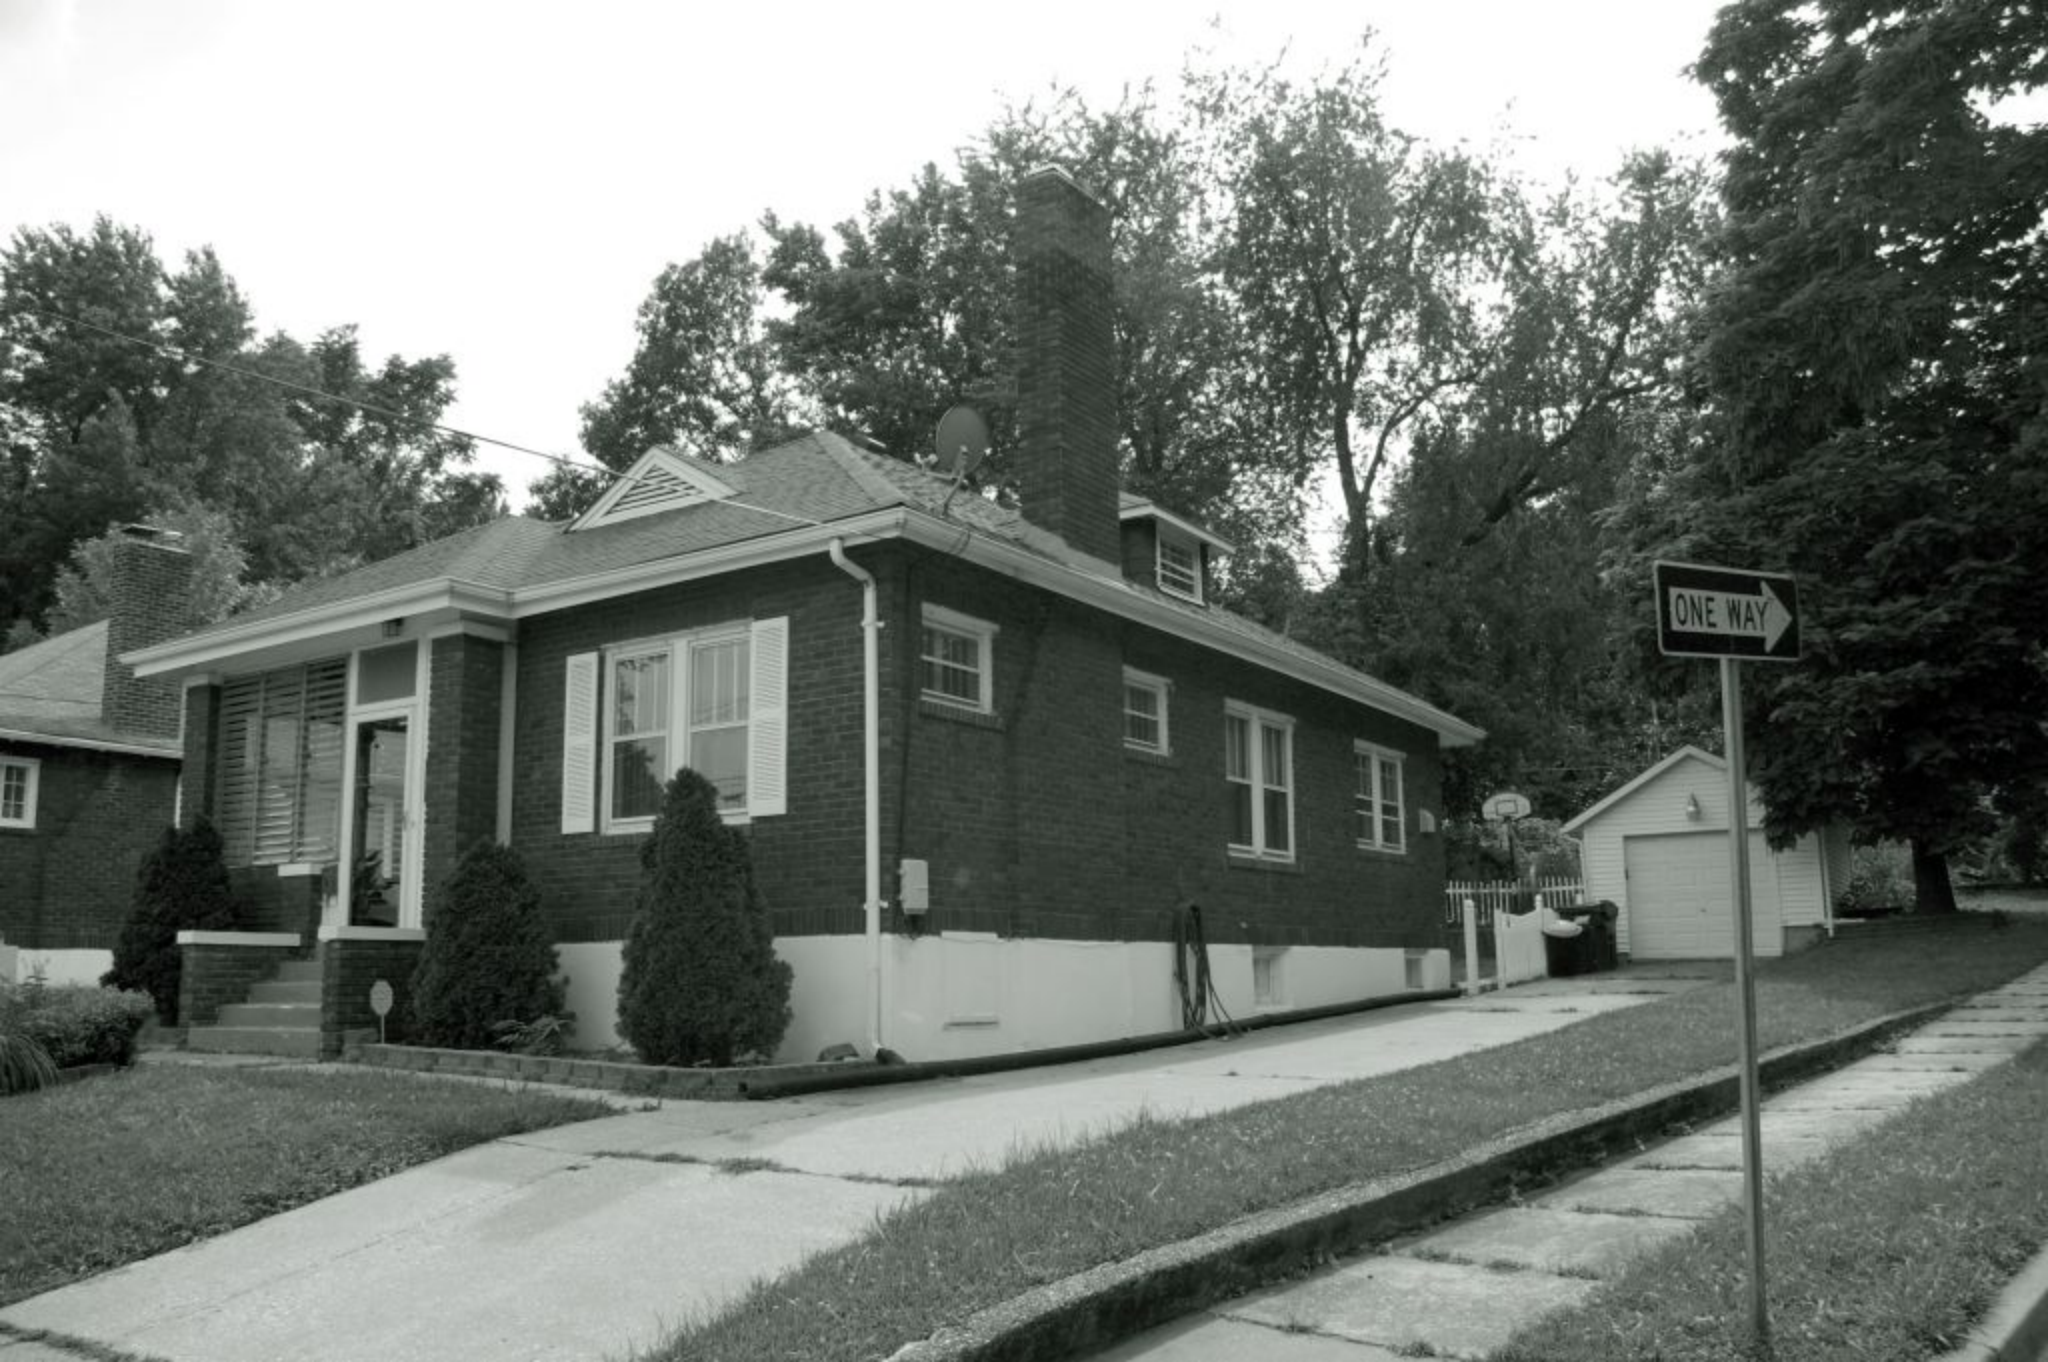
The one story, red brick, hipped roof Craftsman bungalow has hipped dormers on both sides and a triangular dormer vent on the facade. There are modest cave overhangs and the facade is divided into two bays with a slight projection of the south bay which is an open corner porch. The porch has window height openings with a corner brick pier and the concrete stoop in front has brick knee walls with concrete caps. The porch has been enclosed with a full light storm door and jalousie windows. The other bay on the facade has paired, wood sashed windows. The upper sashes of other windows on the house, and the wood casement windows in the dormers, basement and on the north side, all retain the original vertical muntins, even though aluminum storm windows have been added. The concrete foundation extends to the floor level, making the facade appear more horizontal in appearance.
