ARCHITECTURAL/HISTORIC INVENTORY FORM

1. Survey No. SL-AS-036-001		2. Survey Name: Architectural Survey of Old Ferguson West	
3. County: St. Louis		4. Address: 1 Carson Rd.	
5. City: Ferguson	Vicinity: <input type="checkbox"/>	6. UTM:	7. Township/Range/Section
8. Historic name (if known):		9. Present/other name (if known): Whistle Stop	
10. Ownership: <input type="checkbox"/> Private <input checked="" type="checkbox"/> Public		11. Historic use (if known): TRANSPORTATION/rail-related	11. Current use: COMMERCE/restaurant & RECREATION/museum

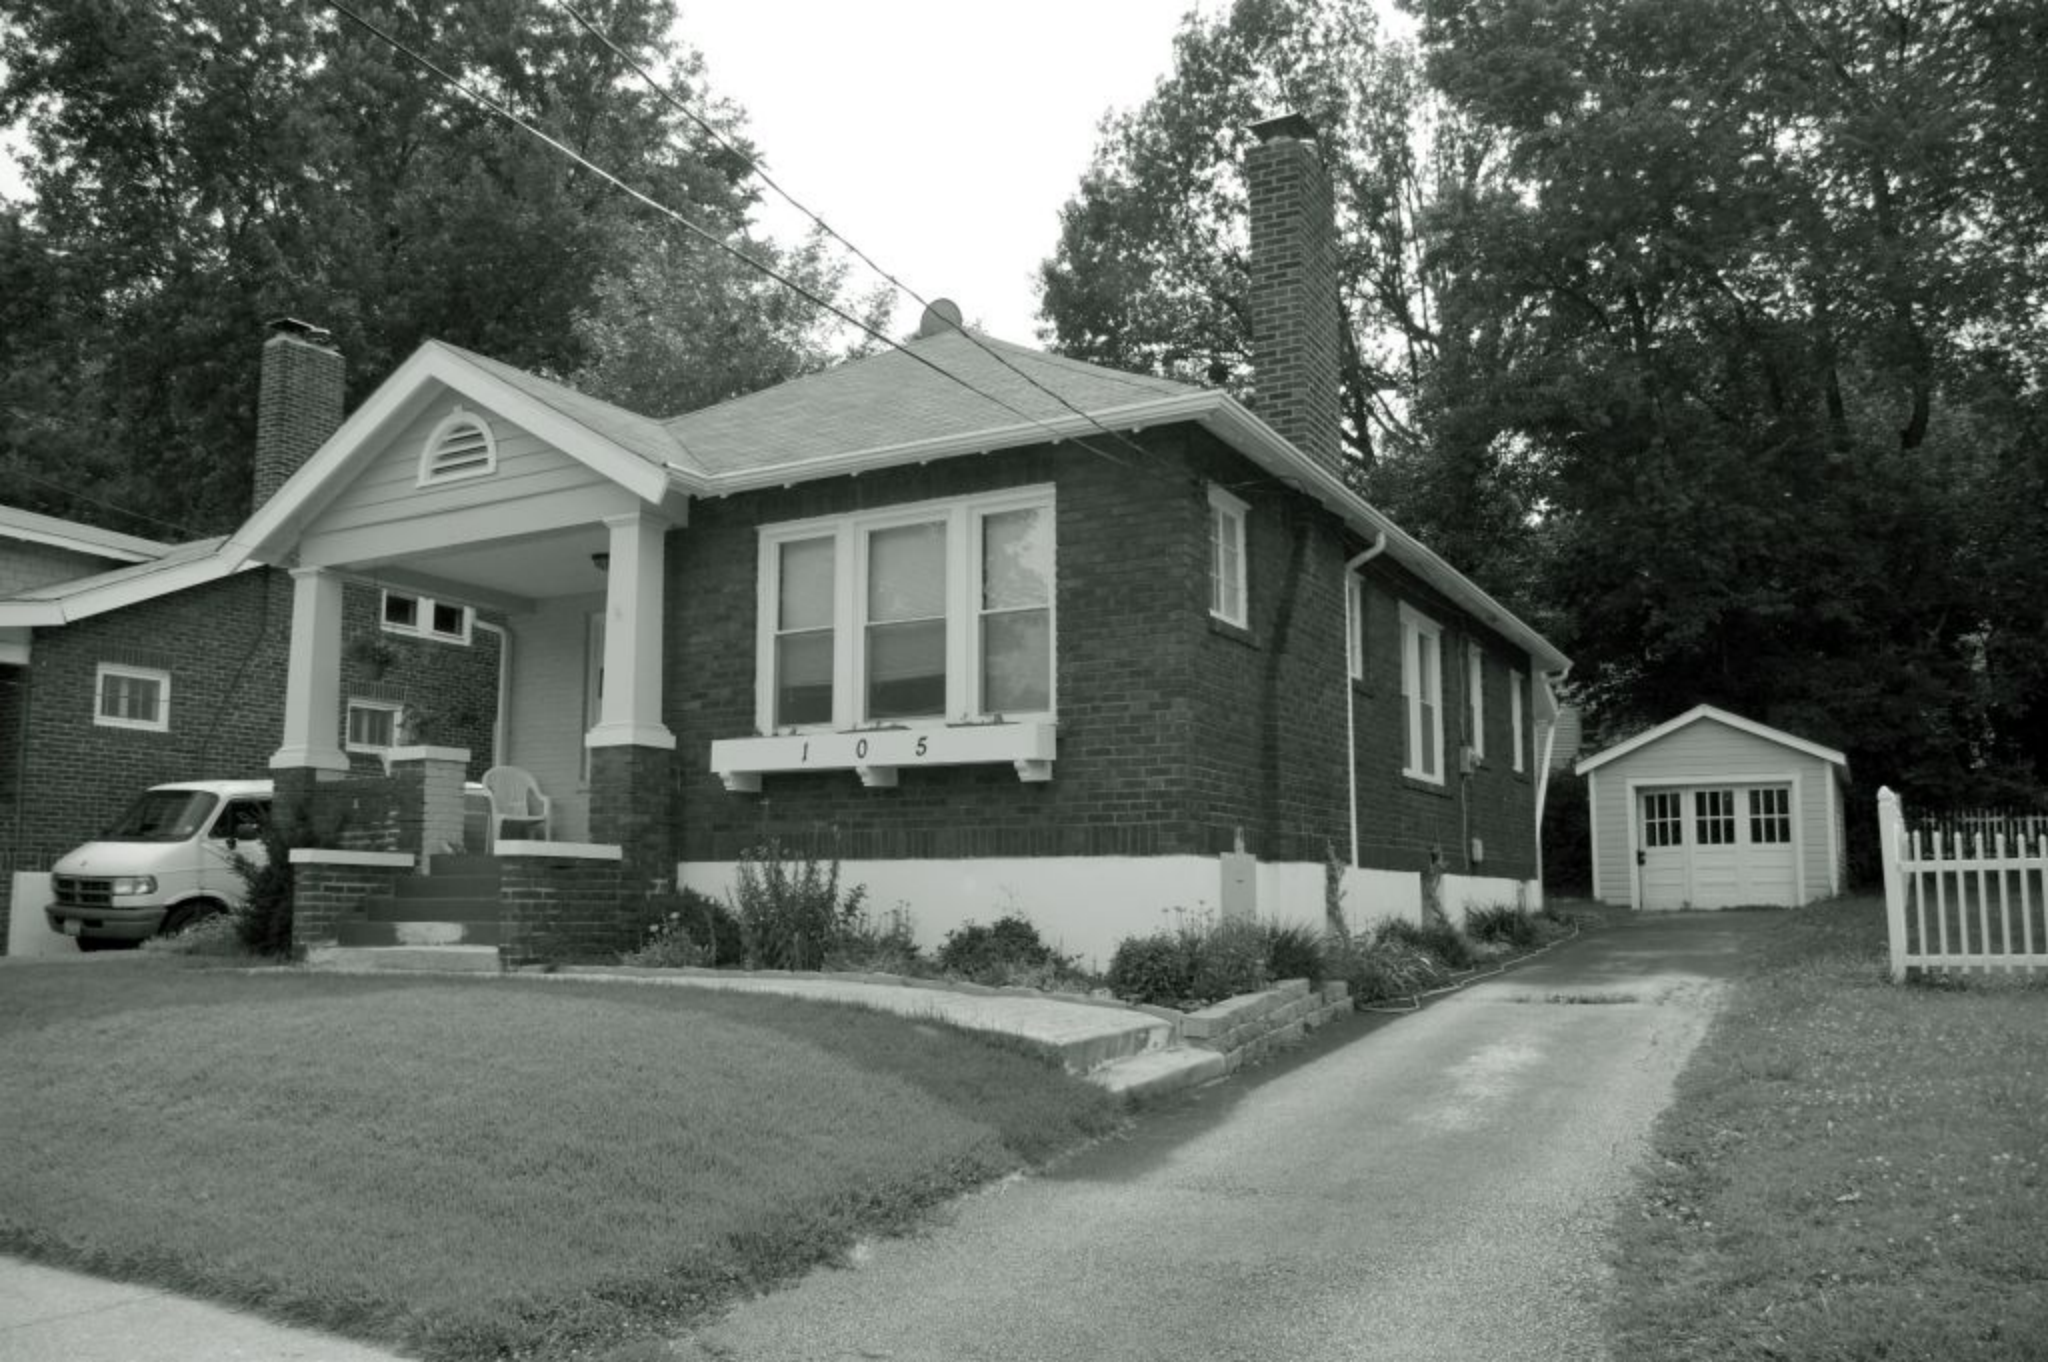
The one story, red-brown brick, hipped roof, Craftsman bungalow has a raised concrete foundation and a tall internal brick chimney that pierces through the roof on the north side of the house. There is a small triangular dormer on the south side. The facade is divided into two bays with a triple, 1 over 1, sashed window with a window box in the north bay and a recessed, corner porch with a cross gabled roof supported by squared half columns resting on brick plinth blocks at the front corners and the porch has brick half-wall railings. The lap siding end gable has a half-round vent. The concrete steps have brick knee walls with concrete caps. There is a paired, sashed window unit facing the street in the porch with the 3/4 vertically lighted wood door facing south inside the porch, but the brick walls of the house on the interior of the porch have been painted tan like the gable end of the porch. Most of the windows have been replaced with single light vinyl sashed windows, but the paired wood casement windows (2 lights in each caement) are intact on the north side.

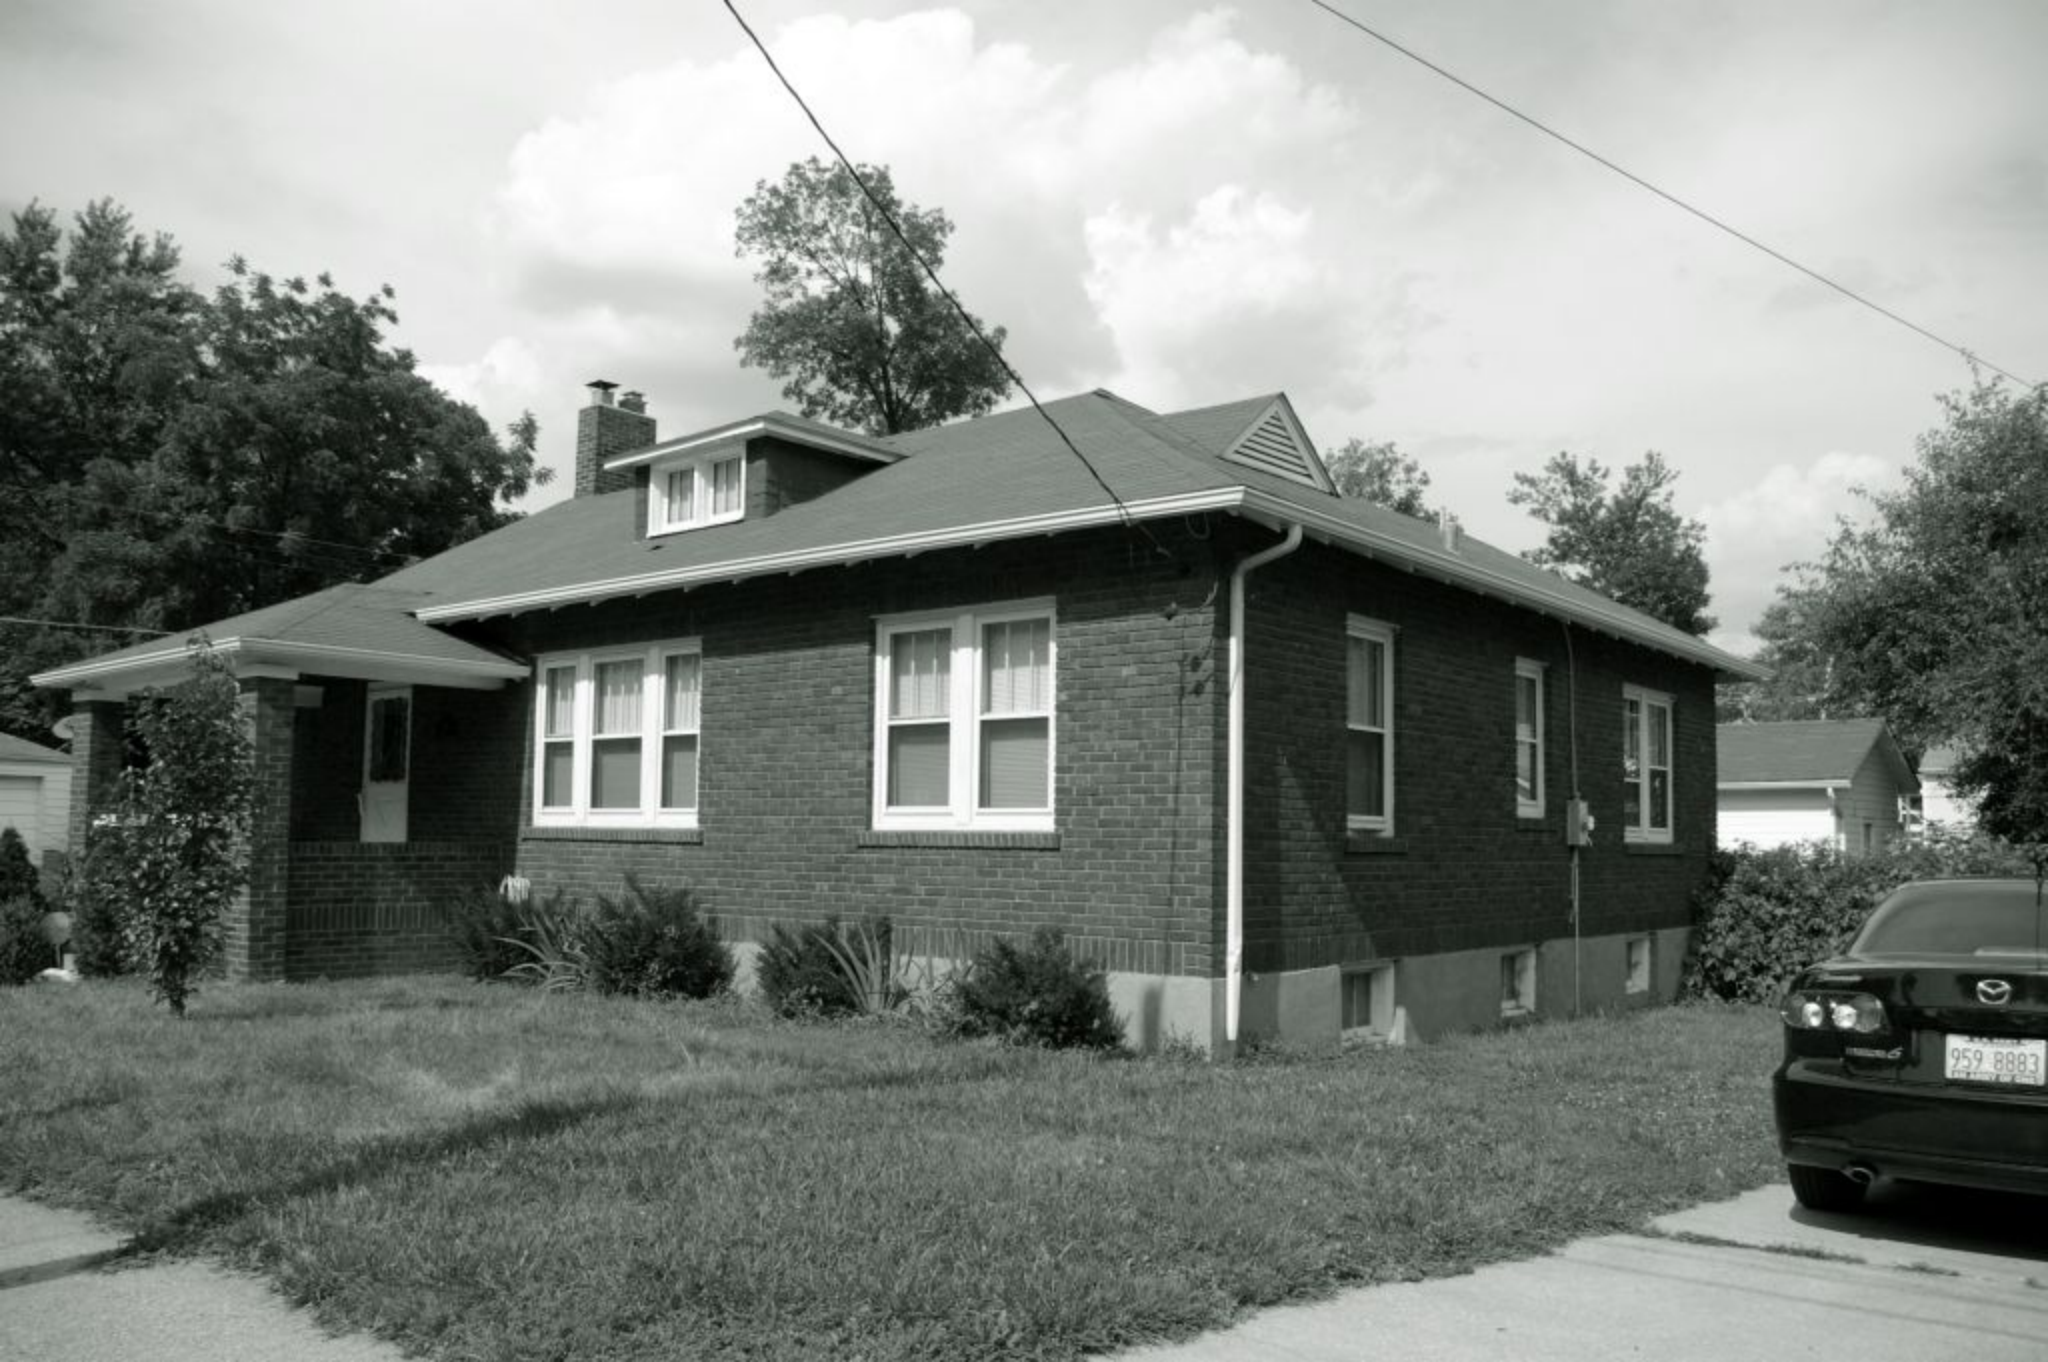
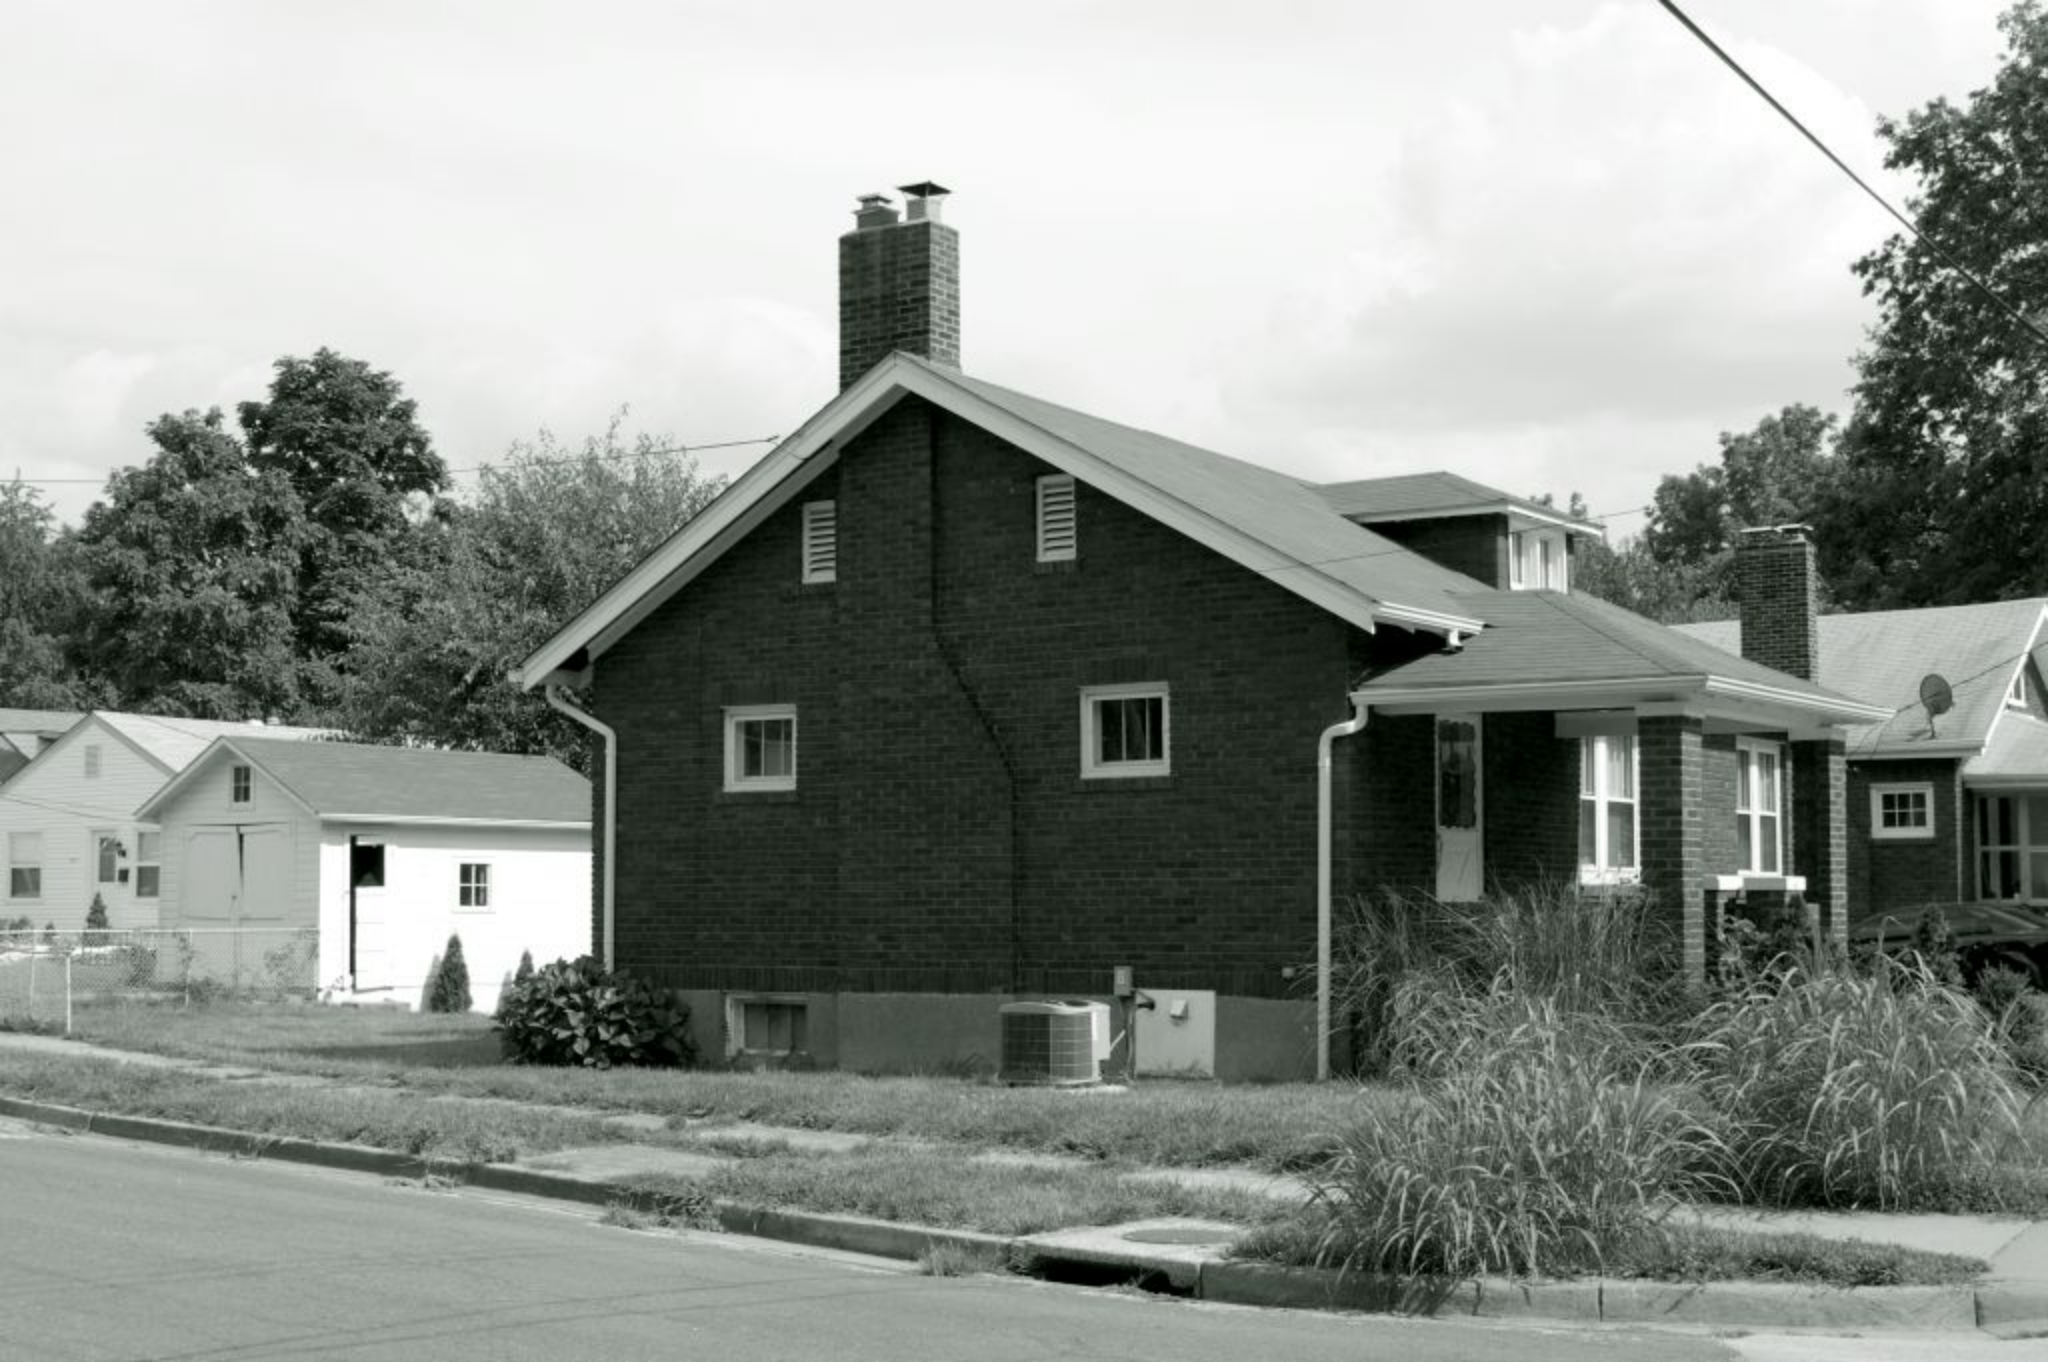
This 1 story, red-brown brick Craftsman bungalow has a hipped roof on the south end with a triangular dormer but it is gabled on the north side and there is a shallow hipped dormer with wide eaves on the facade. The facade is divided into three bays with paired wood sashed windows in the south bay, a triple set of sashed windows off-center, and a small hipped roof porch supported by brick corner piers in the north bay. This porch has brick half-wall railings and concrete steps. On the north side it has an end wall brick chimney that pierces through the broad eaves and roof on that end, flanked by narrow rectangular vents in the attic and small 3 vertical light windows on the first floor. All of the windows, including the paired casements in the attic and the basement windows, as well as the upper sashes of the main windows, have vertical muntins. The entry door is obscured by the half light storm door and the house has metal storm screens.

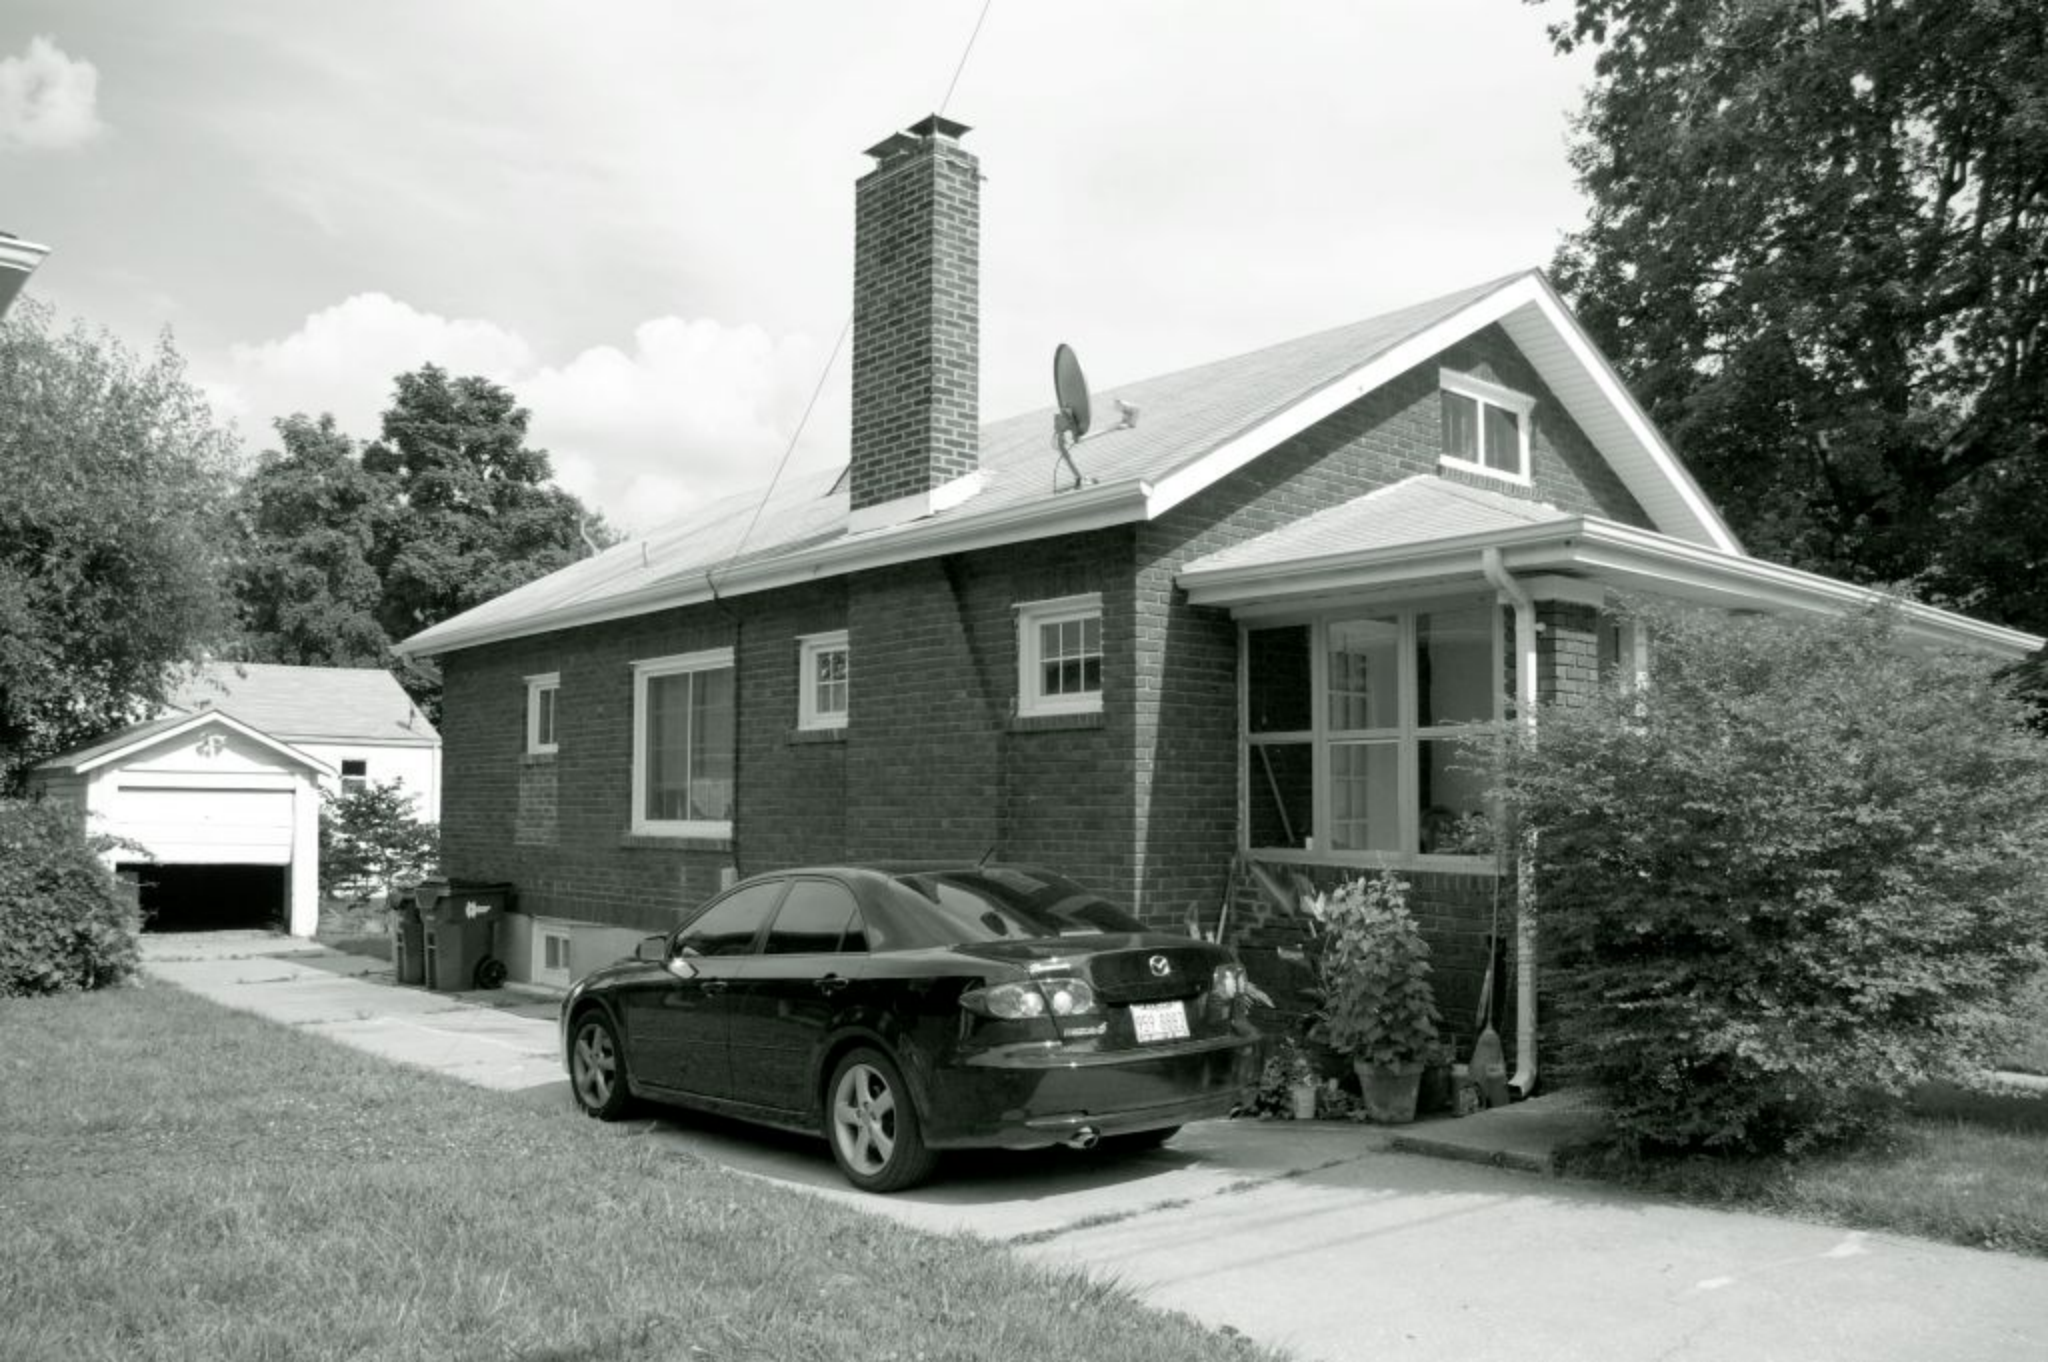
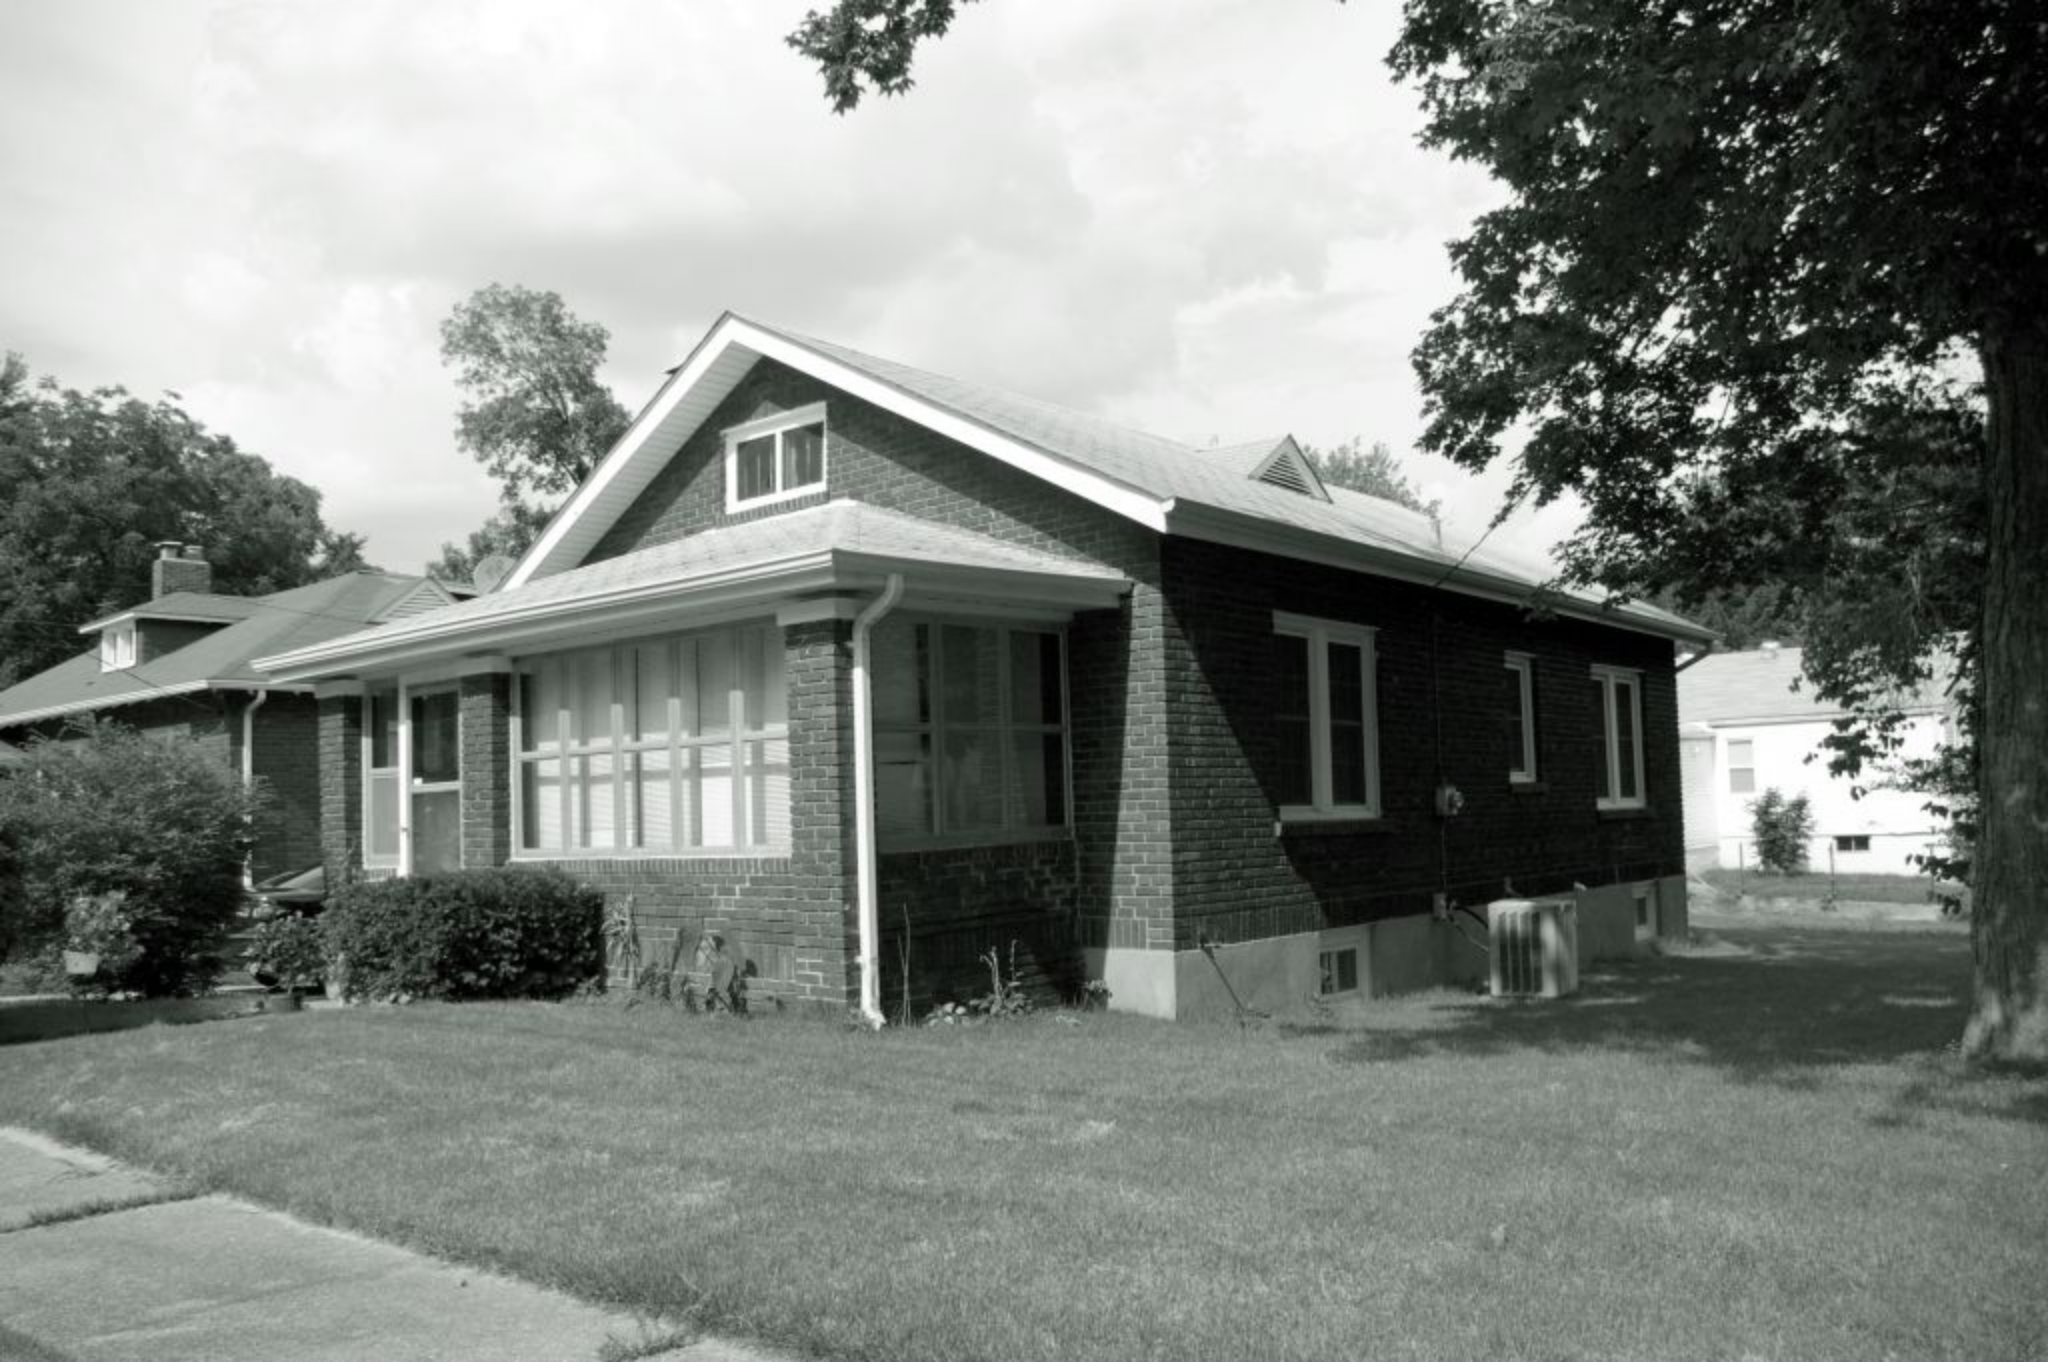
The end gabled, one story, red-brown brick Craftsman bungalow has an end wall brick chimney that extends through the north side of the roof with a tall shaft. The facade is divided into two bays behind the full width hipped roof porch, which is supported by three brick piers, one at each corner and another to define the narrower entry bay. There are half-wall brick railings and concrete steps. The porch has been enclosed with aluminum storm windows and a storm door, but the multipaned, wood door is visible. Windows, whether casement, sashed, or the larger picture window on the north side, are all multipaned with storm screens. The roofs have wider eaves and the house has a raised concrete foundation.

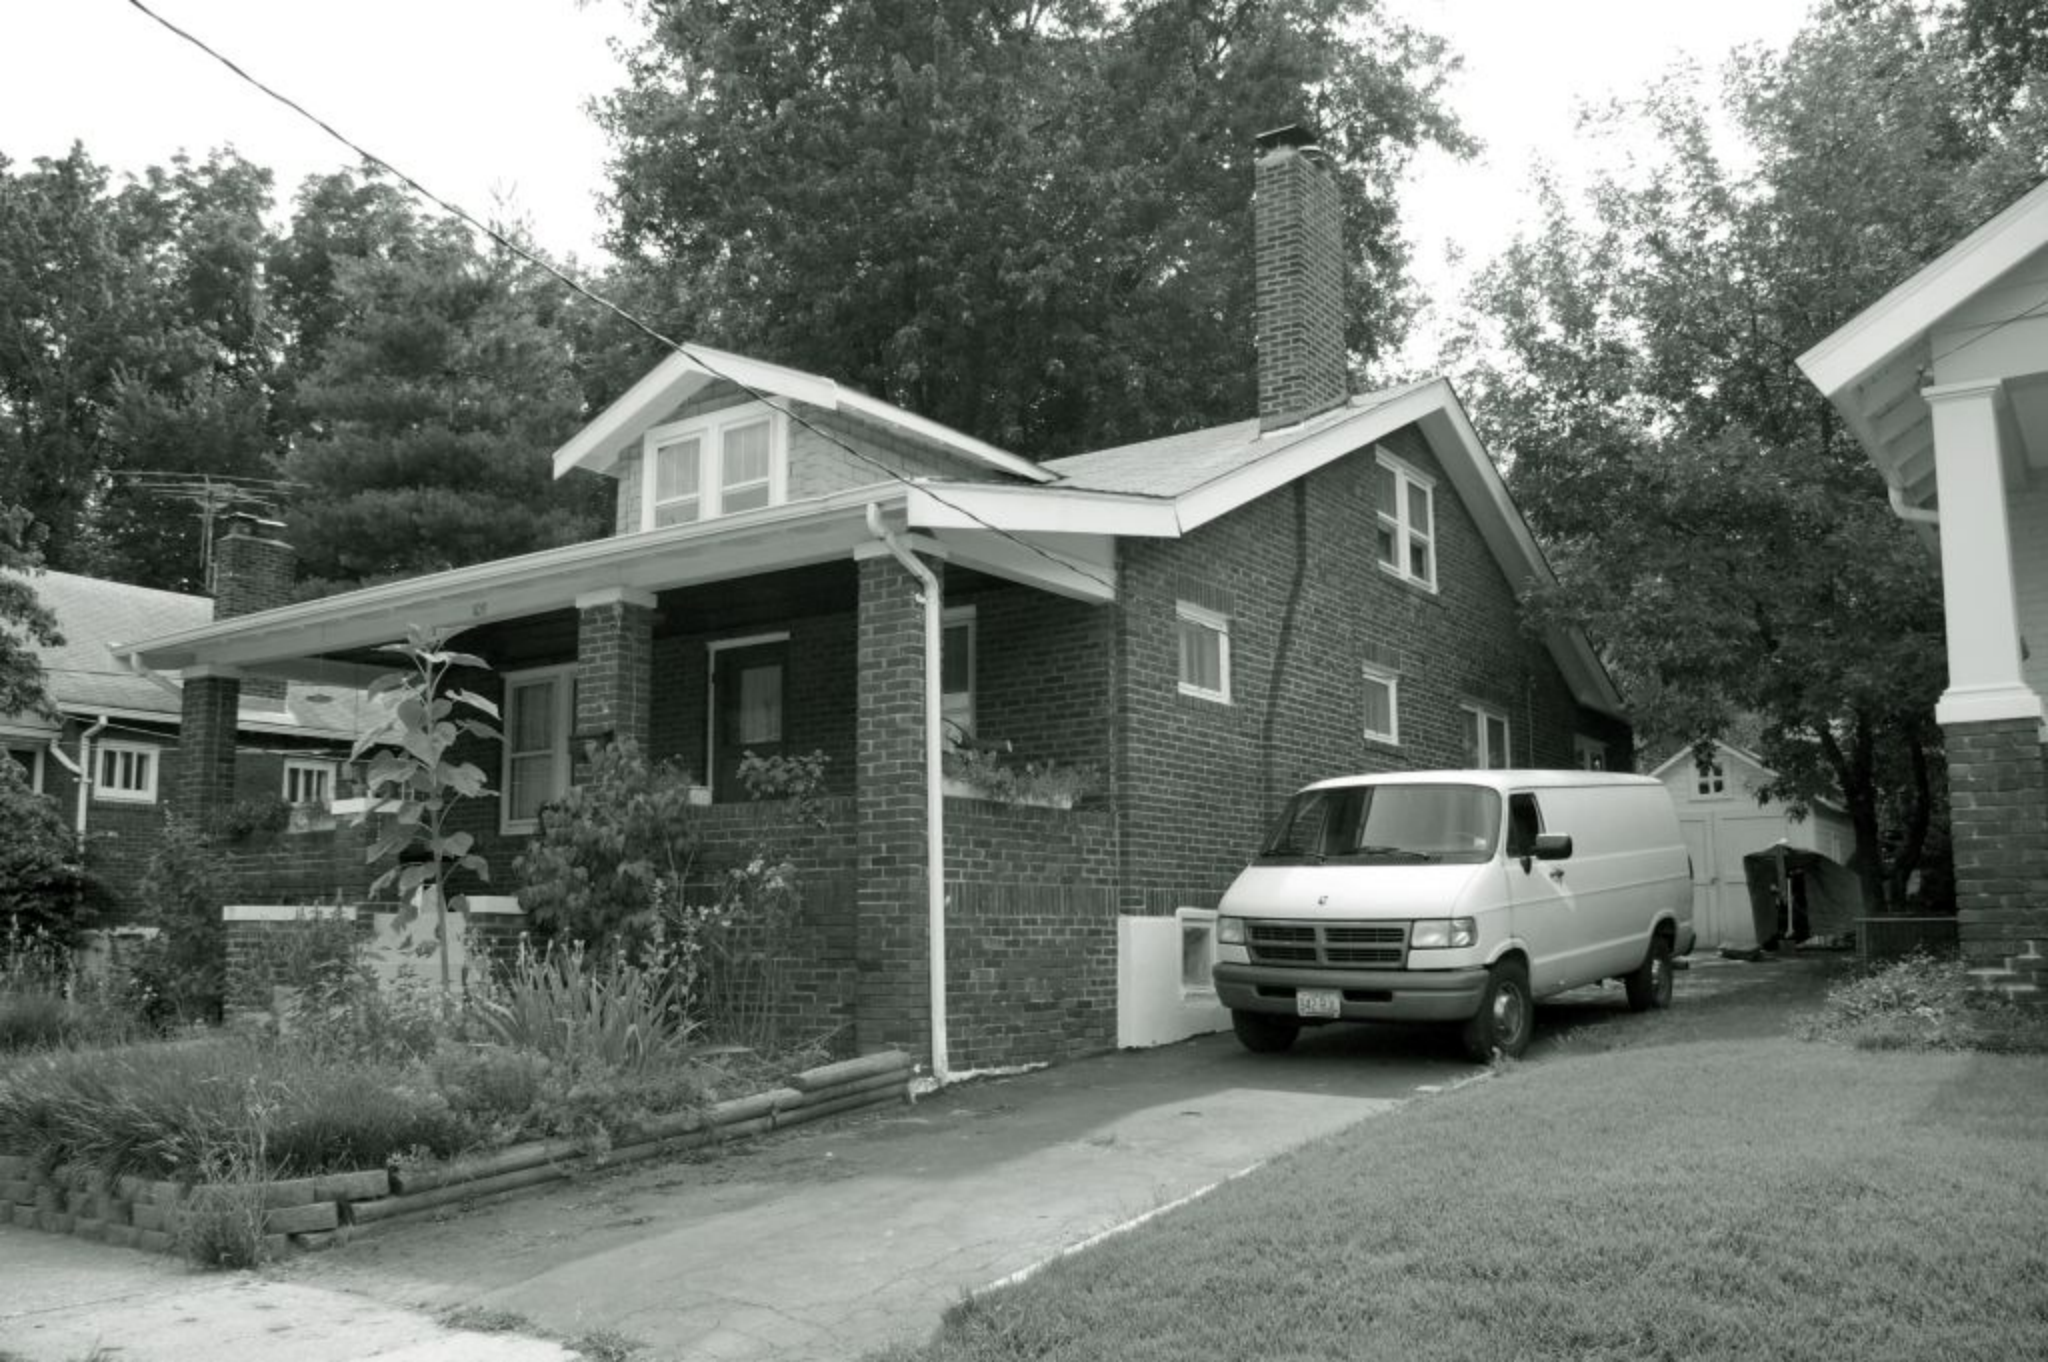
This 1.5 story, brick Craftsman bungalow has a shallow pitched, side gabled roof that connects directly to the shed roofed, full width porch roof. There is a gabled dormer centered on the facade and, like the main roof, this has wide eaves with open rafters. The porch roof is supported by four brick piers that extend to the ground which have brick, half wall railings and centered, concrete entry steps with brick knee walls. There is a brick end wall chimney piercing through the roof on the north side with a tall chimney shaft. The three bay wide facade has a window unit in the north bay that appears to have been altered, but the square light wood door and the other windows appear unaltered--windows are either sashed windows with vertical lights in the upper sashes or casement windows with vertical lights, but they do have metal storm screens. The only other visible alteration appears to be the use of asphalt shingles to re-side the dormer and the installation of gutters on the rafter ends of the porch. Although the concrete foundation is not visible on the facade, it does serve as a high water table on the side elevations.
