ARCHITECTURAL/HISTORIC INVENTORY FORM

1. Survey No. SL-AS-036-001		2. Survey Name: Architectural Survey of Old Ferguson West	
3. County: St. Louis		4. Address: 1 Carson Rd.	
5. City: Ferguson	Vicinity: <input type="checkbox"/>	6. UTM:	7. Township/Range/Section
8. Historic name (if known):		9. Present/other name (if known): Whistle Stop	
10. Ownership: <input type="checkbox"/> Private <input checked="" type="checkbox"/> Public		11. Historic use (if known): TRANSPORTATION/rail-related	11. Current use: COMMERCE/restaurant & RECREATION/museum

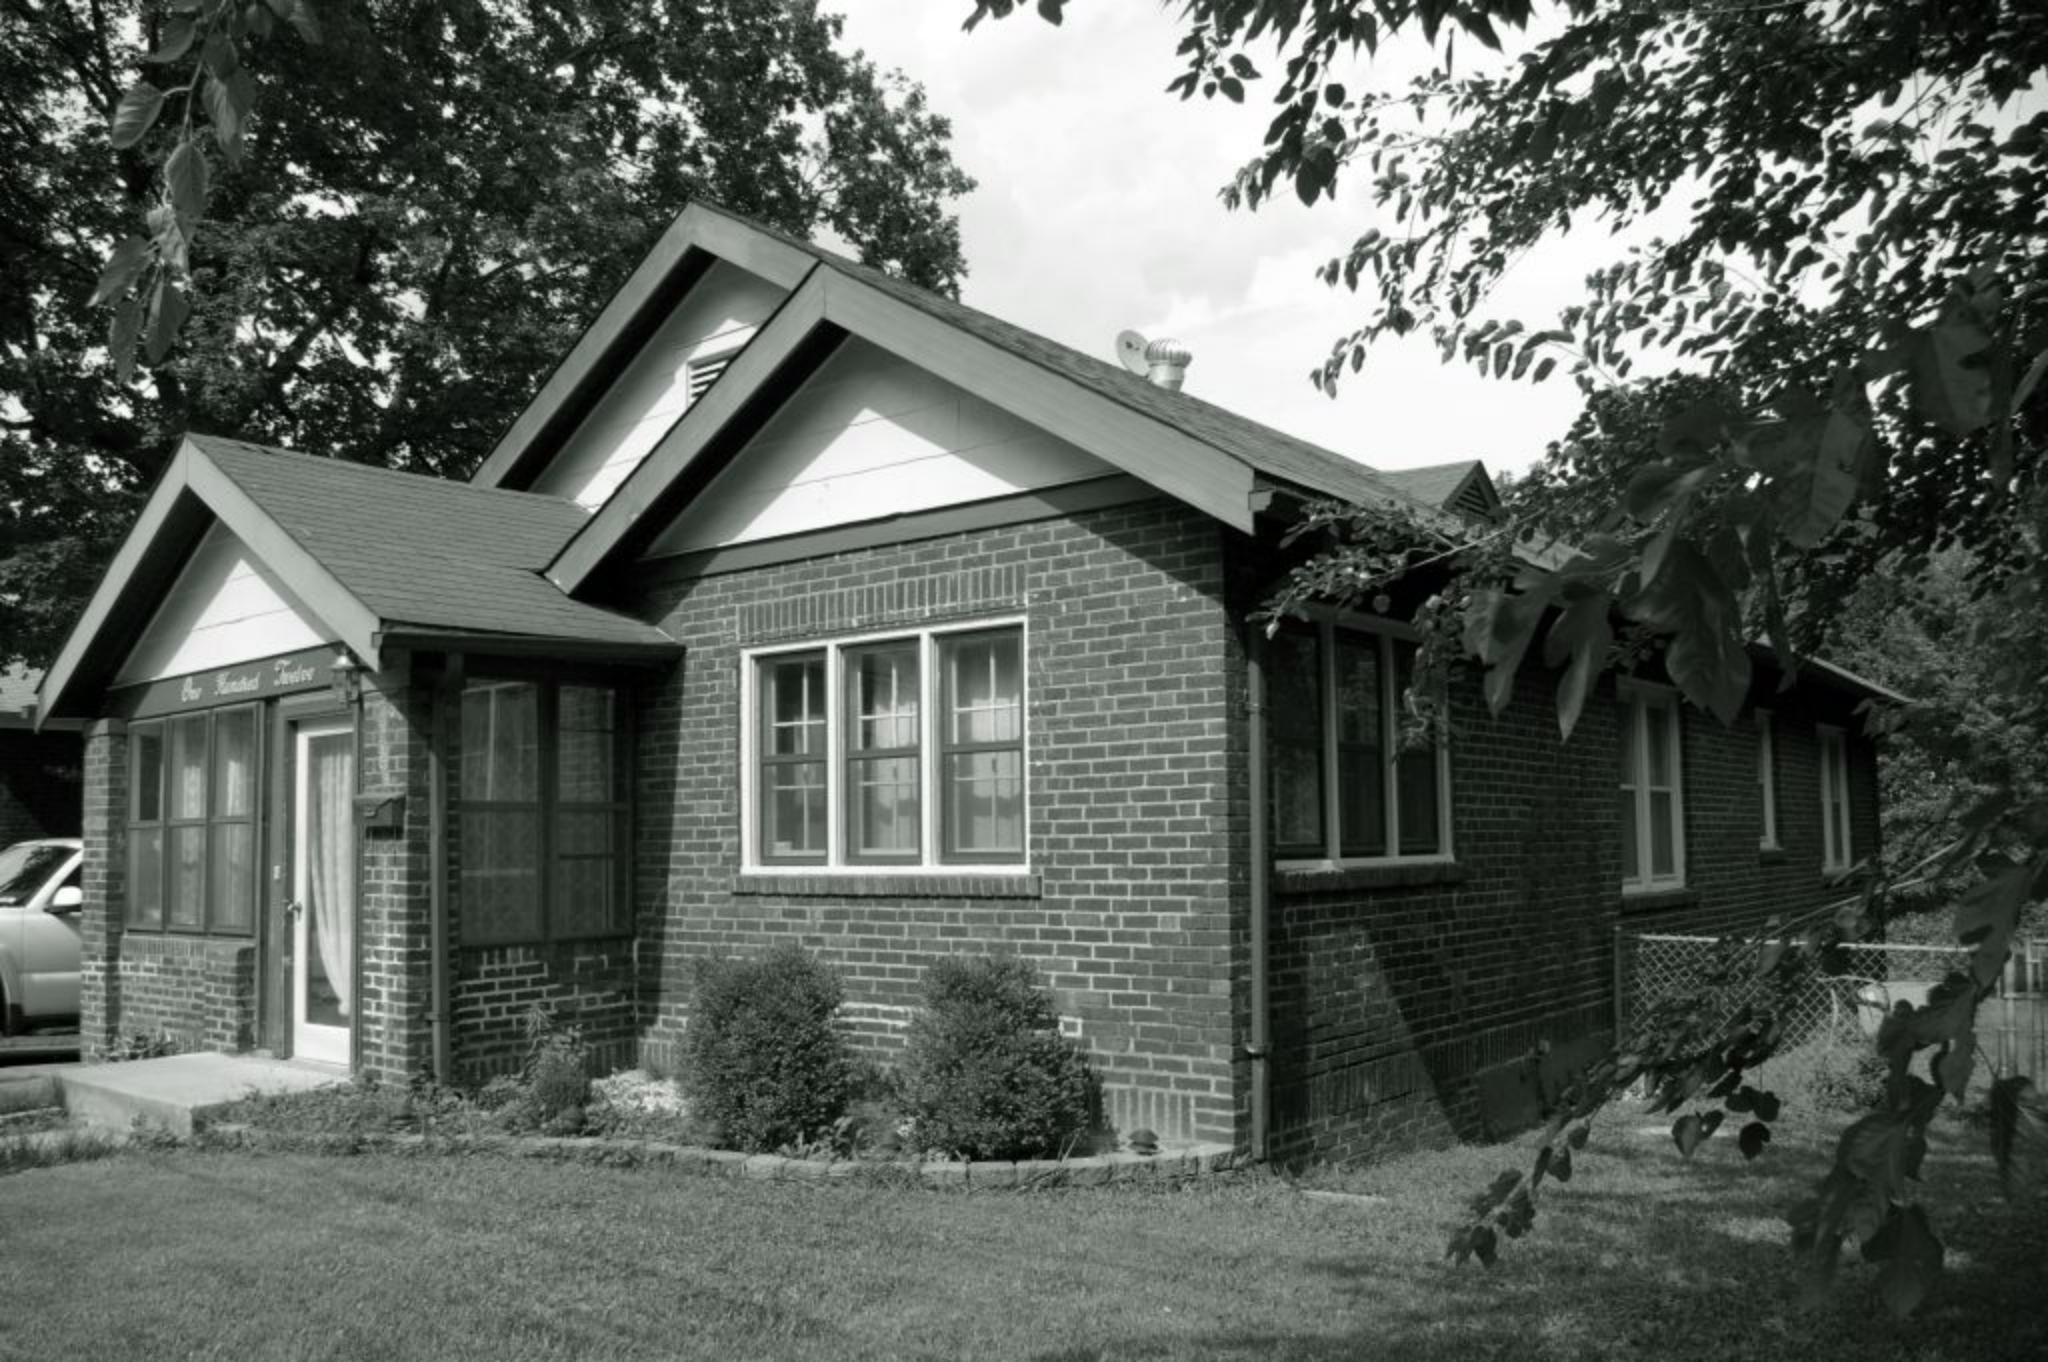
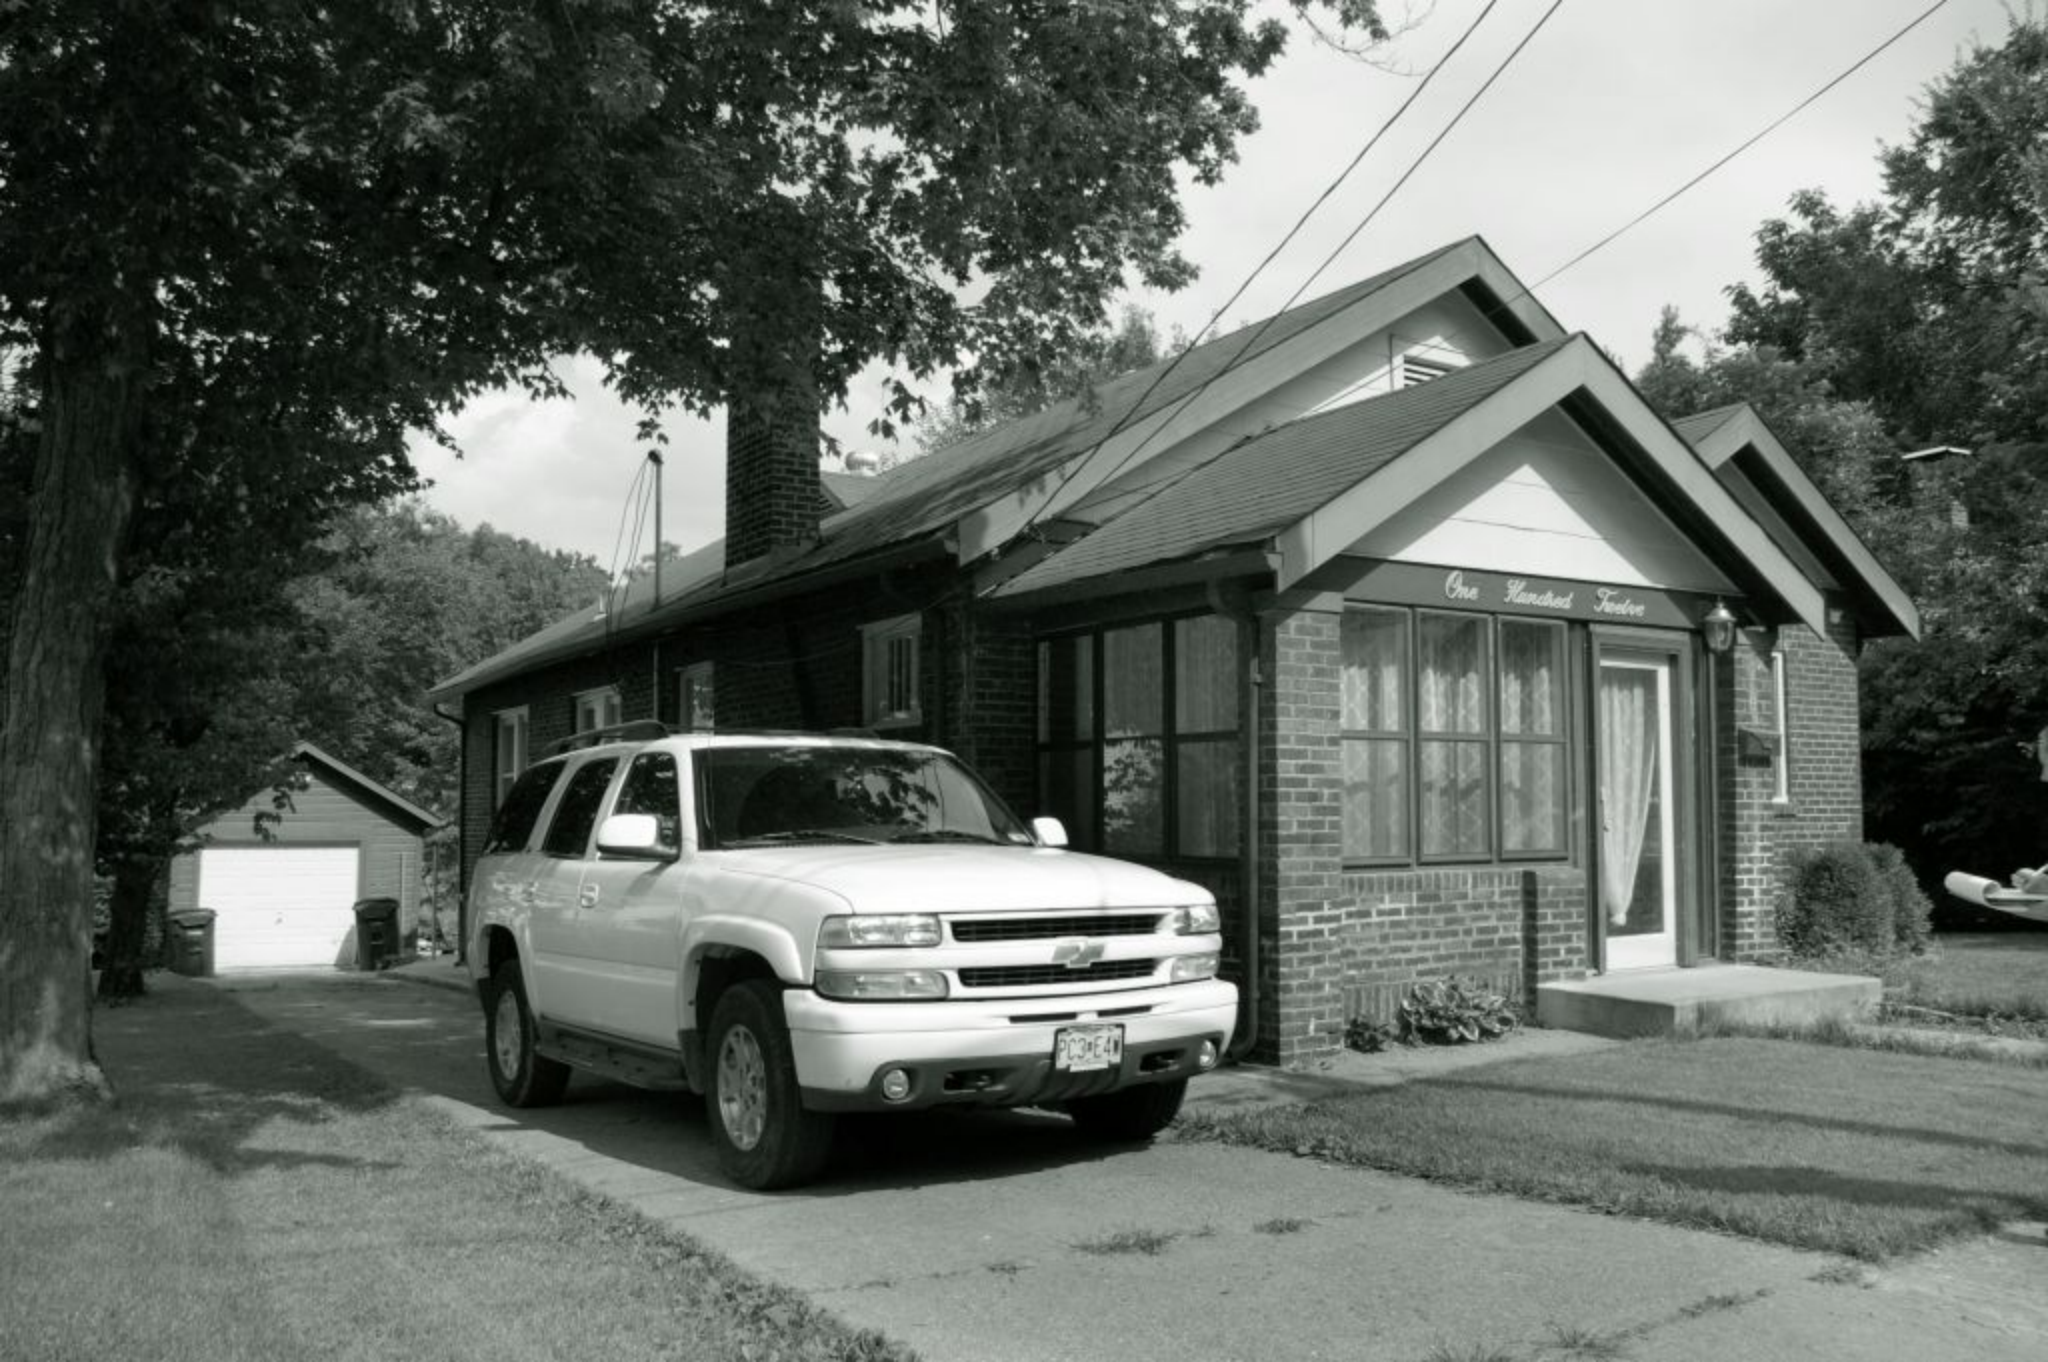
This one story, end gabled, brown brick, Craftsman bungalow has two staggered, shorter gables on the front facade; the gabled bay on the south side has three, 6 light casement windows clustered under the brick soldier course lintel and the gabled entry porch (which has an even shorter height gable) projects further away from the facade across the north bay and is supported by brick corner piers with brick half wall railings creating an entry opening on the south end of the porch. The porch has been enclosed with storm windows and a storm door and currently has curtains obscuring the view of the original door inside. The windows on the side of the house are generally 3 over 3 wood sashed windows with storm screens, but there are some awning windows with three vertical lights on the north side along with an end wall chimney with a tall shaft projecting through the roof. The gable ends have asbestos shingle siding, a later replacement material, probably added in the 1950s when this material was popular.

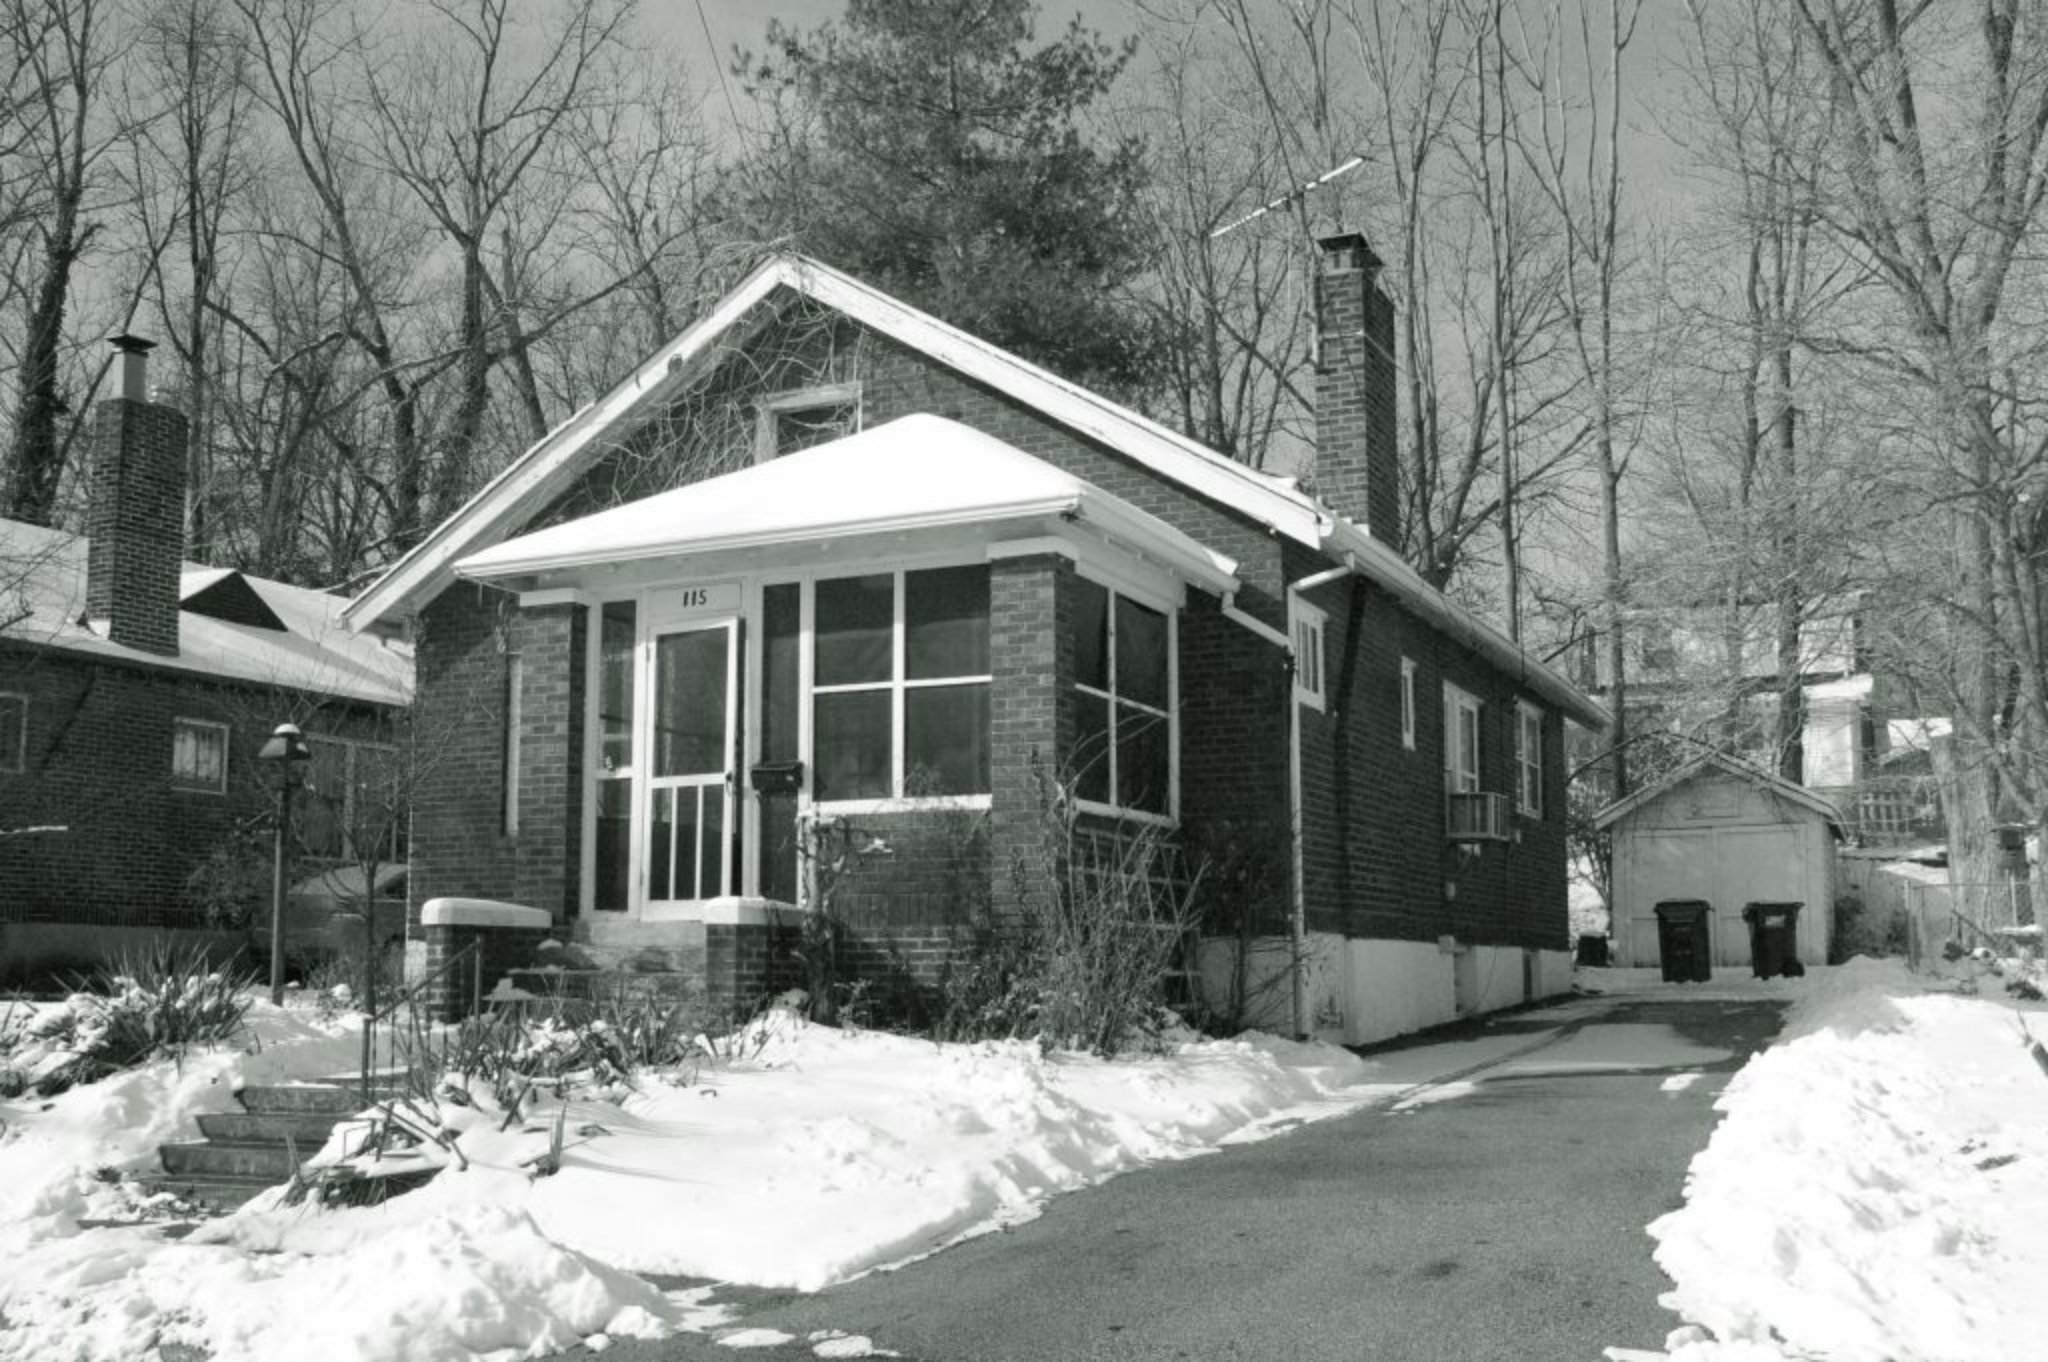
This one story, end gabled, red brick, Craftsman bungalow has a 3 bay facade with a hipped roof porch spanning two bays, one a sashed window and the other the multipaned full light wood door. The porch has brick corner piers and half wall railings as well as brick knee walls on either side of the concrete steps. The porch has been framed with wood screens and a screen door. Most windows are 4 over 1 wood sashed windows, but here are some 2 over 2 awning windows with 3-light wood storm windows on the side of the house. Most other windows also have storms. There is a tall brick chimney piercing through the roof on the north side of the house.

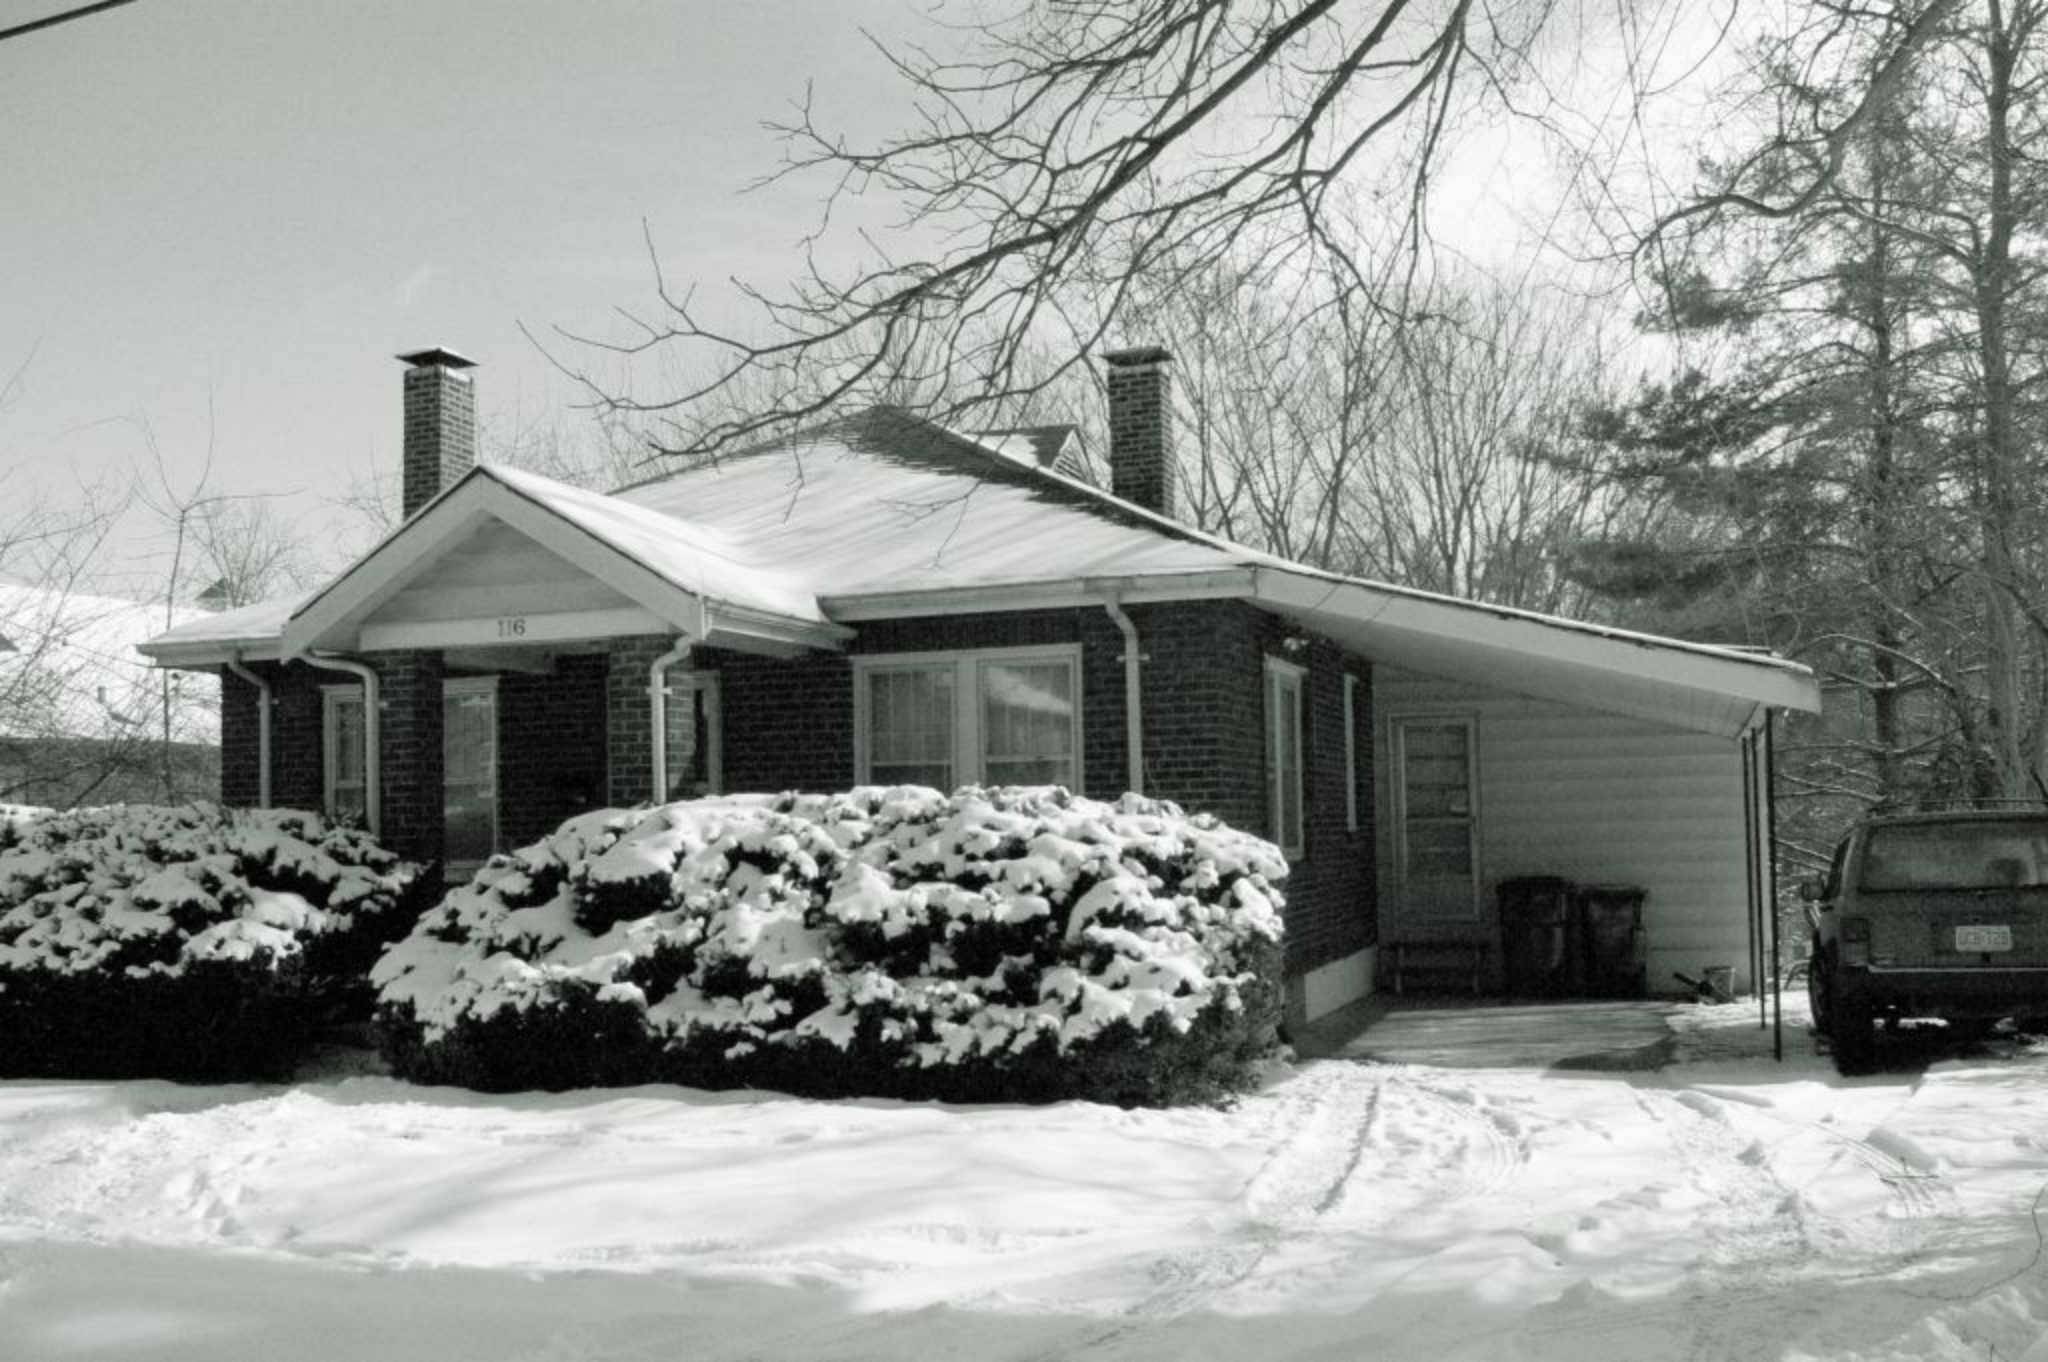
This one story, hipped roof, brown brick Craftsman bungalow has a gabled porch in front of the center bay and entry. The porch end gable has been infilled with aluminum siding but the porch retains its wider eaves and the brick corner piers and concrete steps. To either side of the porch are paired, 4 (vertical muntin) over 1 wood sashed windows, a window pattern utilized on other elevations as well. The house has two chimneys, one on each side, projecting through the roof and a triangular dormer vent on the south side. The house was modified, apparently in the 1950s, given the horizontally lighted door, with a side shed roofed carport with a small room addition behind it, all along the south side of the house, but the basic Craftsman house remains without major alterations.

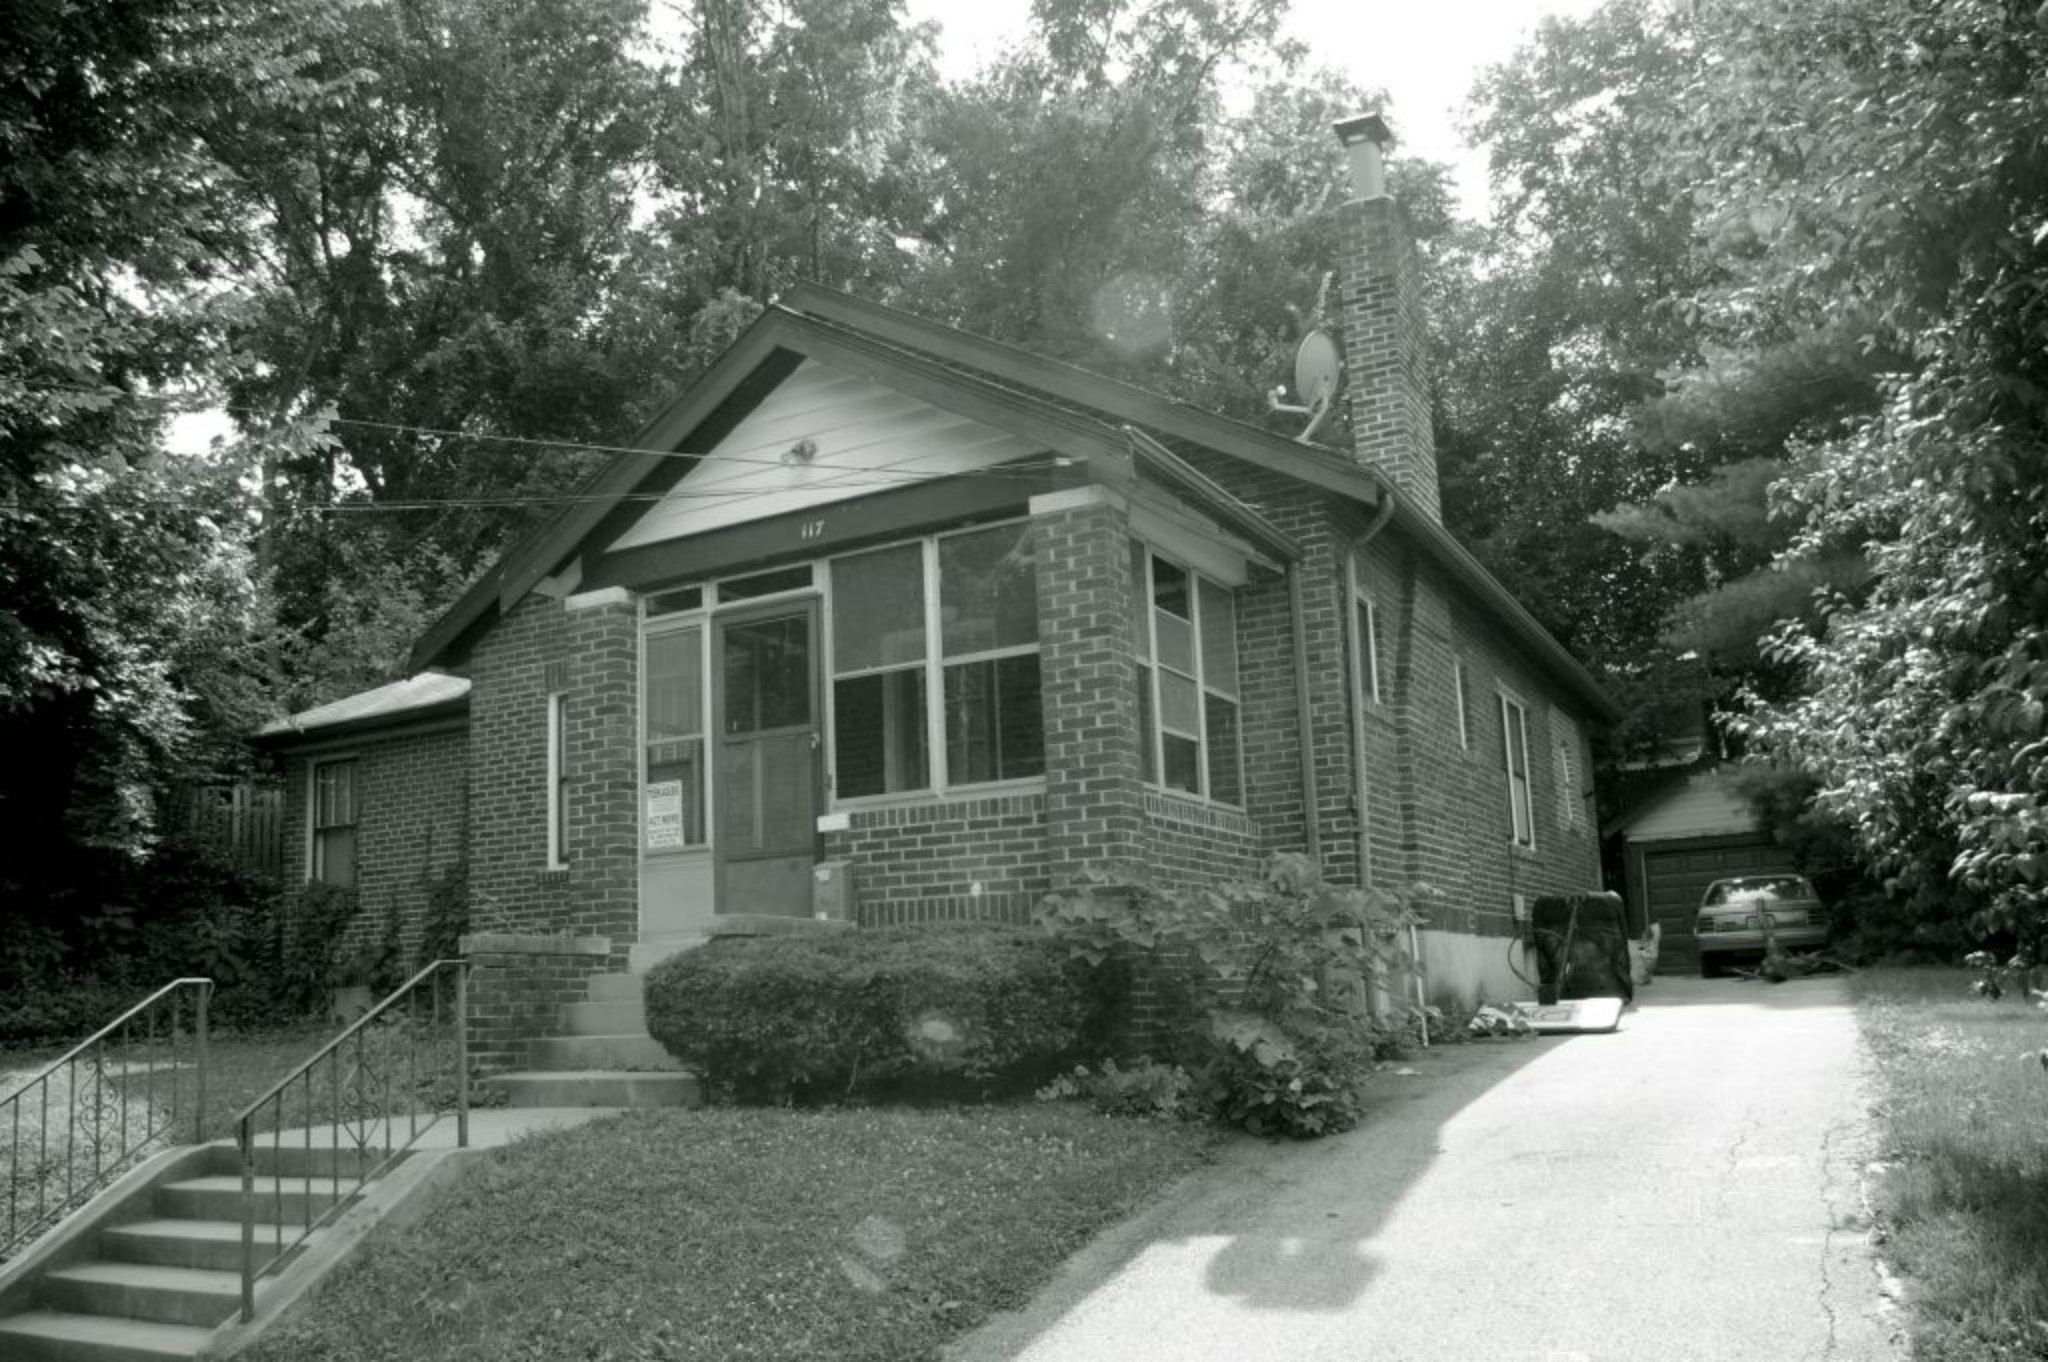
This one story, end gabled, red brick Craftsman bungalow has a four bay facade created in part by the hipped roof wing that extends to the south side of the house. The main gable end facade is divided into three bays with a sashed window to the north of the multipaned, full light entry door and paired windows to the south of the door, which are situated outside the gabled, entry porch with its brick corner piers and half wall railings. The porch spans the north two bays and has knee walls on either side of the steps, positioned off center to align with the entry door in the middle bay. The gable end of the porch has wide wood siding. There is a tall chimney projecting through the roof on the north side. The windows are the original, vertically lighted 3 or 4 over 1 sashed windows. The porch has been enclosed with aluminum storm windows and door, as the other windows also have aluminum storms. The south wing may be an early addition (given the matching, vertical light sashed windows) since the red brick appears to be a lighter color than the main house.

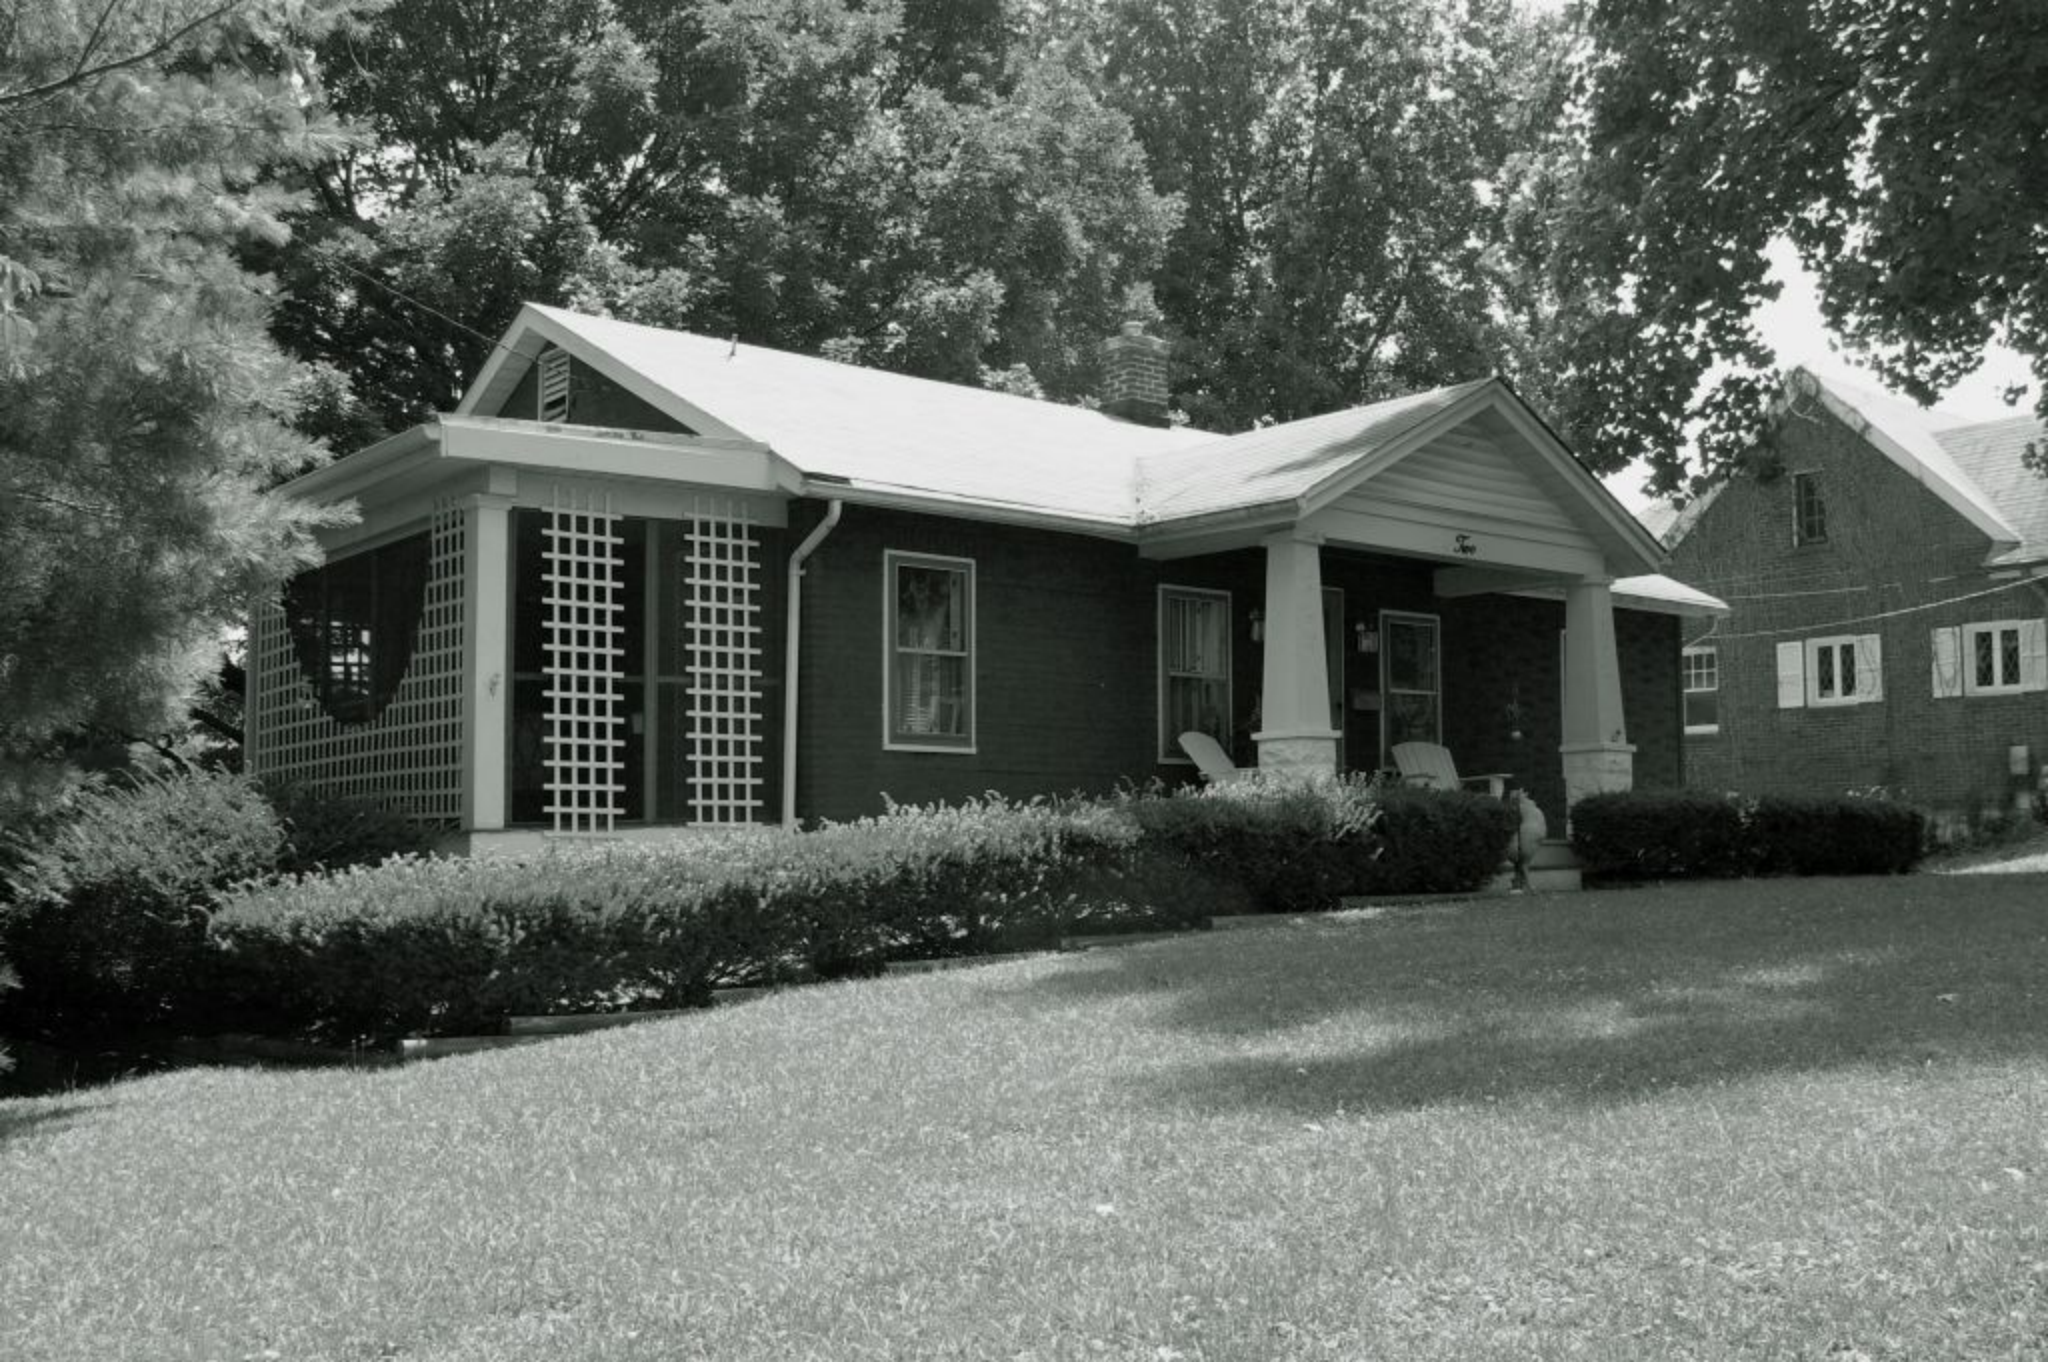
This Craftsman bungalow has a side gabled roof with wider eaves and a cross gabled porch centered on the original facade. The porch piers are faux stone blocks with tapered square columns, and it has a wood porch floor with a single step, but the original railing is missing. The facade is divided into 3 bays with a single, 1 over 1 wood sashed window in each outer bay and two, 1 over 1 wood sashed windows flanking the entry door under the porch roof. The gable end on the porch has vinyl replacement siding and storm windows and door have been added to the house. To the north is a one story, flat roofed, side porch that has trellising added to the sides. It appears that the side porch is not original since it was added after the 1950 fire map was published but its design is in keeping with other houses of this era and it appears to be an early alteration. There is a basement level garage entered from the rear via the driveway on the south side of the house.

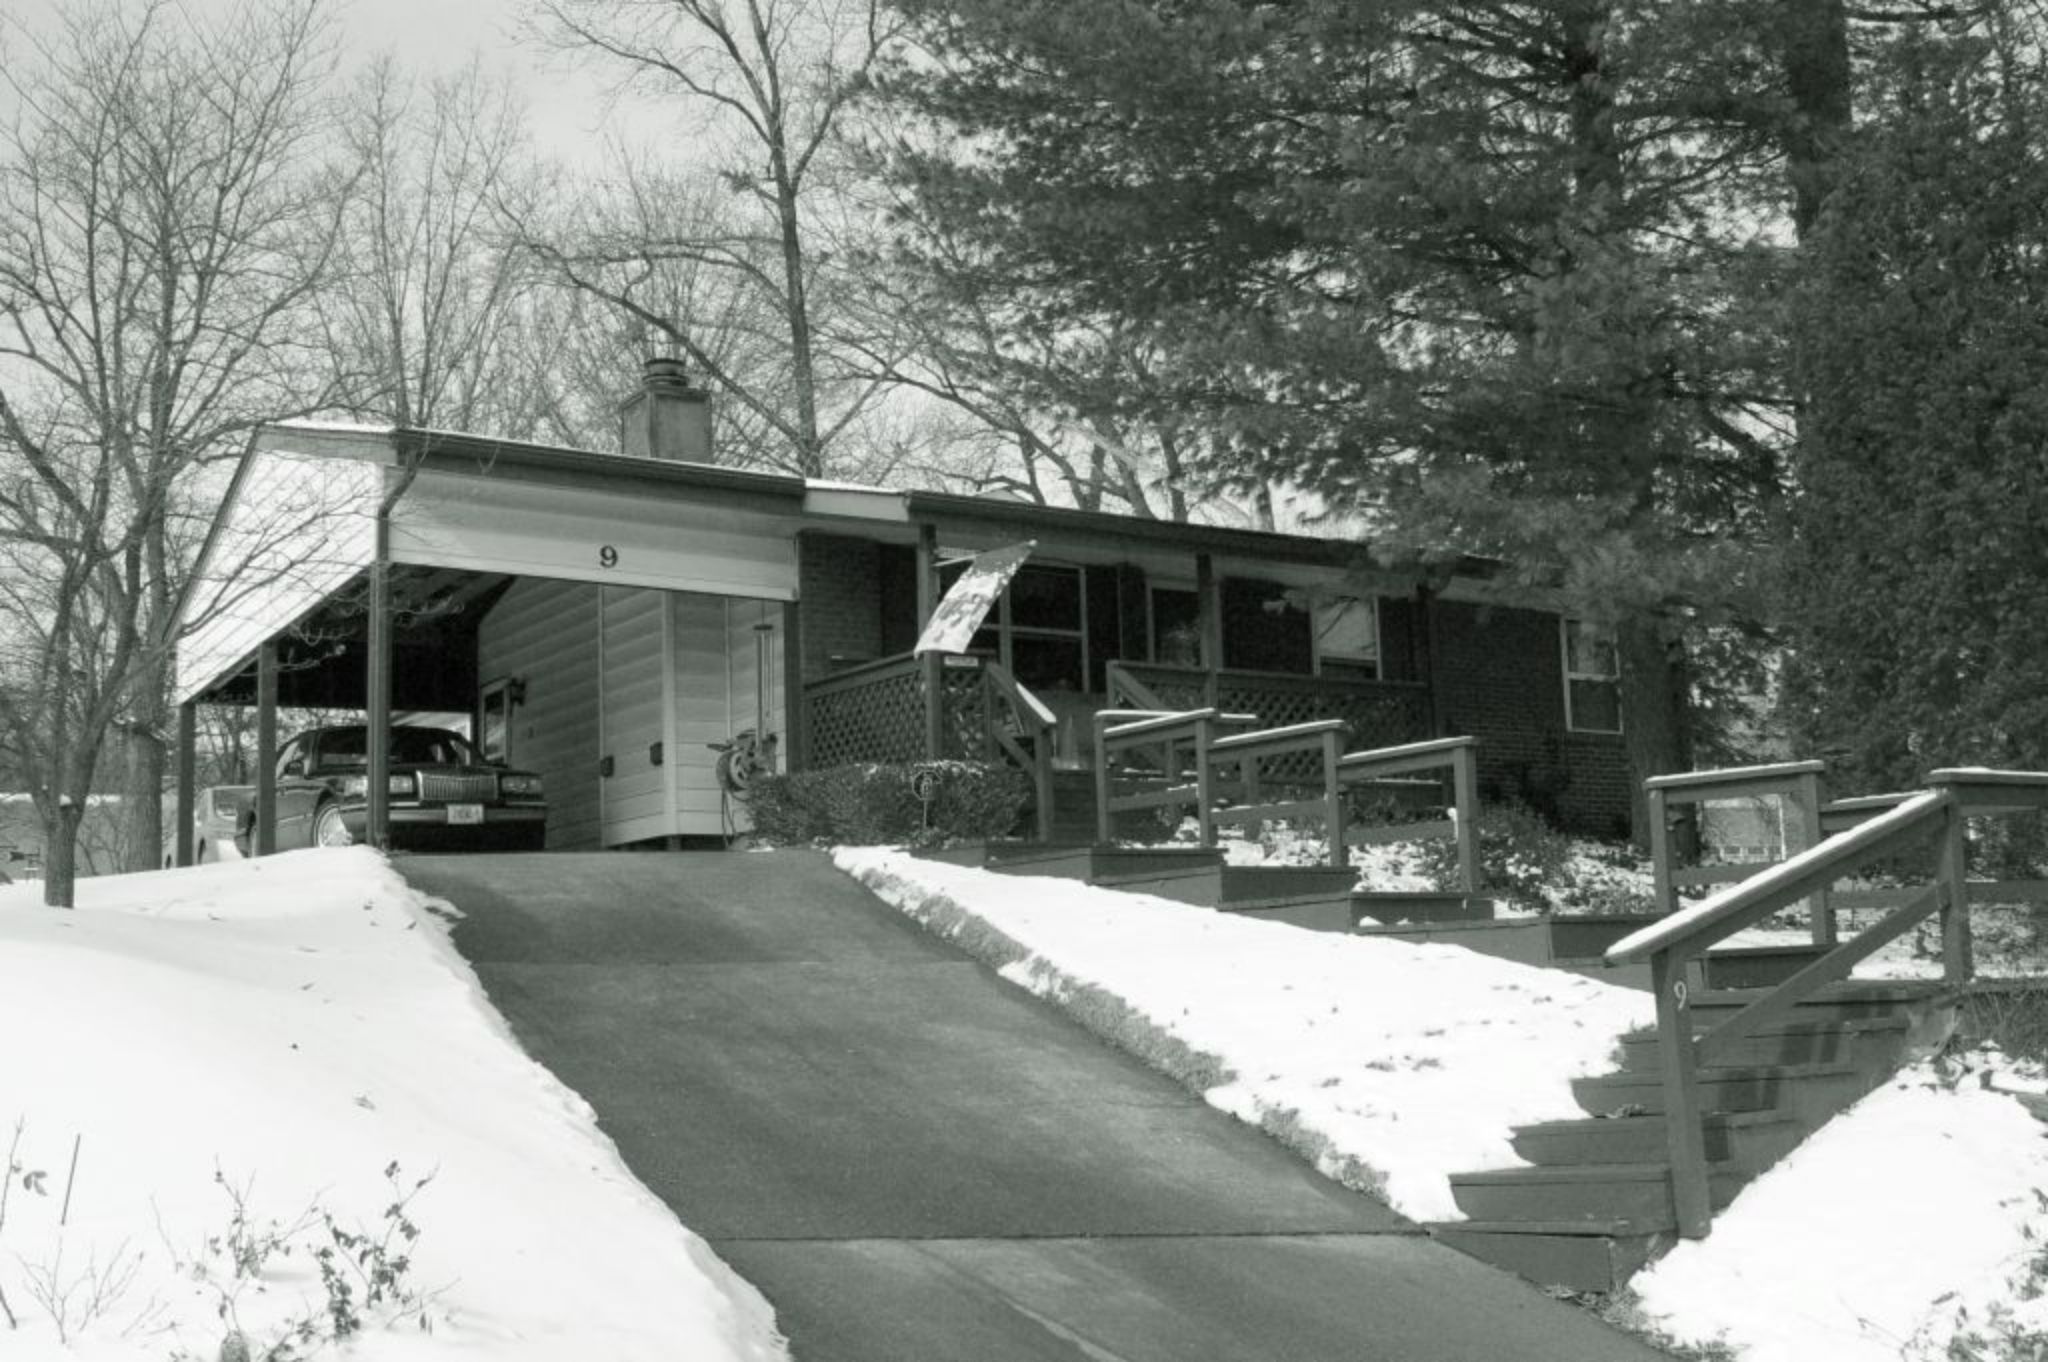
This brick Ranch house has a side gabled roof with four bays irregularly positioned on the facade. At the south side of the brick house is a side gabled carport, covered with aluminum siding, as is the south elevation wall and exterior chimney under the carport roof. There is a shed roofed porch that spans three of the four main bays (the paired windows to the south of the entry door as well as the single window to its north) and there is one other window bay at the north end of the facade. The windows and door are covered by aluminum storms, making it difficult to see the actual door and windows, but they appear to be 1 over 1 windows.
