ARCHITECTURAL/HISTORIC INVENTORY FORM

1. Survey No. SL-AS-036-001		2. Survey Name: Architectural Survey of Old Ferguson West	
3. County: St. Louis		4. Address: 1 Carson Rd.	
5. City: Ferguson	Vicinity: <input type="checkbox"/>	6. UTM:	7. Township/Range/Section
8. Historic name (if known):		9. Present/other name (if known): Whistle Stop	
10. Ownership: <input type="checkbox"/> Private <input checked="" type="checkbox"/> Public		11. Historic use (if known): TRANSPORTATION/rail-related	11. Current use: COMMERCE/restaurant & RECREATION/museum

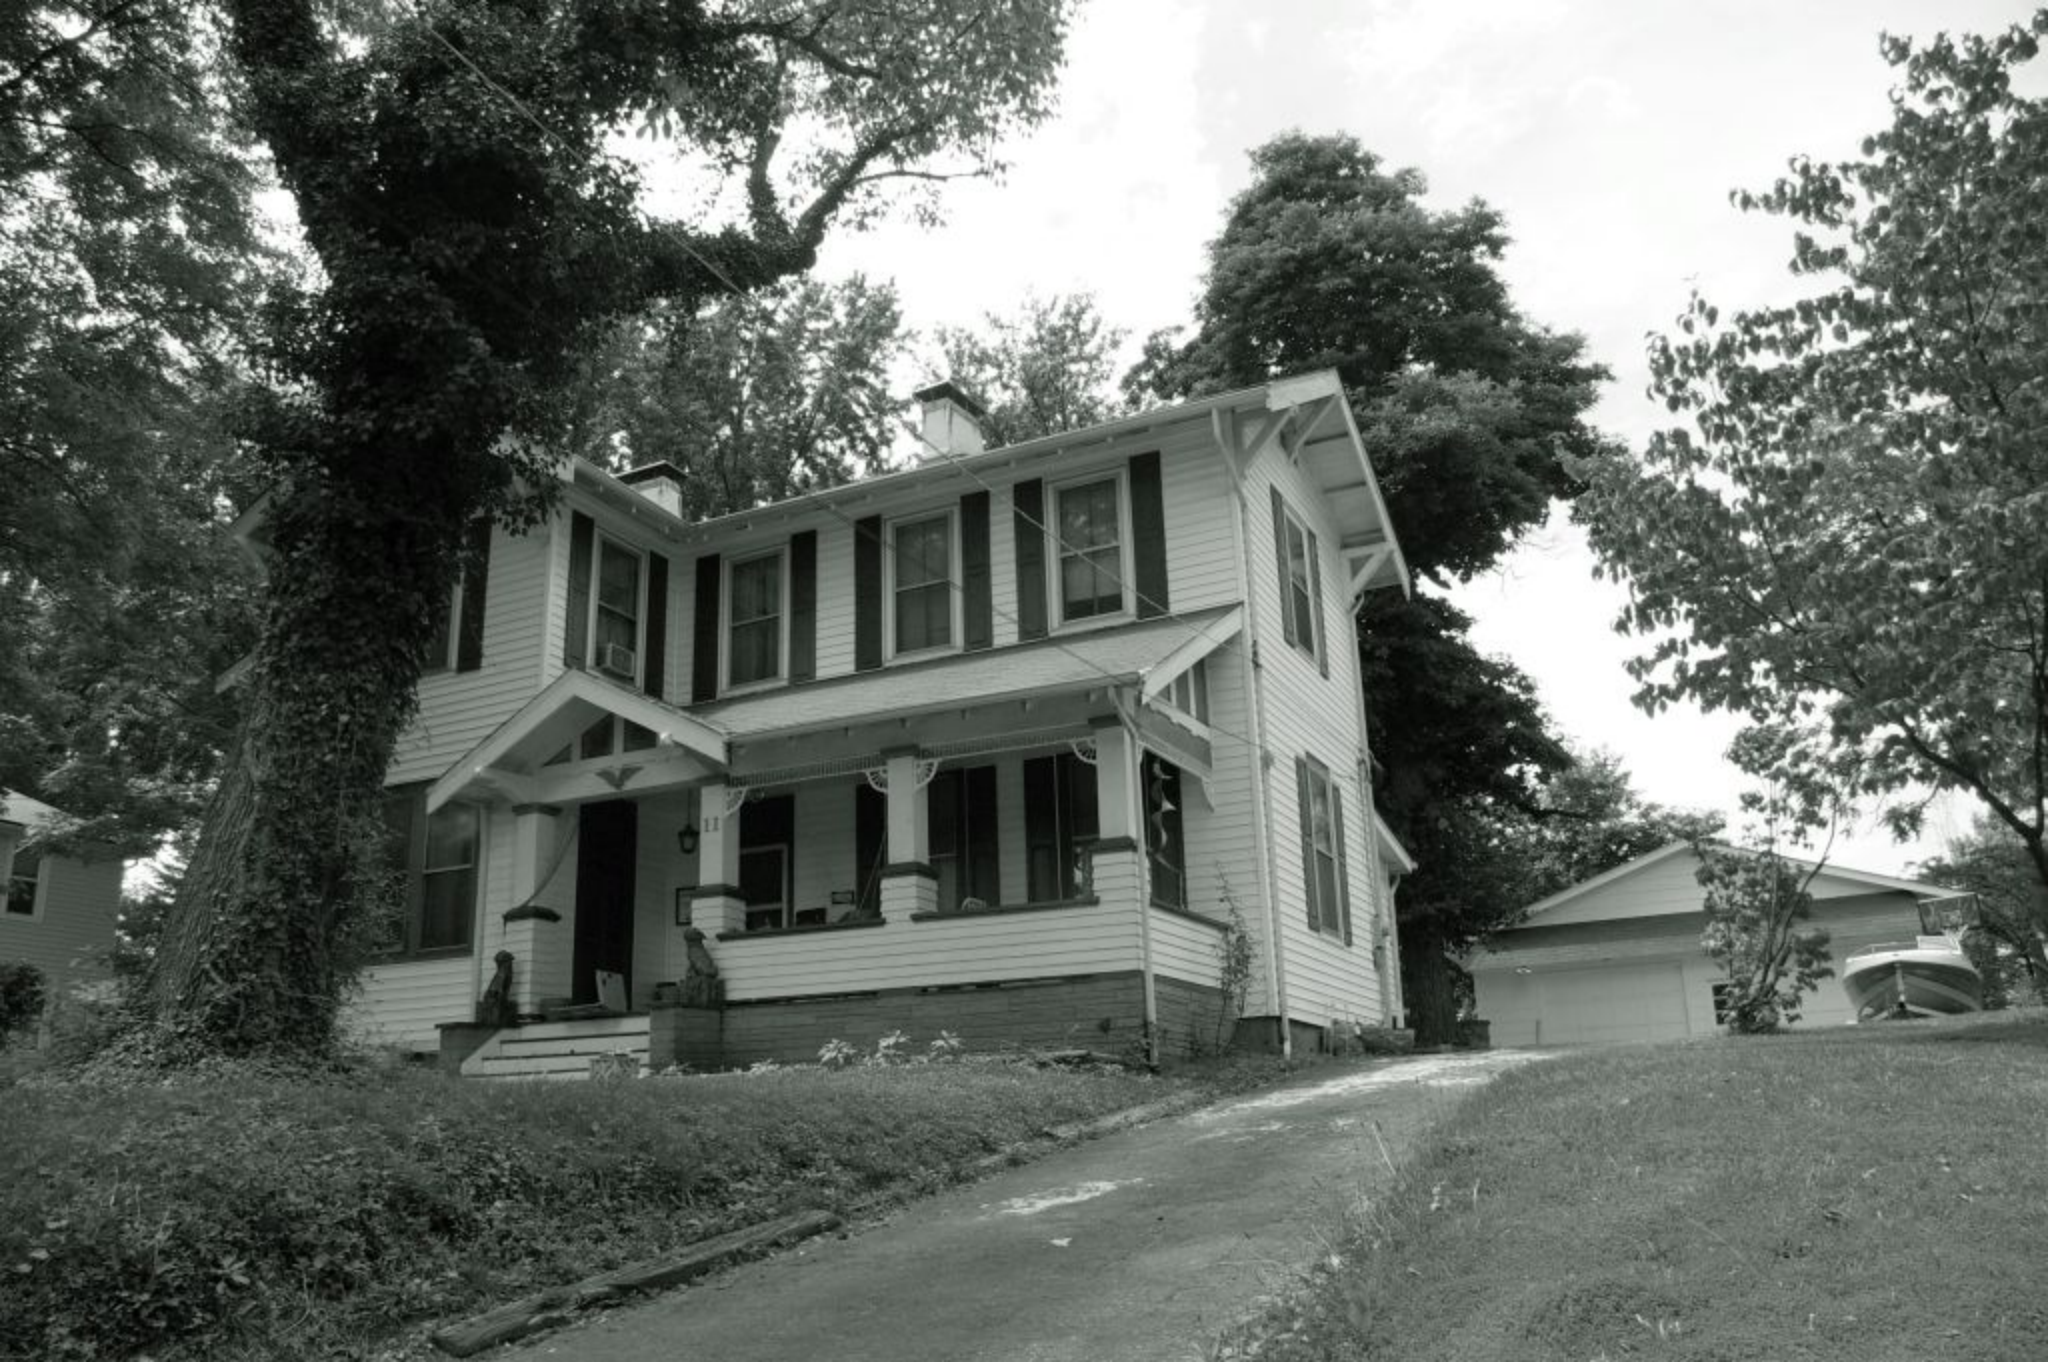
2009 Survey Update: Since the 1983 survey, the wide aluminum siding on the house has been replaced with new vinyl siding, more appropriately sized to match the original clapboard and shutters have been reinstalled, but it is not clear if they were part of the Craftsman era renovations in 1921 or an attempt to make the house appear more like its Victorian era roots, like the small spindle work added to the porch, which is not in keeping with the Craftsman design.

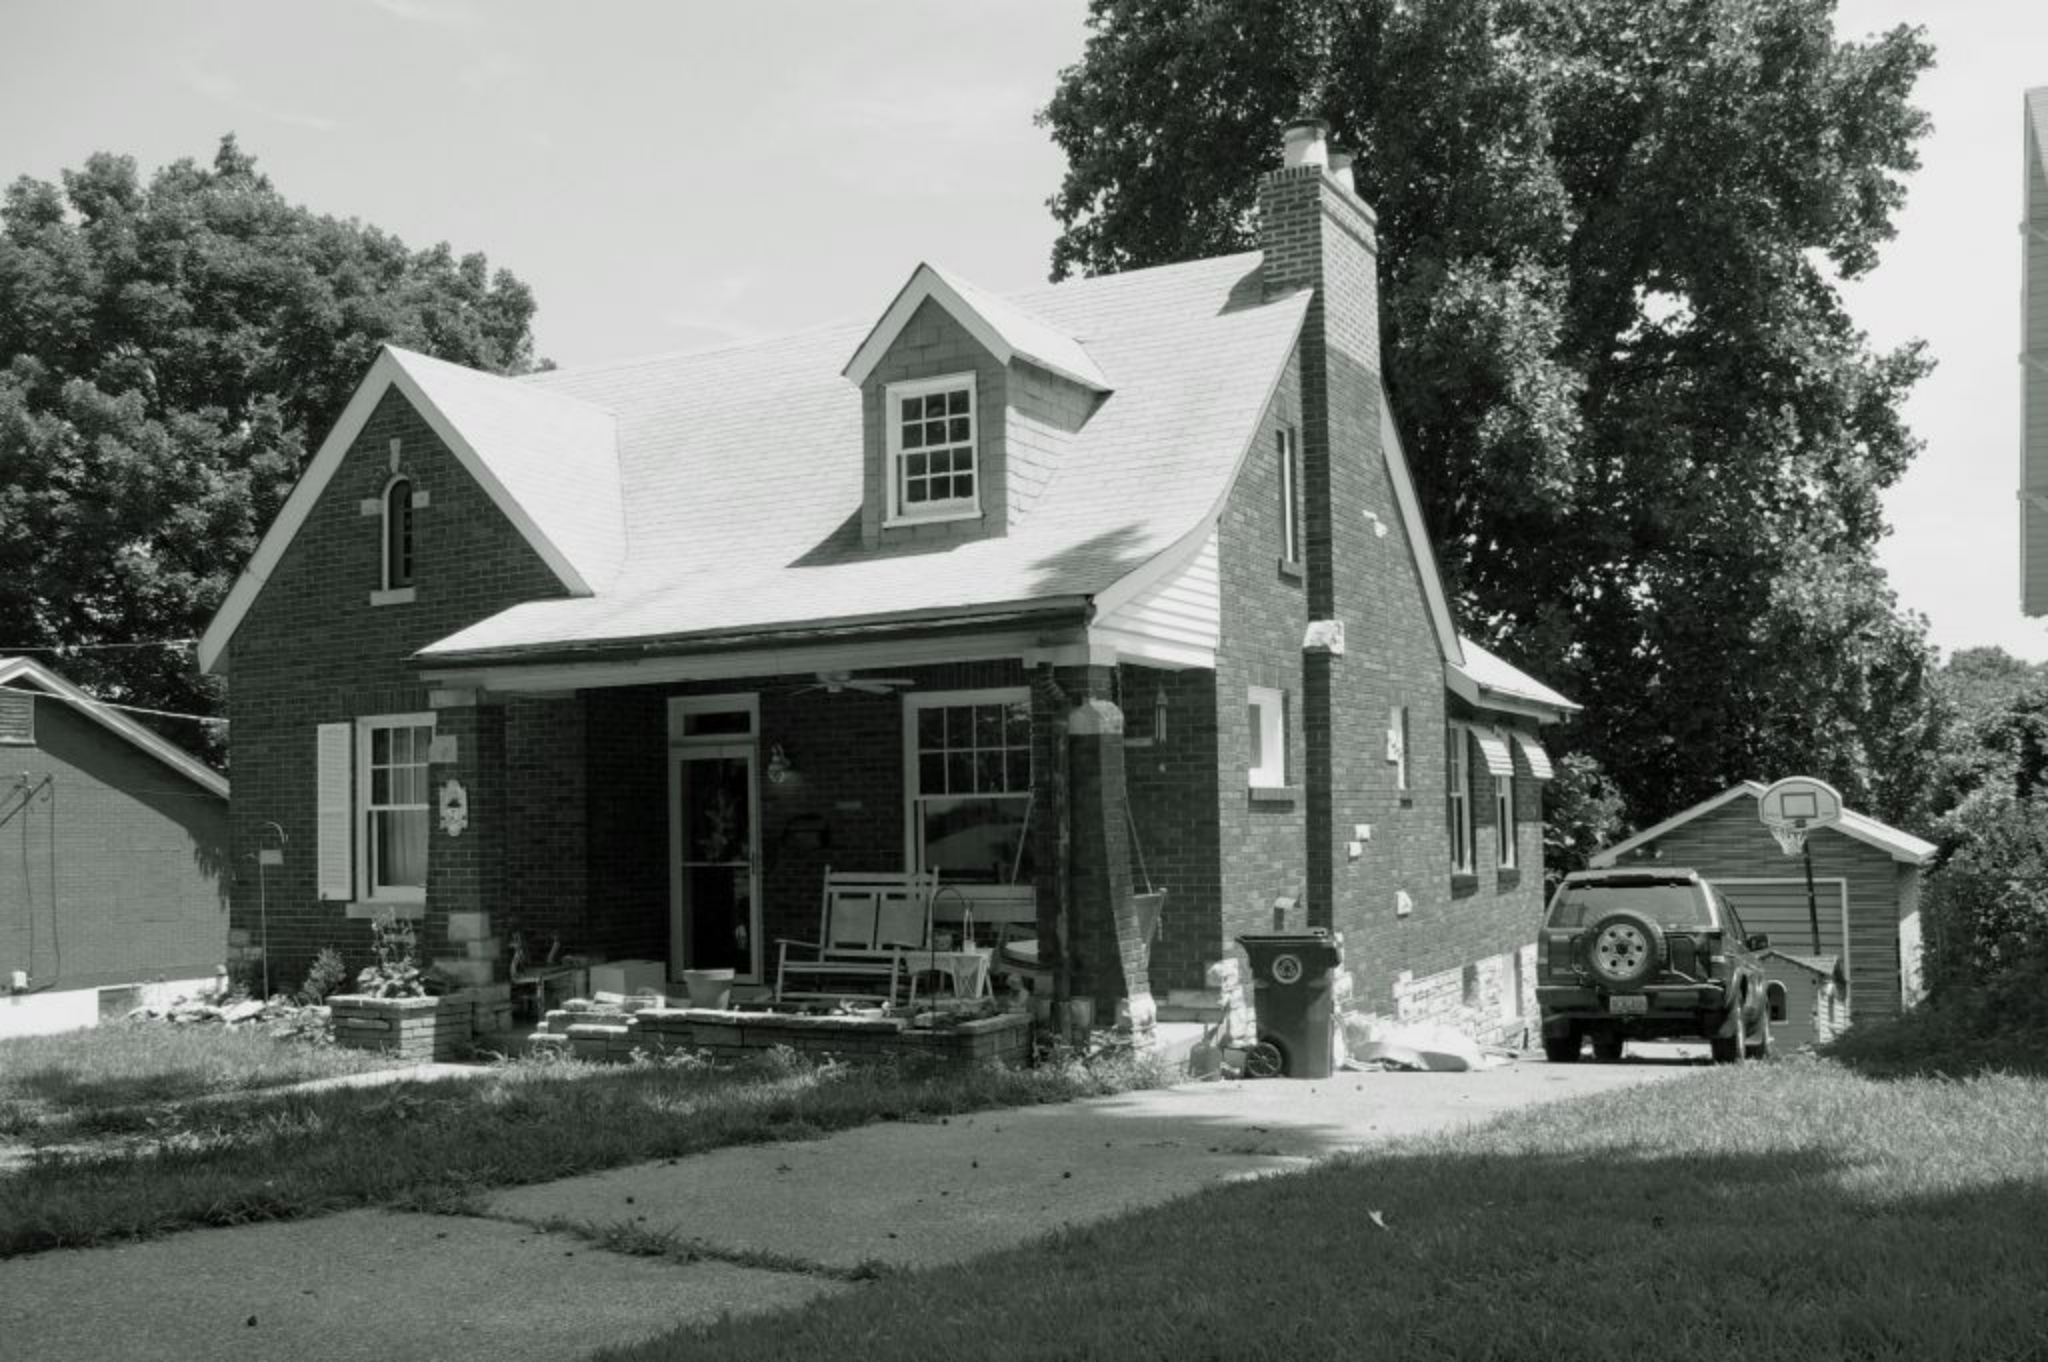
This 1.5 story, brick Tudor Revival house has a side gable with a cross gable wing projecting toward the front at the north end of the facade. In that bay of the facade there is a shuttered, 8 over 1 wood sashed window with a slender round arched window on the second floor. Adjacent to this wing, the roof continues over the front porch, which spans the other two bays of the facade. The porch has a concrete floor and step with brick knee walls and foundation; it is supported by brick corner piers with scattered stone details, a treatment seen elsewhere on the facade. Slender wing wall treatments make these piers appear more substantial. There is another 8 over 1 wood sashed window in the south bay and in the center bay is the transomed wood door, covered by a full light storm door. Above the porch is a gabled dormer, clad in asphalt shingles. It has a 6 over 6 wood sashed window. On the side elevations there are small, multipaned casement windows and on the south side is a brick end wall chimney with paired chimney pots. The ashlar stone foundation is visible as a decorative detail, more so on the sides because of the slope of the land. Unfortunately, the upper portion of the chimney has been poorly repointed. Vinyl siding has been installed on the sides of the porch and there are aluminum awnings on the south side windows.

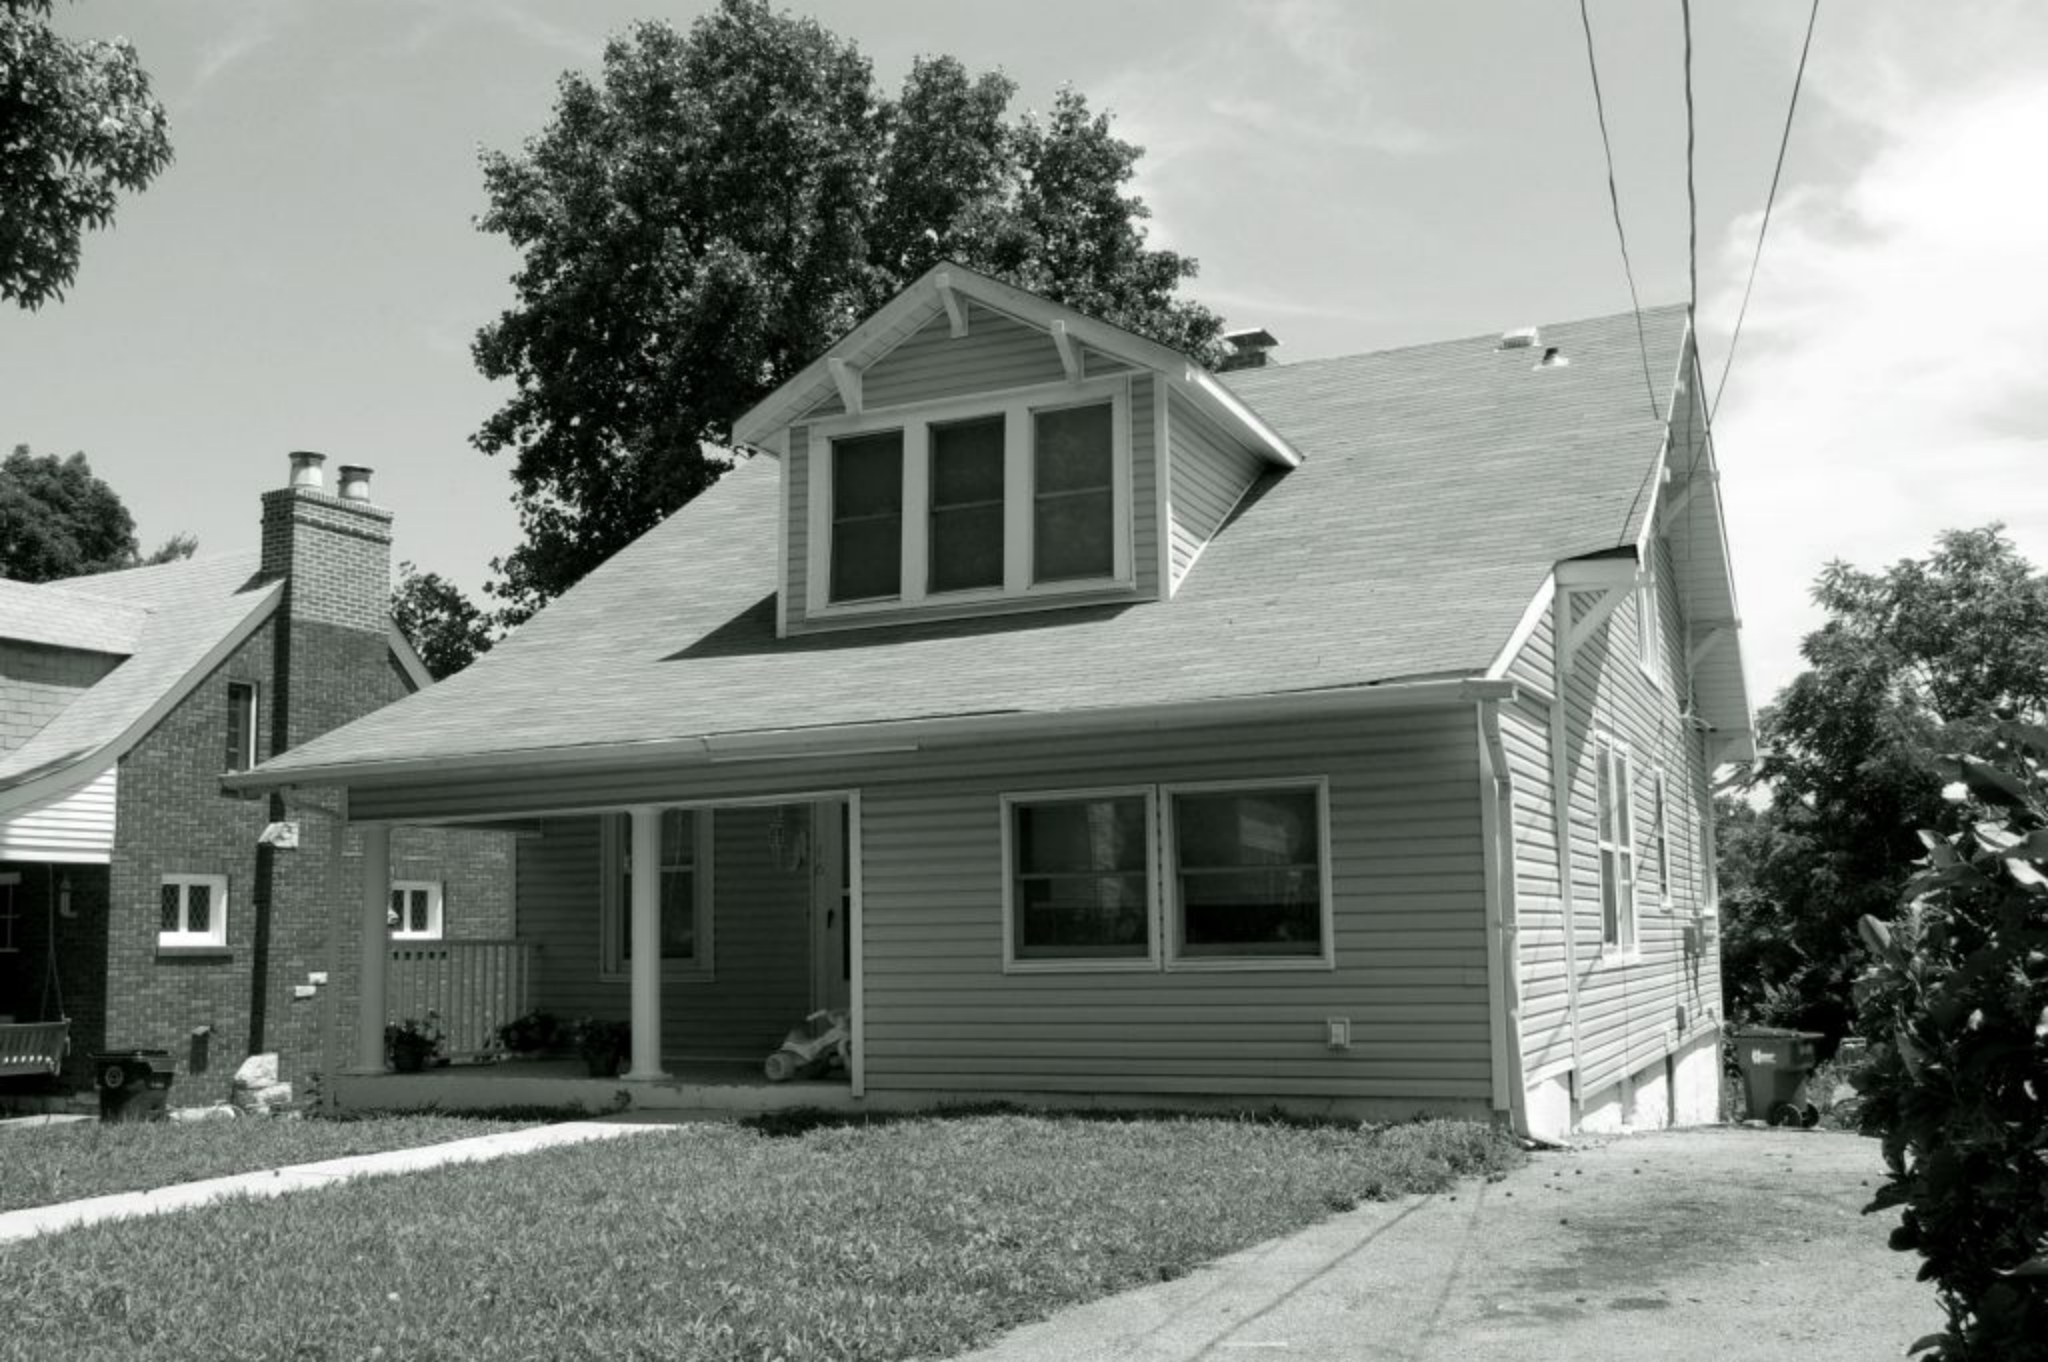
2009 Survey Update: Since the 1983 survey, the aluminum siding has been replaced with vinyl siding and some of the windows have been replaced with vinyl windows. Also the porch columns have been replaced with round columns. Even so, the Craftsman details in the roof shape, dormer, and the knee braces dominate the appearance of the house. Unfortunately, the previous alterations, enclosing the south bay of the front porch, also impact the historic integrity.

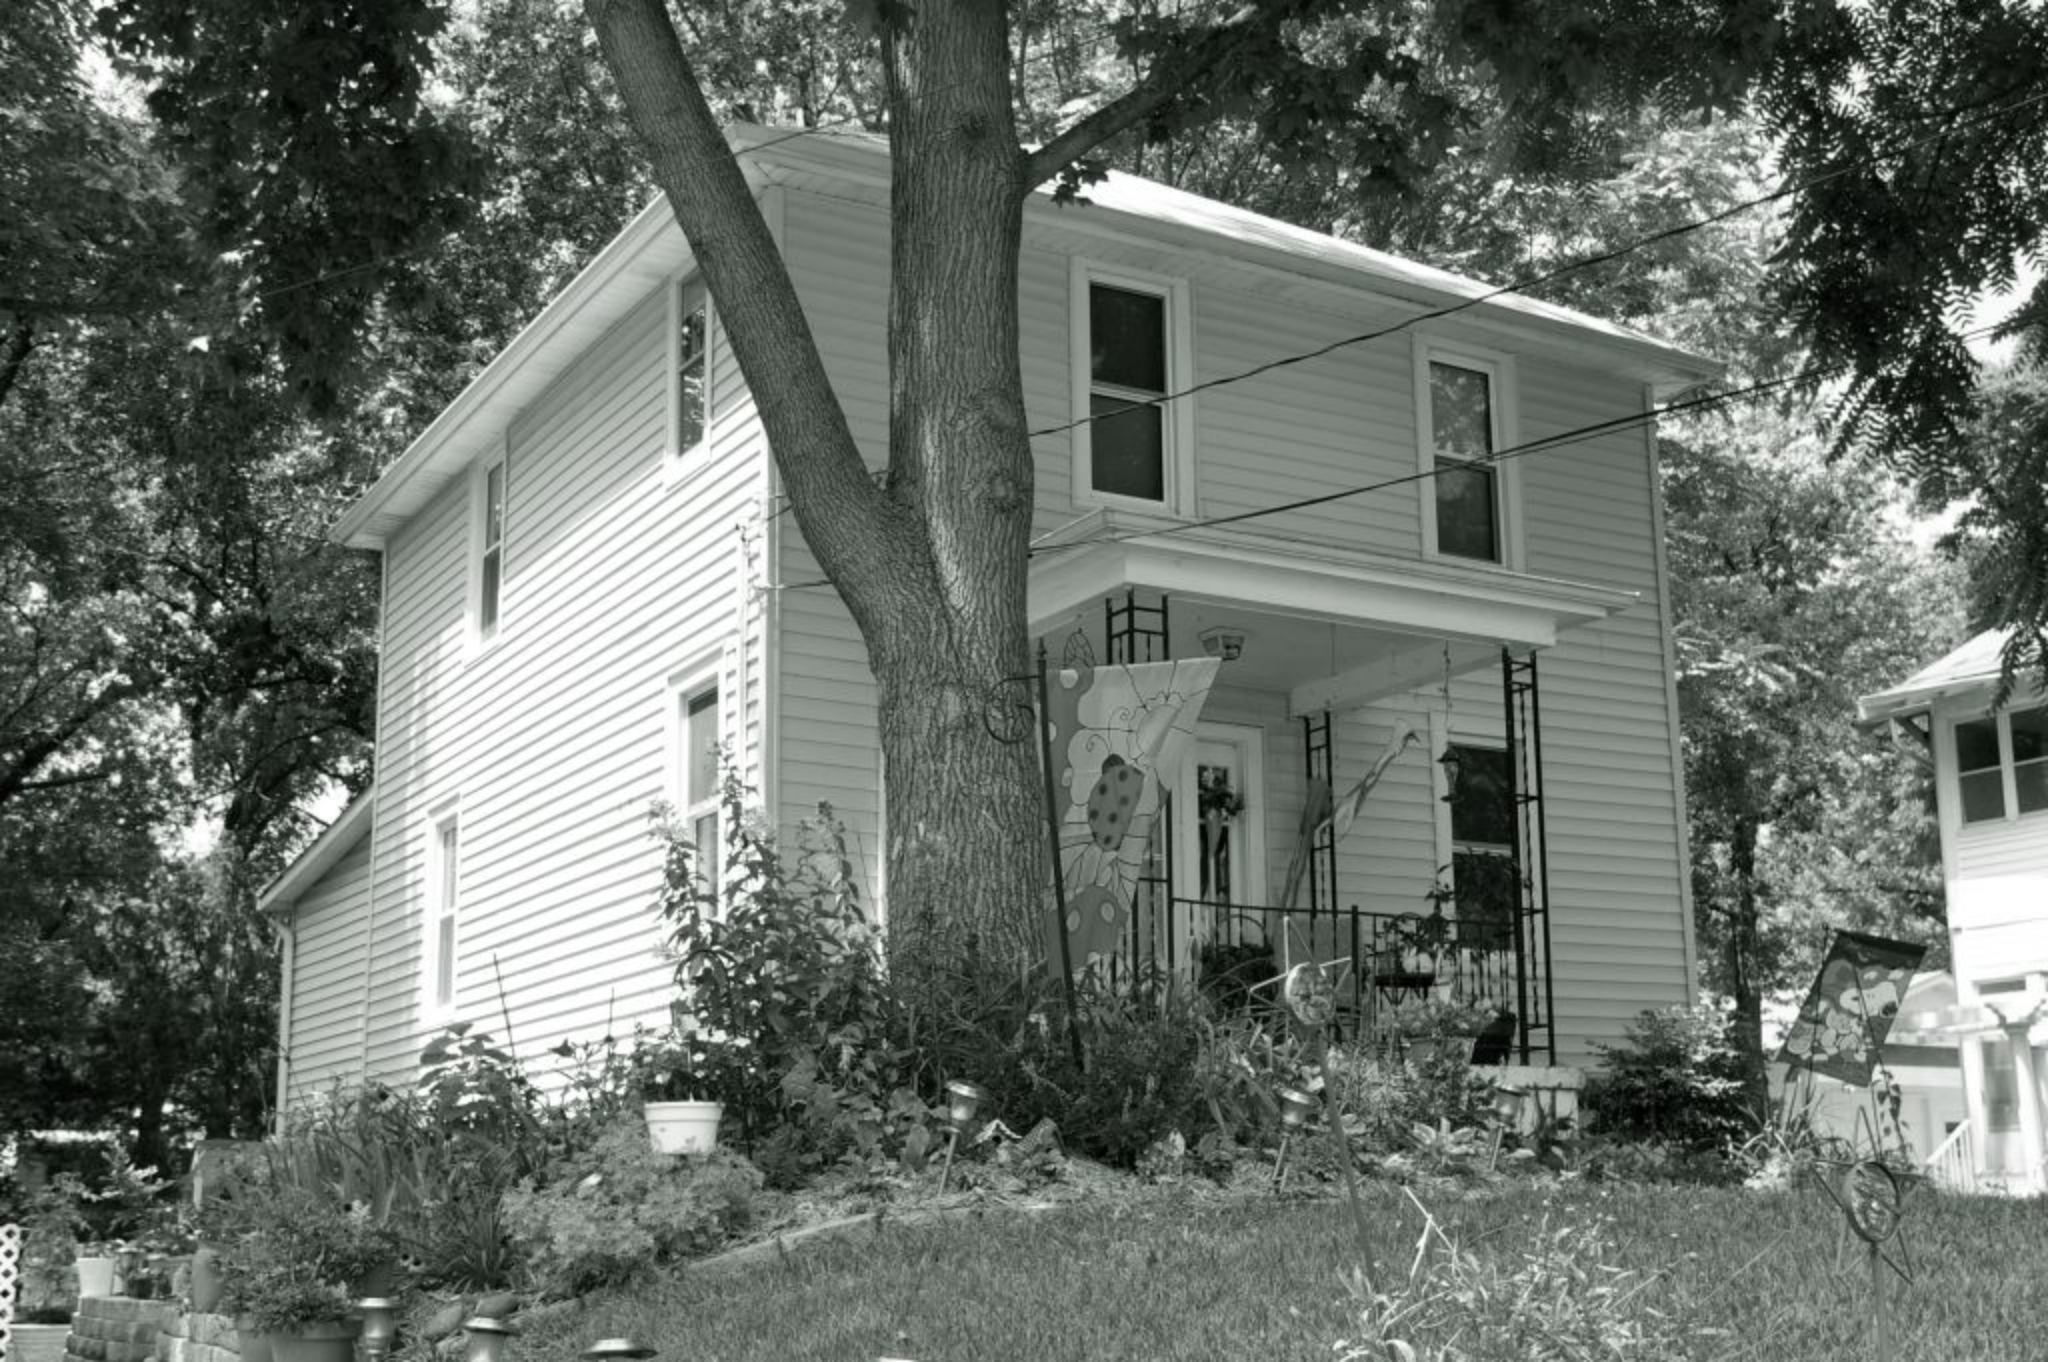
2009 Survey Update: Since the 1983 survey, the asbestos siding has been replaced with vinyl siding, but the original 3 over 1 windows have been removed and replaced with 1 over 1 windows. Even on the 1950 fire insurance map the porch was full width, indicating that the current porch with its wrought iron supports was probably a replacement done in the 1950s or 1960s when that material was popular.

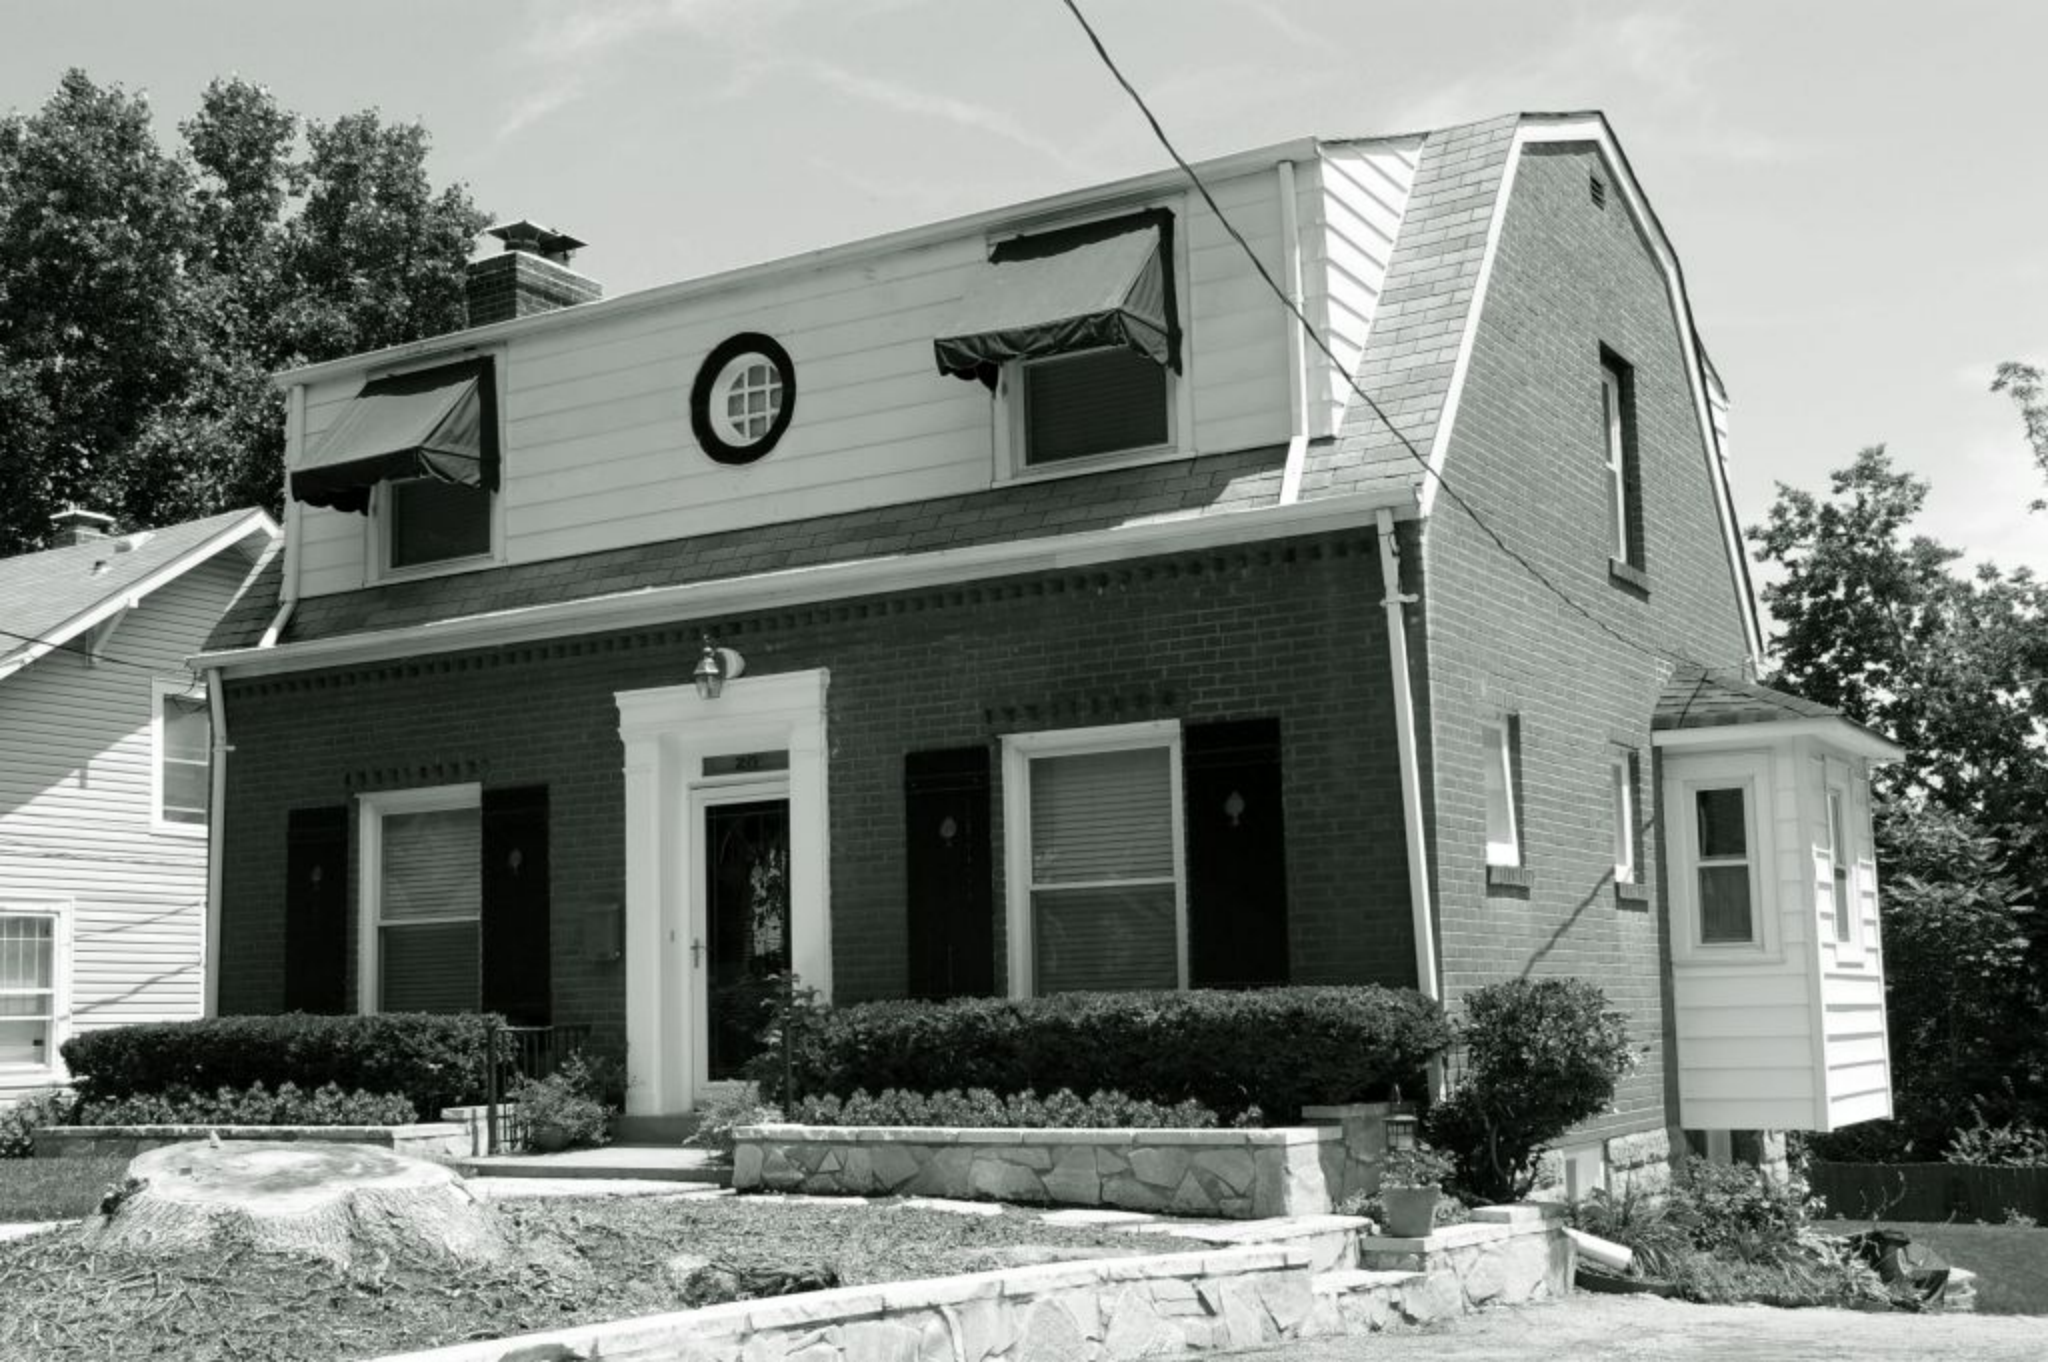
This 1.5 story, red brick house has a side gambrel roof with a full shed dormer on both the facade and rear elevations. The facade is divided into 3 bays aligned on both floors, with a central entry with an octagonal window of 9 lights centered above in the dormer. The transomed paneled door is flanked by pilaster strips that support a simple entablature. The outer bays on both levels have 1 over 1 wood sashed windows, but the first floor windows have decorative brick lintels and the original wood shutters (with the spade cutouts). On the north side the first floor fixed windows are art glass and this elevation is also symmetrical, with a central, end wall chimney between the windows (with sashed windows on the second floor). Visible on this side is what appears to be a basement level garage with a screened wood porch on the rear of the house. The south elevation has asymmetrical windows with a hipped oriel window above the exposed faux stone foundation. The dormers and oriel window have replacement aluminum siding, and the oriel window has vinyl replacement windows. The only other alterations appears to be the addition of aluminum storm windows and a full light storm door.

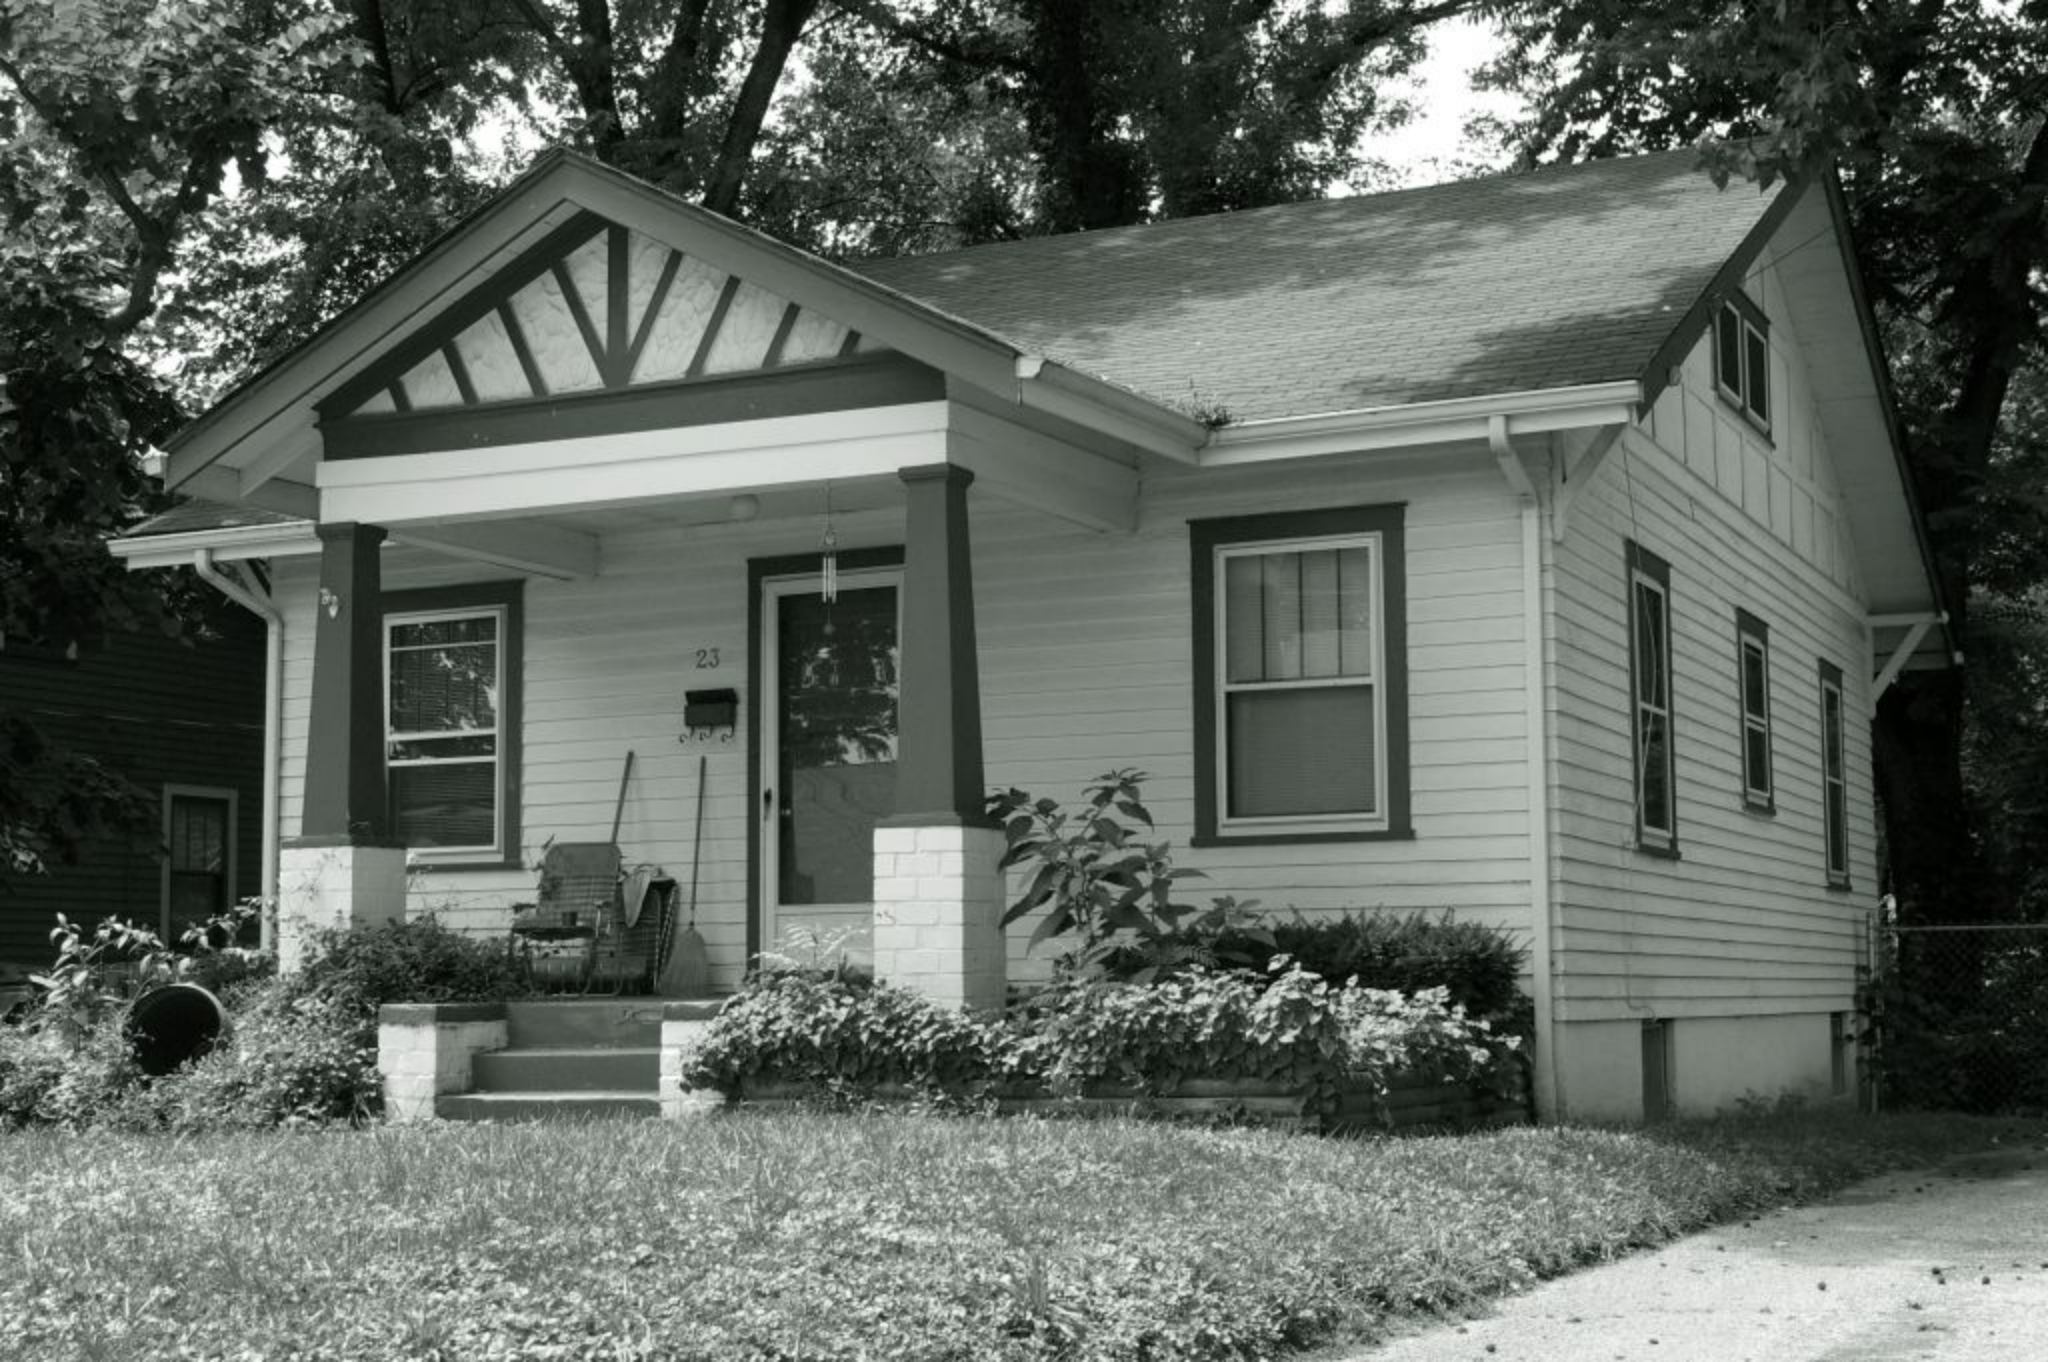
This 1.5 story, clapboard Craftsman bungalow has a 3 bay facade with a gabled porch in the center bay flanked by 4 over 1 wood sashed windows. The porch gable end, as well as the main house gable ends have stucco half timbering. The porch is supported by tapered square columns resting on painted brick plinth blocks. The concrete steps to the porch have brick knee walls. On the south side elevation there is a shed roof supported by knee braces over a side entry door. The adjacent driveway leads around the back to the basement level garage. The gable ends of the house have knee braces. The siding on the house is the original, mitered corner clapboard. The only alterations appear to be a replacement paneled front door and the aluminum storm windows and door.

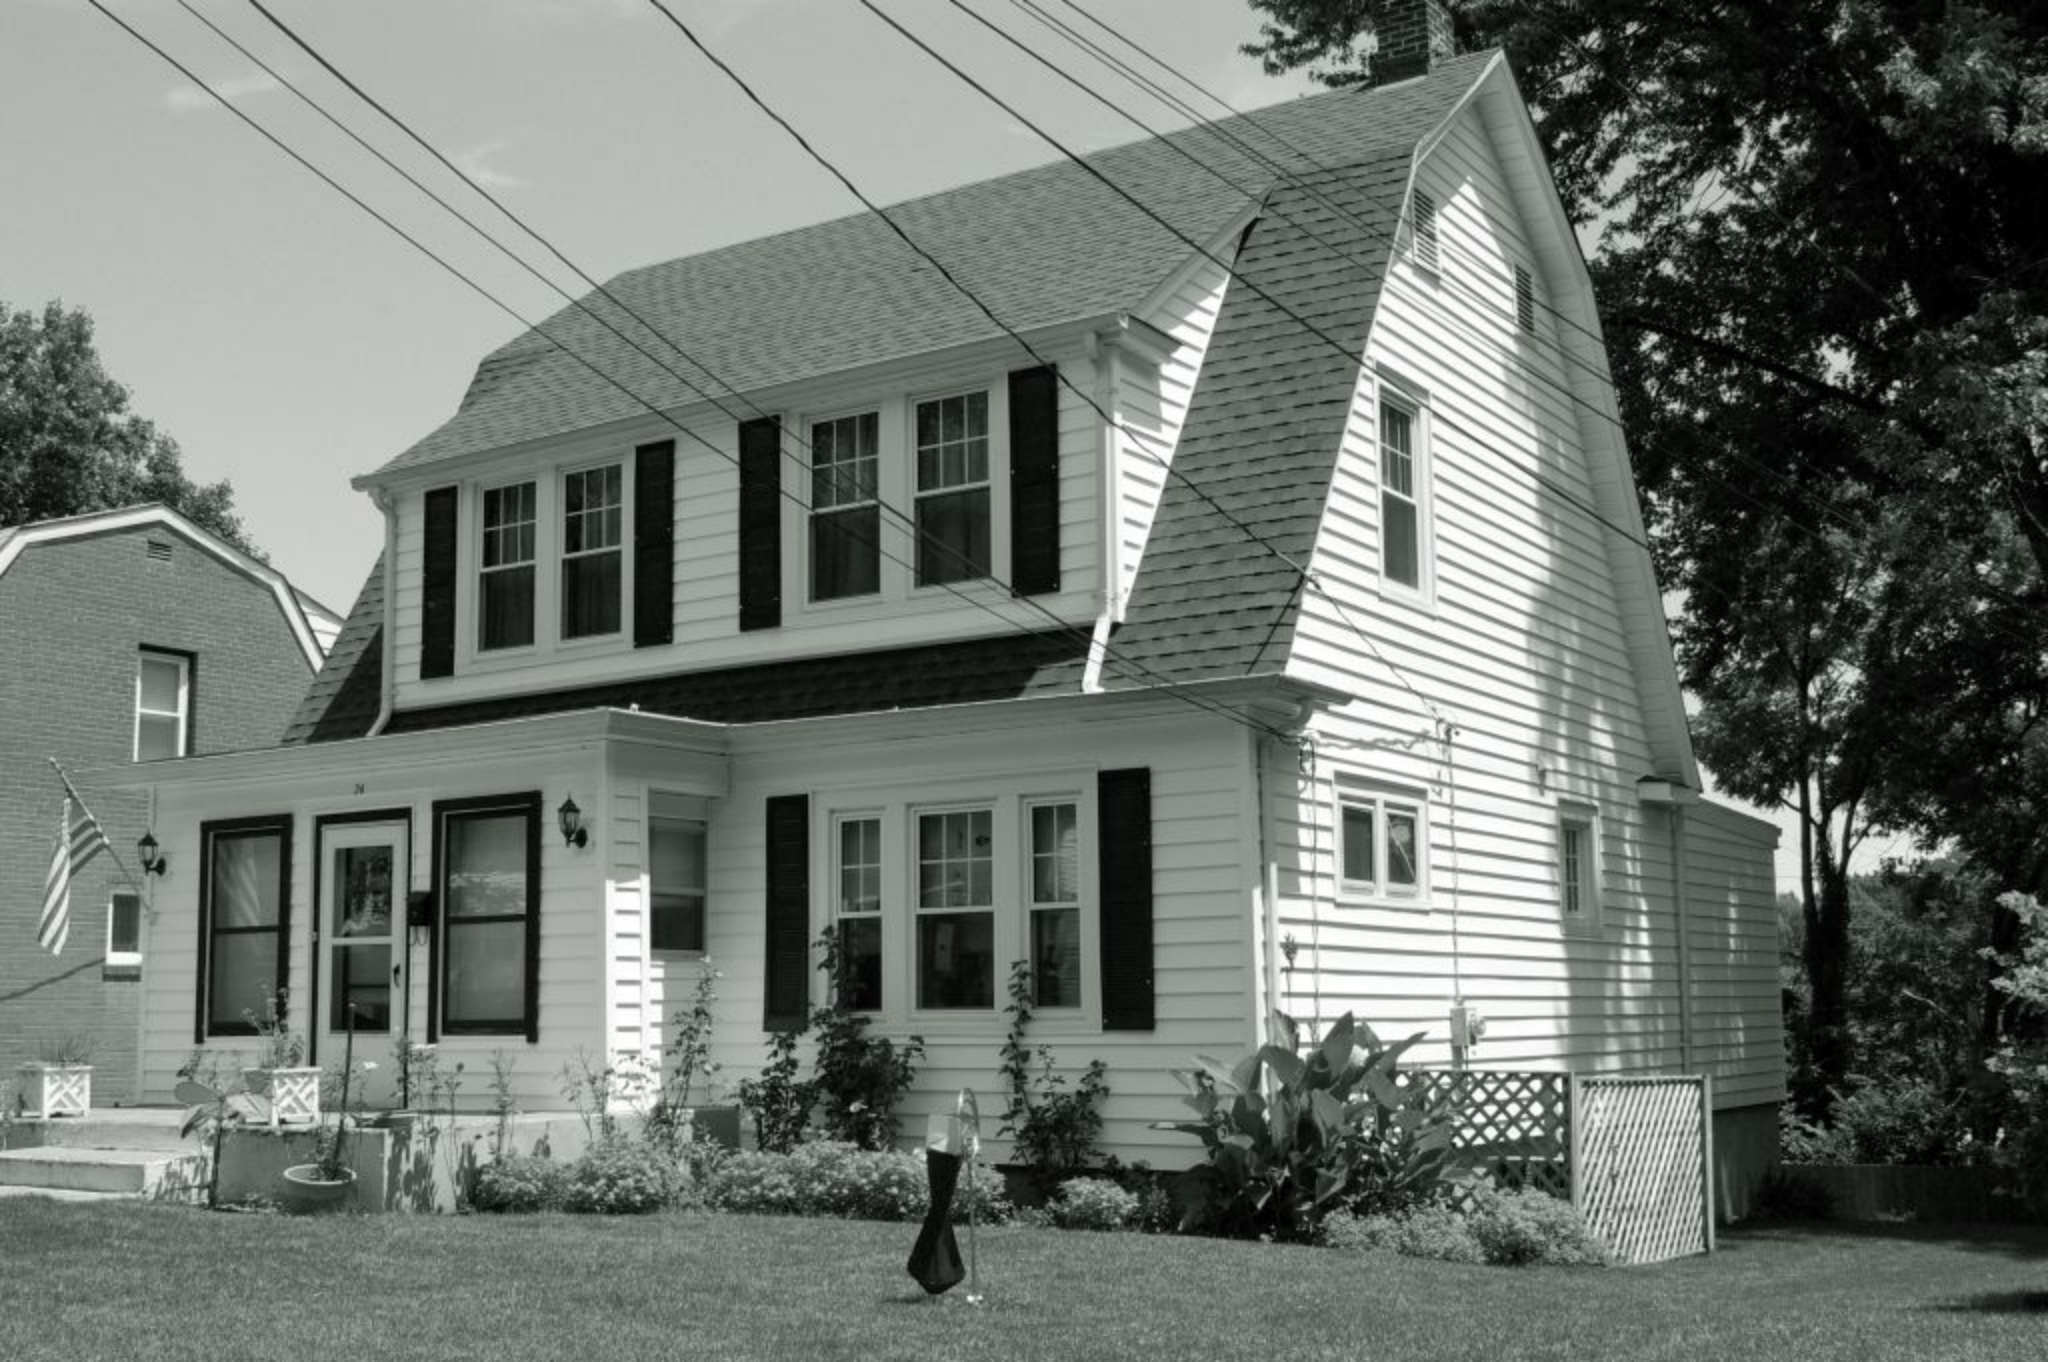
2009 Survey Update: Since the last survey, the enclosed porch has had the casement windows replaced with 1 over 1 sashed windows and the front door replaced with a new metal door.
