ARCHITECTURAL/HISTORIC INVENTORY FORM

1. Survey No. SL-AS-036-001		2. Survey Name: Architectural Survey of Old Ferguson West	
3. County: St. Louis		4. Address: 1 Carson Rd.	
5. City: Ferguson	Vicinity: <input type="checkbox"/>	6. UTM:	7. Township/Range/Section
8. Historic name (if known):		9. Present/other name (if known): Whistle Stop	
10. Ownership: <input type="checkbox"/> Private <input checked="" type="checkbox"/> Public		11. Historic use (if known): TRANSPORTATION/rail-related	11. Current use: COMMERCE/restaurant & RECREATION/museum

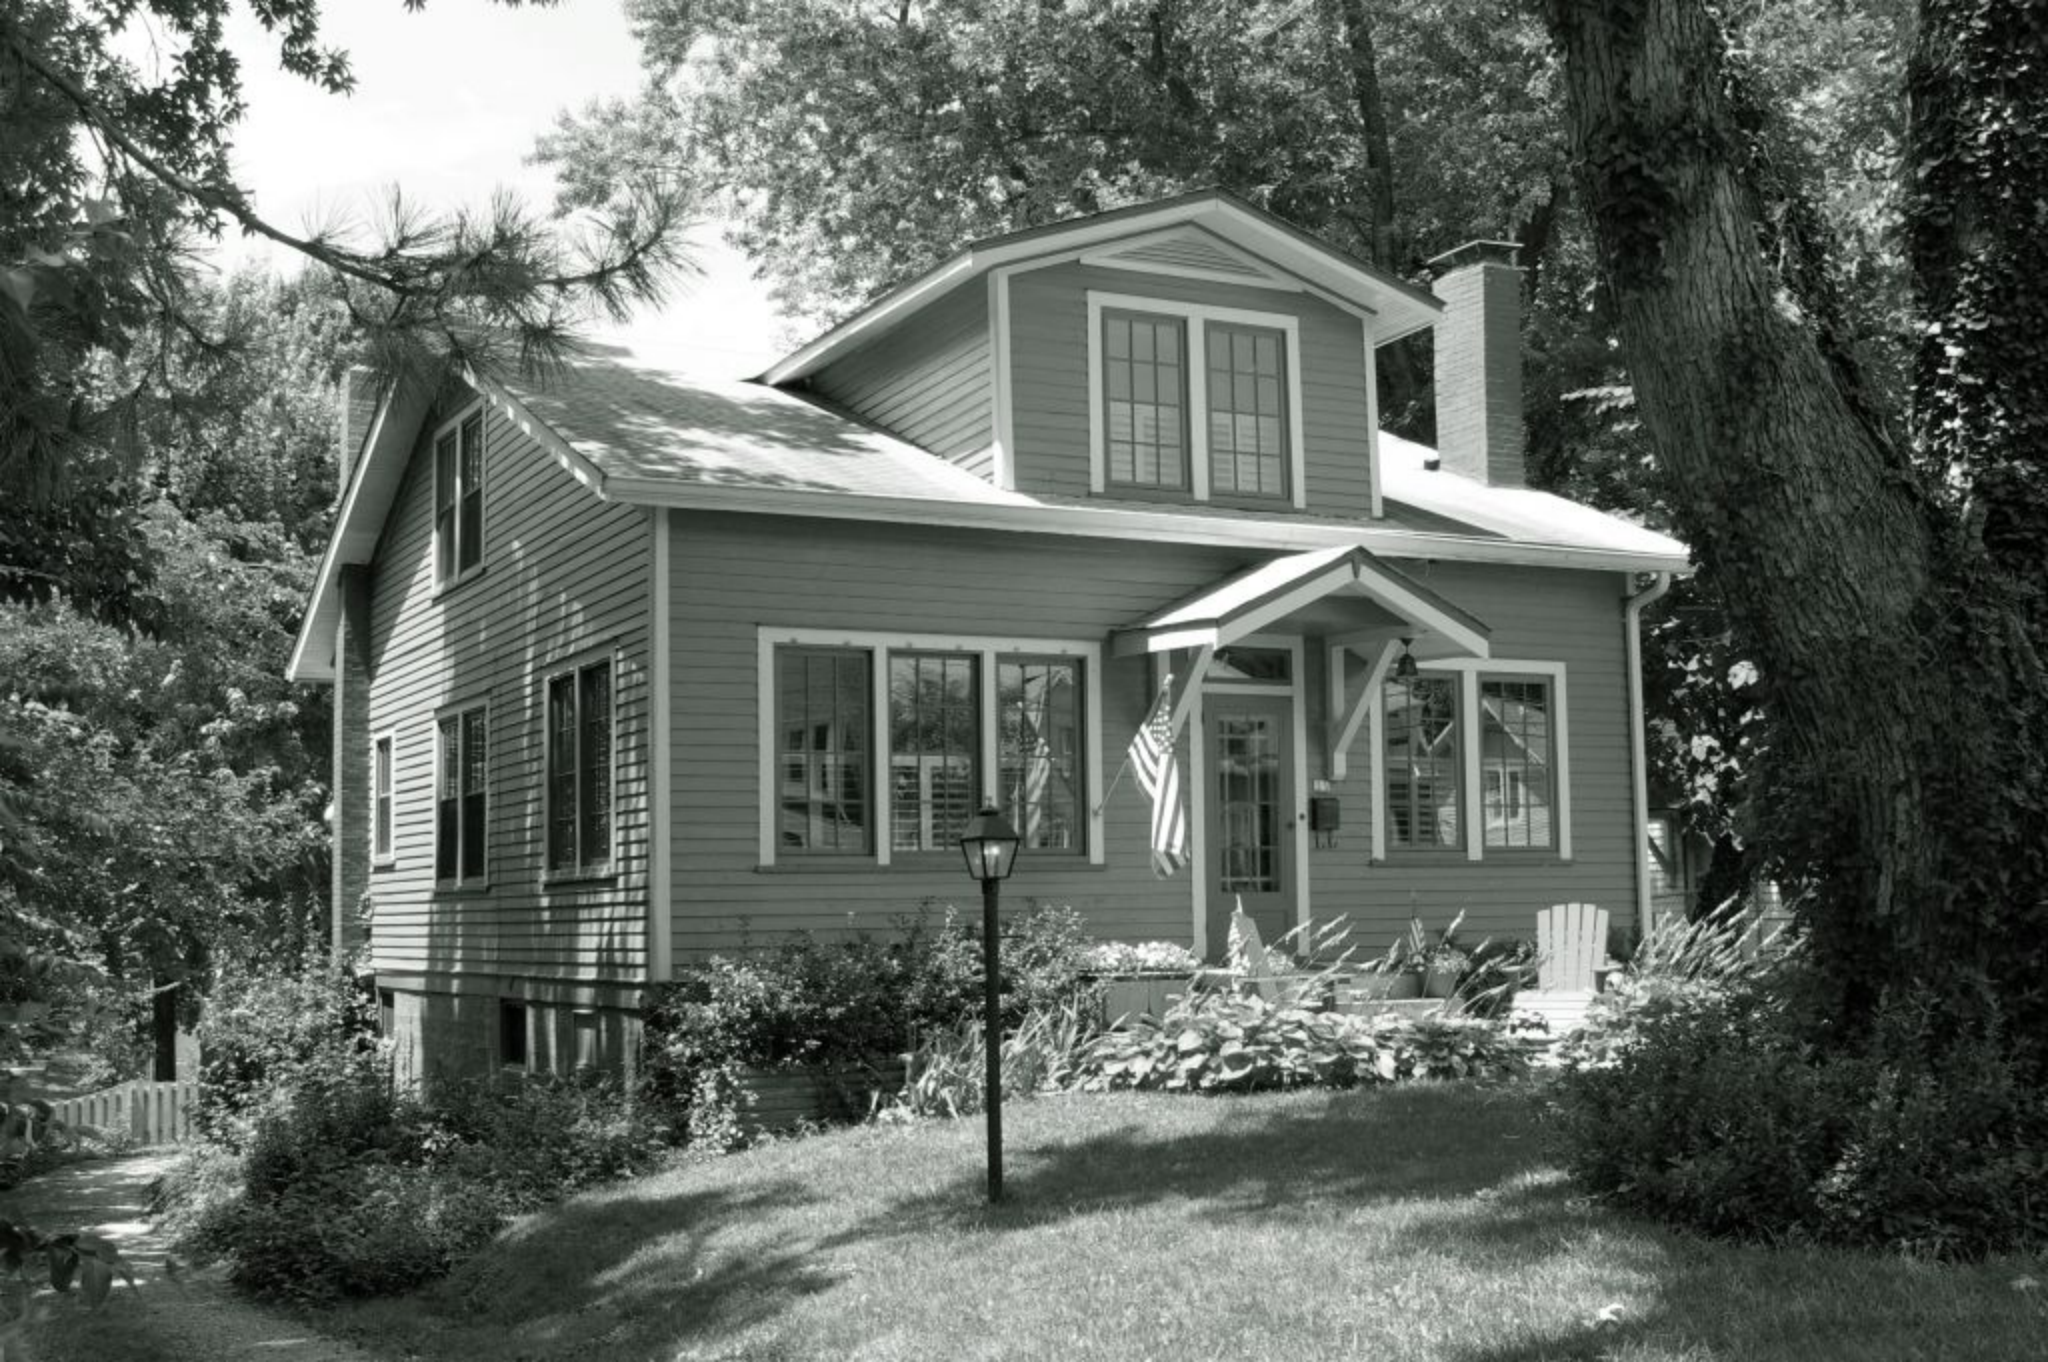
This side gabled, 1.5 story, clapboard house has a large centered gable dormer with paired 6 over 6 sashed windows. The entry door with its full light, multipaned door has a gabled roof supported by knee braces and a shallow concrete stoop. The entry is centered on the facade with a cluster of three windows to the south and two windows to the north of the entry, all with 6 over 6 sashed windows. There is an end wall chimney on each side of the house, the one to the north is near the front and pierces through the roof, while the one on the south is near the rear elevation. Some windows on the house have storm windows and there is 3/4 light storm door. The basement level garage is accessed by the driveway on the south side of the house.

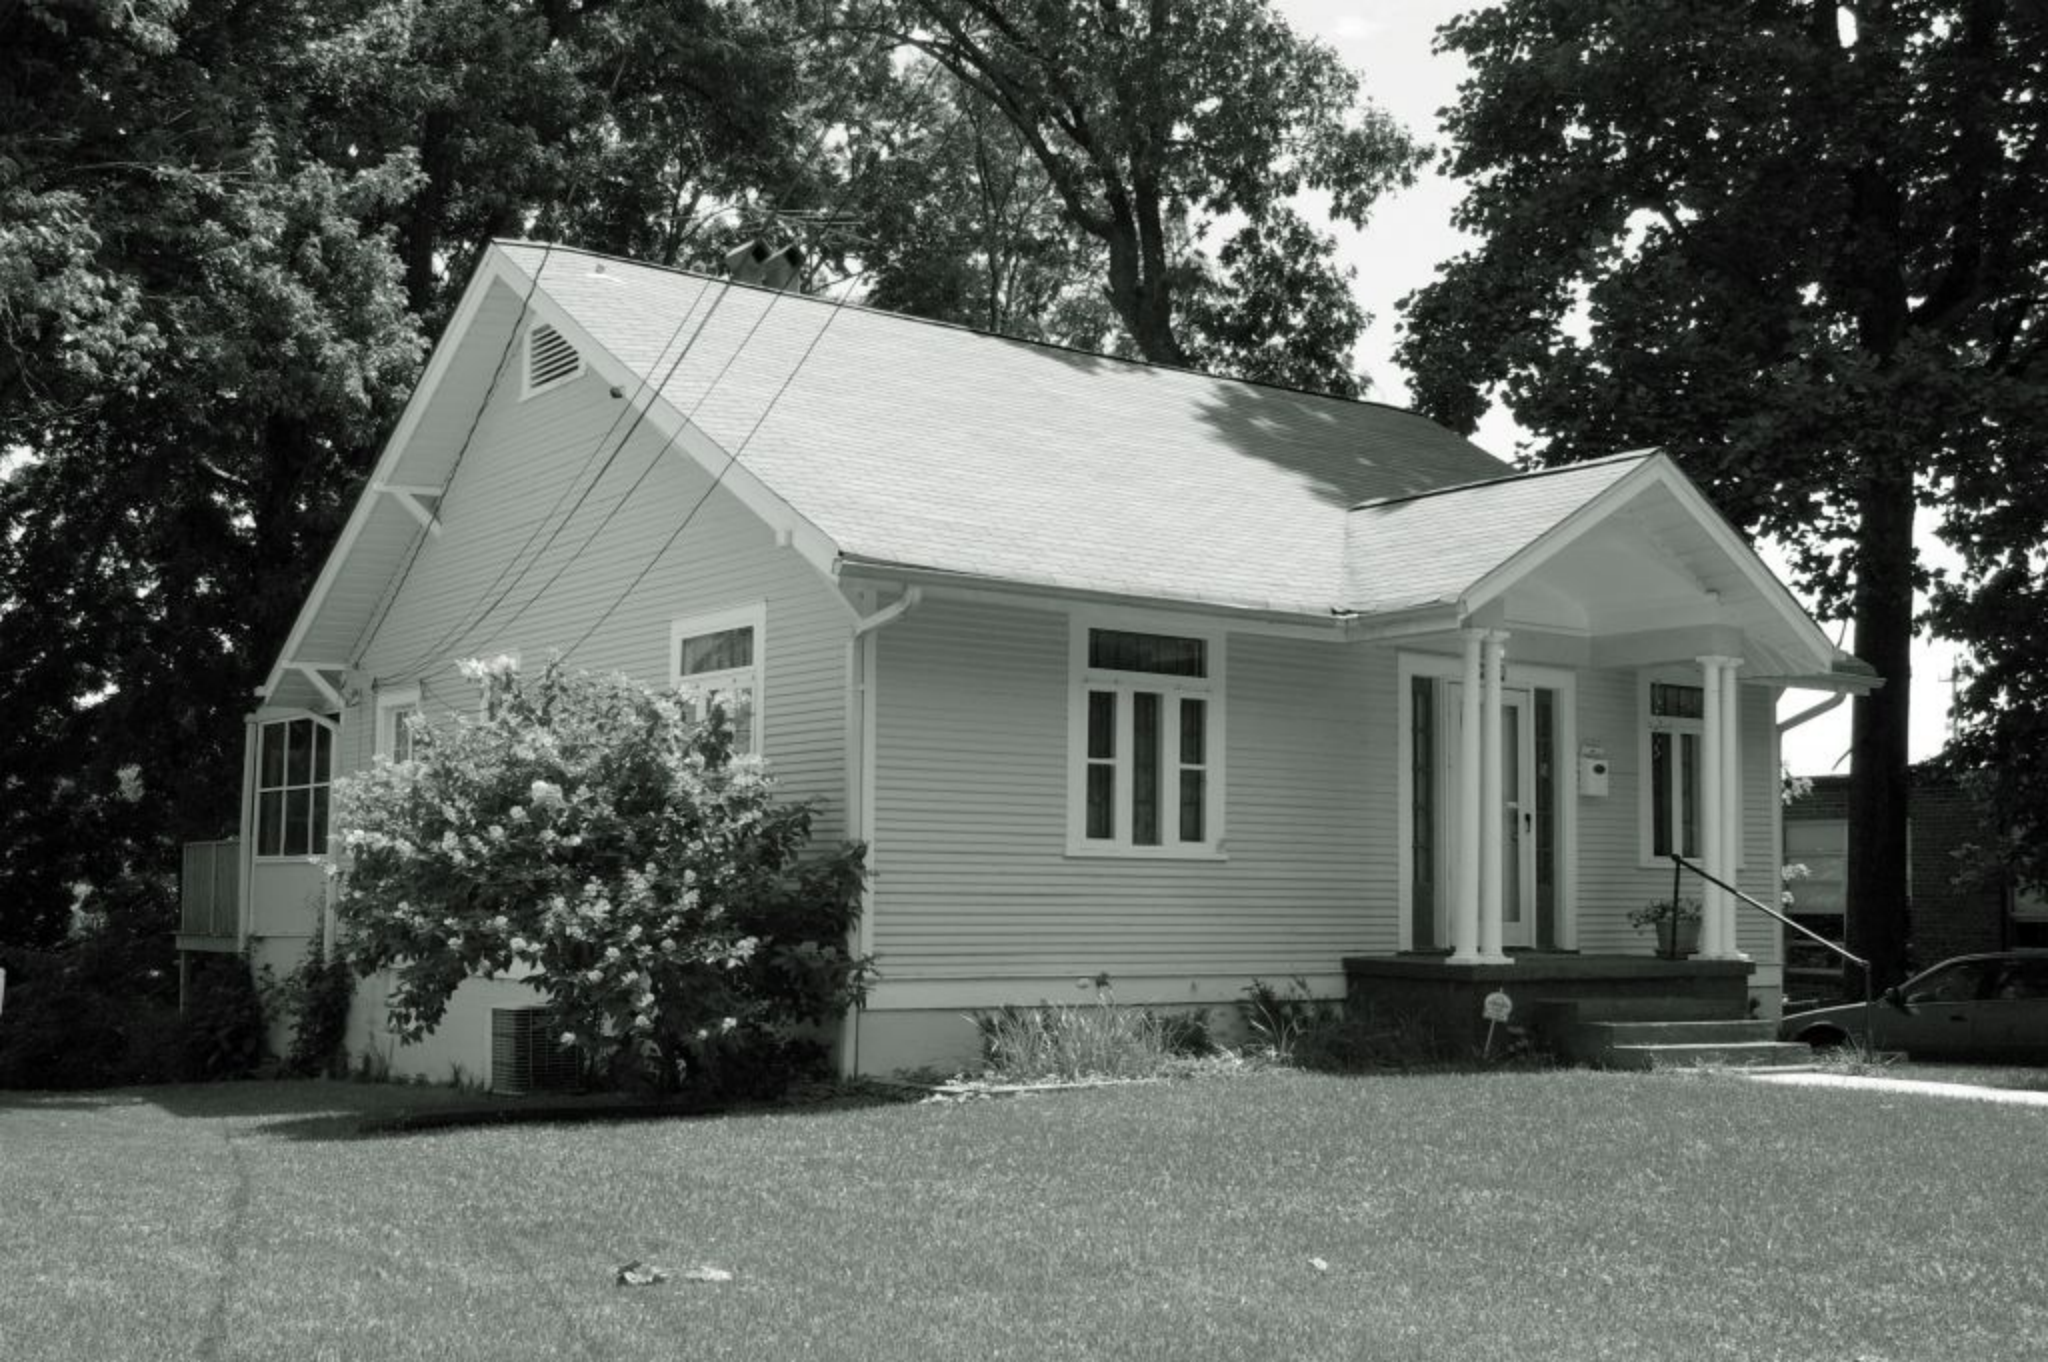
This one story, side gabled house is a mixture of Craftsman features with Colonial Revival elements. The knee braces and wide eaves are characteristic of Craftsman houses, but other features are Colonial Revival: the symmetrical facade with the gabled porch roof with its arched ceiling, the paired Doric columns at each corner that rest on the concrete porch floor, the multipaned sidelights on the entry door, the three wood casement windows spanned by a transom (all of which are multipaned) that flank the entry. The house has wooden storm windows which obscure the original multipaned windows, but these storm windows appear to be original to the house as well. The basement level garage is accessed by the driveway on the south side of the house.

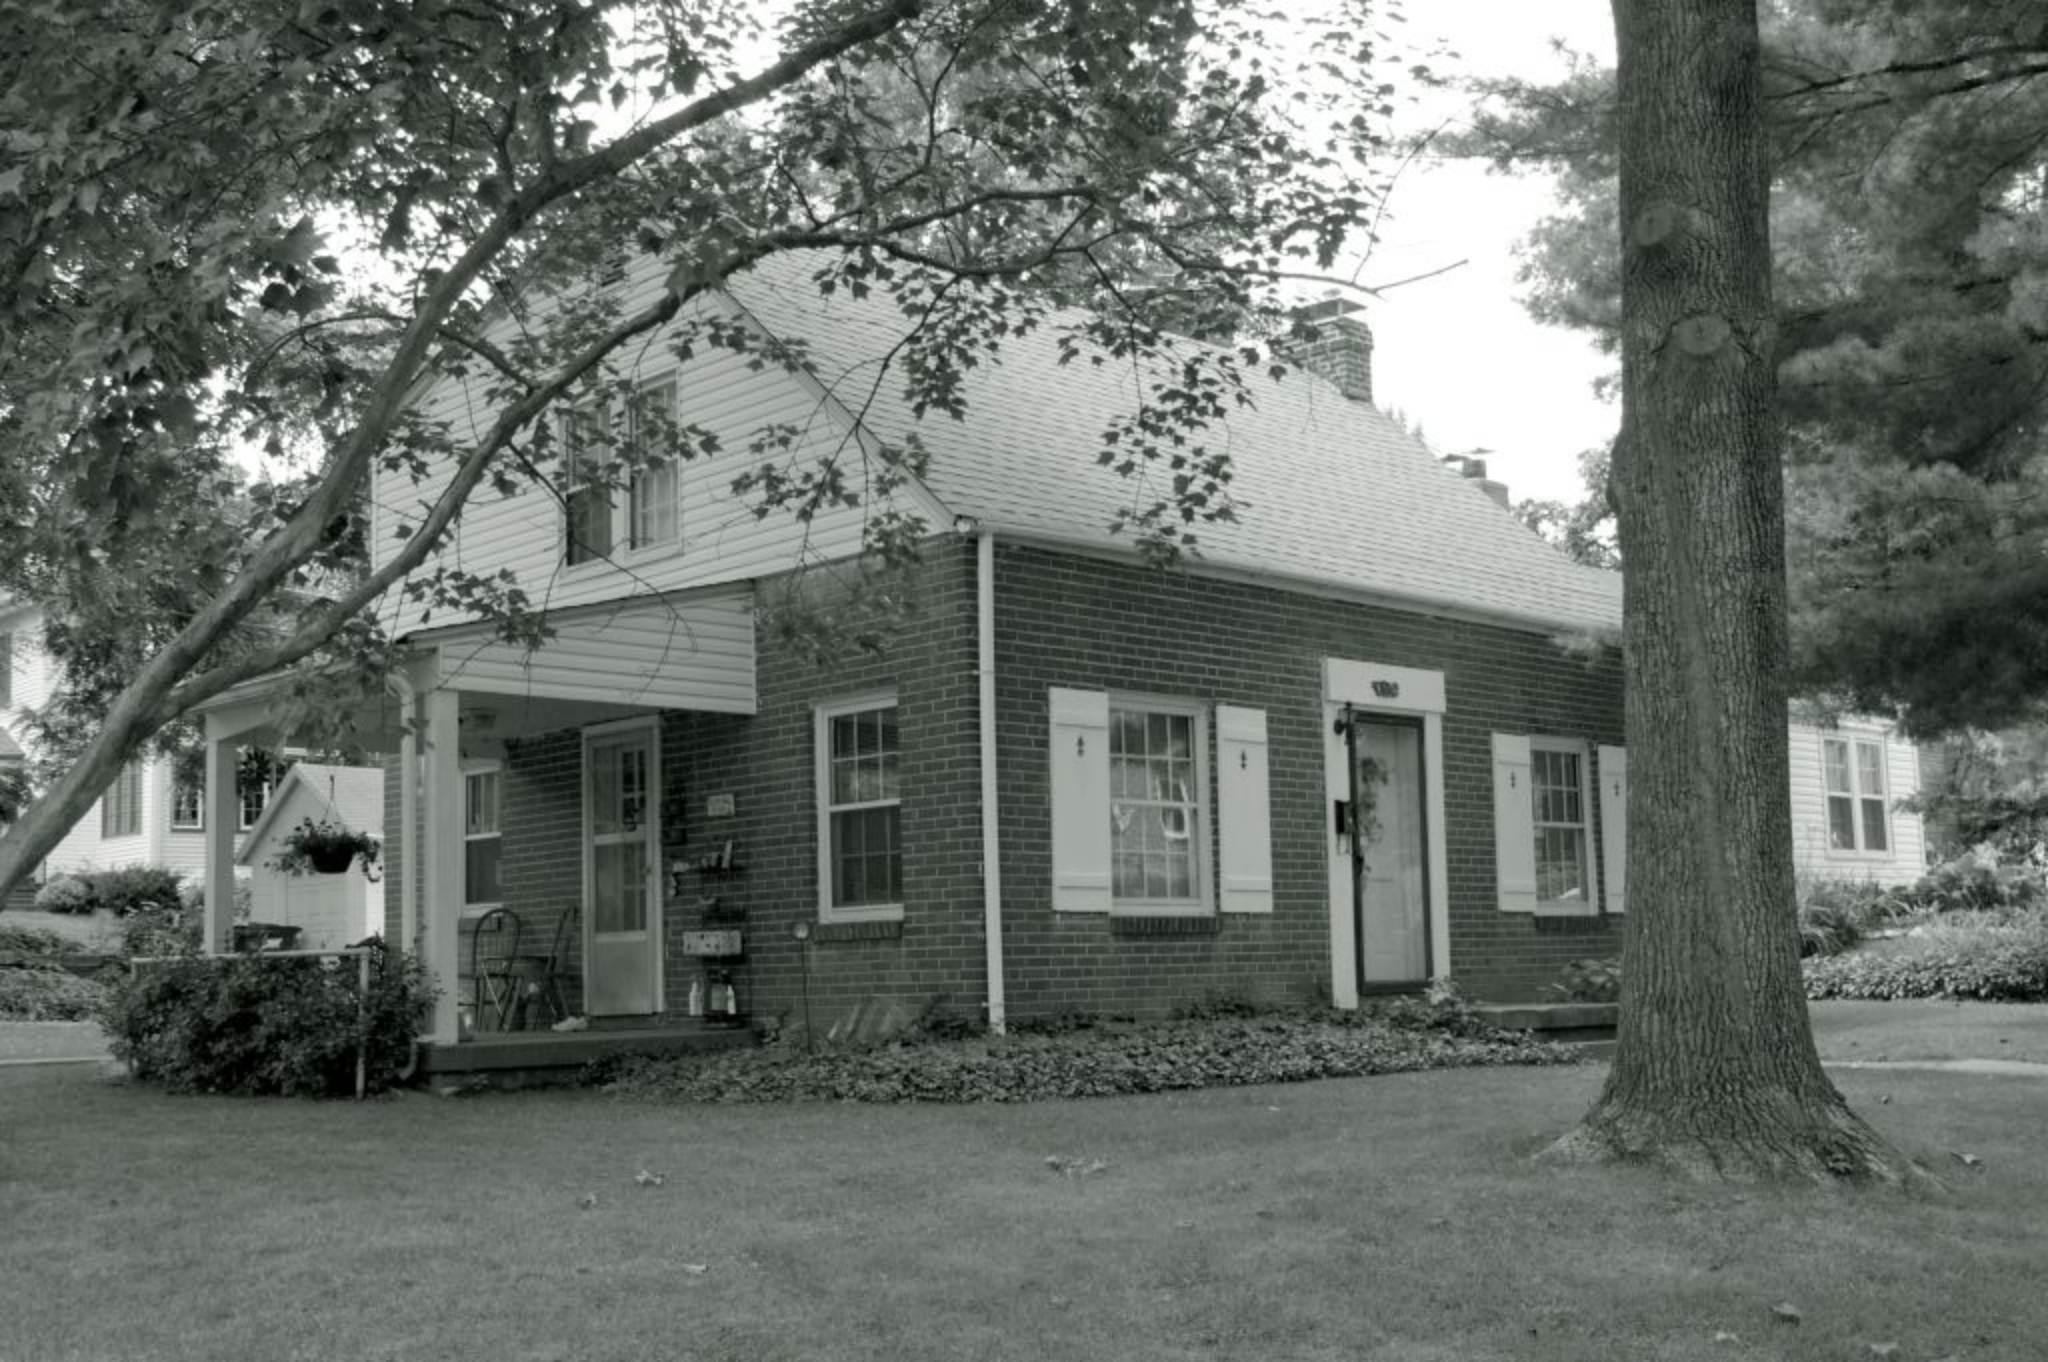
This simple Cape Cod house is 1.5 stories tall with a symmetrical facade that positions 8 over 8 wood sashed windows with the original wood plank shutters in the outer two bays. Centered on the facade is a simple wood paneled entry door that is surrounded by simple wood pilasters and entablature, and in front is a shallow concrete slab entry platform. On the north side of the house there are additional multipaned wood sashed windows on the first floor separated by the end wall, brick chimney. From the side elevations it is clear that the gabled roof does not extend as low in the rear, creating a salt box shaped roof (and allowing for second floor windows on the rear). The south elevation, which faces Wesley Avenue, has paired multipaned sashed windows on the second floor above a centered, shed roof, open side porch that has simple square corner posts and a low concrete slab porch floor that appears on the 1941 fire map, indicating it is part of the original design. There is a multipaned door with this porch and on either side of the porch are more multipaned, sashed windows. The only alterations to the house appear to be the vinyl siding in the gable ends, the storm windows, the storm doors.

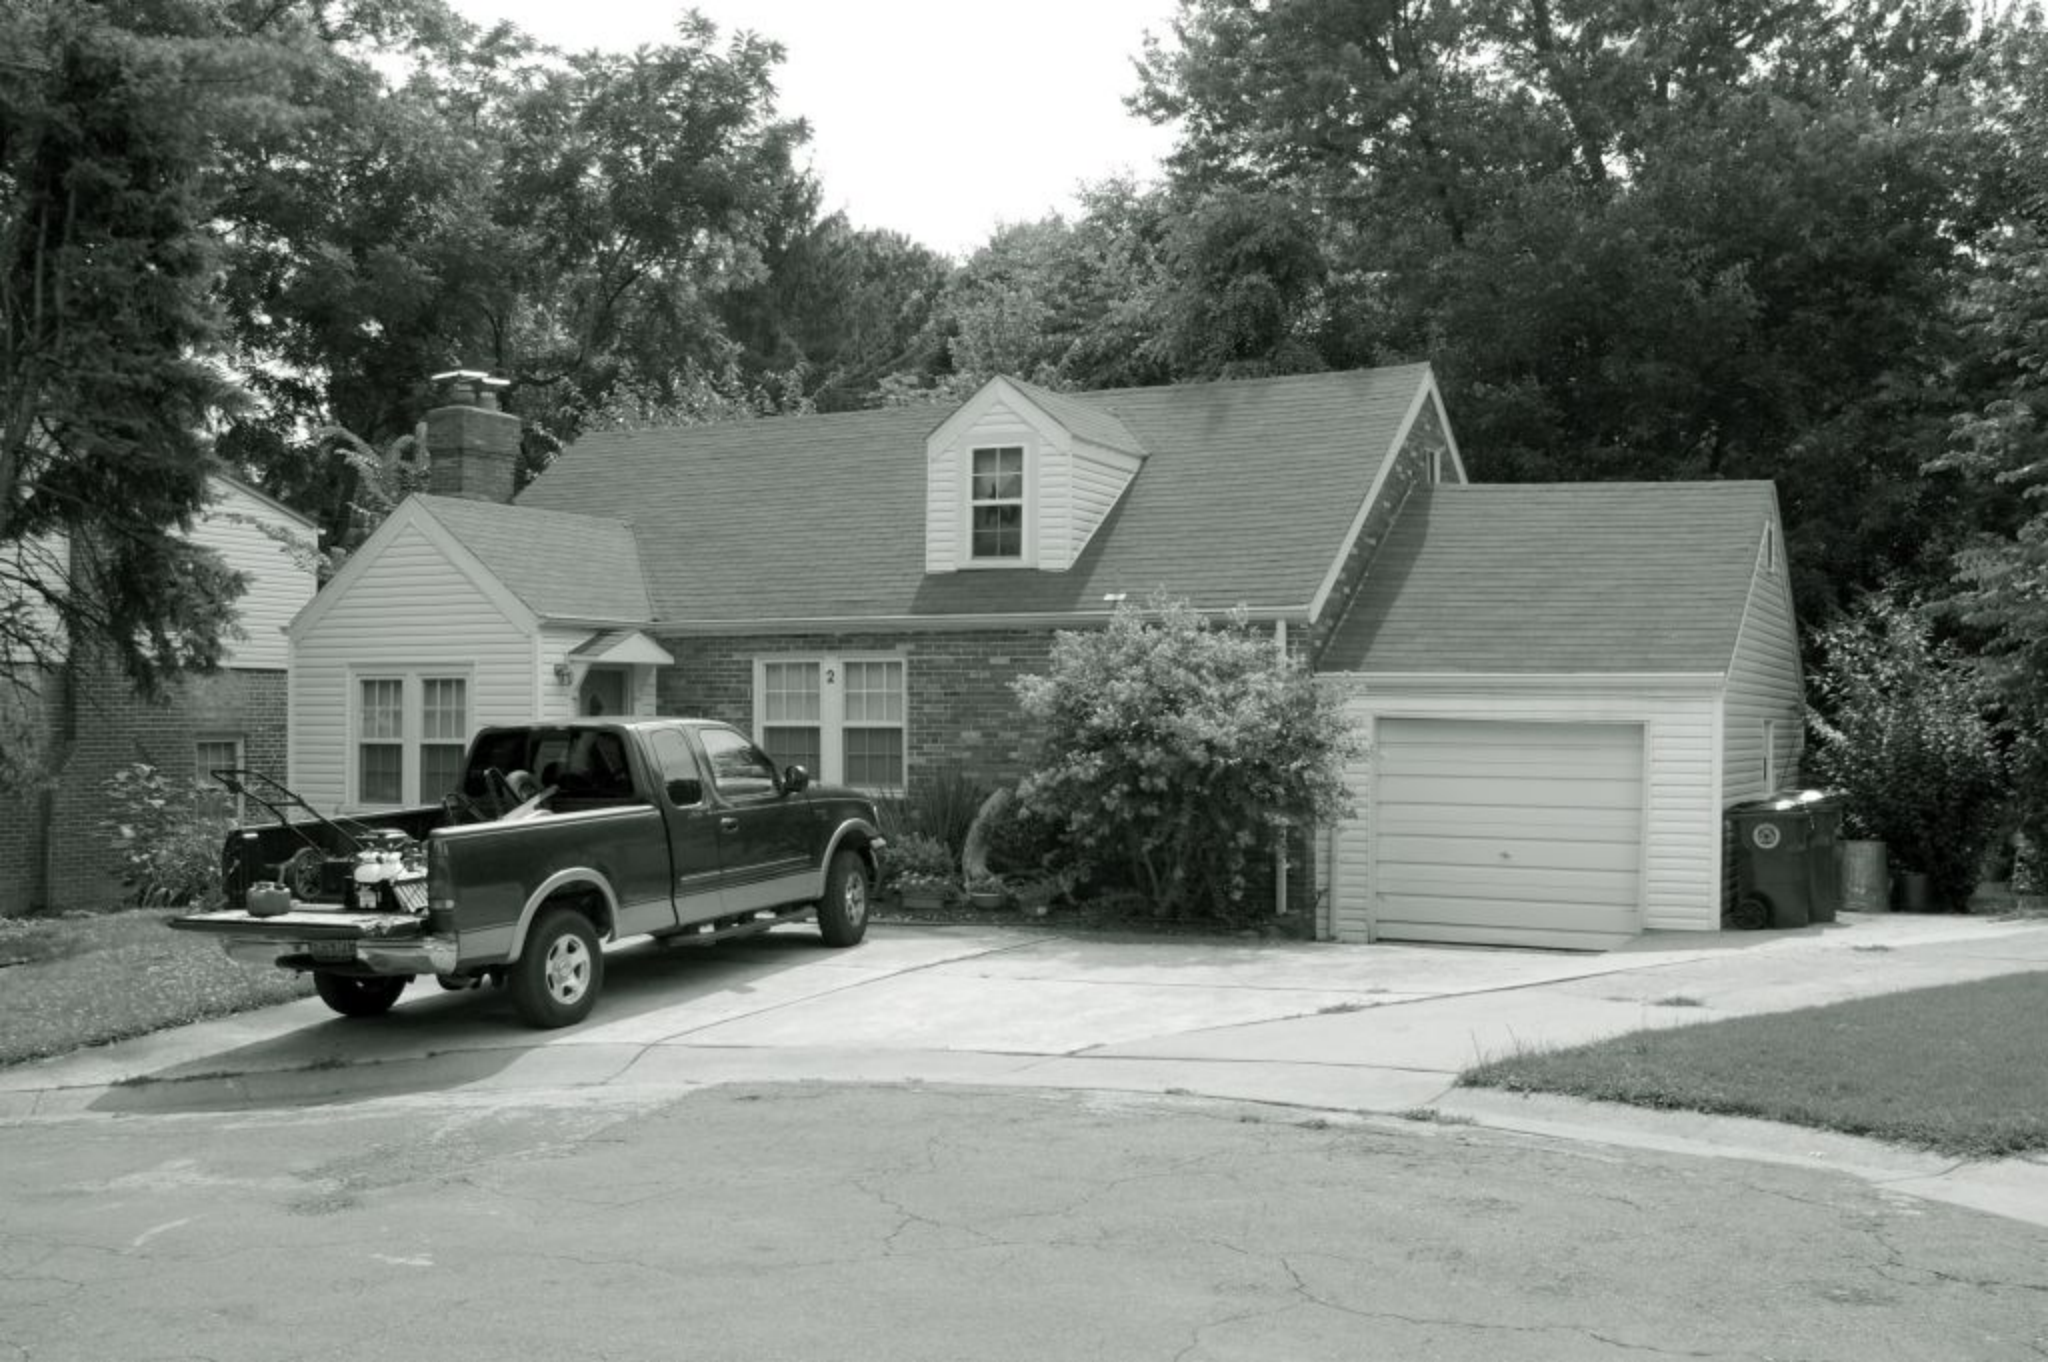
This 1.5 story, side gabled, brick house has an asymmetrical facade created by the small, projecting, 1 story, entry vestibule which has paired sashed windows on the facade and an entry door under a small gabled roof (supported by knee braces) on its side, facing north. This vestibule is located on the south end of the facade, creating an L-shaped plan and there are paired sashed windows on the main facade of the house. Offset from these windows toward the north is a gabled dormer with a sashed window. On the north end of the house is a frame, one story, attached, one car garage with a side gabled roof. On the south side is an end wall, brick chimney. Most of the windows are the original, 6 over 6 wood sashed windows, but the dormer appears to be a replacement, vinyl, 4 over 4 window. The entry door which is a wood door with a diamond light, commonly in use by the 1940s, and the knee braces over the entry gable seem to indicate that the vestibule is original to the house, but the fire insurance map shows it as an open porch in 1951, so it may be an early enclosure or alteration. The vestibule, garage, and dormer have replacement vinyl siding and the windows have storm windows added.

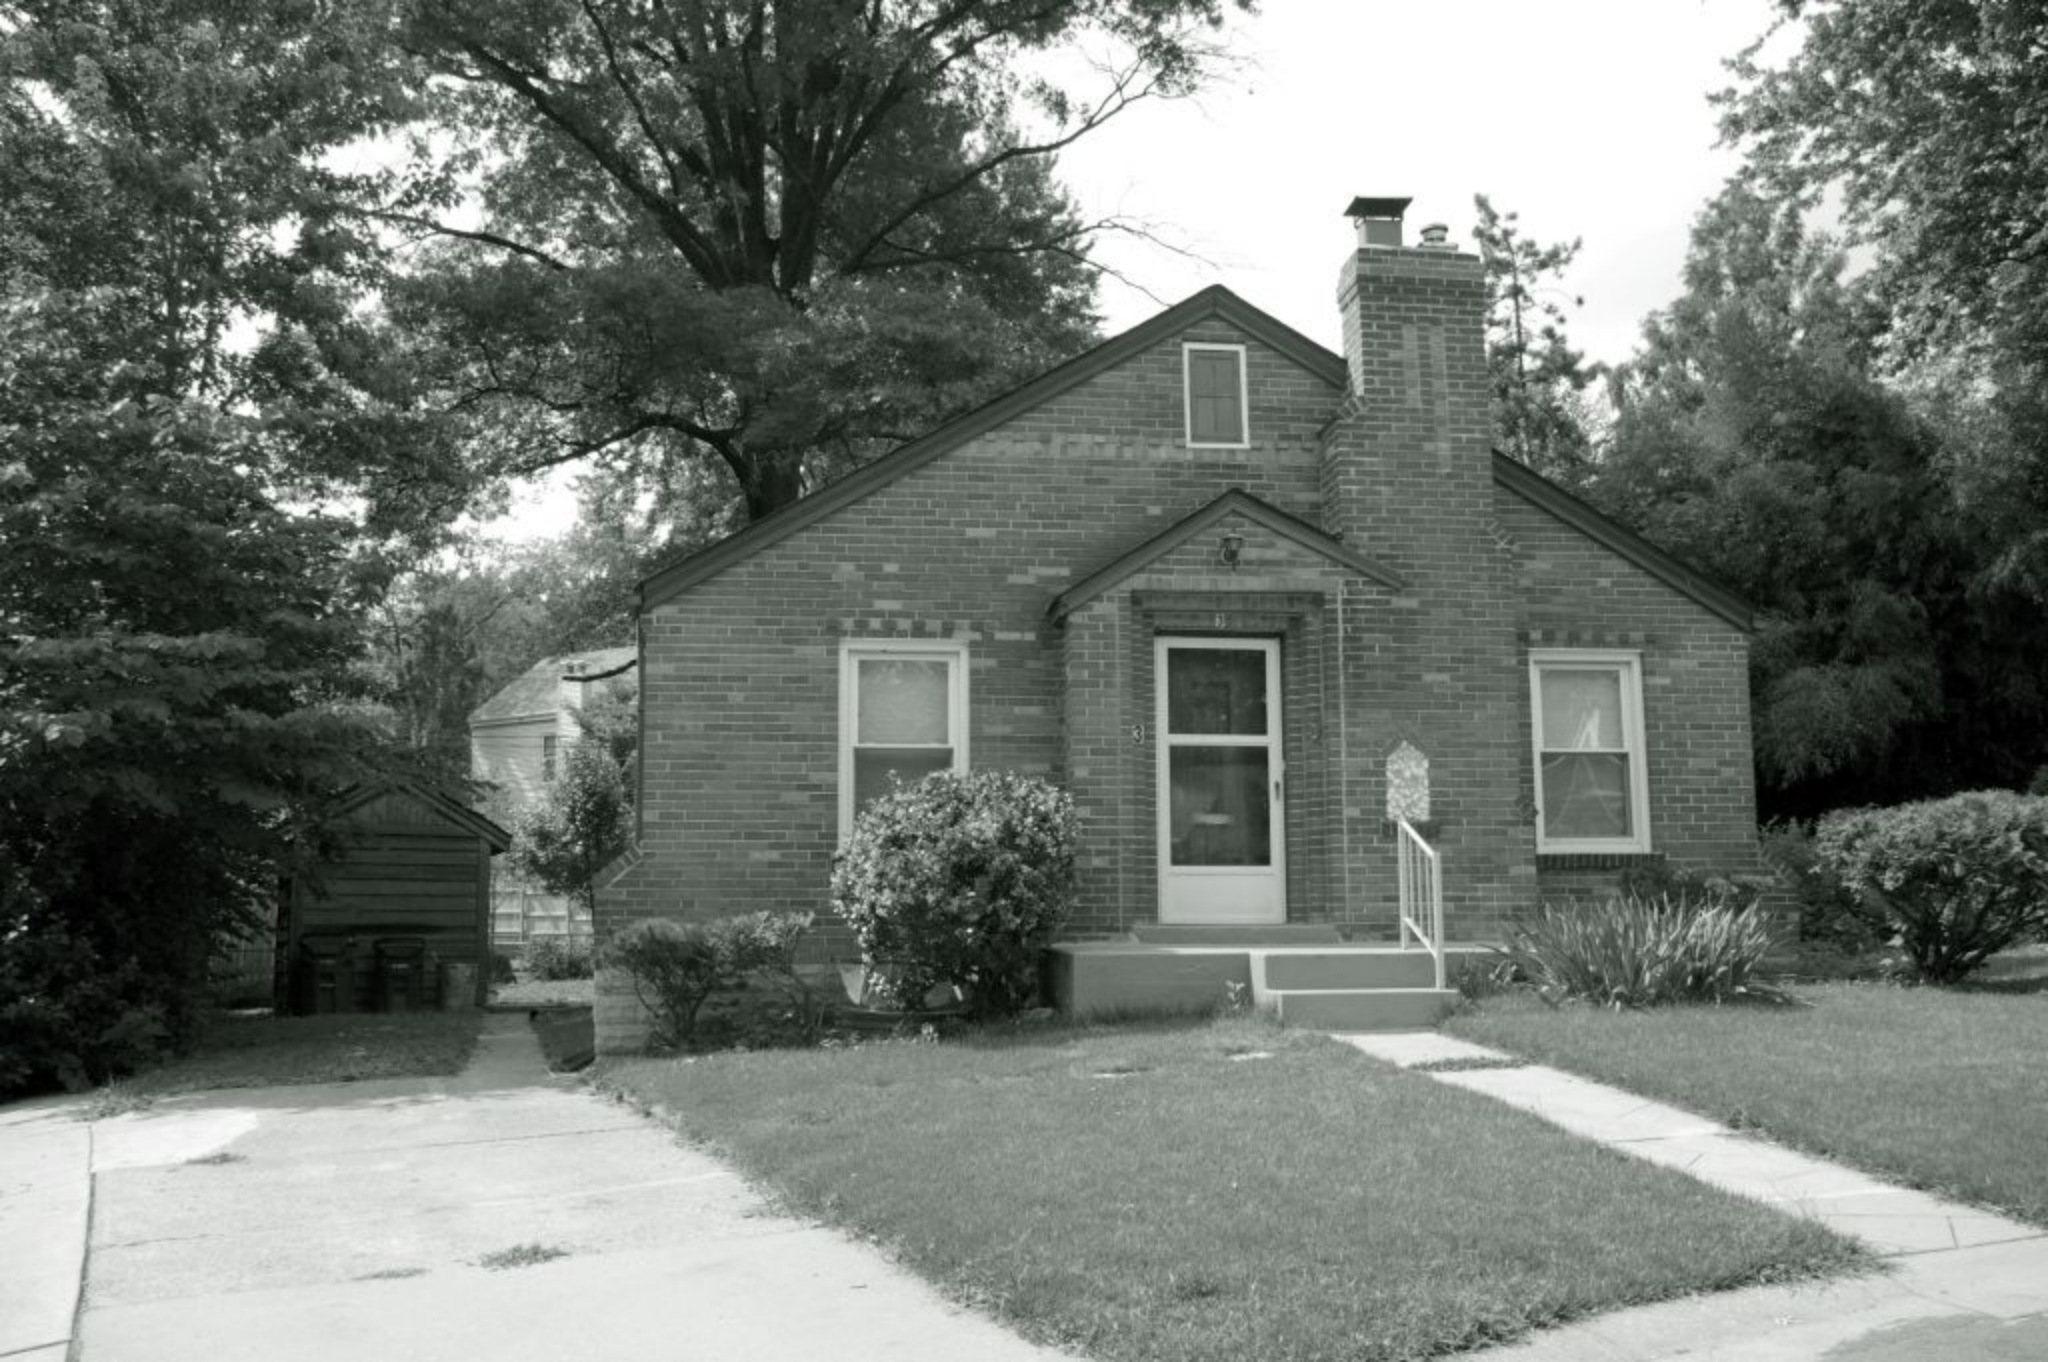
This modest, one story, end gabled, brick Tudor Revival design has a massive end wall chimney on the facade that merges into a one story high gable over the slightly projecting entry vestibule. The wood plank door with the art glass, small rectangular light is positioned in a rectangular opening created by three, tiered, progressively smaller, rectangular surrounds of brick. In front there is a simple concrete stoop. On either side of the vestibule/chimney is a single, 1 over 1, vinyl window with a rowlock of alternating buff and red brick lintel and dark brick sills. There is a small wing wall on each side of the house and a small rectangular wood attic window on the facade. The house has a faux stone foundation, used as a decorative element on the facade.

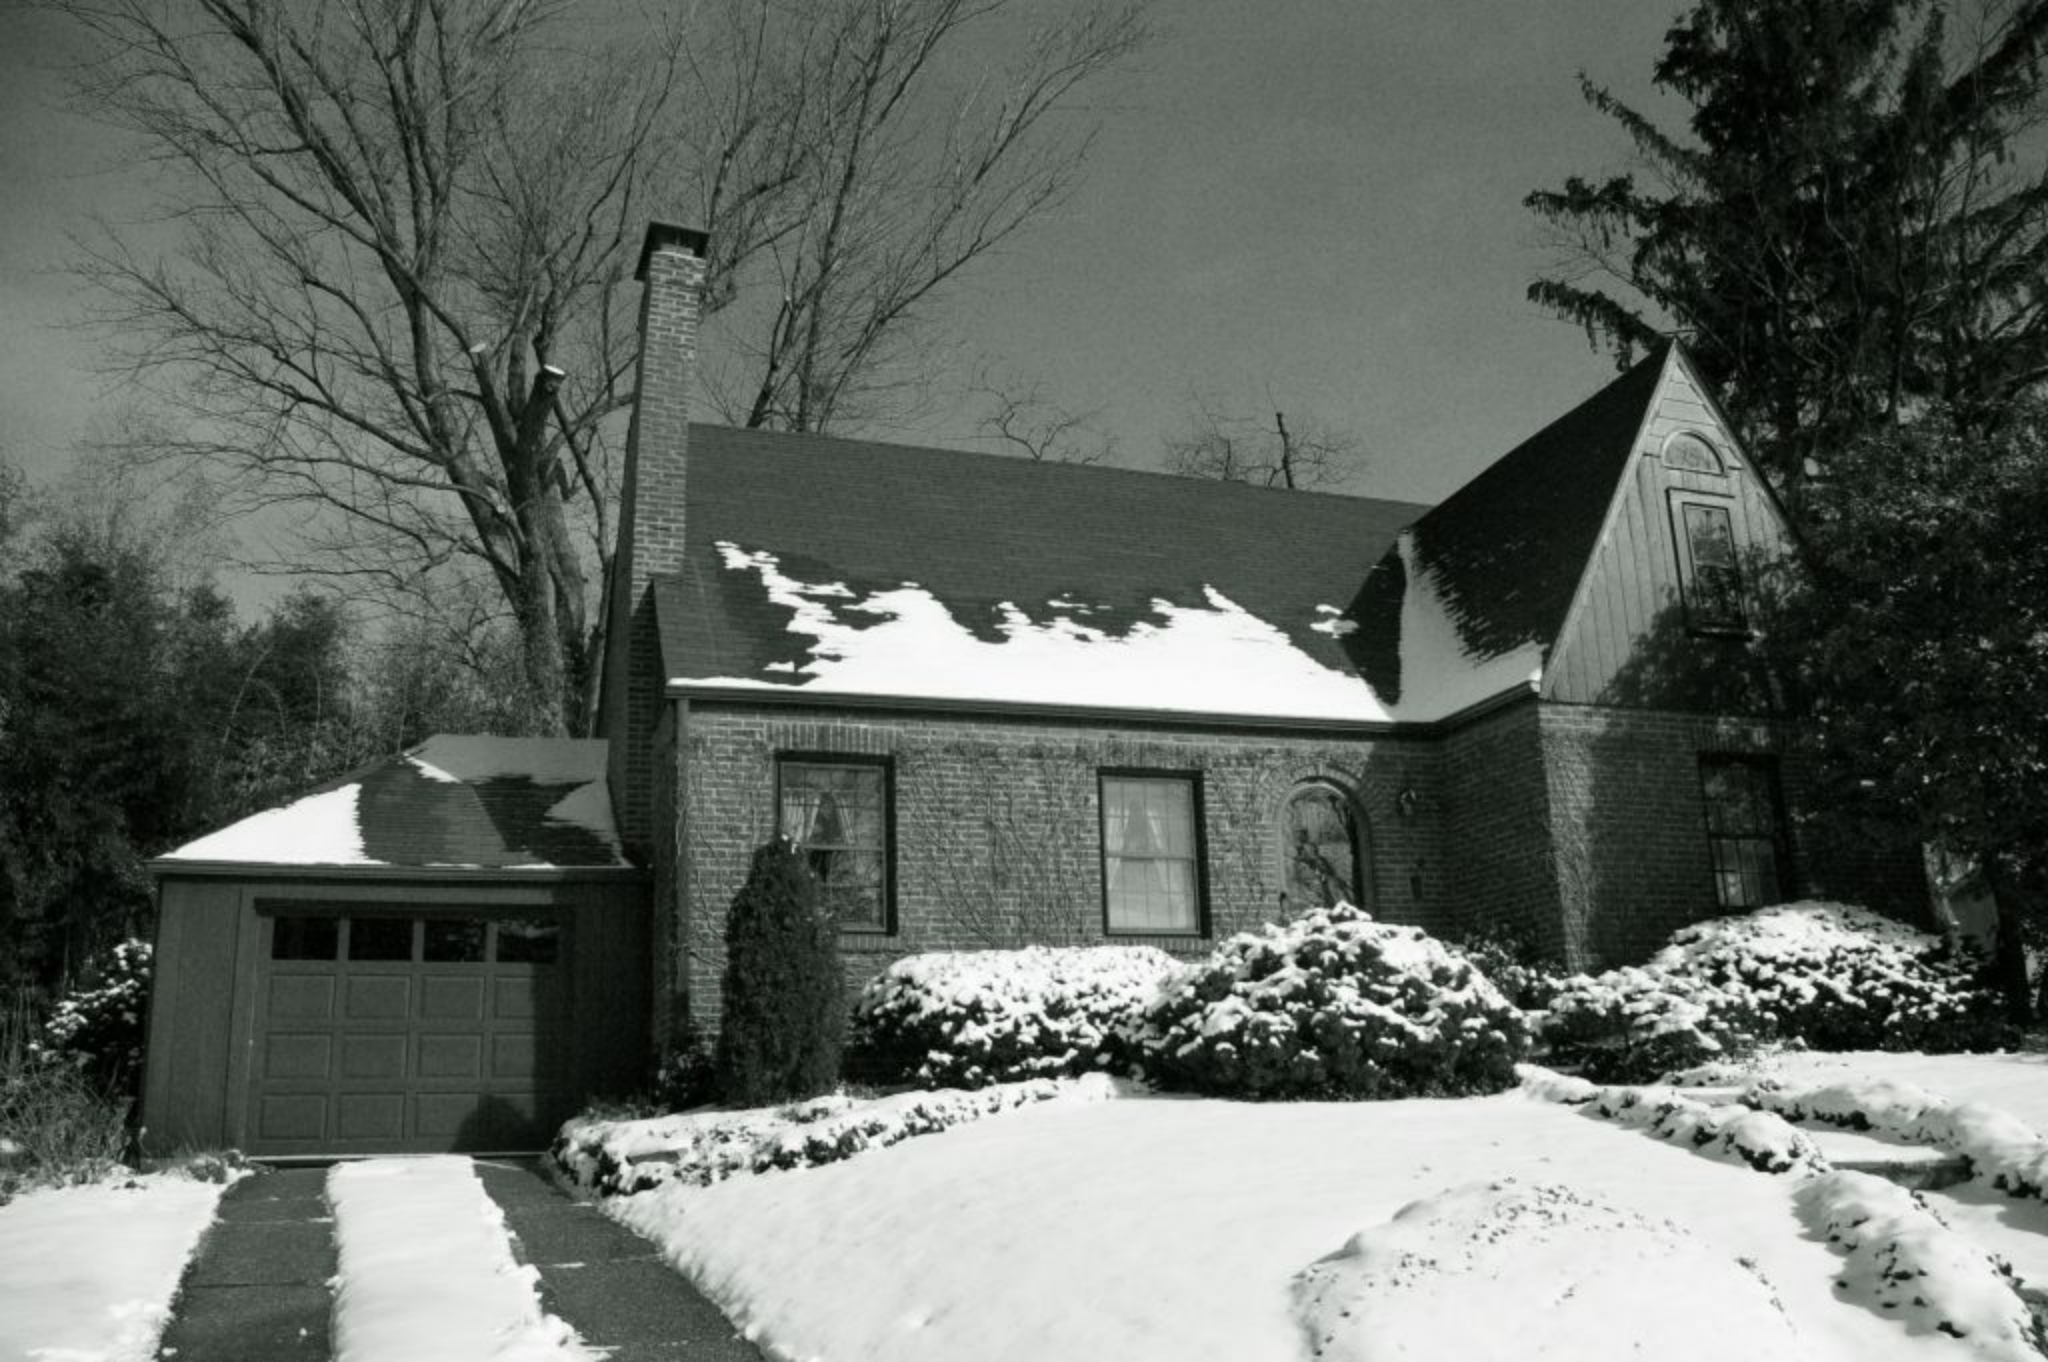
This 1.5 story, brown brick, Tudor Revival house has a steeply pitched roof with an end wall chimney on the west elevation that balances the cross gabled, 1.5 story wing that projects towards the facade at the east end. The main house is divided into four bays with a half round window in the attic above a sashed window on the second floor of this projecting wing. The walls on the upper floor of this wing are a combination of vertical boards with weatherboards in the tip, original to the building but painted now so that the detail is not evident. The first floor below has an 8 over 8 wood sashed window with a storm window. Adjacent to this wing is the entry with a simple round arched opening and wood plank door. The other two bays on the facade both have 8 over 8 wood sashed windows. The fifth bay of the facade is a one story, hipped roofed, frame garage at the west end of the house that appears to retain its original wood paneled overhead door.

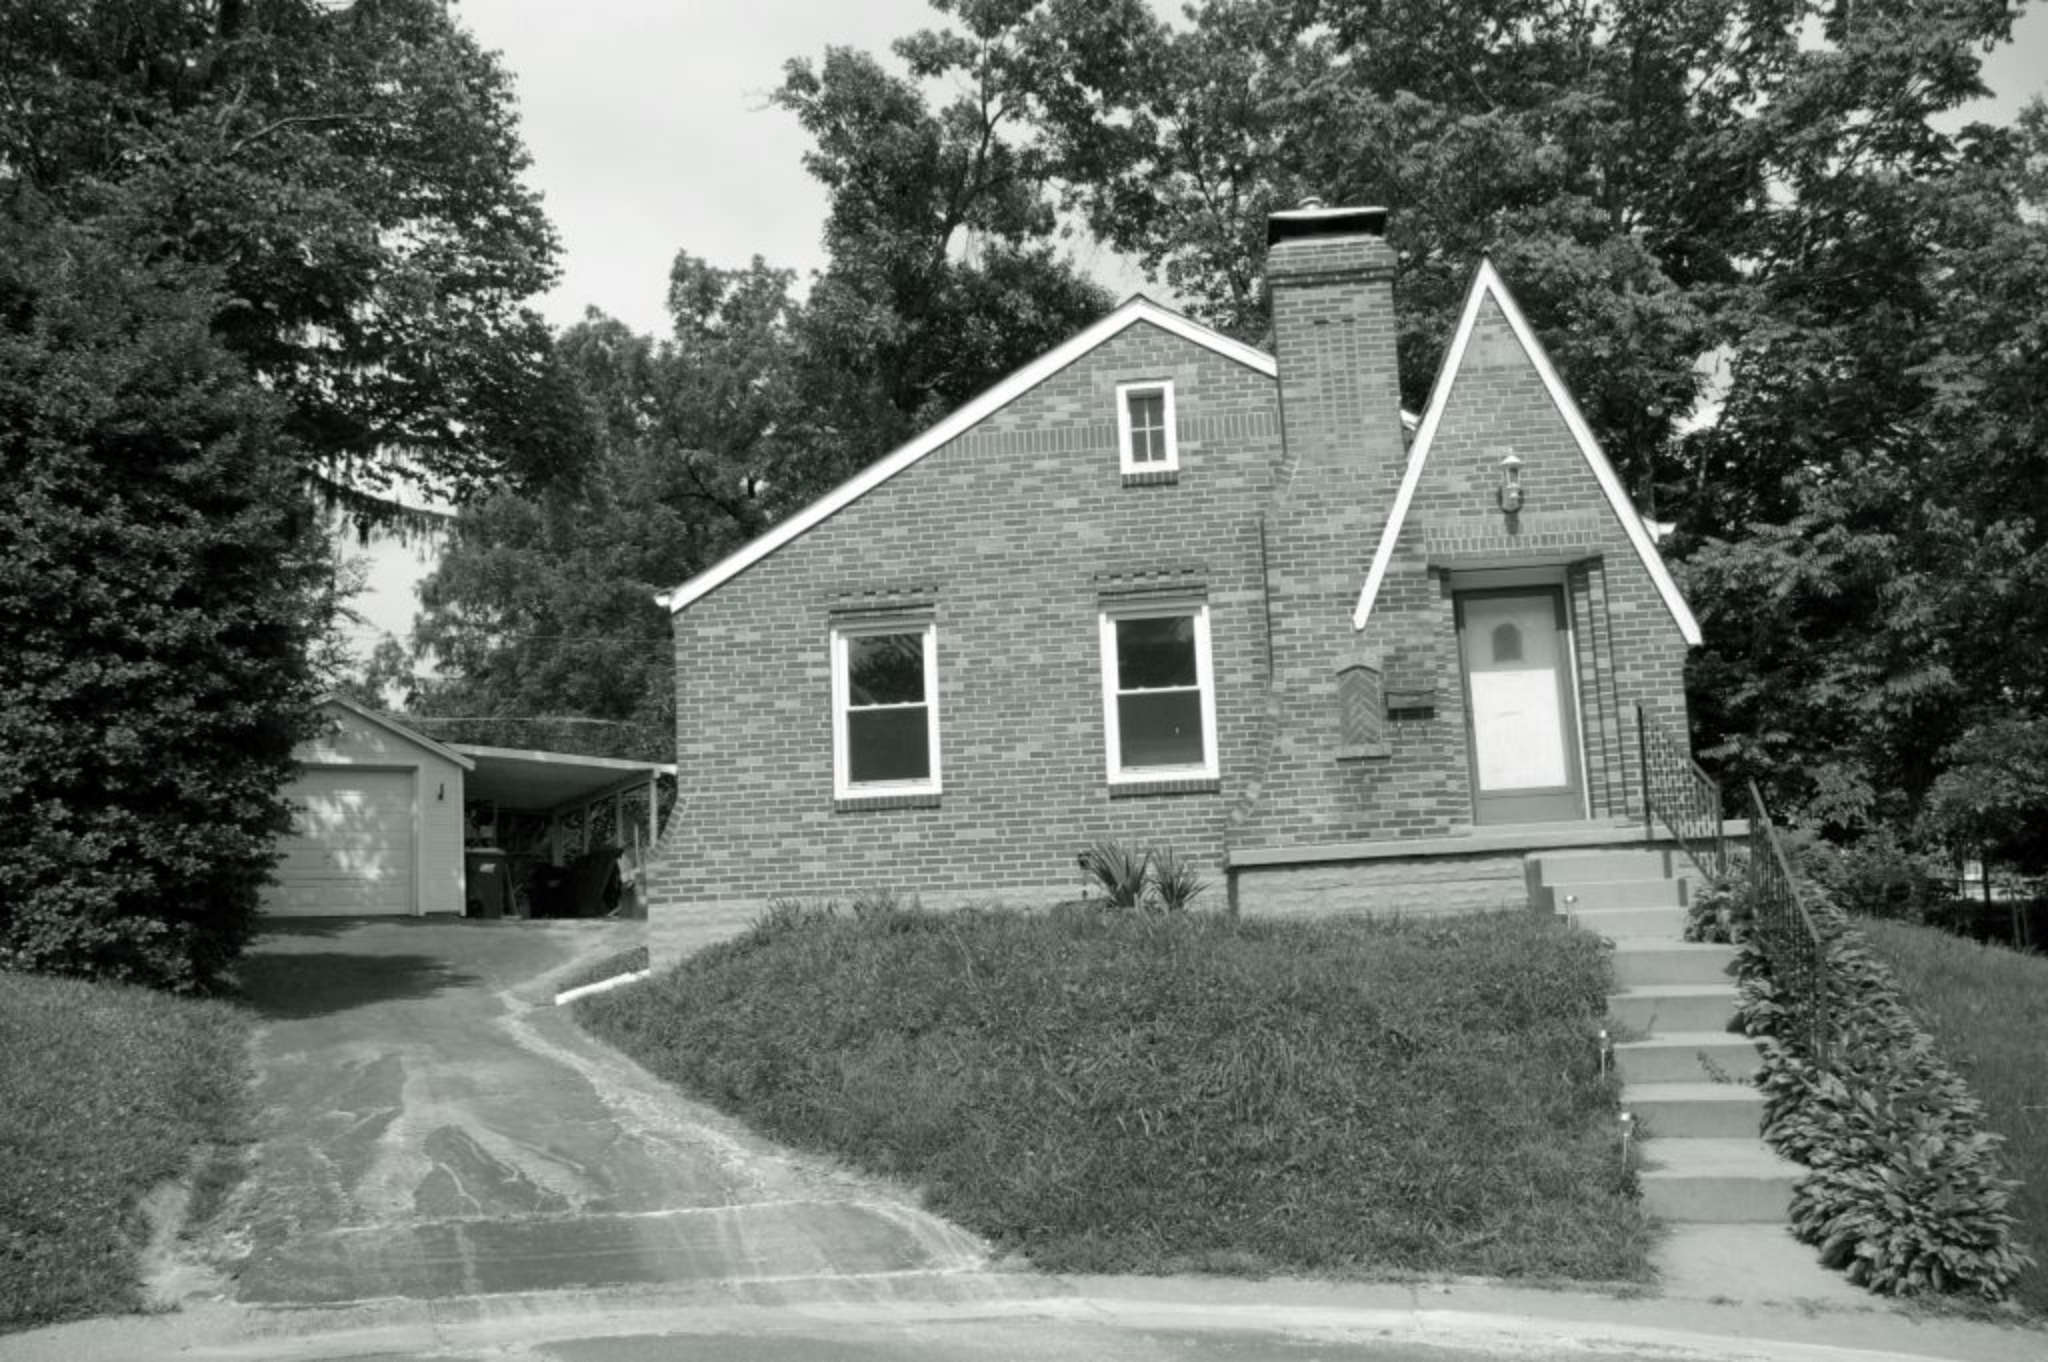
This 1 story, broad end gabled, multicolored brick house has a steeply pitched roof over the entry vestibule, which has a rectangular wood door with a small, arched, art glass light. The door is recessed in an opening that has tiered rowlock bricks that make the opening flare out on each side. It retains the original light fixture above the door and the wall of the vestibule merges into the massive end wall chimney that has a decorative brick pattern near its base that gives the appearance of a niche. The faux stone of the foundation also serves as the base of the concrete stoop which spans both the vestibule and chimney. The other two bays of the facade have single, 1 over 1 replacement vinyl windows with decorative brick lintels. In the attic on the facade is a small wood framed, multipaned window. There is a brick wing wall on each side of the facade. There is a full light storm door. Despite the loss of the original windows, which were most likely a multipaned pattern, the house retains its distinctive Tudor Revival design in form.
