ARCHITECTURAL/HISTORIC INVENTORY FORM

1. Survey No. SL-AS-036-001		2. Survey Name: Architectural Survey of Old Ferguson West	
3. County: St. Louis		4. Address: 1 Carson Rd.	
5. City: Ferguson	Vicinity: <input type="checkbox"/>	6. UTM:	7. Township/Range/Section
8. Historic name (if known):		9. Present/other name (if known): Whistle Stop	
10. Ownership: <input type="checkbox"/> Private <input checked="" type="checkbox"/> Public		11. Historic use (if known): TRANSPORTATION/rail-related	11. Current use: COMMERCE/restaurant & RECREATION/museum

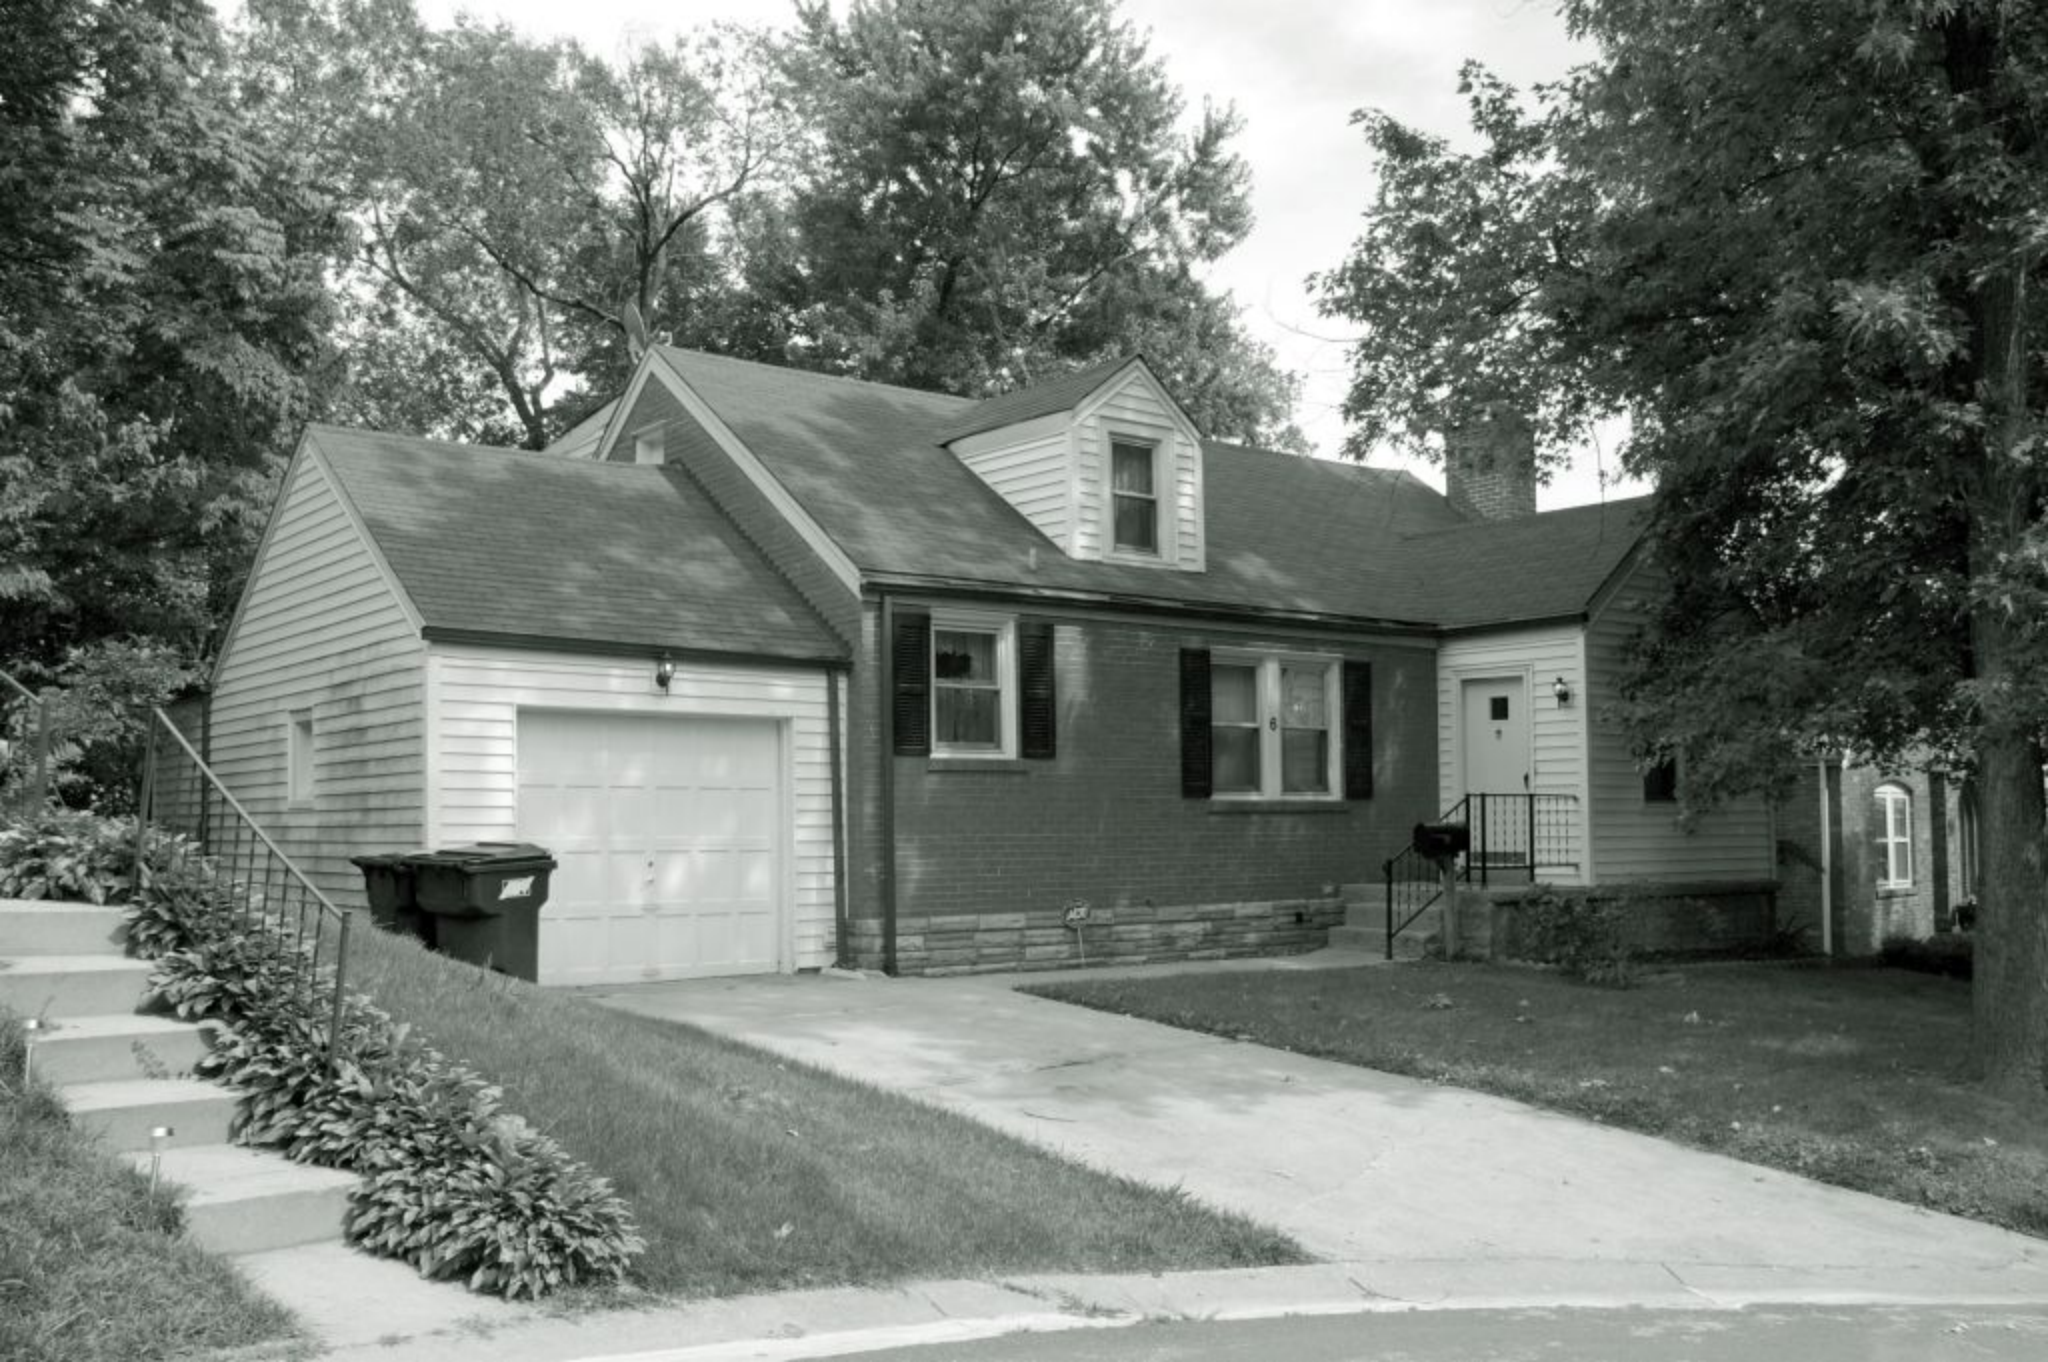
This side gabled, 1.5 story, red brick house has minimal Colonial Revival details, most notably the use of wood shutters on the facade windows. The facade is divided into four bays, three of which are in the main house facade. There is a single 1 over 1 wood sashed window in the north bay and a pair of 1 over 1 wood sashed windows in the middle bay of the house, with a gabled dormer, clad in vinyl siding, with a 1 over 1 wood sashed window centered between these first floor windows. The foundation of this portion of the facade has a stone veneer, ashlar pattern of thin layers, which may have been added later. The north bay is an attached, one story, side gabled, frame garage that has been clad with vinyl siding, but appears to retain the original wood paneled overhead door. On the south end, what was apparently an open, roofed, end gabled, porch has been enclosed at some point as a vestibule, utilizing the original stoop with the faux stone base, a feature which still creates a smaller stoop toward the north where the steps lead down to a sidewalk against the facade. The fact that it was an open porch originally is verified by the 1951 fire insurance map. The vestibule is clad in vinyl siding and has paired wood sashed windows and the simple wood door with a small square light; both the windows and the door seem to indicate that the enclosure of the porch was early in the history of the house. There is an end wall, red brick chimney on the south side and a full width shed dormer on the rear. The wood windows have had metal storms added.

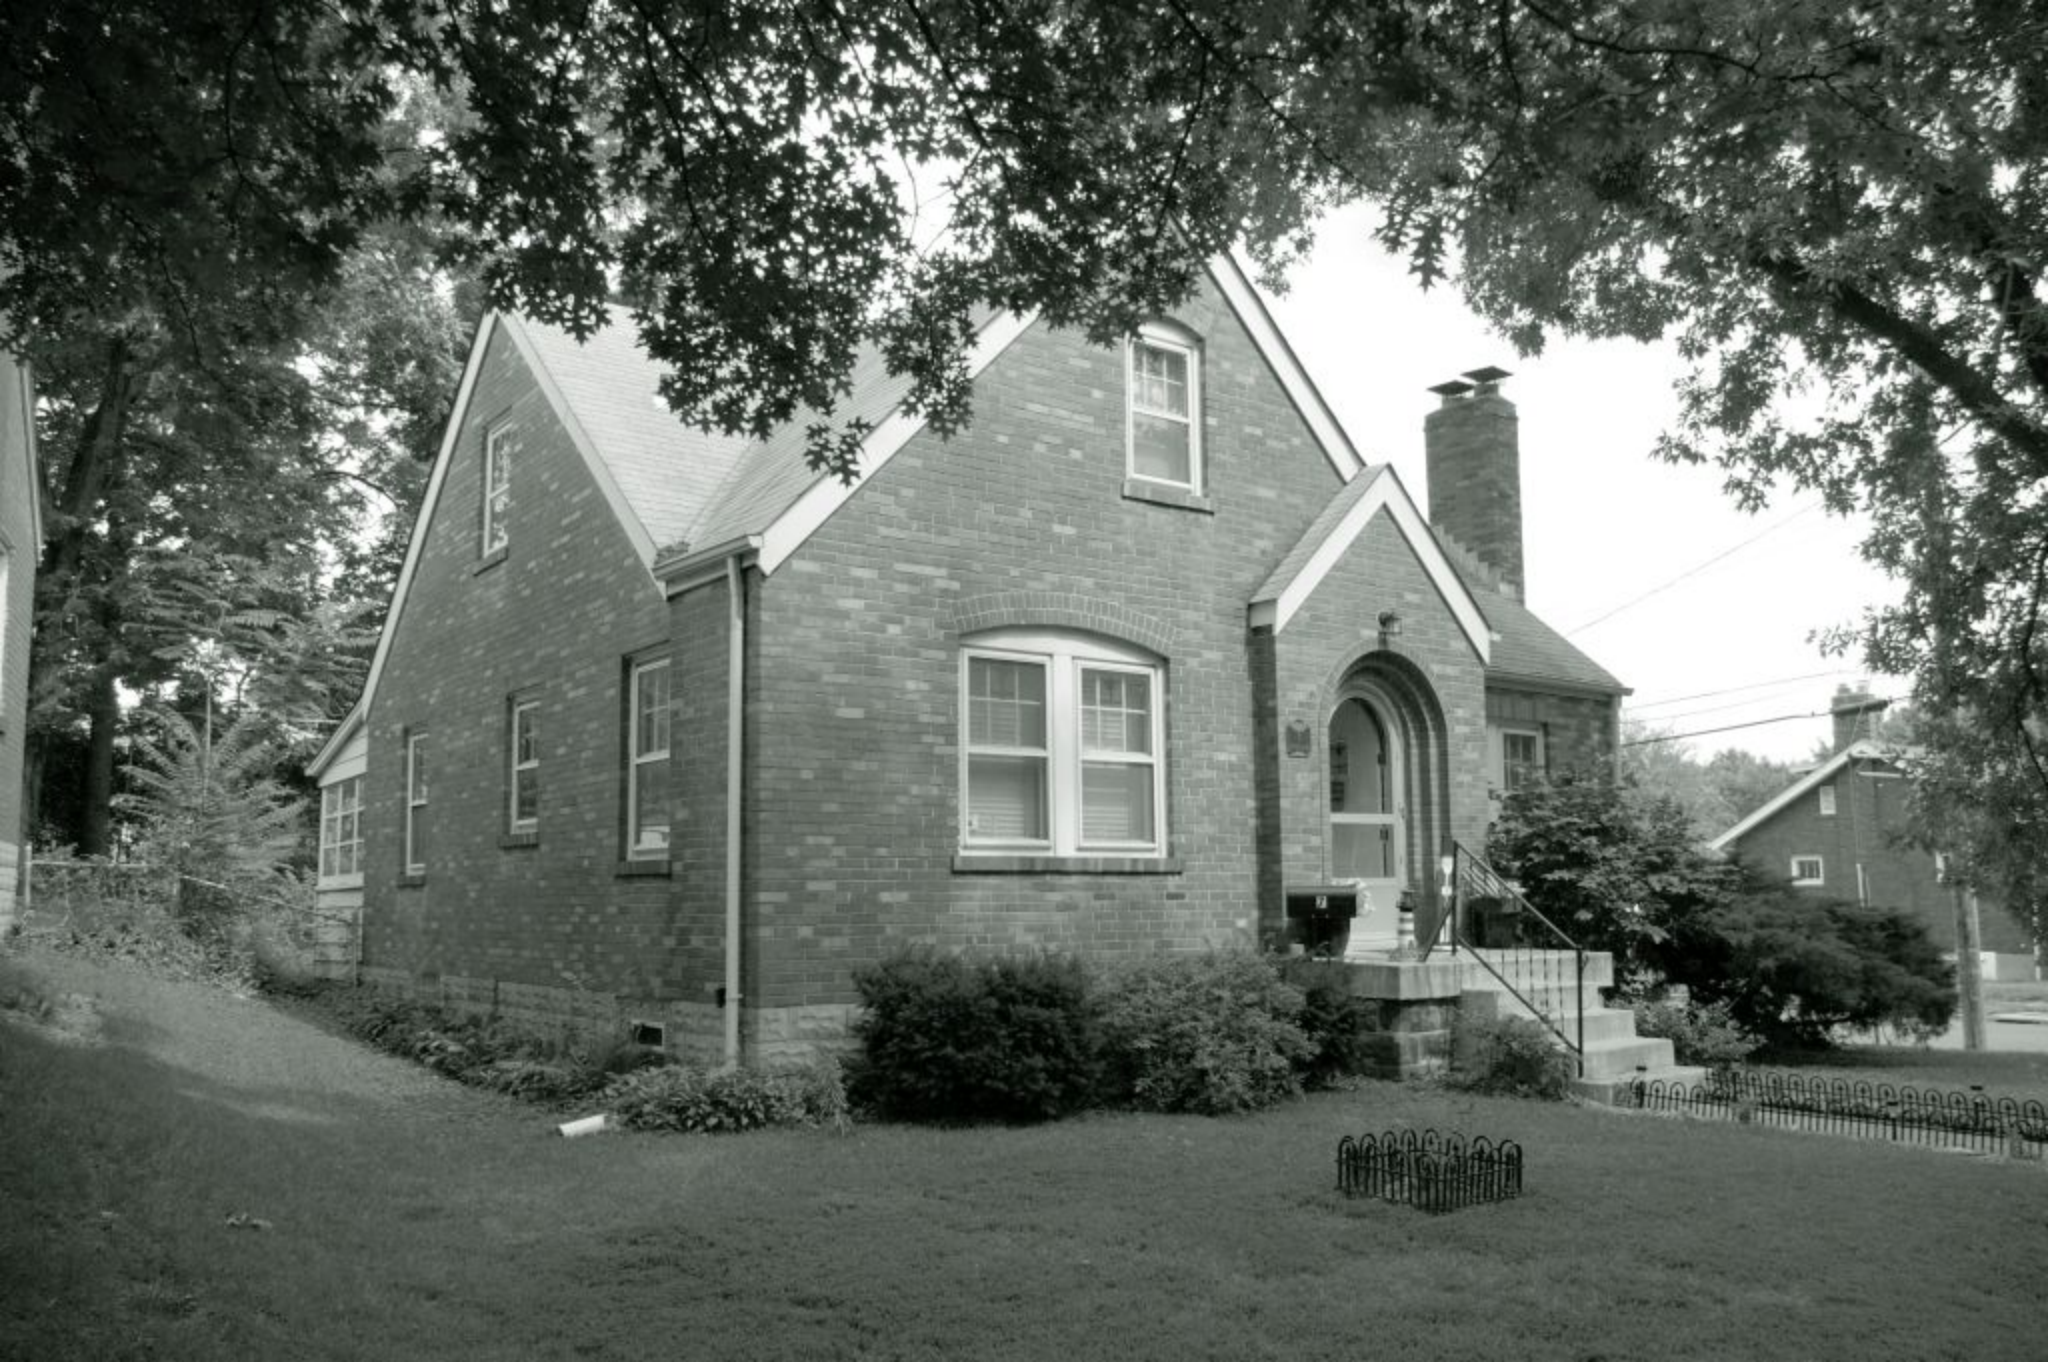
This 1.5 story, multicolored brick, side gabled house has a broad cross gable that spans two of the three bays on the facade. The middle bay has a one story gabled roof over the barely projecting vestibule, with the round arched opening and doorway and a concrete stoop with a faux stone foundation. The entry stoop has had a new concrete cap and steps on top of the original faux stone foundation. The round arched, wood plank door has a small art glass light. The original entry light hangs above the doorway. The north bay has a segmental arched window opening for the paired 6 over 1 wood sashed windows, which have colored glass in one pane of each window. The window centered in this cross gable is also a segmental arched opening with a 6 over 1 wood sashed window. The faux stone foundation is visible on all elevations. The south bay on the facade also has a segmental arched opening with matching paired sashed windows. On the south side, which faces Wesley Avenue, there is a small art glass window in front of the brick chimney and paired windows behind the chimney as well as a window in the upper level. Attached on the rear of the house and projecting out toward the street is a shed roofed, frame, one car garage with aluminum siding. While the garage is clearly shown on the 1951 fire insurance map, the rear porch, which is enclosed with aluminum siding, behind the garage, is not visible on this map and appears to be a slightly later addition. The windows and the front door have aluminum storms, and the basement windows have been replaced with glass block windows.

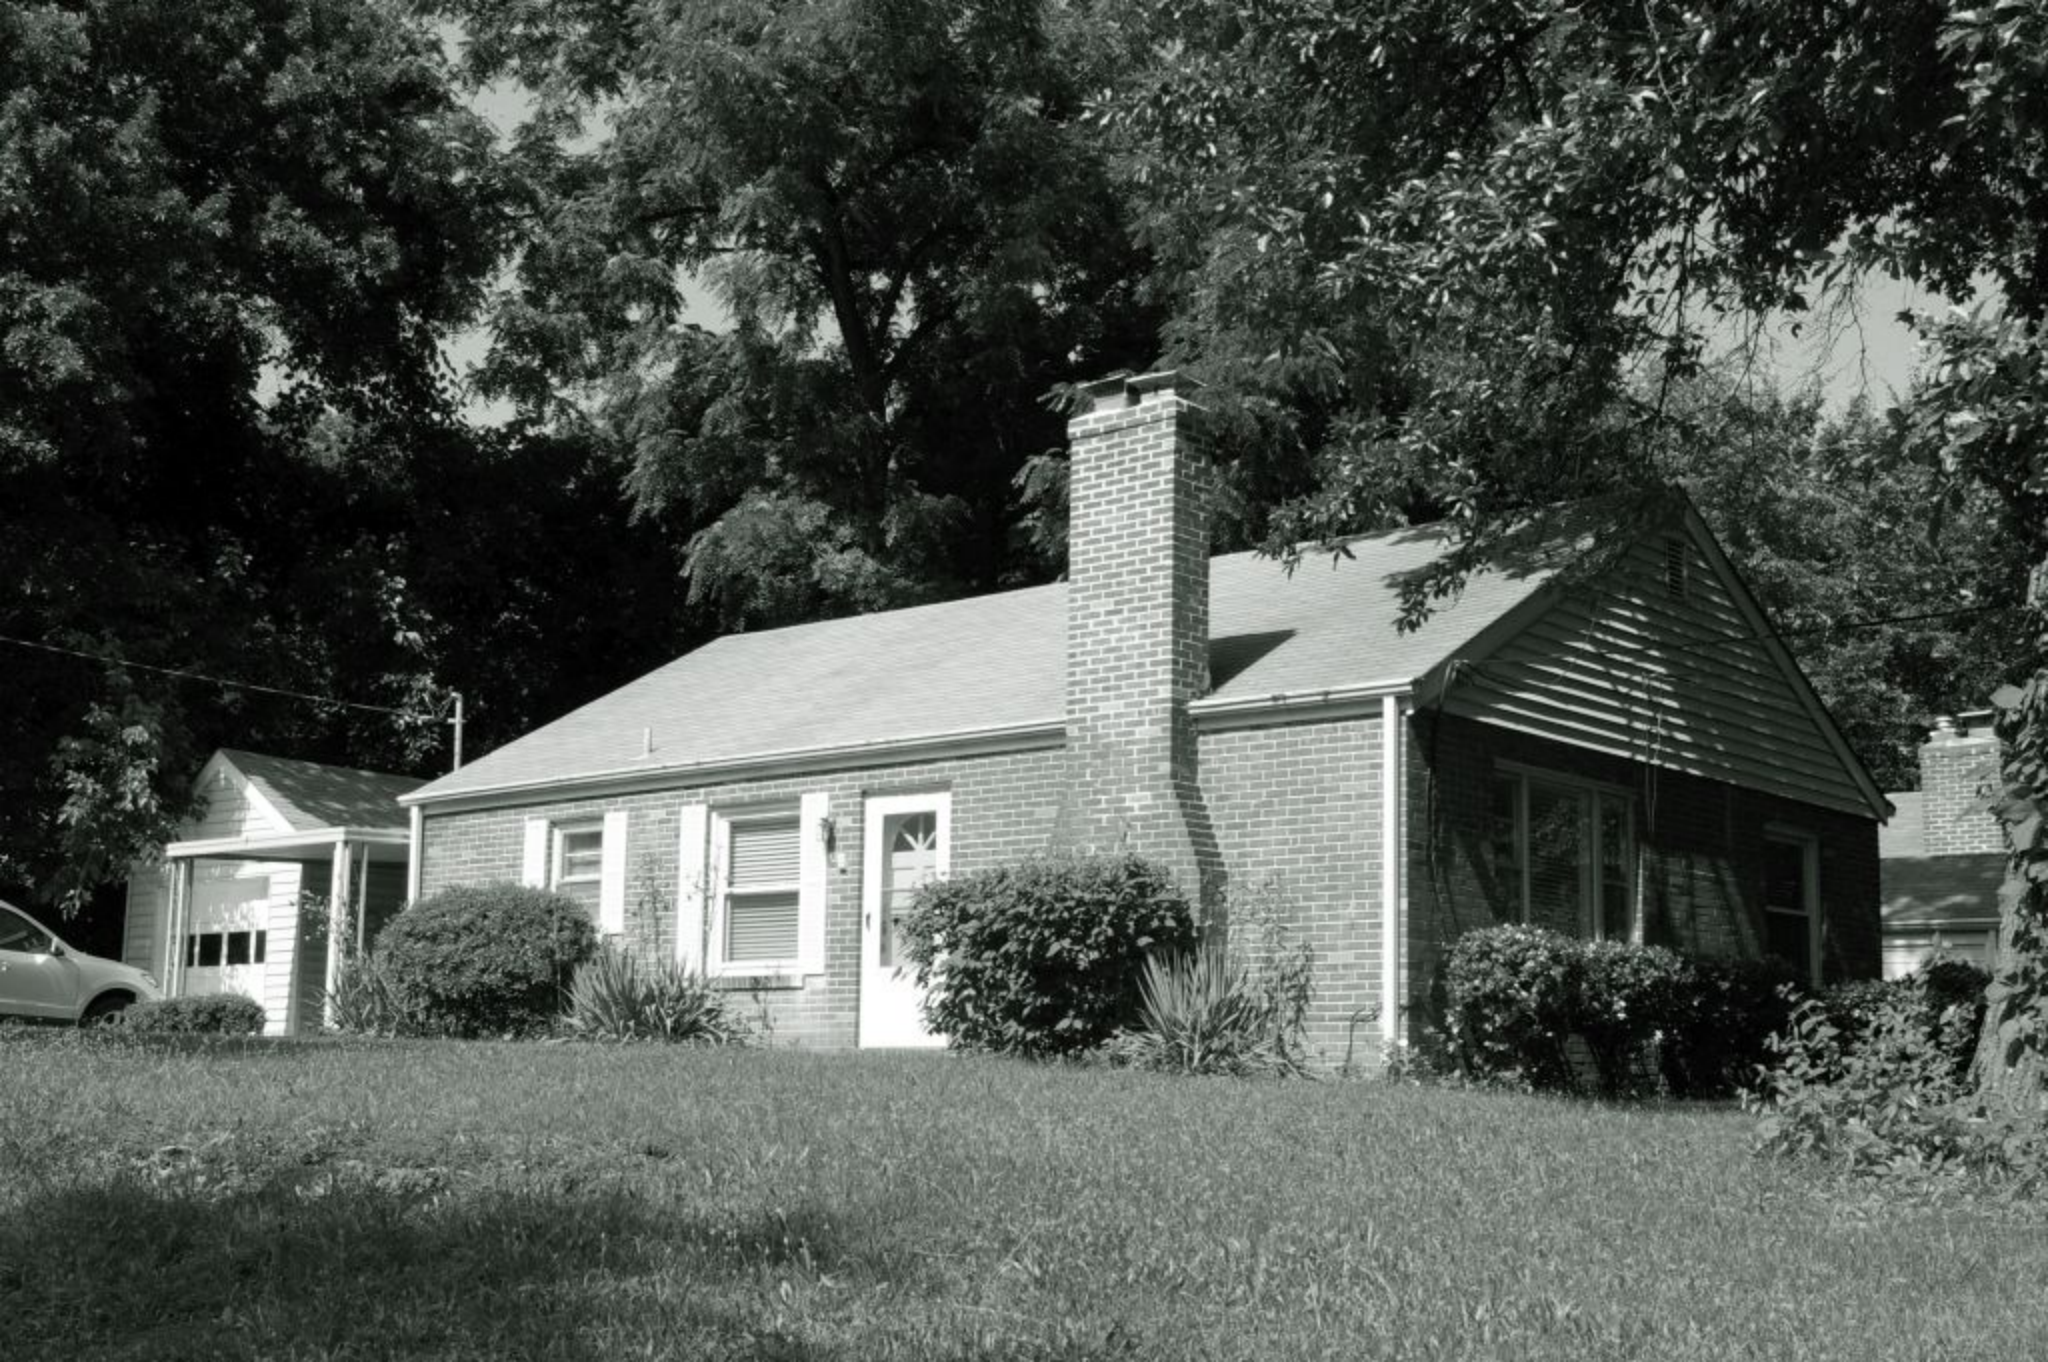
This side gabled, brick house has a four bay facade with a large, end wall chimney in the south bay adjacent to the simple wood paneled entry door with a half round fanlight in the door. The north two bays have wood shuttered, sashed windows. While the one near the door may be a replacement since it is only a 1 over 1 sashed window, the other window is the original 2 over 2 horizontally lighted wood sashed window. To the north of the main house is a shed roofed breezeway supported by wrought iron corner posts that link to the end gabled, frame, one-car garage with clapboard siding and the original wood paneled garage door with a row of glass panes. On the south elevation, facing Carson the end gabled is wood clapboard with a picture window toward the west that consists of two narrow 2 over 2 wood sashed windows (horizontal lights) flanking a plate glass window. At the east end of this elevation is another sashed window. The breezeway may be a laer alteration and the wood sashed windows and original door have aluminum storms.

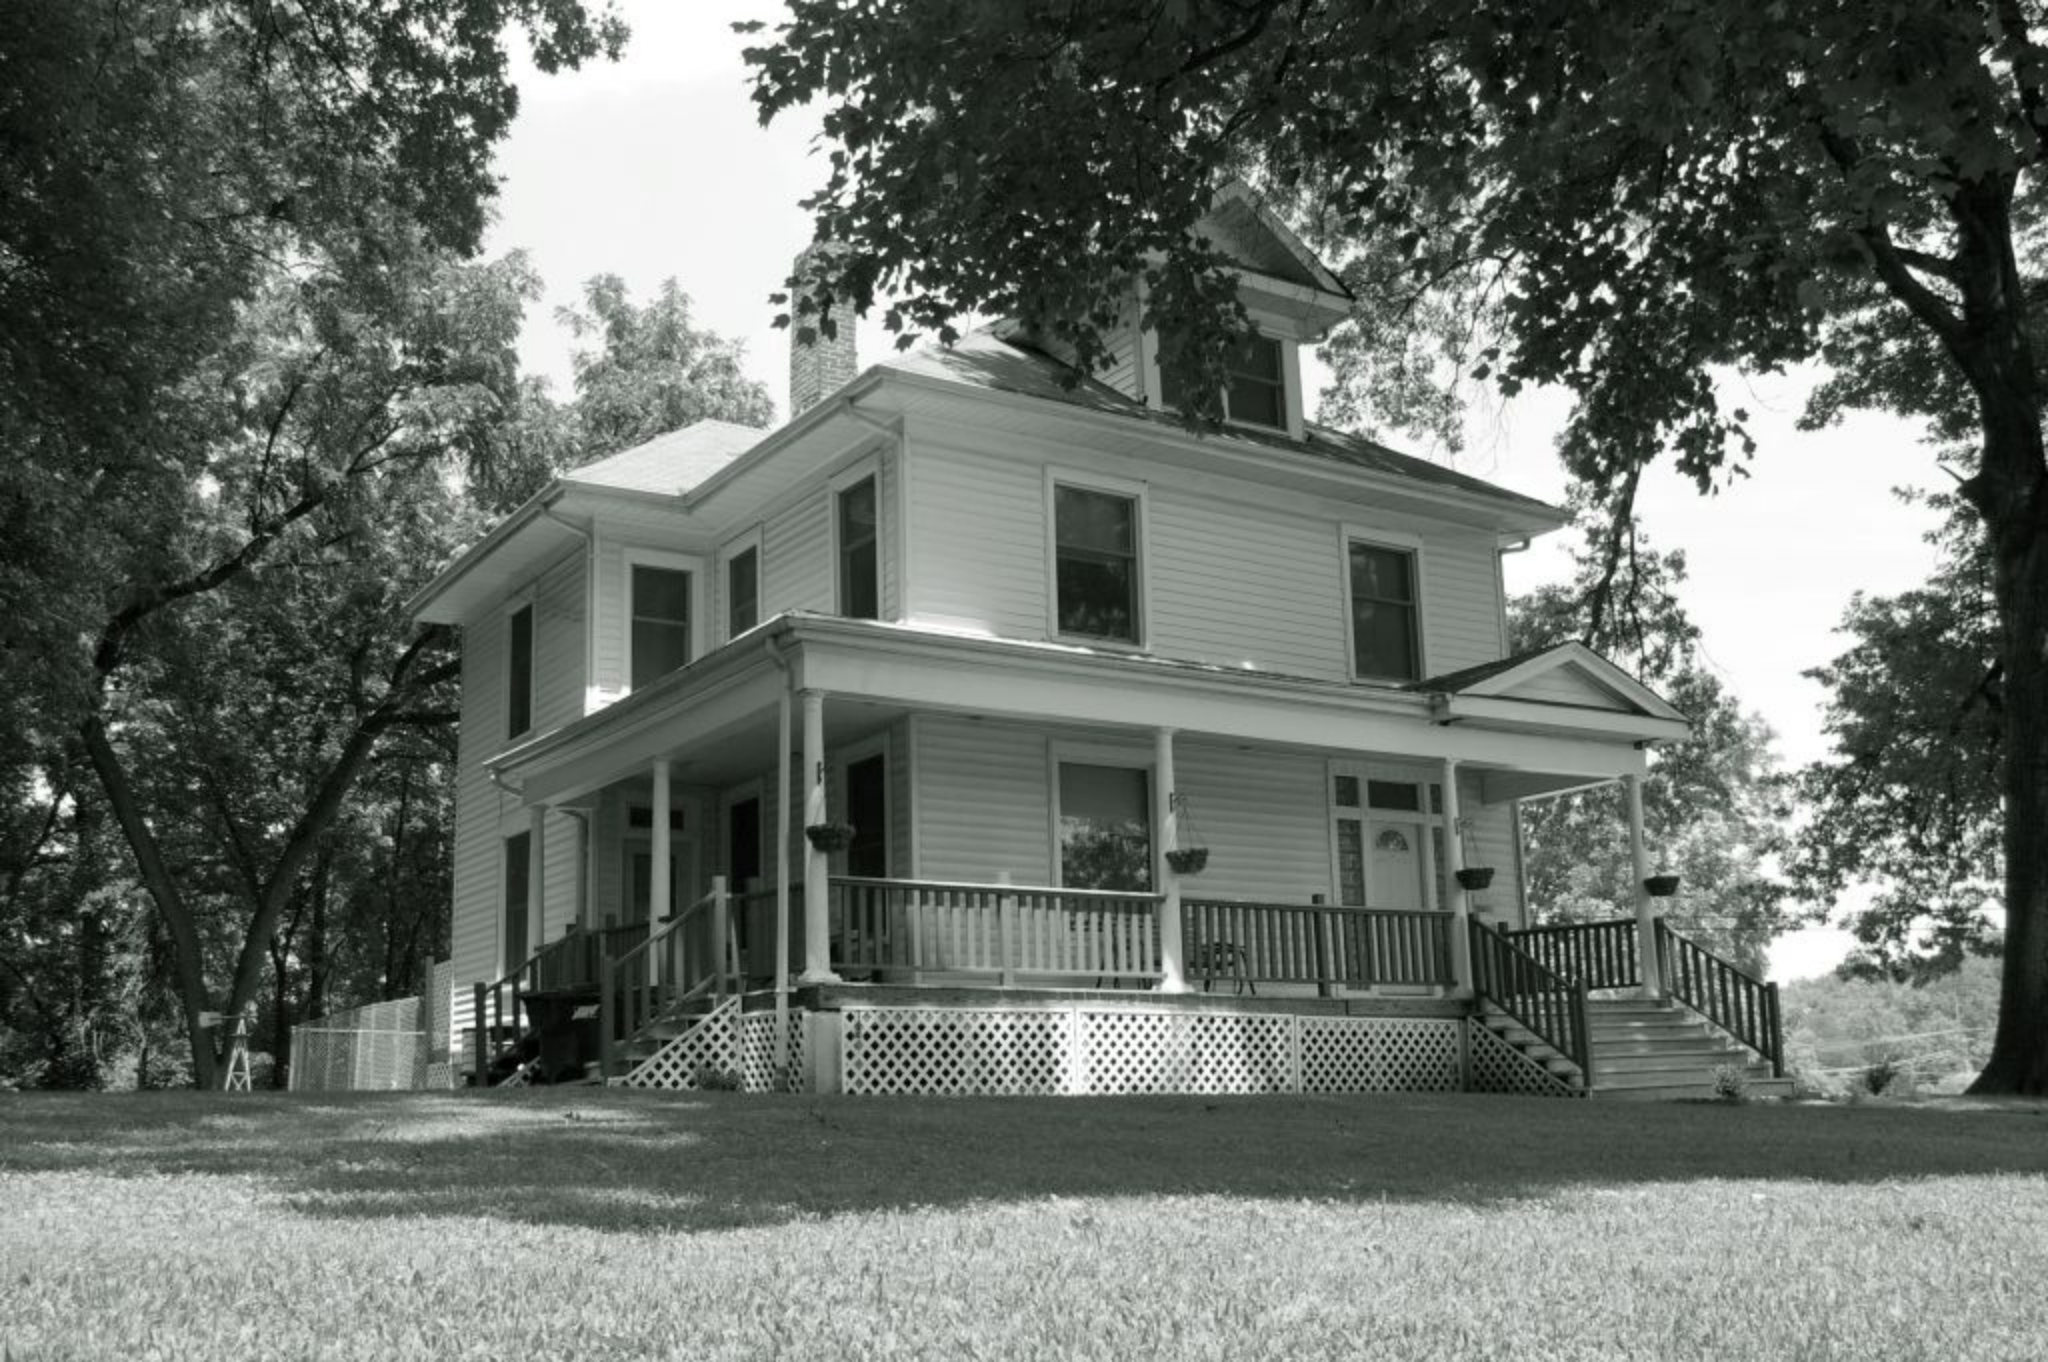
2009 Survey Update: Since the 1983 survey, the house has been covered with vinyl siding and it has new storm windows on the original wood sashed windows (which have raised meeting rail on the one over one windows). The sidelights on the front door have been replaced with glass block and the shorter original railing has been replaced with a higher porch railing. Even so, the overall house form and the distinctive Colonial Revival features remain, especially the slender Doric columns on the wrap-around porch, the pedimented dormers and porch entry.

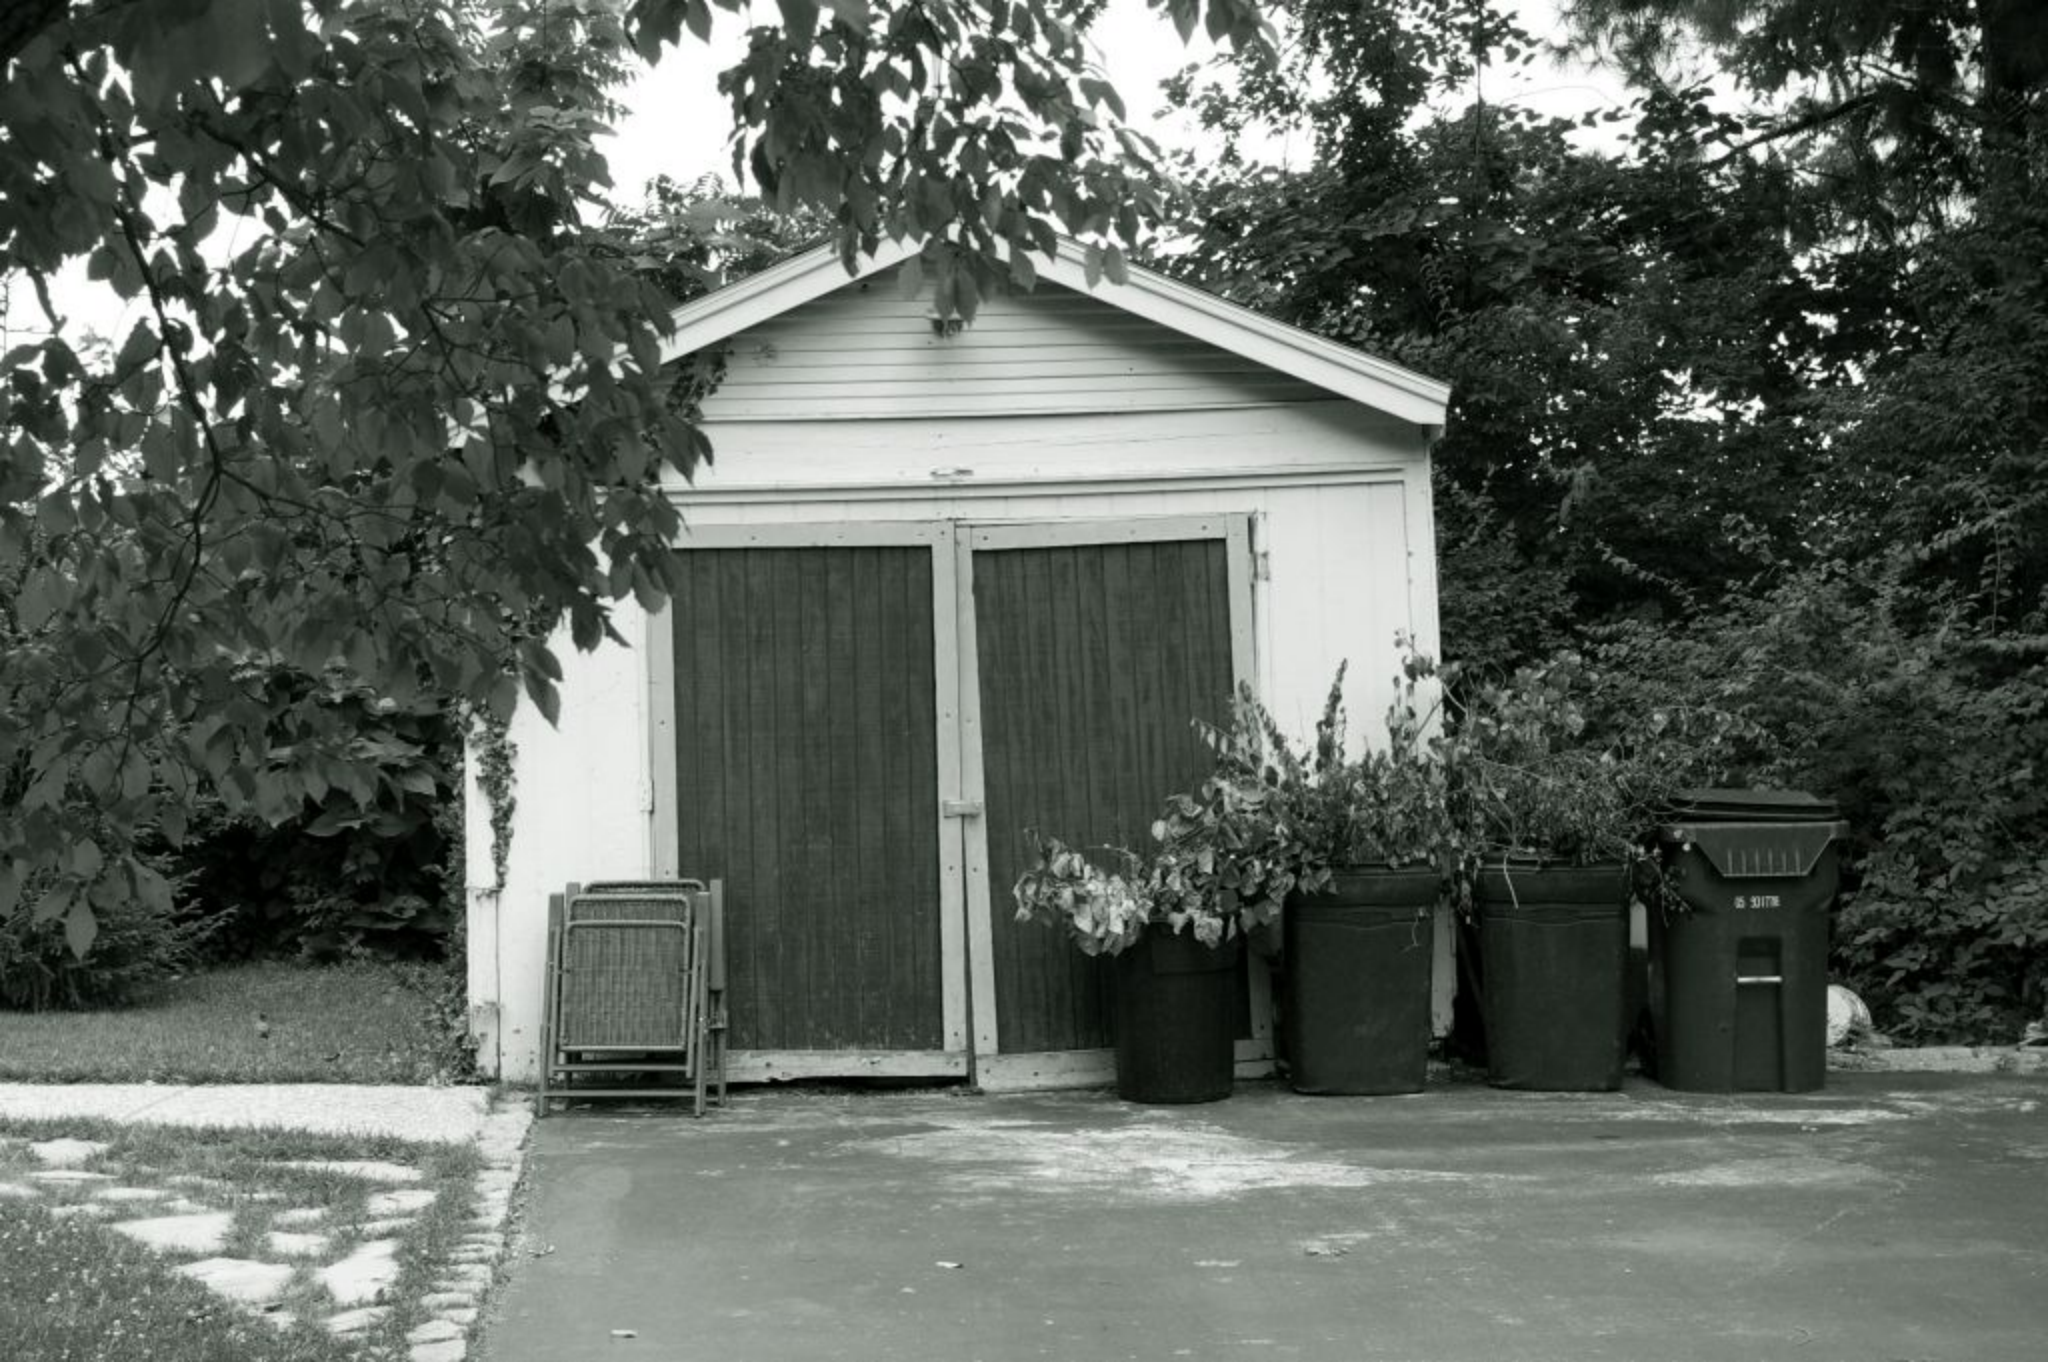
2009 Survey Update: The enclosed porch seen in the 1983 survey photo has been reopened, although some of the framework remains.

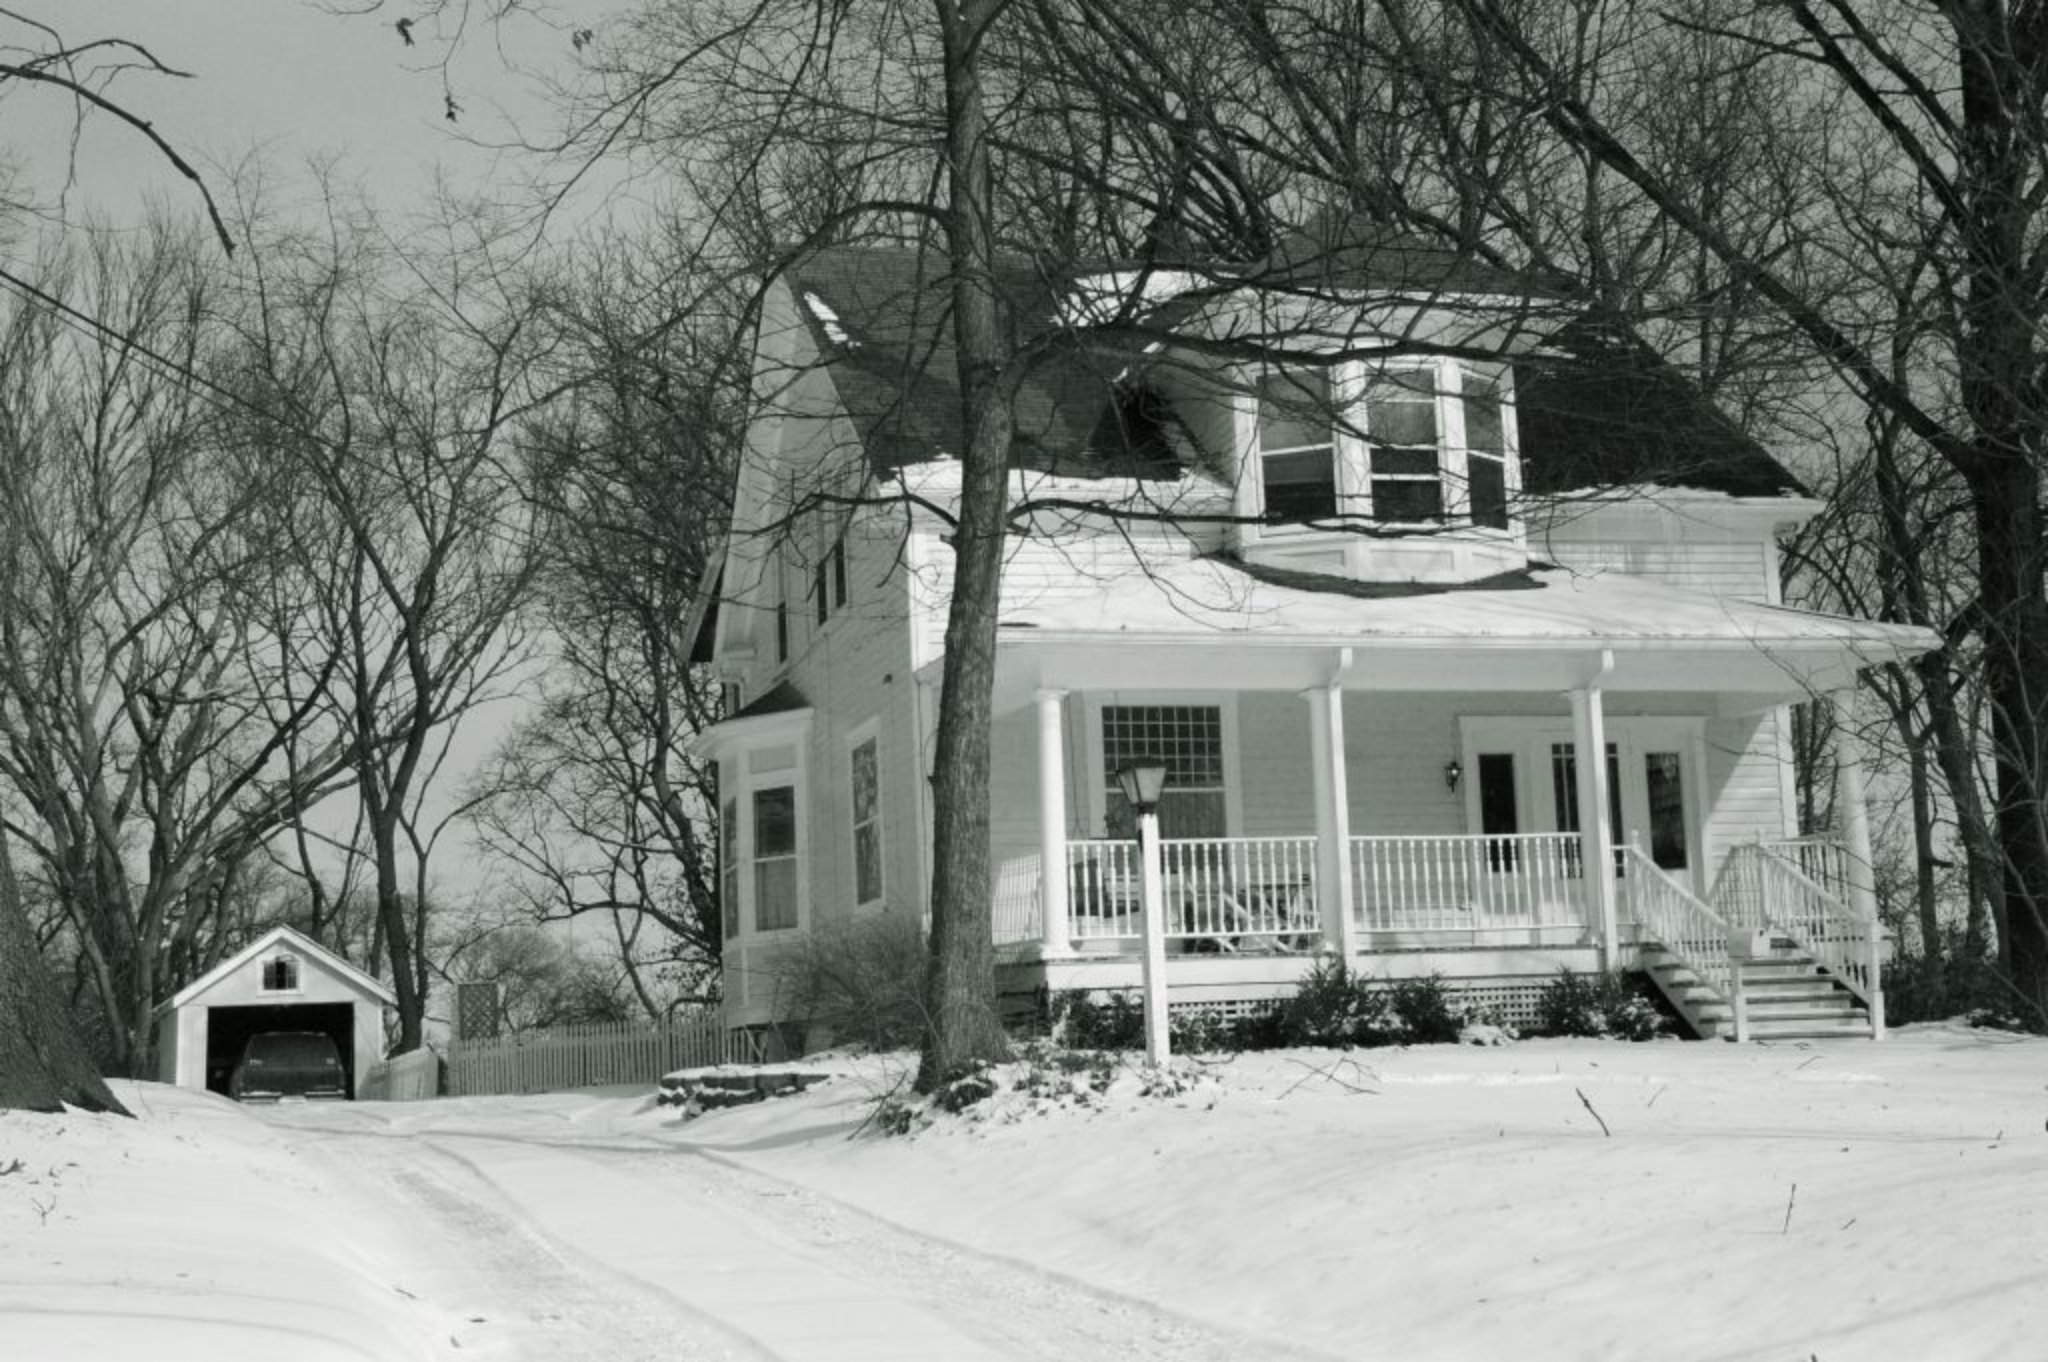
2009 Survey Update: Since the 1983 survey, the screened enclosure of the front porch has been removed and the porch railings replaced with new turned railings but the porch retains its original Doric columns. The house has wooden storm windows on the original wood windows and still retains the original clapboard siding.

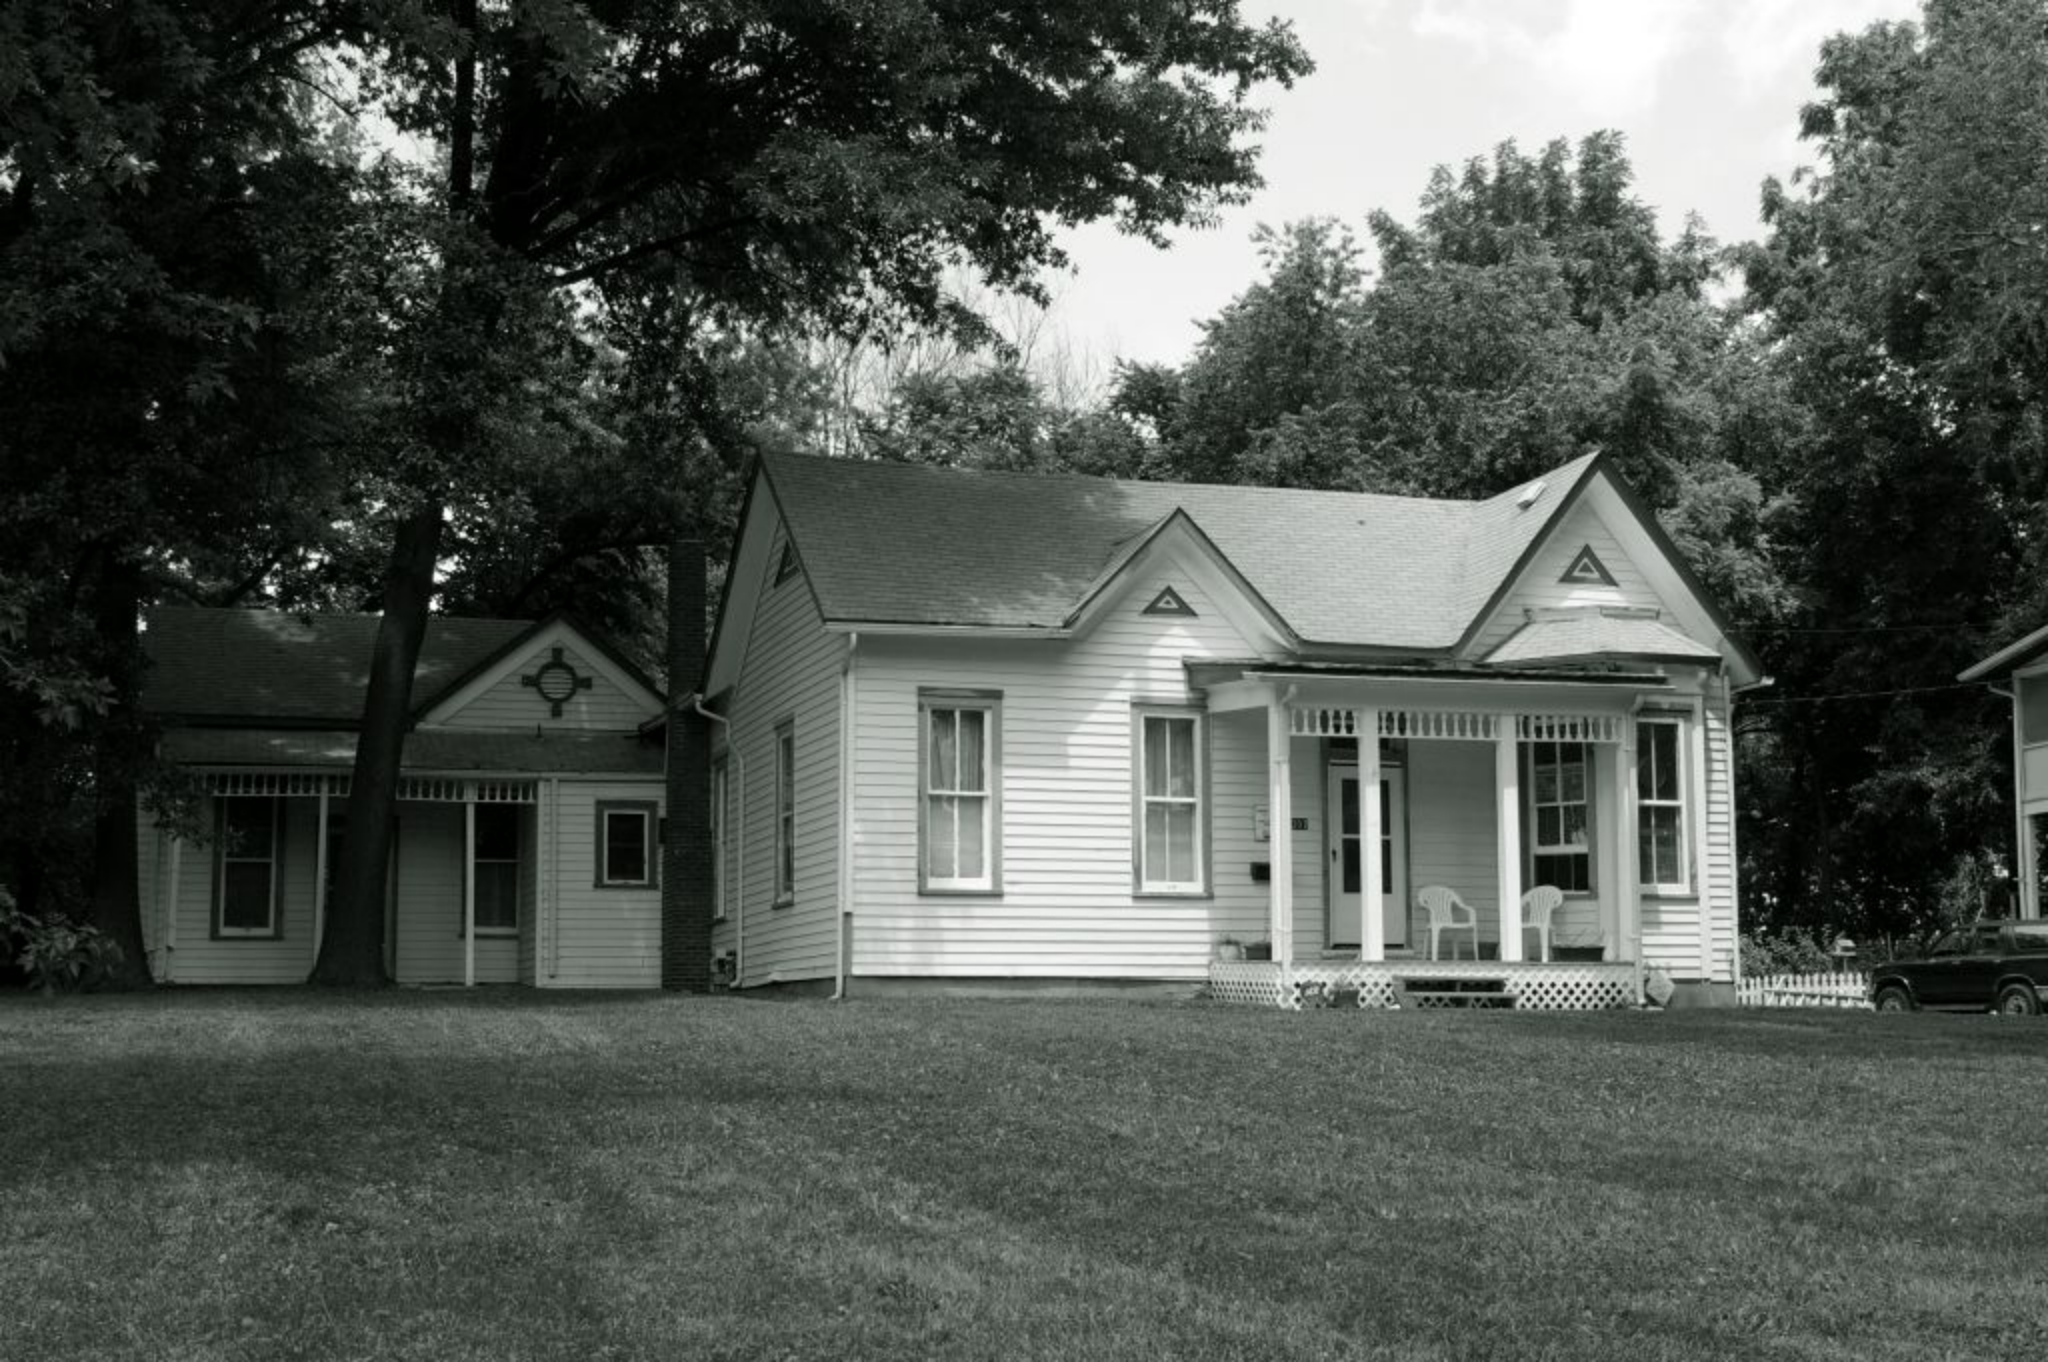
2009 Survey Update: Behind the house is a frame, detached, carriage house that is side gabled with 2 bays and swinging wood doors, but it is in poor condition.
