ARCHITECTURAL/HISTORIC INVENTORY FORM

1. Survey No. SL-AS-036-001		2. Survey Name: Architectural Survey of Old Ferguson West	
3. County: St. Louis		4. Address: 1 Carson Rd.	
5. City: Ferguson	Vicinity: <input type="checkbox"/>	6. UTM:	7. Township/Range/Section
8. Historic name (if known):		9. Present/other name (if known): Whistle Stop	
10. Ownership: <input type="checkbox"/> Private <input checked="" type="checkbox"/> Public		11. Historic use (if known): TRANSPORTATION/rail-related	11. Current use: COMMERCE/restaurant & RECREATION/museum

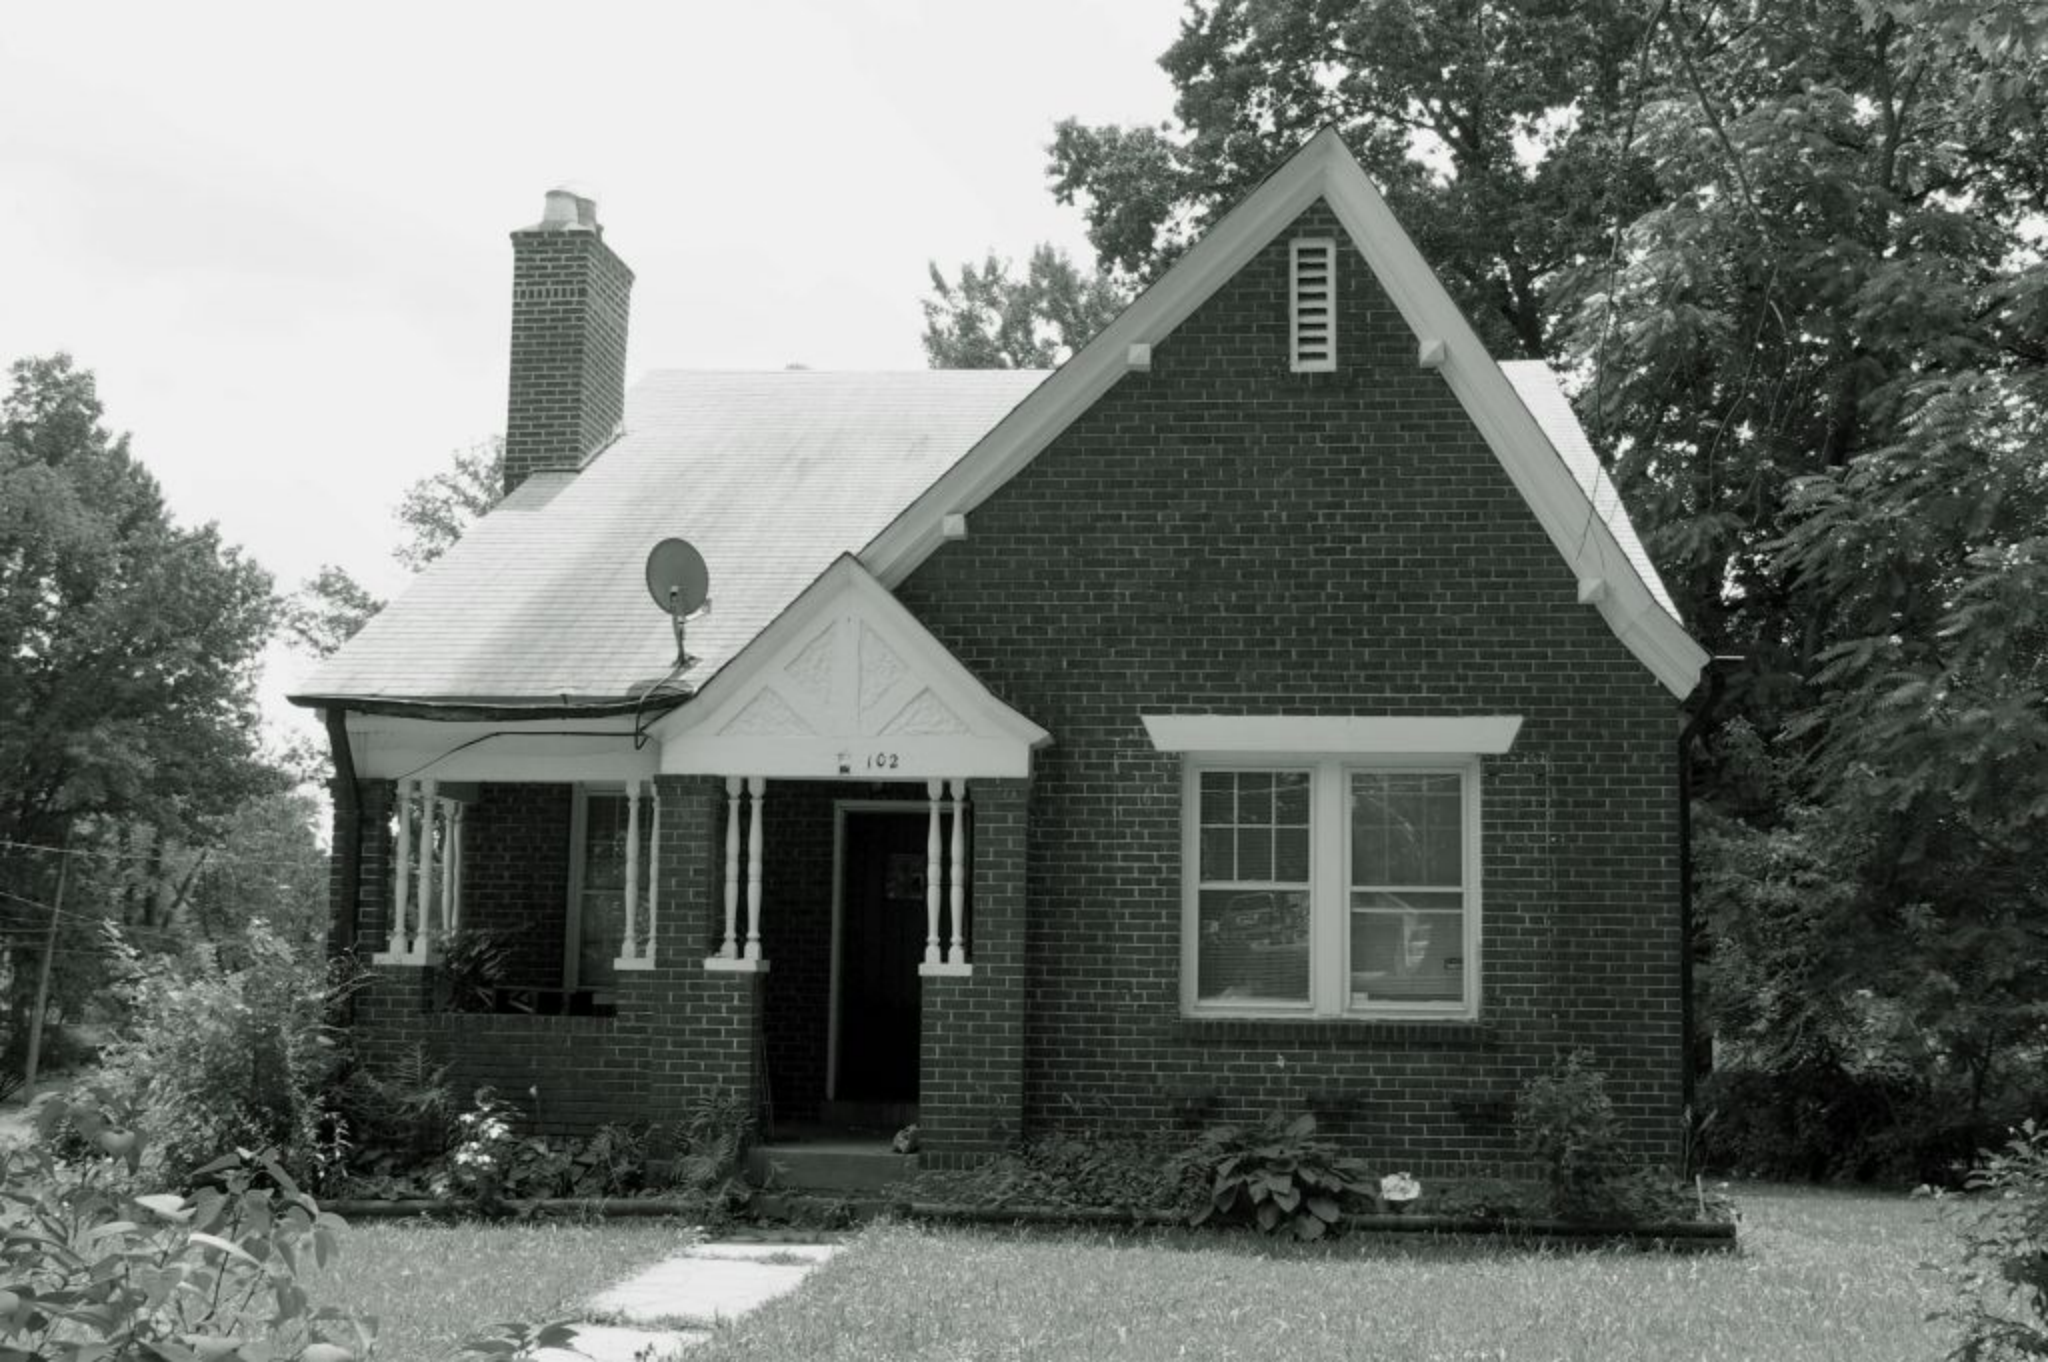
2009 Survey Update: Since the 1983 survey, new combination storm windows have been installed on the house and the original shutters on the front window have been removed.

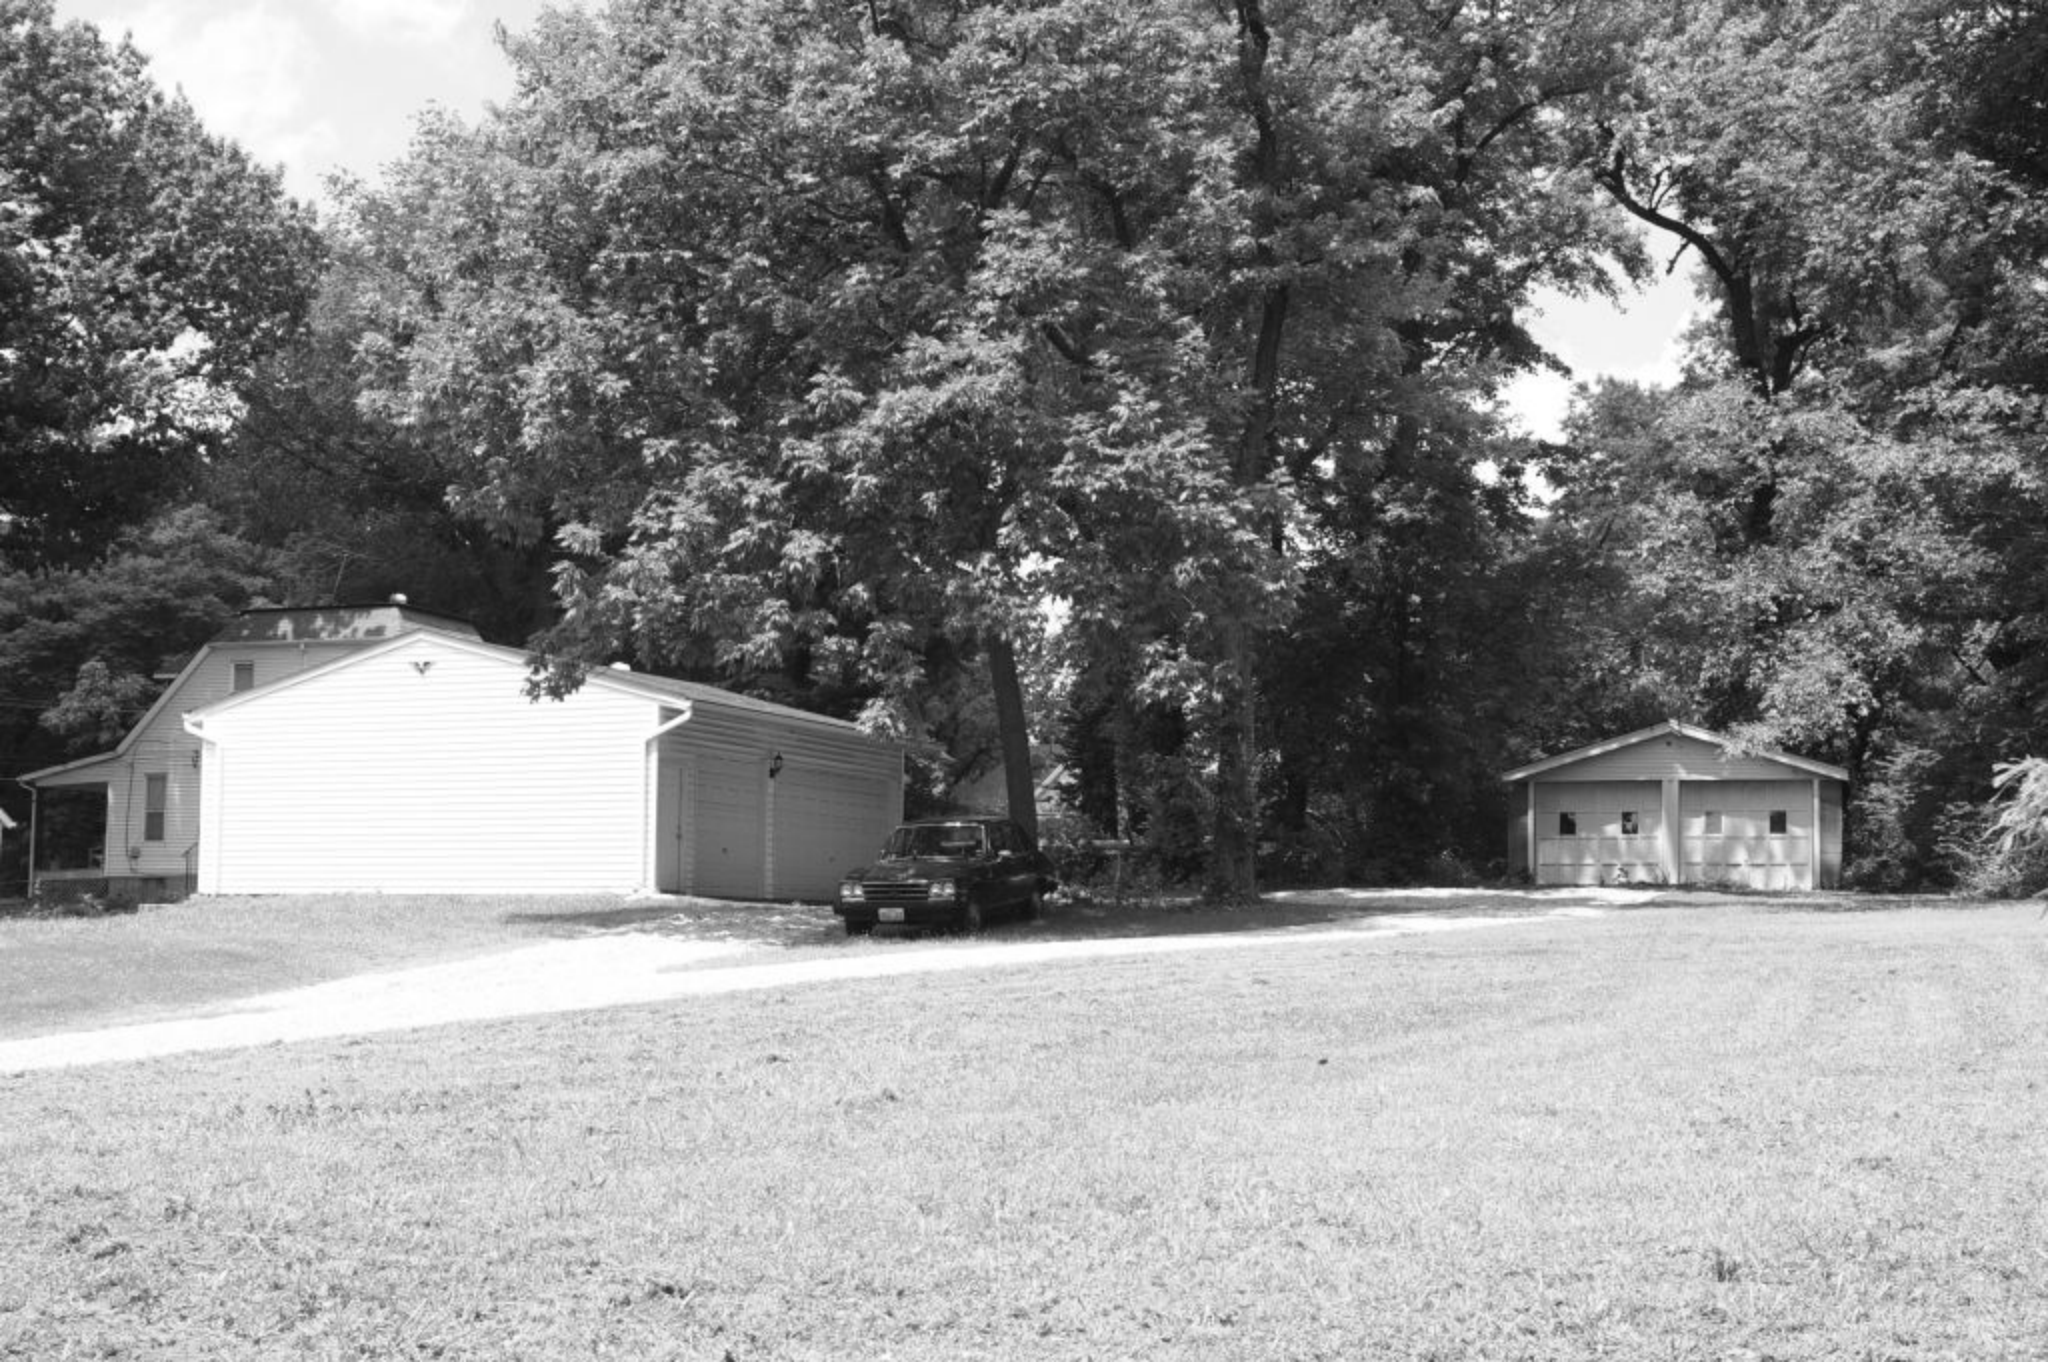
This lot has two garages, one positioned deeply at the end of a long driveway that is an end gabled, two car, two wood paneled door, concrete block garage. The other is on the west side of the driveway, facing east, and closer to the street; it is a side gabled, three car garage with vinyl siding, a man door, a one car overhead door, and a two car overhead door. The concrete block garage appears to have been built in the 1950s or 1960s while the other garage appears to be much newer.

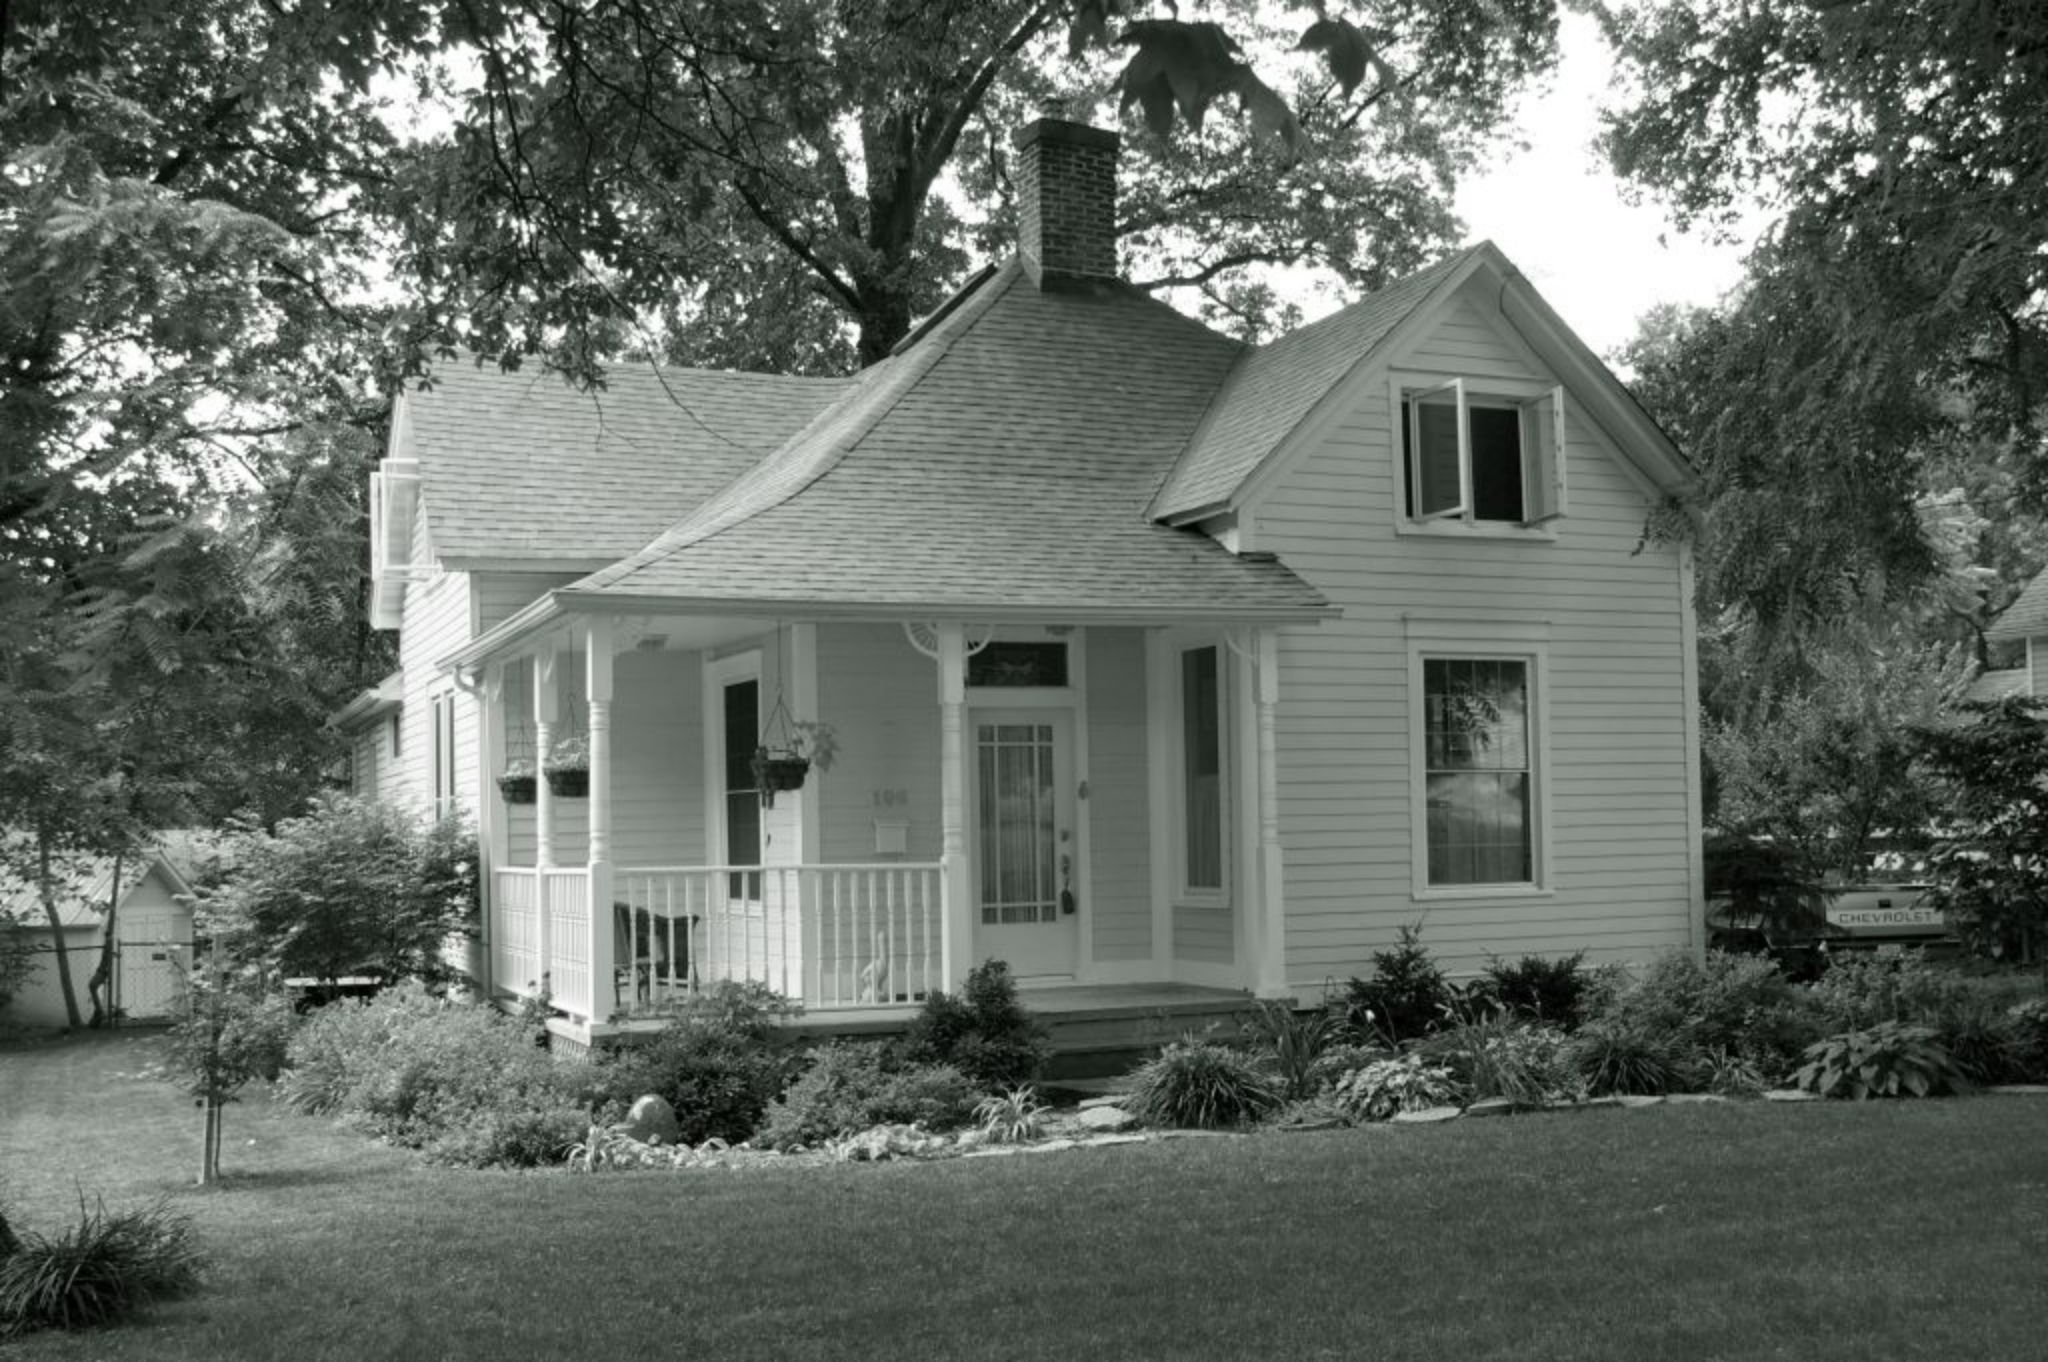
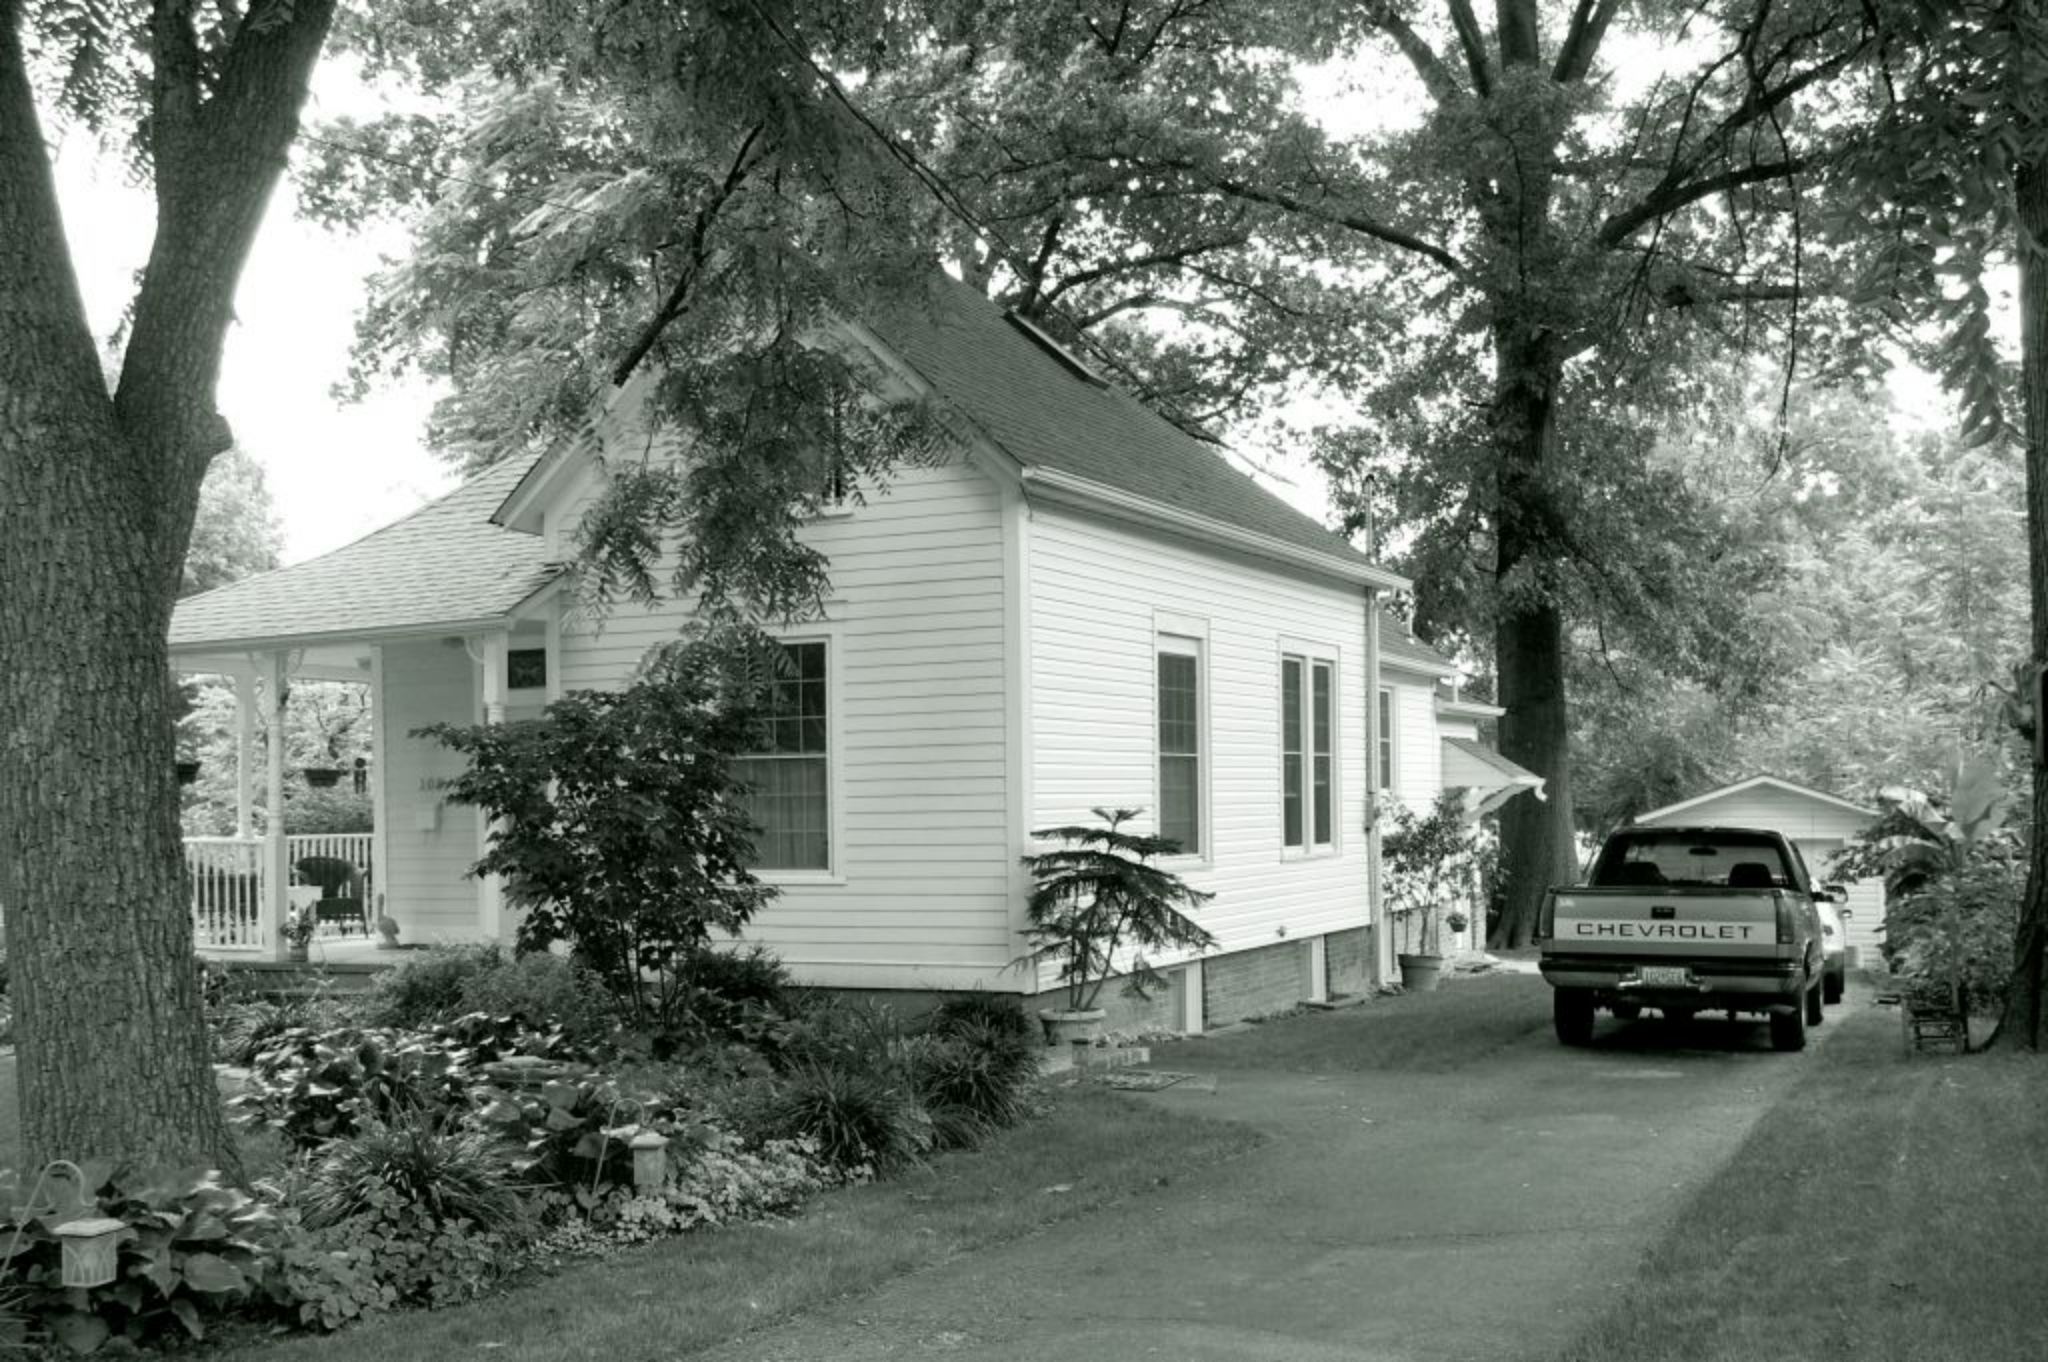
2009 Survey Update: The 1 over 1 wood windows have been replaced with multipaned, vinyl windows (although the muntin grid is only on the interior) and the original porch railing has been replaced with a taller wood railing, but without seeing the original survey photo, it is difficult to tell whether the turned posts are the originals or recent replacements. The front of the house is still clapboard but the sides have been covered with vinyl siding. The house retains its original, transomed, full light wood front door with the vertical muntins crossed near the top and bottom with cross muntins.

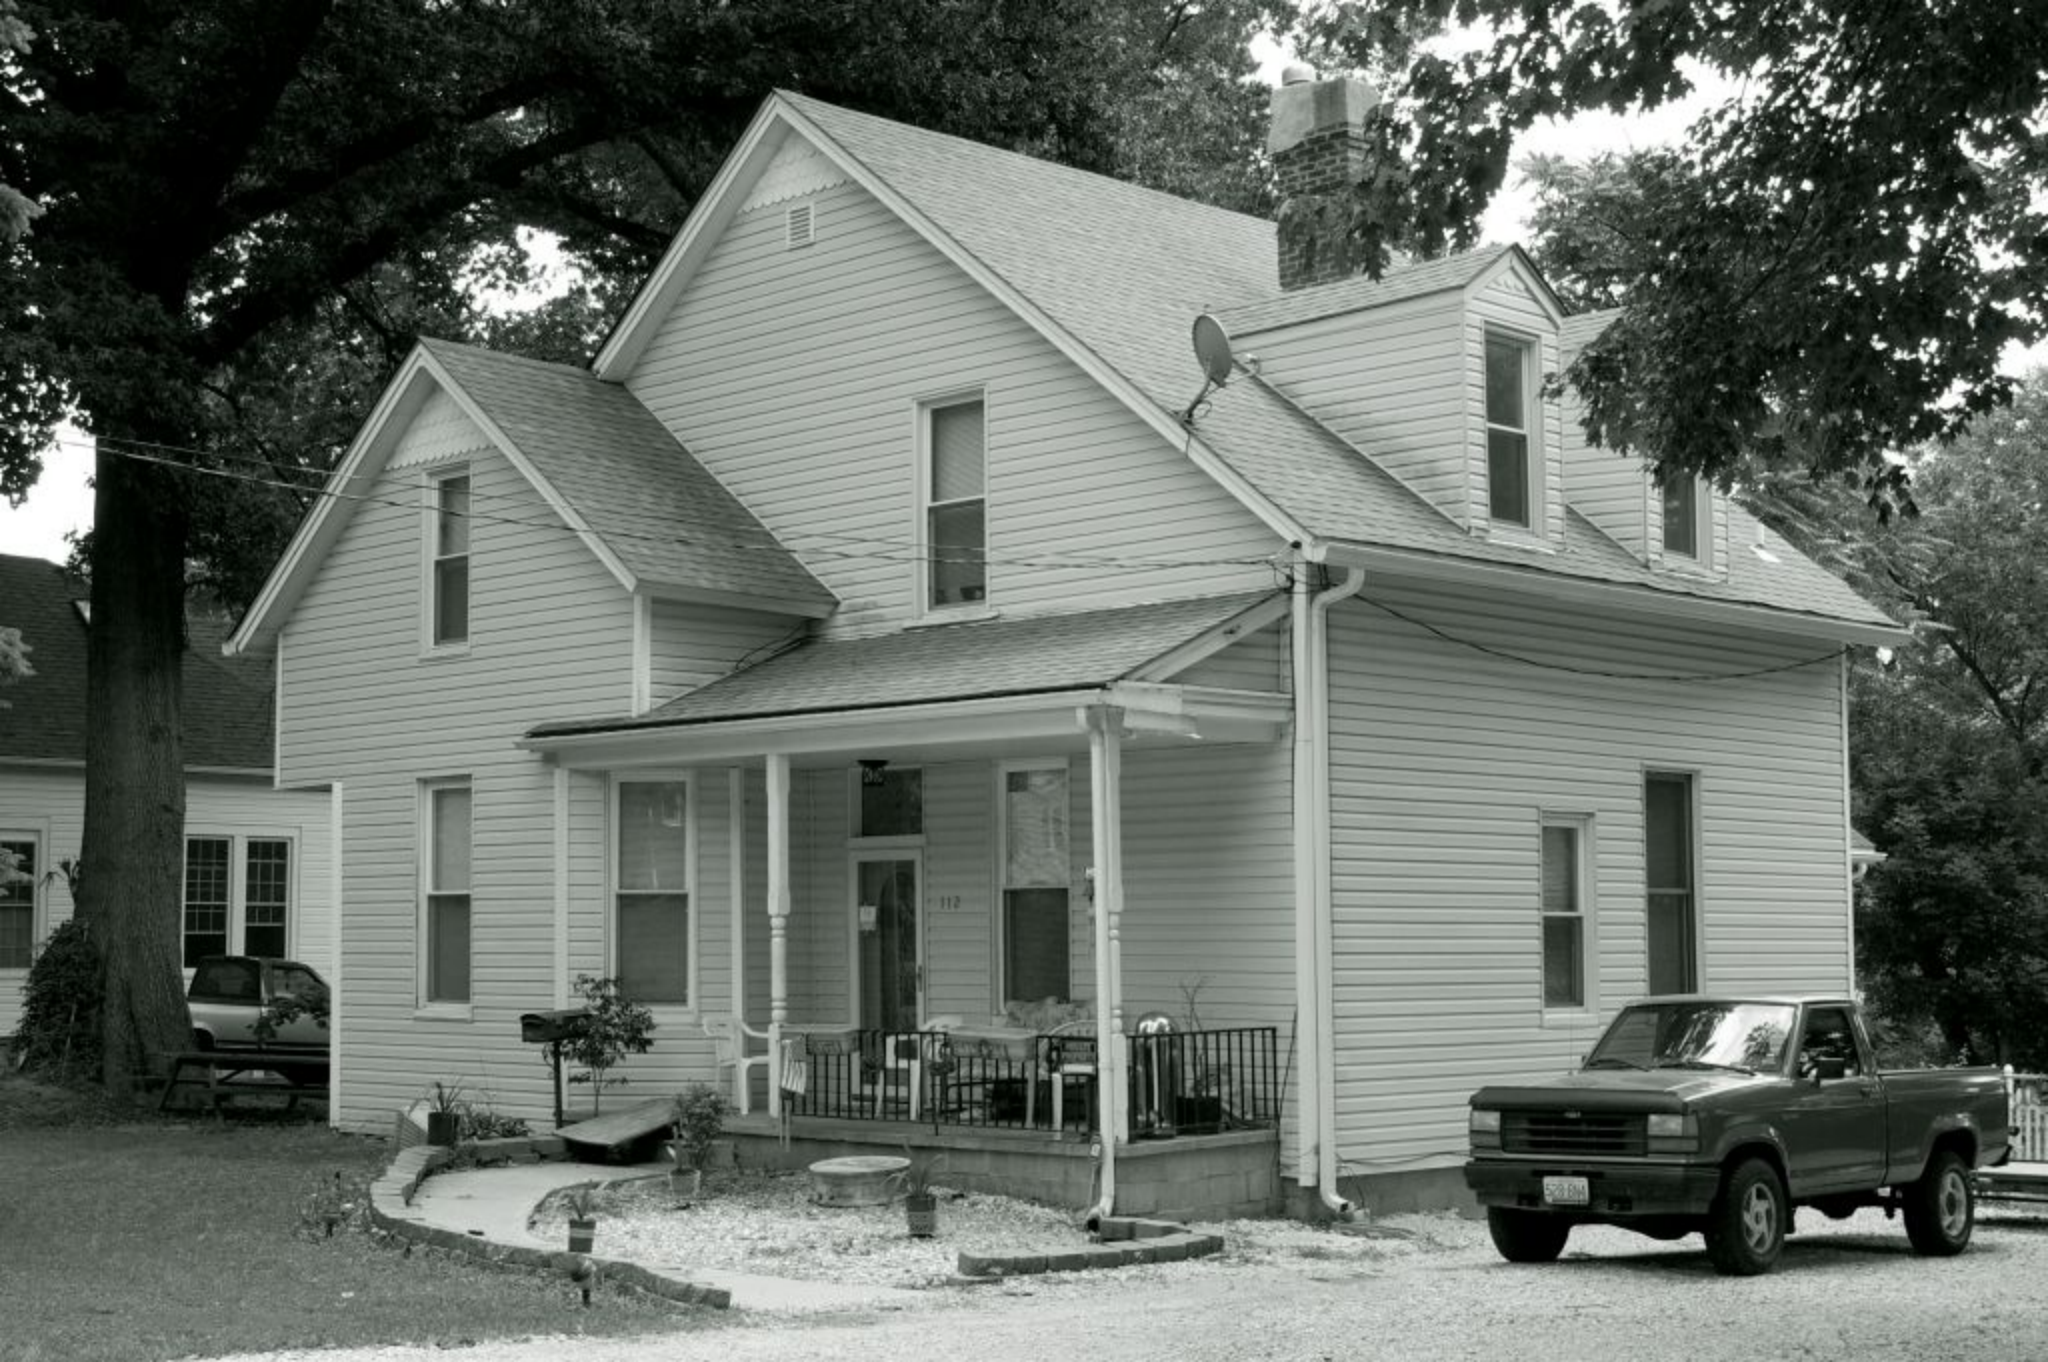
2009 Survey Update: The house, including the window trim, has been covered by vinyl siding and the windows have been replaced with vinyl windows. In the 1983 survey the porch did not have railings and now it has metal railings. The upper portion of the chimney has been capped with concrete. There is a wood deck on the back of the house that has been added.

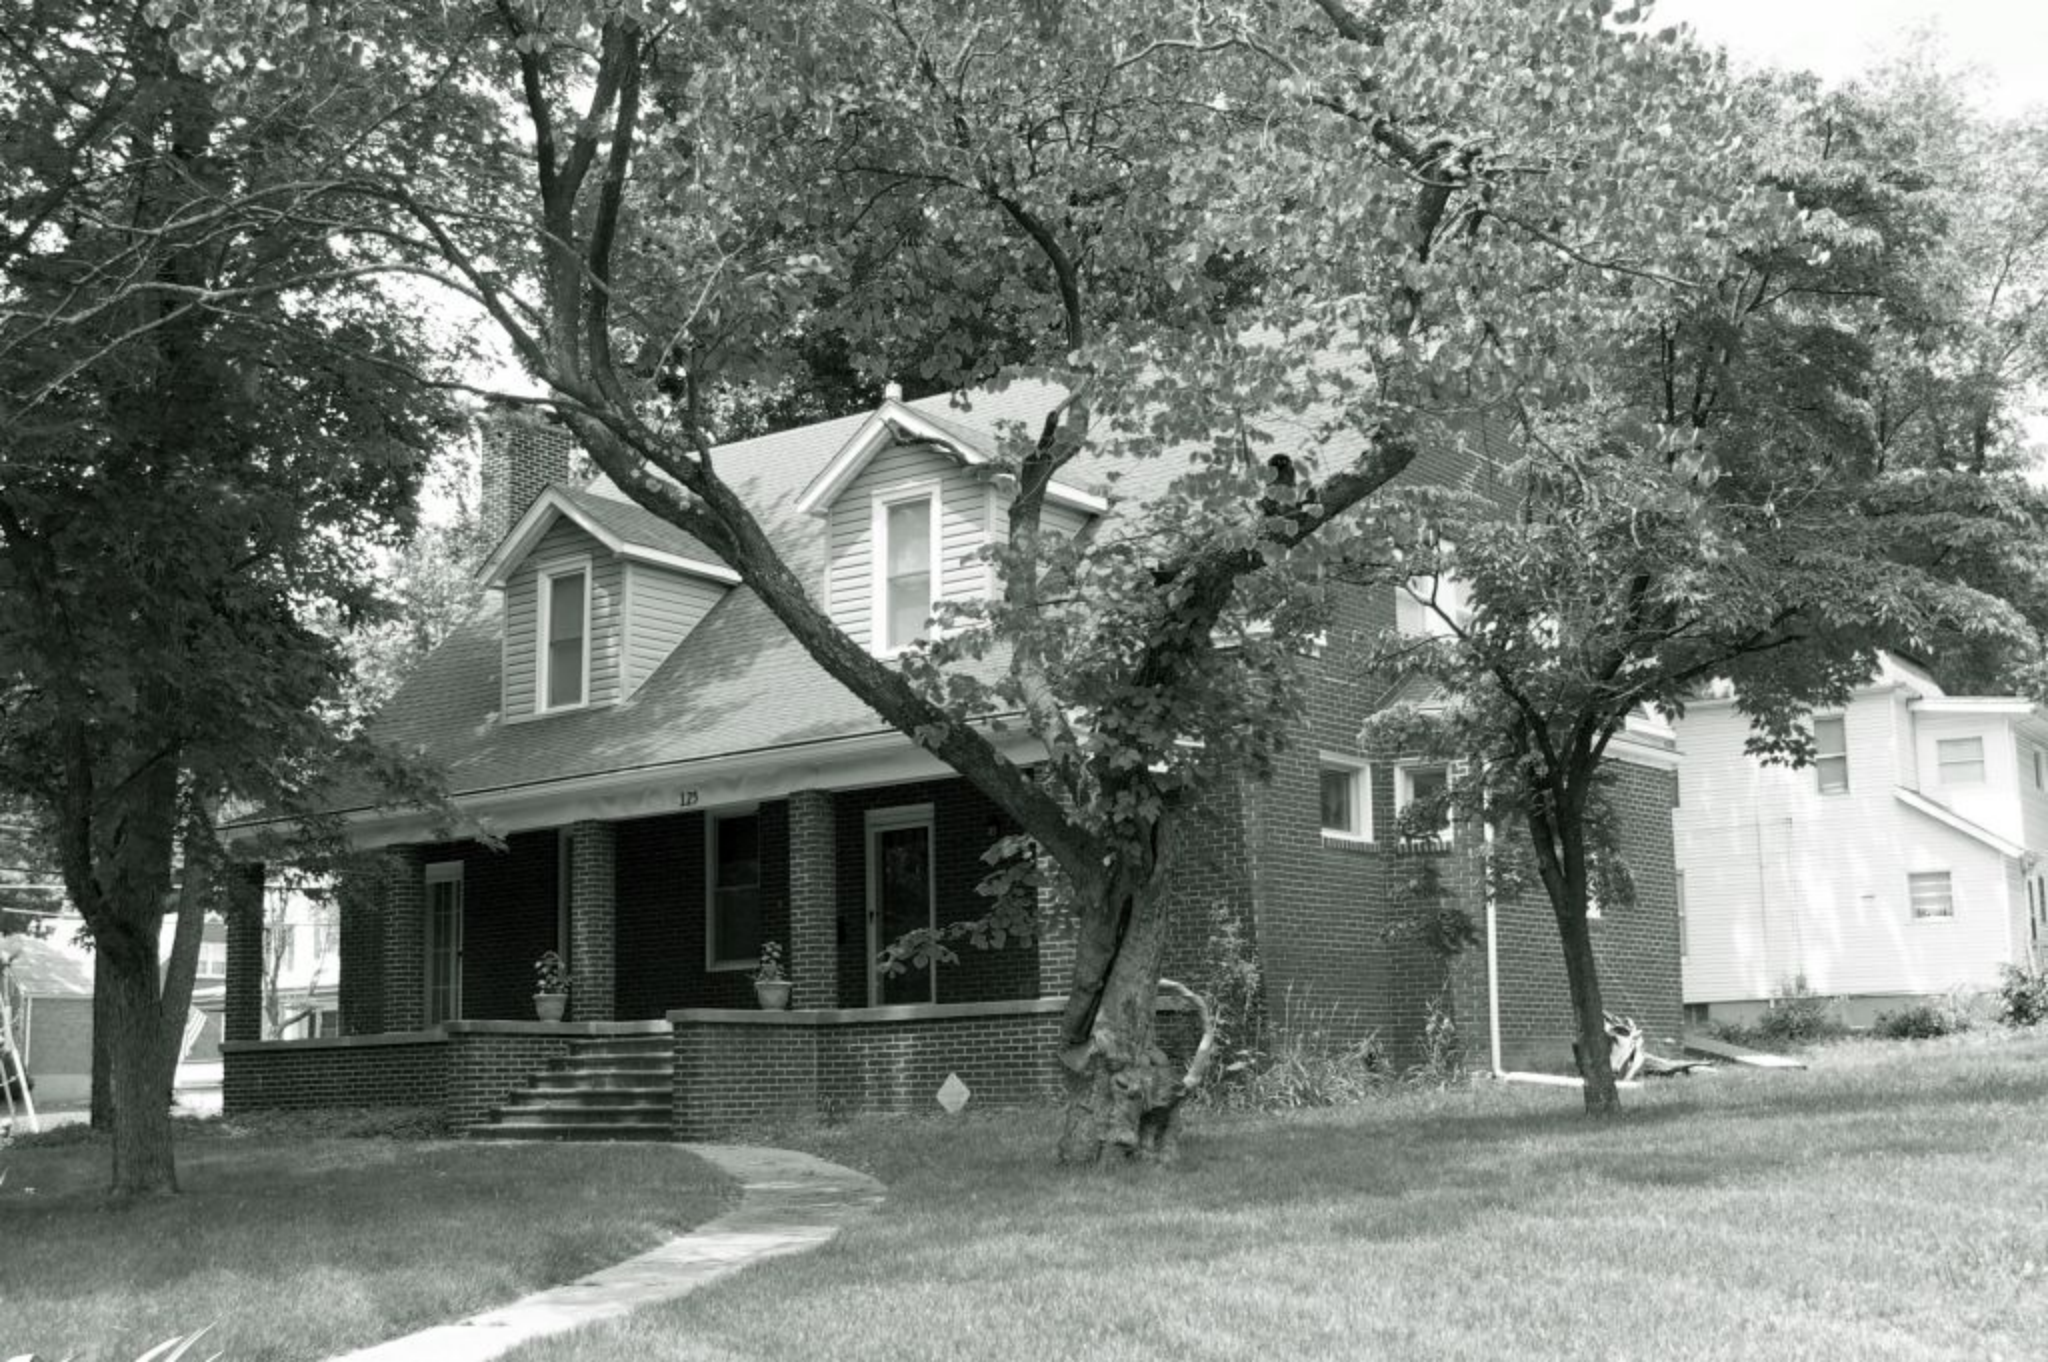
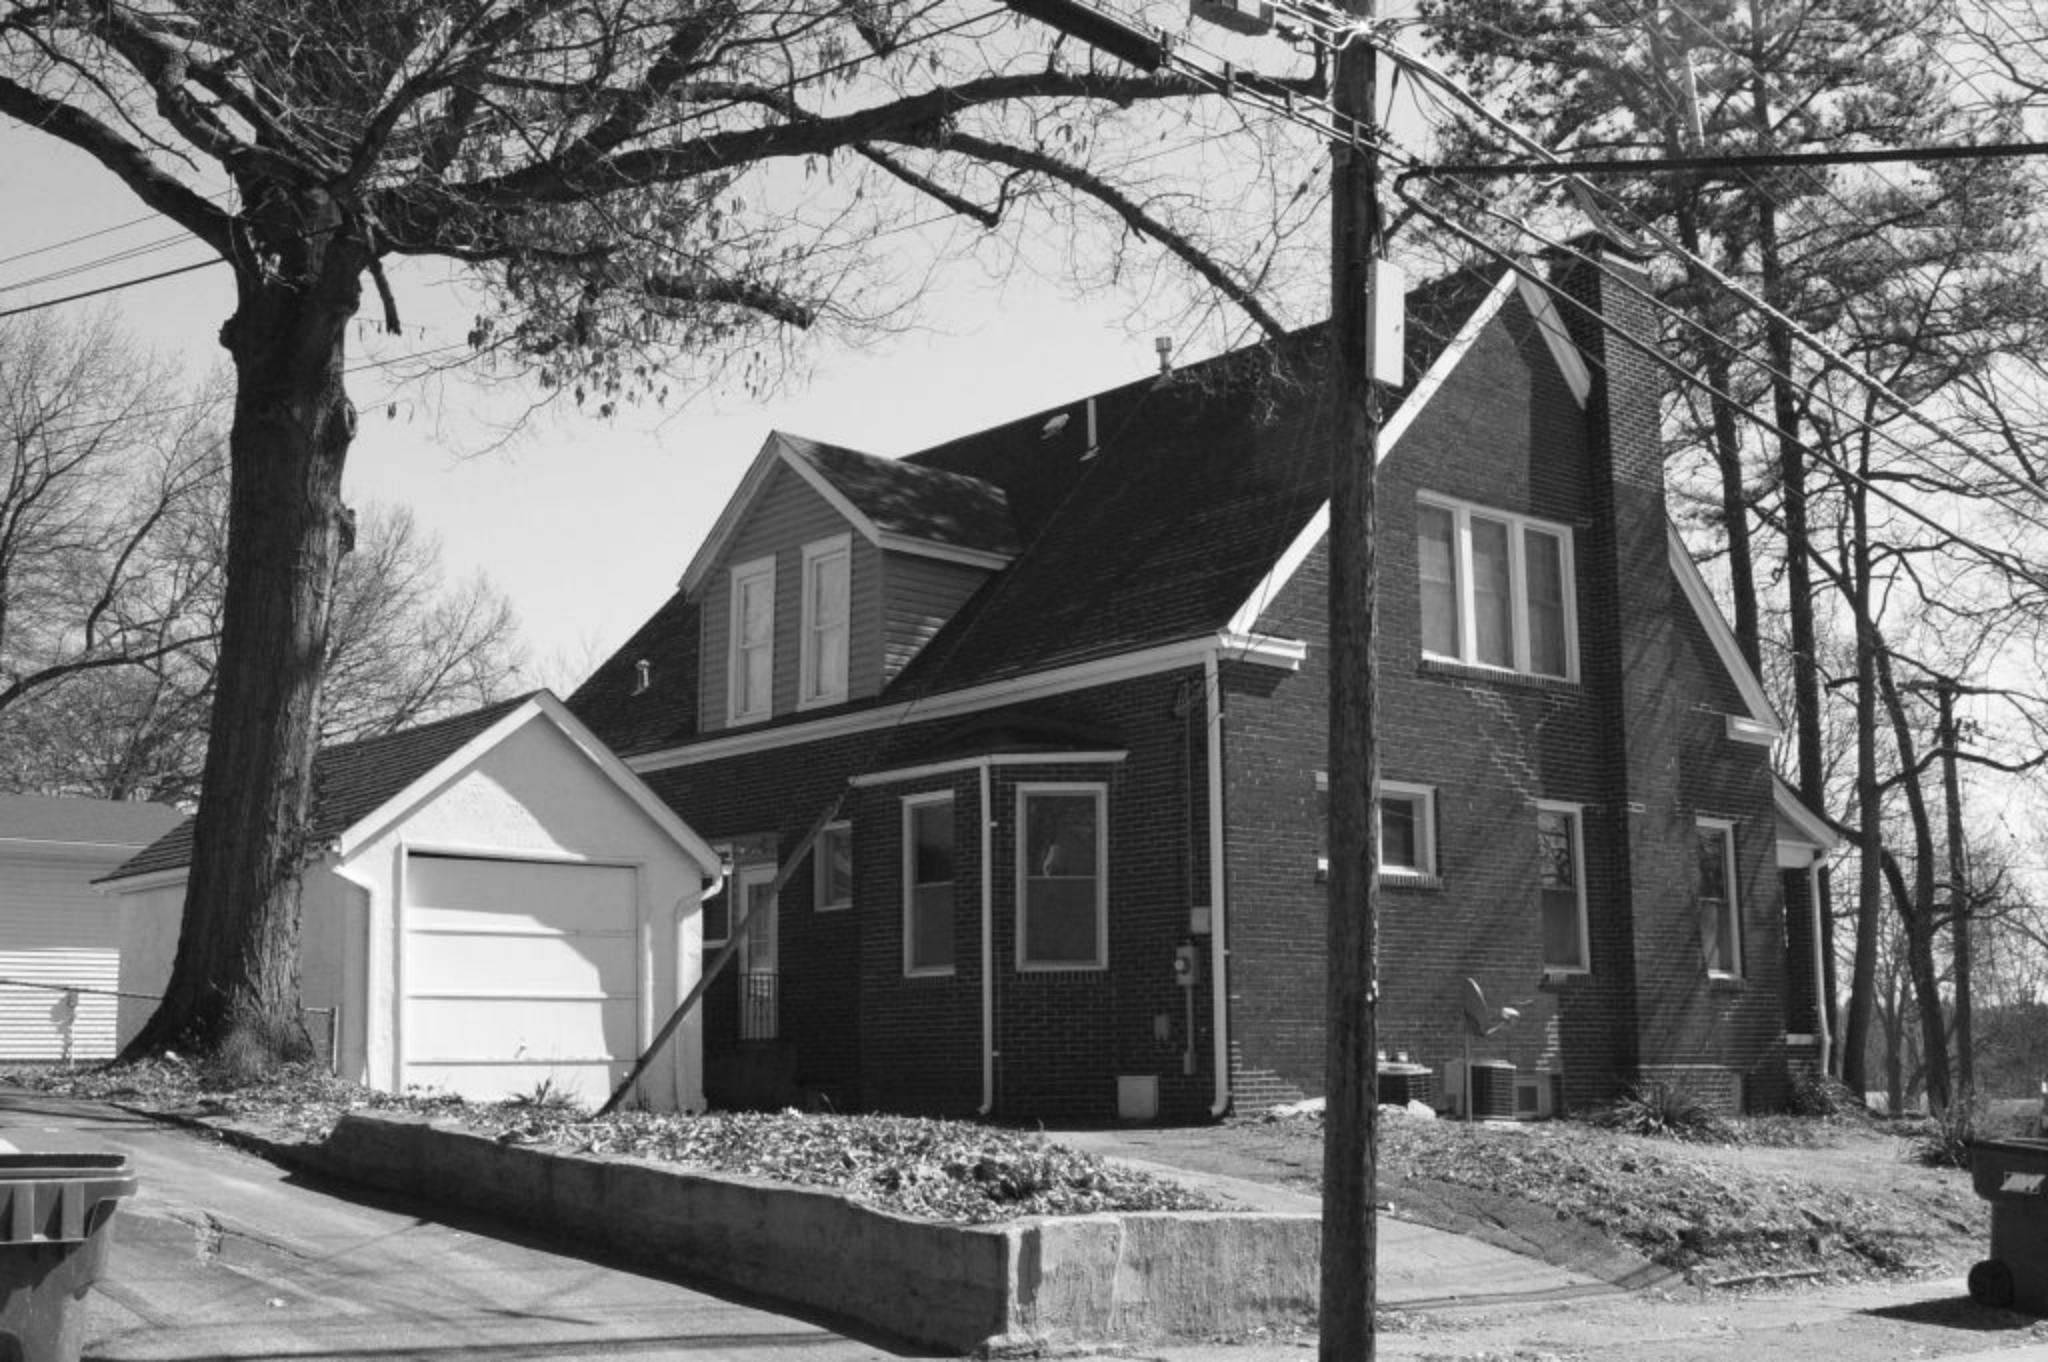
This 1.5 story, red brick, Craftsman bungalow has a side gabled roof that continues over the full width front porch, which is supported by a series of 5 brick pillars resting on top of the concrete porch floor. The base of the porch is also brick and it has brick knee walls that continue the concrete cap and height of the porch floor around the brick steps in the second column bay from the east. Above the porch are paired, gabled dormers with single 1 over 1 windows in each dormer. Like the main house, the dormers have wider, enclosed eaves. On the main level of the facade there is a pair of French doors at the west end with two bays of 1 over 1 wood sashed windows separating these door from the main entry, wood door with a multipaned light near the top. To the east of the entry door is another sashed window. On the east side of the house is a small hipped roof, brick, one story bay below a clustered, sashed window unit. Facing the street, the bay has a small art glass window, similar to one on the east wall of the house in front of the bay. On the west elevation there is a brick end wall chimney. The dormers and gable ends of the porch have been clad in vinyl siding and the second floor windows have been replaced with new vinyl windows.
