ARCHITECTURAL/HISTORIC INVENTORY FORM

1. Survey No. SL-AS-036-001		2. Survey Name: Architectural Survey of Old Ferguson West	
3. County: St. Louis		4. Address: 1 Carson Rd.	
5. City: Ferguson	Vicinity: <input type="checkbox"/>	6. UTM:	7. Township/Range/Section
8. Historic name (if known):		9. Present/other name (if known): Whistle Stop	
10. Ownership: <input type="checkbox"/> Private <input checked="" type="checkbox"/> Public		11. Historic use (if known): TRANSPORTATION/rail-related	11. Current use: COMMERCE/restaurant & RECREATION/museum

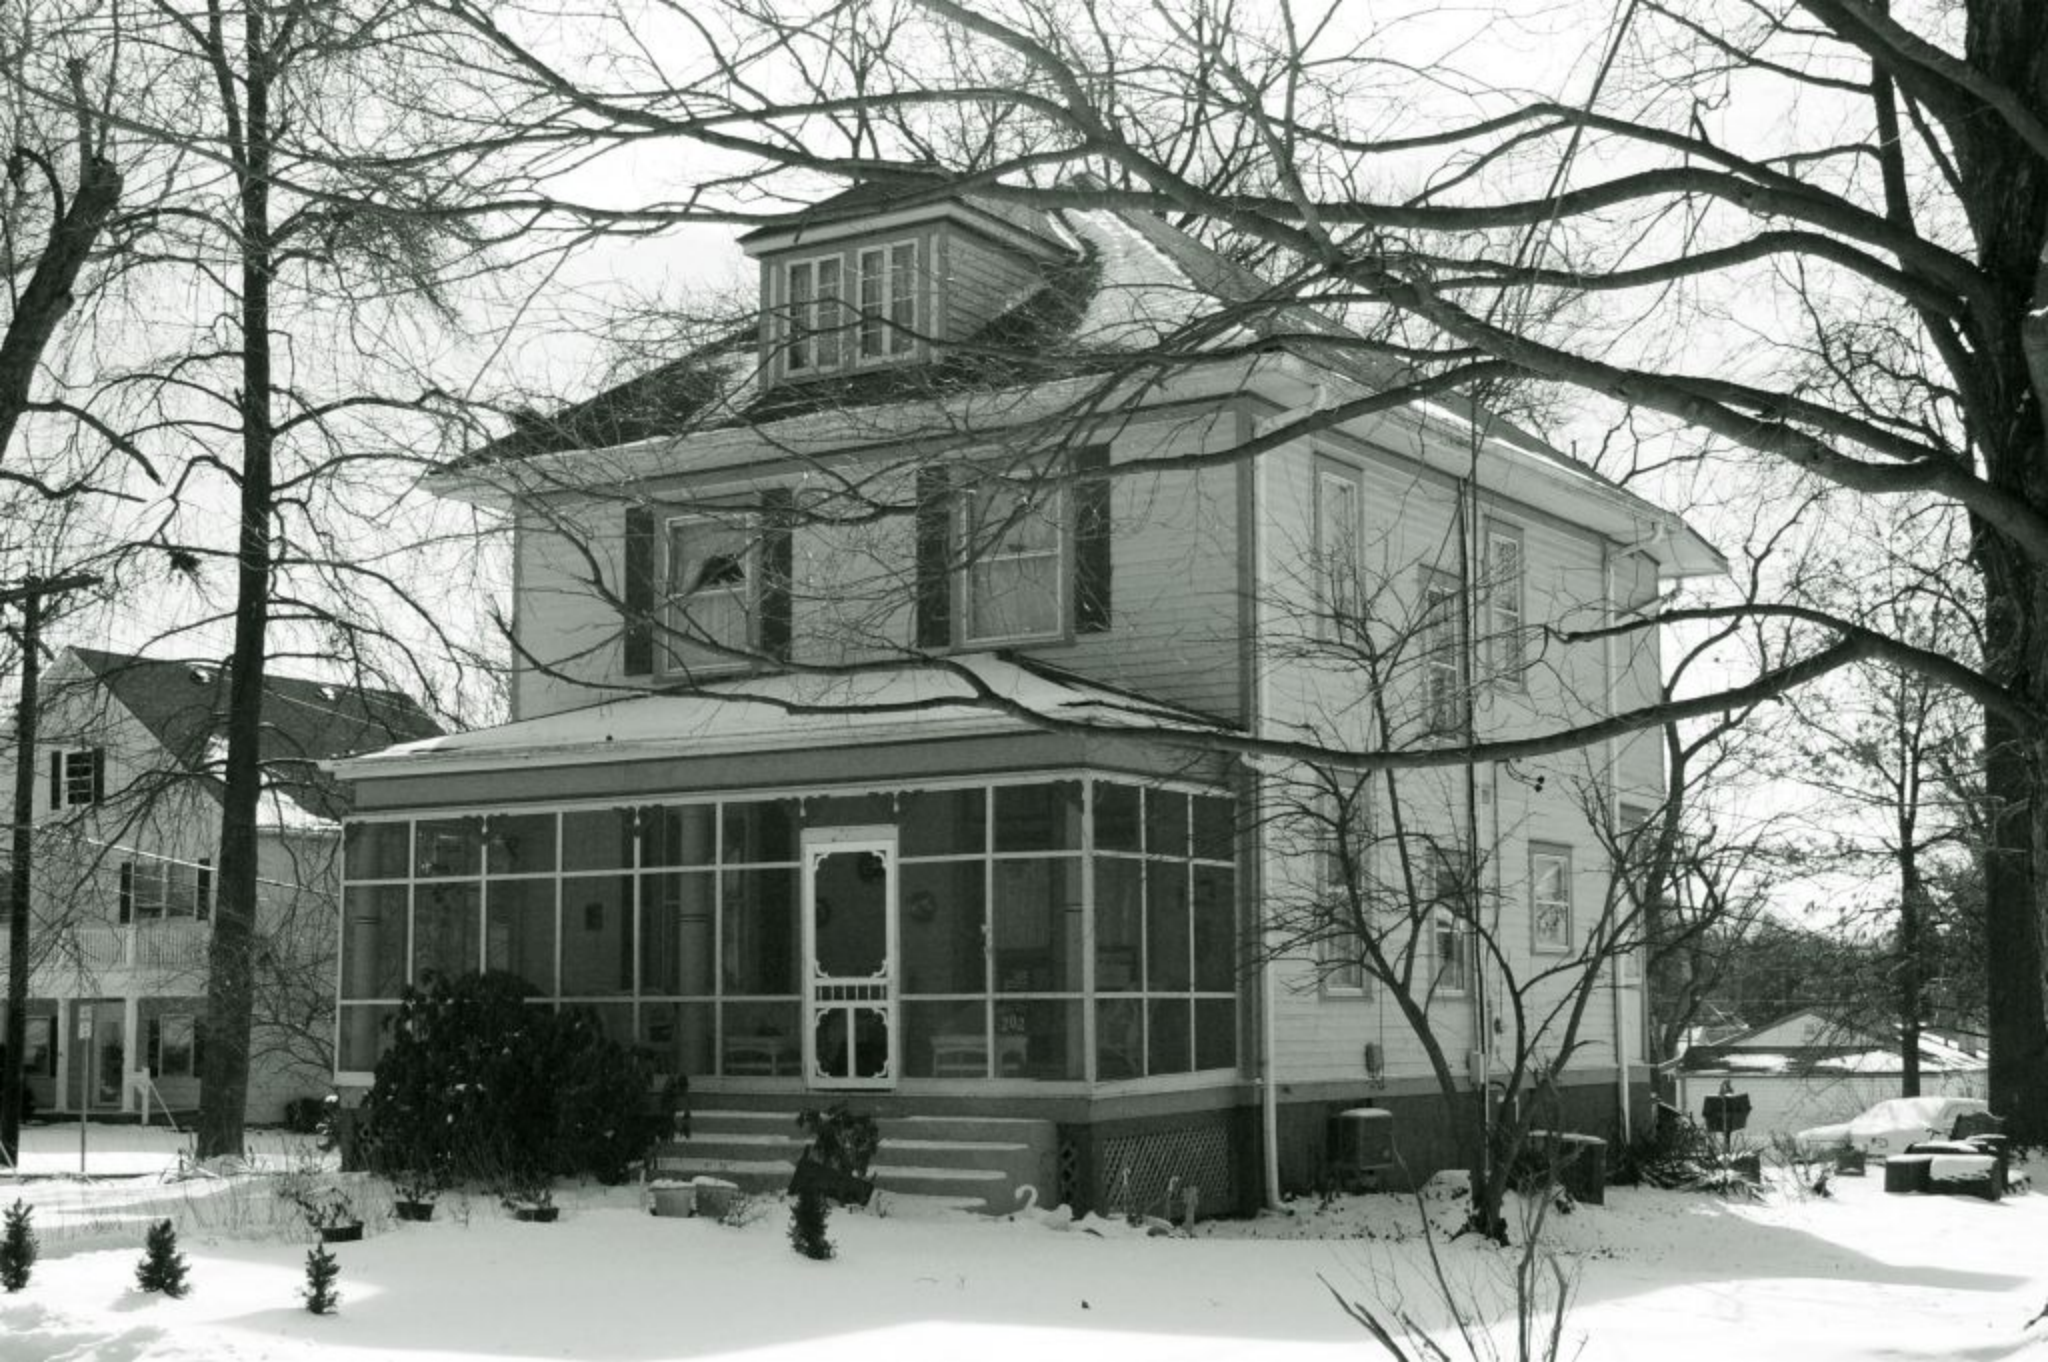
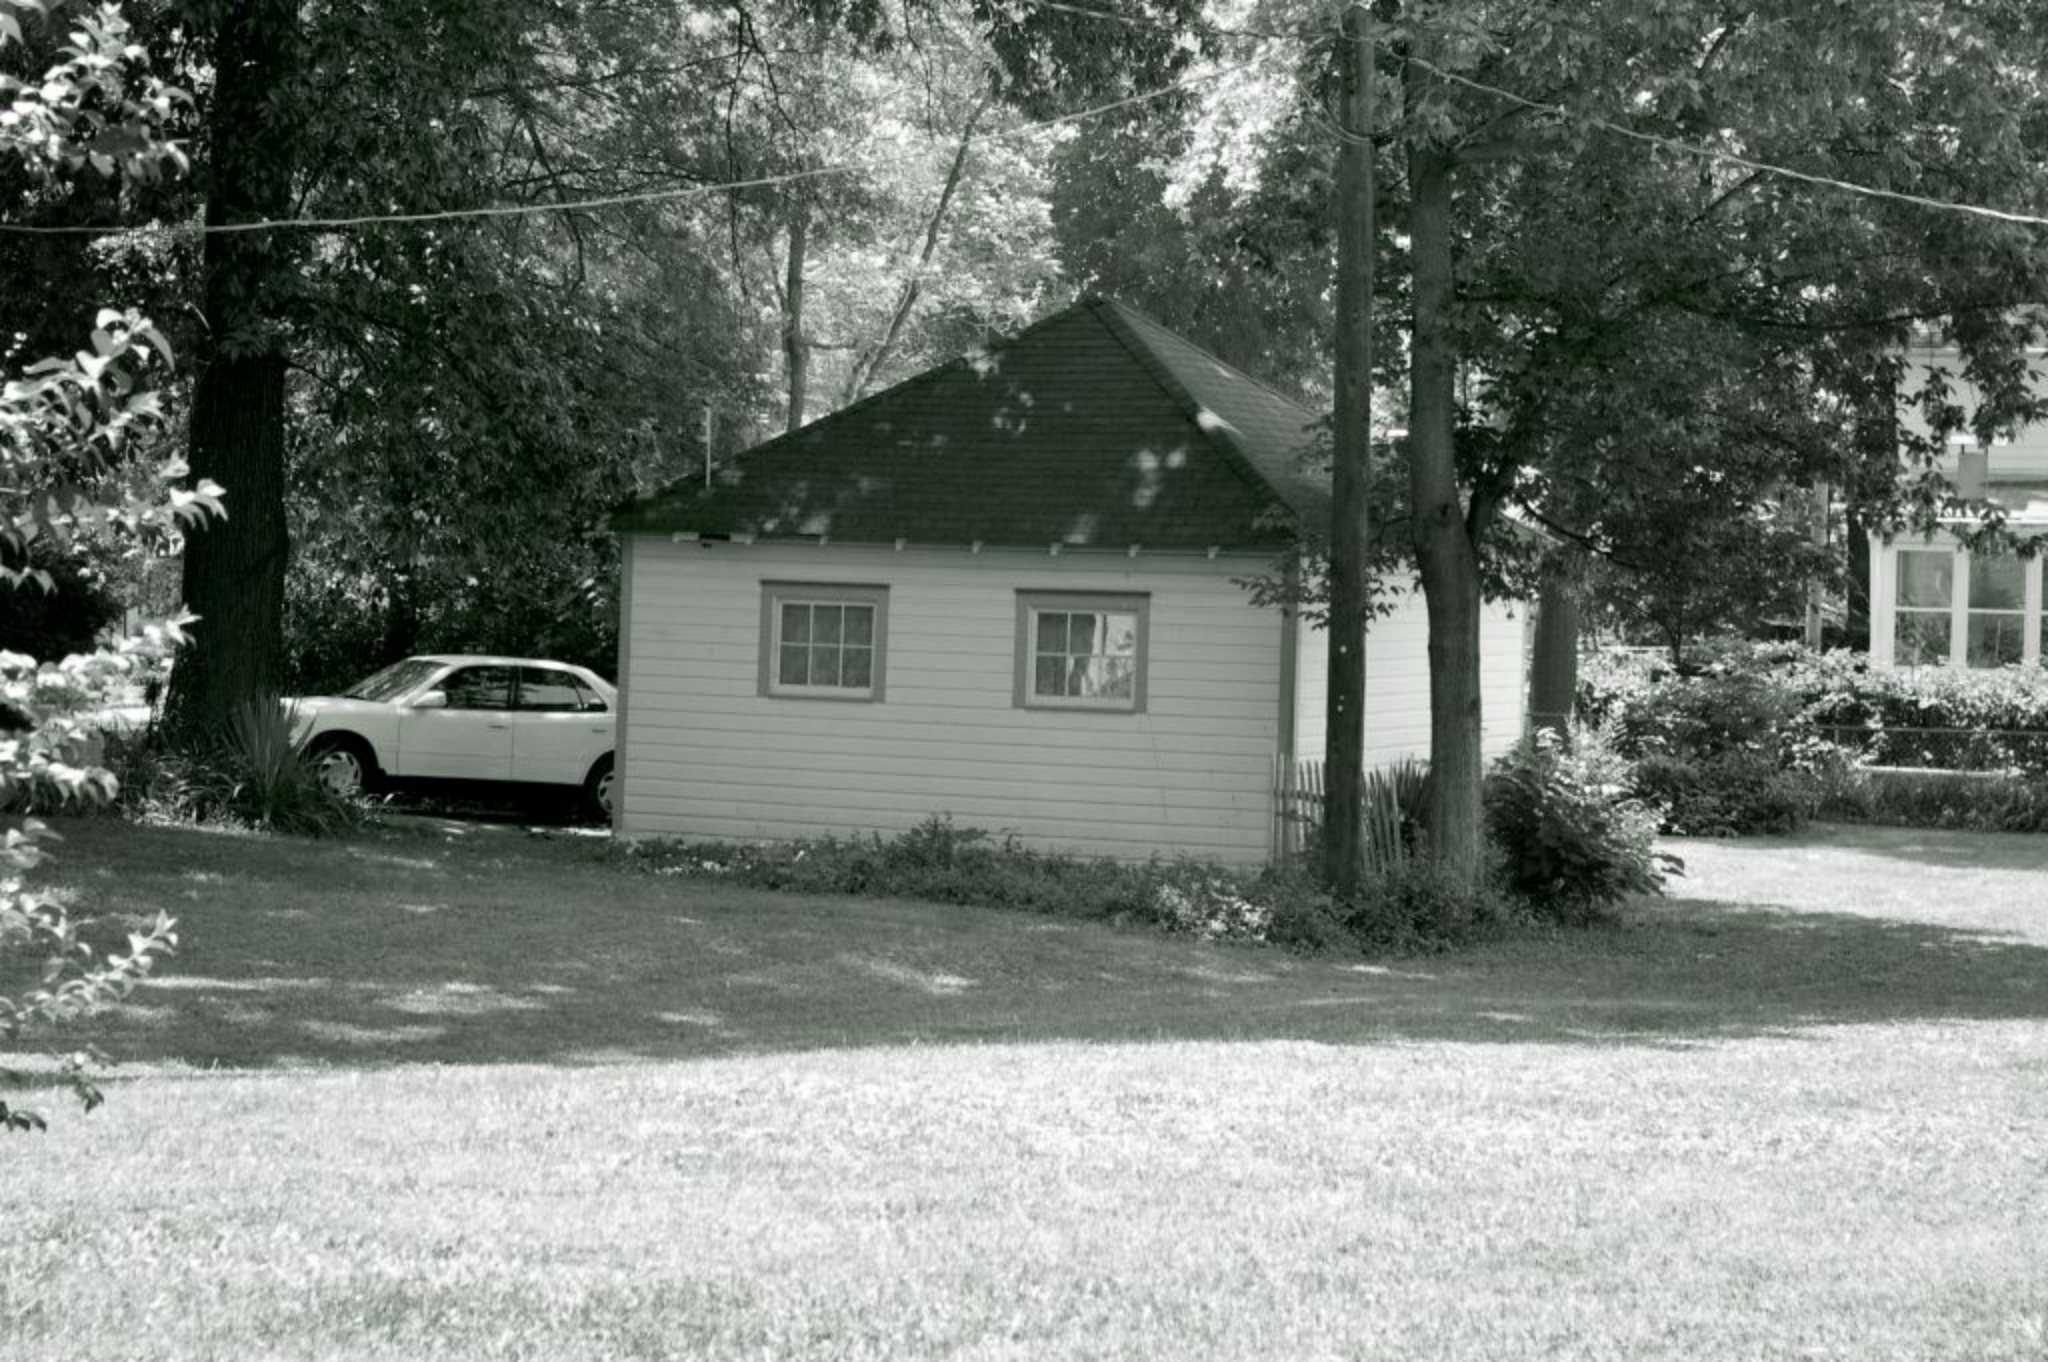
2009 Survey Update: Neither the house nor the garage have been altered, retaining original clapboard siding and wood windows. Even the screening one the front porch is fairly transparent, so that the original columns and entry door features are clearly visible. The only alteration seems to be the addition of storm windows.

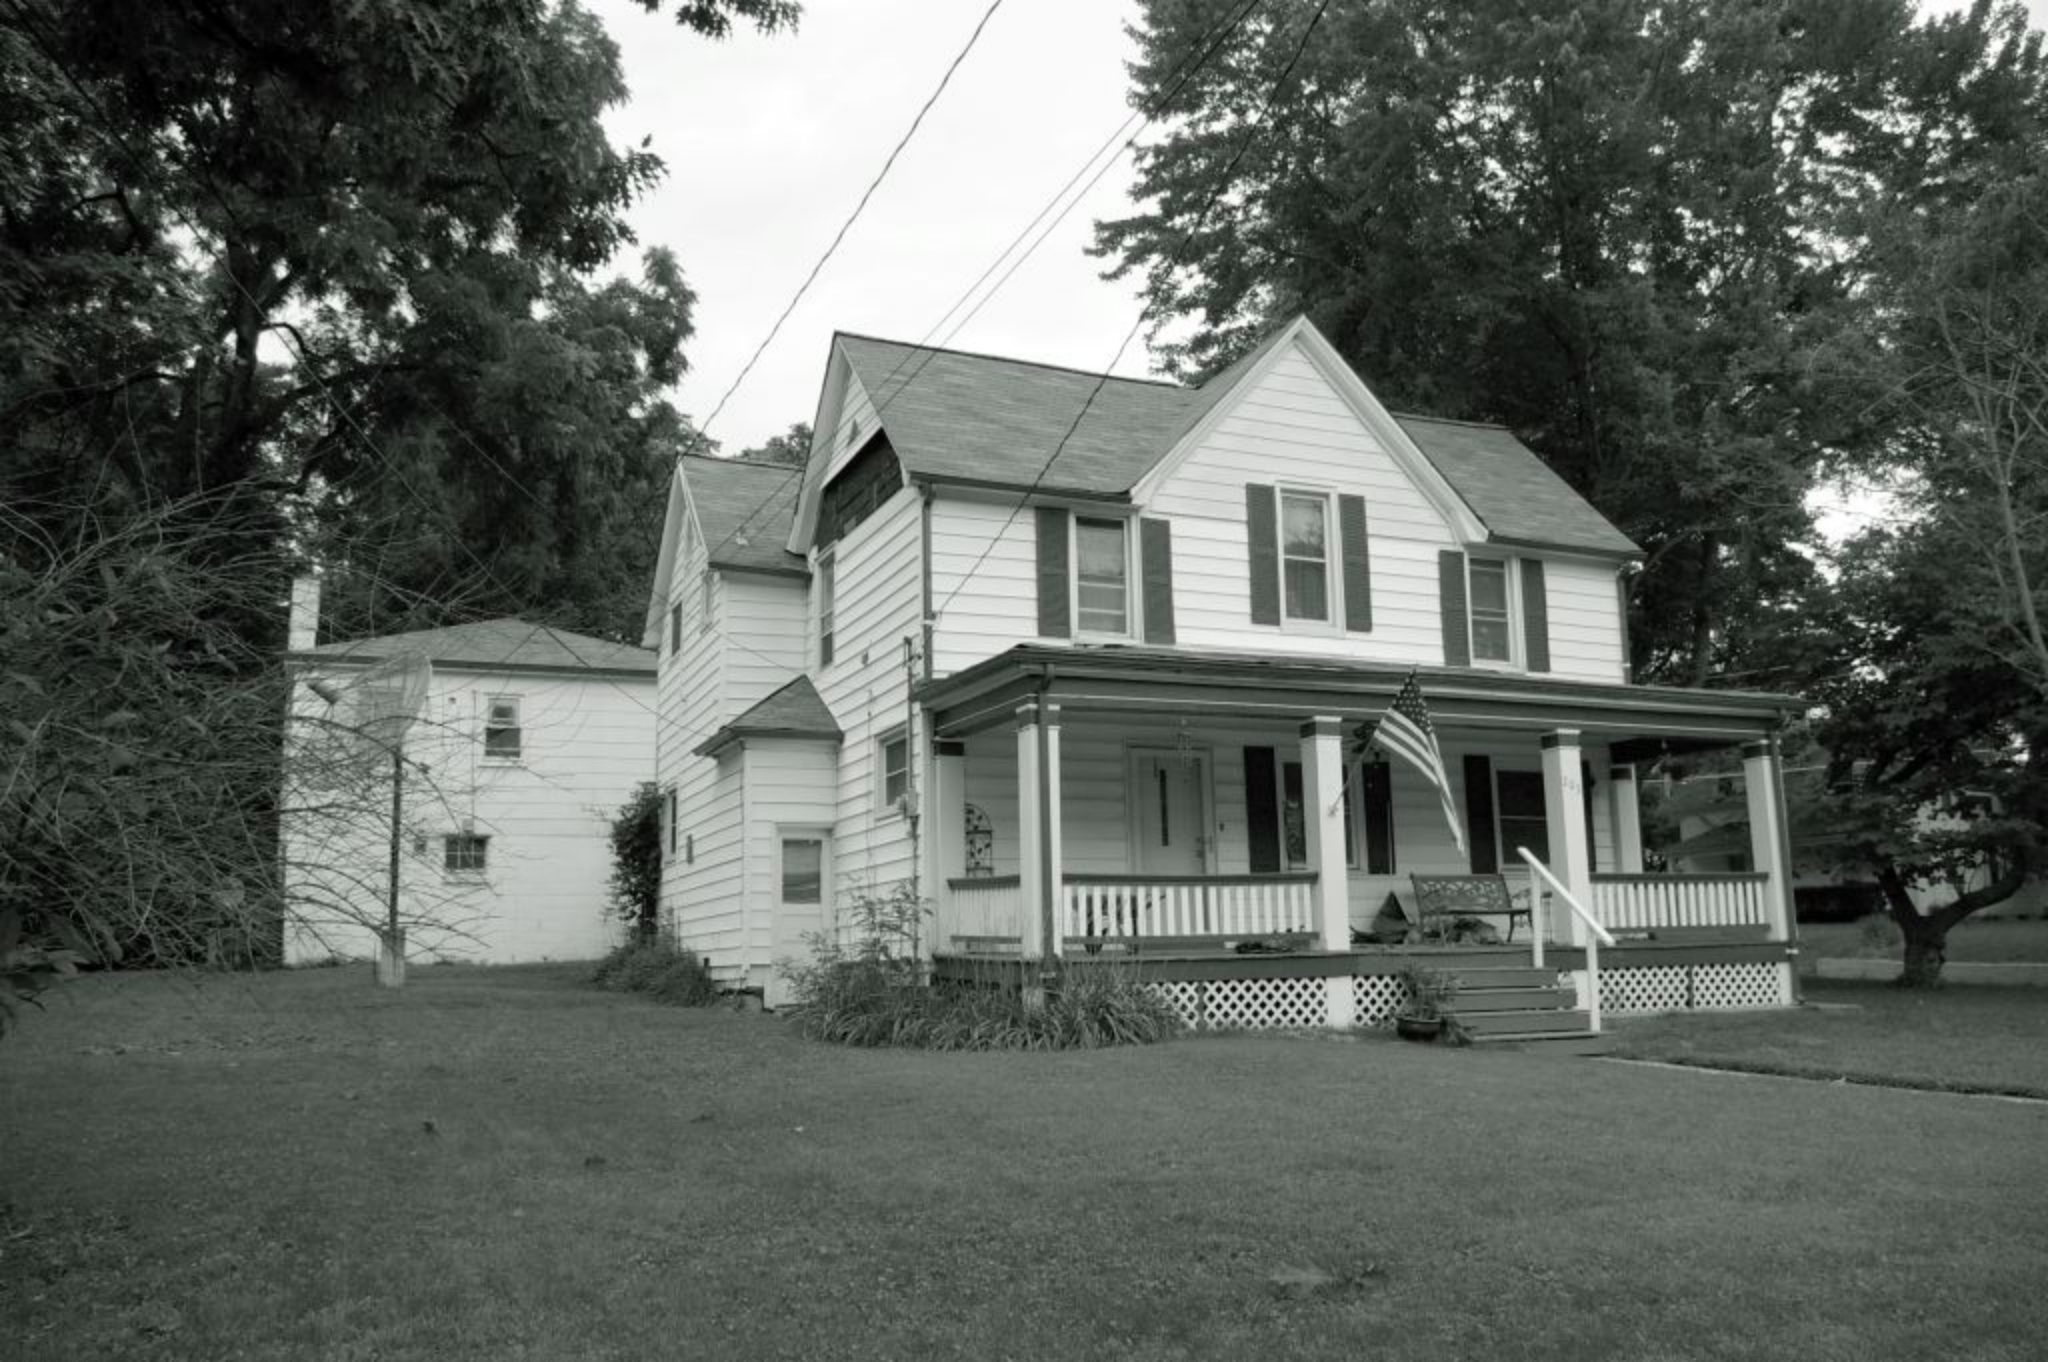
2009 Survey Update: The aluminum siding on the house is starting to fall off on the west side, exposing the asphalt faux brick siding underneath, which was also a replacement siding and it appears that it is clapboard underneath that layer. Even so, it still retains the original square porch columns and balustrades on the full width porch. The front door has been replaced with a new metal door recently and the house has storm windows.

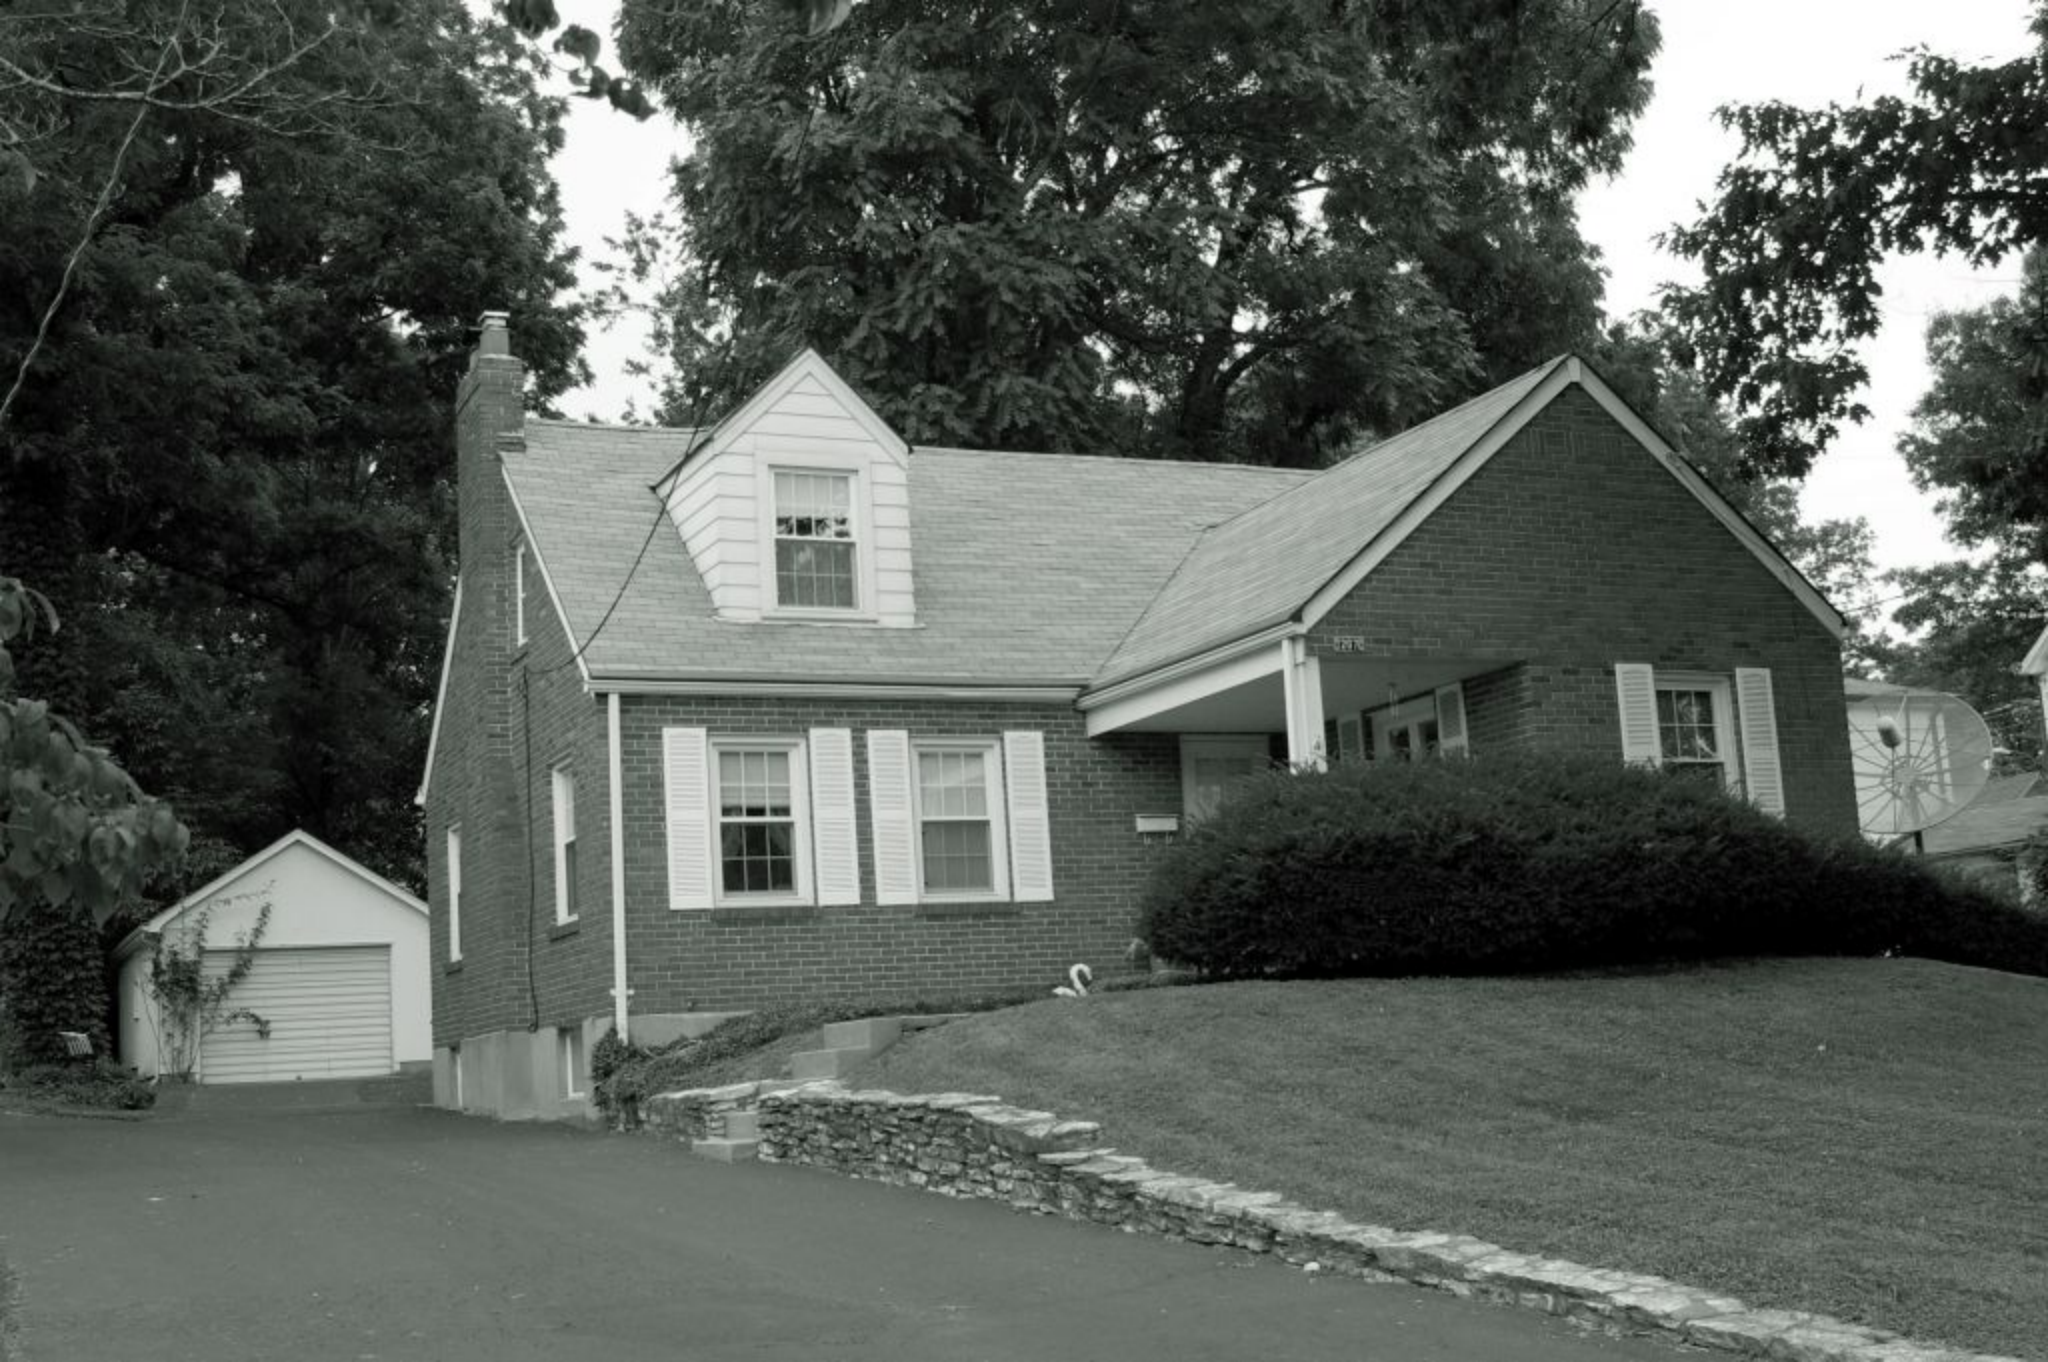
This 1.5 story, side gabled, house has a large, cross gabled, projecting wing at the east end of the facade, creating an L shaped plan. To balance this large wing, there is a gabled dormer near the west end. The facade is divided into two principal bays, created by the gabled wing and the two, shuttered, 6 over 6 vinyl sashed windows on the west bay below the dormer. The facade end of the gabled wing has another 6 over 6 sashed window (this one is the original wood window) on the east half and the west half is the open side to the side entry, recessed porch with its simple corner post. Besides the entry door, it appears that there is a pair of French doors in this entry porch. Although a few of the windows have been replaced with vinyl windows, they match the muntin pattern of the original windows, many of which remain, covered with aluminum storms. While the front windows have shutters, those on the sides do not. There is an end gabled, brick chimney on the west side bisecting the ridge.

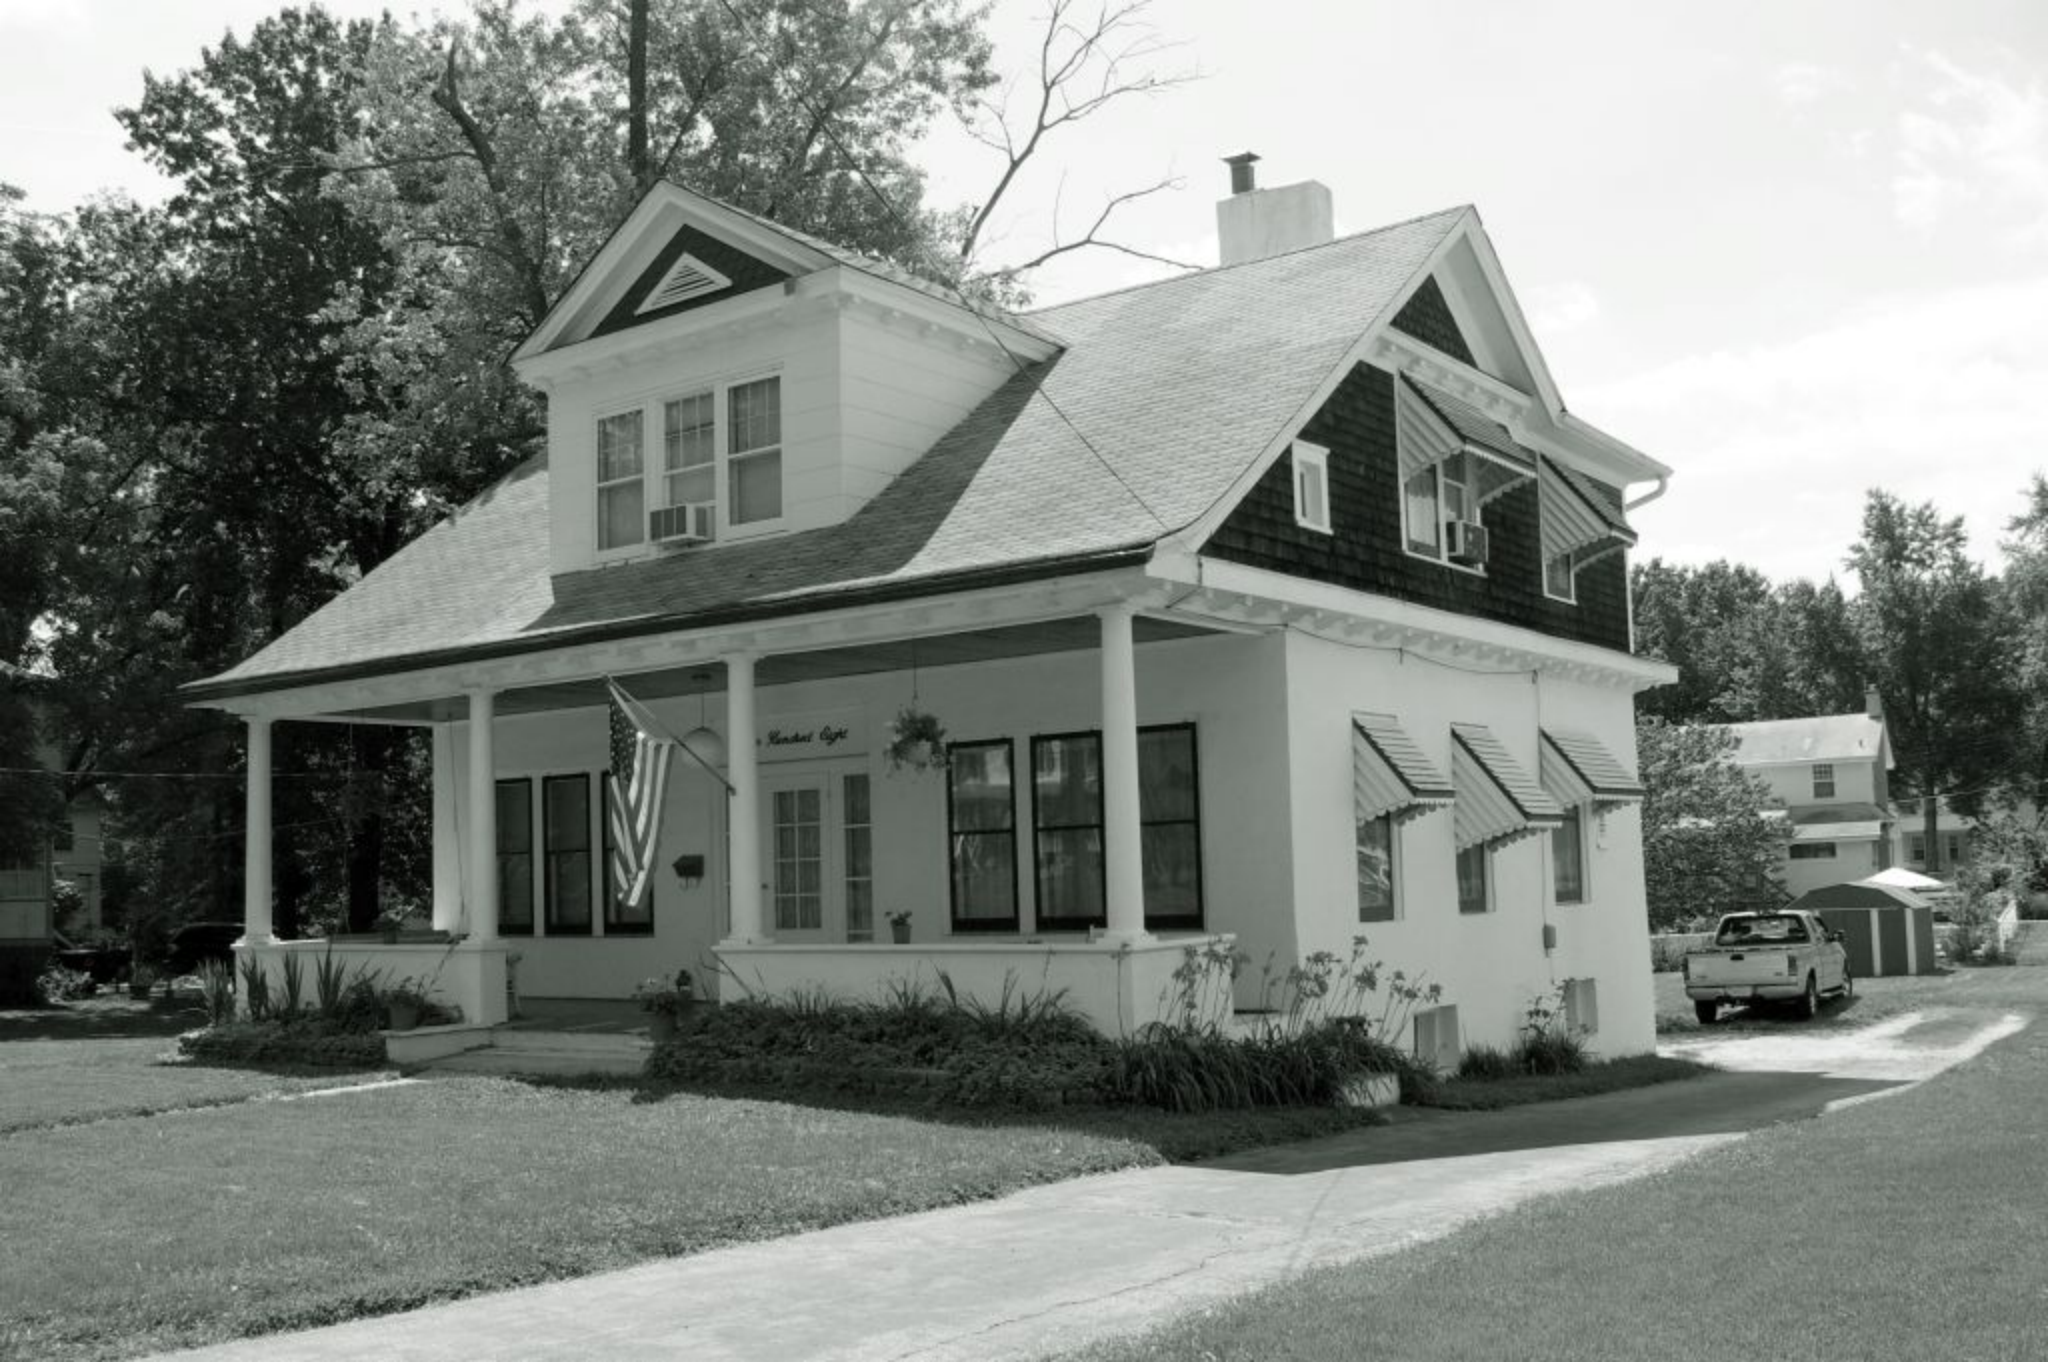
2009 Survey Update: Although the 1983 survey identified the windows as all 1 over 1 windows, the front dormer retains its original wood 6 over 1 sashed windows. The aluminum awnings on the west elevation are not historic. Most windows have storm windows. Since the 1983 survey, the stucco has been repaired and the block underneath is not visible.

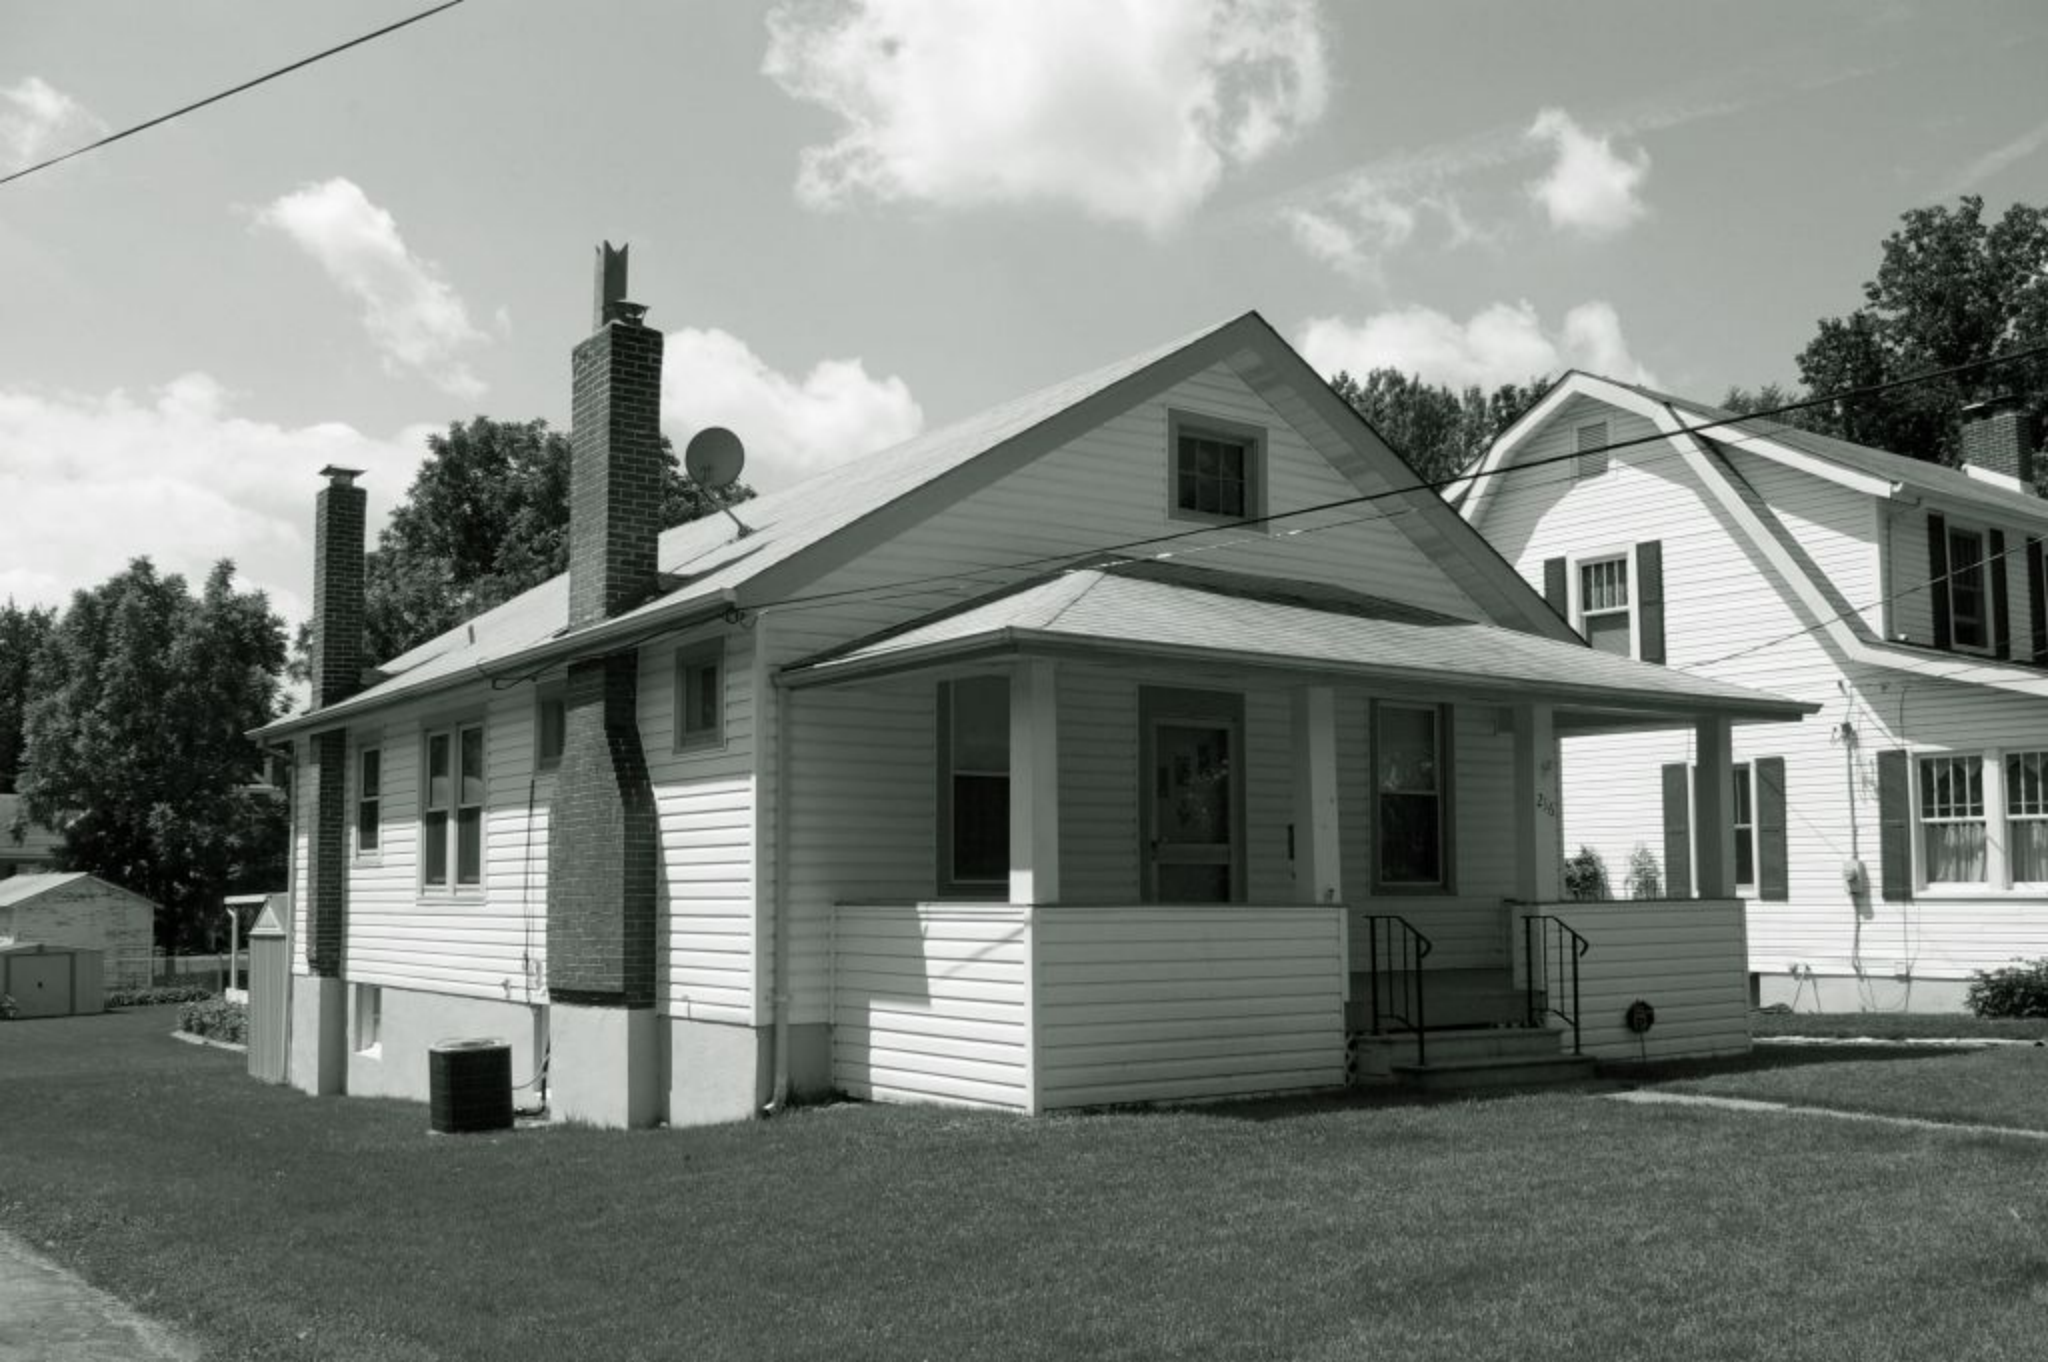
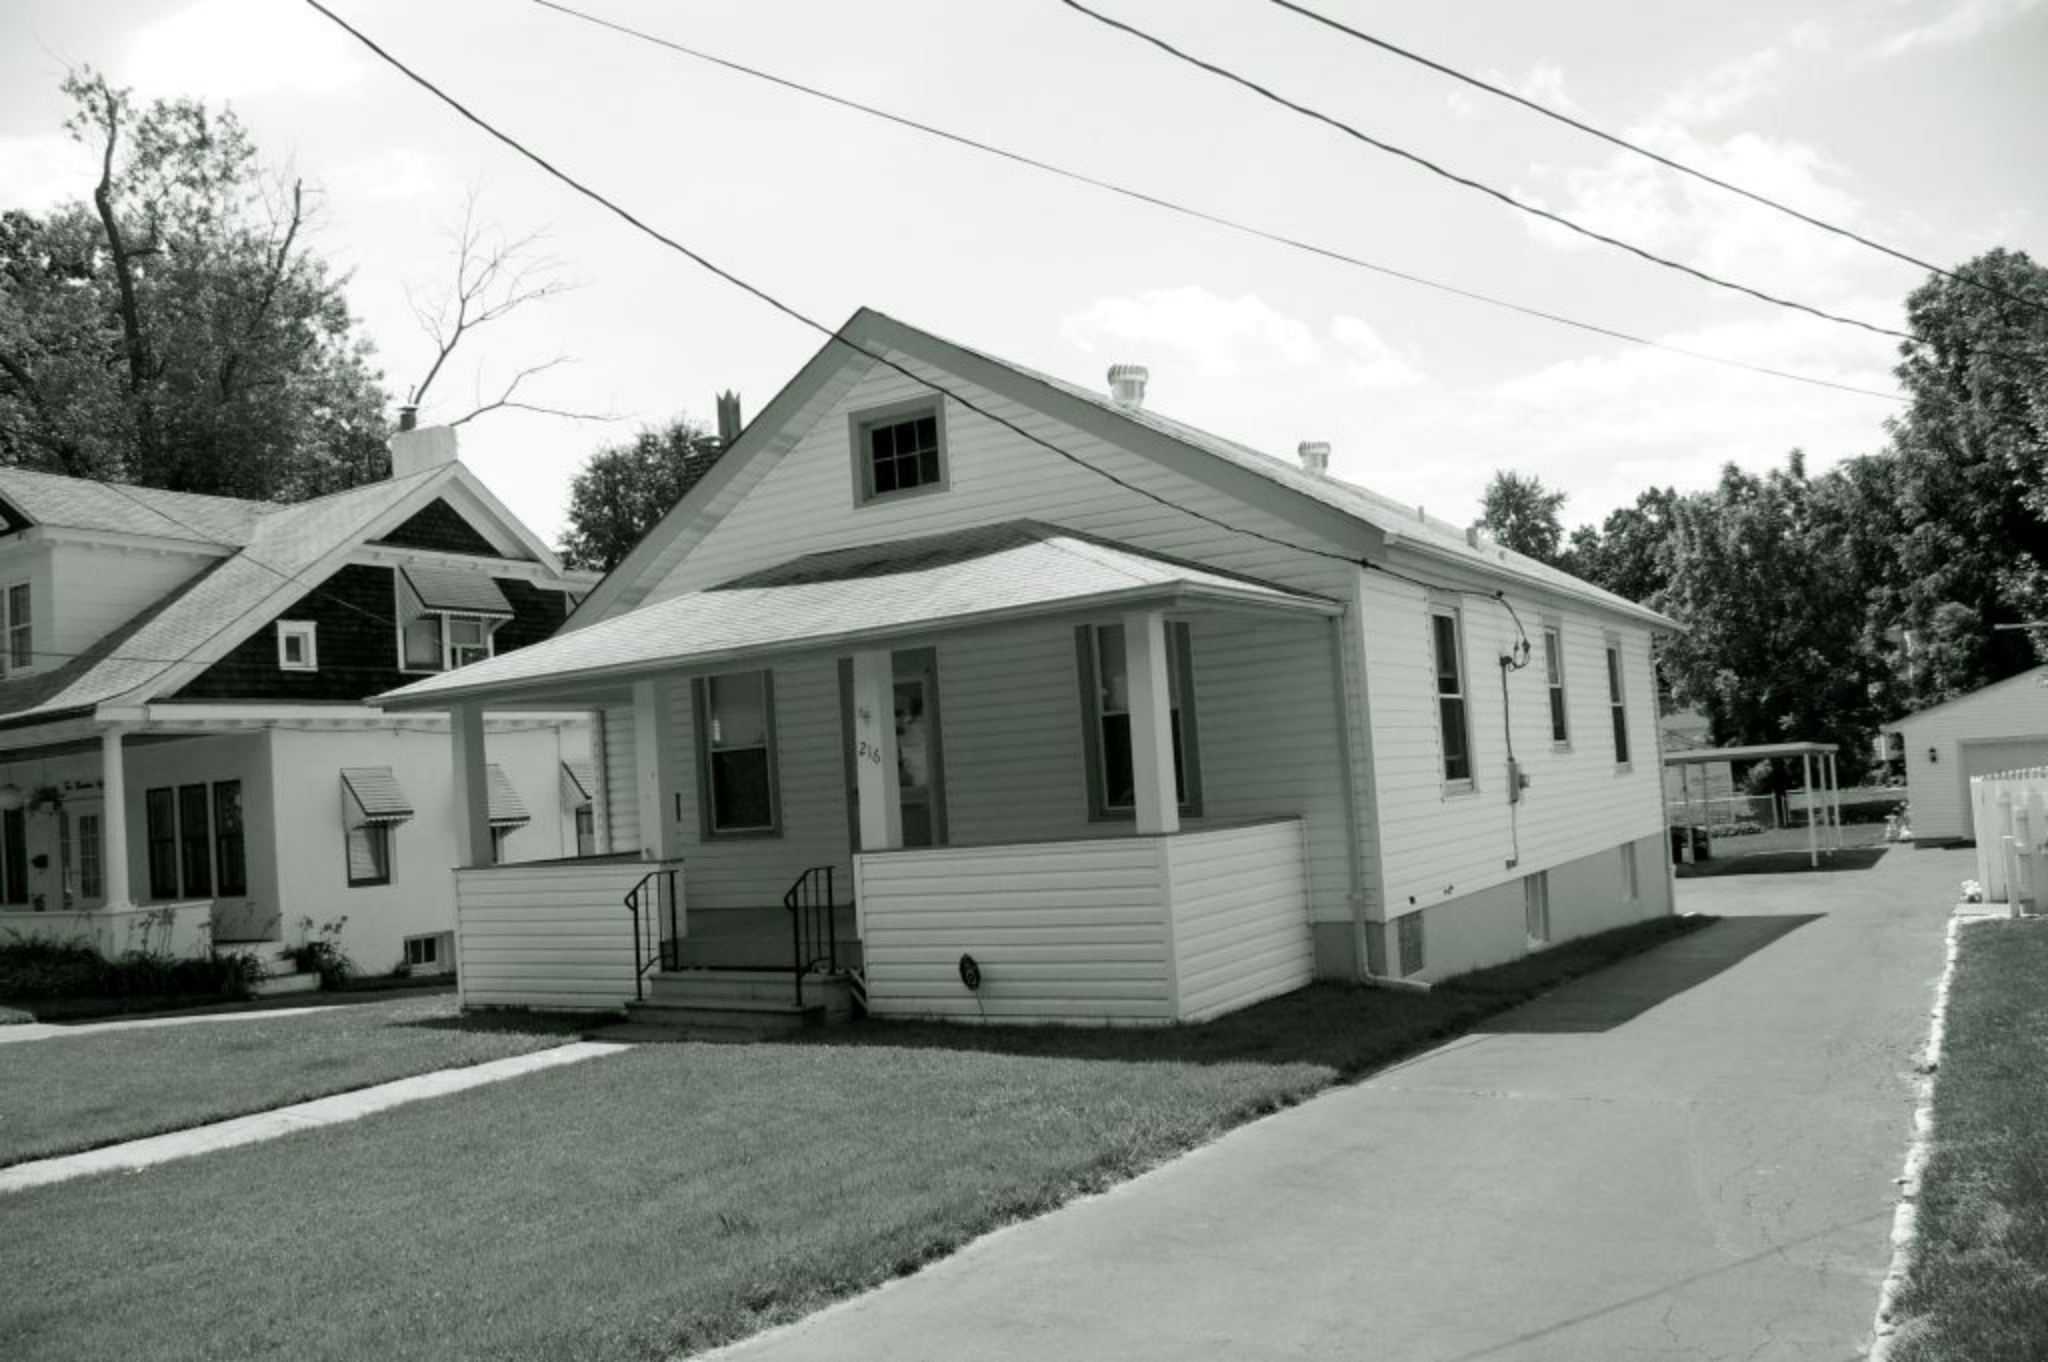
This simple Craftsman bungalow is a one story, end gabled, frame house with a hipped roof, full width porch that is supported by slightly tapered, square, half columns that rest on the frame half wall railings. The three bay facade has a 1 over 1 wood sashed window on either side of the central entry door that aligns with the steps. Above the porch, there is a 6 light wood attic window. On the east side of the house are two brick, end wall chimneys (the rear is a flue chimney), both piercing through the wide eave overhangs. Flanking the front chimney are high, small fixed windows. The house has been clad recently in vinyl siding (including the half height walls on the porch) but care was taken to go around the window and door trim, minimizing the impact. However, the eaves has also been clad in vinyl and they may have been open rafters originally (a distinctive Craftsman feature). Windows and door have storm windows and the front door appears to be a replacement door with stairstepped rectangular lights near the top of the wood door (a 1950s or 1960s alteration).
