ARCHITECTURAL/HISTORIC INVENTORY FORM

1. Survey No. SL-AS-036-001		2. Survey Name: Architectural Survey of Old Ferguson West	
3. County: St. Louis		4. Address: 1 Carson Rd.	
5. City: Ferguson	Vicinity: <input type="checkbox"/>	6. UTM:	7. Township/Range/Section
8. Historic name (if known):		9. Present/other name (if known): Whistle Stop	
10. Ownership: <input type="checkbox"/> Private <input checked="" type="checkbox"/> Public		11. Historic use (if known): TRANSPORTATION/rail-related	11. Current use: COMMERCE/restaurant & RECREATION/museum

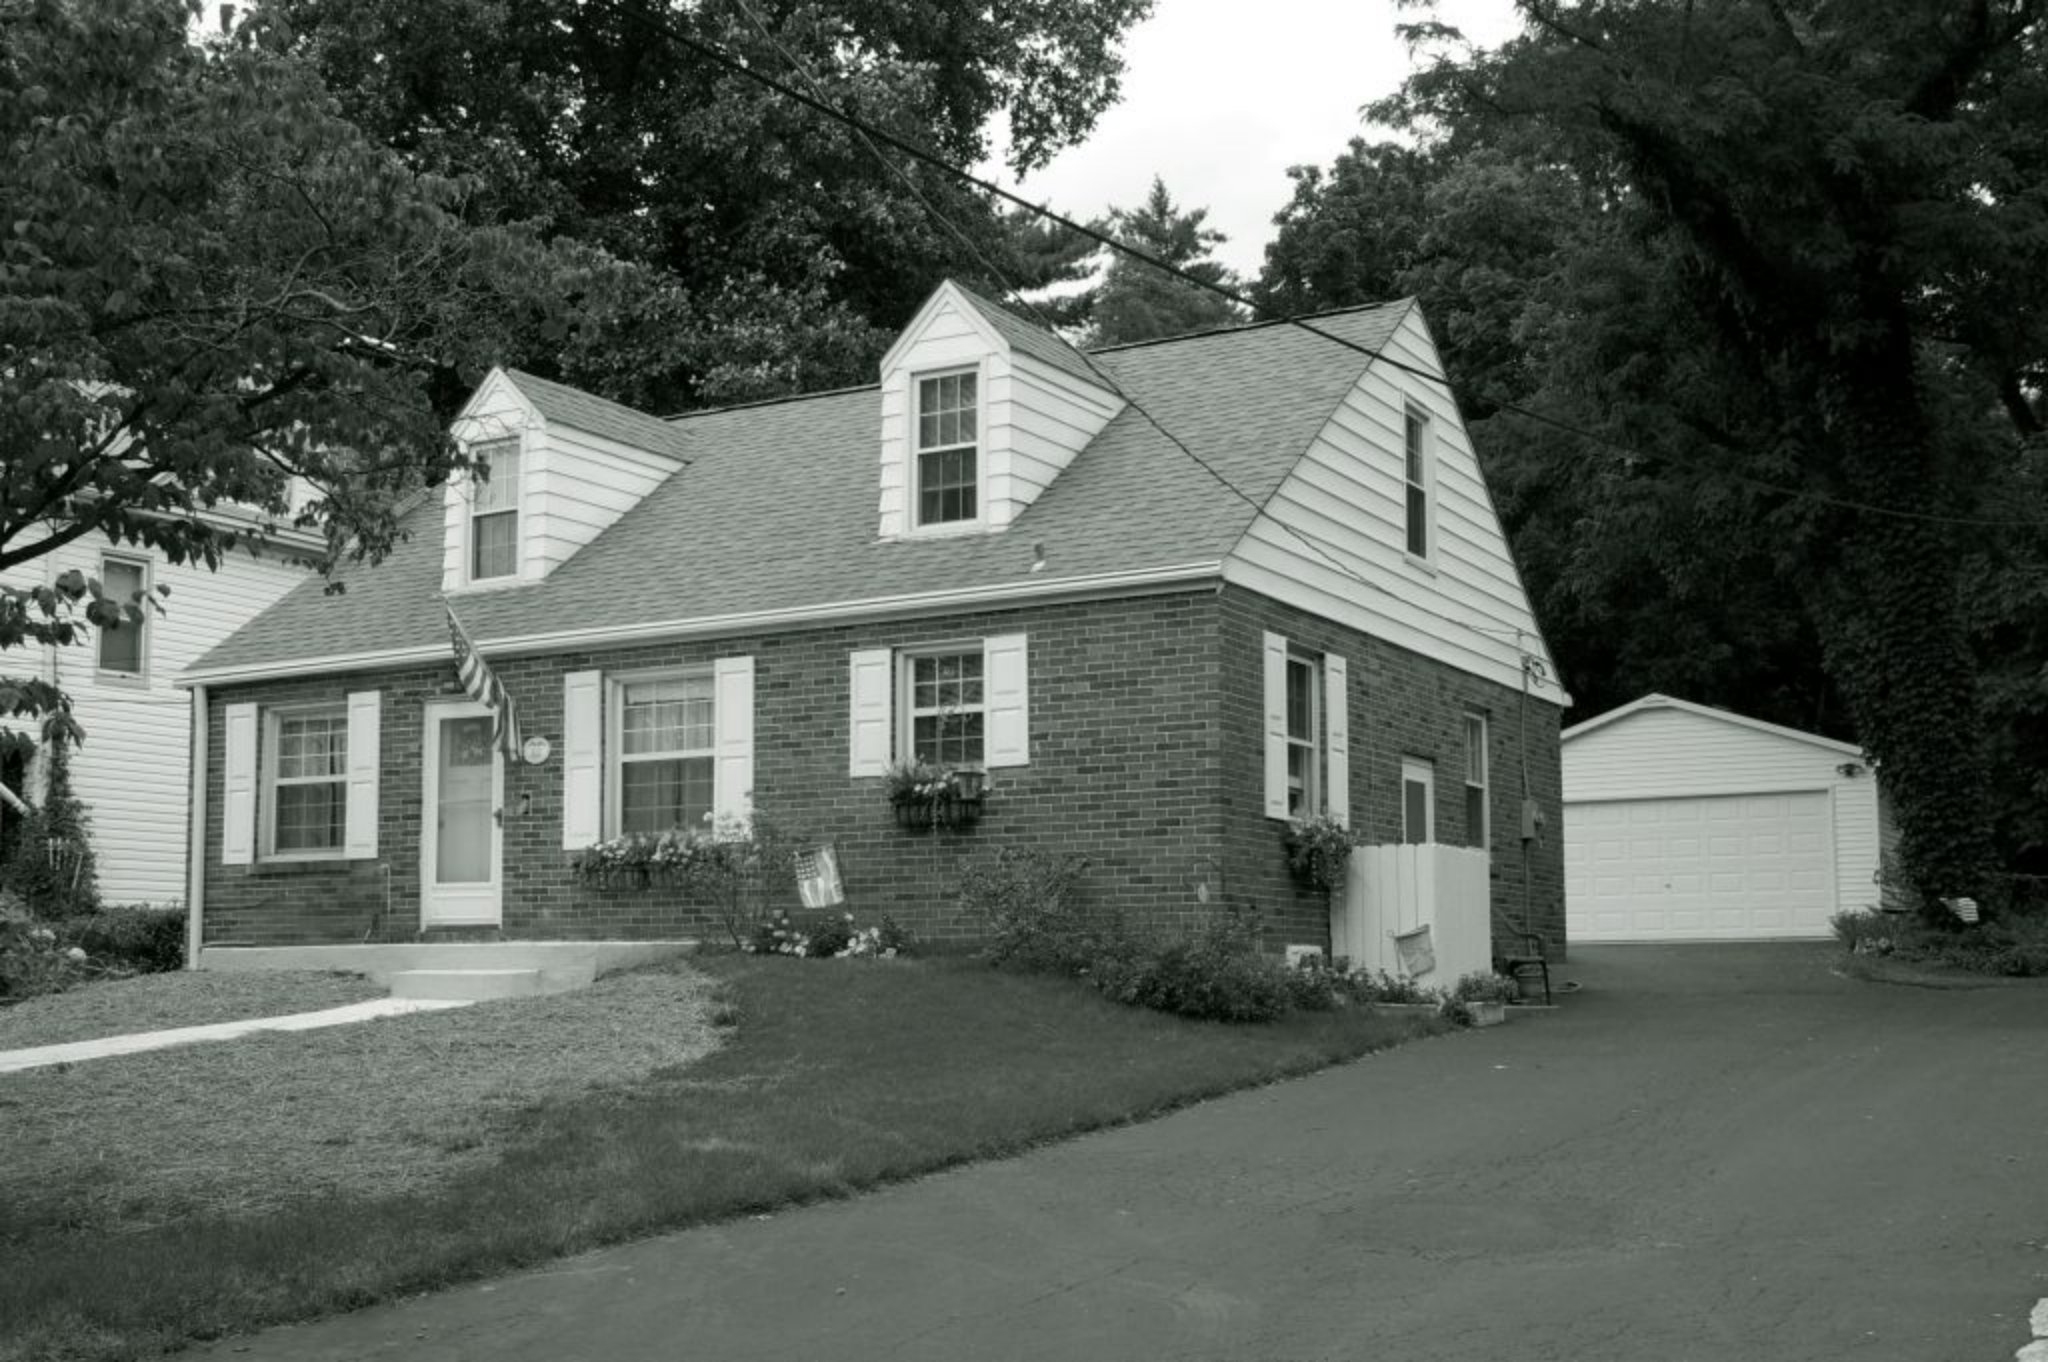
This 1.5 story, side gabled, Cape Cod house has two gabled dormers on the facade with 6 over 6 wood sashed windows. The first floor of this multicolored brick house is divided asymmetrically into four bays with replacement 9 over 9 vinyl sashed windows flanking the original door with its two vertical panel capped by a small rectangular light. At the east end of the facade is a smaller 6 over 6 vinyl sashed replacement window. The facade windows, as well as the first window on the side elevation have shutters. The windows on the side elevation are the original wood sashed windows (multipaned), and like the dormer windows, they have aluminum storm windows. Between the first floor windows on the east side is a side entry door that opens onto the adjacent driveway. The gable end of the house and the dormers are clad in aluminum siding, which is most likely a replacement material given the date of construction. The concrete stoop in front of the door has been repoured and enlarged.

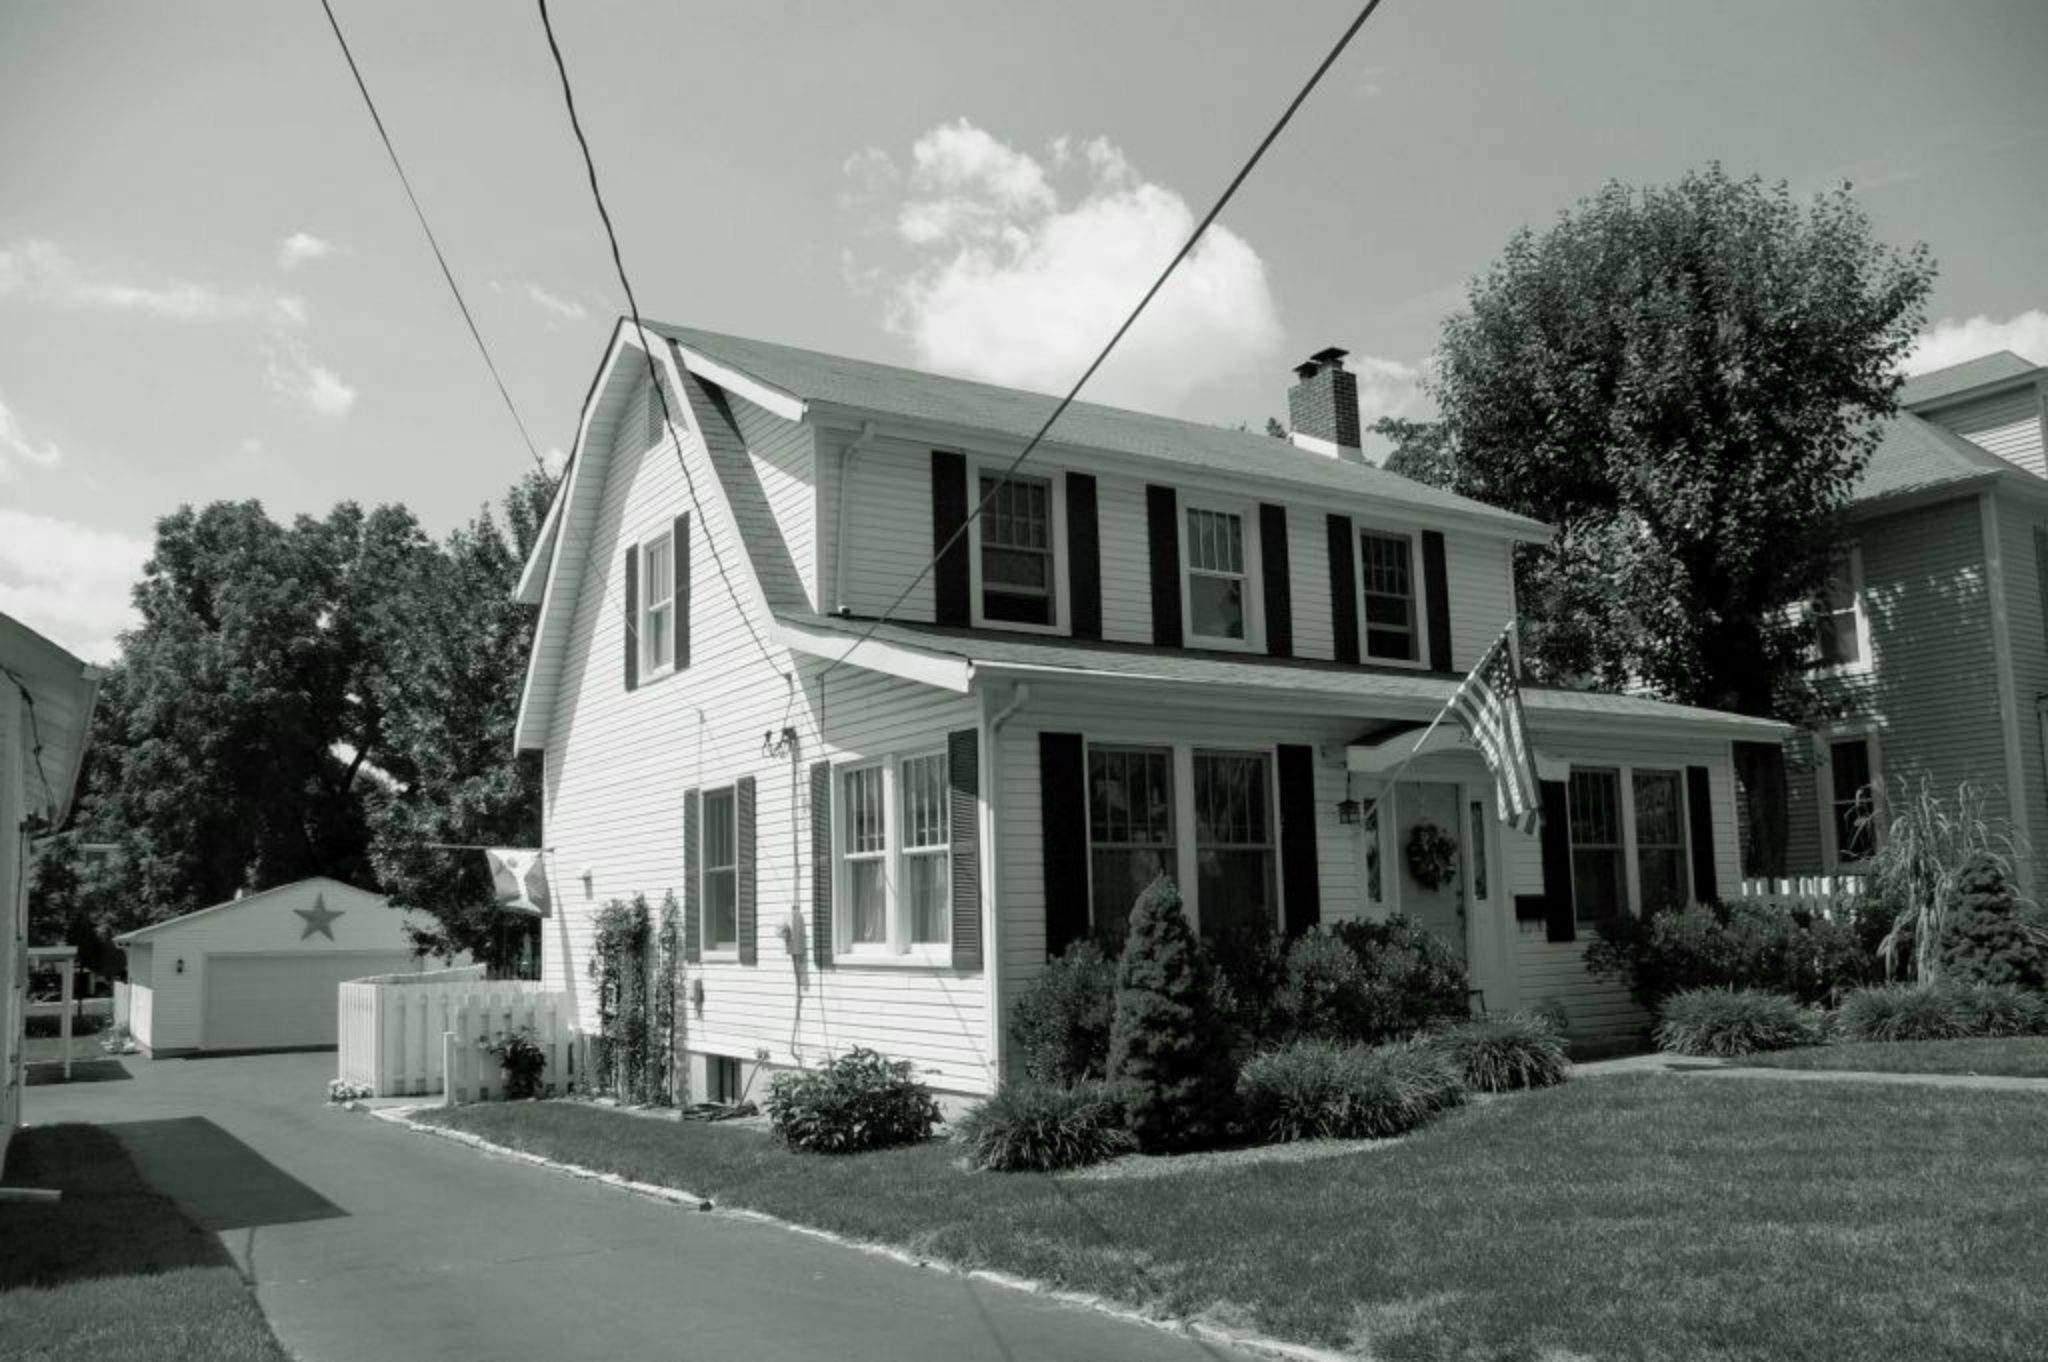
2009 Survey Update: The house looks little changed since the 1983 survey but the aluminum siding has been replaced with vinyl siding.

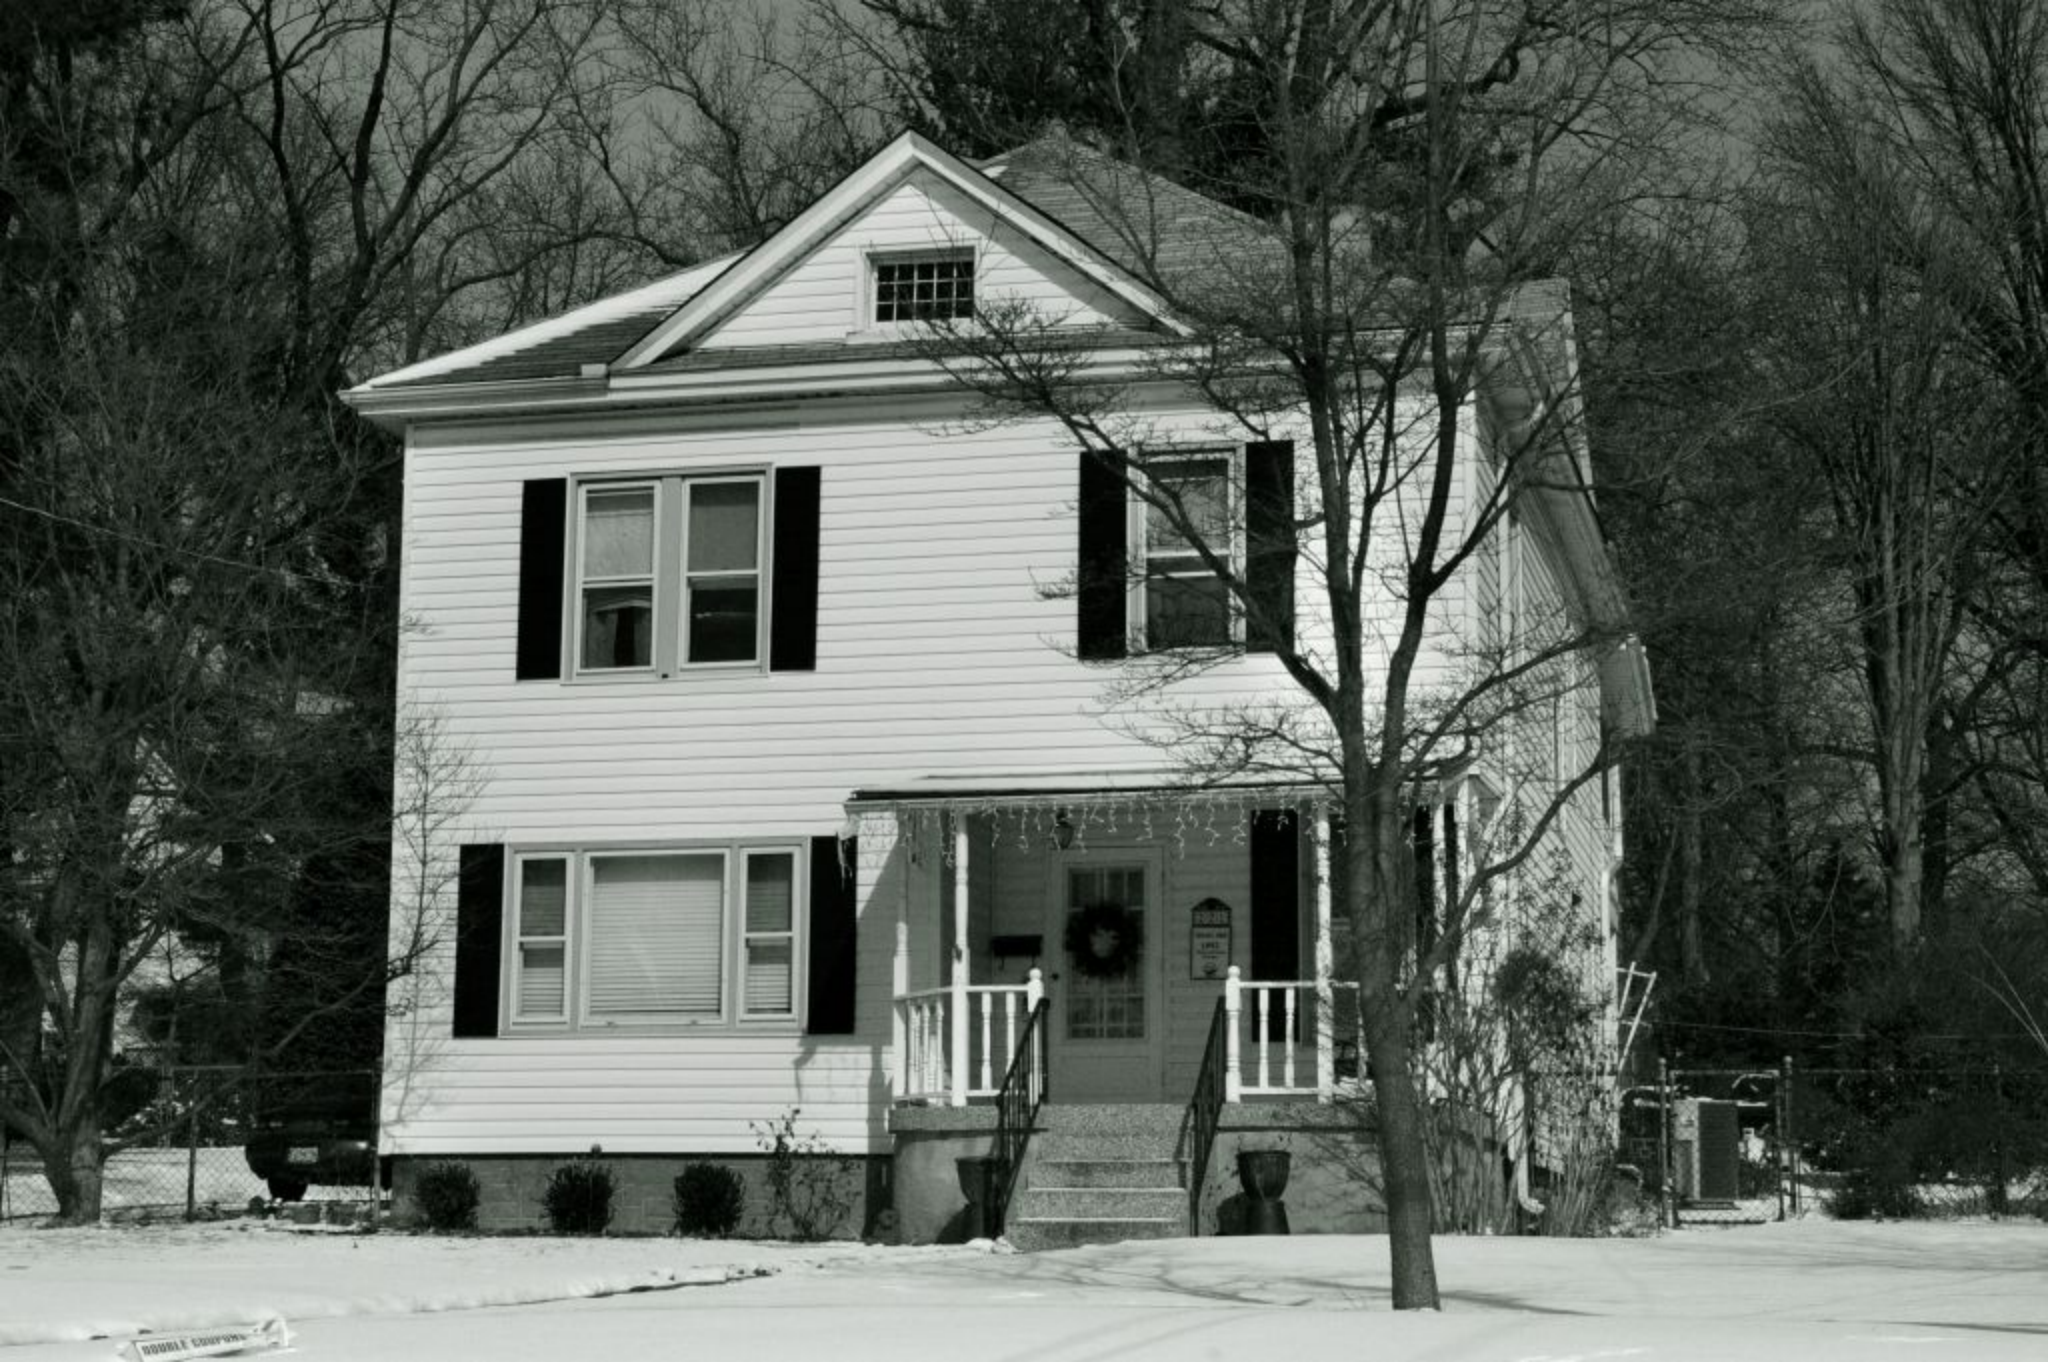
2009 Survey Update: Since the 1983 survey, the asphalt shingle, faux brick siding has been replaced with vinyl siding and a small shed roof extension across the east half of the facade with turned posts and a balustrade added to the recessed porch. The house still has its original wood windows with storm windows added. Fire insurance maps indicate that at least until 1951, the house had a full width porch on what was essentially a Four Square house, presumably with the recessed section within that porch. The picture window was probably added with the asphalt siding alterations since it is characteristic of 1950s residence, not 1892 houses.

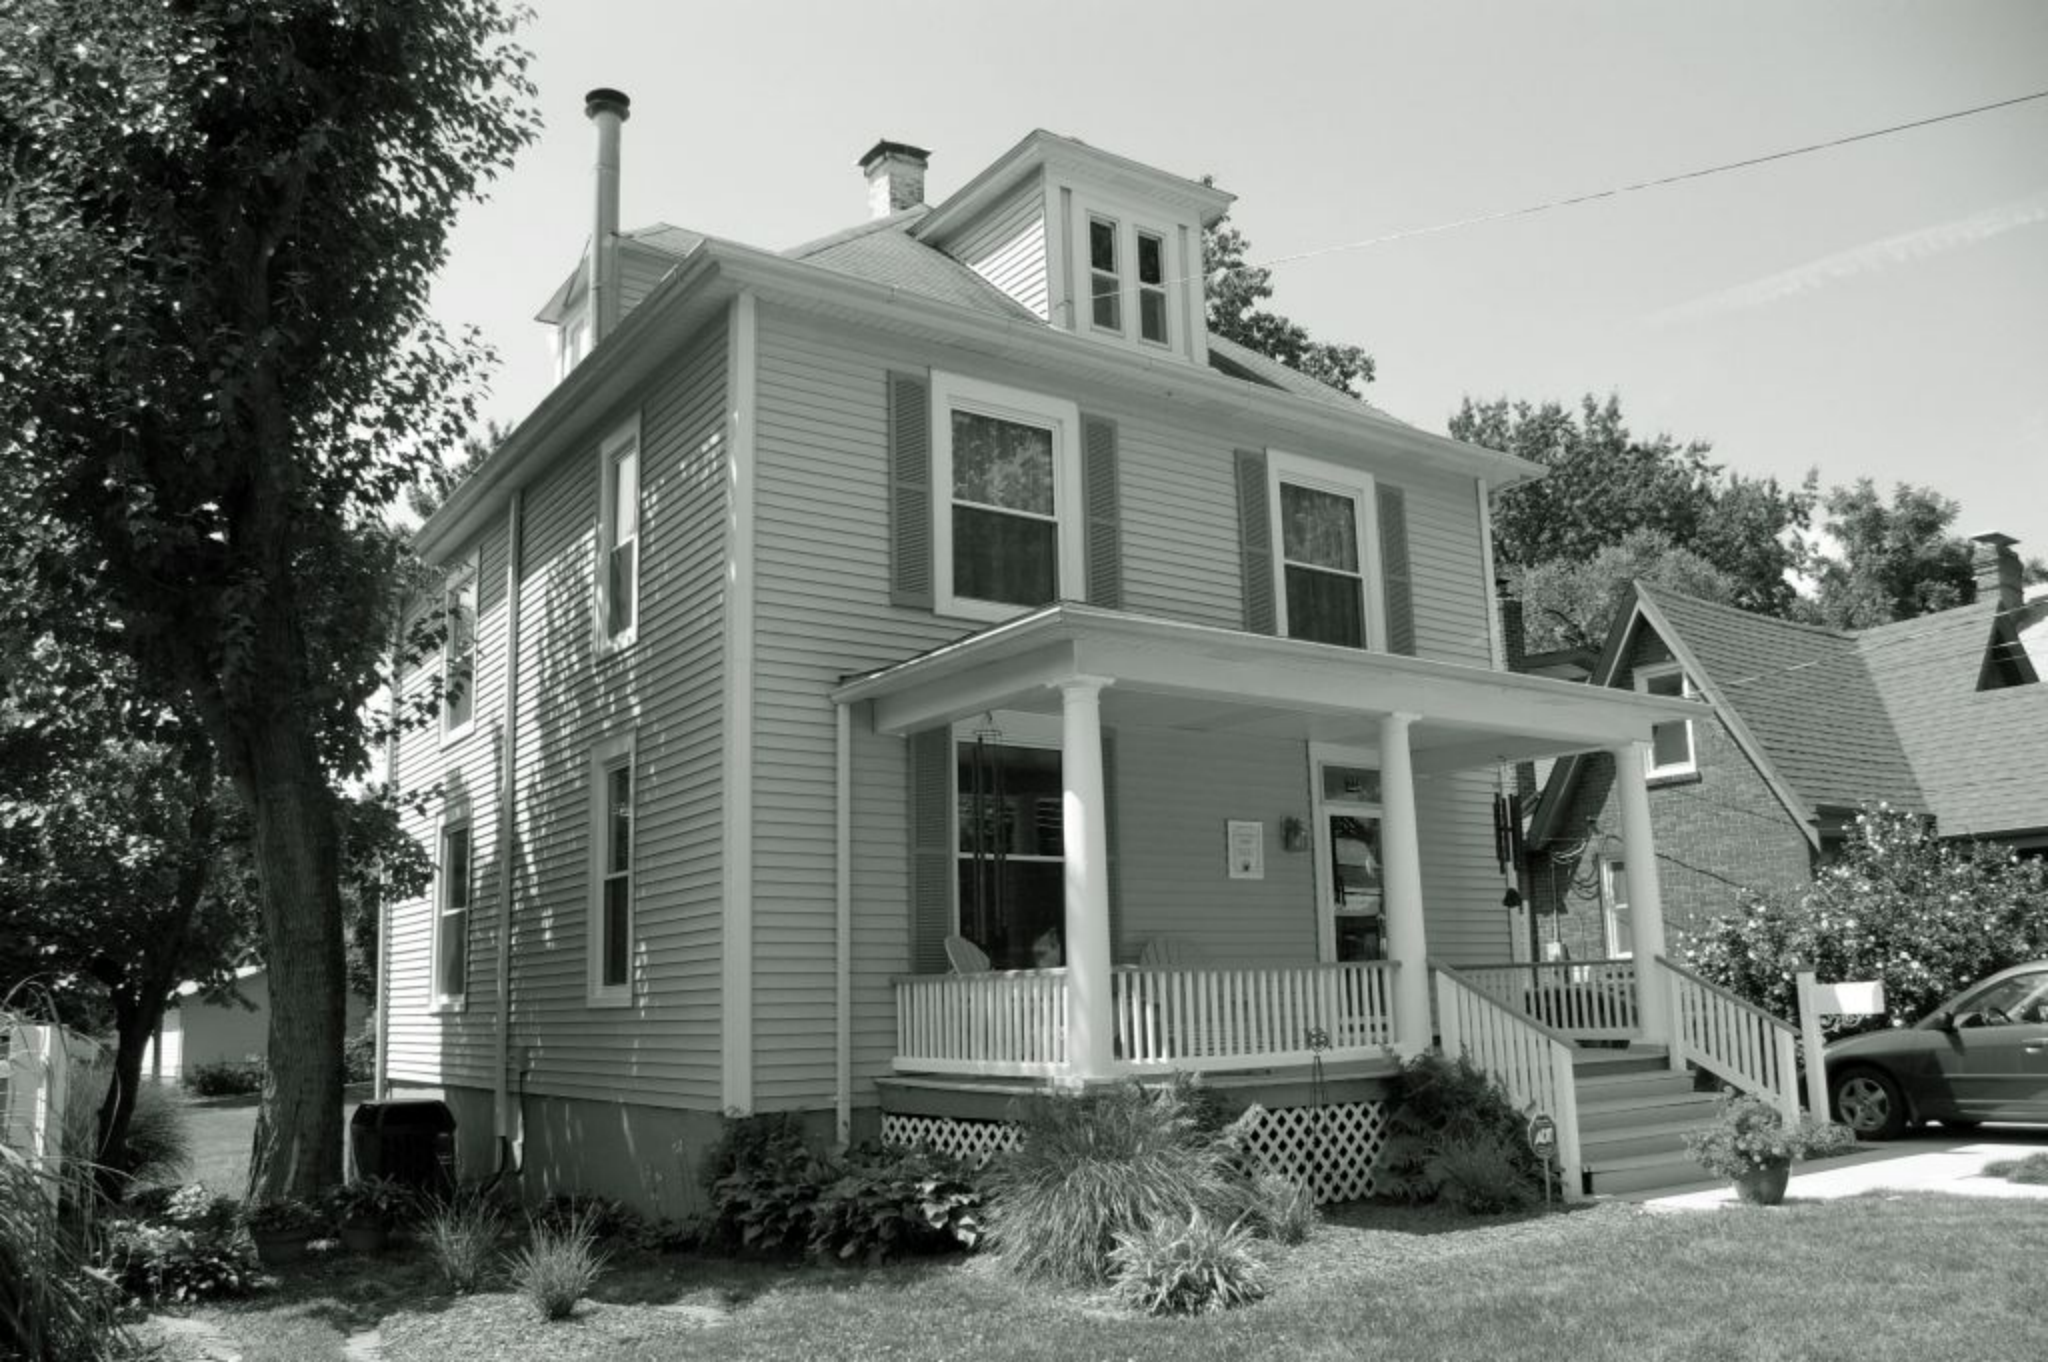
2009 Survey Update: The house has been clad with vinyl siding (originally clapboard of similar width in the 1983 survey), shutters have been added to the facade and metal storm windows added. The house still retains its original porch railings, but this railing has been used as the template for railings now installed on either side of the broad stairs. A metal chimney flue has been installed on the east side of the house.

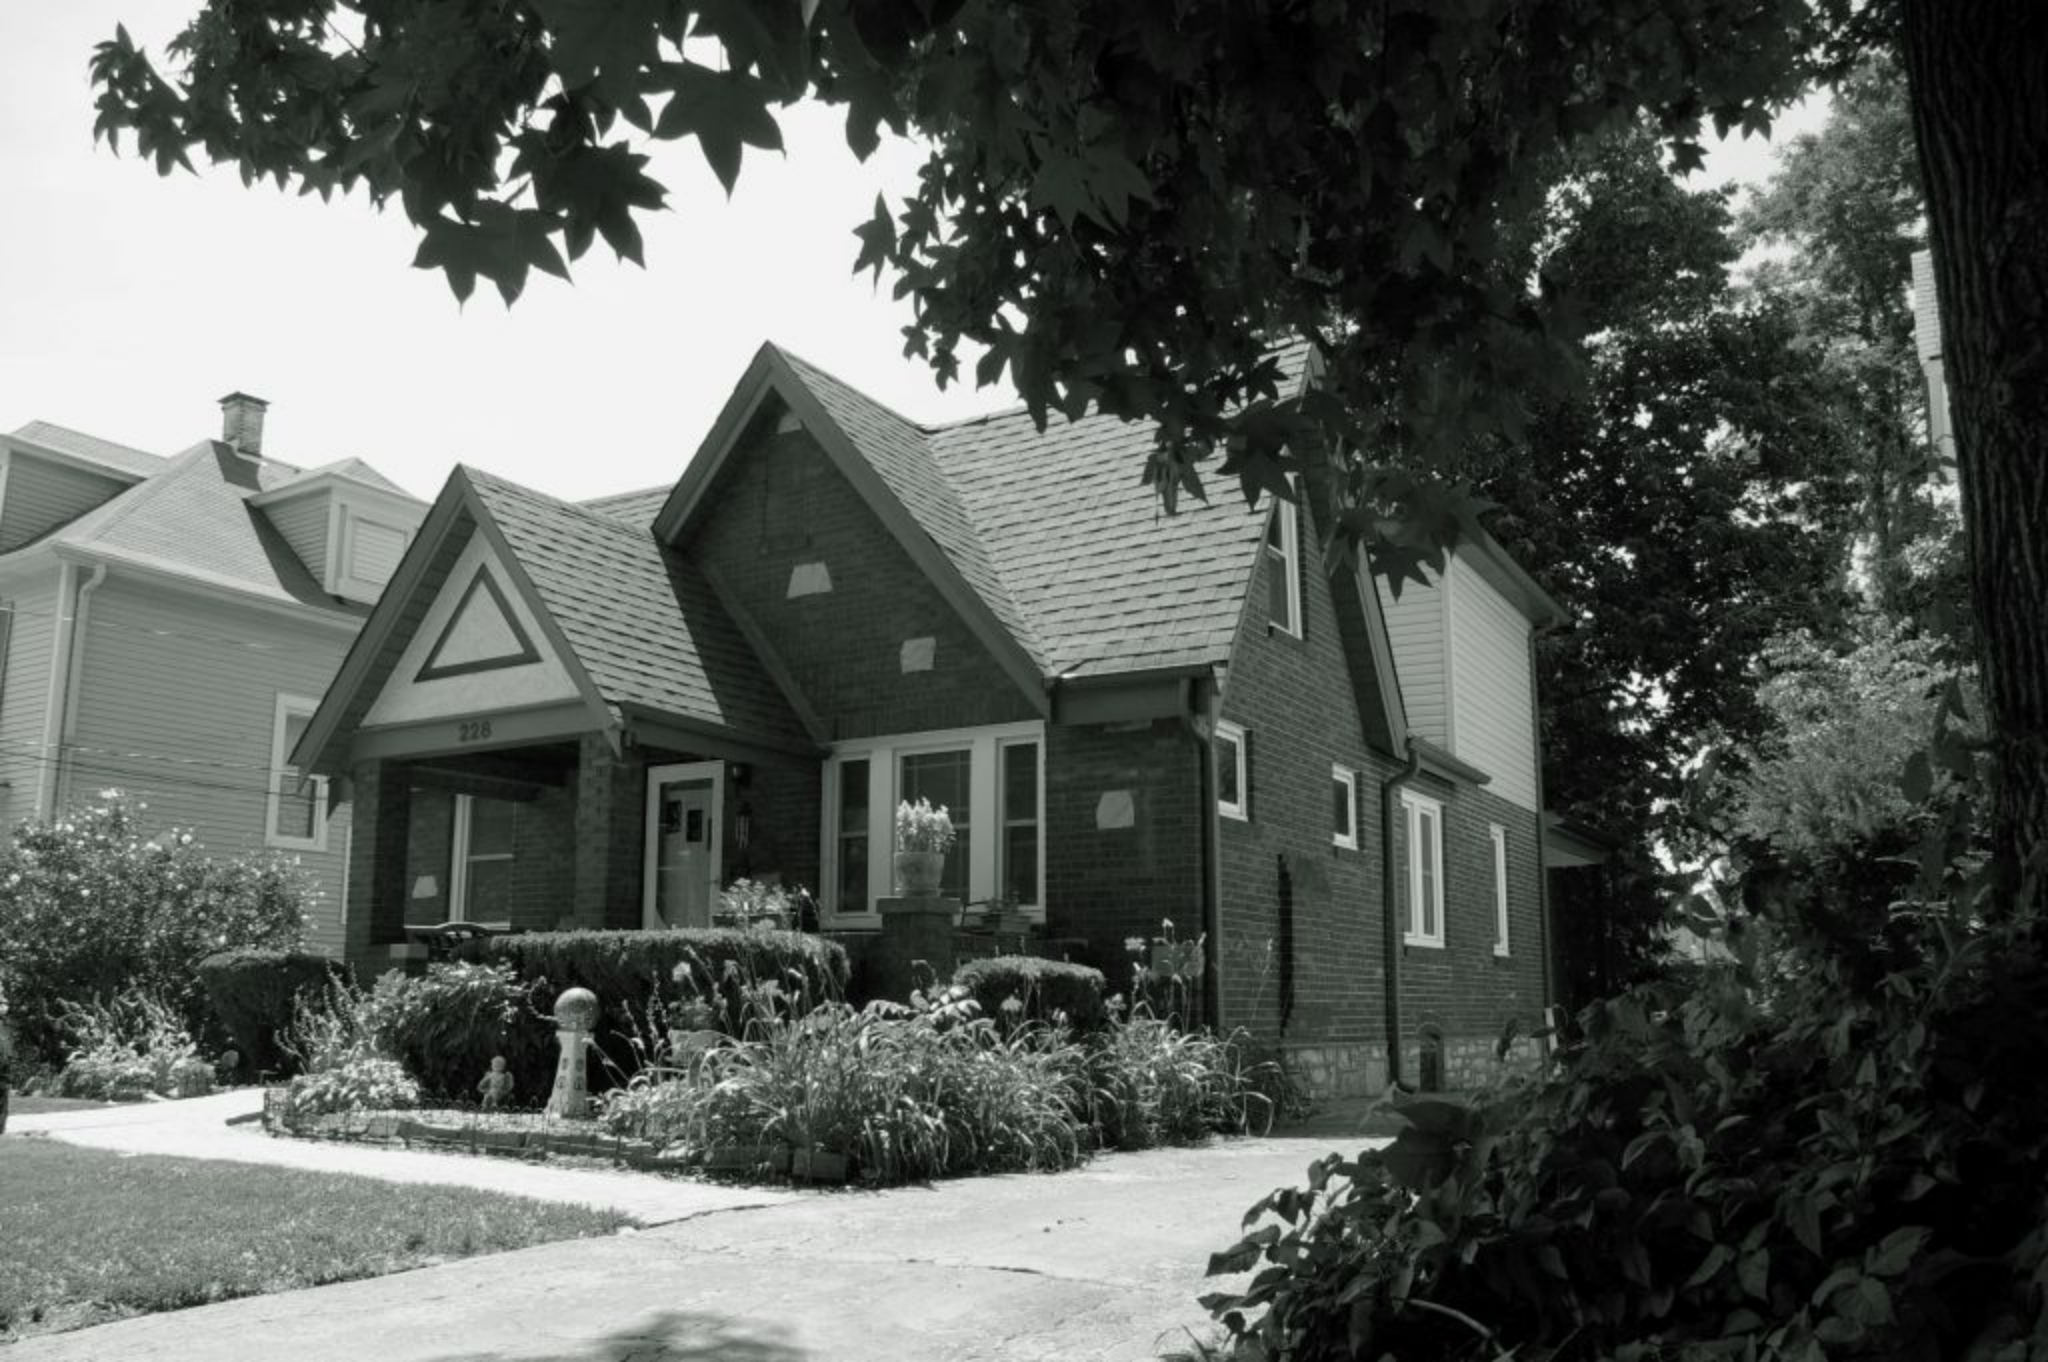
This 1.5 story, multicolored brick, steeply pitched side gabled, Tudor Revival house has overlapping cross gables on the facade, the shorter of which projects to form the roof of the porch. The porch is supported by brick corner piers and has pierced brick half-wall railings and the gable end of the porch is a textured stucco. The entry door is a wood plank door with tiered small lights near the top. It appears to have a slightly rounded transom above this door, but it is obscured by the rectangular full light storm door. To the west, the three part window consists of three sashed windows, with a decorative muntin pattern. To the east, there is a wood framed stained glass window, with a similar window on the east elevation. Originally it appears that there used to be a one story, cross gable spanning across the rear, but a portion of this has been removed to add a second floor, vinyl clad addition with shed roofs off toward each side elevation (on top of the original first floor brick walls). Behind the original brick section of the house, there is a one story frame addition as well. These additions are not very noticeable since they are positioned lower than the main roof ridge and behind the brick side walls. These new additions have vinyl siding and the windows in the house have storm screens.

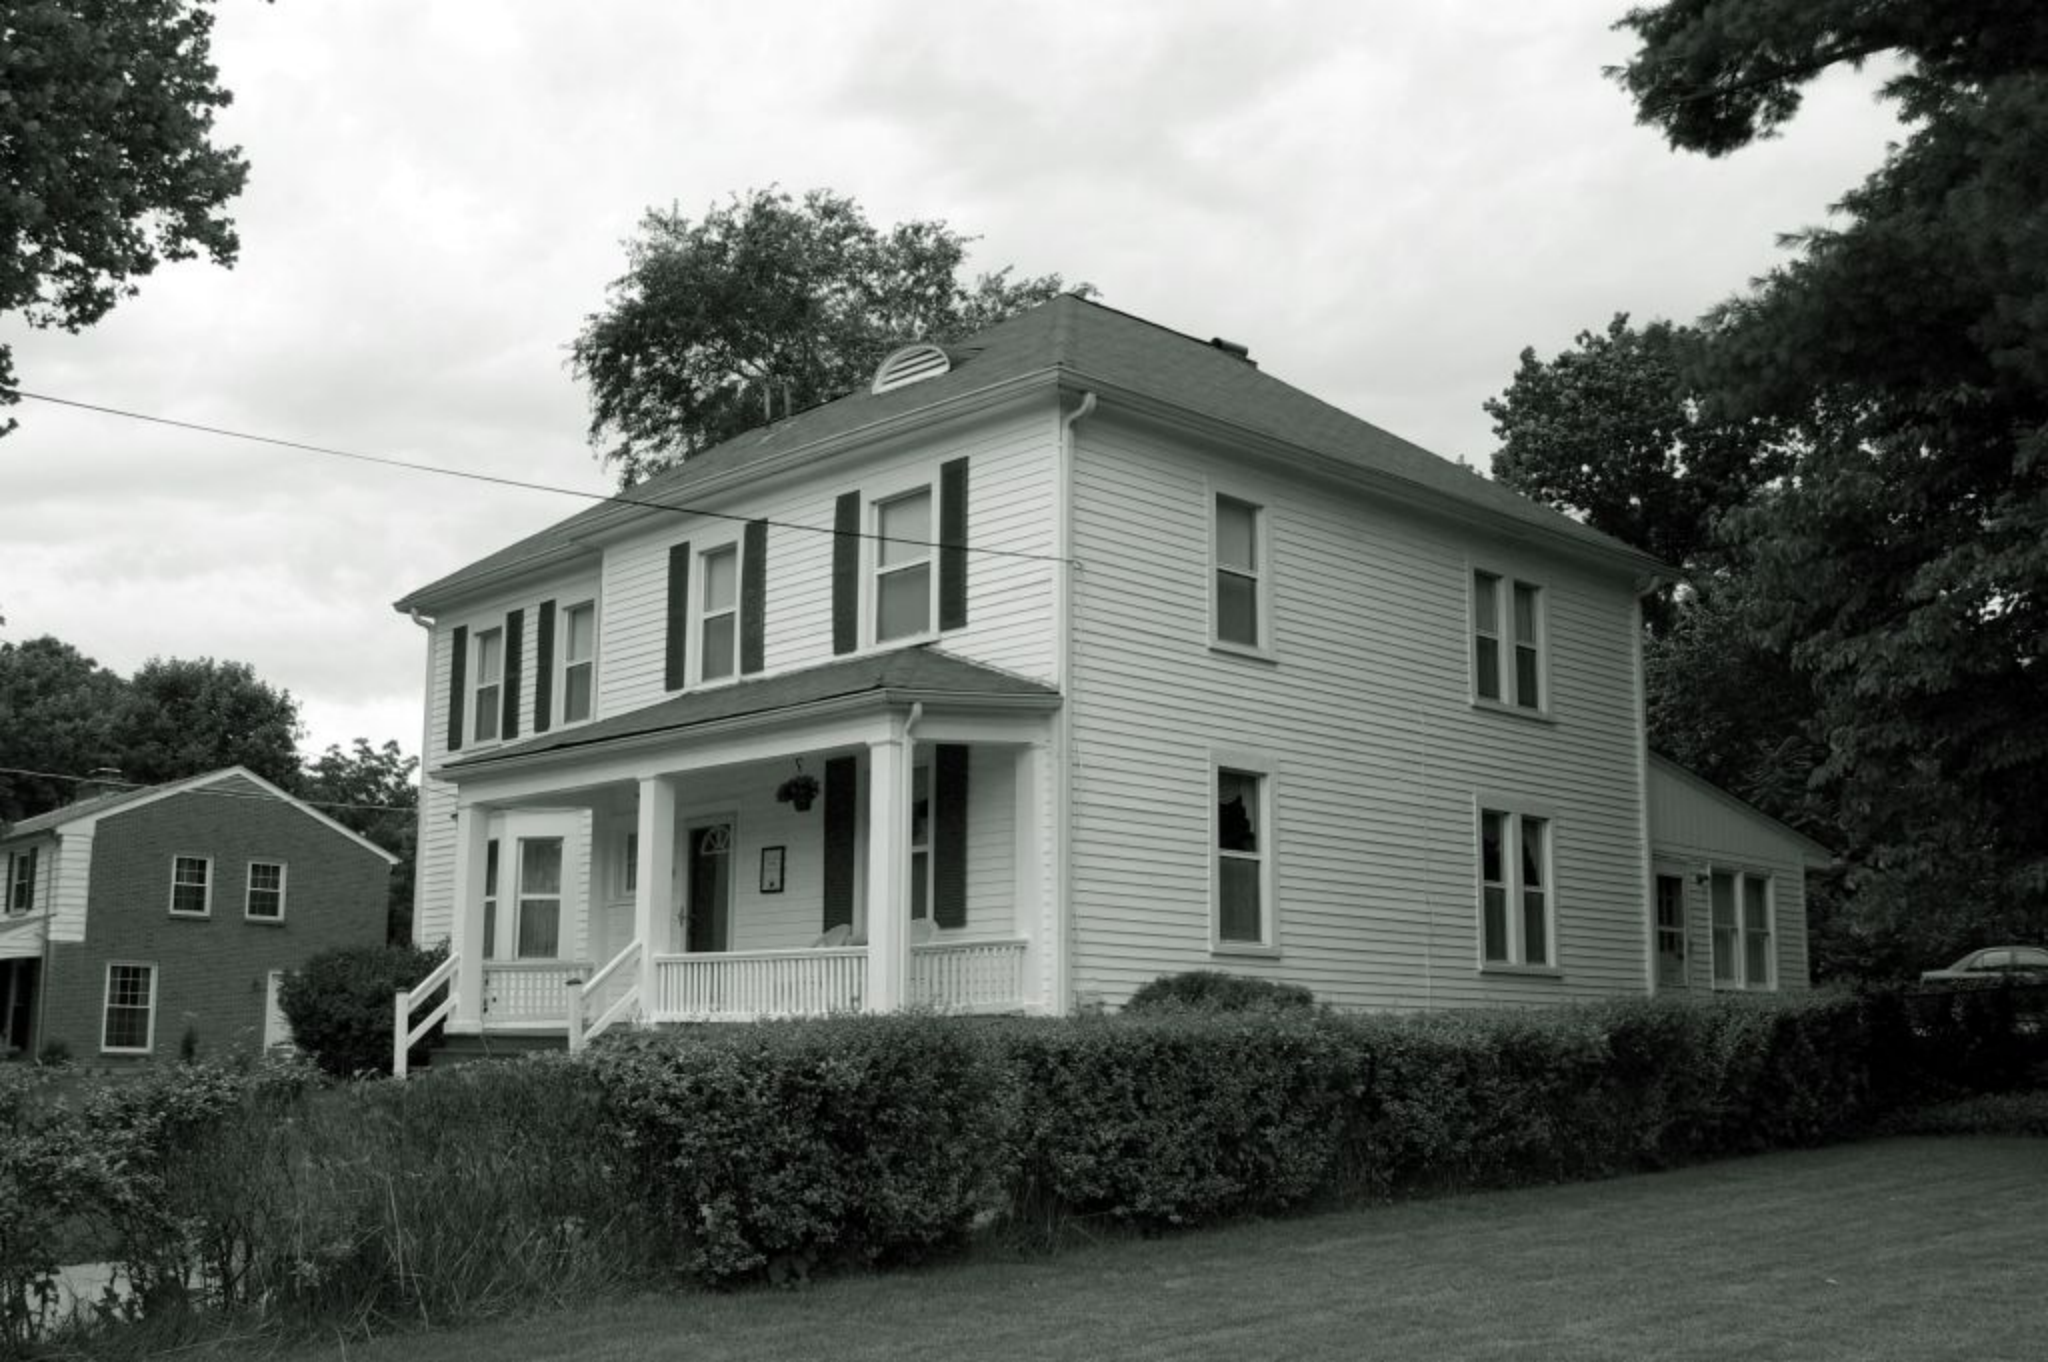
2009 Survey Update: Wooden railings have been added to either side of the front steps and shutters have been added to the facade windows. The house also has storm windows and a storm door with a nonperiod door with a fanlight in the top portion of the paneled door. The house started out as a simple Four Square design, but it was modified during the period of significance for the historic district when the western half of the house was added between 1931 and 1950 based upon the fire insurance maps. On the back is a shed roofed, one story addition, which does not show up on the 1950 fire insurance map update, but it is not clear if it was built by the time of the 1983 survey.

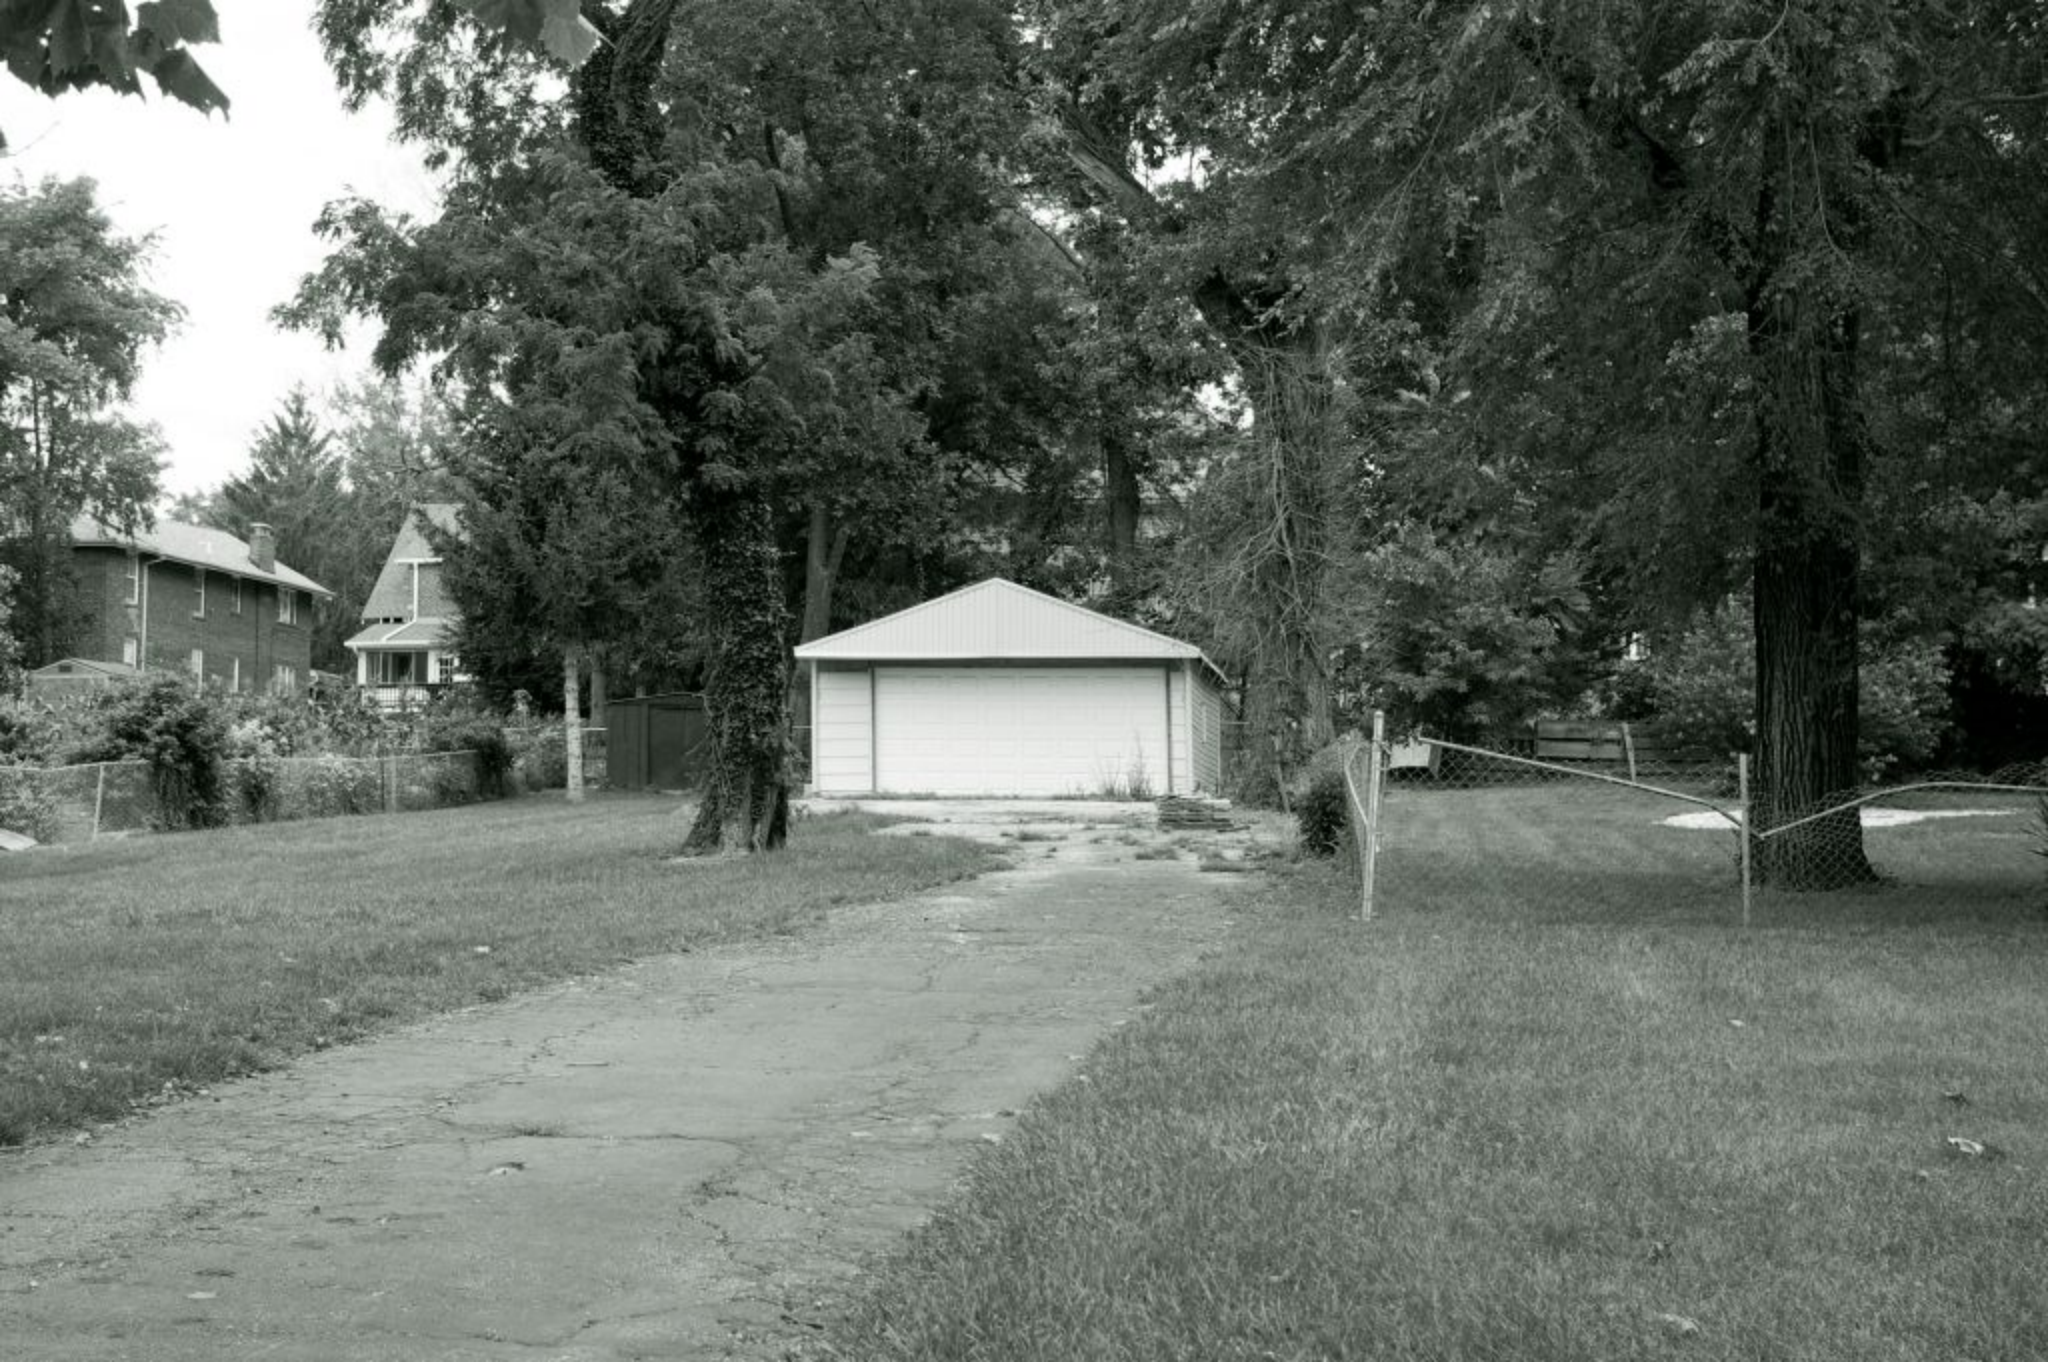
2009 Survey Update: There is a one car, detached, hipped roof frame garage but it has a replacement metal overhead door and replacement wide aluminum siding. It appears to pre-date 1931 since it appears on that year's fire insurance map.
